ARCHAEOLOGICAL INVESTIGATIONS OF STONE DETERIORATION IN  
KALECIK (ANKARA) CASTLE

A THESIS SUBMITTED TO  
THE GRADUATE SCHOOL OF NATURAL AND APPLIED SCIENCES  
OF  
MIDDLE EAST TECHNICAL UNIVERSITY

FEBRUARY 2012

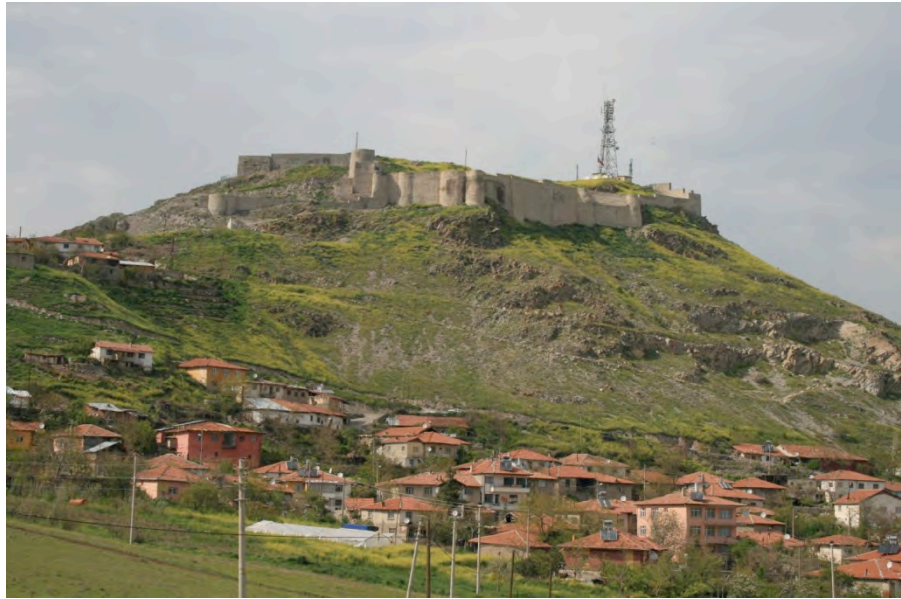
**Figure 2** Kalecik Castle as seen from south

The walls of the castle is built from roughly cut prismatic stones and their sizes vary to a great extent. The lengths of the long sides of the prismatic stones are 10 to 50 centimeters. The stones forming the walls are mostly arranged in rows but at some parts of the walls, irregular shaped stones are used. The foundation of the castle is mostly made of rough stones and they are generally arranged irregularly.

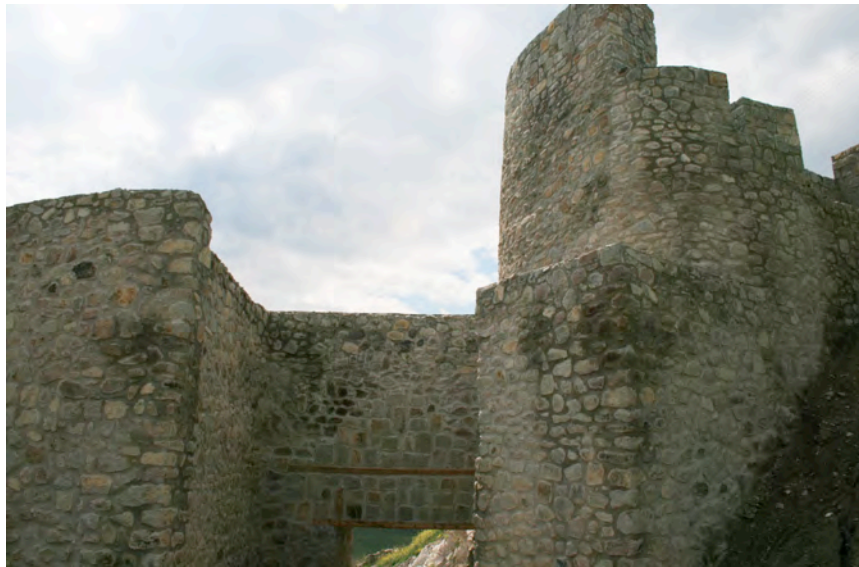
**Figure 3** Restorated southern walls of the castle

The completely ruined walls were rebuilt carefully where the bases of the walls were remaining (Figure 3). The stones used in the restoration were gathered from the region forming the foundation of the castle. No cement or derivatives were used in mortar of the restoration project. Instead, the restoration was made by using Horasan Mortar (a mixture of crumbs of bricks and tiles mixed with lime and some organic materials like egg yolk, milk, animal hair, etc. (Böke et al., 2004).

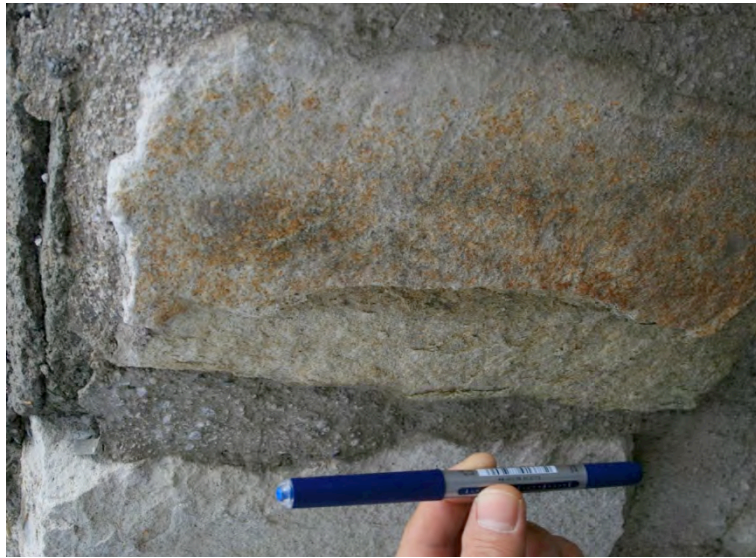
**Figure 4** Deterioration in restored stone

The walls of the castle were built from dacite stones which was largely deteriorated (Figures 3 and 4) and ruined by the year 2007. Especially the western and northern

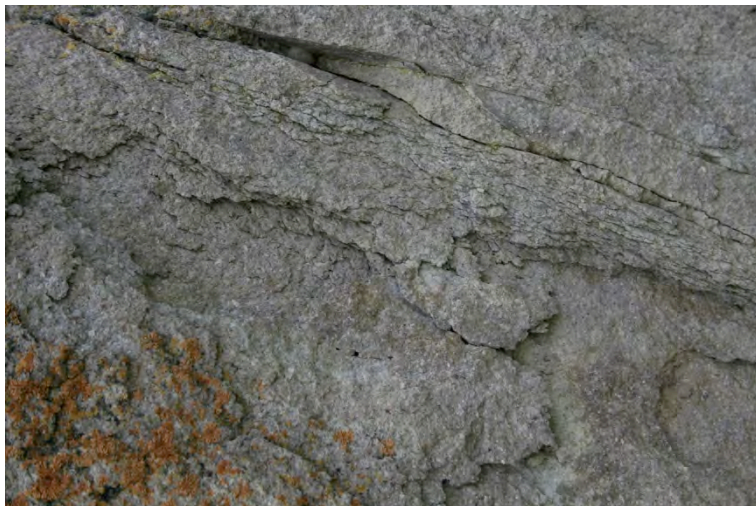
**Figure 5** Deterioration in natural stone forming the base of the castle

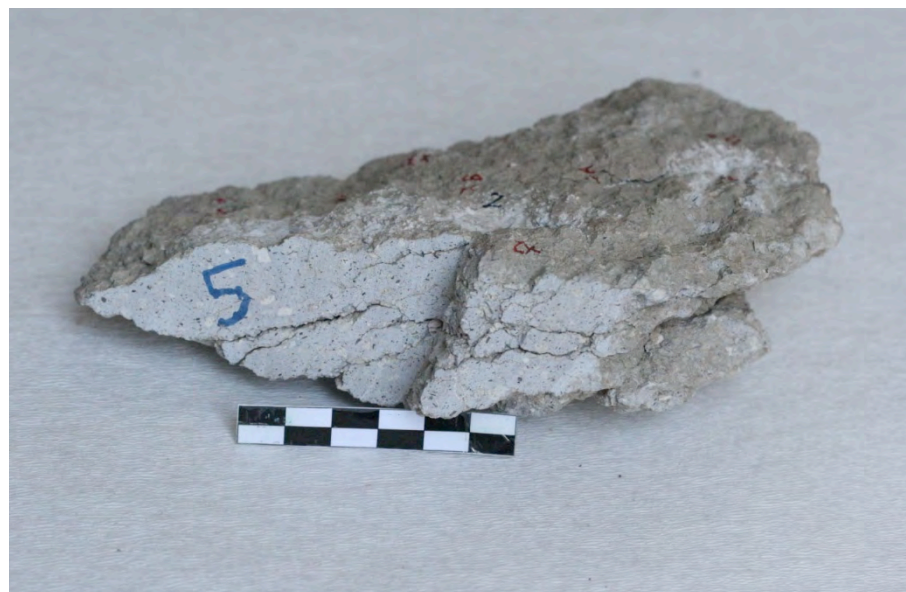
**Figure 9** Cut surface of Stone 5

**Stone 5:** This is the most deteriorated stone that was collected from the foundation of the castle. Its interior parts are heavily deteriorated. (Figure 9)

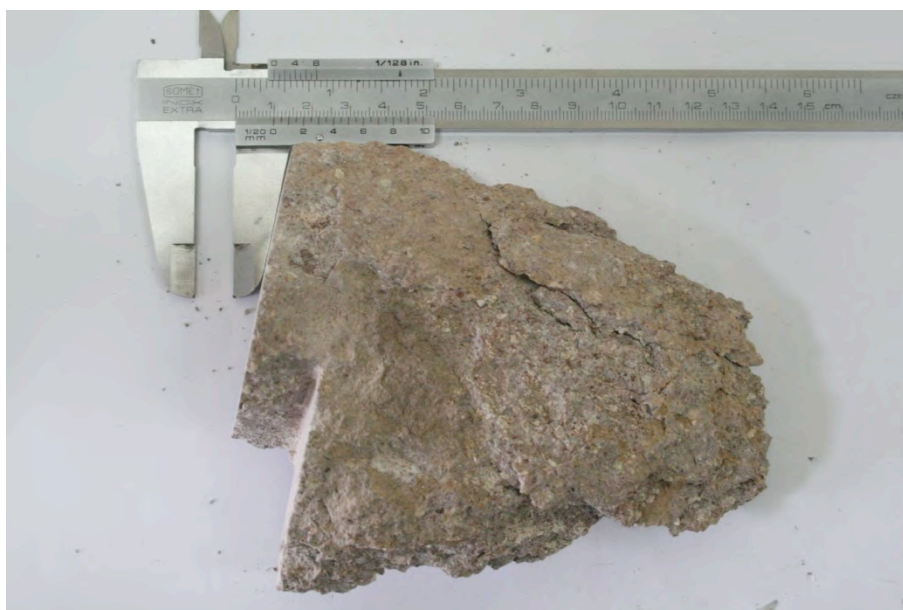
**Figure 10** Deteriorated and flaked surface of Stone 4

Stone 4 had a heavily flaked surface (Figure 10). But the air-dried clayey sample prepared from these flaked pieces did not show significant peaks. This was an expected result, because very little amount of clay was collected from this sample. The last sample was prepared from the dirtiest and the most deteriorated stone (Stone 5) by scraping a thin layer from the surface assuming that the clay minerals are concentrated near the surface (Figure 11).

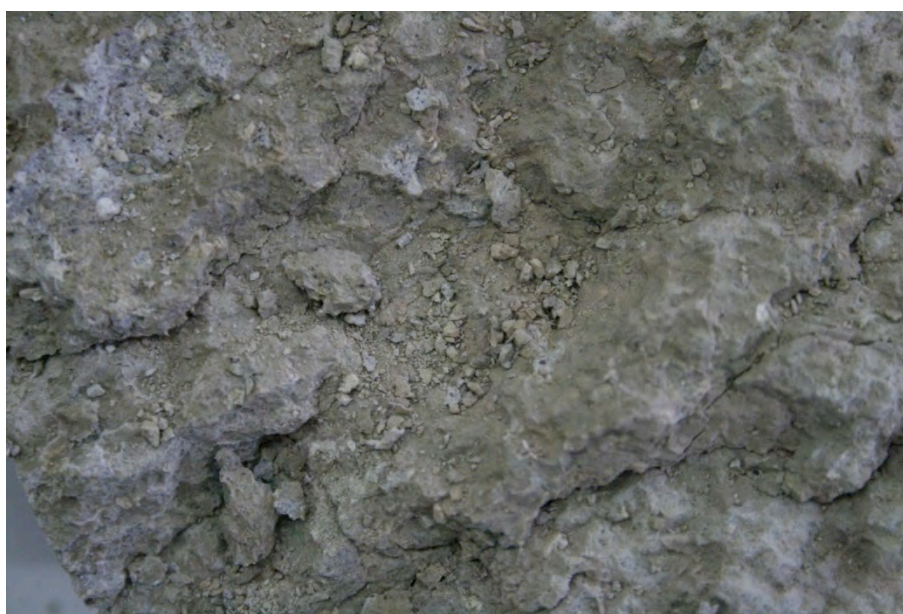
**Figure 11** Deteriorated and flaked surface of Stone 5

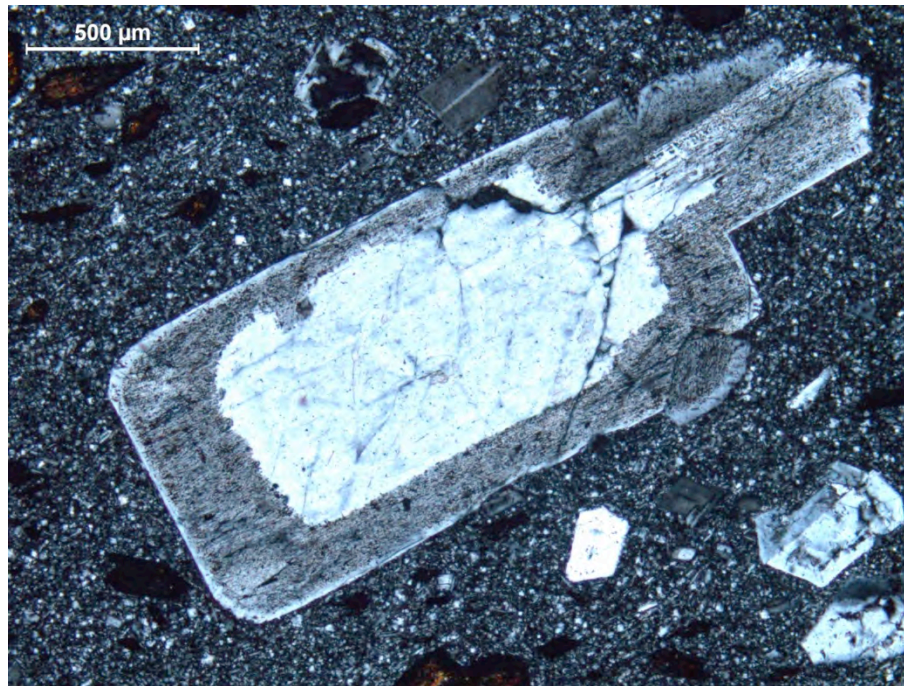
**Figure 13** A large plagioclase phenocrystal having sieve texture

Some plagioclase crystals have sieve texture (also called moth-eaten texture) and they are also very lightly clayey plagioclase (Figure 13). There are also smaller phenocrysts which are opaque. There are opaque mafic minerals (rich in magnesium and iron). Amphibole is partially or completely altered to opaque.

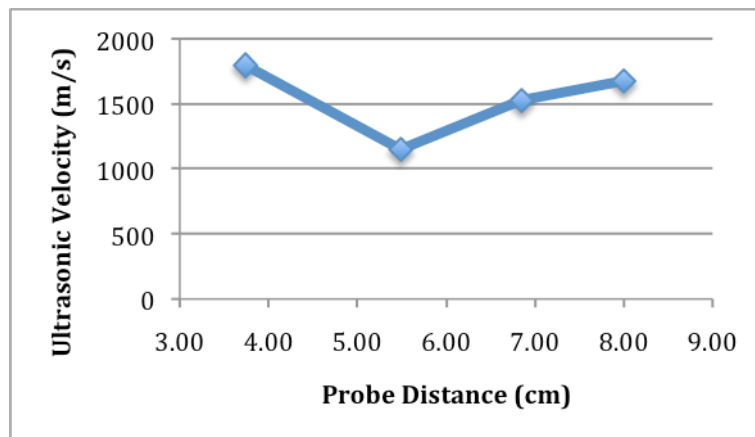
**Figure 22** Indirect ultrasonic velocity measurements with one probe fixed for Stone 1

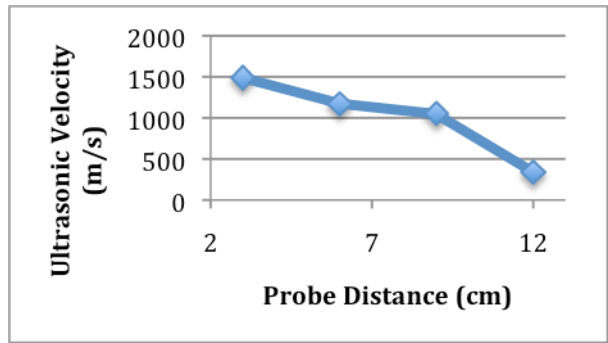
Probe Dist. (cm)	UV (m/s)
3	1487.60
6	1170.35
9	1053.86
12	339.30

**Figure 24** Indirect ultrasonic velocity measurements with one probe fixed for Stone 5

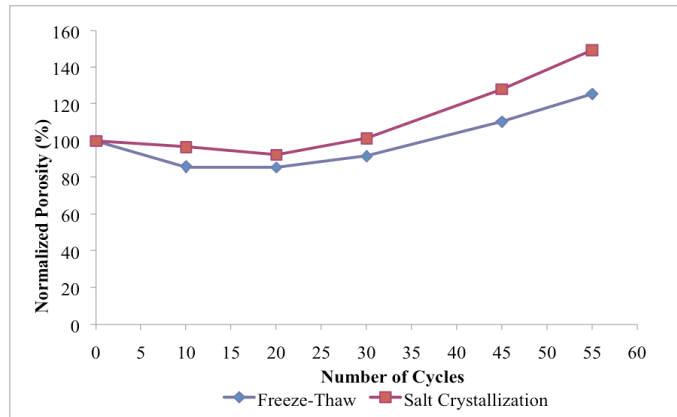
**Figure 28** Change in porosities after repeated freeze/thaw and salt crystallization cycles

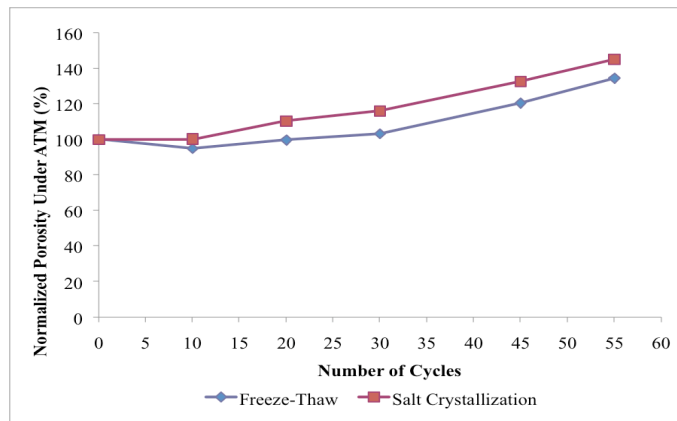
**Figure 29** Change in porosity after repeated freeze/thaw and salt crystallization cycles under atmospheric pressure

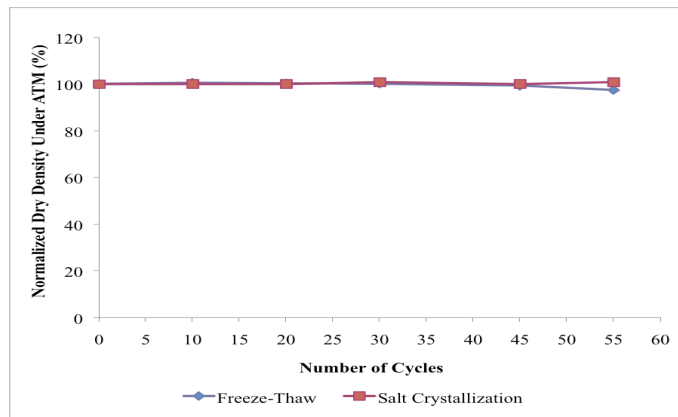
**Figure 31** Change in dry densities after repeated freeze/thaw and salt crystallization cycles under atmospheric pressure

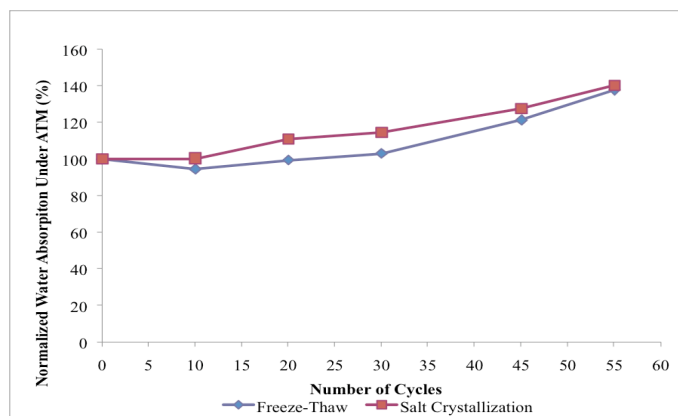
**Figure 33** Change in water absorption capacities after repeated freeze/thaw and salt crystallization cycles under atmospheric pressure

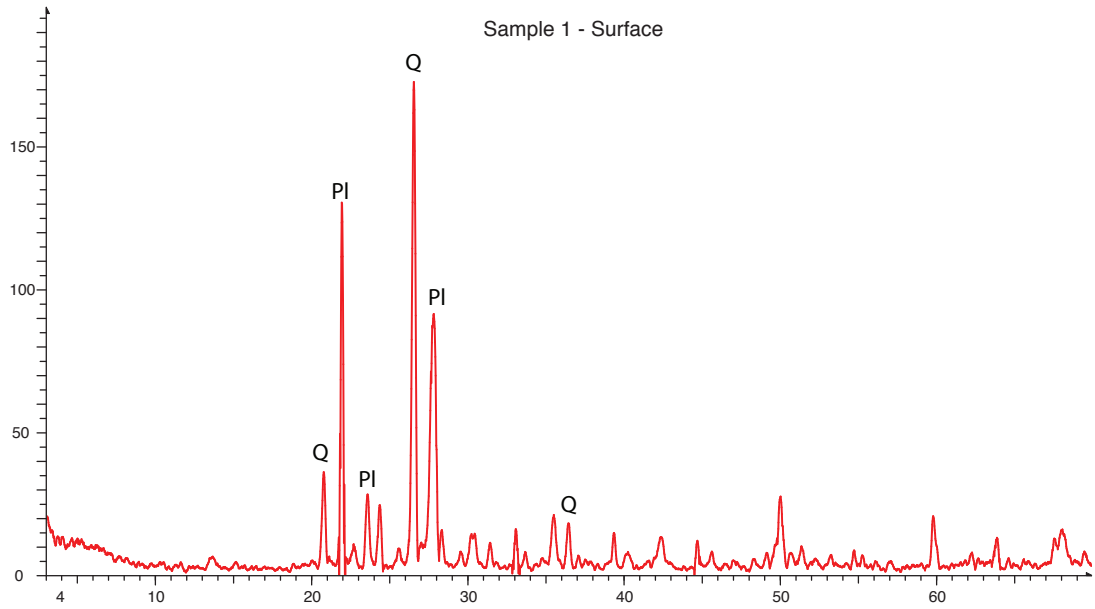
**Figure 35** X-ray diffraction chart for samples collected from the surface of Stone 1  
Q: Quartz, Pl: Plagioclase

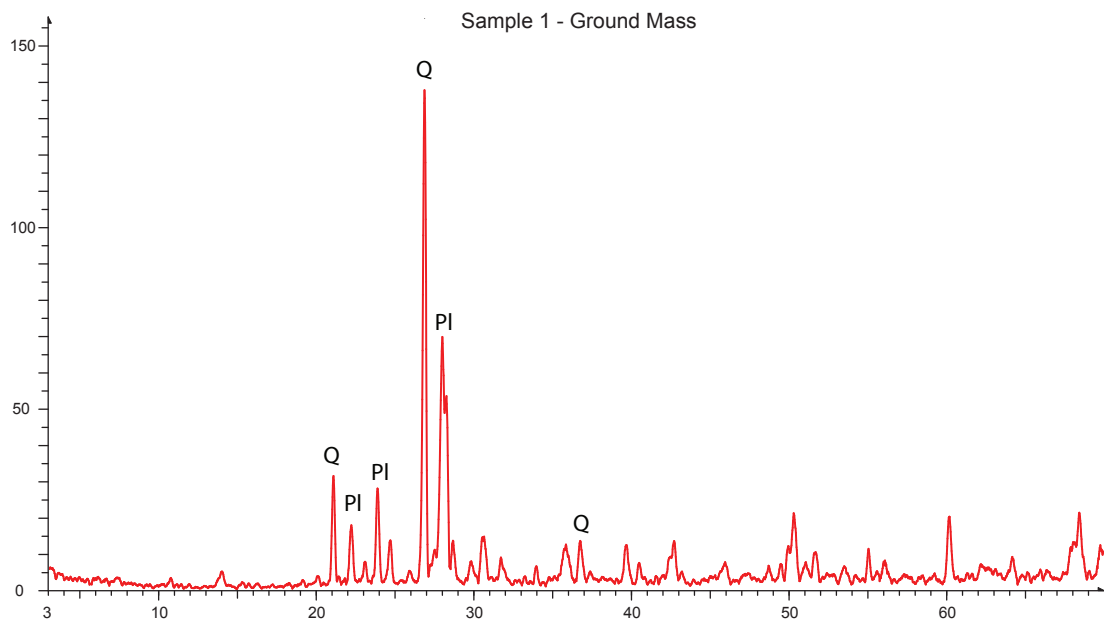
**Figure 36** X-ray diffraction charts for samples collected from the ground mass of Stone 1  
Q: Quartz, Pl: Plagioclase

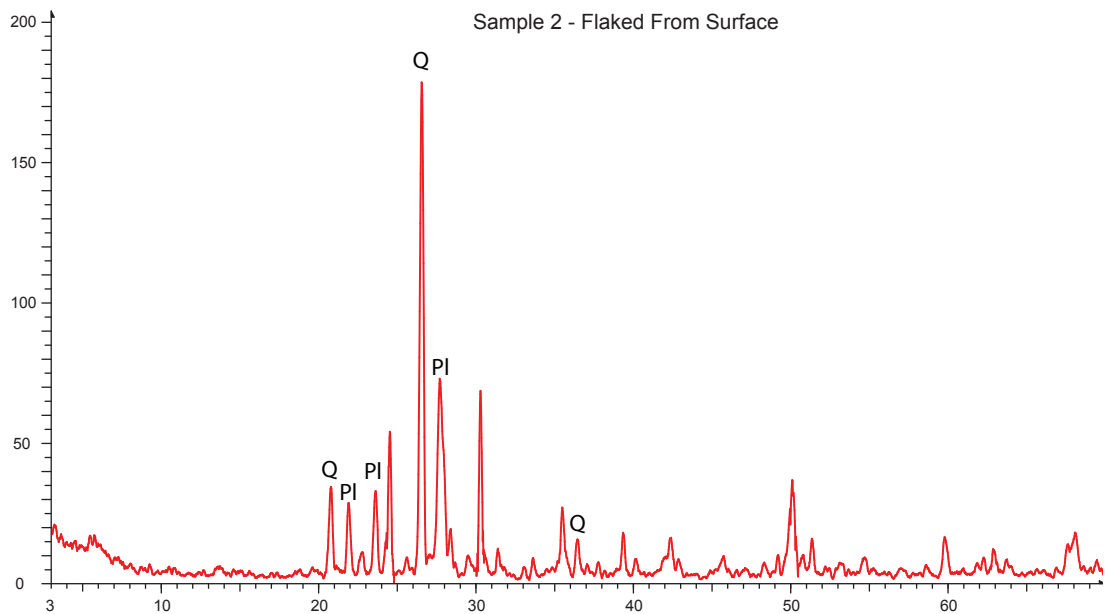
**Figure 38** X-ray diffraction charts for samples collected from the surface of Stone 2  
Q: Quartz, Pl: Plagioclase

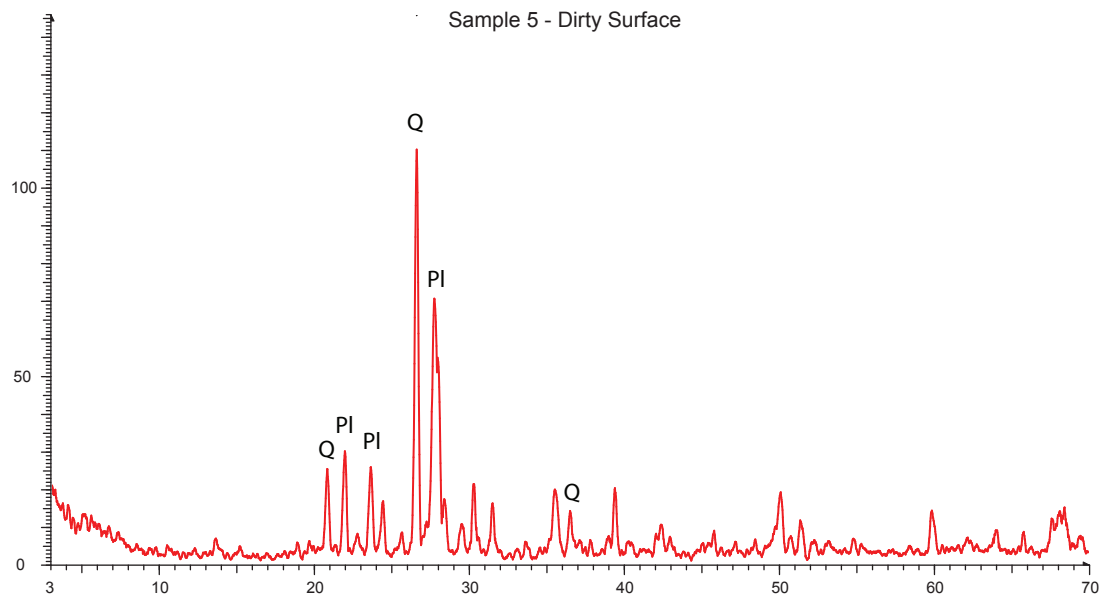
**Figure 43** X-ray diffraction chart for samples collected from the surface of Stone 5  
Q: Quartz, PI: Plagioclase
