EVALUATION OF PROTECTIVE STRUCTURES
IN ARCHAEOLOGICAL SITES FOR IN SITU CONSERVATION OF
ARCHITECTURAL REMAINS AND ARTIFACTS

IN PARTIAL FULFILLMENT OF THE REQUIREMENTS
FOR
THE DEGREE OF THE MASTER OF SCIENCE IN
RESTORATION IN ARCHITECTURE

SEPTEMBER 2012

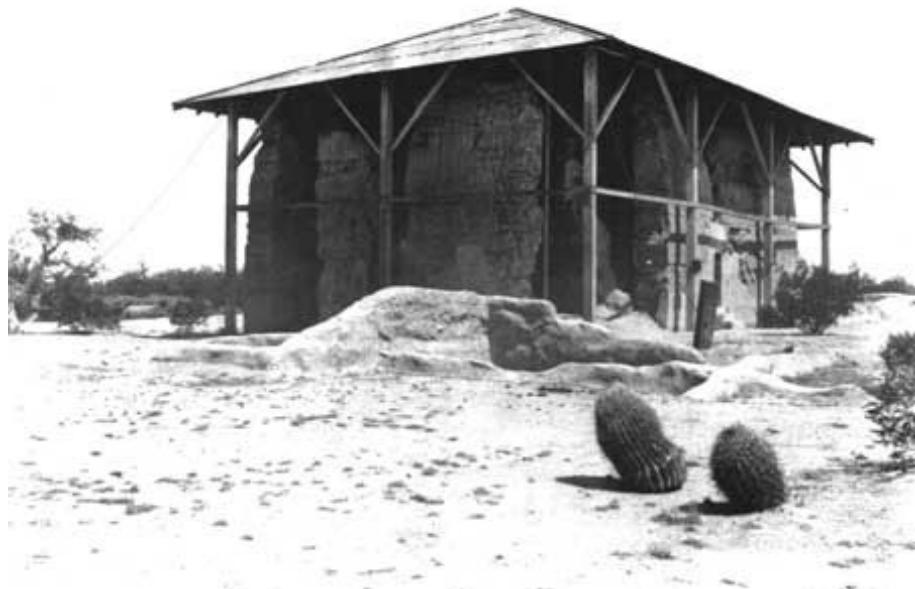
Fig. 3-2: Temporary Protective Shelter

The structure was composed of timber posts embedded into the ground, supported by iron cables on the corners and covered with corrugated iron roof panels. The timber structure was replaced in 1932 with a hipped metal roof supported by steel trusses over four angular pillars (Fig. 3-3). There are openings on the roof standing about 14 meters away from the ground. Shelter designed by Frederick Law Olmsted Jr. was attempting to have an incongruous structure different from the ruins in terms of its material and design and forming a hierarchical order with the remains being in the foreground rather than blending with them (Fig. 3-4), (Rael, 2008).

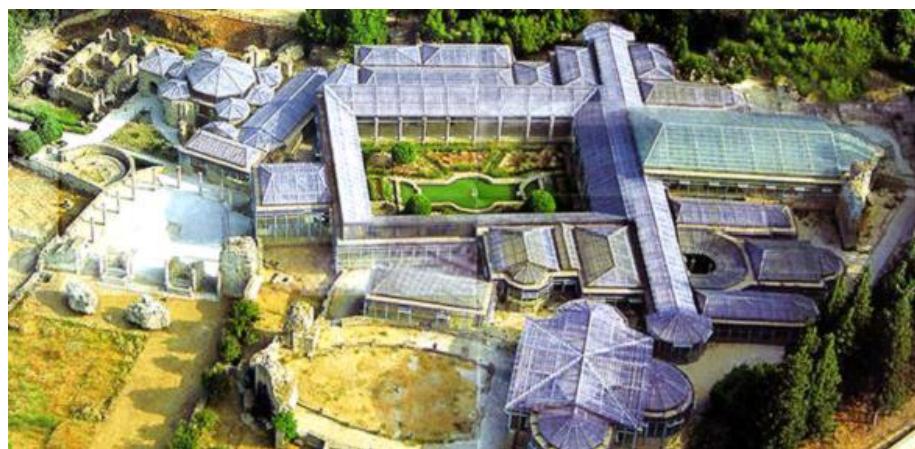
Fig. 3-6: Aerial View of the Protective Enclosures

One of the earliest examples of enclosures is the Villa del Casale in Piazza Armerina, Sicily (Fig. 3-5). Modern structures were designed by Franco Minissi in accordance with Cesare Brandi in 1957. It is a transparent reconstruction of the

original buildings derived from the archaeological researches (Rizzi, 2008) (Fig. 3-6).

The experience of the glass houses had proved that, modern structures also need maintenance. Due to some inaccurate interventions and the nature of the construction materials the protective structure doesn't provide necessary conditions for the remains and harm them with its side-effects. The metallic

supports started to corrode; glasses and plastic sheets went yellow. Steam and glare on the glasses and uncontrolled shadows hardens viewing the remains and it is not possible to control the microclimatic parameters such as the temperature, condensation and relative humidity with a transparent structure (Rizzi, 2008). Currently a new structure is being constructed replacing the Minissi's design.

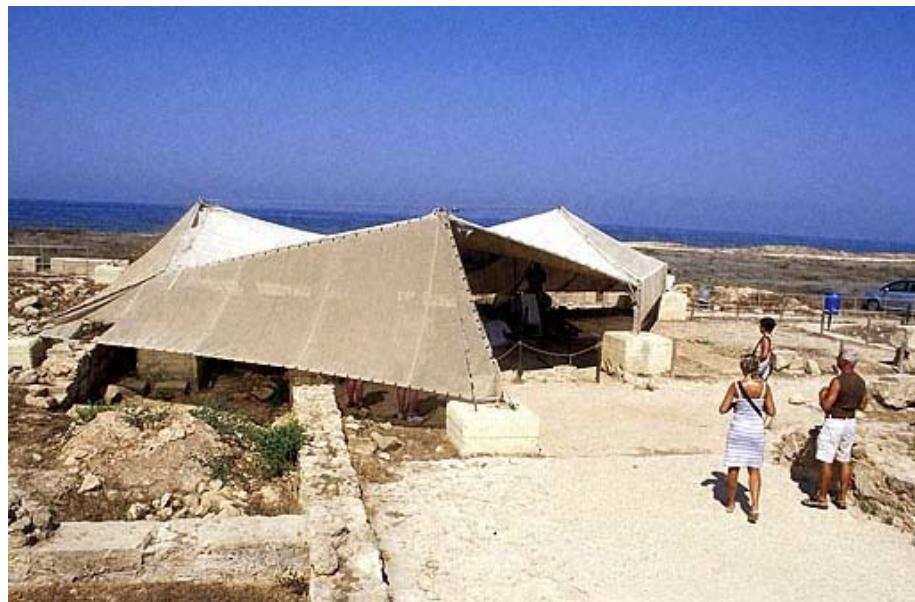
Fig. 3-8: Hexashelter in Israel

shelter is removed, shelter would stay in place with renovations or a new structure satisfying the required conditions may be designed. An example of a temporary structure that turned into a permanent one is at the site of Caesarea, Israel which was the 'hexashelter' built for the preservation of Orpheus Mosaics in 1989 but remained in place with some alterations (Fig. 3-7), (Getty, 2009). The aluminum frame shelter with textile side covers and roof was selected for its ease to erect, lightweight requiring minimal foundations and modular design to expand in the future. When the shelter is decided to be removed, it may be easily without any destruction and an evidence of its existence. The shelter was centralized over two points, one on the Orpheus Mosaics and the other on the Herculaneum and Amazon Mosaics. The original side panels with polyethylene aerotextile fabric were renewed in 1990 with impermeable tri-laminated vinyl material against water (Fig. 3-8), (Agnew & Coffman, 1991).

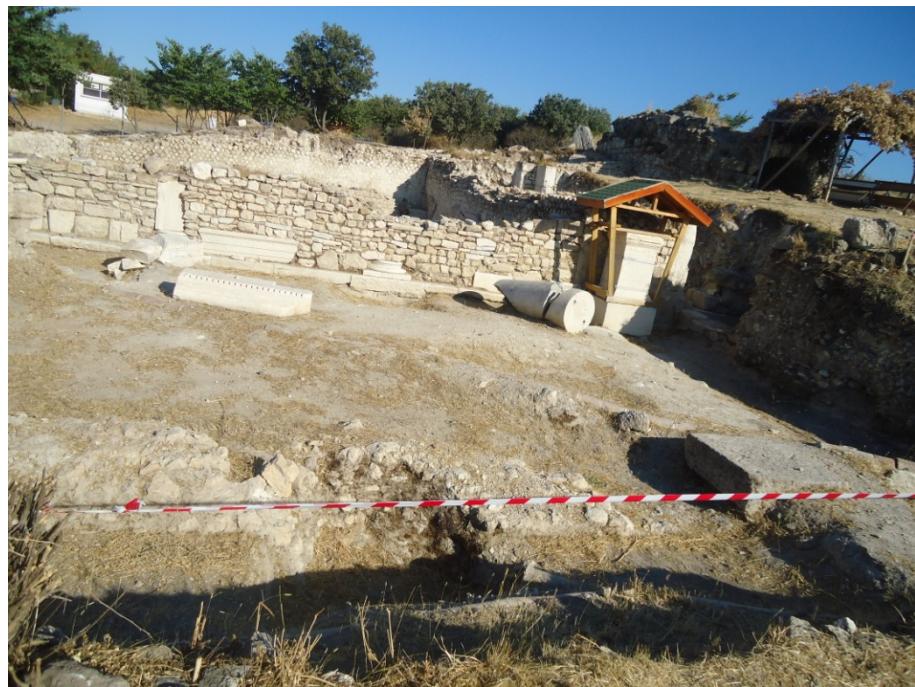
Fig. 3-11: View of the roof in Alexandria Troas

Protective structures differ in size and mass covering a single remain to a whole site. Archaeological site of Alexandria Troas in Gülpınar has one of the smallest protective roofs in Turkey. The structure over a statue base with inscriptions is covering an area of 1 m². The roof covered with green asphalt composition roof shingle stands over wooden frames nailed around the base (Fig. 3-11).

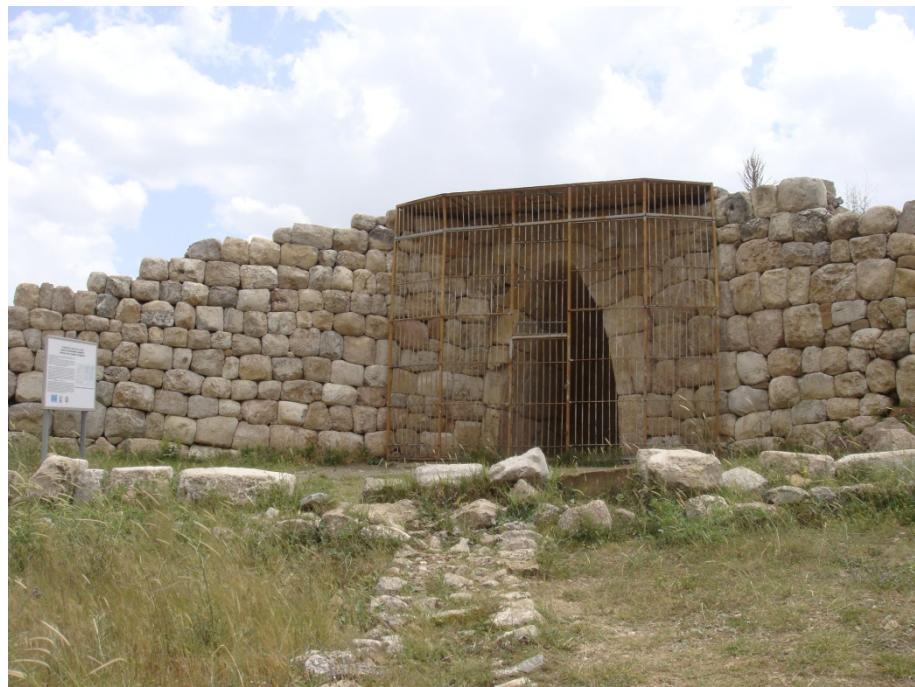
Fig. 3-12: View of the cult chamber with the protective additions

Another example for the small size protective covers is in Hattusa for the protection of the hieroglyphic inscriptions on the stone walls of the cult chamber built by Šapiluliuma II around 1200 BC. The remains are used as vertical elements and iron sheeting was applied over for preventing the direct rain. In order to protect the remains from human destruction remains are circled with iron fences avoiding physical contact and assuring visual access (Fig. 3-12).

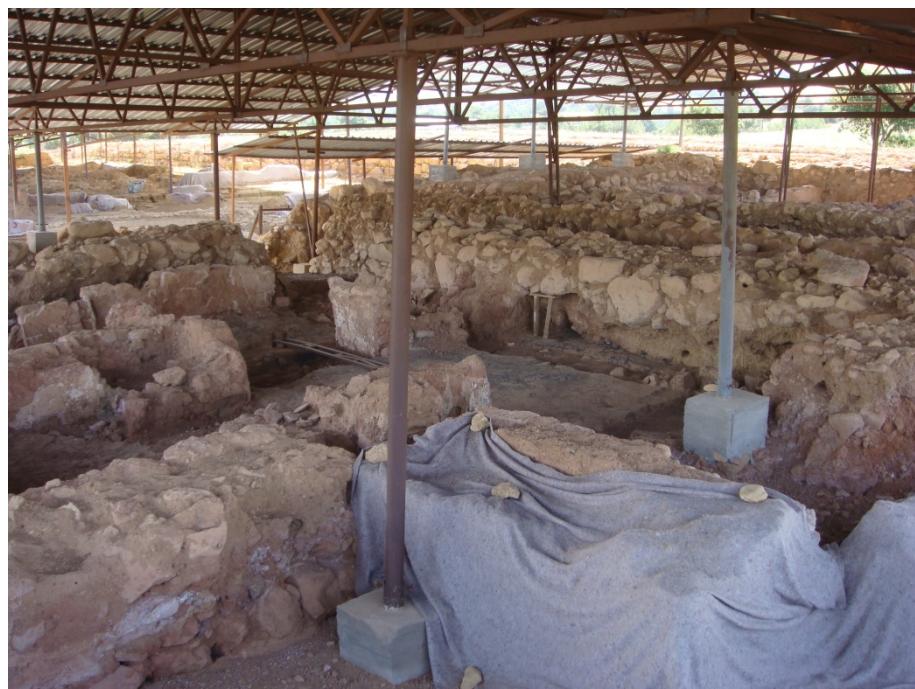
Fig. 3-13: A view of the temporary shelter in Şapinuwa

of two days from Hattuşa in Çorum, is one of these sites where the protective structures are covering the whole area. Easily built protective structures is the solution found by the excavation team against weathering factors and developed by trial and error (Personal communication with Mustafa Süel, June 22, 2010). The iron truss roofs are covered with corrugated iron sheets that are replaced with transparent glasses for giving visual access in the areas where circulation is over the roof level. Light superstructure with slim vertical elements doesn't require bulky foundations. Concrete foundations of the structure stand over the ground without destructing the underlying layers and making the removal easier. At the beginning of each season, maintenance of the structures is carried out. During the excavations when new remains are explored, structures are erected for the protection of the earthen materials using the same technology of the previous shelters (Fig. 3-13). When the site is seen from a distance and within the site perception of the remains is all but impossible with the shelters covering all over the site.

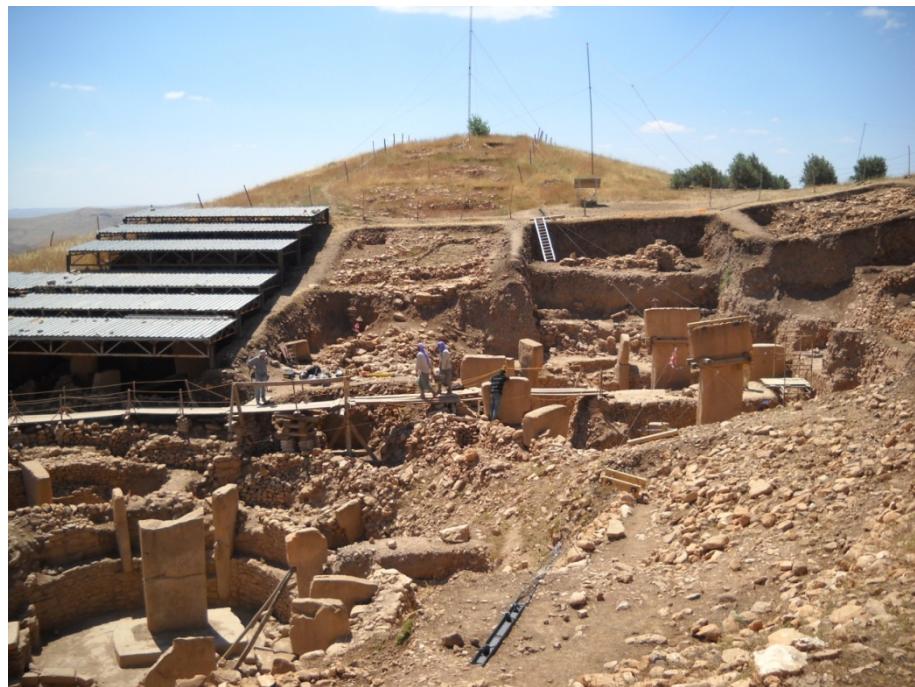
Fig. 3-14: A view of the temporary shelters in Göbekli Tepe

Göbeklitepe, the world's first temple dating back to 9600 BC, is another example of the prehistoric sites covered with protective structures where the rectangular trenches are used as modules. The vertical elements of the protective covers are built over the accumulated soil in between the trenches. Additions always with the same material following the modern grids seem habitual within the site with an impartial approach. The height and form of the structures doesn't differ with the underlying remain. They stand as a neutral element within the site while satisfying protective concerns (Fig. 3-14). In Göbeklitepe there is a preparation for a permanent protective structure. Salvage excavations are conducting for deciding and preparing the places of the foundations.

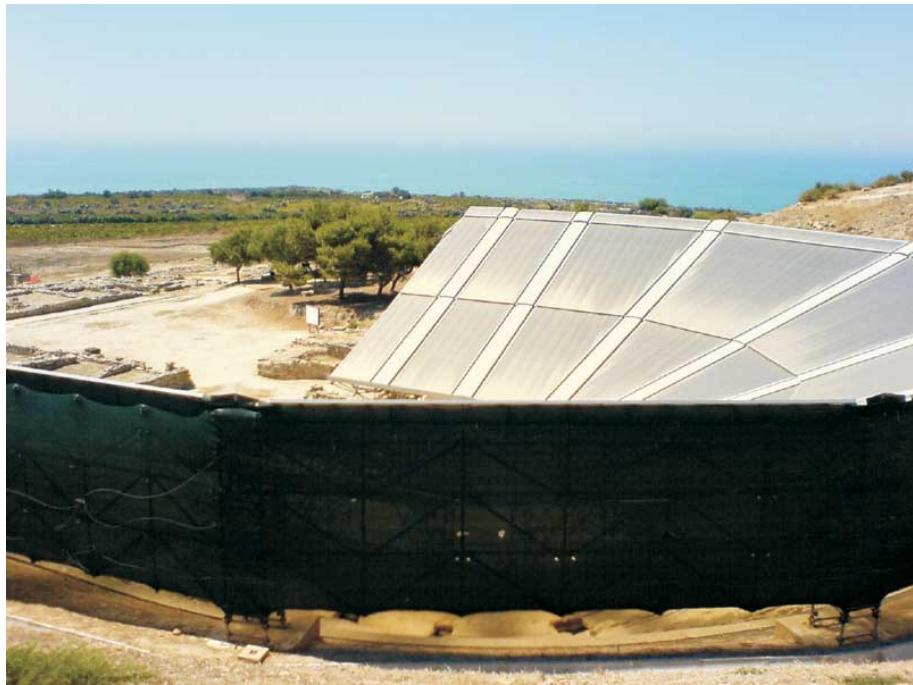
Fig. 3-16: View of the Protective Shelter

Protective structures are used extensively in historic preservation not depending on the belonging period of the remains, mass of the remains and ancient functions of the buildings. There are remarkable worldwide cases for protective structures that generate questions about the impact of the modern additions to the site. As generally referred, protective structures are preferred due to their clear understanding in differentiating the old and new, providing the required weather conditions. However, these structures aren't suitable for each remain. A metallic protective canopy was built over the amphitheater in the ancient city Heraclea Minoa located in the Province of Agrigento, Sicily in order to preserve the sandstone structure (Fig. 3-15-16).

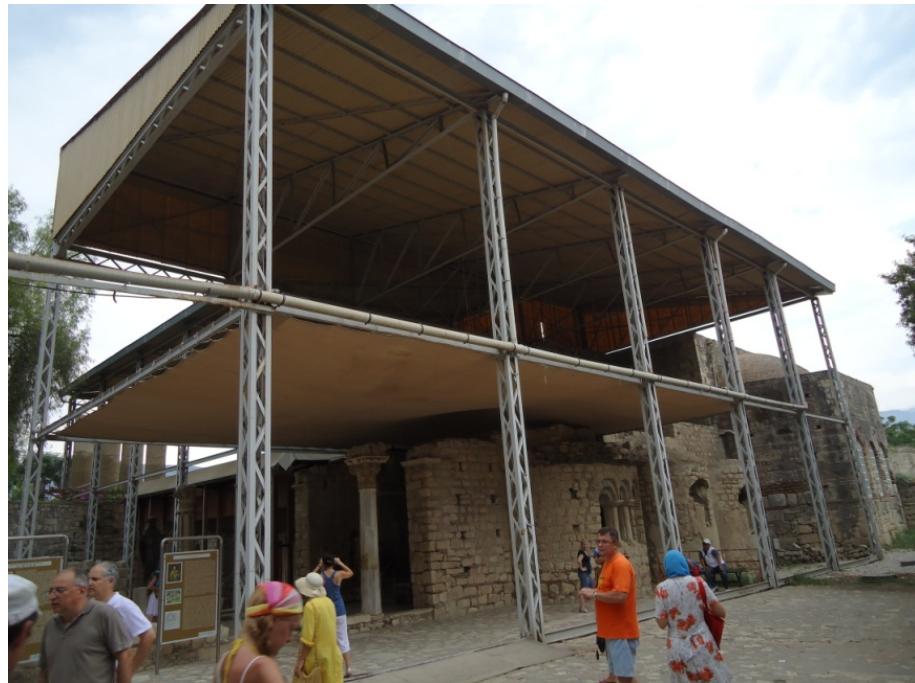
Fig. 3-17: A view of the protective structures over Saint Nicholas Church

In case of Saint Nicholas Church in Demre, due to the inadequacy of the structures or further requirements of the building, more than one protective structure is built for the preservation of the edifice. These structures built in different times with various materials form a roof complex over the structure and prevent the viewing of the historical building (Fig. 3-17).

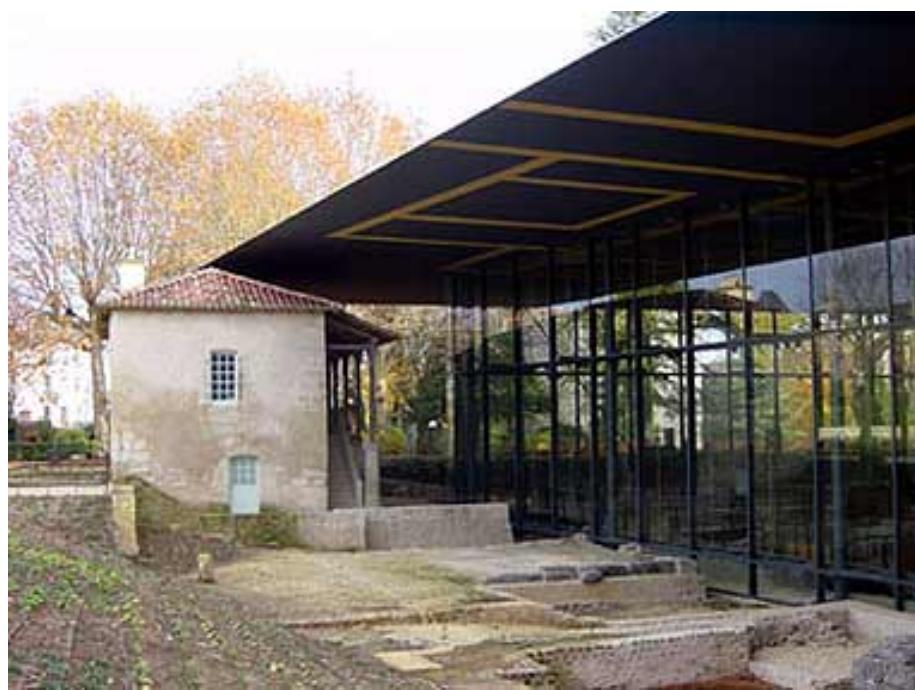
Fig. 3-18: Vasunna Gallo-Roman Museum

The Vesunna Gallo-Roman Museum, France is built after a competition. Jean Nouvel is the designer of the protective structure. The remains of a Gallo-Roman residence are covered with a steel and glass construction. The wooden platforms and walkways that are going all around and above the ruins are guiding the visitors in the house and describing the daily life of the inhabitants. On the ceiling mirrored floor plan is drawn (Fig. 3-18-19) (ArcSpace, 2003).

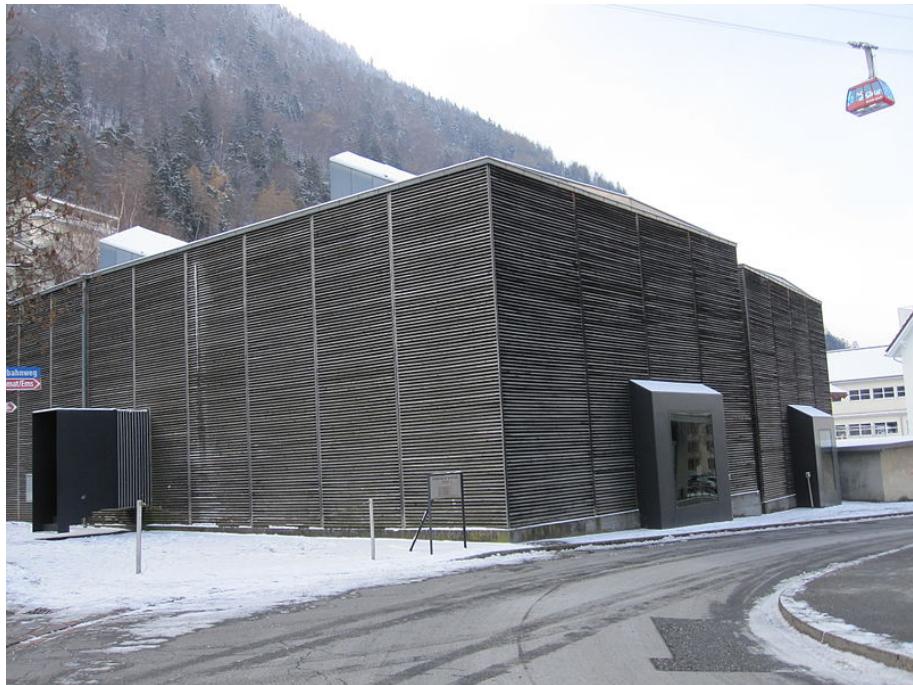
Fig. 3-20: Cubes of Zumthor in Chur

Another protective structure designed by a well-known architect is the cubicles by Peter Zumthor for the foundation remains of Roman buildings in Chur. The enclosure is also arranged as a museum for the small findings. The lightweight construction follows the outline of the ancient buildings is covered by wooden blinds (Fig. 3-20). Three buildings are connected to each other with a metal bridge at the estimated level of the original floor. From the two large openings on the street level, interior of the structure can be viewed without entering the structure. From the holes left on the roof and the permeable walls ventilation and illumination of the structure is provided. There are electrical appliances inside the structure for artificial lighting. With the help of the switch turning on the lights inside the structure placed beside the windows, night viewing is possible. The structure provides the security of the architectural remains and the movable objects presented inside (Fig. 3-21).

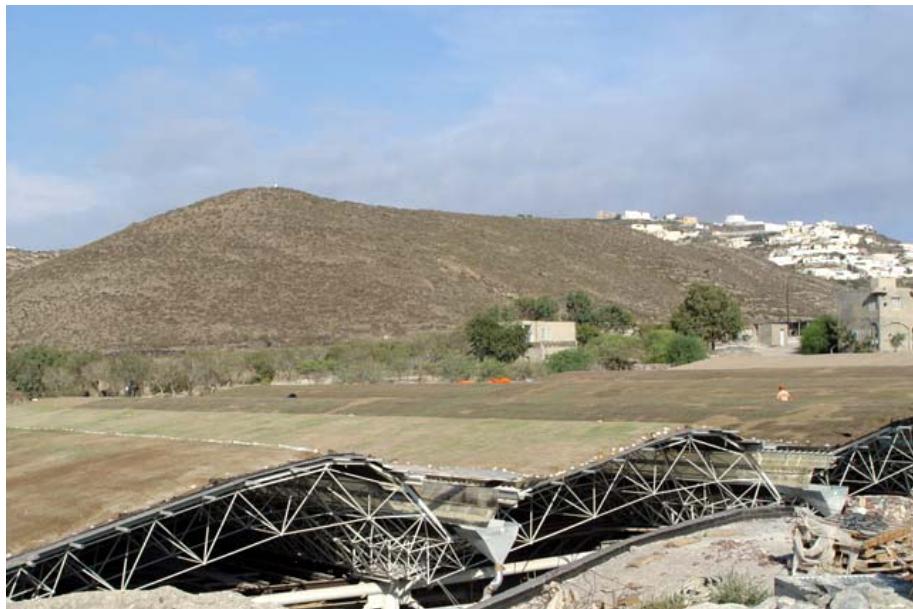
Fig. 3-22: Modal Section of the Shelter in Akrotiri, Thera

With the miscalculations or the natural catastrophes, protective structures collapse harming the remains underneath or resulting in a different disaster. The shelter over Akrotiri's Minoan city was erected in 2000 as a temporary structure. Shelter was designed constituting a single space for the earthen remains of the prehistoric site. In line of the roof compatible with the topography has a flouting appearance providing natural light on the intersection points of the roofs (Fig. 3-22). The shelter was collapsed partially in 2005 causing the death of a visitor. Till the works on roof in 2011 the site was closed to visitors.

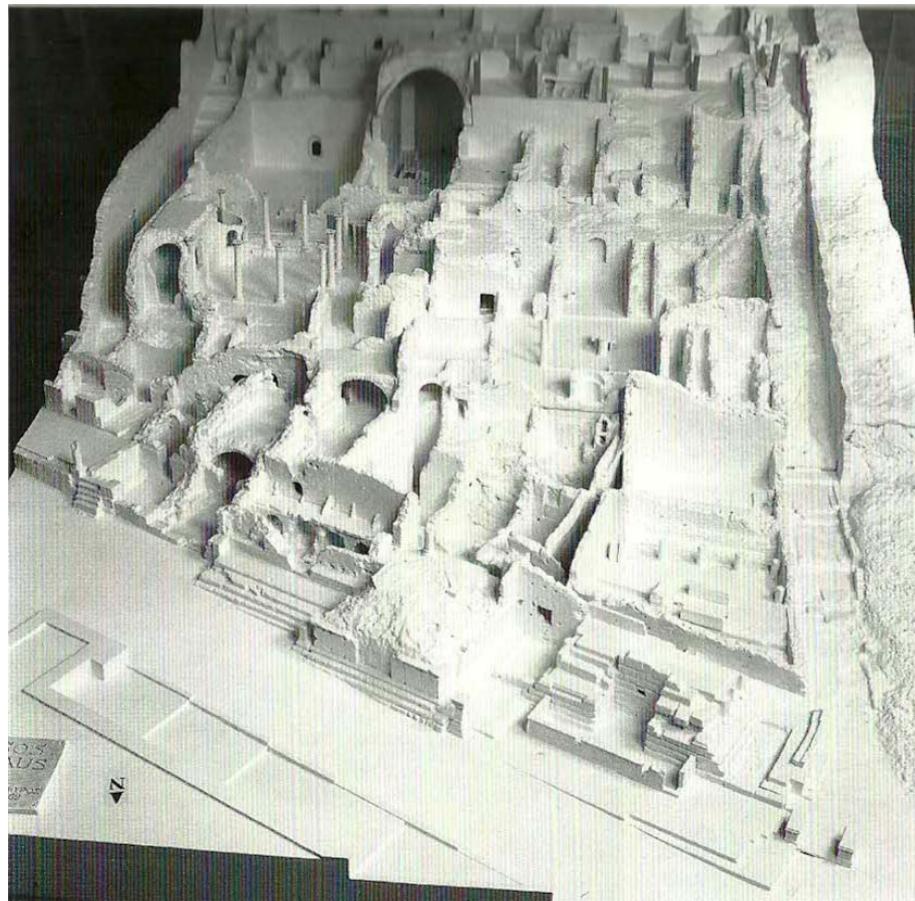
Fig. 3-30: Modal of Terrace Houses II out of Plaster

Terrace Houses II having an area of approximately 4000 m² was composed of seven housing units over terraces like the Terrace Houses I. Areas of the units differed leaving a larger unit at the west end (Fig. 3-30).

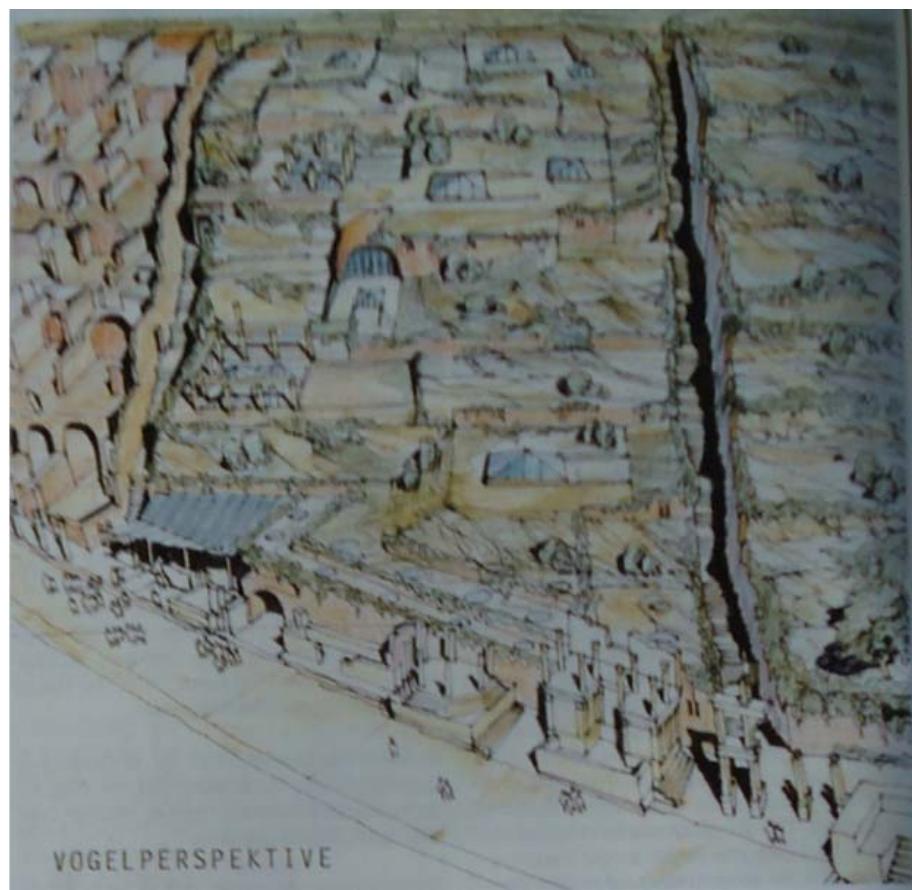
Fig. 3-36: Hueber's Proposal, Bird's Eye Perspective of the Houses

Institute of Australia, in order to find new concepts for the protection of the houses (Schmidt, 1988). In the closed competition with the invitation of five participants, the proposal of Friedmund Hueber with his Projekt Nr.4 was selected. Hueber proposed a reinforced concrete roof over the remains following the incline of the slope (Fig. 3-36-7). Over the roof, second floor of the terrace houses would be reconstructed. Rest of the roof would be planted where the remains are single-storied (Fachjournal, 1989).

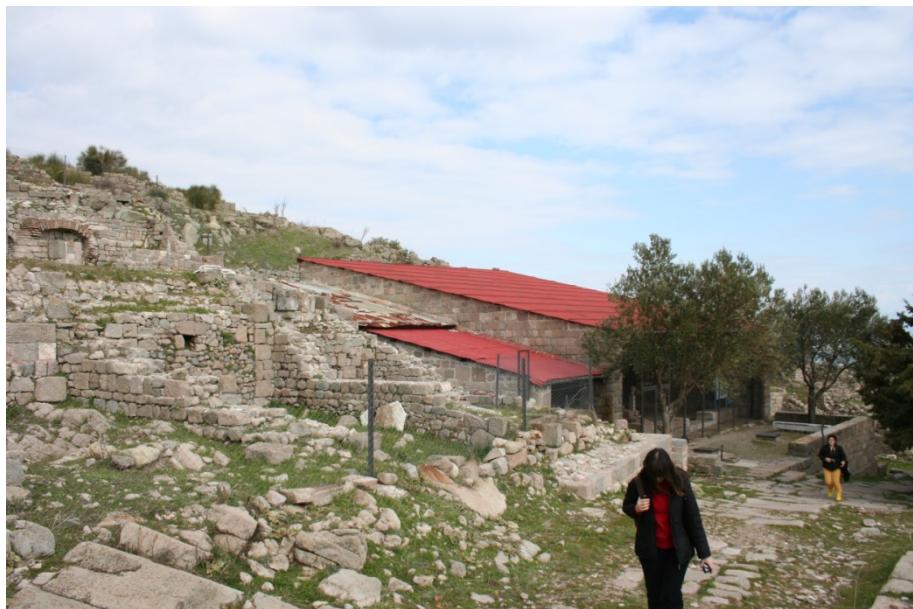
Fig. 3-47: Another Protective Structure in Pergamon

There are other protective structures in Pergamon over the ruins beside the Trajanum and on the lower part of the Building Z (Fig. 3-47).

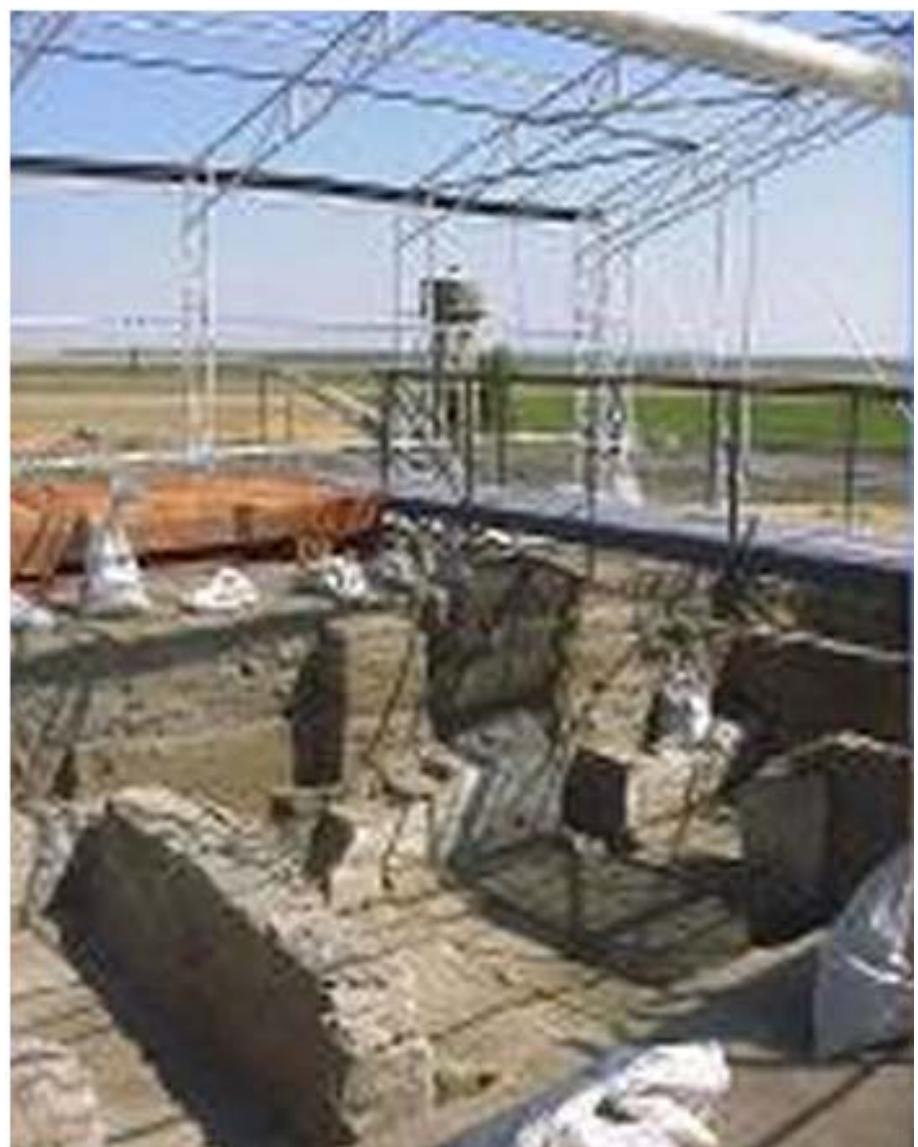
Fig. 3-64: During the Construction of the Tent Structure

Due to the shortage of the budget, the structure over Building 5 was decided to be consisted of steel frame structure covered with an opaque canvas. The steel construction was prepared by the company Cumra. The structure was designed by Lindsay Flack with the contributions of Caitlin Moore, David Small, Paul Lapinski. The building was designed as a simple shed, covered with two layers of tent with a slot on the roof (Fig. 3-64). The area in between two tents was providing ventilation with the circulation of air going through the opening on the roof. An iron bridge was designed covered with wooden panels as the walkway inside the structure overlooking the remains (Falck, 2000) (Fig. 3-65).

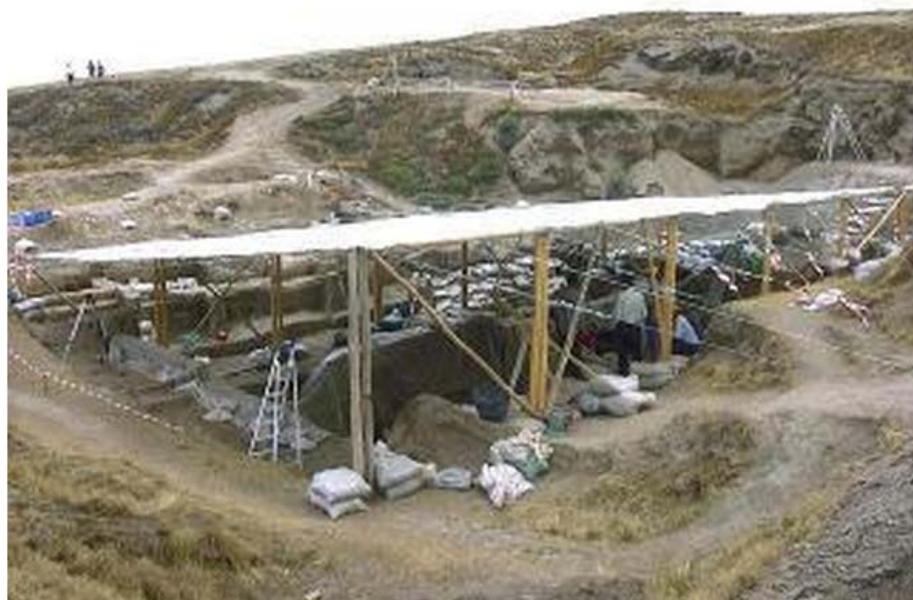
Fig. 3-67: Temporary Shelter on the South Area

Single pitch shelter was placed in north-south direction prevailing winds from the north. Poplar pole columns were placed over wood spreader plates which were supported with sand bags. Columns were strung by steel cables in 3 m intervals. Netting was prepared over the columns and a canvas was laid. The materials were supplied in Konya and construction was carried by the local workers. Shelter provided ideal working conditions with the shade it offers and natural illumination through the translucent canvas (Falck, 2000).

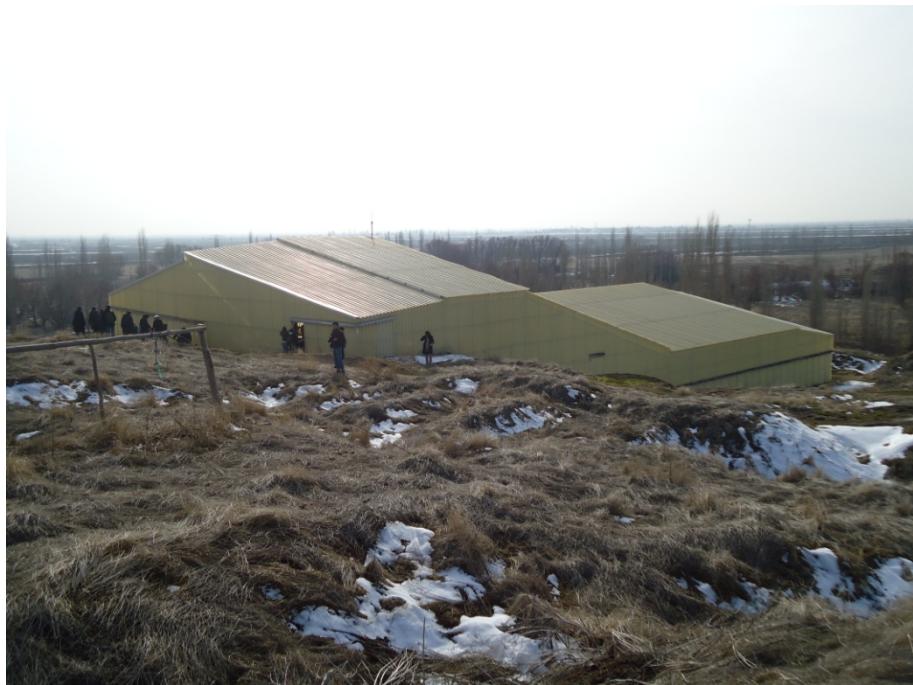
Fig. 3-68: View of the South Shelter

The structure was composed of steel space frames covered with fiberglass panels (Fig. 3-68-70). The panels were translucent allowing 50% light penetration inside. Side panels were designed as removable in order to allow opening in the summer season. Drainage channels were excavated around the building (TEMPER, 2004).

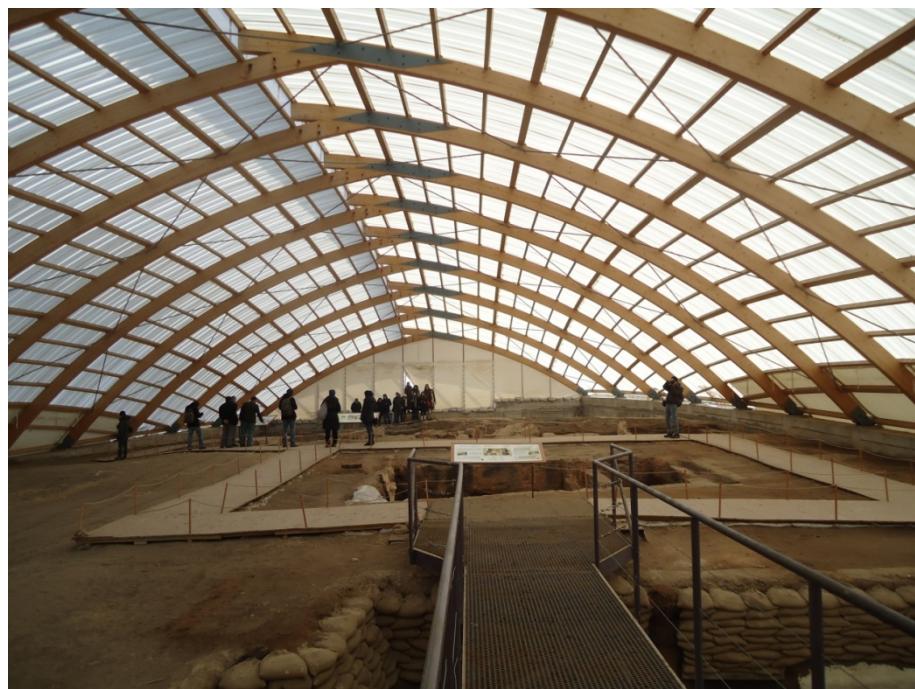
Fig. 3-73: Wooden Walkways within the Shelter

The structure was composed of wooden arches with various heights having the same diameter over the reinforced concrete foundations. Wooden purlins were fixed over the arches and covered with translucent induline polycarbonate panels (Omacan S. , 2011). The doomed superstructure made of compressed wood was brought from Austria and polycarbonate panels from France. The panels on the ends and sides of the shelter are removable. The construction was carried by a local Konya company. An interlocking wooden planking walkway was designed by Karis Eklung standing over sandbags. Information panels were placed within the walkway.

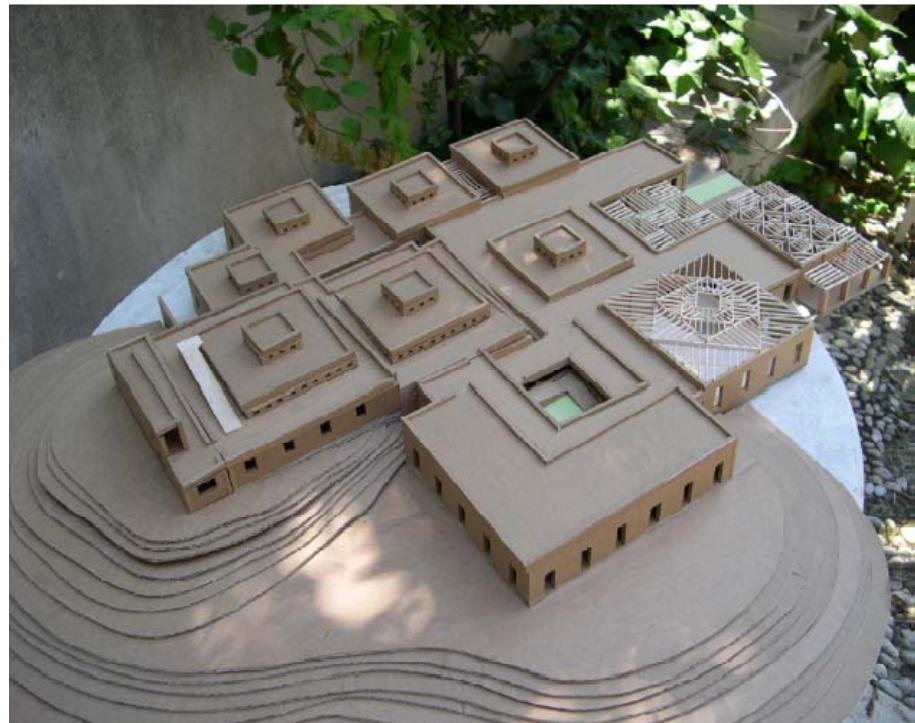
Fig. 3-78: Museum designed by Cengiz Bektaş

A site museum designed by Cengiz Bektaş is planned since 2005. The museum made of mud brick is decided to be 1.5 km's away from the site, near Çumra. However the excavation team faced financial obstacles and needed financial assistance. Resembling the Çatalhöyük settlement, the museum was planned like two hills with a welcoming center at the entrance and a playground for the children. Show rooms connected to each other with ramps were accessible addressing all the visitors. The dissemination of the findings were planned to be in layers imitating the stratigraphy in the archaeological site (Hodder, 2005).

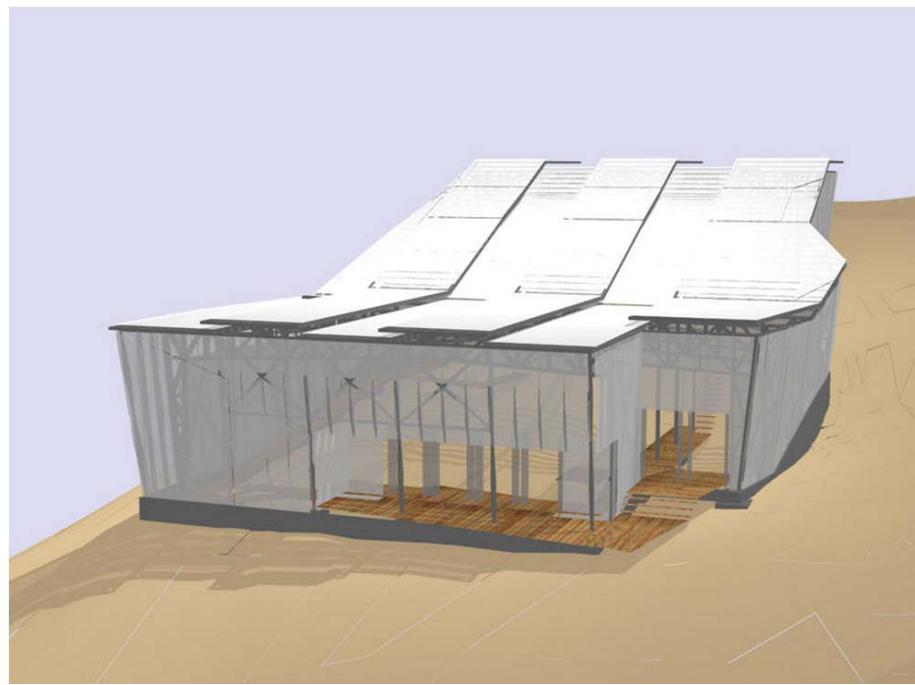
Fig. 3-83: Modal of the Structure

Foundations of the structure were developed according to the locations of the remains on the site. After the preliminary drawings and surface surveys, the locations of the foundations were decided. The concrete foundations circulated the remains. With the help of the long span steel trusses, load bearing steel columns were placed upon the foundations, leaving a 30 m wide, singular space within the structure. Inner shell was composed of porous textile net and the exterior part was covered with a semi permeable, perforated metal plate. Materials were selected with the concern of achieving the ideal ventilation and illumination conditions inside the structure (Omacan S. , 2011).

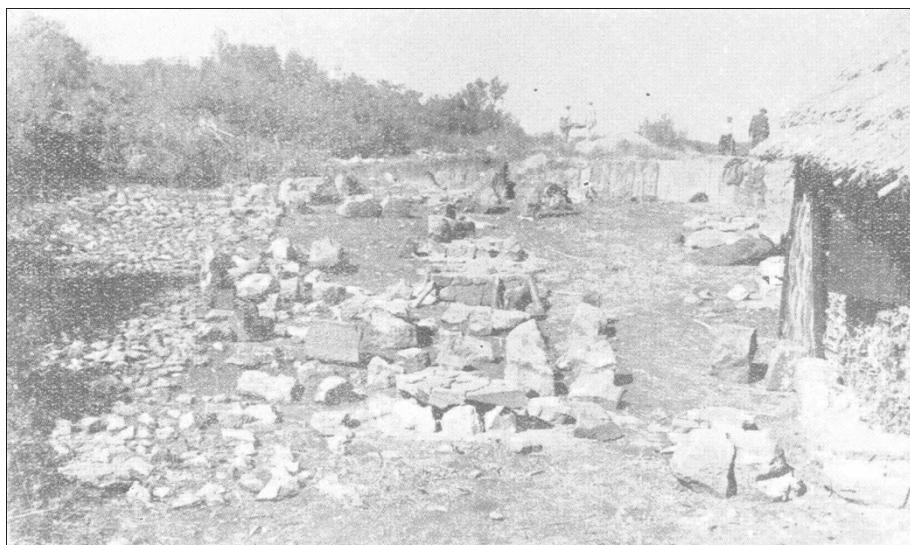
Fig. 3-87: North East Portico

Due to the location of the site, it was hard to move the remains to another place without proper roads and a good place for their protection (Çambel, 1999). In between the alternatives of reburying, moving the remains to somewhere else and in situ conservation, Çambel (1956) decided to build a protective structure

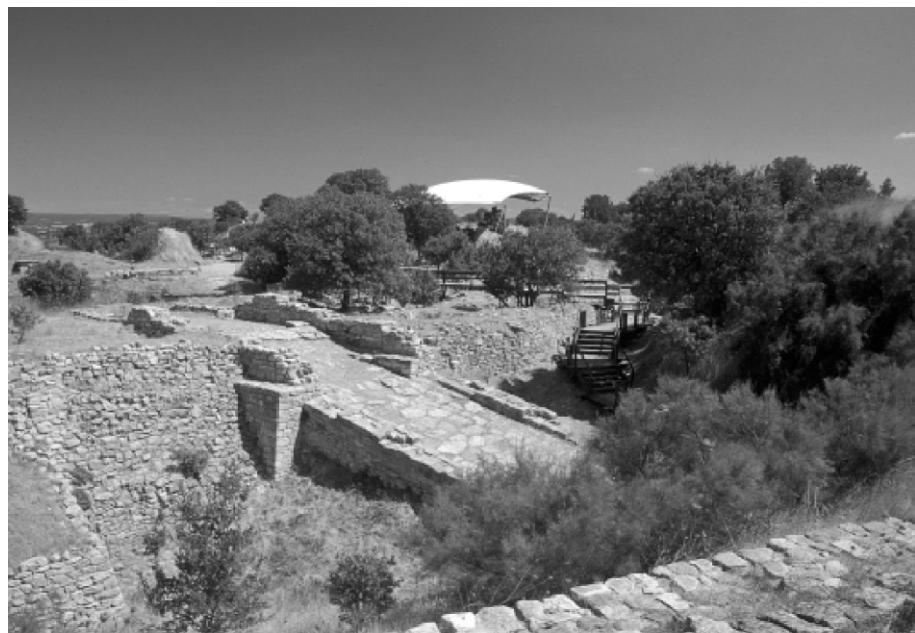
Fig. 3-104: Protective Shelter from the West

protective shelter was erected on the remains of Megaron Building. The steel frame membrane tensile structure is designed by Björn Rimner. The financial sponsorship was undertaken by DaimlerChrysler and Siemens A.Ş. (İstanbul). The surveys for placing the foundations were done before the erection of the structure. Calculations were made and precautions were taken estimating the area in centimeters (Korfmann, 2004).

The structure was designed as a landmark that can be easily seen from a distance in the boundaries of the conservation area. The height of the shelter matched up with the original height of the mound of Hisarlık when Schliemann had started his excavations in 1871. The sail-like membrane and the form of the shelter imitates the wind blowing from the north-east, which brought wealth to Troia. The remains of the megaron and citadel walls are the only mudbrick structures in Troia. The shelter emphasizes the significance and vulnerability of the structures beneath. It is important for the visitors to see the mudbrick walls, which were once composing the overall mound (Korfmann, 2004).

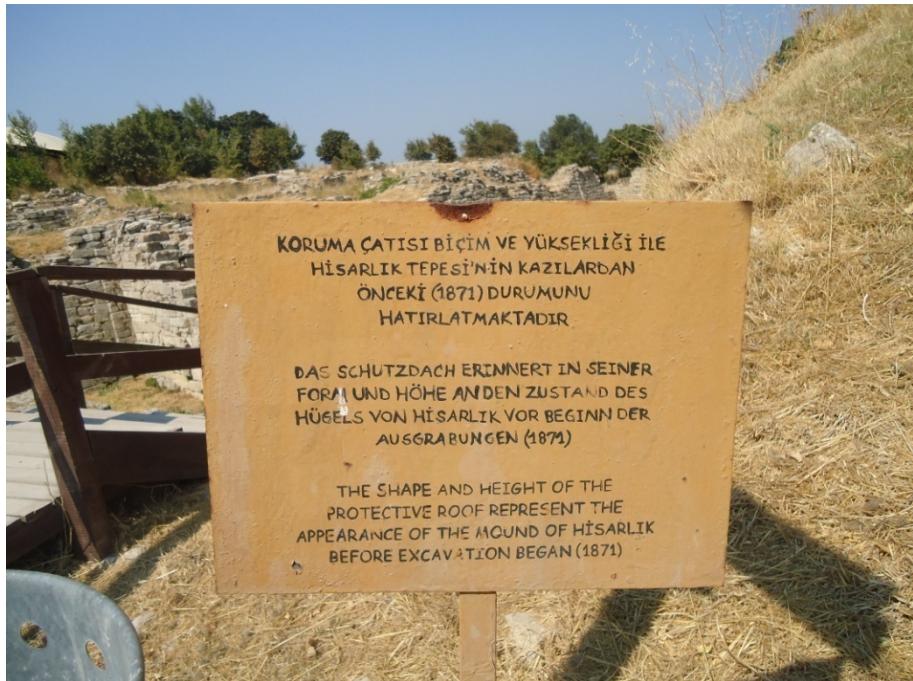
Fig. 3-106: View of the Shelter and Information Sign

a distance, a sign informs the tourists about the shelter imitating the appearance of the mound before Schliemann's excavations (Fig. 3-106).

The walking path gives various perspectives of the shelter on the way. At the beginning of the wooden walkways where the shelter can be seen at a distance, a sign informs the tourists about the shelter that it resembles the appearance of the mound before Schliemann's excavations (Fig. 3-106).

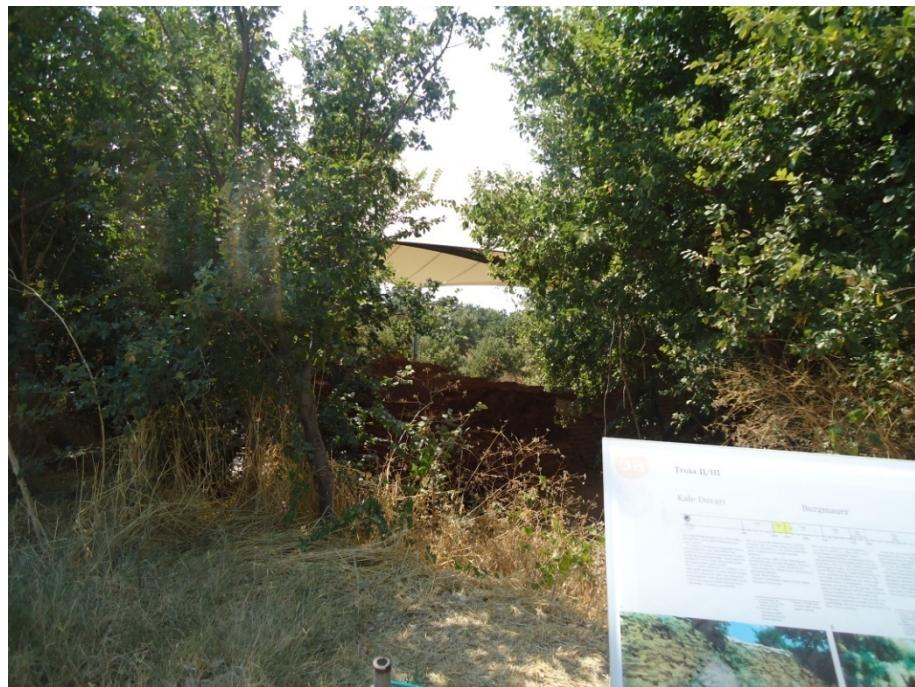
Fig. 3-107: View of Citadel Walls and the Shelter

Another confrontation with the shelter before entering the area of Megaron, is beside the beginning of citadel walls with a perspective in between the trees (Fig. 3-107). On the information panel, significance and period of the citadel walls and interventions are described including the photos after the exploration and process of reconstructions. Information about the designer and sponsors of the shelter is given. An extra sign is put beside the information panel describing the shelter representing the winds contributed affluence of Troia (Fig. 3-108). The same sign welcomes the visitors under the shelter.

Another confrontation with the shelter before entering the area of Megaron, is beside the beginning of citadel walls with a perspective in between the trees (Fig. 3-107). On the information panel, significance and period of the citadel walls and interventions are described including the photos after the exploration and process of reconstructions. Information about the designer and sponsors of the shelter is given. An extra sign is put beside the information panel describing the shelter representing the winds contributed affluence of Troia (Fig. 3-108). The same sign welcomes the visitors under the shelter. Tourist route turns around the megaron under the shelter and leads to the other remains within the site.

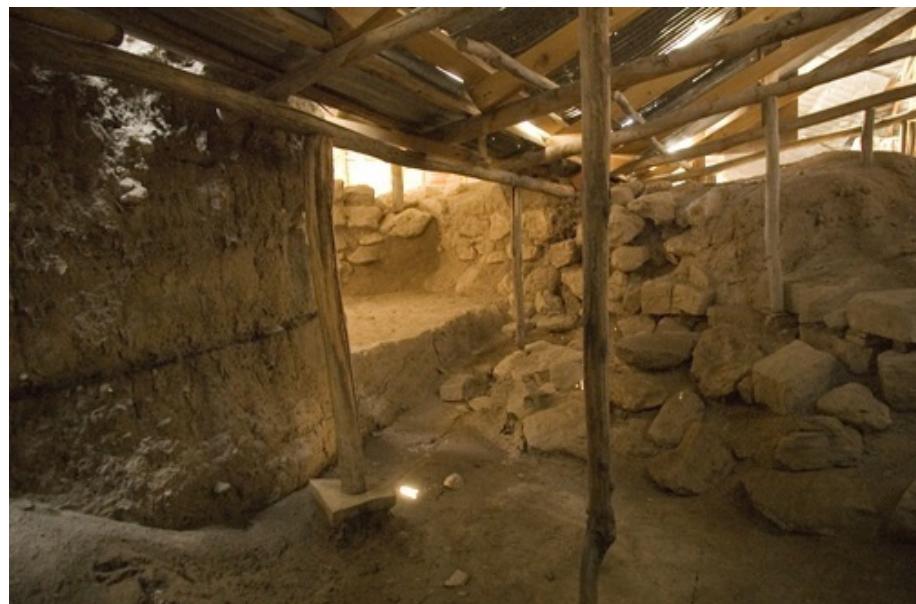
Fig. 3-115: Temporary Protective Shelter of Arslantepe

After the exposition of the walls, temporary shelters were built over the remains after each excavation season in order to protect them, which were removed during the next excavations (Fig. 3-115). The protective shelter made of portable wooden material covered with corrugated sheet was effective in terms of protection, however didn't allow visiting (MAIAO, 2011). Visitor circulation under the shelter was hard due to the frequently used, poor vertical elements. Materials preventing the rain penetration were also blocking the day light precluding the dissemination of the remains.

Through the experiences of sheltering, it was discovered that, for maintaining the ideal conditions for the remains, water penetration should be avoided and air circulation should be provided. Over the frescos, double sheeting was applied just to be on the safe side. Erection of protective shelters was always accompanied with regular monitoring, annual checkups and consolidation of the cracks and erosion on the walls. The consolidation was achieved with the mortar prepared mixing mud with chaff in the proportions determined with the analysis of the traditional material. Wall paintings were covered with a coat of diluted Paraloid (Frangipane, 2010).

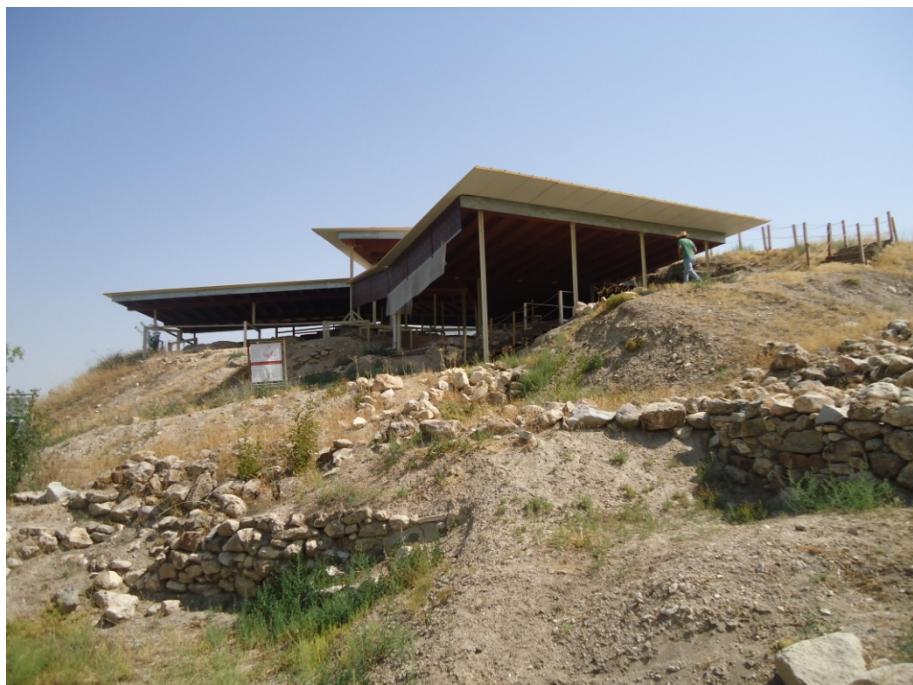
Fig. 3-117: View of the Shelter

The structure is composed of iron beams over metal posts resting on metal bridges constructed over the walls and fixed with reinforced concrete foundations built directly on the surface. The shelter is not a single structure, rather a complex of shelters built over the remains on various levels and heights. This makes it possible to perceive the arrangement of the buildings beneath and their volumes. These modules may be removed or new modules may be added in the

future extensions. Without the intention of reconstruction, each building has its own roof made of wooden boards covered with timber clad. The overall structure is covered by a few layers of insulation panels. The timber cladding of the roofs inside, gives the visitors a perception of the original look of remains. The height of the shelter strengthens the idea of monumentality of the remains (Frangipane, 2010).
