EVALUATION OF PROTECTIVE STRUCTURES
IN ARCHAEOLOGICAL SITES FOR IN SITU CONSERVATION OF
ARCHITECTURAL REMAINS AND ARTIFACTS

IN PARTIAL FULFILLMENT OF THE REQUIREMENTS
FOR
THE DEGREE OF THE MASTER OF SCIENCE IN
RESTORATION IN ARCHITECTURE

SEPTEMBER 2012

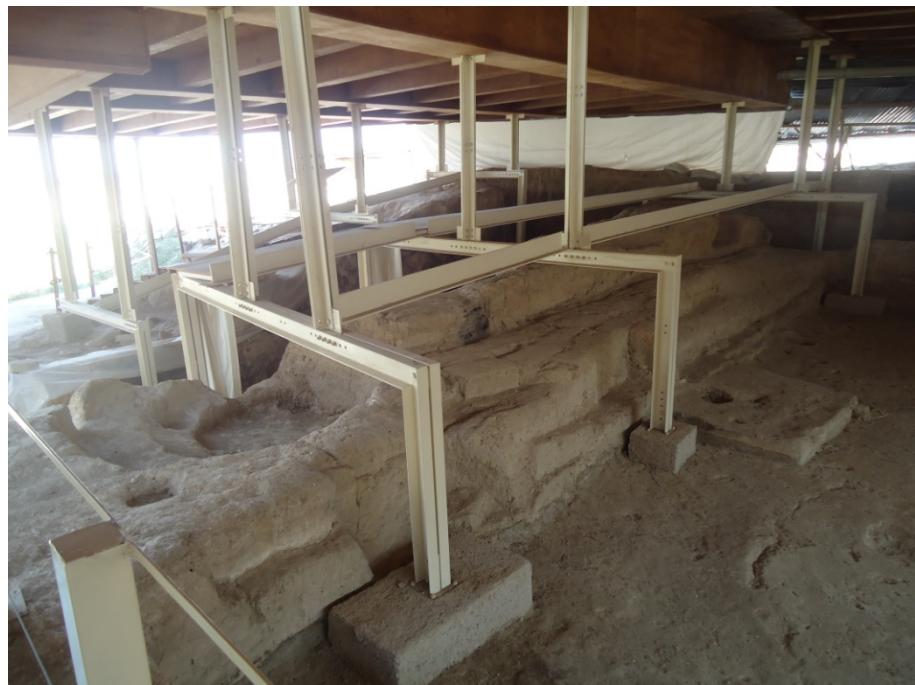
Fig. 3-120: Bridges over the Walls

Vertical posts are placed over the projections of the walls, this way posts don't disturb the visualization and reflect the plan organization of the ancient

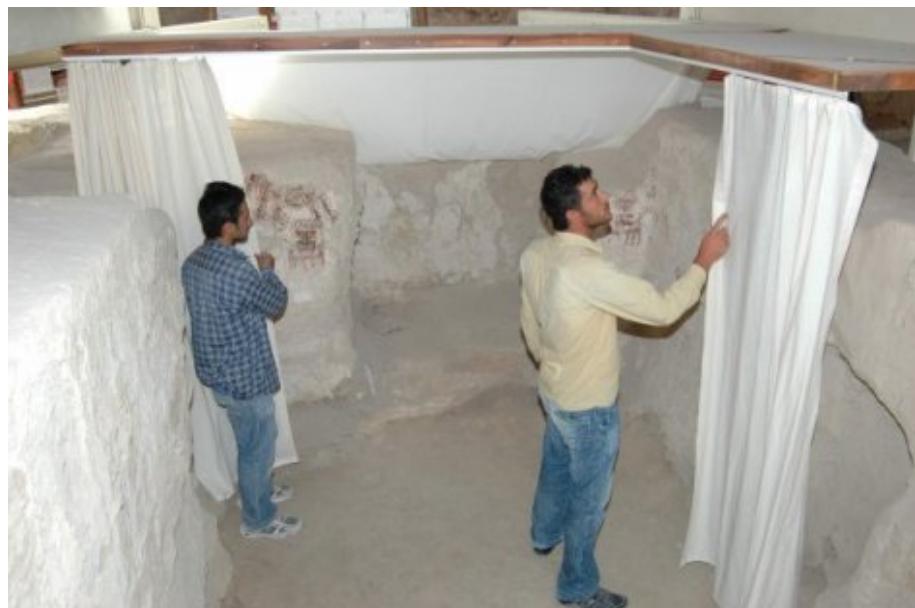
Fig. 3-125: Protection of the Wall Paintings

The opaque roof helps the protection of the plasters from light and sun. Natural light and ventilation is provided through the openings covered with shatterproof glass over the large central courtyard and middle access corridor. In order to achieve the original atmosphere, it is planned to install white canvases under these lighted parts as it were in the open areas of the traditional buildings (Frangipane, 2010). 5000 year old wall paintings are protected under secondary roofs, covered by curtains (Fig. 3-125).
