INCREASING WALKABILITY CAPACITY OF HISTORIC CITY CENTERS:  
THE CASE OF MERSİN

A THESIS SUBMITTED TO  
THE GRADUATE SCHOOL OF NATURAL AND APPLIED SCIENCES  
OF  
MIDDLE EAST TECHNICAL UNIVERSITY

IN PARTIAL FULFILLMENT OF THE REQUIREMENTS  
FOR  
THE DEGREE OF MASTER OF SCIENCE  
IN  
URBAN DESIGN

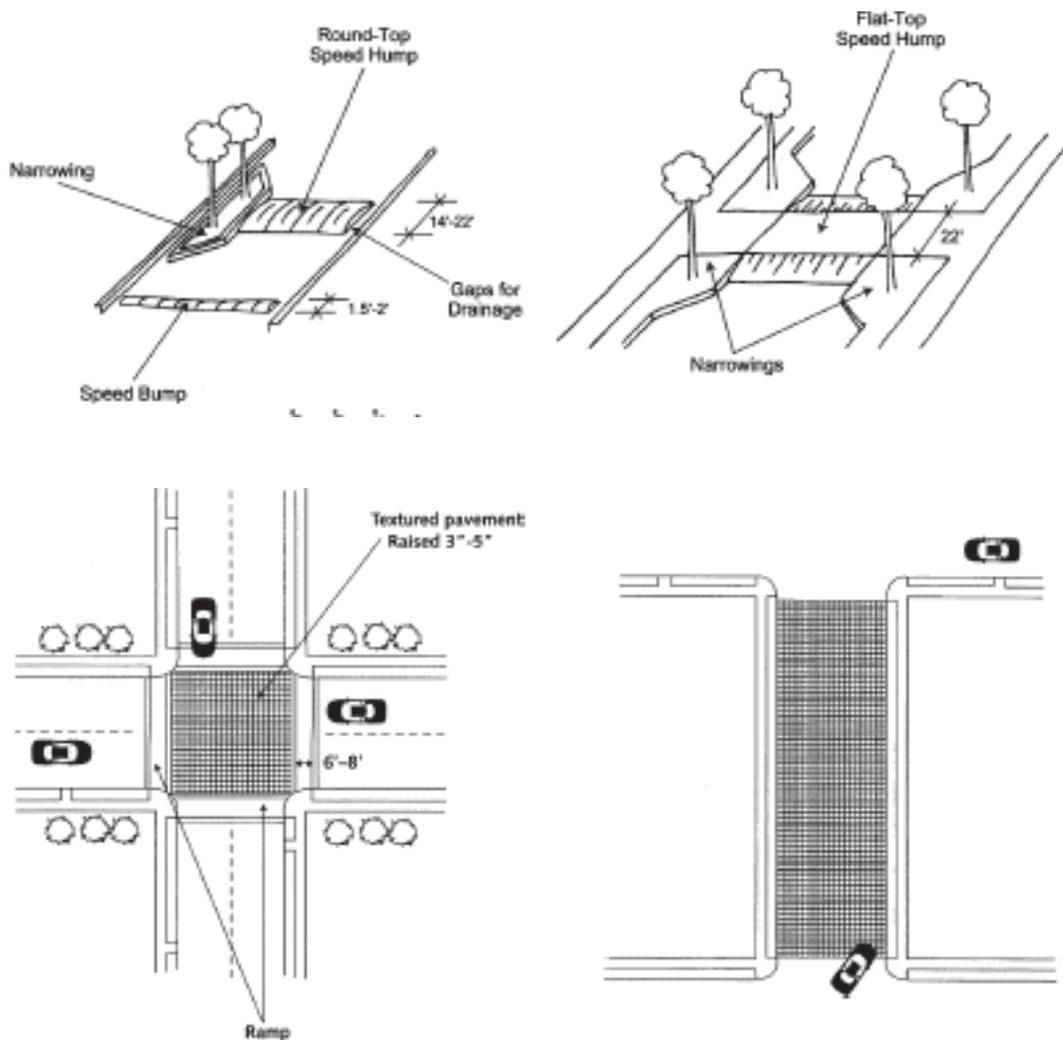
Figure 2-6: Traffic Calming Elements; speed hump, narrowings, speed bump and textured pavements. (Time-Saver Standards for Urban Design, 2003: 7-2-2 / 7-2-3)

- Speed Humps are rounded-raised areas placed across the roadway. They are generally 3 to 4 meters long (in the direction of travel), making them distinct from the shorter “speed bumps” found in many parking lots, and are 7 to 10 cm high (Figure 2-6).

- Traffic Signals are used to manage traffic and pedestrians at heavily use extremely hazardous or complex intersection:
- Textured Pavement: Special pavement textures (cobble, bricks, etc.) and markings to designate special areas (Figure 2-6).

- Slow Traffic: Element to slow traffic include on-street parking, engineered traffic calming measures (for example, speed bumps), visual complexity and narrow roads (Figure 2-6).

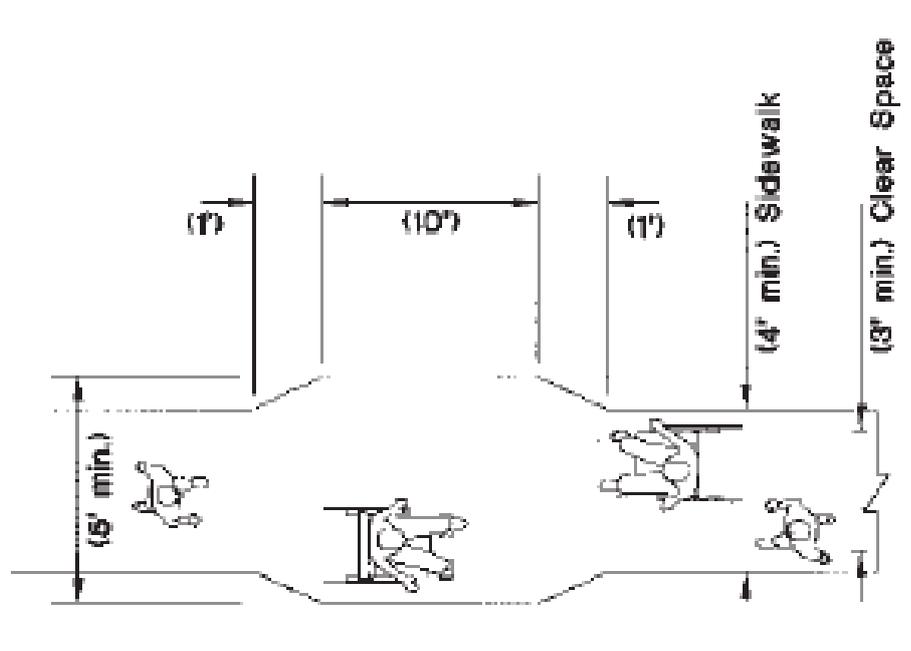
Figure 2-9: Accessible passing area (Pedestrian & Streetscape Guide, 2003, Figure 10)

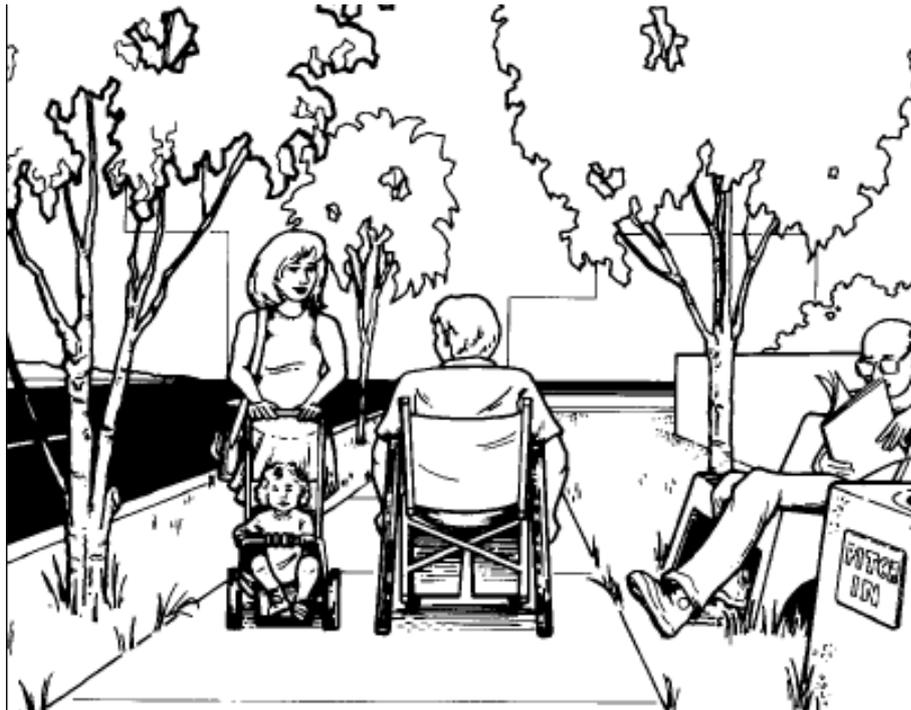
Figure 2-10: Accessible passing area (Burden, 1995: 1)

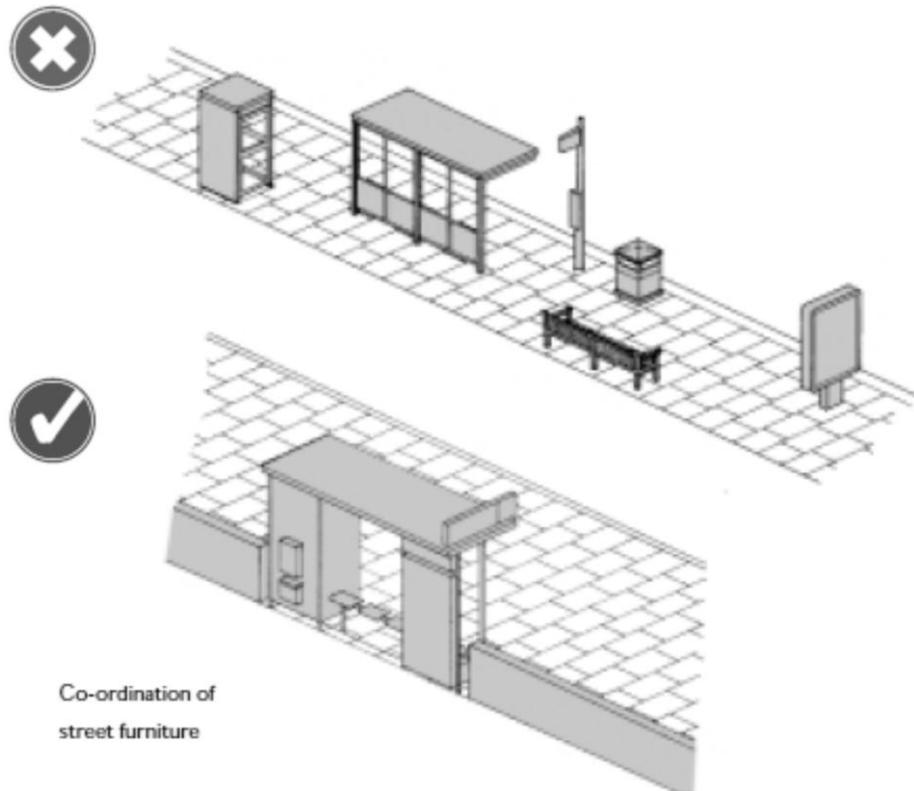
Figure 2-11: Co-ordination of street furniture for a clear walking zone (English Heritage, 2000: 27)

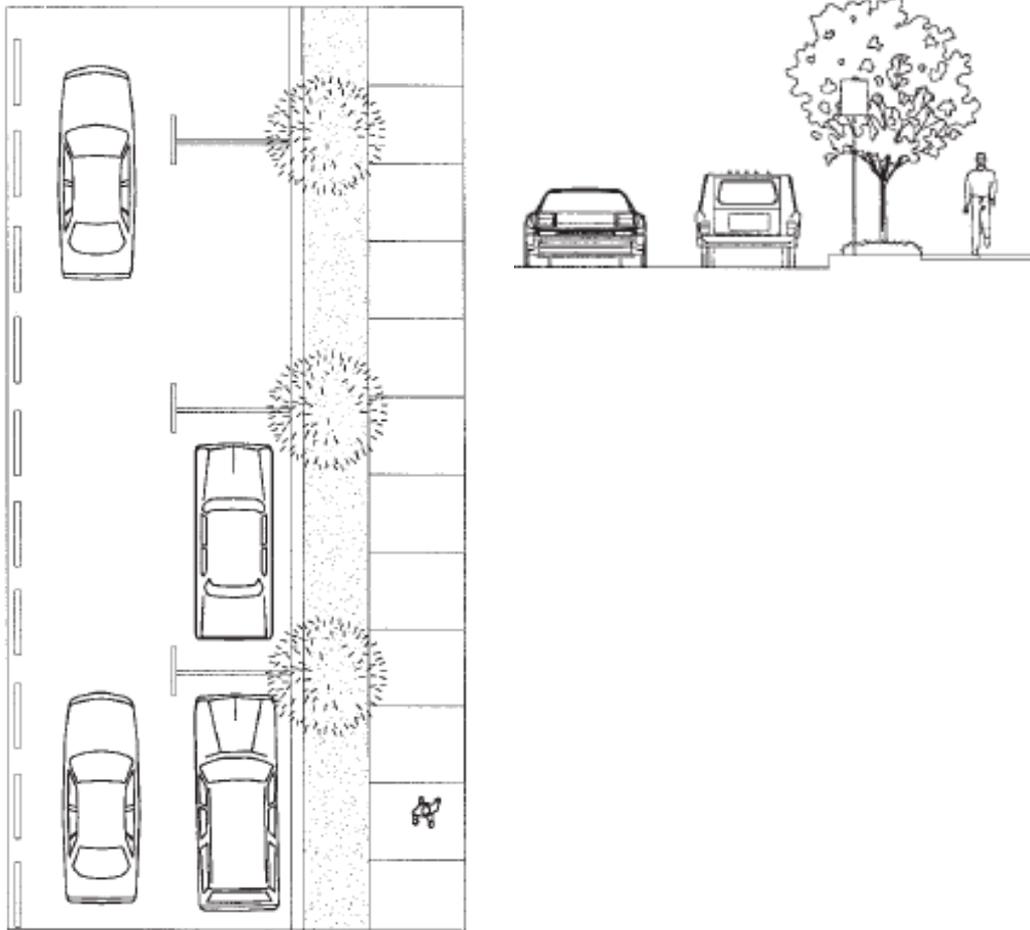
Figure 2-18: On-street parking as a buffer between street and pedestrian walkway (Pedestrian and Streetscape Guide, 2003: 111)

of security. However, in some cases, on street parking causes problems when there is not enough space for people to safely get out of their cars or walk between cars. Also, it leads to lack of visibility of pedestrians entering the roadway from between parked cars (Crankshaw, 2009: 94, Pedestrian & Streetscape Guide, 2003: 111). For this reason, on-street parking should be designed to be set back from intersections and crossings to allow pedestrians to see oncoming traffic (Pedestrian & Streetscape Guide, 2003:111,112).

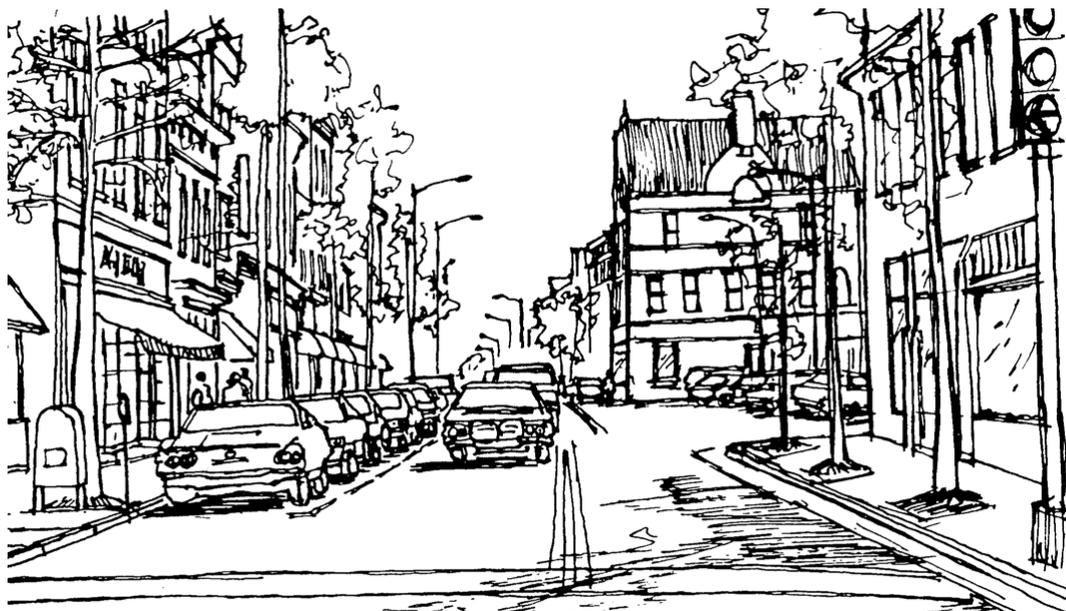
Figure 2-19: On-street parking and pedestrian walkway (*Time Saver Standards for Urban Design*, 2003: 5-1-9)

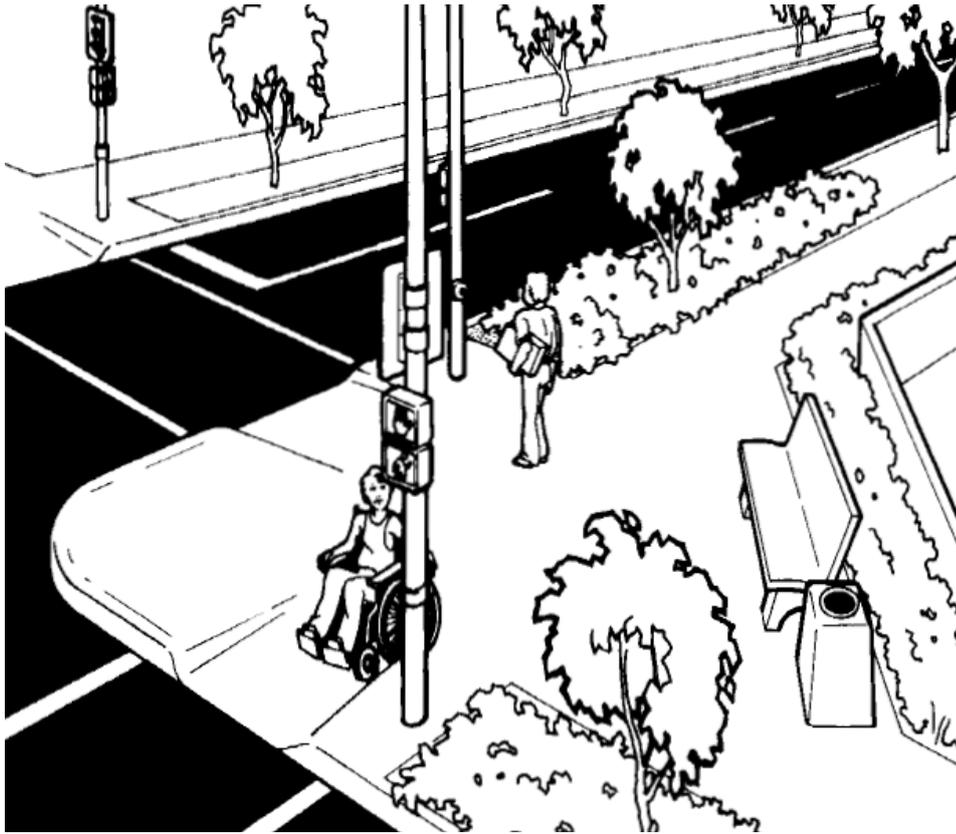
*Figure 2-20: Unimpeded movement for everyone (Burden, 1995: 4)*

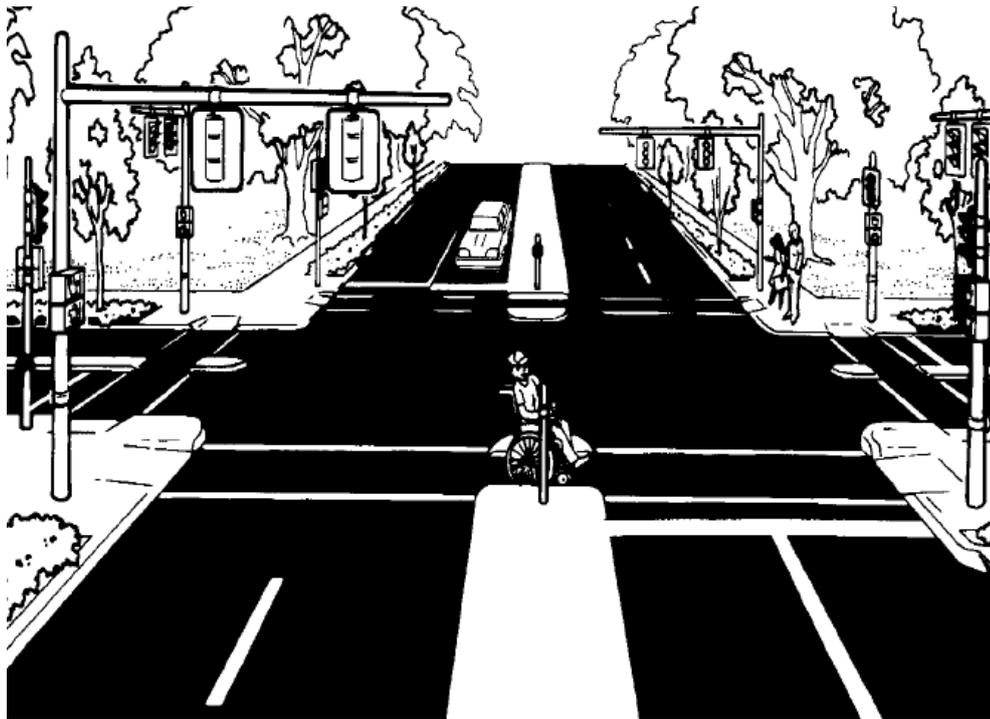
*Figure 2-21: Signal placement for unimpeded movement (Burden, 1995: 5).*

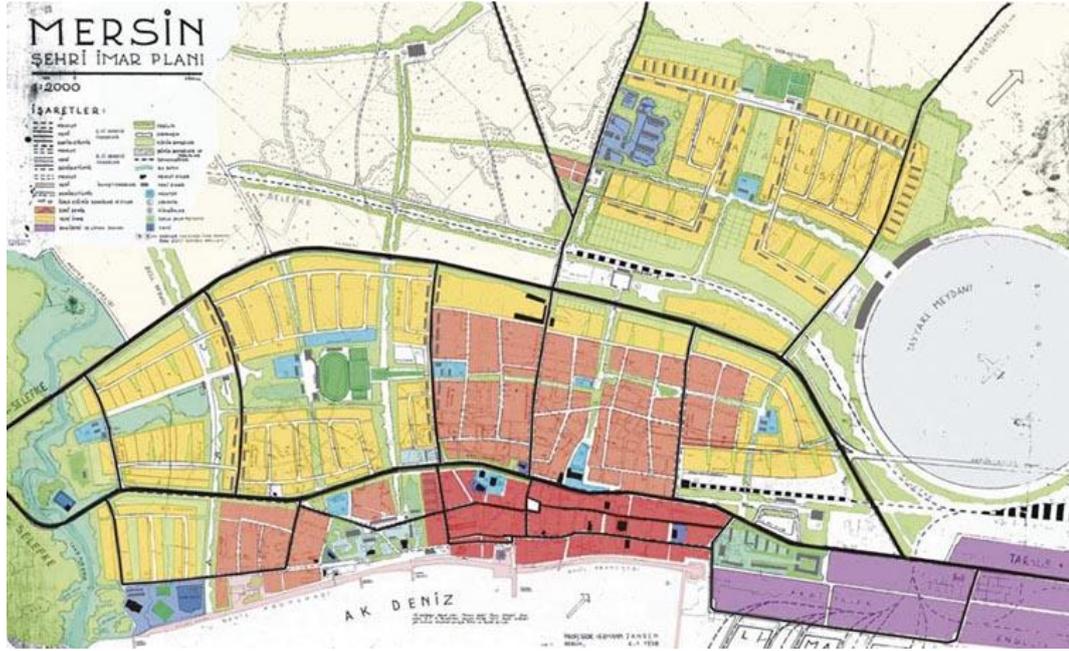
Figure 4-3: Jansen Plan - 1938 (Ünlü, 2007: 429)

The area between İstiklal Street and Efrenk (*Müftü*) Stream were formed by the decisions of Jansen Plan. However, the plan could not respond to the rapidly increasing urban population and urban development. Nevertheless, the vision of Jansen Plan which envisaged the development of “commercial city”, “coastal city” and “the relation between sea and city” and was enhanced by pedestrian ways and promenade, let Mersin to gain an identity and the plan stands a significant position in urban development and planning history (Ünlü, 2007: 429).

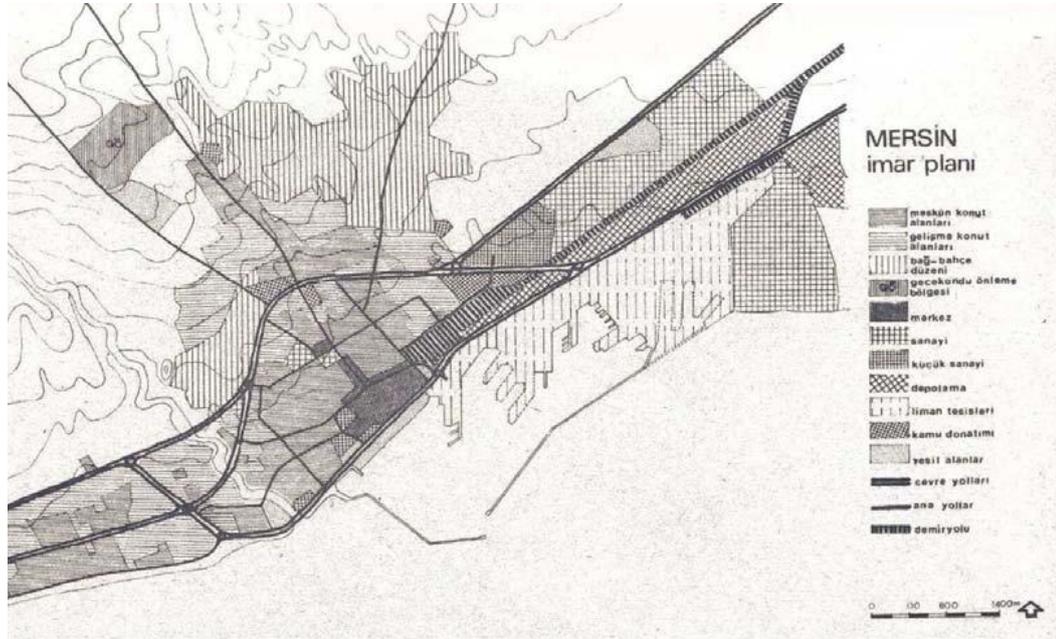
Figure 4-4: The plan prepared by the Bank of Provinces (İller Bankası) (Akçura, 1981:175, cited in Ünlü, 2009: 36)

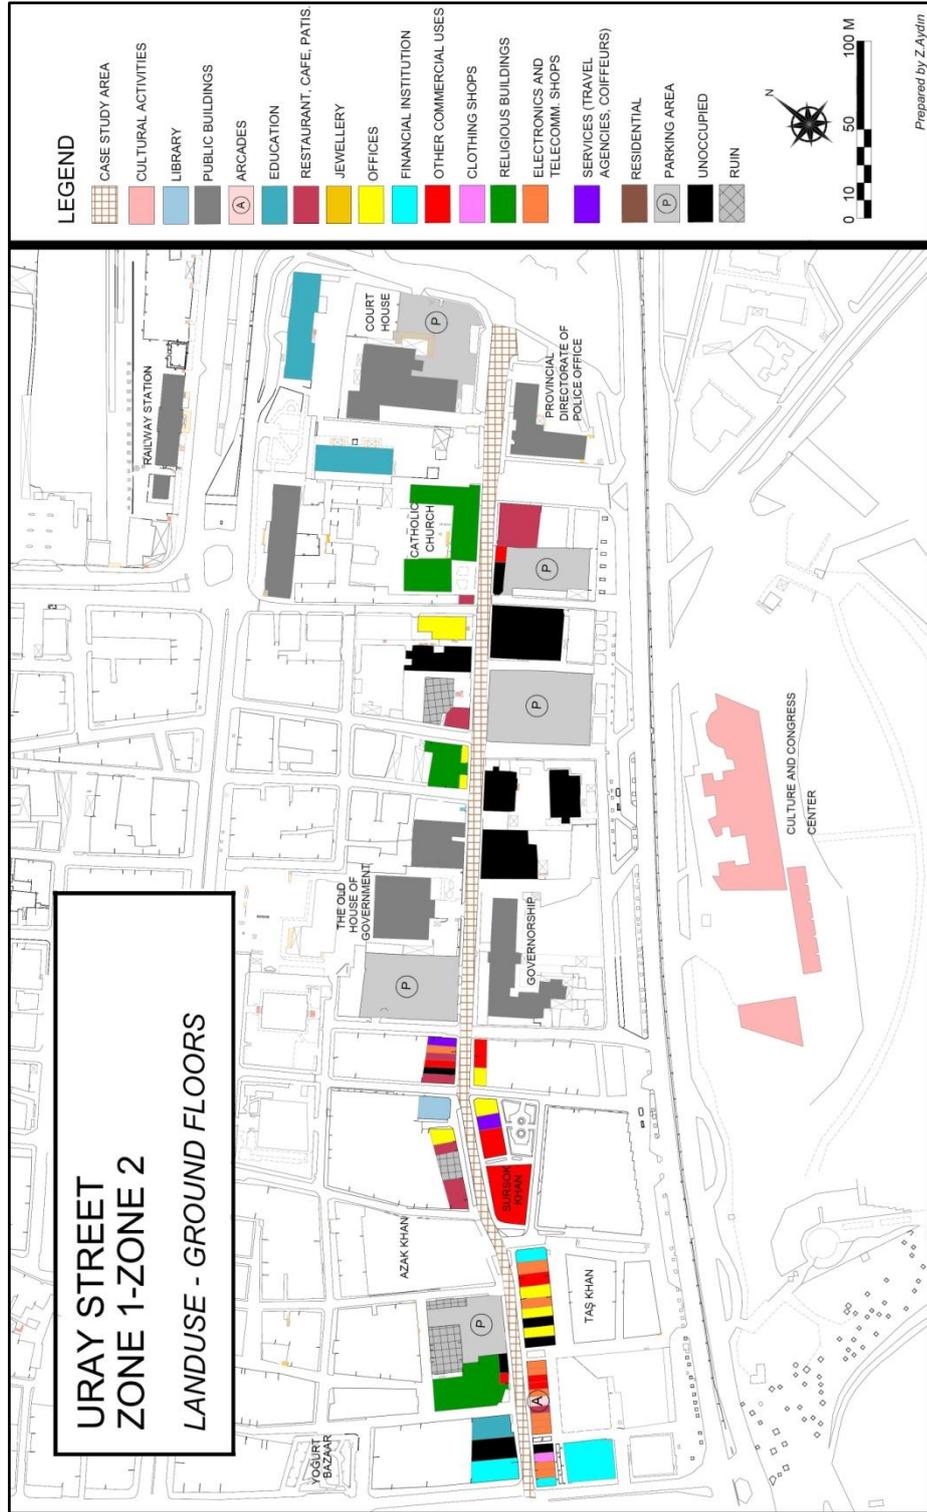
Figure 4-16: Land use / ground floors in Uray Street

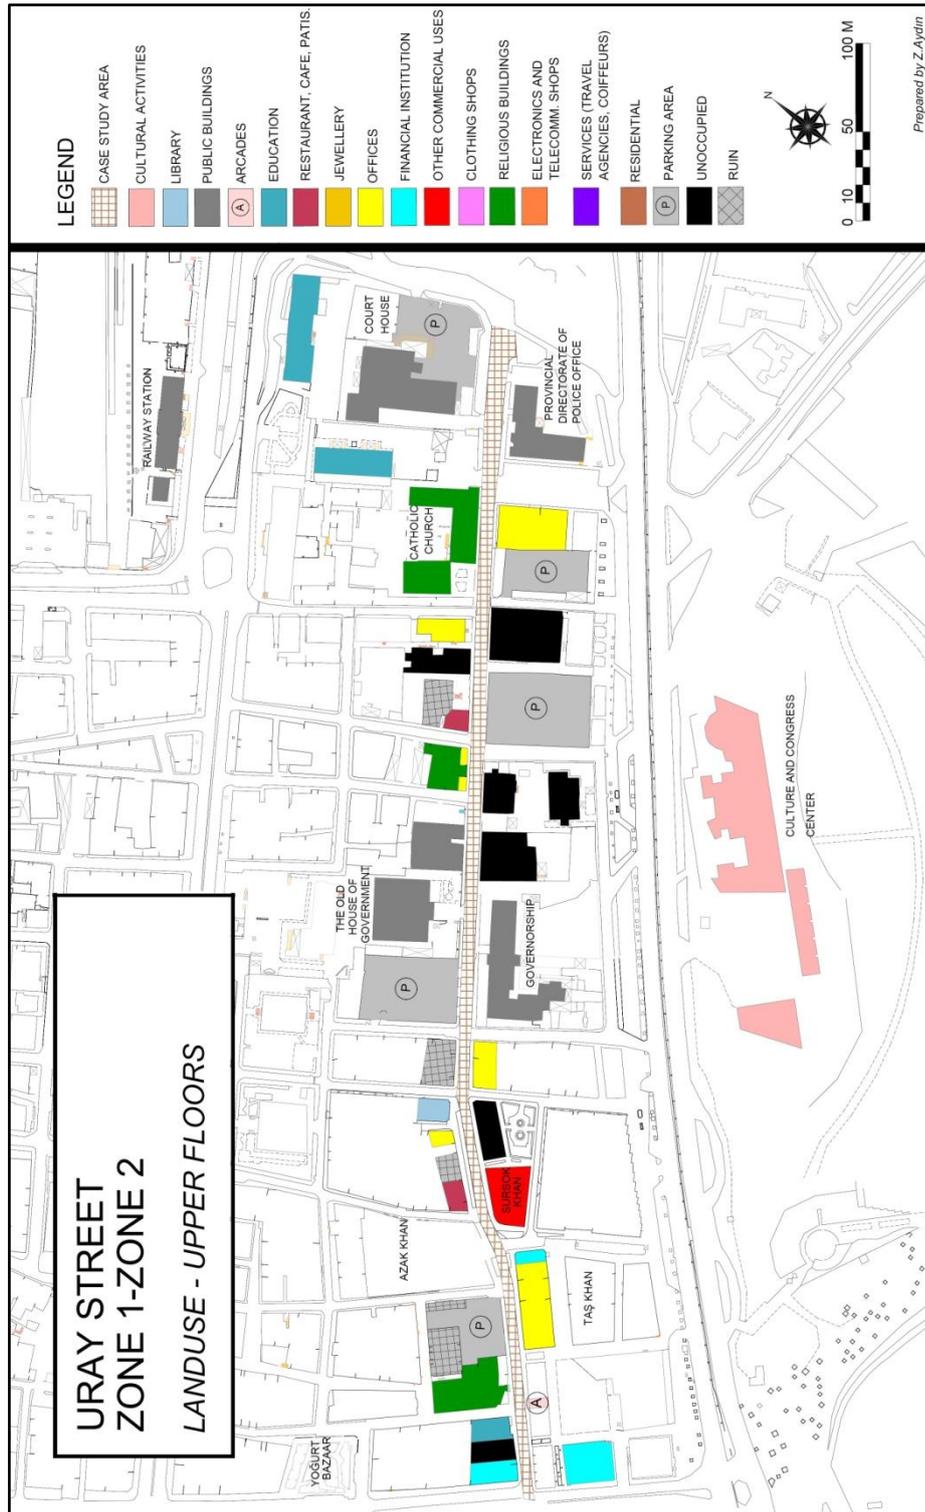
Figure 4-17: Land use / upper floors in Uray Street

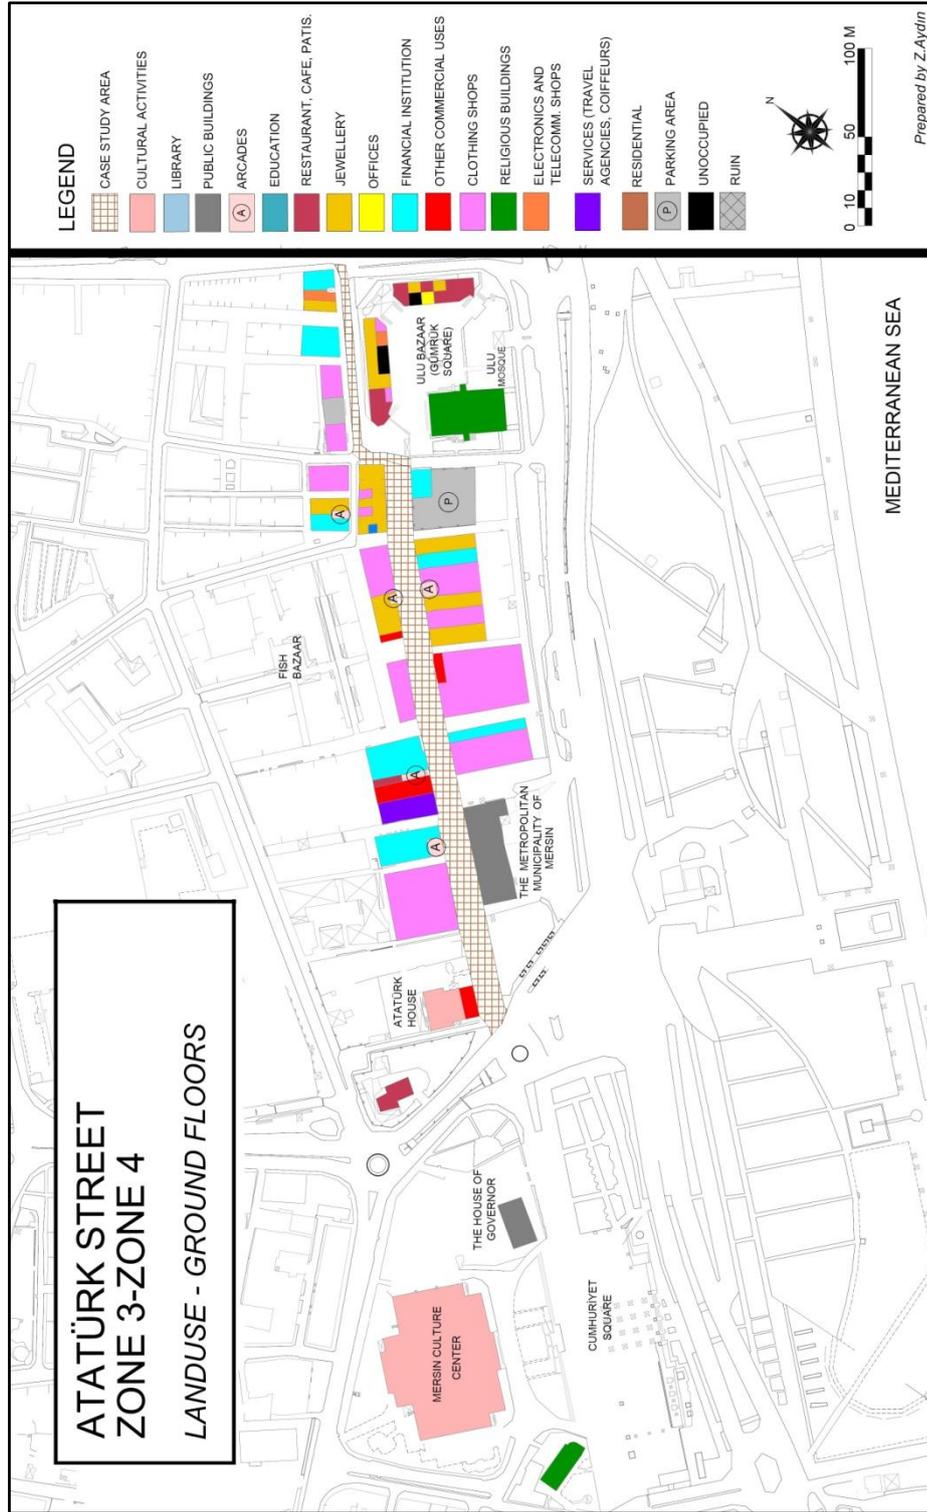
Figure 4-18: Land use/ ground floors in Atatürk Street

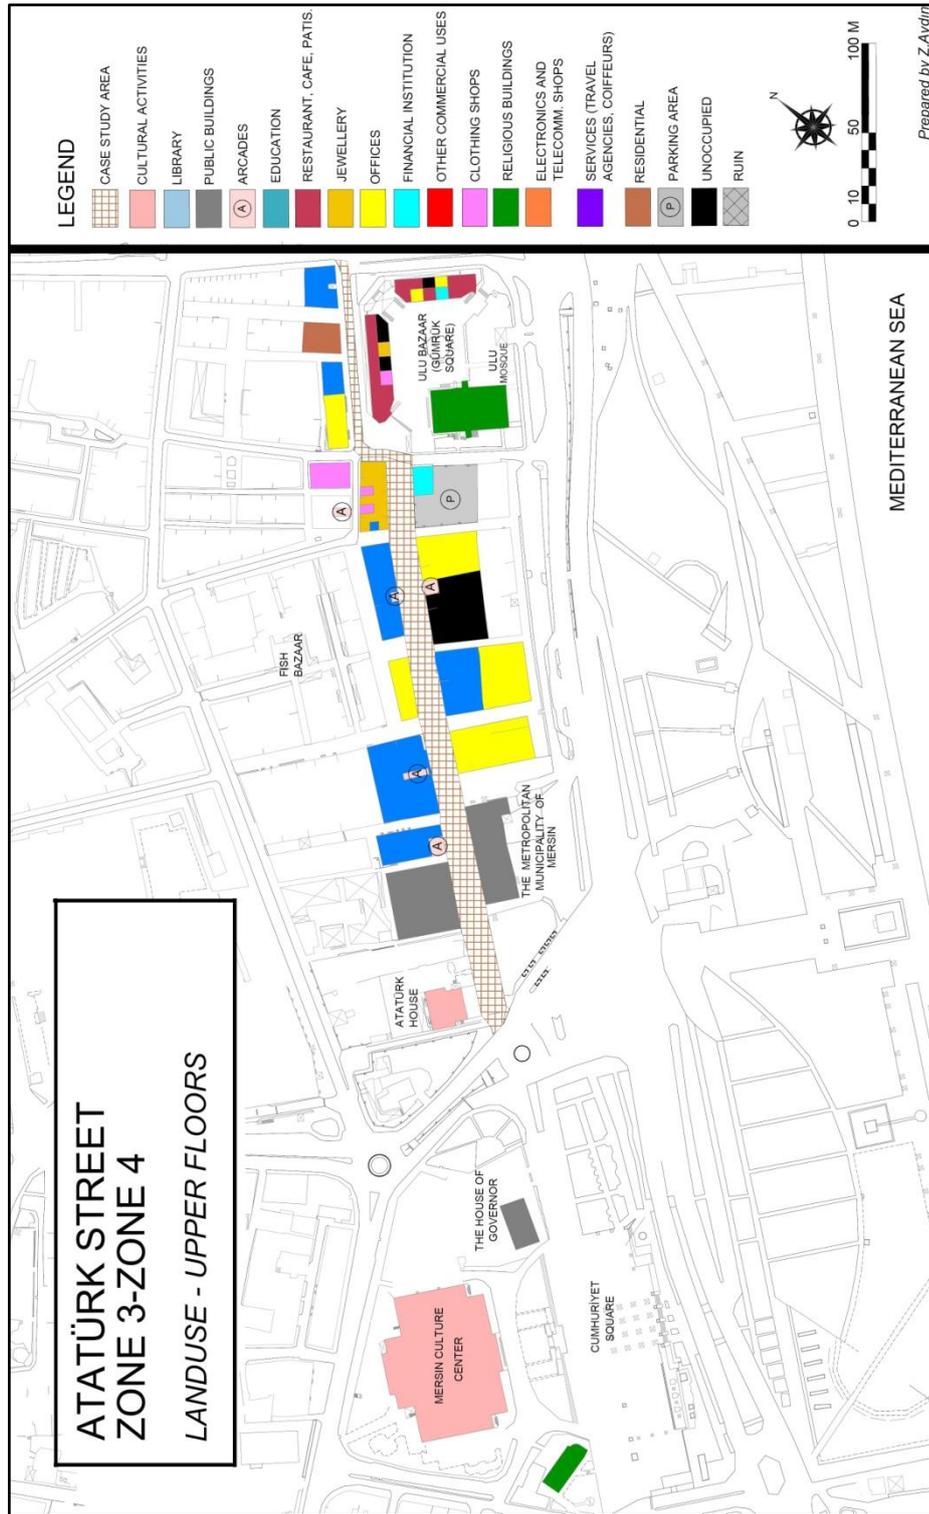
Figure 4-19: Land use/ upper floors in Atatürk Street

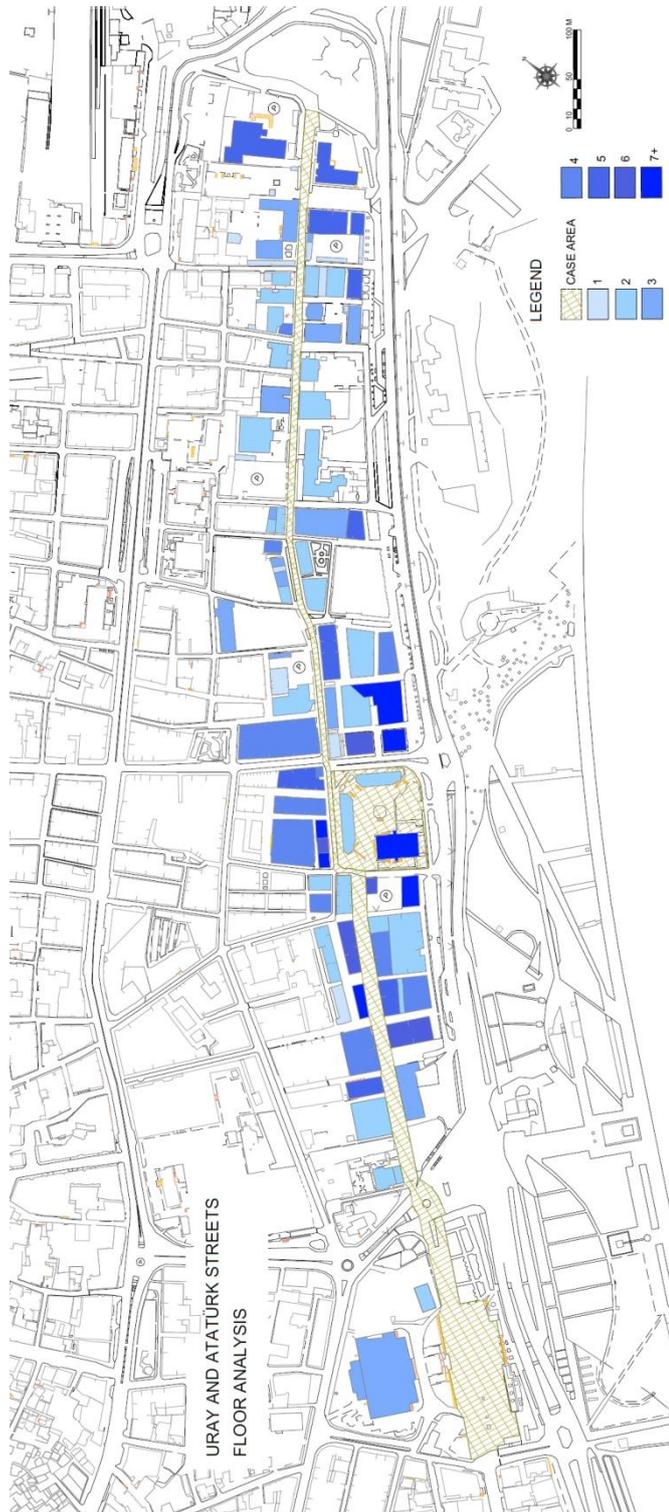
Figure 4-20: The height of buildings in Uray and Atatürk Streets

In Z3 that includes Ulu Bazaar, Ulu Cami and their near surrounding, because of junction of Uray, Atatürk and Hastane Street, there are buildings higher than 4-5 floors. In addition, buildings lie parallel to İsmet İnönü Boulevard are higher than 10 floors. In Z4, although it is a pedestrianized street, the most of buildings are higher than 3-4 floors and there is a coherence between them (Figure 4-20).

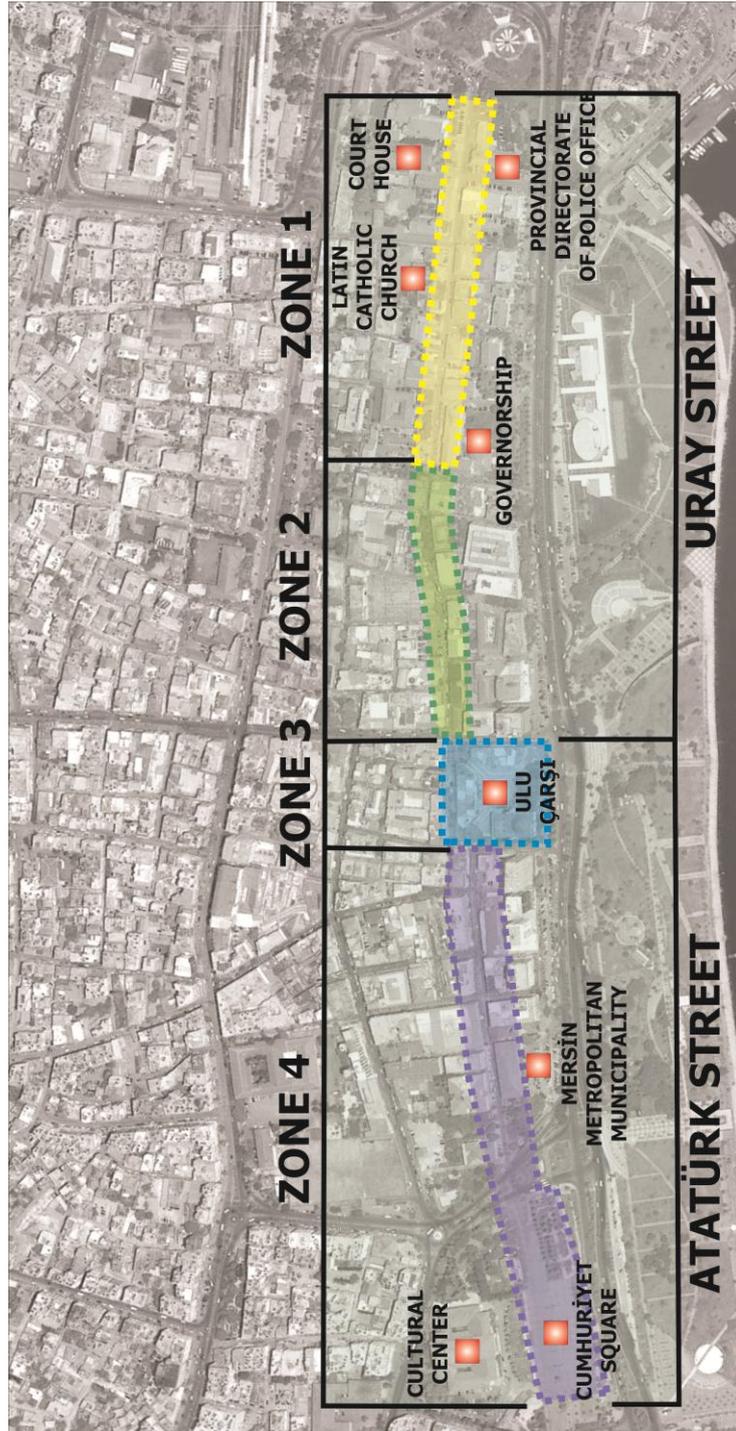
Figure 4-21: The zoning map of Atatürk and Uray Streets (prepared by Z.S. Belge).

These four zones are used in the following sections of the study to assess the walkability capacity of these zones and their comparison between each other. Therefore, the success and handicaps of current system in the case study area will be investigated in details in the next chapter. Zones are used with their initials as Z1, Z2, Z3 and Z4.

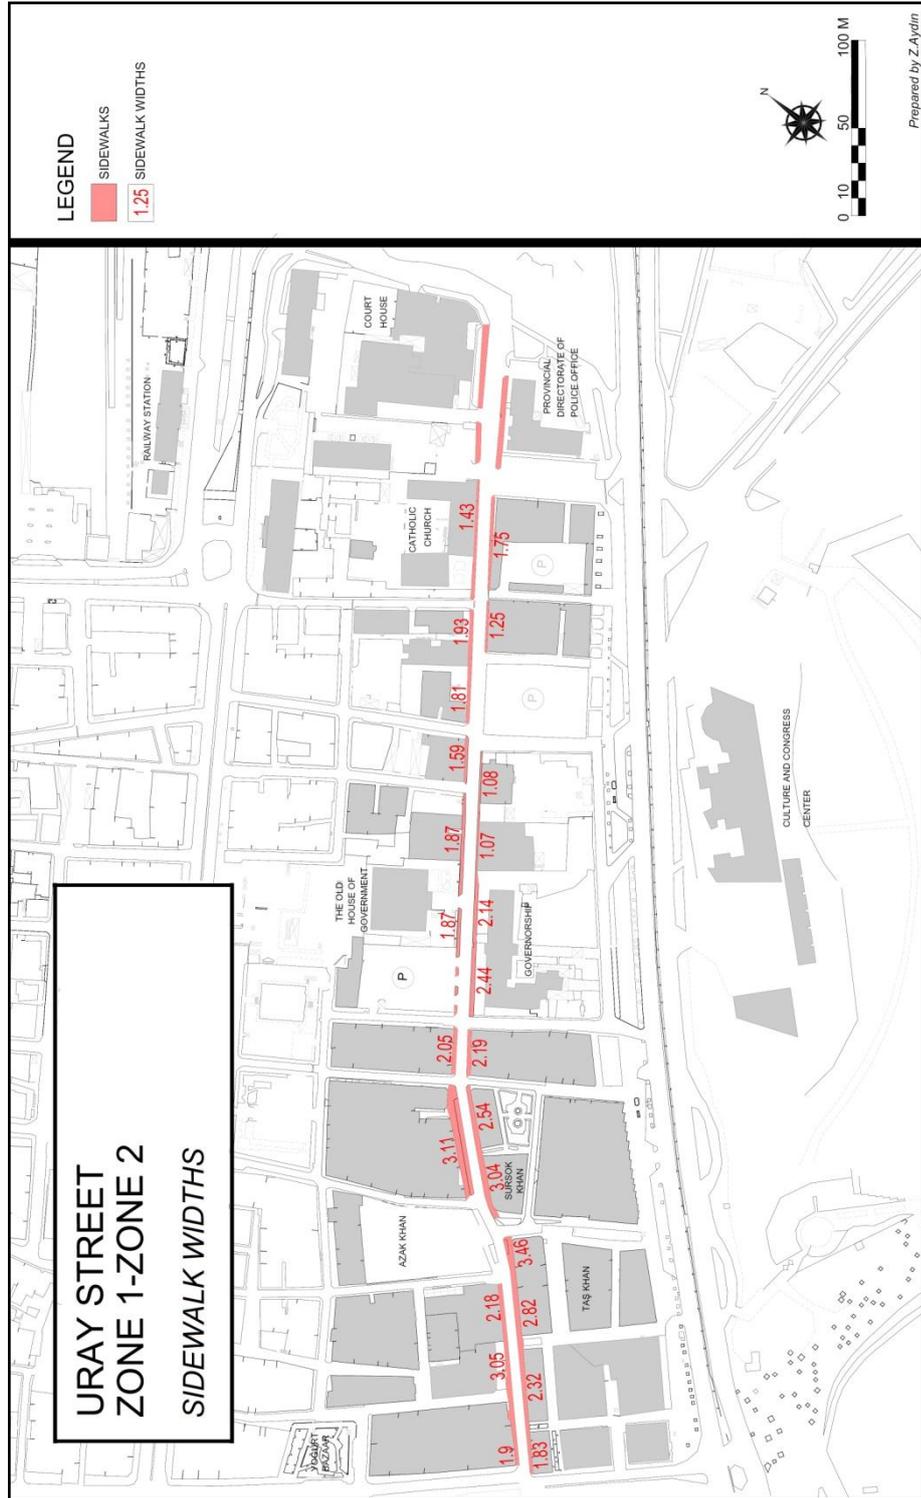
Figure 5-29: Sidewalk Widths of Z1 and Z2

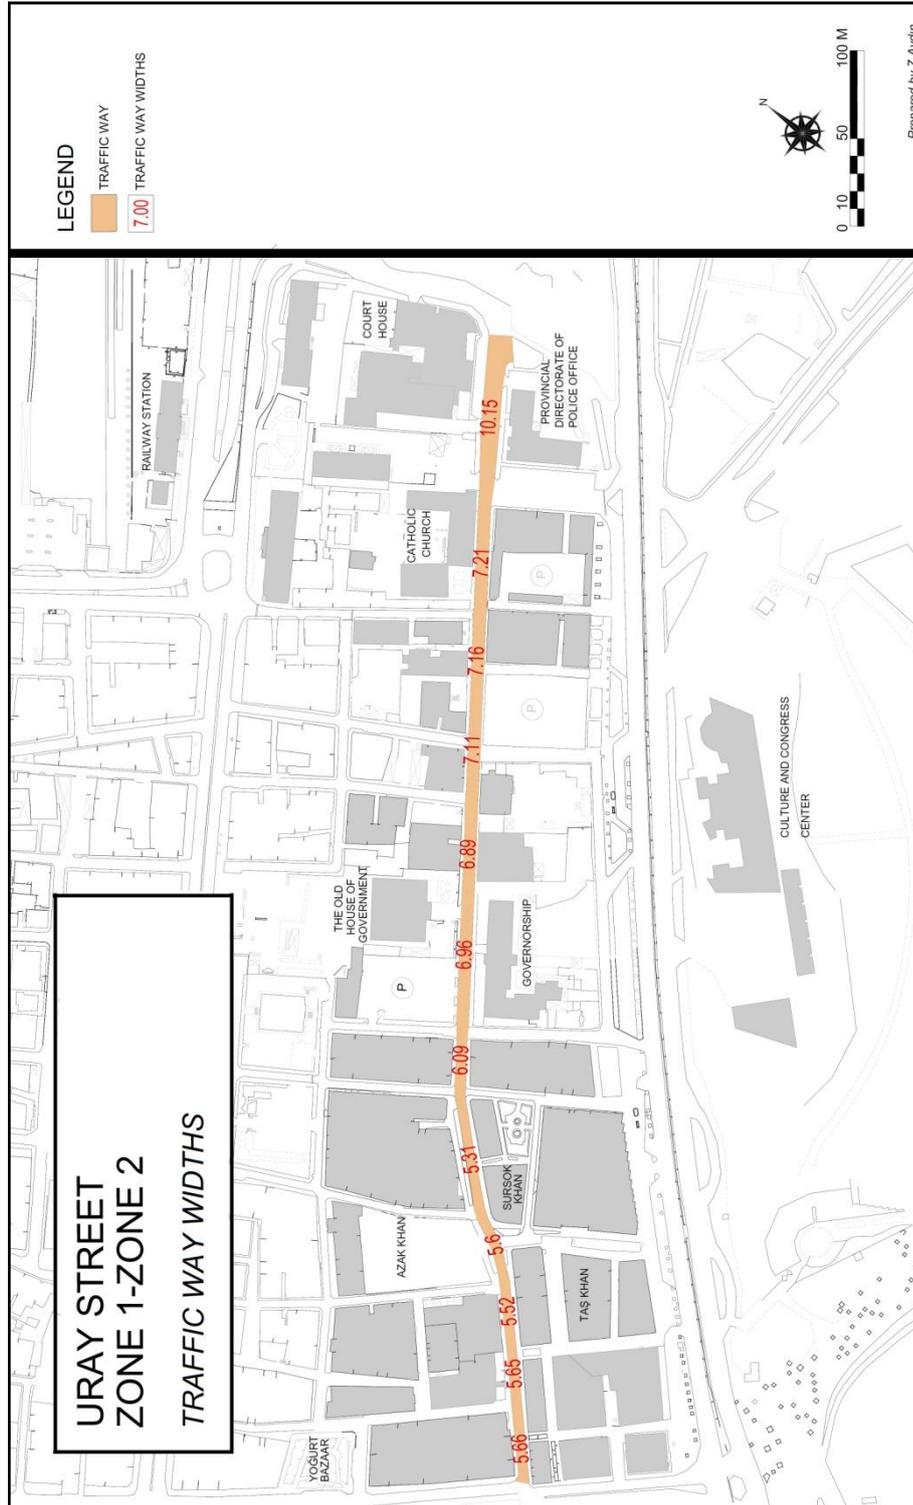
Figure 5-30: Traffic Way Widths of Z1 and Z2

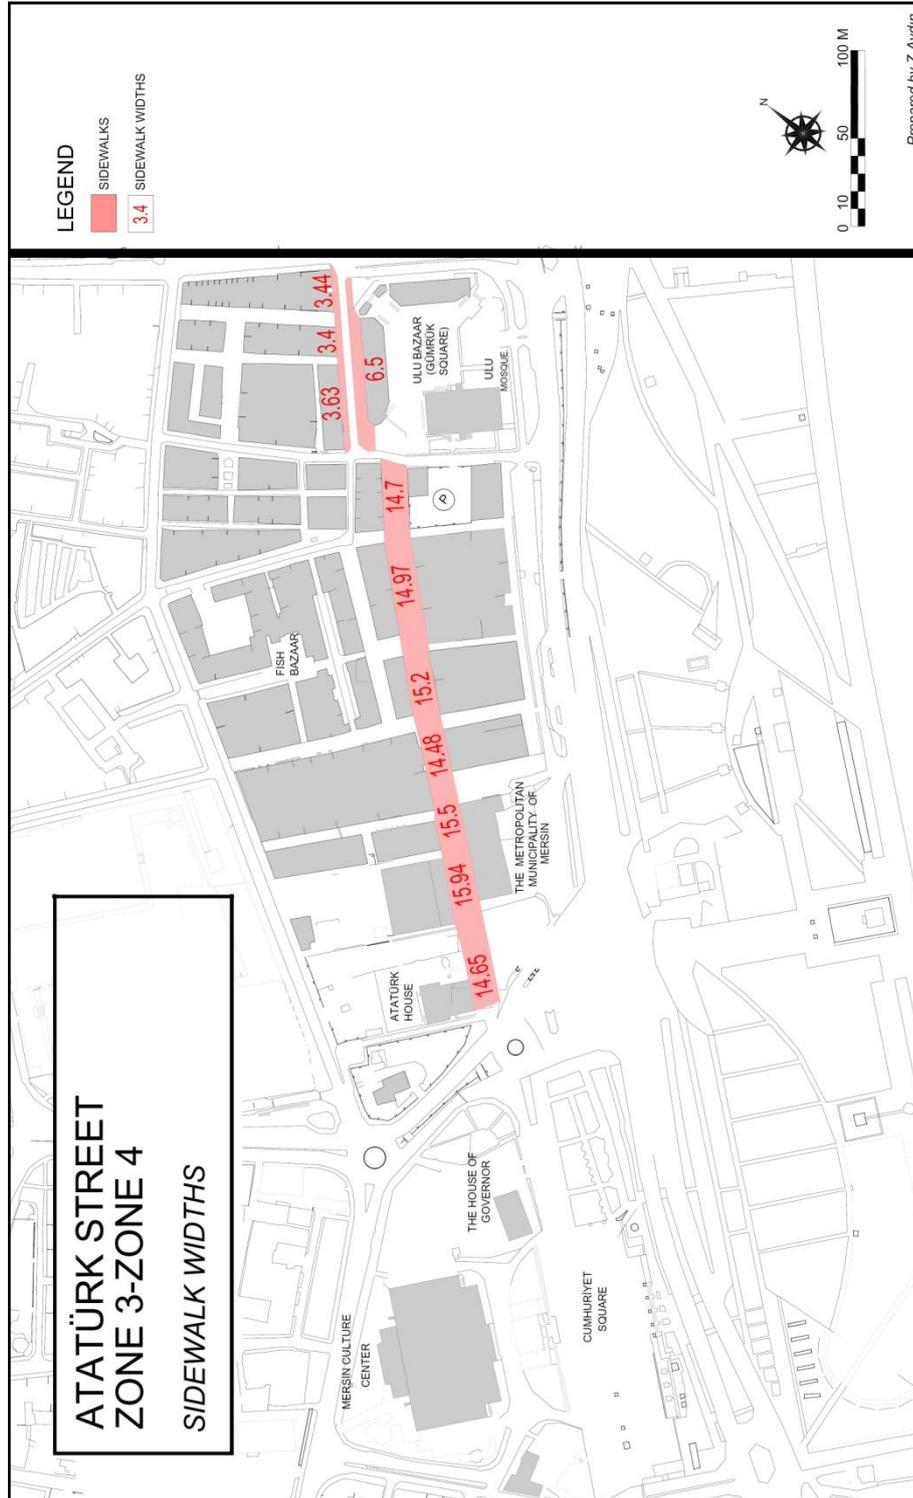
Figure 5-31: Sidewalk Widths of Z3 and Z4

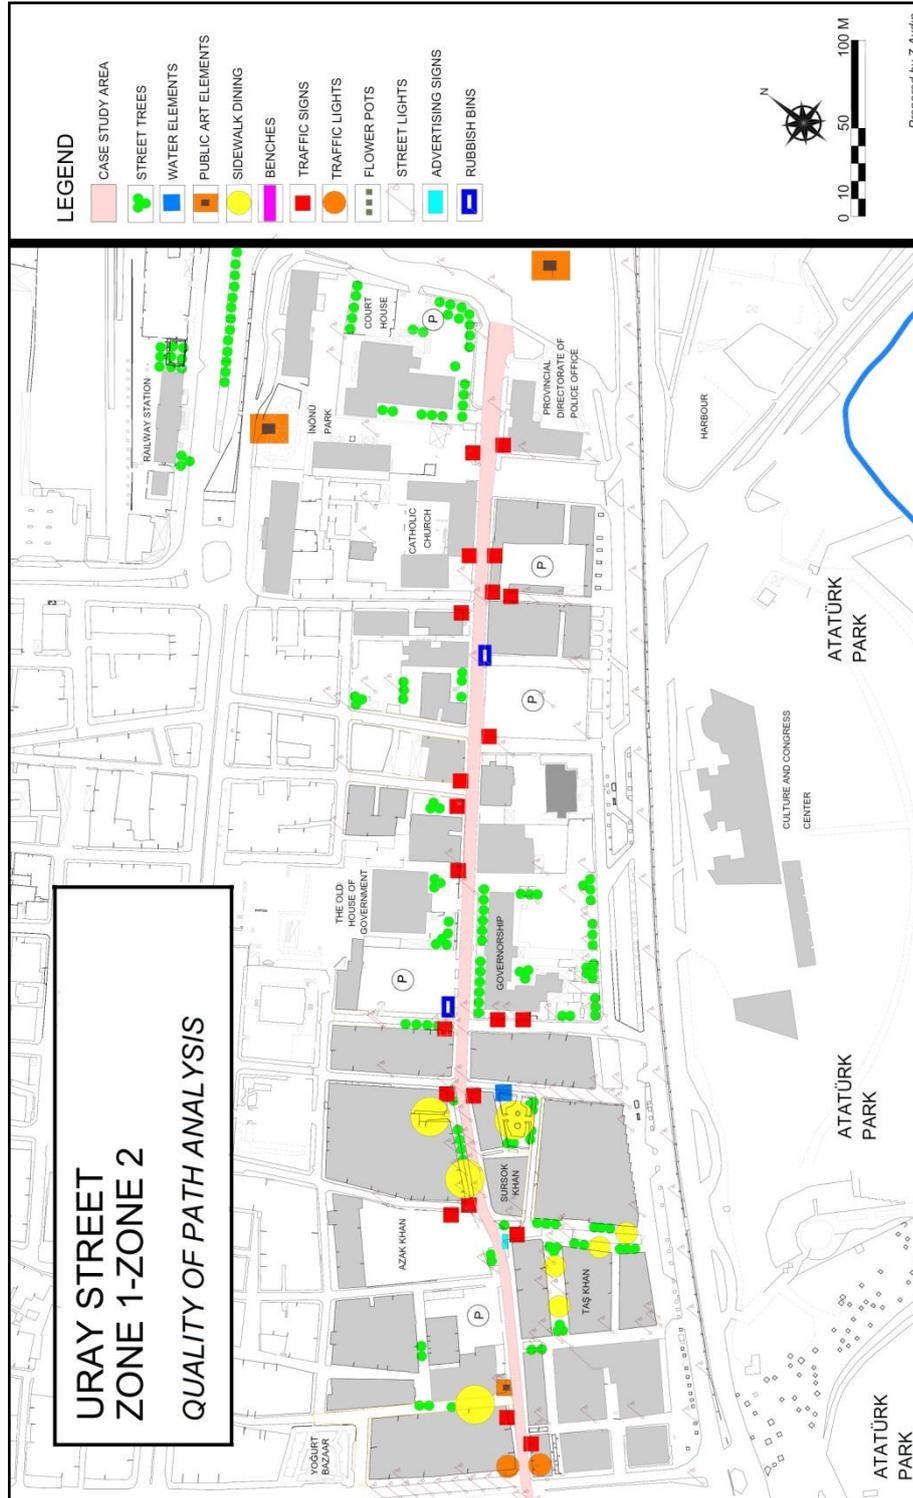
Figure 5-67: Quality of path analysis / Uray Street

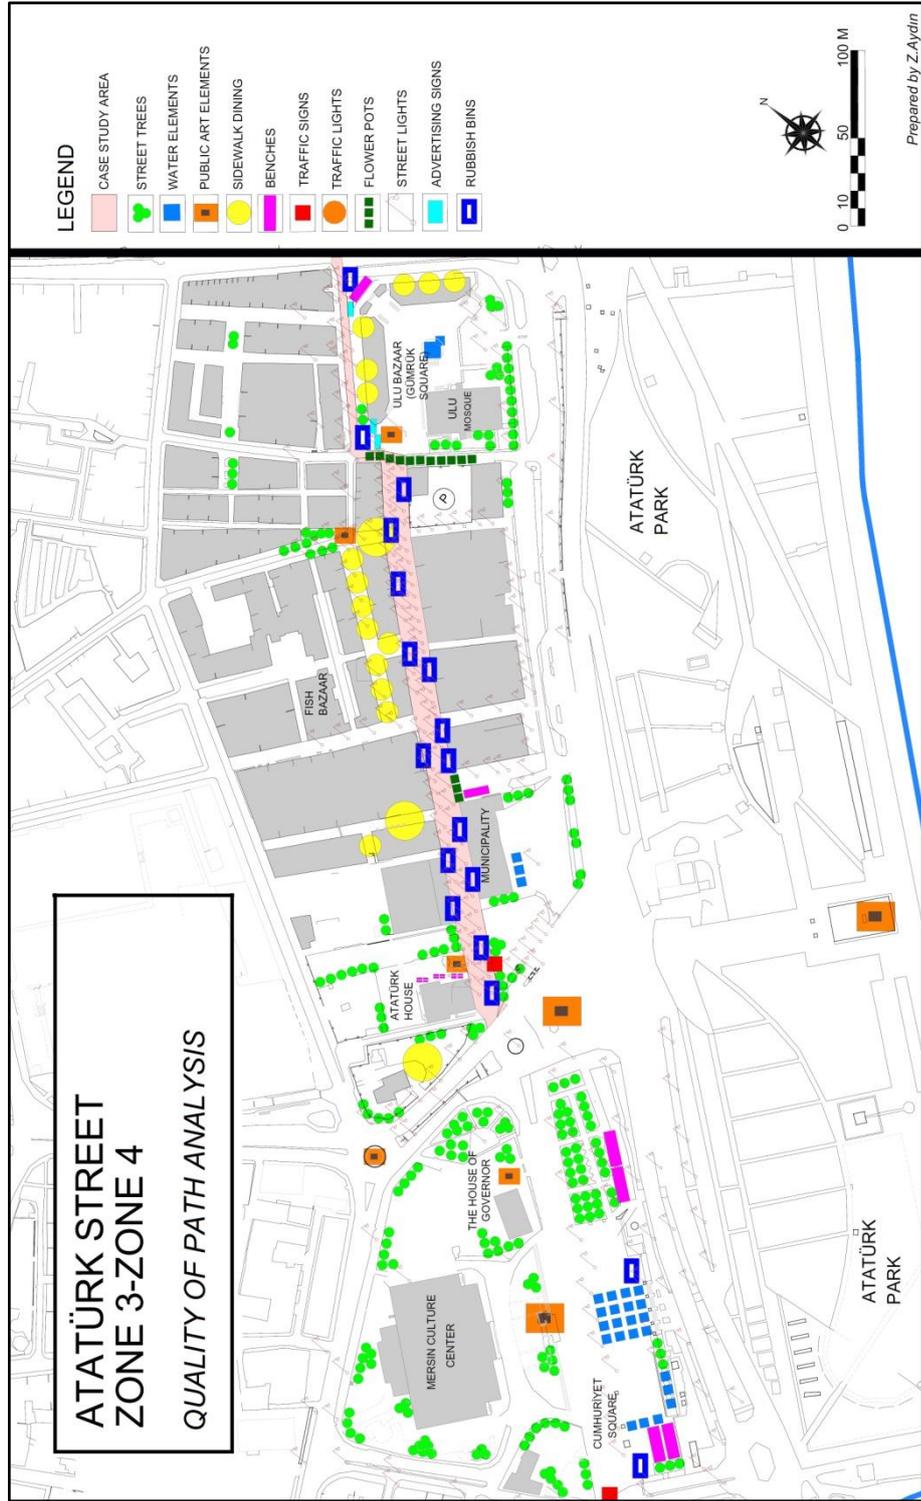
Figure 5-68: Quality of path analysis / Atatürk Street
