INCREASING WALKABILITY CAPACITY OF HISTORIC CITY CENTERS:  
THE CASE OF MERSİN

A THESIS SUBMITTED TO  
THE GRADUATE SCHOOL OF NATURAL AND APPLIED SCIENCES  
OF  
MIDDLE EAST TECHNICAL UNIVERSITY

IN PARTIAL FULFILLMENT OF THE REQUIREMENTS  
FOR  
THE DEGREE OF MASTER OF SCIENCE  
IN  
URBAN DESIGN

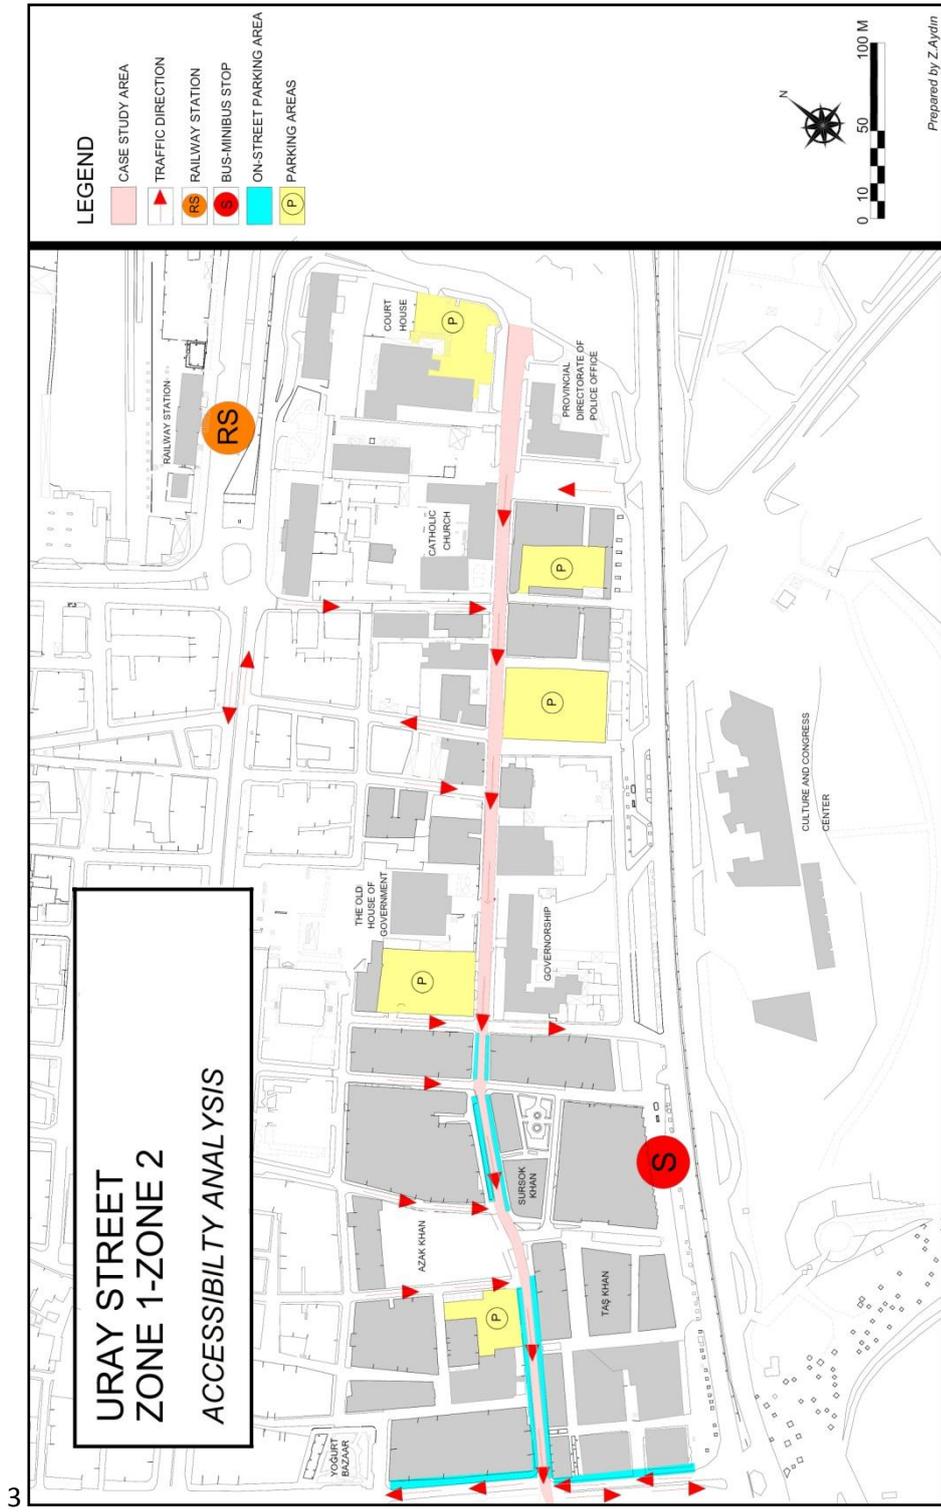
Figure 5-73: Accessibility Analysis / Uray Street

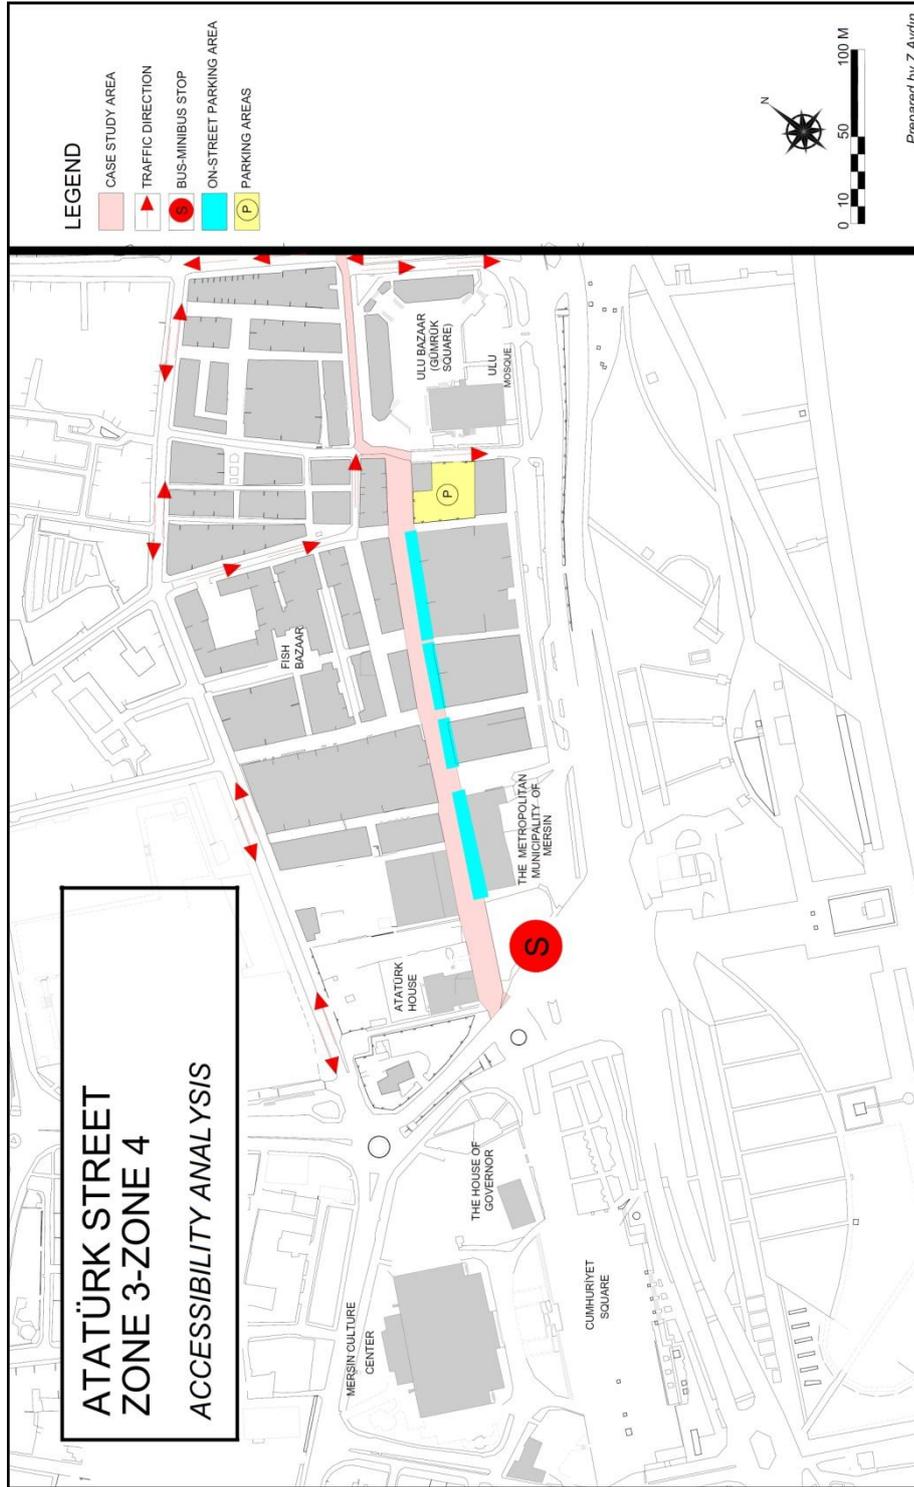
Figure 5-74: Accessibility Analysis / Atatürk Street

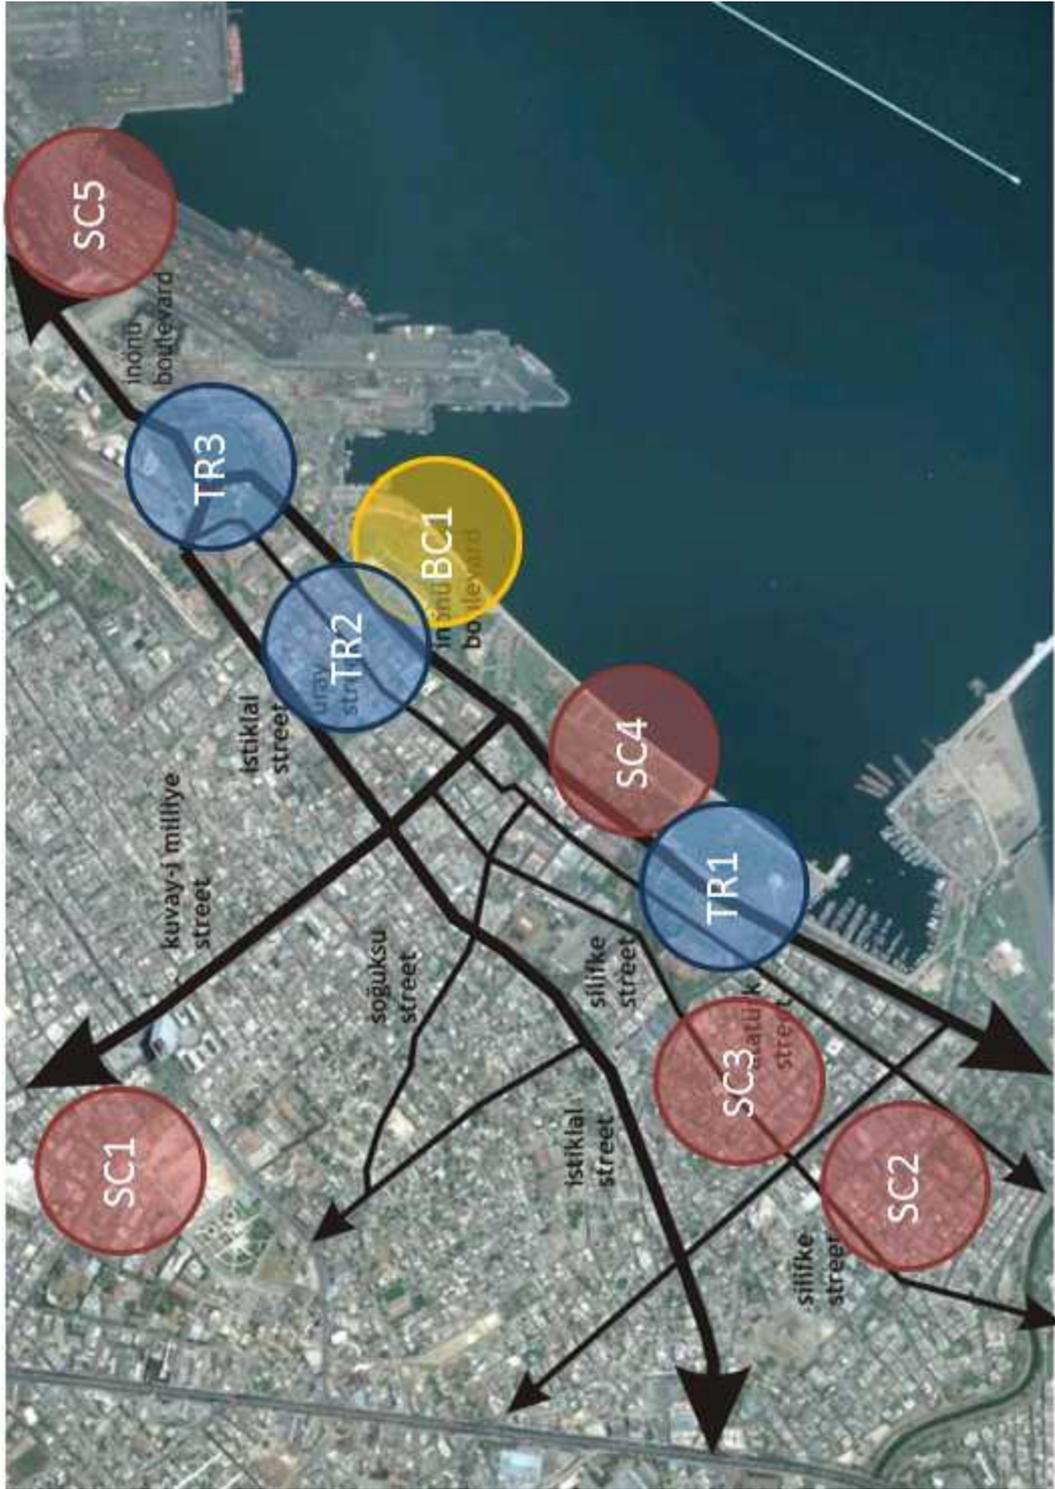
Figure 6-1: Main spatial problems in the case study area effecting walkability capacity.

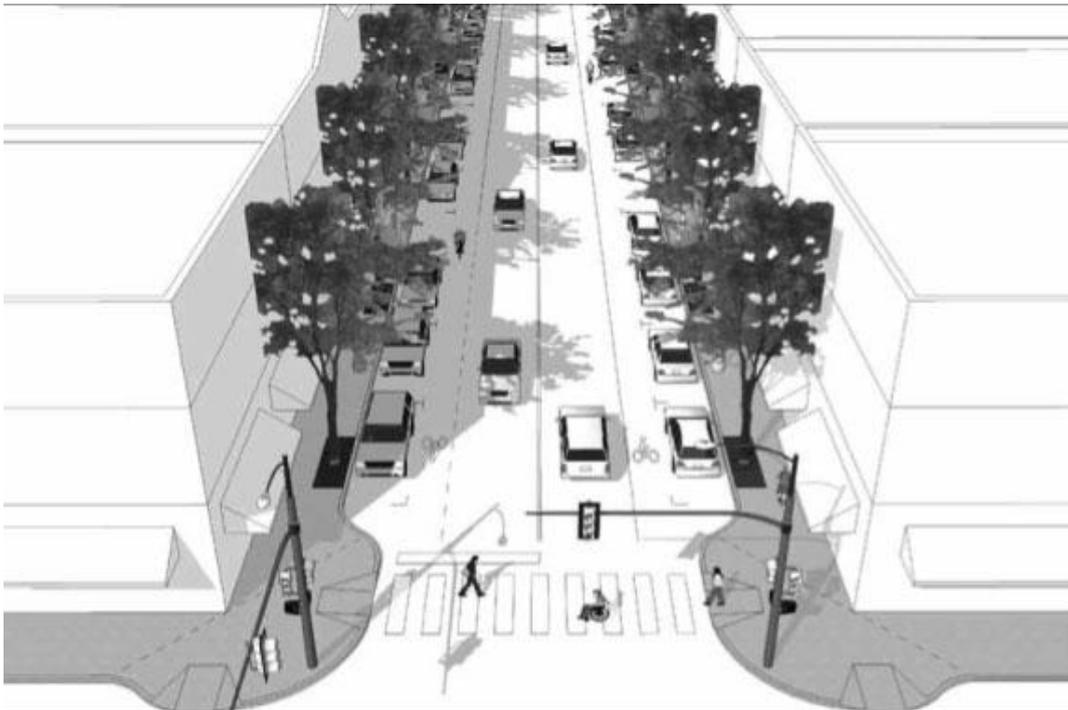
Figure 6-4: Traffic calming elements such as curb extensions, textured crosswalks, bollards, and plantings that encourage pedestrians to walk around within slowing vehicular traffic, and disabled people to increase their ease of movement and accessibility. (<http://www.streetsblog.org/2010/04/08/making-streets-for-walking-dan-burden-on-reforming-design-standards/>)
