RESOLVING THE HISTORIC URBAN TISSUE BY TRACING THE CHANGES AS A BASIS FOR ITS  
CONSERVATION: SAMSUN FROM 20<sup>TH</sup> CENTURY UNTILL TODAY

A THESIS SUBMITTED TO  
THE GRADUATE SCHOOL OF NATURAL AND APPLIED SCIENCES  
OF  
MIDDLE EAST TECHNICAL UNIVERSITY

IN PARTIAL FULFILLMENT OF THE REQUIREMENTS  
FOR  
THE DEGREE OF MASTER OF SCIENCE IN RESTORATION  
IN  
ARCHITECTURE

JANUARY 2013

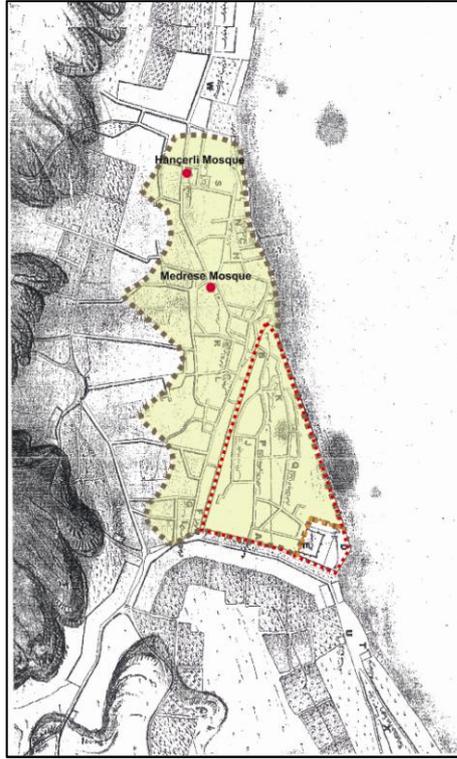
Figure 20: Map showing the approximate area that is affected by fire<sup>45</sup>

Mr. Briyo, the Chief Engineer of Trabzon Province, came to Samsun and examined the fire zone with the engineer Mr. Hirsan (Sarisakal, 2007). According to their report, an area of 125 000 square meters is primarily affected by the fire and shops and houses in this area are completely burned.

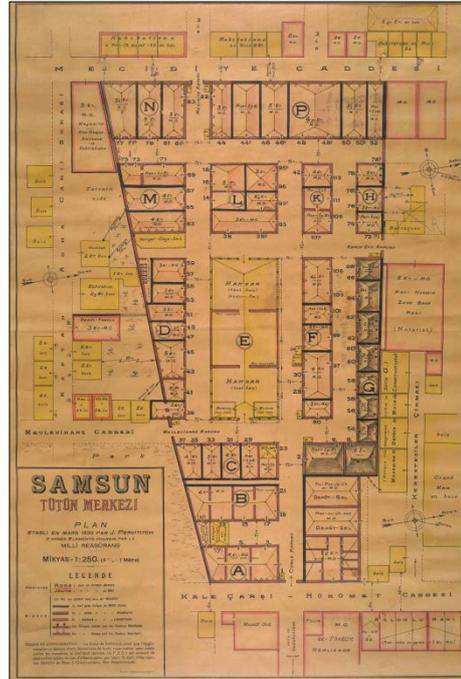
Figure 65: 1930 map of the Samsun Tobacco Center drawn by Pervititch  
The map is retrieved from Ottoman Bank Archives in March 2012

Tobacco Center was an important place for Samsun because tobacco production was the main source of income. The tobacco center was a closed market area with divided with streets and it was constructed due to the protection of tobaccos from the weather conditions.

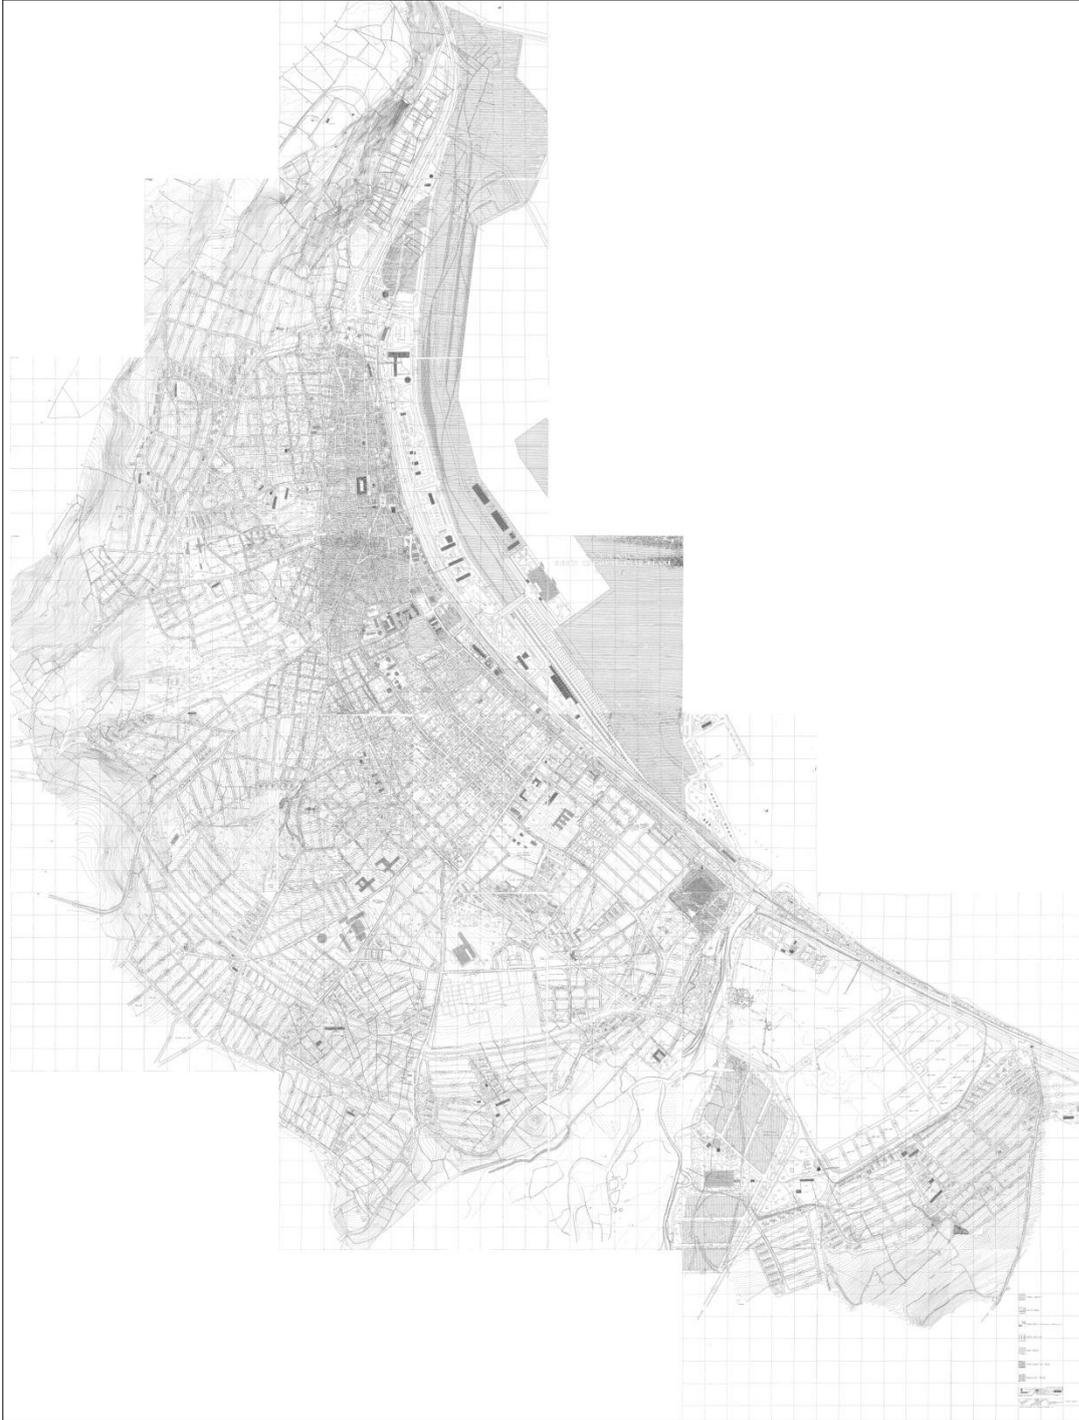
Figure 72: 1960 Samsun Development Plan in 1/1000 Scale

The most significant change of the urban character of Samsun can be seen from the 1960 development plan. In this plan, large boulevards are built, like *Atatürk, 100. Yıl and 19 Mayıs* Boulevards. Many buildings are demolished due to the construction of these boulevards and along these boulevards high-rise buildings began to be constructed.

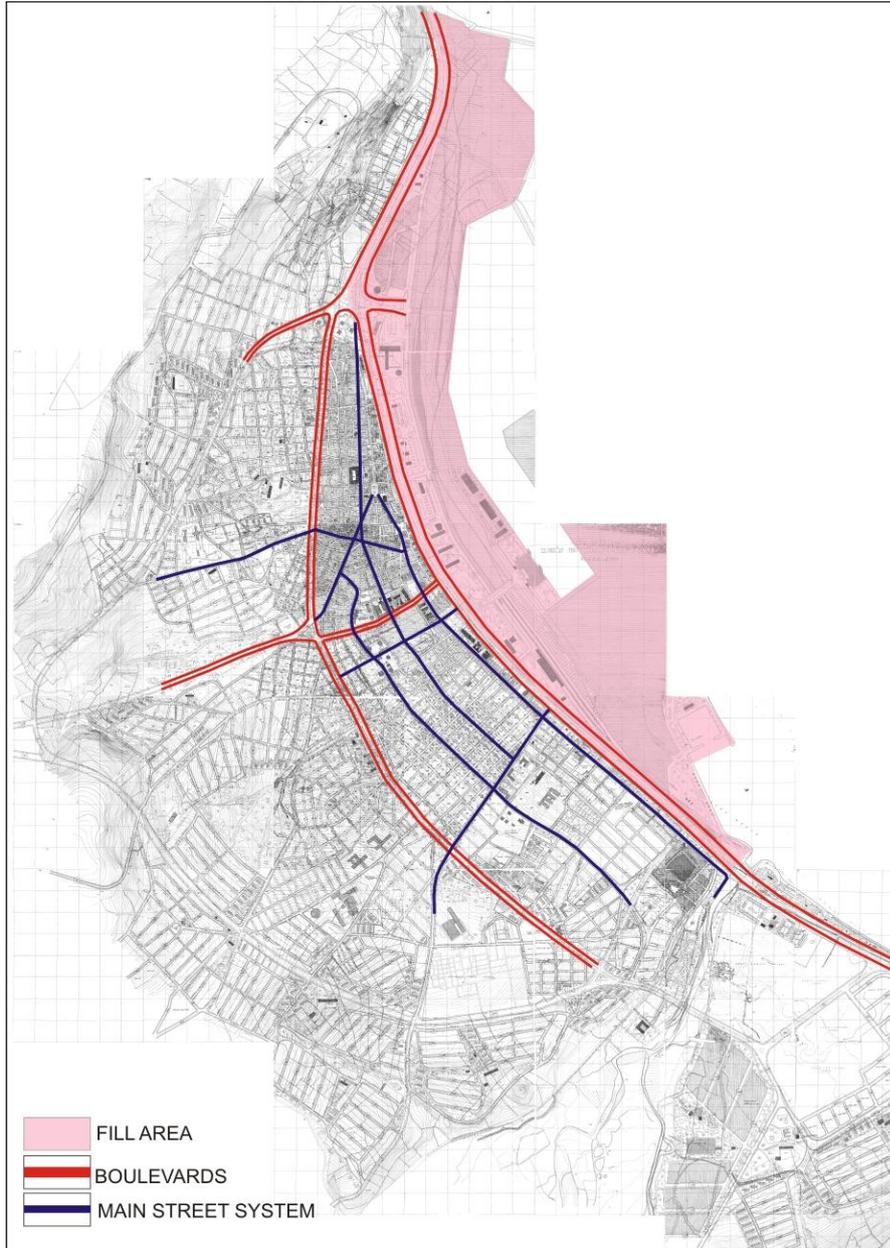
Figure 73: The boulevards and fill area that are proposed in 1960 plan<sup>67</sup>

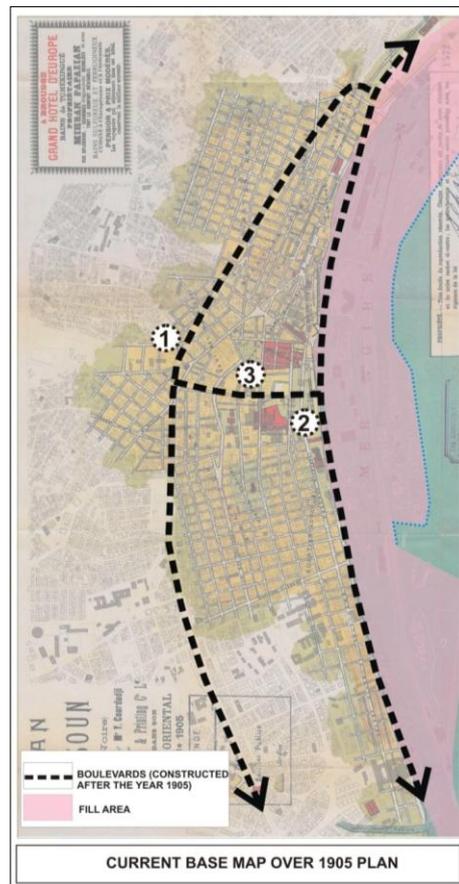
Figure 101: Superposition of the Boulevards and Fill Area with the 1905 plan<sup>84</sup>

The biggest changes that are evident when the 1905 plan and the current state of the city are compared are the boulevards and the fill area. In Figure 101, 3 different boulevards are shown on the 1905 plan. The no. 1 100. Yıl boulevard is 30 meters, the no.2 Atatürk Boulevard is 50 meters and the no. 3 May 19 Boulevard is 25 meters wide. When we consider the widths of these roads it is obvious that the boulevards which have been built within the historical tissue have caused a significant amount of destruction and damage in the tissue. The axis that the 100. Yıl Boulevard is on does not have any traces of the traditional tissue and this axis passes over residential areas. According to this it can be said that the 100. Yıl Boulevard has caused a lot of damage to the historical fabric of the area and destroyed many traditional structures. It has split neighborhoods and become a threshold. The no 2 Atatürk Boulevard passes through the coastline of the city and, for the length of the road's axis, no areas that were developed in the 1905 plan can be seen. The Atatürk Boulevard has cut the city off from the coast. The no 3 19 Mayıs Boulevard connects the 100. Yıl and Atatürk Boulevards to each other. A big part of the 19 Mayıs Boulevard axis is shown in the 1905 plan. Therefore the axis of this road was widened to become a boulevard. It can be said that developed areas along this road axis have been damaged during this widening.

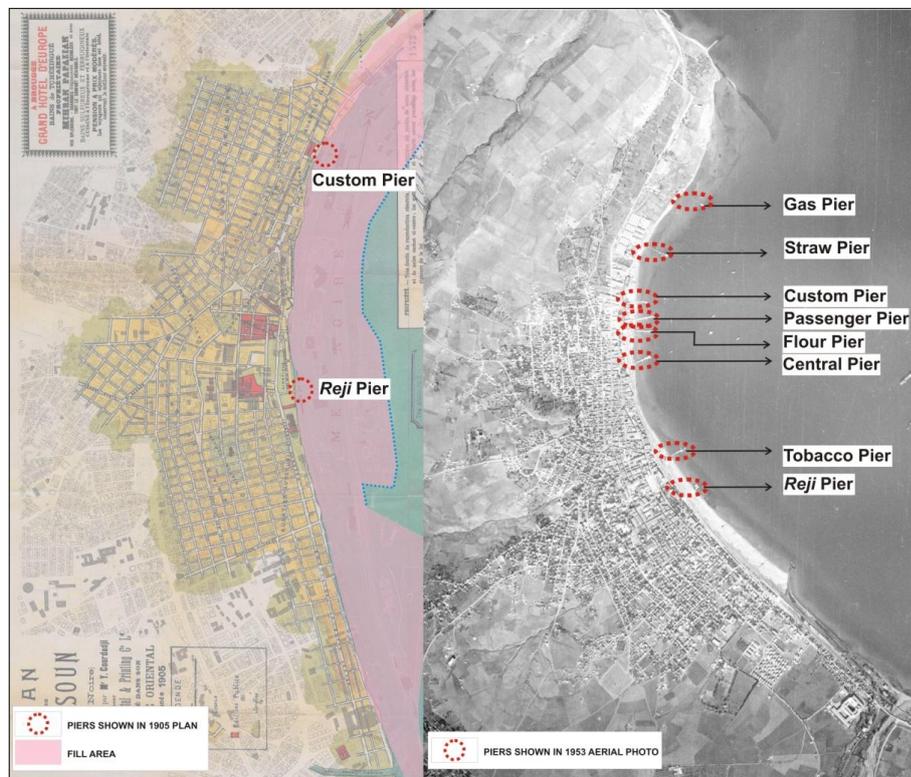
Figure 102: Location of the piers in 1905 plan on the left and 1953 aerial photo on the right<sup>85</sup>

Today the arrival of Atatürk and his friends to Samsun is monumentalized by the symbolic pier and sculptures made by Municipality of Samsun shown in figure 103. However, this symbolic pier is not in the place of the tobacco pier today. So, in case of urban memory, it serves an important problem by changing the historical data.

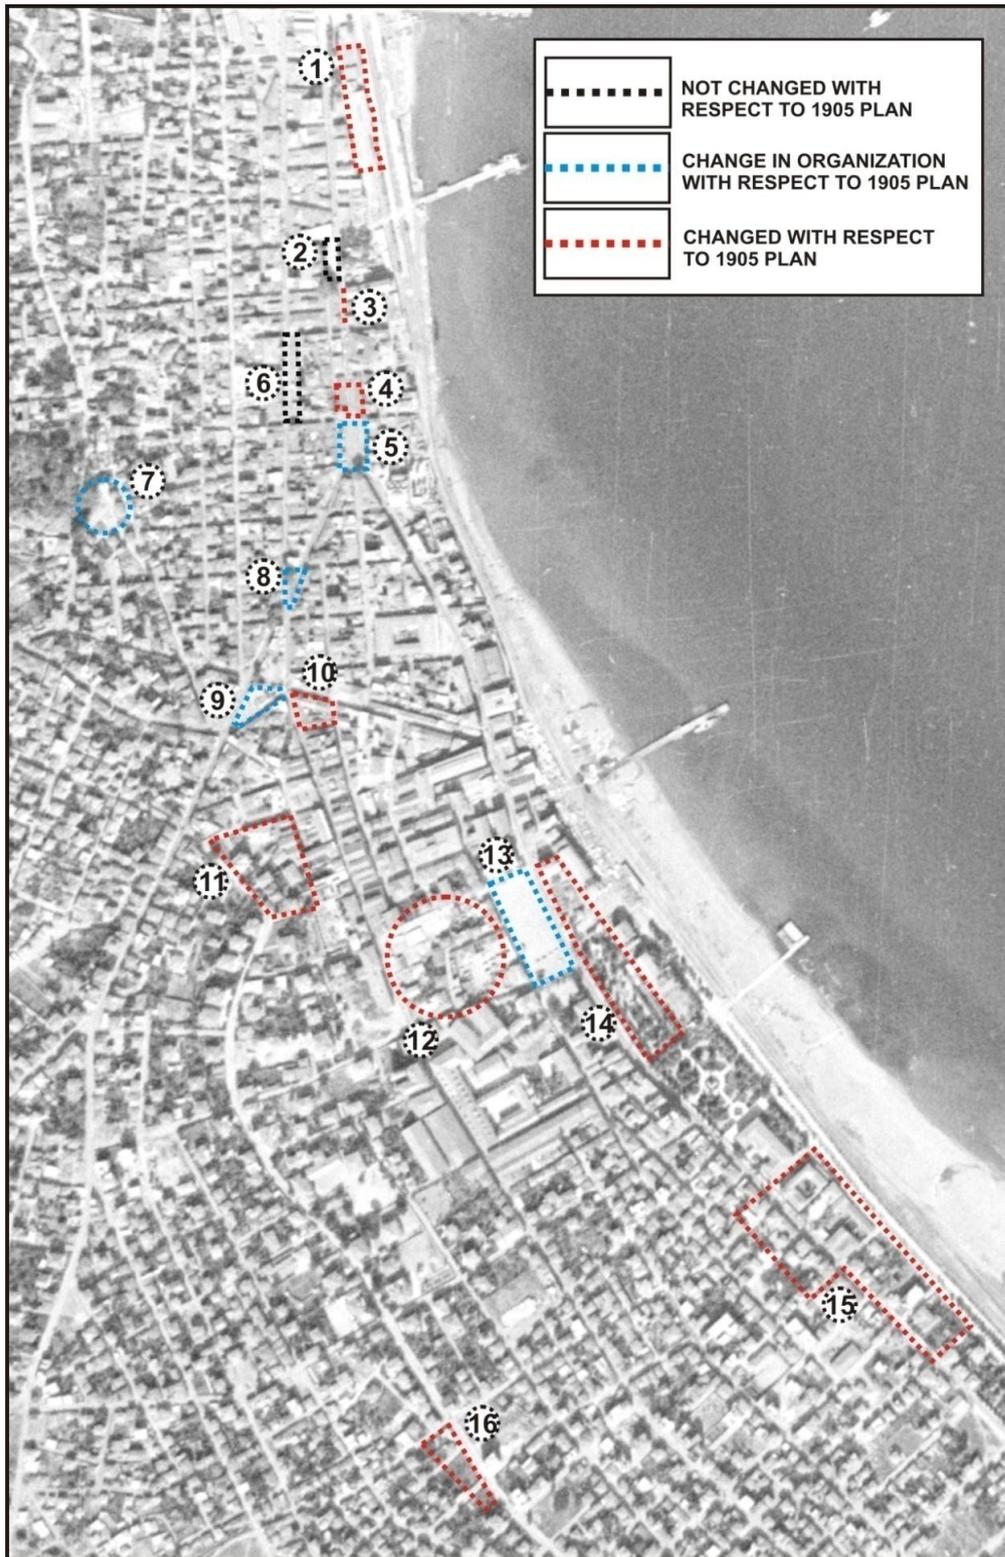
Figure 107: Change in open areas of the year 1953 with respect to the plan of 1905<sup>89</sup>

According to this, some of the open space areas are preserved without any changes even in their form; some of them have changed with some adjustments but are still open space areas, thirdly, the change in some of them are related to their forms but not the function; lastly, some of them have lost their function of being an open space area by construction. These open space areas are shown in Figure 106 as numbered. In Figures 107, 108, 109 and 110, to understand the process of change in the open space areas, the situations of them in the old aerial photos and in the old plans are examined. The aerial photographs and the plans are ranked in chronological order, but, in some cases, one change existing in the 1960 development plan is observed that it hadn't been reflected in the 1972 aerial photograph yet. This is a result of the delays in the implementation of the decisions of the plan.

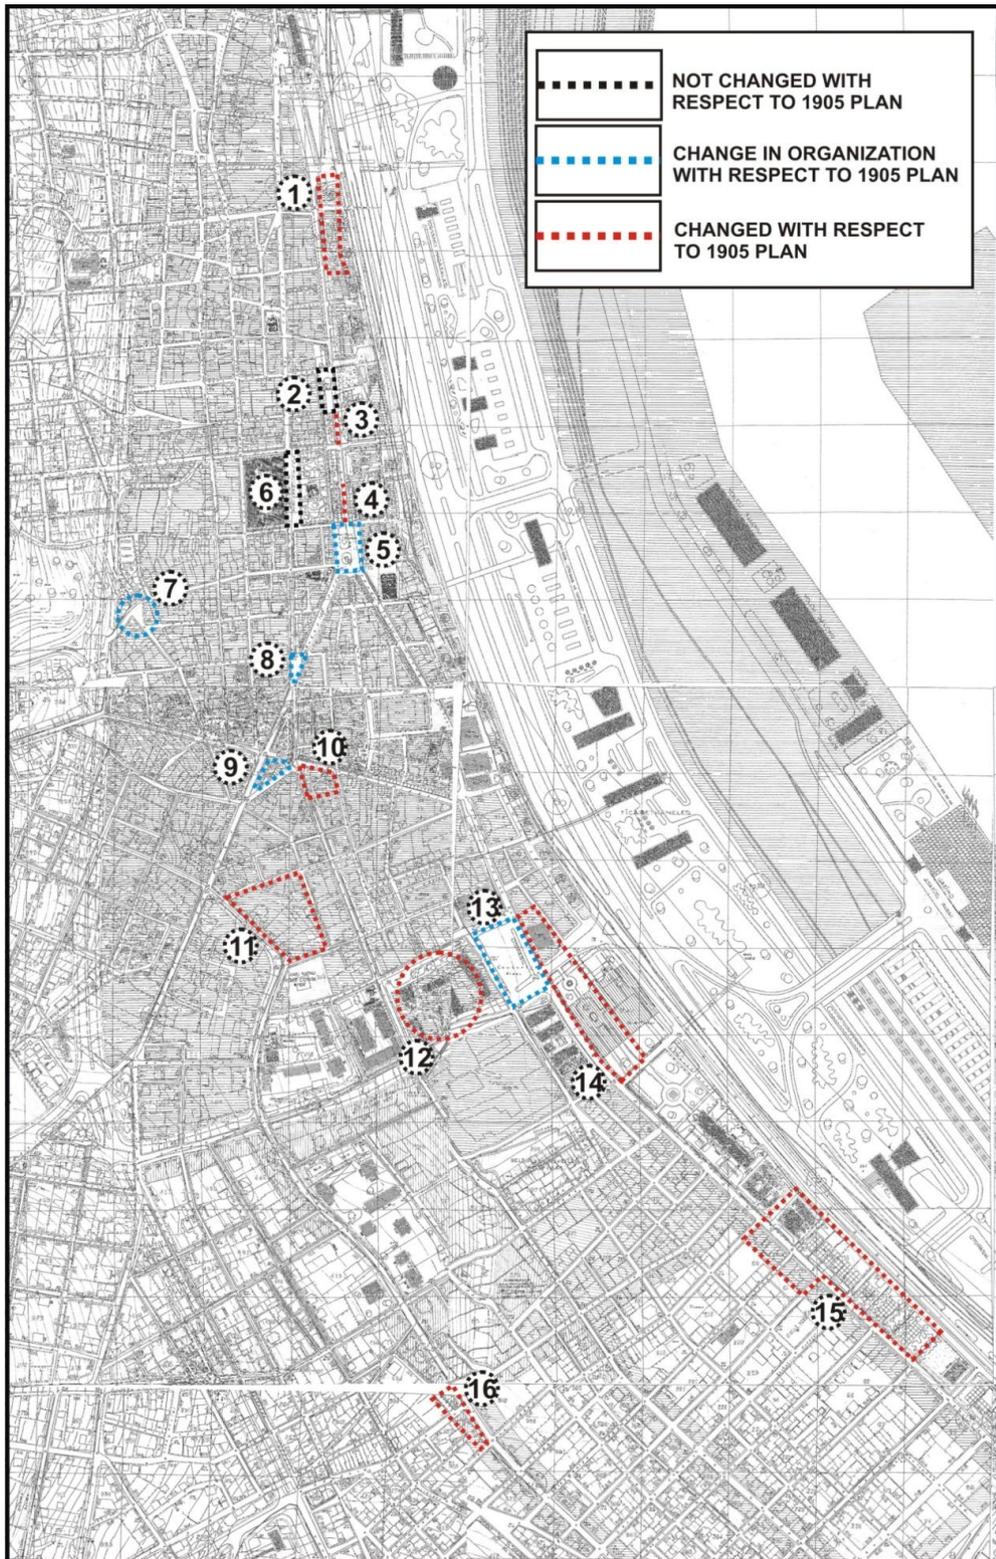
Figure 108: Change in open areas shown in the plan of 1960 with respect to the plan of 1905<sup>90</sup>

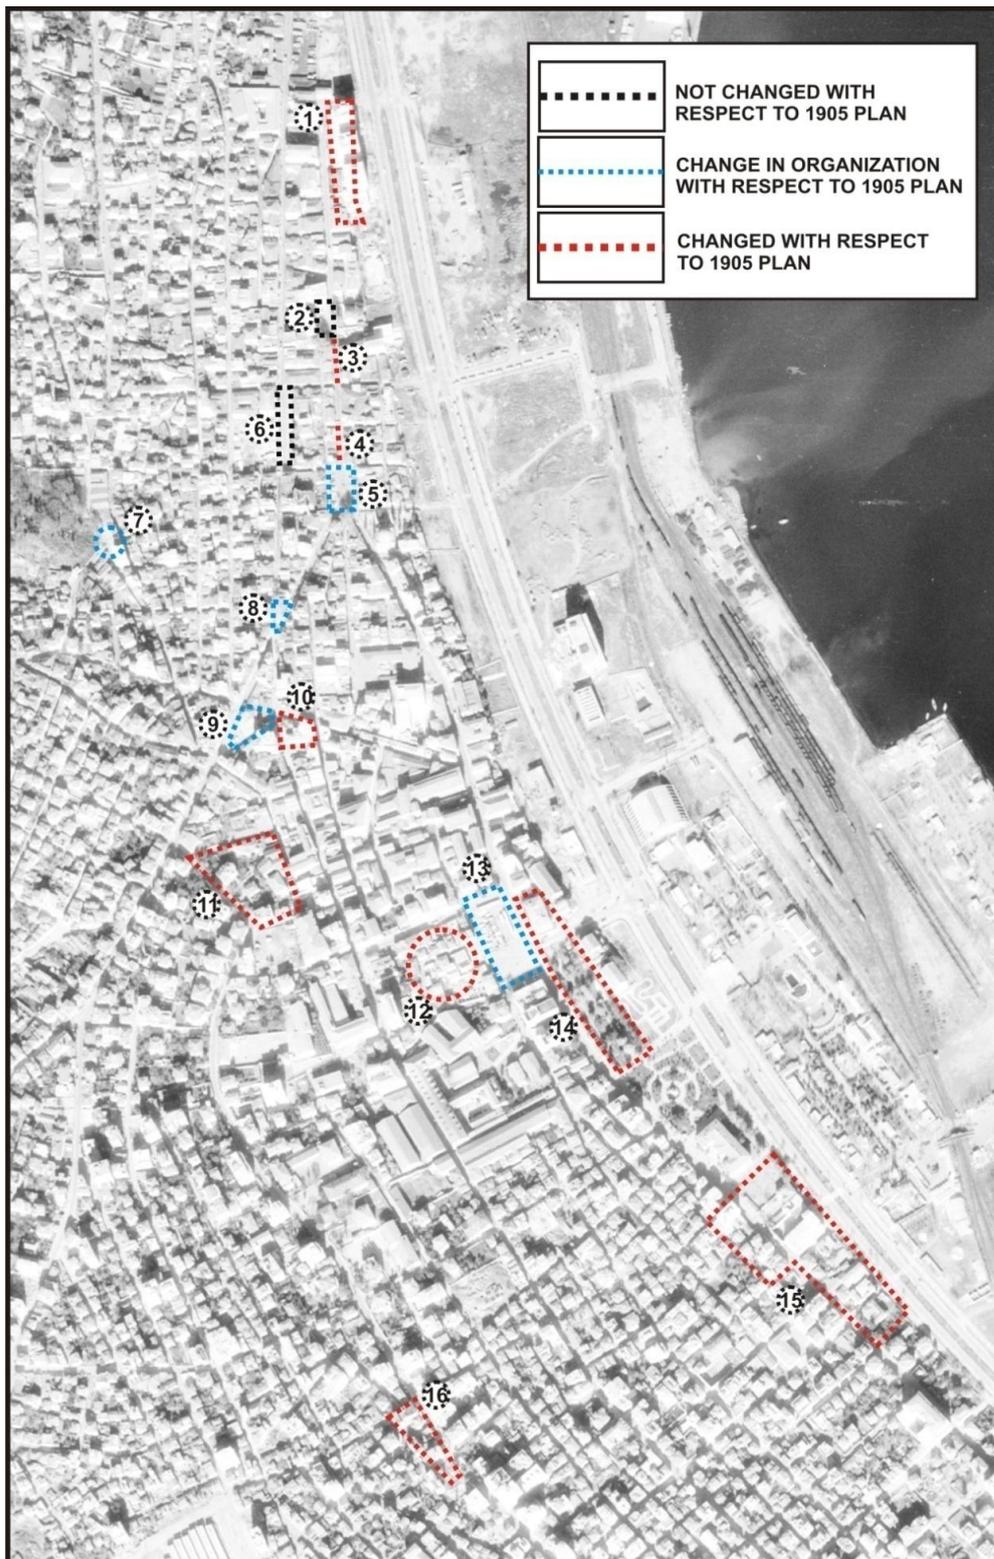
Figure 109: Change in open areas of the year 1972 with respect to the plan of 1905<sup>91</sup>

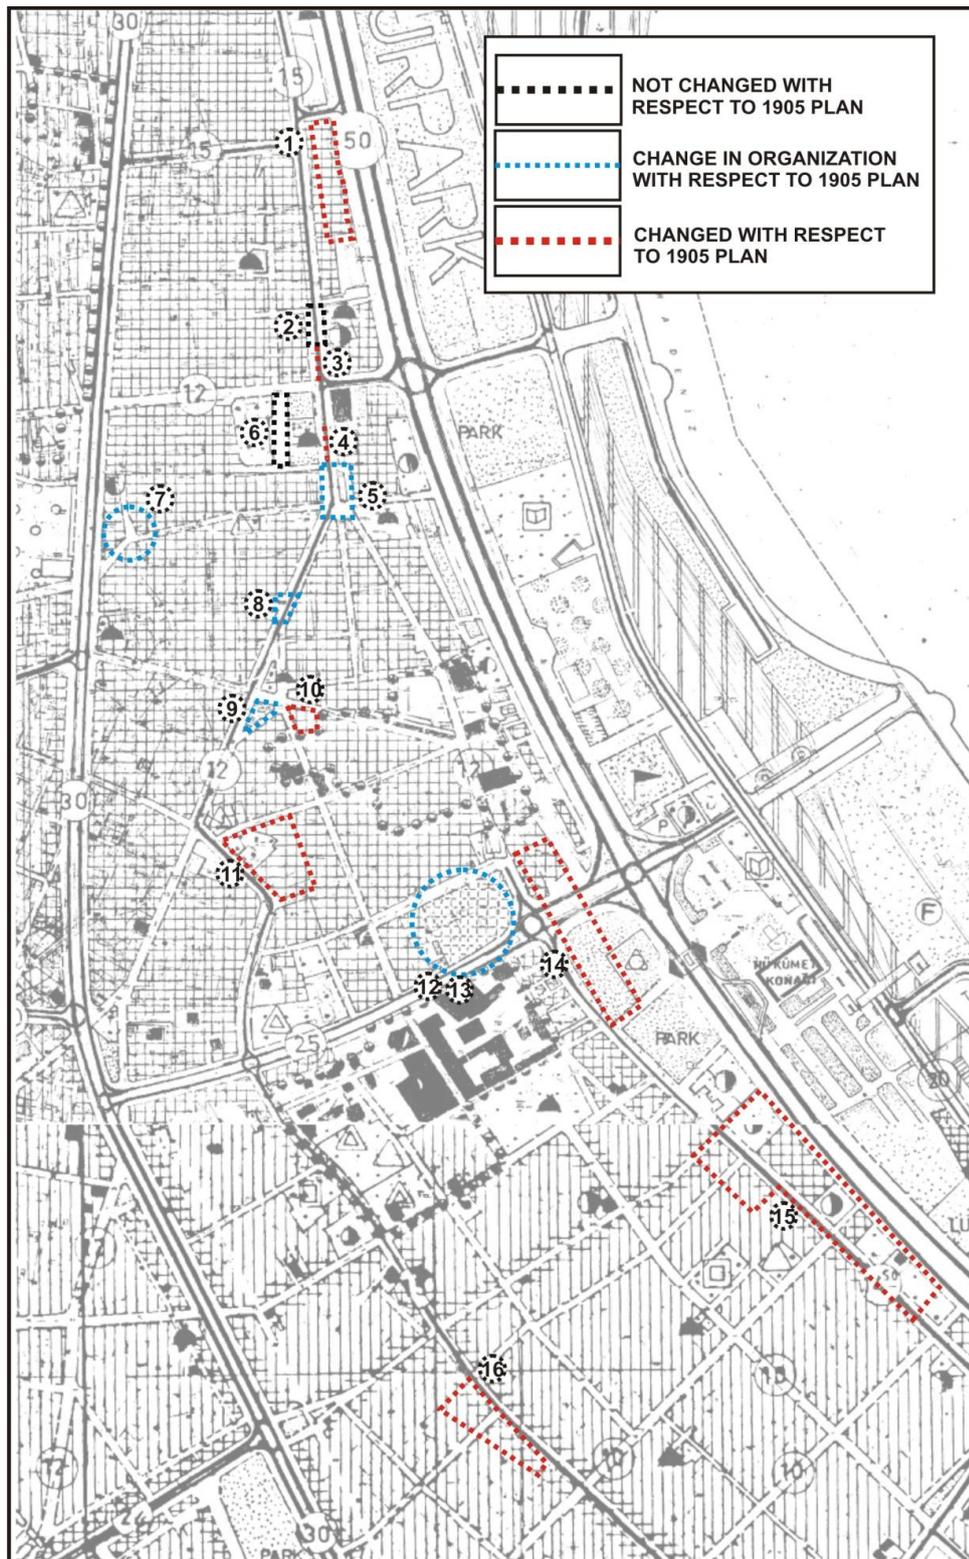
Figure 110: Change in open areas shown in the plan of 1988 with respect to the plan of 1905<sup>92</sup>

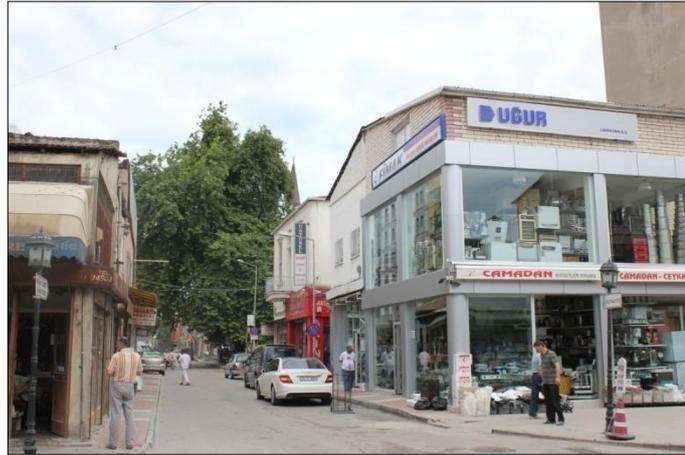
Figure 114: Square numbered 3 turned into street today (Author, June 2012)

The increasing development around the square area no 3 shown in the 1905 plan have made the area narrower and caused it to lose its square feature. The area that appears to be transformed into traces of a street in the 1953 aerial photo has remained the same in our current day. When the existing situation is compared to the 1905 plan, it is apparent that the development on the right as seen in Figure 114 has reduced the area.

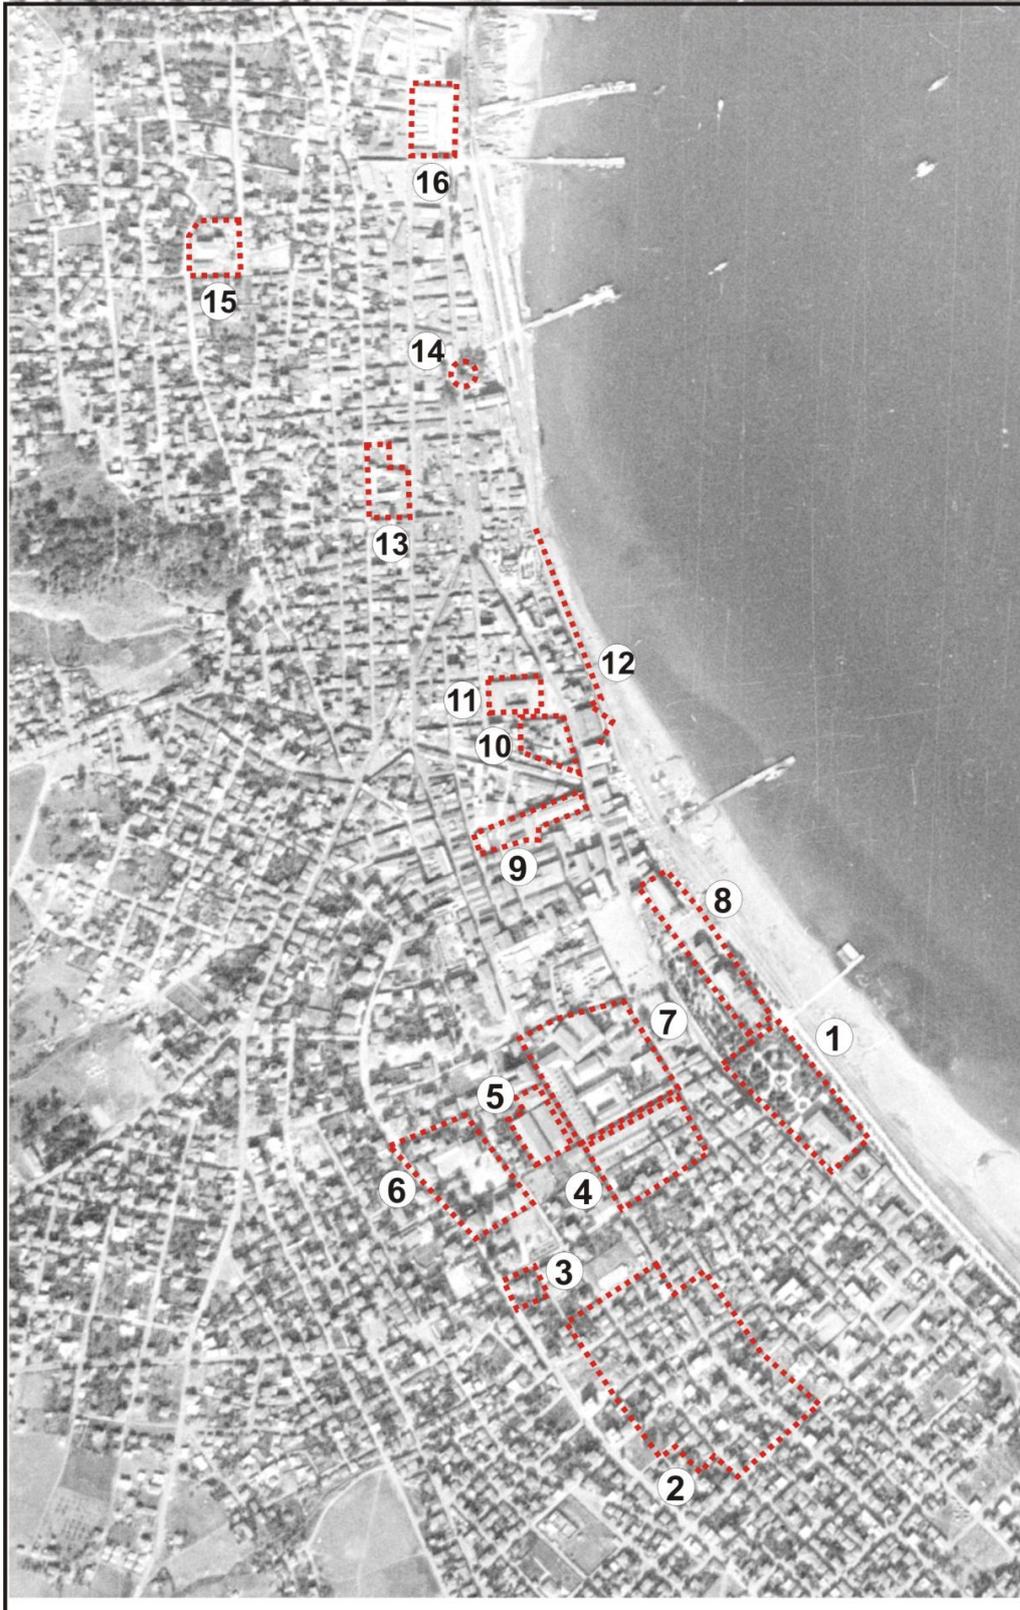
Figure 128: Change in buildings of the year 1953 with respect to the plan of 1905<sup>96</sup>

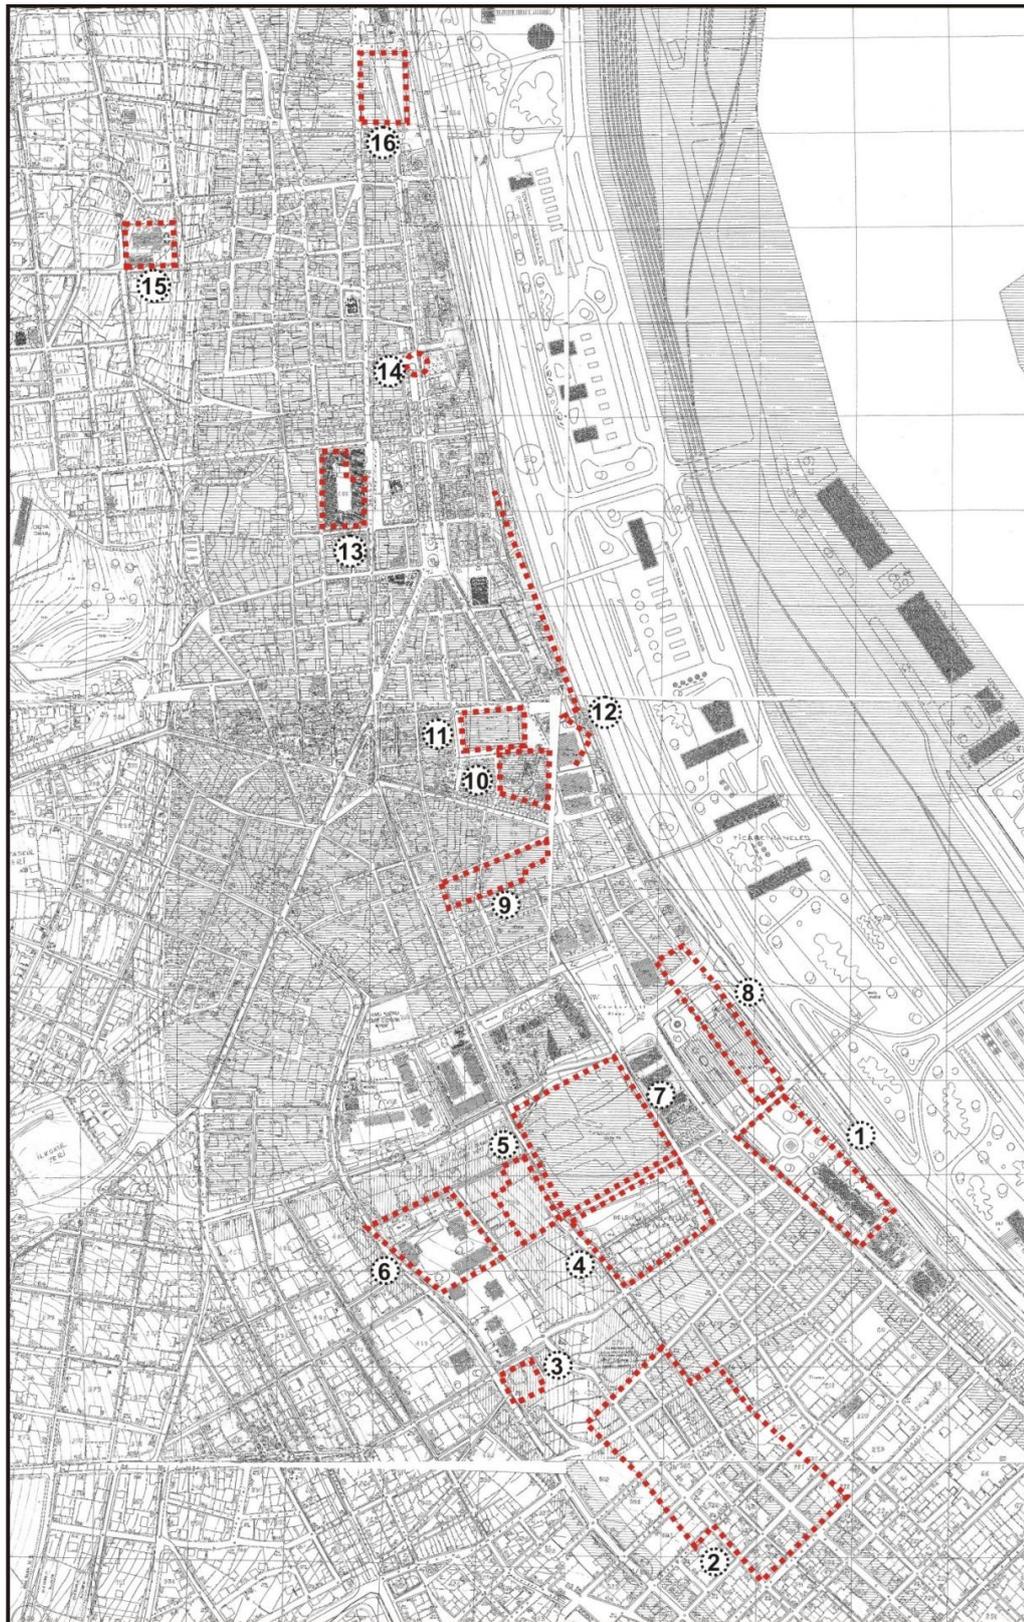
Figure 129: Change in buildings shown in the plan of 1960 with respect to the plan of 1905<sup>97</sup>

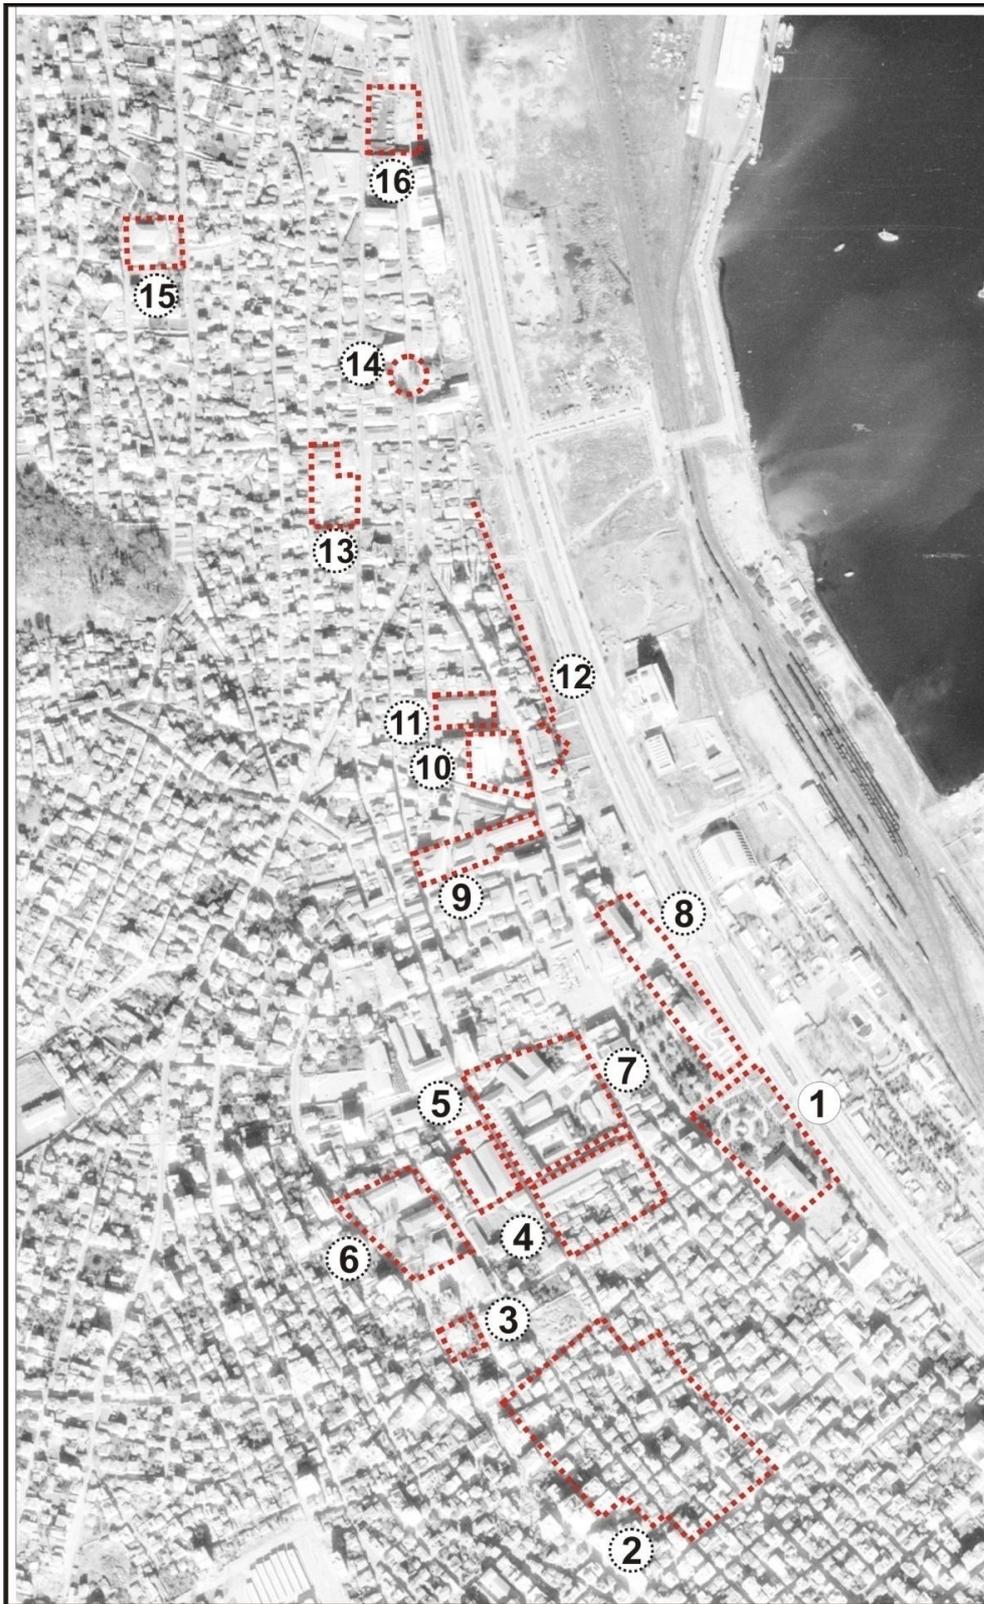
Figure 130: Change in buildings of the year 1953 with respect to the plan of 1905<sup>98</sup>

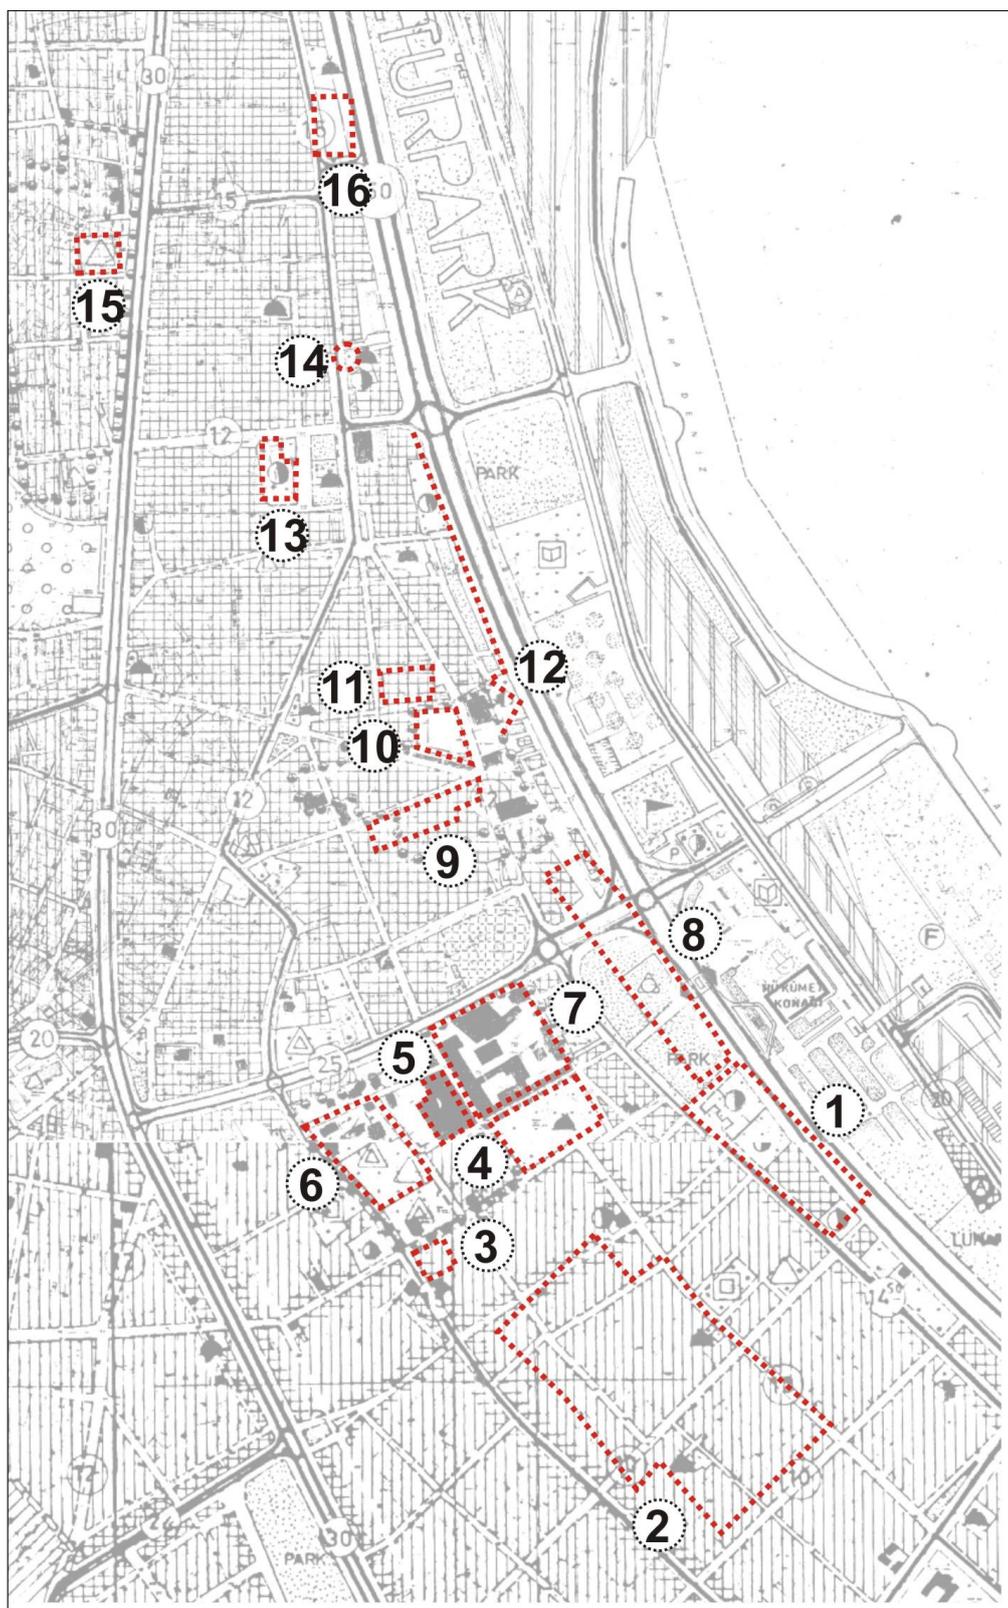
Figure 131: Change in buildings shown in the plan of 1988 with respect to the plan of 1905<sup>99</sup>

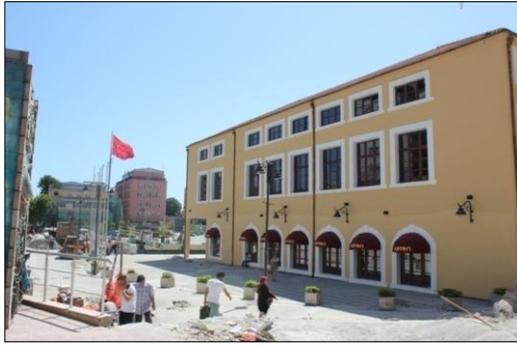
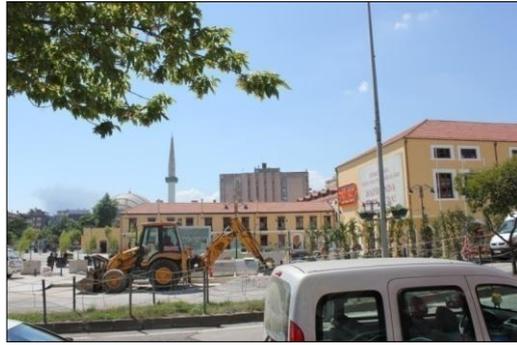
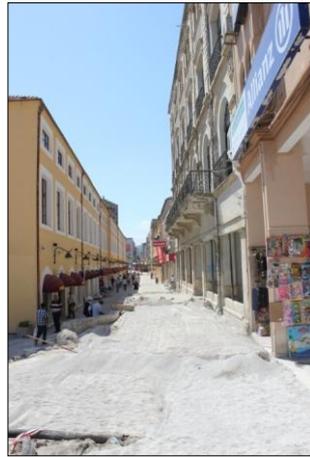
Figure 148: Tobacco factory today (Author, June 2012)

Area no. 7 in figure 127 is the location of the tobacco factory. When the 1905 plan and current base map are overlaid, some additional structures appear to have been built. It is understood that there are additional buildings different from today's buildings in 1953 and 1972 aerial photos and they have torn down. Later on as 19 Mayıs Boulevard was being constructed, these structures were torn down. The tobacco factory has changed during this time, with some additions made to it and other parts of it have been demolished. The structure is registered in its current condition. In figure 148, the buildings of the tobacco factory appear in their current condition.

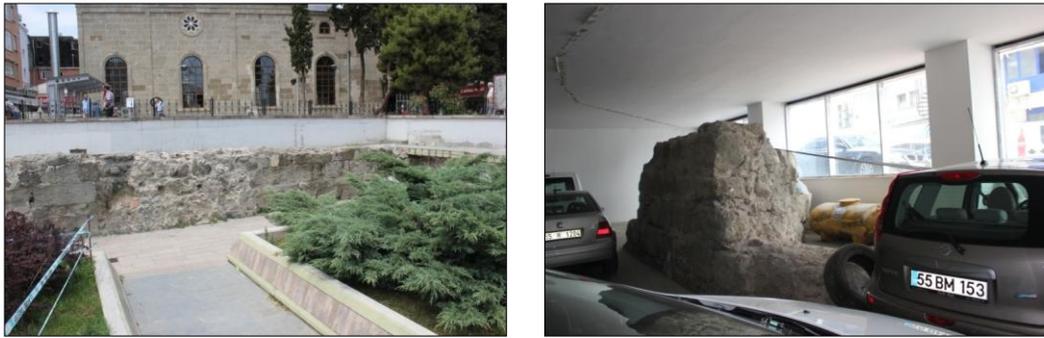
Figure 154: Remains of the citadel walls today (Author, June 2012)

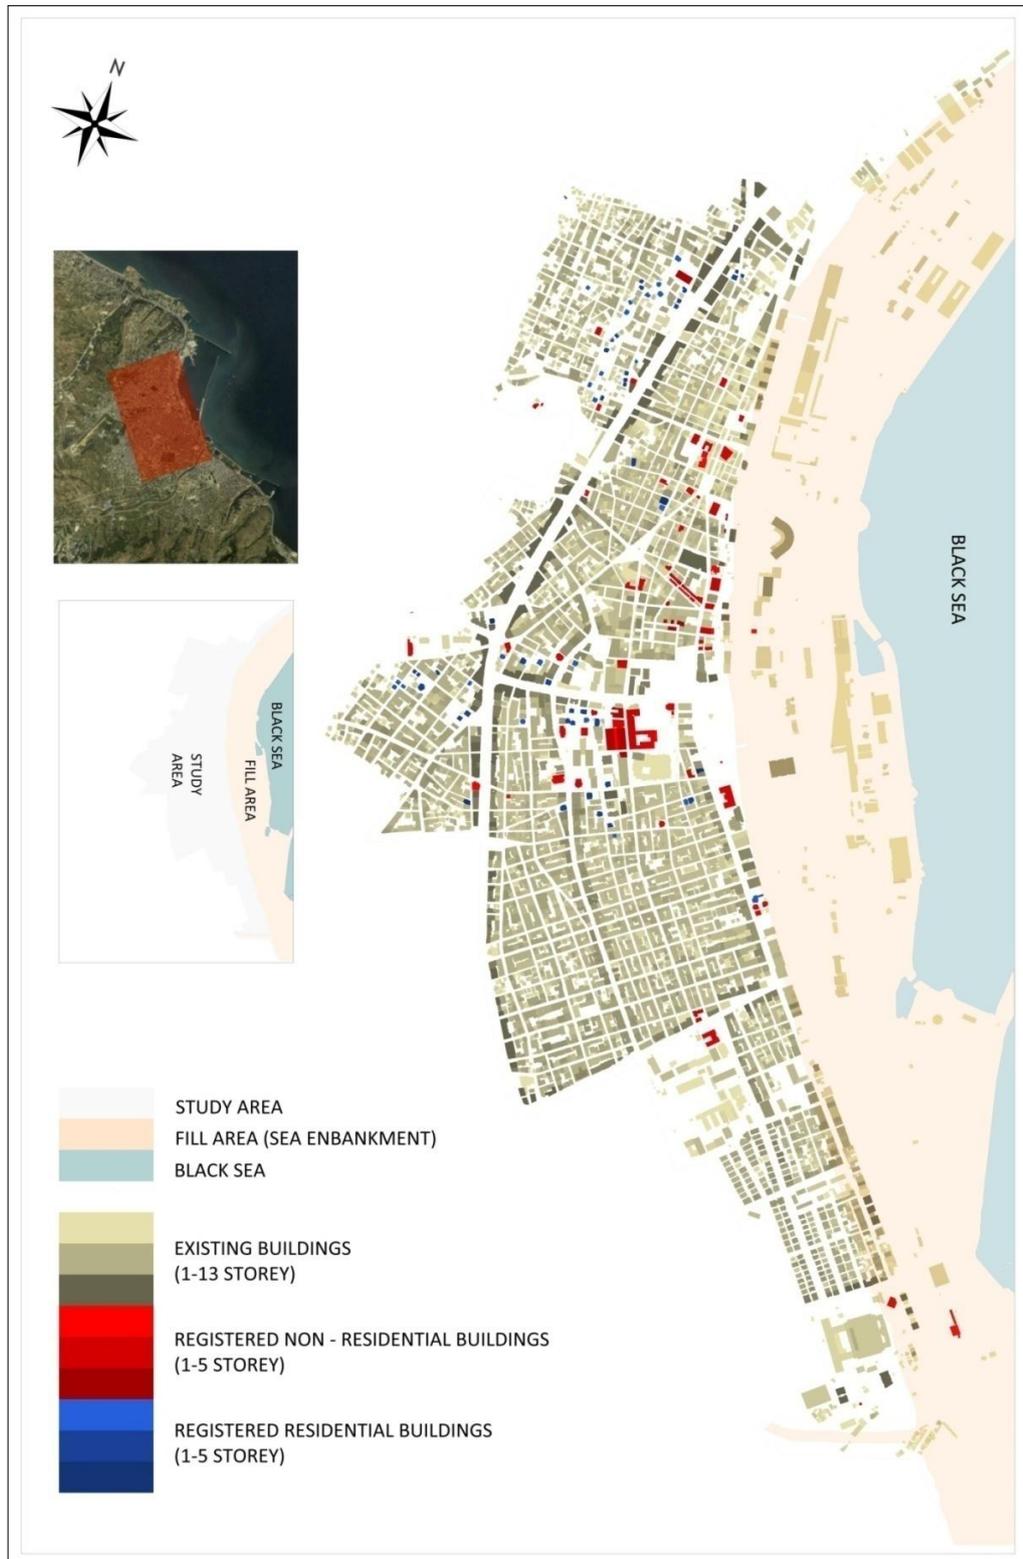
Figure 166: Map showing the number of storeys<sup>101</sup>

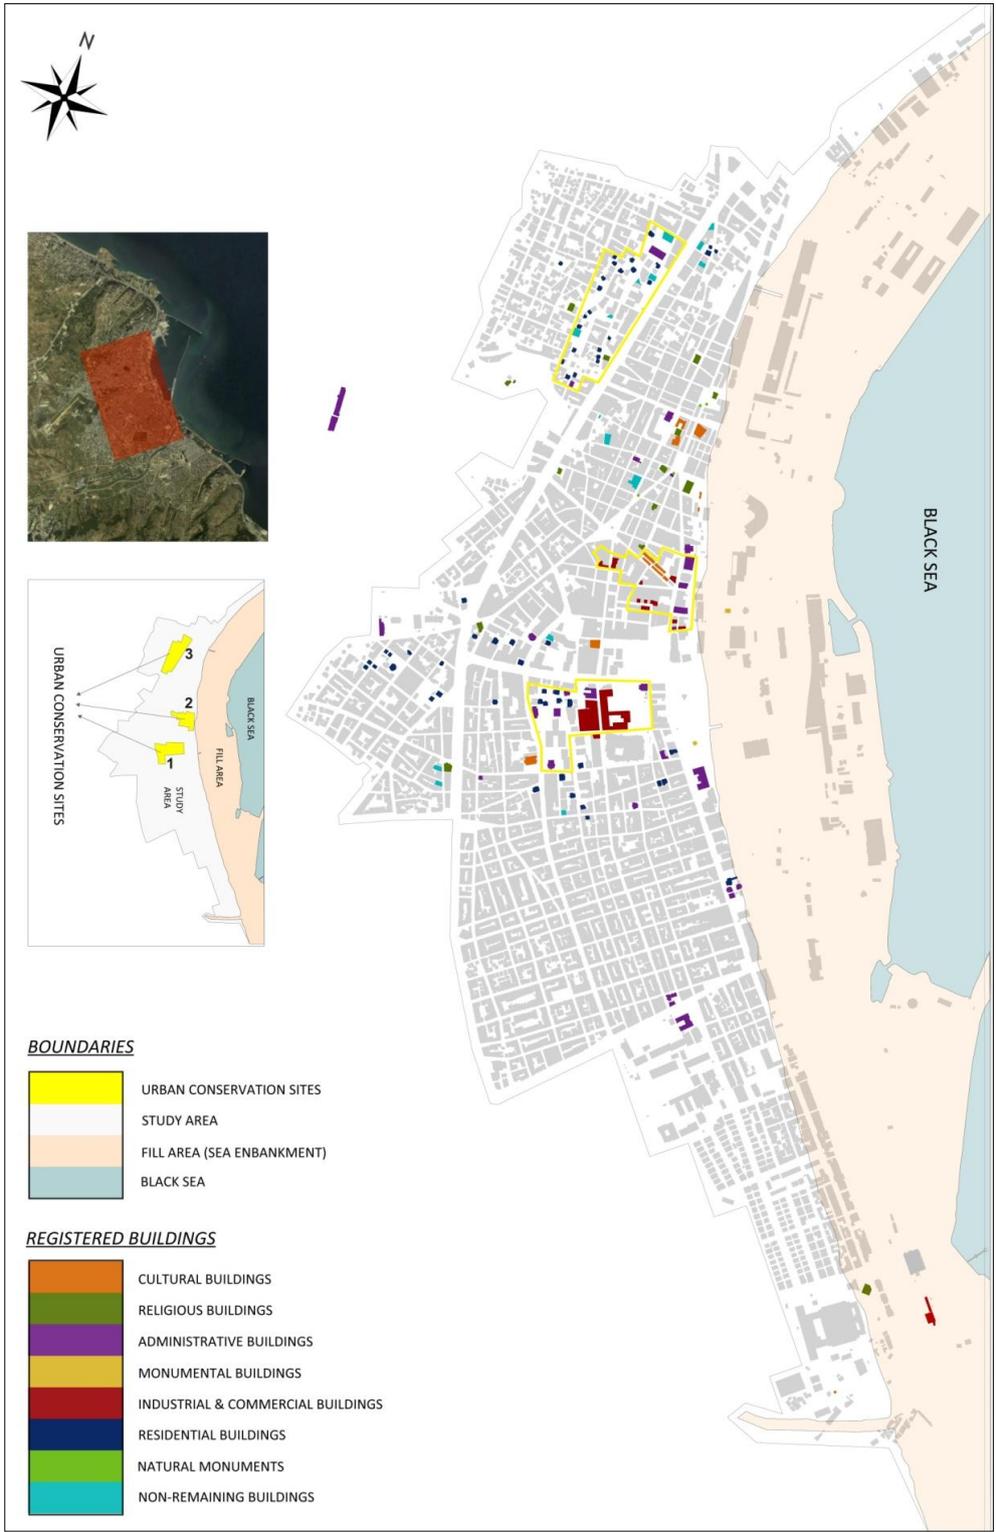
Figure 171: Urban Conservation Sites and Registered Buildings<sup>106</sup>
