RESOLVING THE HISTORIC URBAN TISSUE BY TRACING THE CHANGES AS A BASIS FOR ITS  
CONSERVATION: SAMSUN FROM 20<sup>TH</sup> CENTURY UNTILL TODAY

A THESIS SUBMITTED TO  
THE GRADUATE SCHOOL OF NATURAL AND APPLIED SCIENCES  
OF  
MIDDLE EAST TECHNICAL UNIVERSITY

IN PARTIAL FULFILLMENT OF THE REQUIREMENTS  
FOR  
THE DEGREE OF MASTER OF SCIENCE IN RESTORATION  
IN  
ARCHITECTURE

JANUARY 2013

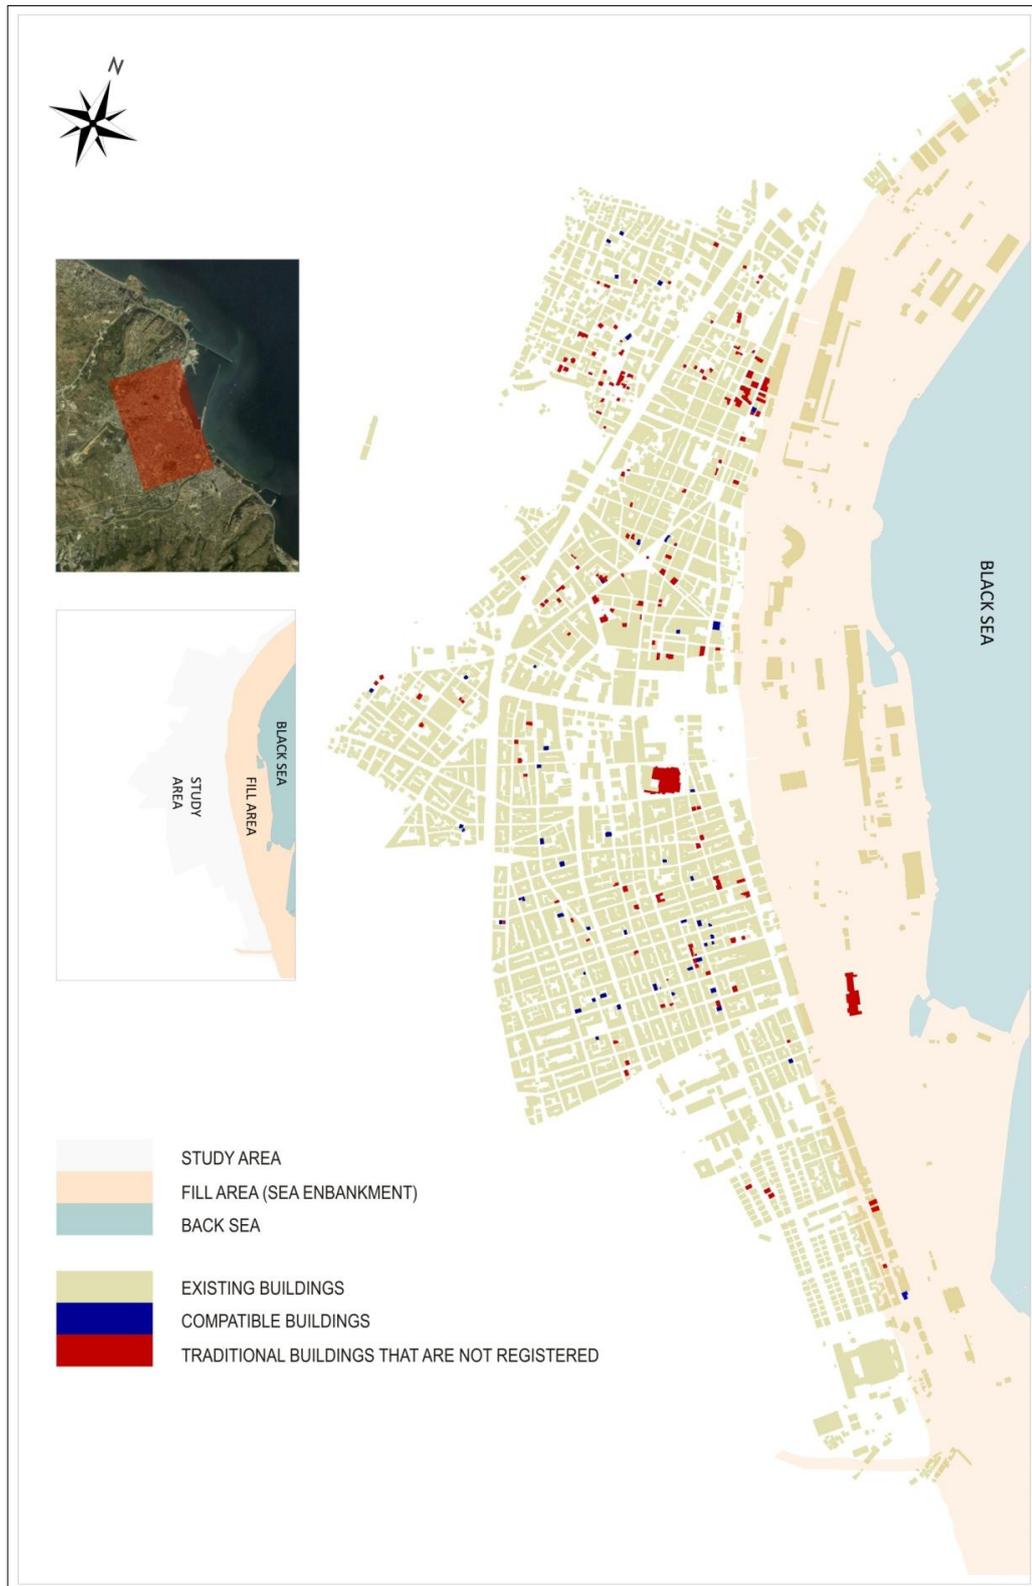
Figure 173: Traditional Buildings that are not registered and Compatible Buildings<sup>109</sup>

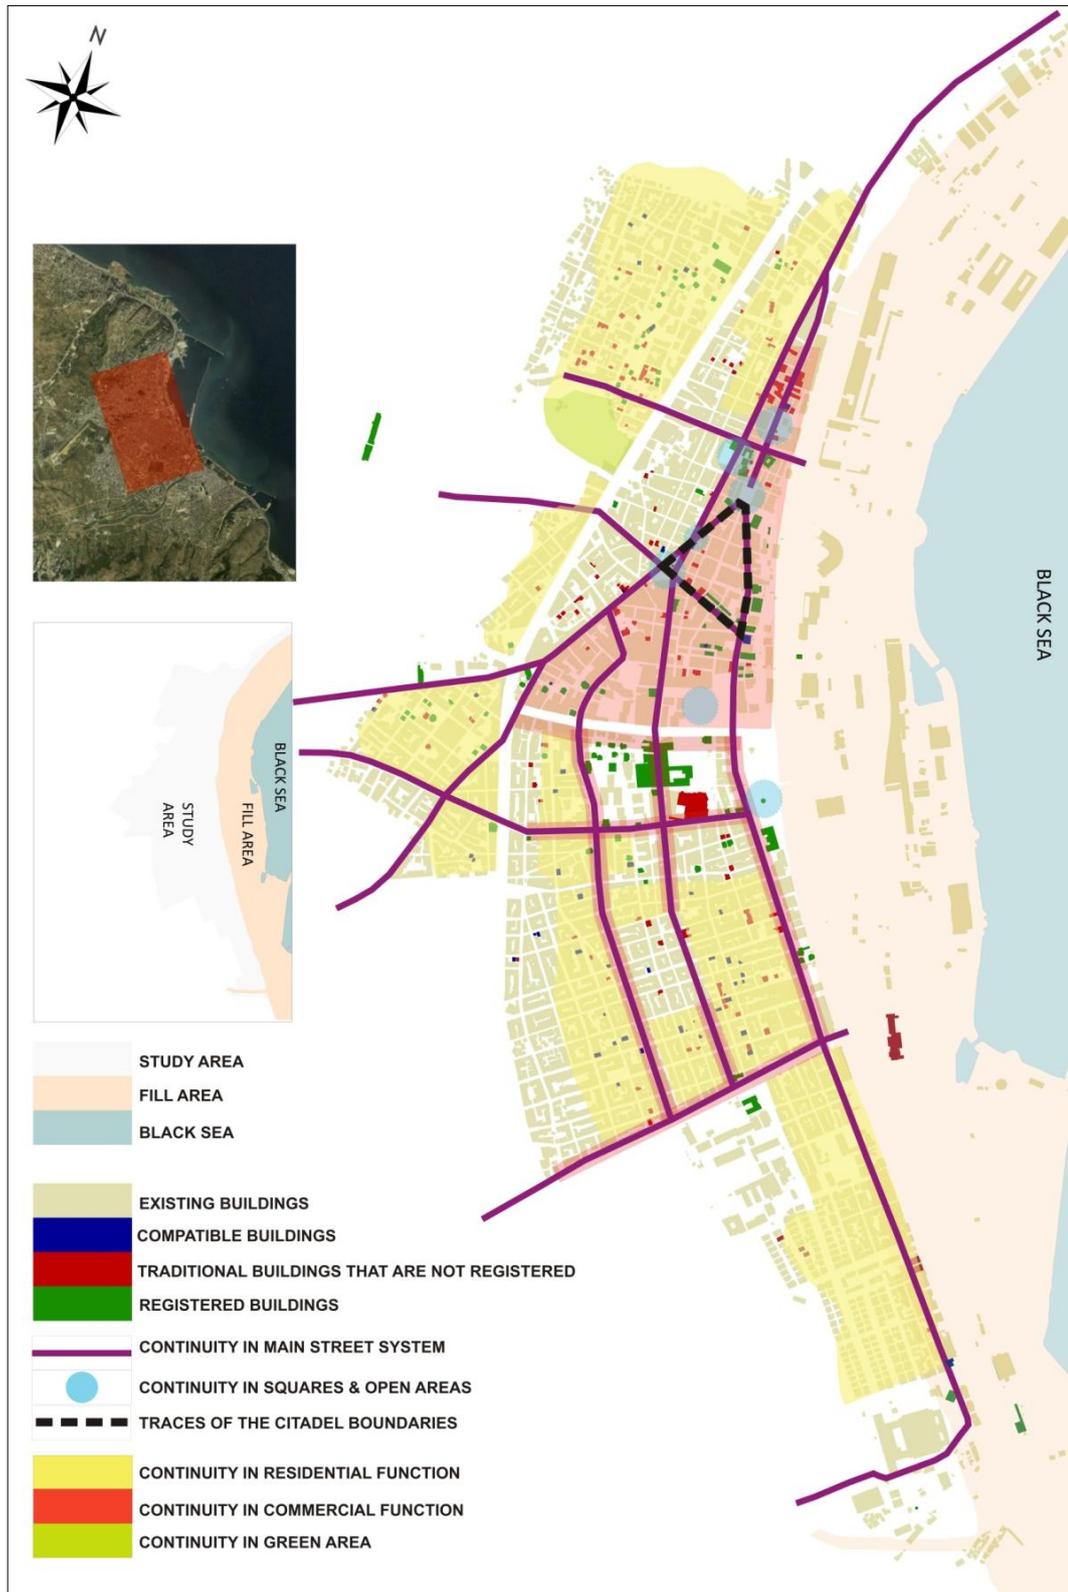
Figure 176: Superposition of the continuousness<sup>111</sup>

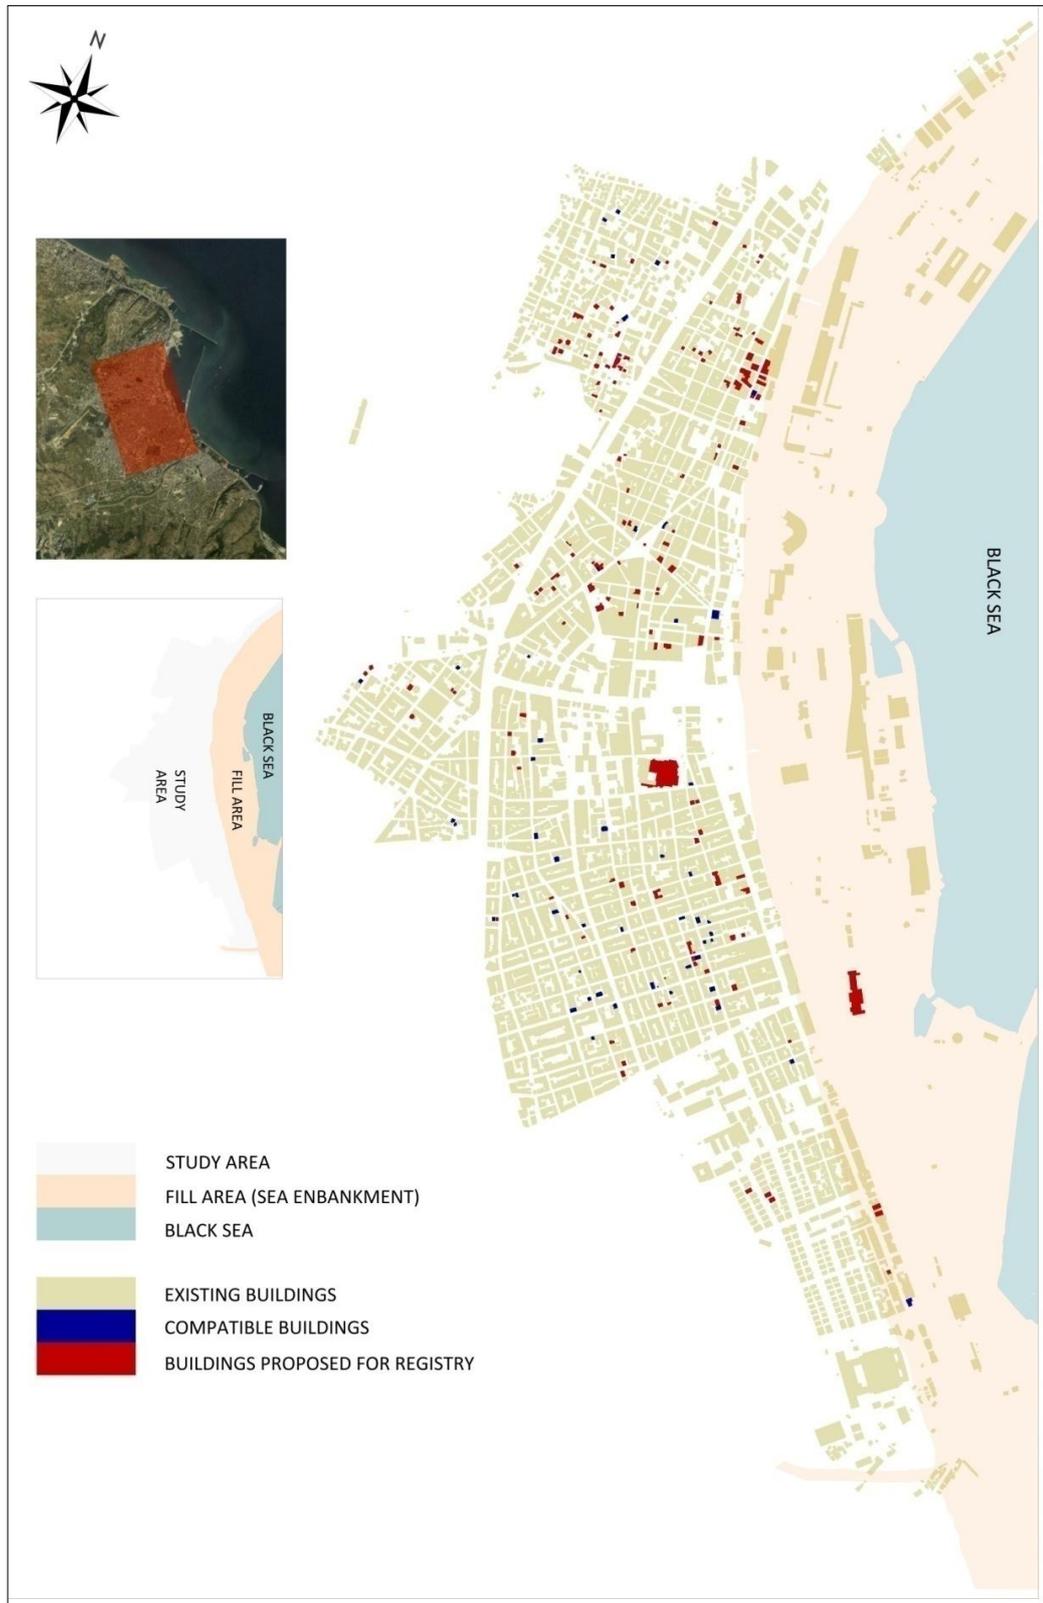
Figure 177: Location of the buildings proposed for registry and compatible buildings<sup>113</sup>

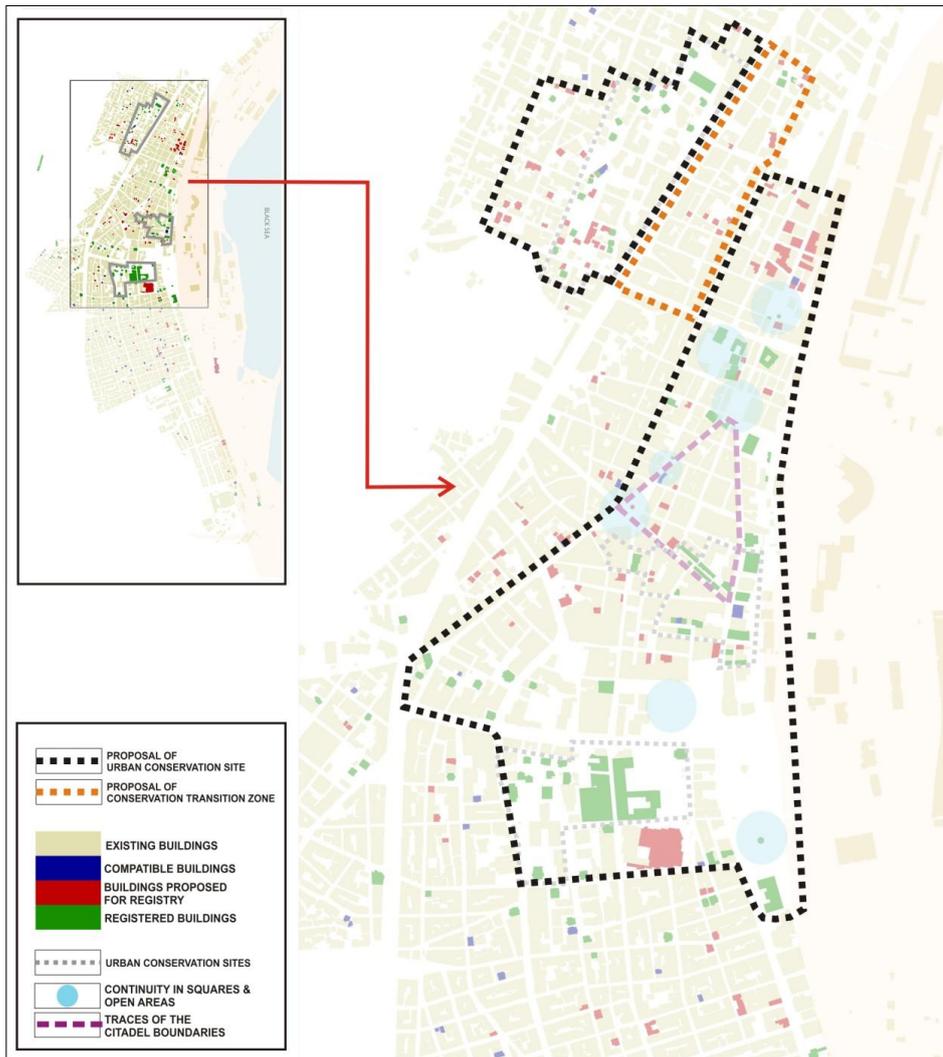
Figure 179: Boundaries of the proposed urban conservation area<sup>115</sup>
