SEISMIC PERFORMANCE EVALUATION OF REINFORCED CONCRETE FRAMES  
INFILLED WITH AUTOCLAVE AERATED CONCRETE MASONRY

A THESIS SUBMITTED TO  
THE GRADUATE SCHOOL OF NATURAL AND APPLIED SCIENCES  
OF  
MIDDLE EAST TECHNICAL UNIVERSITY

UMAIR AHMED SIDDIQUI

MARCH 2013

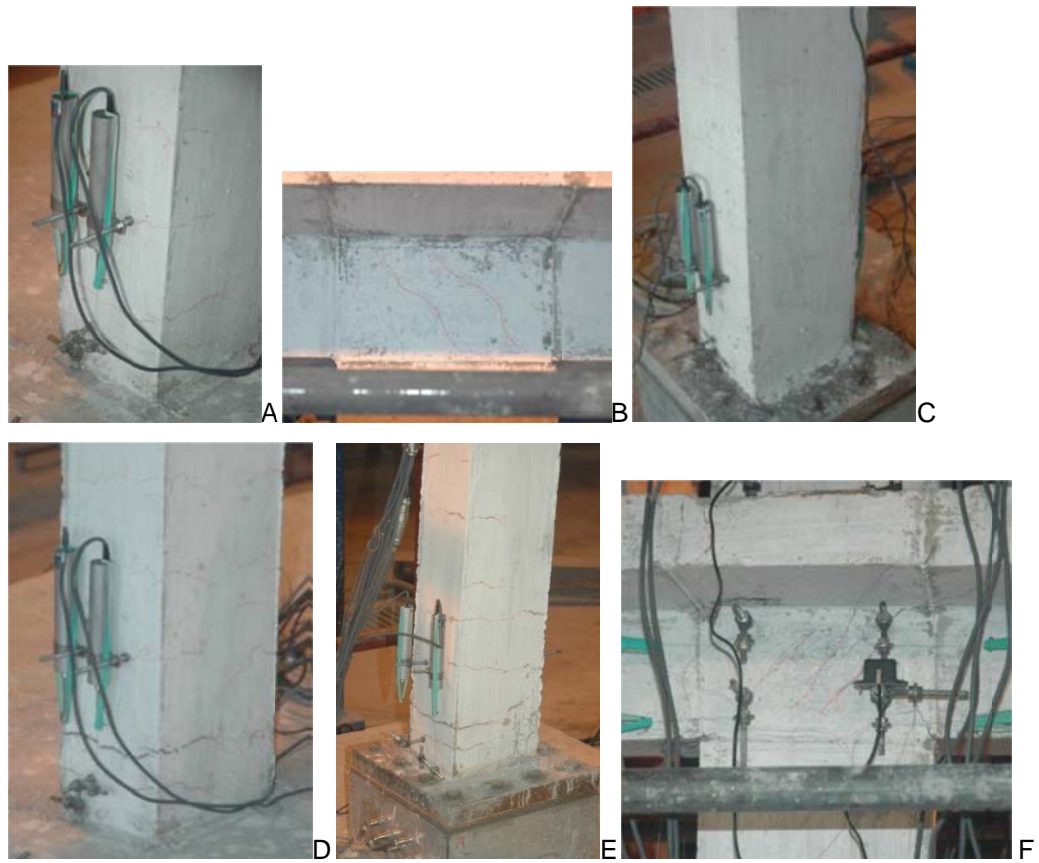
**Figure 2.8(a): Roof displacement time-history and observed damages (SP#1)**

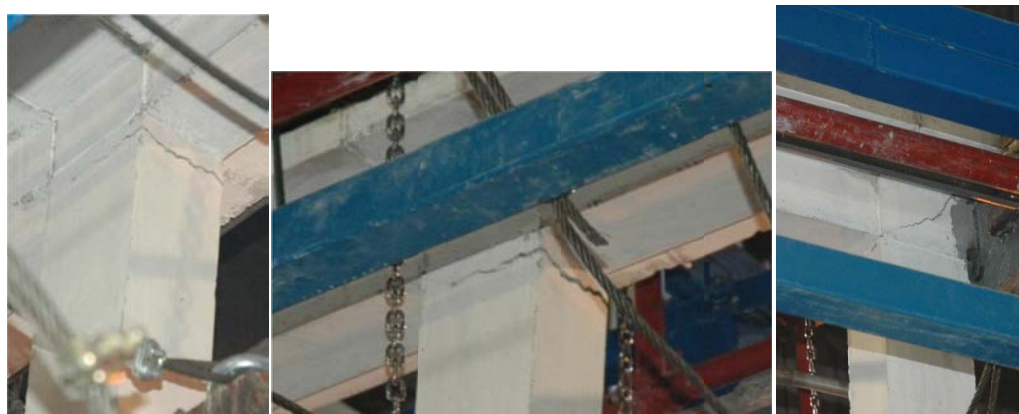
**Figure 2.8(b): Damages observed in the 3<sup>rd</sup> Storey columns at point-E (SP#1)**

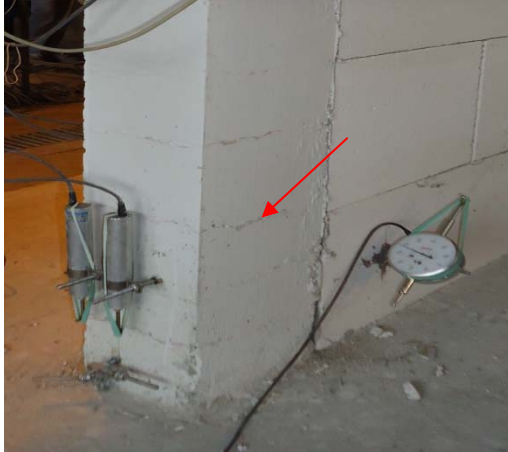
Point C – Flexural cracks at the bottom of interior column

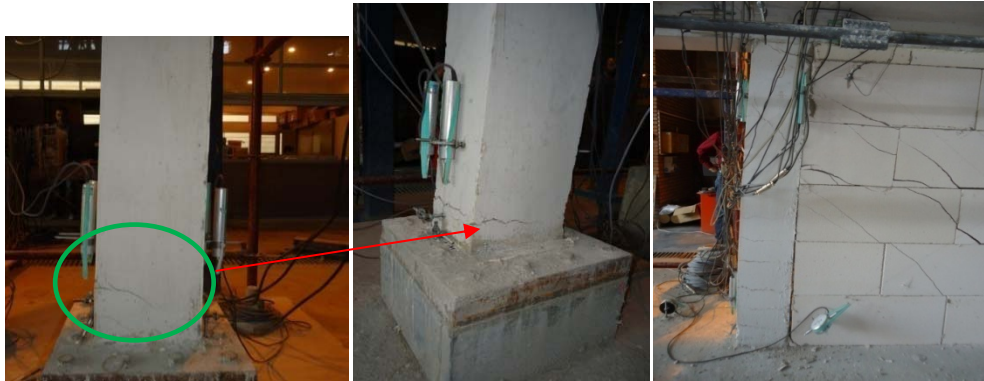
Point E –Formation of plastic hinge and permanent deformation of exterior column and overall damage to infill panels

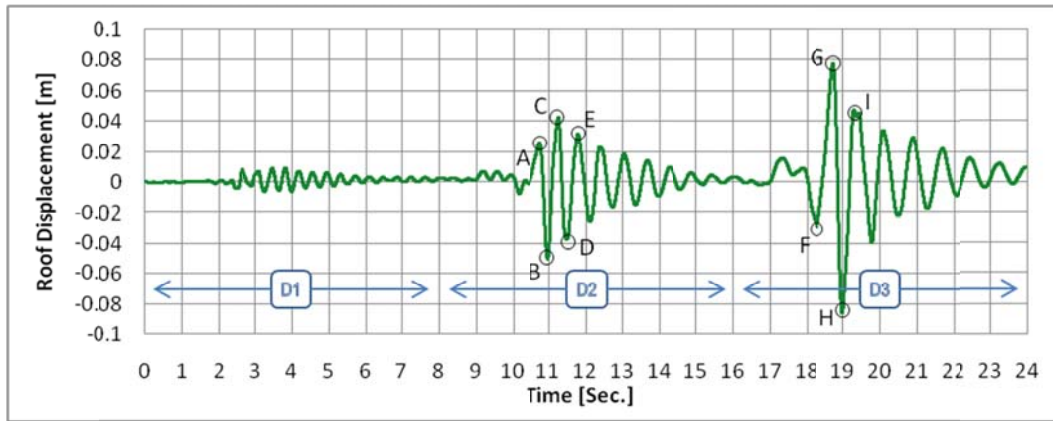
**Figure 2.15: Roof displacement time-history (SP#3)**

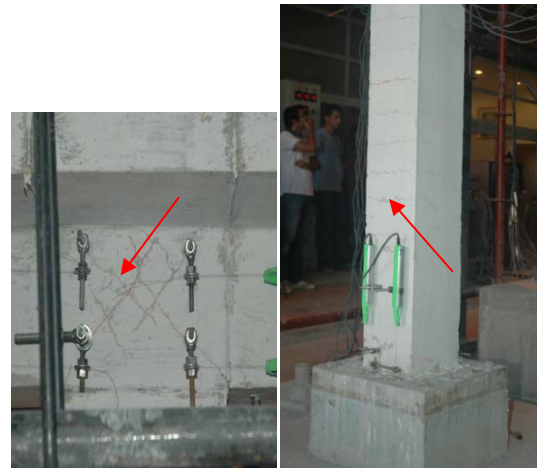
Point G – Widening of interior joint cracks. Distribution of flexural cracks in 1<sup>st</sup> and 2<sup>nd</sup> storey exterior columns.

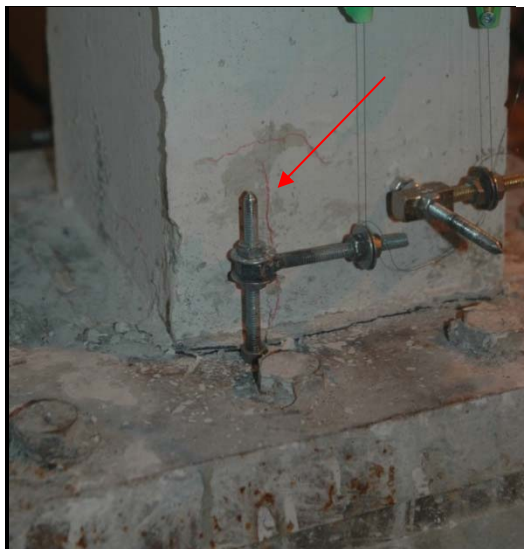
Point H – Bond slip cracks in column 104

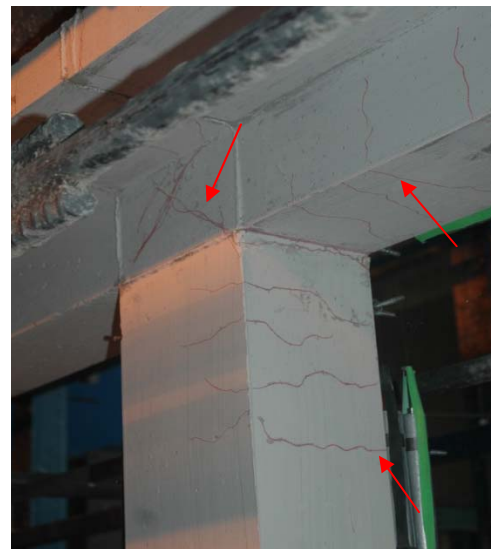
Point I – Overall damage in interior joint region

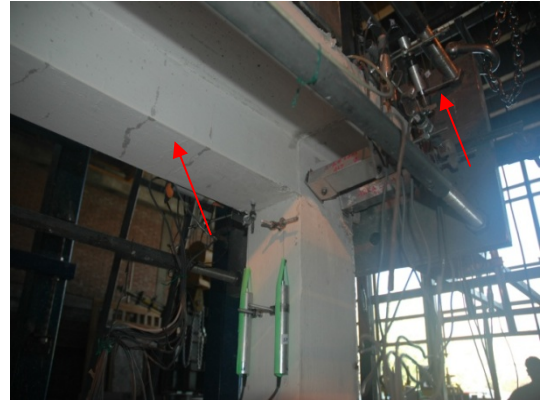
Point D – Flexure cracks at 1<sup>st</sup> storey exterior beams

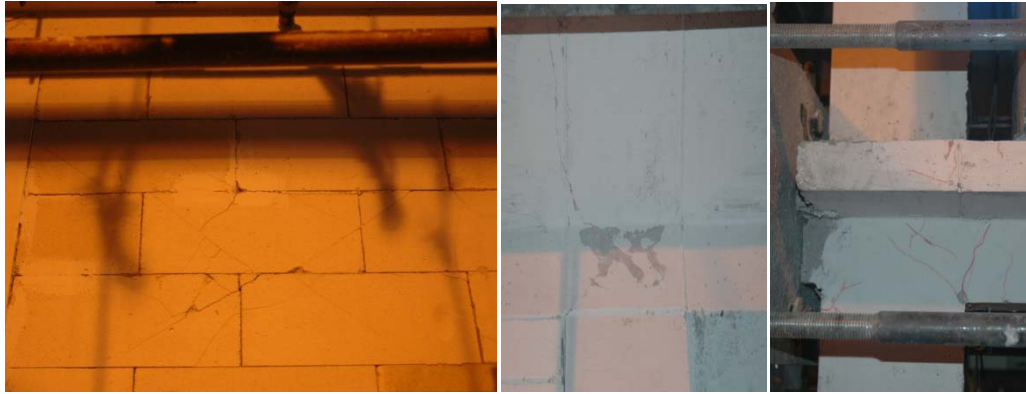
Point H – Overall damage to infill panel and diagonal cracks in 1<sup>st</sup> and 2<sup>nd</sup> storey joints.

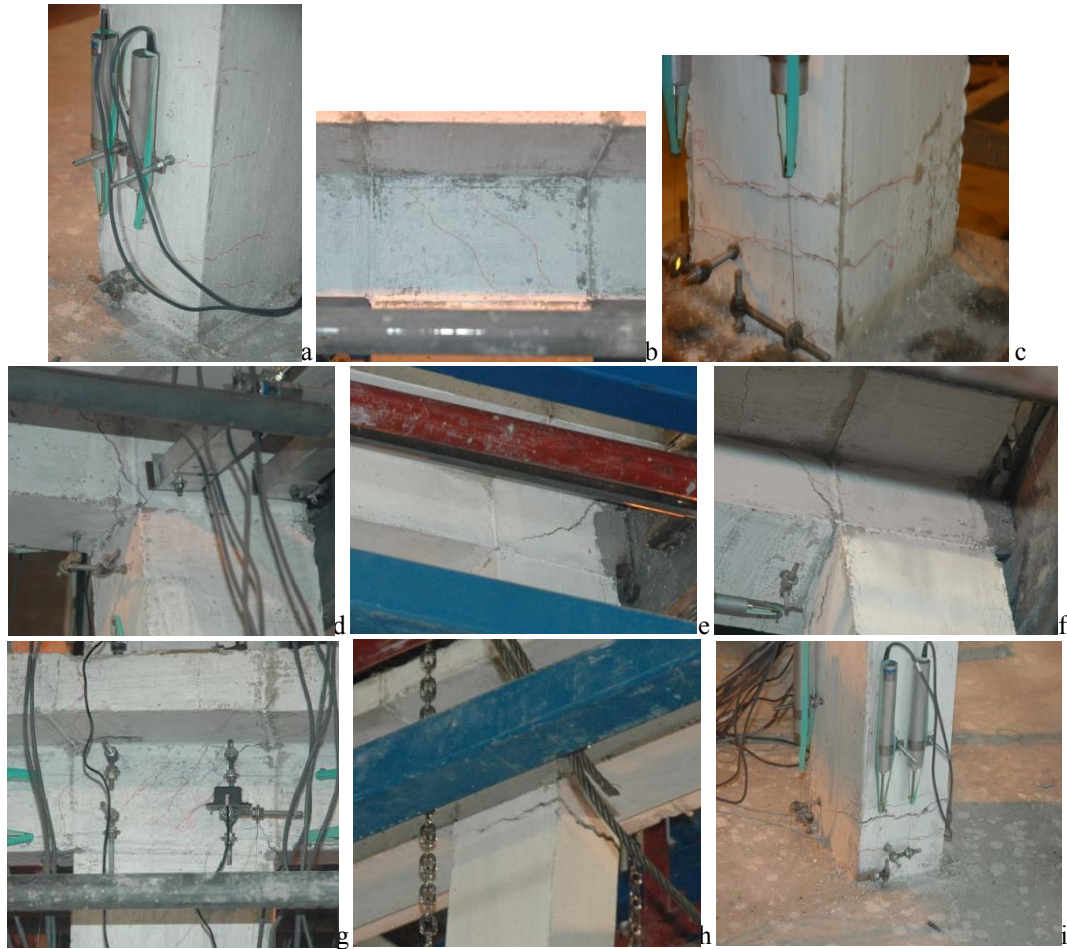
enough to see through. The brittle failure of columns resulted in the apparent permanent deformation of the entire frame. The specimen suffered severe damage with the failure of first storey columns.

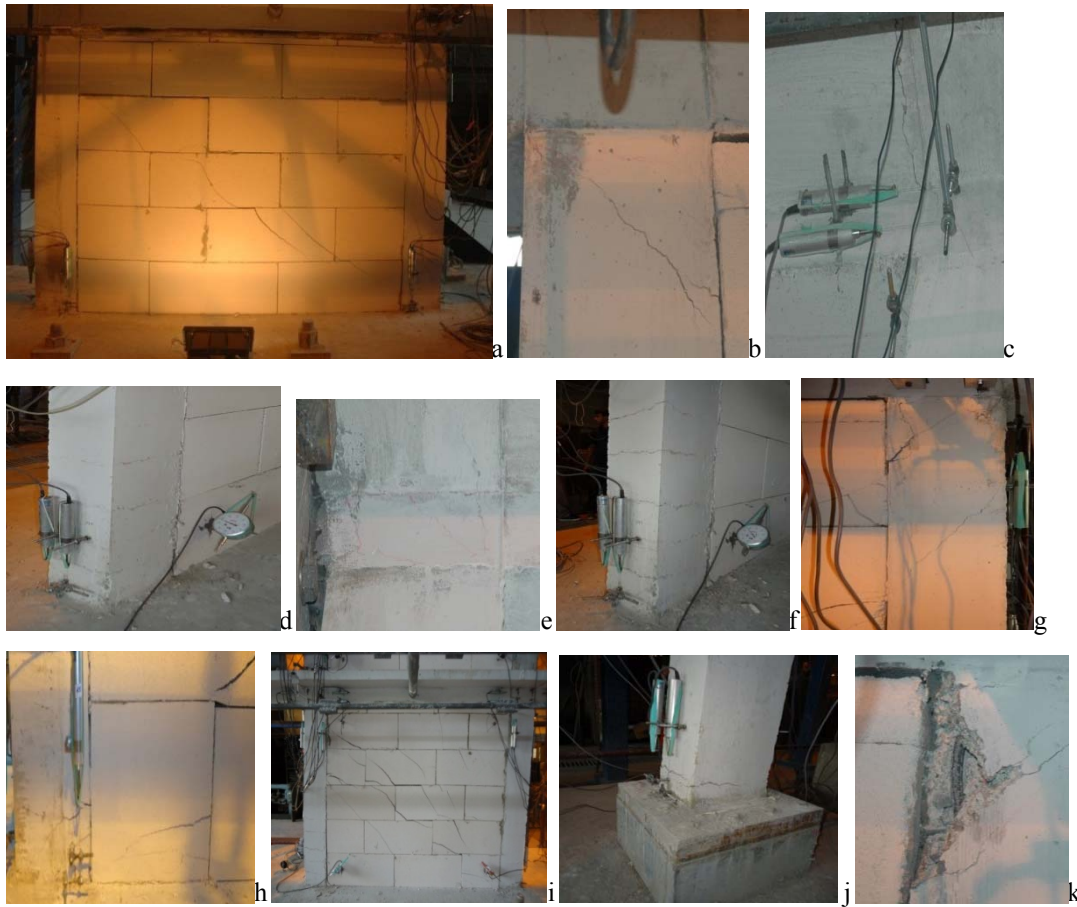
The failure of Specimen # 2 was also governed by the failure of first storey columns however the failure mode of columns differs from each other. The exterior columns depicts flexure failure at the bottom but the failure was abrupt with sudden increase of inter-storey drifts which is similar to the one observed in bare frame (Specimen #1). On the other hand, the failure of interior columns surrounding the infill panel was brittle caused by excessive diagonal shear cracking at the column tops. The cracking thereby resulted in spalling of concrete and buckling of reinforcement. The primary mode of failure of the first and second storey infill panels is diagonal cracking. The ratio of mean compressive strength of frame to the infill is as high as 4.5 indicating the strong frame-weak infill system and given that, the masonry panel behaved as expected, however the excessive diagonal cracking and shear failure in the bounding columns is unusual for this system. The main cause of such failure is the transfer of shear stress from the loaded diagonal of the infill panel and the absence of adequate confinement reinforcement to resist these stresses signifying the impact of poor seismic detailing.

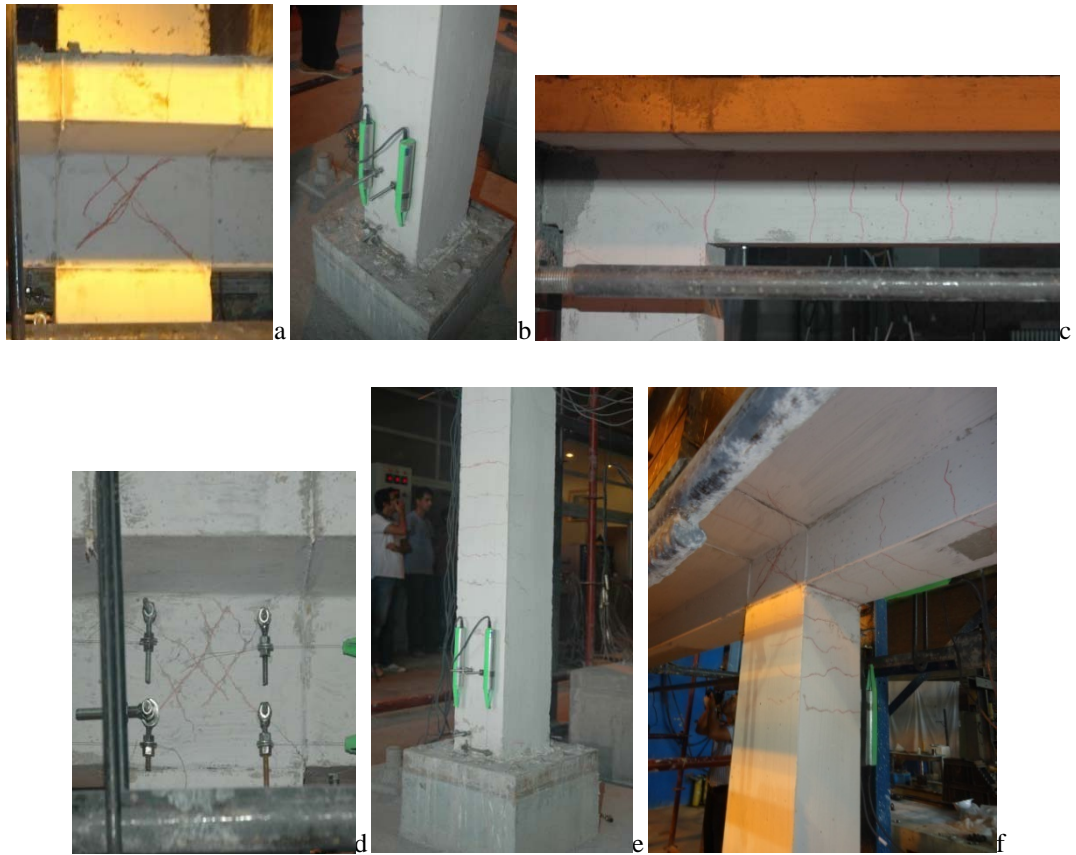
During D3, further diagonal cracks appeared in the 1<sup>st</sup> and 2<sup>nd</sup> storey masonry panel parallel to the loaded diagonal leading to the failure by crushing. Bounding columns of 1<sup>st</sup> and 2<sup>nd</sup> storey receives shear cracking due to the shear stresses transferred through the compression strut. Flexure cracking of exterior columns spread along the length and diagonal cracks in joint region also widens. Overall the observation suggests moderate damage to the specimen without any sign of failure in RC members.

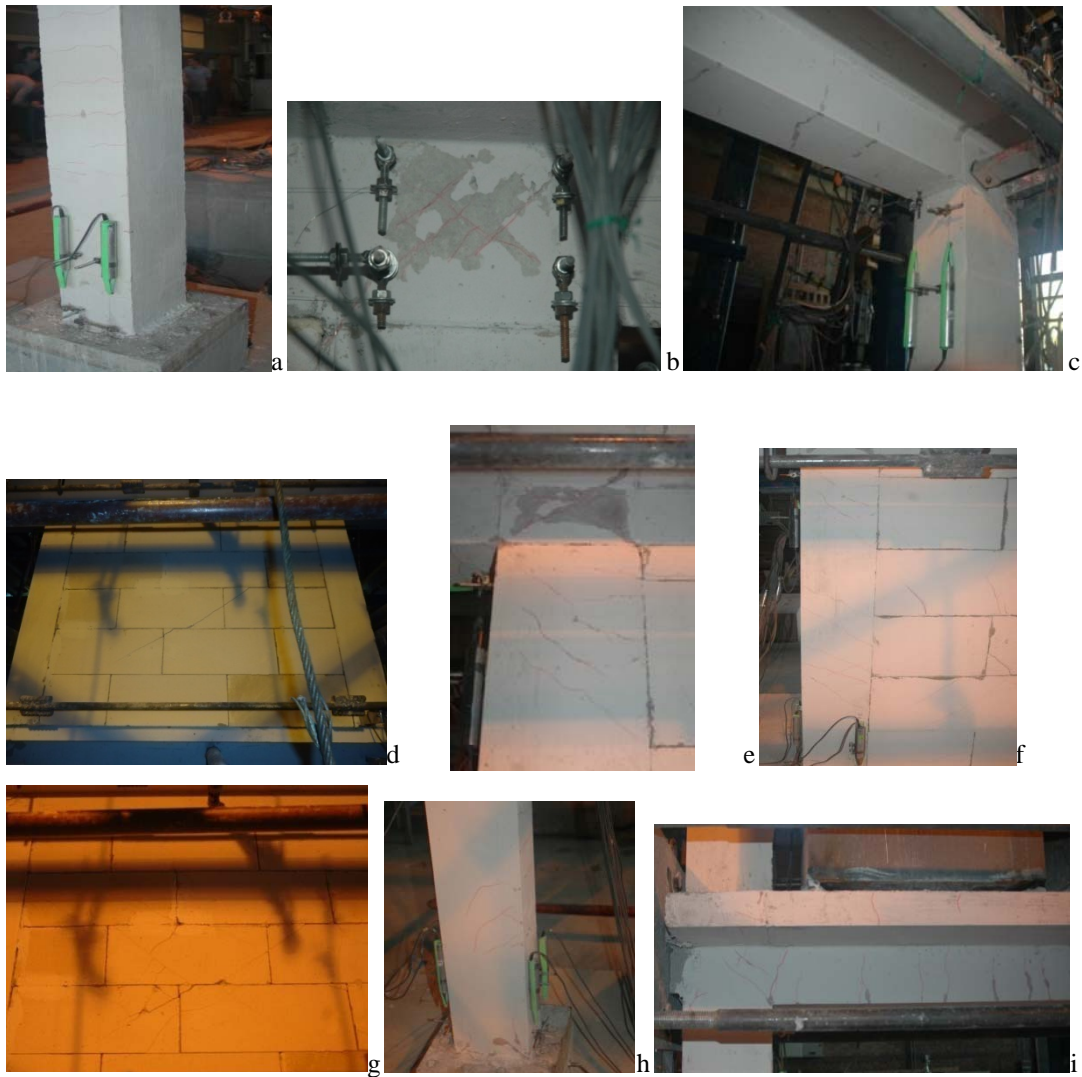
In Specimen #3 the inelastic deformations both in columns and beams comprise mainly of flexural yielding. The cracking in the bottom storey columns were distributed along the length with wider cracks near the ends. No sign of brittle failure was observed. There were no notable permanent/residual deformations in any member.
