**CAUSES, ANALYSIS AND STABILISATION OF A COASTAL SLIDE,  
SOUTH OF SINOP, TURKEY**

**A THESIS SUBMITTED TO  
THE GRADUATE SCHOOL OF NATURAL AND APPLIED SCIENCES  
OF  
THE MIDDLE EAST TECHNICAL UNIVERSITY**

**DECEMBER 1999**

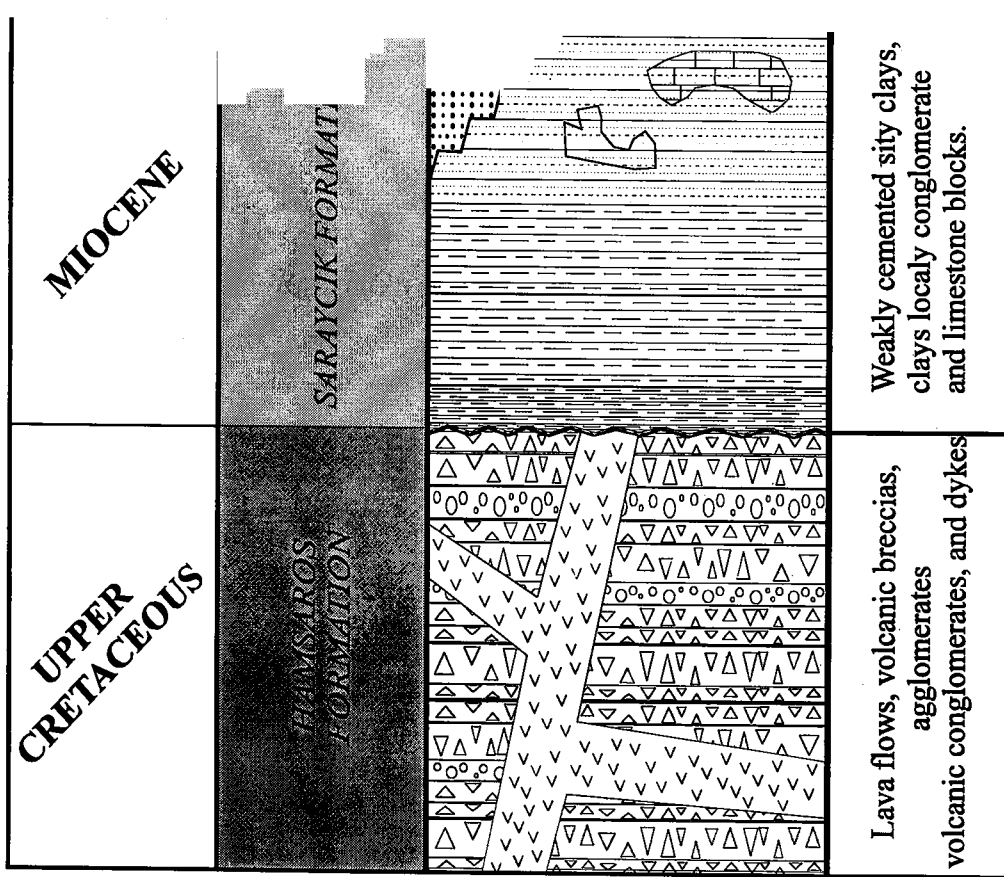
Figure 3.1. General stratigraphic column of the site (not to scale)

The recent deposits include beach sands and coastal dune deposits along the shore line. These deposits overlie older formations unconformably (Figures 3.1 and 3.2).

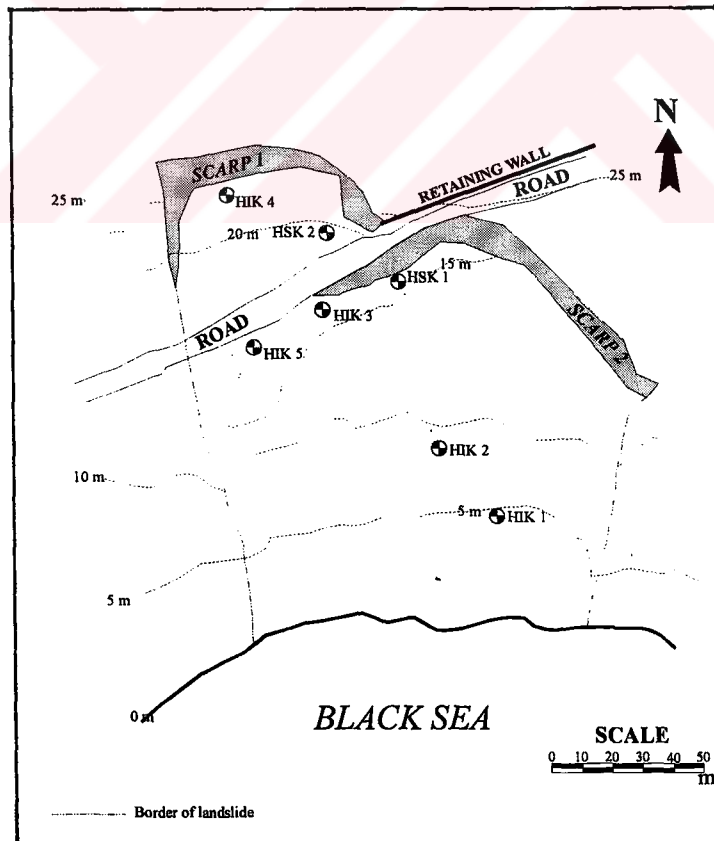
Figure 4.1. Borehole locations.

In order to investigate soil and rock conditions at the landslide area, seven boreholes were drilled by Yüksel Proje Uluslararası A.Ş. (1998). Through the boreholes numbered Hik 1, Hik 2, Hik 3, Hik 4, and Hik 5, inclinometer measurements were taken in order to determine the position of the slip surface and the rate of sliding. The boreholes Hsk1 and Hsk2 were drilled for ground investigation purposes. Table 4.1 shows the type of drilling, diameter of boring, depth to groundwater level, borehole elevations, coordinates and in-situ tests performed. At all boreholes SPT measurements were taken at almost every 1.5 meters and UD (undisturbed) samples were taken at Hik 1, through Hik 5 boreholes. At each boring three UD samples were taken. Figure 4.1 shows the landslide area and the borehole locations. Figure 4.2 shows simplified boring logs.

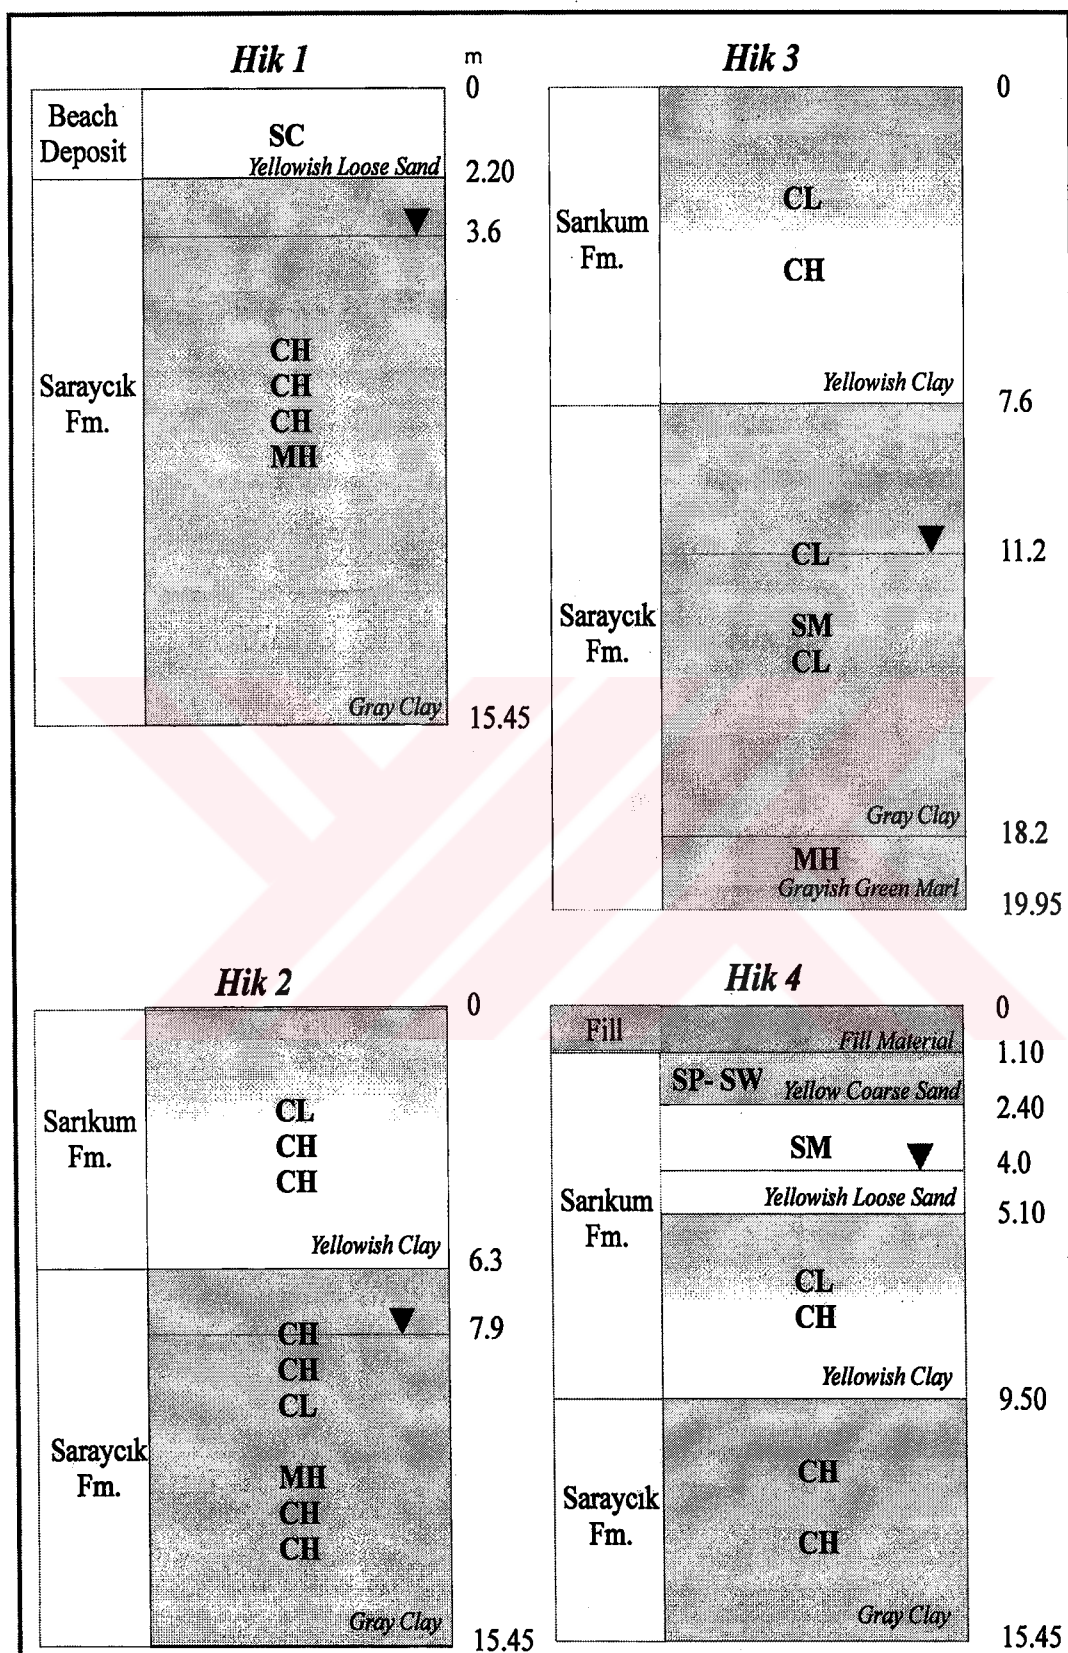
Figure 4.2 Simplified boring logs

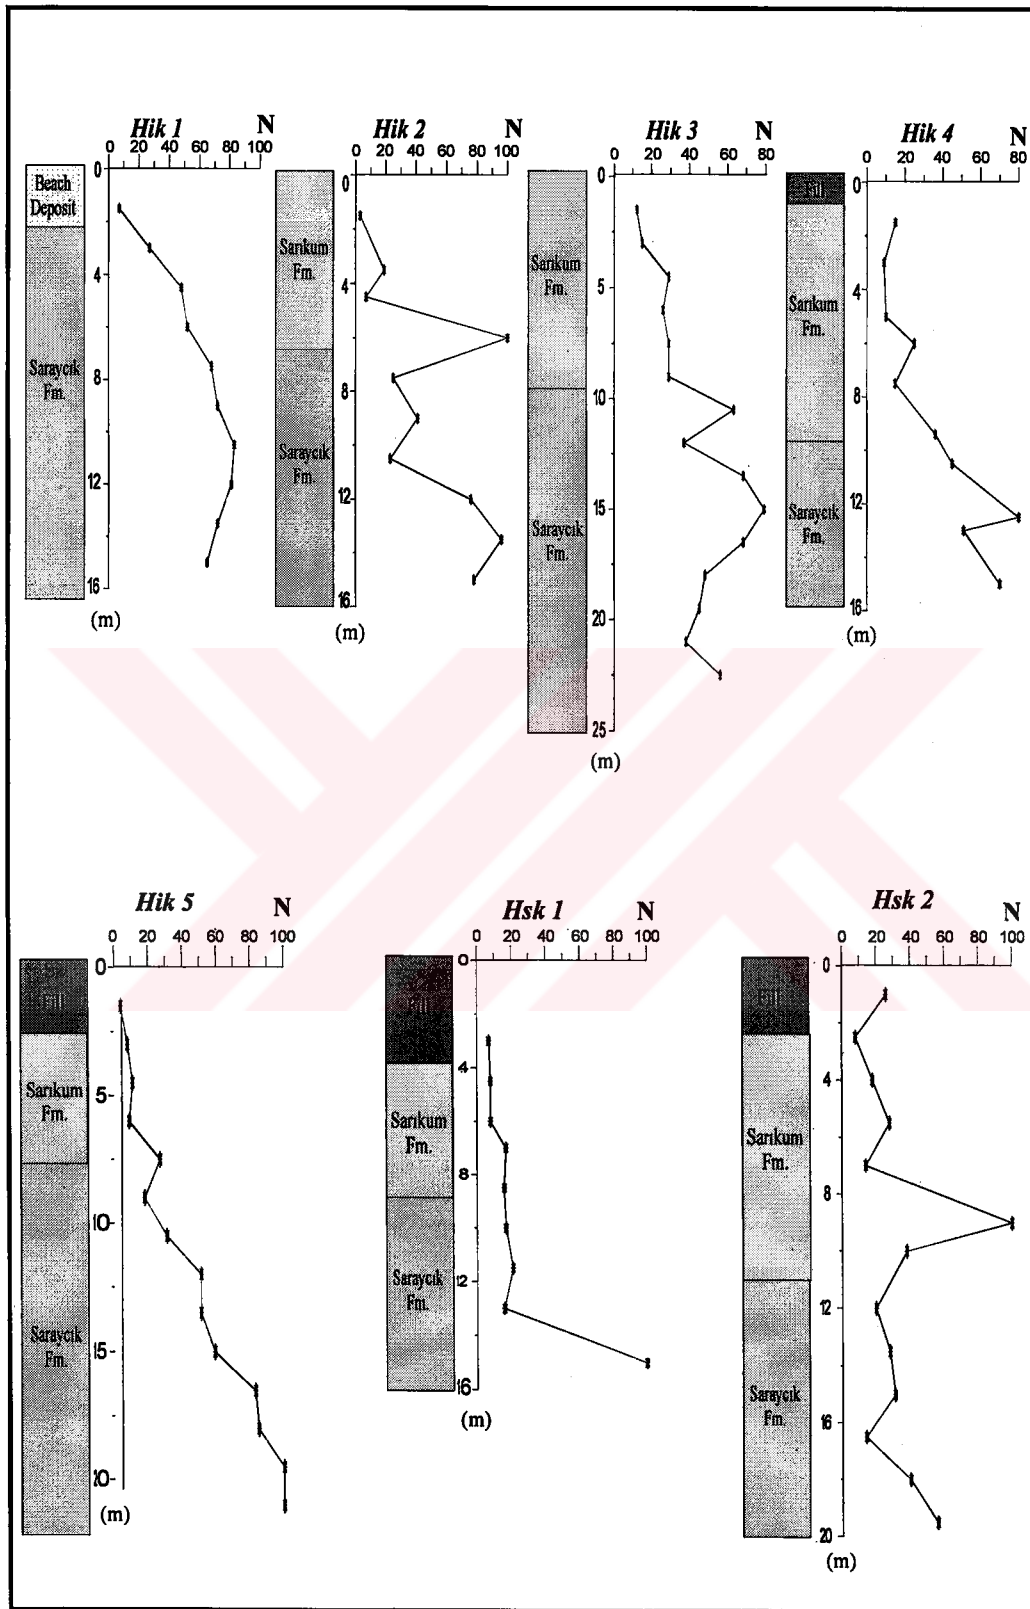
Figure 4.3 Graphical presentation of SPT results.

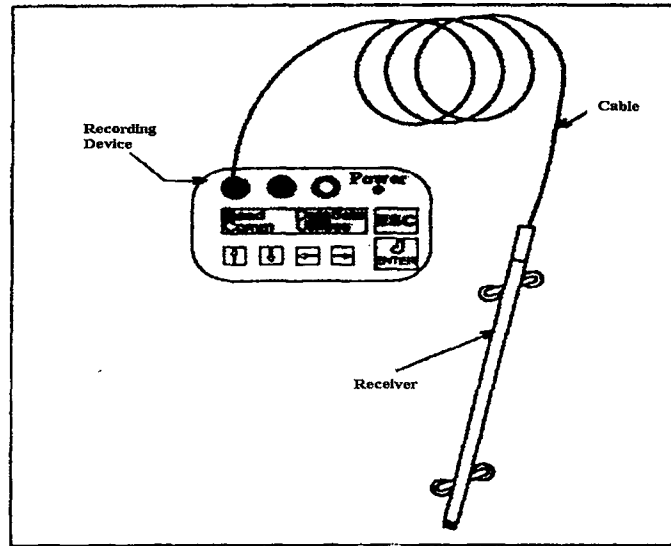
Figure 4.4 Inclinometer (Slope Indicator Company, 1994).

Inclinometers are used to monitor lateral earth movements in landslide areas and embankments (Figure 4.4). They are also used to monitor the deflection of retaining walls and piles under load (Slope Indicator Company, 1994). Horizontal inclinometers are used to monitor settlement in foundations and embankments.

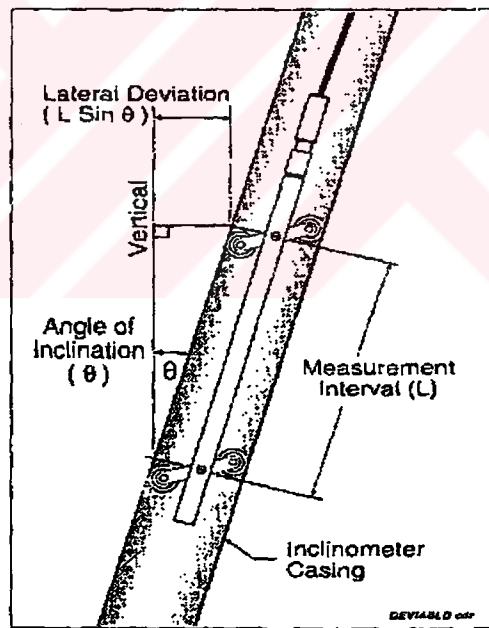
Figure 4.5 Inclinometer Measurement (Slope Indicator Company, 1994).

Inclinometers are used to measure movements which are perpendicular to borehole axis. By the inclinometer measurements, movement location and movement rate can easily be measured (Figure 4.5). By one inclinometer device, measurements can be taken from many boreholes, at desired time intervals.

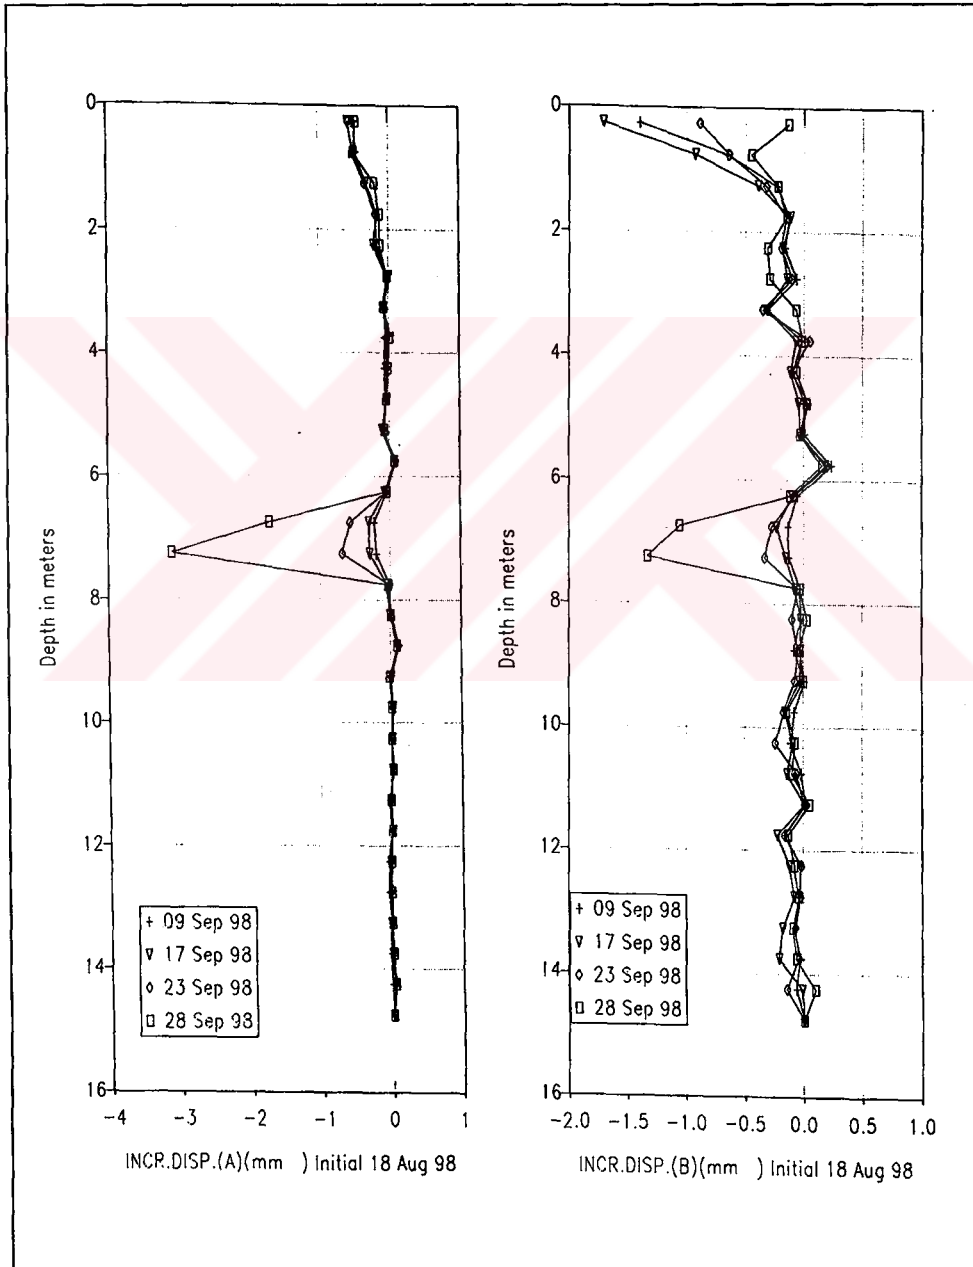
Figure 4.6 Inclinometer measurement graphs of Hik 1.

At Hik 1, through Hik 5, inclinometer measurements were taken and cumulative displacement and incremental displacement graphs were drawn. Figure 4.6 shows the inclinometer measurements taken from Hik 1 as an example. From these graphs (Appendix A ), the failure surface in each borehole was determined. Table 4.2 shows failure surface depths determined from the inclinometer measurement graphs.

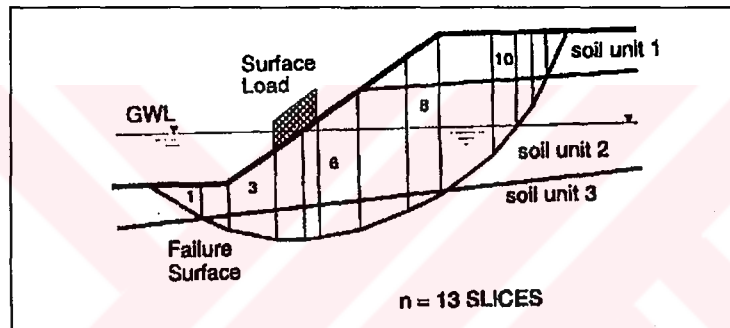
Figure 6.1 Dividing the potential sliding mass into slices.

All limit equilibrium methods for slope stability analysis divide a slide mass into (n) smaller slices (Figure 6.1). Each slice is affected by a general system of forces (Figure 6.2). The thrust line indicated in the figure connects the points of application of the interslice forces ( $Z_i$ ).

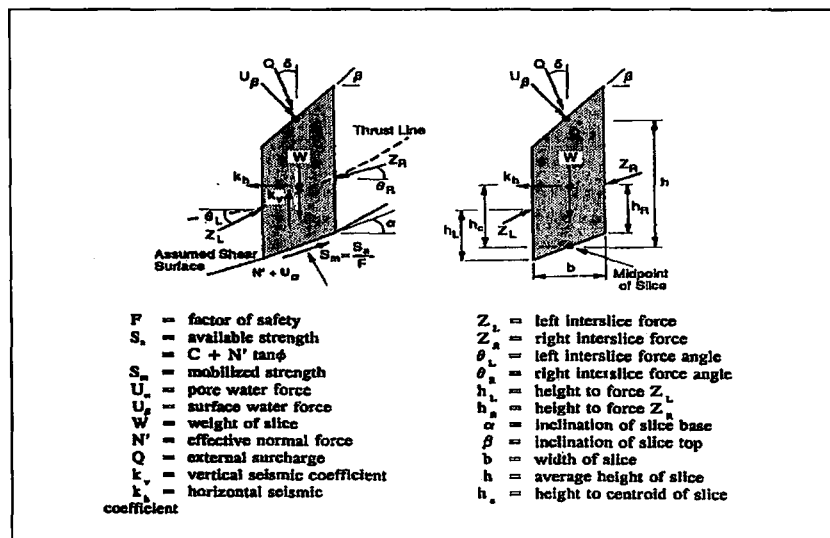
Figure 6.2 Forces acting on a typical slice

For the system shown in Figure 6.2, there are  $(6n-2)$  unknowns (Table 6.1). Also, since only four equations can be written for the limit equilibrium for the system, the solution is statically indeterminate. However, a solution is possible providing the number of unknowns can be reduced by making some simplifying assumptions. One of the common assumptions is that the normal force acts at the midpoint, thus reducing the number of unknowns to  $5n-2$ . This then requires an additional  $(n-2)$  assumption to make the problem determinate (Abramson, et al, 1996). It is these assumptions that generally categorise the available methods of analysis (Sharma and Lowell, 1983).

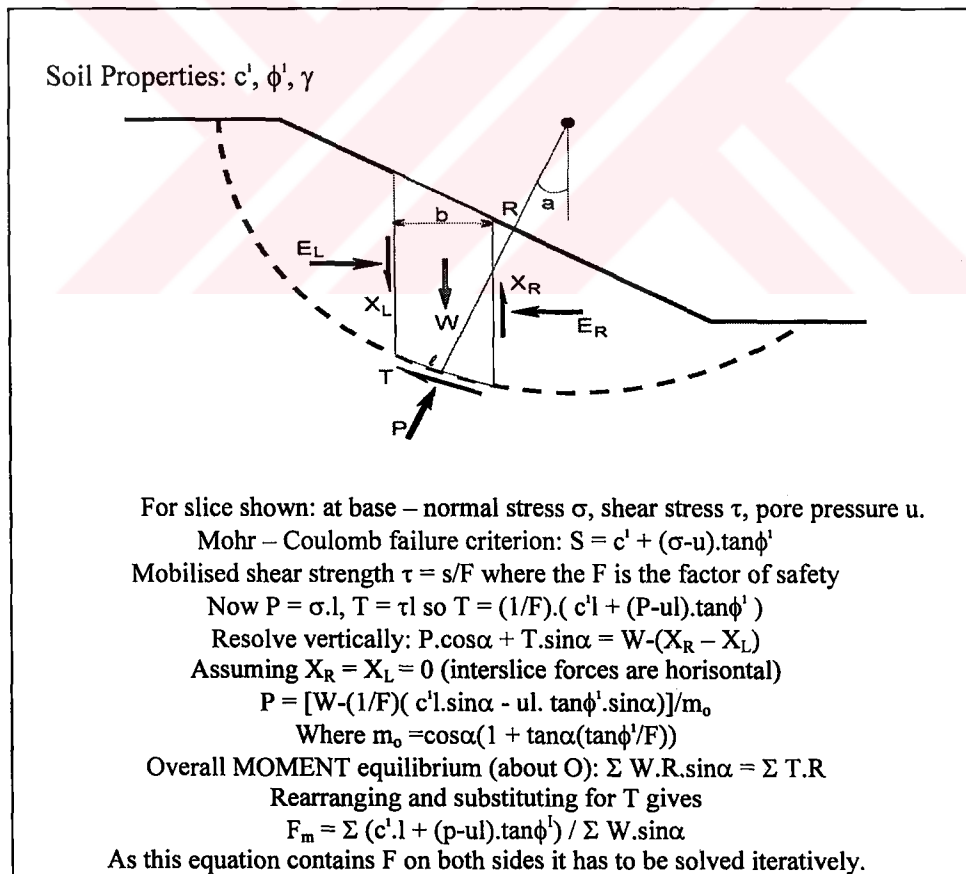
Figure 6.3 Bishop simplified method

Whitman and Bailey (1967) have looked closely at the performance of the Bishop simplified method and have concluded that the error involved in using this type of analysis against the more rigorous formulation is usually only 2% or less. These authors also point out that the method may be inaccurate in the case where the angle  $\alpha$  of the base of the slice is negative (which may happen at the toe of the circle); they suggest that the value of the term  $m_\alpha$  ( $m_\alpha = \cos\alpha (1 + (\tan\alpha \cdot \tan\phi^1)/F)$ ) be checked and if  $m_\alpha \leq 0.2$ , the results should be regarded as unreliable.

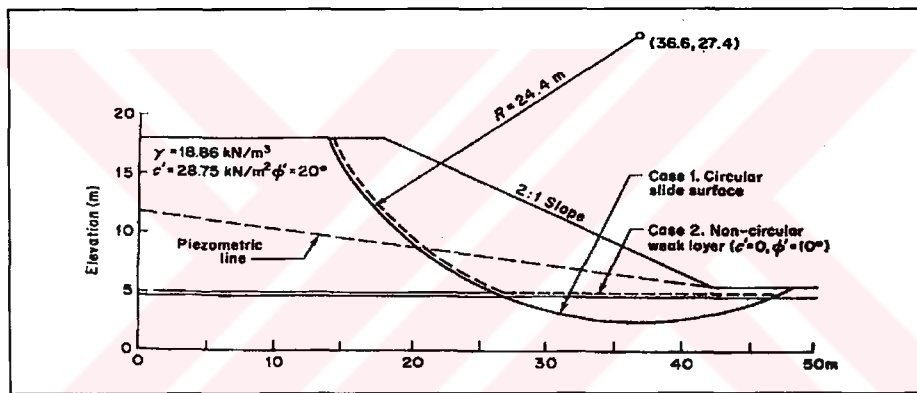
Figure 6.4 Problem used by Fredlund and Krahn.

The accuracy of the analysis of a particular slope depends on the accuracy with which the geometry of the slope, the groundwater conditions, the soil properties, and the stability model of the slope. A number of studies have been made in which several methods are used to analyse the same problem. Fredlund and Krahn (1977) compared the results of a number of methods of analysis when applied to an example slope stability problem (Figure 6.4). Table 6.3 shows the results of Fredlund and Krahn (1977) study.

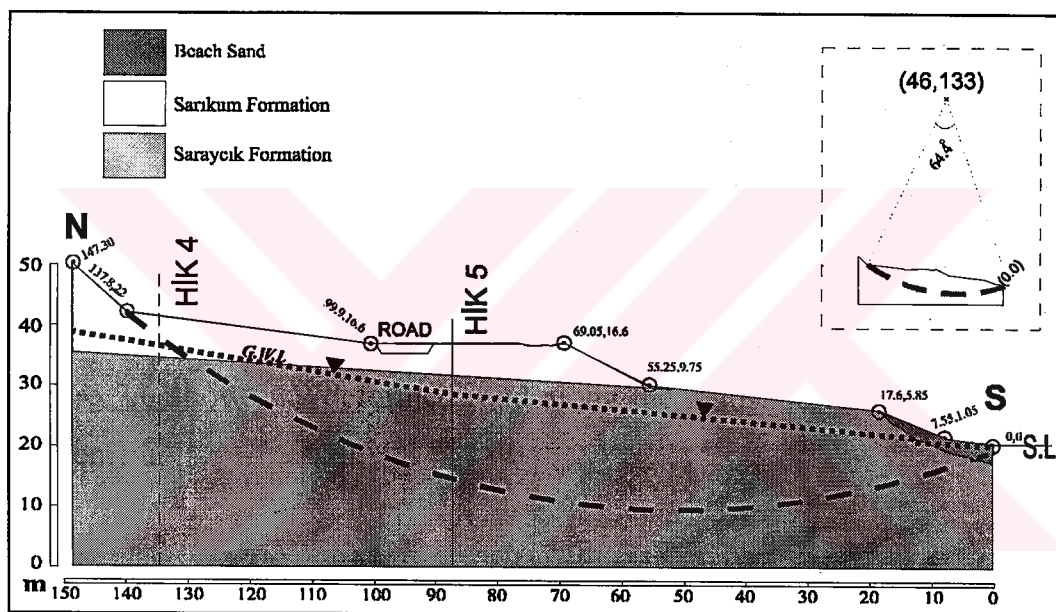
Figure 7.1 Geological cross section of the landslide investigated (cross section 1)

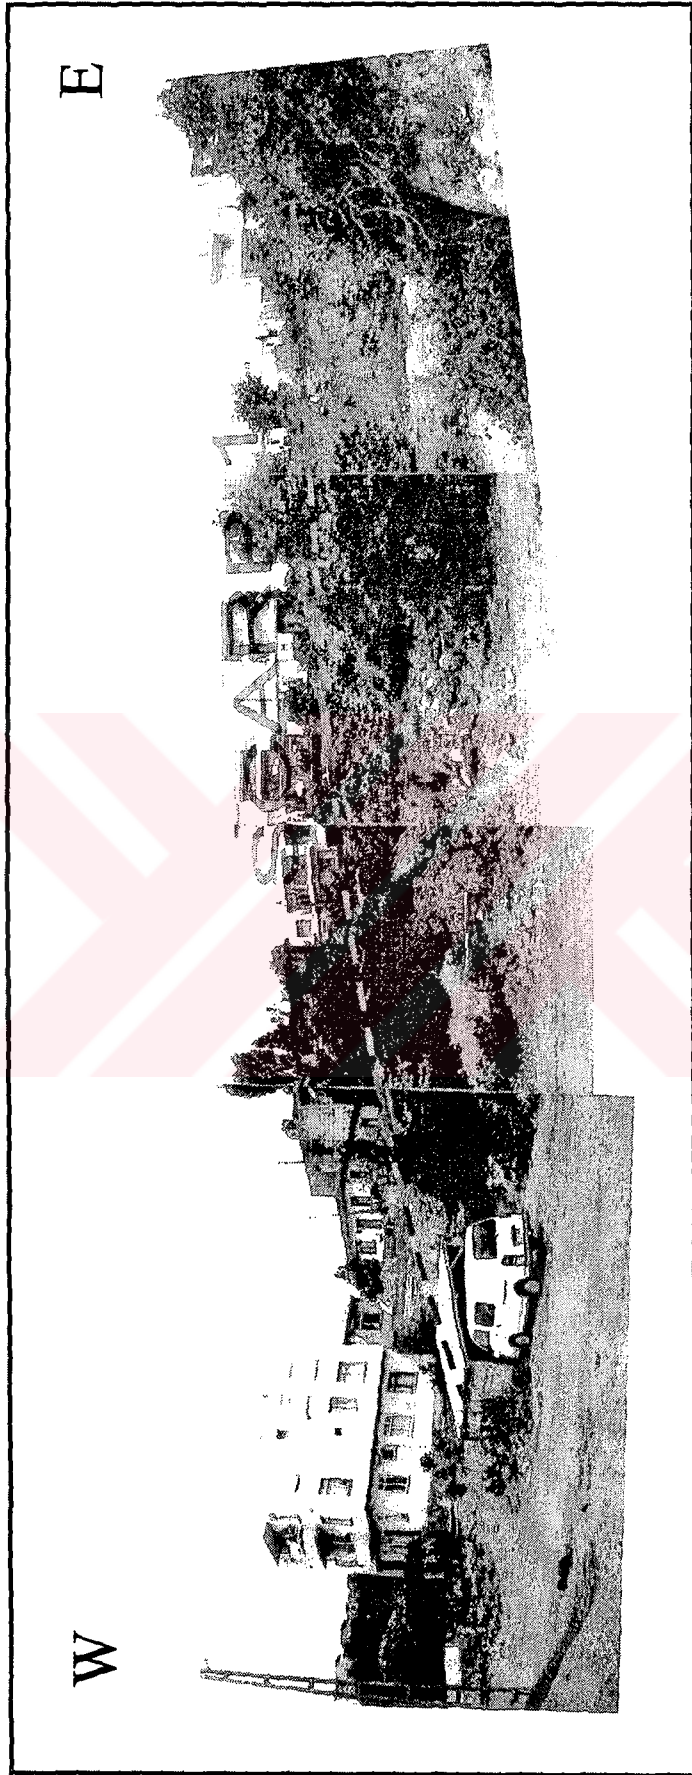
Figure 7.2 Panoramic view of scarp 1

(Figure 7.3) as also shown in Figure 4.1. The deepest part of slip surface is about 22 m, at sector 1 and 12 m at sector 2. Figure 7.4 shows the topographic model of the landslide. Retaining wall just above the road, probably prevented the advance of Scarp 1, because retaining wall is highly deformed (Figure 7.5) so Scarp 2 was formed below the retaining wall. Figure 7.6 shows the deformed road along the landslide due to continuous movement.

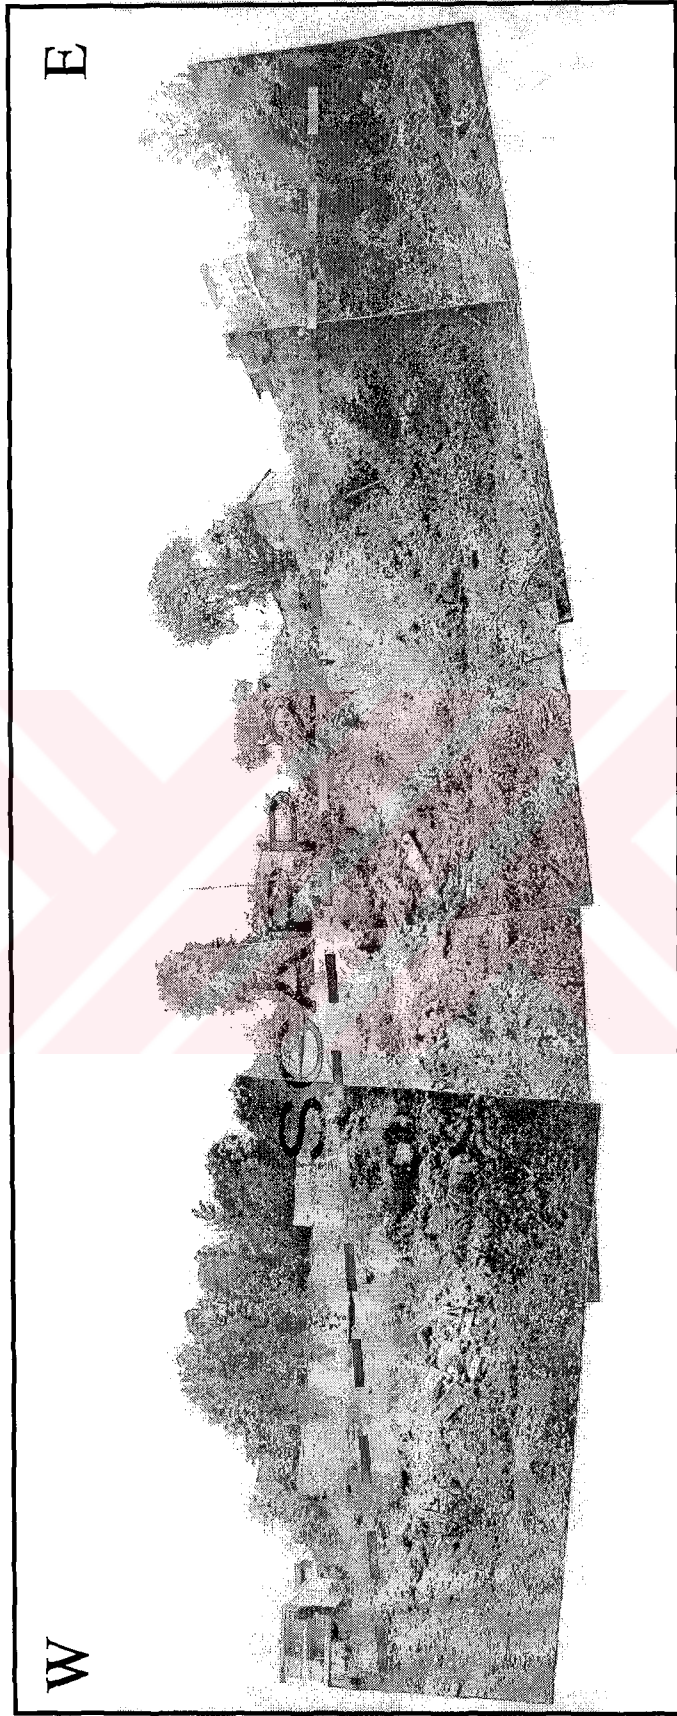
Figure 7.3 Panoramic view of scarp 2

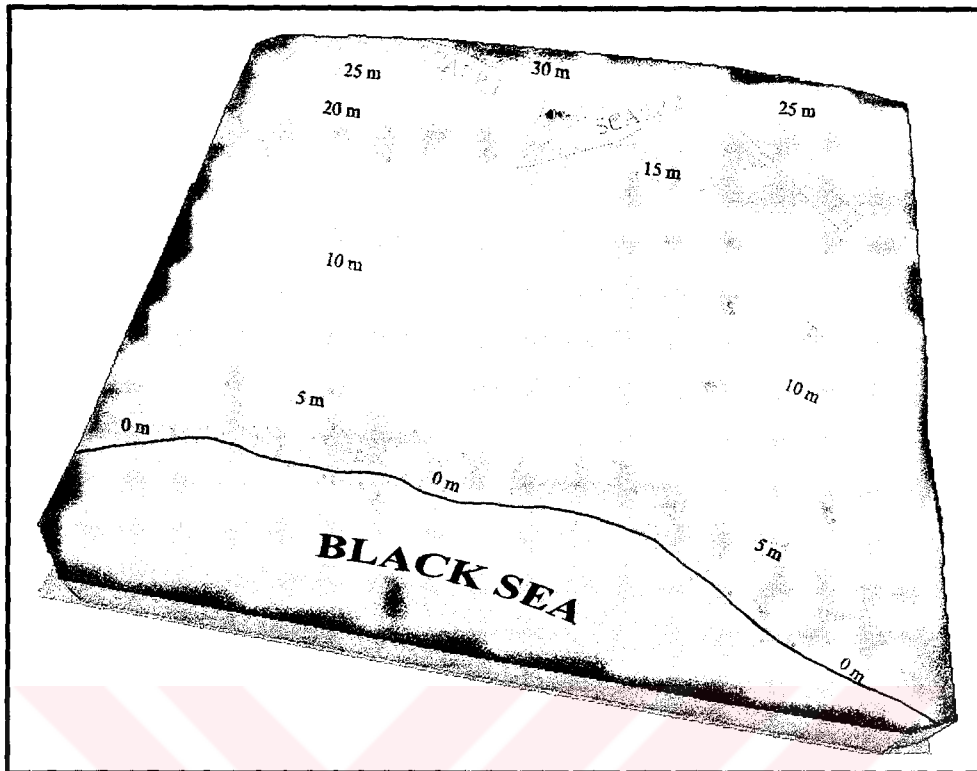
Figure 7.4 Topographic model of the area investigated

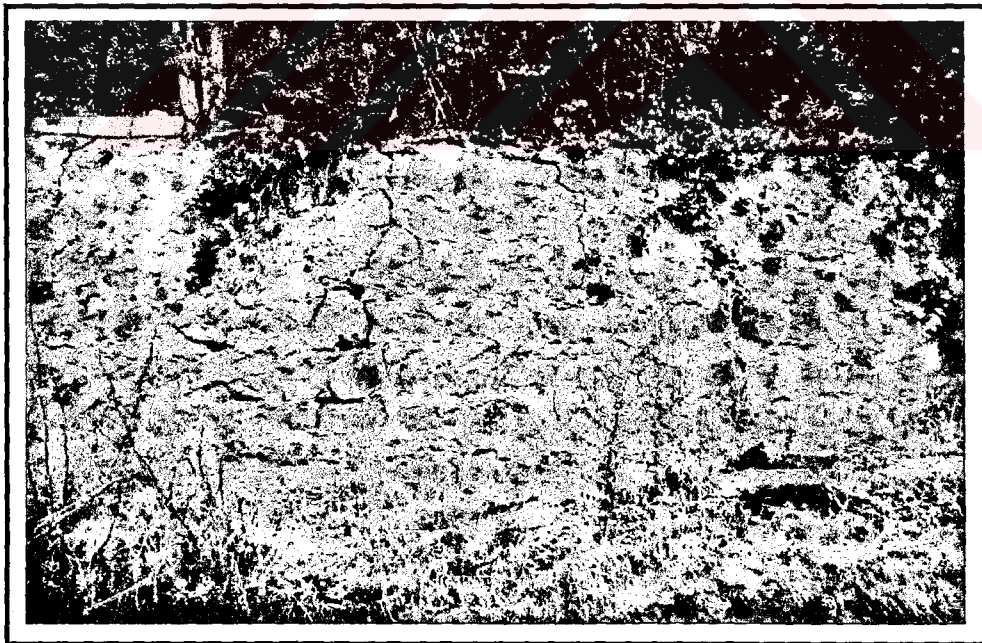
Figure 7.5 Deformed retaining wall at the east of scarp 1 (see Figure 4.1)

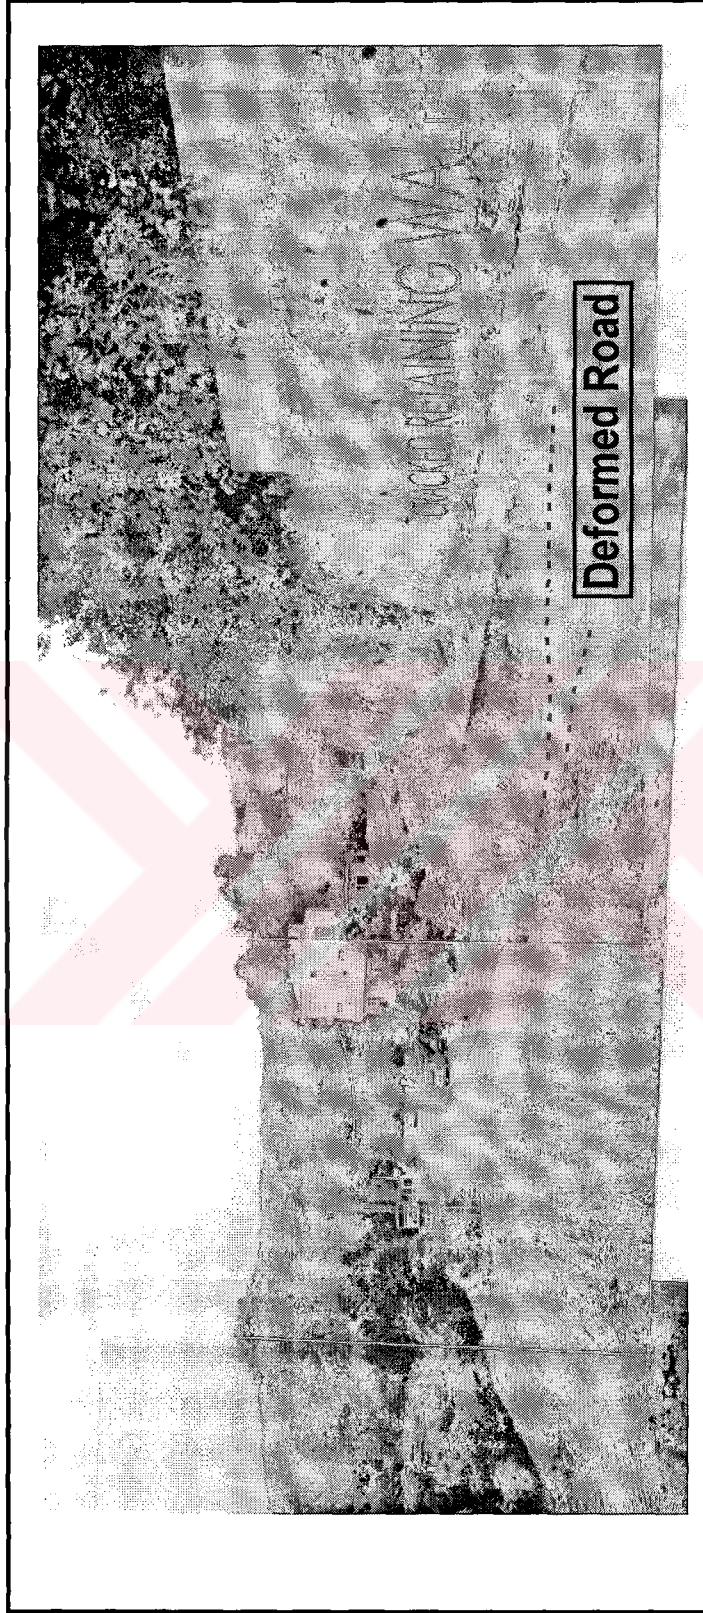
Figure 7.6 View of deformed road

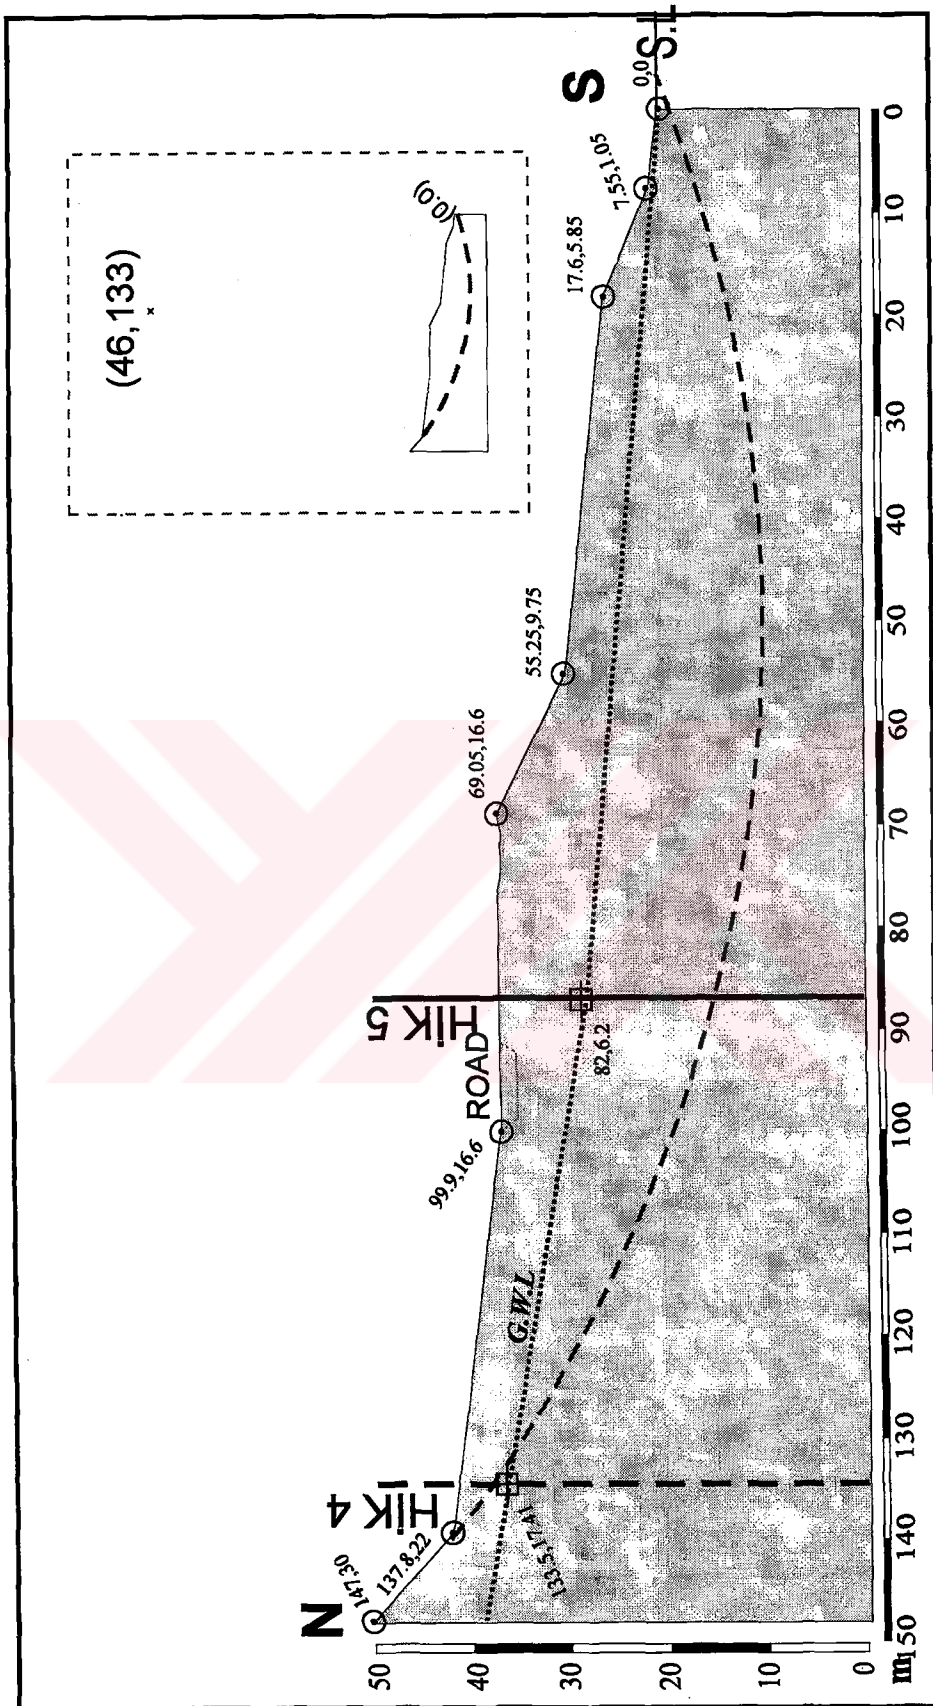
Figure 7.8 Cross - section 1

C. Section 1 ( $c,\phi$ ) for FS = 1.0	C. Section 2 ( $c,\phi$ ) for FS = 1.0	C. Section 3 ( $c,\phi$ ) for FS = 1.0	C. Section 4 ( $c,\phi$ ) for FS = 1.0
29 kPa, 2 deg	19.6 kPa, 2 deg	13 kPa, 2 deg	16.4 kPa, 2 deg
20.2 kPa, 5 deg	12.6 kPa, 5 deg	8.4 kPa, 5 deg	11.5 kPa, 5 deg
11.1 kPa, 8 deg	5.4 kPa, 8 deg	4 kPa, 8 deg	6.5 kPa, 8 deg
0 kPa, 11.7 deg	0 kPa, 10.3 deg	0 kPa, 10.45 deg	0 kPa, 11.7 deg

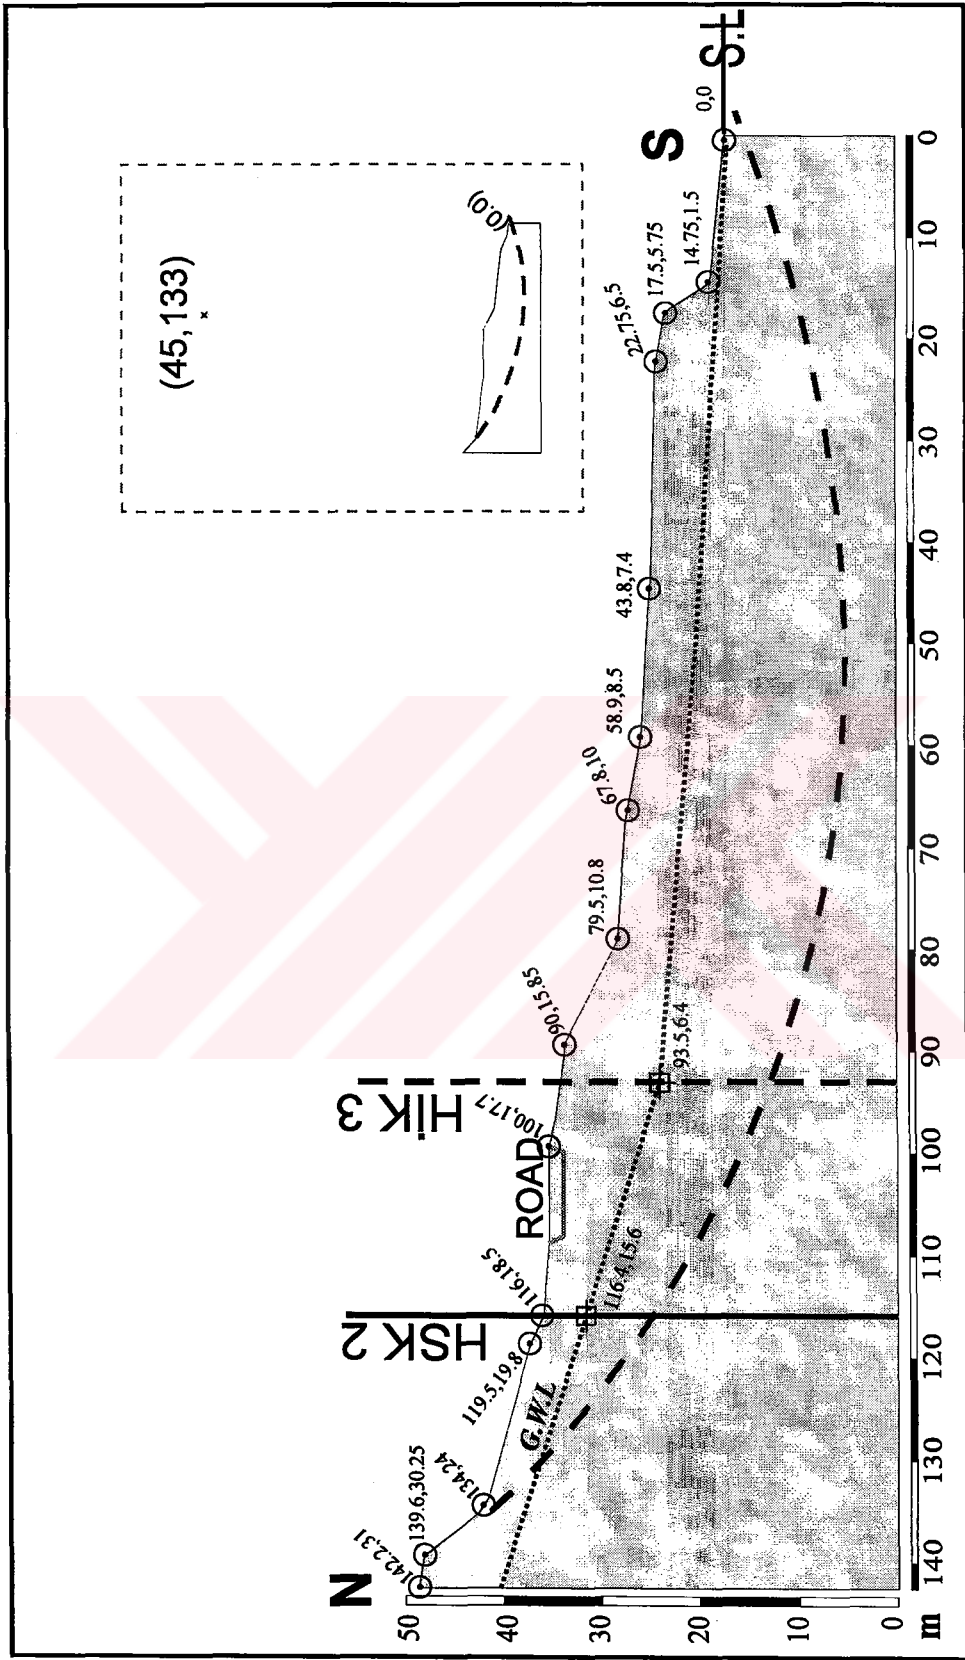
Figure 7.9 Cross - section 2

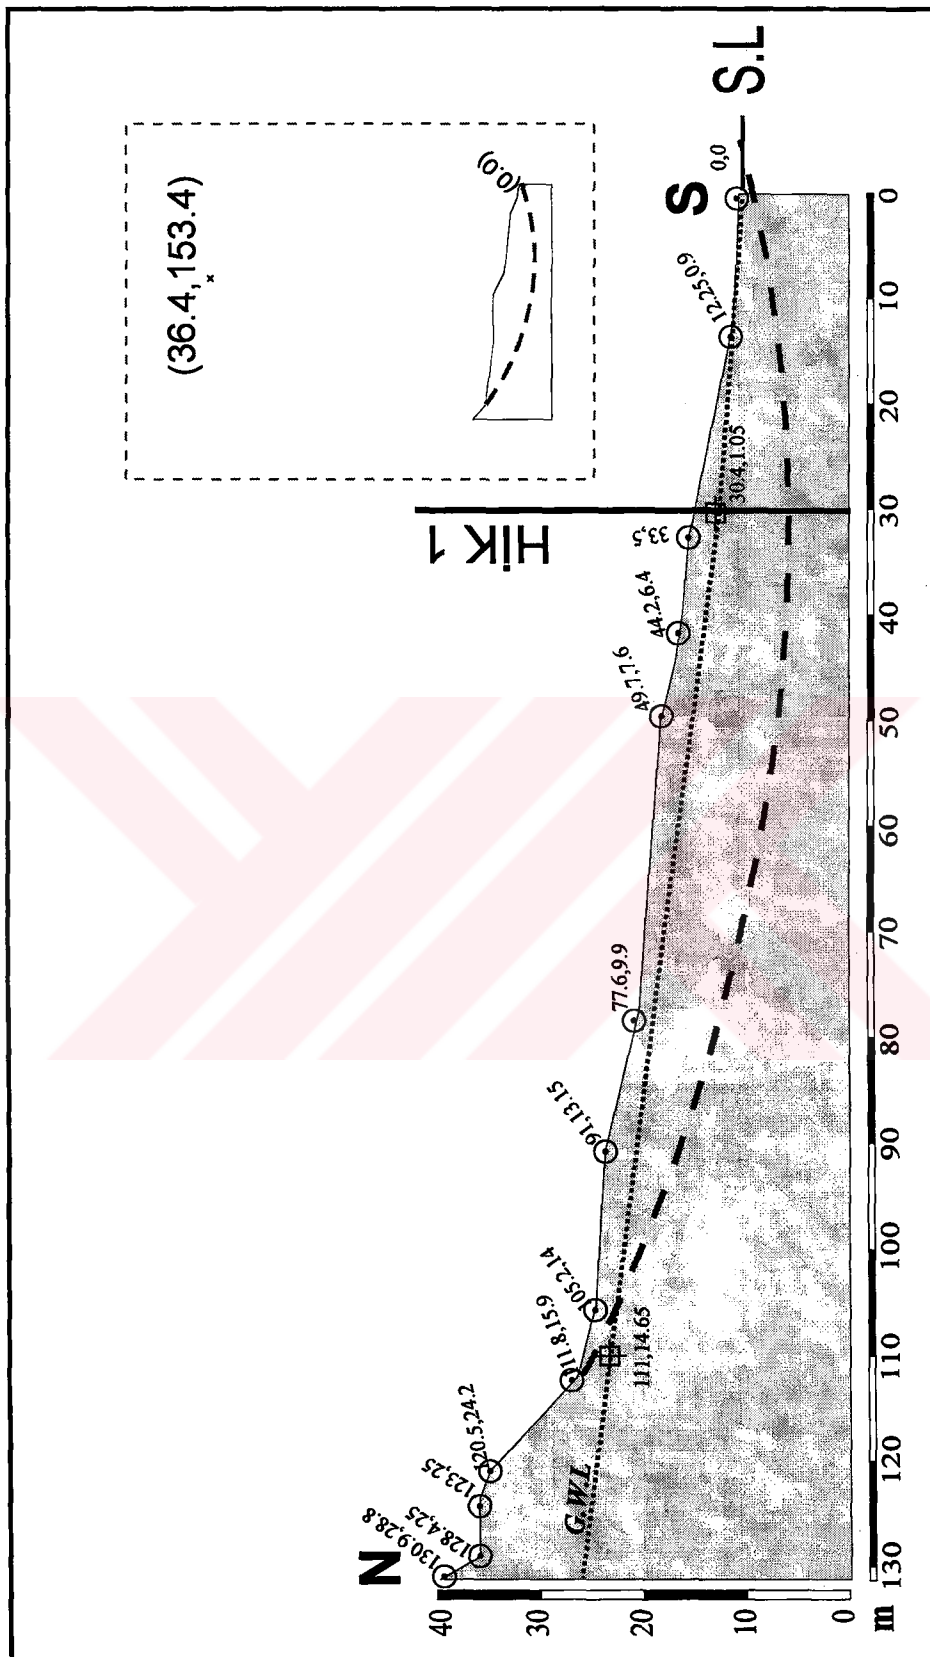
Figure 7.11 Cross section 4

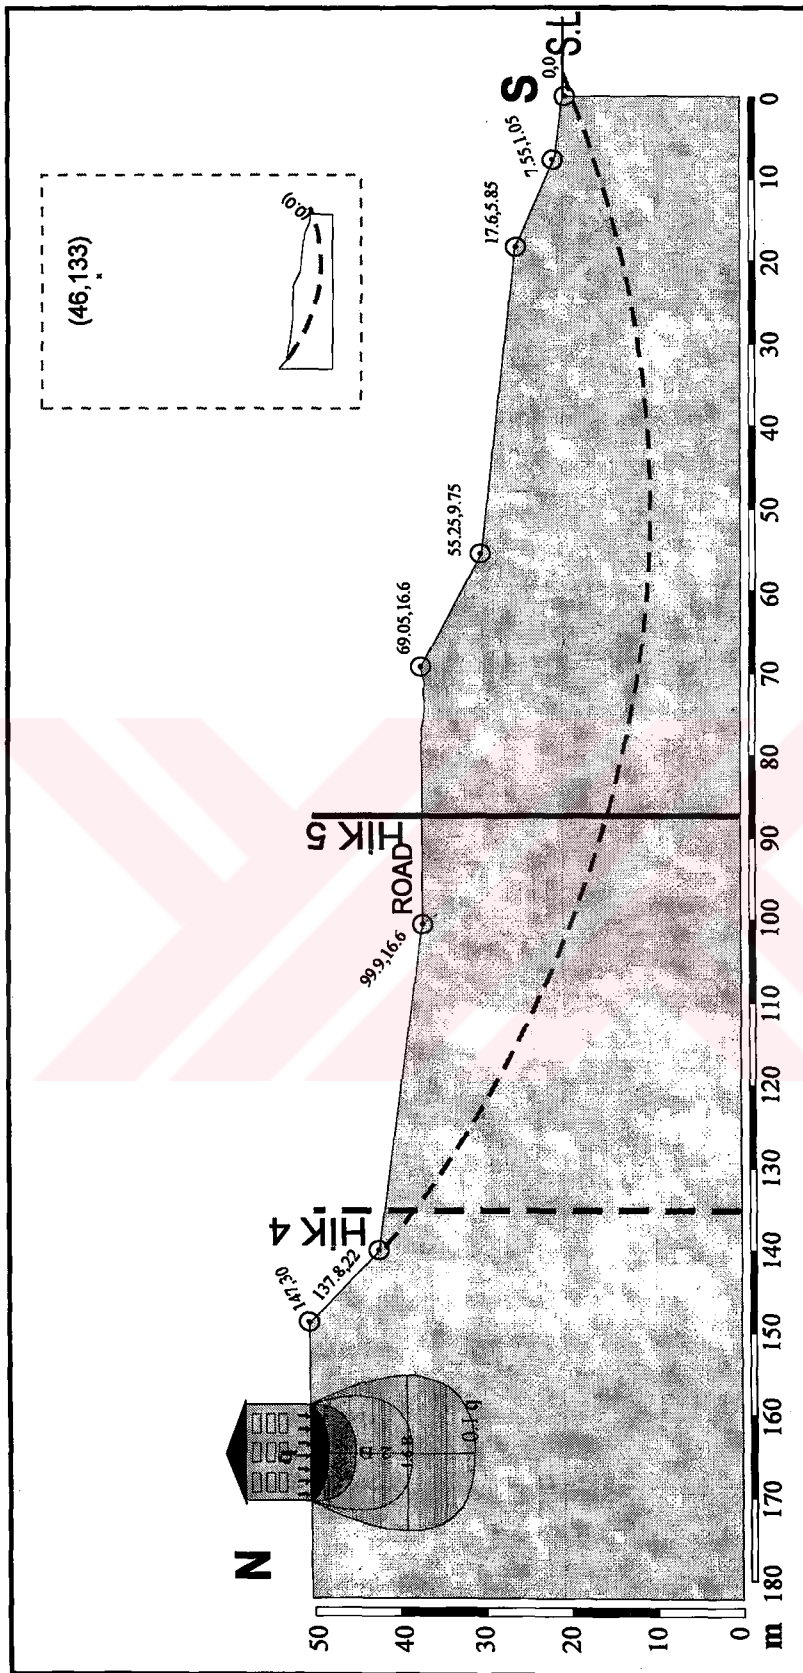
Figure 7.12 Pressure exerted by the building behind scarp 1 on cross - section 1.

There is no surcharge load acting on the slope, because effect of buildings behind the scarp 1 is negligible. Figure 7.12 shows pressure bulb exerted by building behind scarp 1 (Drawings are scaled, elastic pressure distribution for a circular footing from Whitlow, (1983)).
