**CAUSES, ANALYSIS AND STABILISATION OF A COASTAL SLIDE,  
SOUTH OF SINOP, TURKEY**

**A THESIS SUBMITTED TO  
THE GRADUATE SCHOOL OF NATURAL AND APPLIED SCIENCES  
OF  
THE MIDDLE EAST TECHNICAL UNIVERSITY**

**DECEMBER 1999**

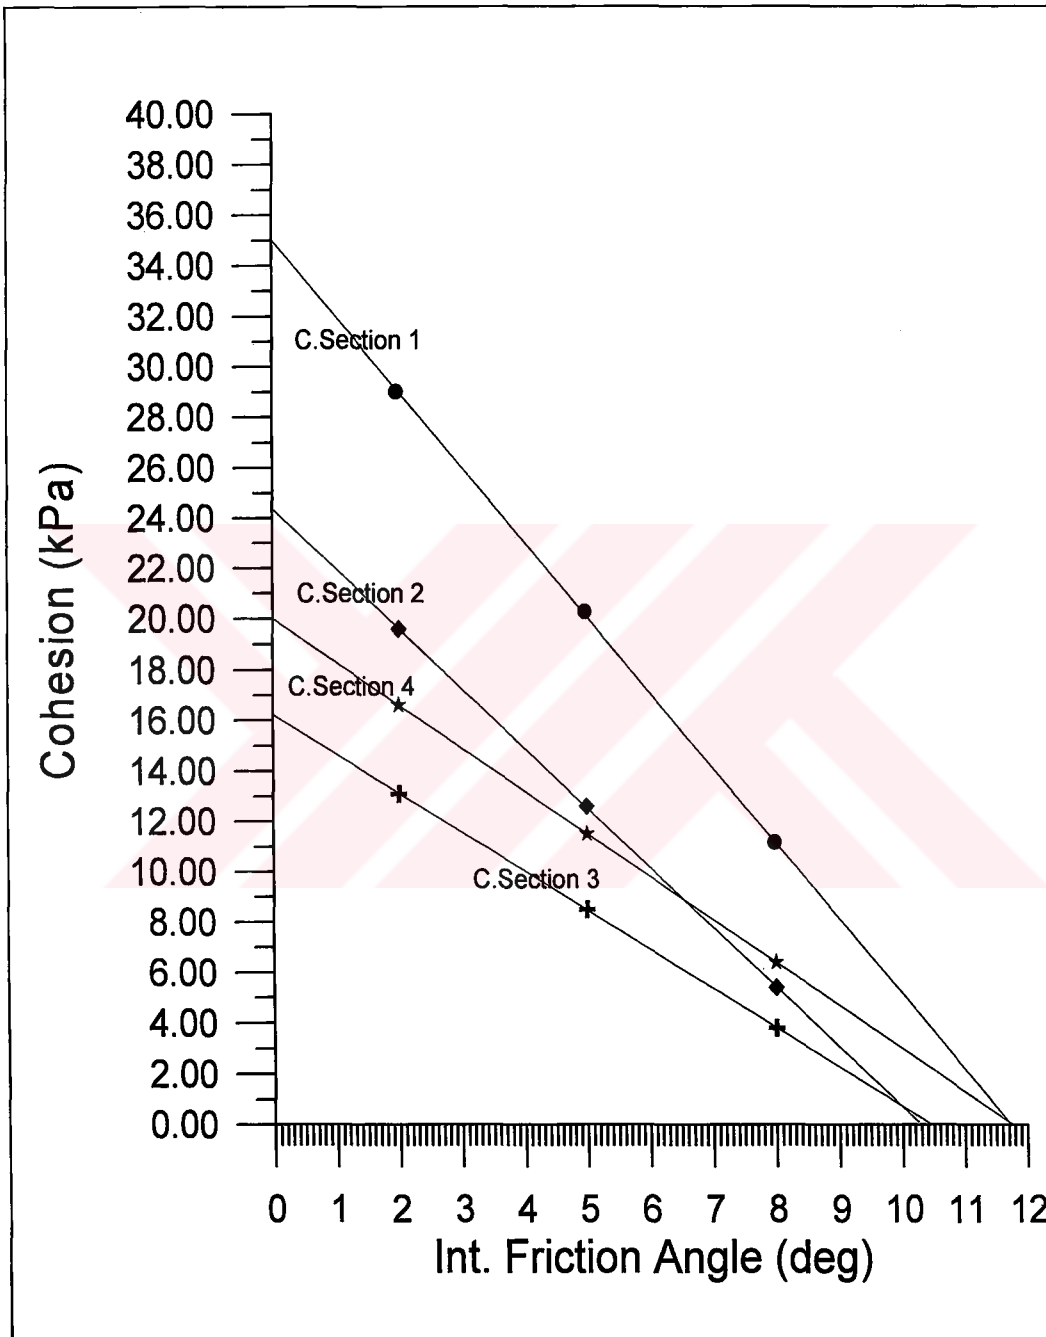
Figure 7.13 Graphical representation of back analysis results

The back analysis results, indicate that for a cohesion value of 0 kPa, 10.3°, 10.45° and 11.7° residual friction angles were obtained. Lines connecting, limiting equilibrium conditions for each cross section tend to intersect at zero cohesion, 10.3° - 11.7° zone. 10.3° friction angle was selected for final static and pseudostatic analyses. Bell (1992), gives similar residual shear strength parameters for Weald and Atherfield Clays ( $c=0$  kPa,  $\phi=6^\circ - 14^\circ$ ).

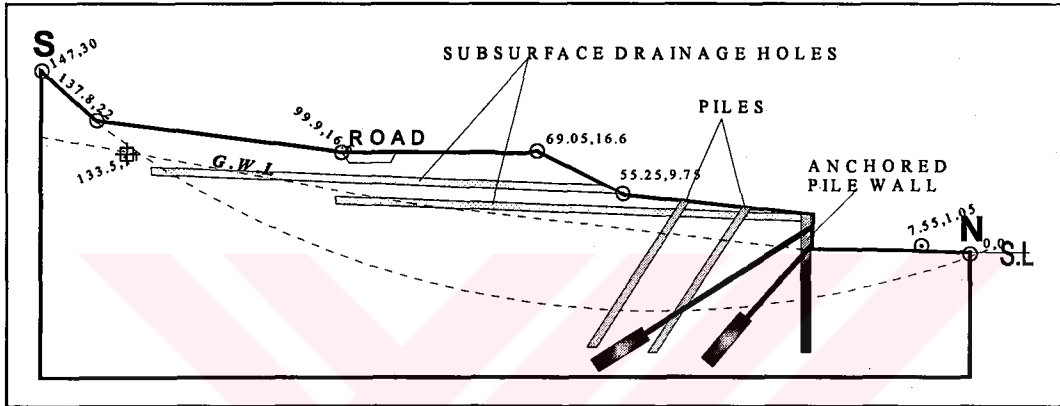
Figure 7.14 Design alternatives evaluated for the stabilisation of the investigated landslide

Increasing shear strength along the failure surface, by using laterally loaded piles or by an anchored wall is not practical, because, failure plane is rather deep seated. If an anchored wall is to be used, required pile lengths must be approximately 15 metres and required anchor lengths must be approximately 30 metres. Figure 7.14 shows these design alternatives.

Because of the difficulties associated with subsurface drainage, pile or pile anchored system briefly discussed above, the toe support with surface drainage is selected as stabilisation technique.

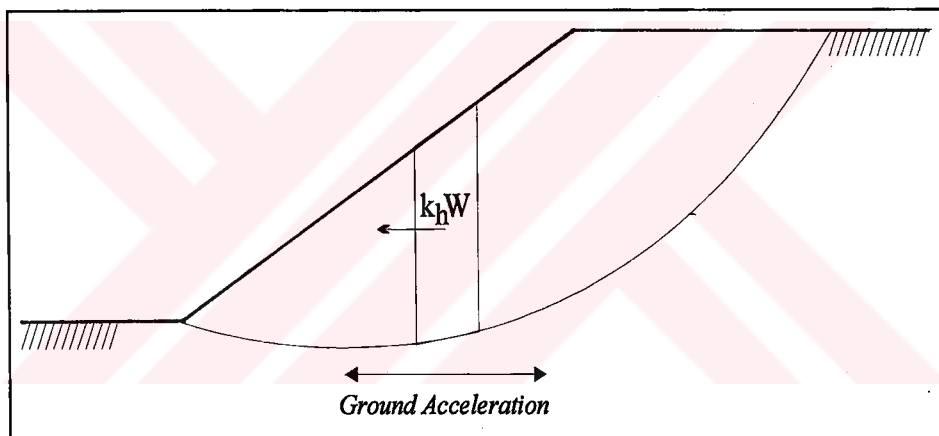
Figure 7.15 Effect of seismic force on a typical slice

Figures 7.16 through 7.19 show stabilised slope sections 1, 2, 3, 4, respectively. Rock butress shapes were determined by trial and error procedure. For pseudostatic seismic analyses, peak horizontal ground acceleration is taken as 0.093 for 100 year return period and 0.119 for 225 year return period (for details refer to Chapter 5). Horizontal seismic coefficient used in the analysis is selected as 1/3 of PHGA (Marcuson and Franklin, 1983) (for details refer to section 6.4.1).

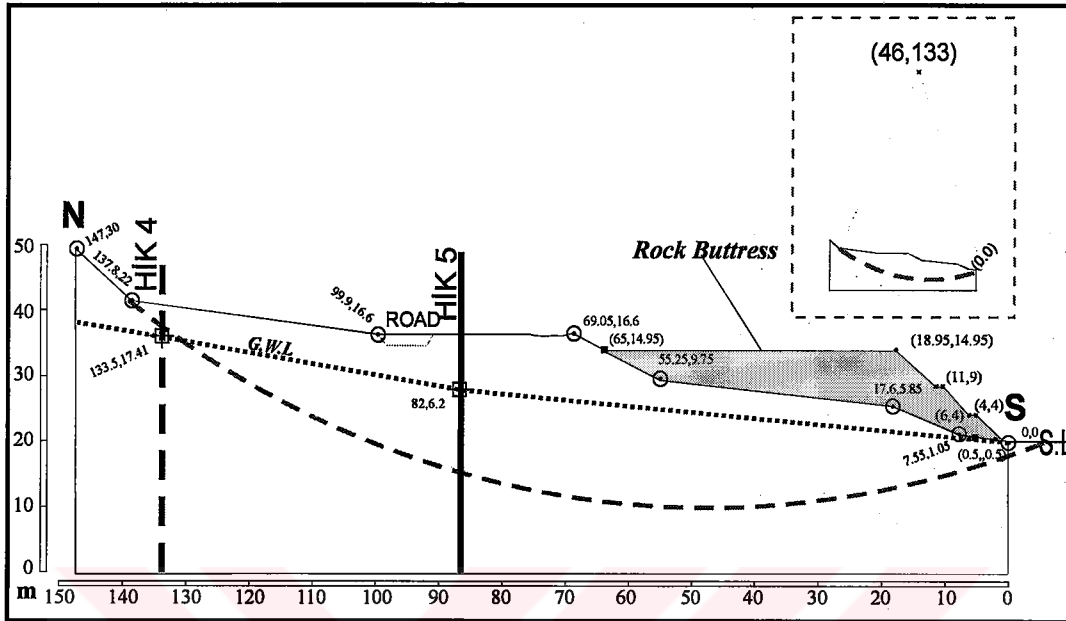
Figure 7.16 Stabilised slope, cross - section 1.

Stability analysis were performed by using Bishop's rigorous method with a computer program called Geosolve ver. 7.01. Table 7.3 shows values of factor of safety of stabilised slope sections under static and seismic conditions.

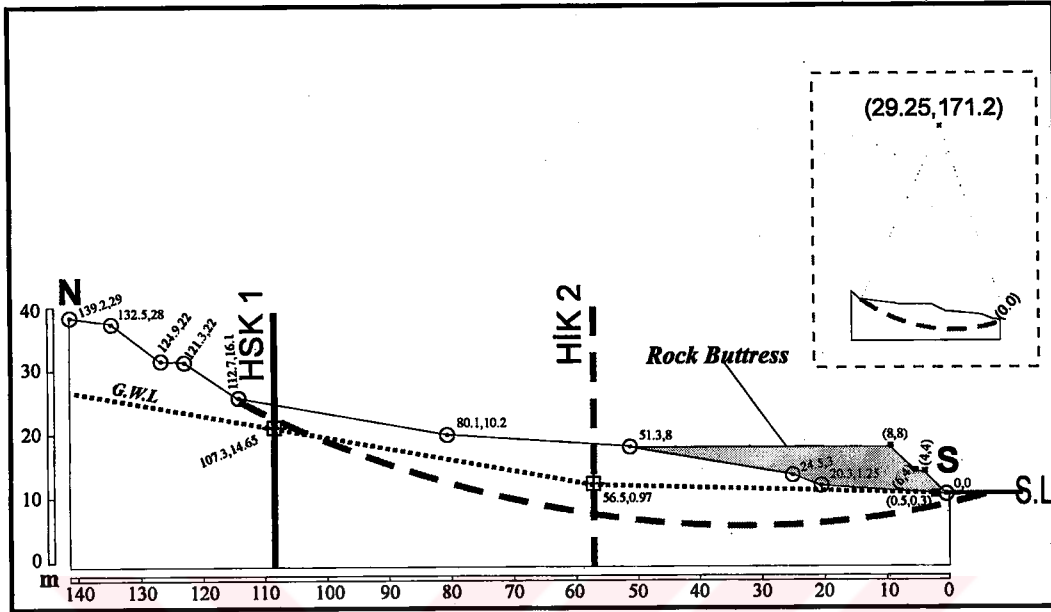
Figure 7.18 Stabilised slope, cross - section 3.

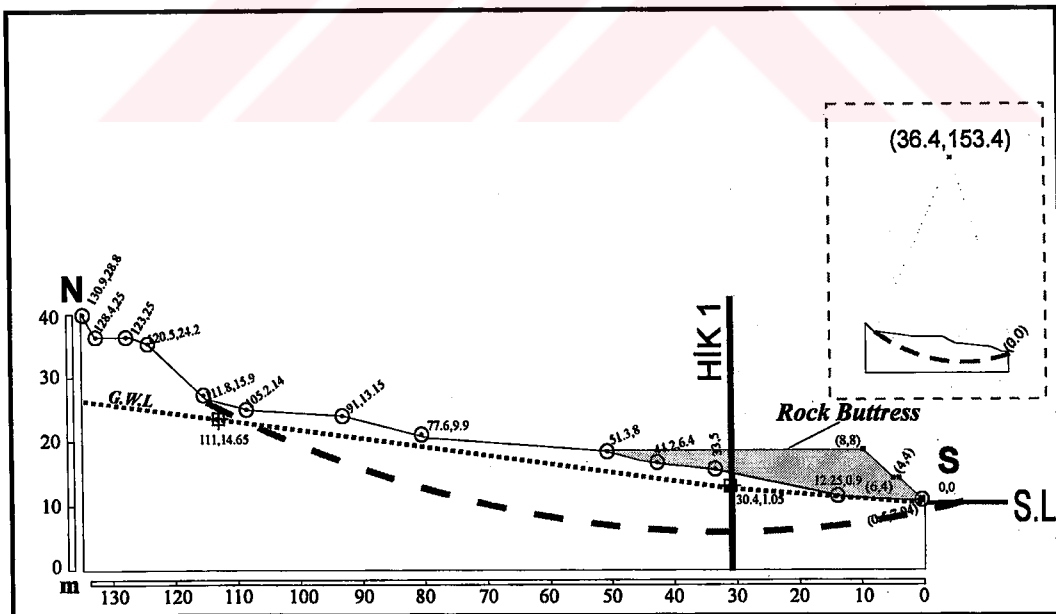
Figure 7.19 Stabilised slope, cross - section 4.

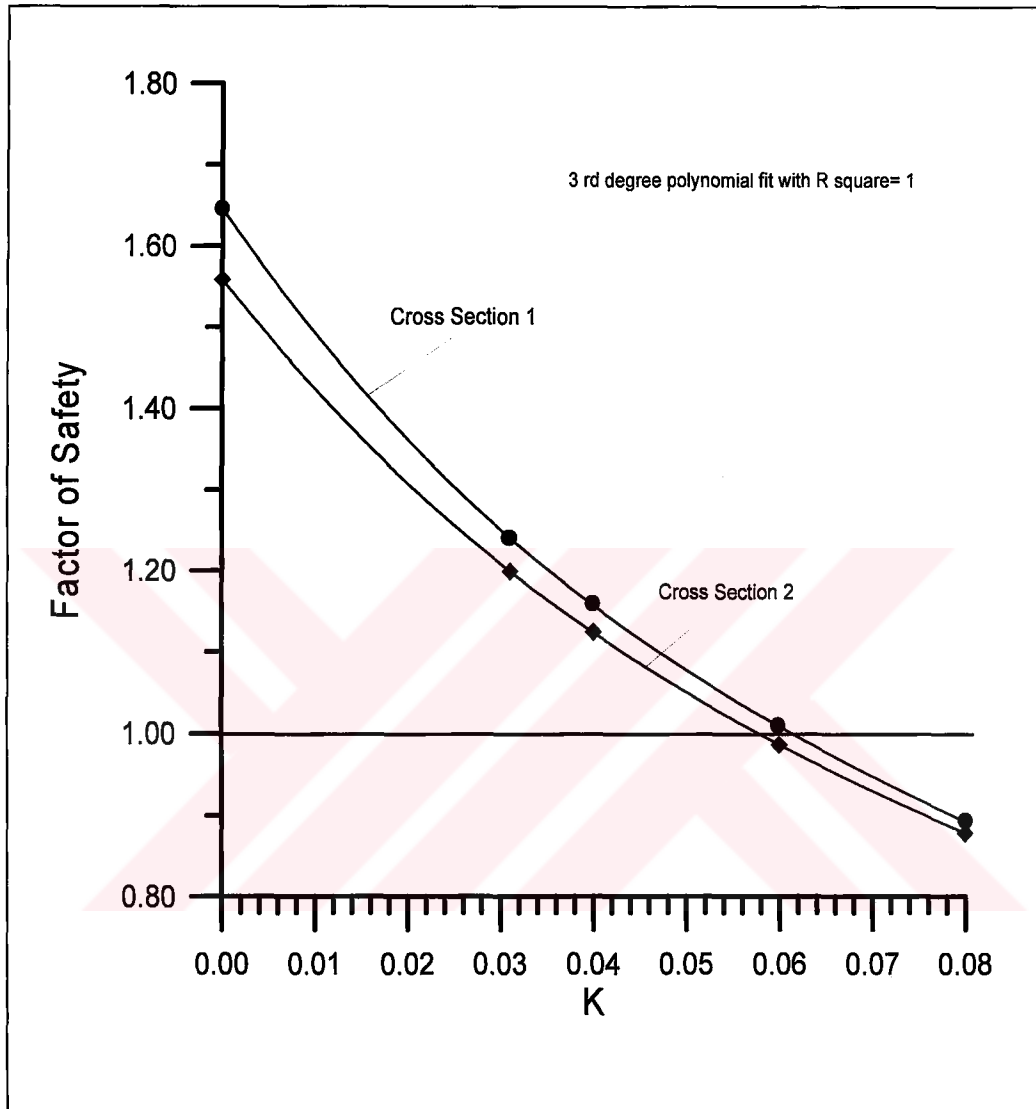
Figure 7.20 Results of the sensitivity analyses performed on cross-section 1 and 2.

According to Figure 7.19, failure will occur if  $k_h$  exceeds 0.063 on cross-section 1 and 0.058 on cross-section 2.

However, because  $k_h$  is the most difficult parameter to determine, sensitivity analyses were performed by using  $k_h$  values on each cross section. Figure 7.19 and 7.20 show the result of sensitivity analyses.

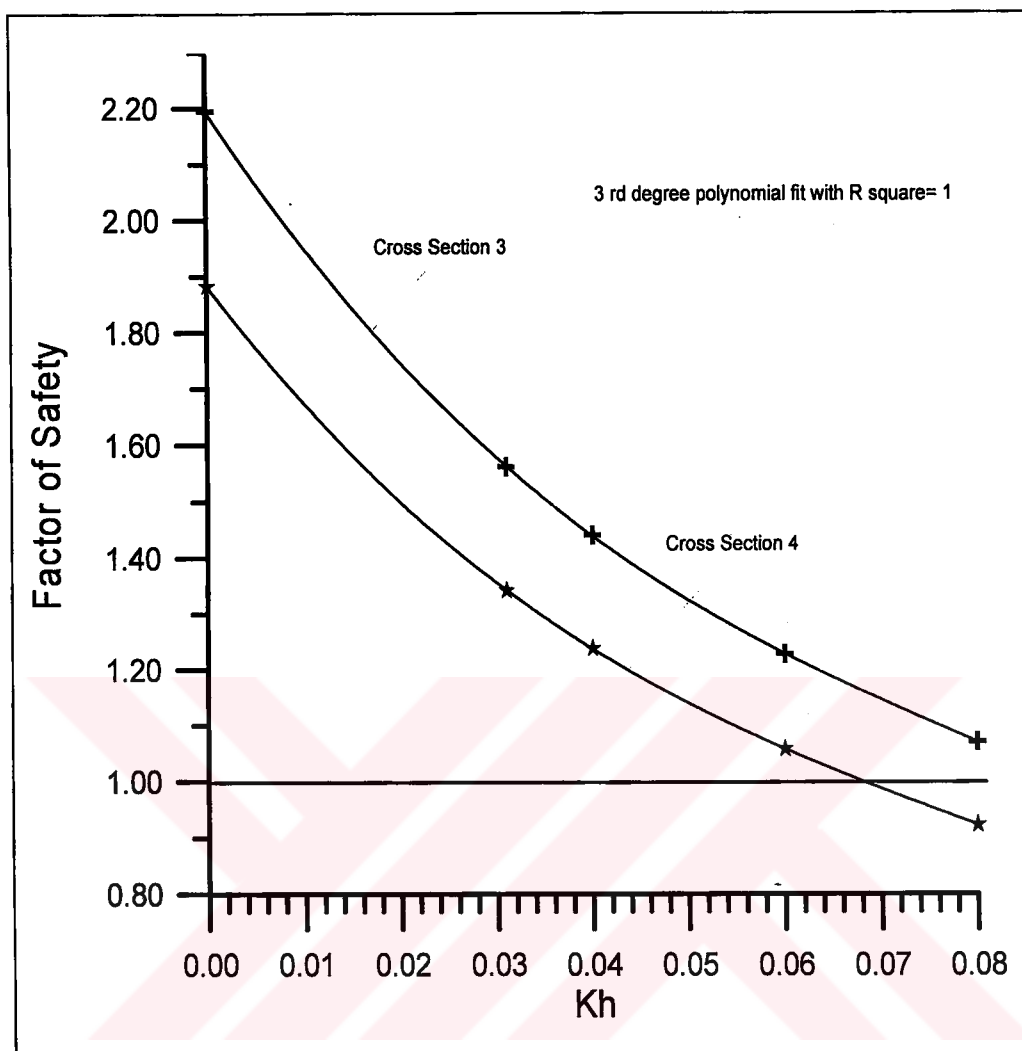
Figure 7.21 Results of the sensitivity analyses performed on cross-section 3 and 4

According to Figure 7.20, failure will occur if  $k_h$  exceeds 0.090 on cross-section 3 and 0.068 on cross-section 4.

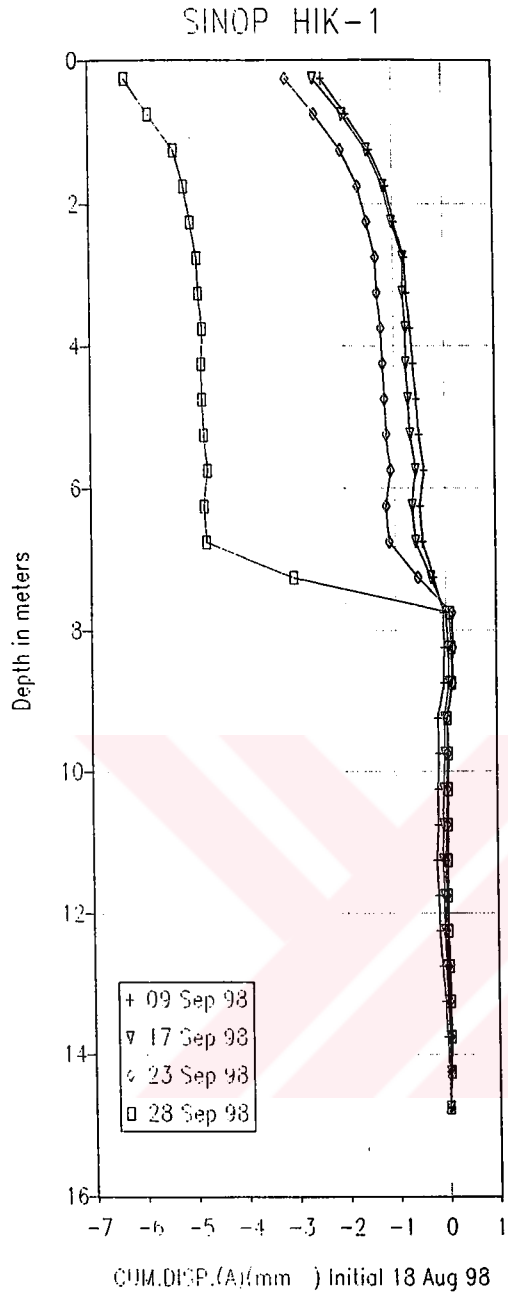
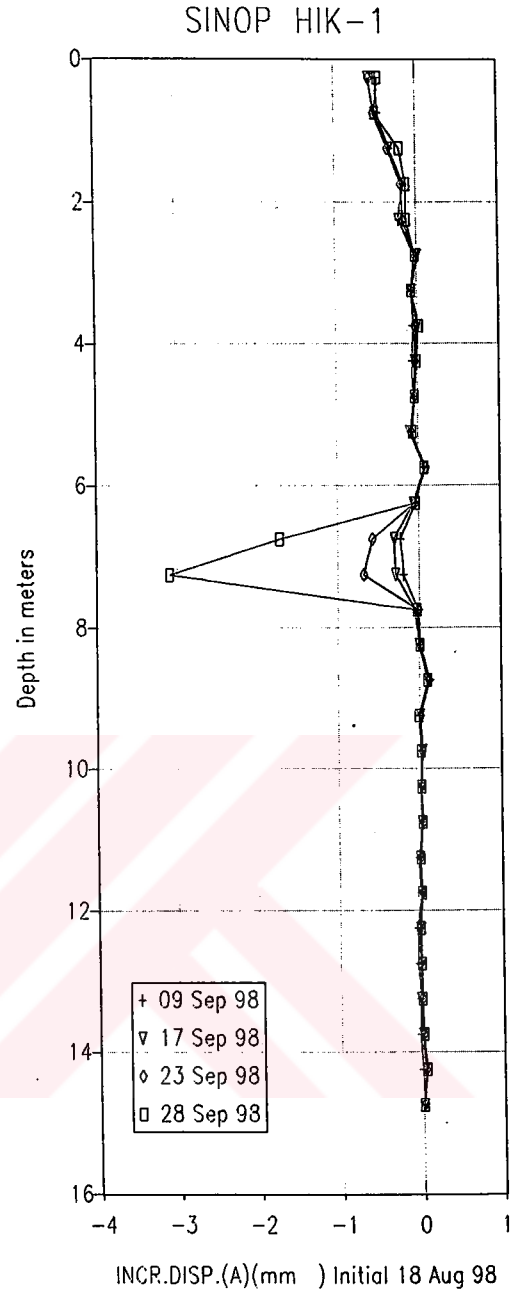
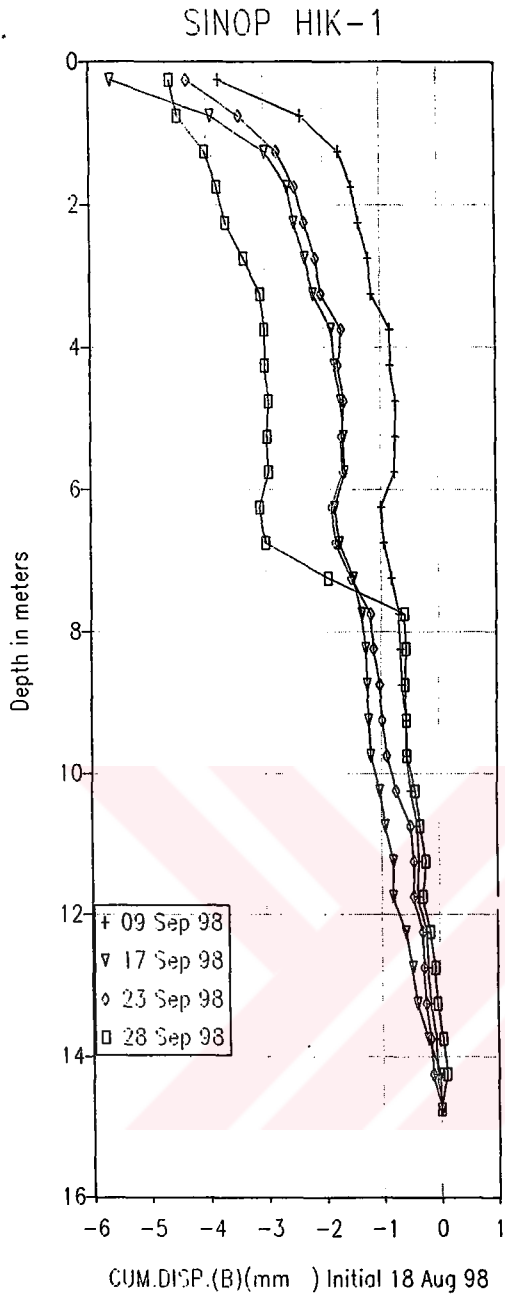
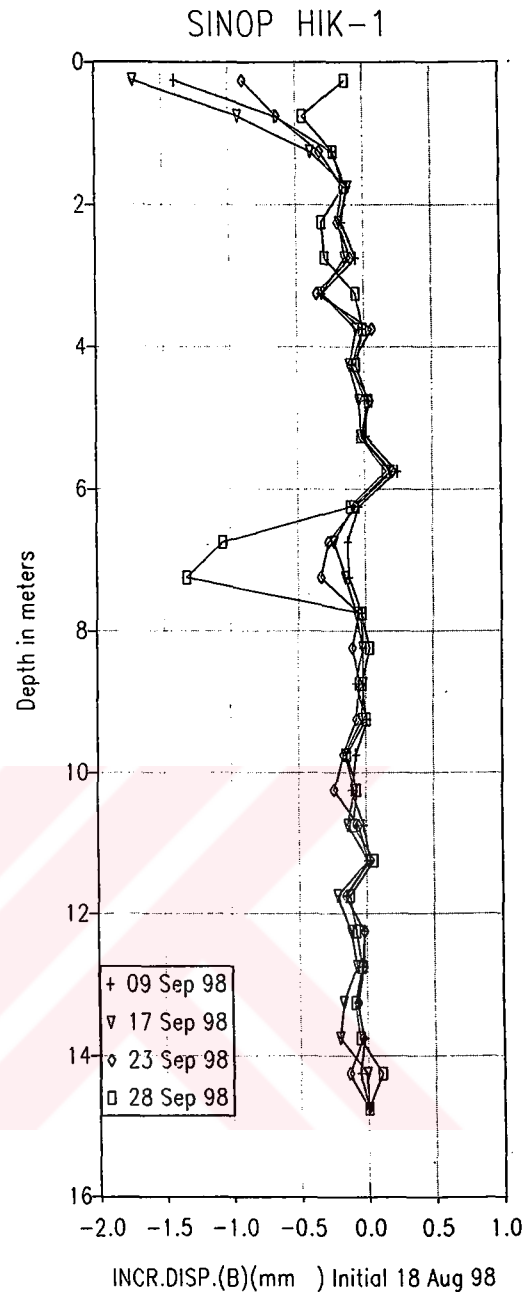
Figure A1. Inclinometer measurement graphs of the borehole Hik 1

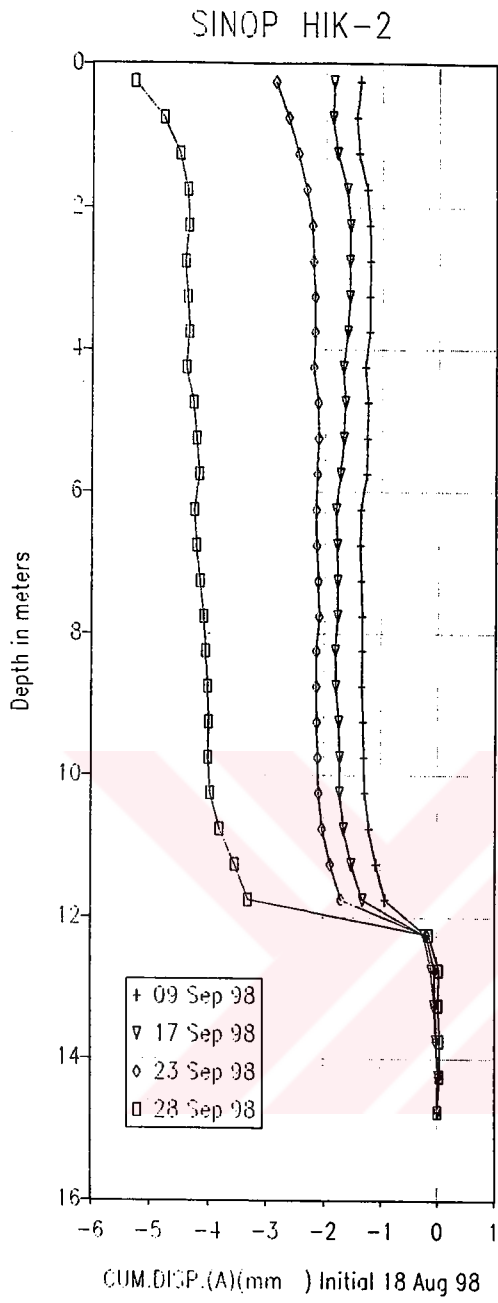
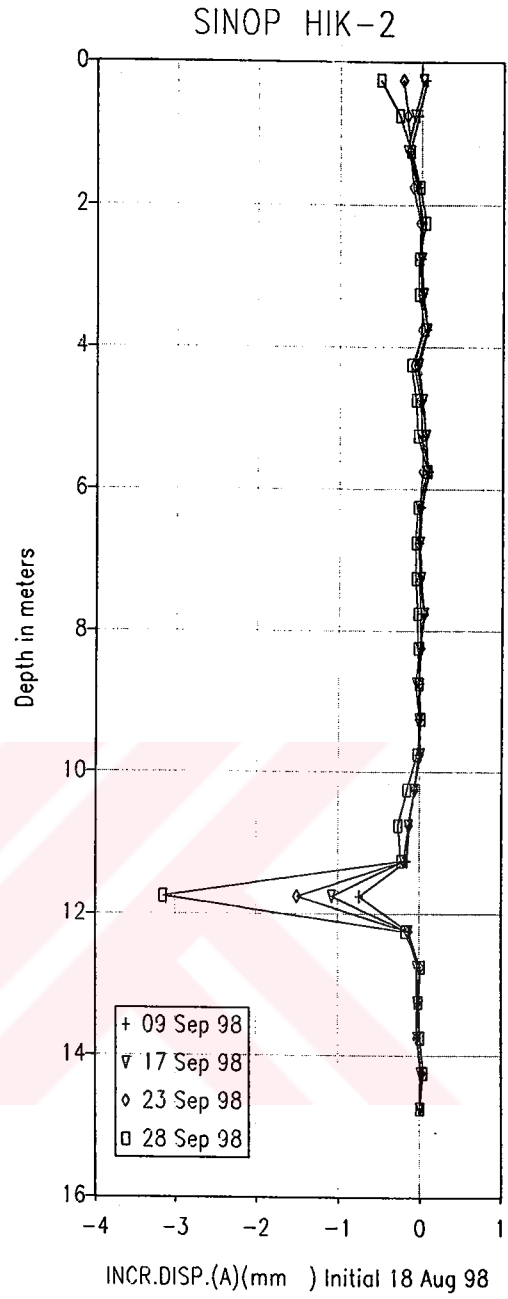
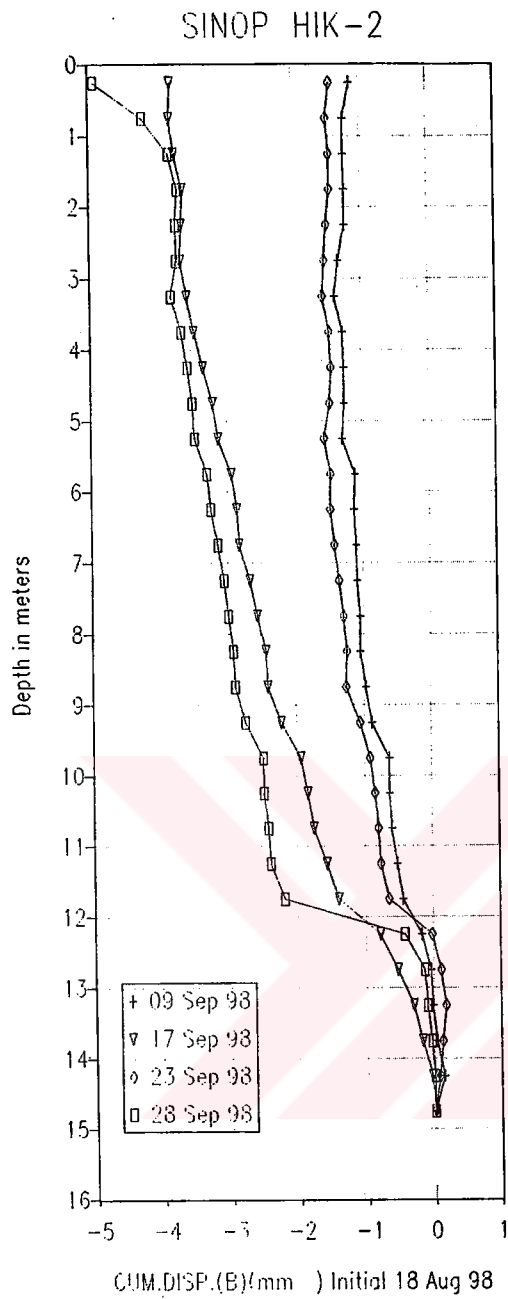
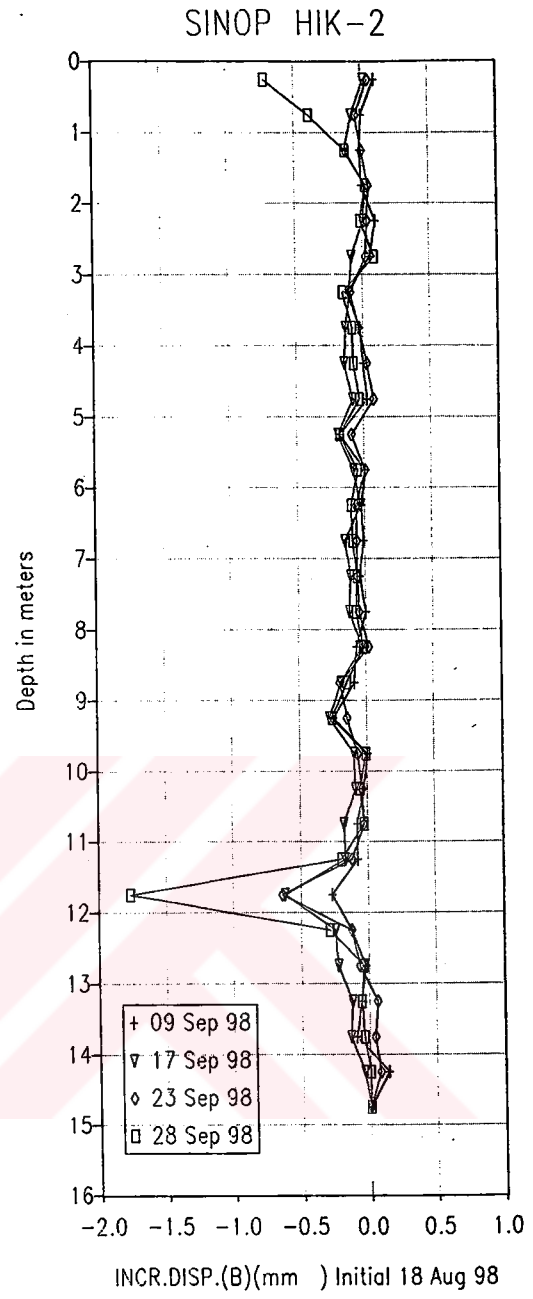
Figure A2. Inclinator measurement graphs of the borehole Hik 2

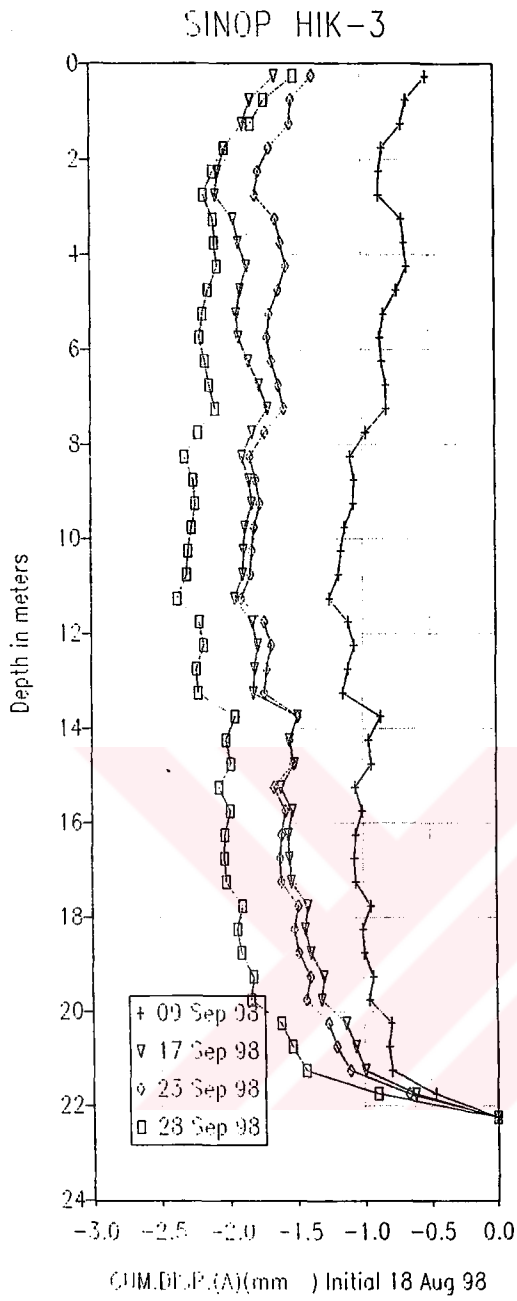
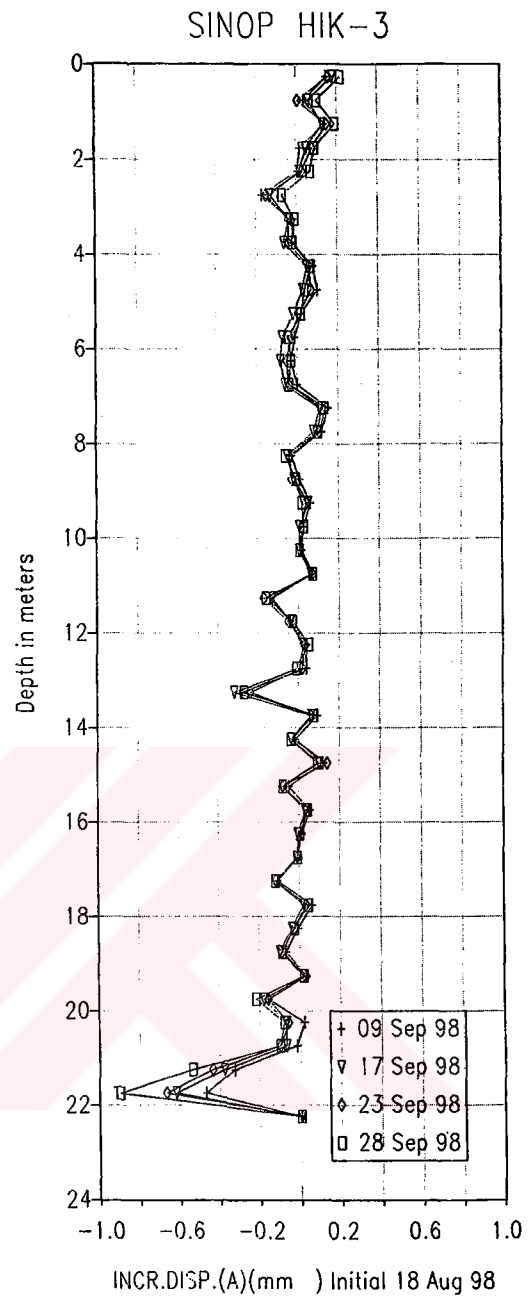
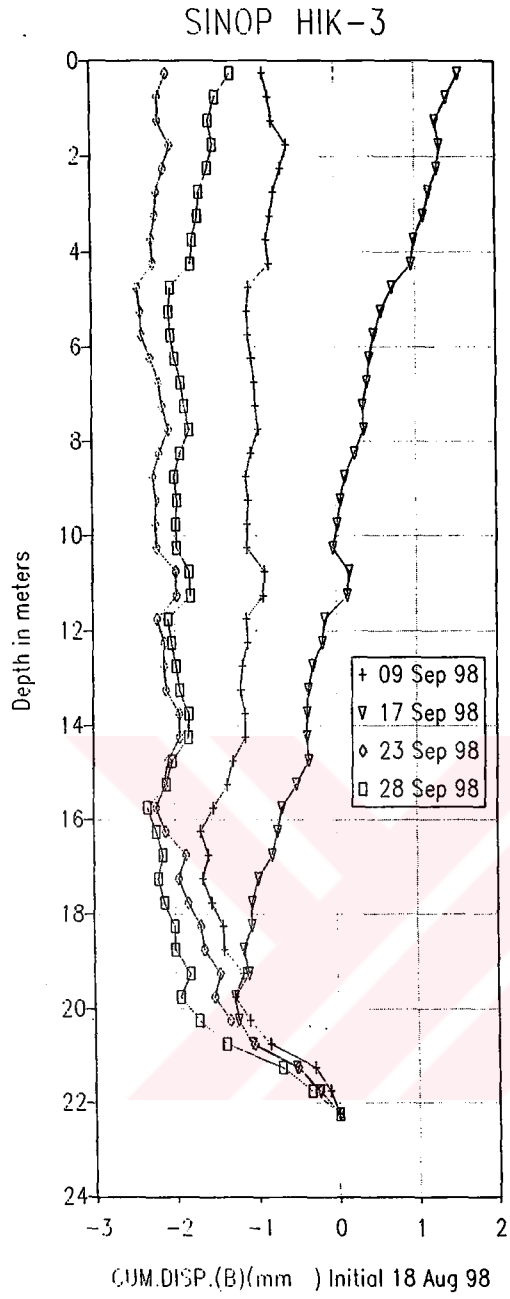
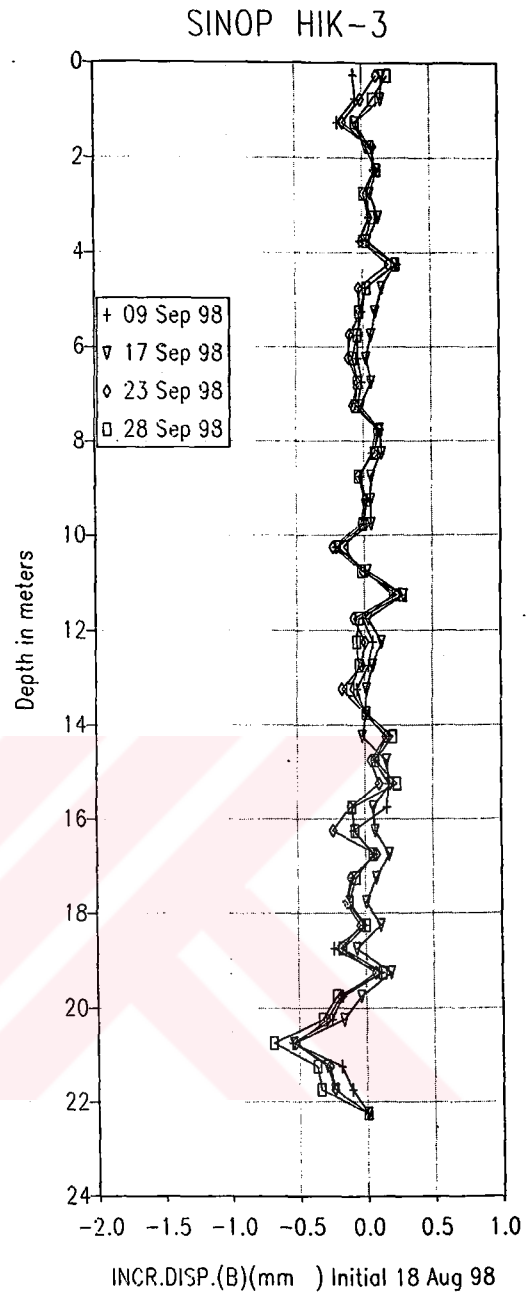
Figure A3. Inclinometer measurement graphs of the borehole Hik 3

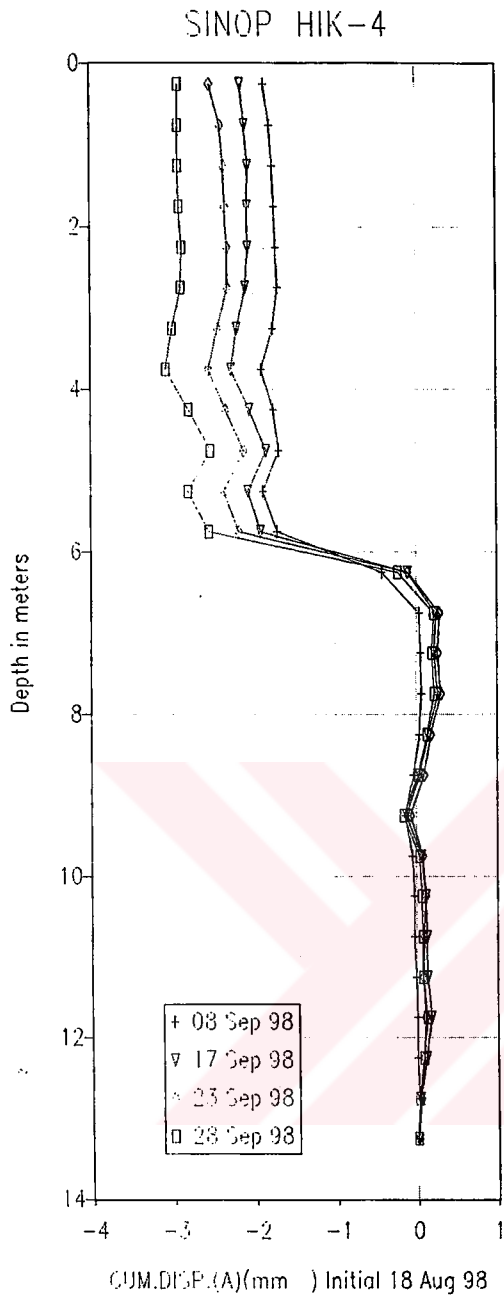
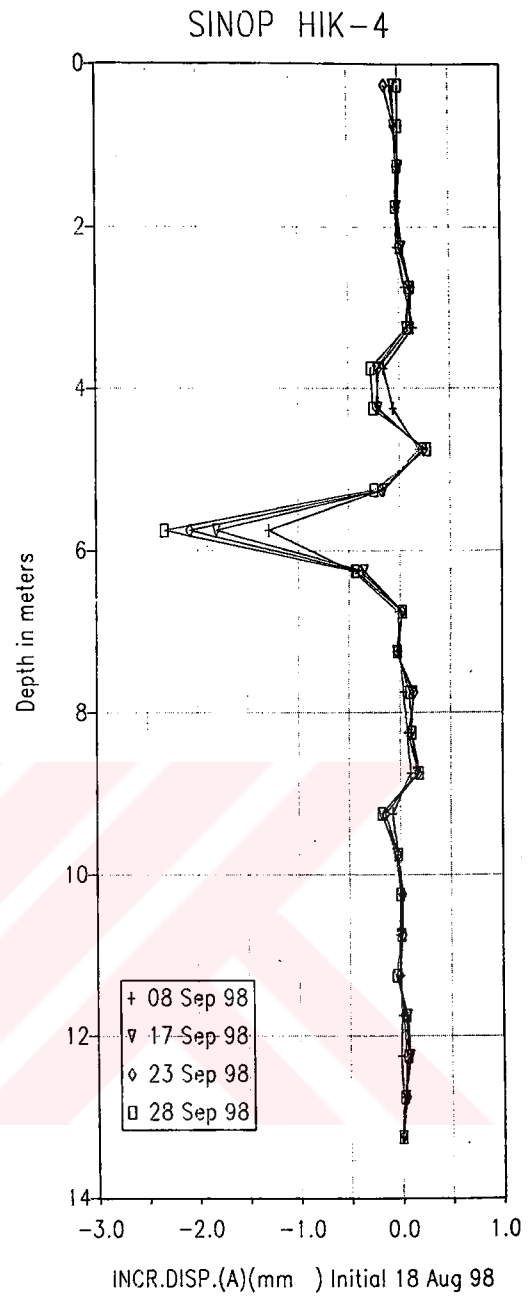
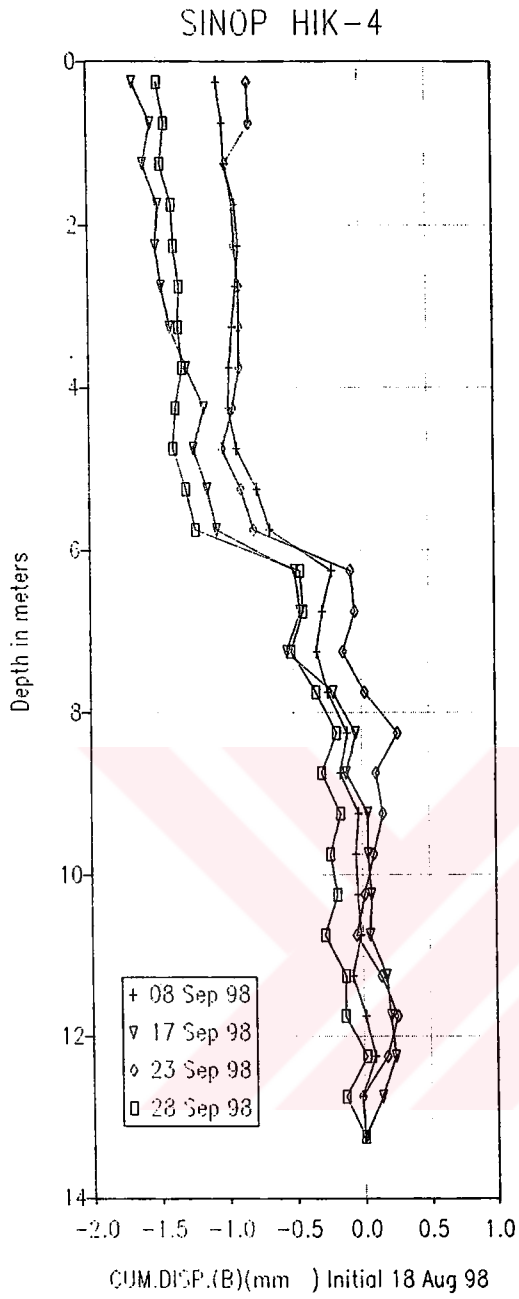
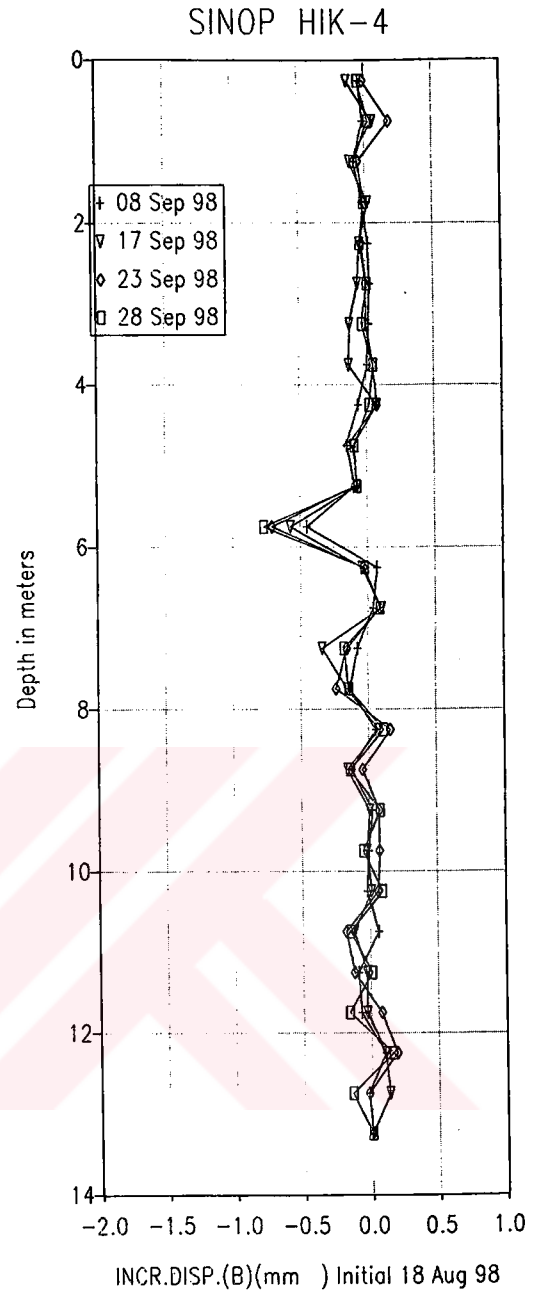
Figure A4. Incliner measurement graphs of the borehole Hik 4

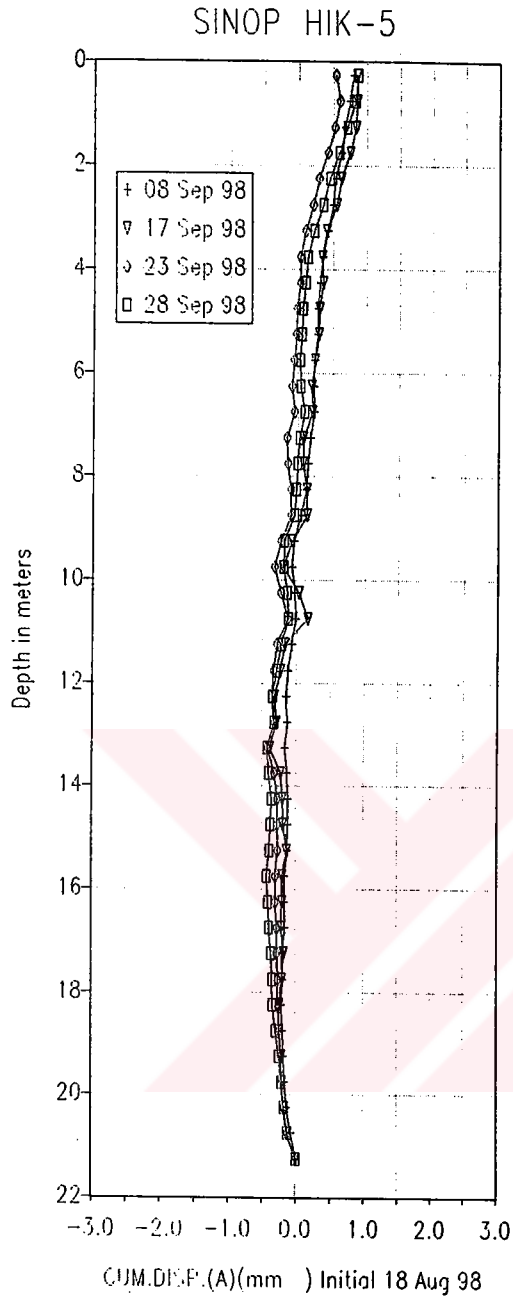
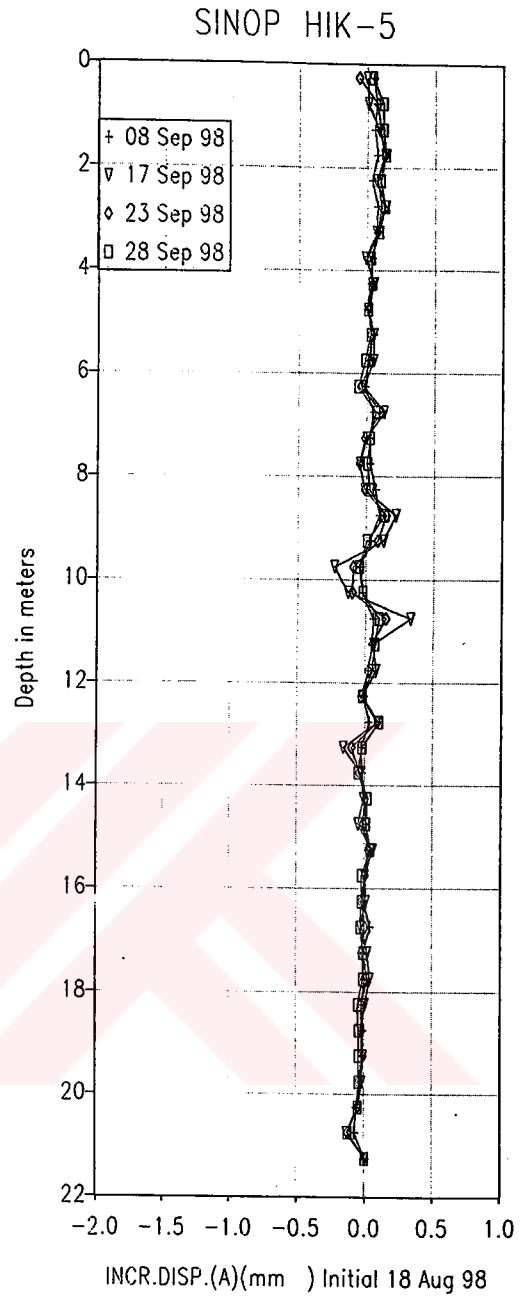
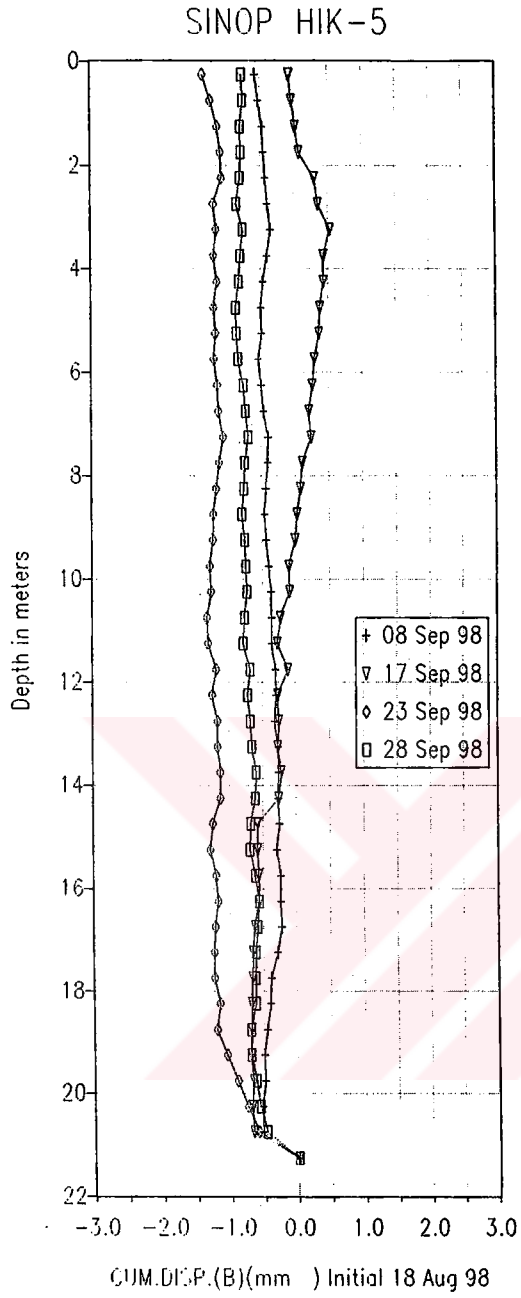
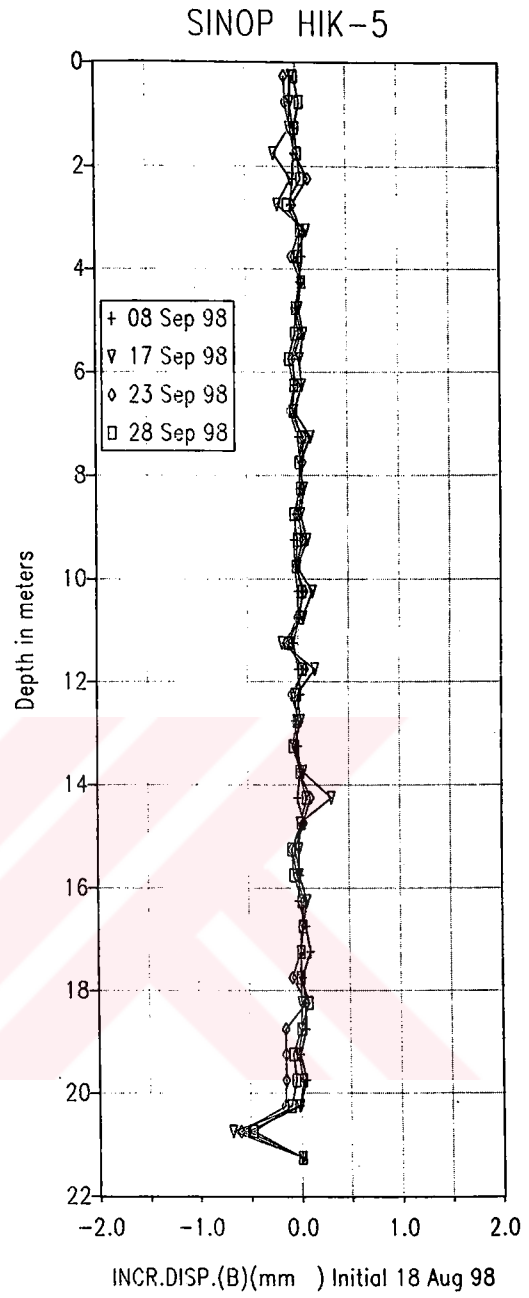
Figure A5. Inclinometer measurement graphs of the borehole Hik 5
