INVESTIGATION OF ROCKFALL AROUND ANKARA CITADEL

A THESIS SUBMITTED TO
THE GRADUATE SCHOOL OF NATURAL AND APPLIED SCIENCES
OF
THE MIDDLE EAST TECHNICAL UNIVERSITY

JUNE 2017

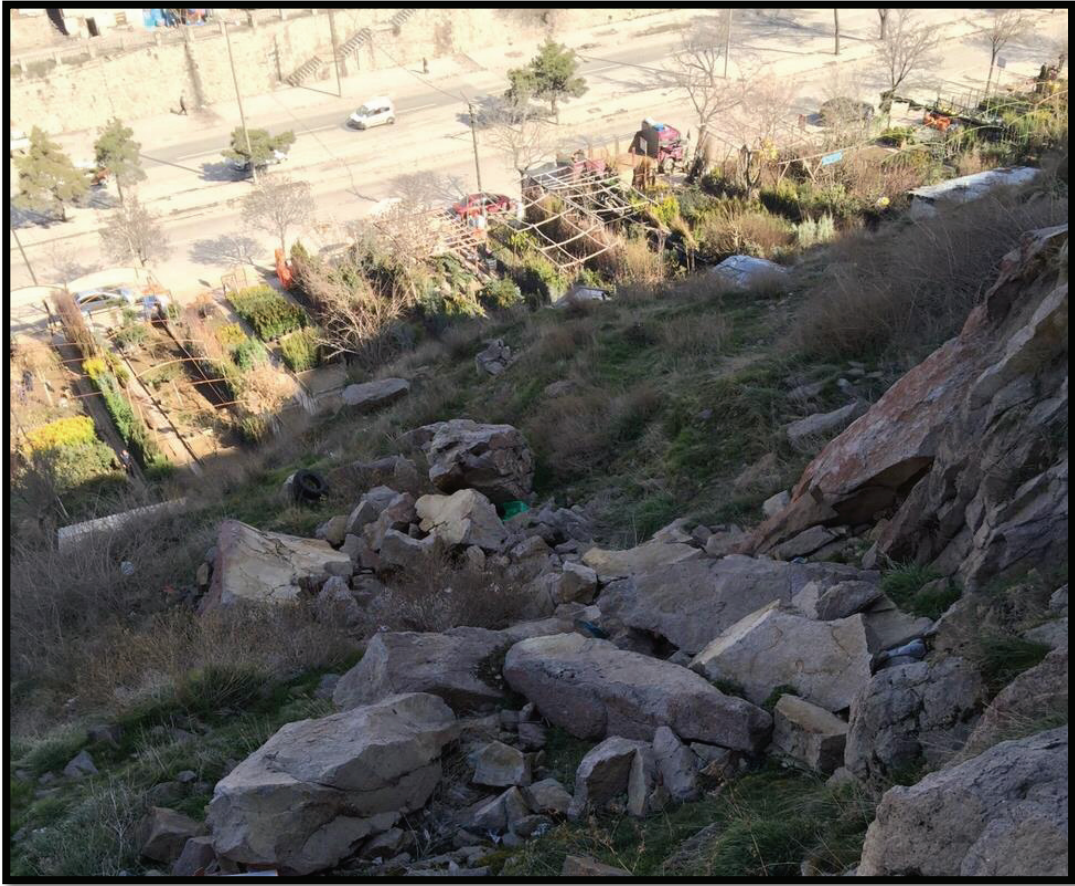
Figure 1.2 Fallen blocks seen in the study area and the floral shops at the bottom of the hill.

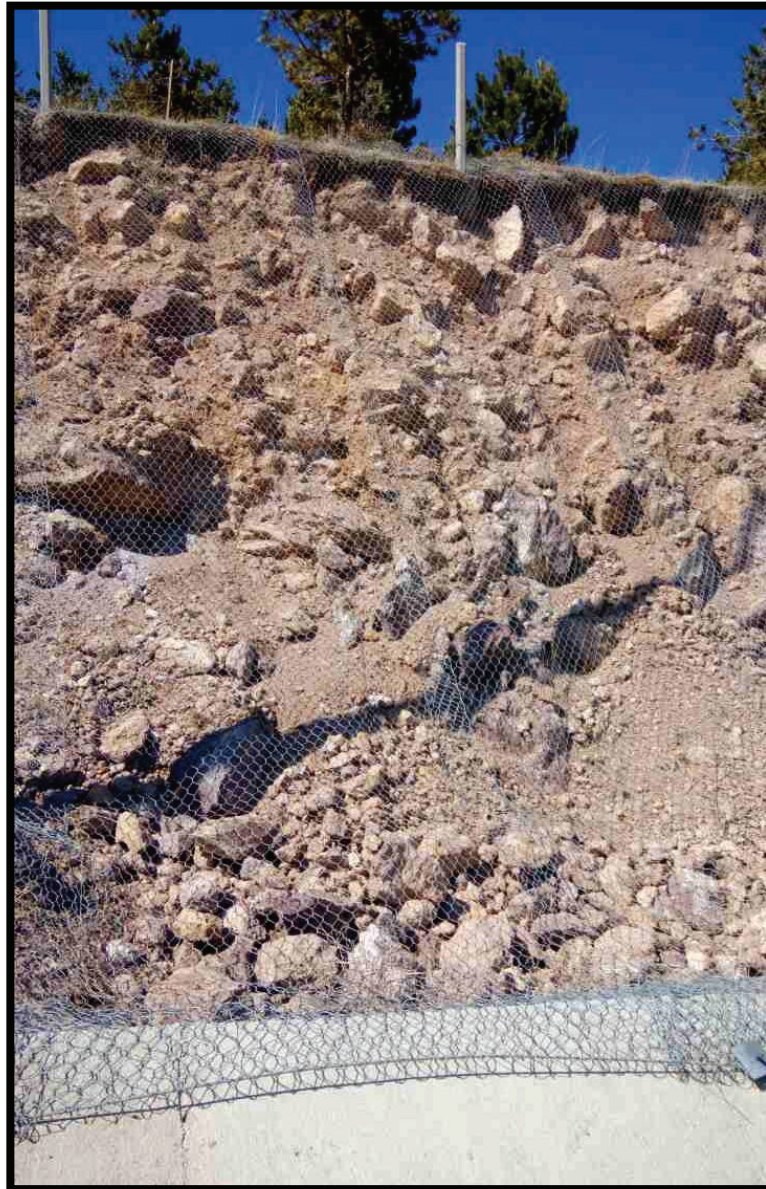
Figure 2.11 Wire mesh protection over the slope on Kayseri-Develi highway.

Wire Mesh: In the cases where there is no suitable space for structures like ditches, wire mesh may be draped over the slope surface (Wyllie, 2015). They can be designed to prevent the detached blocks from reaching the road and enable them to drop only vertically and slowly (Maerz, 2014). The rock slope covered with a typical design of wire mesh on Kayseri-Develi highway is shown in Figure 2.11.

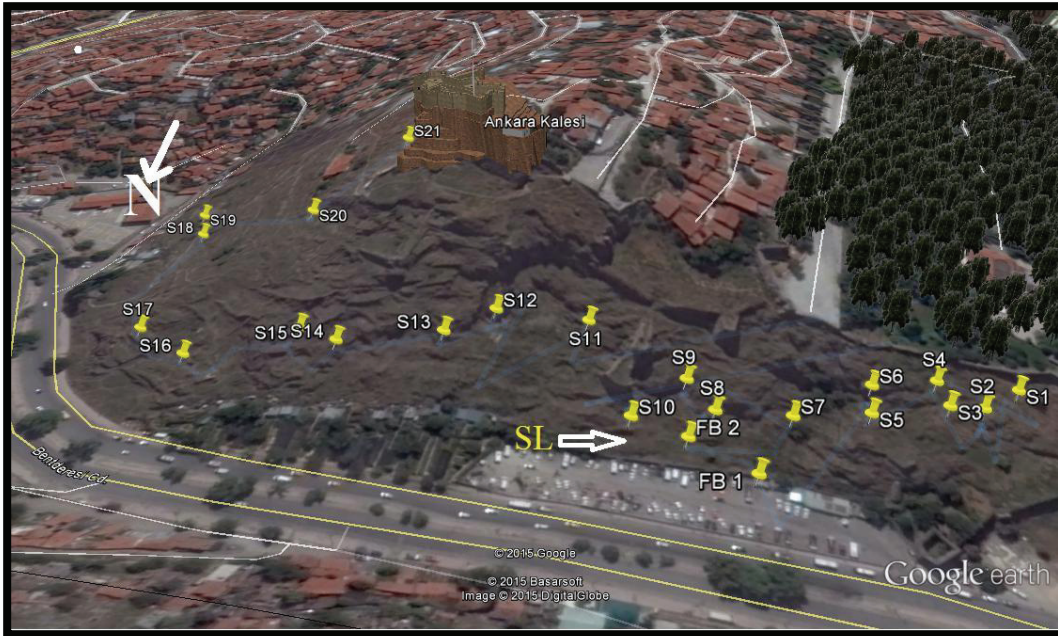
Figure 3.1 Google Earth view of the northern part of the Ankara Citadel with measurement locations.

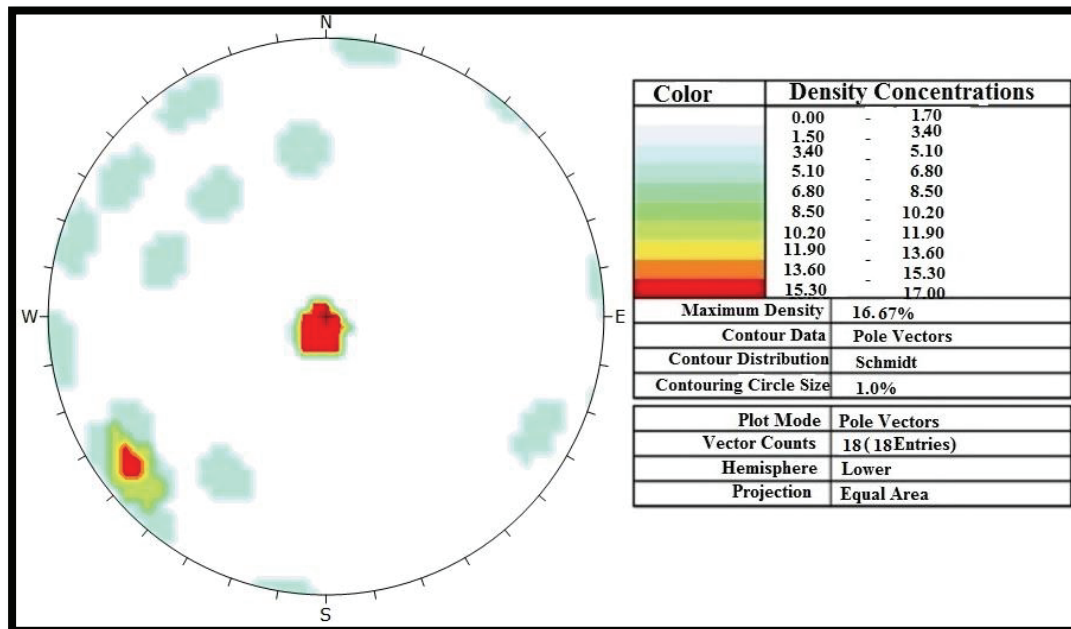
Figure 3.7 Contour diagram of the discontinuities at the 2nd location.

At the second stop, the rock is pinkish grey and slightly weathered. The surface of the discontinuity is undulating rough. The main dip amounts and dip directions of the flow layers are $04^{\circ}/022^{\circ}$, $05^{\circ}/022^{\circ}$ and $04^{\circ}/023^{\circ}$, and those of the slope is $82^{\circ}/315^{\circ}$. The contour diagram of the discontinuities is shown in Figure 3.7. The Schmidt rebound hardness ranges from 28 to 38. The joints have spacing values between 30cm and 70cm. The persistence of the joints varies between 50cm and 70cm. The joints have tight to 2mm apertures filled with silty clay only at the surface. The properties of the flow layers are similar to those of the cooling joints but they do not infilling material.

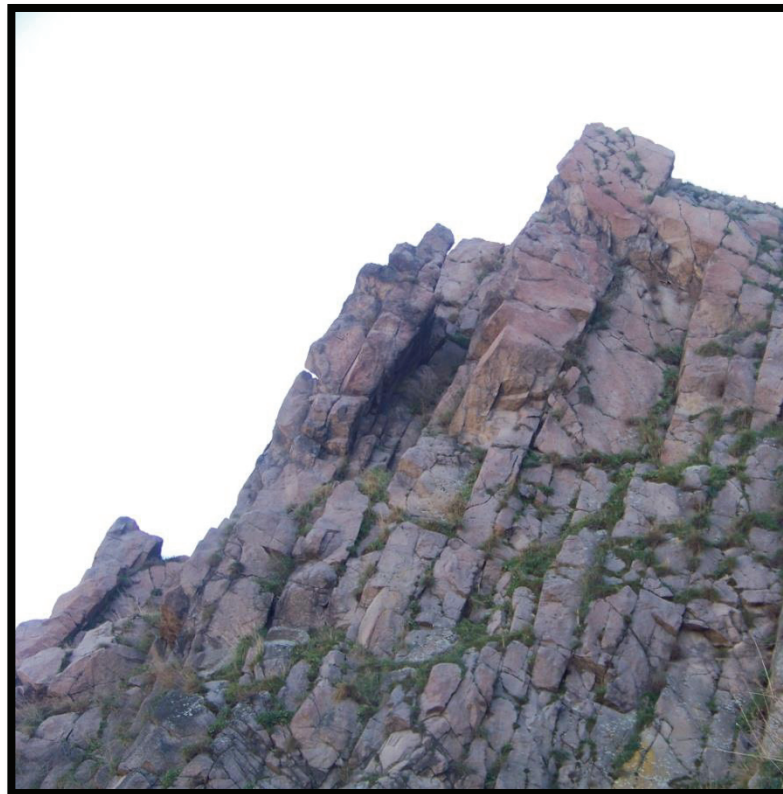
Figure 3.16 Cooling joints of the andesite with high persistence.

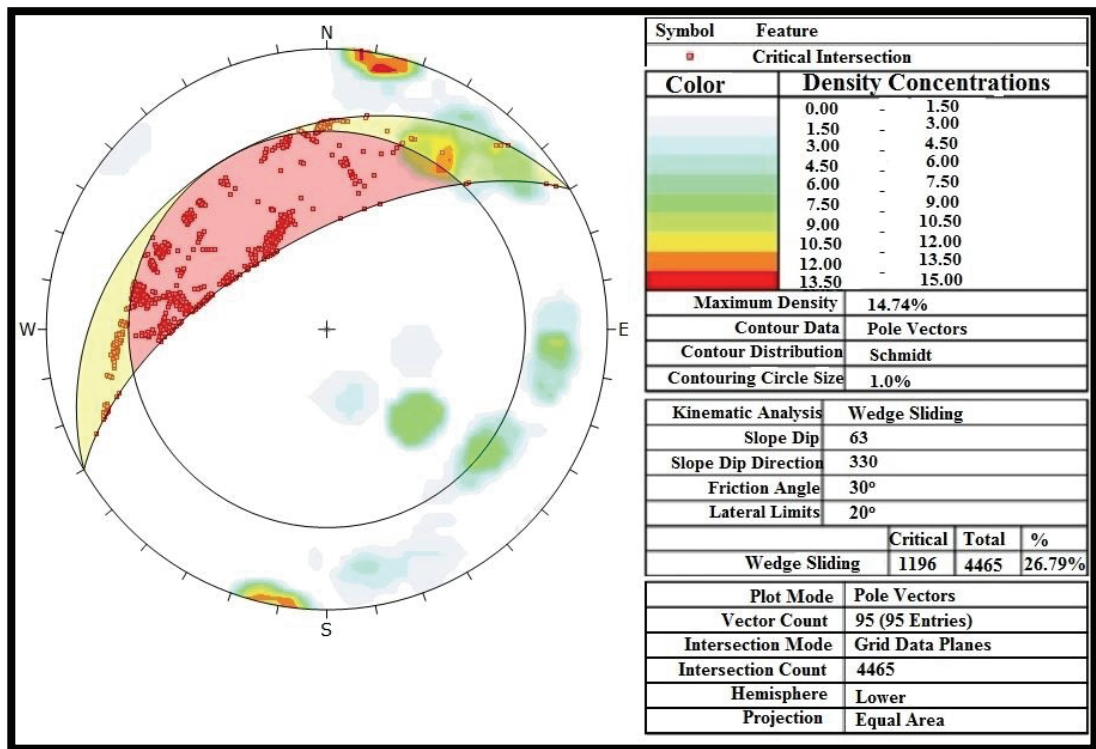
Figure 4.2 Kinematic analysis for wedge failure of the 10th stop.

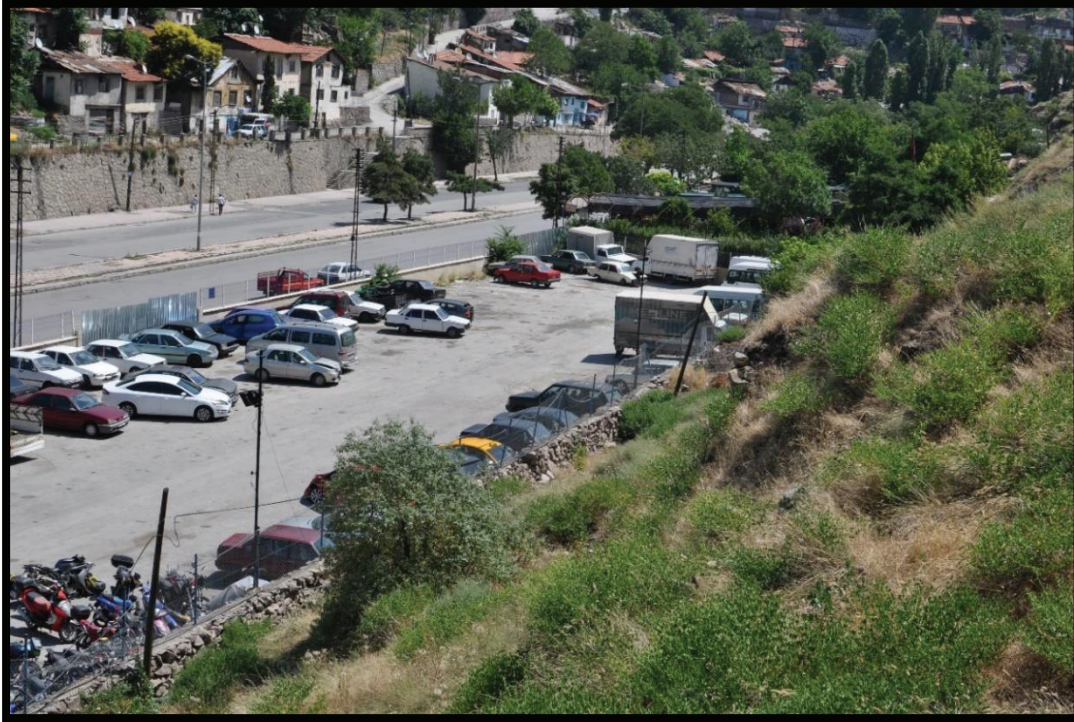
Figure 5.1 The position of car parking and the small barrier with net at the base of the slope.
