UNDERSTANDING AND ASSESSING THE REPUBLICAN HERITAGE OF  
TİRE

A THESIS SUBMITTED TO  
THE GRADUATE SCHOOL OF NATURAL AND APPLIED SCIENCES  
OF  
MIDDLE EAST TECHNICAL UNIVERSITY

EBRU BAKIM

SEPTEMBER 2017

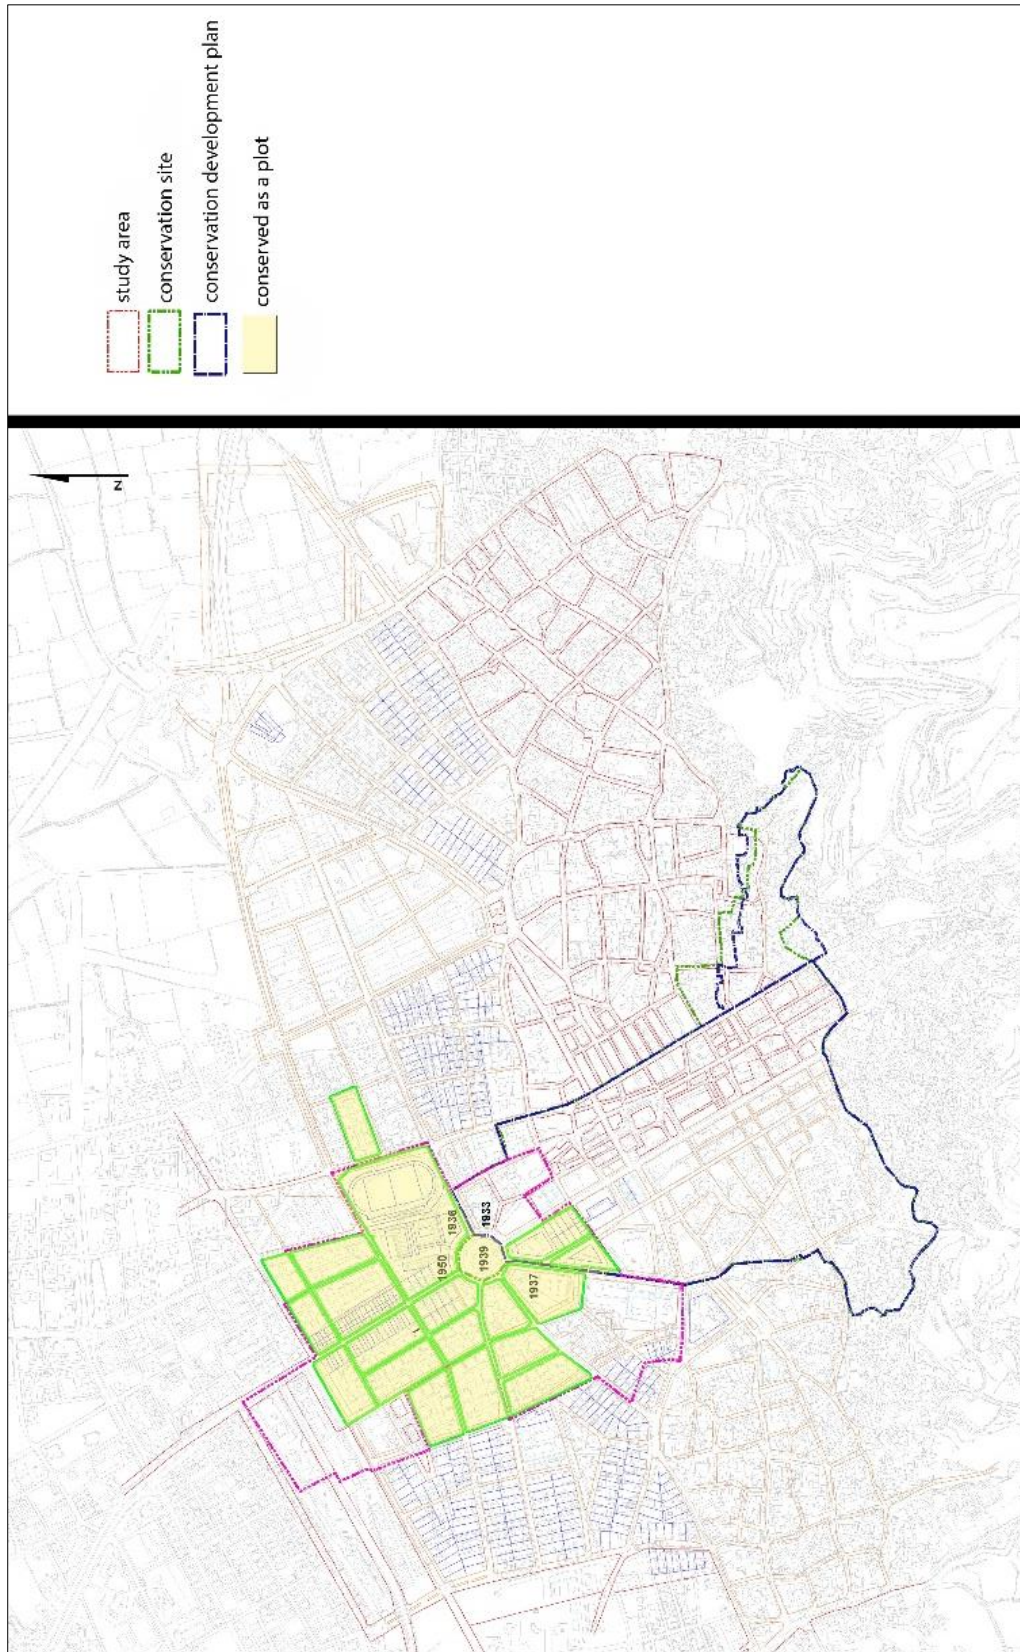
**Figure 1. 1** The overlapping of the existing and the first development plan (1950)

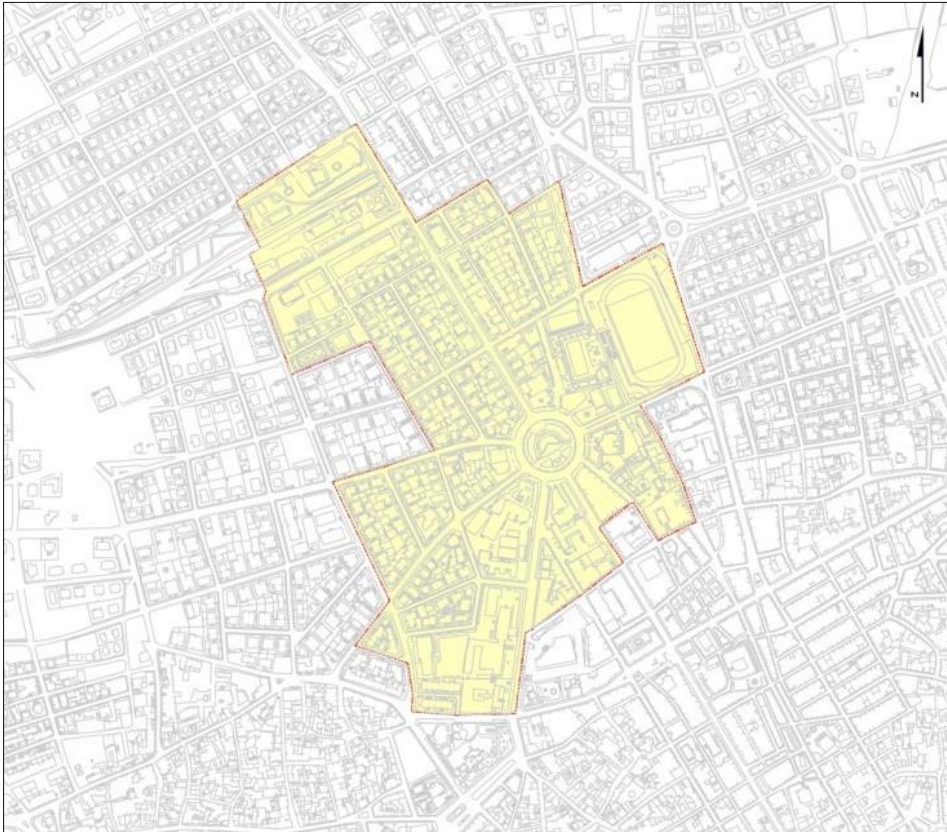
**Figure 1. 2** The study area is shown on the base map (Base map, Tire Municipality, 2012)

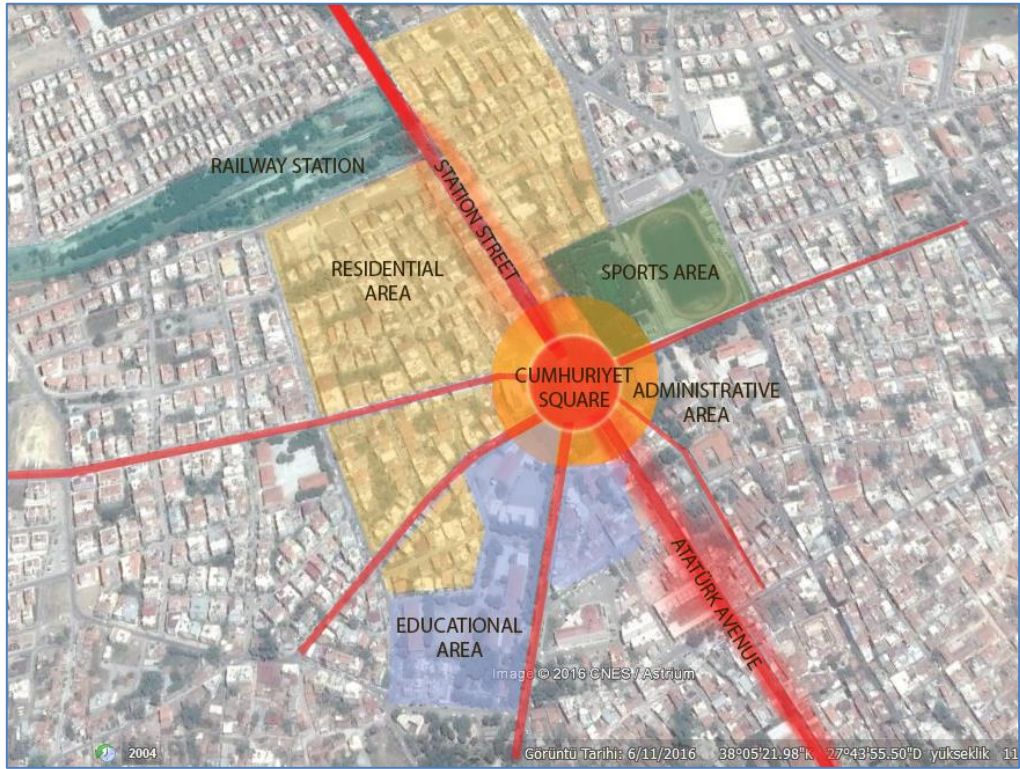
**Figure 2. 2** Cumhuriyet Square, Railway Station, connecting Station Road and surrounding development

Cumhuriyet Square and the wide radial roads starting from the square were planned whereas Station Street and Atatürk Street were planned as the main axis of the district. Cumhuriyet Square, the railway station, Station Street connecting these two important points; administrative, educational and sports facilities surrounding the square; the residential pattern developed between these areas create Republican heritage of Tire on Cumhuriyet District.

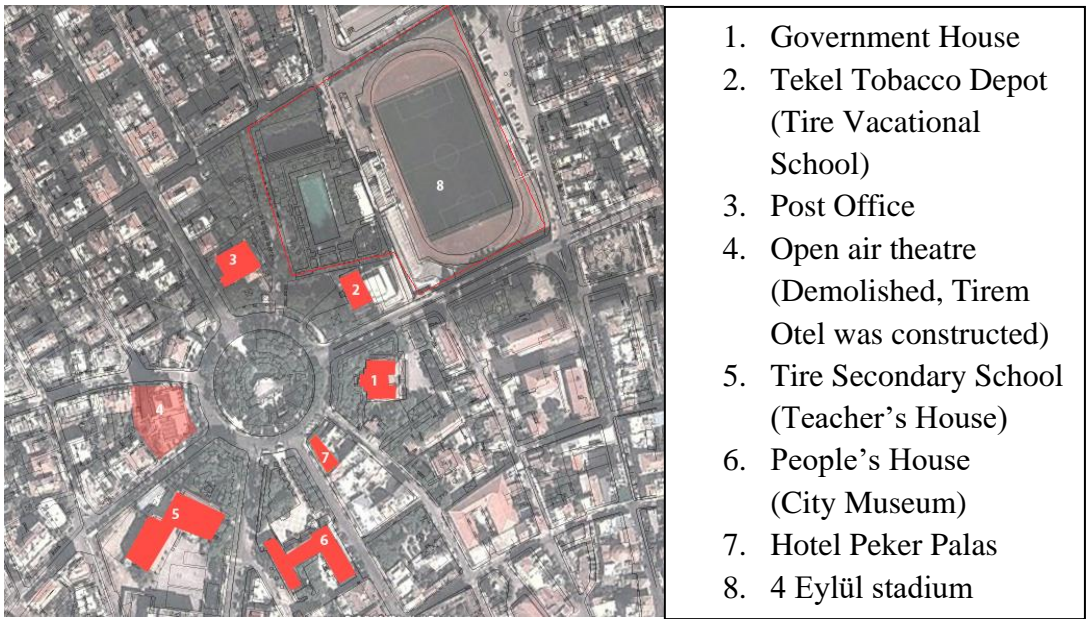
**Figure 2. 4** The site image showing the original and current functions of the buildings surrounding Cumhuriyet Square, Base map Google Earth, 2016

There are administrative, educational public buildings and sport facilities surrounding the Cumhuriyet Square. The government office, the people’s house, Tire secondary school, Tekel tobacco depot, the post office, open air theatre, the stadium and the hotel were the facilities around the square. Among these buildings, the government office, the post office and the sports facilities have maintained their functions. On the other hand, Tekel tobacco depot was renovated and re-functioned as Tire Kutsan Vocational School. The people’s house was converted to the municipality building after the organization was closed in 1950’s and it is re-used as the city museum recently. Tire Secondary School was transformed to Teacher’s House. Moreover, instead of the open air movie theatre, Tirem Hotel was constructed in 1990’s. Furthermore, Peker Palas Hotel now accommodates different types of offices.

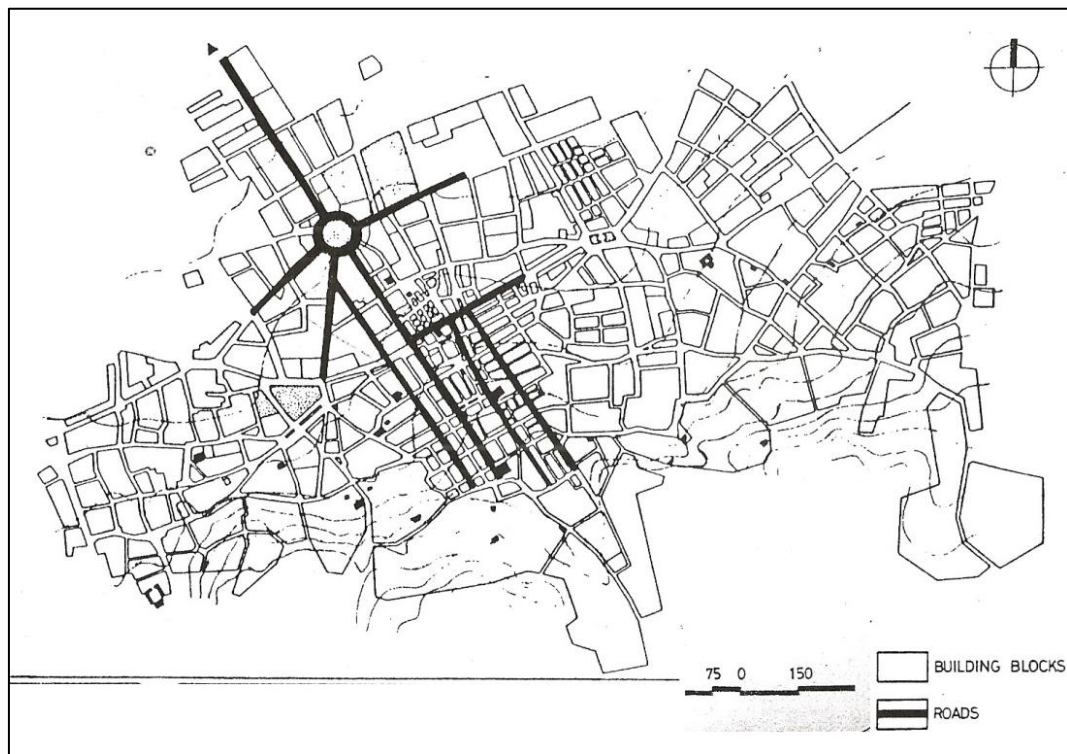
**Figure 2. 8.** Planned area after the 1917 fire, (Göksu, 1986)

Tire was one of the important towns of İzmir who had the development plan activities firstly. The first development plan was applied over Tire in 1950 (Yurt Ansiklopedisi, 1982-1983: 4375). The area damaged by the 1917 fire was distinctive easily seen within the urban pattern as the grid plan was made over the traditional organic pattern (Göksu, 1986: 135). In the Figure 2. 8, Göksu shows the planned area after 1917 fire (Göksu, 1986: 106). Göksu states that “Cumhuriyet Square at the entrance of the town, the radial roads starting from the square, the commercial centre and the Greek Mahalle of the town were the grid planned area as a result of application of a physical plan in Tire.”(Göksu, 1986: 105-107).

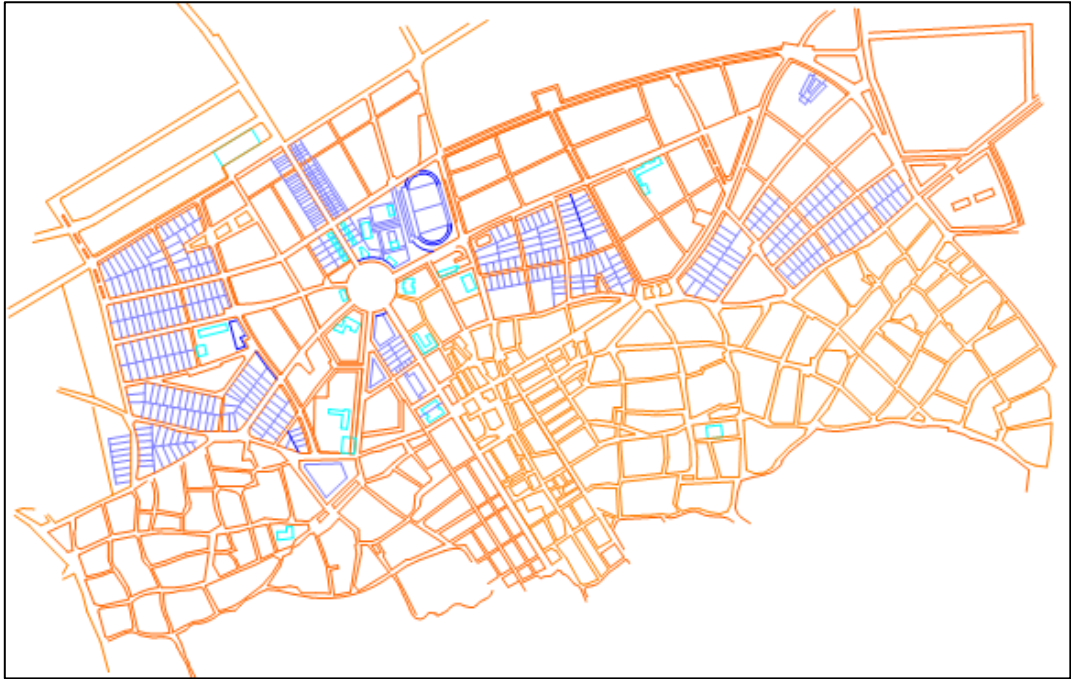
**Figure 2. 9** The drawing of the first plan (1950 Development Plan) (redrawn from the plan)

The first development plan of Tire was prepared by Vedat Erer at 25.03.1950 consisting of a sheet in 1/2000 scale and six sheets in 1/1000 scale. However, plan in 1/1000 scale or plan decisions cannot be found from Tire Municipality and İlbank (See official letters in appendix A). The second plan was prepared by Arif Akay at 27.03.1984 consisting of five sheets in 1/5000 scale and 30 sheets in 1/1000 scale.

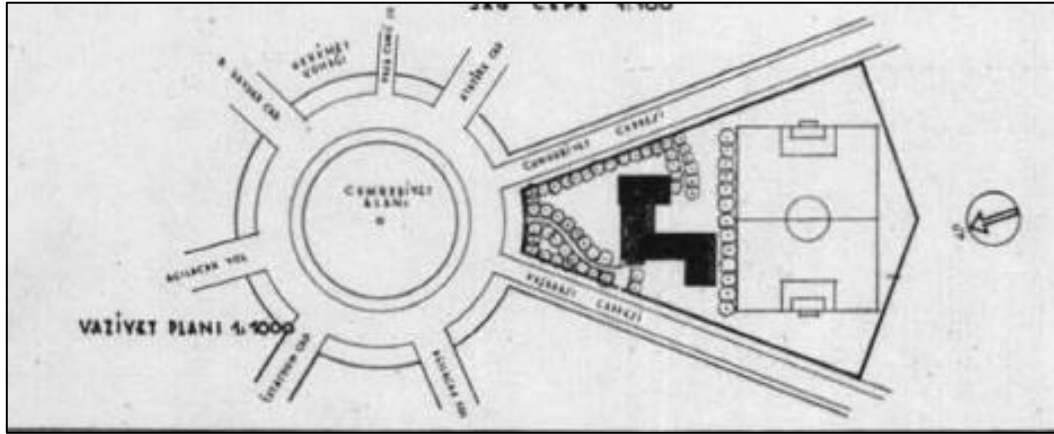
**Figure 2. 11.** The site plan of “Tire Orta Mektep” (1937), Arkitekt, 1937-09 (81): 252

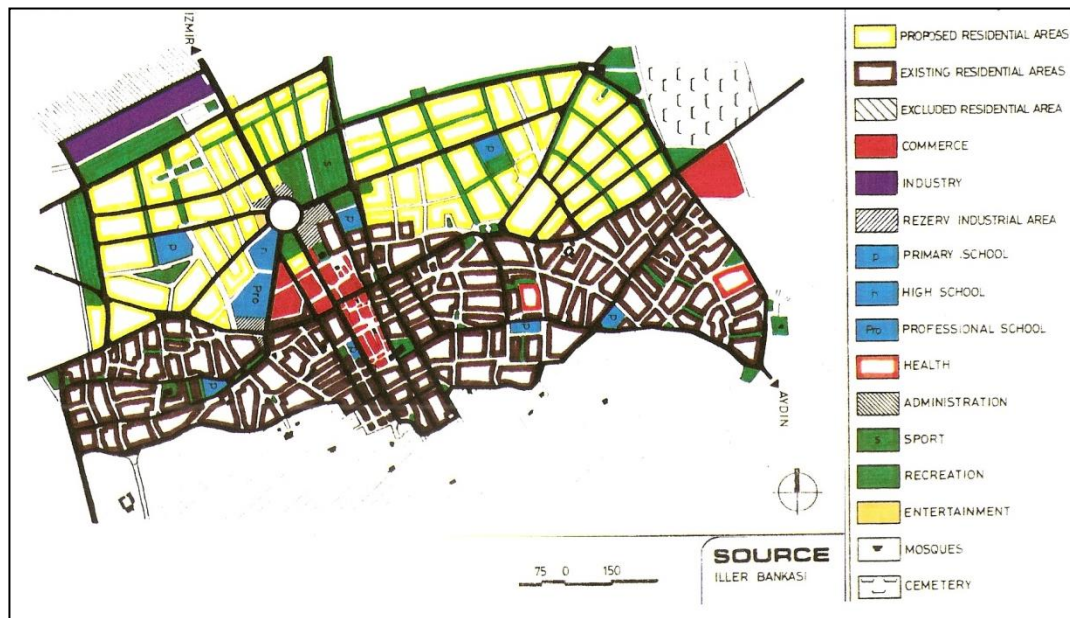
**Figure 2. 13.** The Development Plan of Tire (1950), (Göksu, 1986), taken from İller Bankası

Göksu compares two development plans of Tire in 1950 and 1980 and states that they had intriguing characteristics. 1950 development plan prepared by Vedat Erer on 25<sup>th</sup> March 1950 changed the macro form of Tire remarkably. As a result of this plan, the development of residential areas went through the İzmir highway whereas the railway created a border on the north side. In the first development plan, the Cumhuriyet Square and the radial roads starting from the square were dominant. Göksu states that “The development plan of 1950 emphasized the only centralization in town depending on the radial road system.” (Göksu, 1986: 153-161). Although Göksu found the plan generally successful, she criticizes the plan due to the width of the roads and the coherence of the functions within the location in the town.

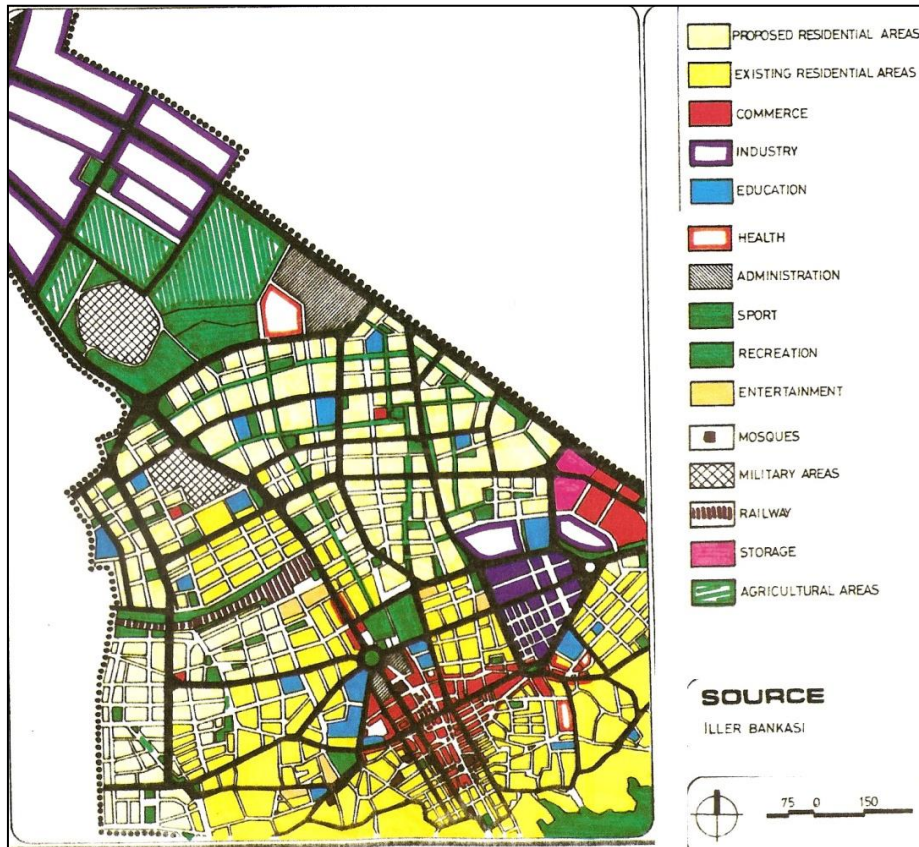
**Figure 2. 14.** (a) The Development Plan of Tire (1984), (Göksu, 1986), taken from İller Bankası

As a result of these inadequacies, in the next development plan, the location of the industrial zone was changed and moved near the cemetery. On the other hand, the historical residential pattern on the slope was not taken into consideration in this development plan. There was no approach for that historical context as this was one of the remarkable deficiencies of the plan. Since there was no decision about this historical zone, the lower income people settled creating unhealthy condition. Göksu criticizes to not define the ‘residential area’ and ‘historical texture’. Nevertheless, Göksu found coherent the plan due to the macroform, vehicular and pedestrian traffic. As a result of the conservation approach of that period, the historical buildings except monumental ones remained intact unconsciously. 1984 development plan approved on 23<sup>rd</sup> March 1984 provided further development beyond the station causing to threaten the agricultural lands. The plan stated the absence of the historical context except religious buildings in the town as seen in the plan. With this approach to the historical buildings, the plan proposed only 11 registered buildings such as Matyos Han, Gülcüoğlu Han. Since the buildings were not registered, some buildings in private property had right to be demolished (Göksu, 1986: 153-161).

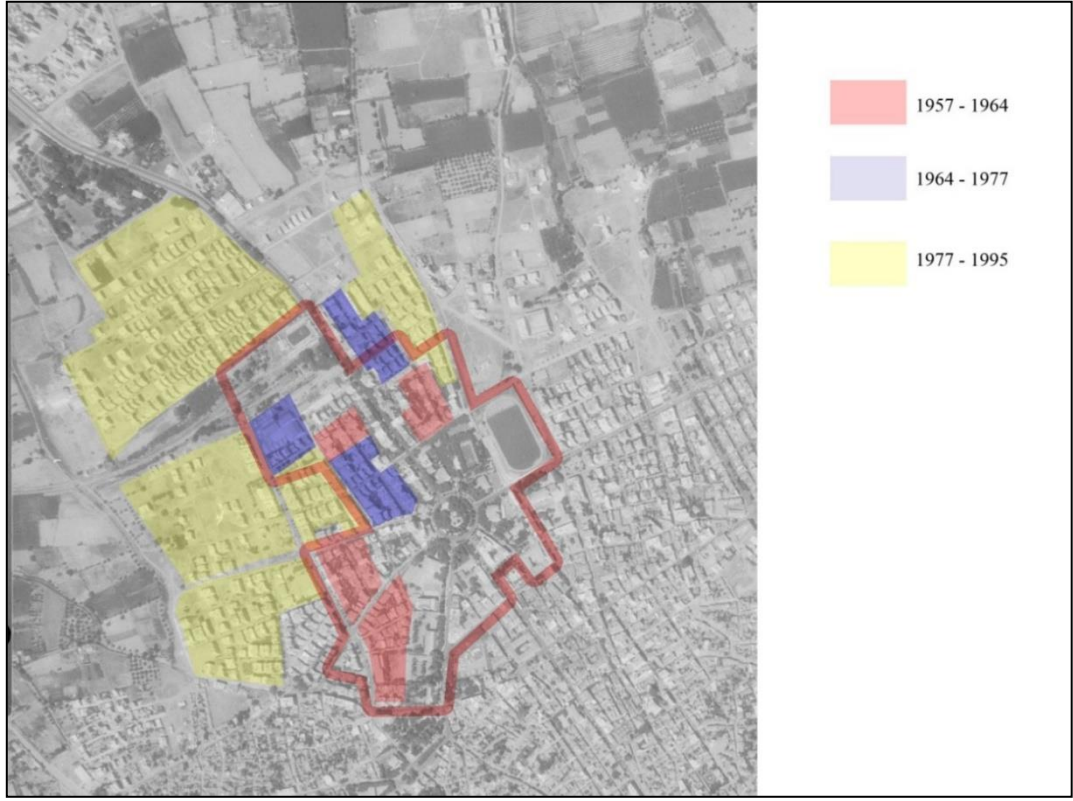
**Figure 2. 15.** The development of Tire Cumhuriyet District between 1957 and 1995, Base Map 1995 aerial photo taken from the General Command of Mapping

The aerial photos in 1957, 1964, 1977 and 1995 (See appendix A) show the development of the town beginning from 1957. According to these aerial photos, firstly, the Cumhuriyet Square, administrative buildings surrounding the square and the Station Road connecting the square directly to the station were built. The development of the area went around the Station Road and Cumhuriyet Square between 1957 and 1977. On the other hand, between 1977 and 1995, the development was accelerated expanding the borders through the İzmir direction.

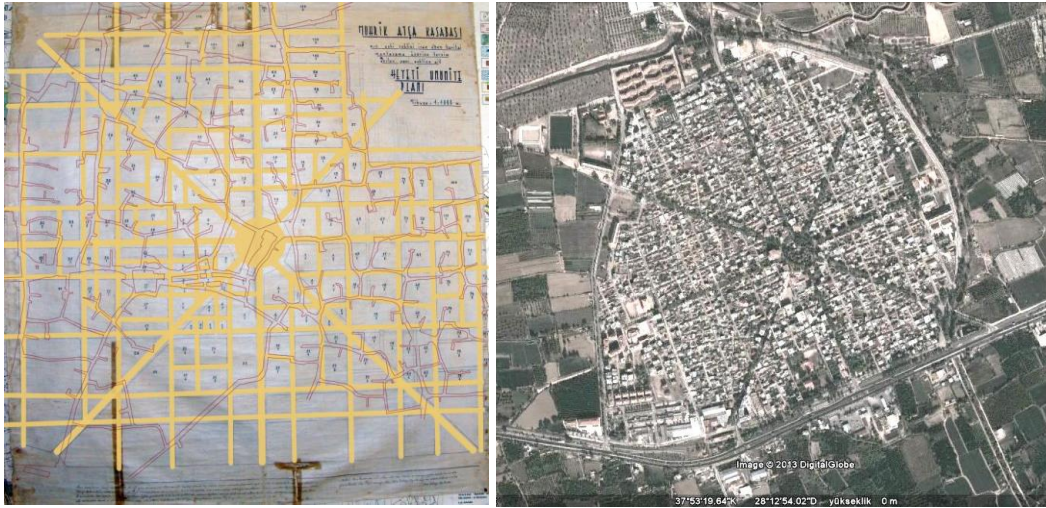
**Figure 2. 19.** (a) The development plan of Atça in 1924, Bilgiç, Ayşegül (2012), taken from Atça Municipality, (b) the aerial photo of Atça, Aydın (2012), Google Earth

Atça(Aydın) was taken out from the invasion on 5<sup>th</sup> September 1922. Abdi Bey who had been educated in Europe prepared the development plan in 3<sup>rd</sup> August 1926 and that plan was executed on the destroyed urban pattern of Atça as seen in Figure 2. 19. Eight radial roads starting from the square are 15 meters width and 500 meters length (www.atca.bel.tr, last visited on 23.06.2013).

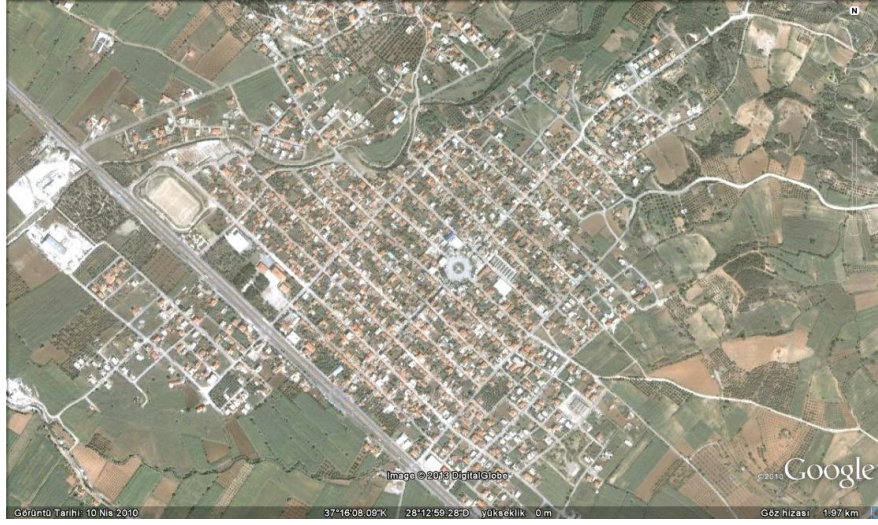
**Figure 2. 20.** The aerial photo of Bayır, Muğla (2010), Google Earth

The town of Bayır (Muğla) was moved to existing location by the reason of the earthquake in 1941 (www.bayir.bel.tr, last visited on 23.06.2014). The town includes Cumhuriyet Square and Cumhuriyet Park in its center. As seen in Figure 2. 20, the grid planning was applied over the town centralizing the square.

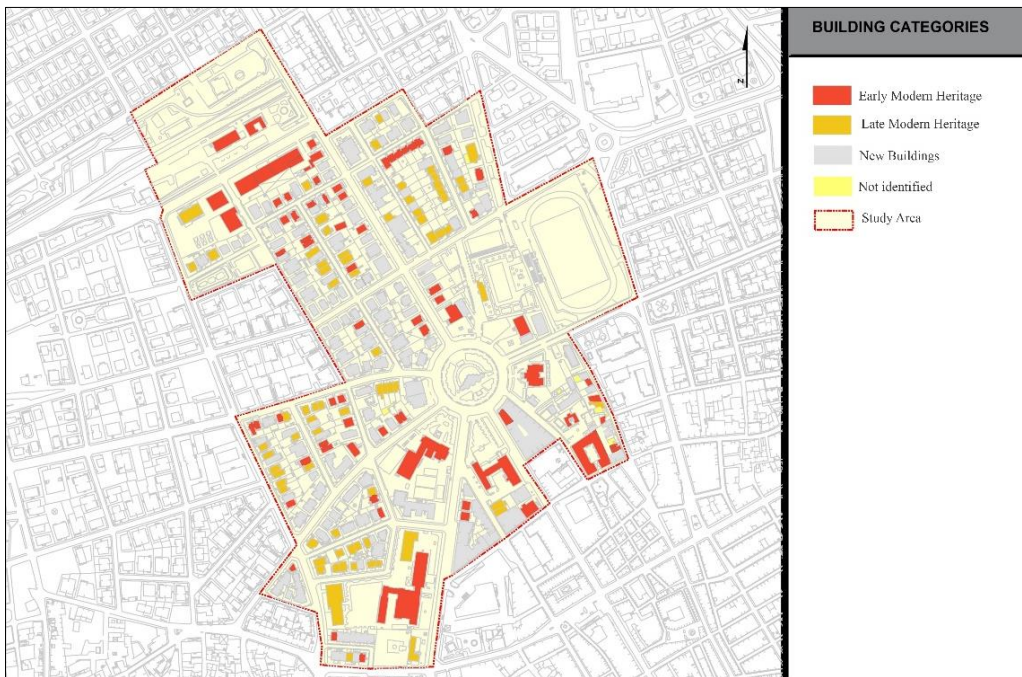
**Figure 2. 24.** The map shows the periods of the buildings in the study area (Base map, Tire Municipality, 2012)

Most of the houses along the Station Street were demolished and new apartments have been constructed along the street. Figure 2. 24 shows that there are a few houses left from that period. There is a rapid transformation in the street. Since they are not registered, the lots of the houses have been sold to the builder and contractor on a flat for land basis. Moreover, this rapid transformation has spread up to the backside of the street.

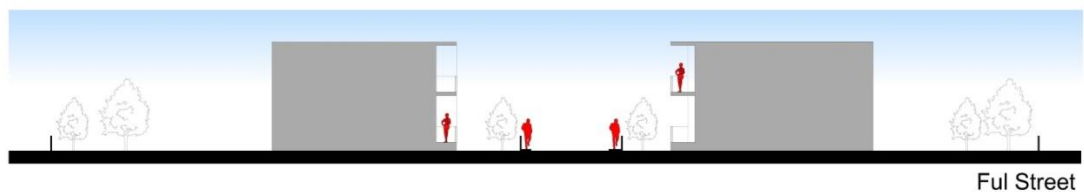
**Figure 2. 25** Schematic section of Ful Street

The use of open areas in public property can be categorized as squares, streets and parks. As seen in the street sections, on the main axis there was a wide vehicular road with trees along a wide pavement. Although the transformation of the function from residential to commercial along the Station Street has occurred in the recent years, the area was planned as a residential zone in a conscious manner in that period. In terms of hierarchal planning of the roads, the secondary streets vertical to the main axis were narrower with narrower pavements. The street was aligned with the low front garden walls with trees providing visual connection with the house. With the changing privacy concept, the balcony was used an architectural element to create a 'new' kind of relationship with the street. The front gardens and balconies which are in a visual relation with publicity were used along the street.

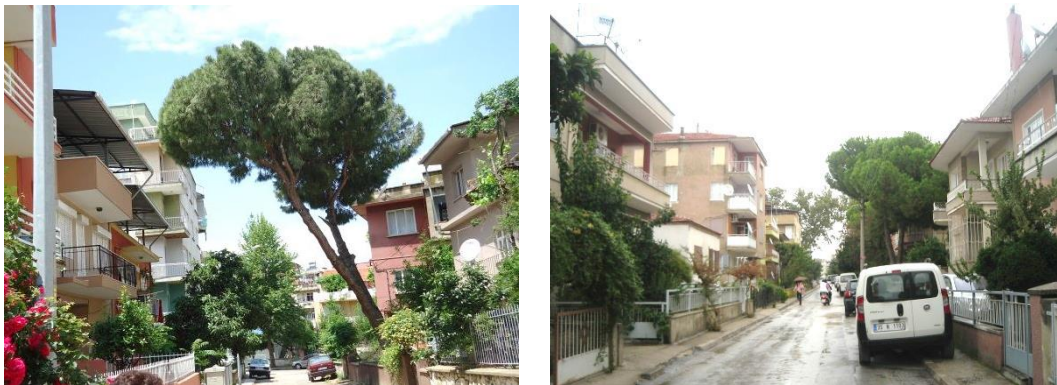
**Figure 2. 26** Photographs of the streets shown in schematic section (right, Ful Street)

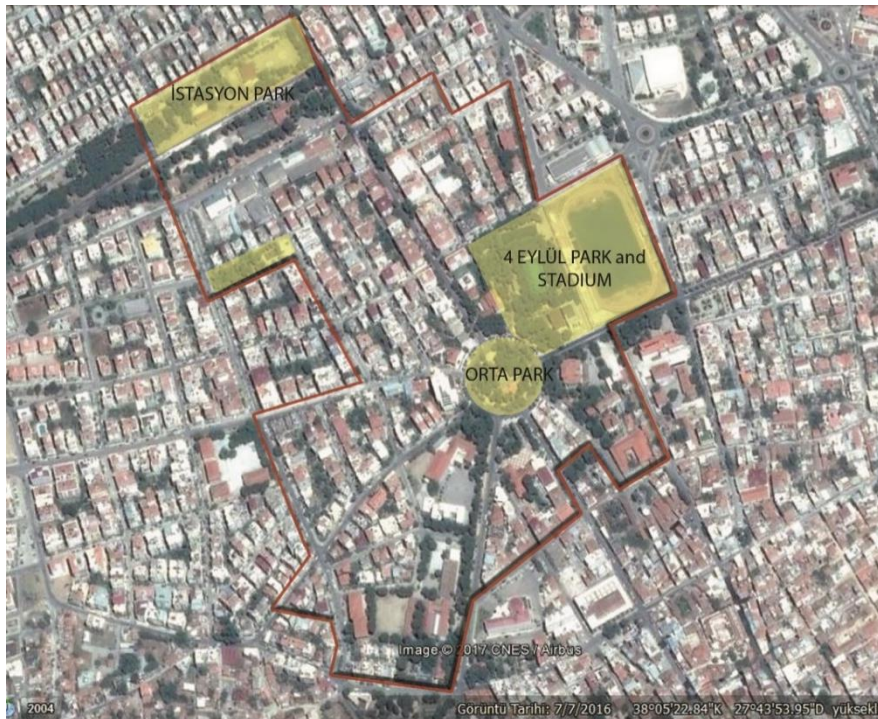
**Figure 2. 28** Parks in the study area

Parks are important in Republican town planning which were planned to be used for sport facilities and green area. Orta Park, İstasyon Park, 4 Eylül and Alay Park are the parks in the study area as seen in Figure 2.28.

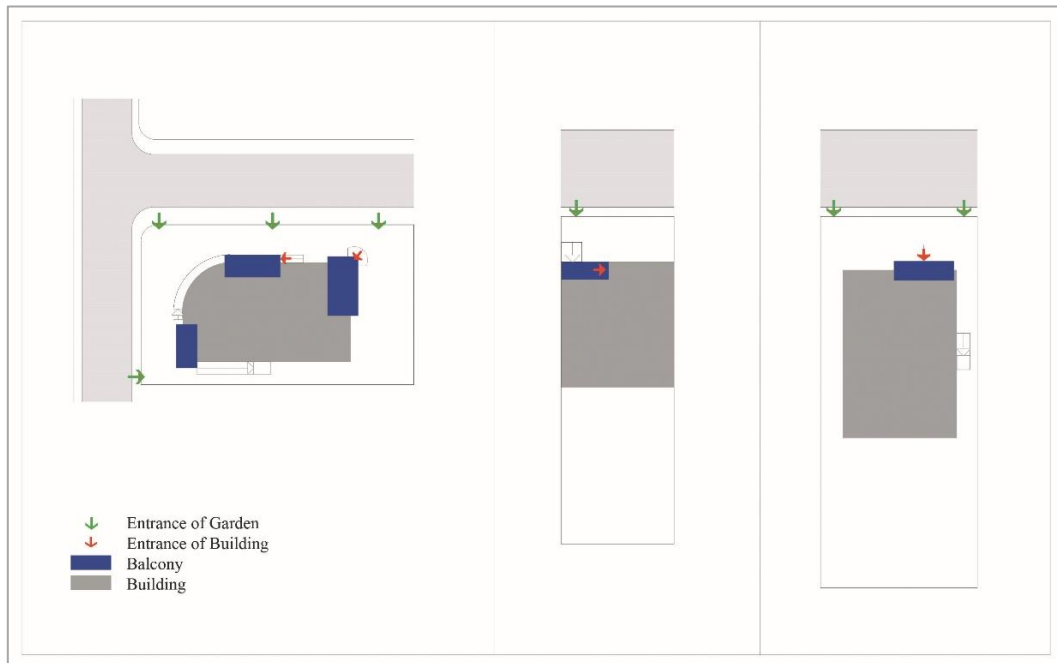
Especially in the corner lots, the buildings were designed and shaped by this parameter. The corner buildings have a round shape which was often seen in the architectural productions of that period.

**Figure 2. 29** Site plans showing the types of building-street relations

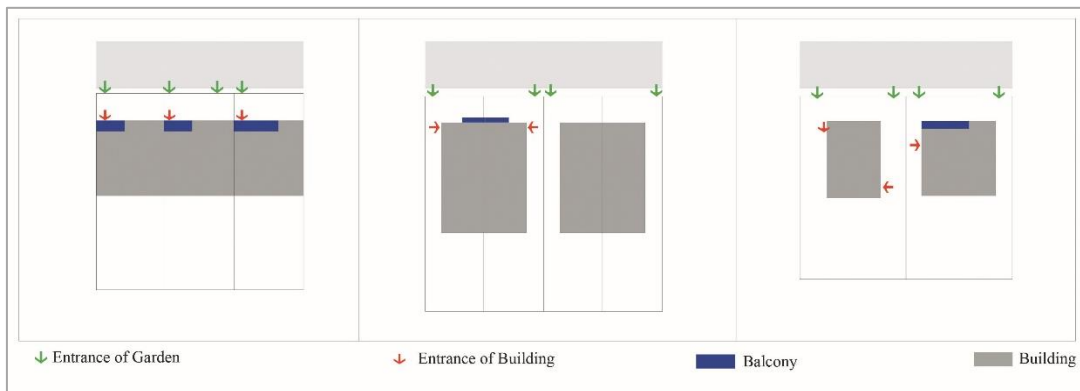
**Figure 2. 30** The types showing building-building relation

In terms of building-building relationship, some of the buildings were organized as blocks of two houses in a symmetrical order where as there are row houses and single houses.

In row houses where the buildings were adjacent to each other, there are no side gardens so they have front and back gardens. On the other hand, in twin houses and single houses, they have side, back and front gardens whereas the entrances are generally from the side of the building.

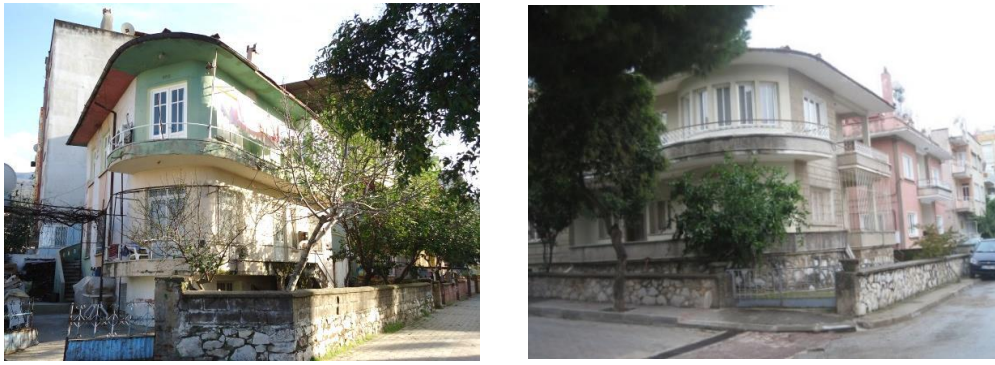
**Figure 2. 31** The examples of buildings located in corner lots

regard to the position of the entrance. In addition, the corner buildings which were shaped according to the street relate the street directly with rounded corners or rounded balconies.

In the corner lots, the setback distances are 4 meters from the streets (front and side) and 3 meters from the adjacent lot. On the other hand, in the lots between, the setbacks are 4 meters from the street and 3 meters from the adjacent lots. The wideness of the back gardens are determined as the half of the building height.

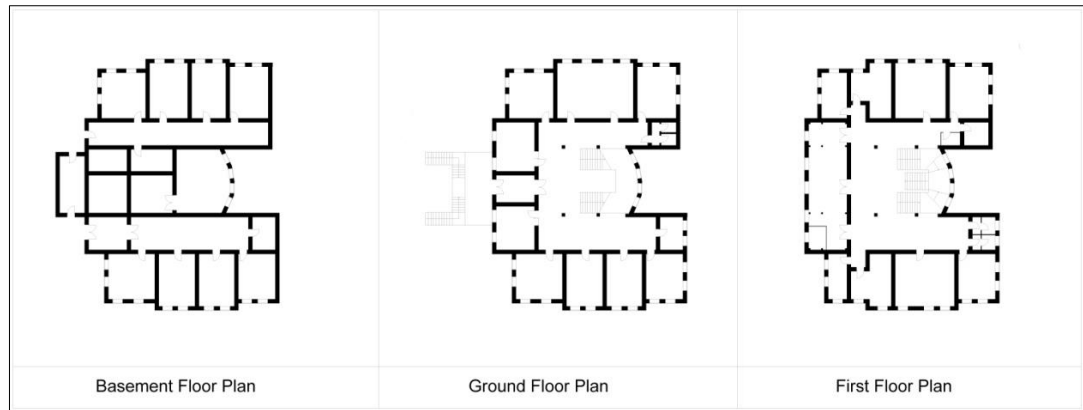
The building was registered.<sup>10</sup> The masonry building has a symmetrical plan and facade according to the main entrance axis. It has arched openings. However, the masonry building was plastered and painted in the later periods (For documentation sheet, see appendix B).

**Figure 2. 33.** The schematic plan layout of Government Office, 2013

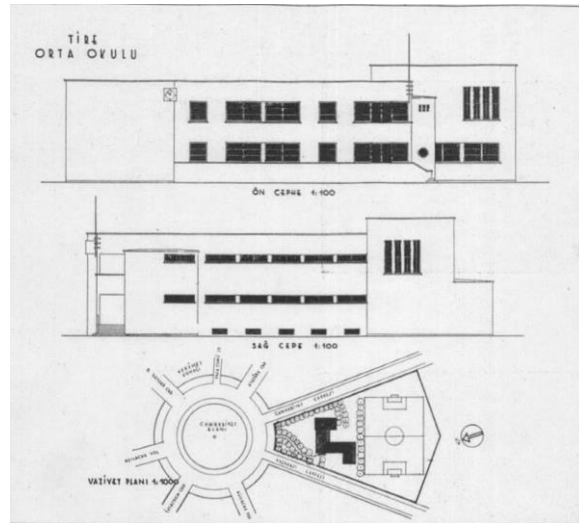
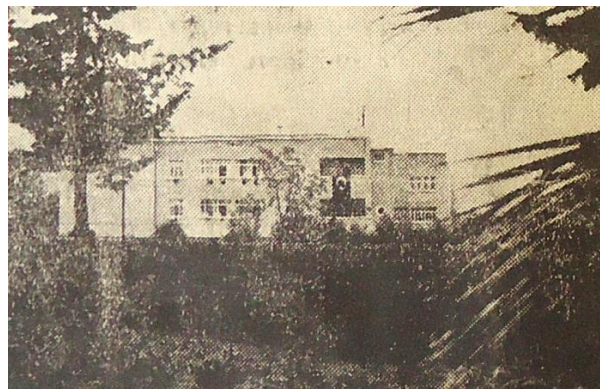
conference hall and a gymnastic hall. In Arkitekt, it was also stated that the school was constructed in reinforced concrete completely. It was set on the area of 900 m<sup>2</sup> size. The plan was organized according to the climatic conditions of Tire and required spaces. The classes were directed to the east since the classes used the sunlight in the morning efficiently for the health. As a result of this direction, the classes did not take the sunlight in afternoon. In the organization of the plan layout, the separation between the administration, student spaces and conference hall, accessibility of the students were taken into consideration. Moreover, it was emphasized that the building had an architectural character due to its general appearance and reflections of architectural movements (Mortaş, 1937: 252-254).

**Figure 2. 37.** (a)“Tire Orta Mektep Projesi”, Mortaş, Abidin (1937), (Arkitekt, 1937-09 (81) : 252-254), (b) The photo of Tire Secondary School, Tire, 1951, (Tire Ticaret ve Sanayi Odası, İzmir, Berrin Matbaası:10)

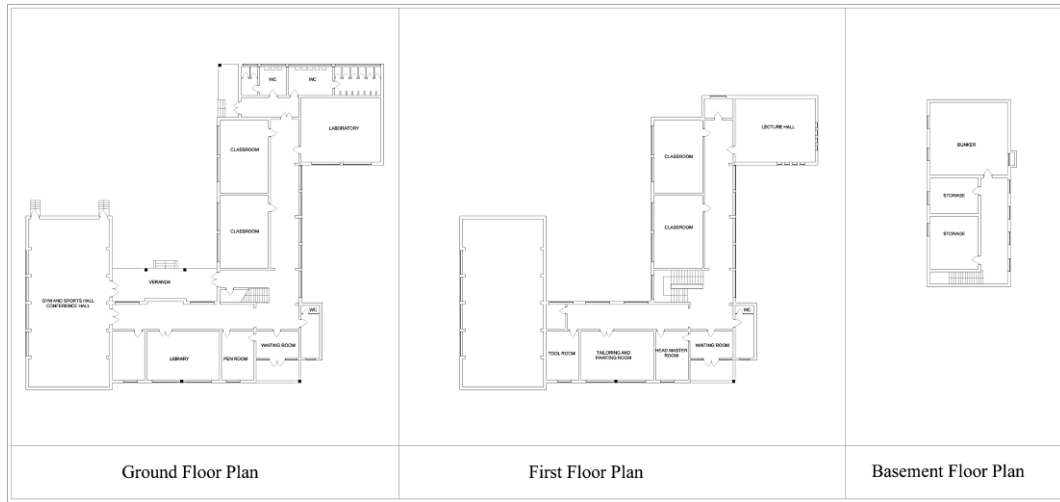
**Figure 2.38.** The floor plans of Tire Secondary School, redrawn from the article, Mortaş, Abidin (1937), “Tire Orta Mektep Projesi”, (Arkitekt, 1937-09 (81):252-254)

Tire Secondary School is used as teacher’s house. The ground floor accommodates the cafe and dining hall whereas the first floor consists of rooms for accommodation (For documentation sheet, see appendix B).

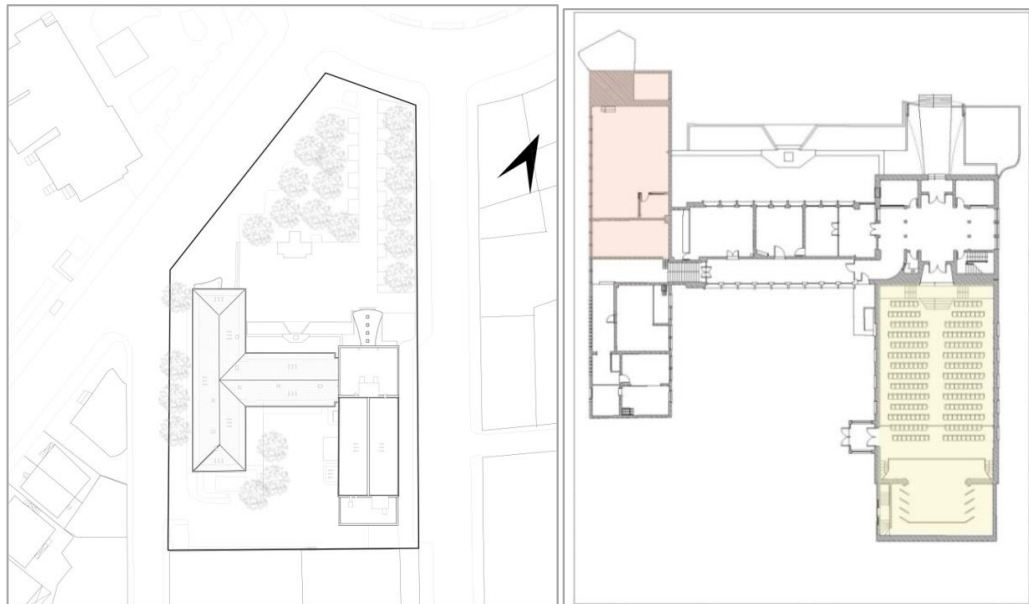
**Figure 2. 39.** (a) The site plan of the building, measured drawings (Kalan Mimarlık, (b) Floor plan of the People’s House in Tire, measured drawings (Kalan Mimarlık)

The People’s House (Halkevi) in Tire was re-functioned as the new municipality building in 1950’s (Tuna, 2006: 43). Although Ertekin (2004) says that the building was constructed in 1953, as seen that it was transformed. The building has I plan scheme as seen in Figure 2.39.

The building has three main parts in different masses. One branch forms the multipurpose hall while the other accommodates the library and the part of the administration offices. The section in the middle forms the offices. The large conference hall was transformed to the wedding hall while the library was rearranged as the public library. In Tire, it seems that the building did not have an accommodation part as well as offices for RPP. The new main entrance of the building was designed by Doğan Tuna with the approval of Can Egeli (See Appendix). The cylindrical shell was 12 cm thickness and set on two piers supported by the main building. The shell was plastered after the concrete was poured consecutively. The entrance shell was about 5 meters width and height, and 10 meters length (Tuna, 2006: 43).

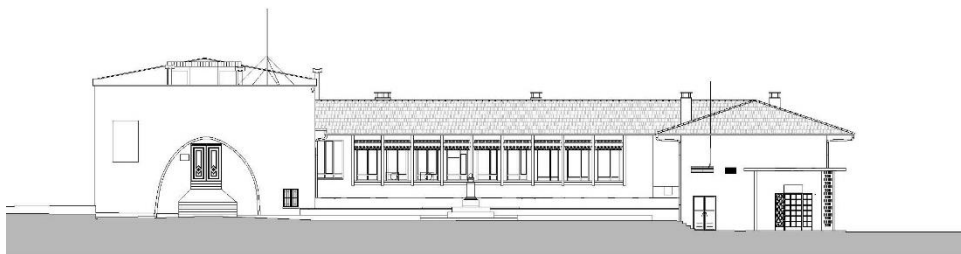
**Figure 2. 40.** The north elevation of People's House in Tire, measured drawings (Kalan Mimarlık)

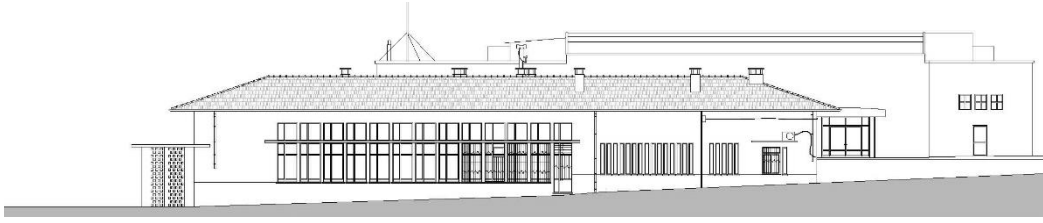
**Figure 2. 41.** The west elevation of People's House in Tire, measured drawings (Kalan Mimarlık)

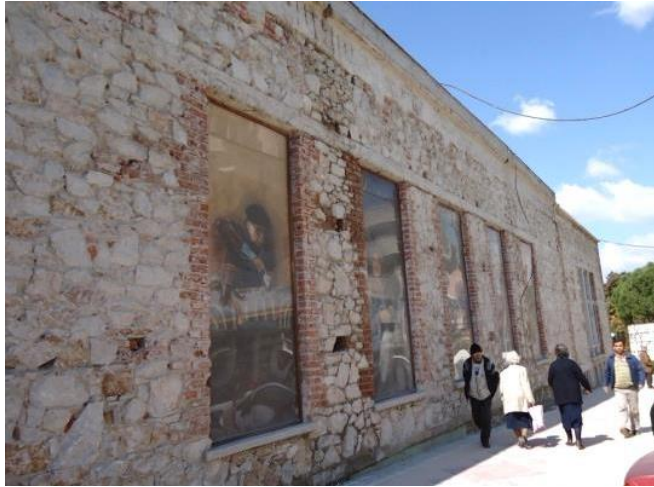
Although it is stated that most of the buildings were constructed in reinforced concrete, Tire people's houses is a masonry building constructed in brick and rubble stone as seen Figure 2. 42. However, it was stated that local materials were taken into consideration in the construction (Gürallar Yeşilkaya, 1999: 170).

**Figure 2. 42.** The photo of the east elevation showing the construction technique and material, March 2012

The restoration project of the building is being implemented now and the building is under construction for the new function as the city museum as seen Figure 2. 42. (For documentation sheet, see appendix B).

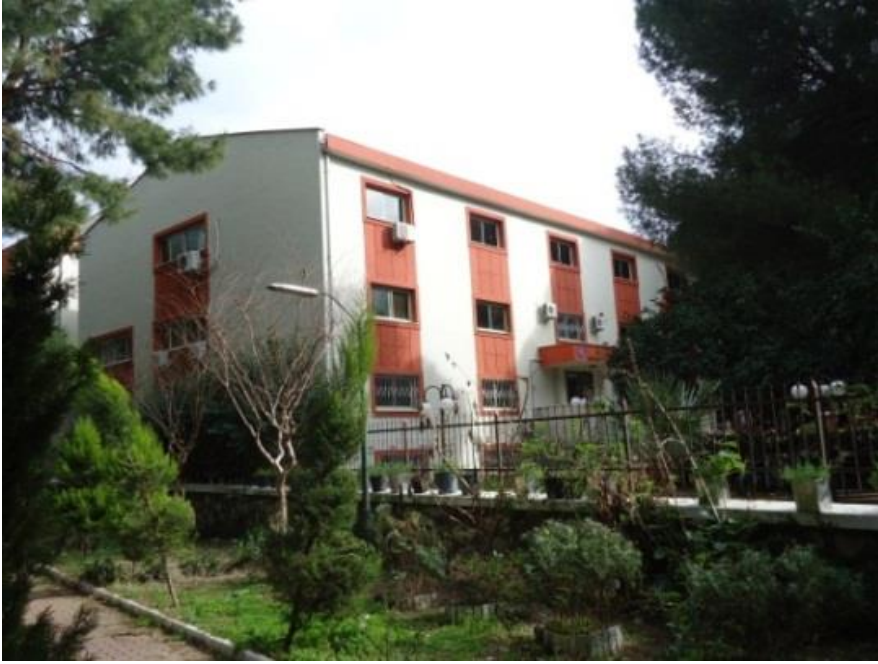
The construction of Tekel Tobacco Depot began in 1936 (For documentation sheet, see appendix B). During the transformation of the depot to Ege University Tire Kutsan Vacation School in 1997, the building was changed and altered that the building lost its authenticity in restoration as seen in Figure 2. 44. The original structure of the building was not conserved (Yıldırım, 2007: 90).

**Figure 2. 44.** The building after restoration project, (2012)

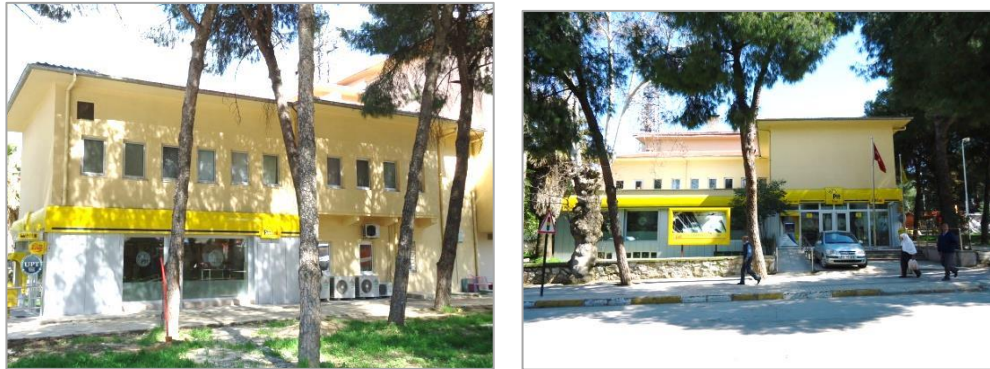
**Figure 2. 47.** The facades of the Post Office, 2012

Although the facade of the ground floor was altered during renovation, the building mass and the facade of the first floor are conserved.

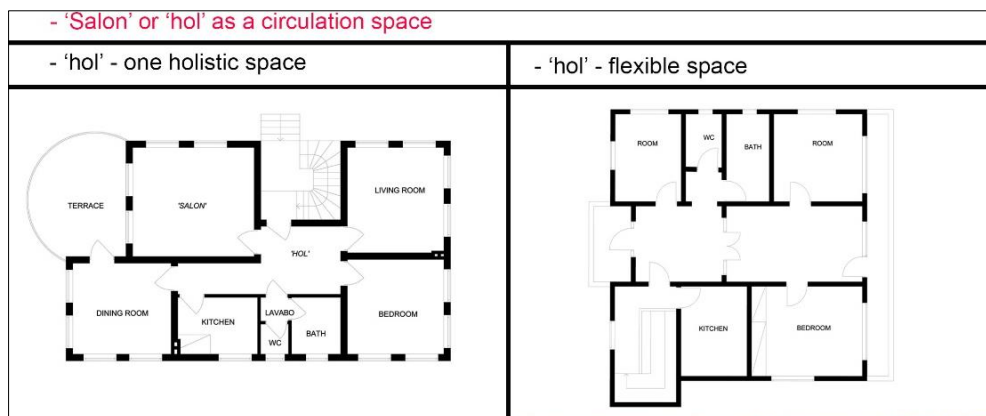
**Figure 2. 48** The example of residential buildings which ‘salon’ or ‘hol’ is used as circulation

In terms of the usage of ‘salon’ and relationships between the living spaces, plan layouts can be categorized as two types of edifices: the plan layout in which ‘salon’ is used as circulation space or as living space. On the other hand, in some plan types, the wet spaces are organized separated from the other spaces with the entrance corridor. In terms of the organization of the ‘salon’, the layouts can be categorized as the schemes that ‘salon’ is separable and flexible, and the layout ‘salon’ is one holistic space (See the table on appendix). In the first layout, there are two variations: in the first one, ‘salon’ is divided to two different and separated spaces, and in the second one, ‘salon’ is a flexible space and has differentiated parts called as ‘salomanje’. The term ‘salomanje’ was used on the architectural plans of the original projects prepared by the architect or technician that concerns dining space in it additionally. ‘Salon salomanje’ is the term that was occurred in 1970’s and means that designing the dining and living spaces flexible or separable providing a transition between each other.

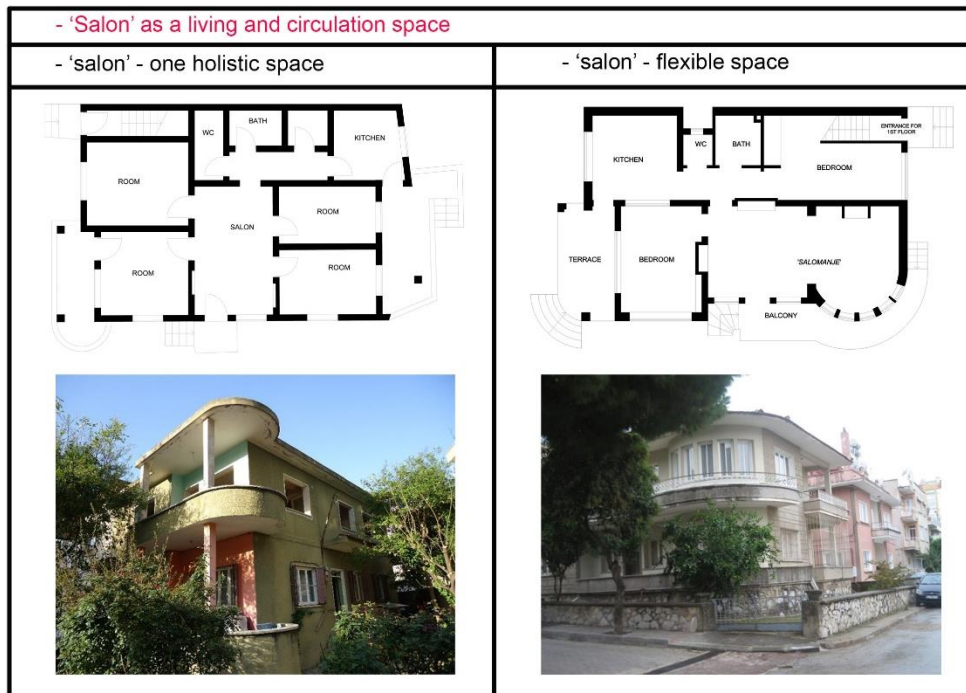
**Figure 2. 49** The examples of the residential buildings which 'salon' is used as living and circulation

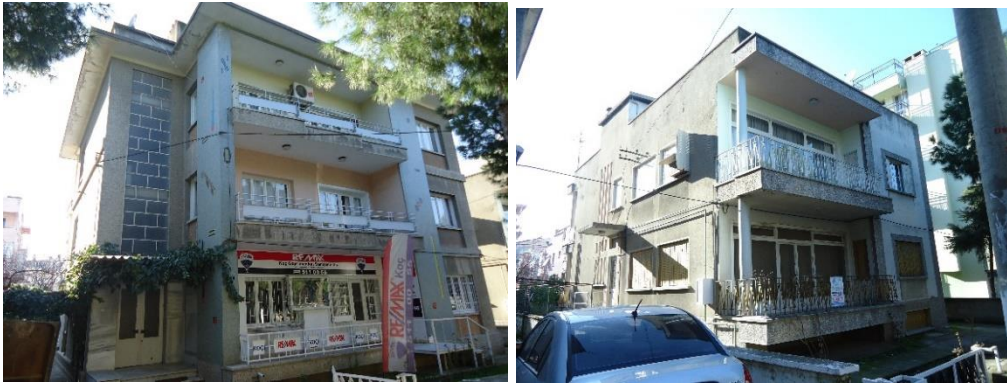
**Figure 2. 50** Examples of single houses

In single houses, symmetrical organization of the openings is broken by the asymmetrical organization of the balcony or composition of the entrance door and exterior stair going up.
