UNDERSTANDING AND ASSESSING THE REPUBLICAN HERITAGE OF  
TİRE

A THESIS SUBMITTED TO  
THE GRADUATE SCHOOL OF NATURAL AND APPLIED SCIENCES  
OF  
MIDDLE EAST TECHNICAL UNIVERSITY

EBRU BAKIM

SEPTEMBER 2017

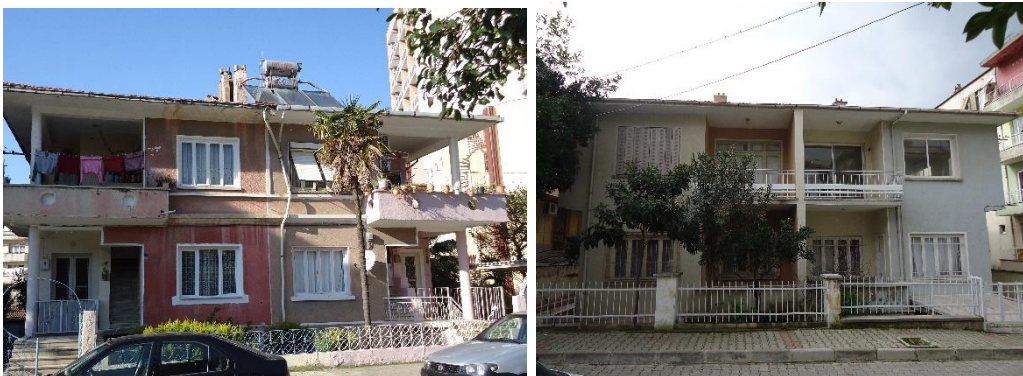
In double houses, balconies are located at the corners projecting from the façade and columns are used as a façade element as they are designed on the behind the parapet of the balcony.

**Figure 2. 51** Examples of double houses

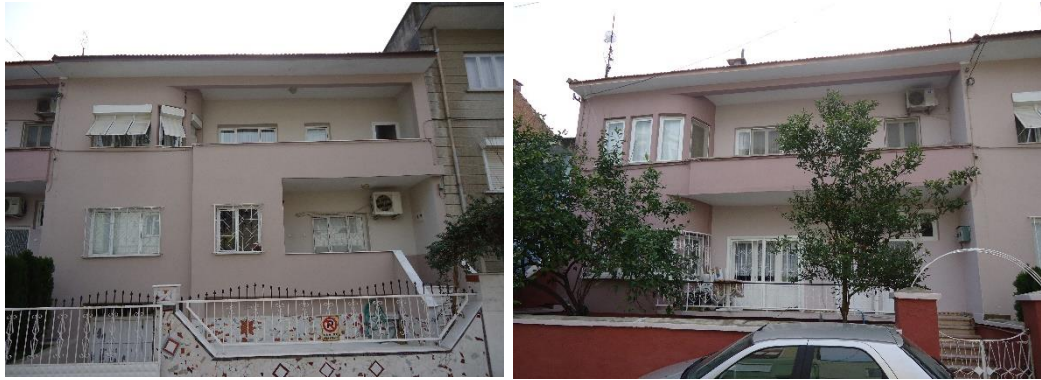
In row houses, entrances were defined by the pulling back the façade and the corners of the rooms that come out were designed as rounded.

**Figure 2. 52** Examples of row houses

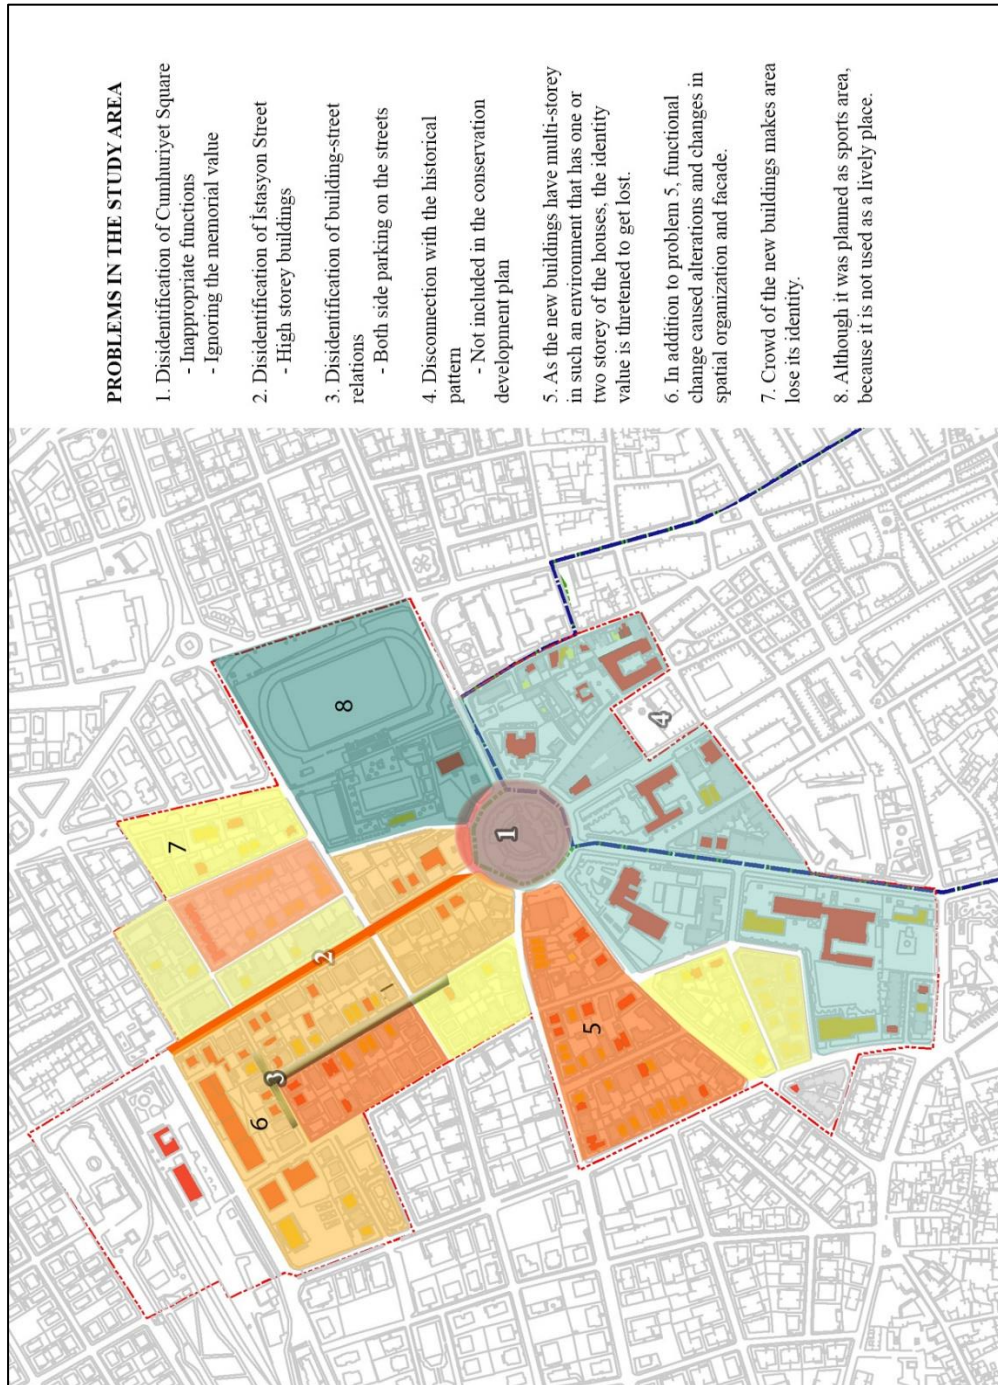
- *Disidentification of Cumhuriyet Square*: The symbolic and commemorative value is ignored because of disidentification of the square and inappropriate function.
- *Disconnection with the historical pattern*: The study area is not included in the conservation development plan since it is not considered as valuable to conserve by the decision makers. Conservation development plan of Tire does not include the boundaries of the study area since it only includes the urban pattern belonging mostly until 20<sup>th</sup> century regarding the general conservation approach of the law and society.
- Existing development plan causes the loss of the urban pattern which has the identity regarding urban values.
- Because of the economic problems, it seems profitable for the habitants to agree with a contractor to demolish the existing and to construct a higher apartment.

**Figure 3. 4.** Problems in the study area

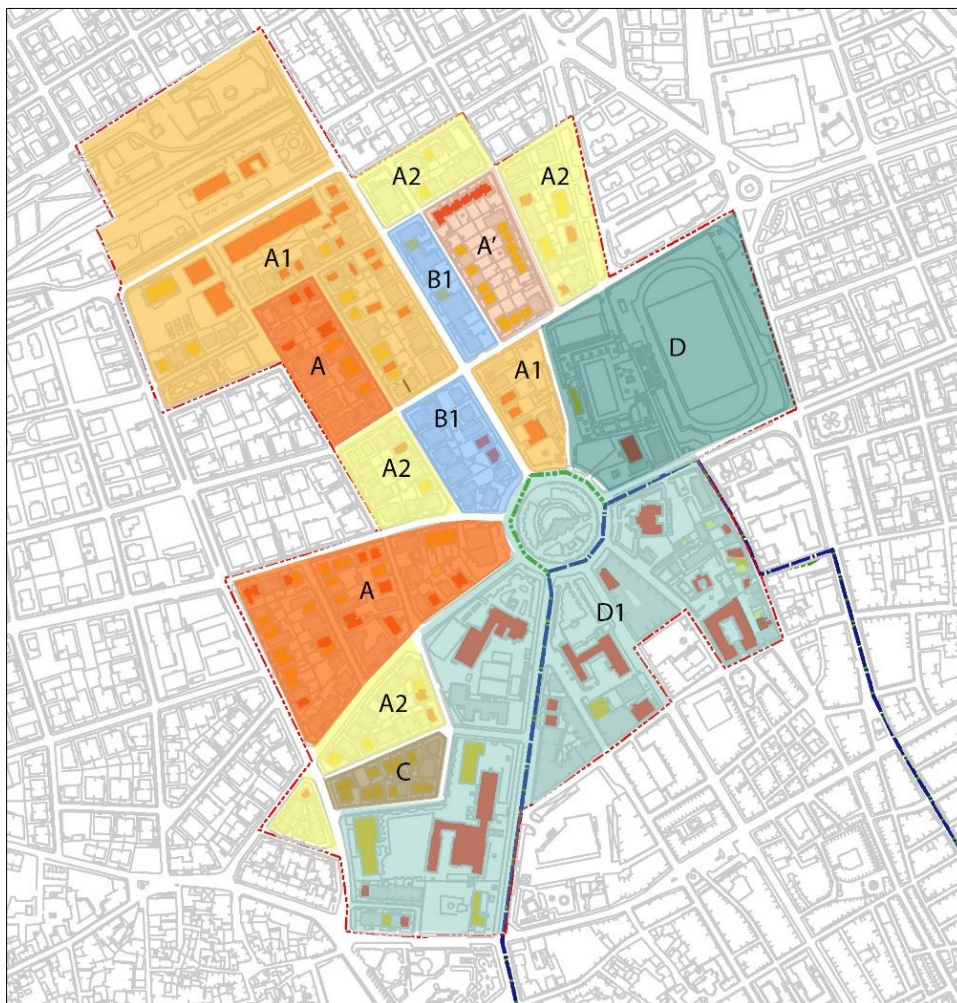
**Figure 3. 5** Category of the zones in the study area

<i>Function</i>	<i>Density of Republican Heritage</i>
<b>A</b>	Residential	Dense + new building
<b>A'</b>	Residential	Dense (Row houses) + new b.
<b>A1</b>	Residential/Commercial/ Indust.	Dense + new building
<b>A2</b>	Residential	Rare + new building (dense)
<b>B1</b>	Residential + Commercial	New building (dense)
<b>C</b>	Residential	Dense + new building
<b>D</b>	Educational + Sports	
<b>D1</b>	Educational Administrative

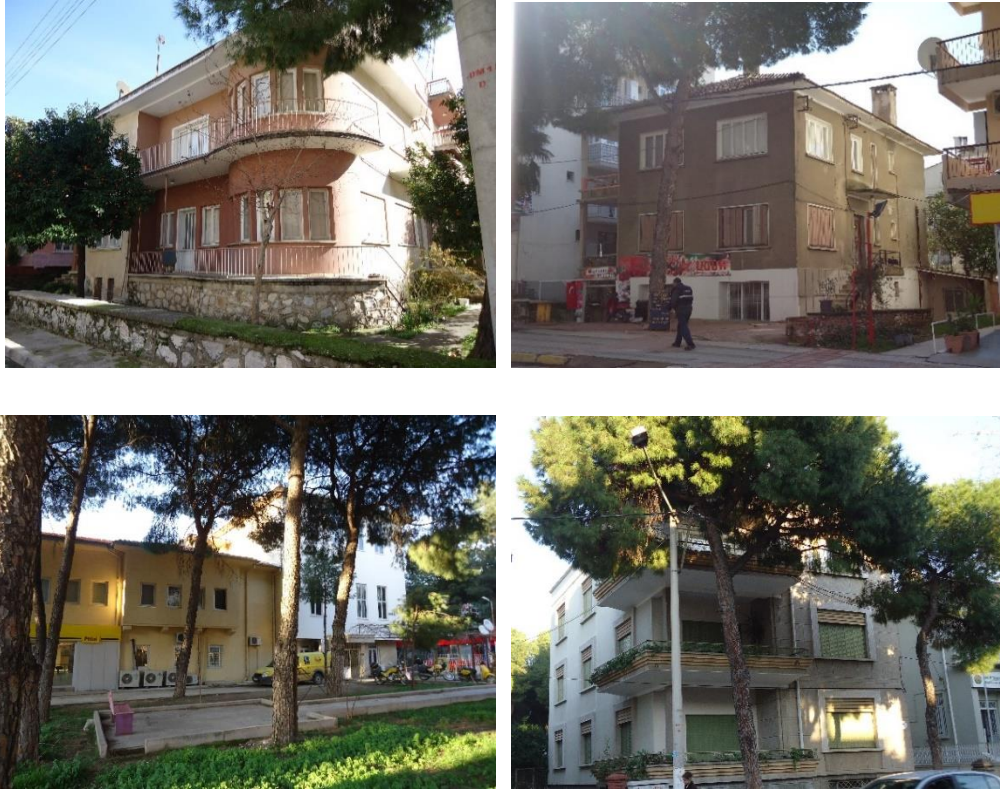
Legal status of the area: In the development plan of Tire, it is allowed to construct attached buildings up to four-storey (B-4).

**Figure 3. 8** The examples from zone ‘A1’

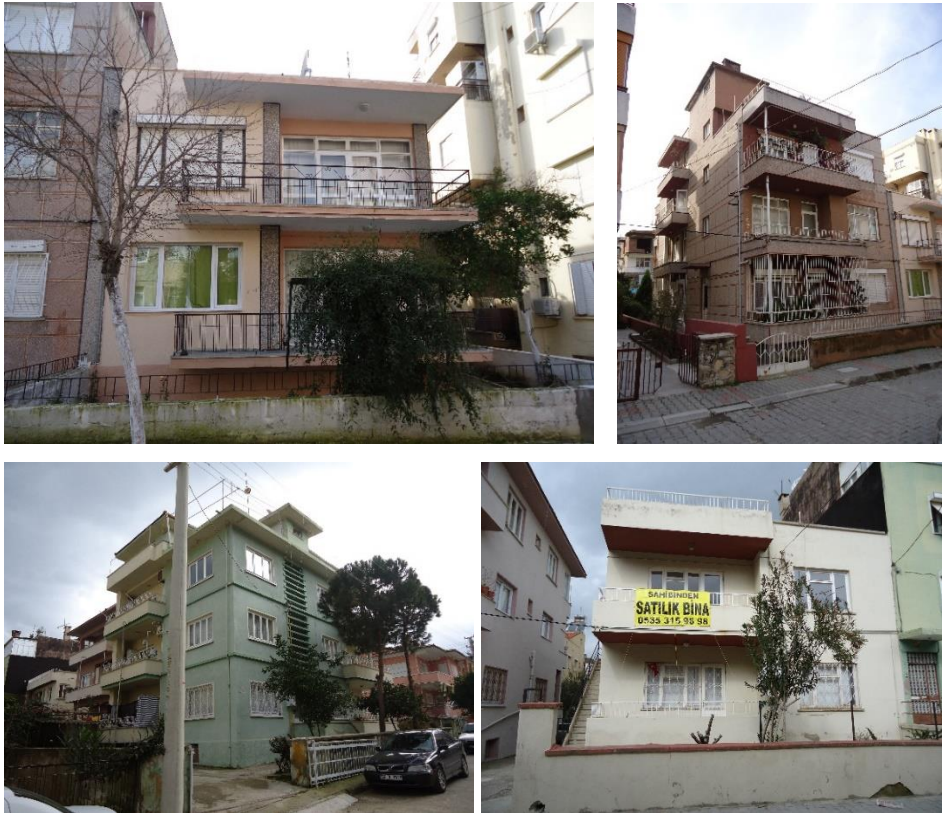
Legal status of the area: In the development plan, it is allowed to construct detached buildings up to four or five-storey. The setback distances from the road is 4 meters, from the near lot is 3 meters and the rear is  $h/2$ . In the area, there is a specific industrial zone near the railway station belonging Tariş. In this area, it is allowed to construct detached buildings in five-storey. The setback distance from the road is 5 meters and from the near lot is 3 meters. (Plot area ratio: 0, 25 / Floor area ratio: 1, 50)

**Figure 3. 9** The examples from zone ‘A2’

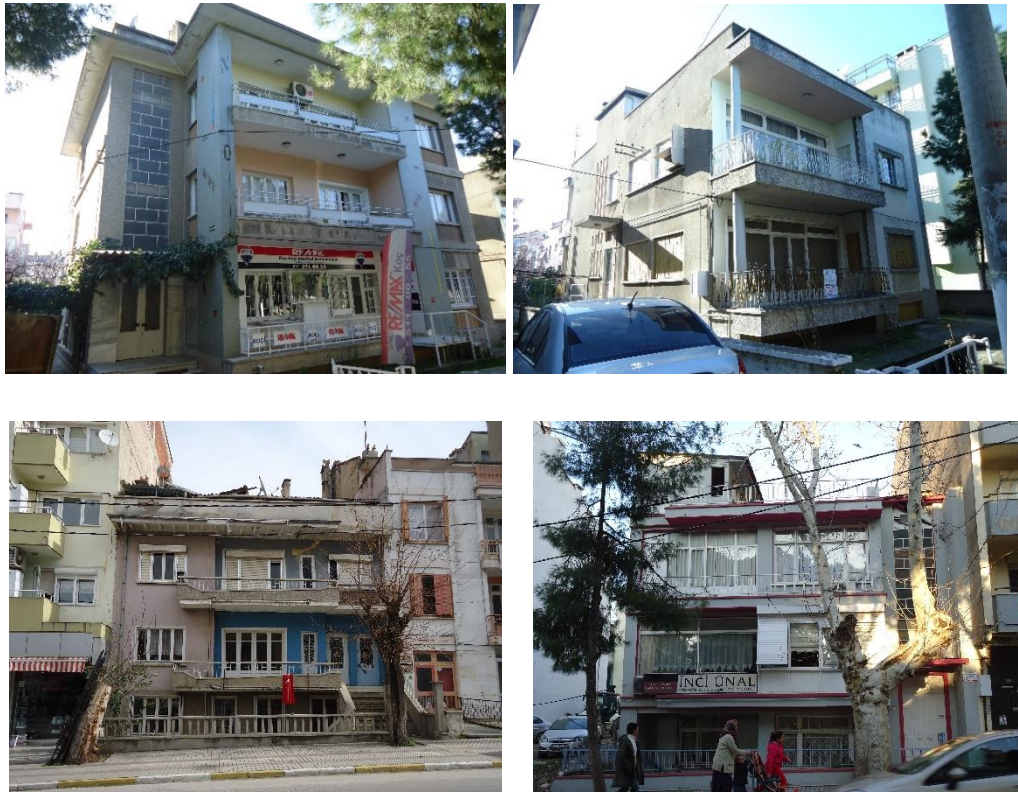
Legal status of the area: In the development plan, it is allowed to construct detached or attached buildings in four or five-storey. The setback distances from the road is 4 meters, from the near lot is 3 meters and the rear is  $h/2$ .

**Figure 3. 10** The examples from zone ‘B1’

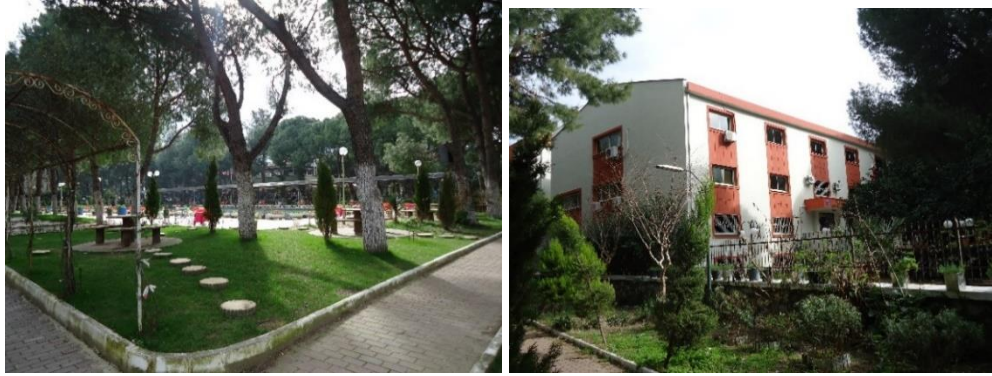
**Figure 3. 12** The examples from the zone ‘D’

D: The educational and sports area that have open public areas

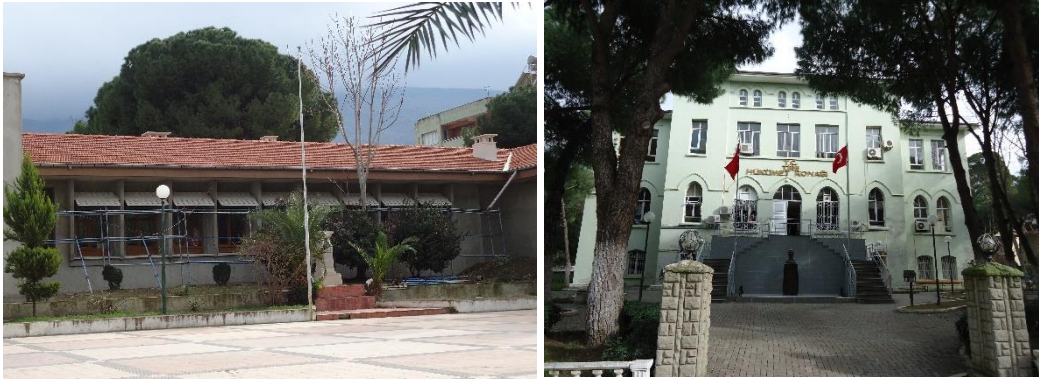
**Figure 3.13** The examples from zone ‘D1’

D1: The areas that have administrative and educational buildings surrounding Cumhuriyet Square.

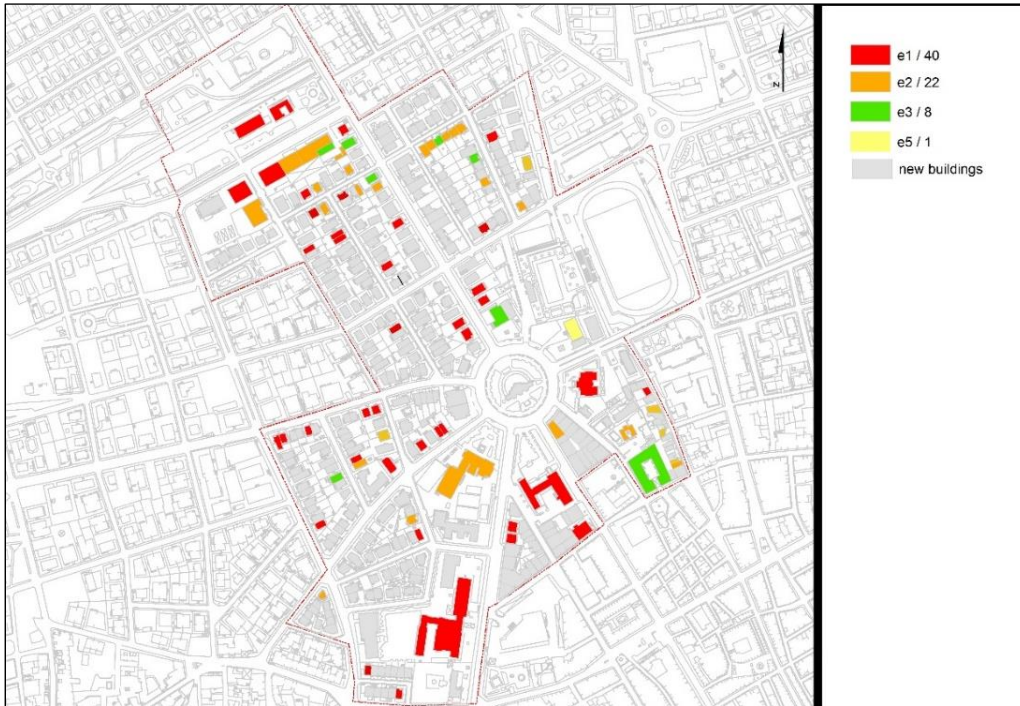
**Figure 3. 14** Change in exterior fiches

As seen in Table 3. 3, overall changes were determined according to exterior and interior changes. The change analysis in exterior and interior fiches is shown in the Figure 3.15.

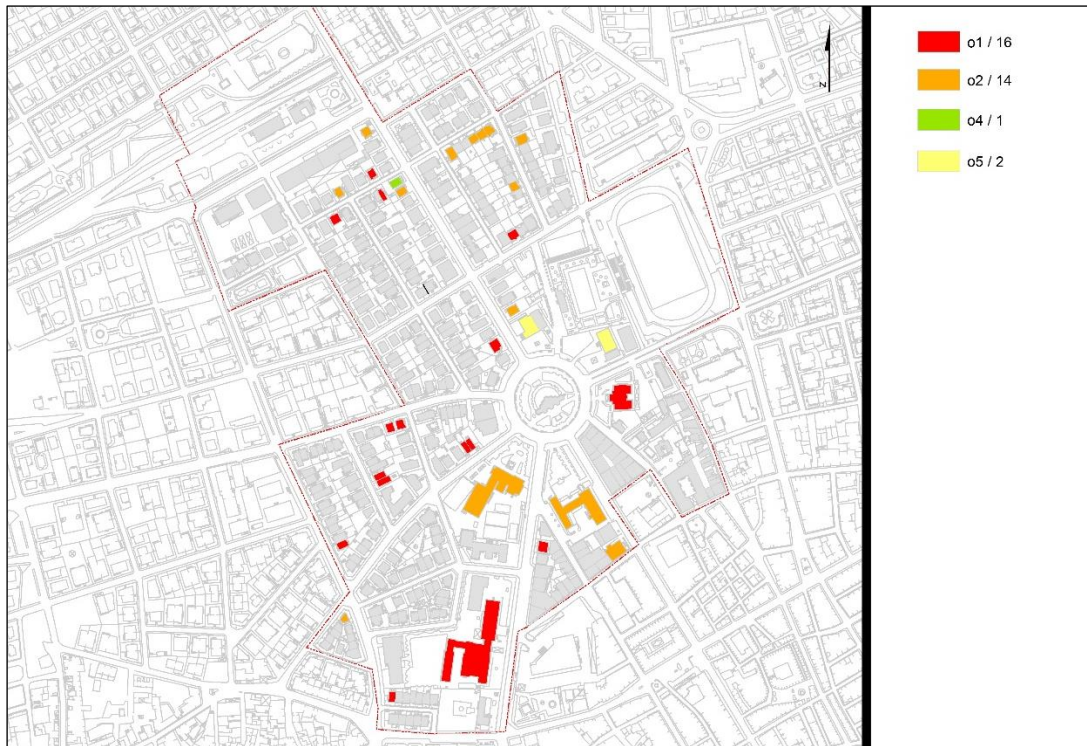
**Figure 3. 15** Change in overall (change in exterior and interior fiches)

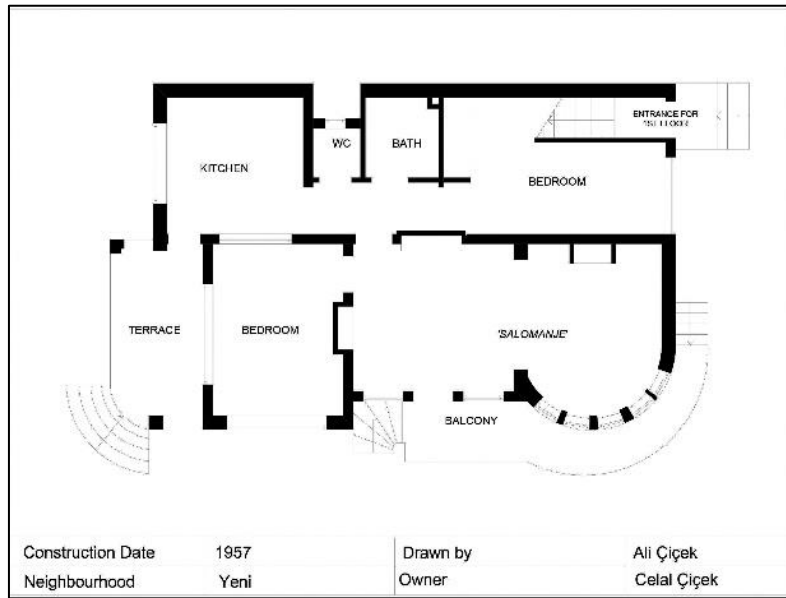
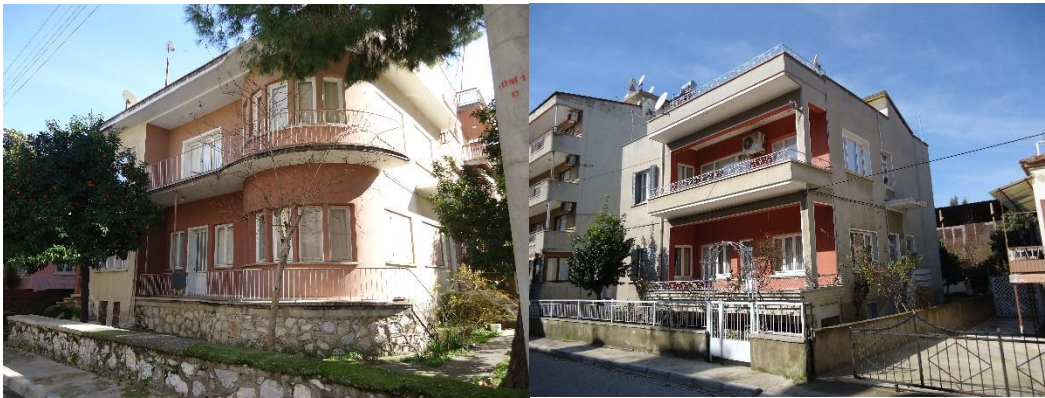
**Figure 3. 16** The plsn and facade examples from category ‘A’

A: Residential buildings with minor exterior changes (In the table, change exterior: e1)

- Since the buildings in that category have functional continuity, they are more convenient to conserve. In terms of the organization of the spaces, the spatial organization of the buildings provides the contemporary needs, thus, there is no need to change the plan layout in the continuity of the function.

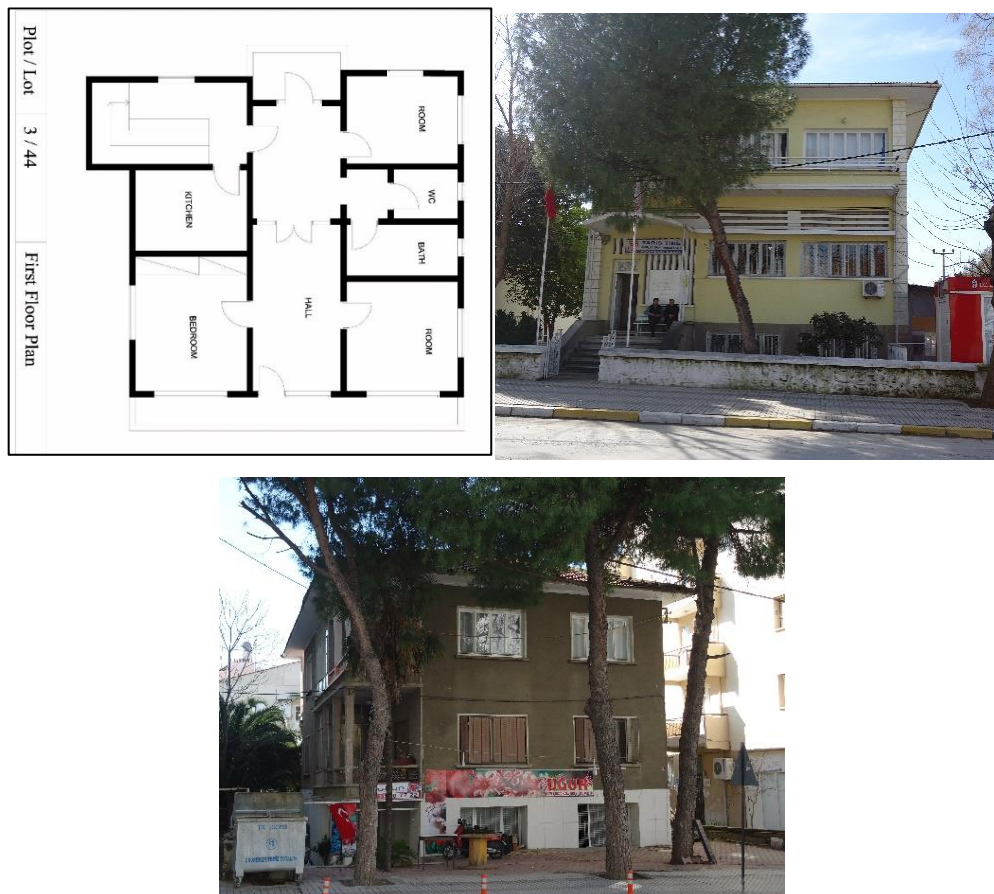
**Figure 3. 17** The examples from category ‘A1’

A1: Commercial buildings with minor exterior changes (exterior change: e1)

- The change of the function from residential to commercial have caused changes and alterations in both facades and plan layout. There is a need of regulation for the changes.

- Although they do not have functional continuity, they are valuable since they have minor changes in their facades and/or plan layout providing significance of place.

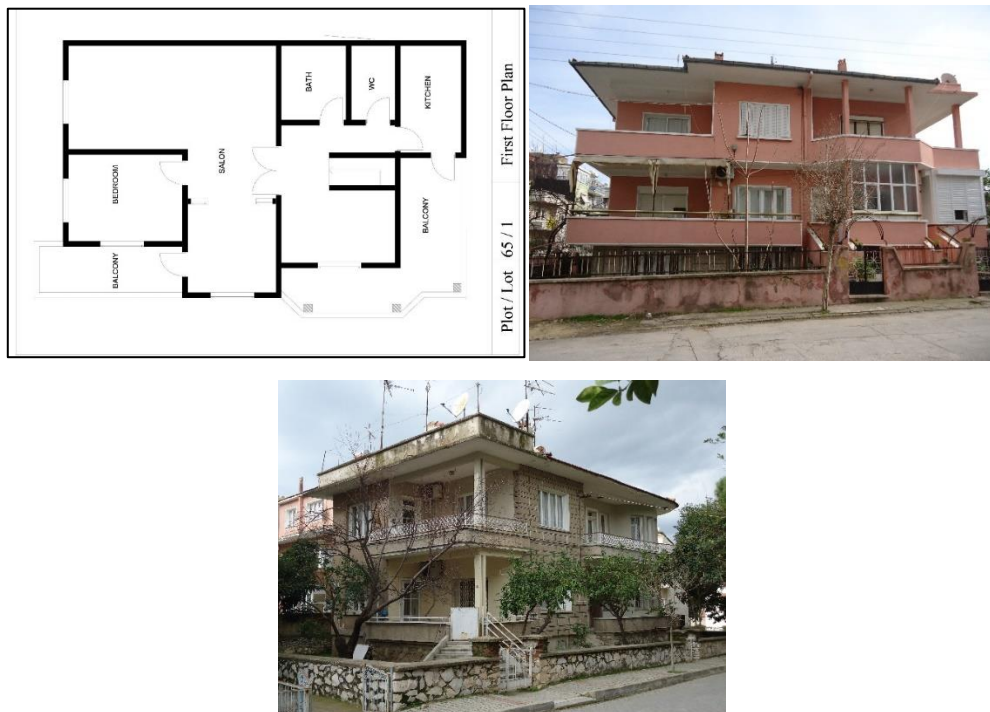
**Figure 3. 18** The examples from category ‘B’

B: Residential buildings with legible exterior changes (In the table, exterior change: e2)

- Since they have functional continuity, there is no need to change the plan layouts and spatial organization of the building.

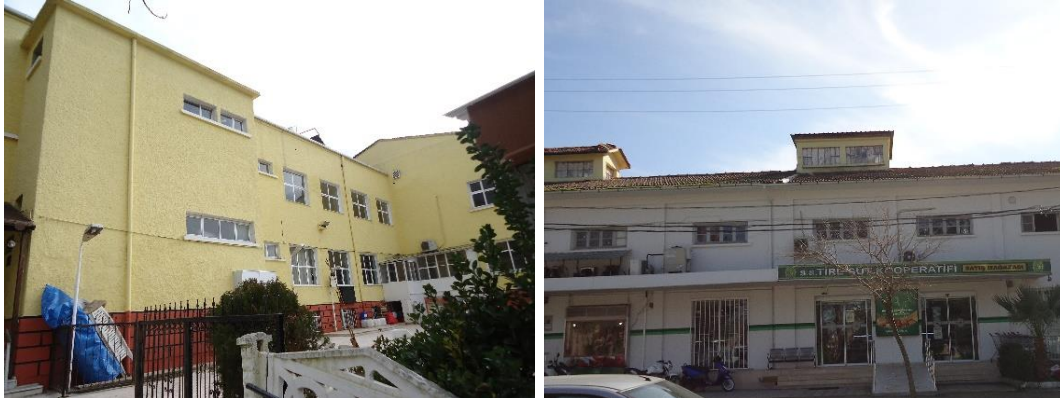
**Figure 3. 19** The examples from category 'B1'

B1: Commercial or industrial buildings with legible exterior changes (In the table, exterior change: e2)

- Since the buildings in that category mostly have large and holistic spaces, they are convenient for adaptive re-use and refunctioning.

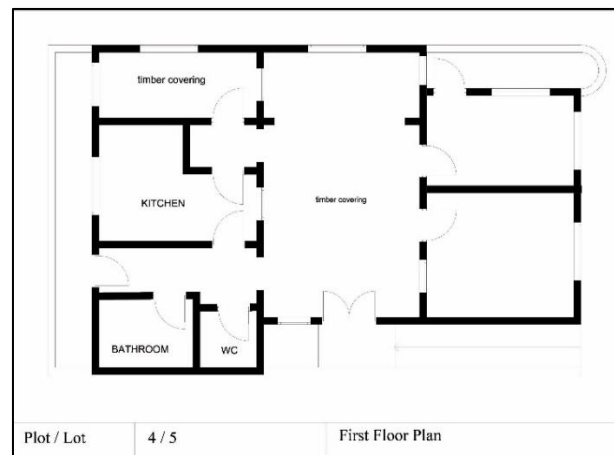
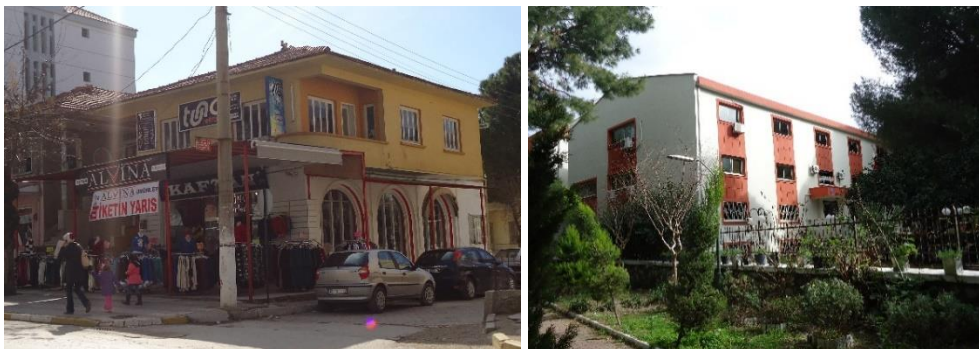
**Figure 3. 20** The examples from category ‘C’

C: Residential, commercial and industrial buildings with illegible exterior changes totally changed (In the table, exterior change: e3, e4)

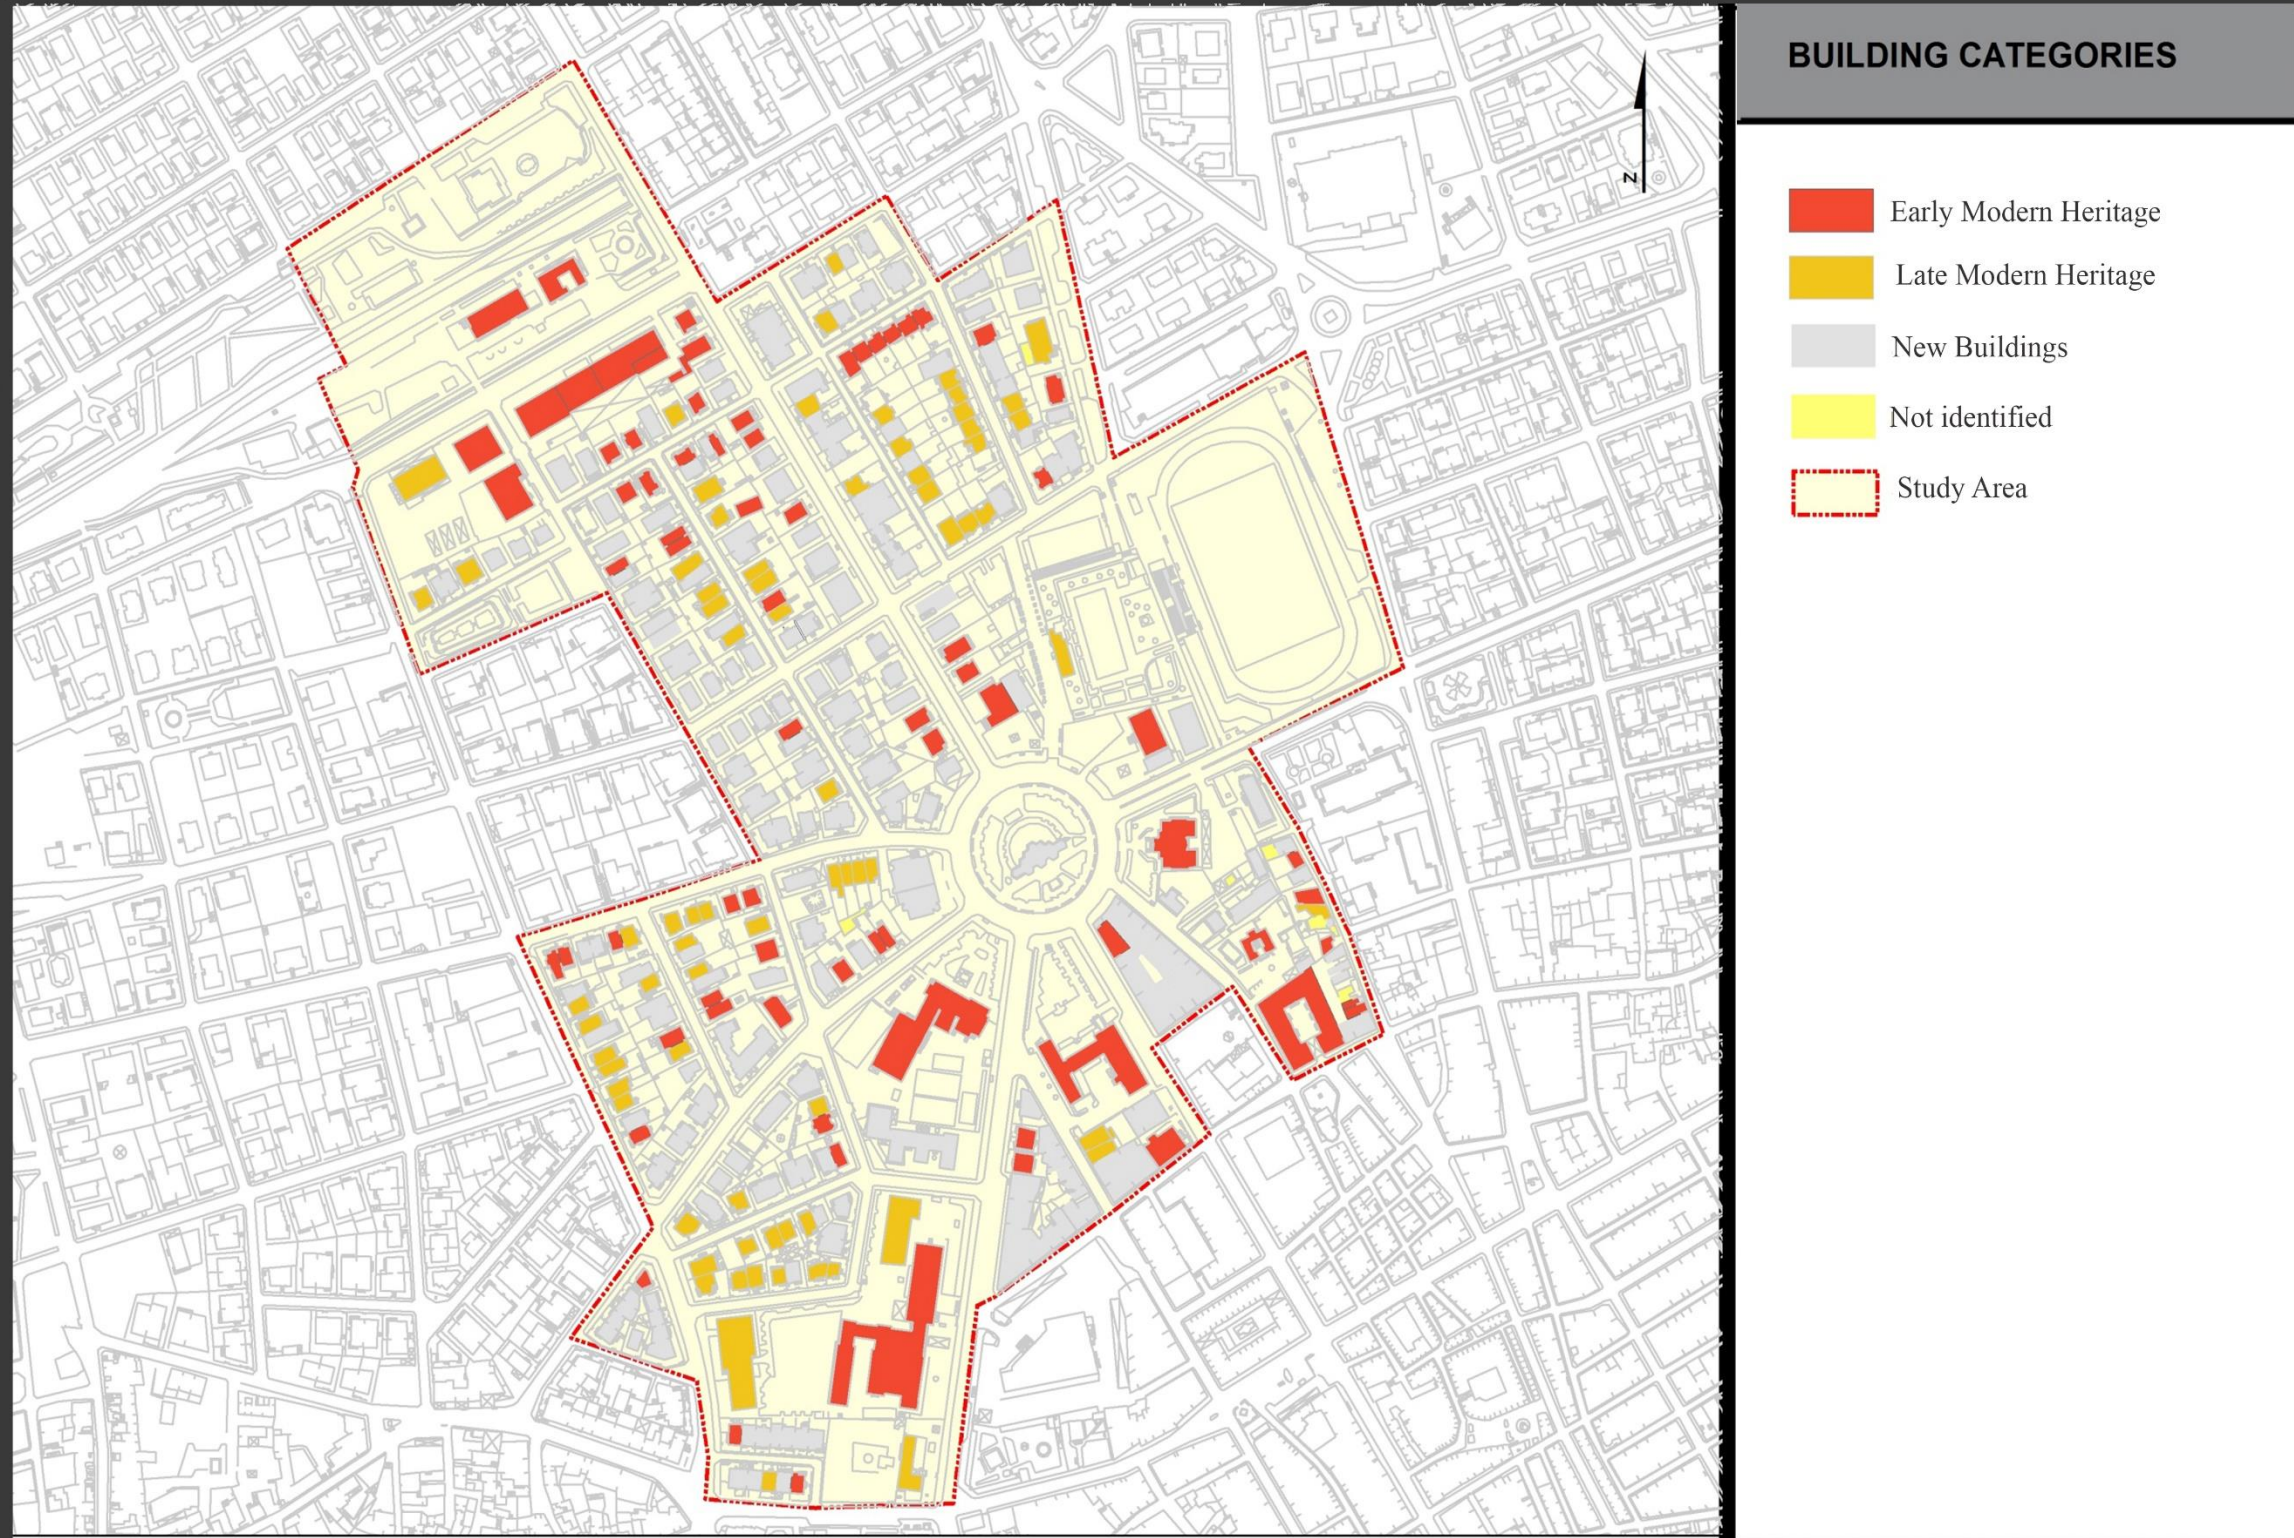
Figure A. 1. Categories of buildings according to their periods

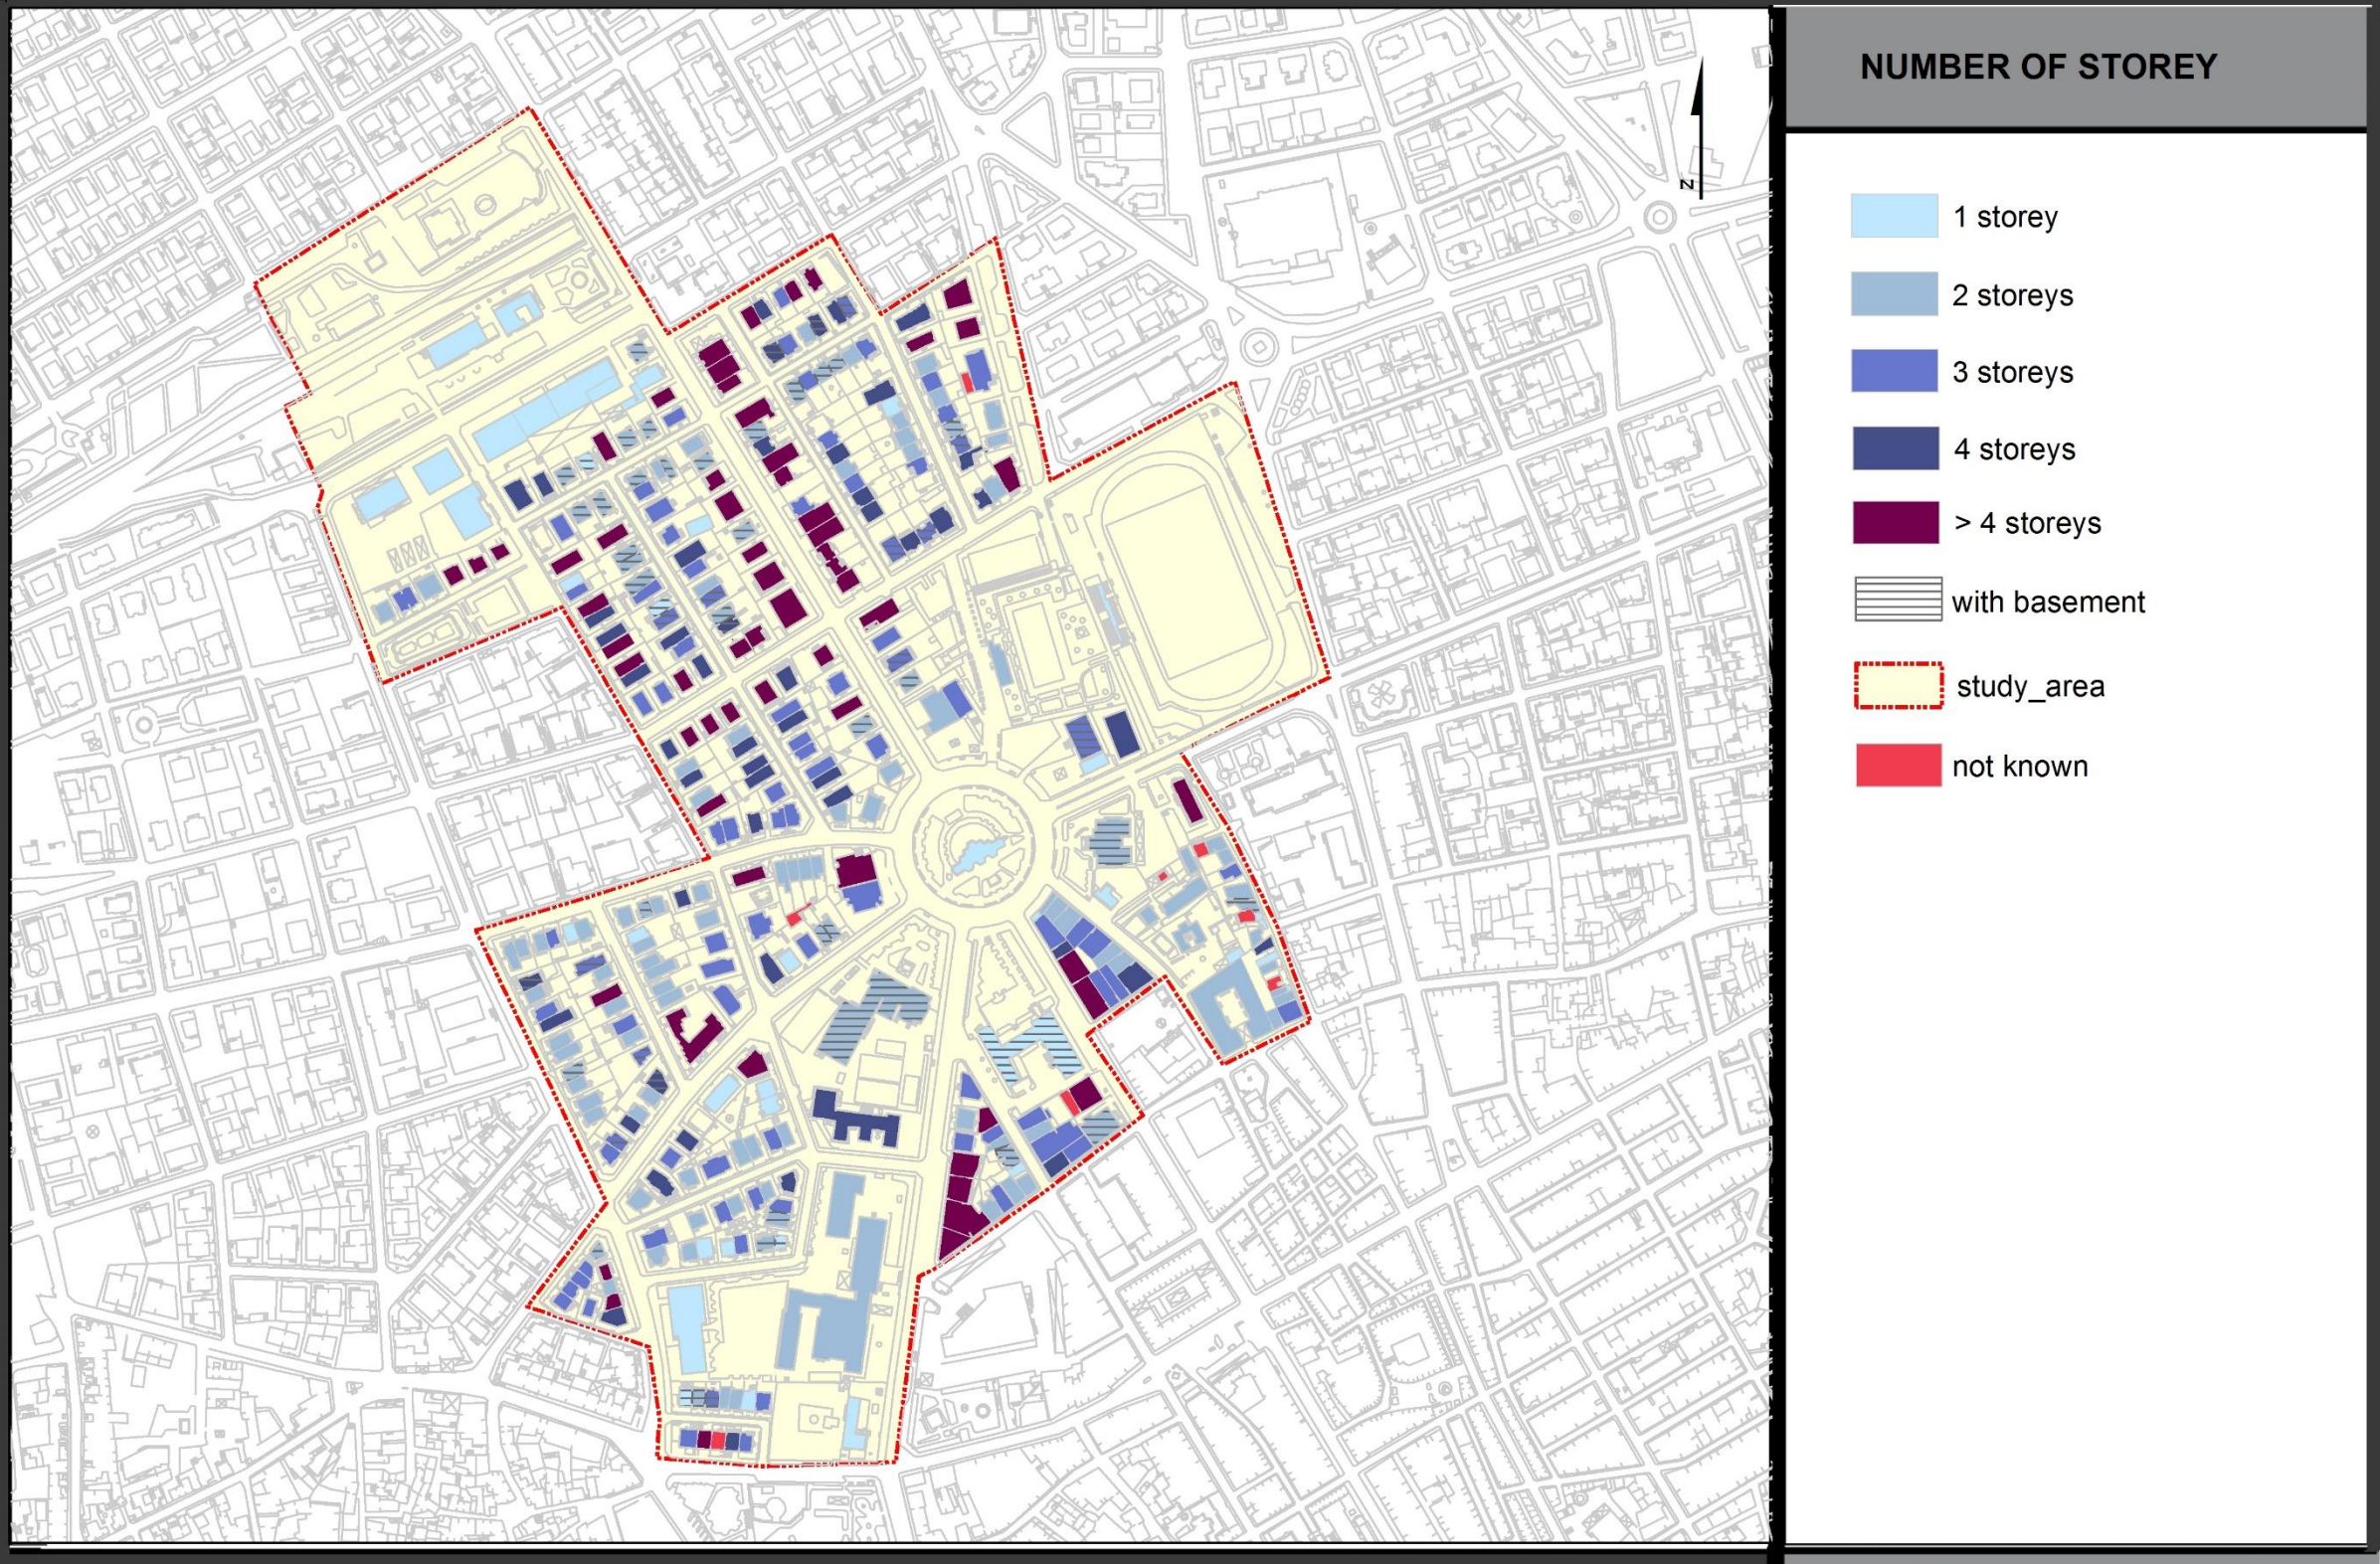
Figure A. 3. Analysis of number of stories
