UNDERSTANDING AND ASSESSING THE REPUBLICAN HERITAGE OF  
TİRE

A THESIS SUBMITTED TO  
THE GRADUATE SCHOOL OF NATURAL AND APPLIED SCIENCES  
OF  
MIDDLE EAST TECHNICAL UNIVERSITY

EBRU BAKIM

SEPTEMBER 2017

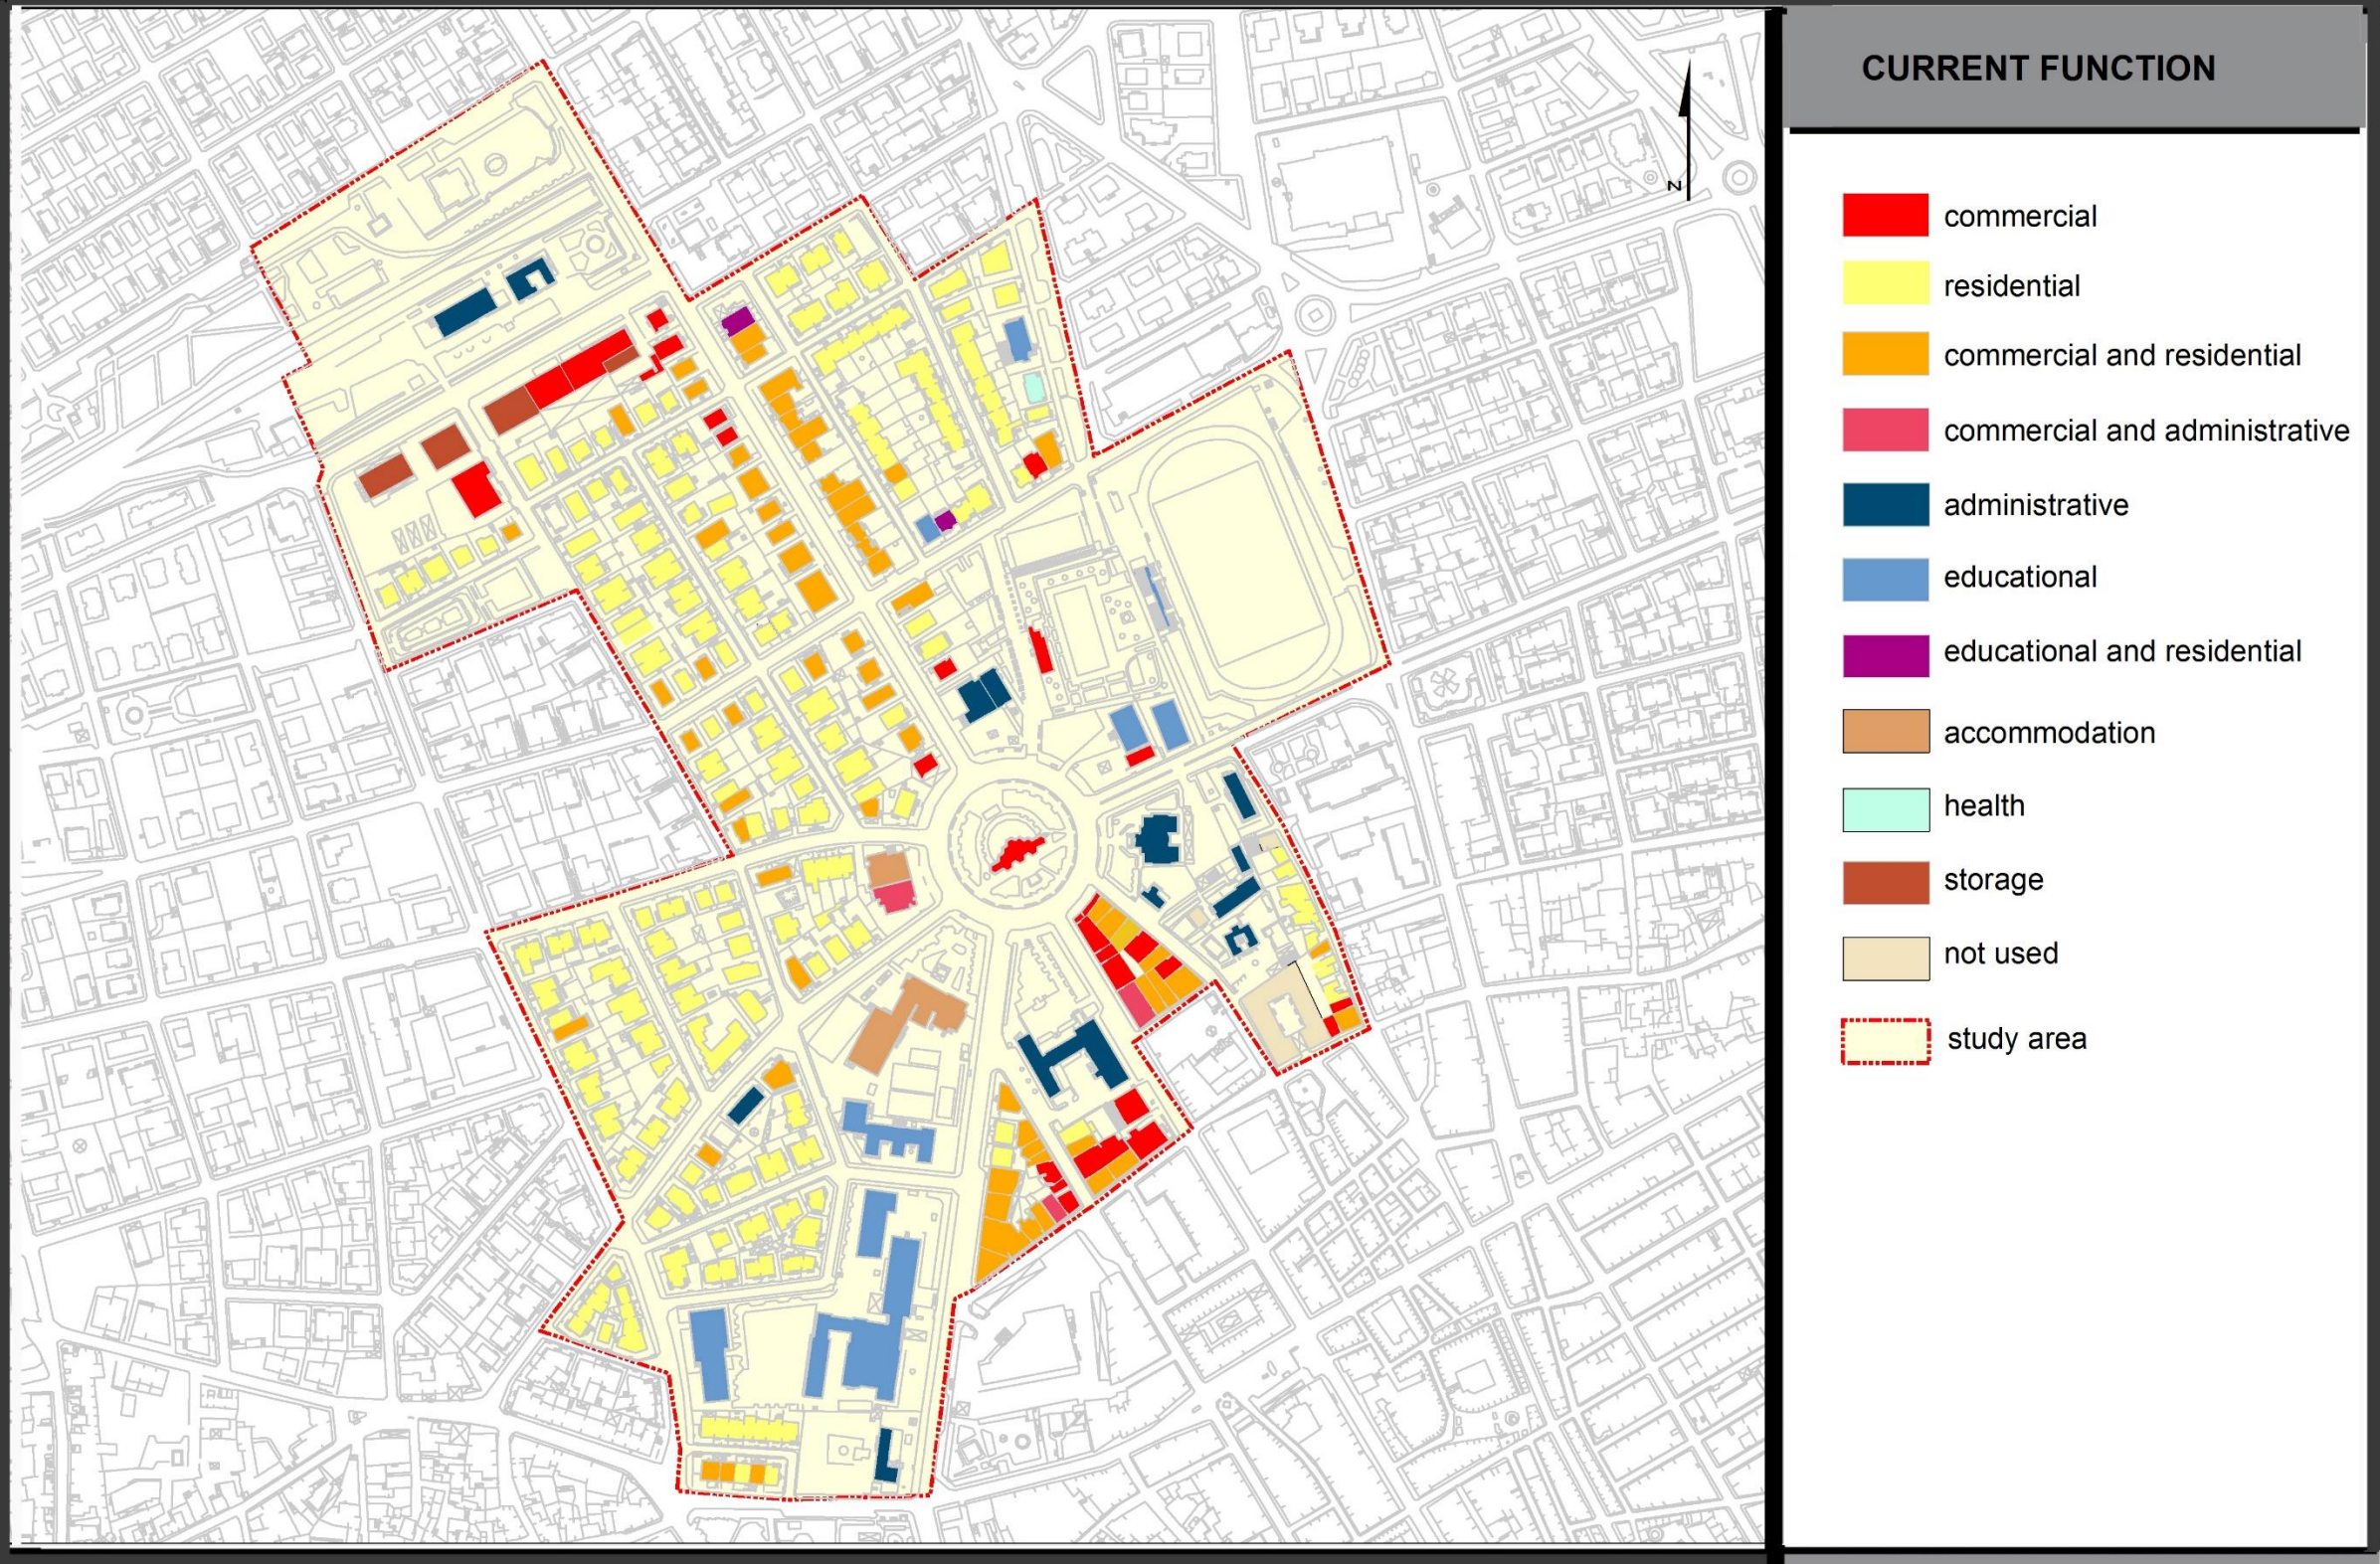
Figure A. 4. Analysis of current function of buildings

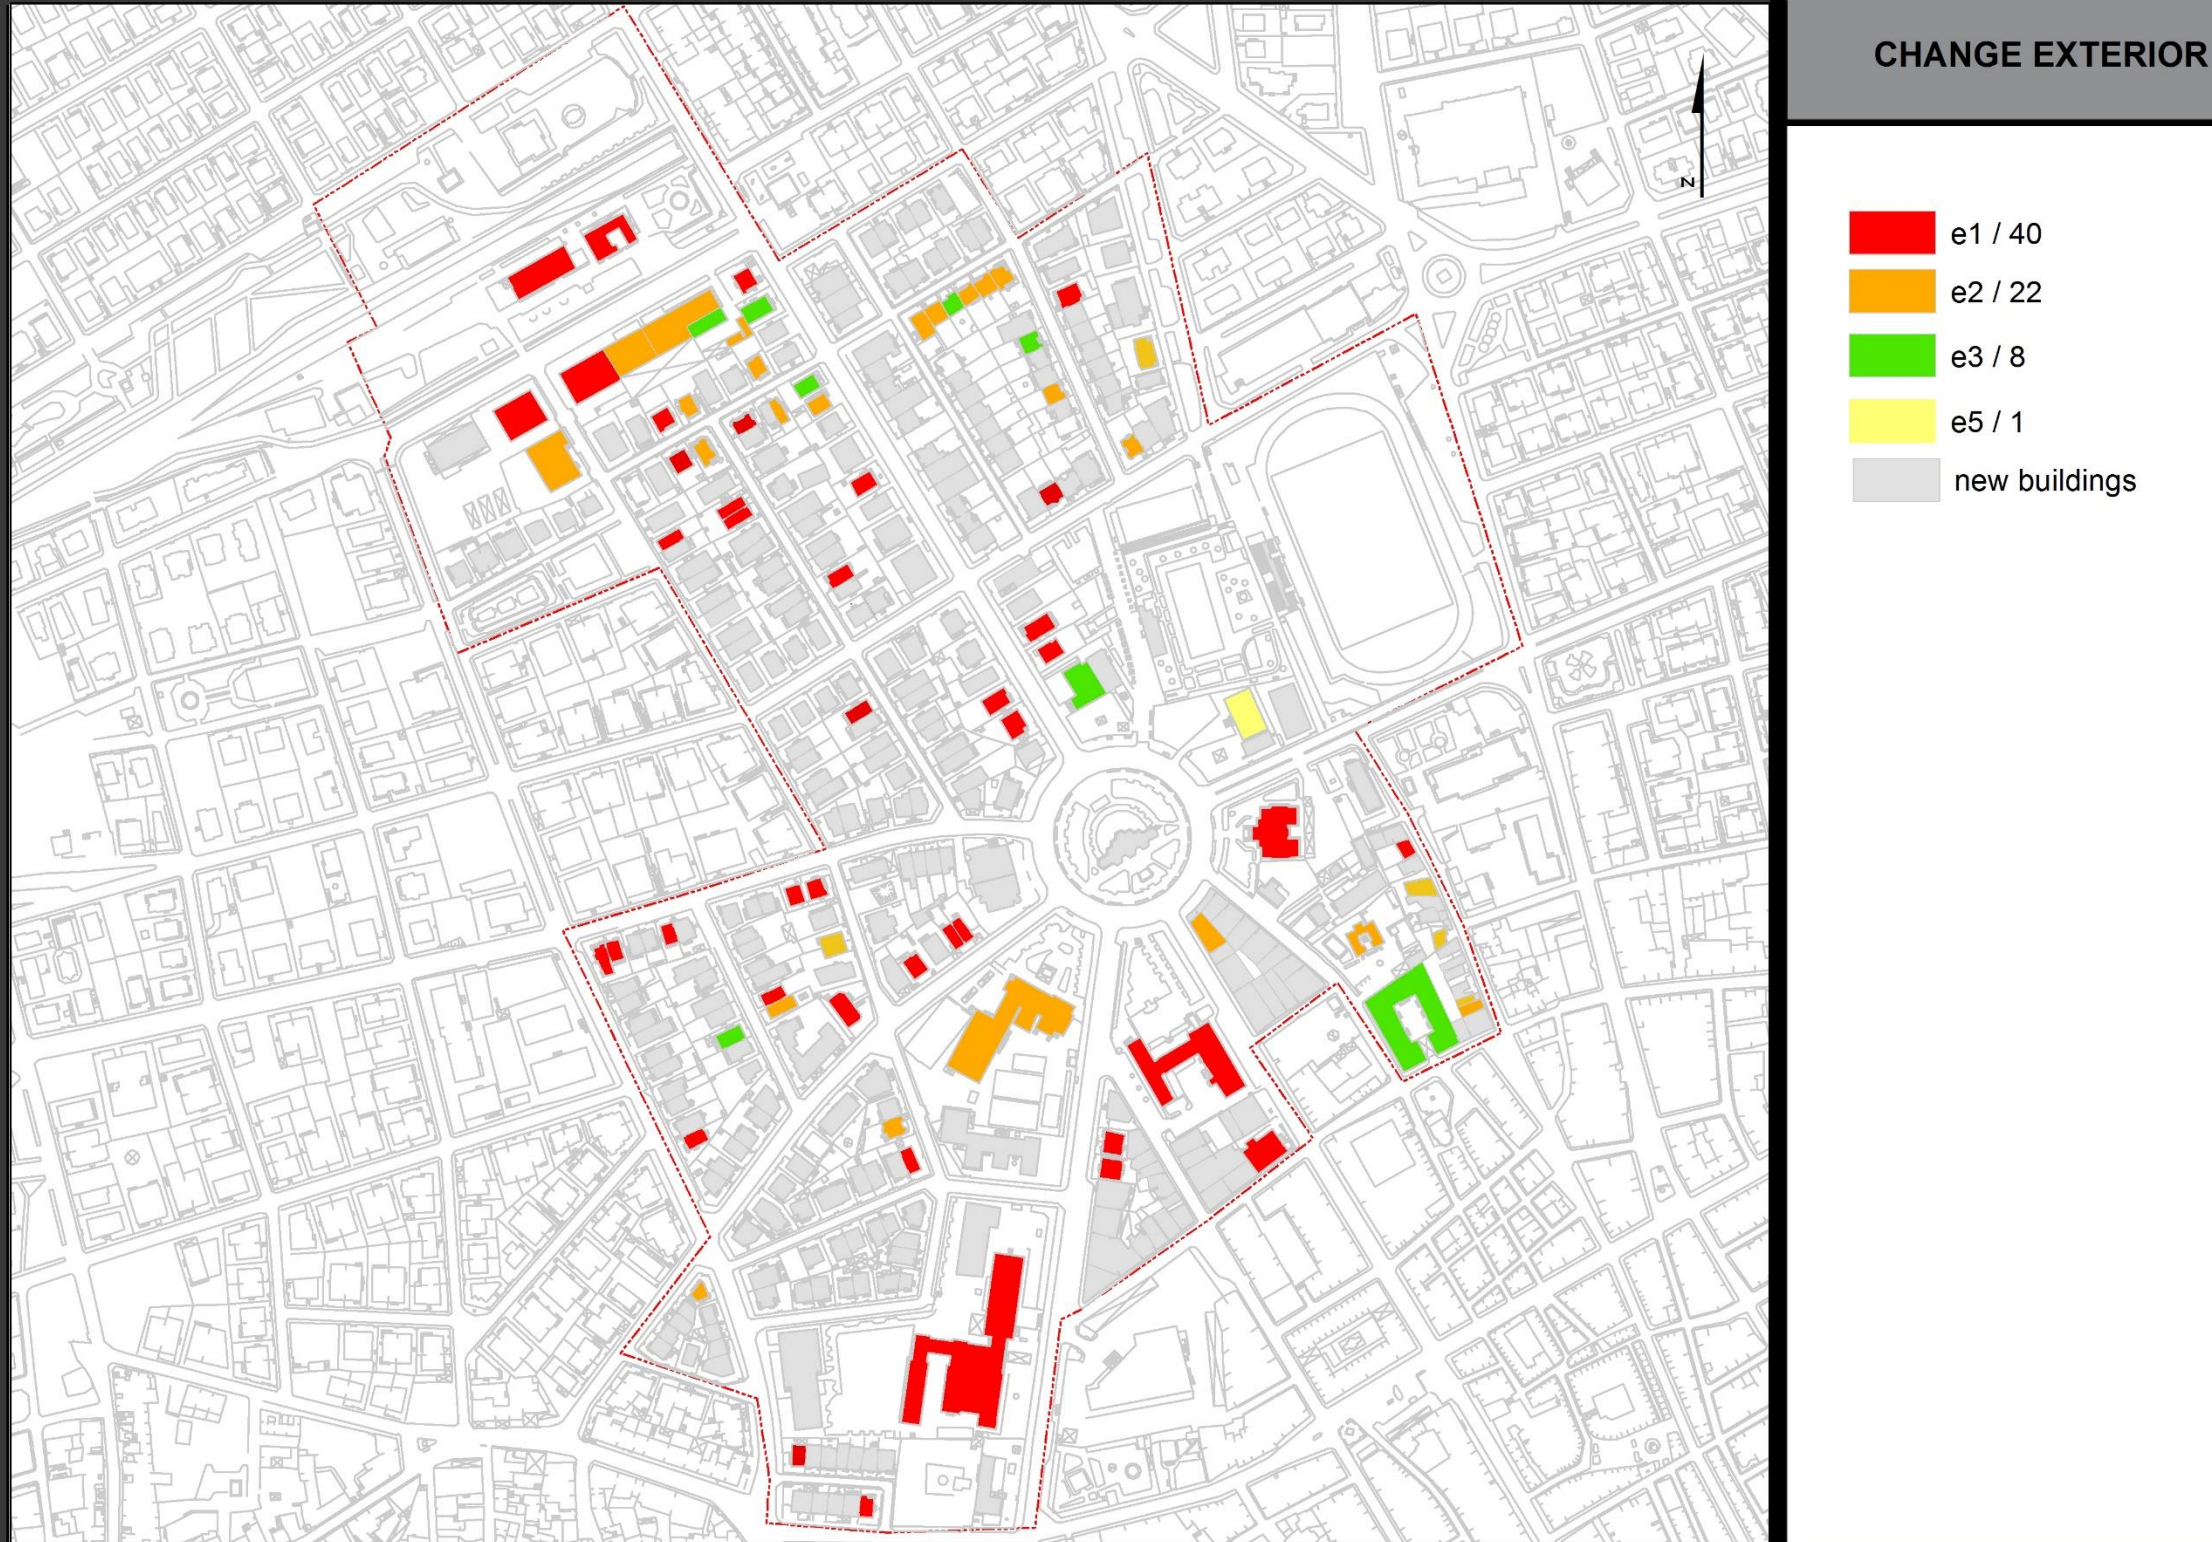
Figure A. 5 . Exterior change of the buildings

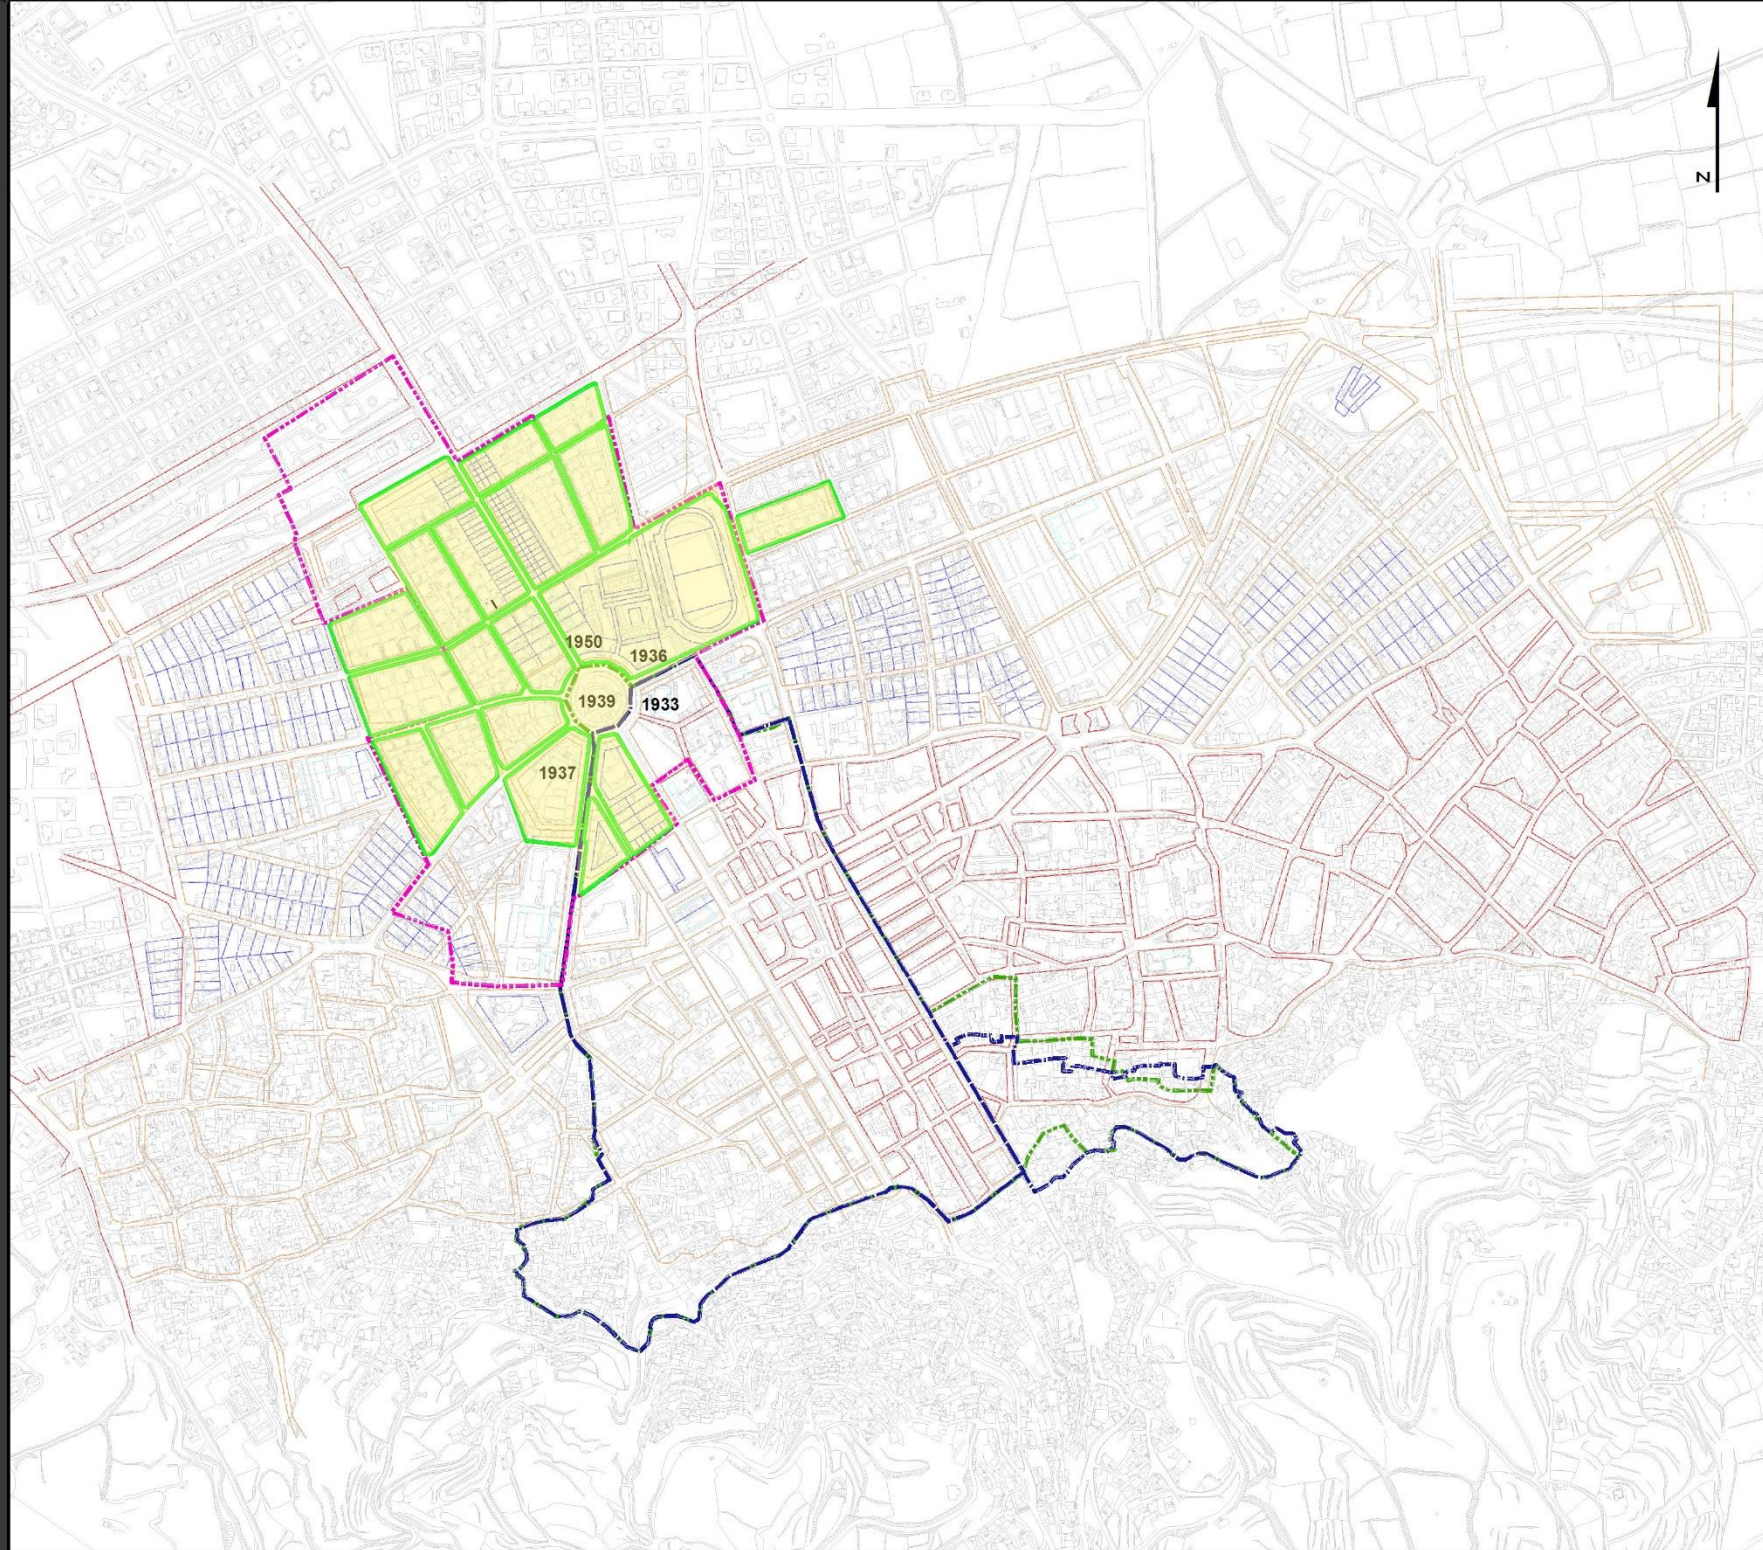
Figure A. 6 . Overlapping existing plan and existing situation

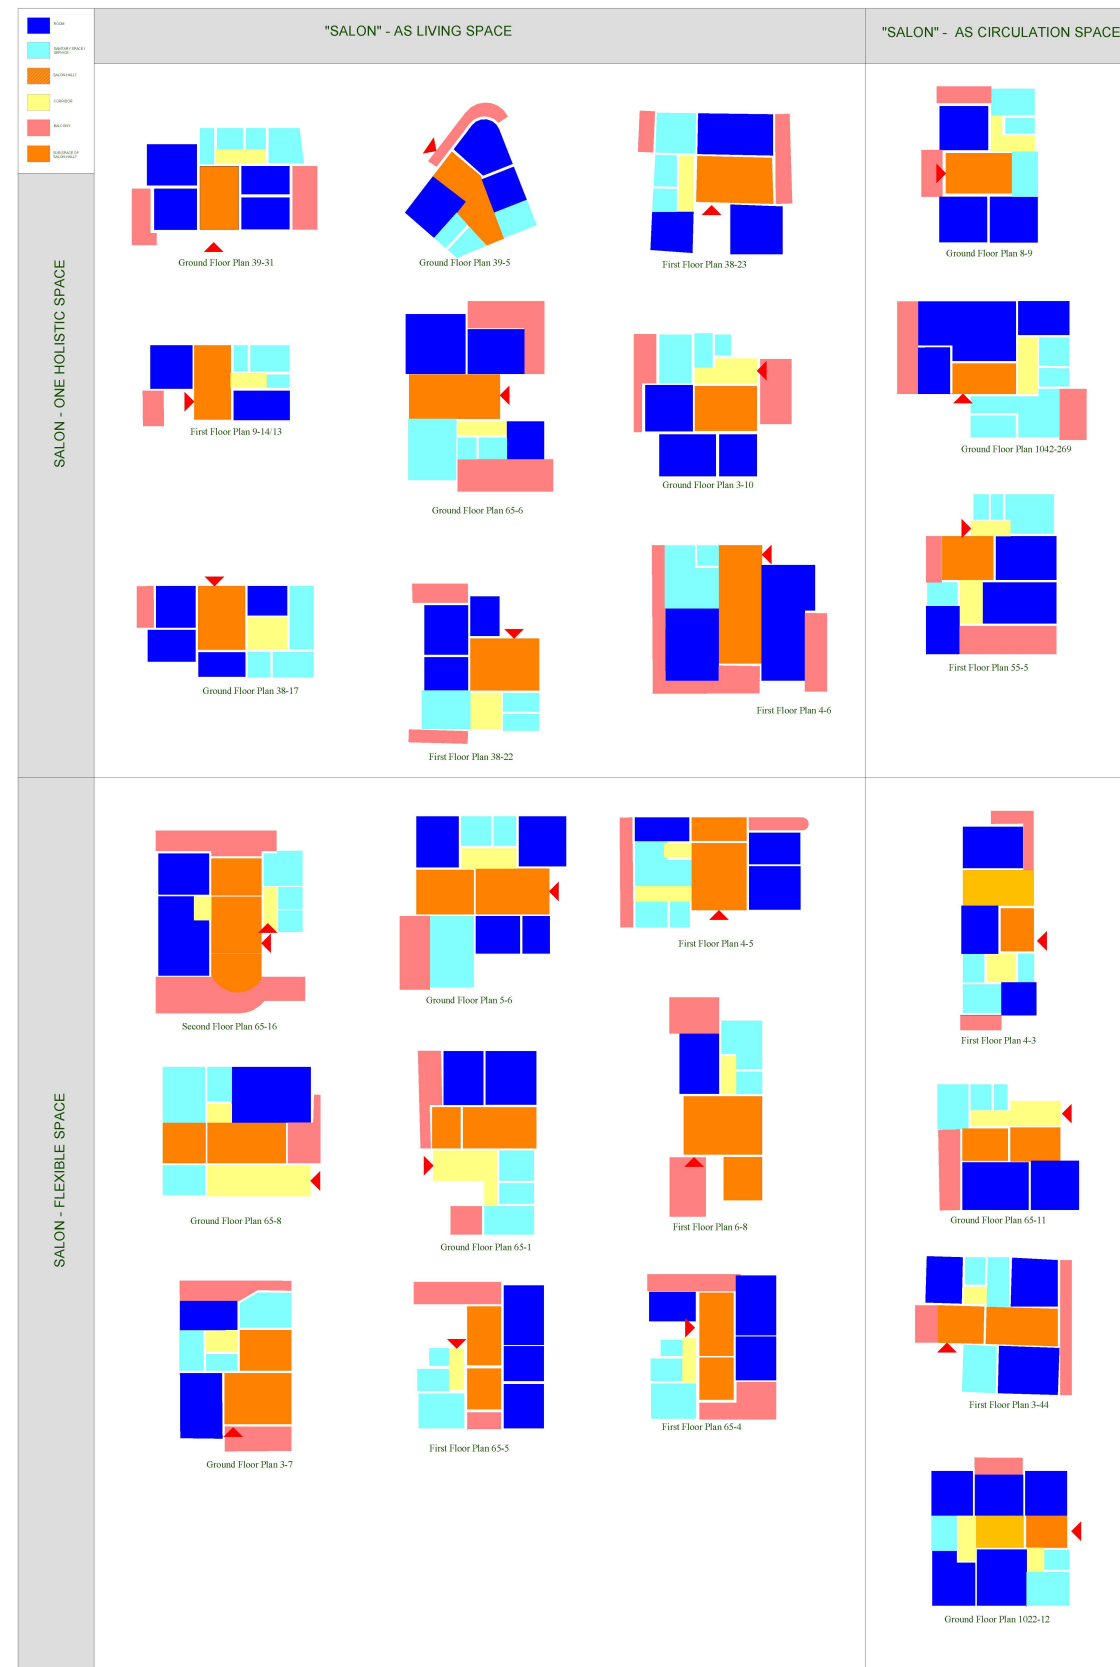
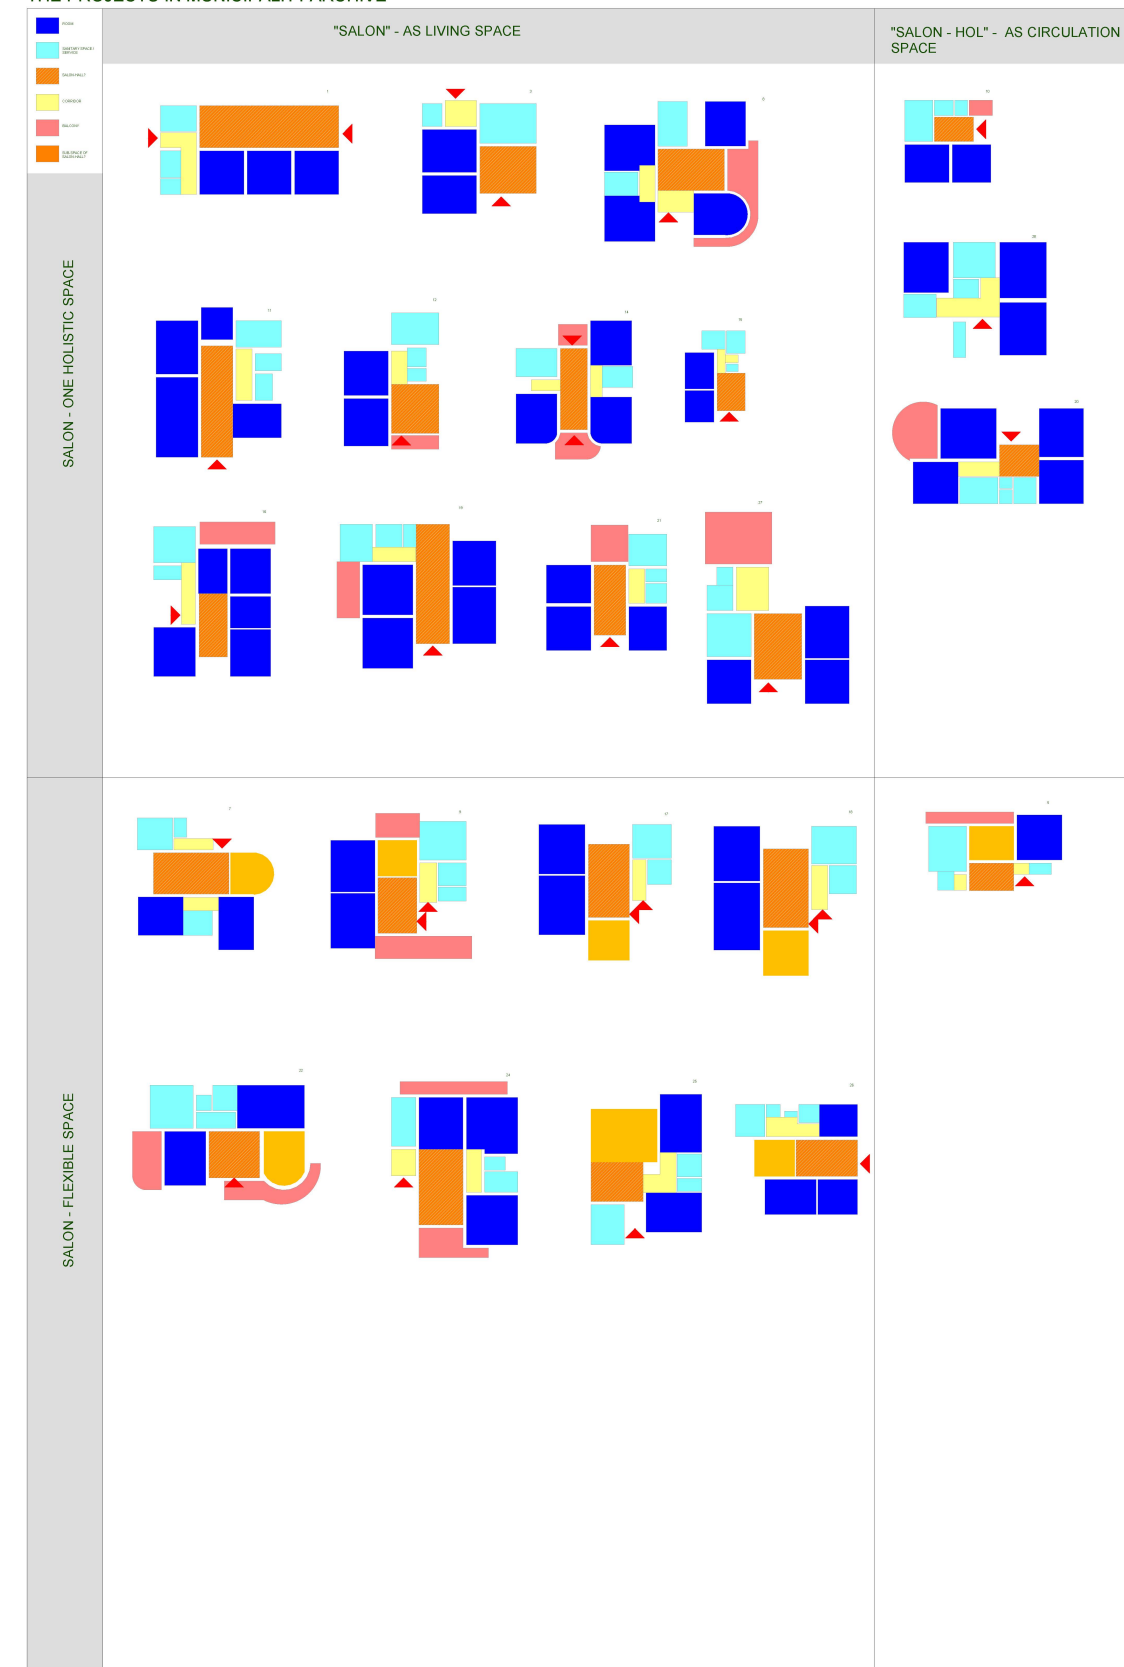
Figure B. 2. Analysis of the residential buildings in terms of spatial organization

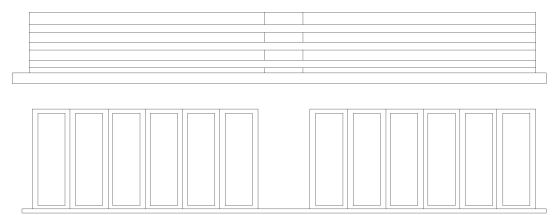
**Figure B. 3.** Window Analysis and Floor Covering

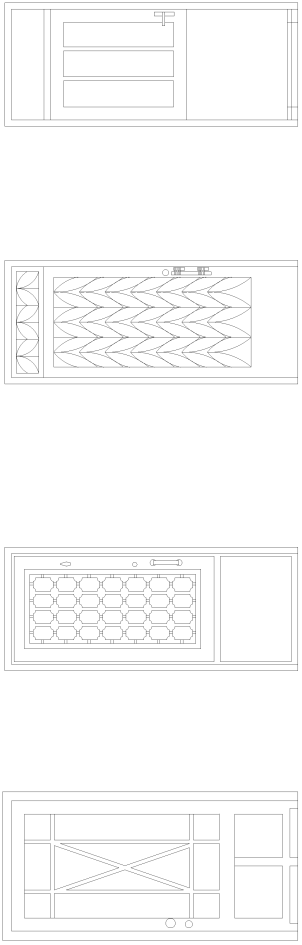
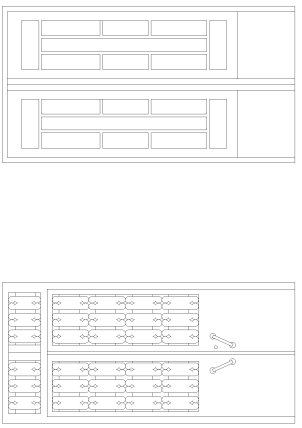
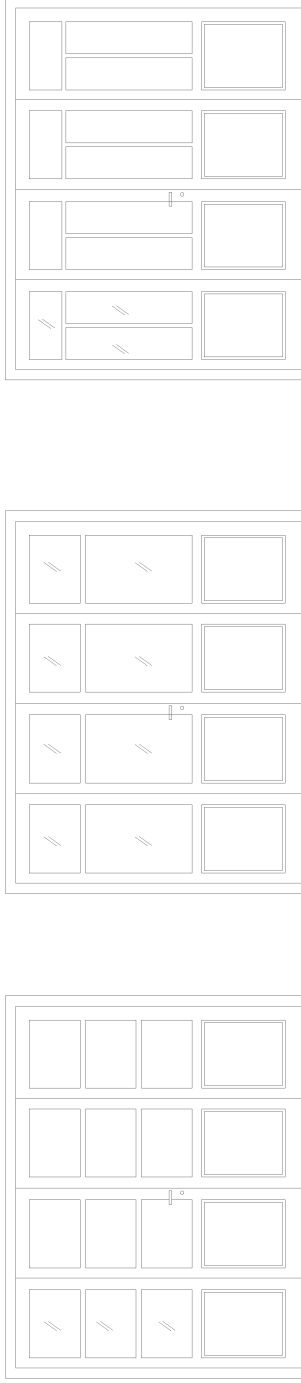
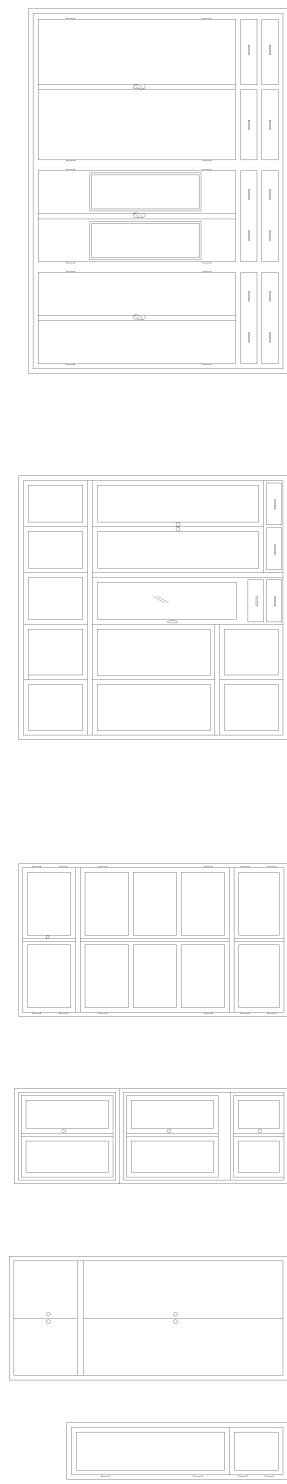
**Figure B. 4.** Door Analysis and Cabinet-Shelf Analysis

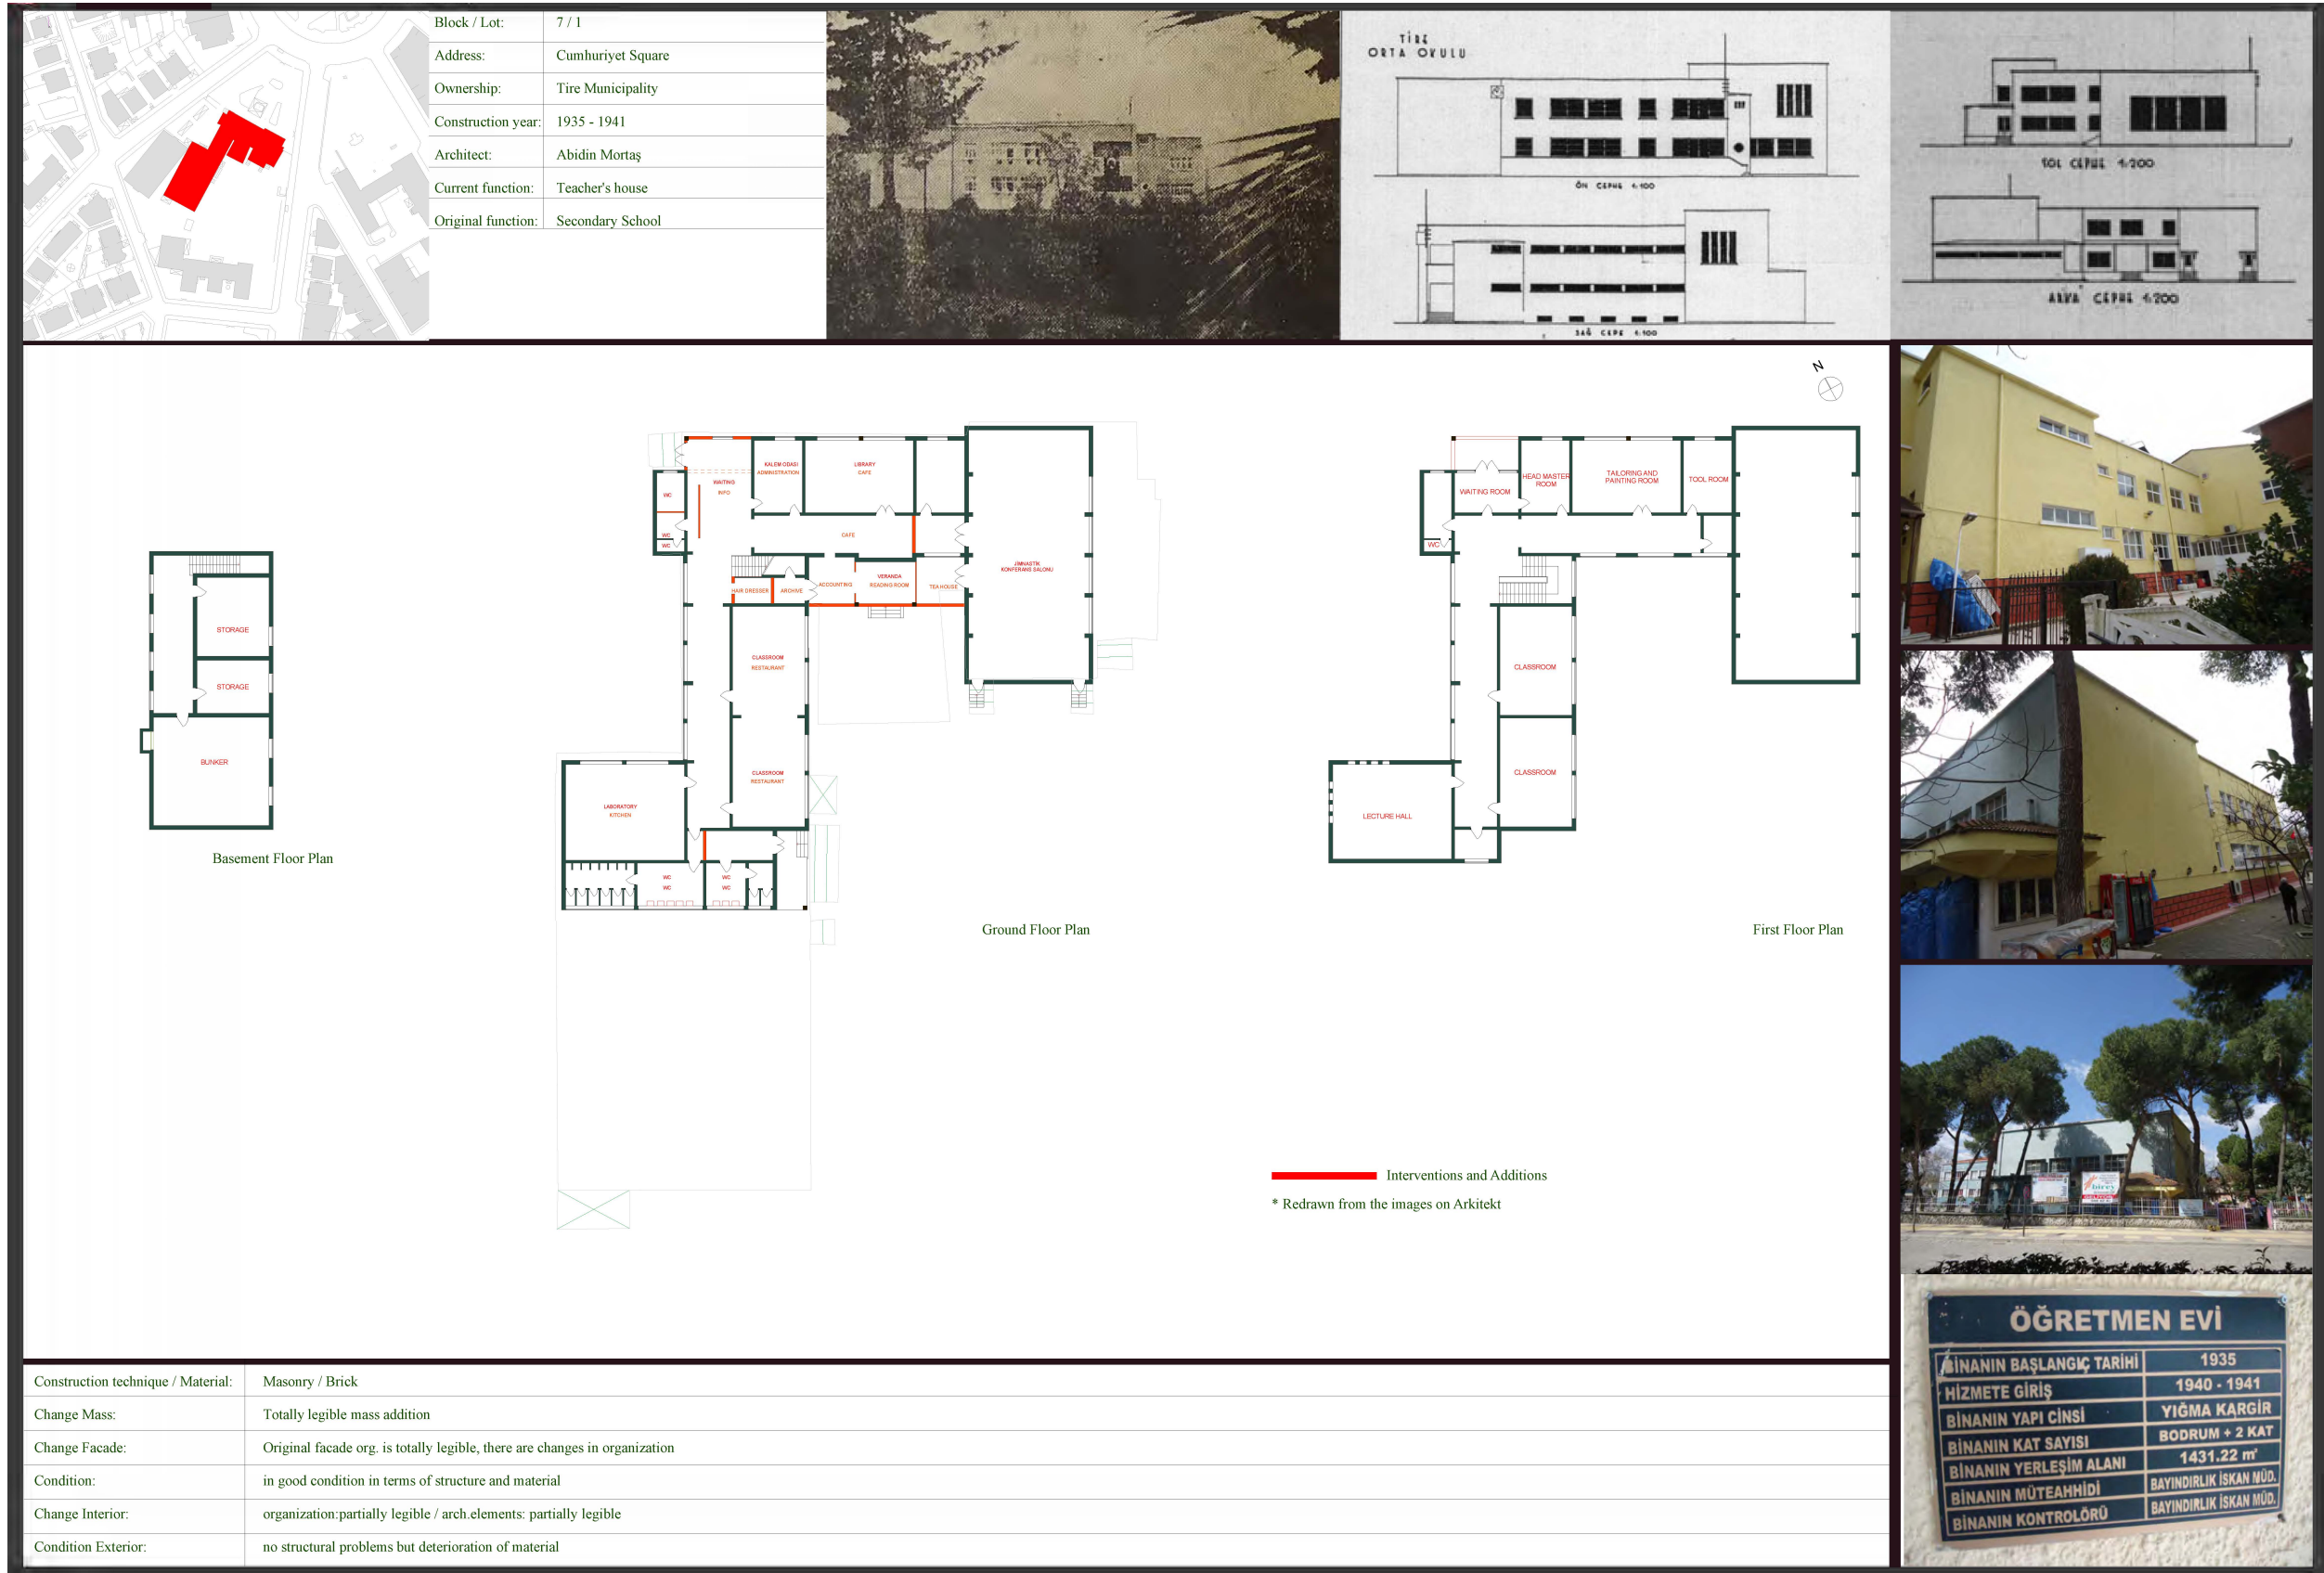
Figure B. 7. Building Sheet-3

Block / Lot:	55 / 8	 
Ownership:	PTT	
Current function:	Post office

Construction technique / Material:	Reinforced concrete	
Change Mass:	Partially legible mass addition	
Change Facade:	Original facade organization is partially legible, whereas there are changes in organization, architectural elements and finishing.	
Change Interior:	totally illegible	
Condition:	in good condition in terms of structure and material	
Block / Lot:	55 / 3	 
Ownership:	Ege University	
Alteration year:	1997	
Current function:	Tire Kutsan Vacation School	
Original function:	Tekel Tobacco Depot

Construction technique / Material:	Masonry	
Change Mass:	Original mass proportion and org. totally illegible.	
Change Facade:	Original facade organization is totally illegible.	
Change Interior:	organization: totally illegible	
Condition:	in good condition in terms of structure and material

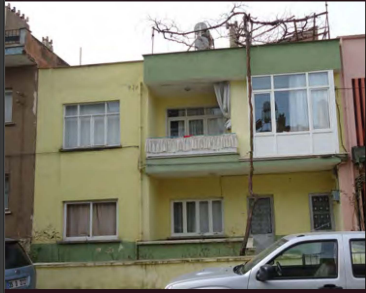
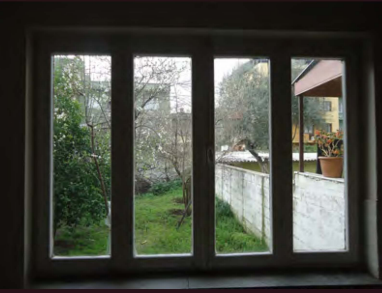
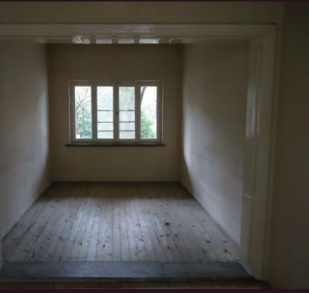
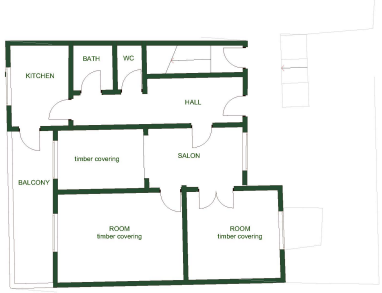
**Figure B. 21. Building Sheet -18**

Address:		
Ownership:	Private	
Construction year:	1960 (oral source)	
Architect:	-	
Current function:	Residential

<p style="text-align: center;">Ground Floor Plan</p>

Construction technique / Material:	Reinforced concrete	
Change Mass:	Totally legible mass addition	
Change Facade:	Original facade organization is partial legible, there are changes in organization and arch.l elements	
Change Interior:	organization: conserved / arch.elements: partially legible	
Condition:	no structural problems but deterioration of material	
Social Survey:	owner (Nafize Duman)

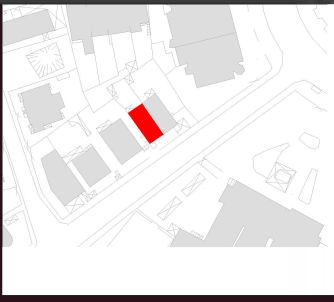
**Figure B. 31. Building Sheet-28**

Address:		
Ownership:	Private	
Construction year:	-	
Architect:	-	
Current function:	Residential	
Type:	Semi-detached house

<p style="text-align: right;">First Floor Plan</p>		
Construction technique / Material:	Masonry + reinforced concrete slabs / Brick	
Change Mass:	Original mass proportion and org. are conserved.	
Change Facade:	Original facade organization is conserved, minor changes in finishing.	
Change Interior: organization:	Conserved / arch.elements: conserved	
Condition:	no structural problems deterioration of material	
Social Survey:	tenant

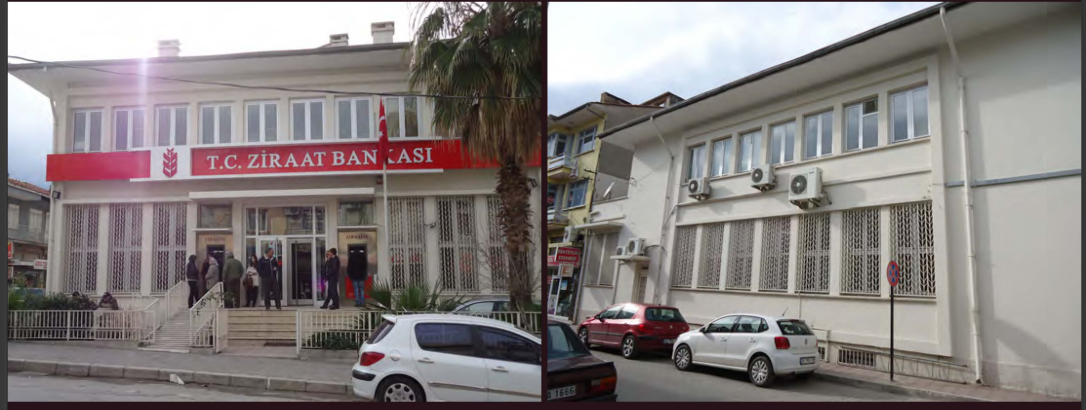
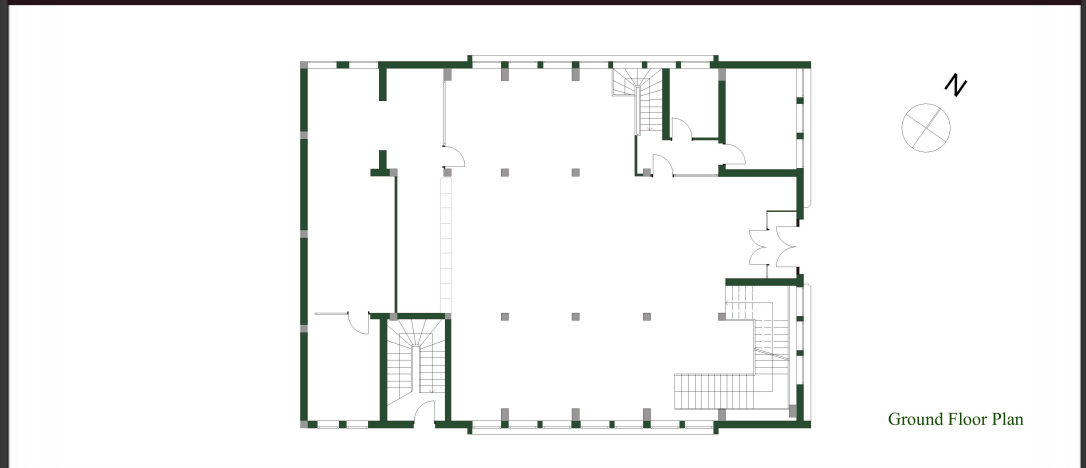
Block / Lot:	70 / 3	 
Address:	Atatürk Cad.	
Ownership:	Ziraat Bank	
Construction year:	1954	
Architect:	-	
Current function:	Ziraat Bank	
Registration Status:	Registered

Construction technique / Material:	reinforced concrete
Change Mass:	Original mass proportion and org. are conserved.
Change Facade:	Original facade organization is conserved, minor changes in finishing.
Change Interior:	Partially legible
Condition:	in good condition in terms of structure and material
Social Survey:	owner
