CONSERVATION OF A MODERN HERITAGE PLACE:  
“ÇARŞI” – THE COMMERCIAL CORE OF  
MIDDLE EAST TECHNICAL UNIVERSITY (METU)

A THESIS SUBMITTED TO  
THE GRADUATE SCHOOL OF NATURAL AND APPLIED SCIENCES  
OF  
MIDDLE EAST TECHNICAL UNIVERSITY

JULY 2018

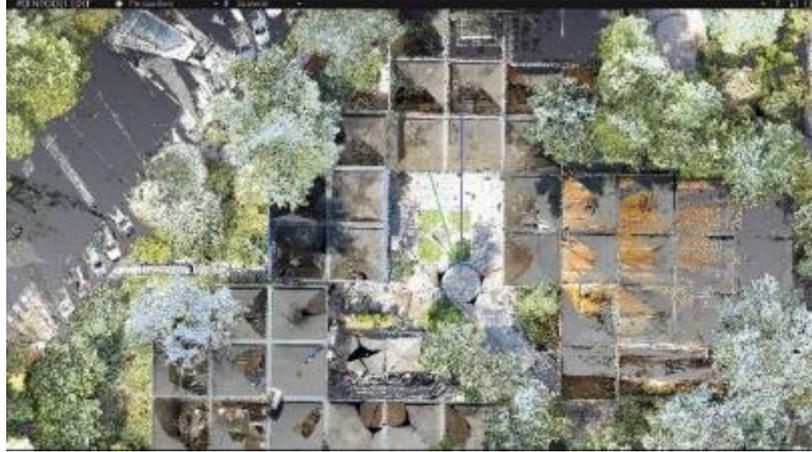
Figure 1-2: Point cloud of *Çarşı*

In the second stage, which is the site survey, *Çarşı* area was measured using a 3D terrestrial laser scanner and a Digital SLR camera integrated with the laser scanner for identifying the visual surroundings. The laser scanner was set at 89 different points. In addition to this documentation, the photographic documentation of the area was produced in detail. Areas which could not be captured using the laser scanner were completed by using traditional methods. After completing documentation of the open areas and facades of the buildings, one of the buildings was selected for more detailed study. The Block D, which is a café, was studied in detail for the following reasons: preserving spatial features in general, being able to take permission from the tenant, not being over occupied by furniture unlike the other buildings.

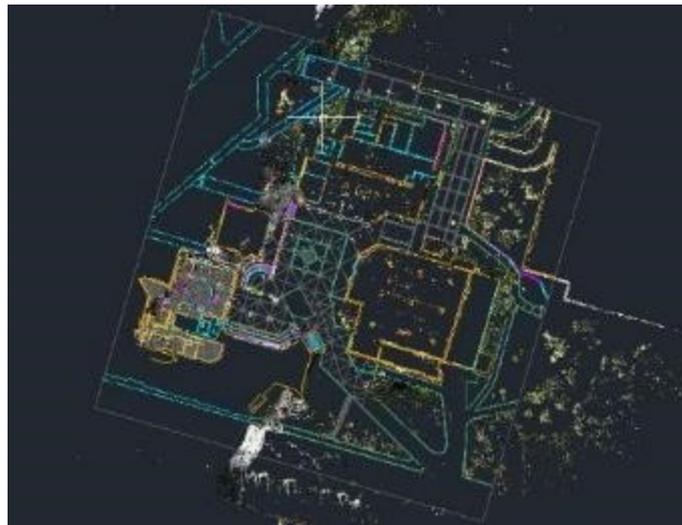
Figure 1-3: A drawing view on AutoCAD Software by using Point Cloud

As the third stage (processing), a 3D colorful point cloud model was constituted by matching the point cloud obtained as the result of measurement by 3D terrestrial laser scanner with photographs taken by the Digital SLR camera integrated with the laser scanner. The model consisted of 606,175,786 colored points (See Figure 1-2). By using this model, measured drawings consisting the of site plan, site sections, silhouettes, the plans of the Block D with the estimated plans of the other buildings and the sections of the Block D were constituted with the help of AutoCAD 2012 and the Pointools software (See Figure 1-3).

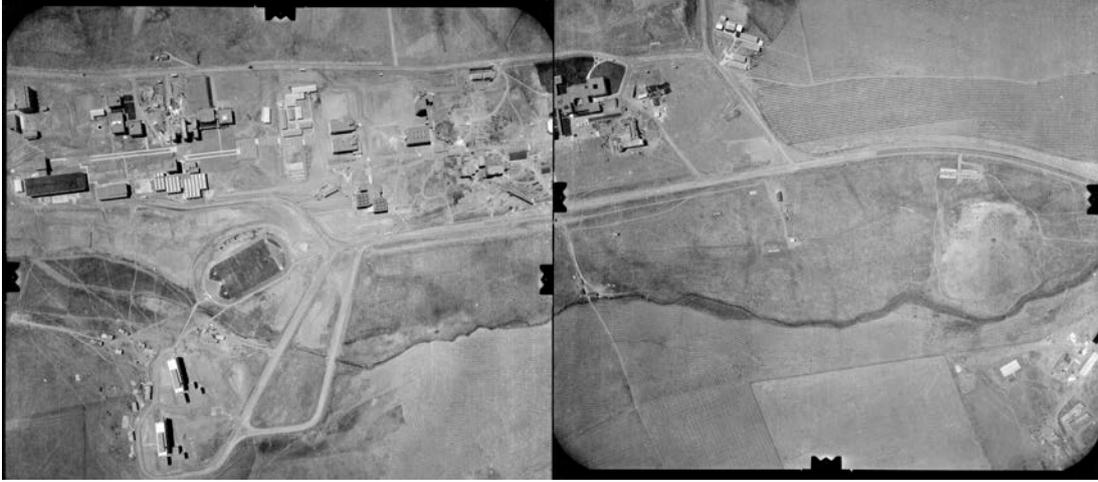
Figure 3-3: Aerial photo of METU, 1963  
Source: General Command of Mapping (*Harita Genel Komutanlığı*)

Construction of METU was started in 1962 with the building of Architecture. About 7 months later, on October 1963, the building was finished, and the new campus began

to be used during the new academic year. Thereafter, construction of the campus proceeded as planned (Kurdaş, 2004).

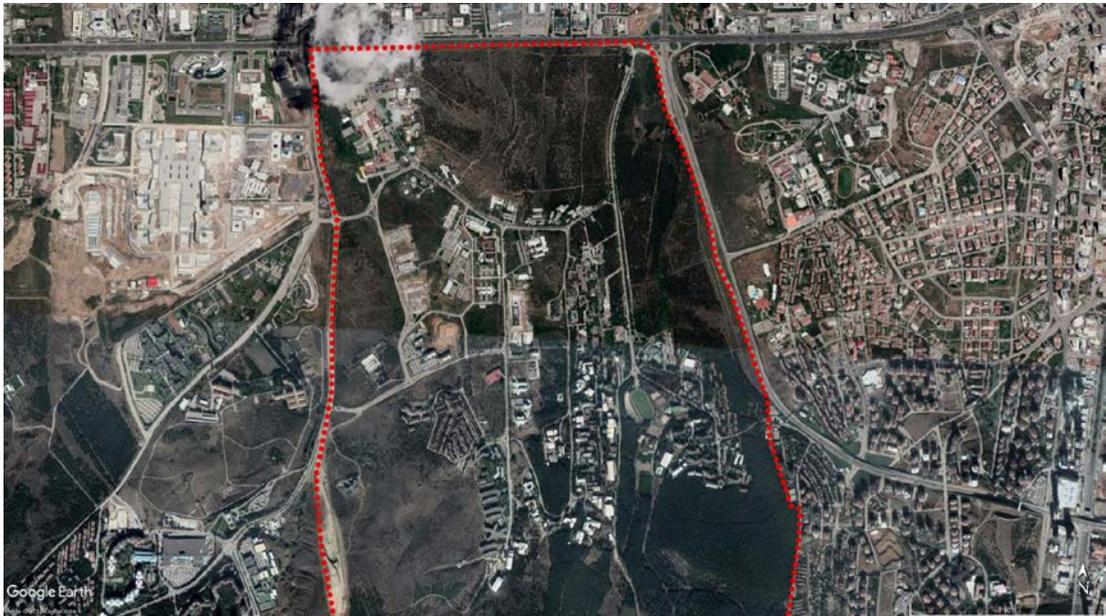
Figure 3-4: Aerial photo of METU, 2018  
Source: Google Earth, picture date 11.03.2017, colored by author

Today, the campus consists of nine districts. These include academic areas, dormitories, housings, sport fields, cultural and commercial areas, service buildings (such as technical guides related to Presidency), ODTÜ Teknopolis (*Teknokent*), ODTÜ Koleji and ODTÜ Forest (Akman, 2016).

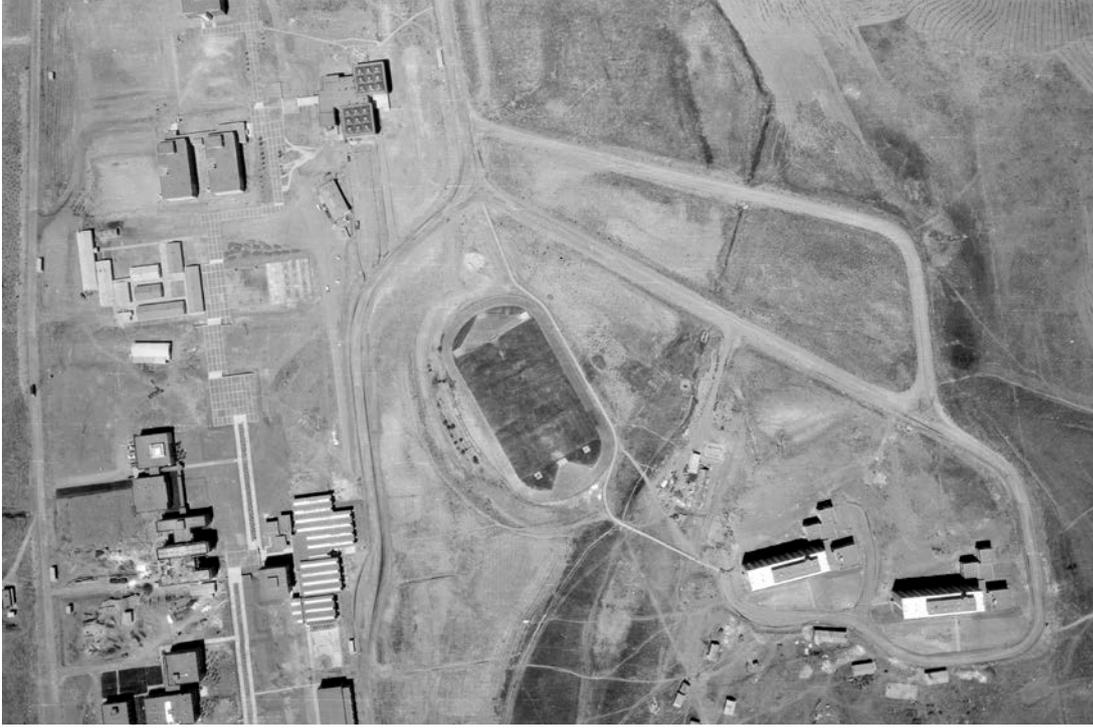
Figure 3-8: Aerial photo, 1963

In the aerial photo of 1963, it can be seen that construction works of two dormitories, Dormitory-1 and Dormitory-2, had started. The construction works of the cafeteria and stadium had also started as a part of center zone. Main roads were shaped. However, there was no work done on the *Çarşı*. Moreover, the construction work of the gymnasium and the faculty housings was not started. Additionally, the river passing through the triangle area reserved for *Çarşı* can be seen on this aerial photo. (See Figure 3-8)

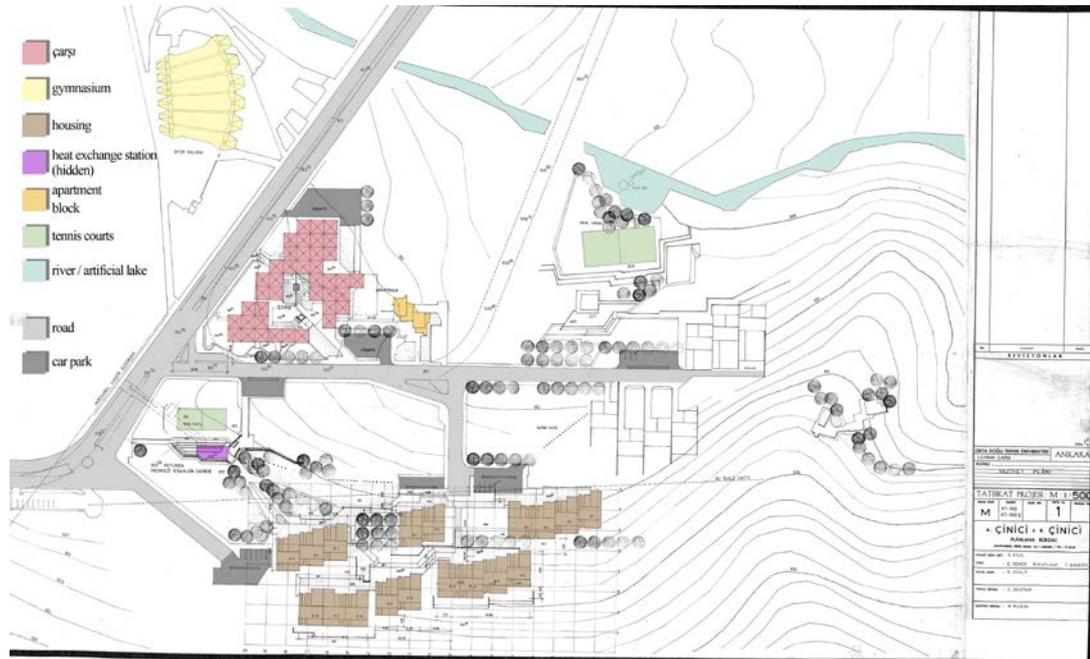
Figure 3-9: Site plan of the area

The construction project of the *Çarşı* was approved in 1968. The nearby environment presents commercial, accommodation, sport and recreation facilities together. When the site plan prepared in 1968 is compared with the competition plan, it can be seen that there is an artificial lake in the direction of the river on the west of the area. Moreover, on the north side of the area, a tennis court is seen in place of housings. There is also an apartment block for single academicians just near the *Çarşı*. On the east of the site, there are faculty housings as well as on the competition drawing. Furthermore there is a tennis court and a hidden heat exchange station under the bleacher of the court. The primary and secondary schools are not seen behind the faculty housings any more on the construction project dated 1968. On the south side of the area, there is a gymnasium as well as on the competition drawing. (See Figure 3-9)

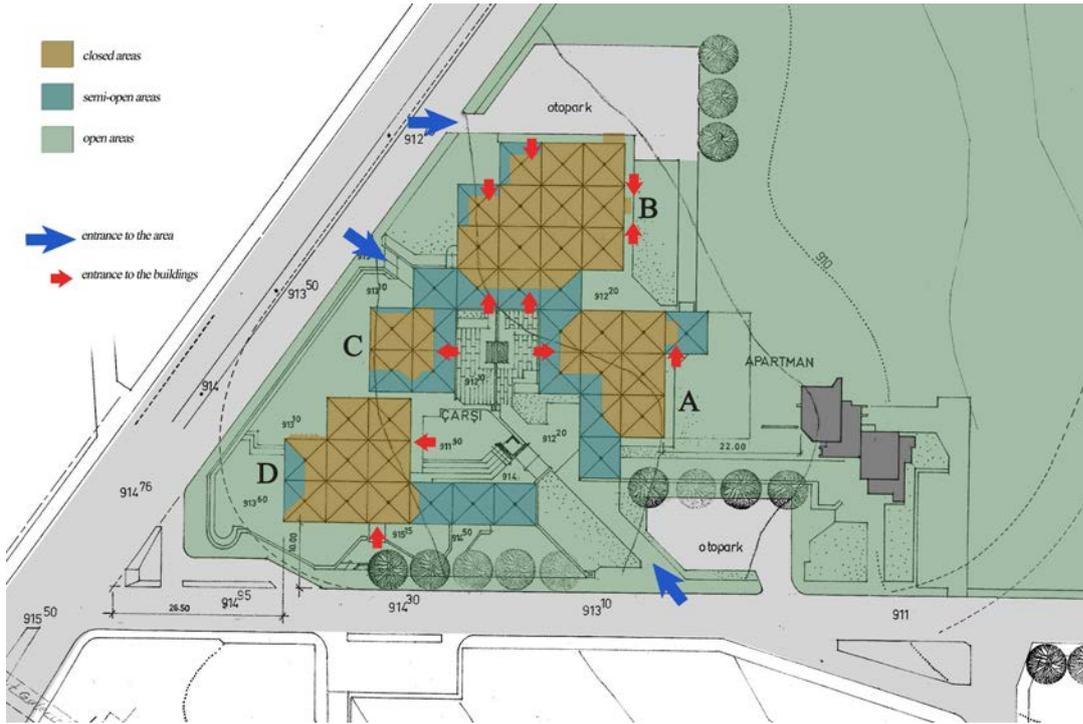
Figure 3-10: Close site plan of the area

According to the project, topography and the buildings are well-integrated. While the discotheque building is two stories and lies on the topography, the other buildings are one story. When the masses come together, they are creating some semi-open areas that enrich the spatial variety. There is a square in the middle of the area, and the semi-open areas are also feeding it. The buildings have entrances from the square. The West and north side of Blocks A and B have also entrances. The reason for this is not just diversity of functions, but also that these sides are *Çarşı* development areas. (See Figure 3-10)

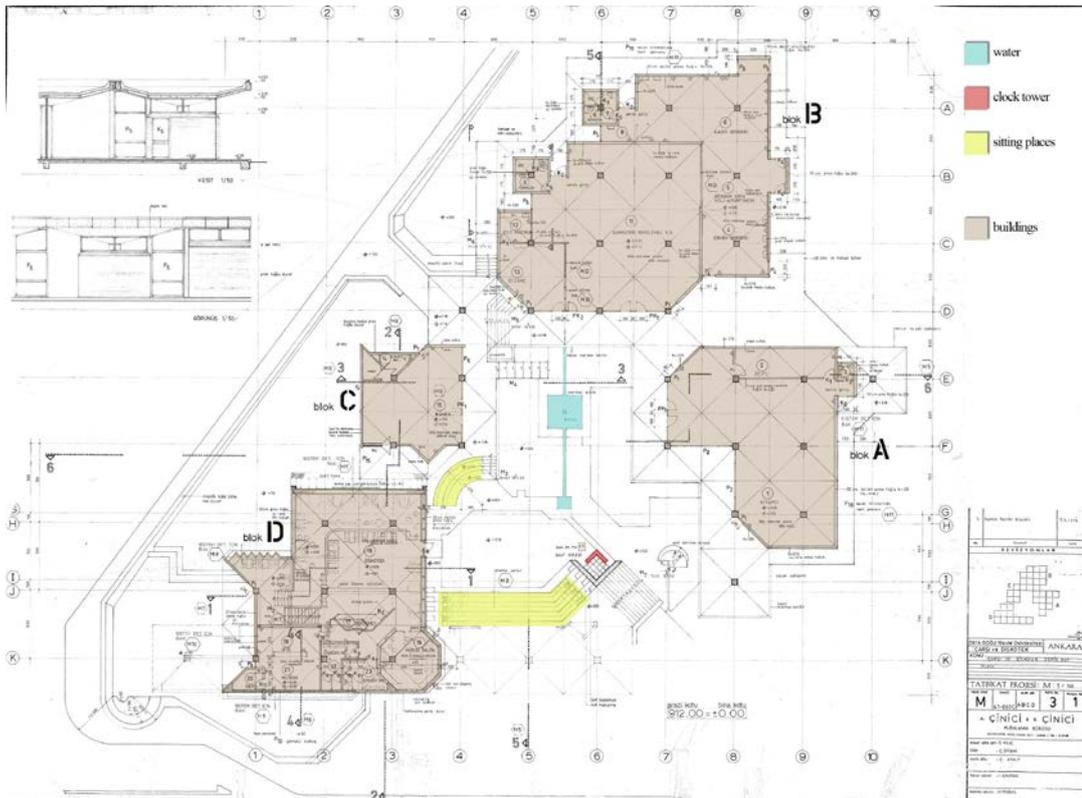
Figure 3-11: Ground floor plan

There are two sitting places formed by the auditorium around the square. One of them is on the north side of the discotheque and has four rows. It is linearly formed. One can reach the platform in front of the north entrance of the discotheque on the upper floor by the stairs near this auditorium. The other sitting place is located on the corner between the discotheque and the bank and has two rows. This one is curved and reaches to the platform in front of the bank (See Figure 3-11).

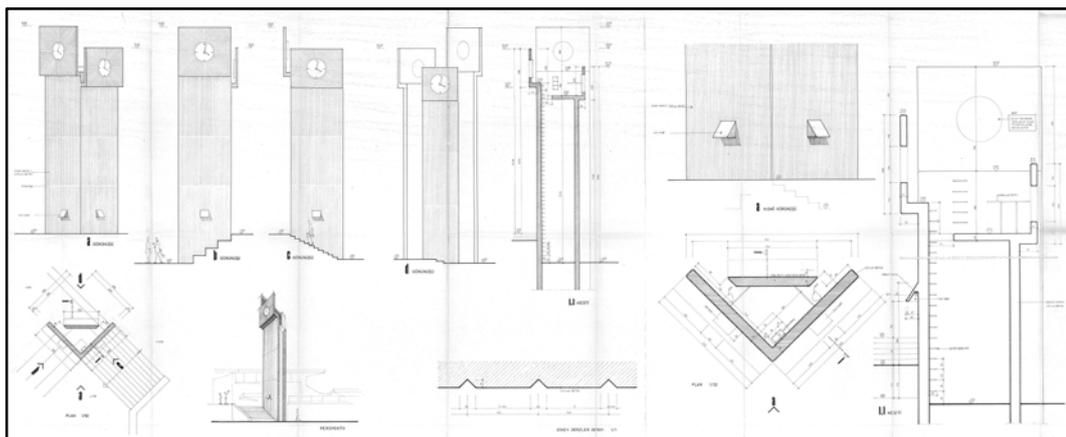
Figure 3-12: Clock tower on project

According to the project, a clock tower contributing vertically to the area is located on the east of the square (See Figure 3-12).

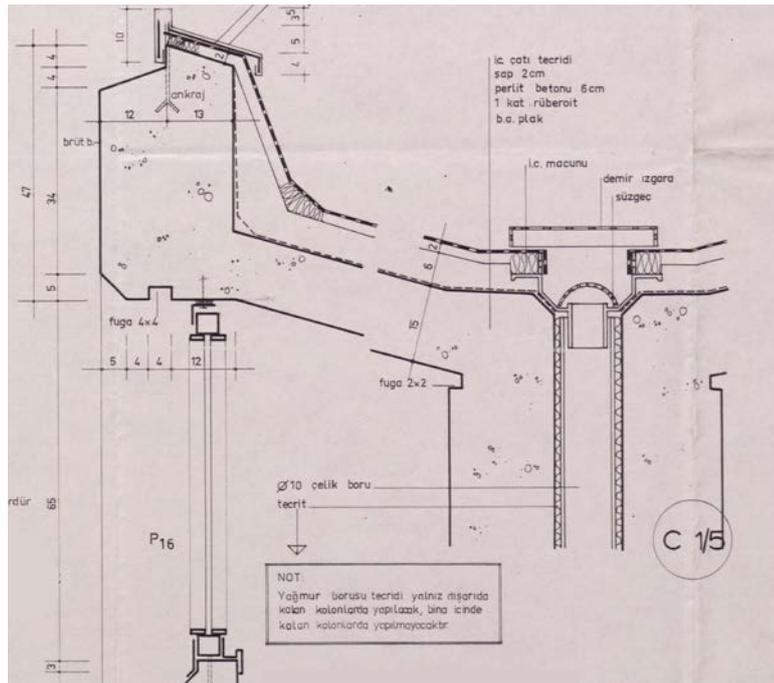
Figure 3-13: Detail of the top of mushroom columns

One of the basic principles of the design of the *Çarşı* buildings is creating distinguishable structures. The construction system and materials used there can be defined at a first glance. In the *Çarşı* project, a mushroom slab construction system was applied. This was the first construction built with this system in the country. Therefore, METU campus was the pioneer of this construction type in Turkey as many others. By means of a mushroom slab system, semi-open areas could be achieved in compatibility with closed areas. Rain water drainage could also be solved invisibly, and there was more freedom obtained in terms of creating space (See Figure 3-13) Moreover, the mushroom slab system can be enlarged through the addition of new mushroom units. Considering that the *Çarşı* would need to be enlarged in following years due to the increasing on the number of habitants on campus, using this system in there was logical.

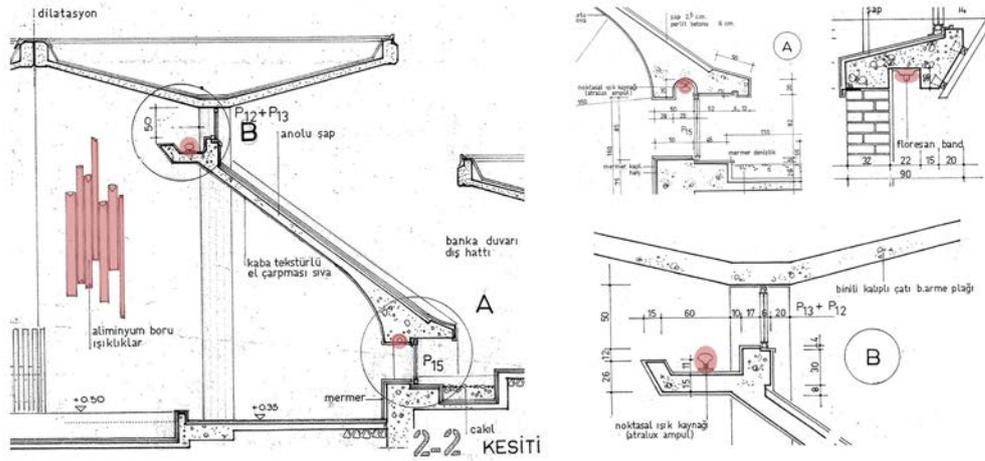
Figure 3-14: Lightning fixtures

Fourthly, the function of the D block is the discotheque. This block has two stories, seven spaces, and about 620 m<sup>2</sup> of area in total. On the ground floor there are five spaces. These are the discotheque continuing the upper entrance floor, private lounge, WC, offices and storage. The ground is covered with marble anchor cast mosaic and the walls are both naked brick and plastered. On the upper entrance floor, there are two spaces: a bar and storage. Moreover, there is a *şahniş* on the south side of the upper floor. The ground of them is covered with marble anchor cast mosaic and the walls are plastered. The material used on the stairs is precast artificial stone. The lighting fixtures are also designed on the project (See Figure 3-14).

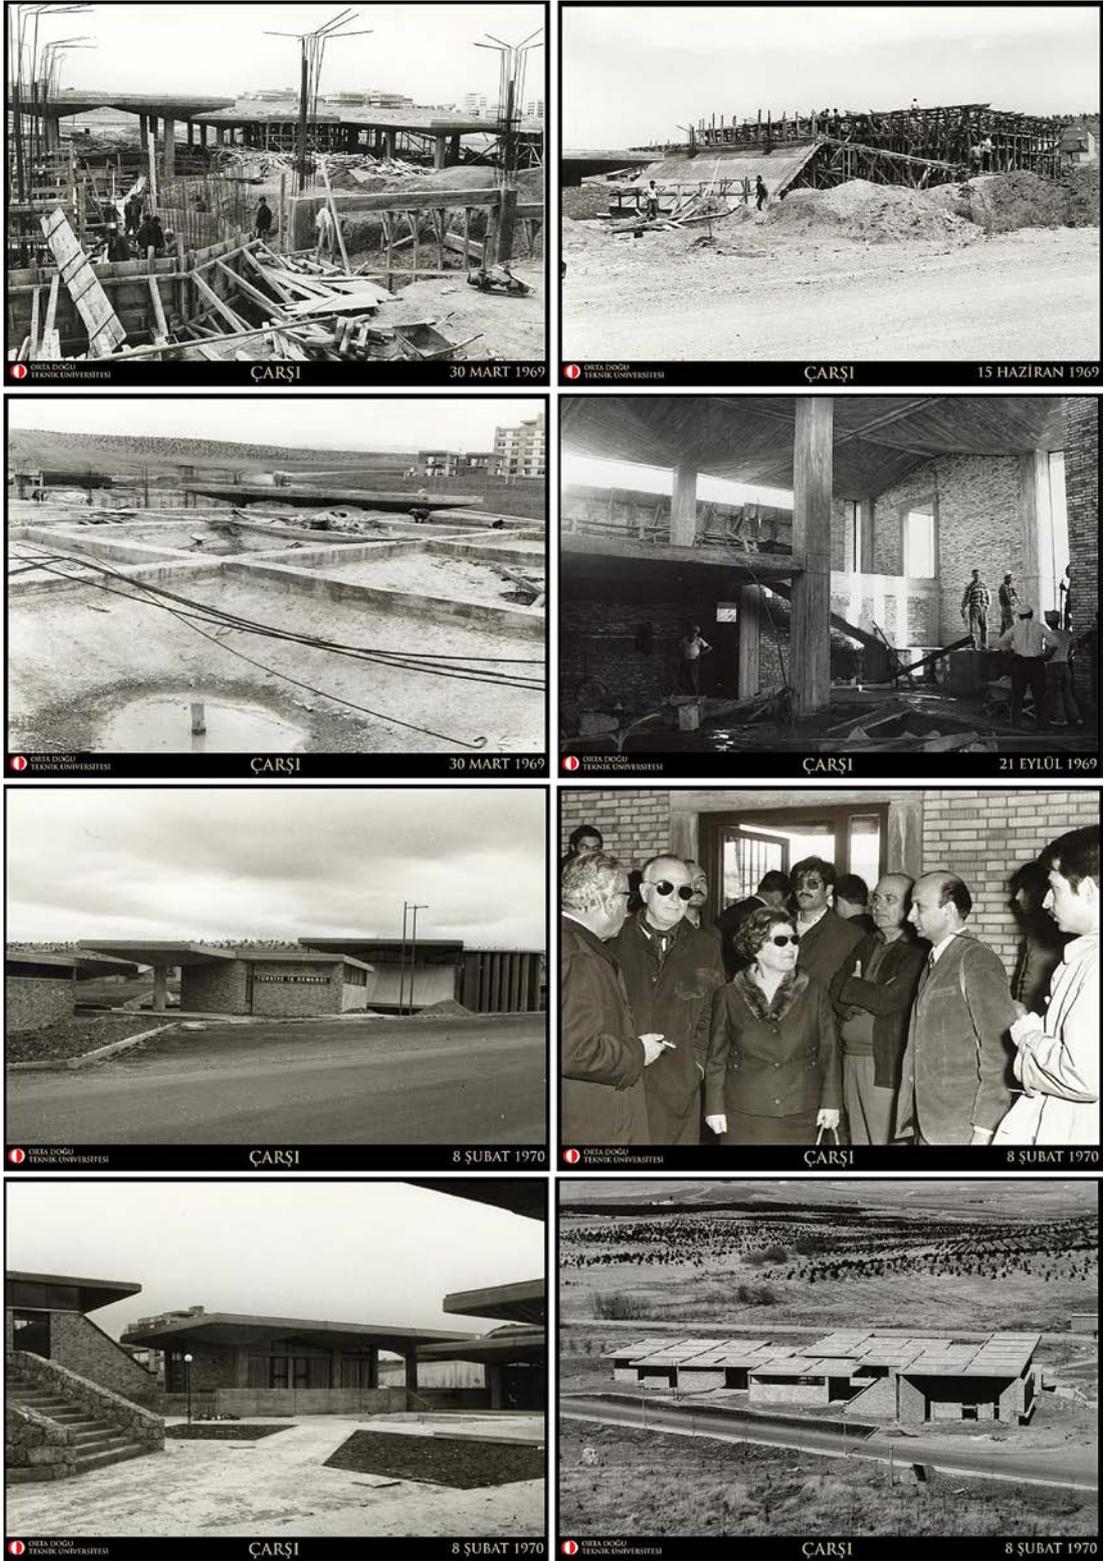
Figure 3-15: Construction photographs

According to another report prepared on June 11, 1969, architects thought that the workers were not qualified. Thus the construction was left unattended. Bituminous isolation was applied incorrectly and it needs to be replaced.

In the report written on July 31, 1969; architects said that the courtyard wall in front of the bank was out of order and could be corrected by using bentonite. The brick works of the discotheque were going poorly. In addition to that, there was a 7 cm mistake on the details of the iron doors of the other buildings.

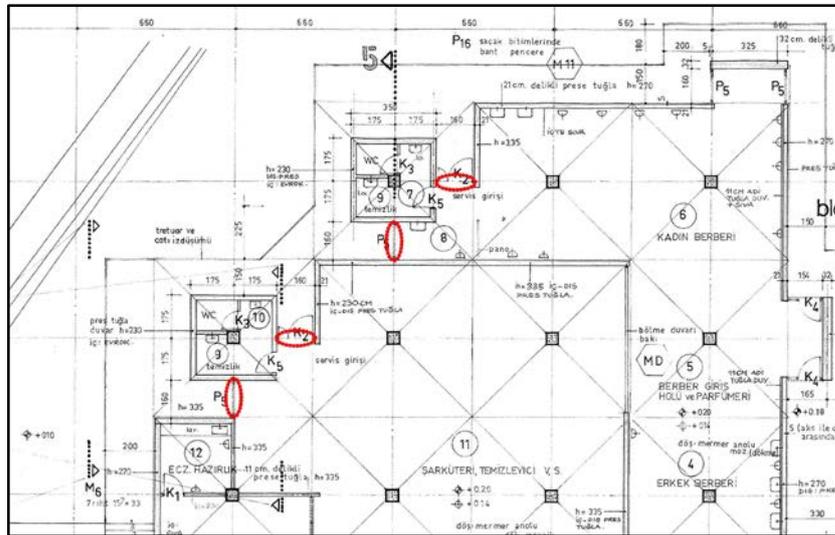
Figure 3-16: Joineries located inside on Block B  
Source: METU Directorate of Construction & Technical Works

Firstly, by placing the joineries inside of the solid area, a solid-void relationship is created on Block B. An indented facade design is observed as a result of this relationship. (See Figure 3-16)

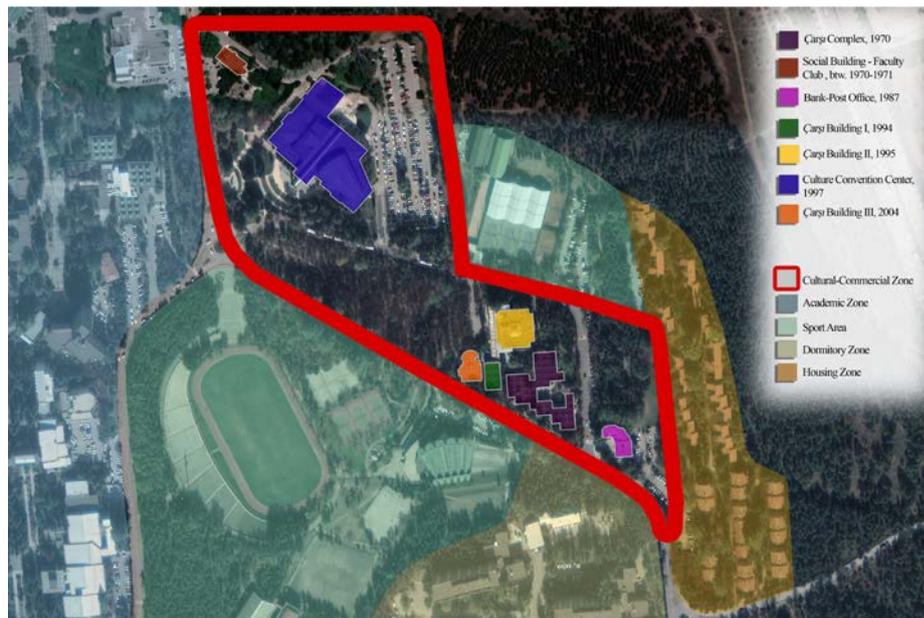
Figure 3-18: Site plan

Today, the commercial center of METU, *Çarşı* complex, is one of the components of the cultural-commercial zone of METU. The cultural-commercial zone is located on the area connecting the academic zone, the central sport center, the central dormitories and the central housings. That zone consists of the original *Çarşı* complex, three additional building around it, the complex between housings and the original *Çarşı* complex (İşbank and Post Office), Culture and Convention Center and the Social Building-Faculty Club. The construction of the *Çarşı* and Social Building-Faculty Club is nearly at the same years; 1970-1971. The complex between the *Çarşı* and housings is constructed in 1987. After that, two additional *Çarşı* buildings are constructed just near the *Çarşı* in 1994-1995. A culture and convention center is constructed on the north side of the cultural and commercial zone of METU. Finally, an additional commercial building is constructed on the west side of the *Çarşı* area. (See Figure 3-18)

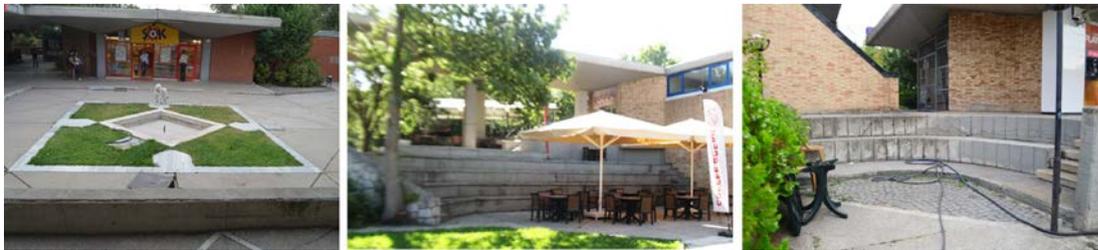
Figure 3-19: Open area elements

There are two auditorium-shaped sitting areas around the square. The smaller one at the corner of the bank is all concrete. The larger one adjacent to the cafe-restaurant is also concrete, but it has an additional metal frame to attach the wooden covering. Around the original *Çarşı* complex, cube stone and cut red andesite are used as ground covering. This covering continues the development areas as well.

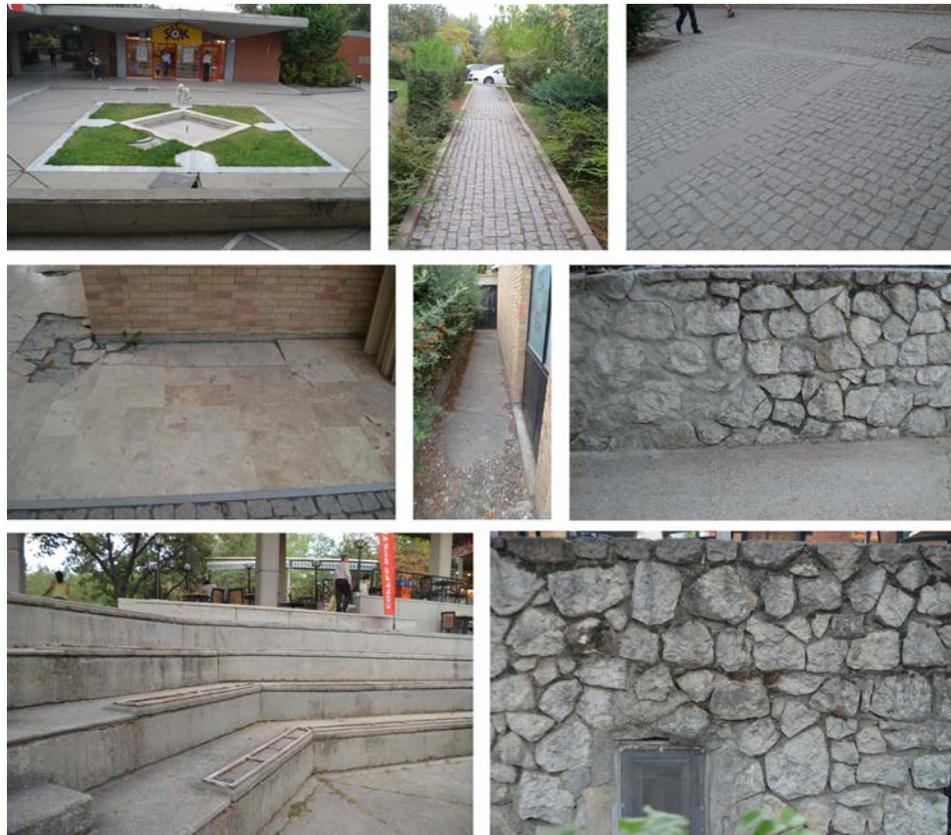
Figure 3-29: Photos of alterations

One of the terraces of the cafe is enlarged. That can be seen not only by comparing the architectural project and the survey drawings, but also observing the trace on the wall elevation. Moreover, there are plenty of metal lighting fixtures and balustrades in that area, and there is no such a detail on the original architectural project of *Çarşı* complex.

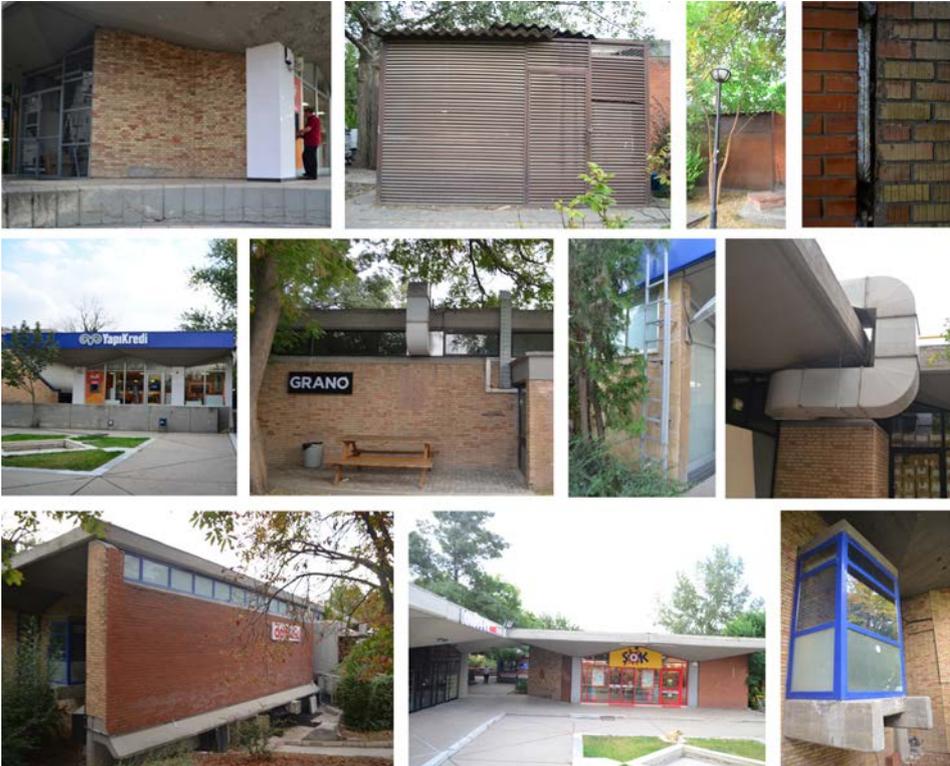
Figure 3-30: Photos of facade alterations

The joineries of the buildings are not iron anymore, except the ones on Block B. According to the project prepared by the METU Directorate of Construction & Technical Works on 2008, all joineries of Block B were renewed as similar to the original details (See Appendix A). The joineries belonging to other buildings are aluminum, and some of them are colorful. The joineries of the cafe are blue painted aluminum and, ones of the market are red painted aluminum.

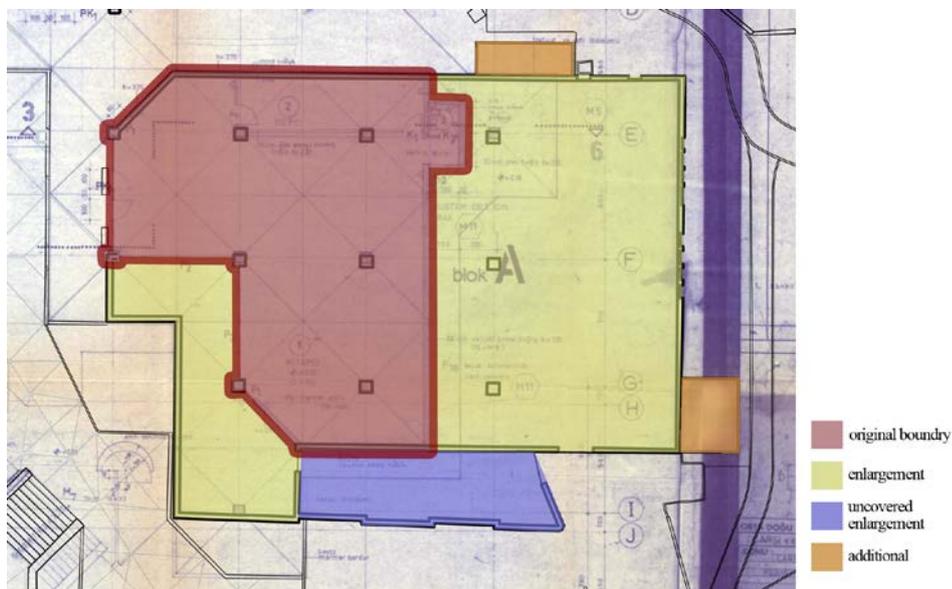
Figure 3-33: Architectural alterations on Block A

On the other hand, the service area of the cafe today was quite different on the architectural project. According to project the kitchen was smaller than today's, and there was a private lounge near the kitchen. Moreover, there was no service staircase from the kitchen to the upper floor on the southeast corner of the building. There is no clue as to the time of these changes.

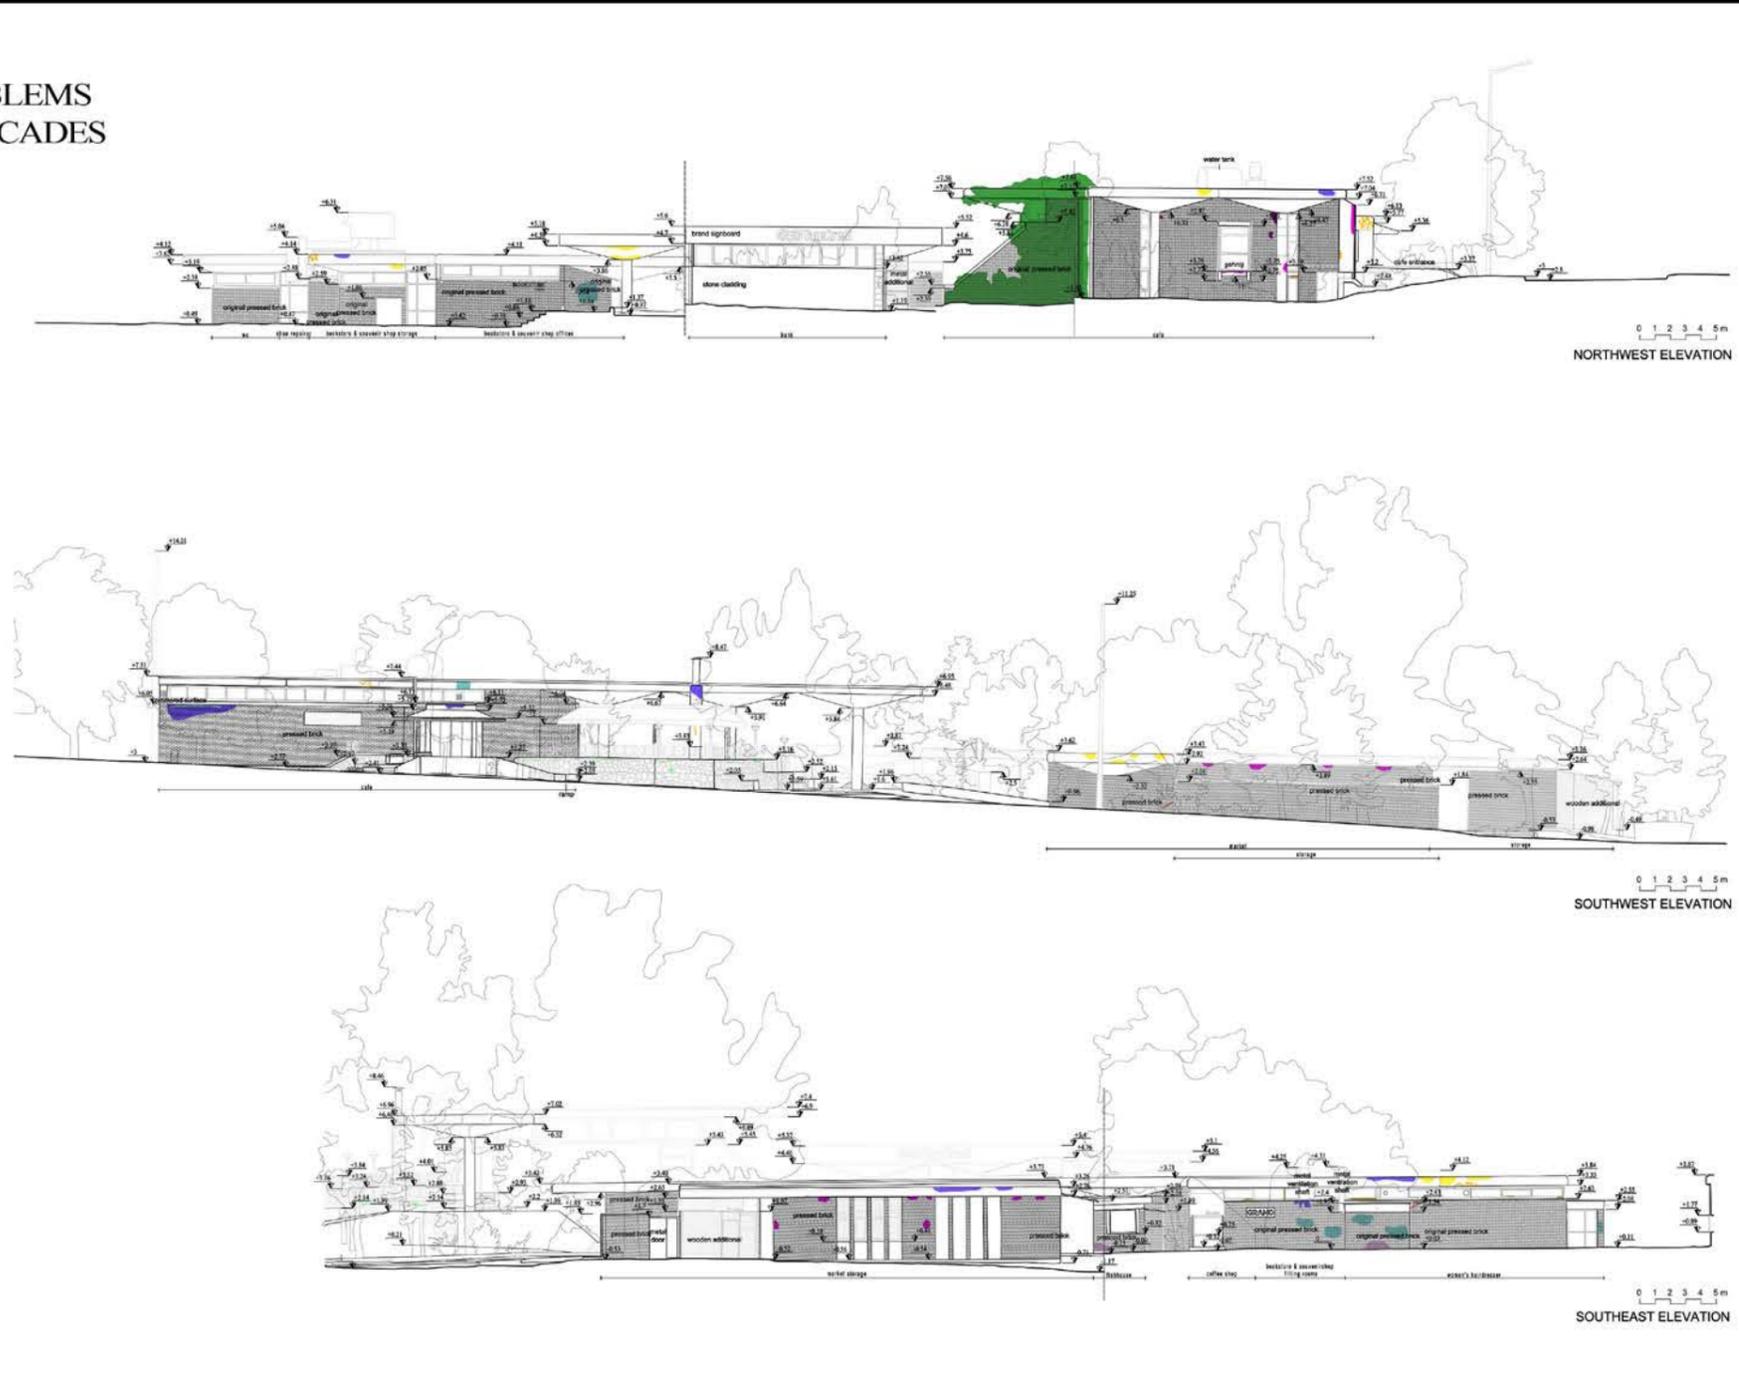
# PROBLEMS ON FACADES

- CRACKS**
  - STRUCTURAL CRACKS
  - FINE CRACKS
- MATERIAL PROBLEMS**
  - FLAKING
  - ABRASION
  - CORROSION ON JOINERY
  - LOSS OF UNIT MATERIAL
  - LOSS OF MORTAR
  - BREAK OF SURFACE MATERIAL
- DAMPNESS**
  - RISING DAMP
  - RAIN PENETRATION
- BIOLOGICAL FORMATION**
  - MOSS
  - CLIMBER
  - LICHEN
- VANDALISM (GRAFFITI)
