EFFECT OF HYDROGEN ON FATIGUE BEHAVIOR OF A CADMIUM
COATED HIGH STRENGTH STEEL

A THESIS SUBMITTED TO
THE GRADUATE SCHOOL OF NATURAL AND APPLIED SCIENCES
OF
MIDDLE EAST TECHNICAL UNIVERSITY

JUNE 2019

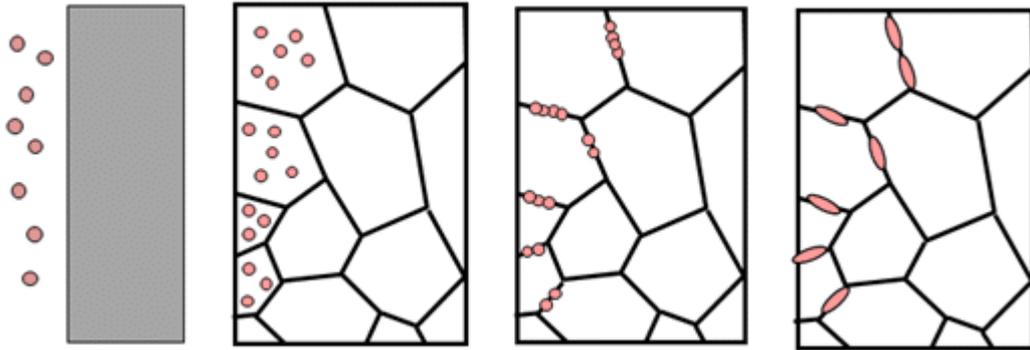
Figure 2.1. Hydrogen bubble migration to grain boundaries and formation of bubbles along these sites [13]

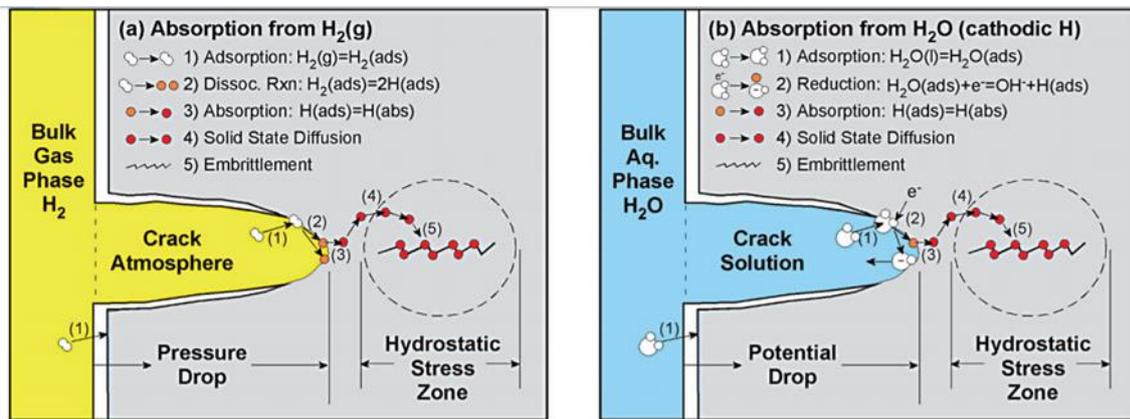
Figure 2.2. Hydrogen uptake from (a) Gaseous Environment and from (b) Aquatic Environment [14]

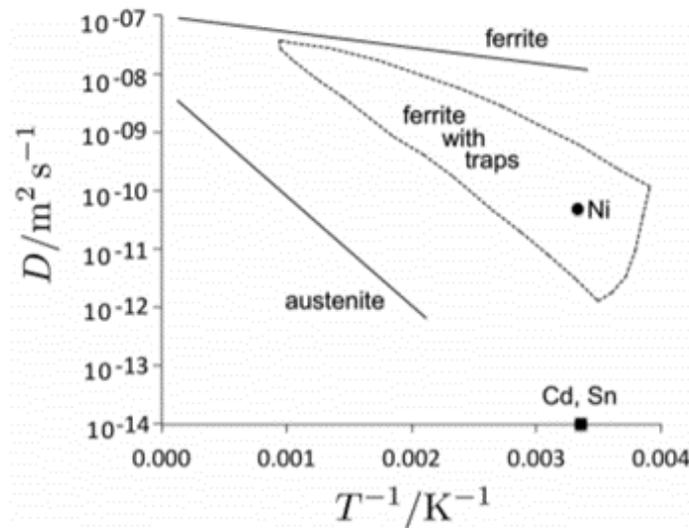
Figure 2.3. Diffusion coefficient of hydrogen in ferrite and diffusion coefficient of hydrogen in austenite. diffusion occurring in ferrite with strong traps is represented by the dashed region. hydrogen's diffusivity in nickel, cadmium and tin at ambient temperature is also represented [13]

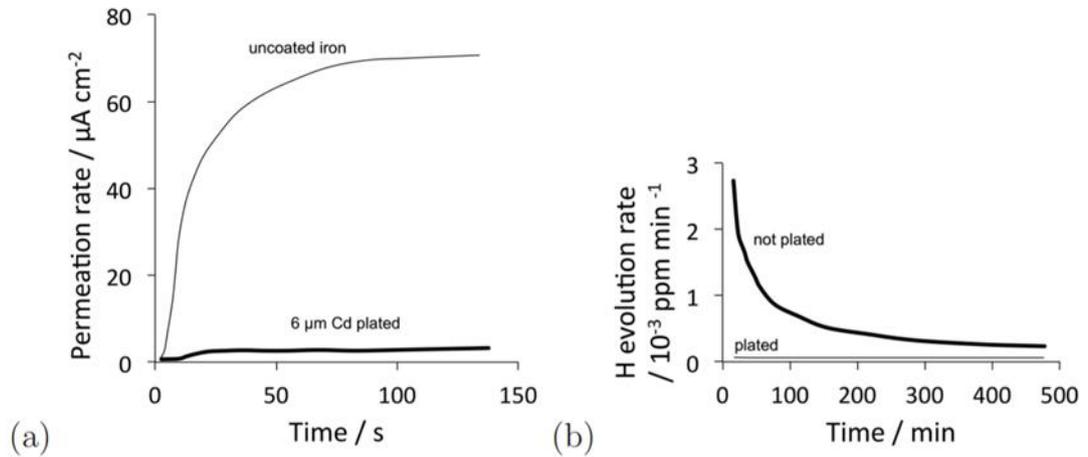
Figure 2.4. (a) Permeation rate of hydrogen to uncoated steel vs steel coated with 6 μm cadmium (b) comparison of hydrogen evolution rates under same conditions given in (a)

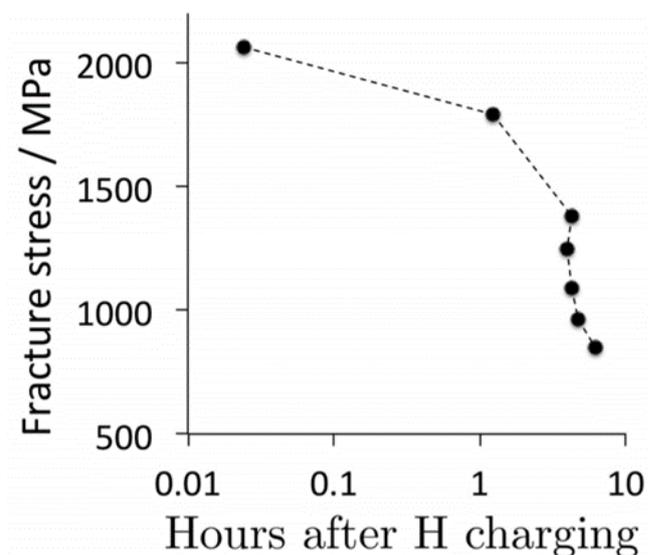
Figure 2.5. The change in fracture stresses of a high strength (1516 MPa) steel alloyed with nickel, chromium, molybdenum that is electrically charged with hydrogen over time after hydrogen charging

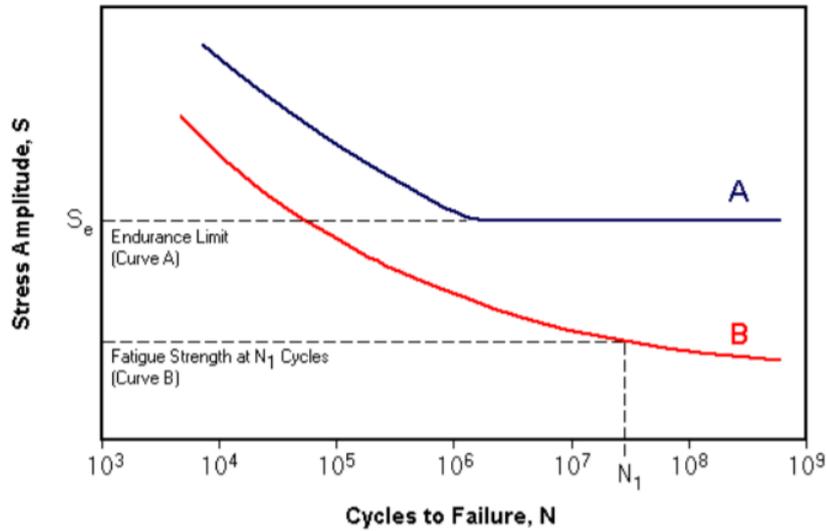
Figure 2.6. Sample S – N curves of two different materials, behavior of material A shows an endurance limit whereas material B does not exhibit an endurance limit [18]

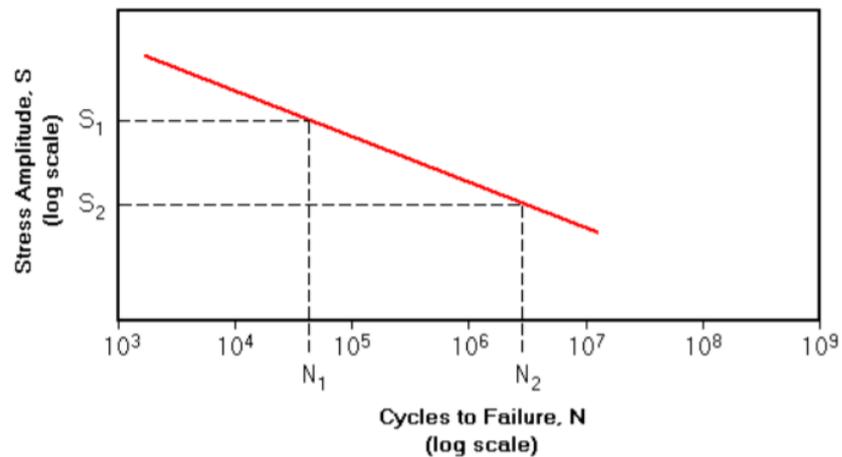
Figure 2.7. Graphical representation of the Basquin Slope

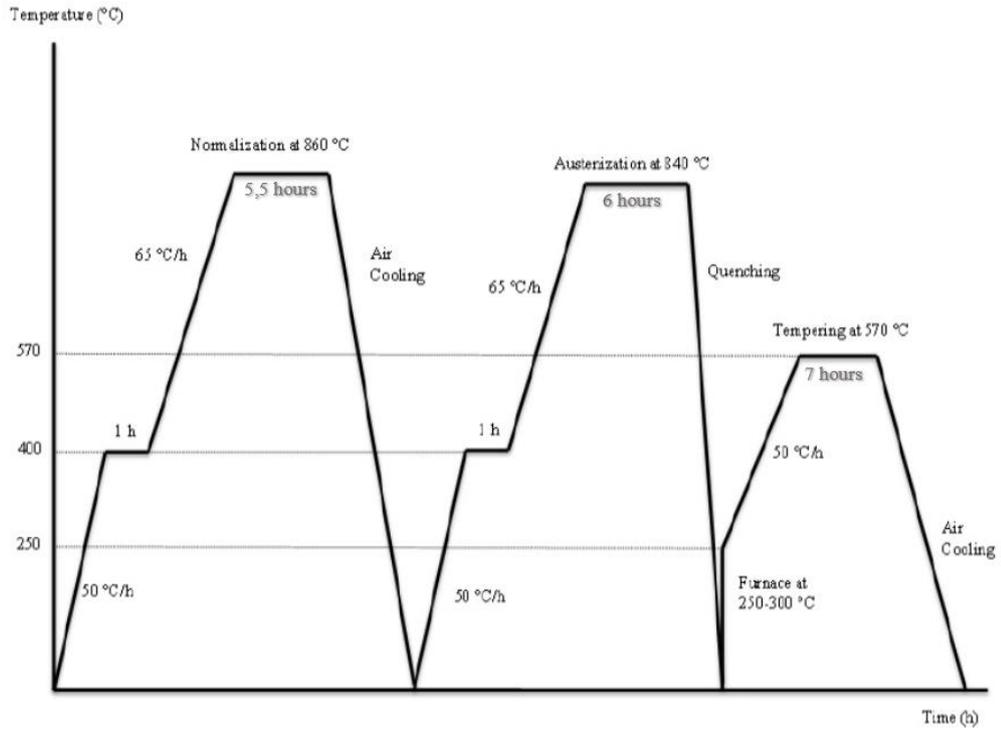
Figure 3.1. Heat treatment cycles that the modified 4340 steel used in experiments undergo (process parameters are supplied by the source manufacturer of the material)

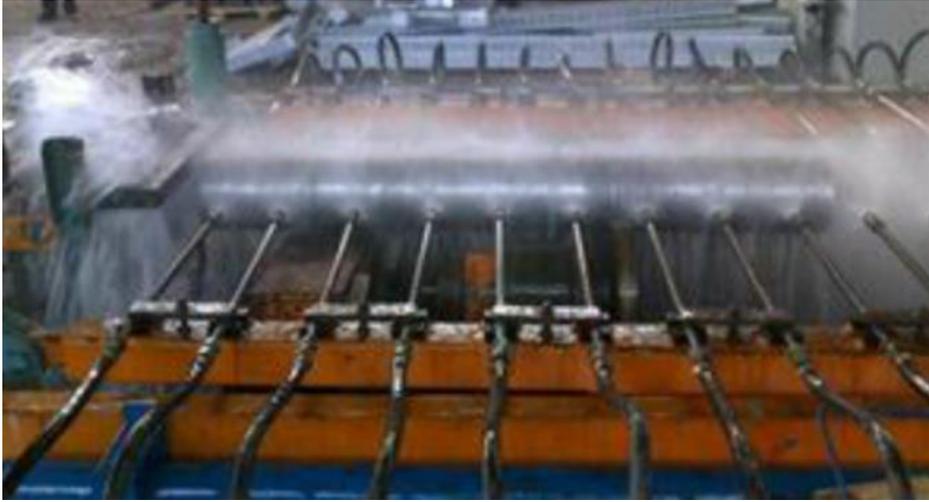
The austenitized material was placed at the water quenching apparatus within 2 minutes of after removal from heat treatment furnace. The water quenching system seen below that has a rotation speed of 20 – 30 rpm. The water pressure was 2.8 ± 0.2 bars.

Figure 3.2. Setup used by the entity that manufactured the modified 4340 steel for the water quenching operation

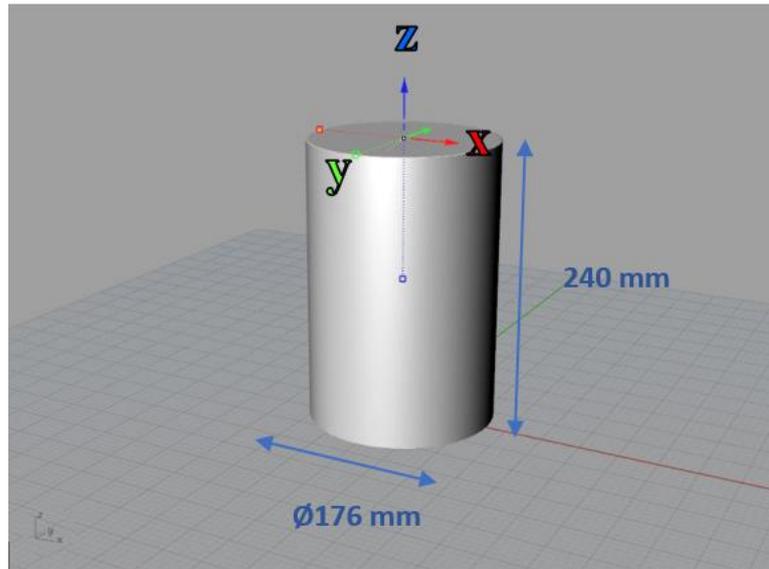
Figure 3.3. Representation of the modified 4340 billet and sample directions

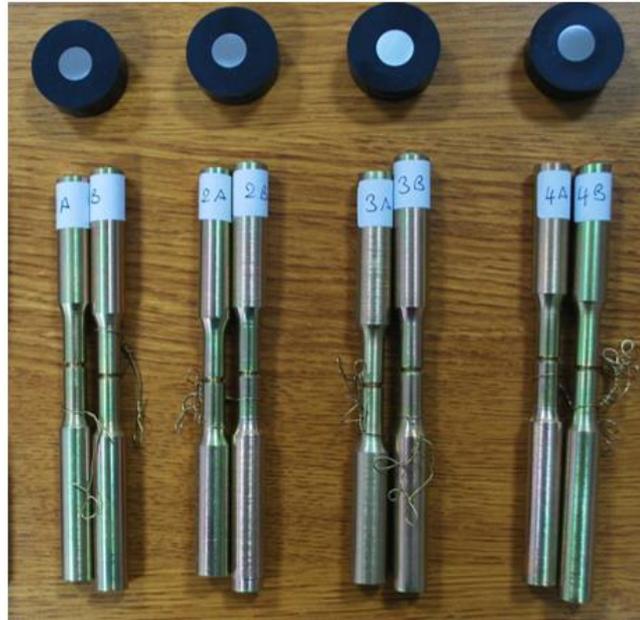
Figure 3.6. Two sets of identical cadmium coated, notched tensile specimens and sections cut to measure thickness molded into Bakelite. Etching and coating parameters are given in Table 3.3

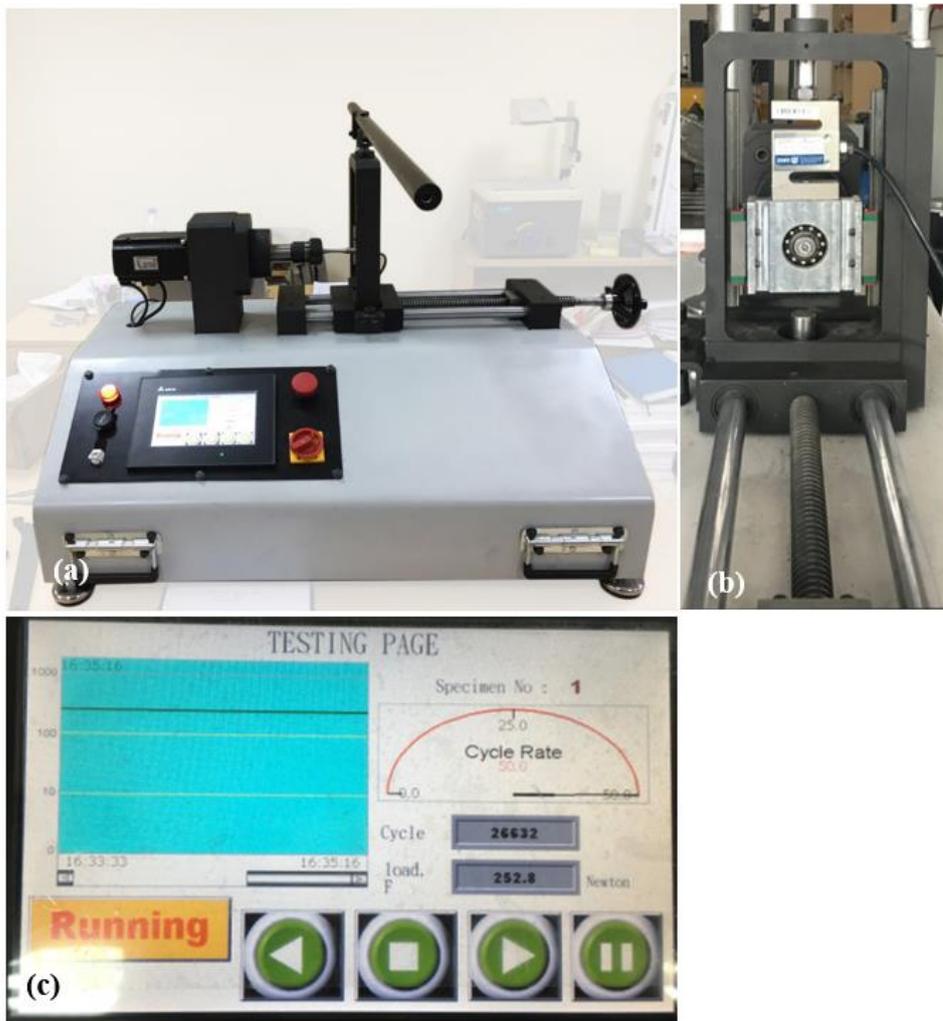
Figure 3.7. Rotating beam testing machine (a) general appearance (b) closer look to the rotating end and the load cell above the fixture (c) data screen

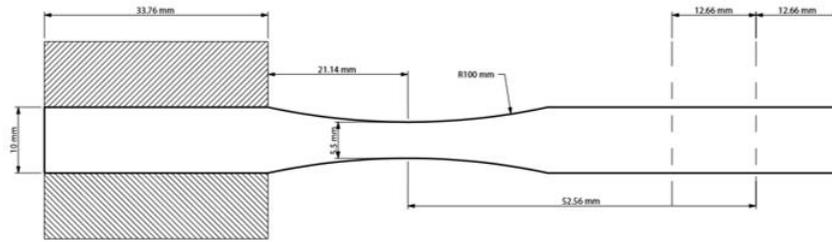
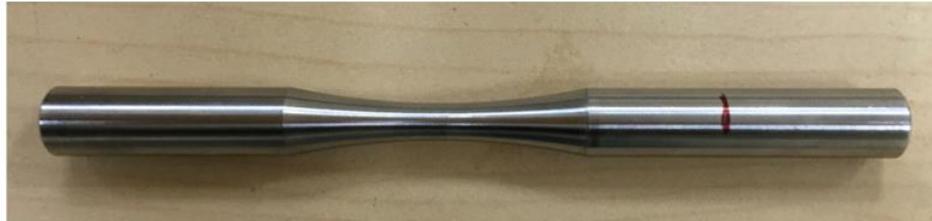
Figure 3.8. Rotating beam fatigue specimen, technical drawing and the actual sample

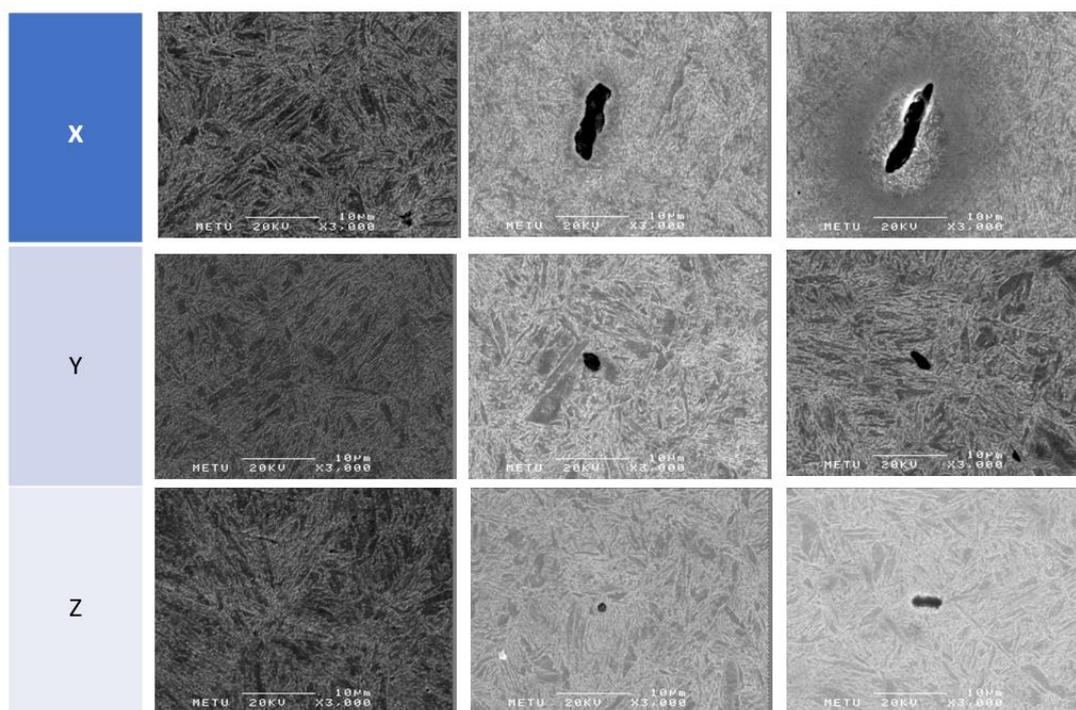
Figure 4.1. SEM images of the microstructure taken from samples cut from x, y and z directions under 3,000x magnification. First column is the general appearance, some inclusions can be seen on 2nd and 3rd columns.

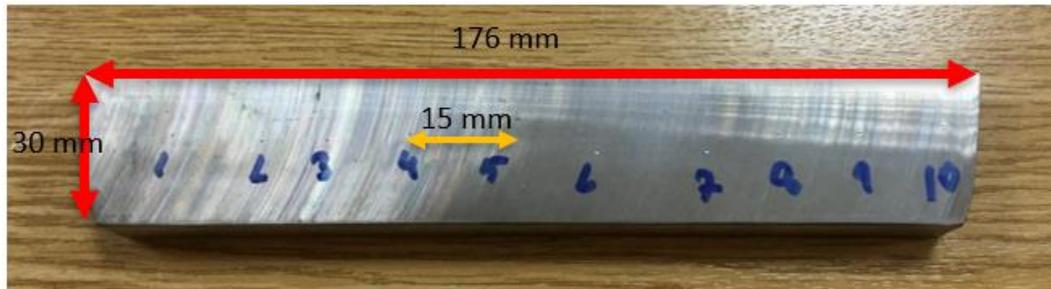
Figure 4.2. Hardness measurement points and the actual section used for these measurements

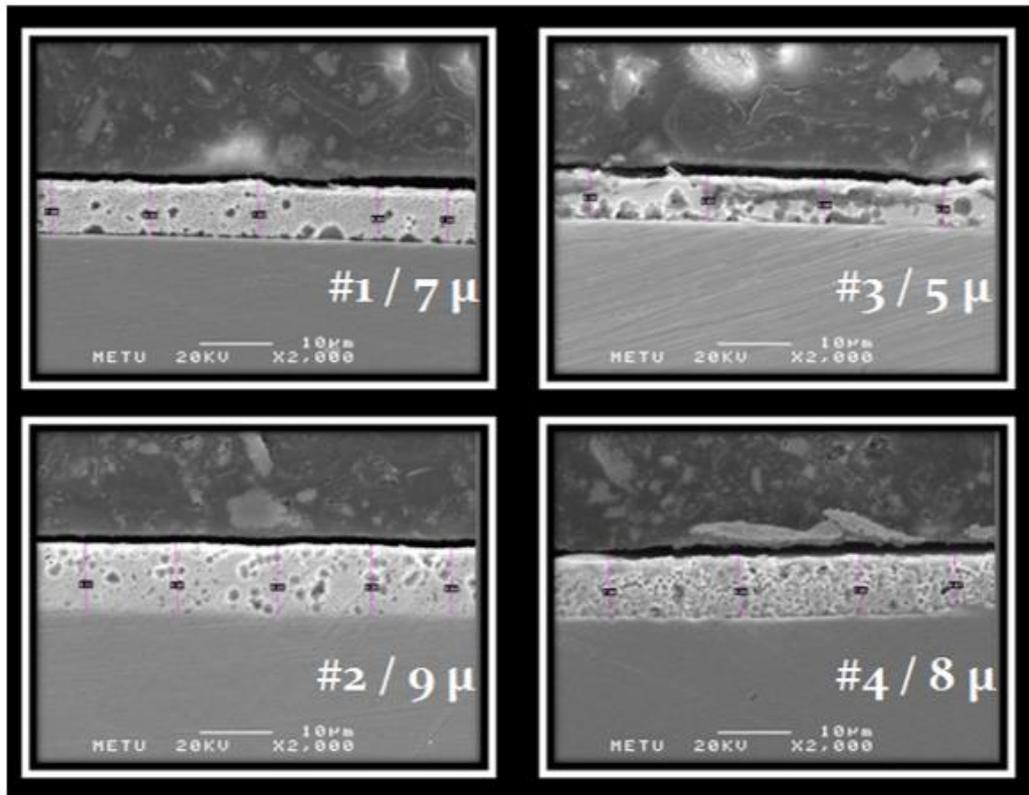
Figure 4.3. The coating thicknesses measured under SEM

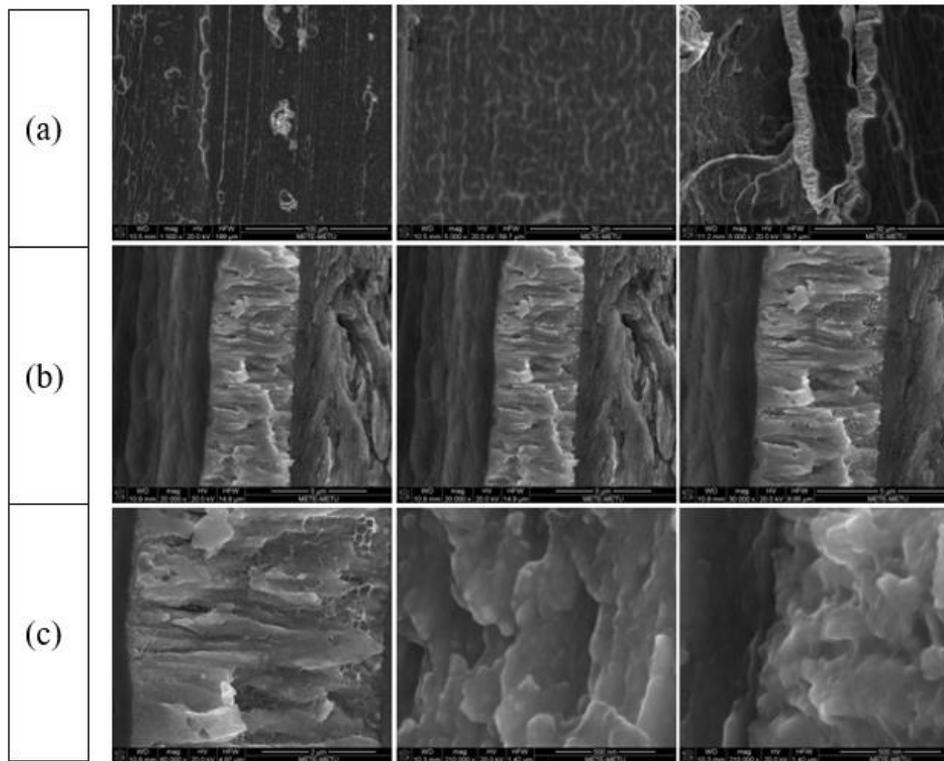
Figure 4.4. SEM images of the electrodeposited cadmium layer. (a) Top row is the appearance of the surface of the coating, (b) second row the cross section can be seen and (c) a closer view to the coating inner structure is given on the third row

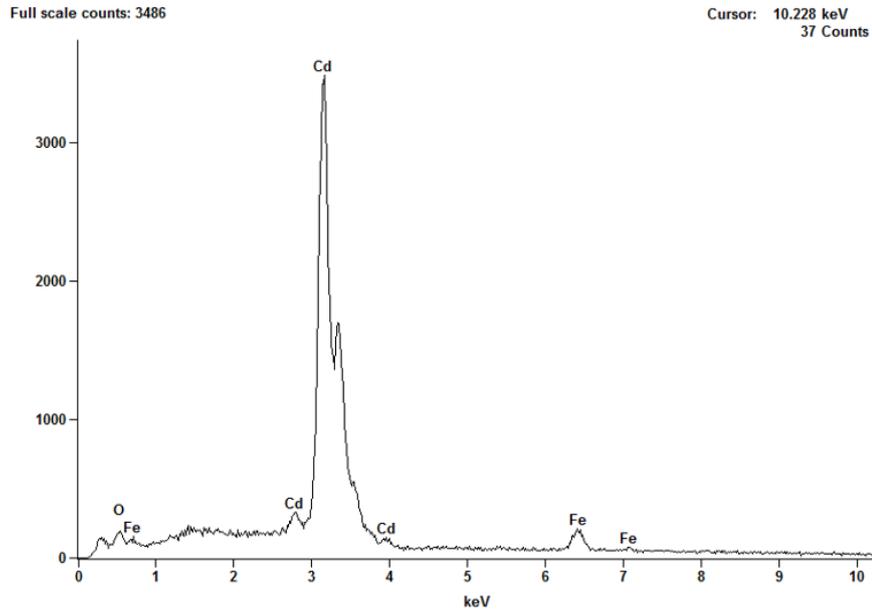
Figure 4.5. EDS spectra of the coating layer from the middle of the coating thickness

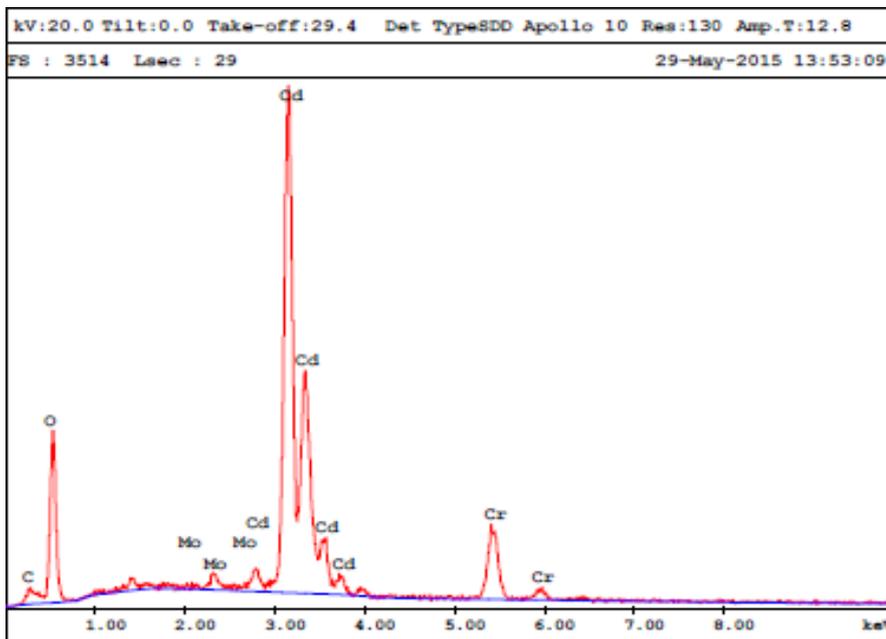
Figure 4.6. EDS spectra of the coating close to the passivated surface

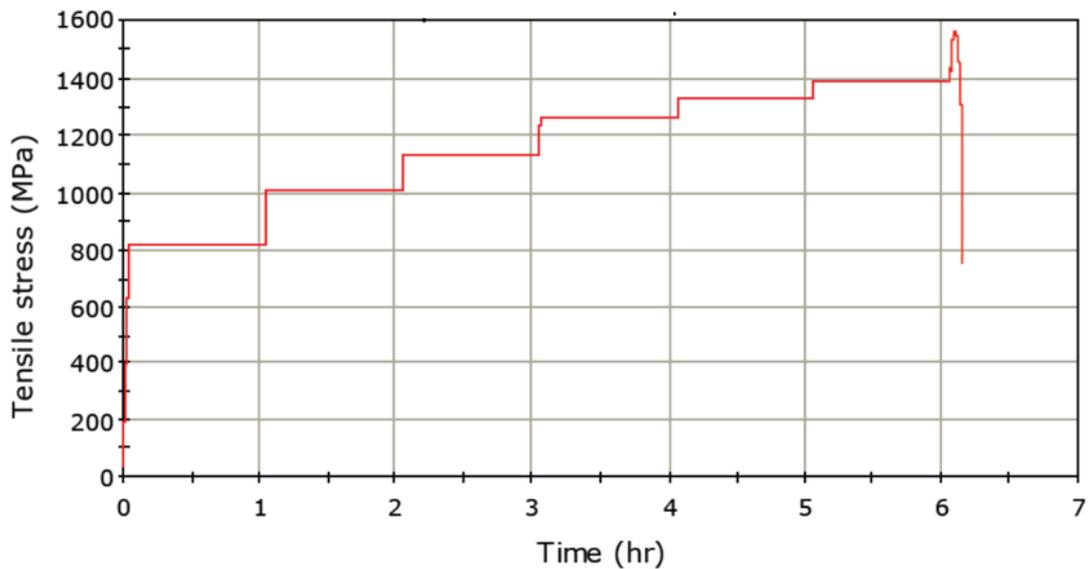
Figure 4.7. Time vs Tensile Stress graph of uncoated and notched, round tensile specimen made of modified 4340 steel subjected to 8-hour test. Sample finished the test and met the criteria so it is accepted that no hydrogen is present in the structure

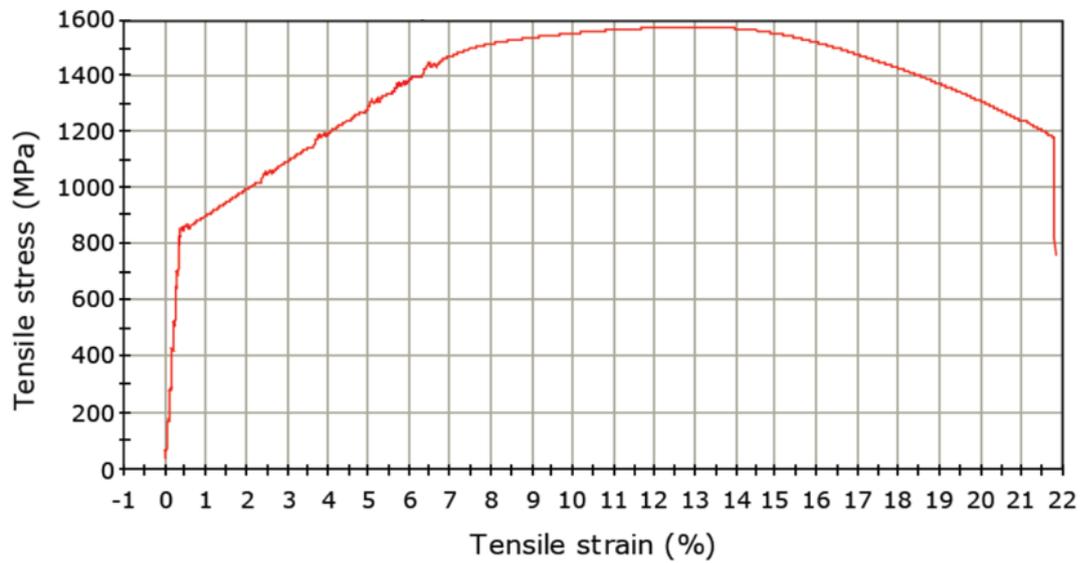
Figure 4.8. Stress vs Strain curve obtained from the 8-hour test of uncoated and notched, round tensile specimen made of modified 4340 steel

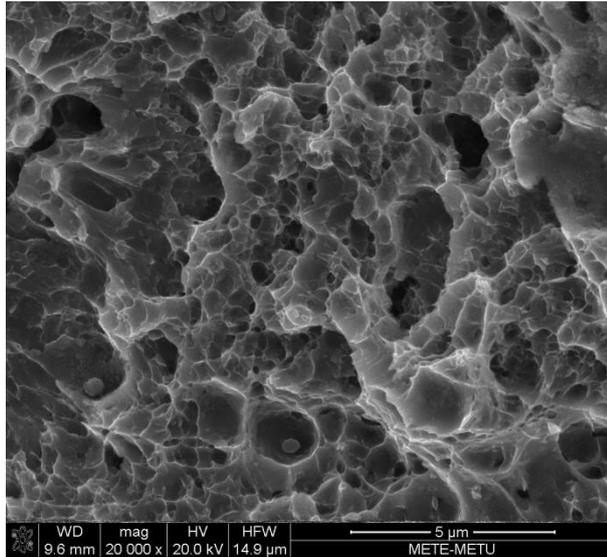
Figure 4.9. SEM image of the fracture surface of uncoated specimen subjected to 8-hour test taken from the core (magnification 20,000x)

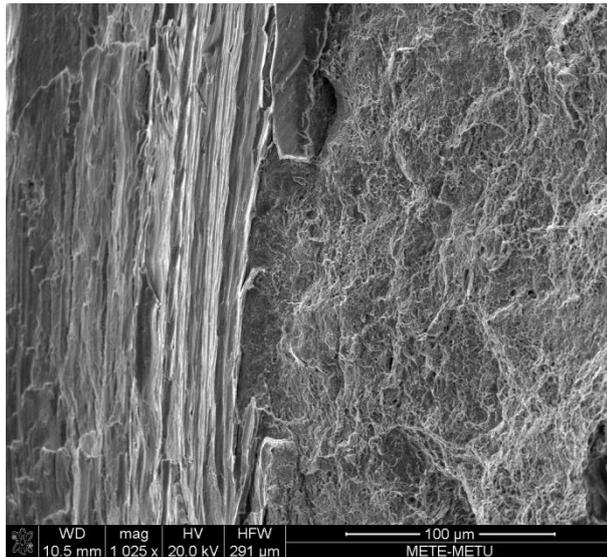
Figure 4.10. SEM image of the fracture surface of uncoated specimen subjected to 8-hour test taken from the modified 4340 steel and cadmium coating interface (magnification 1,025x)

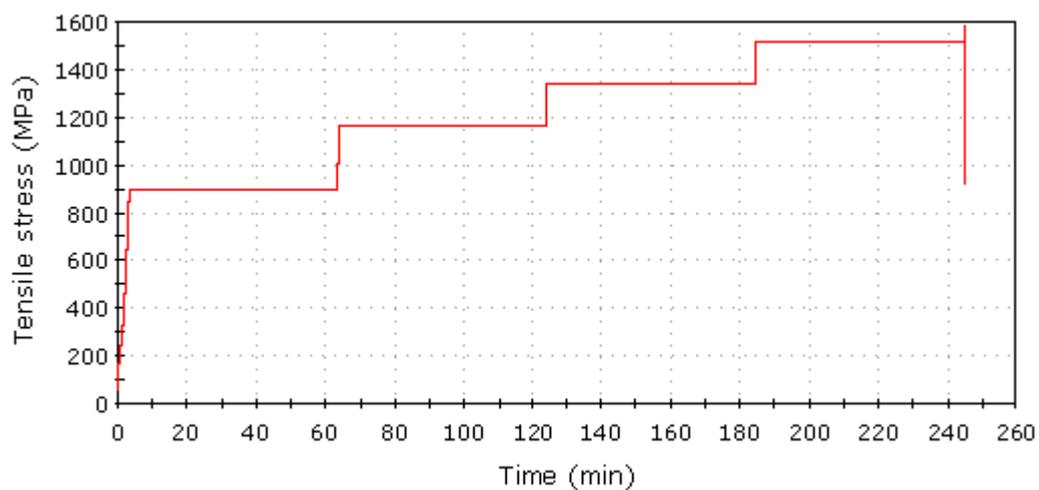
Figure 4.11. Time vs Tensile Stress graph of notched, round tensile specimen 1 (2 – 4), made of modified 4340 steel subjected to 8-hour test, break at 4th cycle

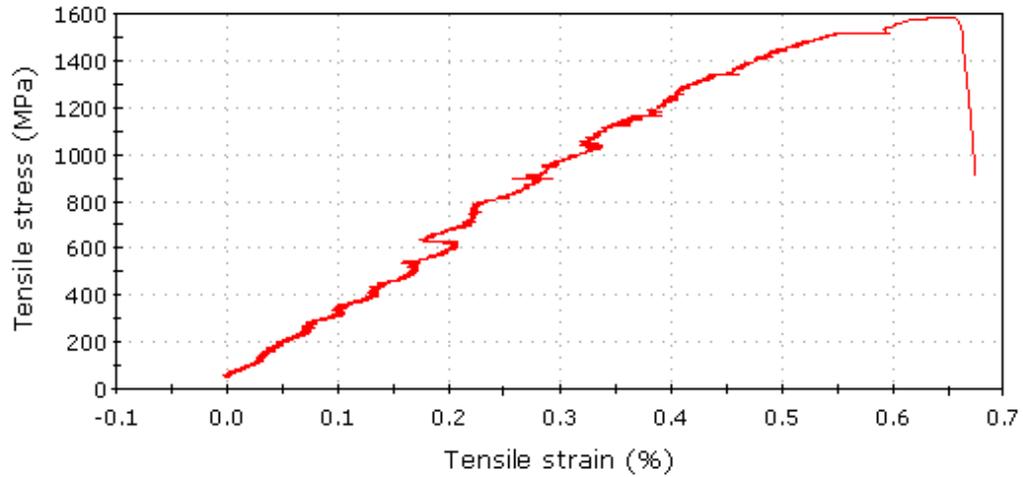
Figure 4.12. Stress vs Strain curve obtained from the 8-hour test of notched, round tensile specimen 1 (2 – 4)

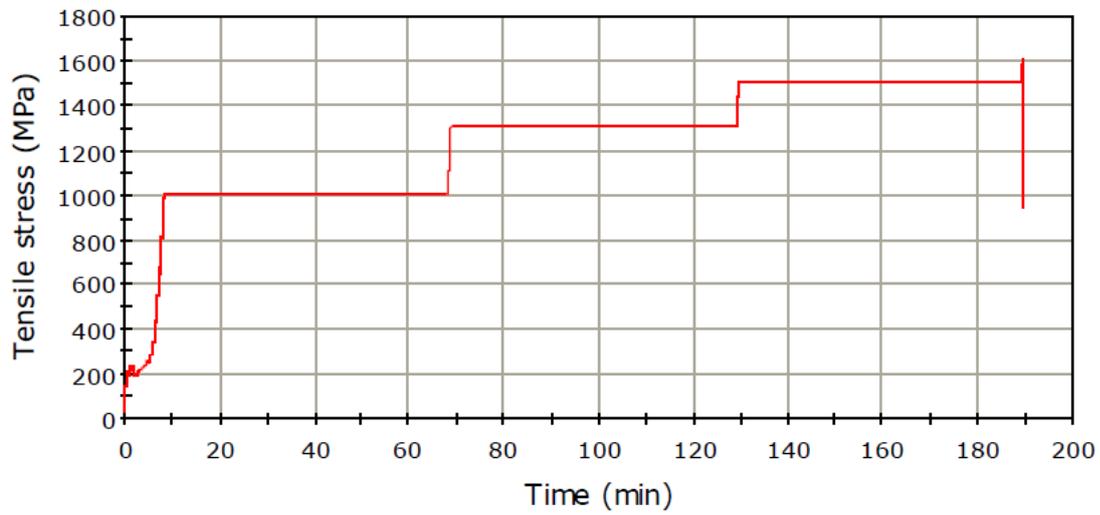
Figure 4.13. Time vs Tensile Stress graph of notched, round tensile specimen 2 (2 – 8), made of modified 4340 steel subjected to 8-hour test, break at 3rd cycle

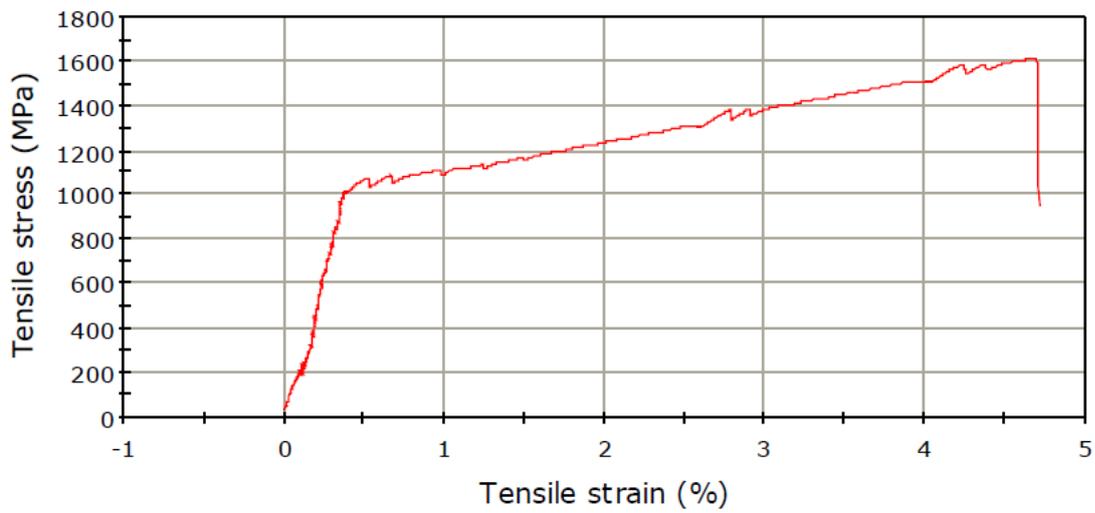
Figure 4.14. Stress vs Strain curve obtained from the 8-hour test of notched, round tensile specimen 2 (2 – 8)

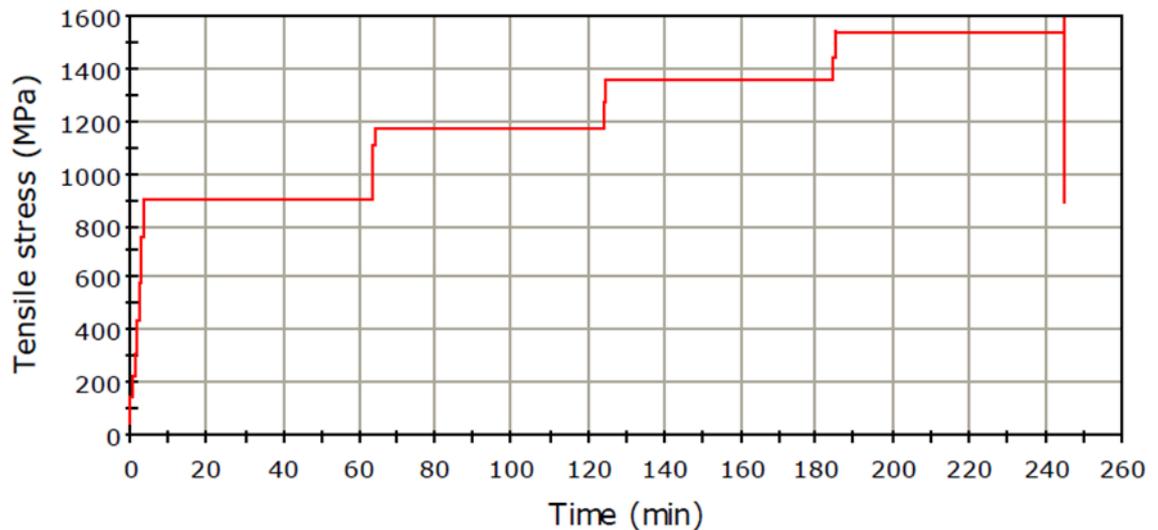
Figure 4.15. Time vs Tensile Stress graph of notched, round tensile specimen 3 (4 – 4), made of modified 4340 steel subjected to 8-hour test, break at 4th cycle

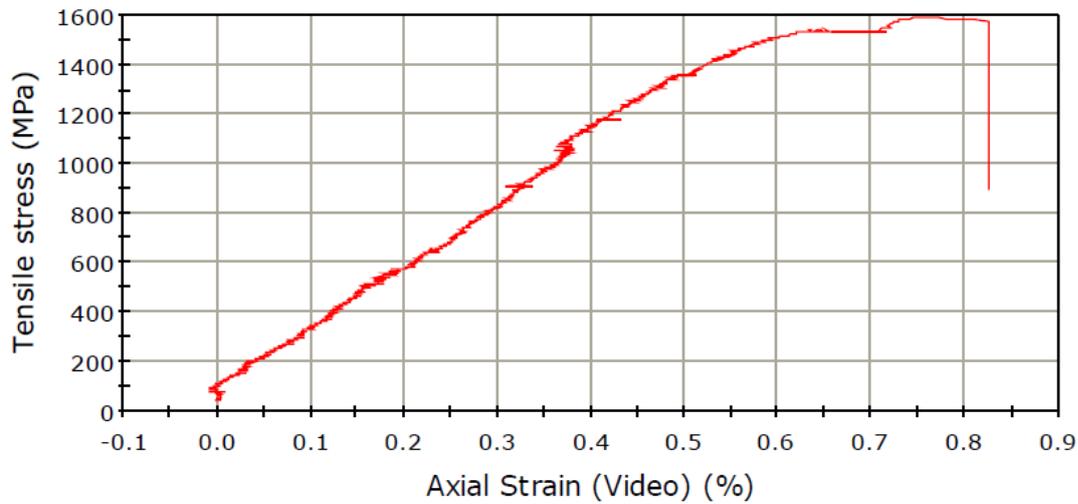
Figure 4.16. Stress vs Strain curve obtained from the 8-hour test of notched, round tensile specimen 3 (4 – 4)

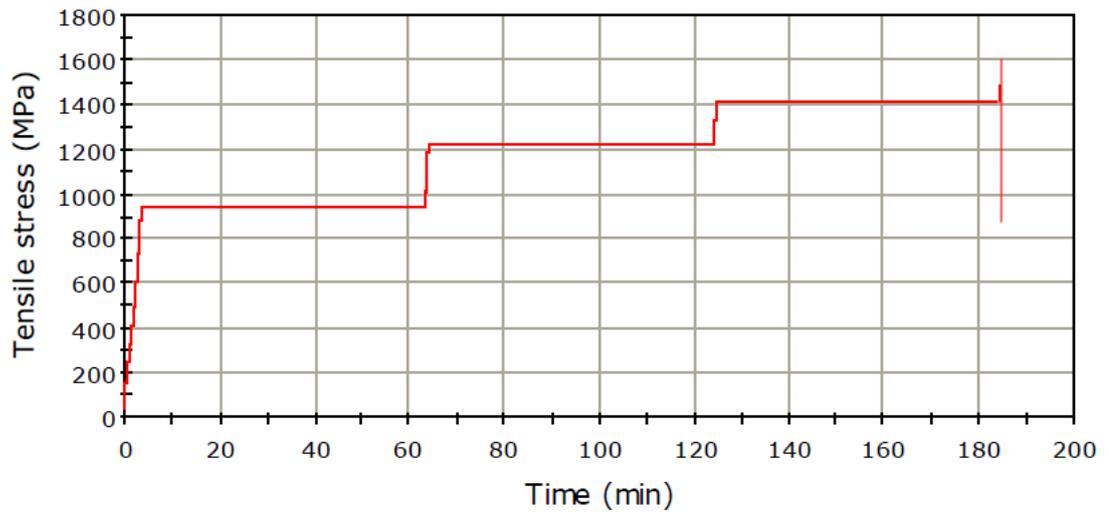
Figure 4.17. Time vs Tensile Stress graph of notched, round tensile specimen 4 (4 – 8), made of modified 4340 steel subjected to 8-hour test, break at 3rd cycle

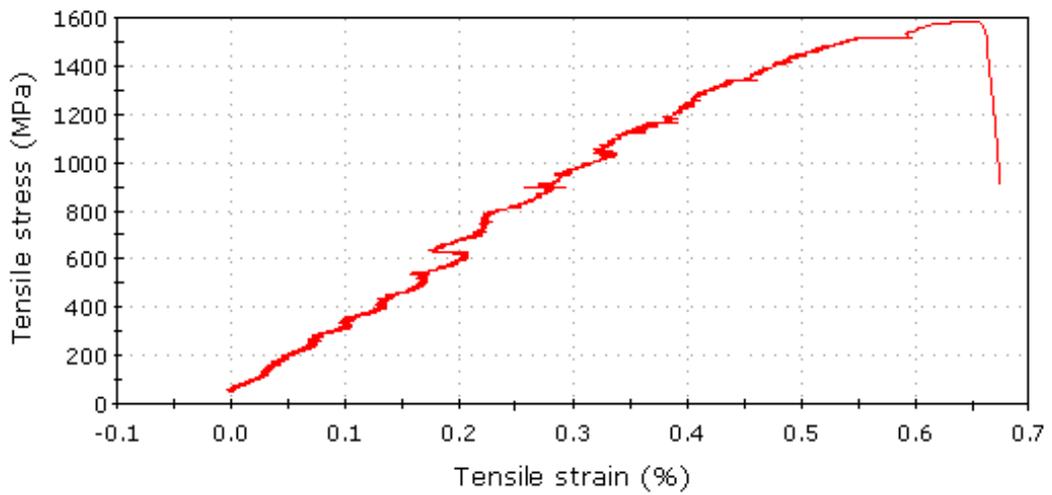
Figure 4.18. Stress vs Strain curve obtained from the 8-hour test of notched, round tensile specimen 4 (4 – 8)

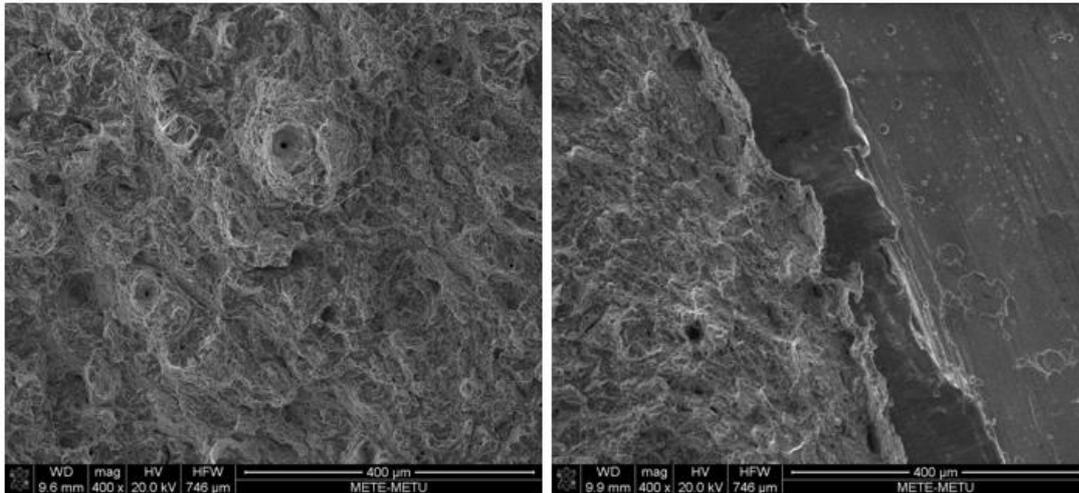
Figure 4.19. SEM image of the fracture surface of specimen 1 (2 – 4) subjected to 8-hour test taken from the core of the sample (on the left) modified 4340 steel and cadmium coating interface (on the right).

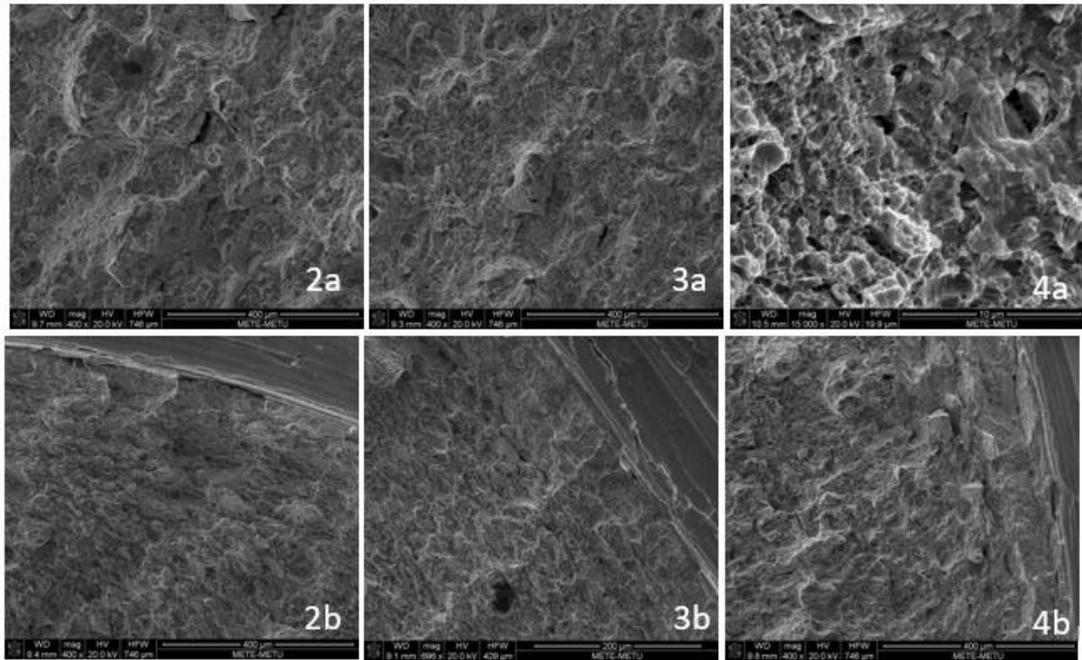
Figure 4.20. SEM image of the fracture surface of specimen 2 (2 – 8), 3 (4 – 4) and 4 (4 – 8), respectively, all after being subjected to 8-hour test. Photos are taken from (a) the core of the sample and (b) from the modified 4340 steel and cadmium coating interface

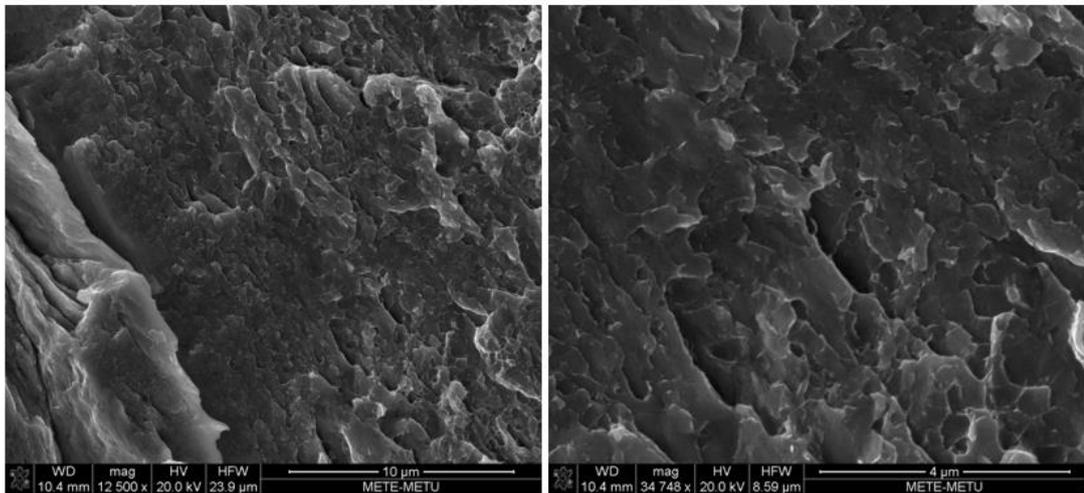
Figure 4.21. Some interesting features at fracture surface of 3rd specimen (4 – 4) located near the modified 4340 steel and cadmium coating interface

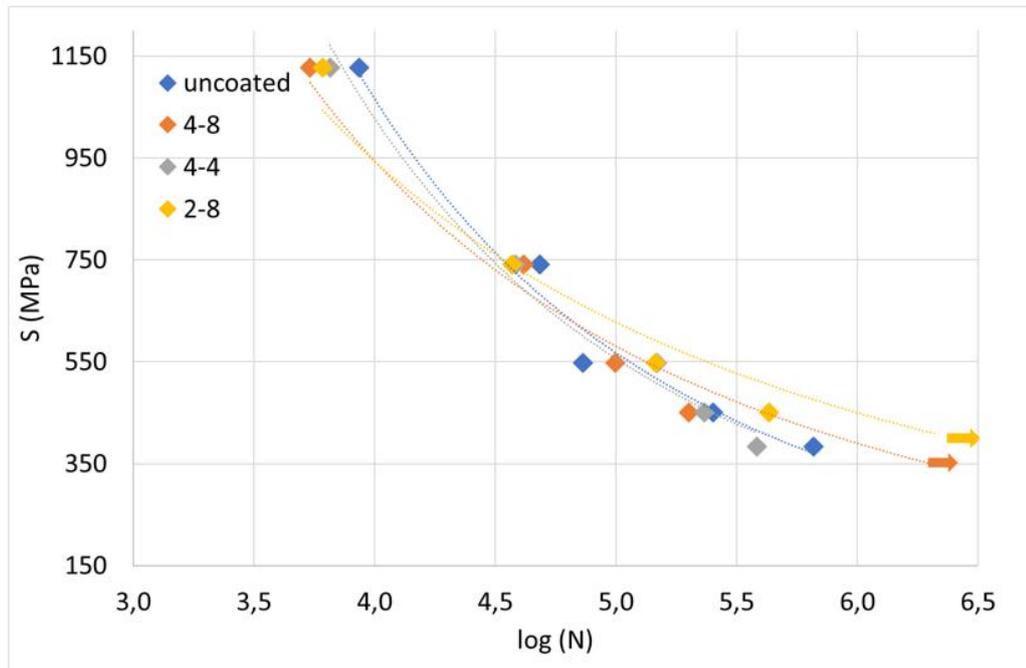
Figure 4.22. The semi log plot of S vs N for uncoated, 4 min etched 8 min coated (4 – 8), 4 min etched 4 min coated (4 – 4), 2 min etched 8 min coated (2 – 8) samples using data tabulated in Table 4.12

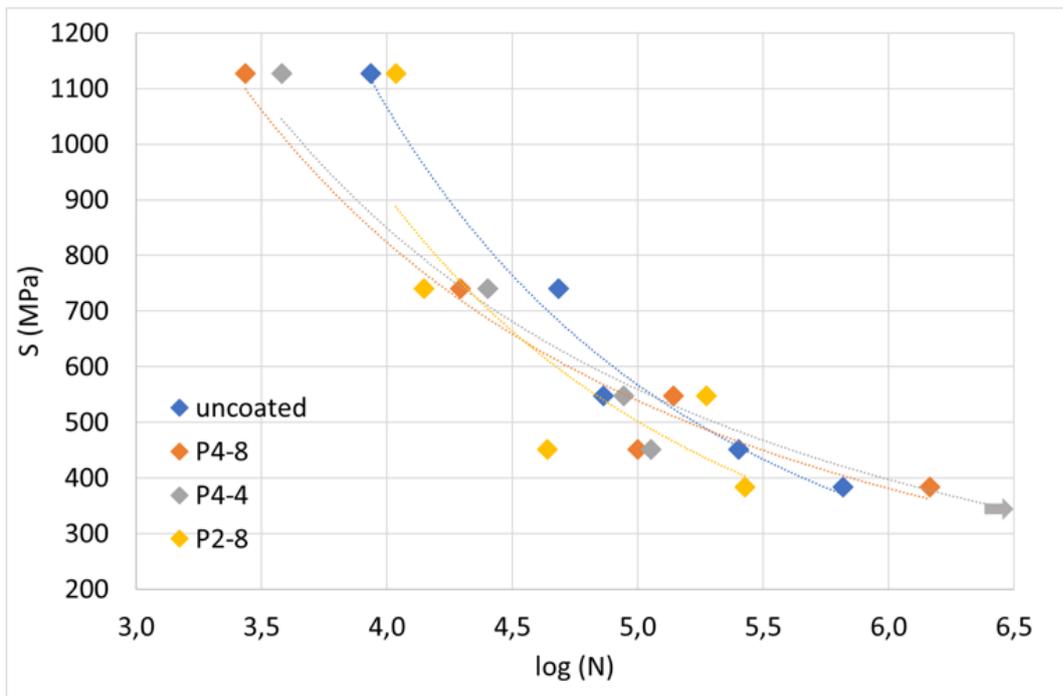
Figure 4.23. The semi log plot of S vs N for uncoated, preloaded samples of 4 min etched 8 min coated (P4 – 8) condition, preloaded samples of 4 min etched 4 min coated (P4 – 4) condition and samples of 2 min etched 8 min coated (2 – 8) condition using data tabulated in Table 4.13

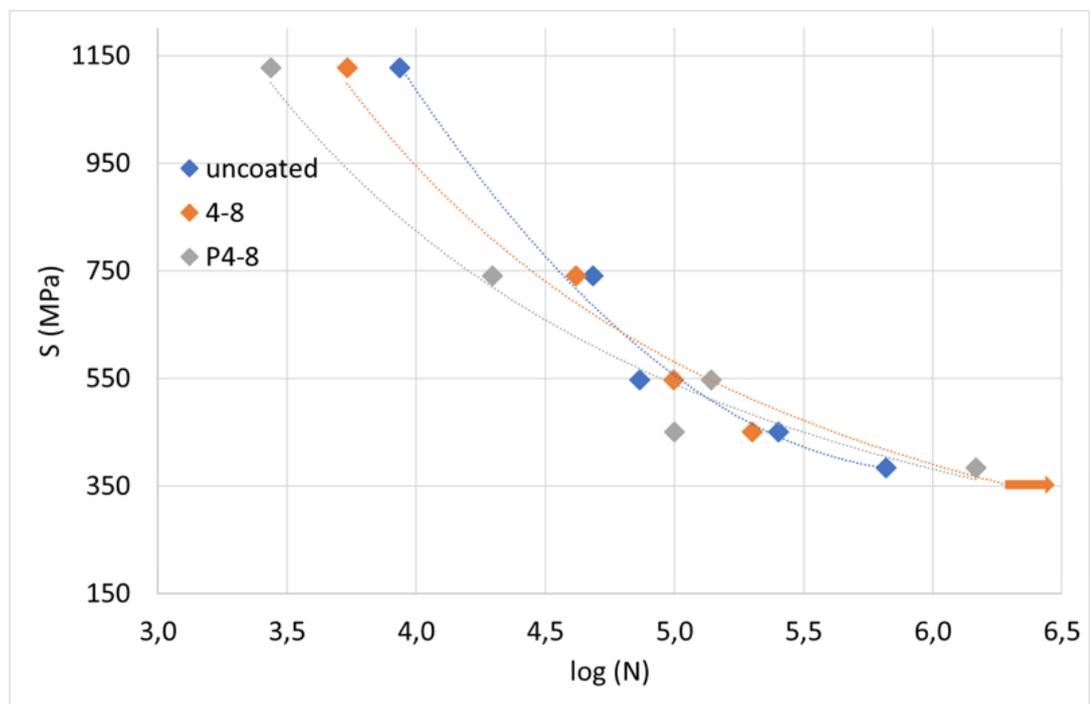
Figure 4.24. Comparison of S – N curves belonging to uncoated samples, unloaded (4 – 8) and preloaded (P4 – 8) samples of 4 min etching 8 min coating condition

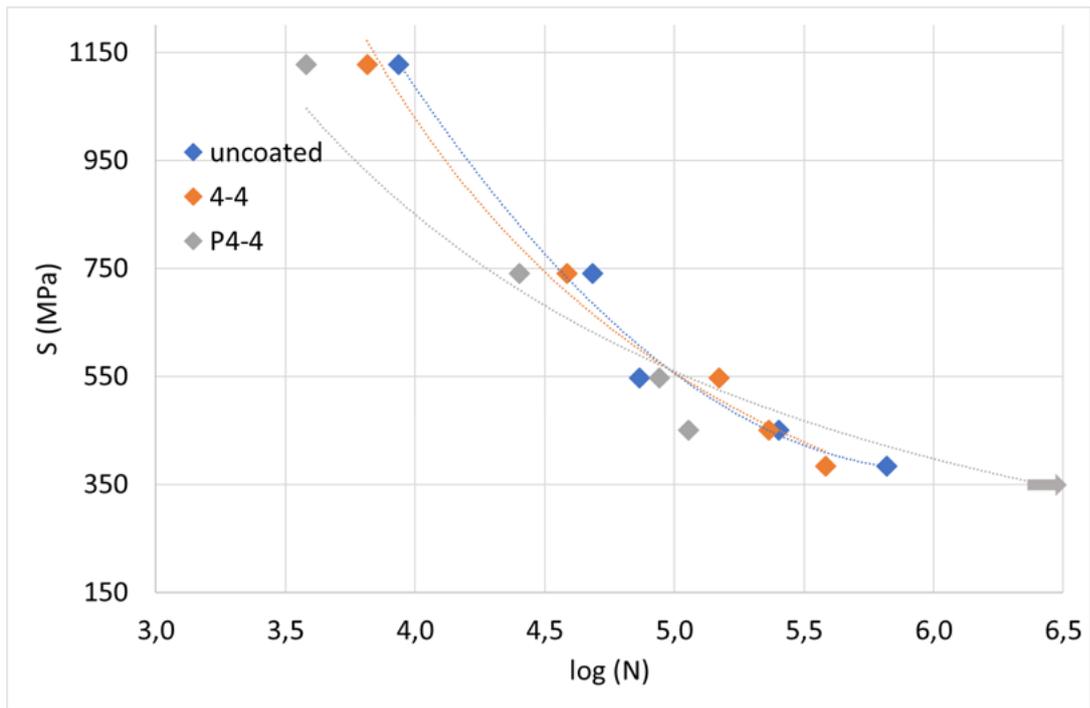
Figure 4.25. Comparison of S – N curves belonging to uncoated samples, unloaded (4 – 4) and preloaded (P4 – 4) samples of 4 min etching 4 min coating condition
