EFFECT OF HYDROGEN ON FATIGUE BEHAVIOR OF A CADMIUM
COATED HIGH STRENGTH STEEL

A THESIS SUBMITTED TO
THE GRADUATE SCHOOL OF NATURAL AND APPLIED SCIENCES
OF
MIDDLE EAST TECHNICAL UNIVERSITY

JUNE 2019

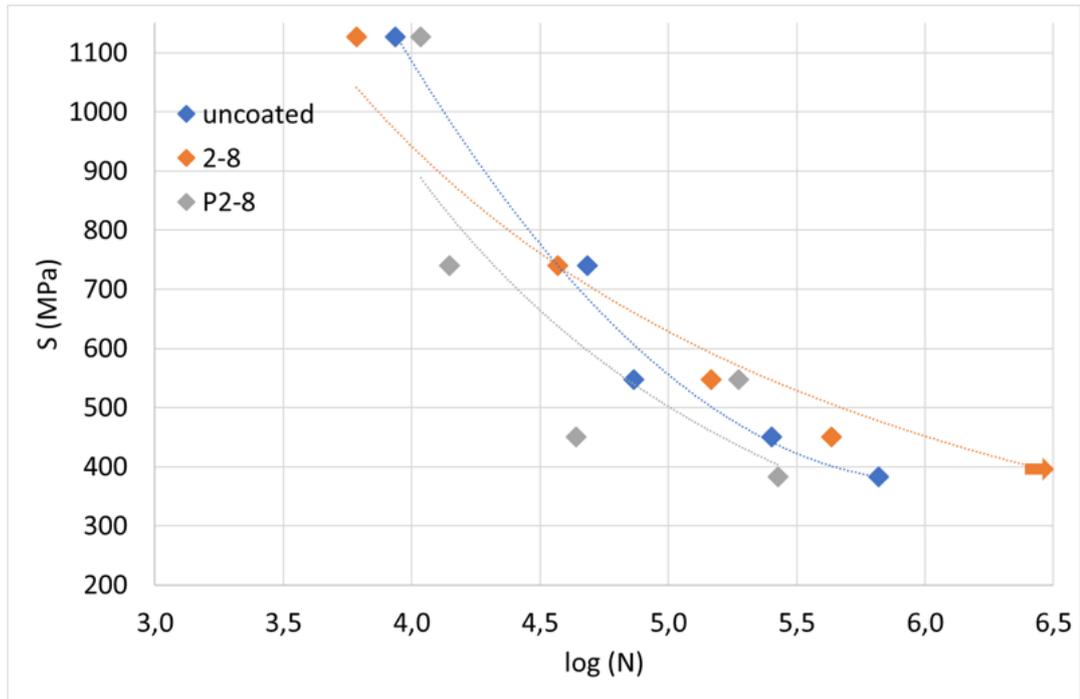
Figure 4.26. Comparison of S – N curves belonging to uncoated samples, unloaded (2 – 8) and preloaded (P2 – 8) samples of 2 min etching 8 min coating condition

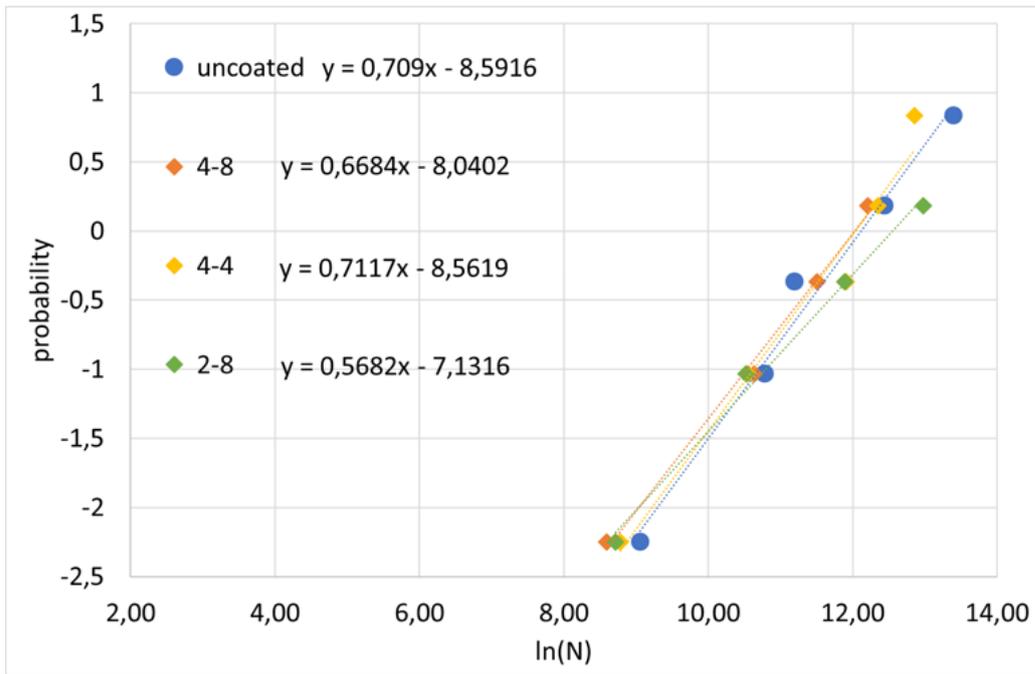
Figure 4.27. Weibull distribution of uncoated samples and samples without preloading

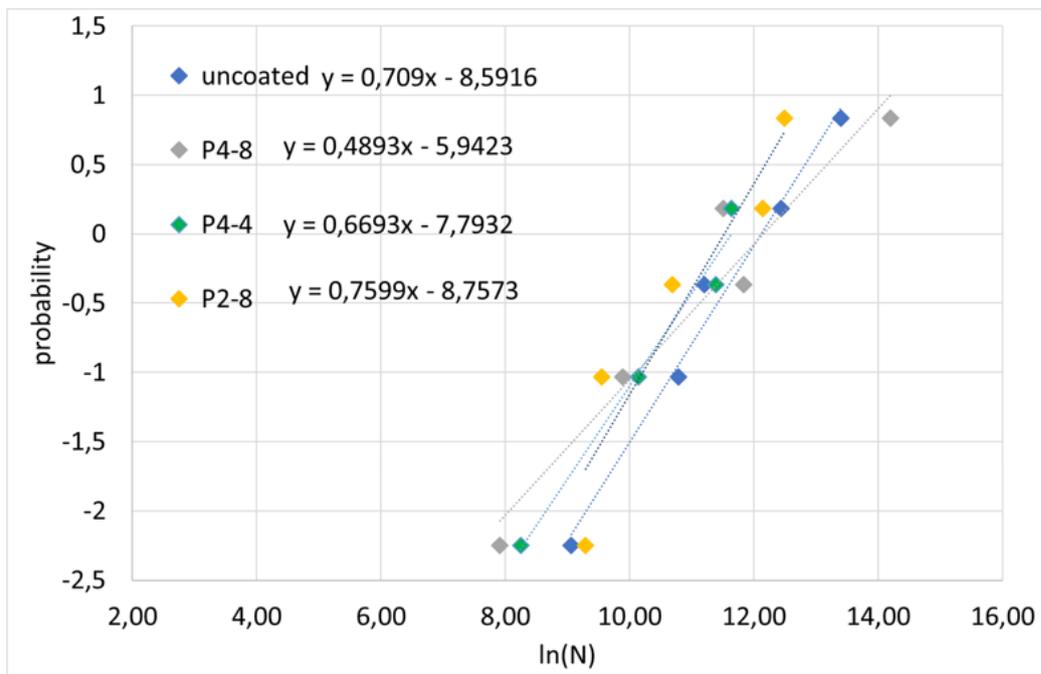
Figure 4.28. Weibull distribution of uncoated samples and samples with preloading

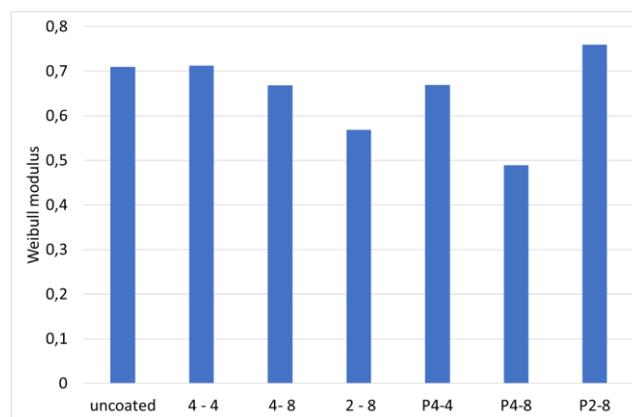
Figure 4.29. Graphical representation of Weibull modulus of $S - N$ data collected from all coating and loading conditions

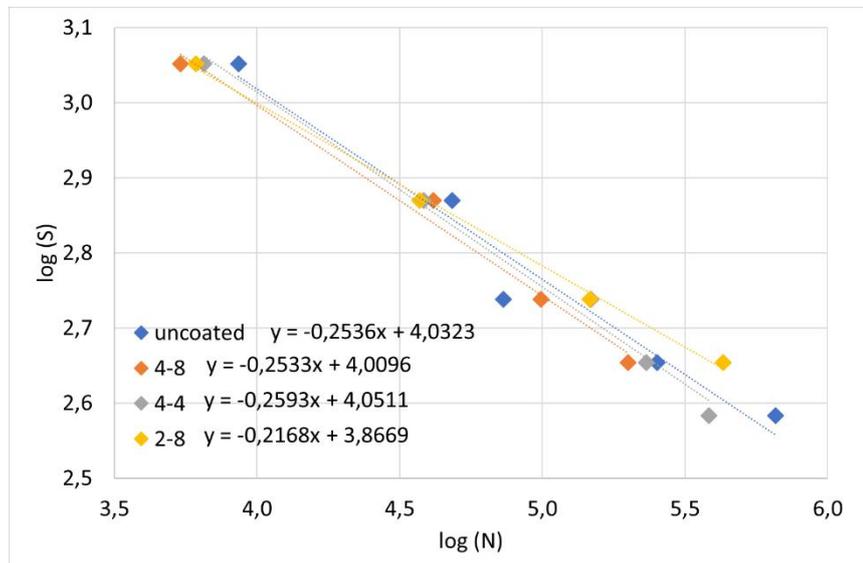
Figure 4.30. Graphical representation of the Basquin slope along with related equations for uncoated sample and unloaded samples

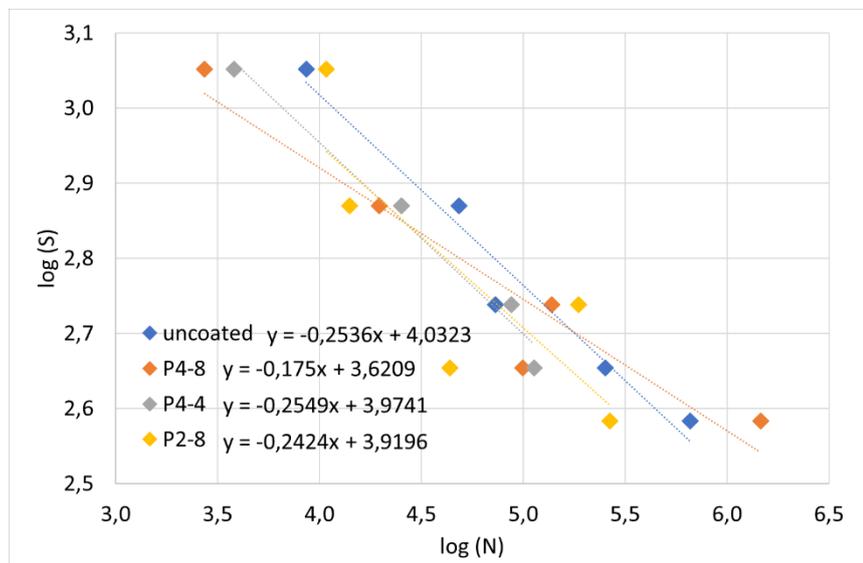
Figure 4.31. Graphical representation of the Basquin slope along with related equations for uncoated sample and preloaded samples

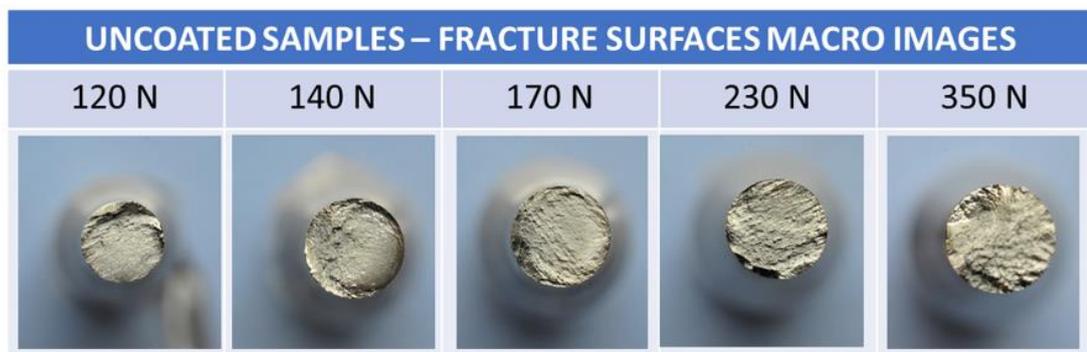
Figure 4.32. Macro images of the fracture surfaces of uncoated samples after the rotating beam fatigue test

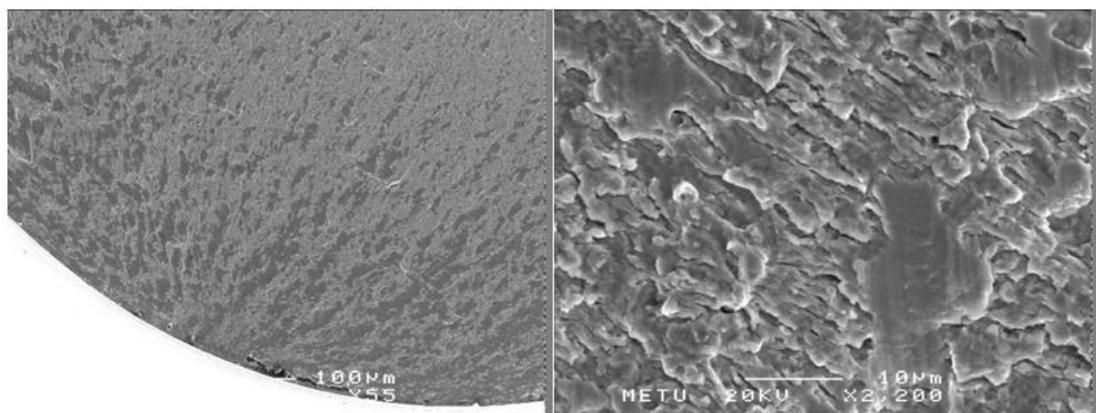
Figure 4.33. SEM images of possible crack initiation point and typical fatigue marks observed on the fracture surface of uncoated sample subjected to cyclic loading under 140 N.

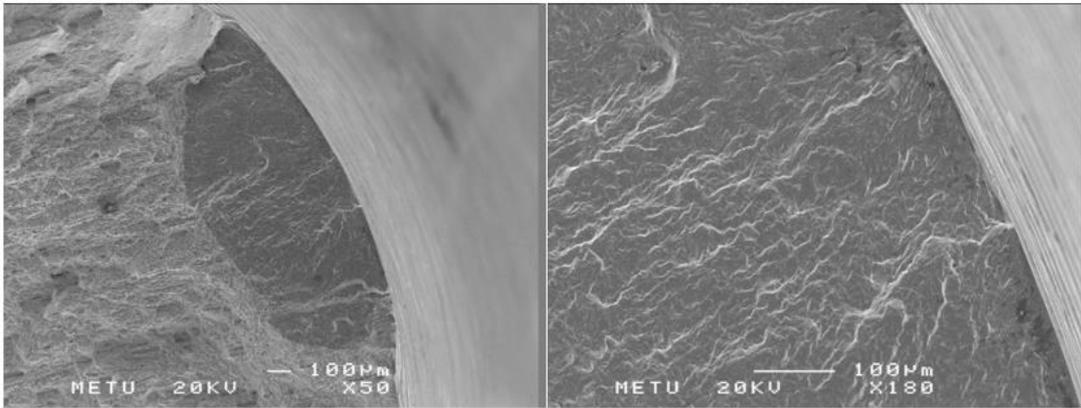
Figure 4.34. SEM images of possible crack initiation point and typical fatigue marks observed on the fracture surface of uncoated sample subjected to cyclic loading under 350 N.

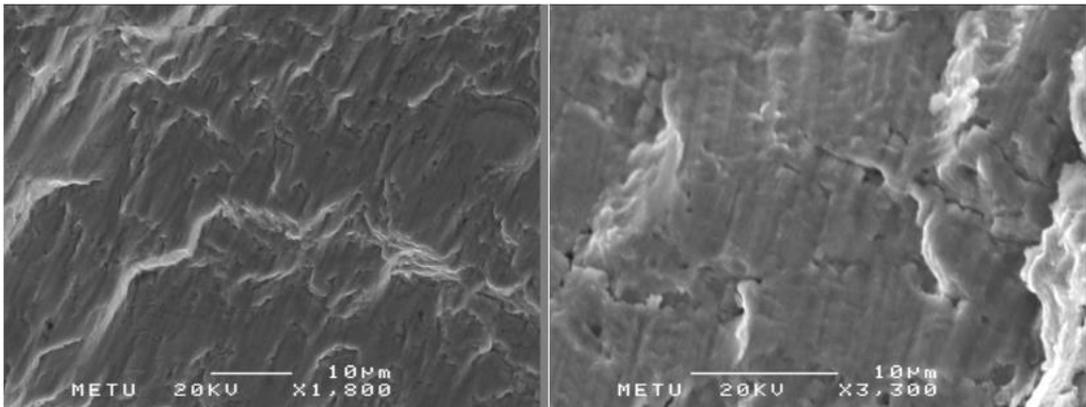
Figure 4.35. SEM images of a representative area where crack propagation can be observed on the fracture surface of uncoated sample subjected to cyclic loading under 350 N

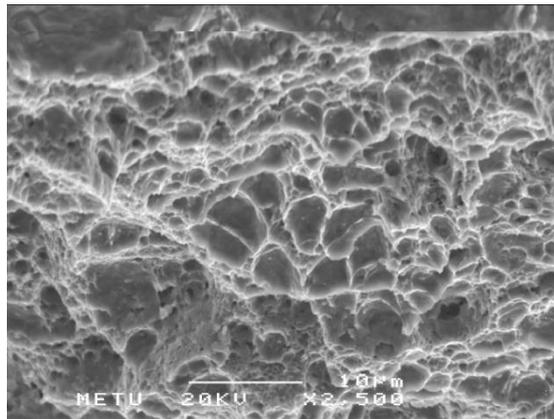
Figure 4.36. SEM image of fast fracture are ductile nature is observed on the fracture surface of uncoated sample subjected to cyclic loading under 350 N

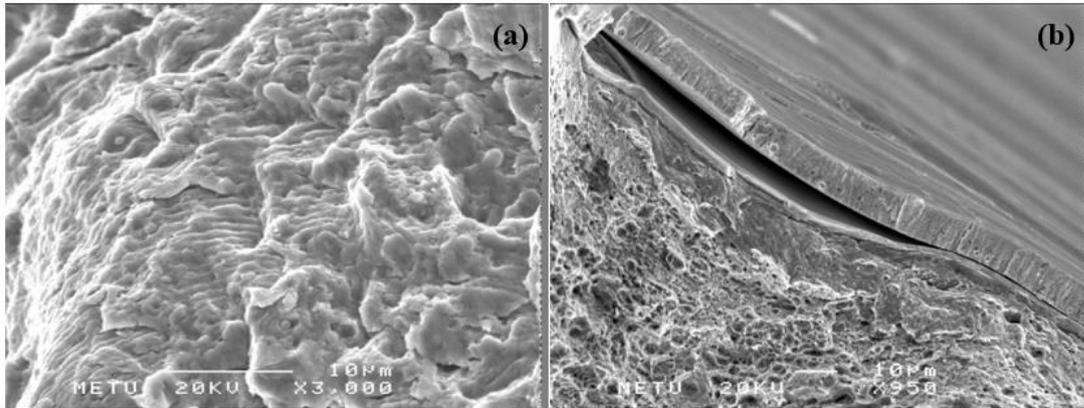
Figure 4.38. Image from the Sample (2 – 8) fractured under cyclic loading of 140 N showing (a) crack propagation at center and (b) possible fast fracture area at the edge

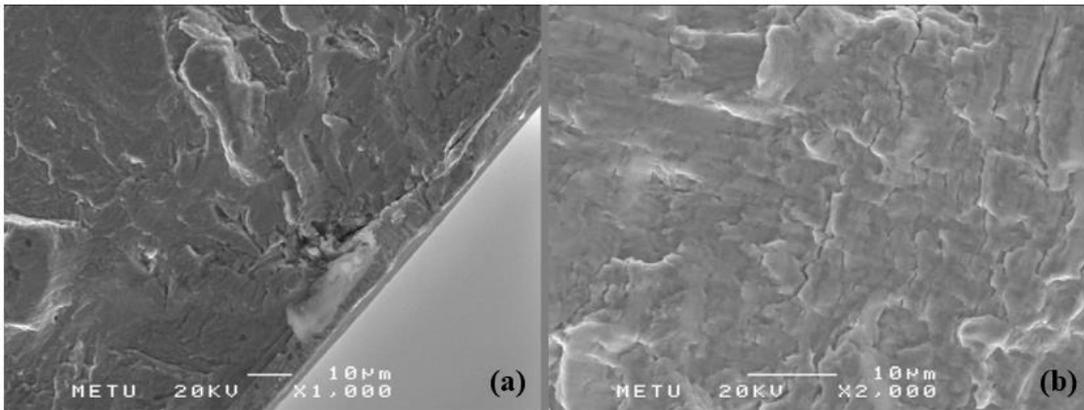
Figure 4.39. Image from the Sample (2 – 8) fractured under cyclic loading of 350 N showing (a) crack initiation and (b) crack propagation

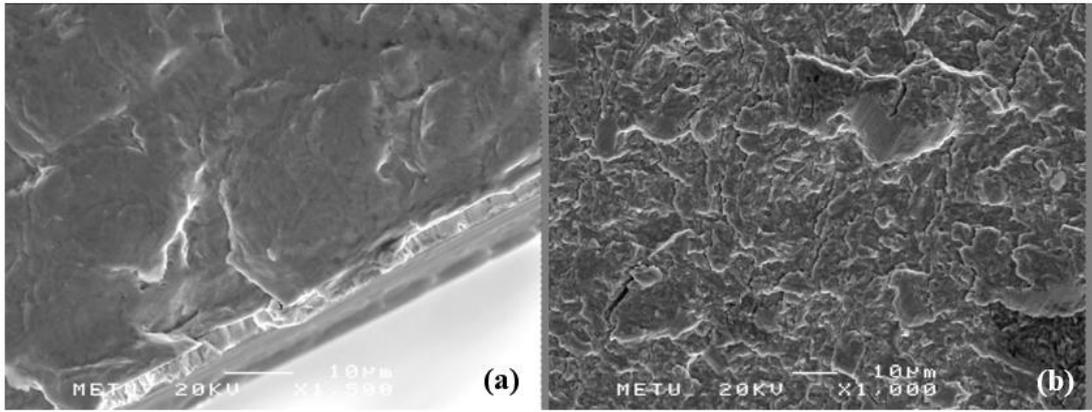
Figure 4.40. Image from Sample (4 – 4) fractured under cyclic loading of 140 N showing (a) crack initiation propagation and (b) crack propagation

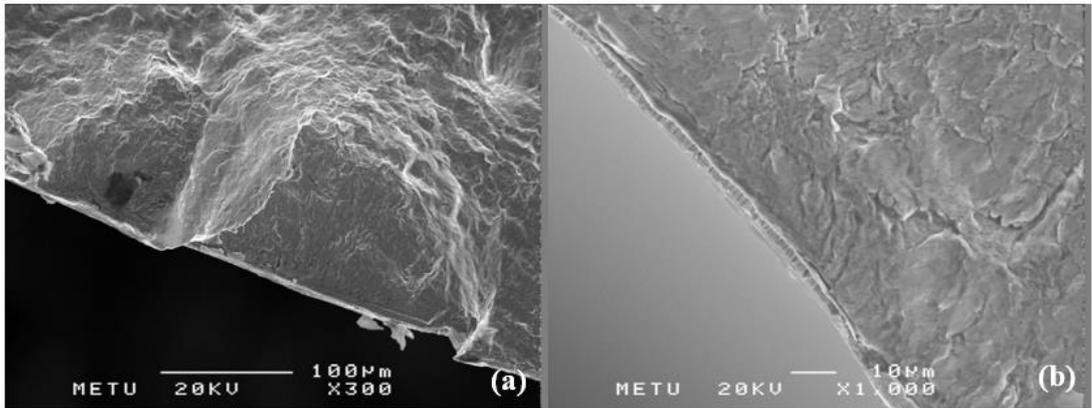
Figure 4.41. Image from Sample (4 – 4) fractured under cyclic loading of 350 N showing (a) small fatigue cracks and (b) representative fatigue area

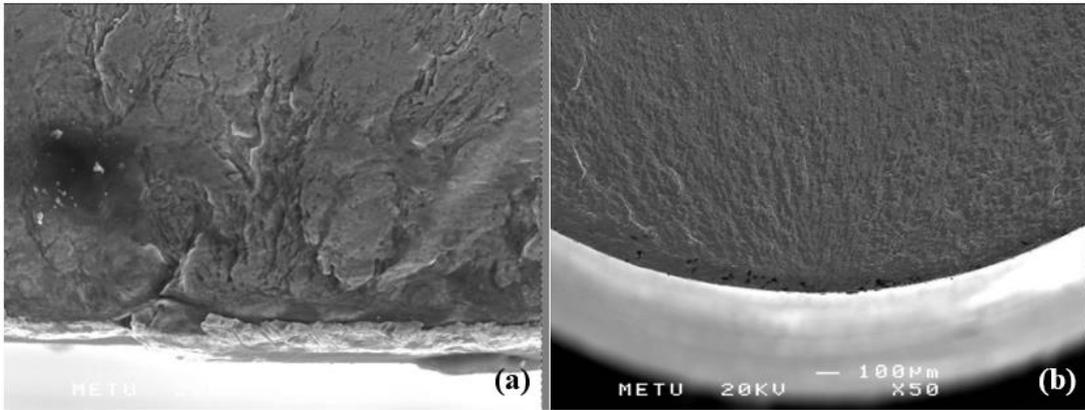
Figure 4.42. Image from the Sample (4 – 8) fractured under cyclic loading of 140 N showing (a) crack initiation and (b) crack propagation

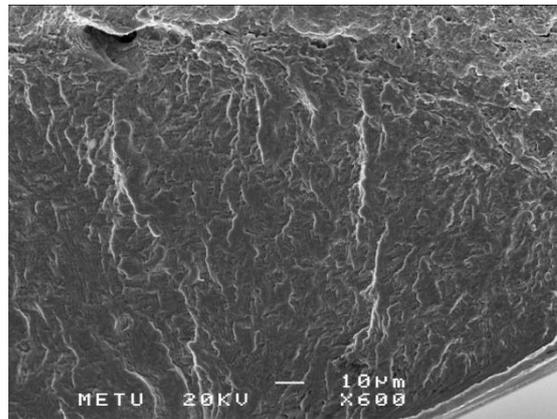
Figure 4.43. Image from the Sample (4 – 8) fractured under cyclic loading of 350 N showing river patterns at the fatigue surface

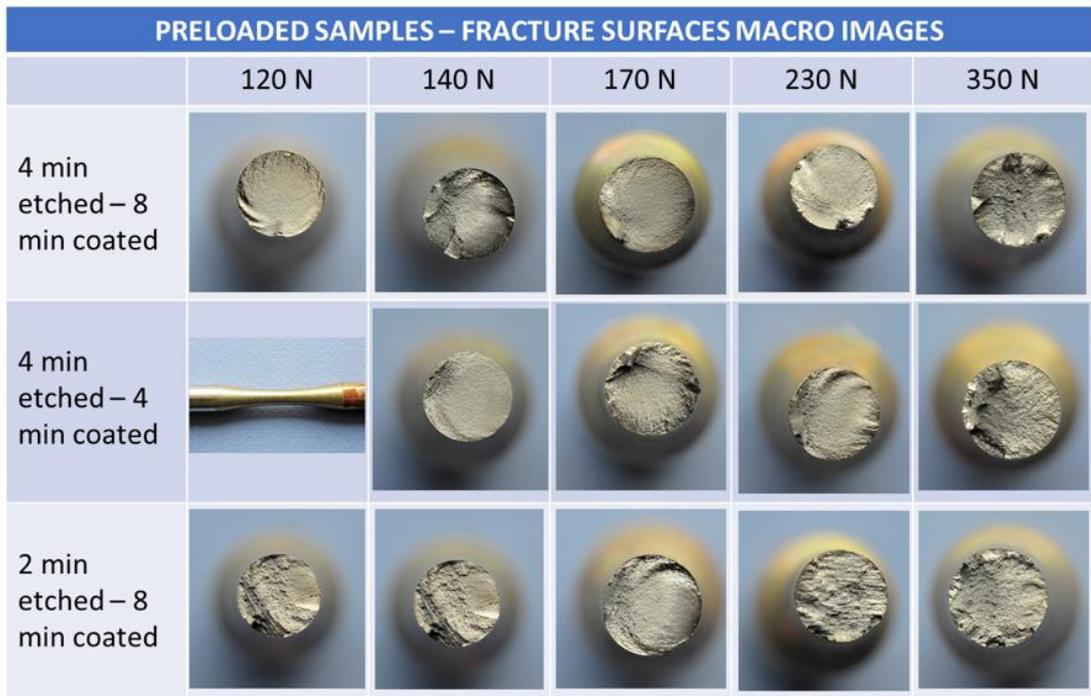
Figure 4.44. Macro images of the fracture surfaces of the samples that were coated under given conditions after the rotating beam fatigue test. The samples were preloaded prior to fatigue testing

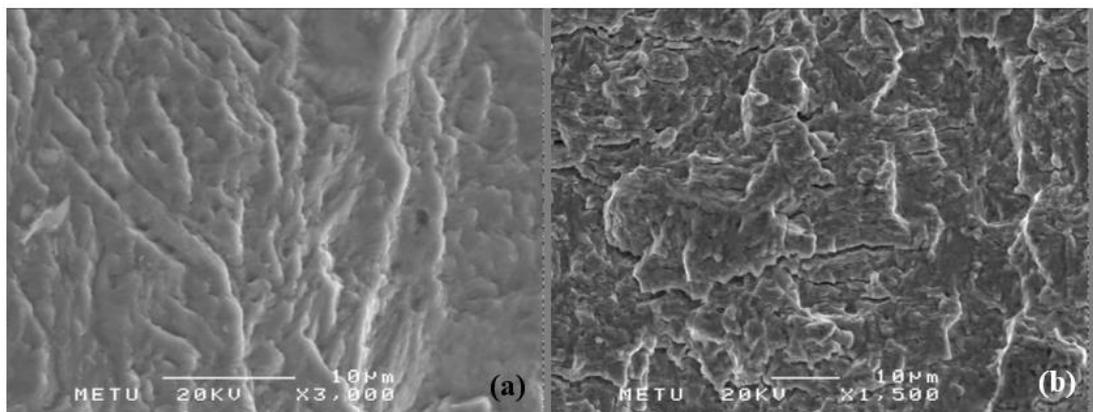
Figure 4.45. SEM images of possible crack propagation areas (a) close to edge and (b) from the centre observed on the fracture surface of preloaded sample (P2 – 8) subjected to cyclic loading under 140 N

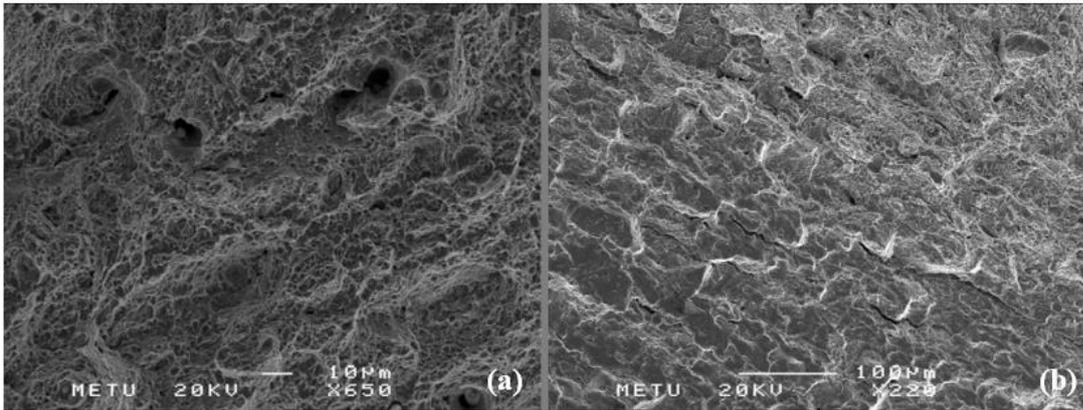
Figure 4.46. Image from the Sample (P2 – 8) fractured under cyclic loading of 350 N (a) sudden fracture area and (b) an area with intergranular fracture like appearance

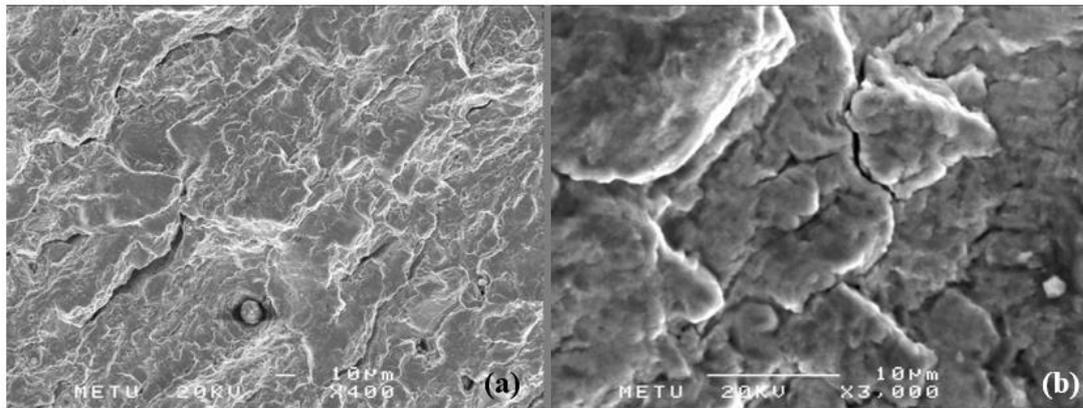
Figure 4.47. Image from the Sample (P4 – 4) fractured under cyclic loading of 350 N (a) sudden fracture area and (b) an area with intergranular fracture like appearance

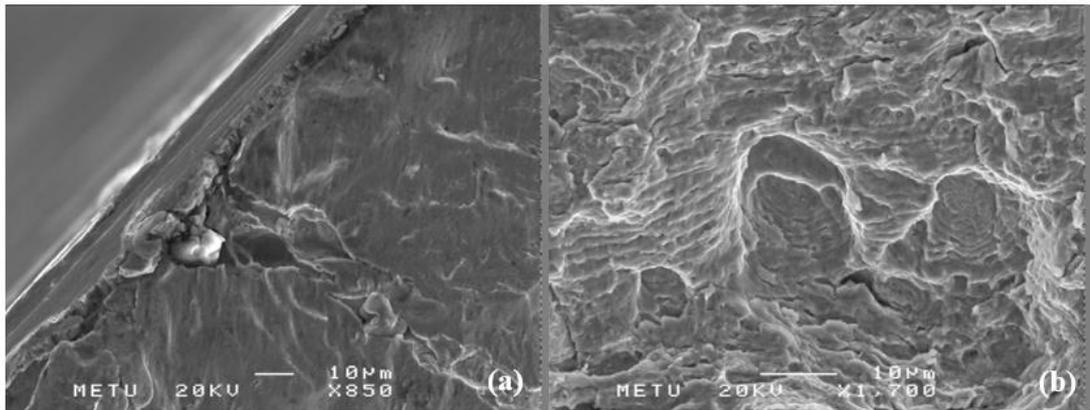
Figure 4.48. SEM images of (a) possible crack initiation point and (b) striation marks and crack propagation from the center observed on the fracture surface of preloaded sample (P4 – 8) subjected to cyclic loading under 140 N

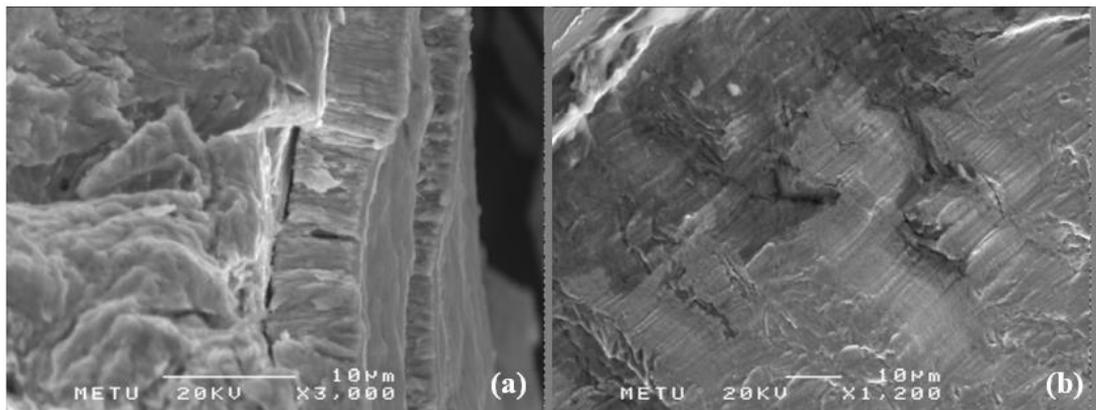
Figure 4.49. Image from the Sample (P4 – 8) fractured under cyclic loading of 350 N (a) close up of a fatigue crack and (b) typical propagation surface
