THERMAL PERFORMANCE OF THREE DIFFERENT STRAWBALE BUILDINGS AT THE KERKENES ECO-CENTER

Soofia Tahira Elias-Ozkan¹ and Francoise Summers¹

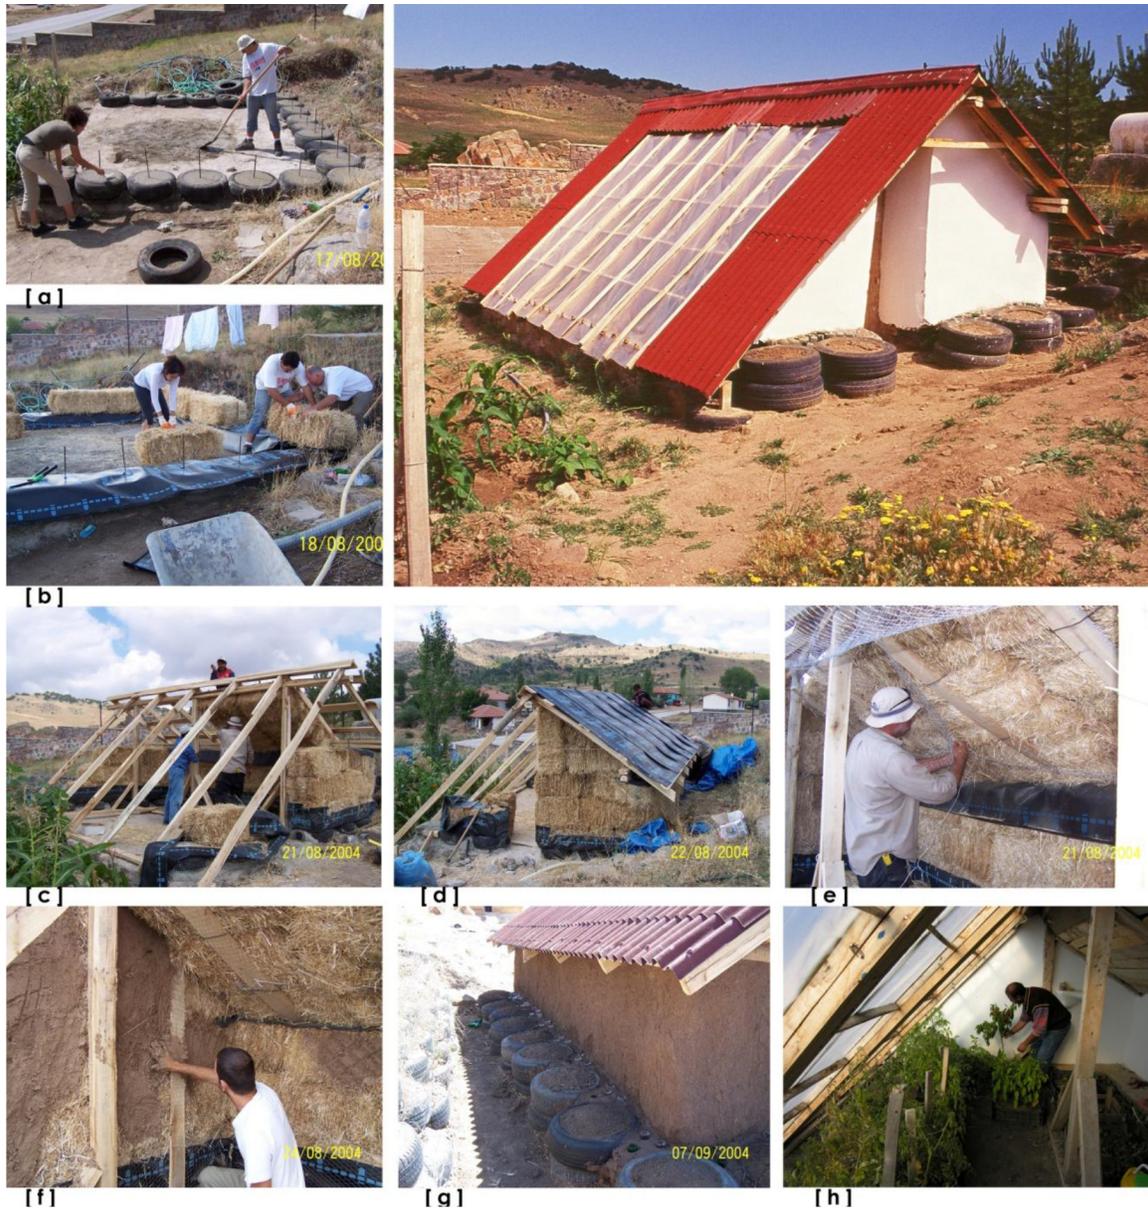
FIGURE 1. The Strawbale Greenhouse: [a] laying the foundations; [b] anchoring the first row of strawbales for the walls; [c] erecting the wooden structure; [d] roof insulation; [e] sewing on the chicken-wire before mud-rendering; [f] plastering the bales with mud and straw mixture; [g] plinth protection made of old tires, bottles and mud; [h] interior of the greenhouse.

The straw bale Greenhouse is a small building measuring 5 m by 3.75 m, built mostly with indigenous and waste material, such as straw, mud, discarded tires and glass bottles. The base of the straw bale walls was made of tires lined up on a concrete platform. The tires were

filled with stones and a meter long rebar was anchored vertically in the centre of each, before pouring in the concrete mixture. A bituminous waterproofing membrane was then laid on top of the plinth and the first row was anchored down by impaling the bales on the rebar that had been embedded in the tire foundation. The subsequent rows were laid in a running bond and pinned down by driving rebar through them at regular intervals.

The walls on three sides are load-bearing and support the timber structure for the sloping straw bale roof; which is also held up in the middle by timber posts. The bales placed on the

roof were covered with a waterproofing membrane and bituminous corrugated roofing sheets for protection from rain and snow. The entrance door was inserted in the side wall between two posts. Bale needles were used to secure the chicken wire net to both sides of the straw bale walls and the ceiling, in order to bind the mud and straw plaster to the bales. Two layers of plaster were applied: first a rough coat by hand and then a second coat with hawk and trowel. After the plaster had dried completely, lime wash was applied to the walls and wooden planks were nailed on the ceiling to support the weight of the straw bales. The sloping southern façade was covered with a thick transparent nylon sheet, instead of glazing. Car tires and discarded glass bottles were used to build a protective bench around the greenhouse. The straw bale greenhouse and its construction stages are shown in Figure 1.

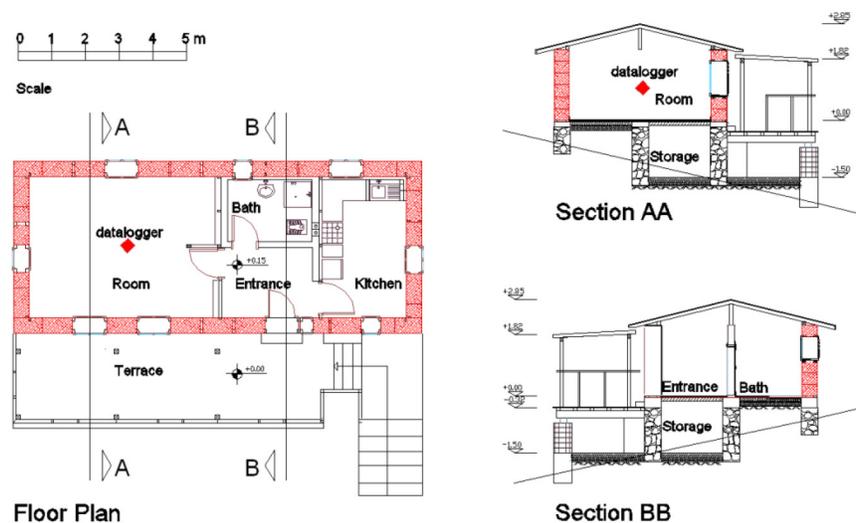
FIGURE 2. Floor plan and sections of the Strawbale House, showing location of the datalogger.

The Strawbale House is a single-storey building with a total covered area of 96m², including the terrace; and a net usable area of 54.4 m². It consists of a living room, a kitchen, a bathroom and an entrance vestibule. The sloping ground permitted the provision of an open storage space under a part of the floor slab. The floor plan and the construction stages of the Strawbale House are shown in Figures 2 and 3 below.

The foundations and above grade walls of the house were built with stone masonry and concrete mortar, up to plinth level. Tires filled with rubble and concrete were placed, one on top of the other, to form columns that supported the terrace deck. Water proofing was applied to the foundations and below-grade walls. Reinforced concrete tie beams were poured at the plinth level, and the ground floor slab was made by pouring concrete over a bed of rubble stone. A water proofing membrane was laid down on the tie-beams and the timber frame structure was erected on these beams. The foot-plate of the timber frame was fixed to the concrete plinth by means of rebar that had been anchored into the concrete at regular intervals. Glass wool was laid between the two parallel timbers components of the foot-plate before constructing the straw bale infill walls. Half a meter high rebar had been embedded into the tie beams before pouring the concrete and the first layer of straw bales was anchored to the beams by

The second set of data discussed here illustrates the thermal behavior of the two straw-bale buildings during summer and winter months. Temperature and humidity values were recorded at 15 minute intervals throughout the year with three Tinytag dataloggers. One was placed inside the Strawbale House, on a wooden desk at the center of the main room; another was placed at the center of the Workshop on a wooden stool, and a third was hung outside at a height of 2.5m (8ft) from the ground, under the eaves of a nearby building in the Eco-center. The locations of data loggers inside the Strawbale House and the Workshop are shown in Figures 2 and 4, respectively.

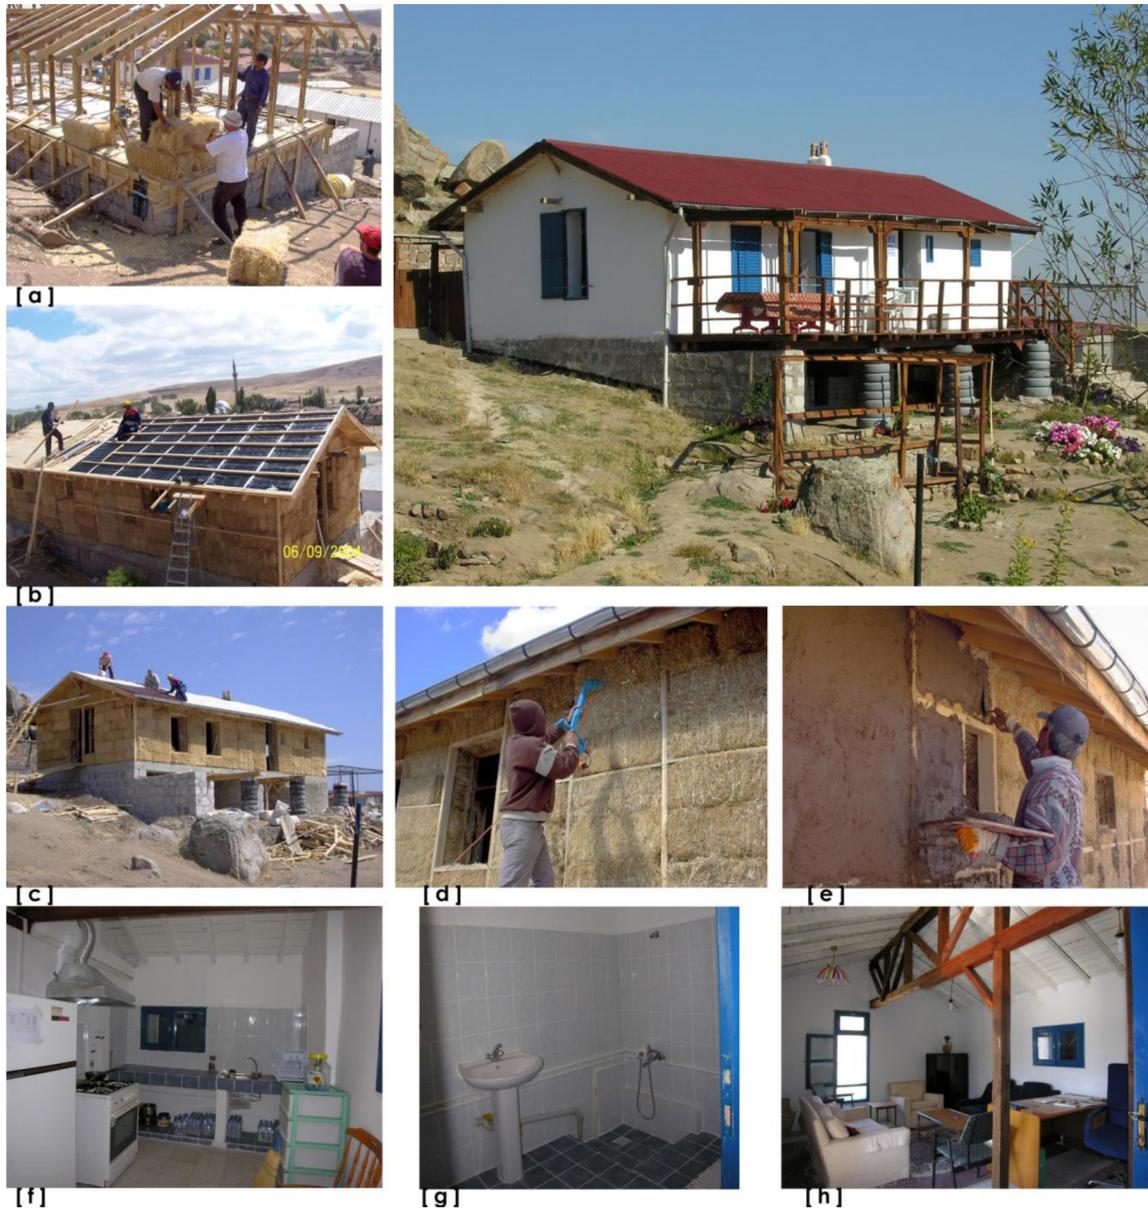
FIGURE 3. The Strawbale House: [a] Timber structure on stone foundations; [b] erecting the roof structure; [c] finishing the roof; [d] trimming the straw; [e] applying mud-plaster on the walls. [f] The kitchen; [g] bathroom; [h] and interior of the strawbale house.

impaling them on these bars. Bales measuring $45 \times 90 \times 35$ centimeters were stacked plumb and level in a running bond, while smaller gaps were stuffed with loose straw. In this way the external straw bale walls were built up to the timber roof-plates, which provided rigidity to the timber structure and also helped to contain and stabilize the stacked up straw bales.

A timber truss supported by the walls and posts ran along the centre of the building to hold up the roof ridge. Rafters spanning the distance between the central truss and the peripheral roof plates supported the timber roof decking, which in turn was covered with a waterproofing membrane, 5 cm thick glass wool insulation bats and bituminous corrugated roofing

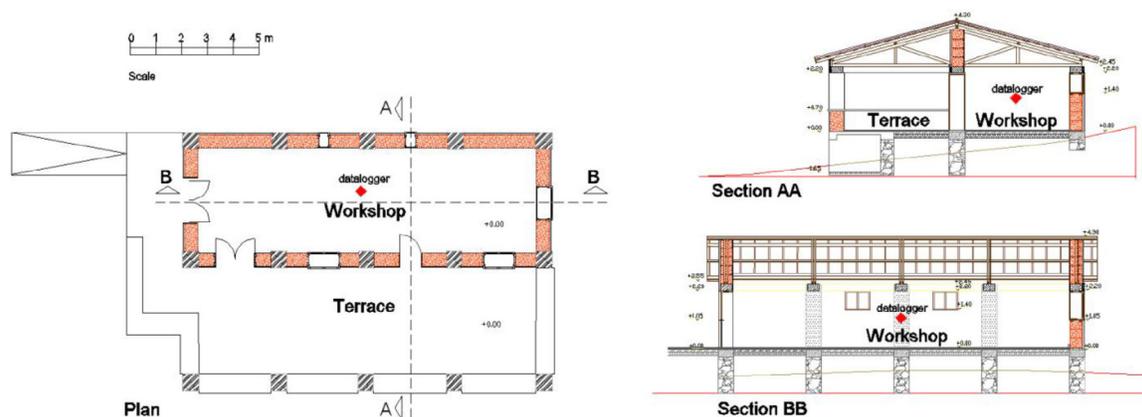
FIGURE 4. Floor plan and sections of the Strawbale Conservation Workshop showing location of the datalogger.

The Conservation Workshop has a net usable area of 63.4 m² and consists of a large multi-purpose hall with an equally large covered veranda in front. As this building was also constructed on a sloping site, storage space could be provided under the floor slab of the veranda (Figs 4 and 5). Since the building was built for conservation of stone elements from the nearby archaeological site, it was necessary to minimize fluctuations in humidity levels as well as prevent winter minimum temperatures to drop below frost level even during the winter season when the building is neither used nor heated. The innovative combination of straw bale and AAC blocks provided a very high level of heat insulation while the internal mud plaster rendering helps regulating humidity levels within the building. Details of the construction process are given below.

Just like the Strawbale House, the foundations and above grade walls of this building were also built with stone masonry up to plinth level. However, the superstructure was very different; the structural system was composed of Autoclaved Aerated Concrete (AAC) piers (columns) and reinforced concrete beams instead of a timber frame structure. The 60 × 60cm piers were fashioned out of three 20 cm-thick AAC blocks laid side by side, each course being perpendicular to the previous one. The concrete tie beams were anchored to these piers and

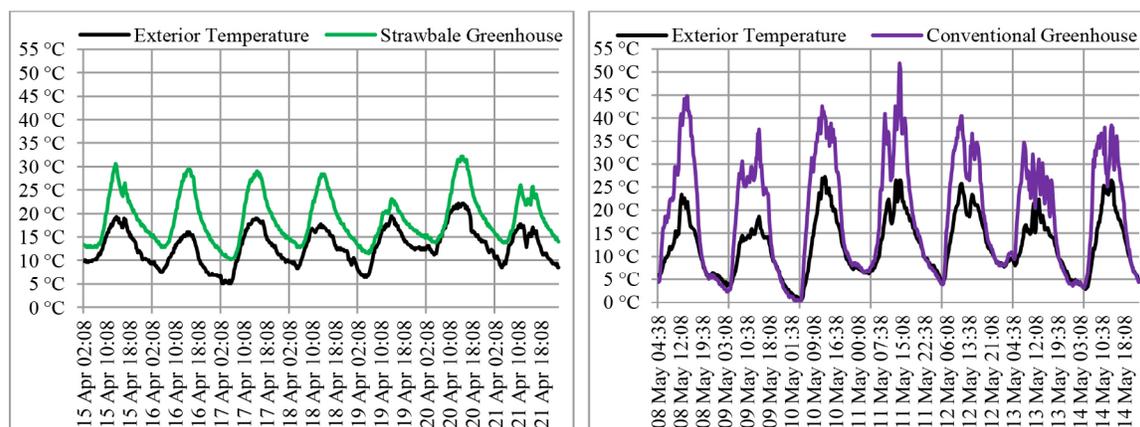
FIGURE 6. Indoor temperature readings collected during a week in spring from the Strawbale Greenhouse and the Conventional Greenhouse, as well as the external temperatures at their locations.

Comparison of data from the Kerkenes Strawbale Greenhouse and the Balaban Conventional Greenhouse clearly illustrates the difference in the behavior of the two structures even if the data could not be collected simultaneously. Temperature and humidity data were recorded, first in the straw bale greenhouse, from 10th to 25th April 2006, and then in the conventional greenhouse, from 7th to 28th May 2006. In order to compare the thermal behavior of the two greenhouses, charts prepared for a week long data set from each greenhouse are presented side by side in Figures 6 and 7.

As seen from the charts below, solar gains led to much higher daytime temperatures within the greenhouses except for the days when solar radiation was reduced due to cloud cover; *e.g.* the fifth day in the Strawbale Greenhouse location. On the other hand, night time

temperatures dropped to the level of exterior temperatures in the conventional greenhouse, leading to a daily fluctuation from 35 to 40 °C; while in the Strawbale Greenhouse the night time temperature never went as low as the exterior, thus maintaining a 15 °C fluctuation (see Fig. 6). This phenomenon was also observed during winter months when incident solar energy was low due to snowfall, yet interior daytime temperatures in the straw bale greenhouse remained higher than the exterior. Similarly, during the night, when temperatures dropped below freezing, the nighttime temperature remained above 0 °C due to the high thermal-insulation properties of the strawbale walls.

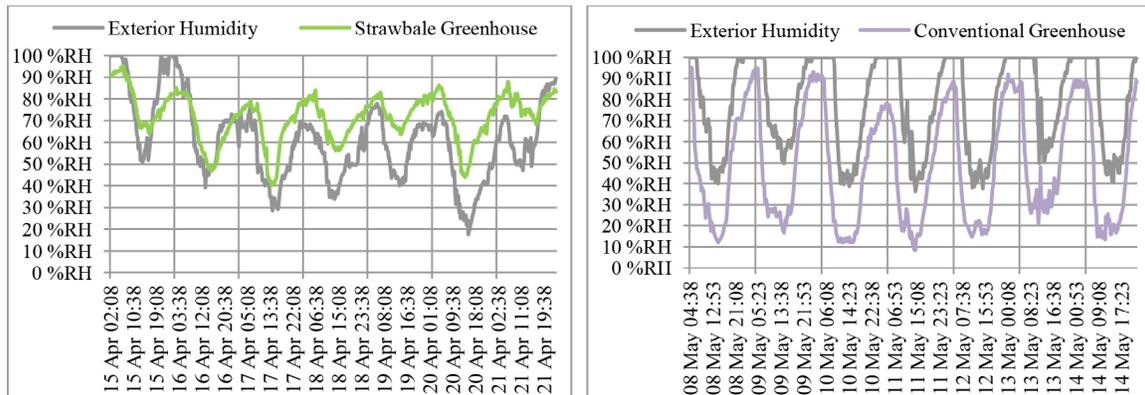
FIGURE 7. Humidity readings from the two greenhouses and the two locations during a 7 day period in spring.

The relative humidity charts show how the levels fluctuate within a 30% range in the straw bale greenhouse even when outside weather fluctuations are up to 60%; but the fluctuations in the conventional greenhouse are observed to be much higher, to the order of 70% (see Fig. 7). Since higher temperature in winter season and stable humidity levels are desirable in a greenhouse the straw bale greenhouse can be declared as superior to a conventional one. These attributes were seen to extend the harvesting season at Kerkenes well into the winter months.

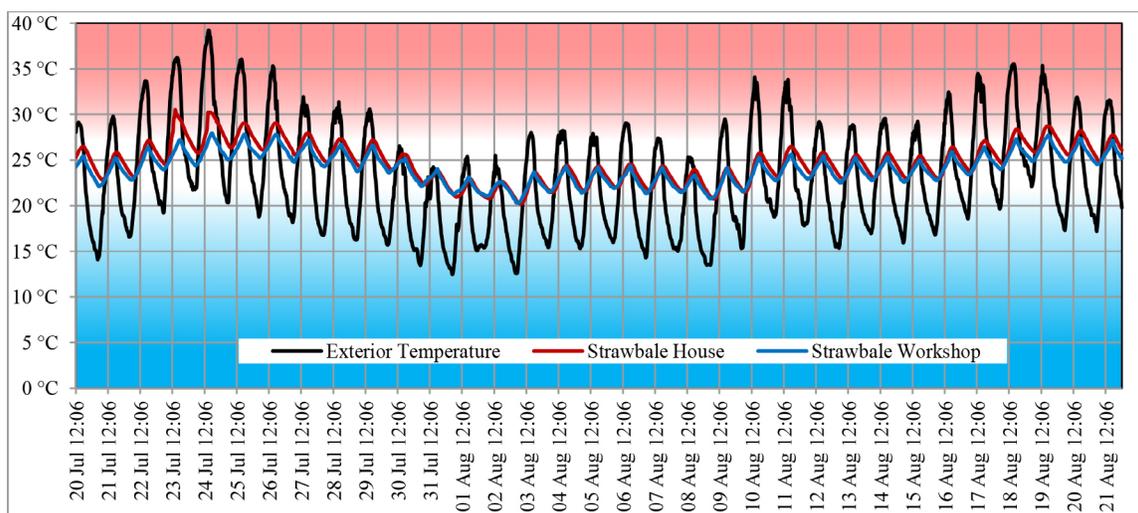
FIGURE 8. Temperature data from the exterior and interior of the two strawbale buildings at the Kerkenes EcoCenter during four weeks in summer; the graph shows diurnal fluctuations as well as the thermal comfort band.

Although strawbales do not have enough thermal mass to provide an interim heat sink that helps to keep temperatures stable and prevents them from rising to discomfort levels, its higher thermal insulation overcomes this drawback. This is evident from the comparative temperature charts prepared from data collected in both summer and winter months (Figs. 8 and 9). There was considerable diurnal fluctuation in external weather conditions and though the temperature within the buildings fluctuated parallel to outside temperature fluctuations, this amount was significantly lower in the strawbale buildings. For example during summer time when the difference in external diurnal temperatures is to the order of 15 °C the interior temperature fluctuates by about 3°C only. For this reason even when external temperature rises to 35 °C the internal temperatures do not exceed 27 °C. The Workshop is seen to be one degree cooler during the day as compared to the Strawbale house, due to the deep covered verandah along its southern façade, which prevents solar gains.

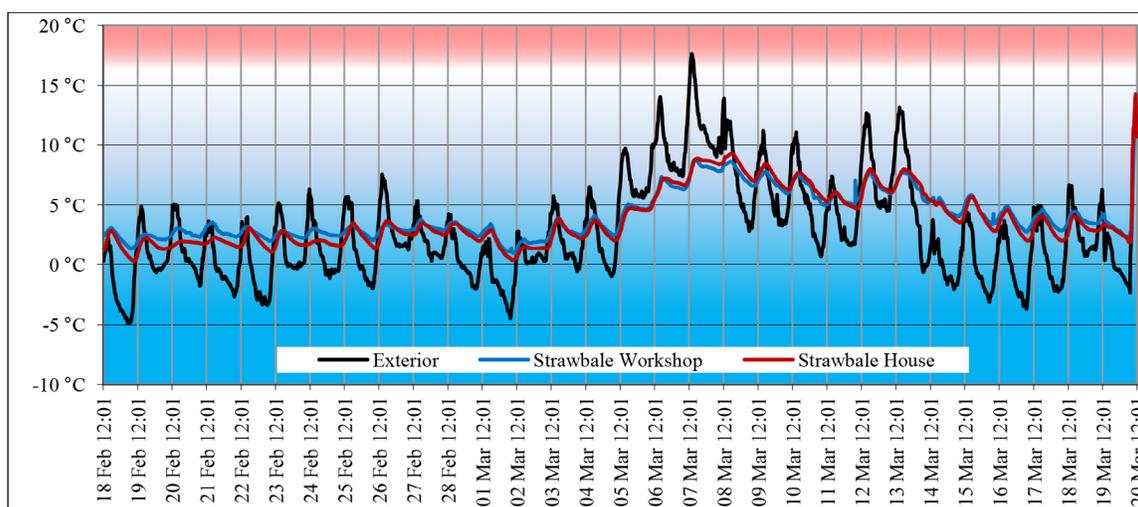
FIGURE 9. Temperature data from the exterior and interior of the two strawbale buildings at the Kerkenes EcoCenter, during four weeks in winter; the graph shows diurnal fluctuations as well as the thermal comfort band.

Similarly, during winter time, the diurnal fluctuations outside are around 7 to 8 °C while those inside the buildings are barely 1 to 2 °C; i.e. the conditions within remain fairly stable. On the other hand the temperature within the Strawbale House is slightly lower than that in

the Workshop. However, both buildings show parallel trends in their graphs, which means that they respond in the same way to external weather conditions. And though the response time-lag is also similar, the Workshop building is slightly faster than the House in responding to external weather conditions.

(Fig. 11). Additionally, the absence of a covered verandah in the strawbale House also allows the winter sun to keep the walls dryer. On 7th March (see Fig. 9) when the external temperature rose unexpectedly to almost 18°C as compared to only 2°C in the week before, and the humidity level dropped to 30% (see Fig.11) the relative humidity went down to only 67% in the strawbale workshop and 76% in the strawbale house.

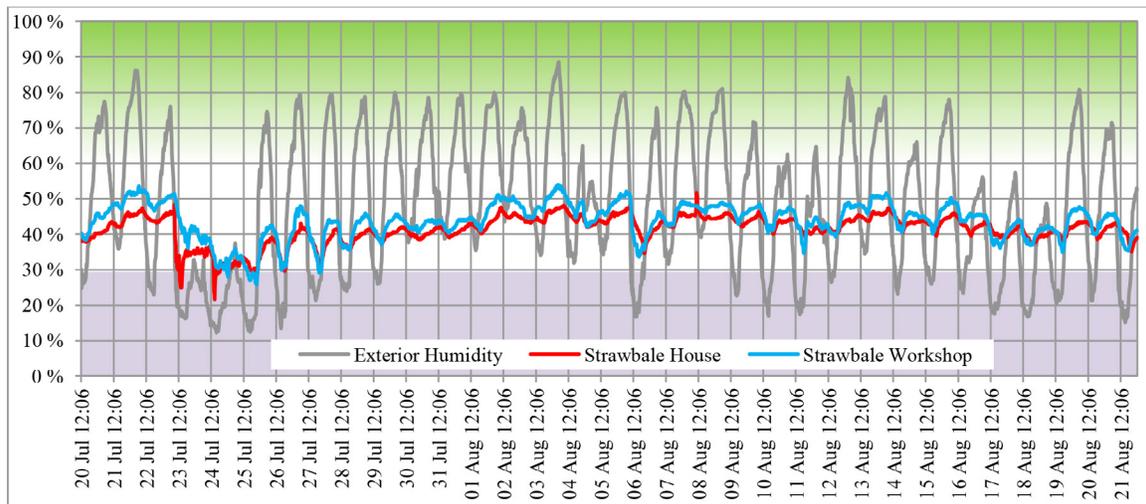
FIGURE 10. Humidity data from the exterior and interior of the two strawbale buildings at the Kerkenes EcoCenter, during four weeks in summer; the graph shows diurnal fluctuations as well as the humidity comfort band.

The comparative charts (Figs. 10 and 11) for relative humidity data collected inside and outside of the buildings show that humidity levels in the straw bale building remain pretty stable even when outside fluctuations are high. This is due to the humidity regulating properties of the mud plaster on the interior, thus ensuring that relative humidity remains within the comfort range.

On clear sunny days during the summer months when outside humidity levels may change by 60%, for example on 26th July when minimum and maximum levels were recorded to be 20 and 80%, the variations within the two buildings are limited to 10% only and the minimum and maximum levels were within the comfort range (40% and 50%). Despite comparable temperatures inside the two buildings (as shown in Fig.8) humidity in the strawbale house is a little less than in the Workshop because the external walls in the former are rendered on both sides by mud-plaster whereas the external finish in the latter is AAC blocks.

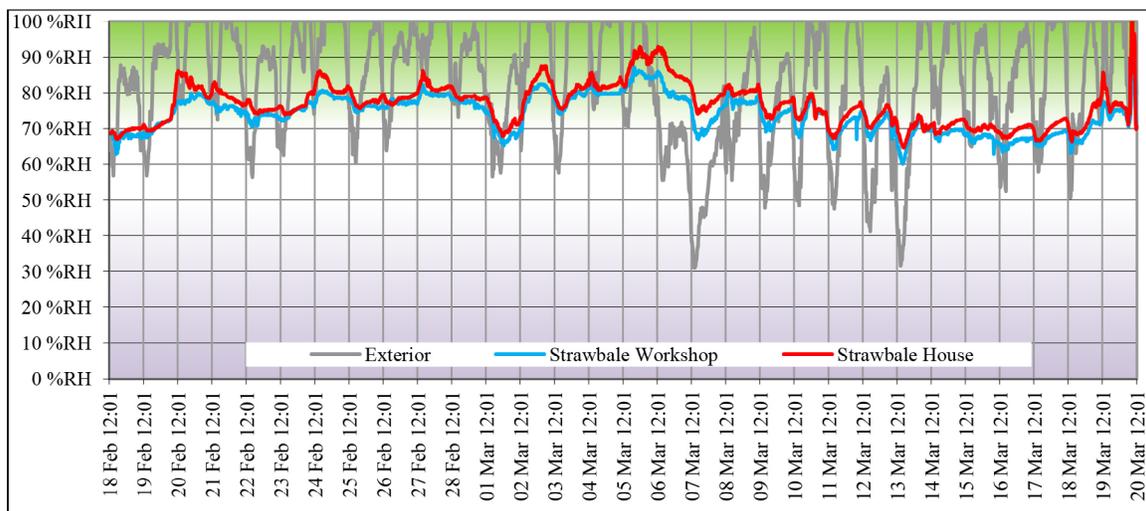
FIGURE 11. Humidity data from the exterior and interior of the two strawbale buildings at the Kerkenes EcoCenter, during four weeks in winter; the graph shows diurnal fluctuations as well as the humidity comfort band.

As can be seen from the data for winter, during wet or snowy winter days when the humidity levels rise to 100%, the internal levels rarely exceed 80% within the two buildings

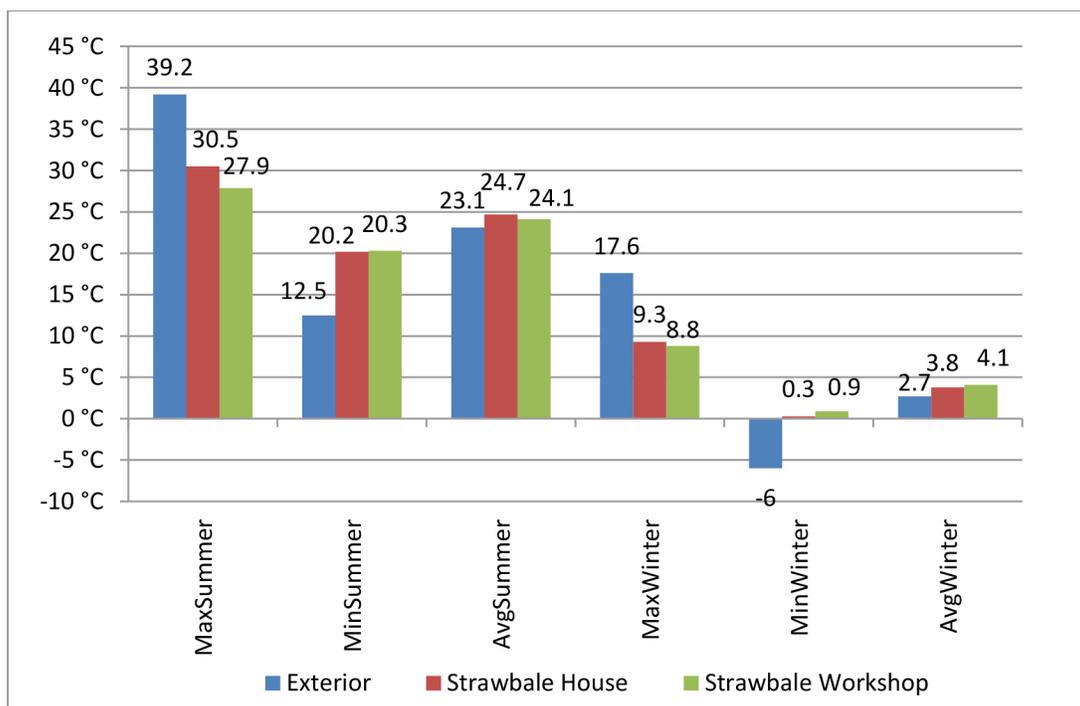
FIGURE 12. Bar chart showing differences in outdoor and indoor temperatures during hot and cold weather conditions.

The “Thermal Comfort Tool for ASHRAE-55” developed at UC Berkley by Hoyt *et al.* (2012) was used to input temperature extremes and averages to calculate thermal neutralities. When the adaptive method was used to determine indoor operative temperatures within 90% acceptability limits, the range was calculated to be 27.5 to 32.5°C for maximum outdoor temperature of 39.2°C. As shown in Figure 12, the maximum temperatures in both the strawbale buildings are within this range. Similarly, the buildings were comfortable even when the minimum outdoor temperature fell to 12.5°C in summer as the indoor temperatures were within the 90% acceptable range of 19.2 to 24.2°C (see Figure 12). In other words, during summer time the buildings were comfortable even without ventilation. On the other hand,

during winter when the outside temperatures were below freezing point the temperatures inside, though uncomfortable, remained above 0°C even when the building had not been heated for weeks on end. Yet, due to the super insulating properties of strawbale walls it is possible to keep the buildings warm with very little heating for a few hours a day (Elias-Ozkan *et al.*, 2006 & 2008).

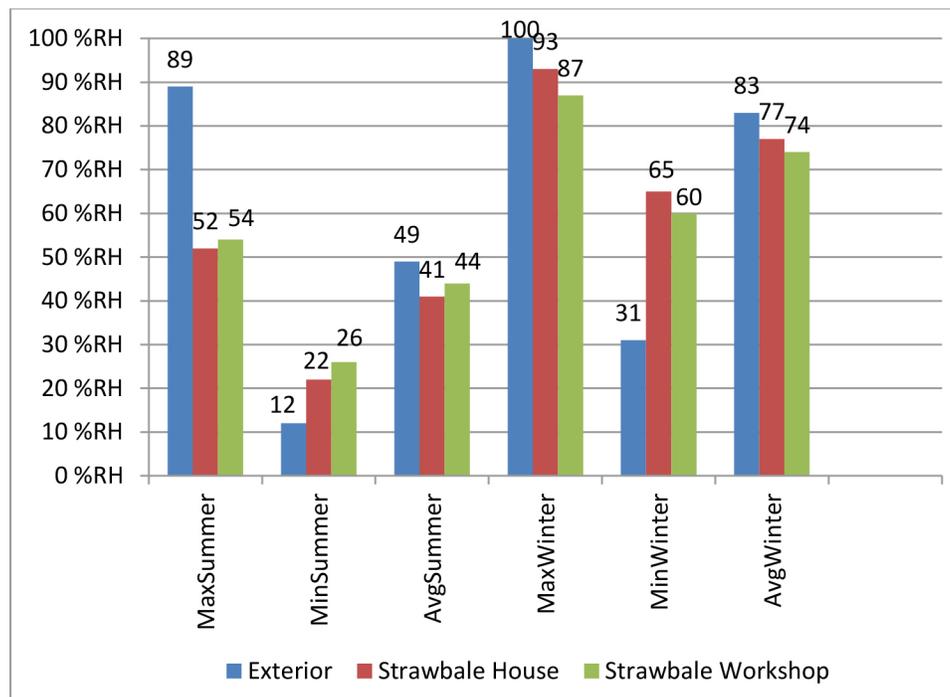
FIGURE 13. Bar chart showing differences in outdoor and indoor humidity levels during hot and cold weather conditions.
