AN INQUIRY INTO THE VALUES AND PROBLEMS FOR CONSERVATION
OF TRADITIONAL MUD BRICK HOUSES IN AĞLASUN, BURDUR

A THESIS SUBMITTED TO
THE GRADUATE SCHOOL OF NATURAL AND APPLIED SCIENCES
OF
MIDDLE EAST TECHNICAL UNIVERSITY

DECEMBER 2019

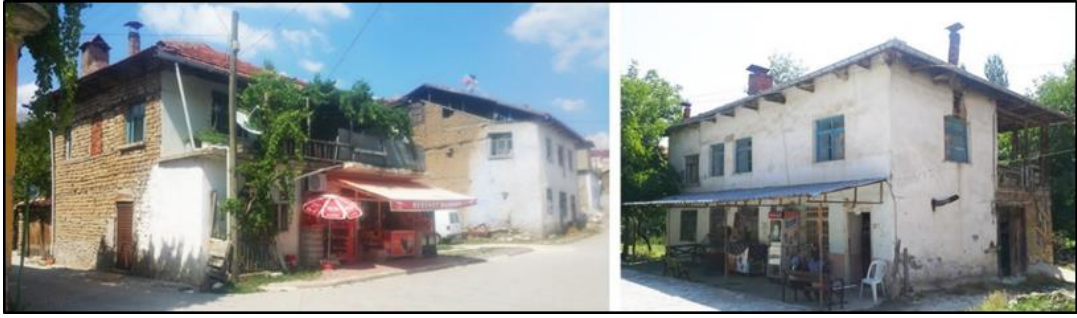
Figure 9: Photos on the both left and right sides show that two storey traditional mud brick masonry houses whose ground floors are used as grocery shops of neighbourhoods that they exist.

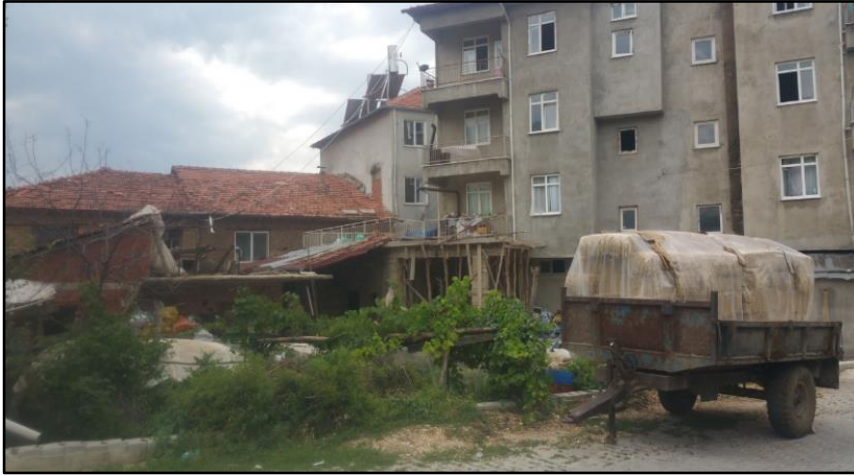
Figure 14: *The conflict between the new housing and the traditional one in Ağlasun.*

Today, especially in the Çınar Neighborhood, where reinforced concrete structures become widespread has started to dominate the characteristic built environment of the district, which is formed by traditional architectural fabric (**Figure 14**).

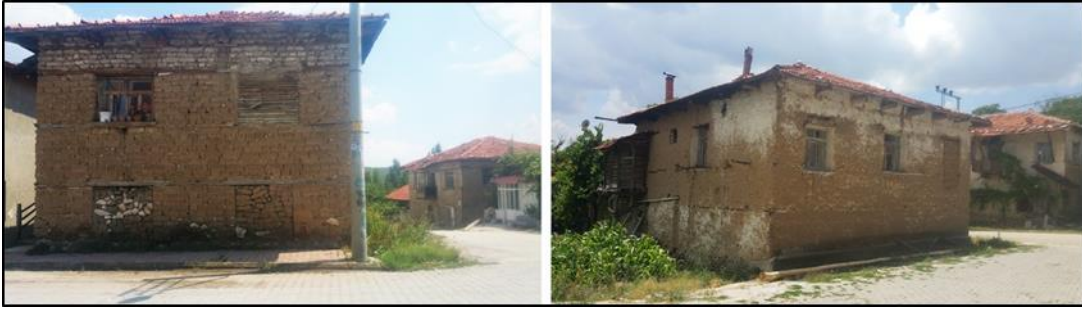
Figure 16: Street views show traditional mud brick masonry houses, located separately, in Ağlasun and the stone masonry constructed up to the sub-basement level.

First one consists mud brick masonry houses, in which the stone masonry is used for constructing the walls of foundation continuing just till the sub-basement level (**Figure 16**). Second one is the houses whose ground floor is constructed with stone masonry while the first floor of them constructed with mud brick masonry system (**Figure 17**). The last group includes stone masonry houses, mostly in which ‘*Köğke*’

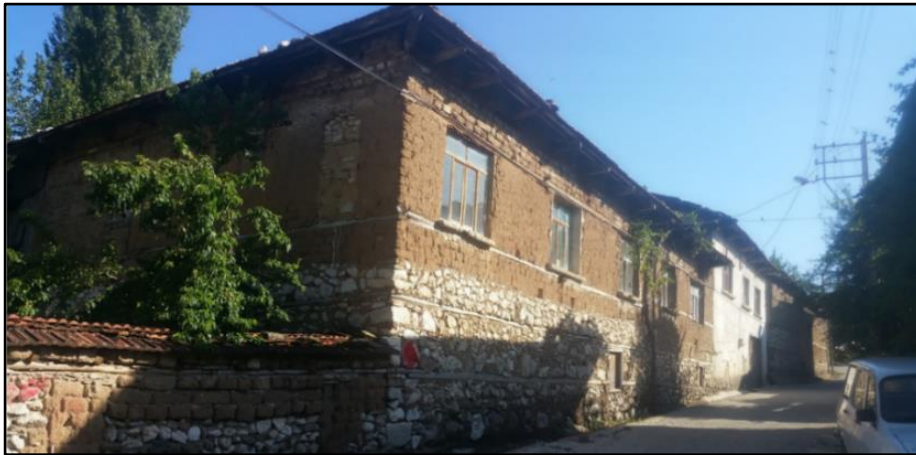
Figure 17: The street view showing traditional mud brick masonry houses, located adjacently, in Ağlasun and the house with the stone masonry, constructed up to the first floor level.

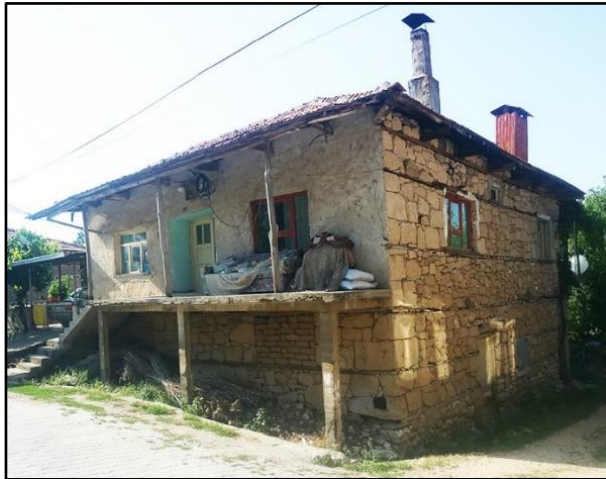
Figure 18: *The traditional house, completely built with stone masonry construction technique.*

is used in the form of a cut stone over the rubble stone masonry used for the sub-basement (**Figure 18**). The first two are discussed in the scope of this thesis.

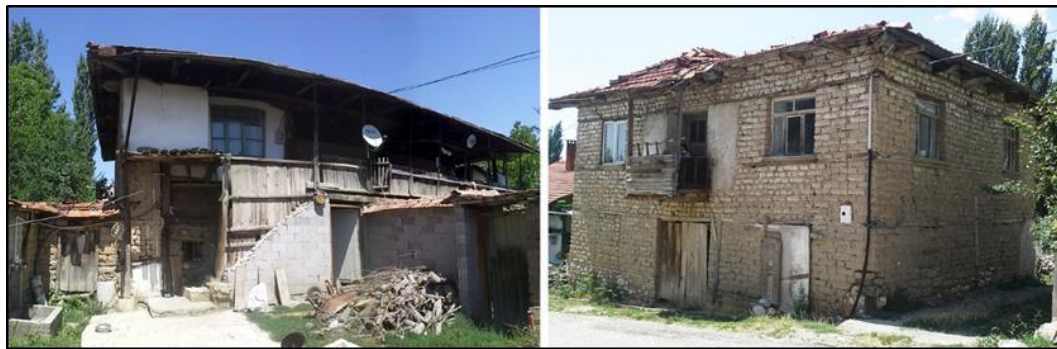
Figure 19: *The early period house on the left and the late period house on the right.*

Traditional Ağlasun houses are also divided into two as the early and late period buildings (**Figure 19**). Spatial relations and mass characteristics of the buildings as reflections of these two periods are explained in the following chapter within the scope of 19 houses studied.

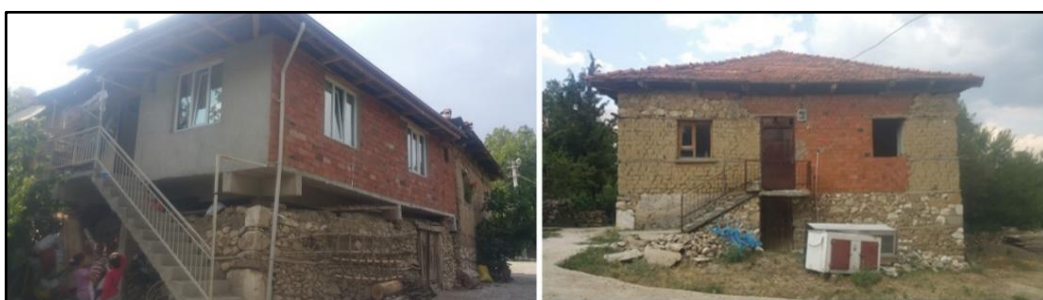
Figure 20: The structural transformation of the traditional mud brick masonry houses in Ağlasun.

However, local people have started to prefer new buildings for accommodation because the traditional houses have become insufficient in time for the contemporary needs of dwellers. Decrease of number of local builders who know traditional construction techniques, easy accessibility of industrial building materials are the causes that locals, who do not have the possibility of moving to newly built houses, prefer using these materials for the interventions to repair or increase the capacity of their traditional houses and this attitude mostly causes a dangerous transformation of traditional structures (**Figure 20**). These changes on traditional mud brick houses are discussed in more detail in the following sections.

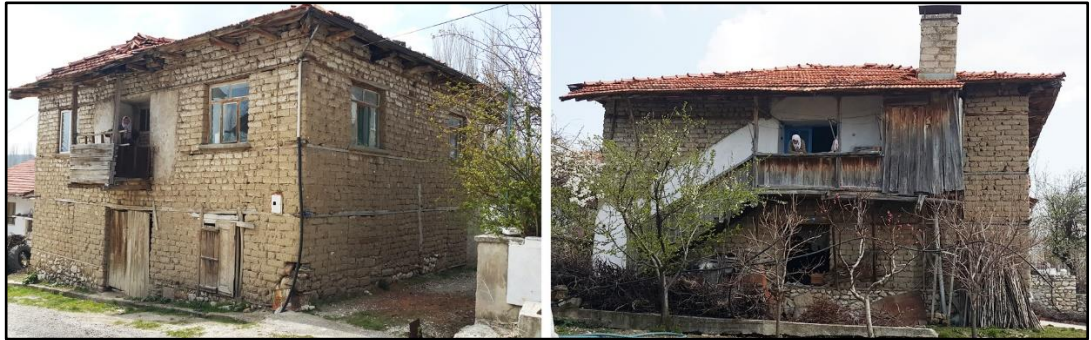
Figure 24: Photos from H-15. On the left, northeast facade facing to the street; on the right, southwest facade facing to the garden.

During the interior surveys among the 19 houses, the House-15, which is located in Bala Neighborhood, was studied by taking detailed measurements in order to obtain and present more information about its construction system as an example among the studied houses (**Figure 24**).

There were some factors for the selection of this house. Compared to other 18 houses studied, architectural and structural interventions by dwellers were minimal and there was no spatial intervention in the House-15. Moreover, it had an undamaged structure except the material loss at the corner of the house. In addition to these, for this selection, the consent and the willingness of dwellers to participate to the study by sharing their knowledge about the house was also essential.

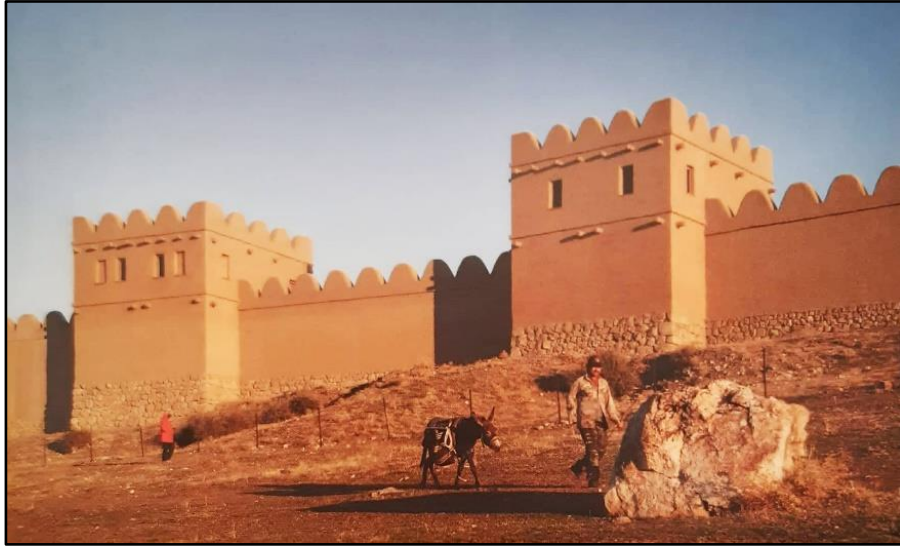
Figure 28: West view of the reconstructed fortification wall. (Seeher, 2007, p. 17)

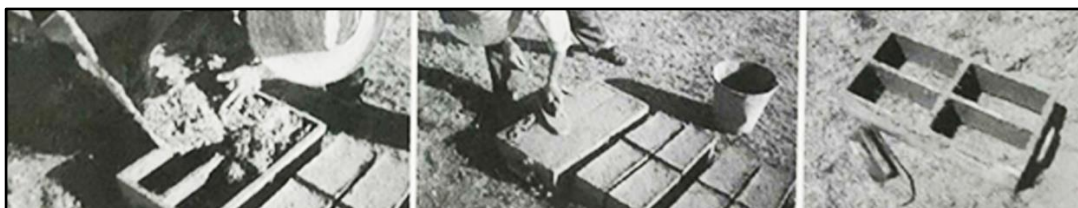
Figure 30: *Mud brick production with traditional molds and equipment. (Cookson, 2010, as cited in Kafescioğlu, 2017, p. 106)*

Kafescioğlu (2017, p. 165) states that this resting period of the mixture provides a homogeneous distribution of the moisture in it and causes the interaction, which probably provides an improvement, between minerals and substances in the mixture. The rectangular wooden moulds are prepared 1-2 cm wider than the dimensions of desired mud bricks because shrinkage occurs during the drying process (**Figure 30**). Water is added to the mixture to achieve the appropriate consistency before pouring it in the prepared moulds, so in this way the mixture is given a certain amount of fluidity. Then, after the mixture is poured into the wooden moulds, it is compressed with a trowel. Drying process takes place under the shadow so that no

cracks occur. It is important to ensure that all four surfaces of the blocks are dried evenly. For this purpose, they are turned vertically after one or two days. Finally, the blocks are collected and stacked.

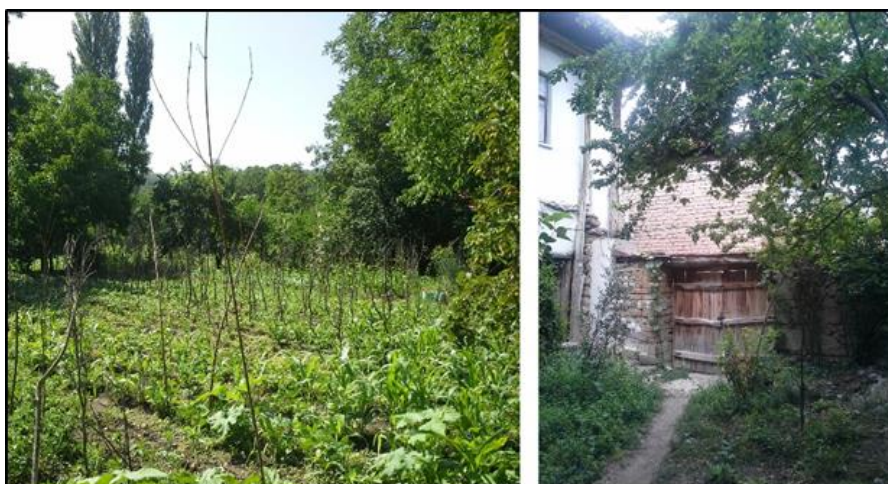
Figure 34: *On the left the garden in H18; on the right is the courtyard at H14.*

Open areas in the lots are defined as gardens or courtyards (**Figure 34**). As mentioned above, gardens exist in larger parcels. They are located at the back side of the houses one facade of which defines the adjacent street. Gardens have neither walls, nor doors opening to the street. On the other hand, the courtyards are open areas surrounded by walls, which were built along the parcel boundaries with at least two meter height. These masonry walls were built with rubble stone, cut stone or mud brick. On these walls, there are double-winged, wide and tall wooden courtyard doors which are suitable for animal transfer.

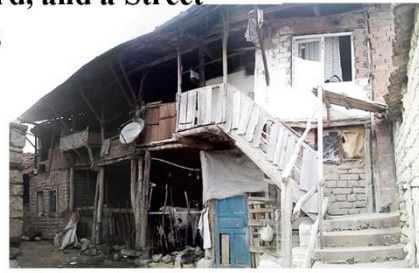
H13

with a courtyard and a 'saçak' (L_1b)

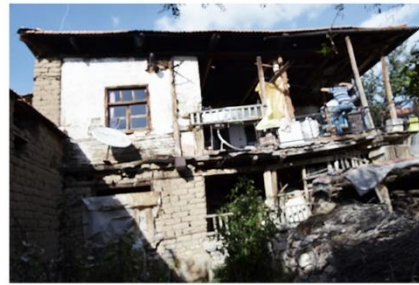
with a courtyard, a 'saçak' and a garden (L_1b)

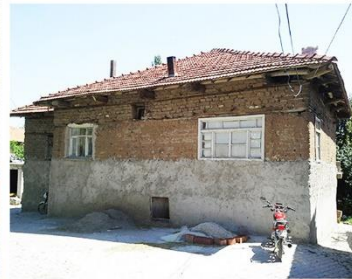
with a garden and a 'saçak', which defines a street with the main building (L_2b)

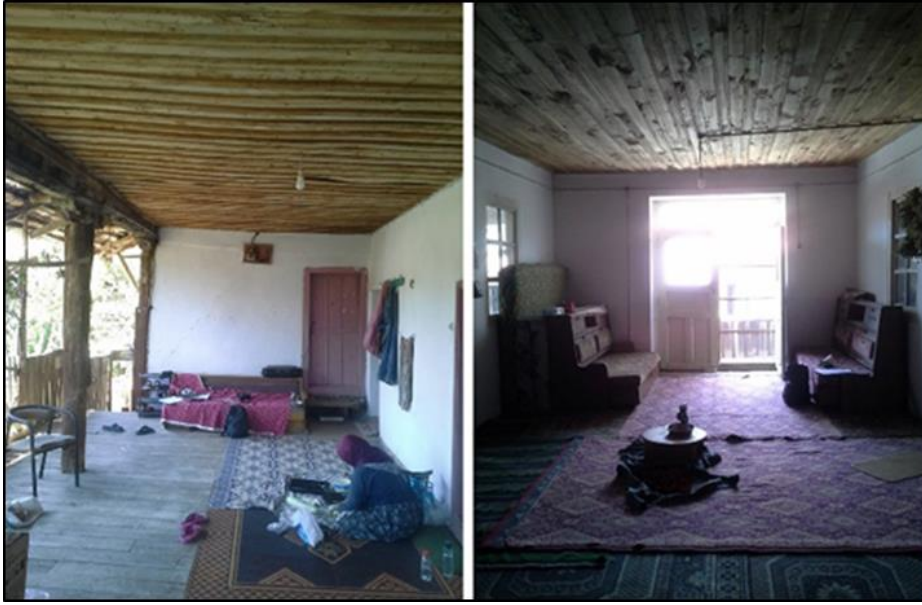
Figure 38: *The first photo, taken from the H16, shows the open ‘sofa’ with rooms located on one side of it; the second photo, taken from the H8, shows the closed ‘sofa’ located in between the rooms.*

The *'sofa'*, also called *'tahtalık'* by the locals in Ağlasun, is the first space to be encountered on the first floor of the house (**Figure 38**). Its function can be defined as both a living space and a circulation area. It is generally rectangular in shape and its wooden flooring is carried by mud brick masonry walls and wooden posts with stone bases located on the ground floor.

The *'sofa'* is the main determinant on the diversity of the plan of the first floor. Both open and closed *'sofa'* are observed in the traditional houses in Ağlasun. In some examples, open *'sofa'* is located on the one side of the sequential rooms, while in other houses, it is located at the entrance of the corridor that provides access to the rooms. The corridors with an average width of 1.5 m (**Figure 39**), located together with the open *'sofa'* on the first floors of some main buildings, serve just as a circulation space. These spaces, which are entered from an originally open *'sofa'*, provide access to the sequential rooms located on their both sides and to *'girelliks'* located between the two of these rooms.

Moreover, apart from the situation that an open *'sofa'* was closed later, it is also observed that there are houses with closed *'sofa'*'s, which were located between the rooms on their left and right side, when they were first built.

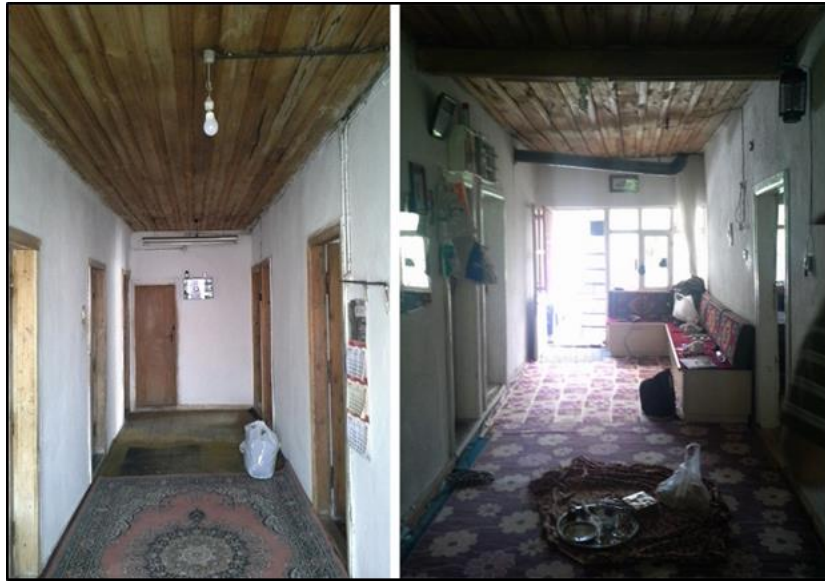
Figure 39: The photo on the left, taken in the H9, shows the corridor; the photo on the right, taken in the H11, shows the enlarged corridor.

The term ‘enlarged corridor’ (**Figure 39**) has been defined within this thesis for the area which is in the transition phase from an open ‘sofa’ to a closed ‘sofa’. Because these spaces are neither as narrow as a corridor nor they are as wide as a ‘sofa’ they are used for different purposes like a ‘sofa’ in addition to being used as a circulation area.

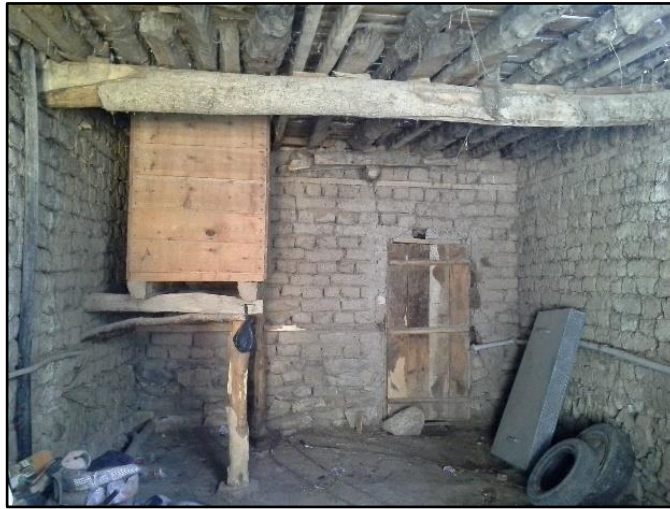
Figure 42 : The granary located on the wooden pillars with stone bases in the ground floor of a main building.

The granary, 'ambar', is a container made of wood with some narrow compartments inside it (**Figure 41**). They are located directly on stone bases or on wooden pillars placed over stone bases on the ground floors of main buildings (**Figure 42**). Products such as corn, wheat and barley are stored in them. Nowadays, the granaries are not used as they are no longer needed.

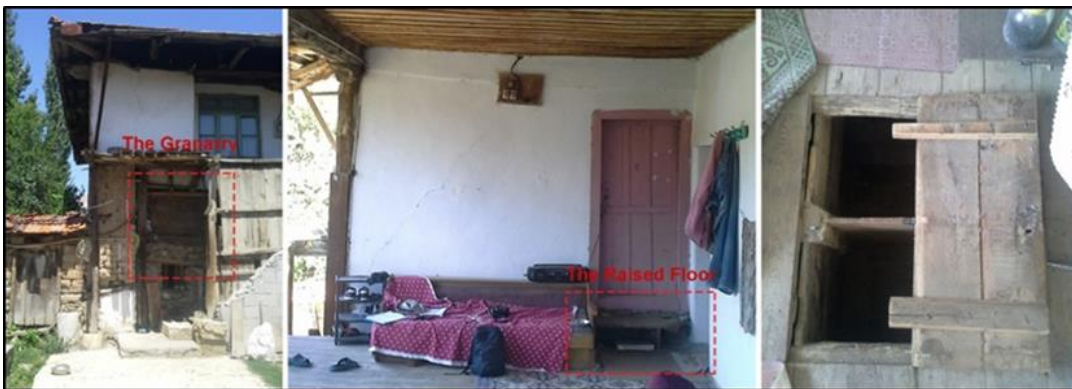
Figure 43: The photos, taken in the H16, shows the granary, the space located above the granary and their location in the house.

The room, called '*Ambar Üstü*' by locals, is located on the short side of the open '*sofa*' which is rectangular in plan. Its flooring is raised about 20-30 cm due to the granary beneath it (**Figure 43**). In some houses in Ağlasun, this area is distinguished from the '*sofa*' only with its raised floor. However, among the houses studied within the scope of this thesis, it is observed that these are separate spaces, surrounded by walls. They also contain traditional architectural elements such as '*ocaks*' and niches and serve as a kitchen or a living space.

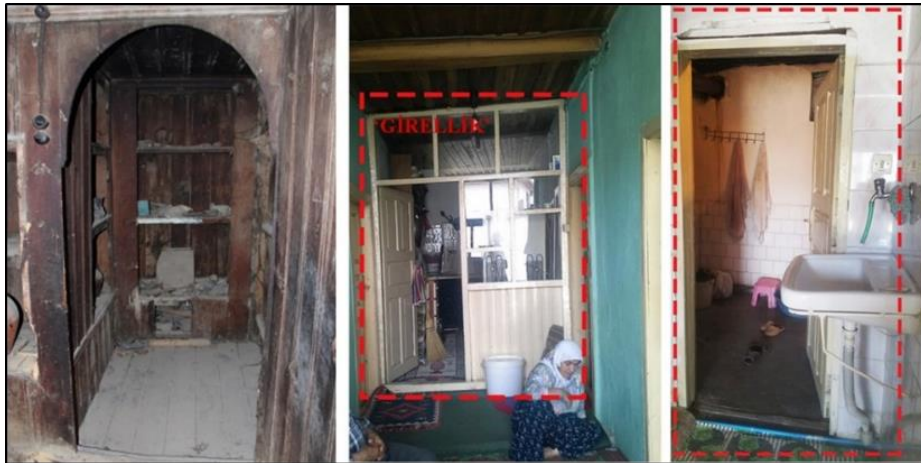
Figure 44: ‘Girellik’ parts of three different houses. First photo, taken by Arsav, is from the ‘Molla Hüseyin House’ (Kurtulus et al., 2017) shows the original ‘girellik’; the photo in the middle, taken in the H4, shows a ‘girellik’ part used as a kitchen; the photo, taken in the H6, shows a ‘girellik’ used as a bathroom.

'Girellik' (**Figure 44**) is located on the first floor, on one side of the 'sofa' and also between two rooms. Locals stated that the word 'girellik' is generated in time by corruption of the word 'kiler' which means cellar, however today, none of them in studied houses are used as cellar. Today, most of them serve as a wet space.

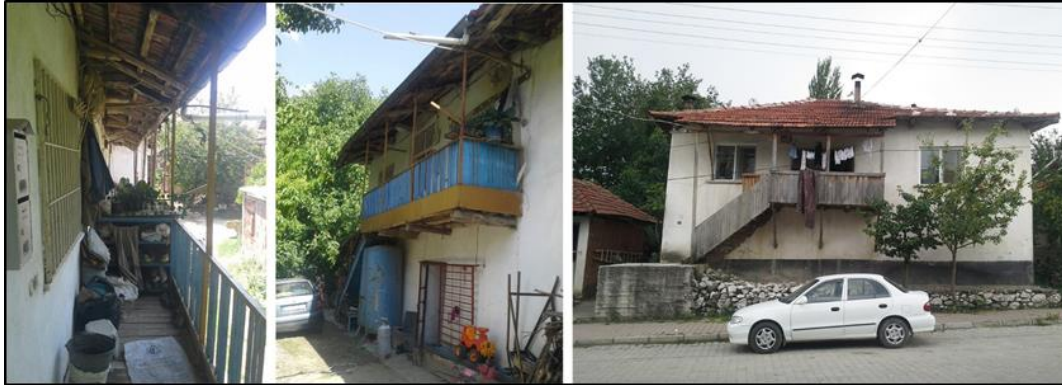
Figure 45: The first and the second photos, taken in the H18, show the ‘gezeneks’; the last photo, taken in the H11, shows the balcony, reached via a staircase.

‘Gezeneks’ are located adjacent to the houses and create a semi-open and narrow circulation area, connecting the staircase and the main entrance of the living area on the first floor (**Figure 45**). In some cases, there are also washbasins and toilets located on ‘gezeneks’.

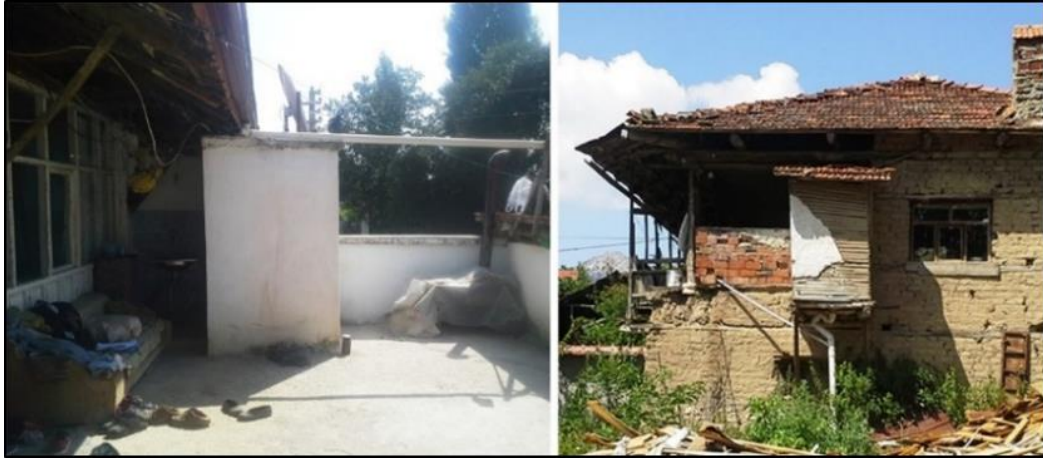
***Figure 46:** The photo, taken in the H6, shows the additional toilet constructed on the 'saçak'; the photo, taken in the H16, shows the additional toilet constructed adjacent to the 'sofa'.*

According to interviews made with locals, original toilets had been located in gardens or courtyards away from the traditional mud brick houses until the when wet rooms were built in the houses (**Figure 46**). Furthermore, except for a space called 'güsulhane', originally there had not been any space used as a bathroom in the houses. All toilets and bathrooms were created later as separate areas by dividing original rooms or adding extra masses to the houses. Moreover, one of the rooms or ‘sofas’ in the houses are used as a kitchen with the addition of water installation. These interventions on the traditional mud brick masonry houses in Ağlasun and the current wet room conditions are discussed in the following chapter.

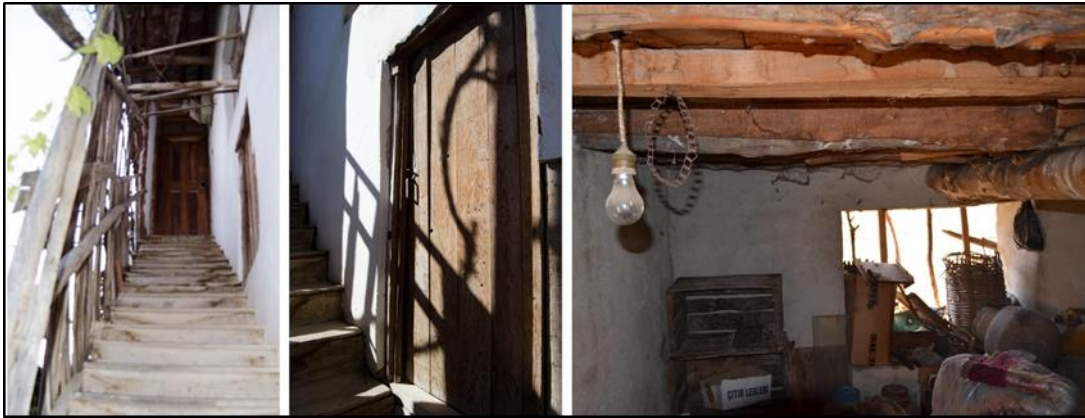
Figure 47: Photos, taken in the H19, show the entrance and the interior space of the mezzanine..

Mezzanine floors are located between the ground floors and the first floors in the main building of the traditional houses in Ağlasun. One staircases, starting from the ground level, provide direct access to the mezzanine floors before reaching the first floors of the houses (**Figure 47**). According to Kurtuluş et al. (2017), spaces located between the ground floor and the first floor are called 'yer evi' and mostly exist in 'Ağa Evi' which is a house of a rich and prominent person in the village.

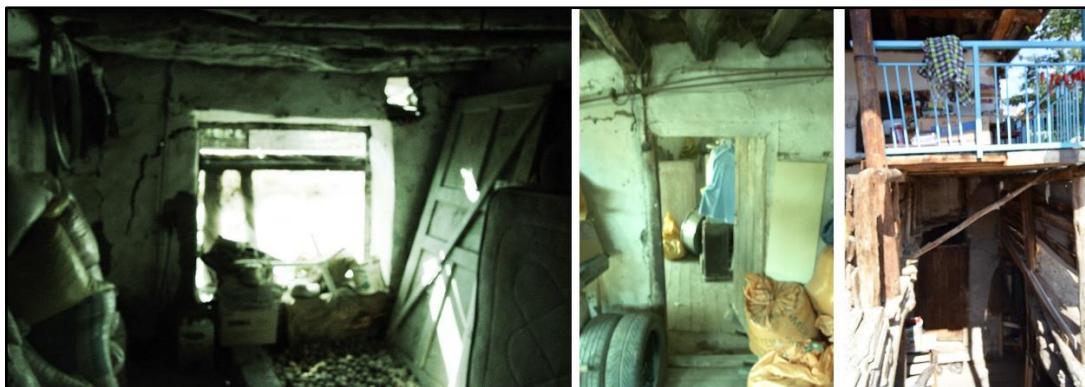
Figure 48: Photos, taken in the H7, shows the spaces on the mezzanine. The photo on the left and the one in the middle shows the room which was used as a guestroom and production space. The photo on the right shows the entrance door of the room used as a storage.

The two out of 19 studied houses (H7 and H19) involve mezzanines with approximately 2 m ceiling height. In both cases, the plan organizations of the mezzanines are similar with the plan organizations of the upper floors. Rooms in the mezzanine of the H7 had been reserved for the household employees and then they were also used for some gastronomic productions in an adequate amount for dwellers of the house (**Figure 48**). However, two separate spaces in the mezzanine of H19 are used as service areas for the furnace. But today, spaces on the mezzanines in both houses are used as storages.

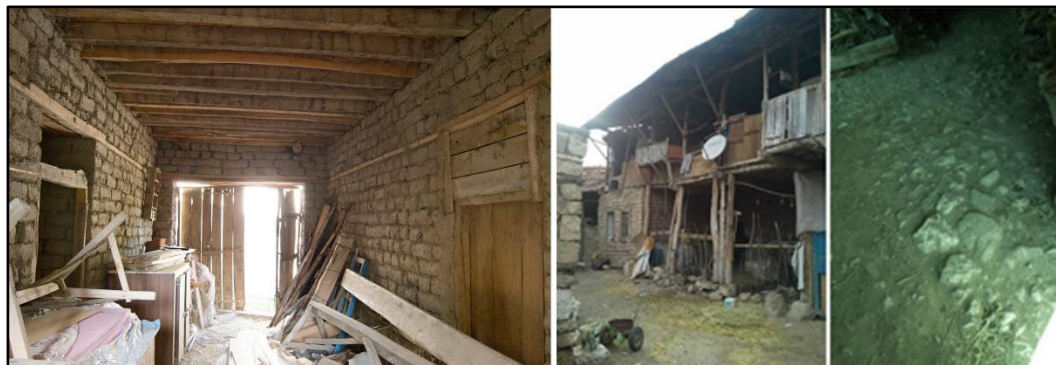
Figure 49: The photo on the left, taken in the H15 shows the circulation space located under the closed ‘sofa’. The photo in the middle, taken in H13, shows the circulation space located under the open ‘sofa’. The photo on the right, taken in the H7, shows the flooring of the ‘taşlık’ space.

These spaces provide connection between the outside, barns and storage areas on the ground floors but in addition to that, in some cases, they are also used as spaces for keeping some goods and animals inside for a while (**Figure 49**).

The top layer of the ground floor is a made up with rammed earth in general. Moreover, use of stone pavement on the floors was observed in three houses, that is, H2, H8 and H19. So, these spaces are also called ‘taşlık’ because of their stone paved floors. It is also possible to observe ground floors consist just barns and storages which are located one after another.

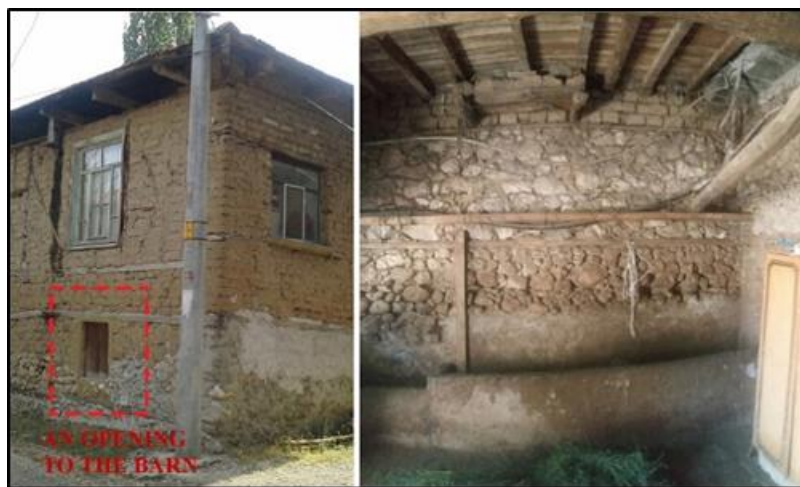
Figure 50: The first photo, taken from the H4, shows the small opening to the barn from the street; the second photo, taken from the H3, shows interior space of the barn.

There are two defining elements for the barns: The first is the small openings on one of the exterior walls in order to put the hay in the barn directly from the street. The second one is the feeder (**Figure 50**).

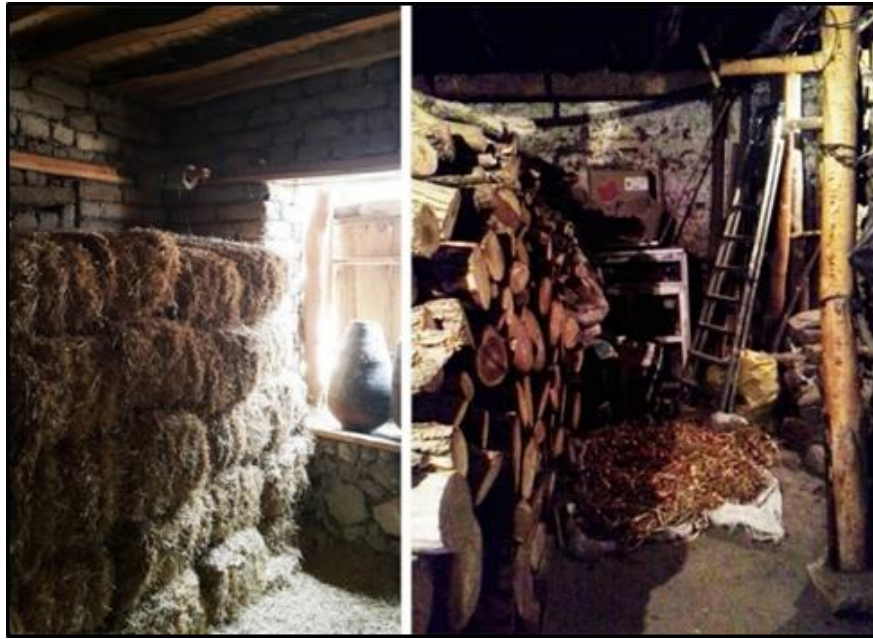
Figure 51: The photo on the left from the H15 shows the storage area called ‘samanlık’; the photo on the right from the H14 shows the storage area called ‘odunluk’.

Hay, wood, dry foods and unused household items are often stored in these areas. Thus, these spaces are also called ‘*odunluk*’ or ‘*samanlık*’ by the local people (Figure 51).

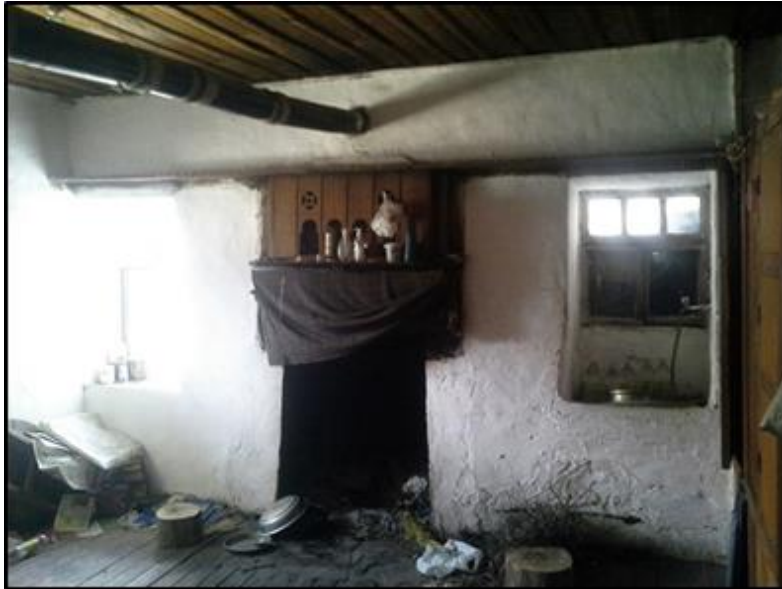
Figure 52: The photo from the H8, shows a space located on the ground floor as a workshop.

In addition to those mentioned above, there is also a space on the ground floor of the H8 with a fireplace, wide windows and a wooden shelf which were observed mostly in the rooms on the first floors of the houses (**Figure 52**). This space was used as a workplace.

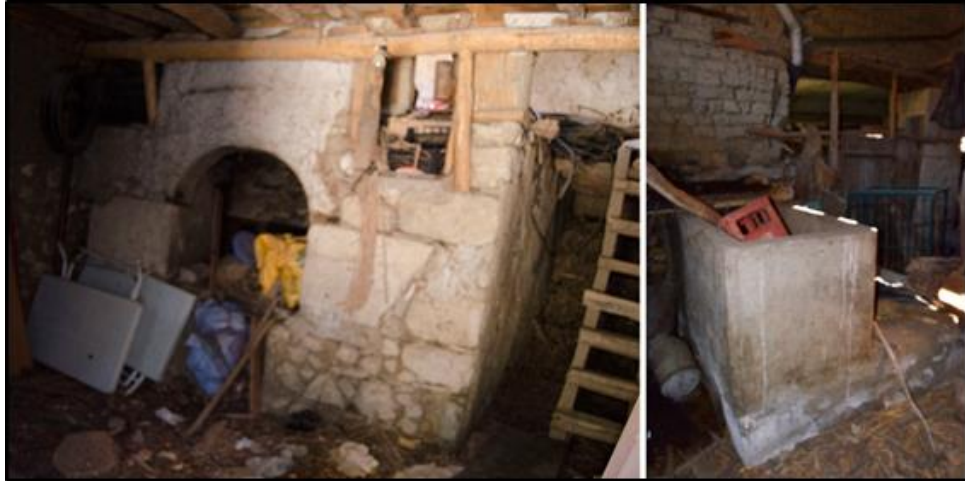
Figure 53: The photos from the ground floor spaces of the H19. The photo on the left shows the furnace and the photo on the right shows the 'gülhane'.

In addition, it was observed that some of the spaces on the ground floor, which are usually used as storages at present, also include a fireplace, niches, 'terek' and wide windows. This shows that they were originally workshops located on the ground floor. Workshops on the ground floors were observed in H8, H9. In addition to that, , there is a furnace on the ground floor of H19, which was used by all villagers, and 'gülhane' which was a space used for the rose water production for many years (**Figure 53**). Today these spaces are not in use.

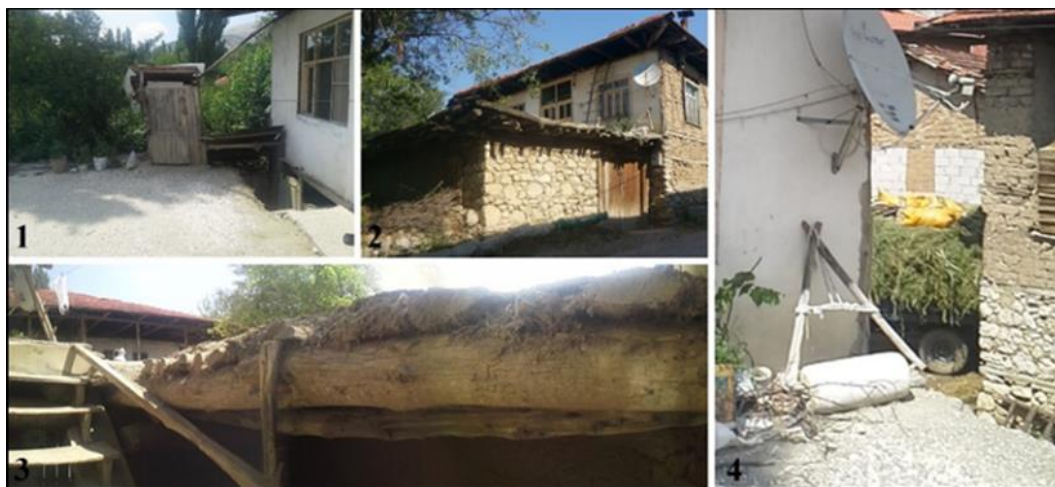
Figure 55: The first photo shows the surface of the original ‘saçak’; the second one shows the relation between the ‘saçak’ and the main mass of the house; the third one shows the layers of the ‘saçak’ structure; the fourth one shows the ‘yuvga’ stone. All photos are from the H4.

Although in the architectural terminology, the word '*saçak*' means 'eave', its use is different for the traditional Ağlasun houses. In Ağlasun, the term '*saçak*' is used for a separate mass which is constructed adjacent to traditional houses (**Figure 55**).

The flat top layer of the '*saçak*' structure is similar to the structure of original flat roofs of the traditional houses, which are called '*kara dam /düz dam*'. This part consists of '*dövers*' (wooden beams), '*mertek*' (girder), '*pargı*' (branches), '*hasır*' (mat) and moisturized soil that is compressed with a '*yuvga*' stone. This top layer of the '*saçak*' is carried by exterior stone masonry walls and timber posts located in the space surrounded by these walls. '*Saçak*' structures started to collapse over time because of neglect and poor maintenance, and then the dwellers demolished them totally and built reinforced concrete ones in their stead. Among the 19 houses studied, the original '*saçak*' structures are seen only in the houses, H4 and H7.

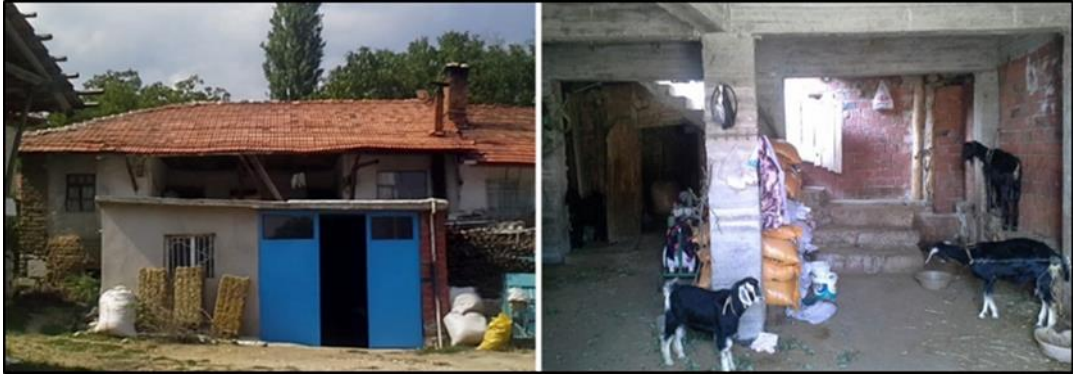
Figure 56: Two photos from the H5 show the 'saçak' that is constructed with reinforced concrete and the circulation area built with hollow bricks beneath the 'saçak' structure. The photo on the left shows the window and door of it and the one on the right shows the circulation space located under the 'saçak' structure.

On the ground level, the space defined by a '*saçak*' structure serves as a circulation space and a temporary storage. The staircase, giving access to the upper floors, is also constructed in this space, adjacent to the main building (**Figure 56**). Most of these stairs are made of steel or reinforced concrete, and are not authentic, even if they are located in the spaces defined by original '*saçaks*'.

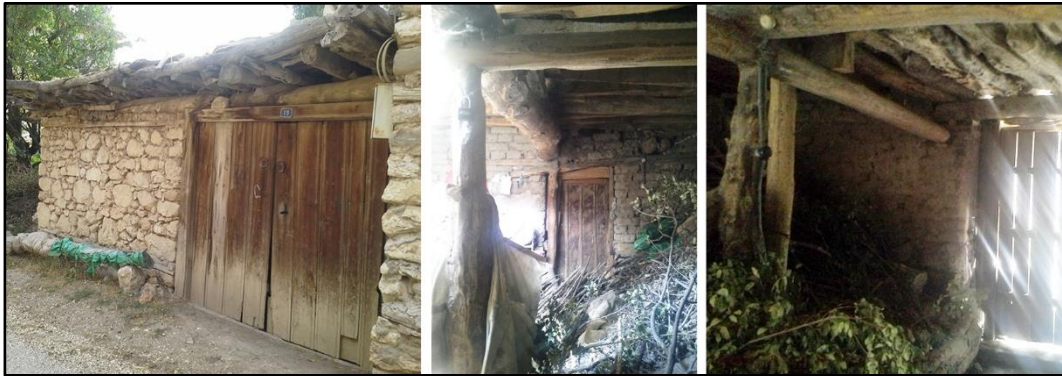
Figure 57: The photos from the H4 show the authentic entrance door of the original 'saçak' and views from inside of it.

On the walls of the authentic ‘saçak’ structures, defining a closed space, there is an entrance door which is also similar to the doors providing connection between the street and the ground floor of the main buildings. However, most of them are not authentic wooden doors but made of steel (Figure 57). Suchlike, window openings on the original ‘saçak’ structures are similar in size to the ones on the walls of the storages located under the main building.

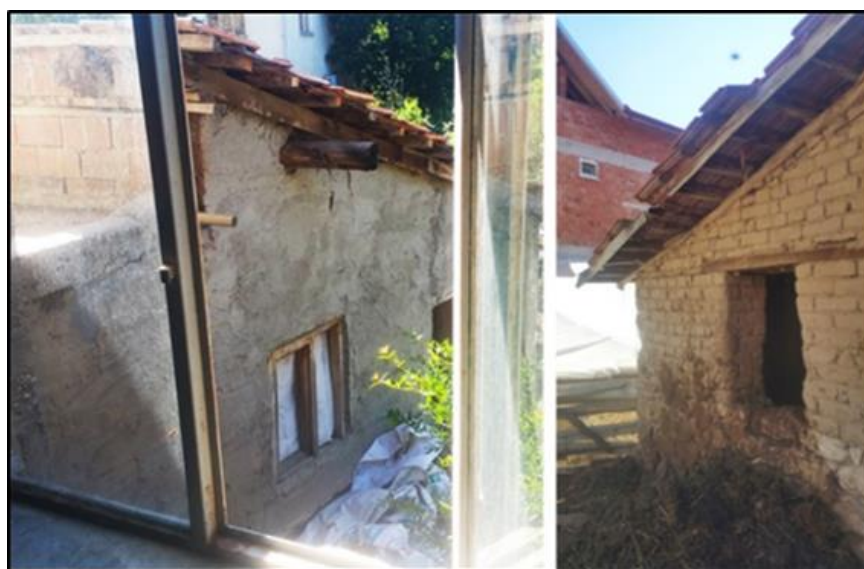
Figure 58: *Windows of the barns which are constructed additionally adjacent to ‘saçak’ structures.*

The doors of the additional spaces having the function of barn and storage are similar to those that can be seen on the ground floors of the main buildings. These are also single-winged wooden doors. However, the openings on the walls of barns called ‘*samanlık*’, which were constructed later, are wider than the those on the walls of the barns located on the ground floor of the main building (**Figure 58**).

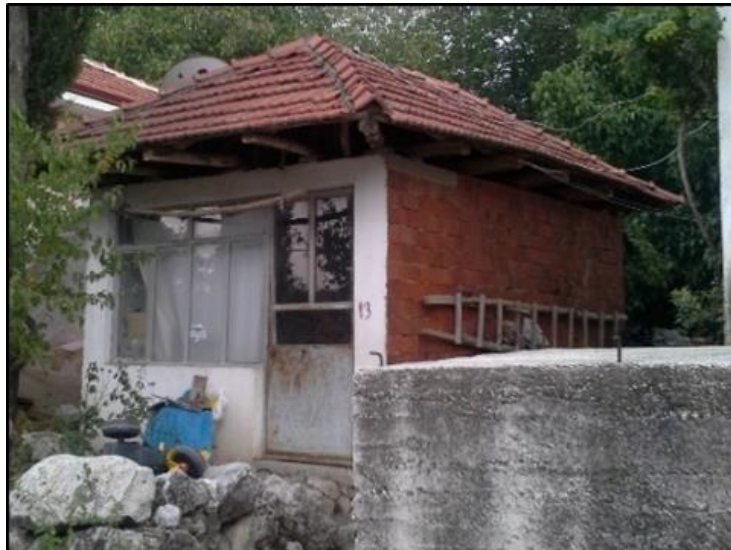
Figure 61: The photo, taken from the H11, shows the additional auxiliary building used as a storage.

Like the additional barns storages are also single-storey buildings composed of a single space and constructed adjacent to ‘*saçaks*’. It is observed in the H18 that a single-storey structure, which is similar to the barns mentioned above in terms of its location and construction system, is used as a storage. It is also observed in H11 that an additional storage is constructed separate from the ‘*saçak*’ and main building (**Figure 61**).

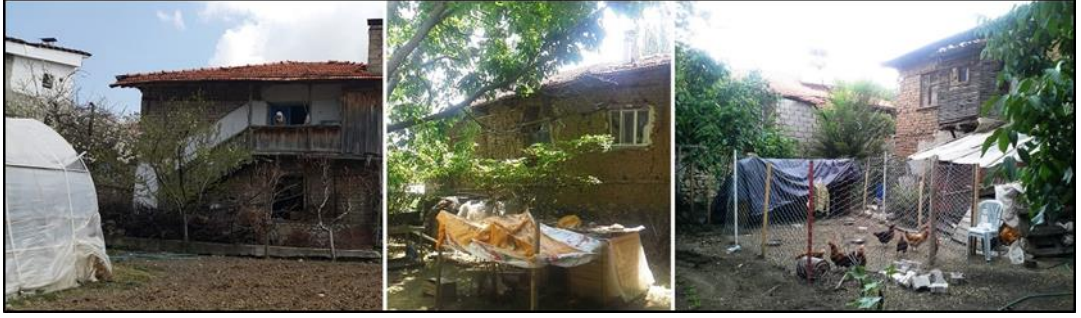
Figure 62: The photo on the left from the H15, shows the greenhouse; the photo, taken in the middle from the H6, and the photo on the right from the H11, show the pens.

They are poor quality small structures defining a single space used for keeping sheep (**Figure 62**). They are mostly constructed with materials such as wood, nylon, wire and hollow bricks. They might be located adjacent to the main structure or separately within the parcel. They were observed in the gardens of three houses, H3, H5 and H6.

It is an additional semi-cylindrical structure, constructed with iron bars and nylon covering in order to grow various vegetables. It is observed in the garden of the H15.

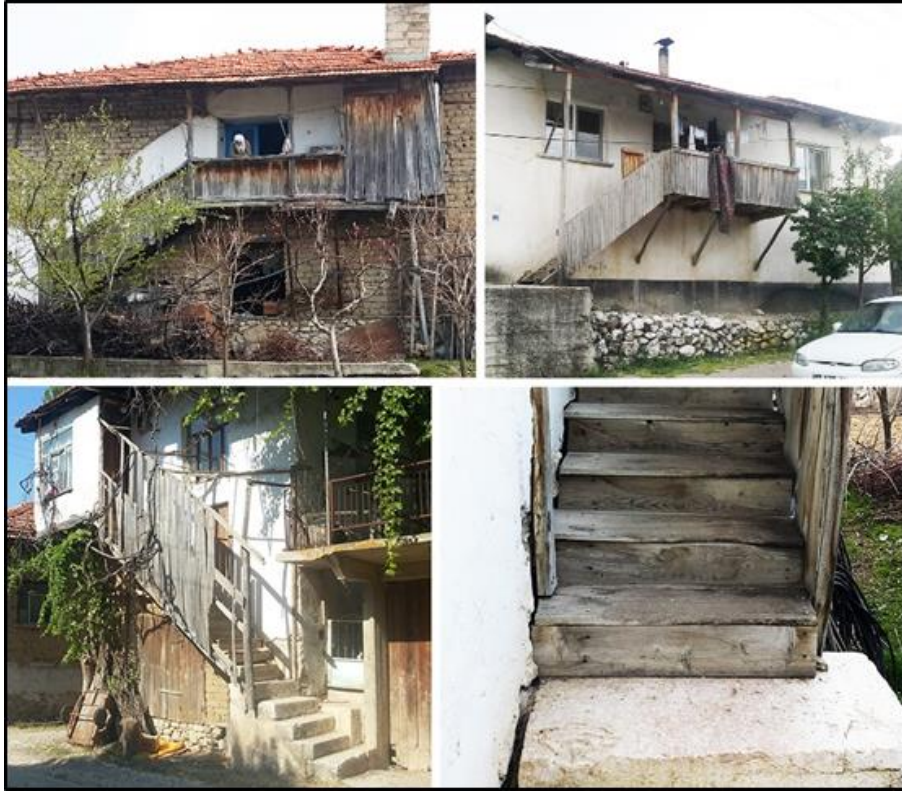
Figure 63: The photos from the H11, H15 and H19; wooden staircases which reach the 'gezenek', the 'balcony' and the 'sofa' on the first floors.

Access between the ground floor and the upper floors are provided by the staircases which are usually located adjacent to one of the exterior facades of the houses (**Figure 63**). In majority of authentic wooden staircases first few steps are built with cut stones. They are always located outside of the houses and if there is a mezzanine in the house, it is reached via the same staircase.

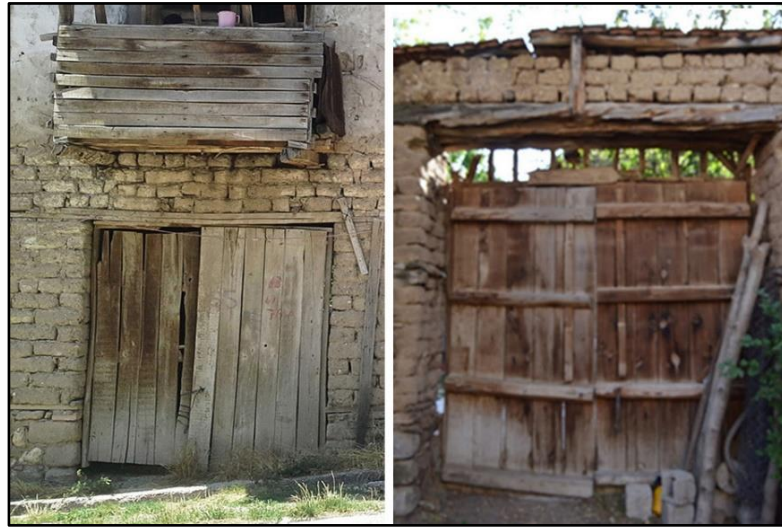
Figure 64: On the left, the entrance door to the ground floor of the main building in the H15; on the right, the entrance door to the courtyard of the H7.

In traditional Ağlasun houses, the doors vary according to their locations, intended uses and sizes. Accordingly, there are six types of wooden doors: courtyard doors, entrance doors to the 'saçaks', ground floor entrance doors, doors on the mezzanines, first floor entrance doors and first floor interior doors (**Figure 64, Figure 66**). Although there are differences in terms of the materials and workmanship, the repetition of certain types can be seen in different houses, especially in their interior spaces. Detailed information about the types and structures of wooden doors encountered in traditional houses is given within the scope of the construction techniques of the Traditional Ağlasun Houses.

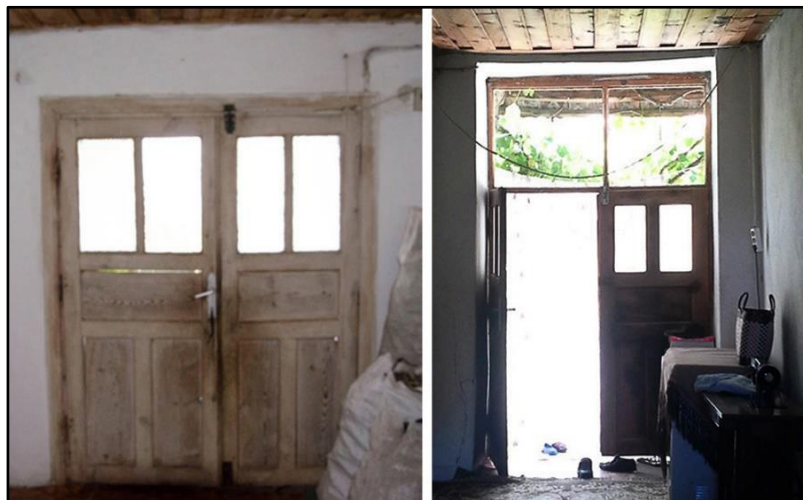
Figure 65: On the left, the entrance door to the first floor of the main building in H15; on the right, the entrance door to the first floor of the main building in the H4.

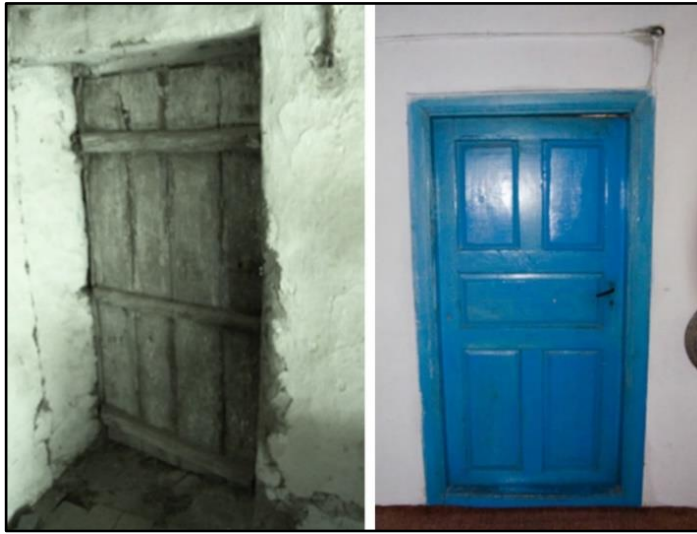
***Figure 66:** On the left the door of a room on the mezzanine floor in the main building in the H7; on the right, an interior door to a room from the 'sofa' in the H15.*

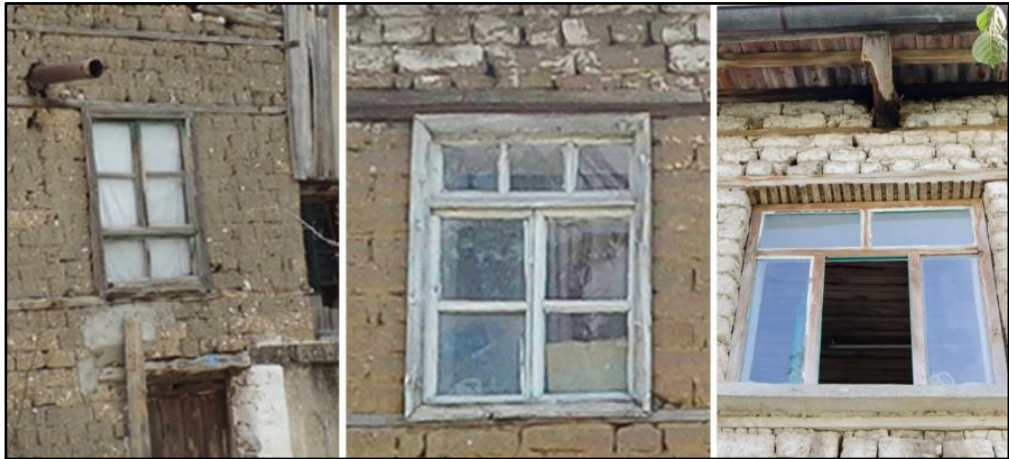
Figure 67: *The most frequently used original window types. The image on the left is produced by utilizing the study ‘Understanding a Historic Rural Landscape in Relation with an Archaeological Site: Ağlasun/ Sagalassos’¹²; the photo in the middle is from the H8; the photo on the right side is from the H15.*

Like the doors, windows of the traditional houses in Ağlasun differ according to their positions, intended uses and sizes. Although there are various window types, it was observed that certain types were repeated in different houses (**Figure 67**). It is possible to specify these varieties as windows on the walls of the storages located on the ground floor of the main building, windows on the walls of the mezzanines, windows on the exterior walls of the spaces on the first floors and the interior windows that provide visual connection between the rooms and a 'sofas' (**Figure 68**).

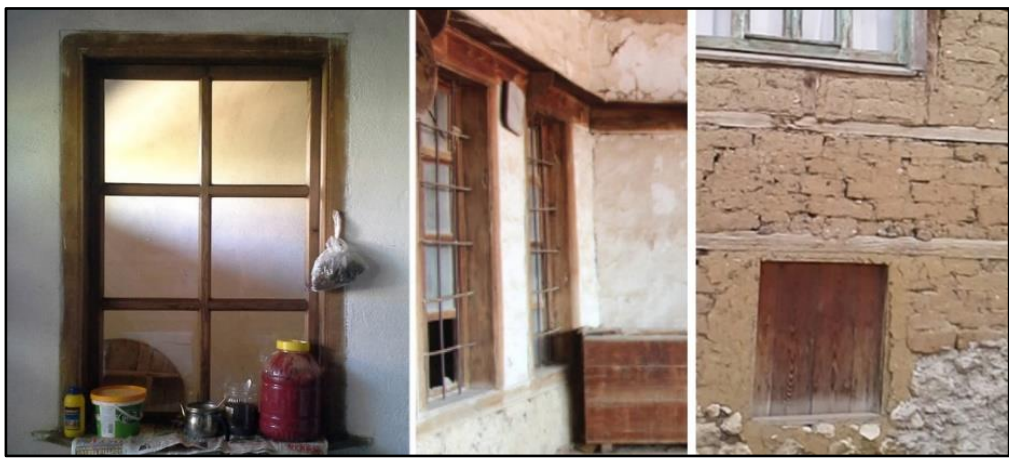
Figure 68: *On the left, the window between the room and the closed ‘sofa’ in the H1; the image, produced by utilizing the study ‘Understanding a Historic Rural Landscape in Relation with an Archaeological Site: Ağlasun/ Sagalassos’, shows the windows between the room and the open ‘sofa’; the photo from the H4, shows the opening called ‘samanlık’.*

In each barn, there is a 50-60 cm wide and 65-75 cm high small opening on one of the exterior walls that is used to put hay inside directly from the street. These openings are called ‘*samanlık*’ (**Figure 68**). Most of them have a wooden pen. Except for these windows and the entrance doors, usually there are not any other opening on the walls of the barns located on the ground floor of the main buildings.
