AN INQUIRY INTO THE VALUES AND PROBLEMS FOR CONSERVATION
OF TRADITIONAL MUD BRICK HOUSES IN AĞLASUN, BURDUR

A THESIS SUBMITTED TO
THE GRADUATE SCHOOL OF NATURAL AND APPLIED SCIENCES
OF
MIDDLE EAST TECHNICAL UNIVERSITY

DECEMBER 2019

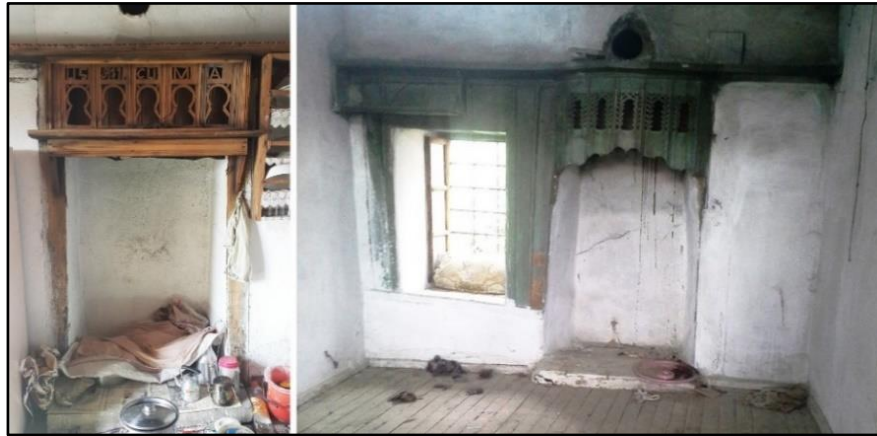
Figure 69: Fireplaces with a 'yaşmak' having a different from and ornamentation from the H15 and H13.

‘*Ocak*’ is located in almost every room on the first floor of the houses (**Figure 69**). They were originally used for cooking and heating purposes but now they are not used anymore except for the ones in the houses H8 and H15. They were usually constructed in the interior surface of mud brick masonry walls without causing any projection on the exterior. The openings of fireplaces measure approximately 90-110 cm in width, 120-150 cm in height and 45-60 cm in depth. Interior spaces of the fireplaces also plastered up to a certain level (generally up to 1.5 height from the ground) with mud or lime-based plaster before white wash application as the final finishing coat. Some of these traditional fireplaces have an ornamented wooden board called ‘*yaşmak*’ whose function is preventing spread of ashes and dust to the room.

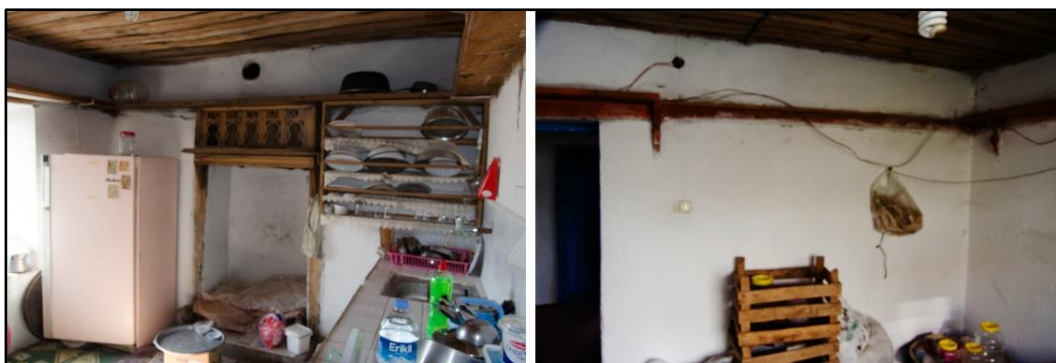
Figure 70: Tereks on the walls of the H15. The photo on the left is from the space used as a kitchen while the photo on the right is from one of the rooms.

25-30 cm wide wooden shelves, called '*terek*' by locals, surround the walls of rooms (**Figure 70**). Although their function is to hold variety of kitchen utensils, including plates and dishes, they also exist in the rooms which are not used as kitchen. Similar to the fireplaces, which were observed in many rooms in the houses, the '*terek*' also reveal that each room with its original spatial potential was also used as a kitchen in the past.

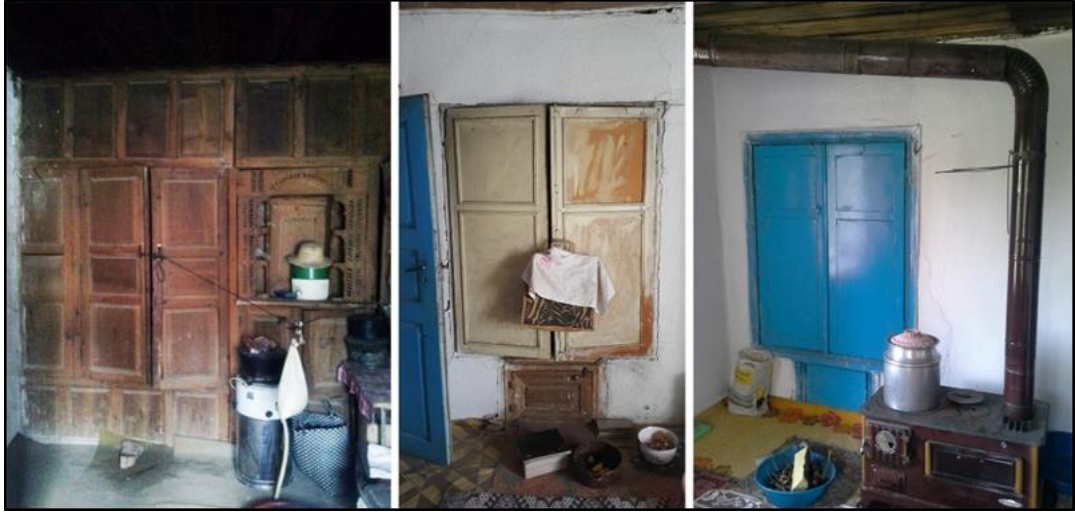
Figure 71: On the left, the ‘yüklük’ in the H7 which serves to just one room; on the right, the ‘yüklük’ in H15 which serves to the rooms located both side of it.

There are built-in wardrobe called ‘*yüklük*’, which are used to store mattresses, pillows, quilts as well as clothes, in traditional rooms (**Figure 71**). In some cases, the area between two walls, constructed with timber frame structure with ‘*bağdadi*’ covering system, is also evaluated as ‘*yüklük*’. In one example, there exists a wardrobe opening with a door to put in or out items and it can be used by the rooms, located both sides of it. However, in another example, there is a timber-frame wall on one side of the ‘*yüklük*’ and there is no opening on this wall to use it while at the side of the room that the ‘*yüklük*’ serves for, unlike the other example, there are wooden pens extending from one side wall to the other. Therefore, also it is possible to see wooden ornaments on them. These decorations are especially found in the wooden niches which are located as part of the ‘*yüklük*’ door or located both sides of an ‘*ocak*’.

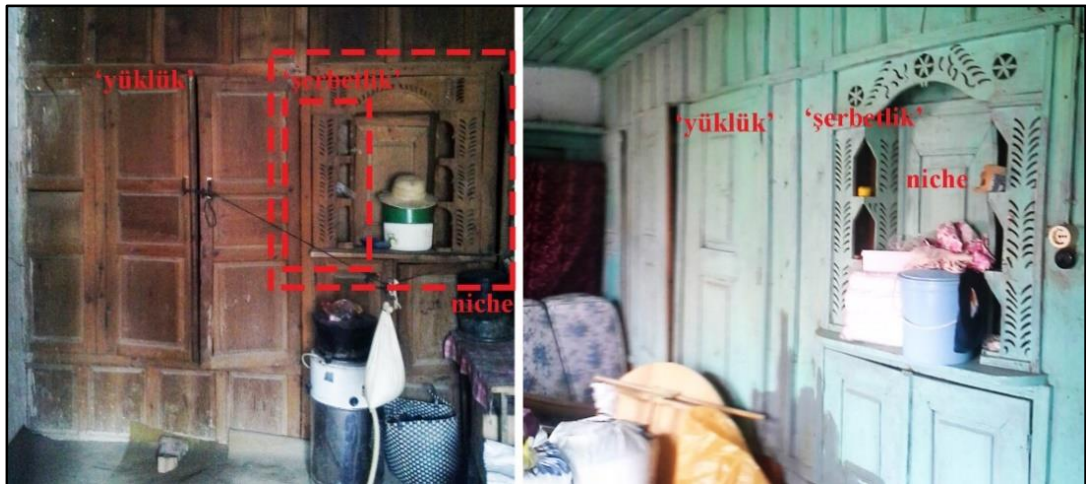
Figure 72: ‘Yüklük’ with ‘şerbetlik’ and ‘niche’ in the H7 and H5.

Moreover there are small shelves called ‘*şerbetlik*’ within some wooden niches as a part of the ‘*yüklük*’ (**Figure 72**).

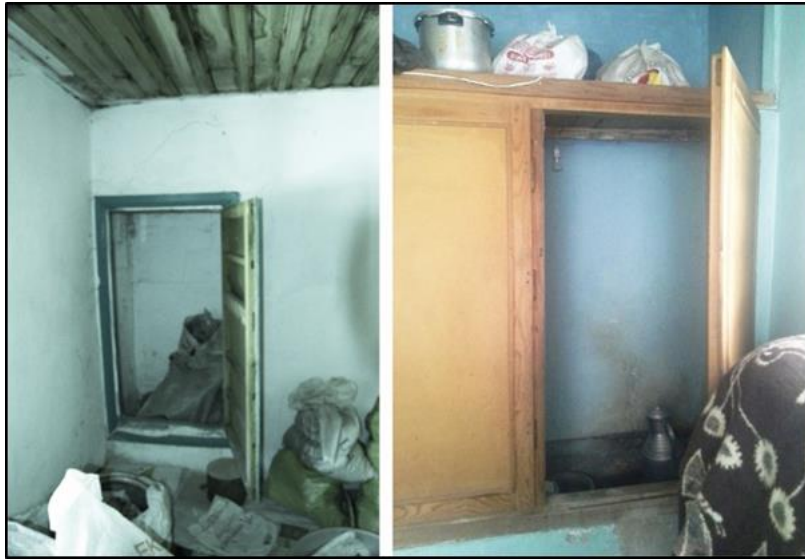
Figure 73: 'Gusülhanes' located on one sides of the 'yüküks' in the H15 and H4.

The 1- 1.5 square meter part of the ‘*yüklük*’ is called ‘*gusülhane*’ and is used for performing ablution (**Figure 73**).

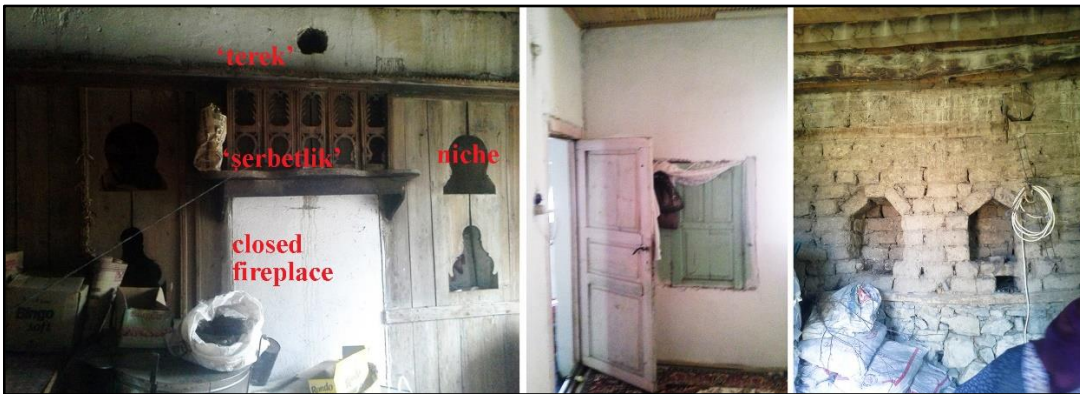
Figure 74: Niches in one of the rooms located on the first floor of the H3; the niches on the wall facing to the circulation area on the ground floor of the H16.

Niches are functional openings in the mud brick masonry walls and they are seen mostly in rooms located on the first floors and rarely in the workshops and circulation spaces on the ground floor. They are small spaces with 45-100 cm width and 60-120 cm height. They are used as storage for various properties and some of them, located

on the first floors, have wooden pens. Moreover it was also observed that there are niches created with wooden elements on both sides of ‘ocaks’ (Figure 74).

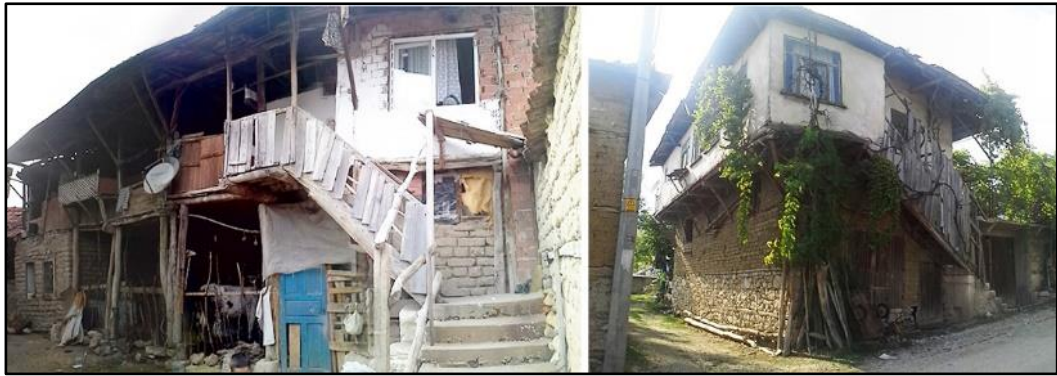
***Figure 75:** The photo on the left from the H13, shows the two storey main building with the open 'sofa' and the staircase on its courtyard facade; the photo on the right from the H19, shows the main building with mezzanine and the closed 'sofa' constructed as a projection.*

It is possible to observe some common features on the facades of the traditional Ağlasun Houses. First of all, except for two houses, which have mezzanines, all studied traditional mud brick masonry houses are two storey structures (**Figure 75**). Second, there are no projections except for the 'sofa' of the H19, a toilet, a balcony and a 'gezenek' (**Figure 76**). Finally, in the current condition, the roofs of the houses are not the original earthen flat roofs, but hipped or gable roofs.

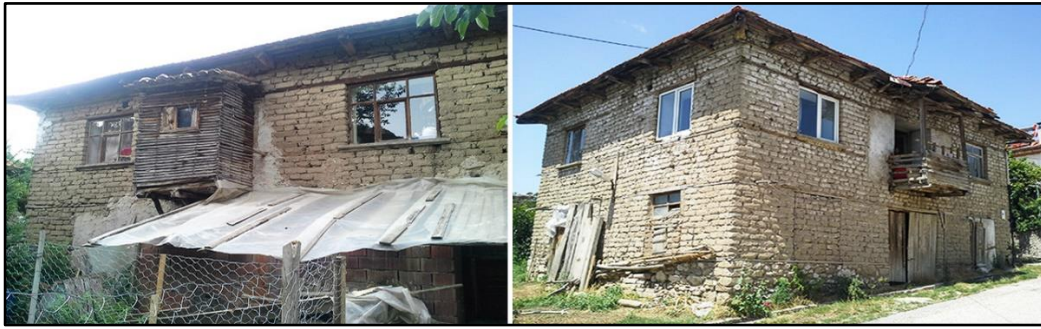
Figure 76: The photo on the left from the H11, shows the toilet located on the facade facing to the garden and the photo on the right from the H15 shows the balcony on the facade facing to the street.

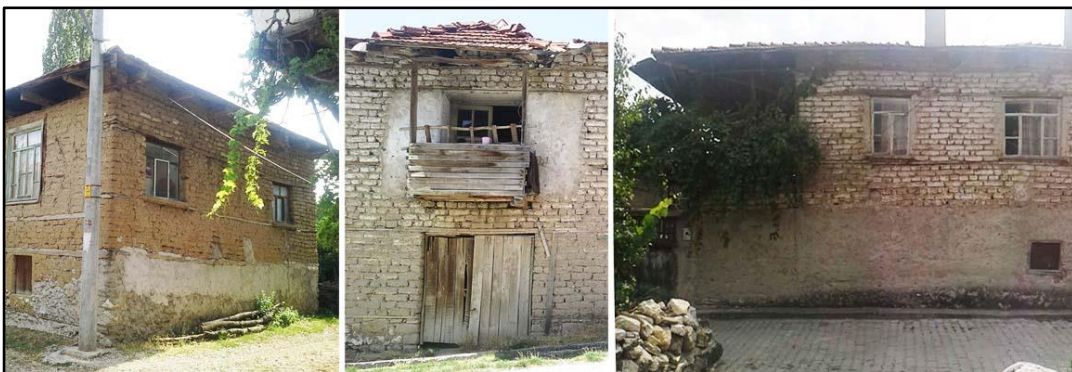
Figure 77: The photos from H4, H15 and H9 show partial plaster on their facades.

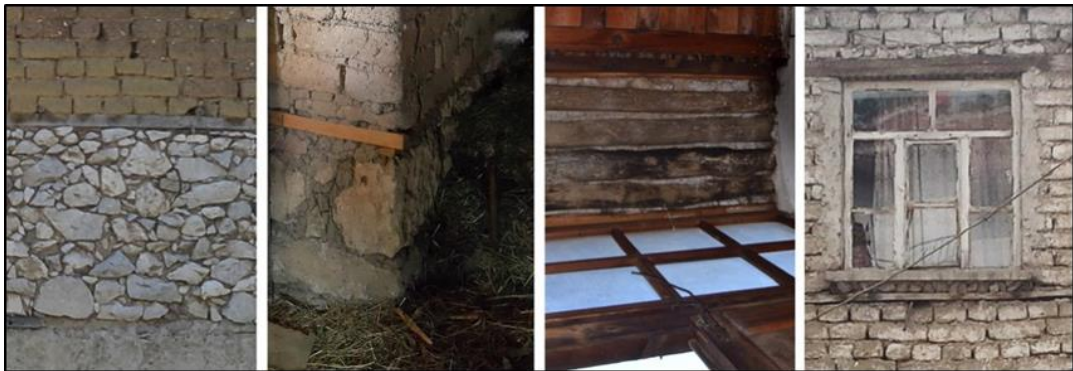
Figure 79: *From the left to the right: rubble stone masonry (H3); cut stones at the corners of the stone masonry part of the wall (H15); ‘helik’ stone as infill material over a door opening (H7); ‘helik’ stone usage as infill material under a window opening (H9).*

Various types of stones were used for different purposes in the Traditional Ağlasun Houses. First, rubble stones and rough cut stones are mostly used for the foundation walls and ground floor walls at least up to the sub-basement level (**Figure 79**). Second, different kinds of stones are also used as bases under the timber posts and as the first few steps of the wooden staircases. Similarly, in some houses the use of spolia, historical architectural fragments taken out of their original context and reused in a different context, is observed as a part of stone masonry wall or a base stone under the timber posts or a part of a staircase (**Figure 80**).

‘*Helik*’ stones, which are small in size, are used as an infill material over the door openings and over and under the window openings.

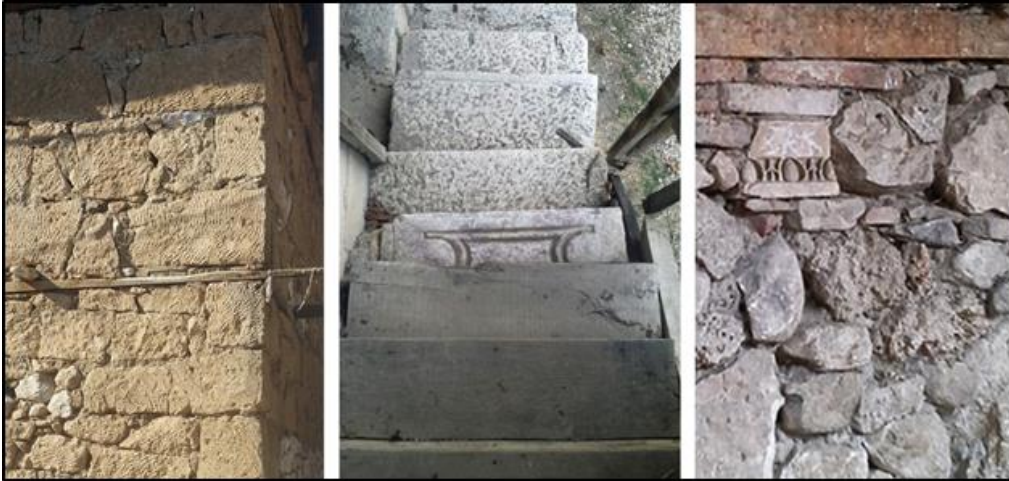
Figure 80: From the left to the right: the stone masonry with 'Köğke' stone; use of spolia as a step of the staircase (H19); use of spolia as a part of stone masonry wall (H13).

‘*Köğke*’ is a kind of soft stone which is used as cut stone blocks on the upper levels of the walls but it was not seen among the nineteen houses studied.

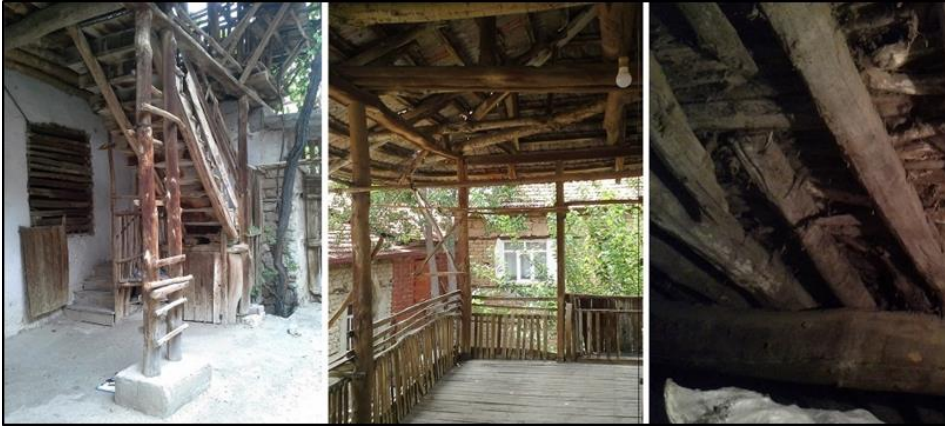
Figure 82: From left to the right, the timber posts carrying the 'sofa'; timber posts carrying the roof structure; timber elements of the flooring system named 'döver', 'mertek' and 'pargı' from bottom to top (H19).

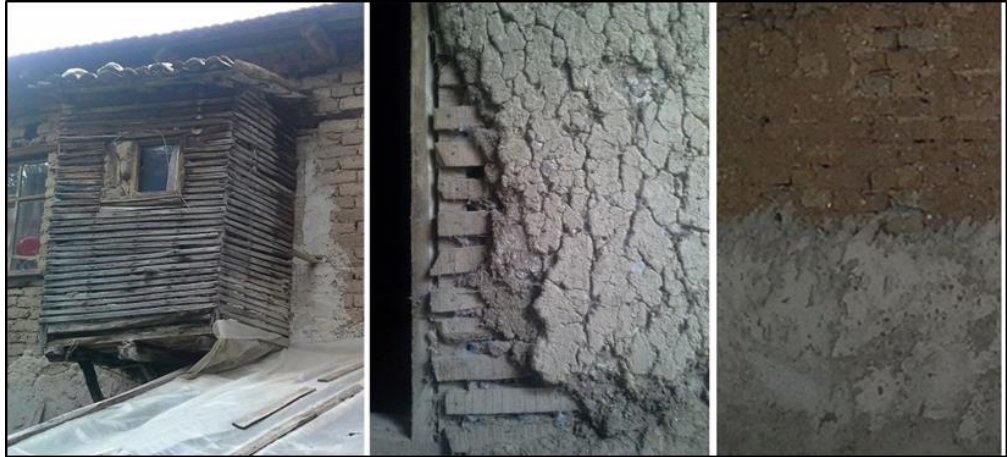
Figure 84: The first photo from H11, shows the 'bağdadi' covering system over the timber frame structure; second one from H4, shows the mud brick plaster on the 'bağdadi' covering; the last one from H2 shows the cement plaster application on the mud brick masonry wall.

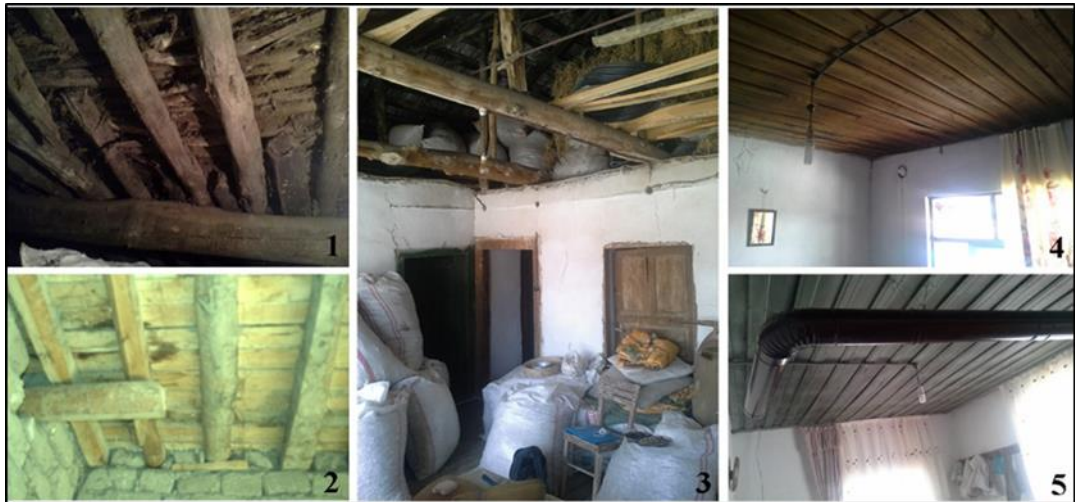
Figure 92: The first photo, showing the relation between ‘*döver*’, ‘*mertek*’ and ‘*pargi*’, is from the ground floor of the H14; The second photo, showing the relation between ‘*döver*’, ‘*mertek*’ and floor boards, is from the ground floor of the H15; the third one shows the ‘*sofa*’ without ceiling covering; the last two photos shows the same type of ceiling with different colours belonging to the rooms of H5 and H4 respectively.

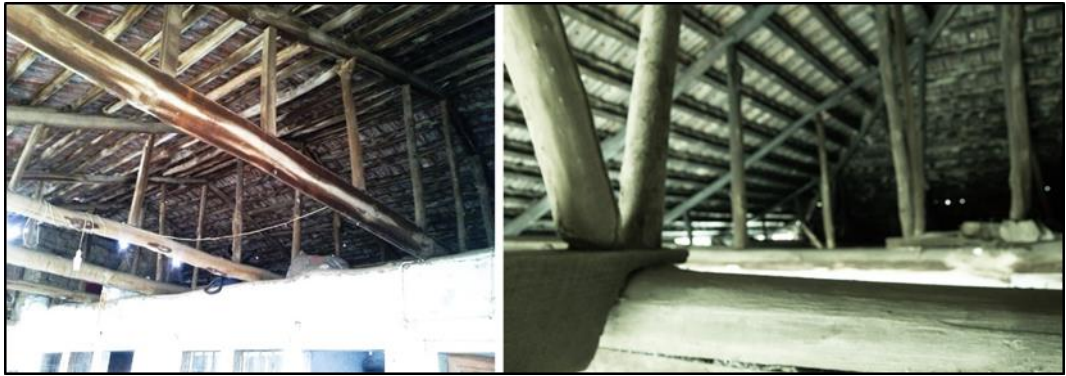
Figure 93: The roof spaces of H13 on the left and H7 on the right.

It is also indicated by dwellers that structure of the original roofs, which is called '*kara dam*' by locals, were the same with the original '*saçak*' structure until 1950s. Then, the original earthen flat roofs were converted to gable or hipped roofs, which can be seen today (**Figure 93**).

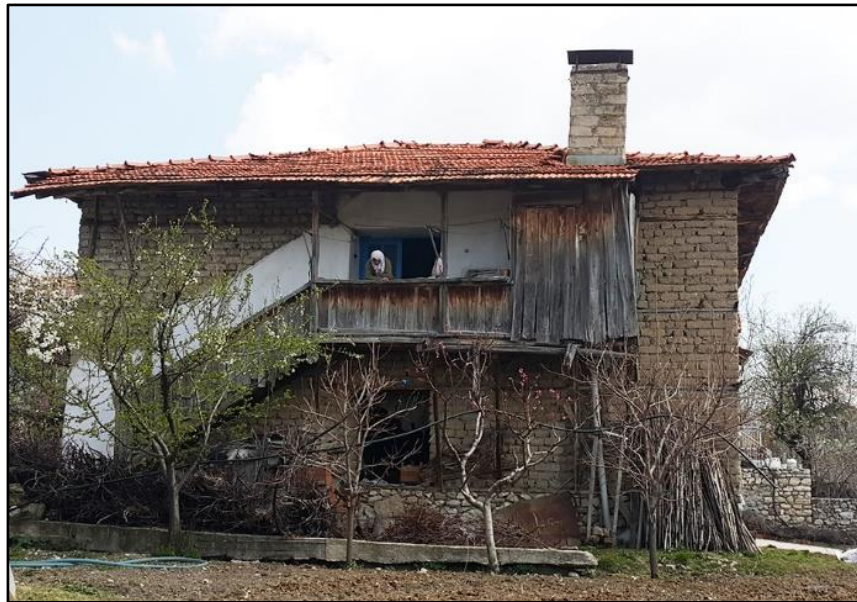
Figure 94: Southwest facade of the H15. An example for the chimney and the eave, extending over the 'gezenek' on which the toilet is located.

Chimneys of some houses still exist and are in use. Their size depends on the width of the mud brick masonry walls with the traditional fireplaces. Shafts of the chimneys emerging from the roof structure are constructed mostly with briquette and their form is rectangular in cross-section.

Uncovered timber eaves with the width, approximately ranging from 50 cm to 60 cm, are essential parts of the roofs to protect the mud brick masonry walls from rain. Their width reaches to 100-120 cm if there is a balcony or '*gezenek*' located under them (**Figure 94**).

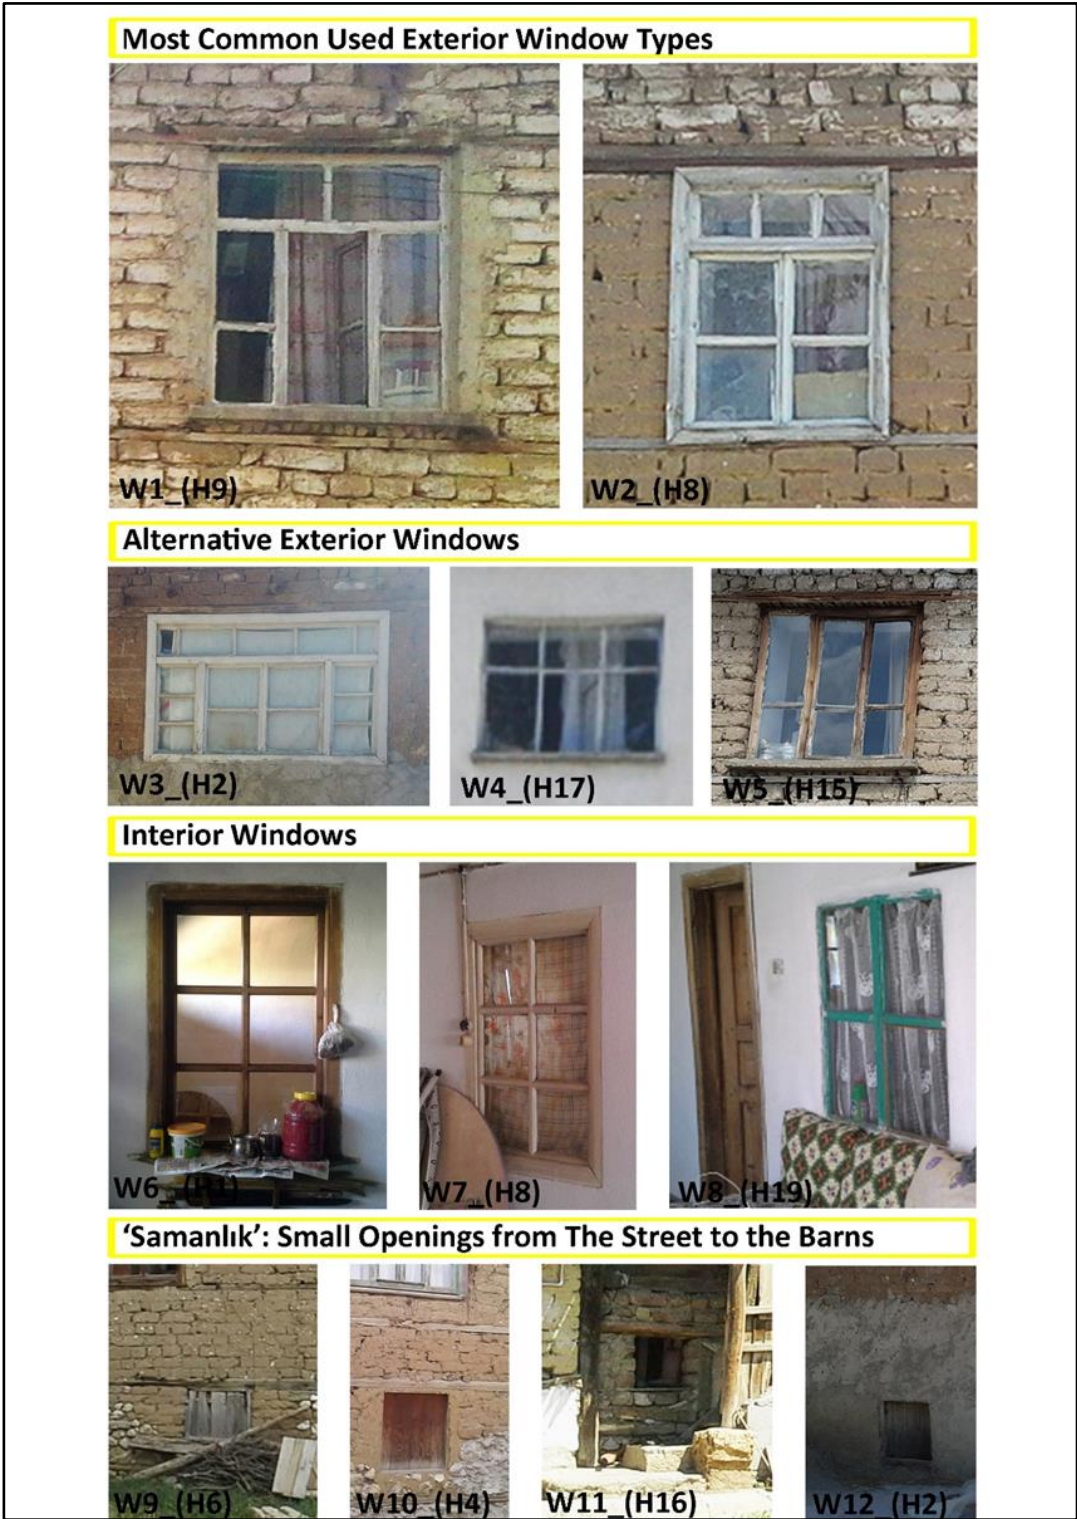
Figure 100: Window types of Traditional Mud Brick Masonry Houses in Ağlasun.

Windows are categorized according to their locations and construction system of the wall on which they are located (**Figure 100**). First of all, there are no windows on the ground floor walls except for 60-80 cm wide and 80-100 cm high small openings called '*samanlık*'. They provide the direct physical connection between a street and a barn. There are timber frame and a wing composed of timber plates. Top of the timber frame is located just below the first lintel, located in the mud brick masonry wall.

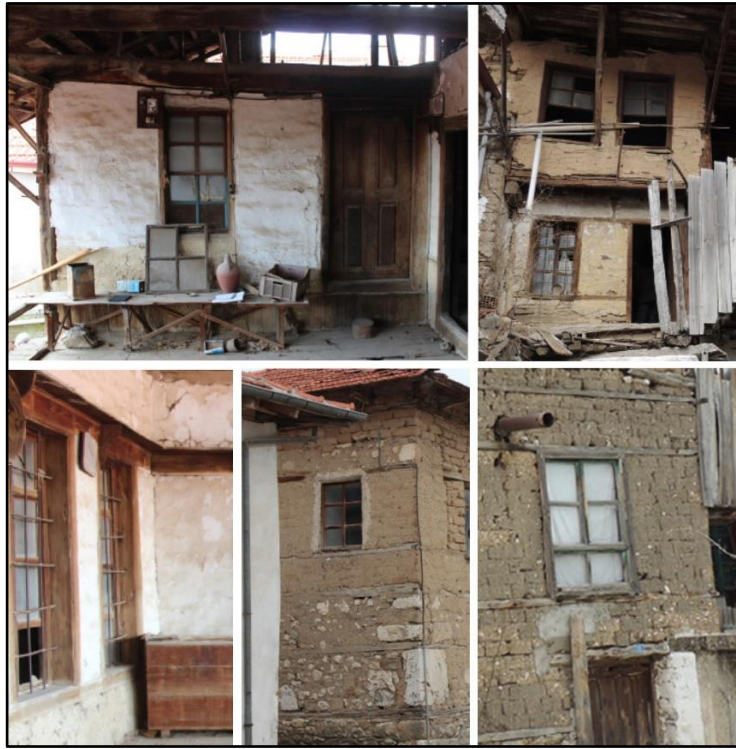
Figure 101: Window types of Traditional Mud Brick Masonry Houses in Ağlasun. Image is produced by utilizing photos from ‘Understanding a Historic Rural Landscape in Relation with an Archaeological Site: Ağlasun/ Sagalassos’¹⁵

In addition, W1 and W2 type windows are also used in timber-framed walls if the "*iskiyet*" wall is constructed as the exterior wall. Furthermore, there are also different examples for the original timber frame window types and sizes than observed ones in the 19 houses studied (**Figure 101**).

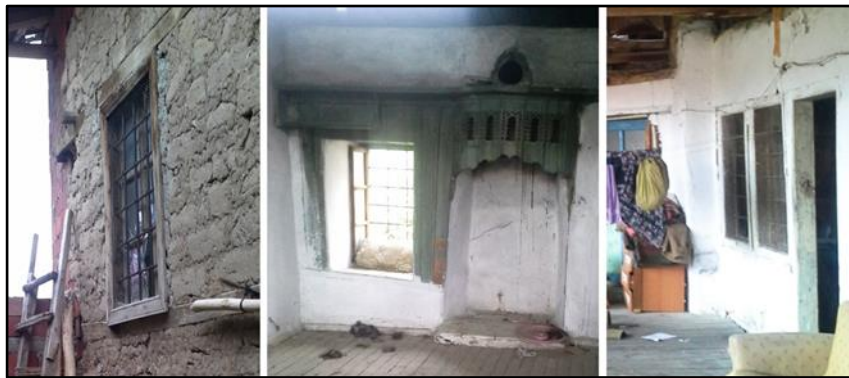
Figure 102: Windows with iron bars. Photos are taken from H13.

the ones in the late period houses. Also, use of iron bars in the windows is commonly observed among the early period houses (**Figure 102**).

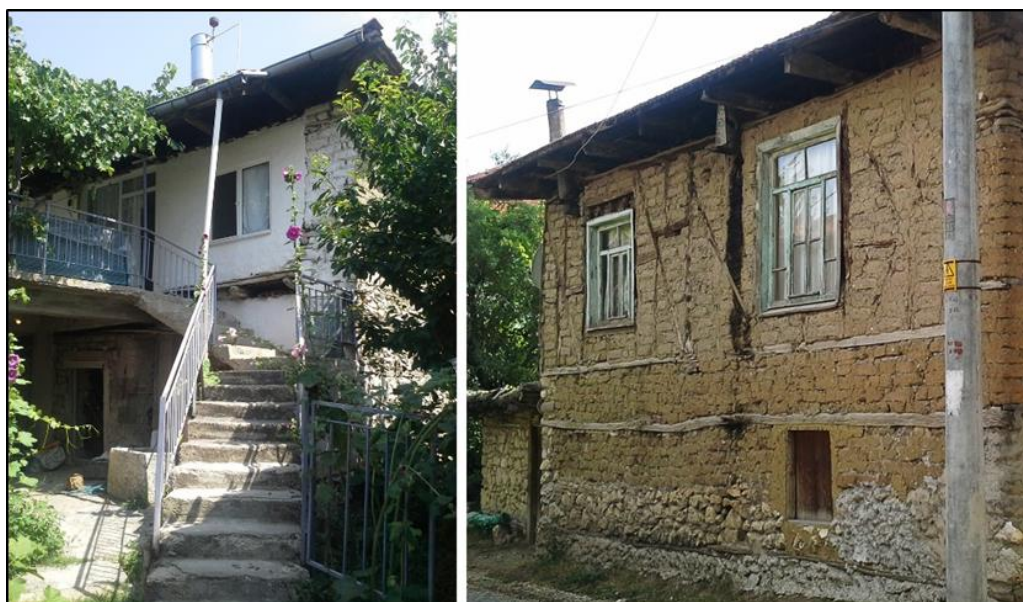
Figure 123: *The photo from the H12 on the left shows the reinforced concrete 'saçak' structure and the stairs which were constructed after the removal of the earthen 'saçak' structure and the wooden staircases; The photo from the H4, shows the timber-framed wall constructed after demolition of the mud brick masonry wall on the first floor of the house.*

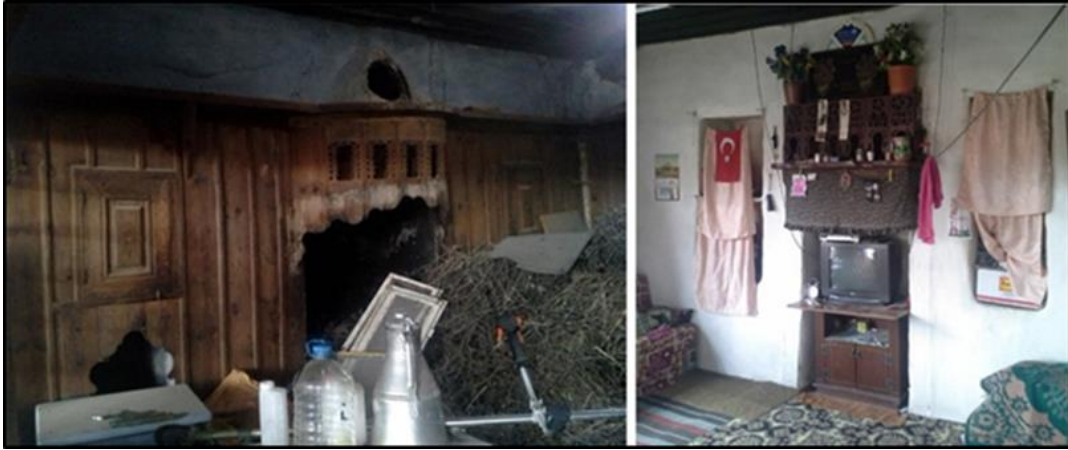
Figure 124: Both photos show the functional changes. The one on the left from H13, is a room that is used as storage. The one on the right from H7, is the usage of the 'ocak' as a niche.

Furthermore, the use of niches and fireplaces for different purposes is also very common. The devices such as electric oven, stove, that were started to be used in daily life, has brought about the loss of the traditional fireplace usage. If an '*ocak*' in a room have not been closed although it is not used for its original function, dwellers utilize the volume, existing inside the mud brick masonry wall, as a niche to put some home devices such as an oven or the television (**Figure 124**).

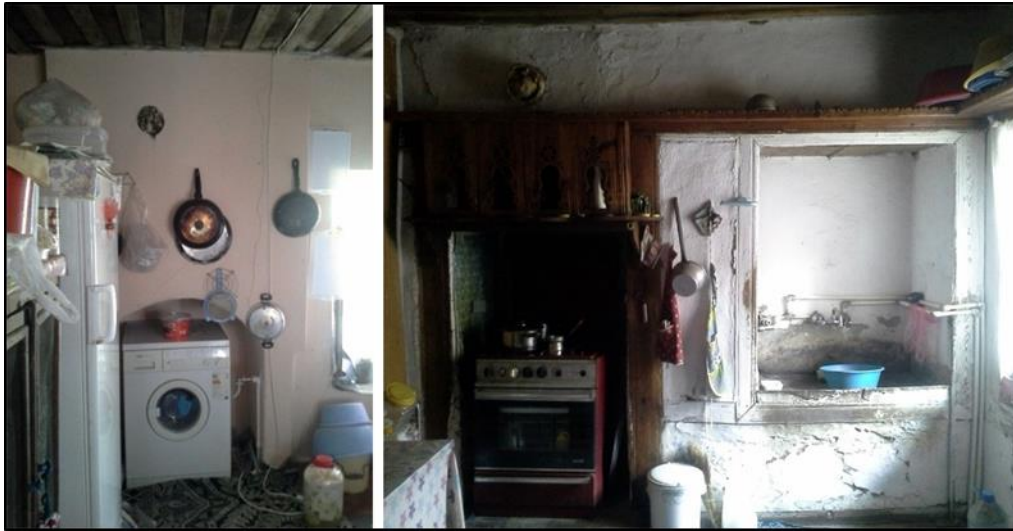
Figure 125: The photo from H19 on the left shows the use of the traditional fireplace as a niche for the washing machine; the photo from the H8 on the right shows the use of the traditional fireplace as a niche for the oven and the use of the transformation of a window opening to the place for a washbasin.

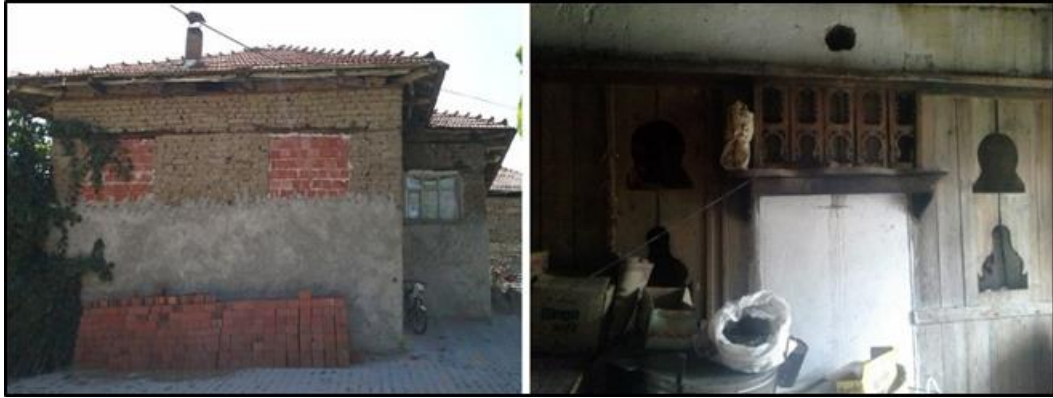
Figure 127: The photo from the H2 on the left shows the removal of the window frames and closing the openings with hollow bricks; the photo from the H7 shows the closed traditional fireplace.

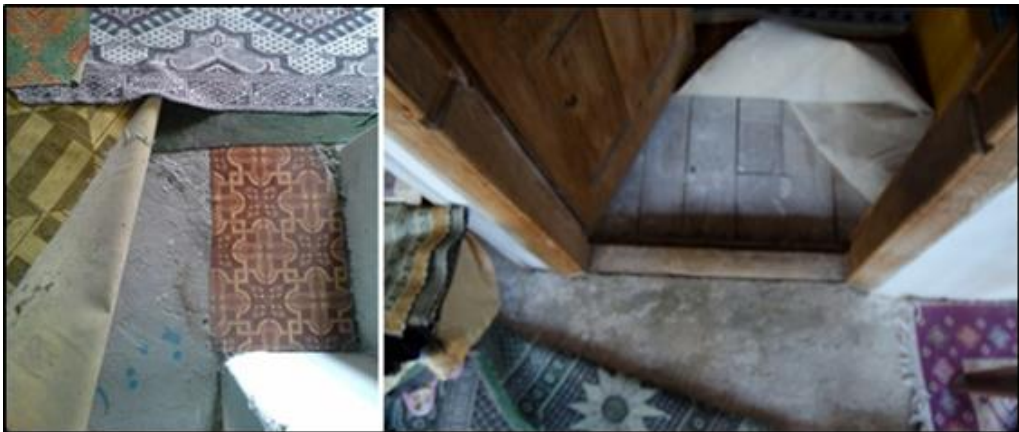
Figure 128: Both two photos shows the additional screed layer on the floorings. The one on the left is from H15; the one on the right is from H19.

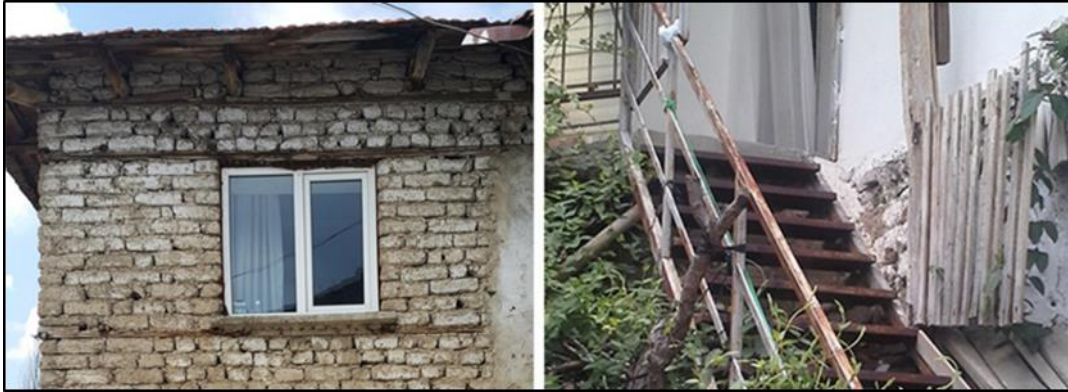
Figure 129: The photo on the left from H15 shows the replacement of the wooden frame window with the PVC. The one on the left one from H14 shows the structural and material change of the wooden staircase with the steel one.

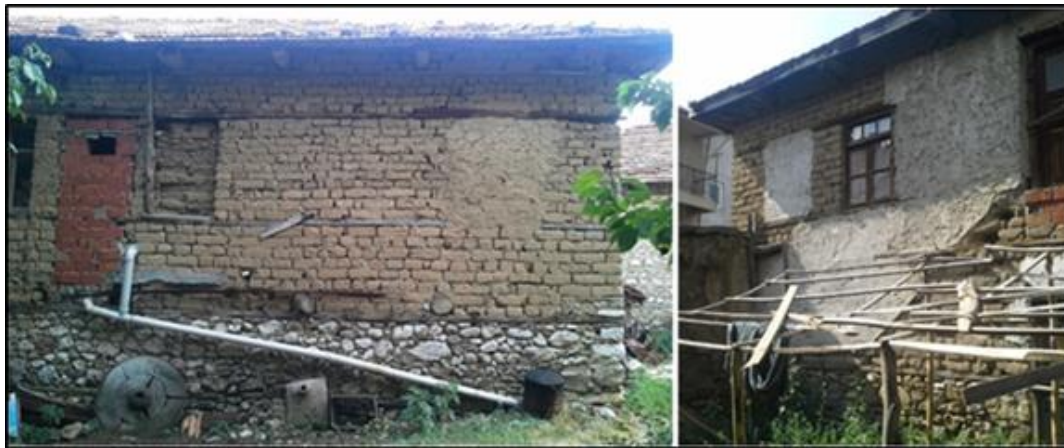
Figure 130: The photo on the left from H5 shows the decommissioning of two window openings and a door opening by using both hollow bricks and mud bricks as infill materials. The one on the right from H8, shows partial cement plaster on the facade.

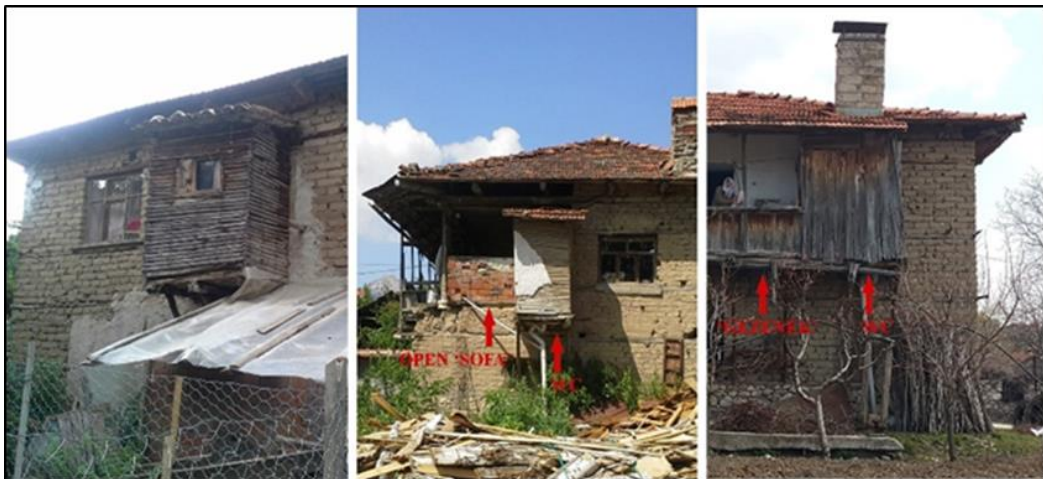
Figure 132: First photo shows the toilet located at the end of the 'enlarged corridor'(H11); the second one shows the toilet located adjacent to the open 'sofa'(H16); the last one shows the toilet located at the end of the 'gezenek'(H15).

Moreover, the interior expansion with mass addition to have new rooms for the house is observed only in the H2 (**Figure 131**). The other purpose of mass addition is to have an interior toilet which is integrated to the living areas of the houses (**Figure 132**).

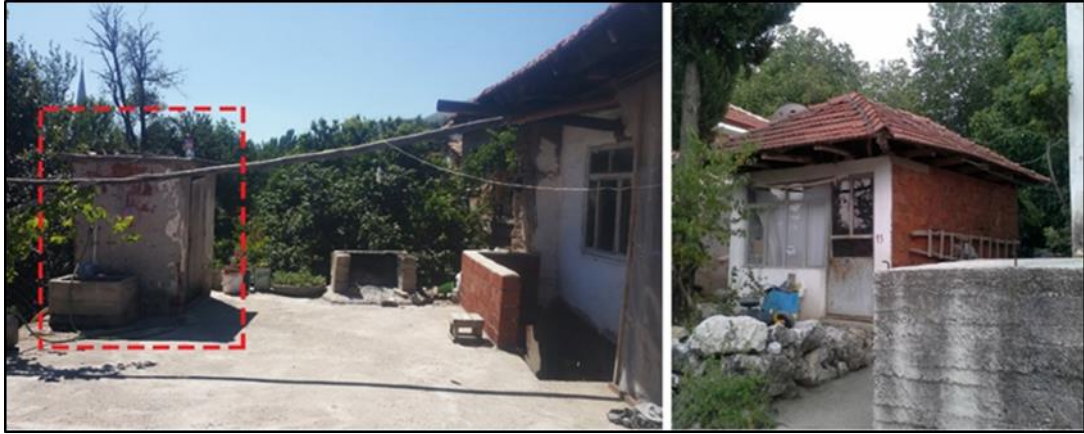
Figure 133: *The photo from H2 on the left shows the toilet as a mass addition on the 'saçak'. The photo from H11 on the right shows the auxiliary building as a mass addition separately located on the same lot with the main housing.*

In addition to these, in 5 out of 19 houses (H1, H2, H6, H8 and H14), there are new wet room additions on the '*saçak*' structures with the contemporary industrial materials such as concrete, screed, hollow bricks, cement mortars and plasters (**Figure 133**). If the structures, located on '*saçaks*' without any physical relation with the house such as the toilets, are required to be removed because of being not qualified and compatible constructions, it is possible to reverse them without causing damages to the traditional houses.

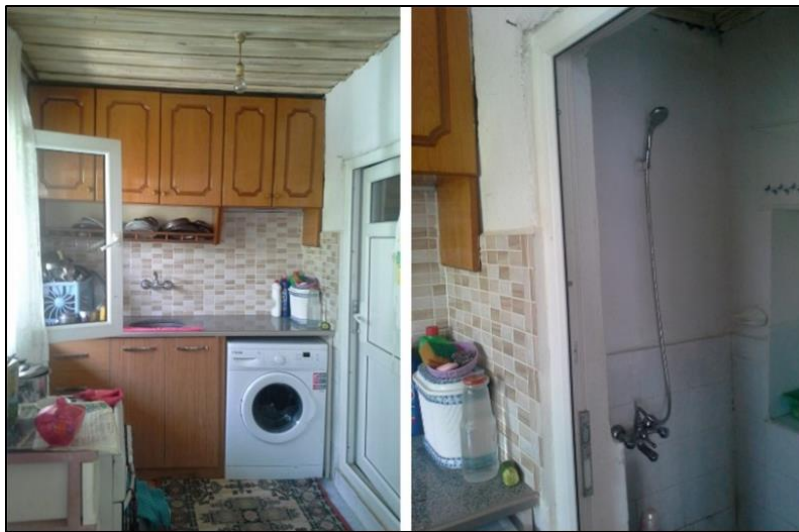
Figure 134: *These two photo show the closed 'sofas', which are used as the kitchen, and the bathroom located just next to the kitchen by dividing the space with additional walls.*

First, additions of new interior walls, which divide existing spaces, were done frequently in order to overcome the lack of original wet rooms such as toilet and bathroom and kitchen integrated with the living area (**Figure 134**). This is the most problematic type of the intervention made by the dwellers because water insulation is very essential for the mud brick masonry structures. Interventions such as poor water installation applications and usage of contemporary construction materials, which are incompatible with the local construction materials damage mainly the structural features of the traditional mud brick masonry houses in Ağlasun. This is observed in the 13 out of 19 houses namely H2, H3, H5, H9, H10, H11, H12, H13, H14, H16, H17, H18 and H19.

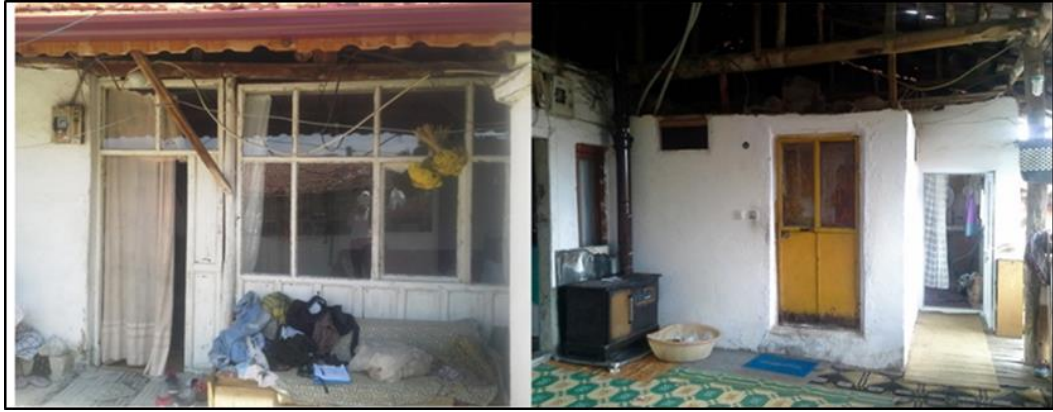
Figure 135: The photo from H6 on the left shows the 'sofa' which was closed later. The one on the right from H13 shows the toilet in front of the kitchen, which are both constructed with additional walls on the open 'sofa'.

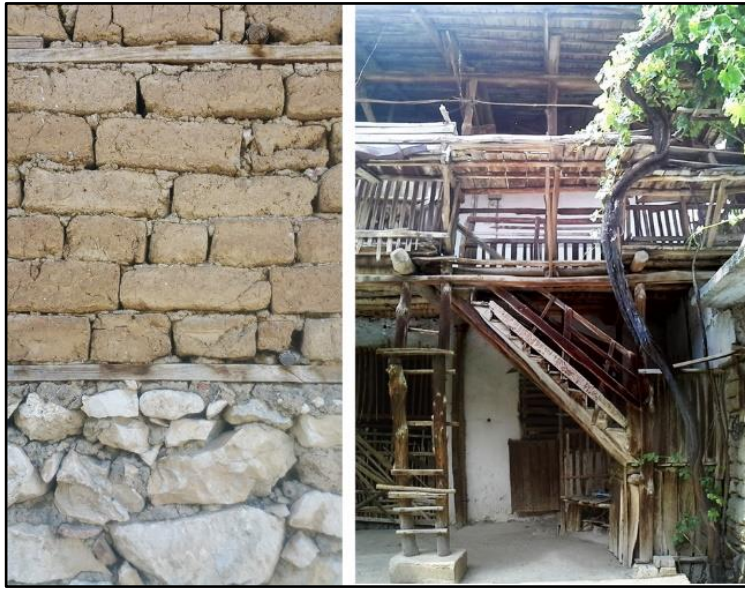
Figure 145 : Stone, mud brick and timber, the local construction materials of the Traditional Houses in Ağlasun. The photo on the left is from the H15 and the photo on the right is from the H9.

Firstly, the contribution to the environmental sustainability and energy efficiency with the usage of local construction materials is the base value of traditional architecture in Ağlasun, as in many rural areas in Turkey (**Figure 145**). In addition to these, the use of spolia construction materials is also an essential value for these houses because this also points out the relationship between the ancient city ‘Sagalassos’ and the life in the Ağlasun settlement (**Figure 146**).

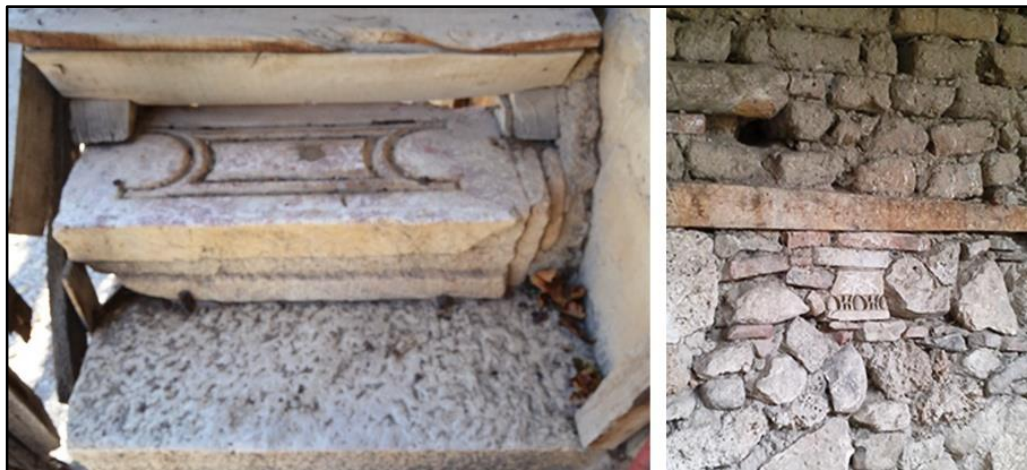
Figure 146: Spolia as a part of a staircase and the stone masonry wall. The photo on the left is from the H19 and the photo on the right is from the H13.

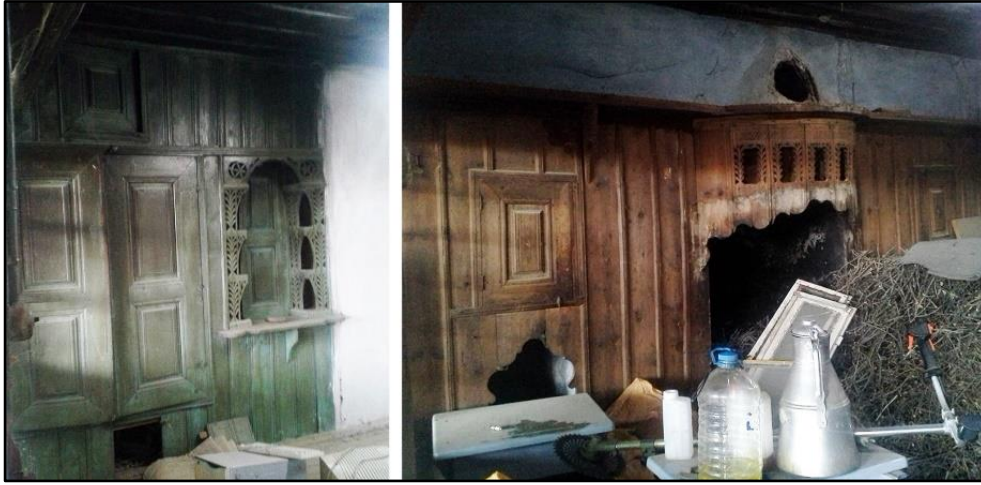
Figure 147: A 'Yüklük', a 'şerbetlik' and an 'ocak' with a 'yaşmak'. The photos are from the H13.

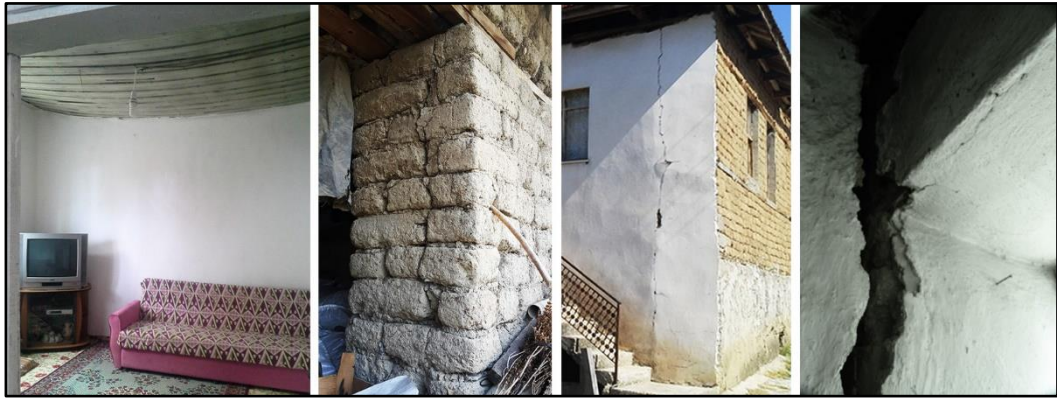
Figure 148: The photo on the left shows the sagging on the ceiling. The others show the structural cracks on the masonry walls. From left to right, the photos are from H14, H15, H3 and H7.

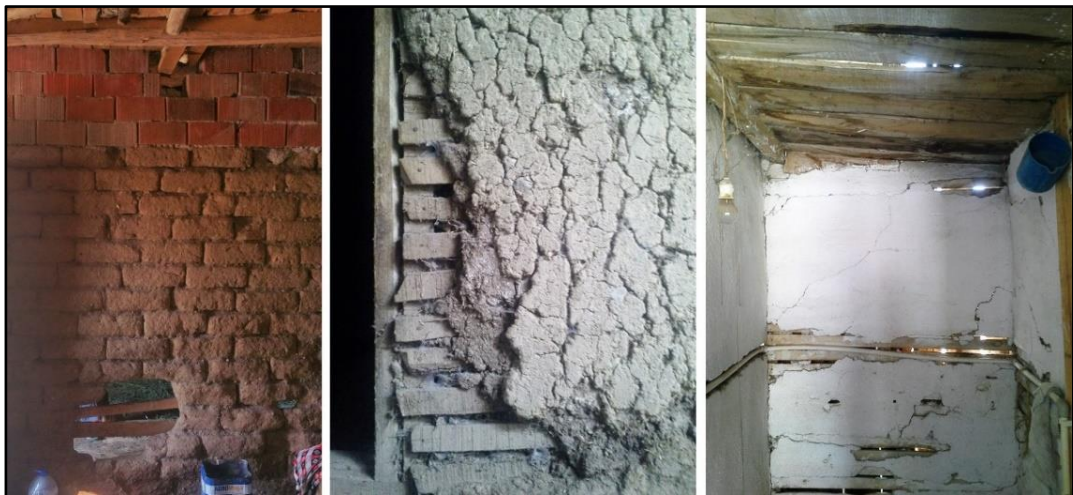
Figure 149: The material loss on the mud brick masonry and timber-framed walls. From left to right, the photos are taken from H3, H4 and H15.

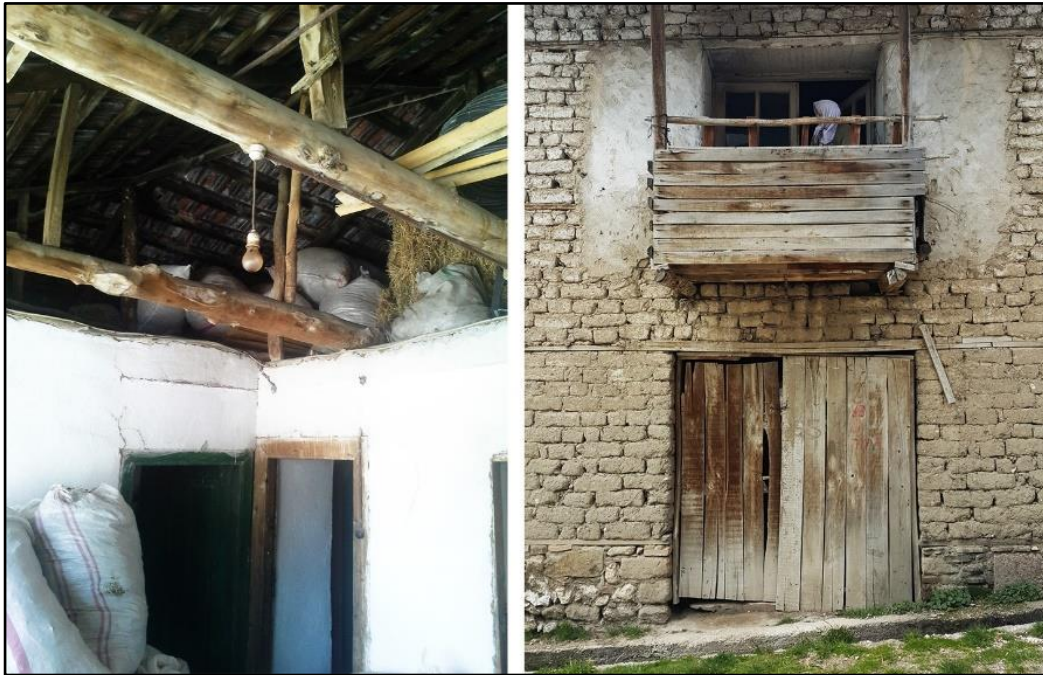
Second, there are surface problems comprising non-structural cracks, which appear mostly on the plasters on the walls, material degradation and material discoloration on stones, mud bricks, timber elements, mortar and plaster (**Figure 150**).

Figure 150: The discoloration problem on the timber elements. The photo on the left is taken from H5 and the photo on the right is taken from the H15.
