AN INQUIRY INTO THE VALUES AND PROBLEMS FOR CONSERVATION
OF TRADITIONAL MUD BRICK HOUSES IN AĞLASUN, BURDUR

A THESIS SUBMITTED TO
THE GRADUATE SCHOOL OF NATURAL AND APPLIED SCIENCES
OF
MIDDLE EAST TECHNICAL UNIVERSITY

DECEMBER 2019

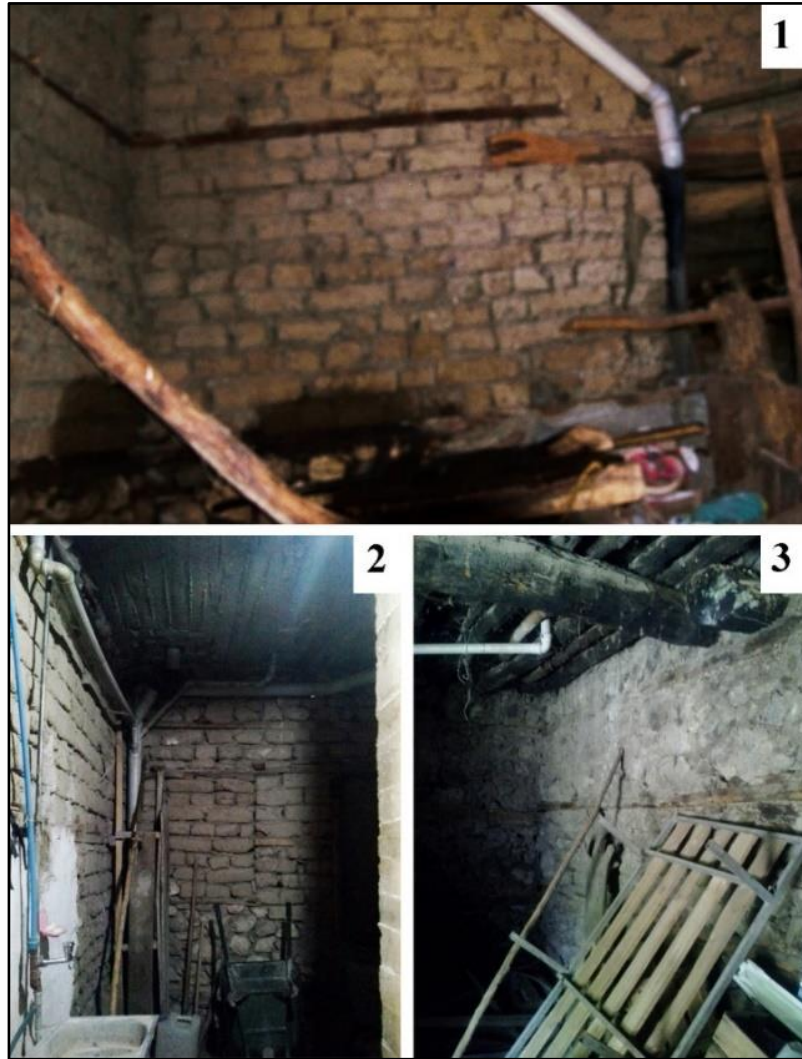
Figure 151: *The first photo from the H19, shows the mud brick masonry wall exposed to water leakage from the pipe; the second photo from the H9 shows the condition of the drainage piping system and its physical relation with the mud brick masonry wall and reinforced concrete slab; the third one shows the relation between the water pipe and the traditional flooring system.*

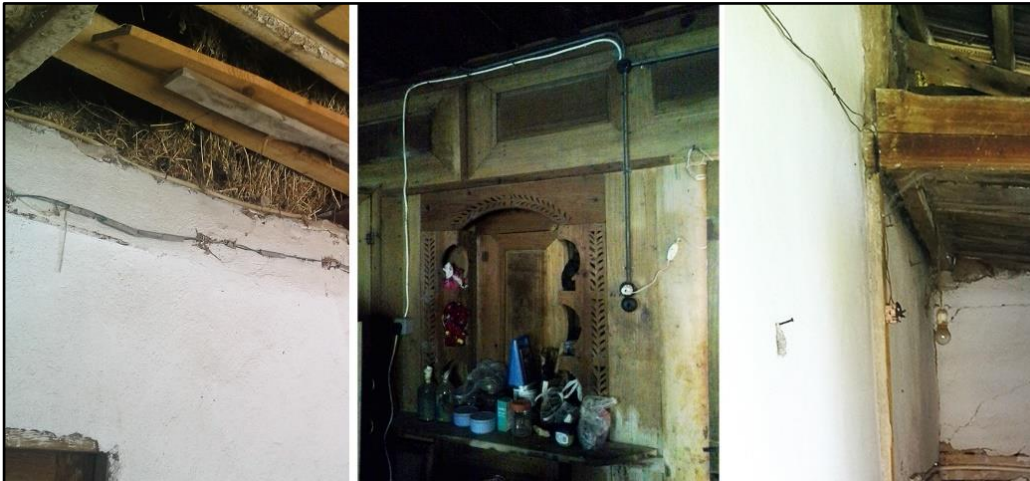
Figure 152: The photos show the electric cables in poor condition without any isolation. From left to right, the photos are from H5, H7 and H15.
