CONSTRUCTION TECHNIQUES OF TRADITIONAL HOUSES IN
CUMALIKIZIK VILLAGE, BURSA (TURKEY)

A THESIS SUBMITTED TO
THE GRADUATE SCHOOL OF NATURAL AND APPLIED SCIENCES
OF
MIDDLE EAST TECHNICAL UNIVERSITY

DECEMBER 2019

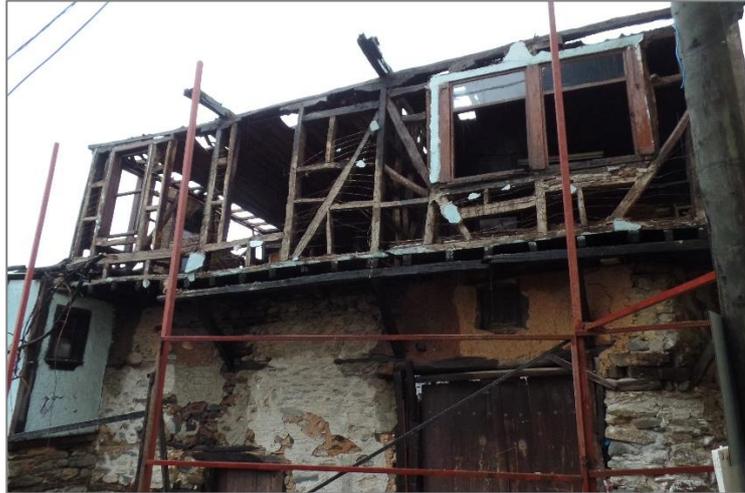
Figure 1.2. Dismantling of the building 2819-1-9 (Group B)

During the first site survey, the dismantling of the building (lot number: 2819-1-9) was monitored. The construction site was visited for five weeks and the details of the building were documented through photographs, partial drawings and measurements. Also, detailed measured drawings, prepared by the construction company, were obtained.

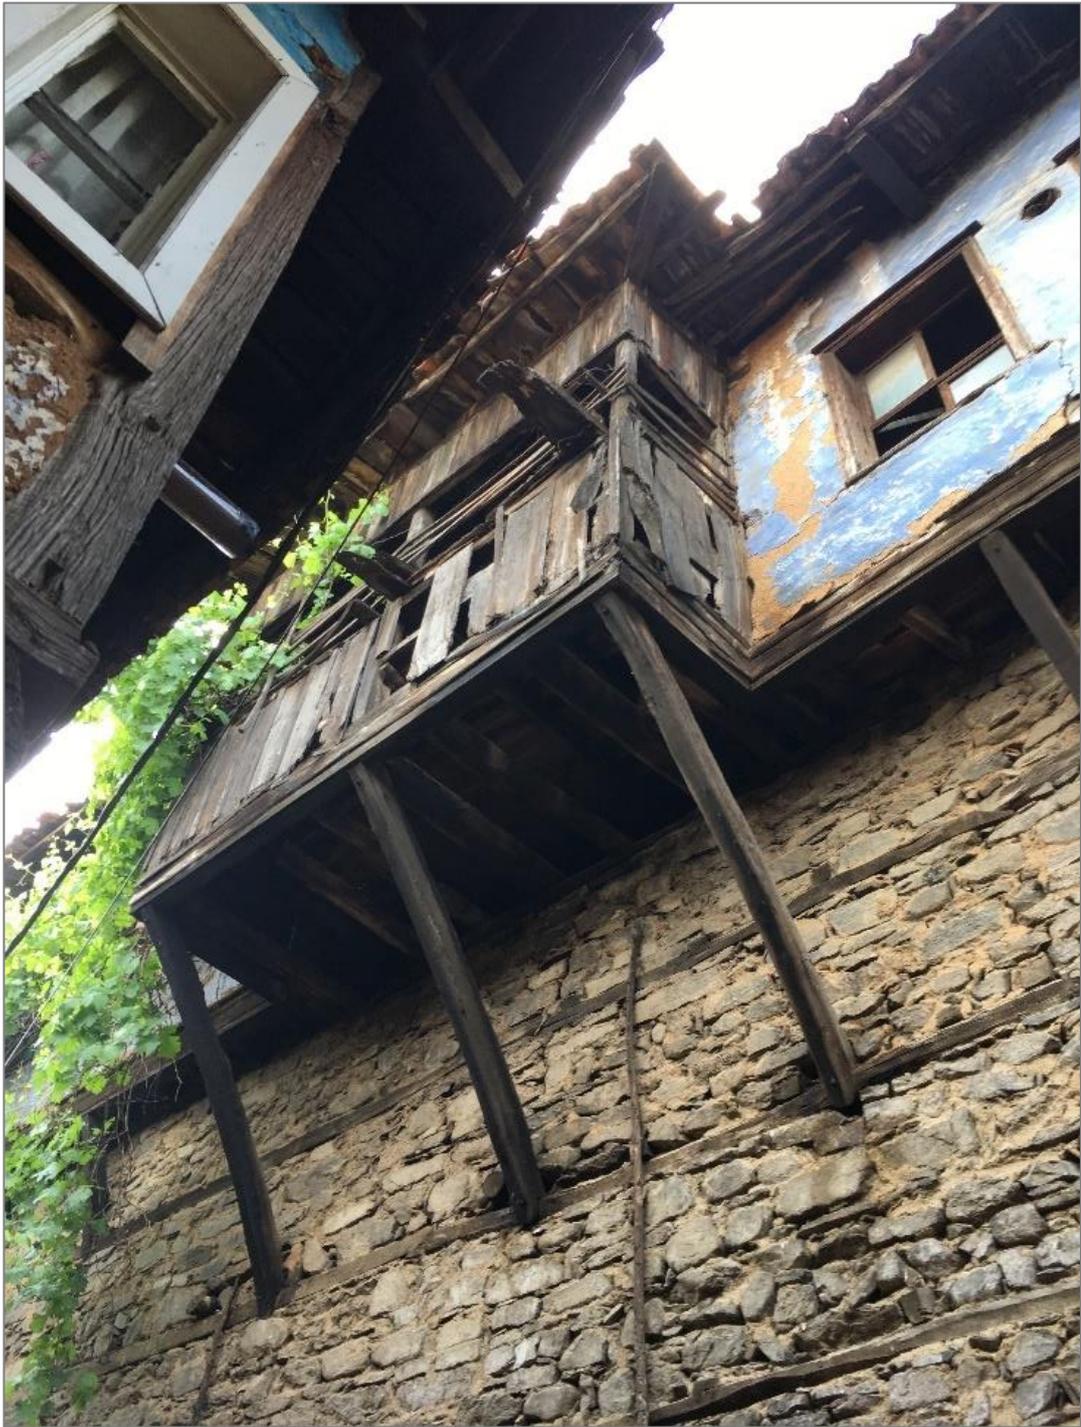
Figure 2.29. Iwan and projections with braces (2805-1)

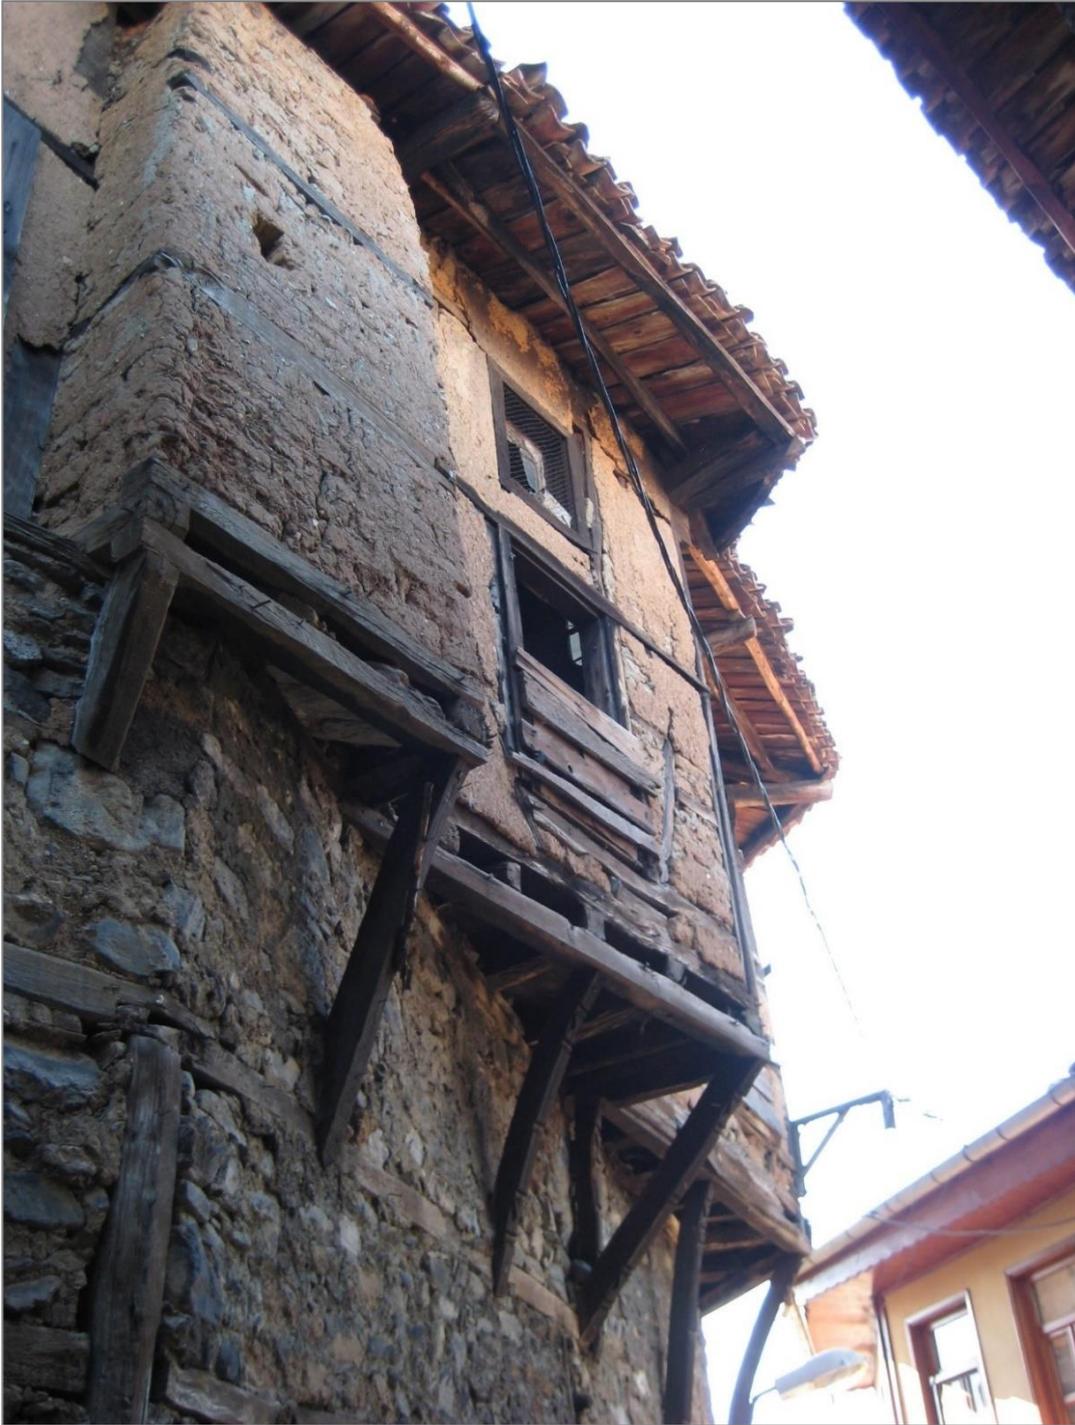
Figure 2.30. Projected fireplace and top windows (2819-3) (Source: Piray Architecture, 2008)

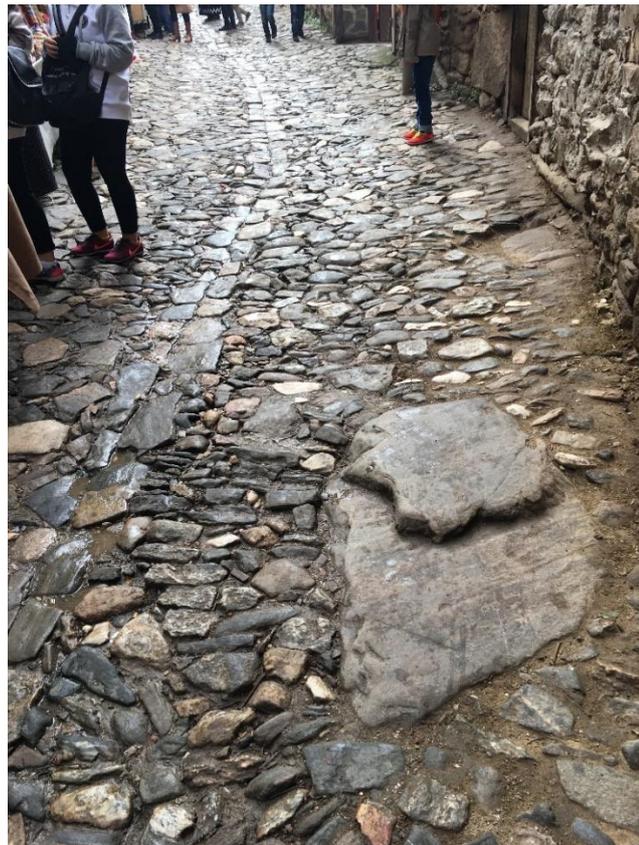
Figure 2.34. Street pavements with slate stone

The pavement of the streets is slate stone. The streets are inclined towards their middle axis for the drainage of rainwater. There is a sewer line under the middle axis of the street. The sewage system of the village can be reached by removing two opposite slate stones, placed in the middle line of the street. In addition, the traditional wastewater outlet of the buildings can be observed at lower levels on the facades of some traditional houses. The streets are framed on both sides by high stone masonry walls of buildings or courtyards. They are protected from rain and are shadowed by projections and wide eaves of the buildings. Corner chamfers are used in the settlement in order to ease the turns at the intersection of the streets. Fountains and projected fireplaces of the buildings are elements enriching the street pattern. In the settlement, there are not any trees along the streets but flowers in the windows and the vines can be considered as natural elements of the streets.

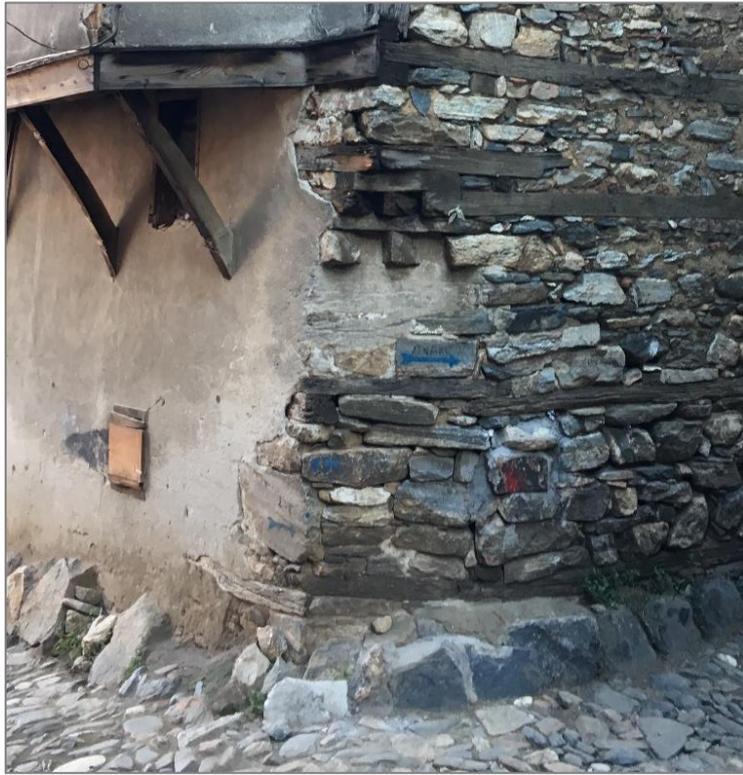
Figure 2.35. Corner chamfer (2800-34)

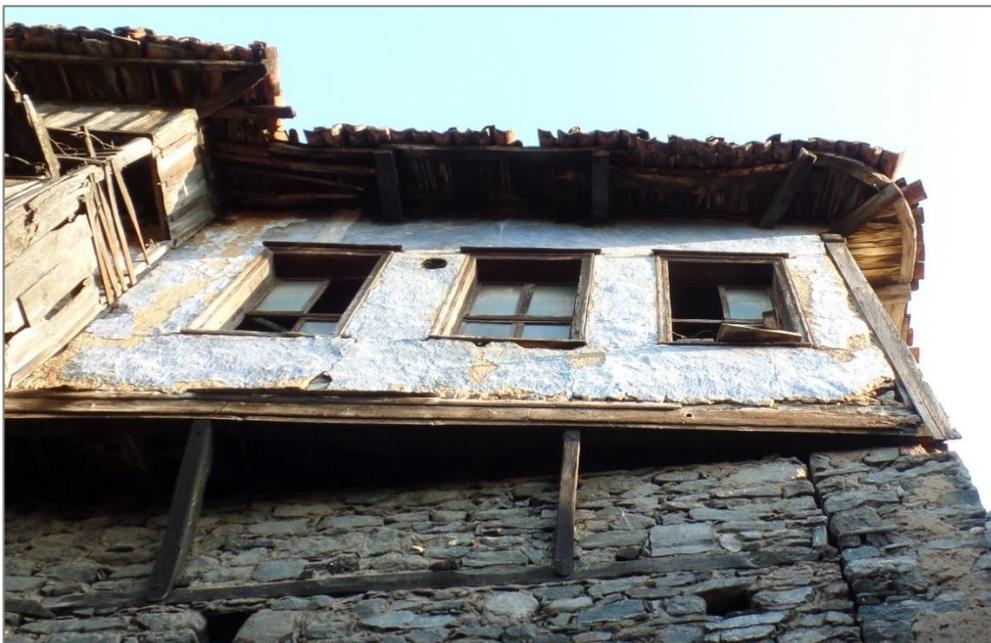
Figure 2.36. Wide curvilinear eaves (2805-1)

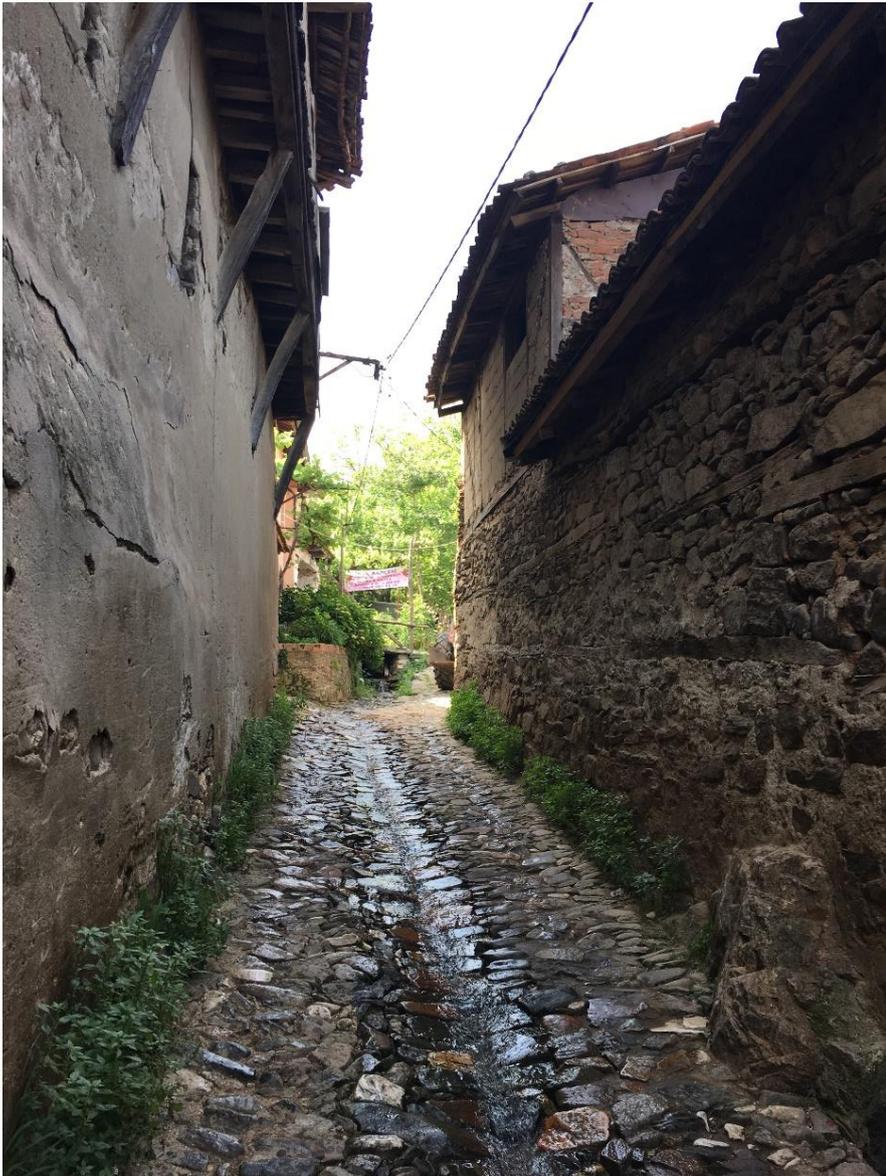
Figure 2.39. Inclined streets towards the middle axis

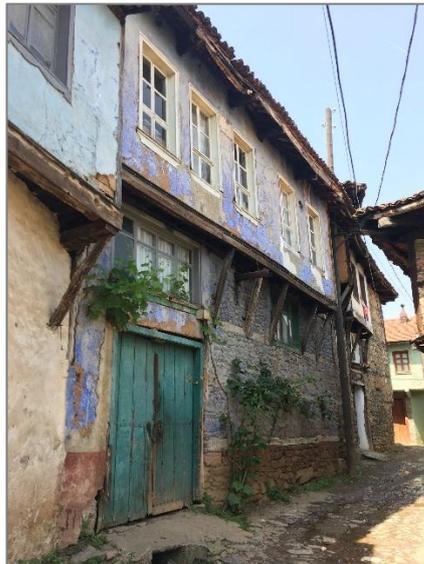
In Type A, the building is situated in the front part of the lot, covering the entire street facade, whereas the courtyard is situated at the back. Entrance is provided through a double-winged door opening in the ground wall of the building. The building is reached directly from the street (See Fig. 2.6, 2.7).

Figure 2.45. Example of Type A. (2814-9)

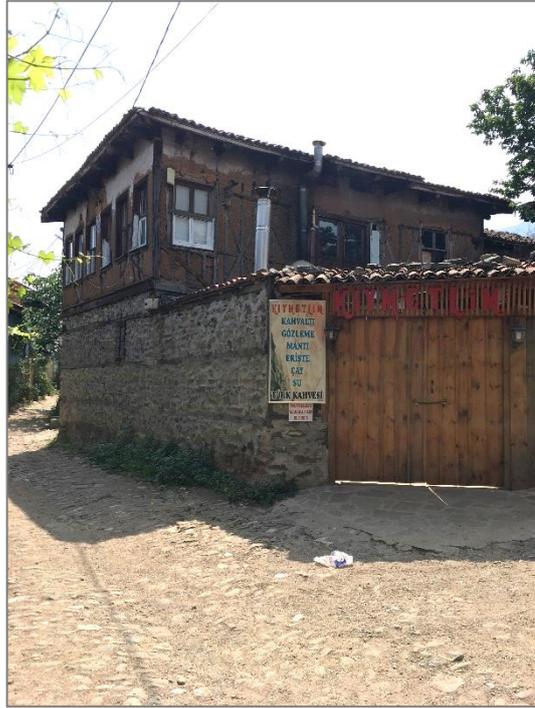
In Type B, both the building and courtyard have a street facade. The entrance is provided through a double-winged door opening, with an eave, usually located in the courtyard wall. From the street, one enters first to the courtyard and then the building (See Fig. 2.8)

Figure 2.46. Example of Type B (2805-3)

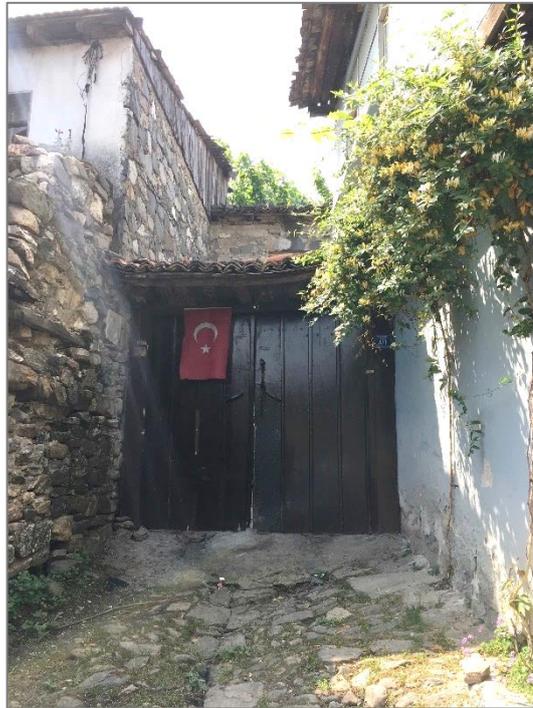
In Type C, the building is located at the back, and the courtyard is in the front of the lot. The entrance is provided through a double-winged door opening, with an eave, located in the courtyard wall. (See Fig. 2.9) The building's location behind the high courtyard walls is advantageous in terms of both privacy and security. It is known that this type of building-lot-street relationship, which can be considered as introverted and protected, is the characteristics of early Ottoman residential fabric (Şahin Güçhan, 2017).

Figure 2.47. Example of Type C (2805-25)

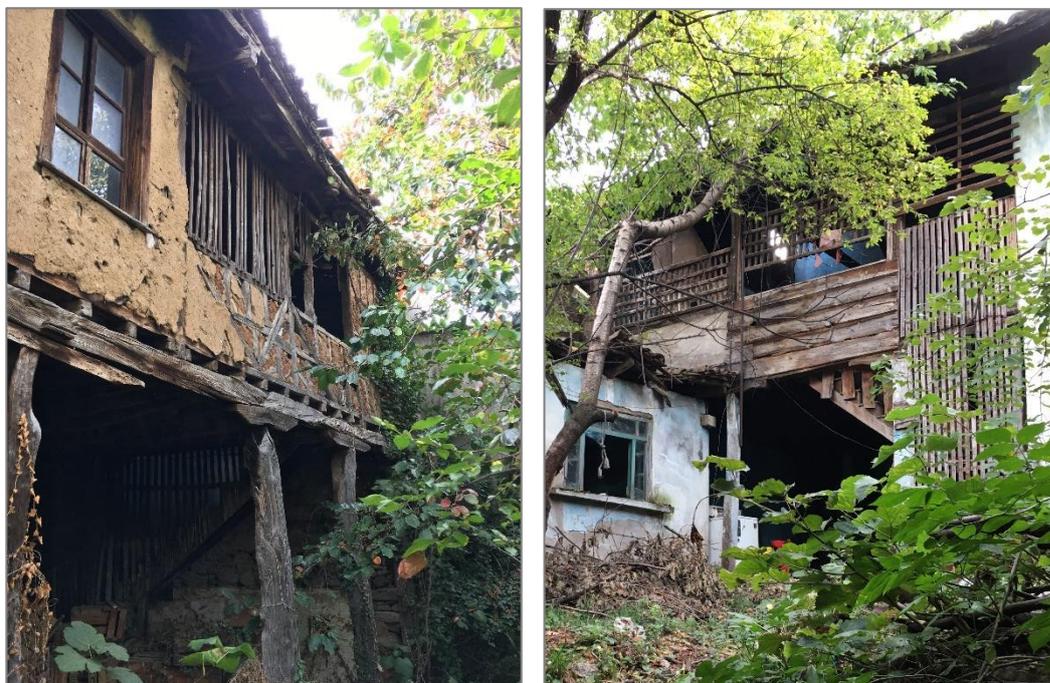
Figure 2.49. Courtyard facade of 2817-34 (left), 2800-41 (right)

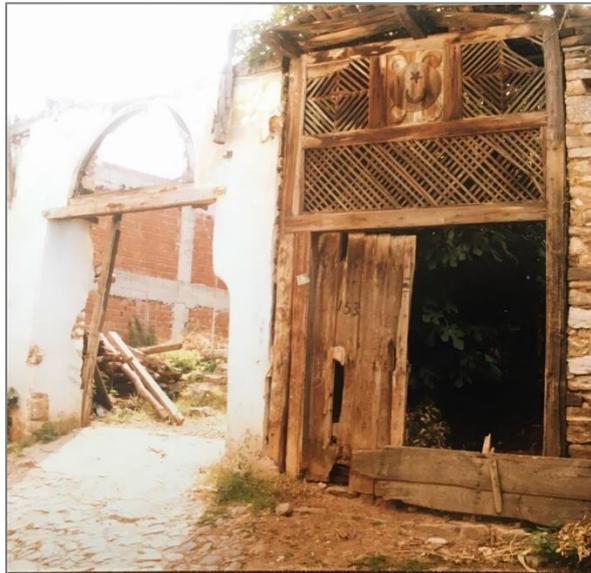
Figure 2.50. Double winged entrance doors (Source: Neriman Şahin Güçhan Archive, 1998)

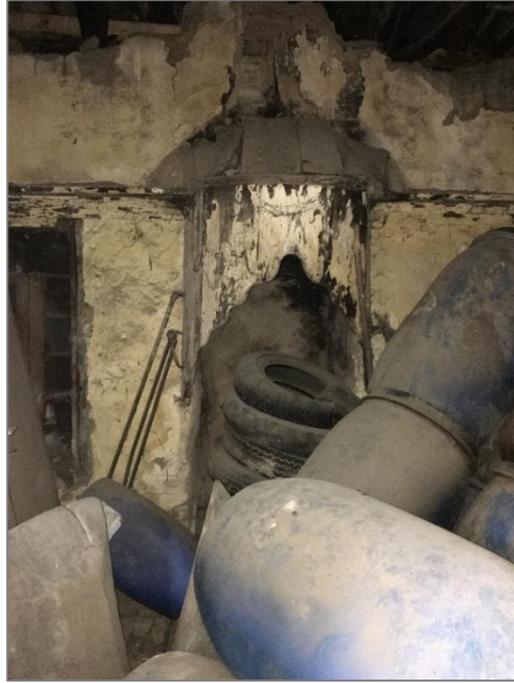
Figure 2.51. Ocak and niches in aşhane (2817-34)

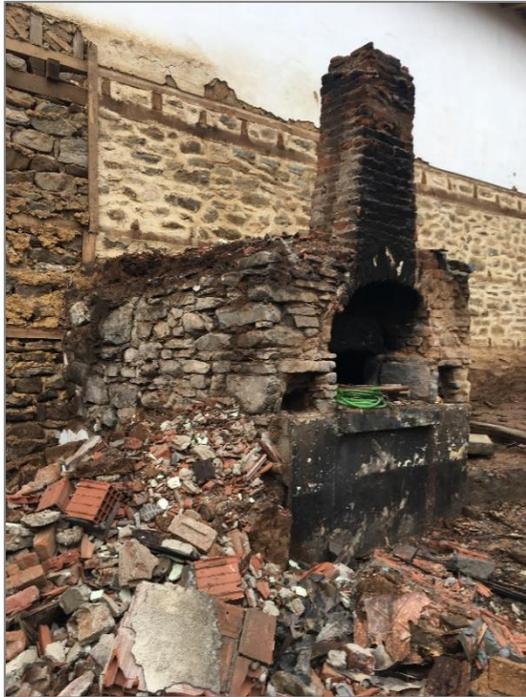
Figure 2.52. Fırın in the courtyard (left: 2819-1-9) (right: source: Neriman Şahin Güçhan Archive)

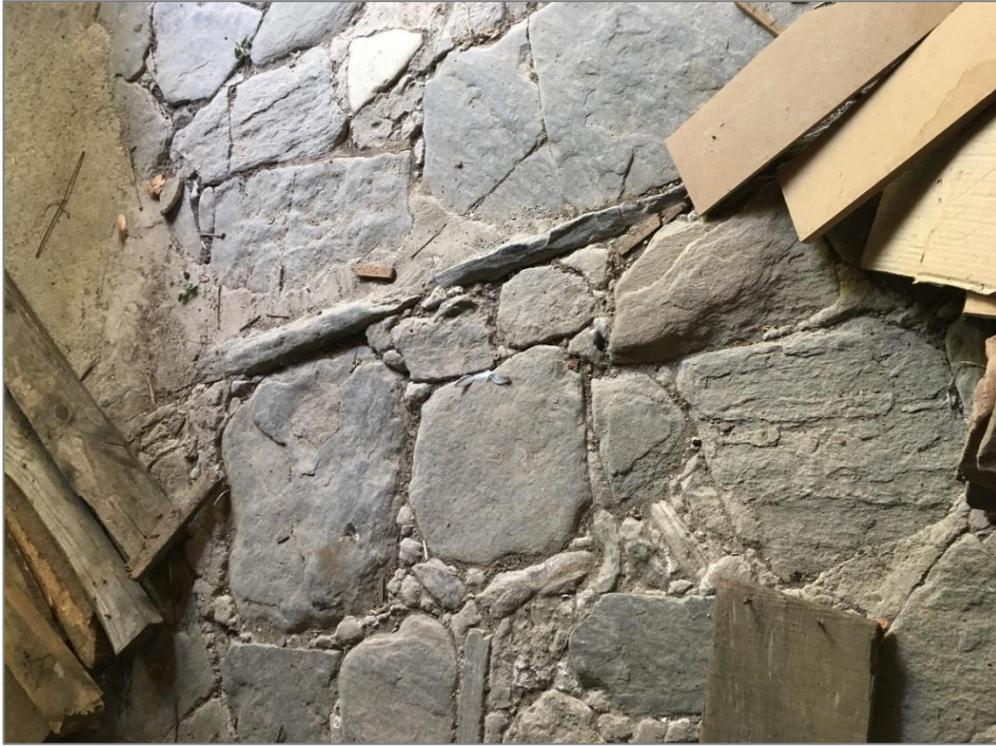
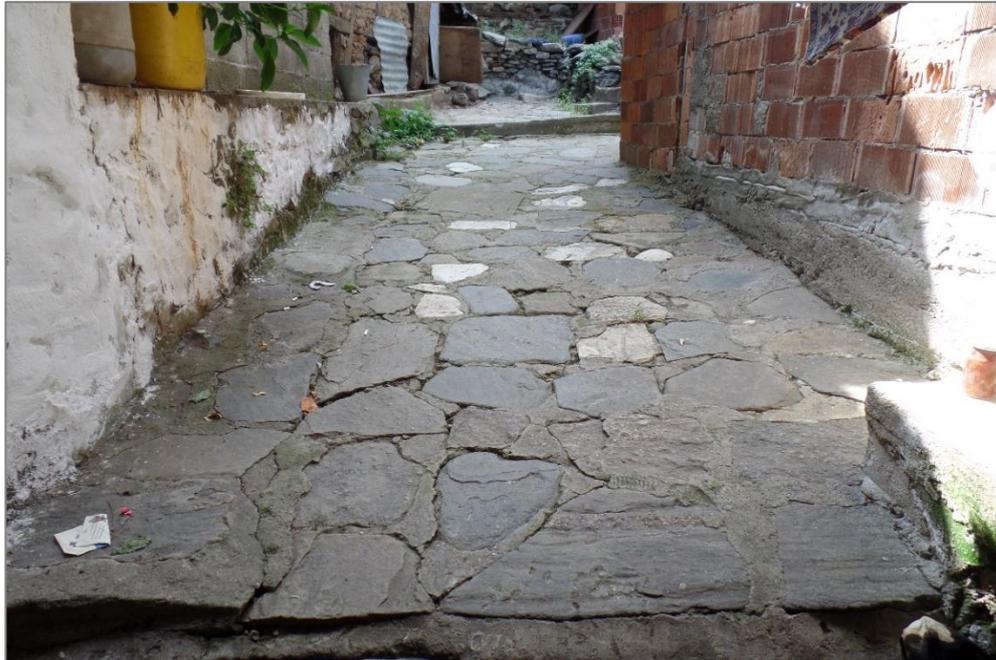
Figure 2.53. Slate stone floor covering in courtyard and *hayat* – 2800-38 (above), 2800-3 (below)

The architectural elements on the ground floor are double winged entrance doors, service doors, small sized windows opening to the street, the fireplace in the *aşhane*, and furnace used for baking bread or laundry and the staircase connecting the ground floor to the upper floor. The courtyard floor is usually covered with slate stones, and in some cases compressed earth is also used. The ceiling of *hayat* and service spaces are not covered. Some buildings have fountains on the street facade.

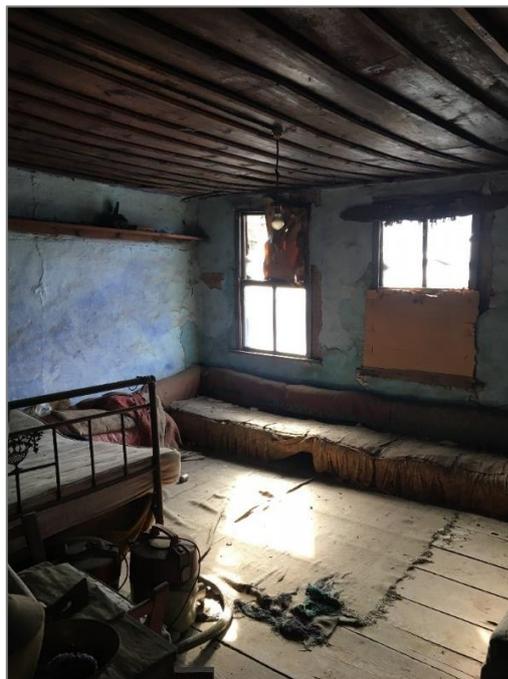
Figure 2.59. Room with *sadir*, *sergen*, floor boards and ceiling boards (2817-34)

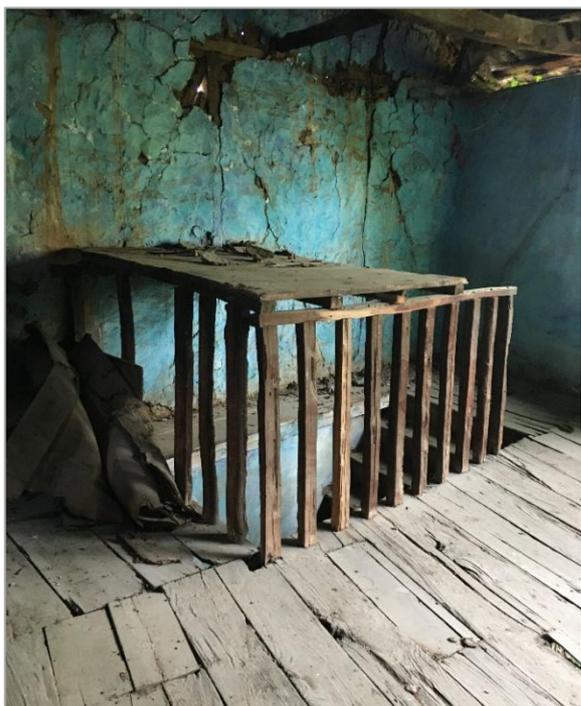
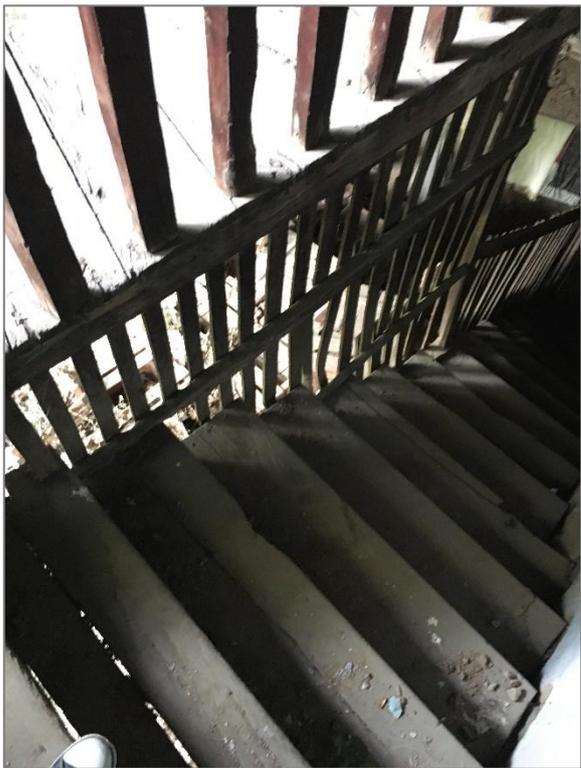
Figure 2.65. Timber staircase in 2817-34

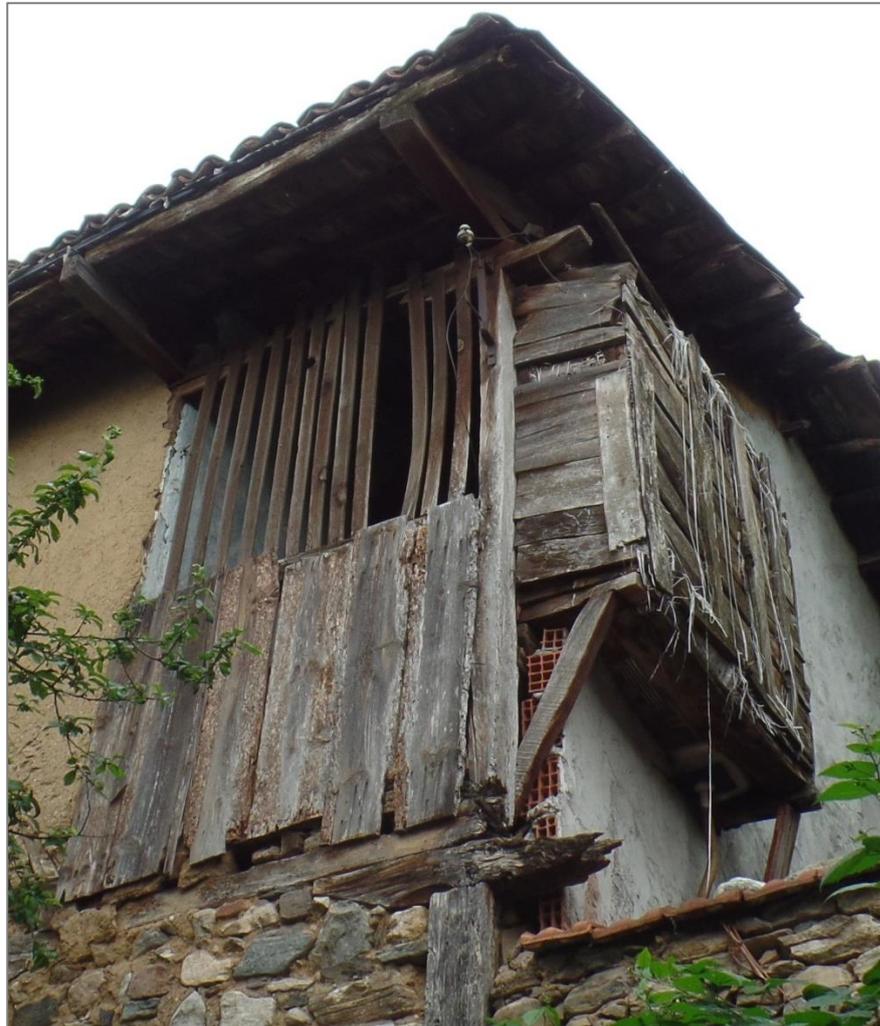
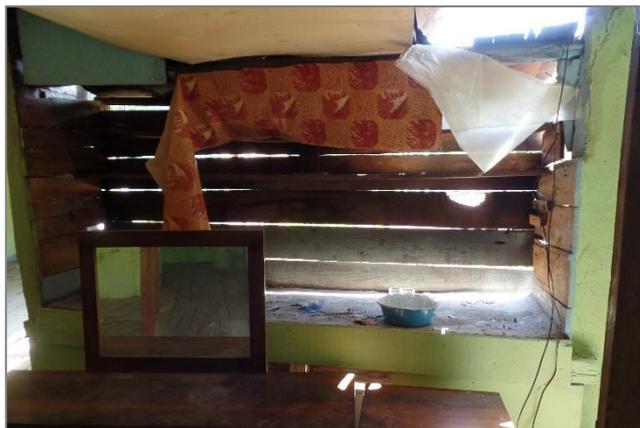
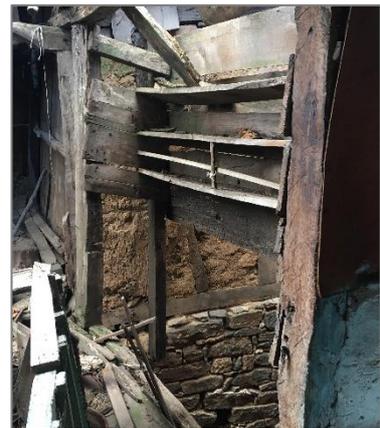
Figure 2.66. Abdestlik in 2806-8 (above), 2800-38 (left), 2805-1 (right)

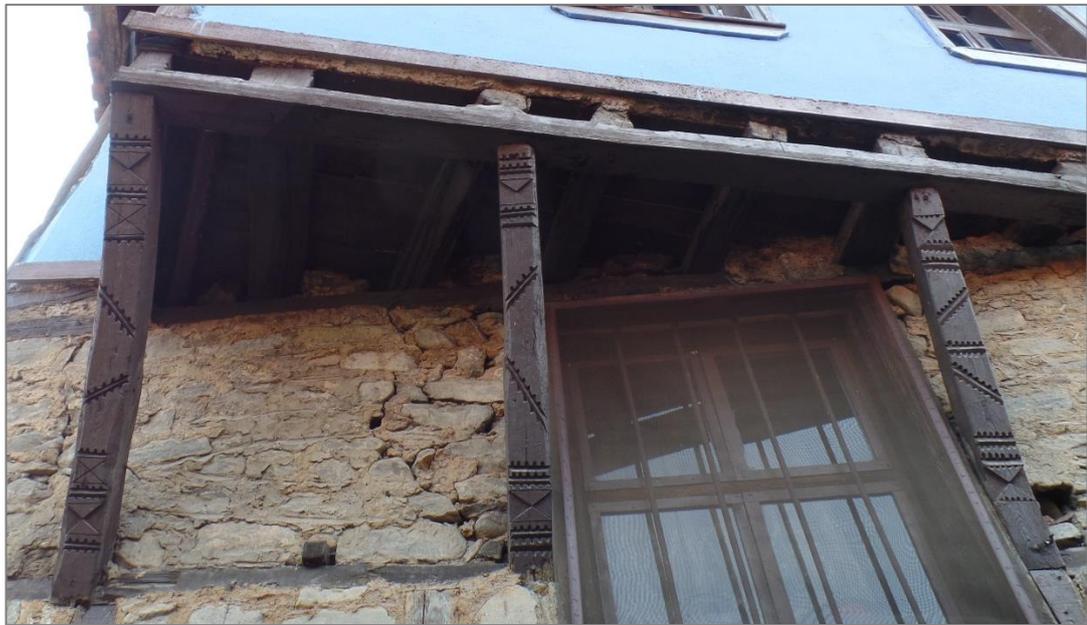
Figure 2.67. Decorated braces – 2812-1

While braces with different patterns carved on are still observed in the settlement, the geometric patterns formed by flat Ottoman bricks and lime plaster, or the decorations painted on plaster on the facades have been lost.

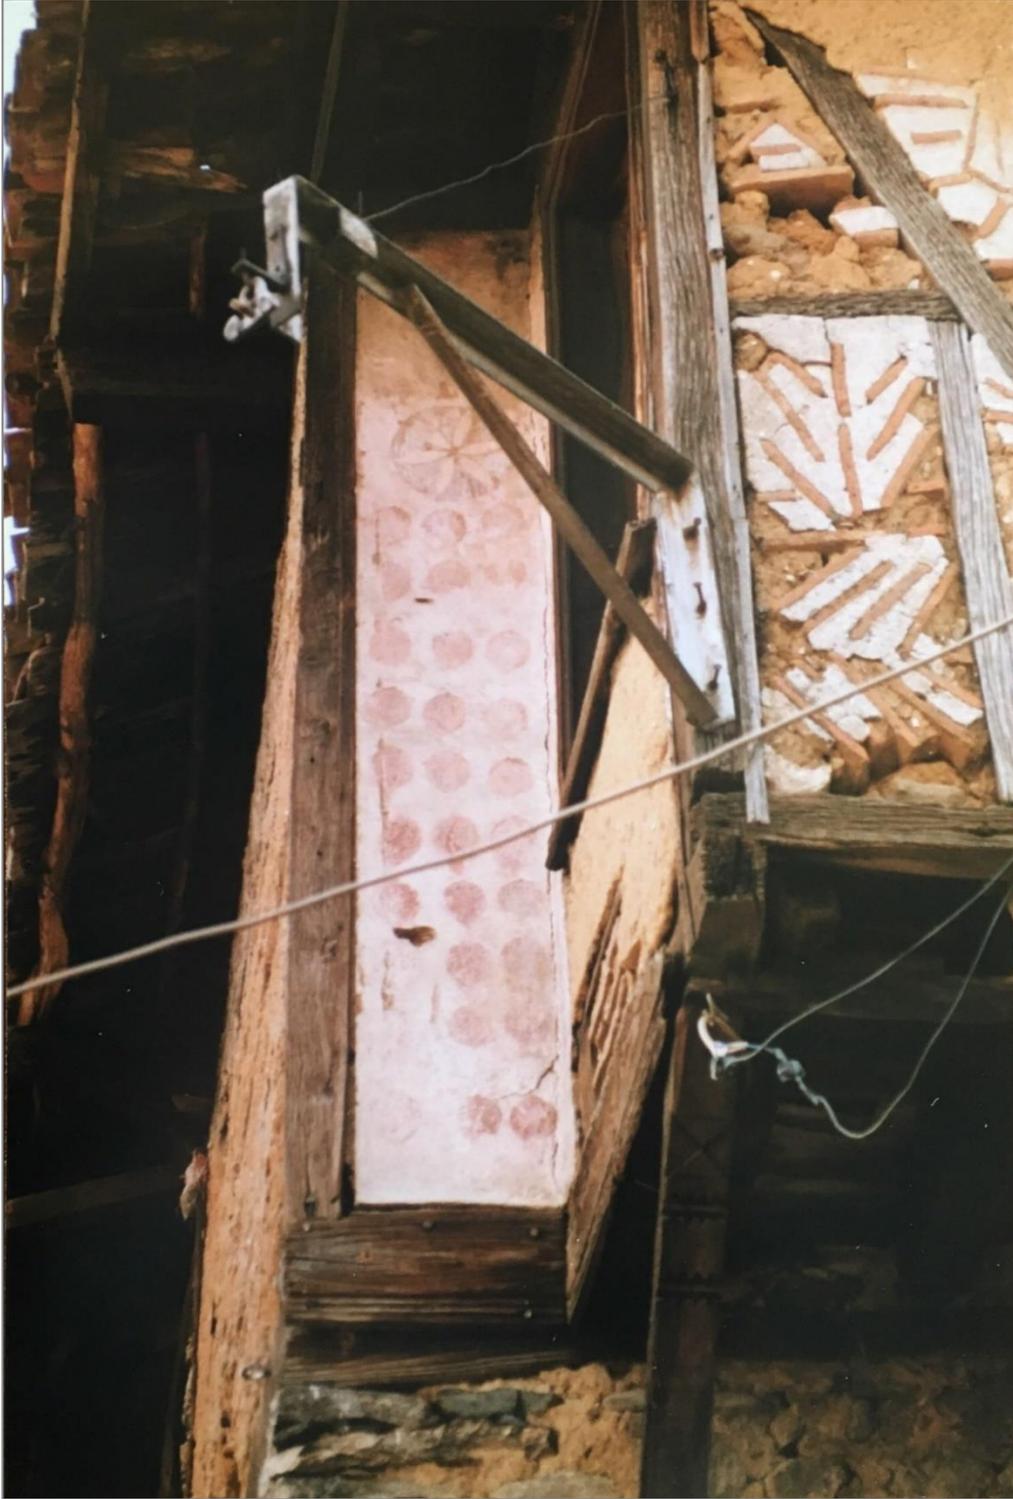
Figure 2.68. Geometric patterns formed by flat Ottoman bricks and decorations painted on plaster - 2817-1 (Source: Neriman Şahin Güçhan Archive, 1998)

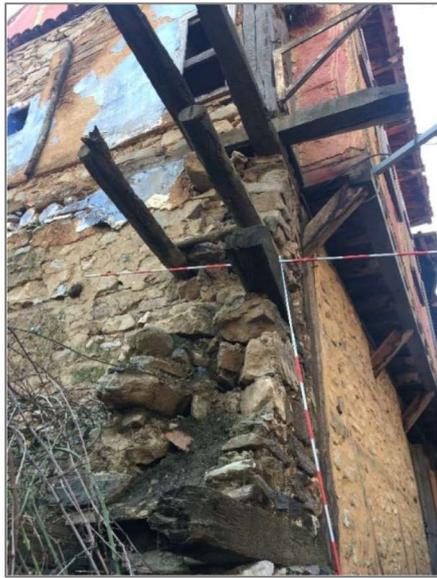
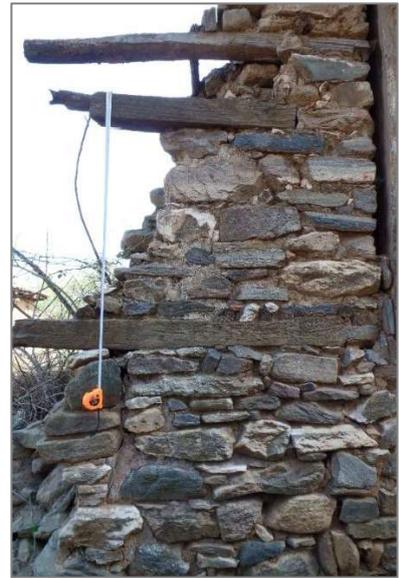
Figure 3.9. Detail from rubble stone masonry wall with timber lintels (lot no:2800-36)

All masonry walls are built by rubble stone. When the wall sections are examined, it is seen that large stones with smooth surfaces are used in the exterior, whereas small stones are used in the interior (See Fig.3.8). The thickness of the stone wall varies 65-100 cm, depending on the height of the wall, the soil structure, and the building's position on the slope.

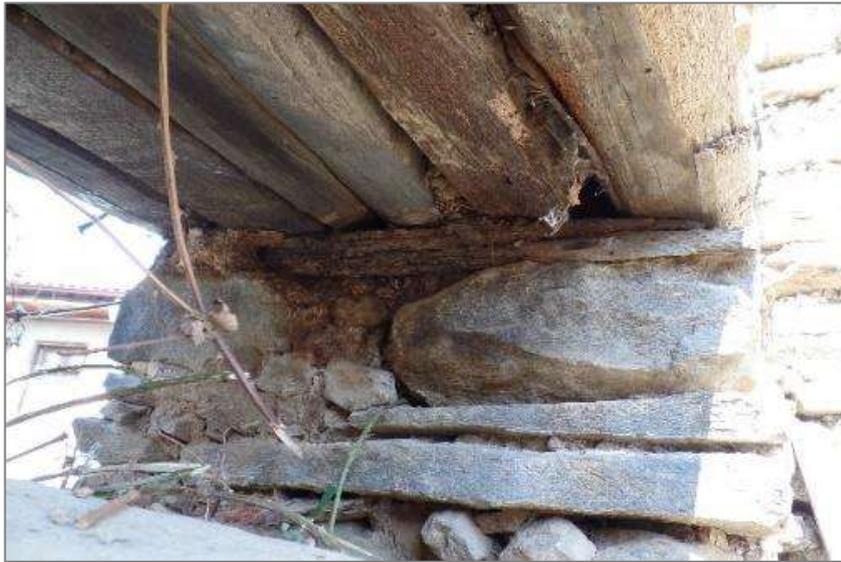
Figure 3.11. Slate stones extending through the section of rubble stone masonry wall (lot no:2800-36)

River stones with different sizes, slates and mud mortar as binding material are used in the construction of rubble stone masonry walls with timber lintels (Deniz, 1991, Perker, 2004). There are not any significant differences in the courses of stone masonry walls in Cumalıkızık houses. Rubble stones, placed irregularly, are surrounded by small rubble stones and slates, which draw attention with their elongated forms. Since these slates continue along the wall thicknesses at certain points, they also serve as lintels (See Fig. 3.11). Large stones are used at the lower levels. Although very subtle, the stone sizes get smaller as the wall rises. Stones generally do not have a regular geometry, but rectangular and square-like stones are also seen in the masonry courses (See Fig. 3.12).

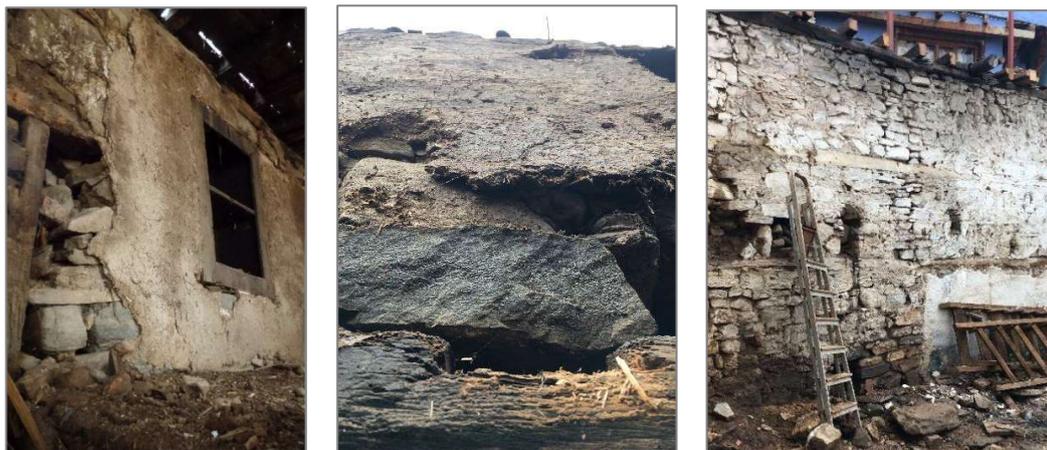
Figure 3.14. Plastered interior surface of wall (left, middle) Washed surface of wall (right)– 2819-1-9

The stone walls in Cumalıkızık are not plastered from the exterior. In the interior, however, plaster or lime wash is seen on the stone wall surfaces, depending on their location (See Fig.3.14).

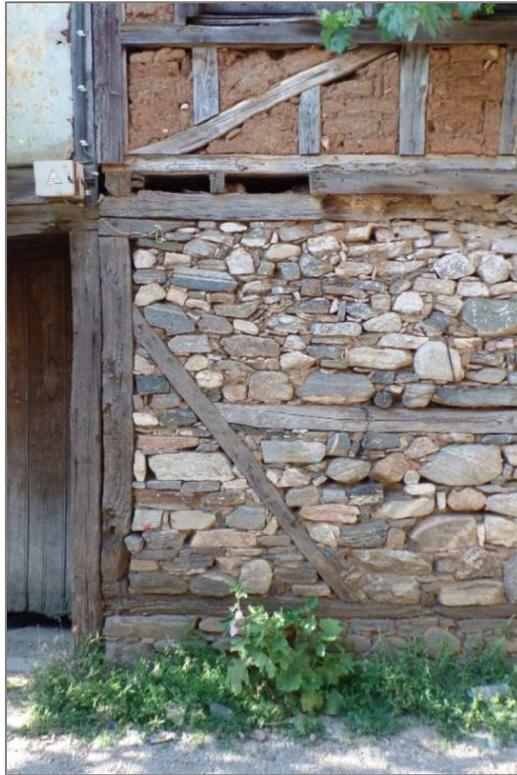
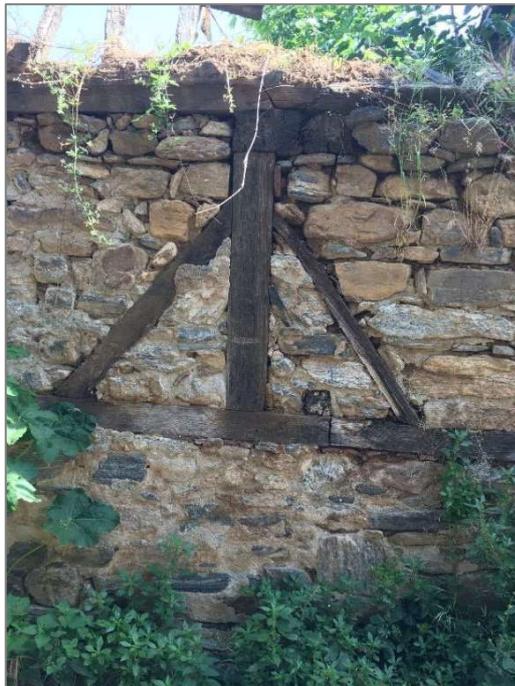
Figure 3.16. Timber posts and braces in stone wall -2800-31(above), -2798-18 (below)

In group A, timber elements are only used as lintels in the stone masonry wall. In group B, there are timber posts at the ends of the walls and in the corners without any braces (2805-1). The timber posts within the masonry wall courses are not placed systematically. (See Fig.3.15). Güçhan (1995) defines this group as ‘framed masonry’. In group C, the vertical and diagonal timber elements form a system together with the timber lintels. The posts placed at the end of the walls, the braces supporting these posts, and lintels extending along the building’s facade form a frame. The timber posts in the corners, and the posts on both sides of the door openings do not directly sit on the ground, but they are rather placed on a stone base on top of the lowest row of timber lintels (2800-31) (See Fig.3.16).

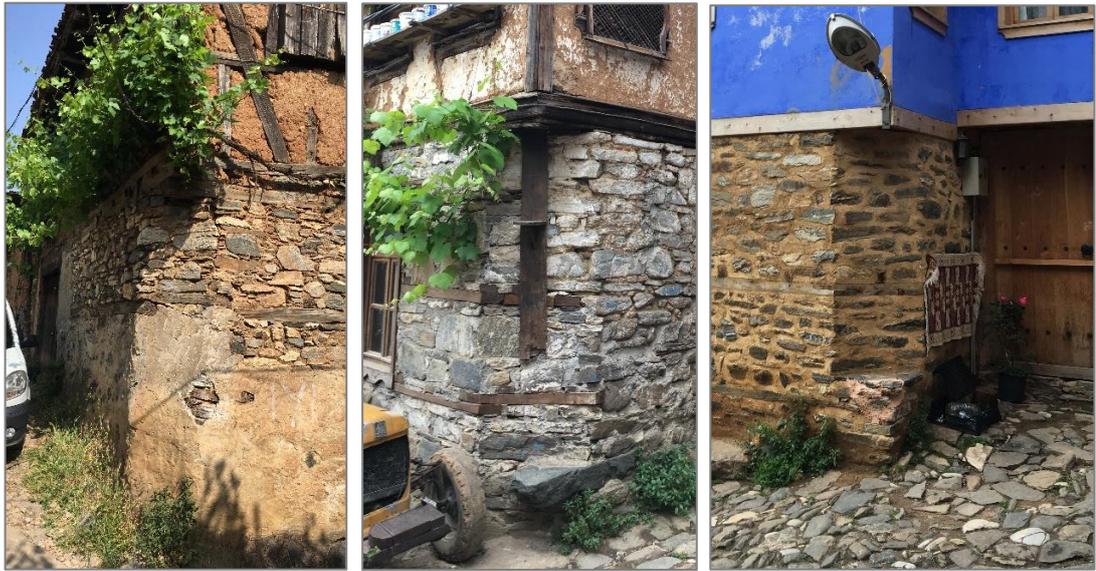
Figure 3.18. 1st group corner chamfer in the building 2819-6 (left), 2794-38 (middle), 2807-1 (right)

Steppingstones are observed near the ground levels of the corner chamfers, particularly in some buildings from the first group (2794-38, 2807-1).

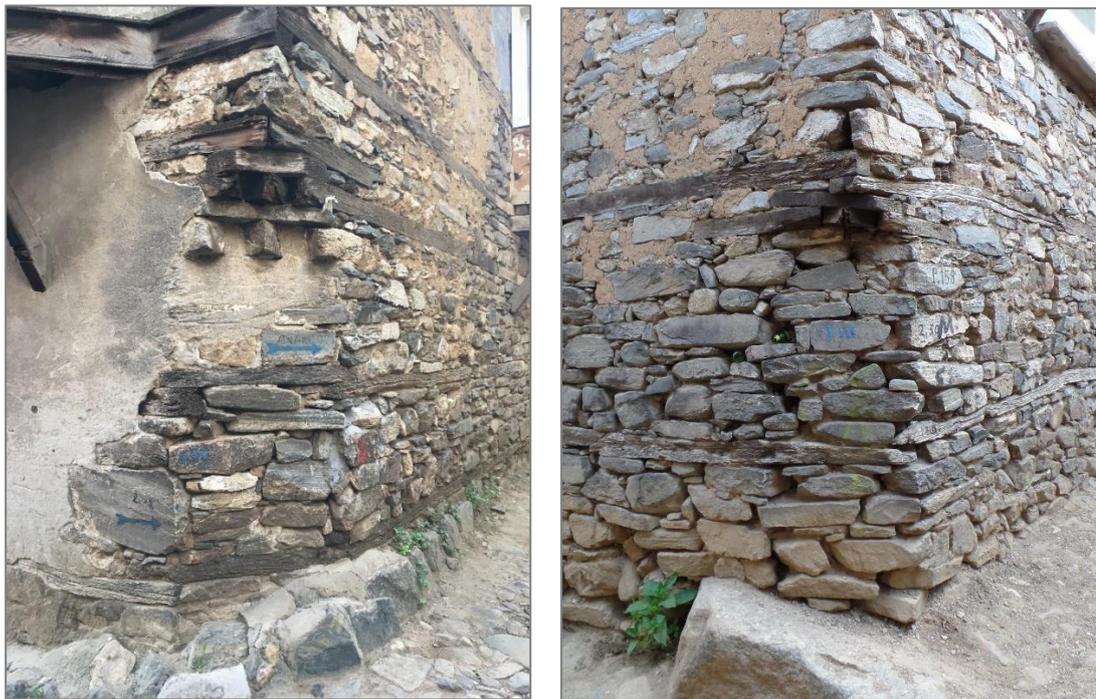
Figure 3.19. 2nd group corner chamfer in the building 2800-34 (left), 2800-1(right)

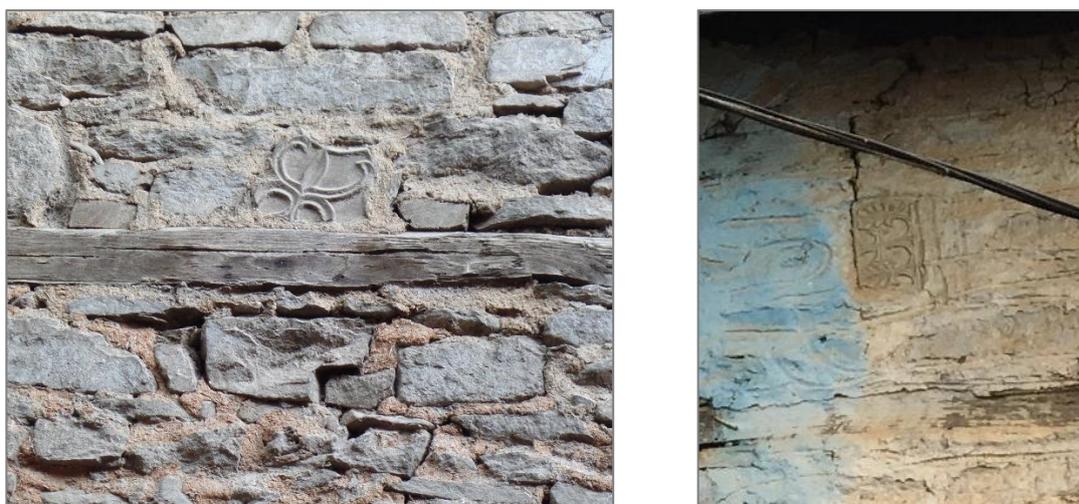
Figure 3.20. Re-use of spolia in stone masonry walls - 2805-1 (left), 2794-44(right)

Elements and fragments of buildings from the pre-Ottoman period are also observed in Cumalıkızık. These elements are reused in the walls without being processed. Some of these elements are placed in visible areas of the buildings such as on top of the entrance door, whereas the others are merely placed in the wall courses.

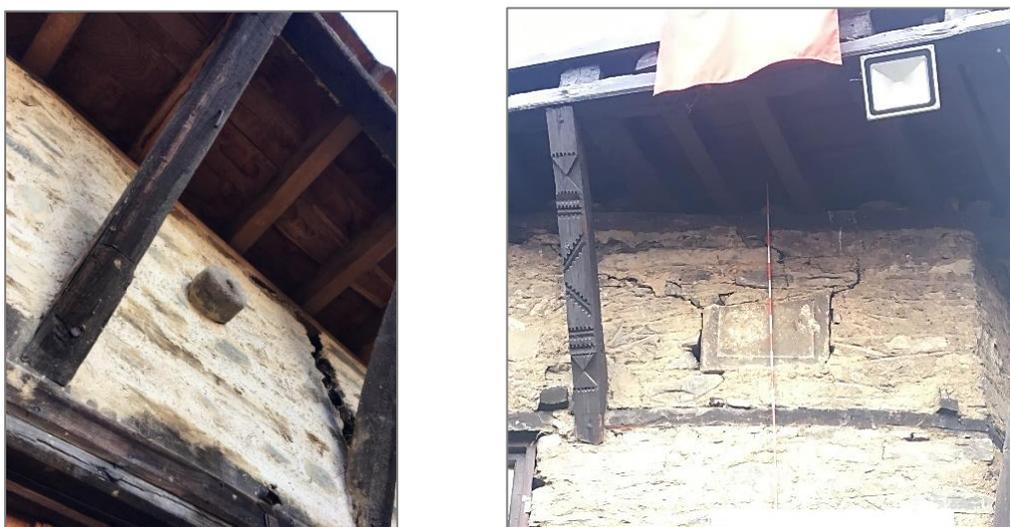
Figure 3.21. Re-use of spolia in stone masonry walls - 2794-38 (left), 2812-1(right)

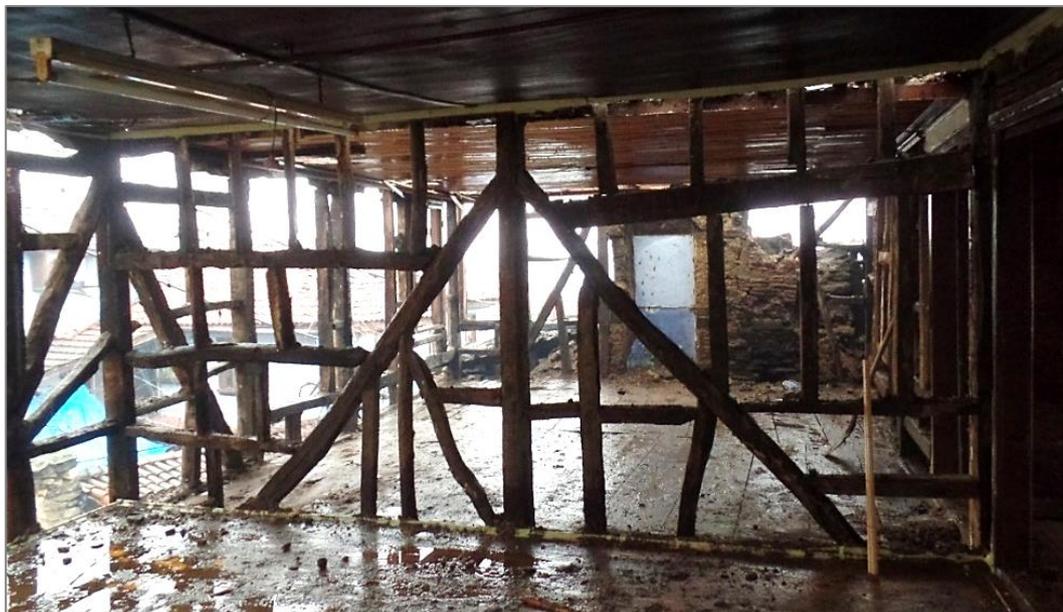
Figure 3.22. Timber frame wall construction – 2819-1-9

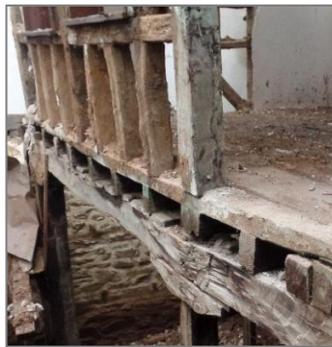
Figure 3.26. Direct connection of foot plate and main post with diagonal nails – 2819-1-9

In the first type of timber frame wall construction, lap joints are used to connect main posts and foot plates with the help of forged nails (See Fig. 3.24, 3.25, 3.28). In the second type of timber frame wall construction, main posts directly sit on foot plates without joints. (See Fig. 3.26, 3.29) While the wall plates of the timber frame system are plastered on the exterior facades of the walls, main posts and foot plates are generally cladded by timber planks. In later examples or interventions to facades, decorative laths or neoclassical column capitals are also used for cladding (See Fig. 3.27).
