CONSTRUCTION TECHNIQUES OF TRADITIONAL HOUSES IN
CUMALIKIZIK VILLAGE, BURSA (TURKEY)

A THESIS SUBMITTED TO
THE GRADUATE SCHOOL OF NATURAL AND APPLIED SCIENCES
OF
MIDDLE EAST TECHNICAL UNIVERSITY

DECEMBER 2019

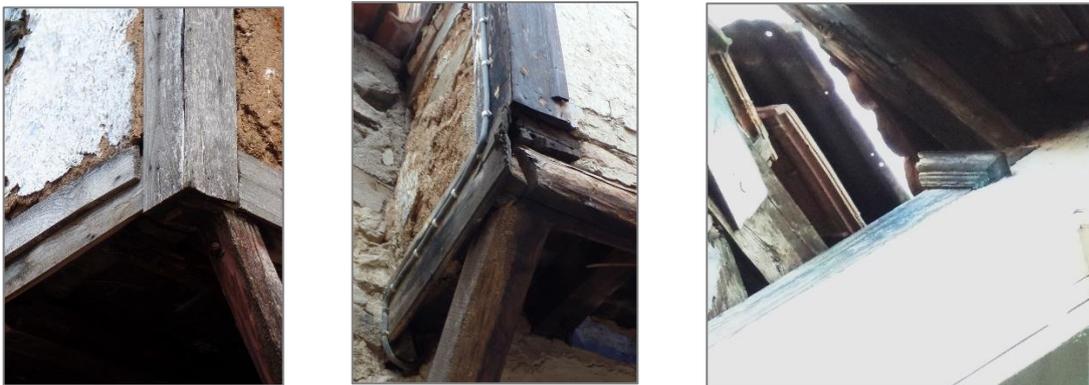
Figure 3.27. Timber planks on main posts and foot plates, decorated laths and neo-classic capitals - 2800-38 (left), 2313-2-3 (middle), 2800-3 (right)

In the first type of timber frame wall construction, lap joints are used to connect main posts and foot plates with the help of forged nails (See Fig. 3.24, 3.25, 3.28). In the second type of timber frame wall construction, main posts directly sit on foot plates without joints. (See Fig. 3.26, 3.29) While the wall plates of the timber frame system are plastered on the exterior facades of the walls, main posts and foot plates are generally cladded by timber planks. In later examples or interventions to facades, decorative laths or neoclassical column capitals are also used for cladding (See Fig. 3.27).

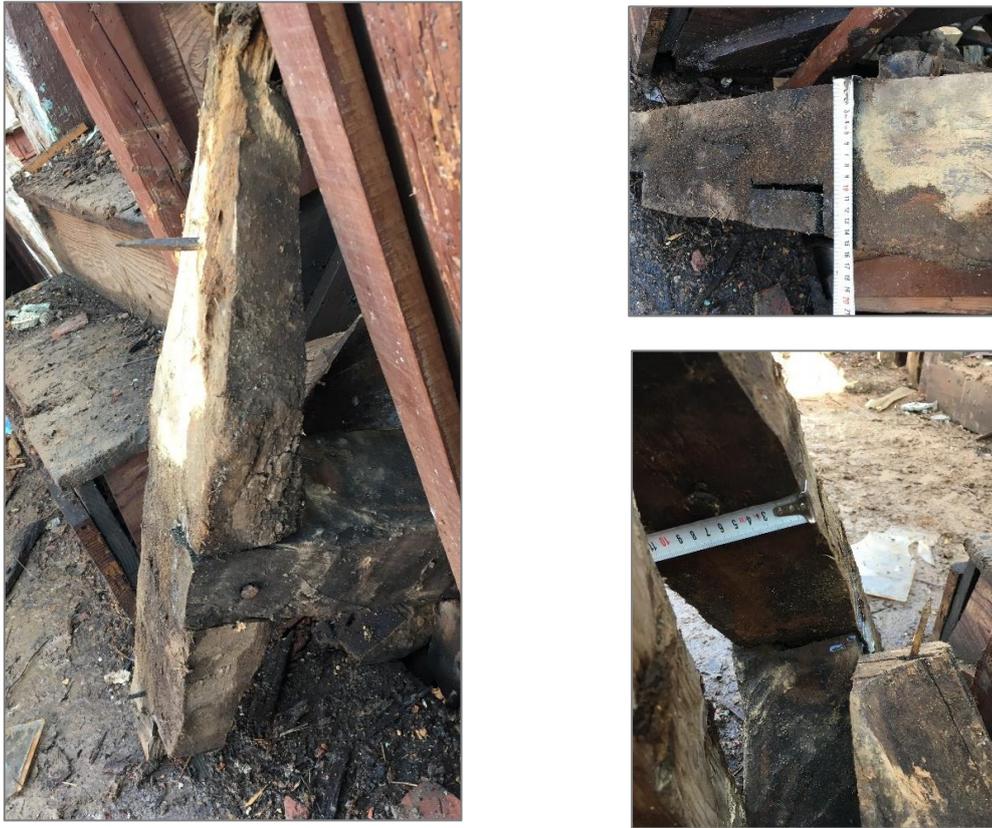
Figure 3.30. Lap joint connection of main post and bolster – 2819-1-9

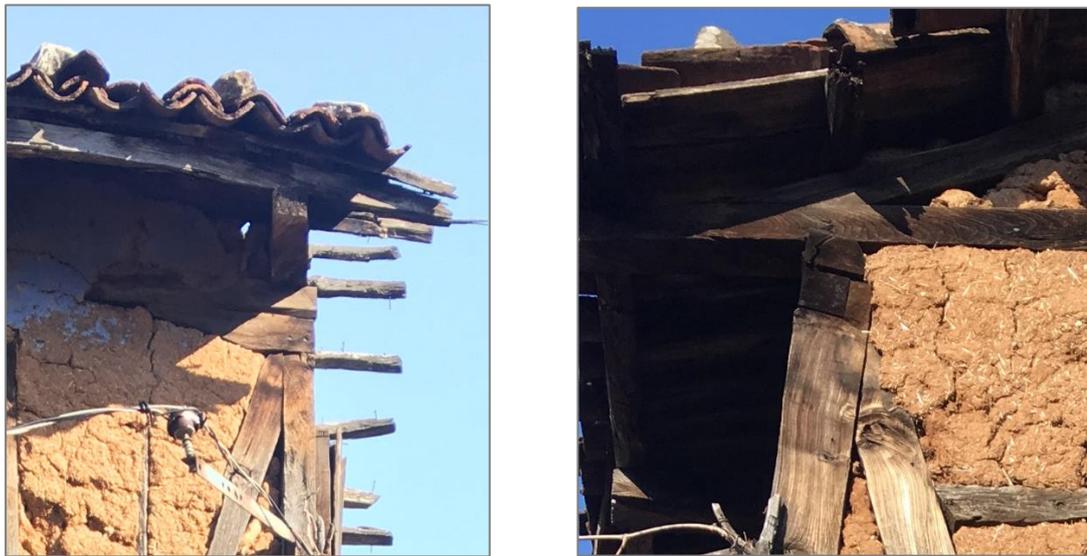
Figure 3.31. Connection of main post, bolster and wall plate 2819-6 front view (left), side view (right)

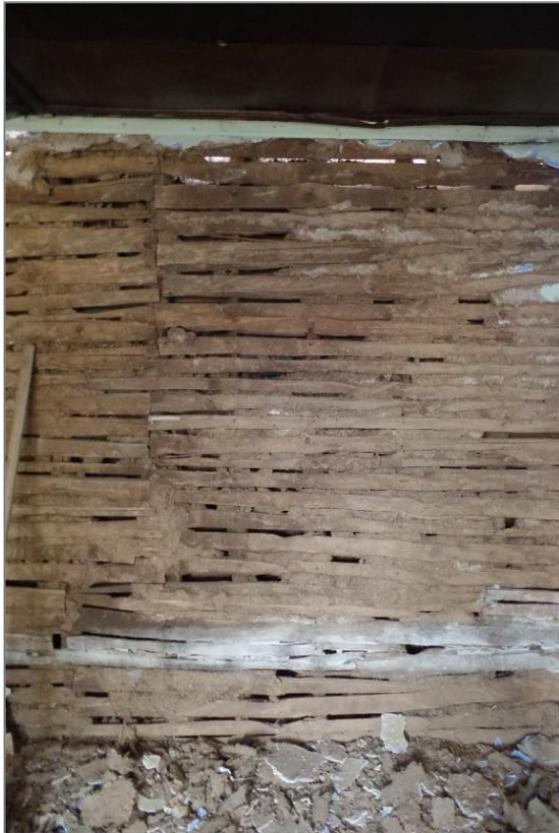
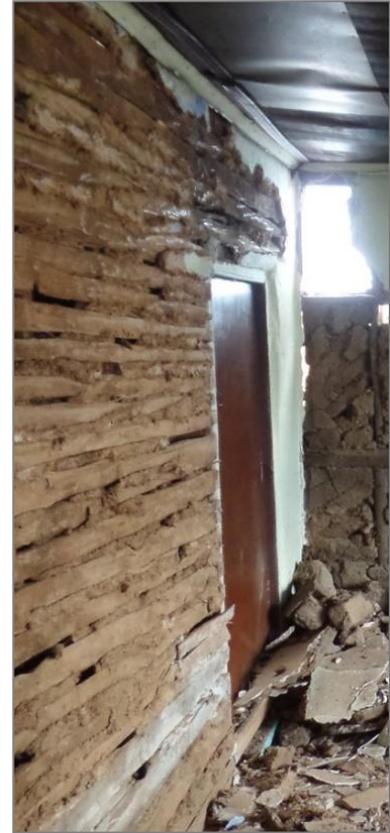
Figure 3.32. Bağdadi technique -2819-1-9 (above), 2805-1 (below)

Timber frame skeleton, constructed with timber elements, is filled with materials such as mudbrick, brick, and stone. Especially in the interior partition walls, the timber frame skeleton is left unfilled and both sides are covered with wood laths, which is known as *bađdadi* technique. Another technique to cover the interior partition walls is the use of hazelnut or chestnut branches. These branches are knitted in opposite directions and fixed to the skeleton to form a vertical plane.

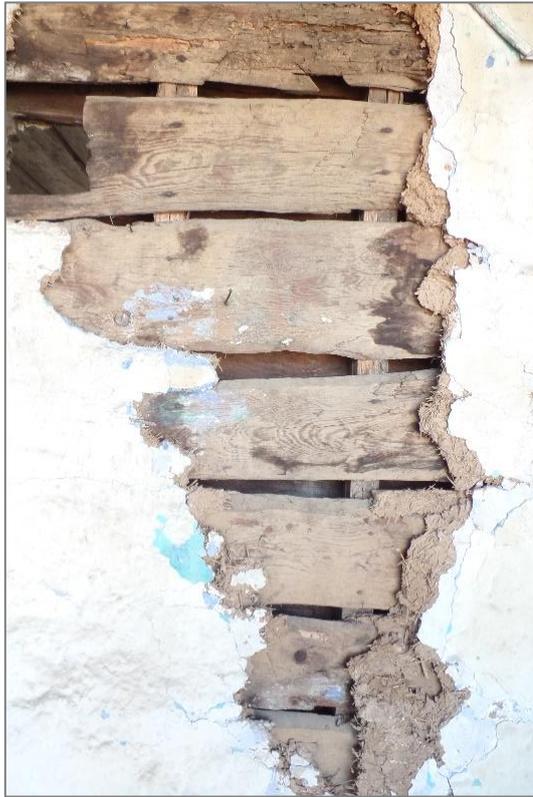
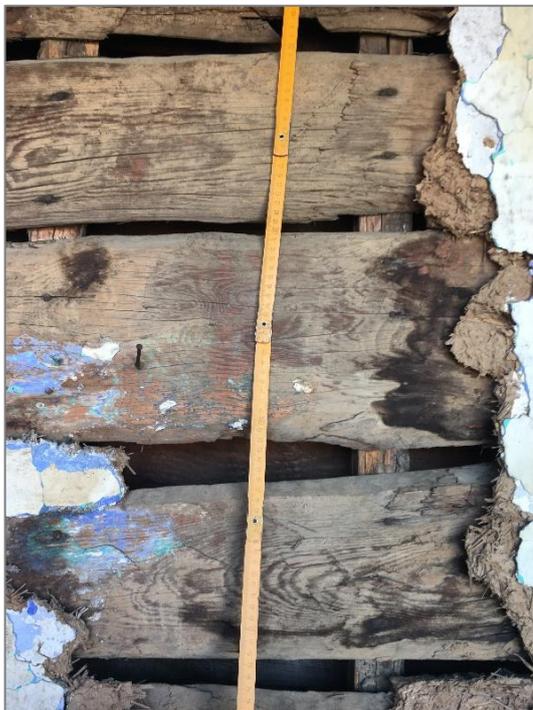
Figure 3.33. Timber planks covering of timber frame walls with no infill (2820-8-7)

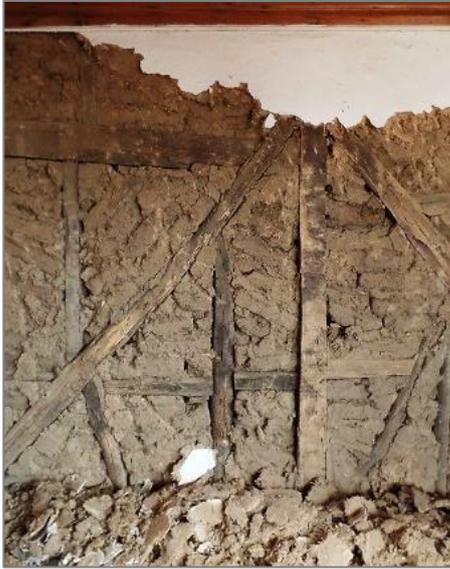
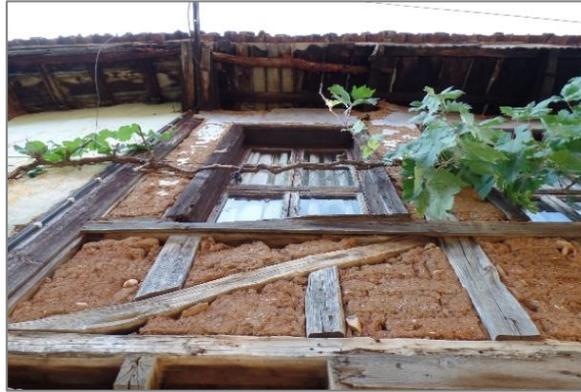
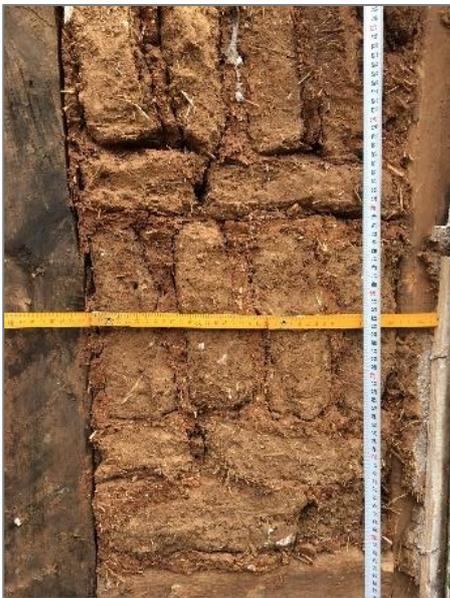
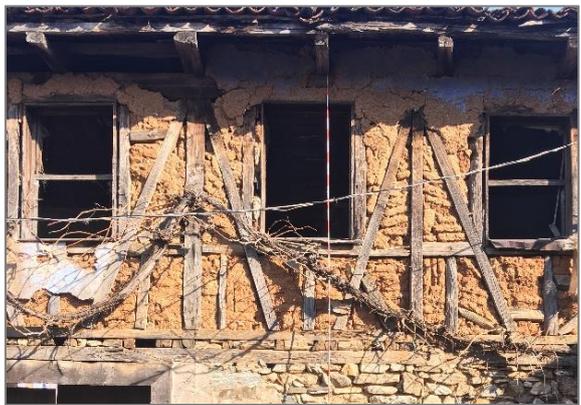
Figure 3.34. Timber frame construction with mudbrick infill– 2819-1-9 (left), 2800-31(right-above), 2819-6 (right-below)

In Cumalıkızık houses, mudbrick is mostly preferred as an infill material of the timber frame construction. Color and size differences are observed in mudbricks. One group of mudbricks is more yellow and contains more straws, whereas the other groups redder and contains less straws. According to the measurements taken onsite, most of the mudbricks have dimensions of 24*8 or 30*8 cm. It is stated the mudbricks are poured into mold, which are called frame molds (*masa kalıbı* in Turkish) and dried for 15-20 days in the meadow located in the upper part of the village (Deniz, 1991). Mud mortar is used as binding material between mudbricks. It can be said that the color of the mortar varies from yellow to red like mudbrick. When the pattern of the mudbrick infill is examined, there is not a certain order and mudbricks are rather placed horizontally, vertically or diagonally.

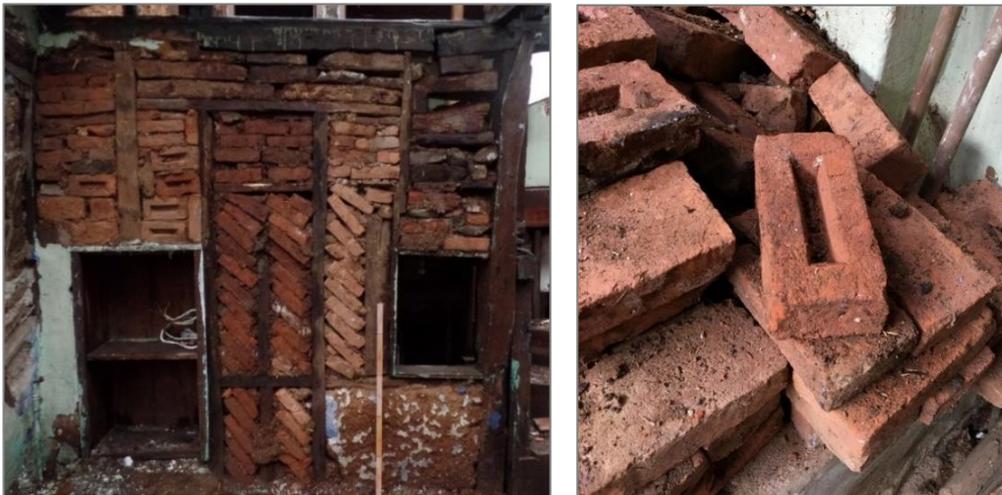
Figure 3.36. Timber frame construction with brick infill – lot no: 2819-1-9

In Cumalıkızık, brick infill used in timber frame construction has two types. In the first type, solid bricks with dimensions of 21*10*6 cm are used and they are randomly placed since the surface will completely be plastered. This type of infill is mostly seen in service buildings and in later interventions.

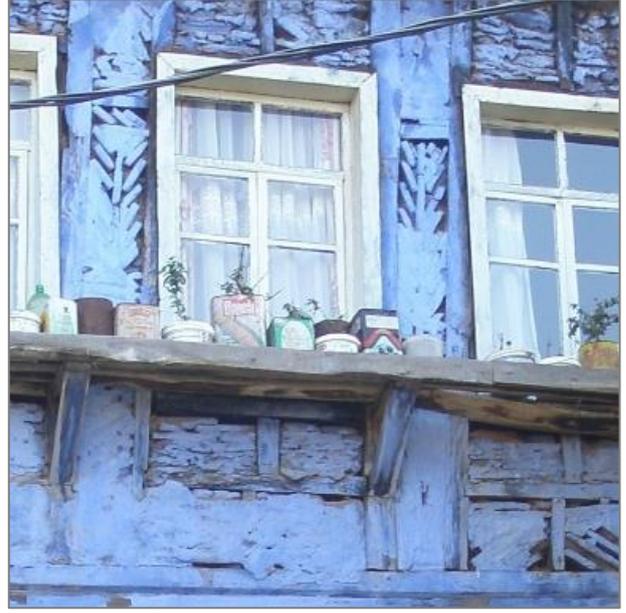
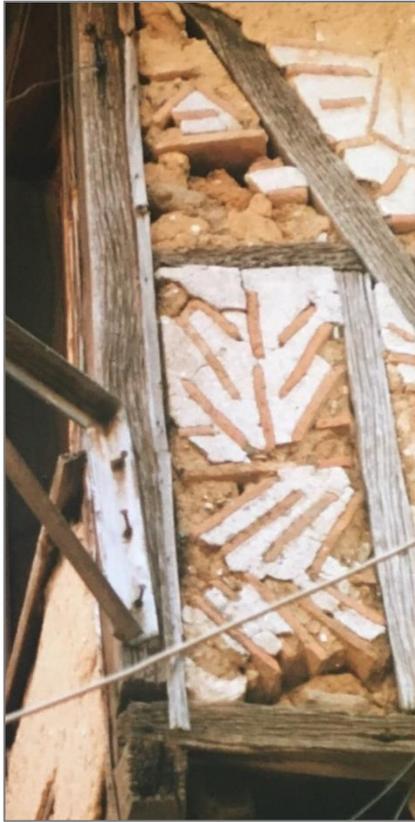
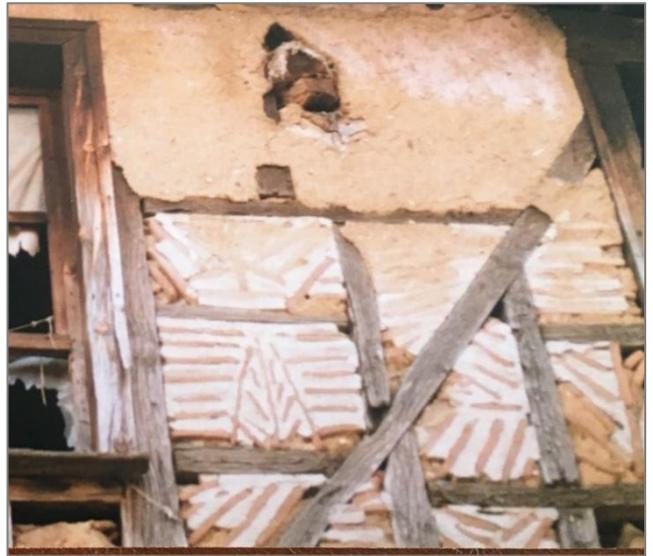
Figure 3.37. Brick decoration & infill in timber frame construction -lot no: 2794-42 (Source: above left: Neriman Şahin Güçhan Archive,1998, above right: Piray Architecture Archive, 2008)
lot no: 2817-1 (below) (Source: Neriman Şahin Güçhan Archive, 1998)

The second type of brick infill is encountered in the archival documents. In this type, bricks are placed in timber frame system with lime mortar to form various patterns, especially on the exterior facade since they are not plastered. Very thing bricks are used in this type with dimensions of 3*12, 3*15, and 3*25 cm. The bricks are not placed too frequently, and at least one brick thickness is left between them. Both of the buildings with this type of brick infill have undergone restoration and therefore their original brick infill has been lost.

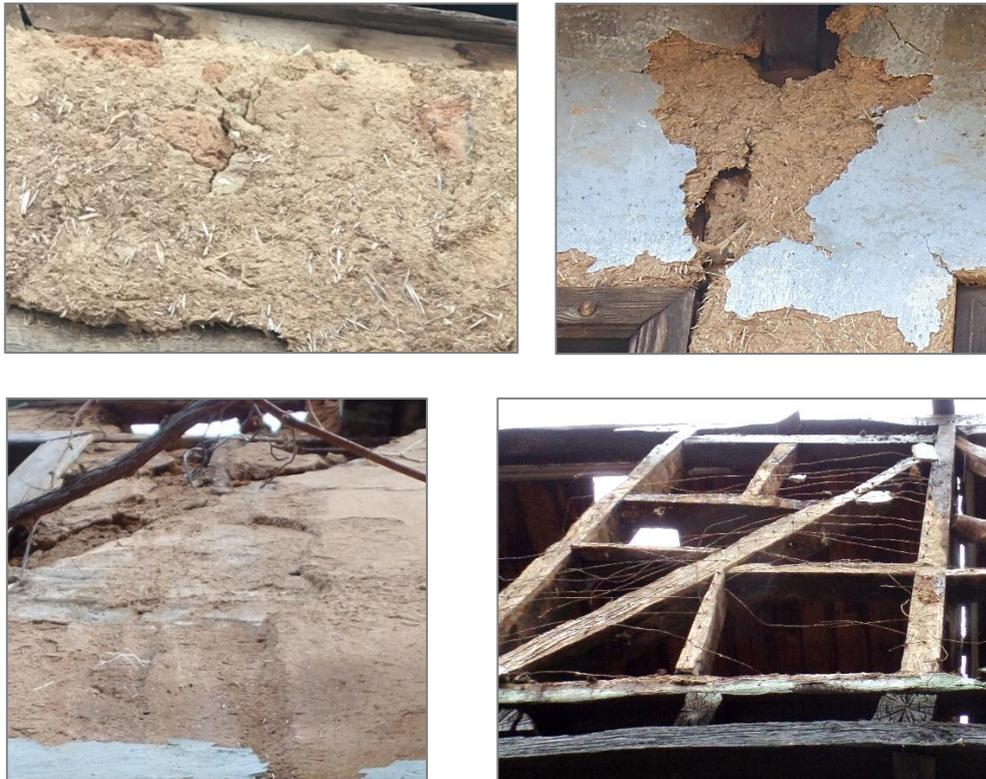
Figure 3.41. Rough mud plaster with lime wash (above) -2820-7-6 (left), -2800-31(right). Fine mud plaster with lime wash (below-left) – 2819-1-9. Wire under the plaster (below-right)– 2819-1-9

In the other type, mud plaster has been observed both on the interior and exterior facades during the onsite examination of the dismantled building (lot no: 2819-1-9). This plaster consists of two layers. At the bottom there is a rough mud plaster with straws, whereas at the top is a homogeneous and smooth fine plaster layer. Wash is applied on this smooth fine plaster layer.

Moreover, it is observed that wire laths are used on one facade of the dismantled house (2819-1-9). Wire laths are put along the facade to form horizontal lines and are fastened to the elements of the timber frame skeleton with nails. Wire laths have been observed in buildings since the end of the 19th century (Günay, 2002).

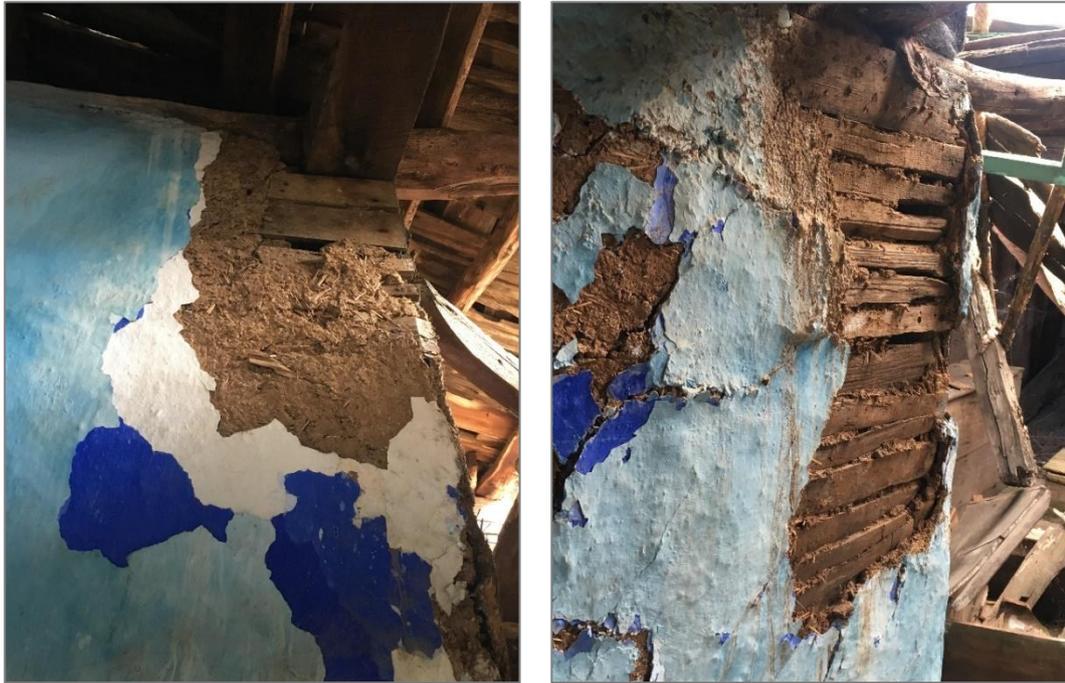
Figure 3.42. Bağdadi wall technique with mud plaster and lime plaster (2805-1)

In the first group of timber frame wall construction technique, as mentioned above, both sides of the timber frame are covered horizontally with wood laths, which are 2.5-3 cm wide. 1cm gap is left between the wood laths. While these walls do not have infill, they are plastered with mud and lime plaster. Timber planks are also used in big sizes in order to cover the timber frame wall surfaces.

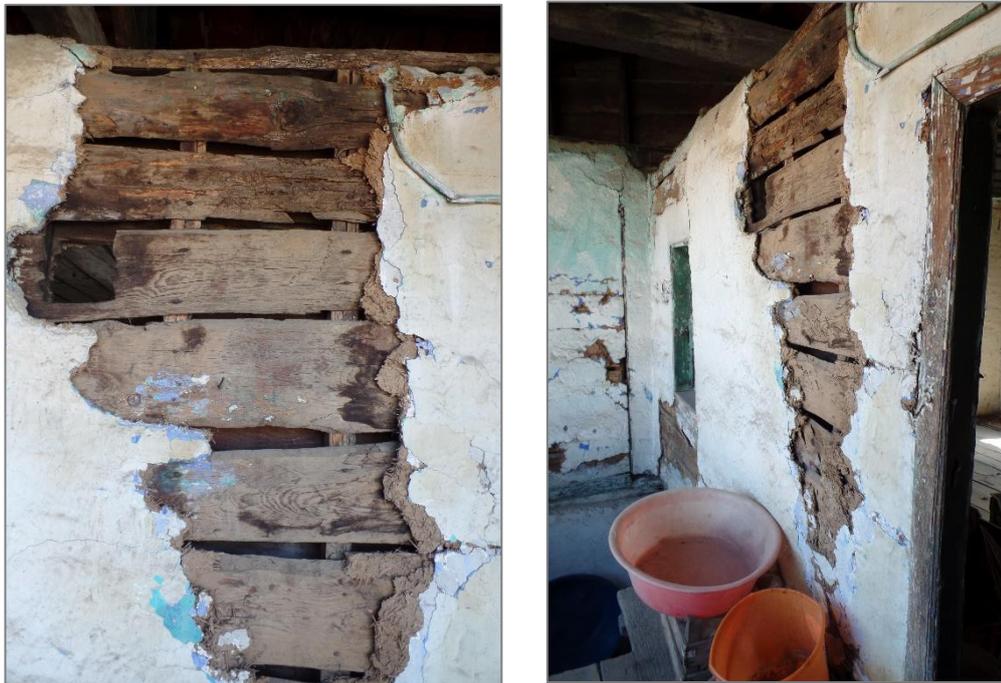
Figure 3.43. Timber planks covering timber frame walls with no infill (2820-8-7)

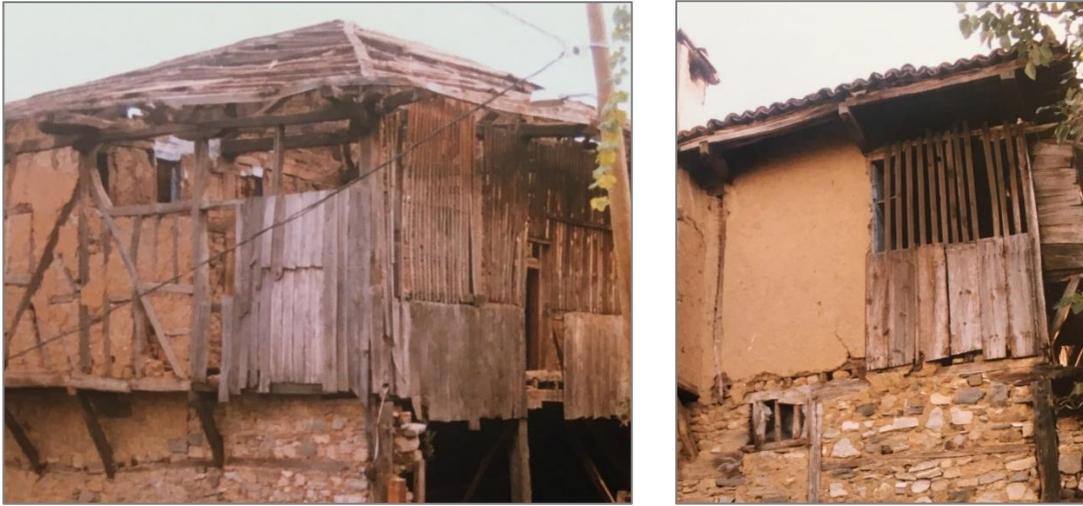
Figure 3.44. Timber boards on facade -2812-1 (left), 2806-8 (right) (Source: Neriman Şahin Güçhan Archive, 1998)

In Cumalıkızık, wide timber cladding boards are also used to cover the facades of open *sofas*, facing the street or the fascia walls. The cladding boards, placed either horizontally or vertically, are nailed to the outer face of the timber frame skeleton. Wood laths, which are placed vertically, are also used on the facades of the *sofa* facing the street along with the large cladding boards (See Fig.3.44, 3.45).

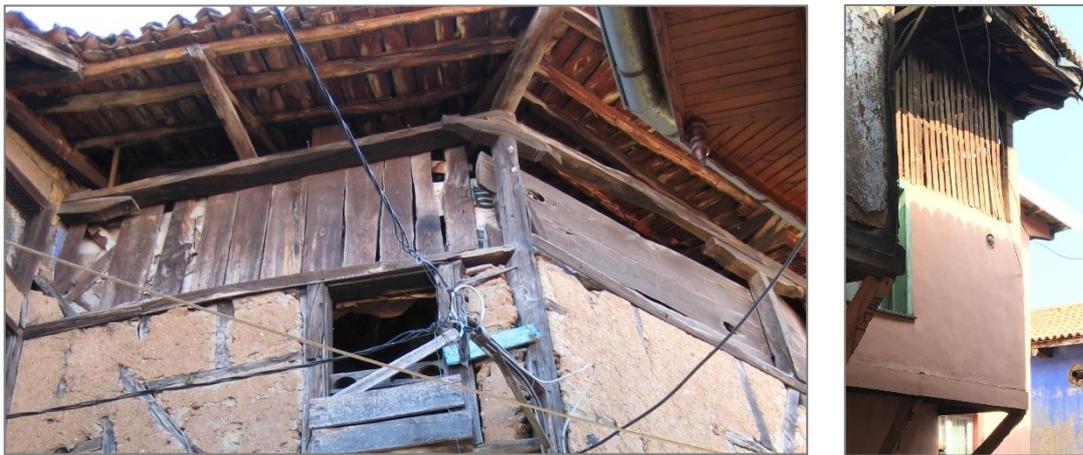
Figure 3.45. Timber boards on facade -2819-3 (left) (Source: Piray Architecture Archive, 2008).
Vertical timber laths on facade – 2819-5

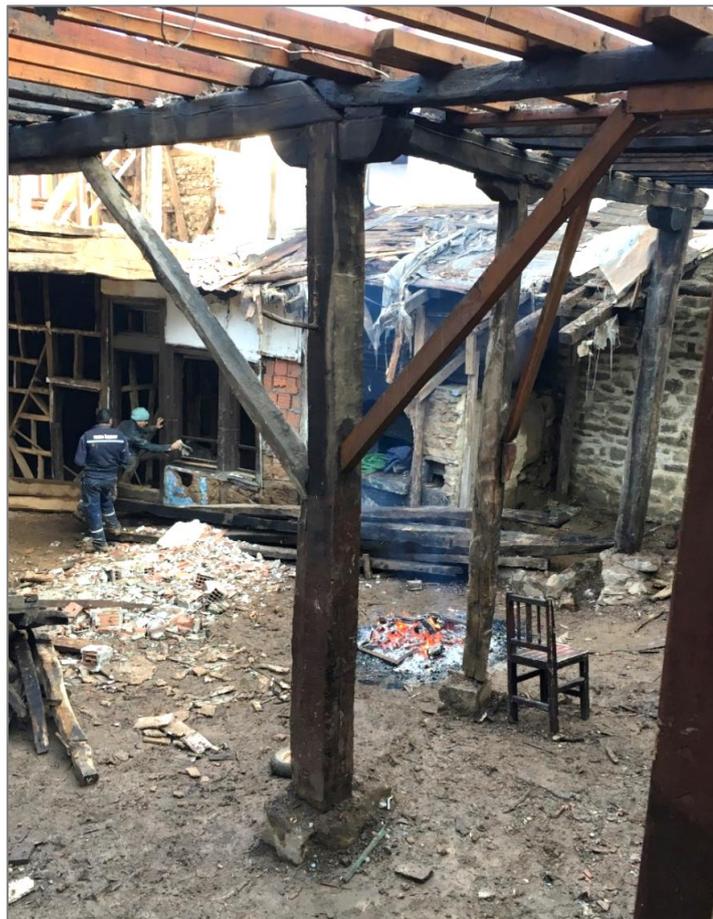
Figure 3.46. Timber post with stone base, bolster and braces. -2819-1-9

Timber posts are structural elements, and they transfer load from the roof and upper floors to the foundation and the ground. The timber posts, used in the *hayat* and open *sofa*, generally have square or square-like cross-sections and their dimensions vary between 10*10 cm and 20*20 cm. The dimensions of 15*15 cm and above are more common. The heights of the timber posts vary between 150 cm and 530 cm, depending on the height of the ground floor and the presence of a mezzanine floor. Braces are used when the height of the posts exceed 3.20 m. These braces are connected to the posts from their bottom and to the beams, carried by the posts, from their top. In some examples, small timber elements can be used to connect the braces to the posts. In other examples, vertical timber elements with small cross-sections are also used, which go all the way down to the stone bases.

Almost all timber posts have bolsters. These bolsters are connected to the posts by 'lap joints' and wrought nails. These columns are called 'papaz başı' (priest's head in Turkish) in Cumalıkızık. The timber posts on the ground floor sit on stone bases. There are not any joints between posts and stone bases. The post sits on the stone base with the weight of the building. Some of the stone bases cannot be observed since they are currently underneath the screed poured on the original floor covering.

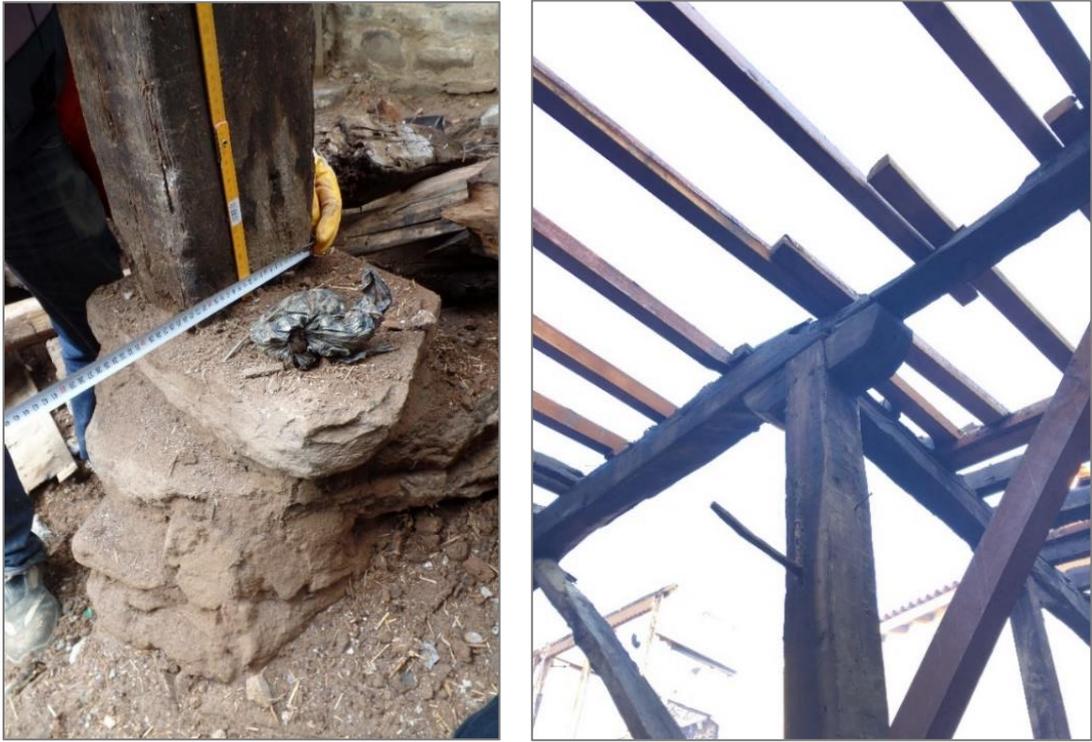
Figure 3.47. Stone base of timber post (left), bolster and girders on top of the post -2189-1-9

The posts have large cross-sections, and they do not have a smooth surface and have traces of adze, indicating that they are hand-cut elements, dating from an earlier period. Timber posts, with large cross sections and a length of 5.5 m are particularly noteworthy.

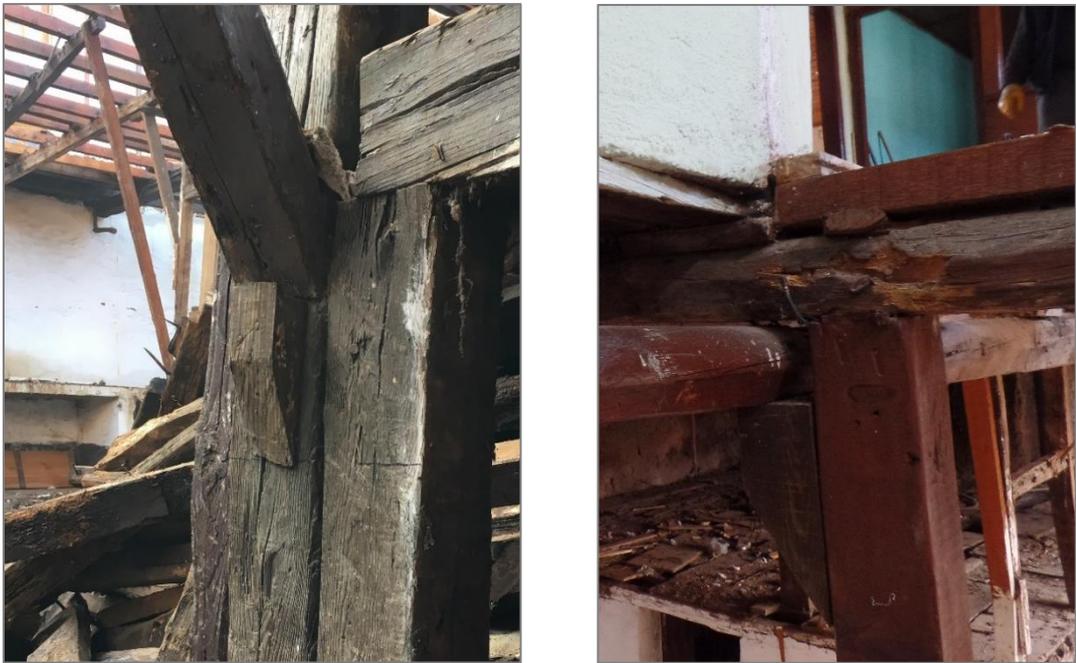
Figure 3.48. Auxiliary element in order to connect the brace or the beam to the timber post -2819-1-9

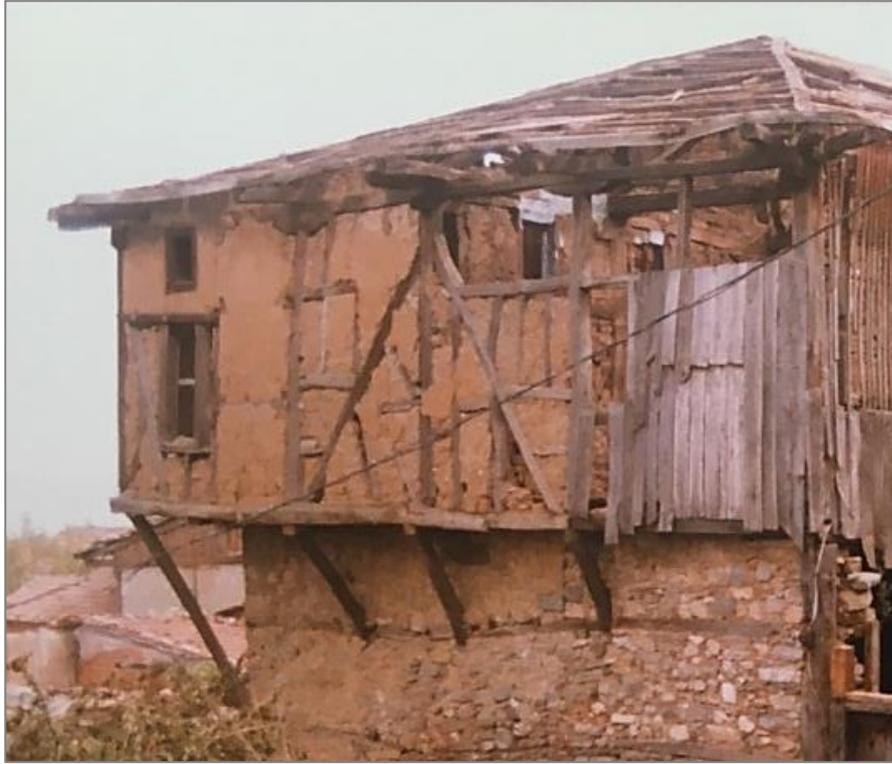
Figure 3.50. Roof girders, following the axis of main post and brace -2812-1 (Source: Neriman Şahin Güçhan Archive, 1998)

On top of the wall plate, roof girders are placed, along the shorter side of the building and on the axis of the main post (approximately 2 m apart). These roof girders have square or rectangular cross-sections and their dimensions range from 10*10 cm to 15*15 cm. While the roof girders with large cross-sections are rough-cut and dark colored, the ones with cross-sections of 10*10 cm are fine-cut and light-colored. The roof girders with large cross-sections indicate an earlier period building (Şahin Güçhan, 2017). It is also observed that the elements previously used elsewhere in both the timber-frame wall and roof construction are reused in the roof. Roof girders, generally projecting 50-90 cm from the walls, also determine the width of the eaves.

The main post, placed in the middle of the roof girder, has a square cross-section with dimensions of 10*10, 12*12, and rarely 14*14 cm. The middle post is connected to the roof girder in two ways. In some connections lap joints and nails are used between the post and the girder, whereas only nails are used in others. The upper points of the posts are notched in two directions.

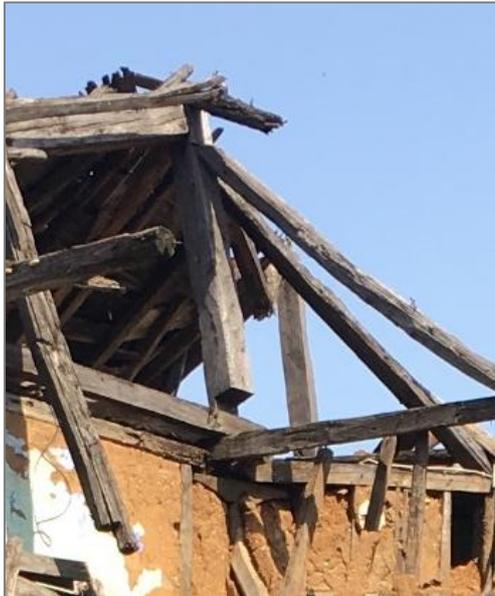
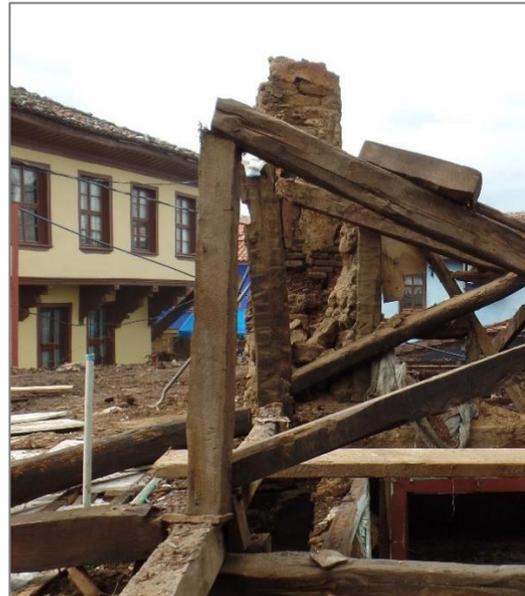
Figure 3.51. Roof girder and main post connection detail -2798-18 (left), -2819-1-9 (right)

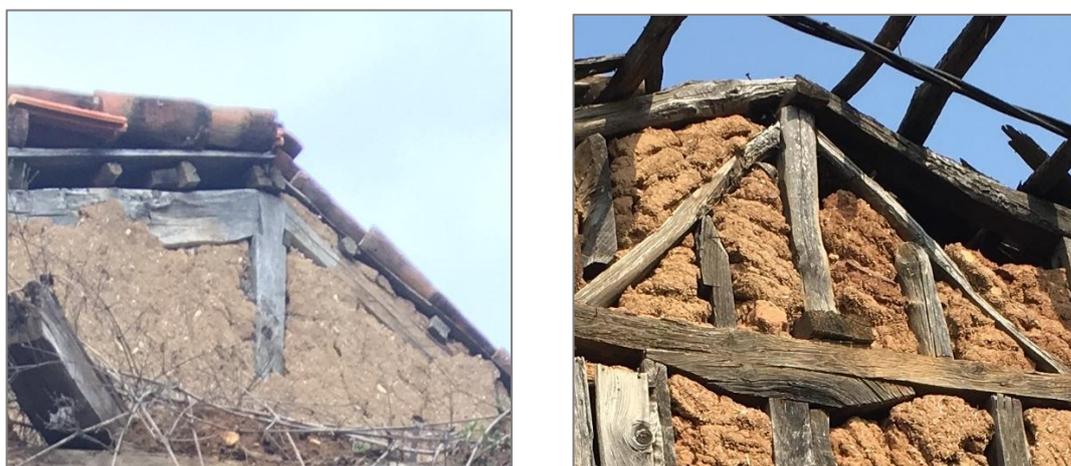
Figure 3.52. Connection detail of post and rafters -2800-22 (left), 2819-6 (right)

Unlike contemporary rafters, the rafters used in Cumalıkızık are parts of the main load-bearing frame and have thick cross sections. While they are connected to the posts from their top, they are connected to the roof girders from their bottom, completing the frame. The rafters, which are generally rectangular, have cross-section of approximately 10*15 cm. The rafter and the roof girder are either connected with nails only, or the rafter sits on the notching on the purlin and nailed. The rafters end 25-30 cm behind the end point of the roof girder. Thus, the first purlin is placed on top of the roof girder, at its end. Subsequent purlins are lined up along the rafter at 40-50 cm intervals. The ridge purlin is placed on top of the post.

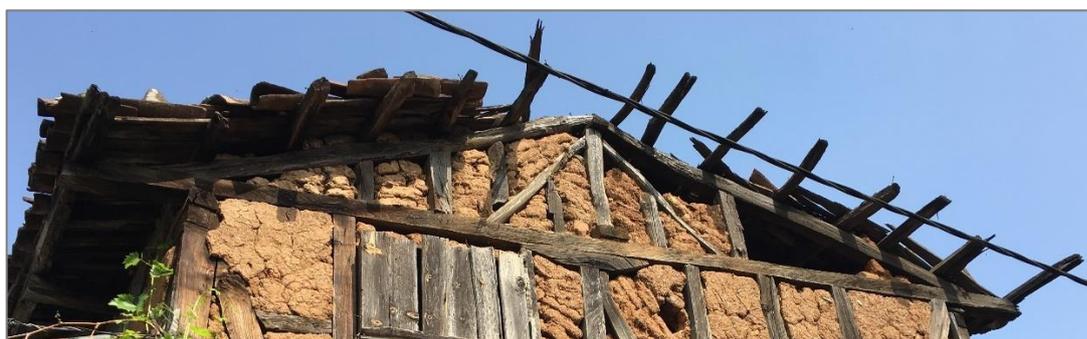
Figure 3.53. Roof girder, post and rafters create main frame of roof construction -2819-6

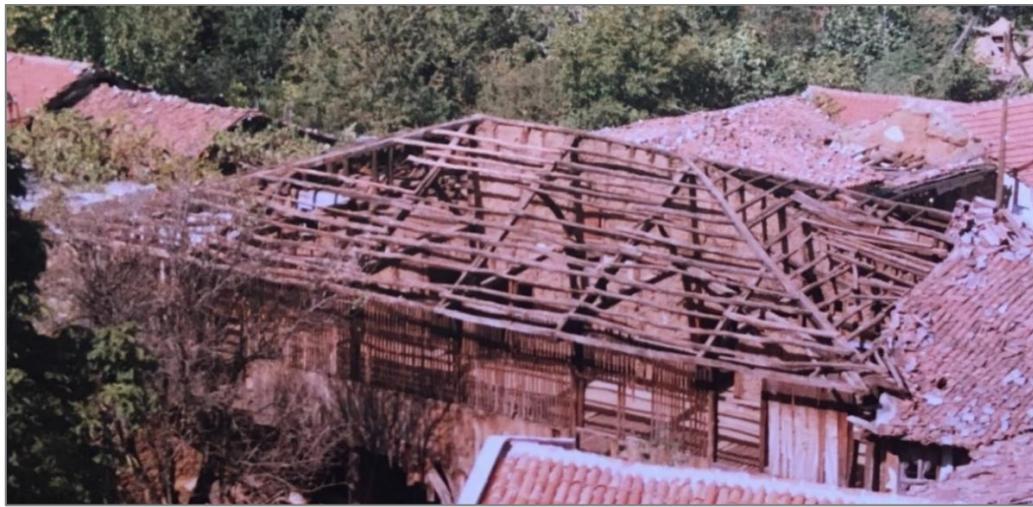
Figure 3.54. Roof skeleton – 2812-1 (Source: Neriman Şahin Güçhan Archive, 1998)

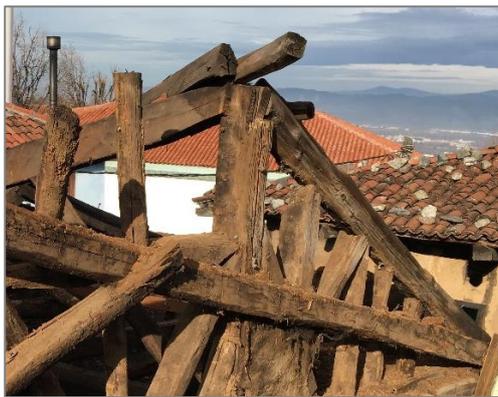
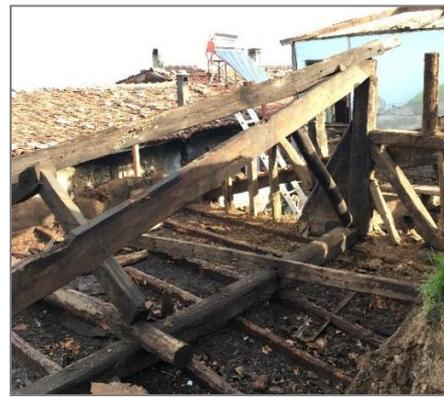
If the roof is pitched roof, the angle rafter extends from the roof girder at the end to the king post in the corner. This angle rafter is fixed on top of the level where posts and rafters meet. Thus, the purlins fixed on rafters, the angle rafter and the ridge purlin follow the same surface so that the roof boards are easily laid on this surface.

Figure 3.55. Angle rafter is placed on the king post and rafters -2819-1-9

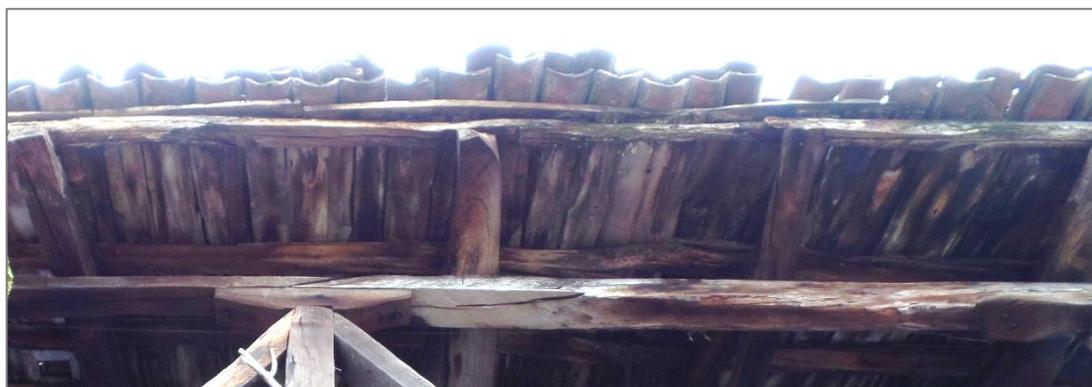
Figure 3.56. Roof girder, rafter, purlins, roof boards and tiles -2819-6

Over and under tiles are used as roof covering. The tiles exceed purlins approximately 10 cm. In Cumalıkızık houses, timber fascia boards or gutters are not used. A decorated timber fascia board is only observed in one house (2800-31). The ornamentation of the fascia board resembles dovetail, which is a very common motif in Cumalıkızık.

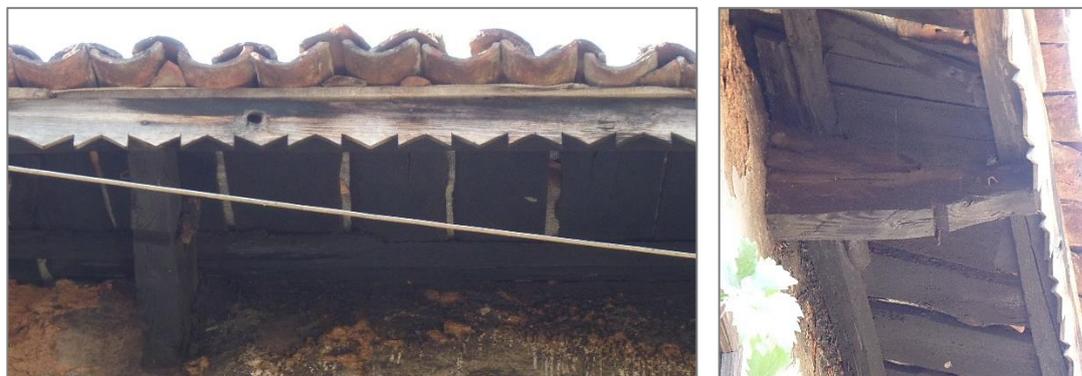
Figure 3.57. Decorated fascia board -2800-31

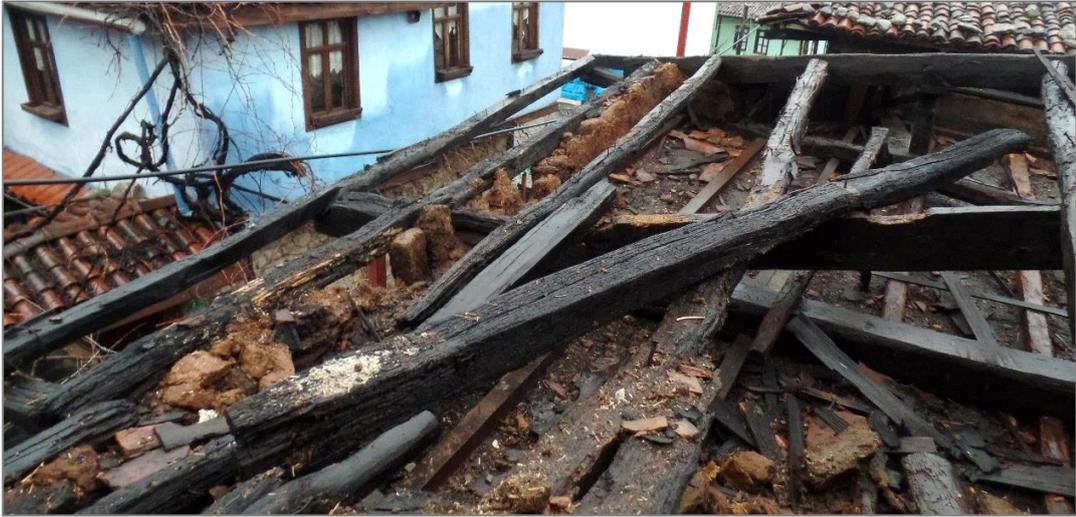
Figure 3.58. Roof construction -2819-1-9

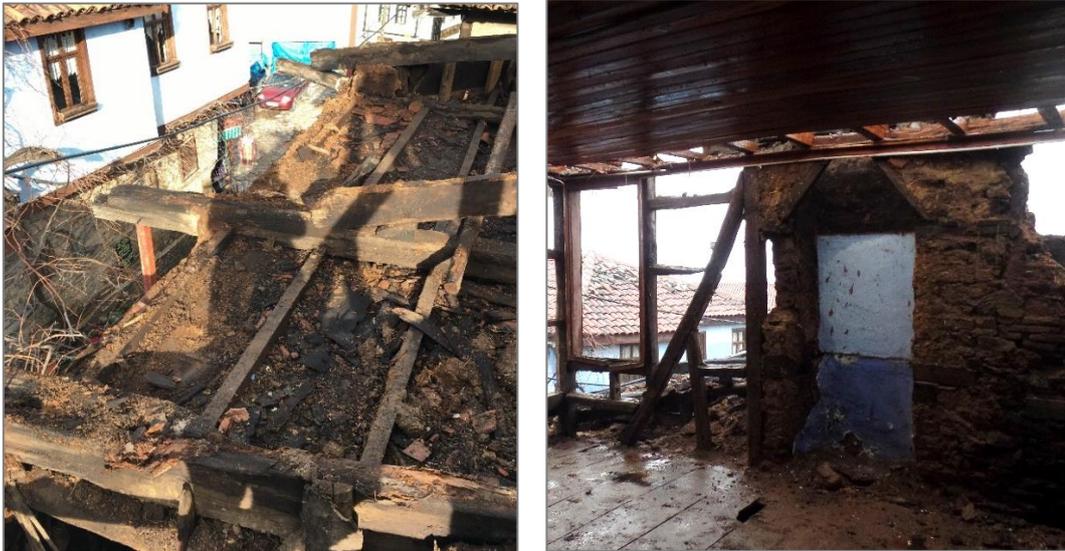
In Cumalıkızık houses, the roof girders are not put in frequent intervals. Therefore, the use of ceiling girders becomes a necessity for rooms with ceiling coverings. Ceiling girders, placed underneath the roof girders to carry ceiling coverings, have the dimensions of 5*5, 5*6, and 5*7cm in examined buildings.

Figure 3.59. Ceiling girders under roof girders – 2819-1-9

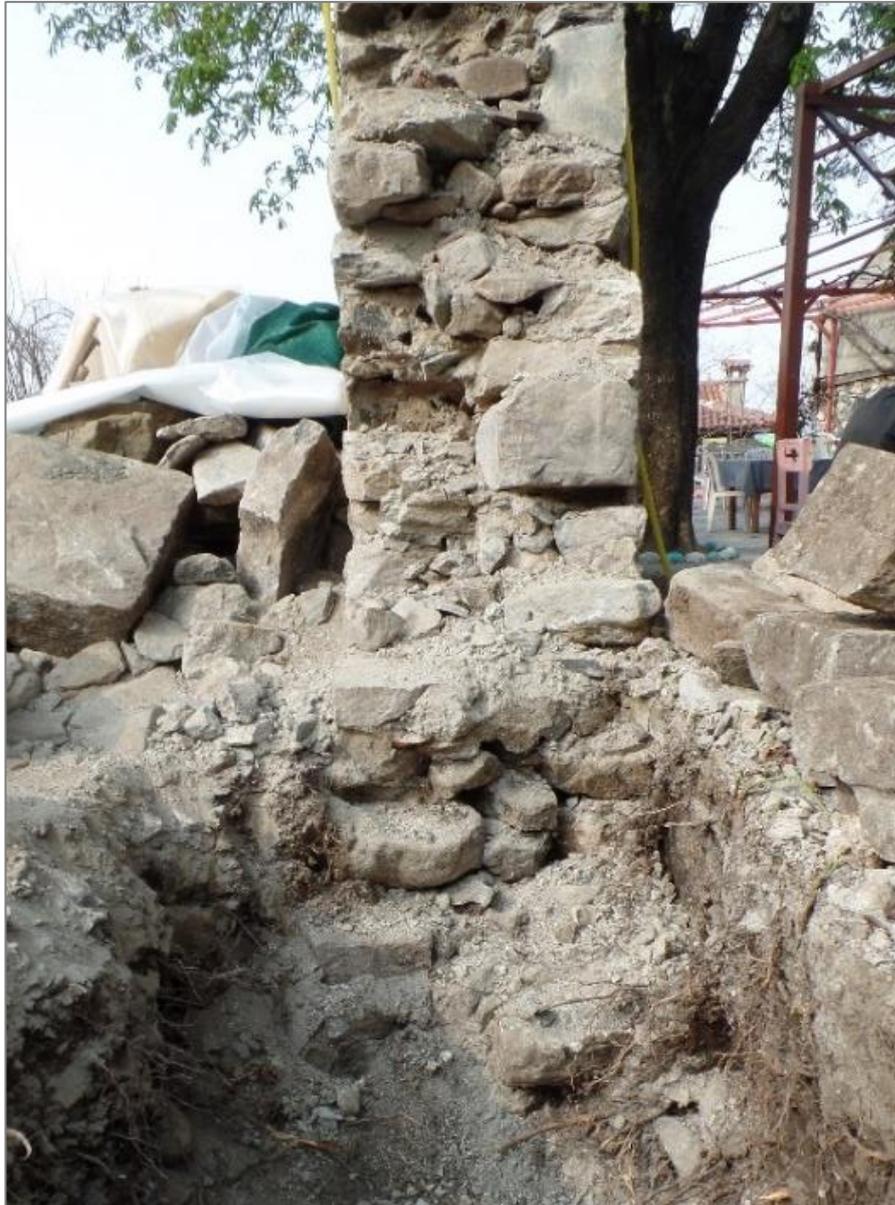
Figure 3.60. Section showing foundation and ground floor

As it is mentioned before, the most reliable information regarding foundation construction was gathered from the foundation excavations of a ruined building within the scope of its reconstruction. The connection between foundation and ground floor wall was also investigated for the other buildings in the settlement. According to these observations, it can be said that stone masonry wall of the ground floor gets thicker at the foundation level and extends deeper to the rock level.

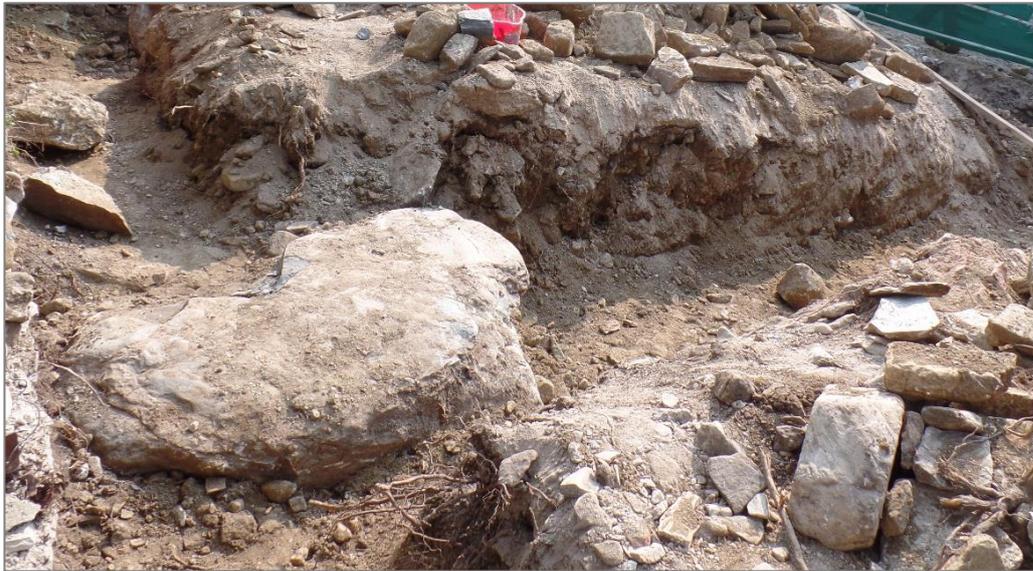
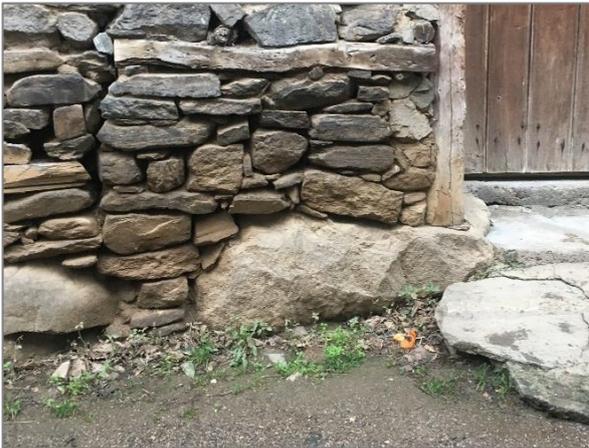
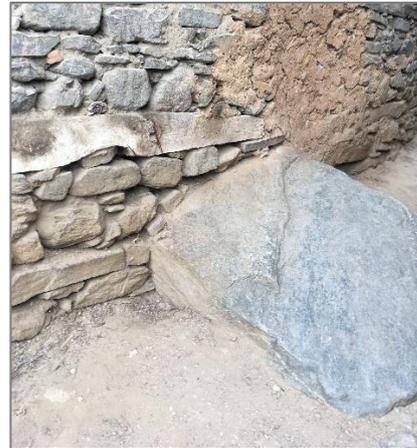
Figure 3.61. Relation of rock and foundation or ground floor wall

The rocks similar to the ones used at the foundation level are seen in the stone course of the ground floor wall. This gives an idea about the connection between the rock and the rubble stone wall. The natural rocks and the course of rubble stone masonry wall are incorporated by the help of small rubble stones.

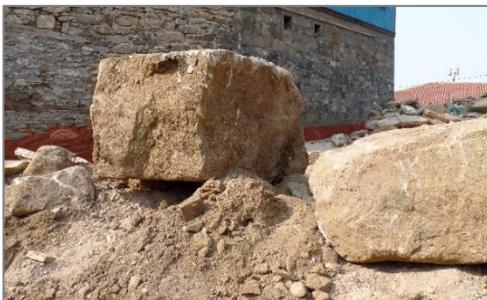
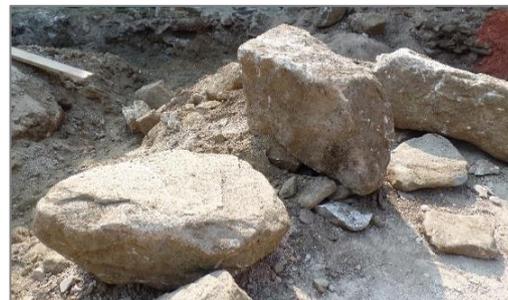
Figure 3.62. Shaped stone blocks removed from foundation level of a building

Like the ground floor wall, when the foundation is built by rubble stone masonry technique, there is no difference in the stone courses except for the wall thickness. Nevertheless, the shaped monolithic stones (35*110*35cm, 60*100*60cm, 90*60*110cm. in dimension) and the rock as a part of earth (180*100*70cm. in dimension) that are observed during the foundation excavation of the building (2812-8-9) indicates that both of them are also used in the foundation construction.
