CONSTRUCTION TECHNIQUES OF TRADITIONAL HOUSES IN
CUMALIKIZIK VILLAGE, BURSA (TURKEY)

A THESIS SUBMITTED TO
THE GRADUATE SCHOOL OF NATURAL AND APPLIED SCIENCES
OF
MIDDLE EAST TECHNICAL UNIVERSITY

DECEMBER 2019

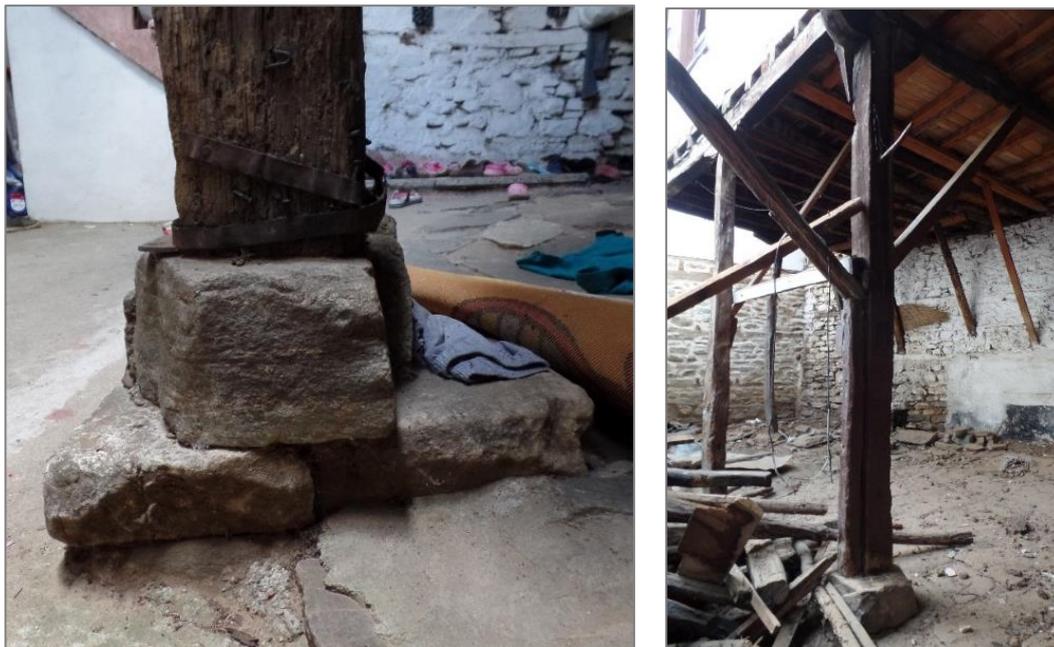
Figure 3.64. Timber post and stone base 2805-1(left), 2819-1-9 (right)

The main timber posts carrying the load of upper timber frame floor(s) sit on stone bases in the courtyard. The base, functioning as discontinuous foundation, is composed of one or several stone blocks with a smooth surface. The height of the base differs according to the slope of the ground or the length of the post, ranging between 20cm. and 60cm. In this way, timber posts are protected from water and moisture. There are not any connection details between the timber post and the base. Timber post sits on the stone base by the weight of the upper structure.

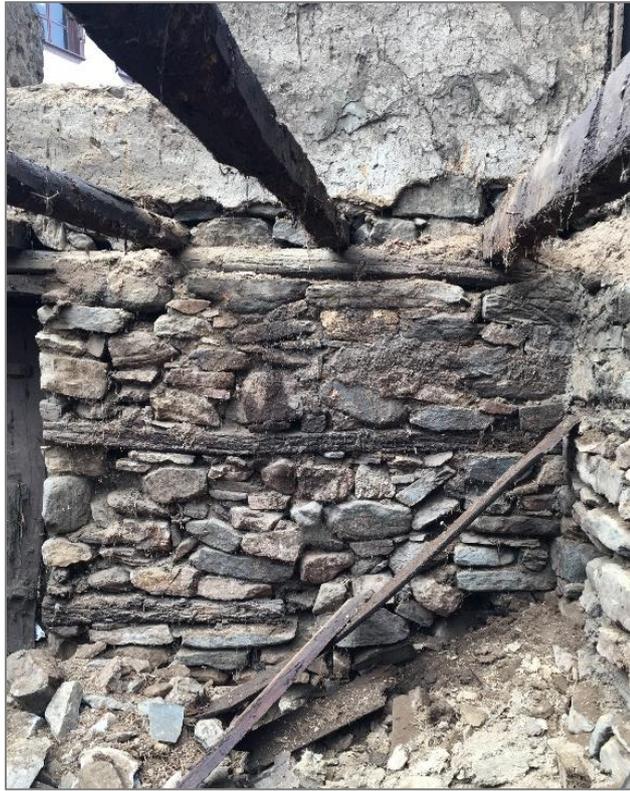
Figure 3.66. Floor girders of mezzanine floors extending perpendicular to the stone wall

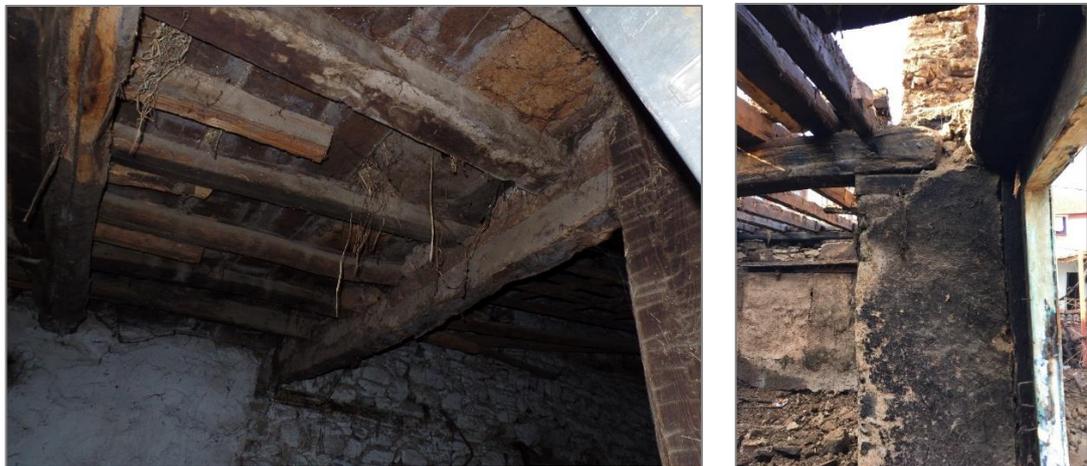
If the floor girders are in the same direction with the stone masonry wall, the main girder carrying the floor girders is inserted into the wall. The main girders, which have larger cross-sections than the floor girders, have a spot connection with the stone masonry wall. The main girder sits either on the row of timber lintel or on a separate timber lintel.

Figure 3.67. Floor girders of mezzanine floors extending parallel to the stone wall

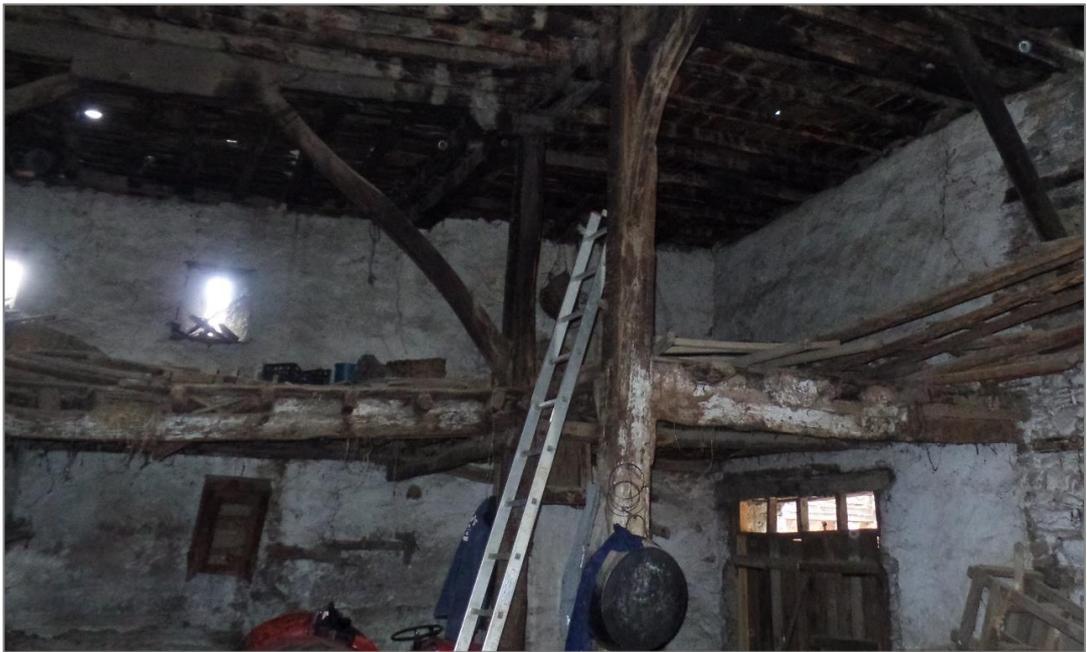
Figure 3.69. Mezzanine floor girders in 2805-1

It is observed that the mezzanine floor, which is often used as a *kat* for storage purposes, functions as a winter floor. When it is used for storage purposes, the floor opens to *hayat* or courtyard by gallery. When the mezzanine floor is used as a living space, it is divided by timber frame walls.

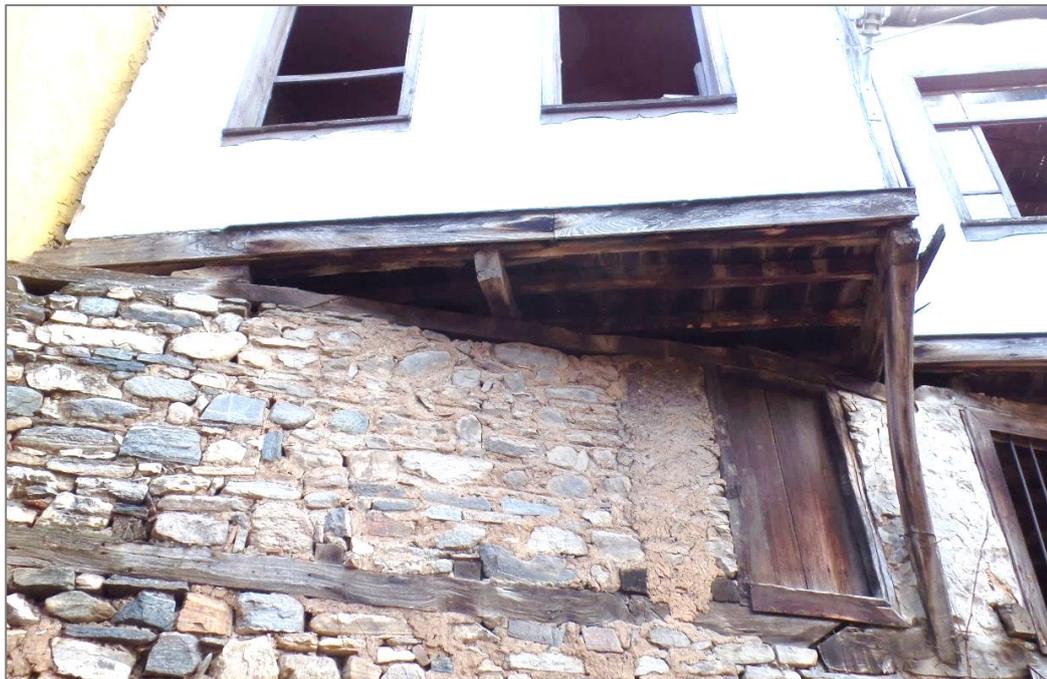
Figure 3.73. Main timber girders sitting on timber lintels on stone masonry wall (2819-1-9)

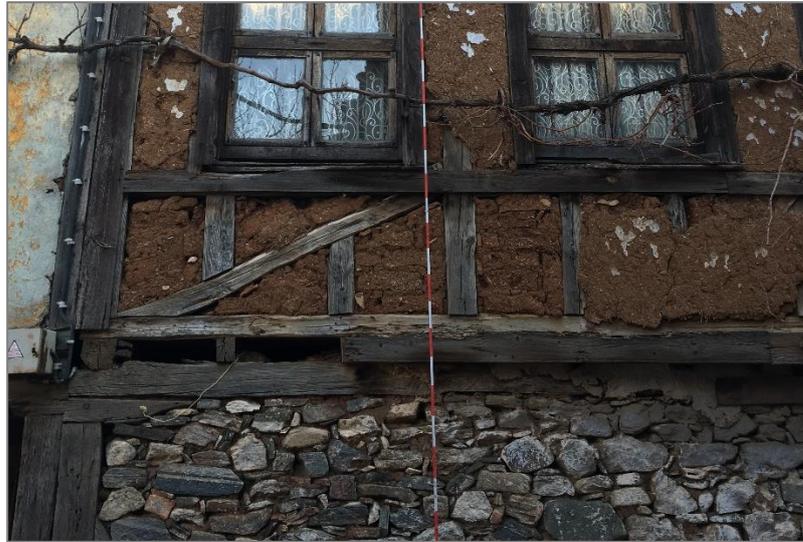
Figure 3.75. Stone masonry wall and timber floor connection

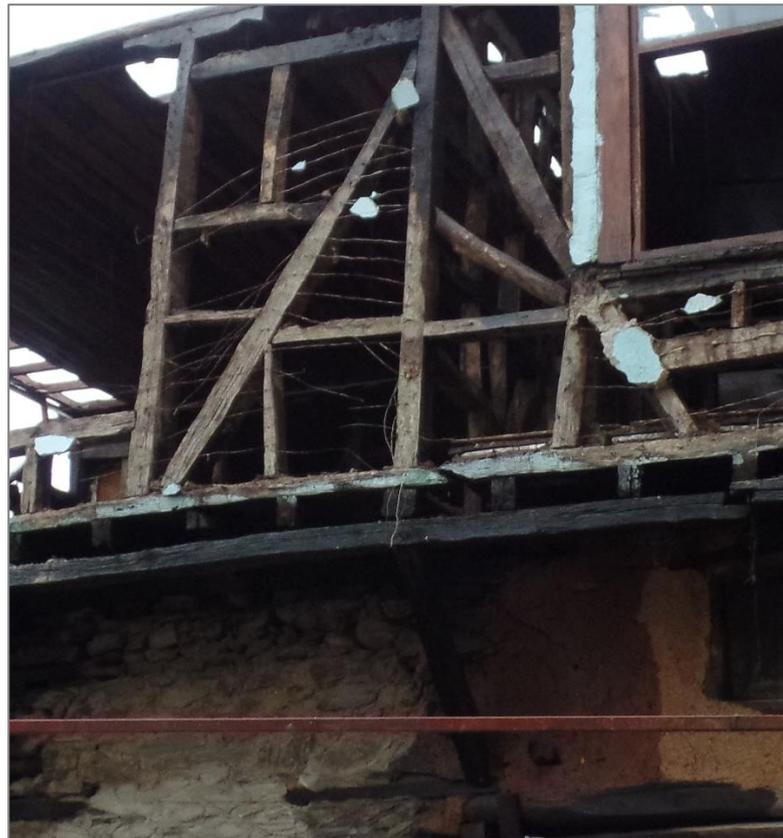
Figure 3.76. Stone masonry wall and timber floor connection

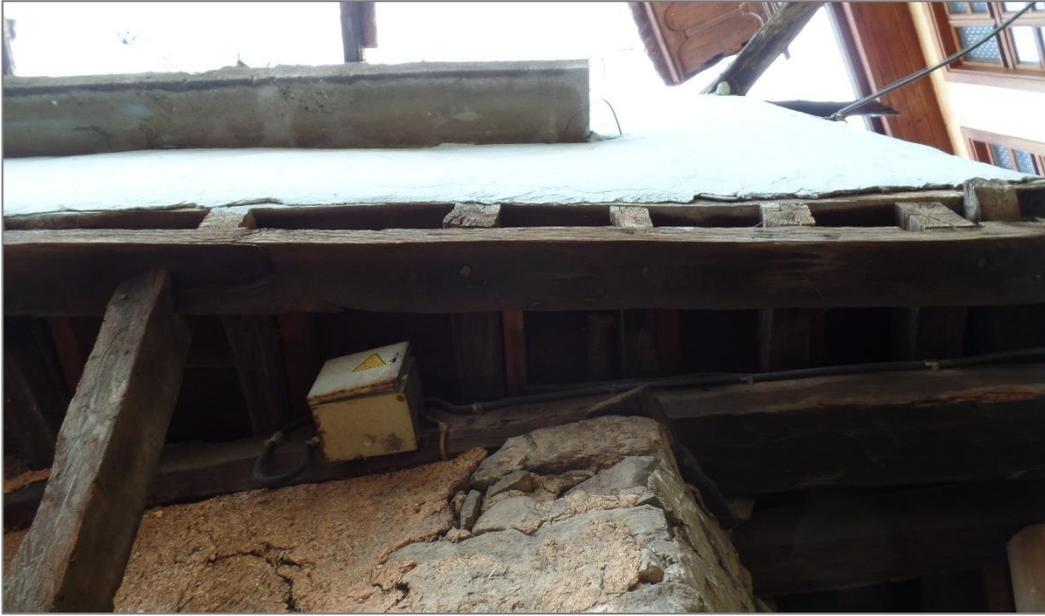
Figure 3.77. Stone masonry wall and timber floor connection

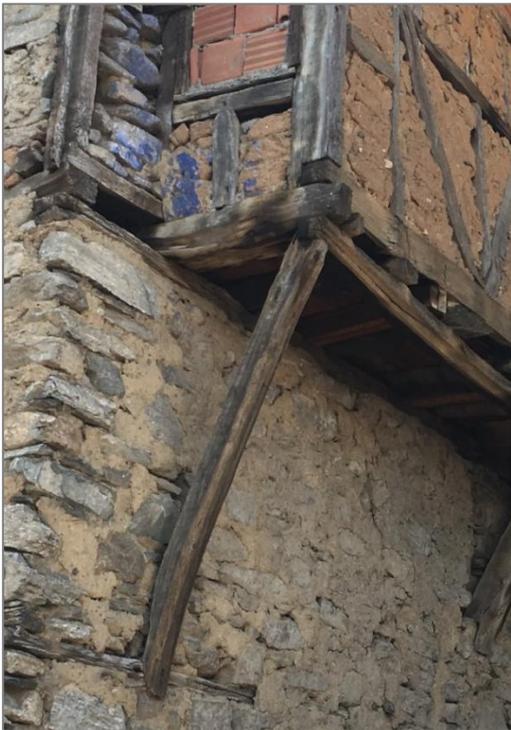
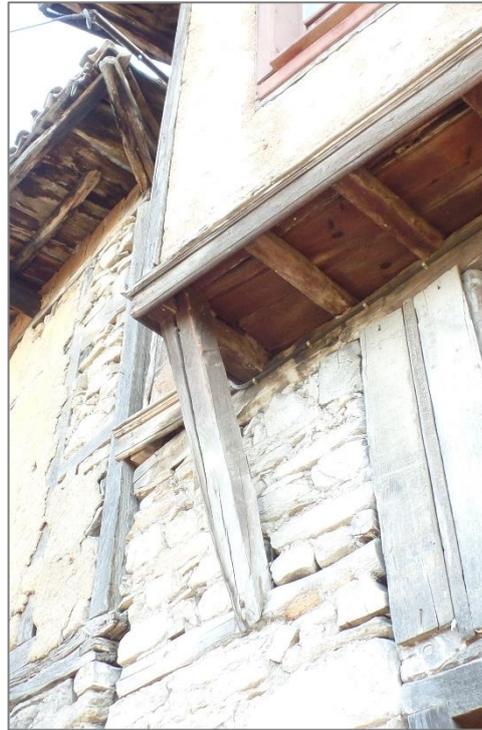
Figure 3.78. Different connection details of timber braces - 2799-1-2 (left), 2819-8 (right)

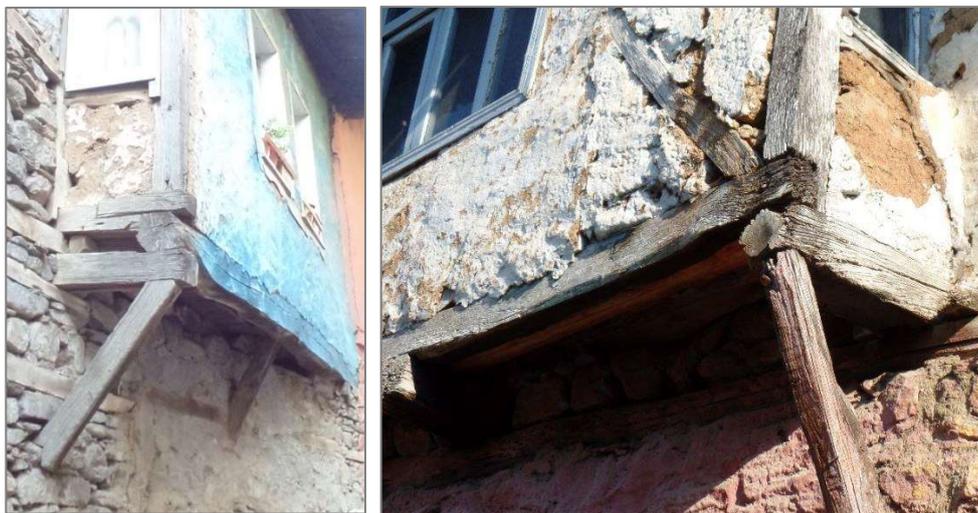
Figure 3.80. Floor girders of first floor extending parallel to the stone wall- 2800-34 (left), 2800-38 (right)

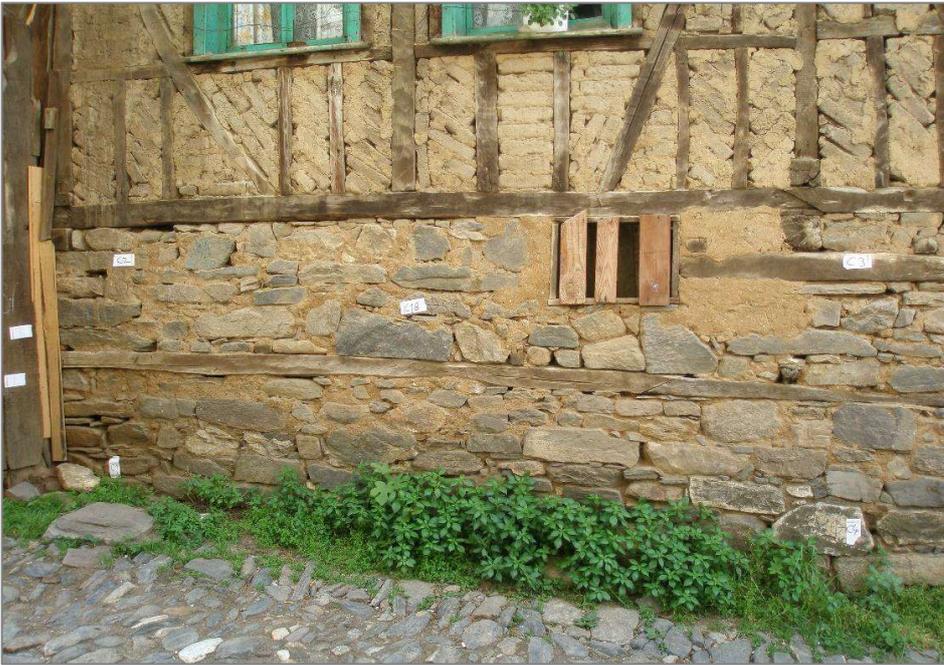
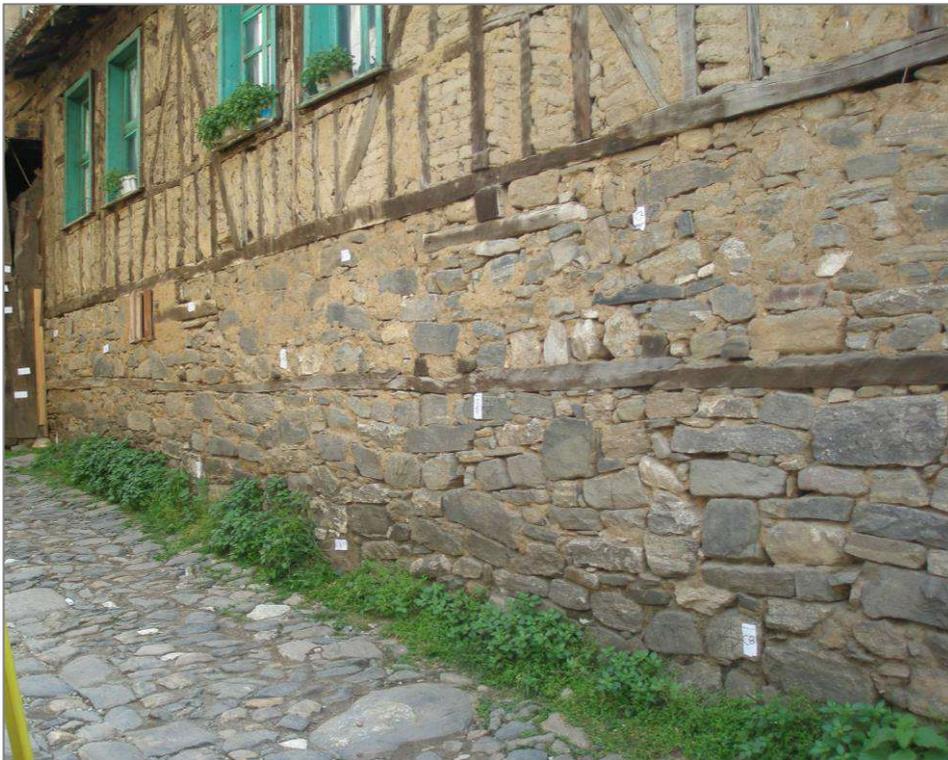
Figure 3.81. Main timber girders sitting on partial timber lintels on stone masonry wall (2794-27)
(Source: Piray Architecture-2008)

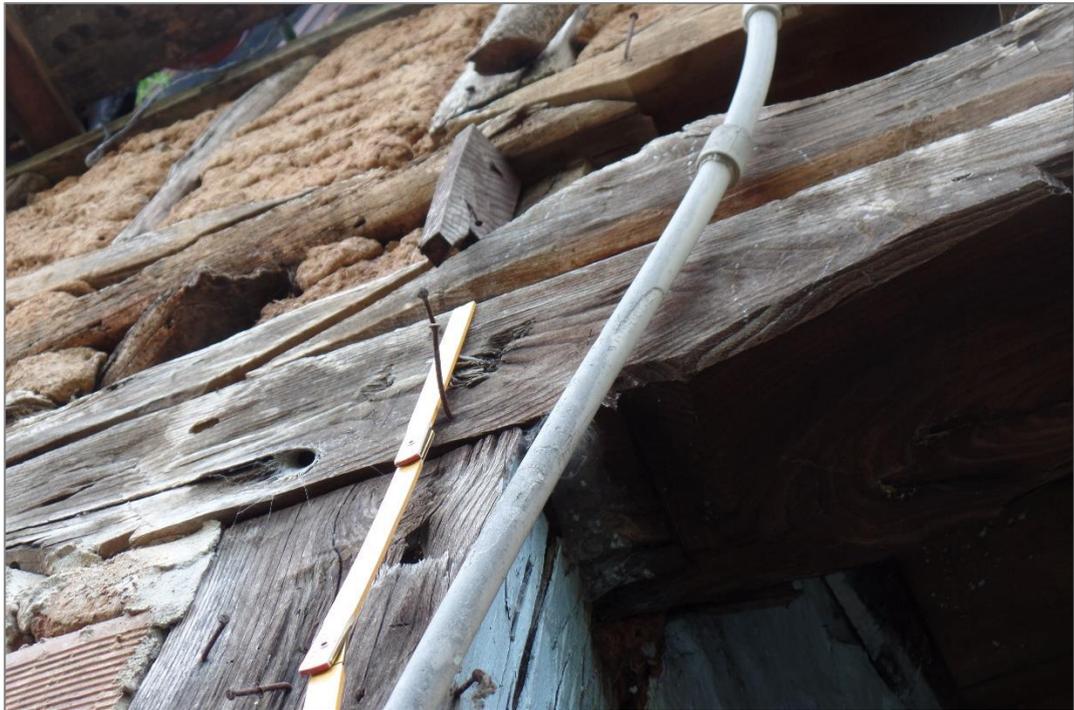
Figure 3.82. F0.2 detail (2800-31)

The connection between the ground floor and first floor has a different detail on courtyard facade. The main post, which has a cross section of 20x20cm, sits on the stone base and extends up to the first floor as a single piece. There are timber bolsters on the main post, which are connected by lap joints. The main timber girder with a cross section of 15*20cm – 20x20cm is placed above the bolster in the same direction. On this main girder floor girders with cross sections of 8x12cm, 7x11cm are placed in the opposite direction at intervals of 30-40cm. Foot plate is put on the floor girders, in the opposite direction. The timber post of the first floor, with a cross-section of 15x15cm is placed on the foot plate in the axis of the main timber post of the ground floor. The main post is connected generally by lap joint. The main timber posts and girders are supported by braces in the buildings with the ground floor heights above 3m.

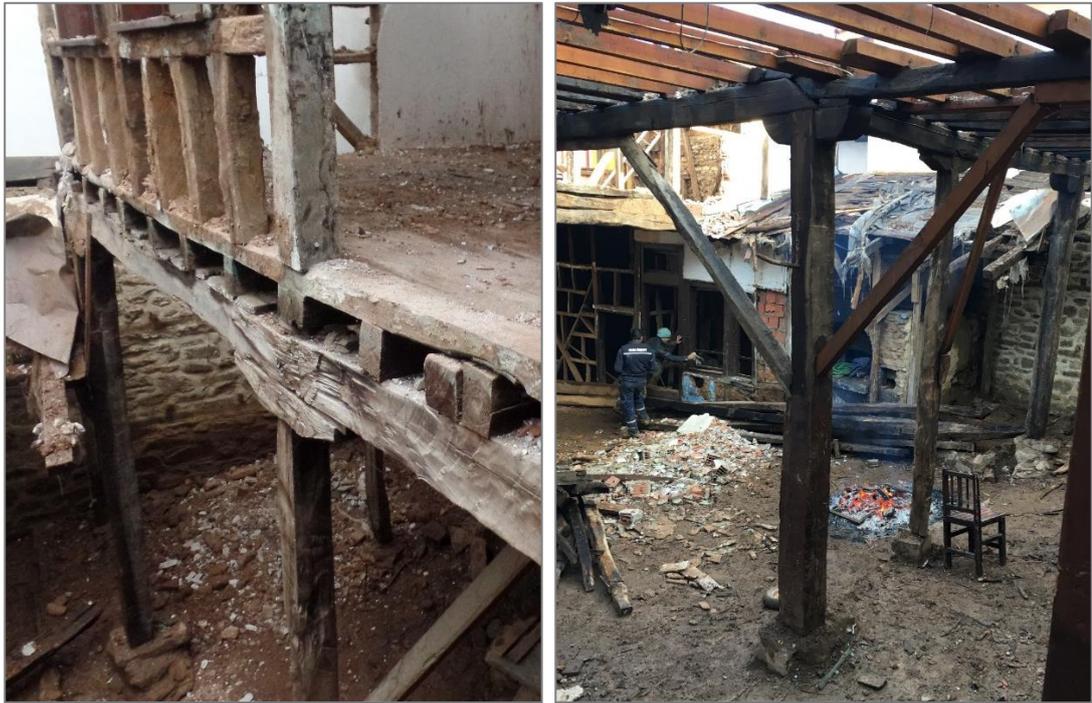
Figure 3.84. Timber post and floor connection (2819-1-9)

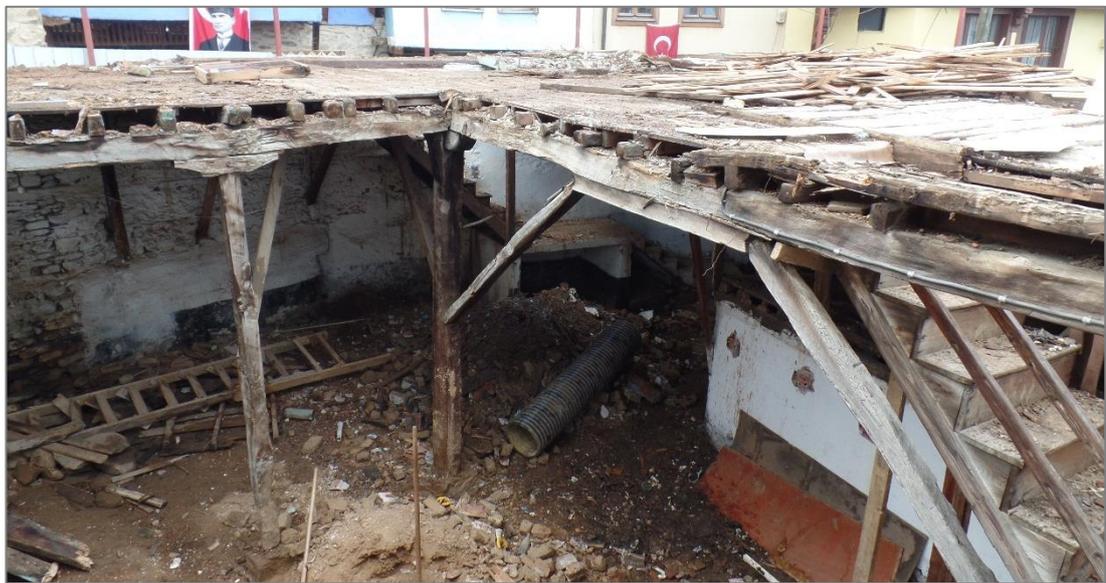
Figure 3.85. Timber post and floor connection (2819-1-9)

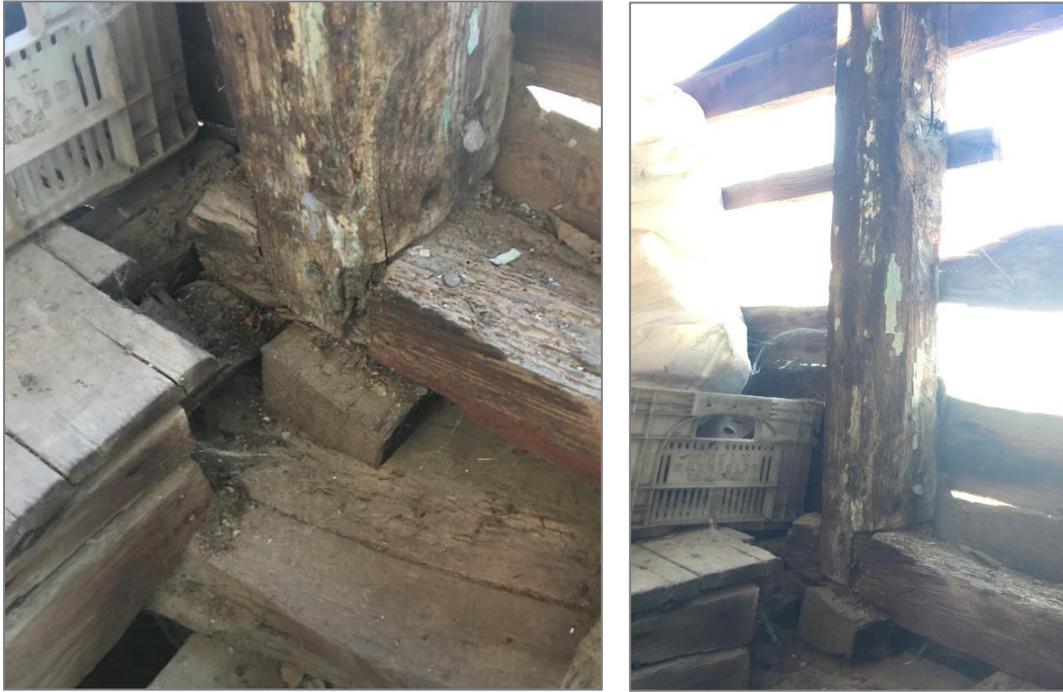
Figure 3.86. Timber post and floor connection (2820-8-7)

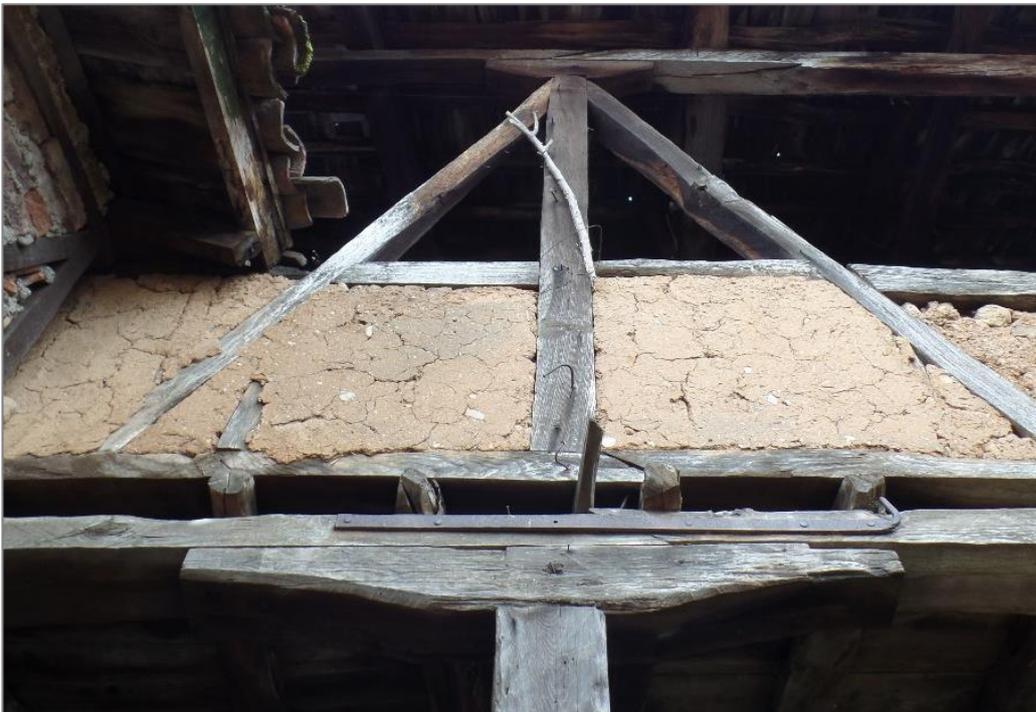
Figure 3.87. Timber post and floor connection (2819-6)

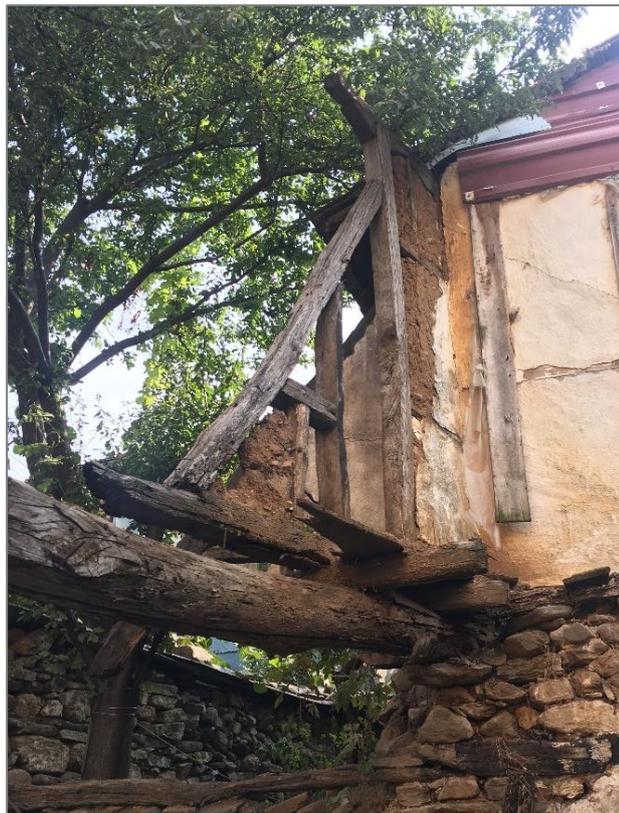
Figure 3.88. F0.3 detail- 2800-24

The third connection detail between the ground floor and first floor is the connection of two different walls in separate directions and the floor construction on the middle axis. The relationship between the timber frame wall separating the rooms and the main hall / *sofa*, timber floor construction and the main timber post and girder of the ground floor is coded as F0.3.a. The relationship between the timber frame wall separating the rooms, timber floor construction and the main timber post and girder of the ground floor is coded as F0.3.b. As it is mentioned before, the wall in the same direction with the floor girders is placed on the floor girder, the wall in the opposite direction with the floor girders is placed on the foot plate which is placed in the opposite direction above the floor girders. If the wall sits on the floor girder, one more floor girder is placed on both sides of the floor girder in order to fix the floorboards.

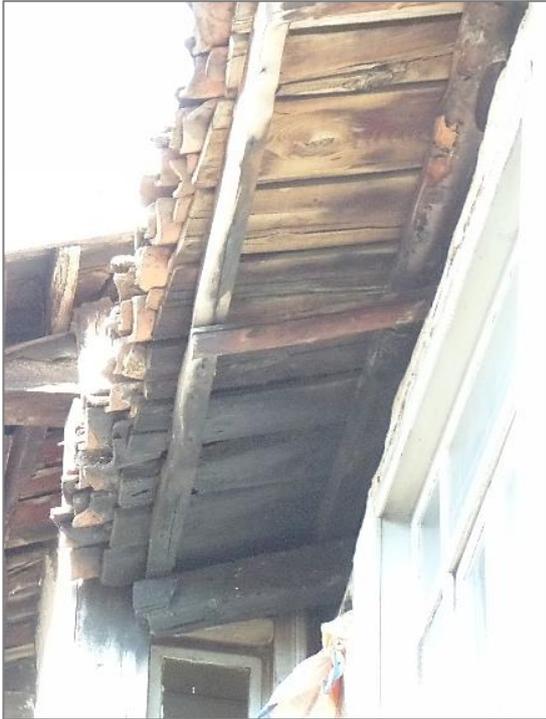
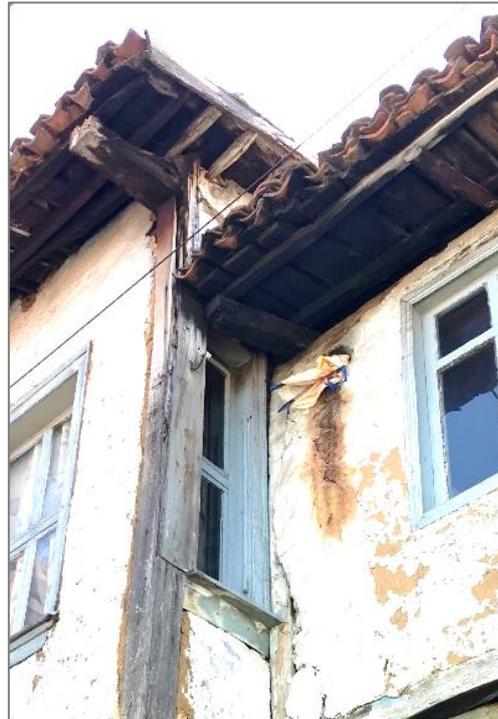
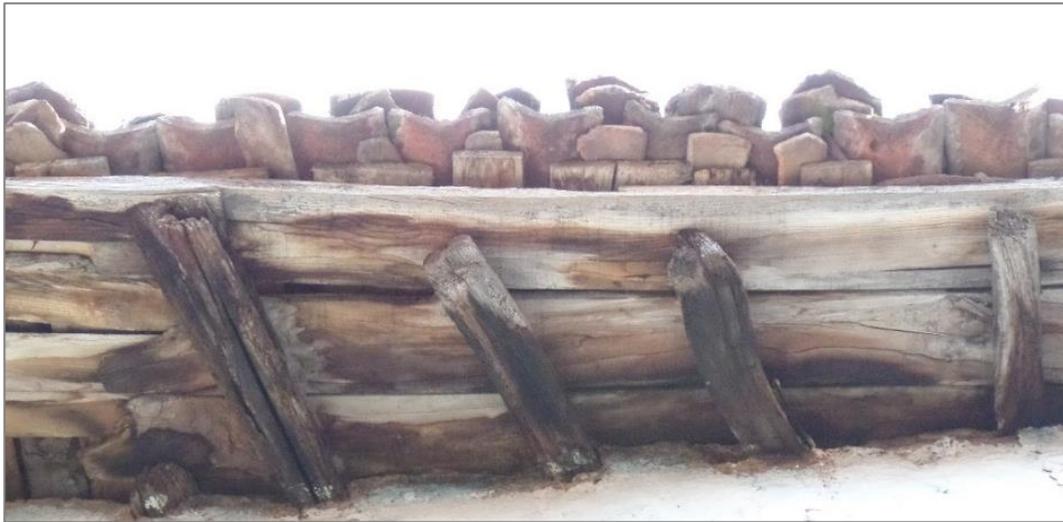
Figure 3.93. R01.b (2800-38)

The roof girder is not used in the detail of R0.1.b, which is seen in very few buildings (2800-38). The main rafters are fixed to the wall plate of the timber frame wall and extend towards the street. Purlins are put on the rafters. Roof boards are placed on the purlins. Over and under roof tiles are placed on the roof boards.

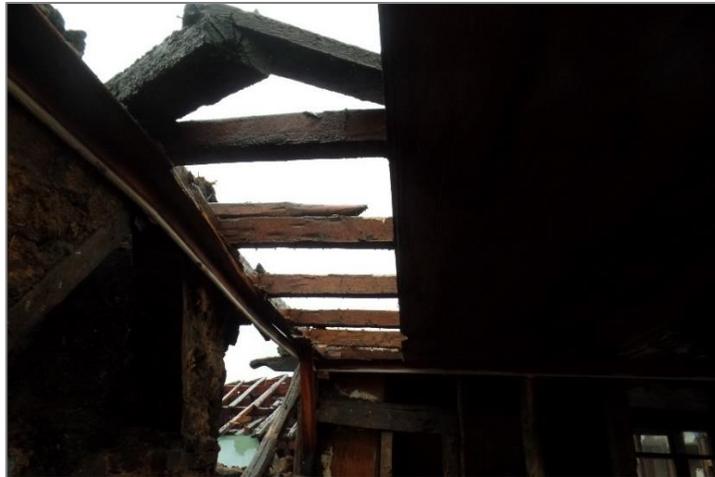
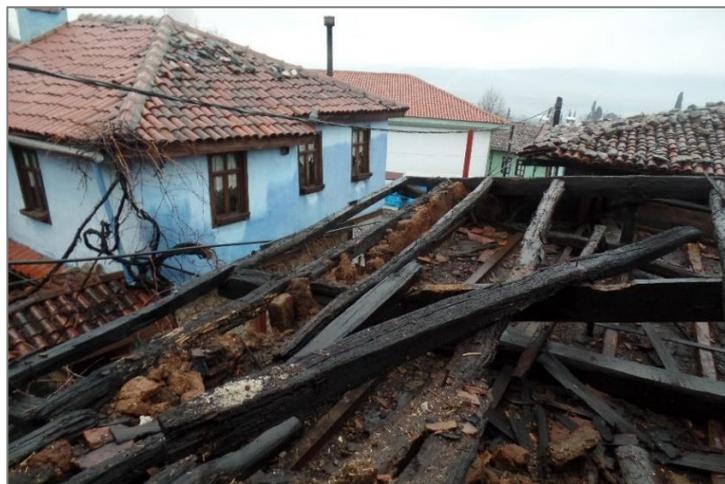
Figure 3.95. R01.1

In this type, ceiling covering is composed of ceiling boards and moldings. Ceiling girders are placed on both sides of the roof girders, extending towards the street. They sit on the wall plate of the timber frame wall. Timber battens are fastened to the ceiling girders from the bottom in the opposite direction. Ceiling boards are nailed to the battens in the opposite direction. Geometric patterns are created with the help of the moldings used to fill the gaps between the ceiling boards. Plain ceiling covering is used more frequently.

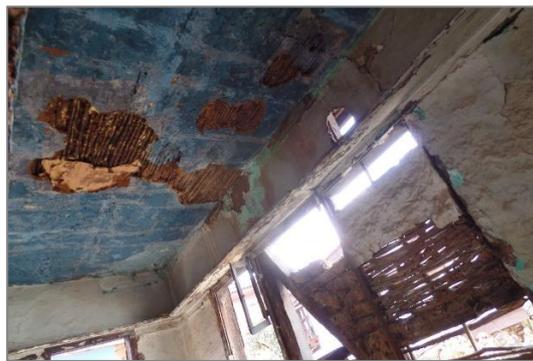
Figure 3.97. R01.2_2820-8-7

In one building, plaster is used as ceiling covering. Ceiling construction is composed of chestnut or hazelnut branches that are connected by wattle technique between the timber battens. These wattled chestnut or hazelnut branches are plastered from the bottom by mud mortar and lime mortar.

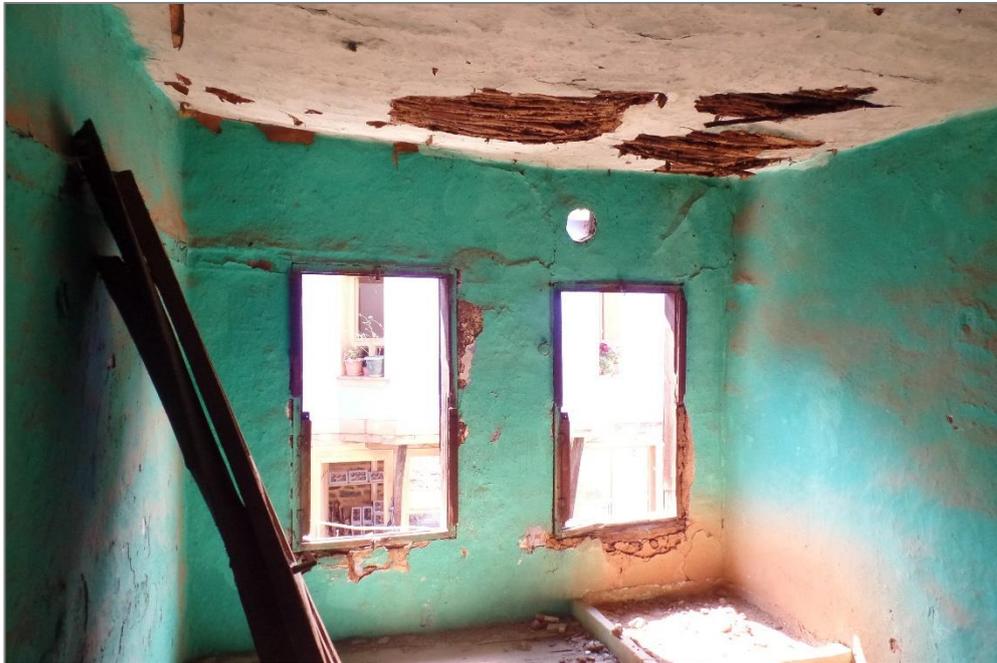
Figure 3.99. Plastered branches on the ceiling (2820-8-7)

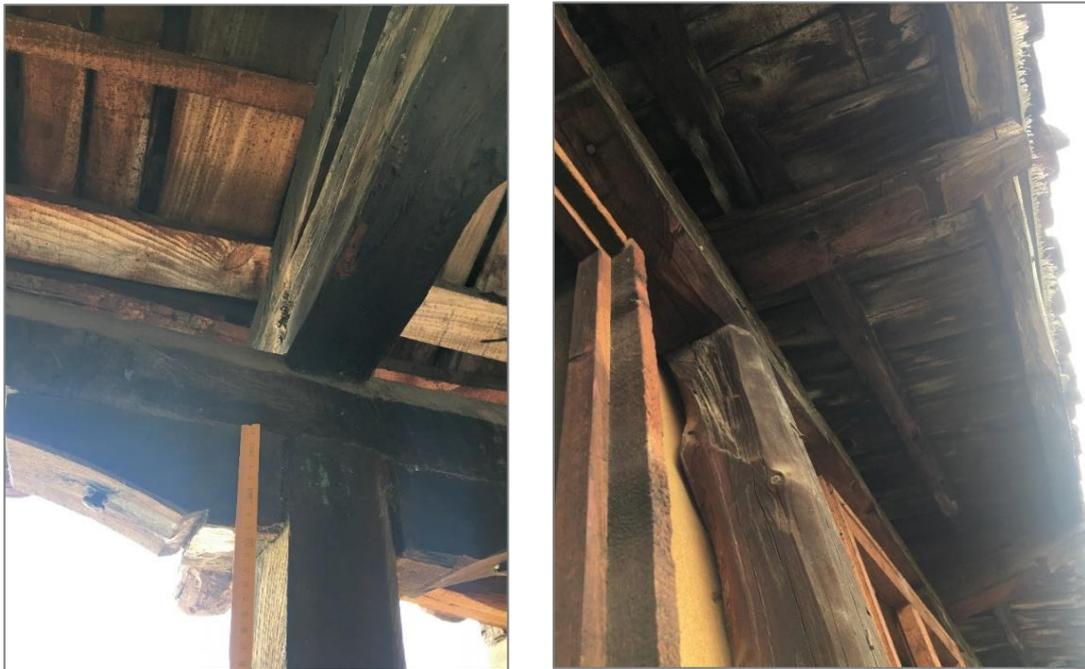
Figure 3.101. Detail - R02 _2820-8-7 (left), 2800-31 (right)

The connection detail between the timber post and the roof does not differ on the courtyard facade. The roof girder, which extends from the middle axis to the courtyard facade and determines the width of the eave, sits on the wall plate on the bolster of the timber post. Like the connection detail on street facade, the roof girder is usually placed on the axis of timber post on the courtyard facade. Unlike the detail of R0.1.a, wall infill is not used on the courtyard facade.

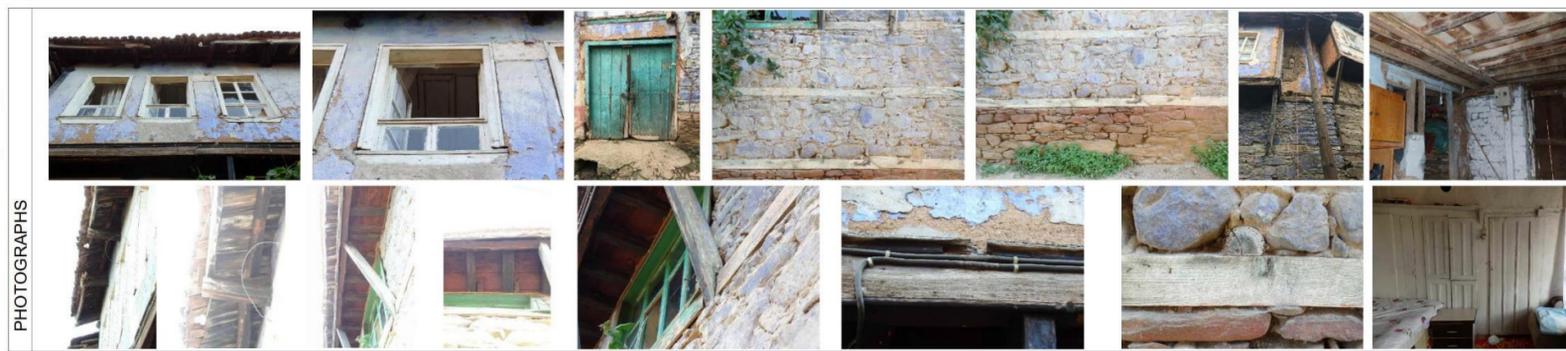
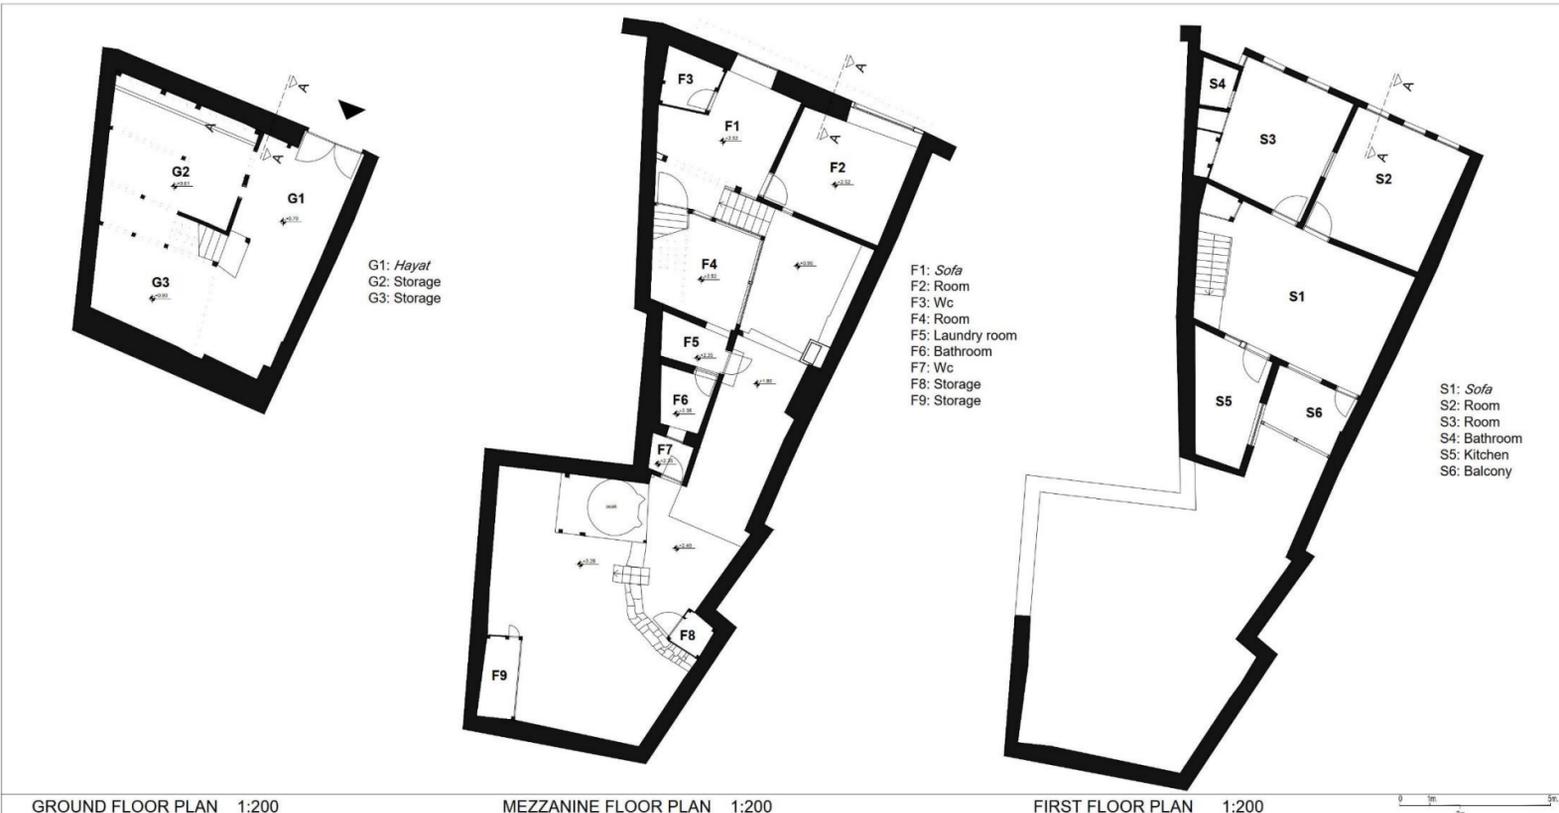
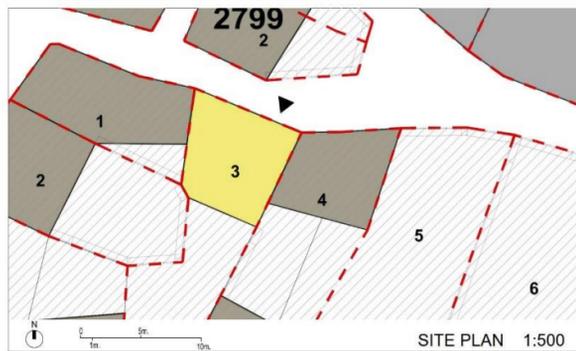
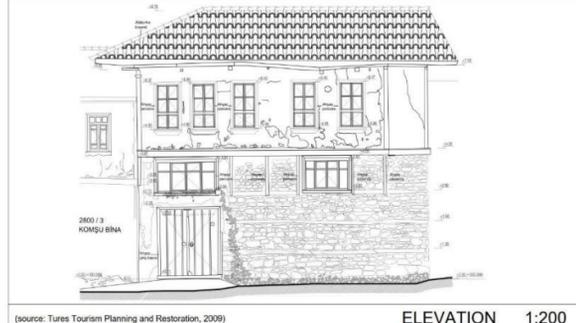
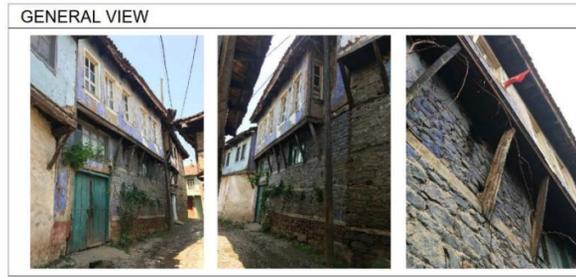
Figure B.1. Information sheet of building A-1: 2800-3

A-1 ADDRESS: KURTBASAN STREET NO:18 BUILDING LOT: 2800 BUILDING ID: 3 (225) ENV. NO: 53 - 1990

Shematic plans were drawn based on the drawings of TURES MIMARLIK prepared in 2008-2009

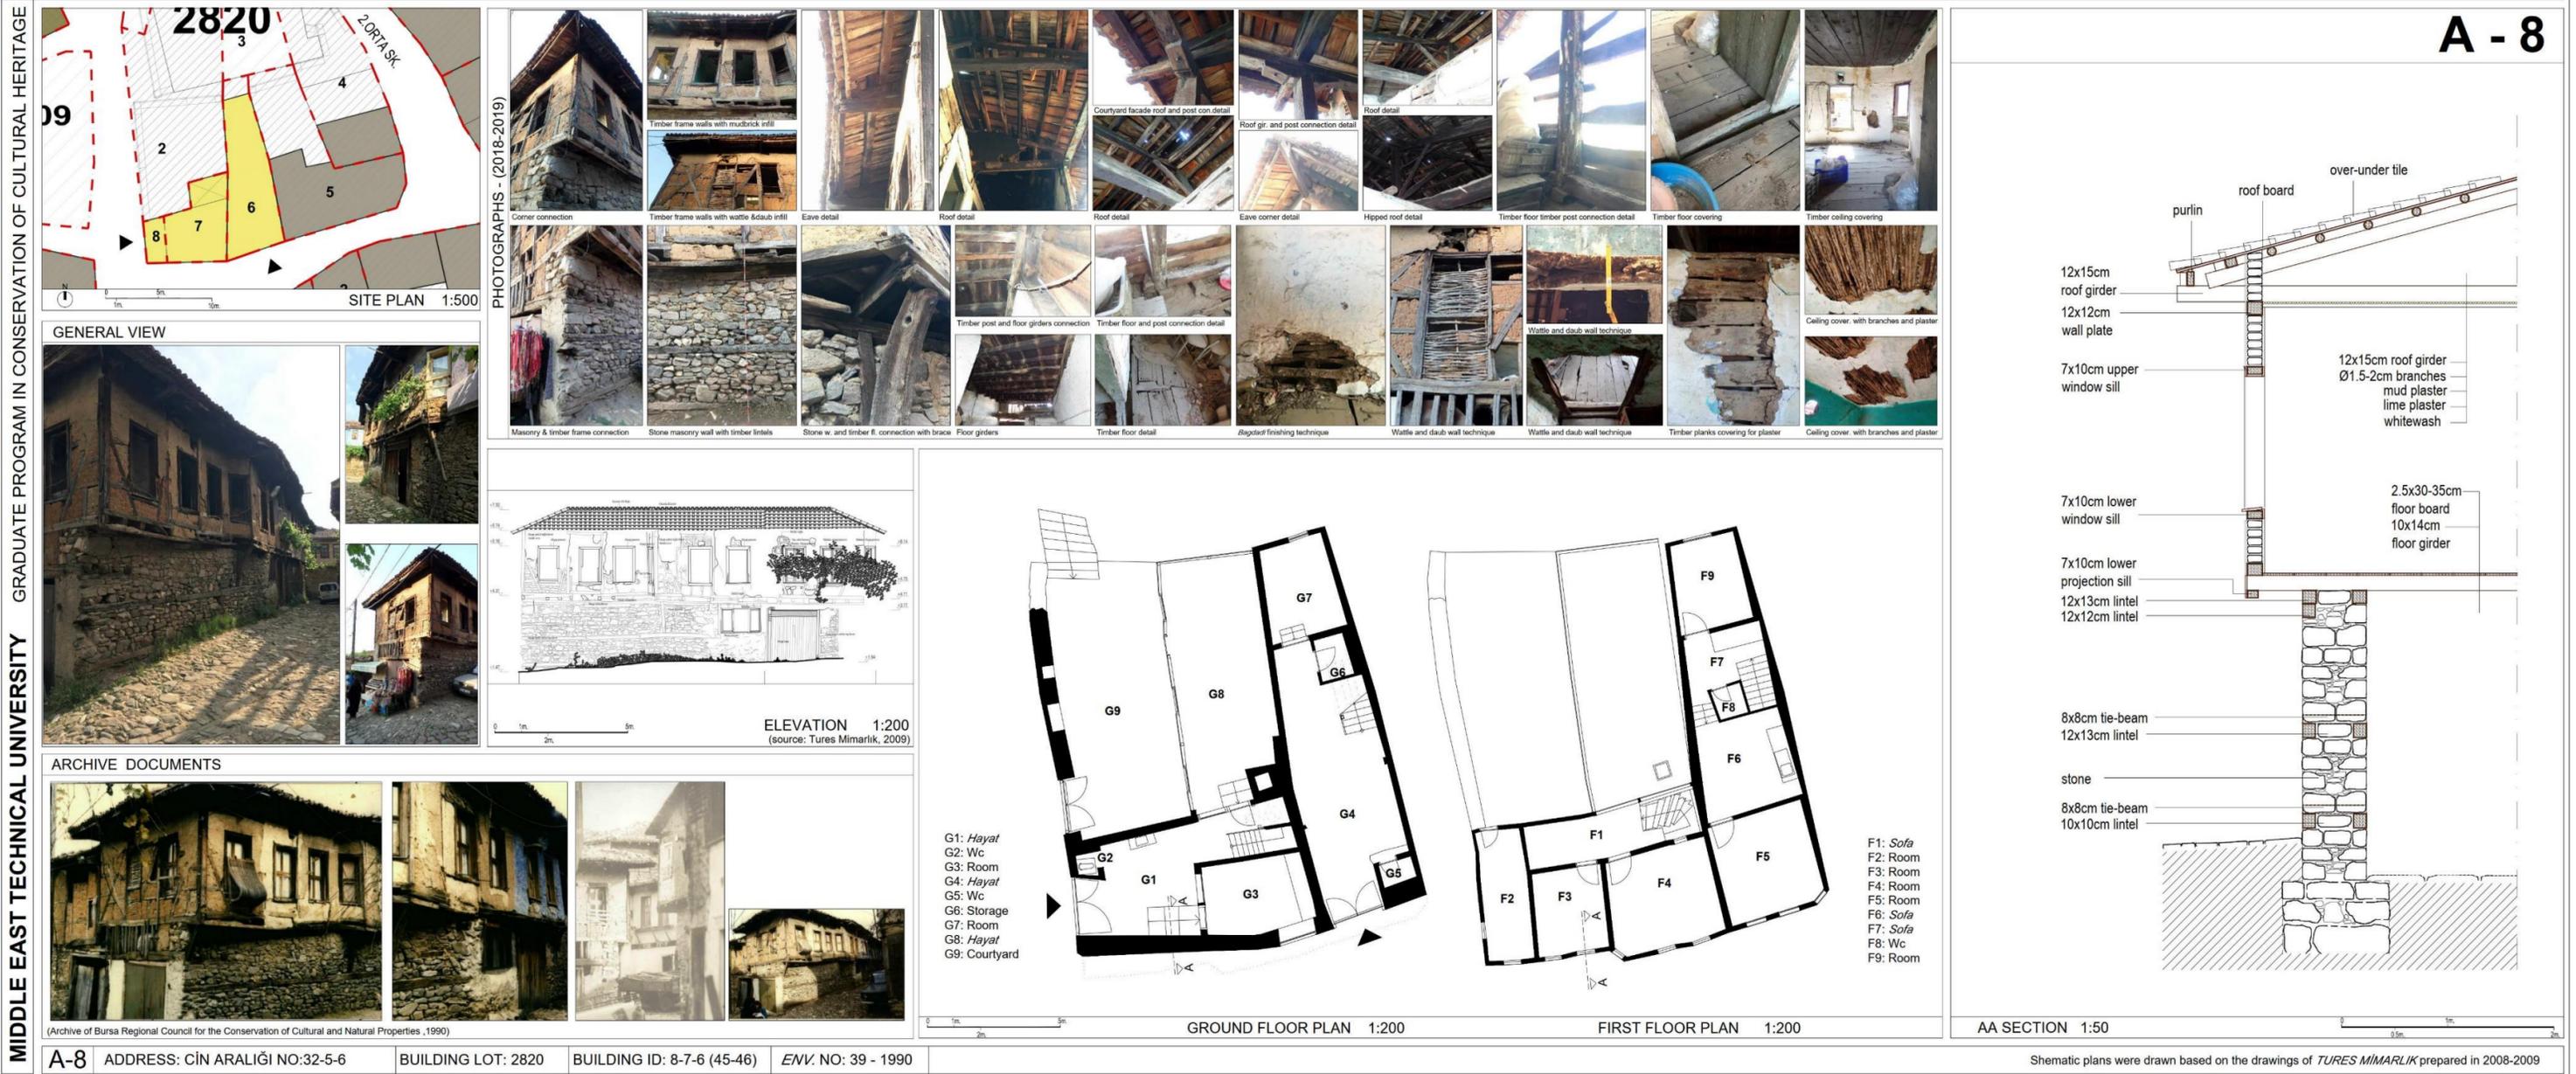
Figure B.8. Information sheet of building A-8: 2820-8-7

A-8 ADDRESS: CİN ARALIĞI NO:32-5-6 BUILDING LOT: 2820 BUILDING ID: 8-7-6 (45-46) ENV. NO: 39 - 1990 Shematic plans were drawn based on the drawings of TURES MIMARLIK prepared in 2008-2009

In some buildings, a similar technique is applied by using timber planks or log boards instead of wood laths (2820-8-7). Most probably this technique is used to reduce workmanship and costs. However, since timber planks or log boards have large surfaces compared to wood laths, the mud plaster cannot attach properly to the walls, causing the loss of plasters in a short period of time. *Bağdadi* and timber planks are generally used in the interior walls, whereas they are observed in the exterior walls in some examples. The use of *bağdadi* technique only in certain sections of the exterior walls can indicate a later period intervention. (2805-1)
