DOCUMENTATION FOR PRESERVATION OF THE FERHAT WATER CANAL IN AMASYA

Gediz URAK and Işık AKSULU

Keywords: Amasya; Ferhat Water Canal;
documentation; preservation.

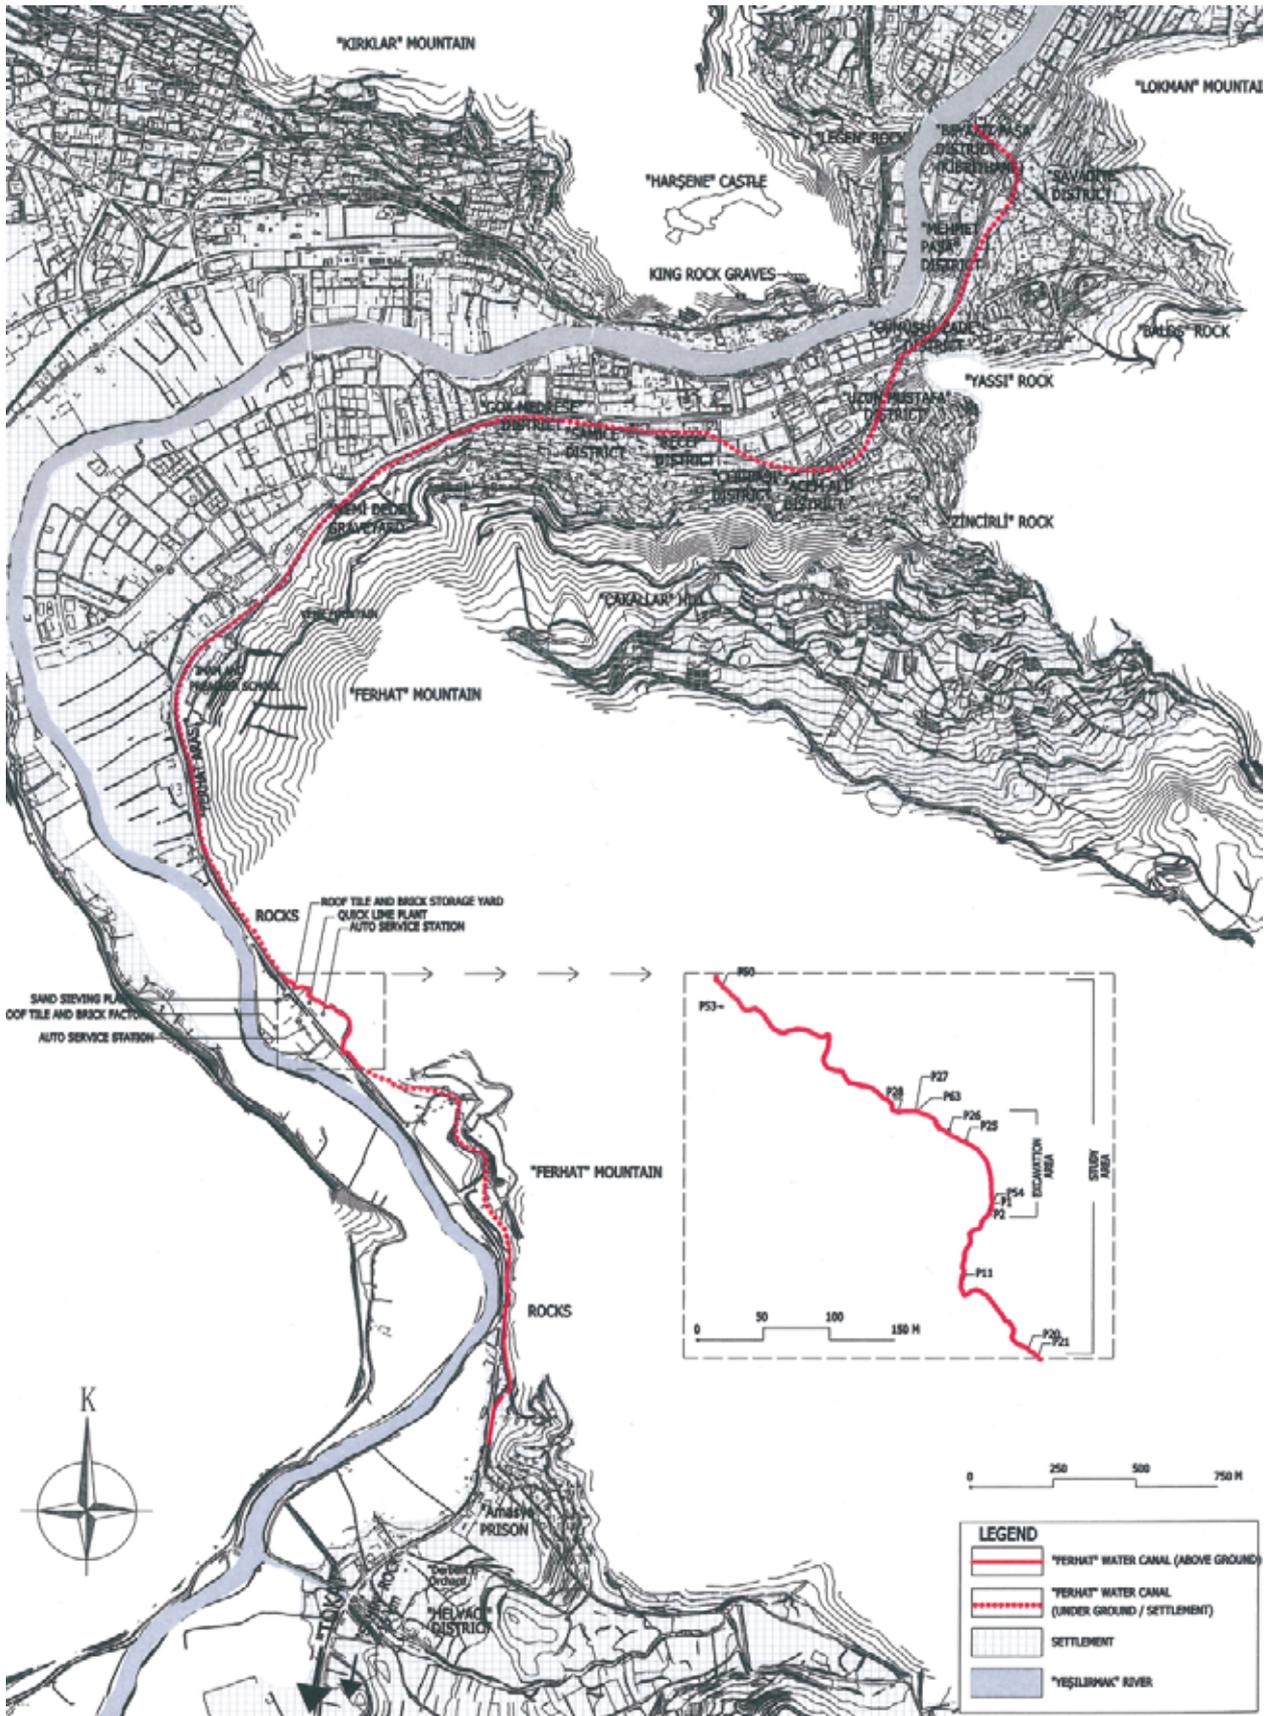
Figure 1. Location of Ferhat Water Canal and the Study Area

From the investigations made in the area, it was felt that the use of conventional measurement methods would be inadequate for a structure like the Ferhat Canal and a 'polar normal coordinate measurement method', jointly with Zeiss-Theo-20A brand theodolite and Leica-NA 820 brand level equipment were used, which allowed the measurement of irregular and curved structures (such as the Ferhad Canal) with minimum error margin. Measurements and drafting of the vaulted canal sections that are narrow and do not allow use of such instruments were made using conventional measurement and drafting methods. The silhouette of the mountain and some canal cross sections located at higher altitudes were measured using the forward deduction method. Some canal cross sections were measured using the Tacometric Measurement Method and the remaining were done by using the 'Normal Coordinates' system (3). With the mentioned survey method and systems, architectural survey studies have been performed at two stages; before and after the cleaning and excavation operations (Figure 1, 2 – 8, 10 - 17).

The First Level Architectural Survey (Figure 1, 2, 4)

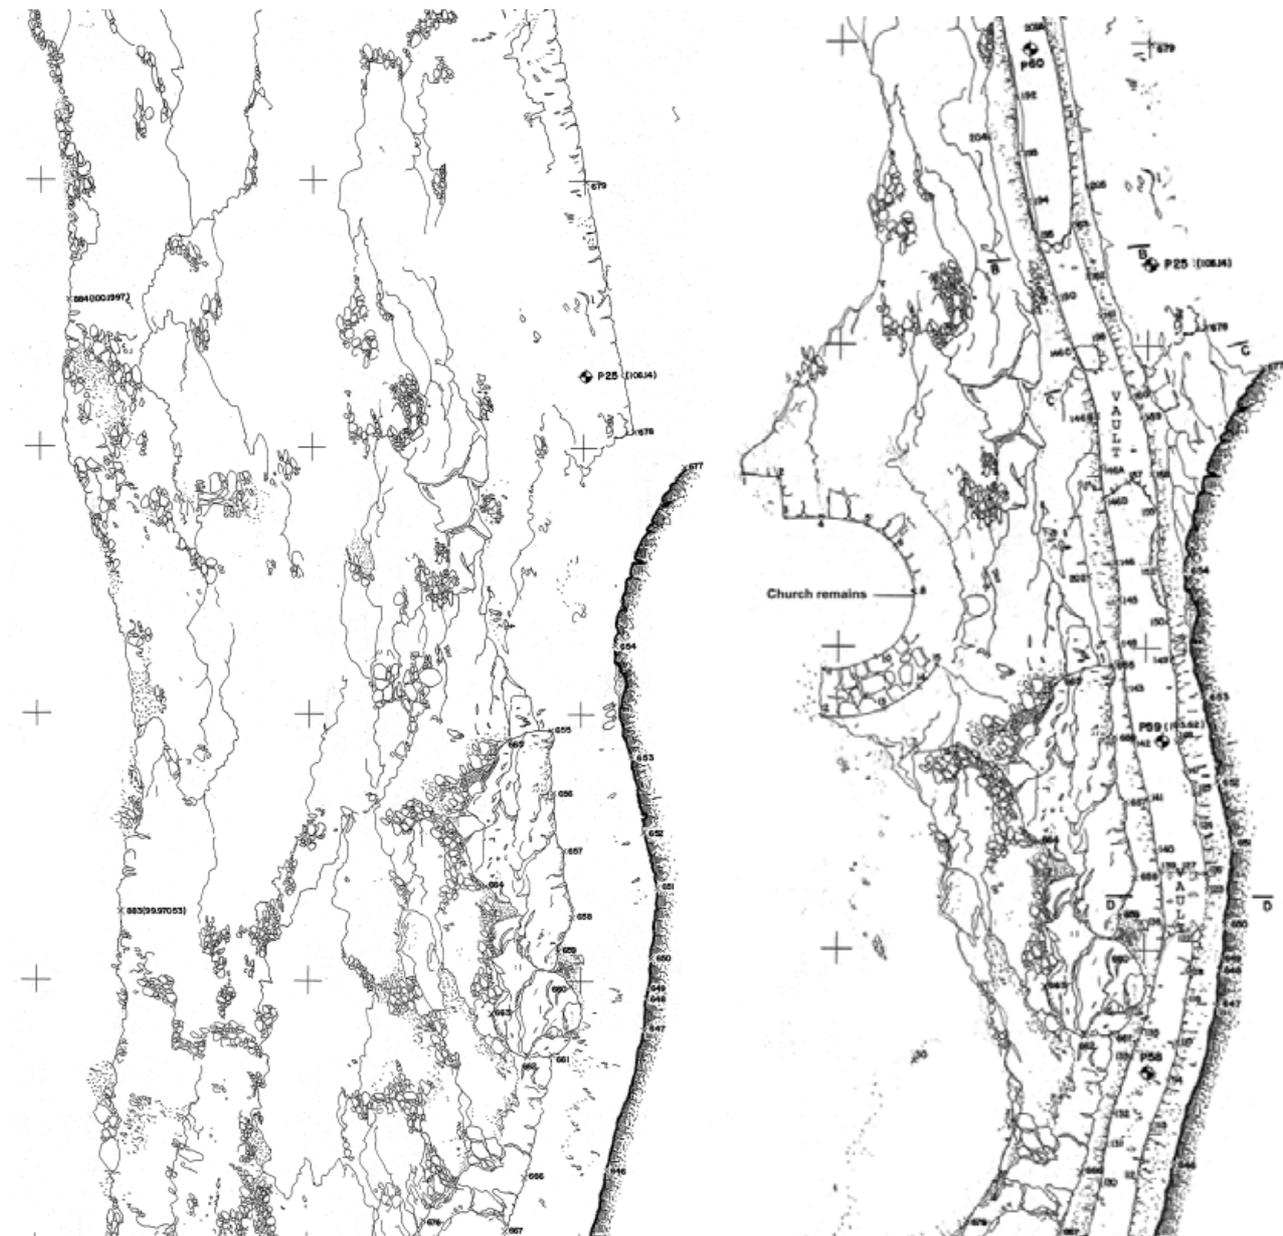
Figure 2. Ferhat Water Canal–
Architectural survey prior to excavation–
Between polygons 24 to 26.

Figure 3. Ferhat Water Canal–
Architectural survey after the excavation–
Between polygons 58 to 61 (24 to 26).

53 polygon points have been set up inside the canal to enable the development of the 1/50 scale architectural survey map of the Ferhat Water Canal. Polygon points have been marked with wooden stakes and steel nails, and highlighted with removable paint. Polygon angles were measured with theodolite using the sequential angle measurement method. The distances were measured twice, using the tape measure. Mean values were used for the polygon calculations. The polygon's starting point was P21, the starting direction was P21-P20 and the coordinates for P21 were taken as $x=300.00$ m., $y=300.00$ m., $z=103.21$ m. This z value is common

The Second Level Architectural Survey (Figure 1, 3, 5 - 8)

rubble stone vaults were built at both sides of the canal and the inside was plaster coated (**Figure 3, 6, 7, 14, 16, 17**). Sedimentation ponds of various dimensions were also observed at the portions that were carved into the stone.

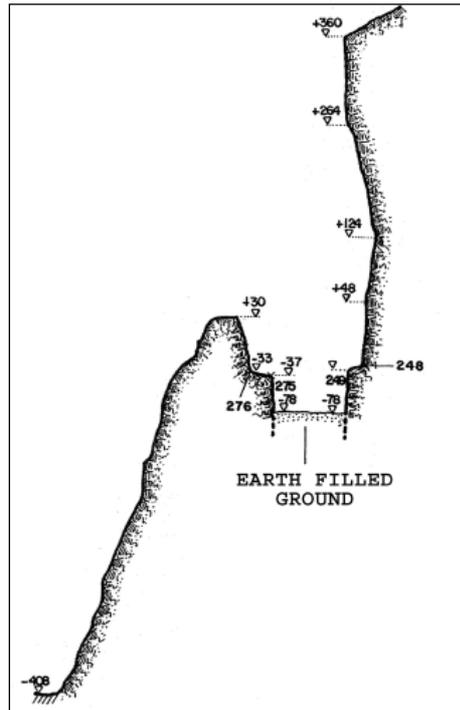
Figure 4. Ferhat Water Canal– Architectural survey prior to excavation– Canal cross section around polygon 12.

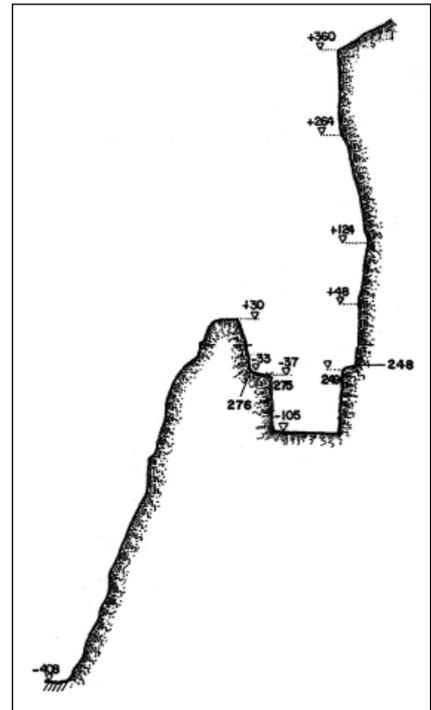
Figure 5. Ferhat Water Canal Architectural survey after the excavation - Canal cross section around polygon 12.

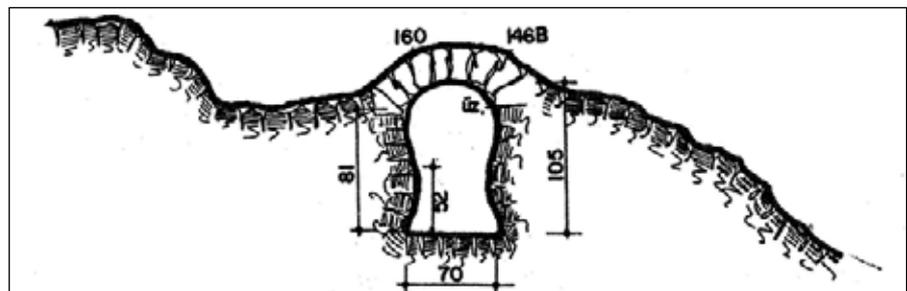
Figure 6. Ferhat Water Canal– Architectural survey after the excavation– Vault cross section found around polygon 4.

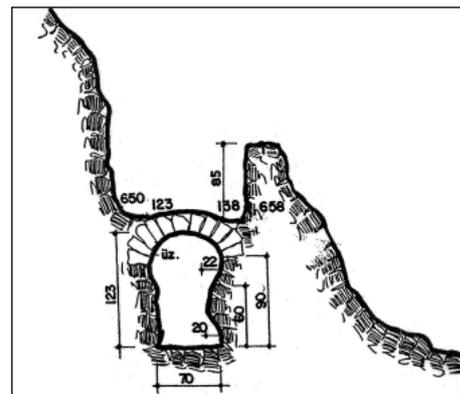
Figure 7. Ferhat Water Canal– Architectural survey after the excavation– Vault cross section found around polygon 27.

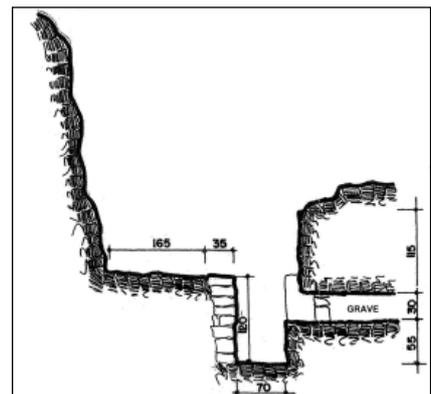
Figure 8. Ferhat Water Canal– Architectural survey after the excavation– Burial and canal cross section discovered around - Polygon 26 (61-62).

A simple grave was found in front of this wall (**Figure 8**). The wall of rubble stone, cuts the canal once more towards west after following the canal for about 4m. A long rectangular setting with plastered interior walls and floors running in the north-south direction over this perpendicular wall has been exposed.

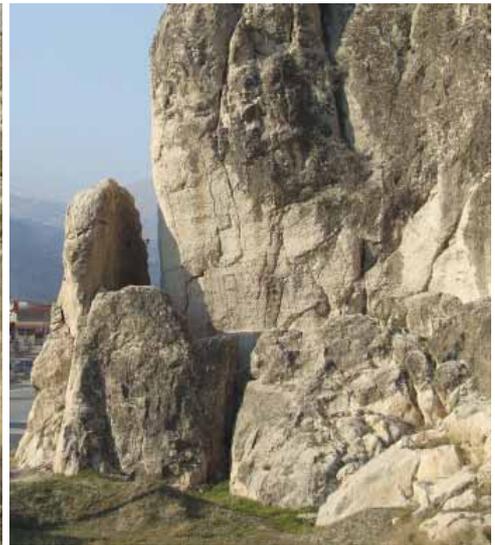
Figure 10. Ferhat Water Way– General view from the Amasya-Tokat Highway– Between polygons 11-13, 2006.

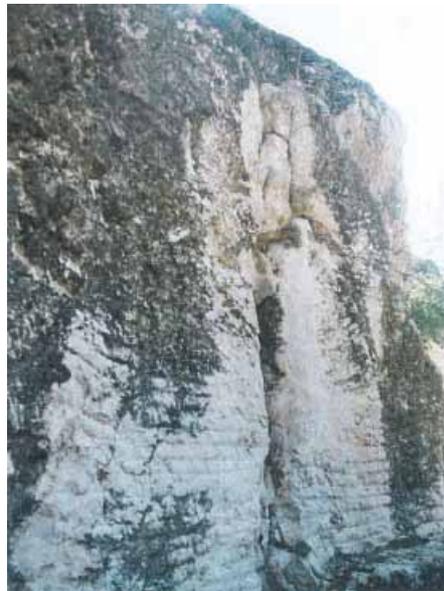
Figure 11. Ferhat Water Way – Canal inside–Around polygon 13.

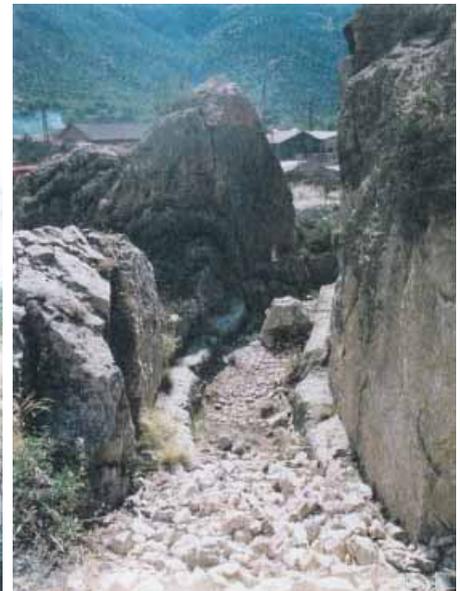
Figure 12. Ferhat Water Canal – Canal inside–Around polygon 28.

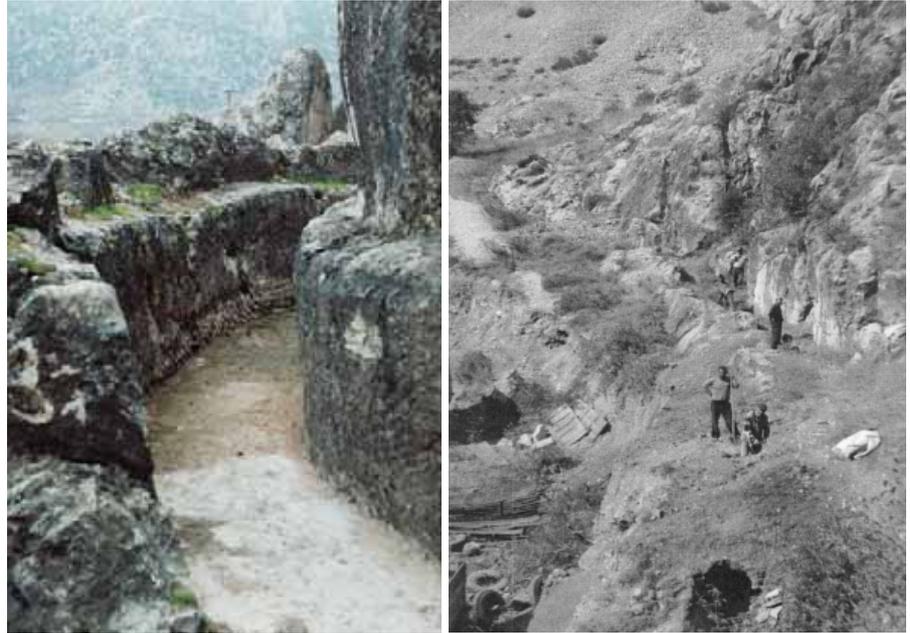
Figure 13. Ferhat Water Canal – Canal inside- Around polygon 51, 2006.

Figure 14. Ferhat Water Canal- during excavation (From Amasya Museum).

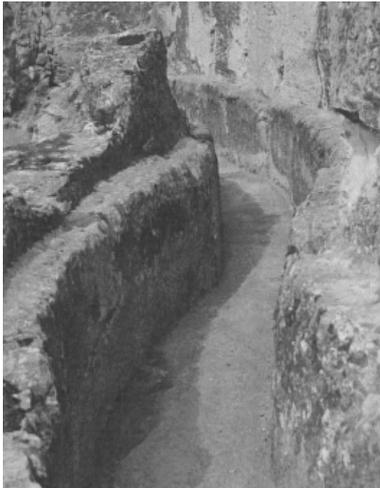
Figure 15. Ferhat Water Canal - Canal inside after cleaning / excavation - Around polygon 13.

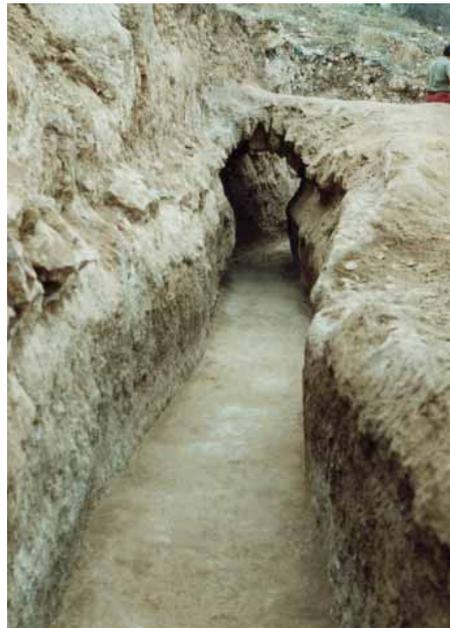
Figure 16. Ferhat Water Canal– Cylindrical arches discovered during the excavation- Around polygon 14.

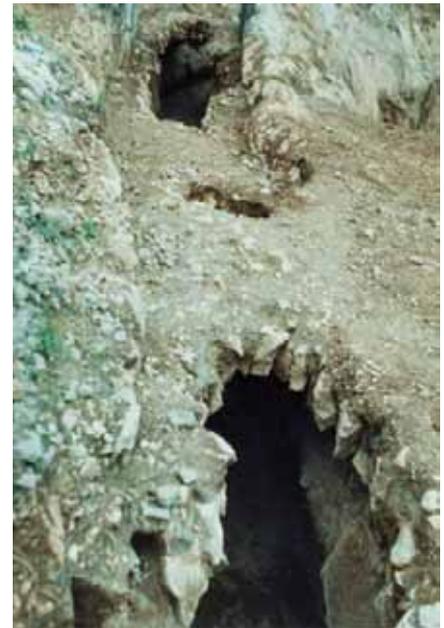
Figure 17. Ferhat Water Canal– Cylindrical arches discovered during the excavation- Between the polygons 59-60.

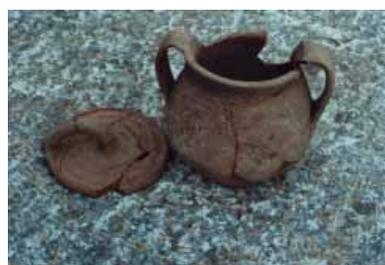
Figure 19. Ferhat Water Canal– Terra cotta materials discovered during the excavation (From Amasya Museum).

Terra cotta pots and a round pot cover with a single handle, belonging to the 11th-12th centuries A.D. were found during the cleaning of the earth fill inside the vault between the polygons 25-26 (**Figure 19**). A 80 cm thick 75-80 cm high apsis with rounded walls, constructed of rubble stone, was exposed on the canal's outer surface near the main rock between the polygons 25-26 (**Figure 3**). The inner sides of the walls were coated with Horosan plaster. An uneven surfaced floor mosaic with designs made of partially decomposed white, brown, light green, yellow, green colored pieces was observed in the base of the apsis. (**Figure 20**). Roof plates embossment-decorated and building decoration plates of terra cotta were found outside the southern side walls of the apsis. A 60 cm wide, 80 cm thick wall opening that cuts the canal at a perpendicular direction near a small arch cover was observed during the excavation studies conducted near the Polygon 26 region. In front of this small wall, 120 cm high walls constructed of even-surfaced cut stones that run towards the inside of the canal, parallel to the inside walls, were observed.

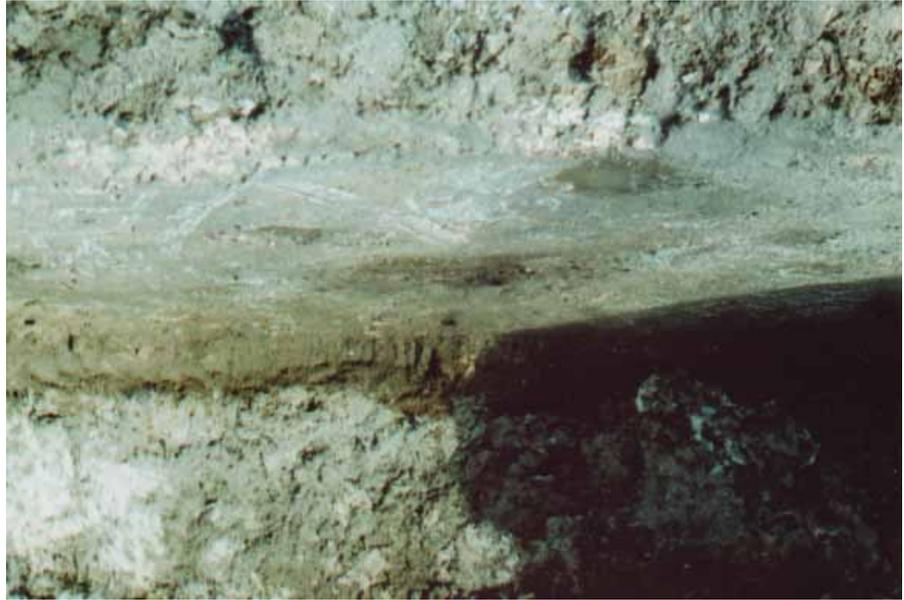
Figure 20. Ferhat Water Canal– Mosaic decoration on apsis floor during the excavation (From Amasya Museum).

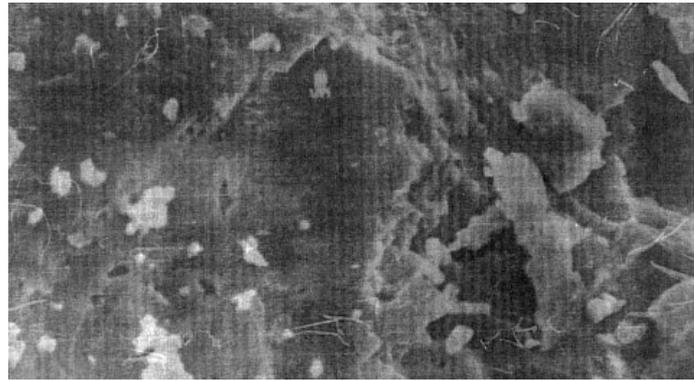
Figure 22. Calcite crystals.

Results from the mineralogical analysis of the three 15 cm x 15 cm rock specimens sent to TCMU showed that the rocks in the area consisted of smooth calcite crystals (**Figure 22**). This will enhance the effectiveness of the plaster/mortar to be injected in the areas where filling will be required. Additionally, because of its smooth crystal structure, aggregate that will be prepared using these calcite materials found in the region will lengthen the bond life of the injected plaster/mortar to the inside surfaces of the cracks and holes.

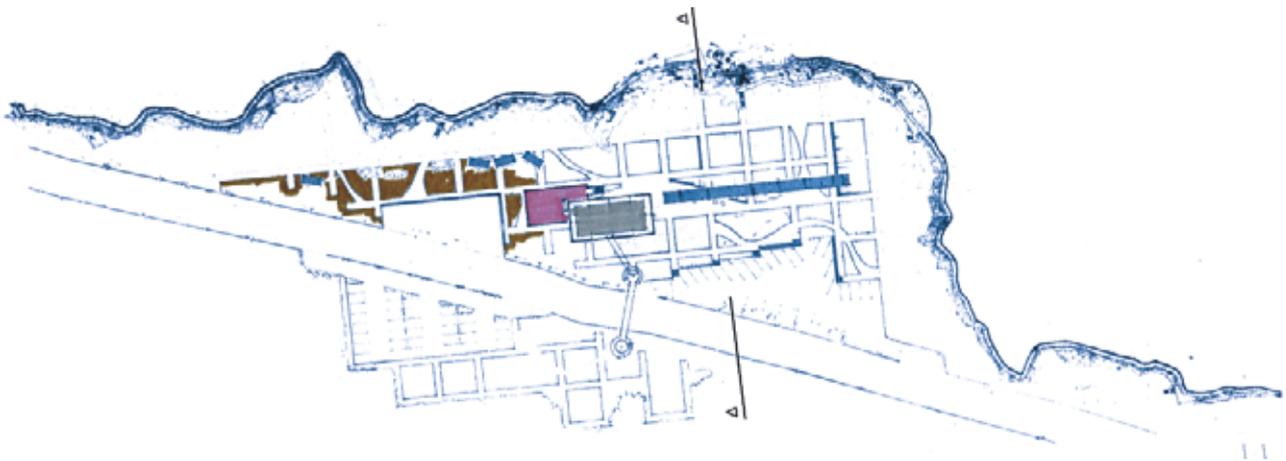
Figure 23. Site Plan of the proposal.

In order to realize the recreational potential of the area and offer the optimum display benefit, a new building and open areas that will not impair its appearance have been designed. A cafe-restaurant, open and covered sitting areas, walkways along the canal perimeter, two parking areas on both sides of the road, and an overpass that connects these, have been planned over a 3 hectare area (10; Figure 23-24). The cafe-restaurant building having 153 m² closed and 120 m² open area, which will be constructed in contemporary techniques and materials is planned not to overwhelm the historic structure. The glazed façades provide a contrast with and reflect the old structure behind, emphasizing the period difference, but complying with international preservation principles. Open and covered sitting areas, walkways, and a botanic garden where the types of plants specific to the Amasya region, can be positioned around the appealing 2.3 hectare pond and the green zone, serving a large number of people. The car park for 52 cars and 2 buses, a lightweight contemporary overpass not visually disturbing the environment, pedestrian paths and observation terraces around the canal perimeter that end with terraces enabling views and vistas from the area, have been provided in appropriate places using elements in a way not to disturb the historic

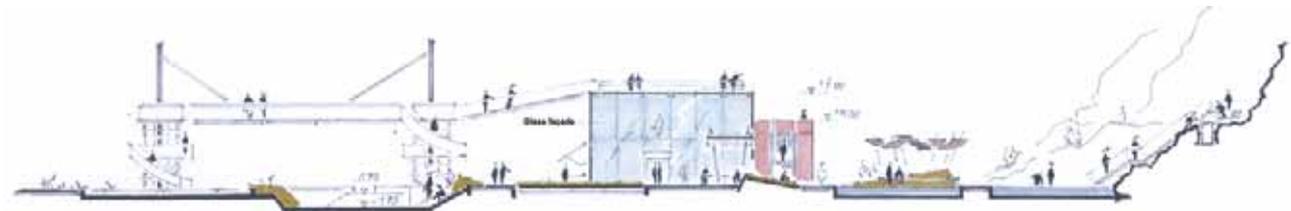
Figure 24. Cross section of the proposal.
