**ANATOLIA ANTIQUA  
ESKİ ANADOLU**

## LA MISSION LABRAUNDA 2013 – RAPPORT PRELIMINAIRE

### 1.1. Conservation project of *Andron A*: intervention proposals as a response to values and problems (par A.G. Bilgin Altınöz, METU)

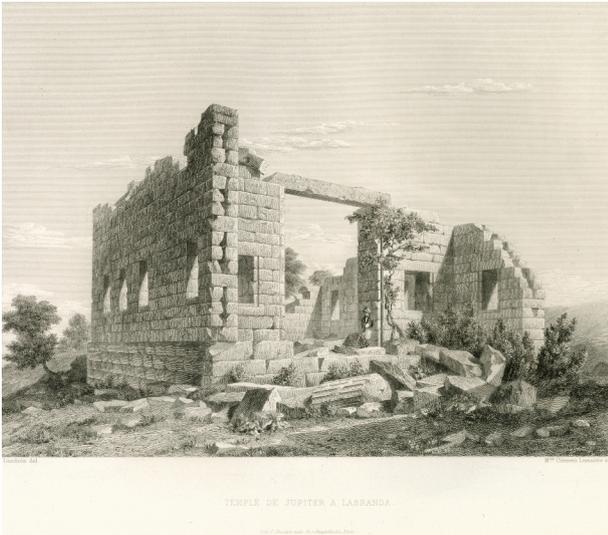
**Fig. 1 : The ‘image’ of *Andron A* within its physical and natural context in 1840s in Eugène Landron’s drawings** (Philippe Le Bas, *Voyage archéologique en Grèce et en Asie Mineure sous la direction de M. Philippe Le Bas (1842-1844). Planches de topographie, de sculpture et d’architecture, gravées d’après les dessins de E. Landron, publiées et commentées par Salomon Reinach, Paris 1888 : 47-48).*

The *Andron A*, a monumental banquet hall built by Idrieus, is one of the most important remains of the archaeological site of Labraunda (Fig. 1). Since the re-discovery of Labraunda by the early excavations of the Swedish team in 1948, *Andron A* has been a central focus for both the field archaeologists as well as the visitors because of its exceptional state of preservation. As one of the most and first visible monumental building while approaching the site,

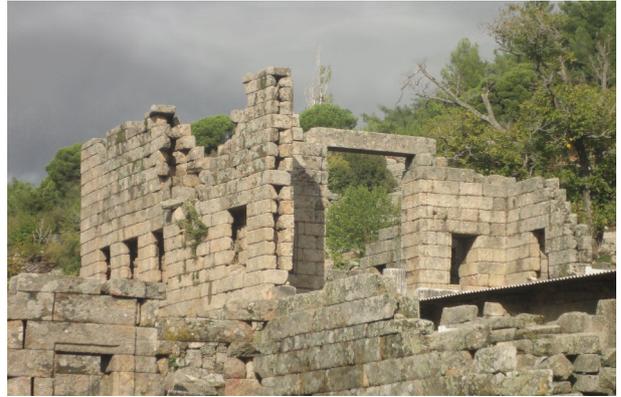
**Fig. 2 : The ‘image’ of *Andron A* within its physical and natural context in 2012** (METU Project Team, 2012).

the image of *Andron A* has come to be a symbol for the site (Fig. 2). Due to its importance, since its discovery until today, the *Andron A* has been documented various times with different techniques.

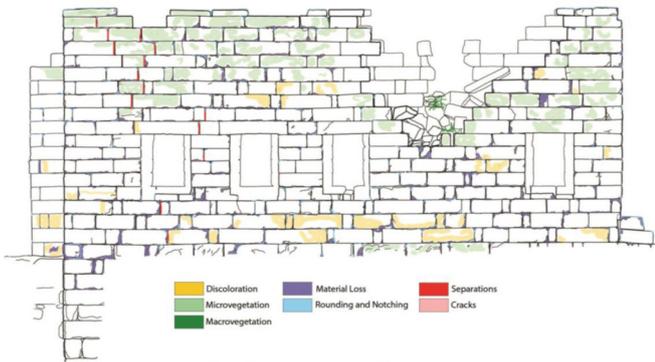
**Fig. 3 : Mapping of visual weathering forms on south facade** (© METU, 2012).

As a part of the geological and material studies, stone samples with no archaeological importance were collected for laboratory analysis. Density, sound velocity, porosity, XRD mineralogical analysis and petrographic analyzes by optical microscopy of thin sections were conducted over these samples, in order to define the physical and physico-mechanical properties of these rocks. It revealed that the building stones used in the *Andron A* are gneiss, with high unit weight, effective porosity, low water absorption and cation-exchange capacity. Hence, their field performances are good, as long as they are used horizontally parallel to their foliation planes and as long as their contact with water is controlled through good drainage. The observations during the site survey also proved that most of the material problems such as discoloration, flaking, surface relief, rounding and notching at the edges of the blocks and material loss in the upper parts of the building are due to repeated contact with rainwater from surfaces and from the top (Fig. 3).

Thereupon, providing water drainage and delimiting the water entry in between the gneiss blocks from the top or from surfaces of the walls have been among the main concerns of the conservation project. Besides, another common form of degradation is the loss of material by eruptions due to the effects of plant roots growing on the walls, which necessitated intervention. There are also micro vegetation such as fungi, algae and lichens. However, as no clear adverse effects of them could be visualized and as removing them is a destructive process causing loss of material from the surface, it is proposed not to intervene on them at the moment, but to monitor their effects on the stone walls in time.

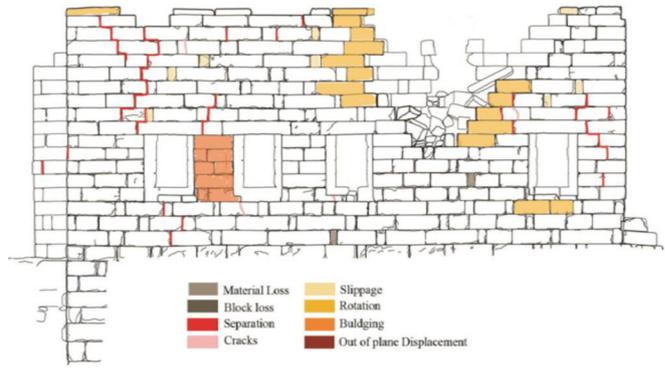
**Fig. 4 : Mapping of structural problems on south facade** (© METU, 2012).

The major conservation issue in *Andron A* is related to its structural stability. Thereupon, comprehensive understanding of the structural condition and of the structural damages became one of the major concerns and tracks of the project<sup>7</sup>. As the first stage of the structural studies, structural problems were detected during the site survey, which were then mapped on the measured drawings of the building. Accordingly, material loss, block loss, separation, slippage, rotation, bulging and out of plane displacement are the structural problems which can be visualized in *Andron A* (Fig. 4).

All these studies revealed that the main problem of the building is the out-of-plane movement under possible seismic forces acting in a north-south direction. The structural problems are mostly concentrated on the south wall, which is leaning towards the south. This leaning causes the separation of the two wall shells, which can be easily visualized through the recessed headers. There are also noticeable vertical cracks on the west wall and the back-wall of the *pronaos* due to the leaning of the south wall. In addition to this, on the upper part of the south wall a triangular area is totally destroyed. Moreover, a horizontal bulging at the base part of the south wall can be visualized. Considering the seismic sen-

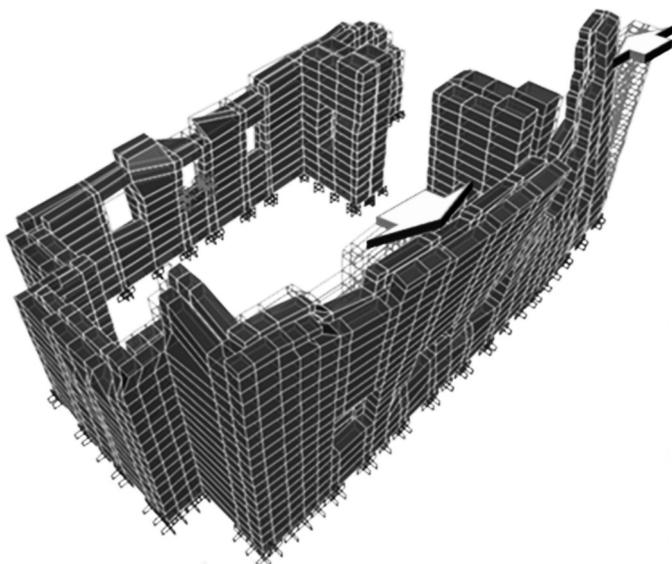
For further analysis and assessments of the structural behavior and problems of the building, a finite element model with a macro modeling approach was created based on the measured drawings (Fig. 5). The analysis over the model helped both understanding the current structural condition and behavior of the building as well as making projections about its future condition and behavior under different forces.

**Fig. 5 : Finite element model of Andron A**  
(© METU, 2012).

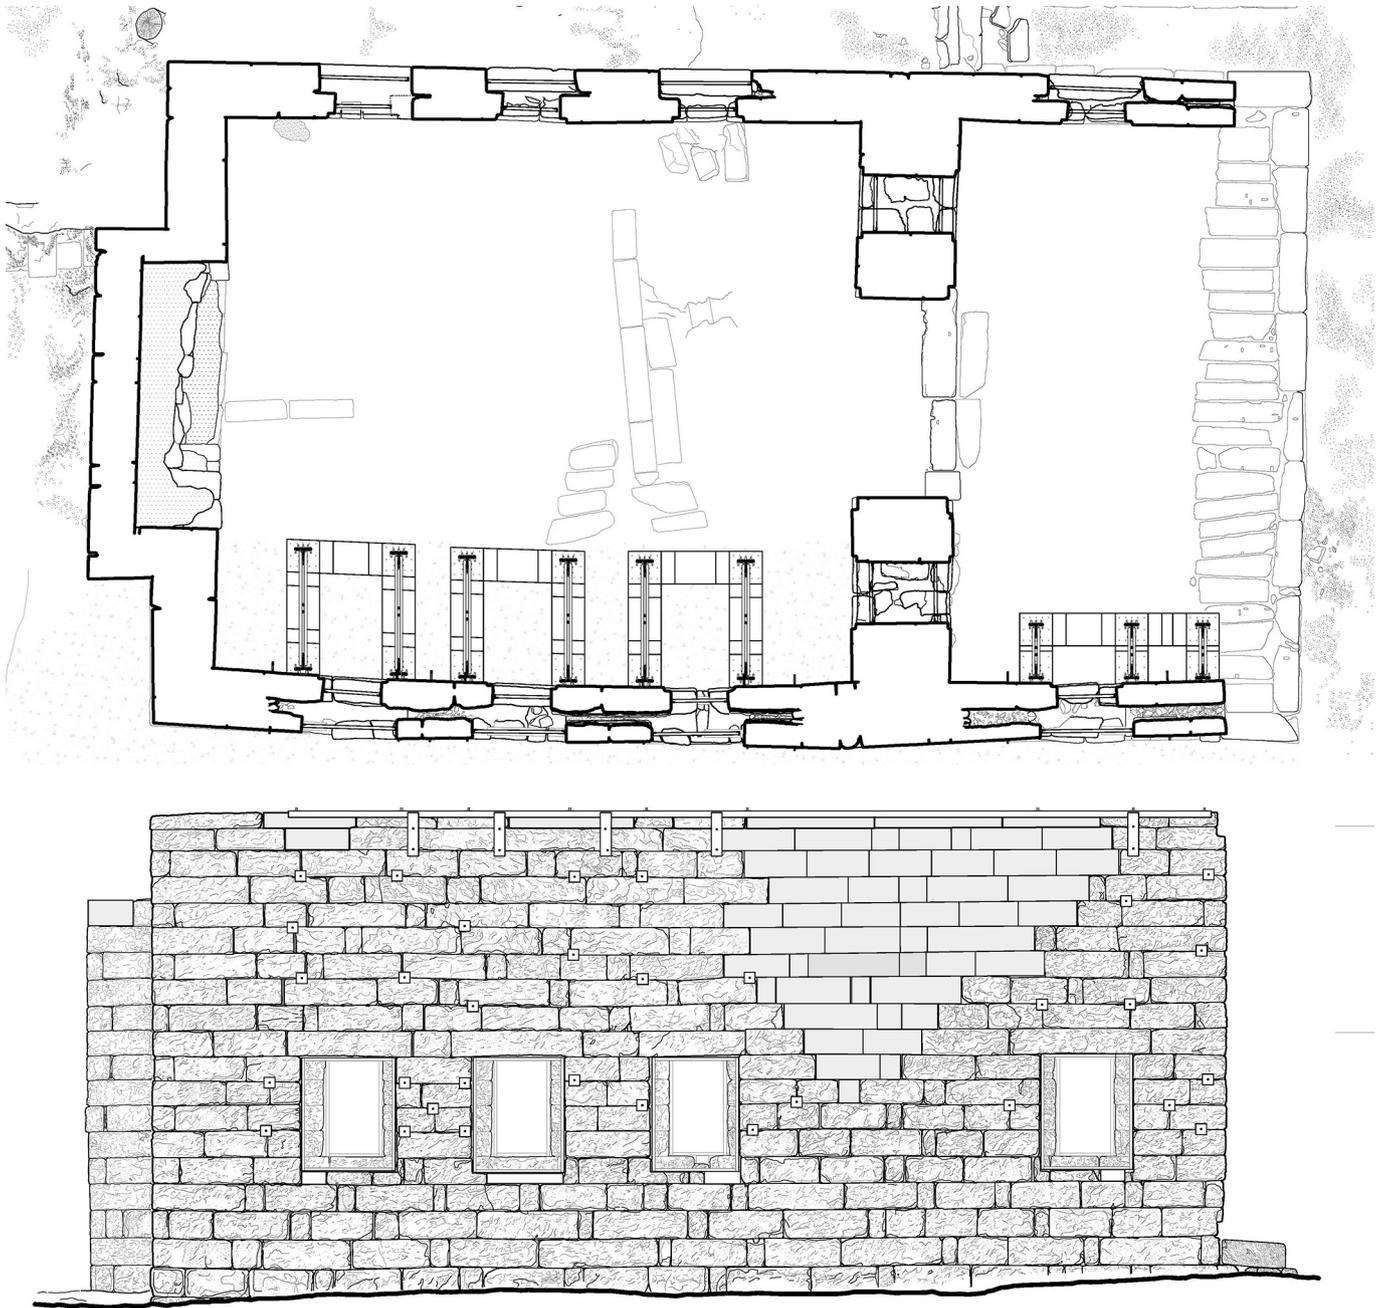
**Fig. 6 : The restoration drawings: plan and south facade (© METU, 2013).**

The assessment of all these alternatives denoted that none of them could totally fulfill all the defined conservation principles and criteria. Among all, the fifth alternative, which is strengthening with truss from the interior, is the most proper one. Therefore, the conservation project of *Andron A* is prepared according to this solution. The conservation project covered the restoration drawings as well as the presentation of the conservation interventions together

with their detailed descriptions and implementation processes (Fig. 6).

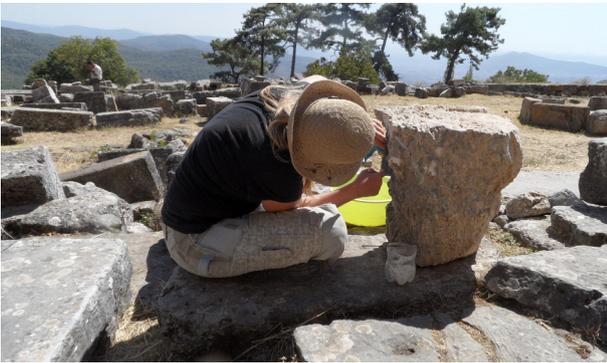
**Fig. 7 : Cleaning of a corinthian capital from the north Stoa** (photo : A. Freccero).

Conservation was concentrated to the North Stoa and the five Corinthian capitals of the colonnade that remain (Fig. 7). Two capitals had been prepared last year when they were treated with biocide, as was the large column drum at *Andron B* (Fig. 8). Two objects found in earth this year were cleaned and consolidated. One of these was a frail fragment of an anta capital, and the second was a large fragment of an architrave with inscription (inv. K81) at the South Propylaea. After being found and registered in 1949, the fragment had at some time fallen and been broken into two parts with the inscribed side in the earth. As the broken blocks were lifted the inscription was identified and placed to the left of the entrance of the gateway. A portion of the central part including some letters is missing (Fig. 9). A few minor rearrangements were made at the South Propylaea in connection with the replacement of the broken architrave. The first part of the left side of the architrave, inv. K4, was placed beside the inscribed part, and a fragment of the pediment positioned upon it. Further, the capital of the left anta was placed on an inscribed anta block, thereby approximately mirroring the arrangement on the right hand side, with the anta capital conserved in 2011.
