ERROR QUANTIFICATION IN CRACK MEASUREMENT OF BUILDING
MATERIALS USING TERRESTRIAL LASER SCANNING (TLS)

A THESIS SUBMITTED TO
THE GRADUATE SCHOOL OF NATURAL AND APPLIED SCIENCES
OF
MIDDLE EAST TECHNICAL UNIVERSITY

IN PARTIAL FULFILLMENT OF THE REQUIREMENTS
FOR
THE DEGREE OF MASTER OF SCIENCE
IN
CIVIL ENGINEERING

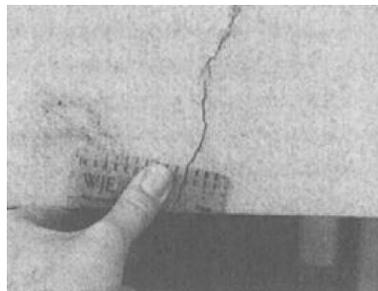
Figure 2.1. Manual Crack Measurement Using a Width Gauge (Farmer, 2004)

In practice, these specialists physically visit structures, inspect damage indicators in building components with naked eye, and gathers observational and quantitative data (The Applied Technology Council, 1998)(Figure 2.1) and (Figure 2.2 (a), and (b)).

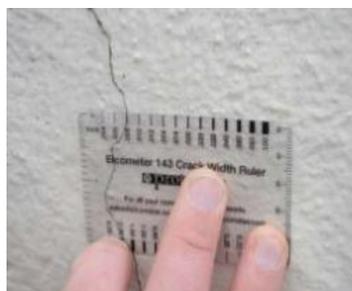
(a) Crack Width Measuring

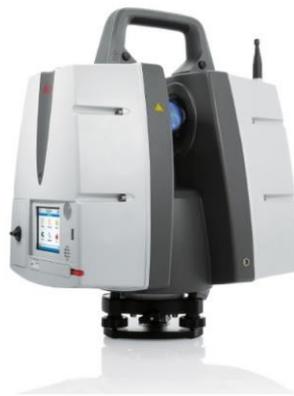
Figure 3.2. Leica ScanStation P40 (Leica Geosystems AG, 2018)

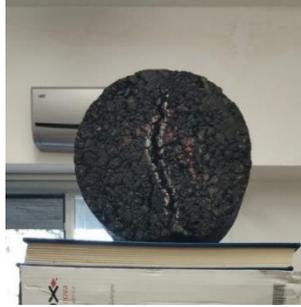
Figure 4.1. Cracked Asphalt Specimen

This case study is conducted in two stages. In both stages, the cracked pavement specimen given below in Figure 4.1 is scanned.

Before the sample is marked with white chalk, an initial scanning is carried out without markings; however, it is observed that it is not easy to make any measurements along the cracked line due to the absence of a contrast on the surface of the object. For this reason, first, the surface is marked with white chalk to create a contrast, then the rest of the experiments are carried out.

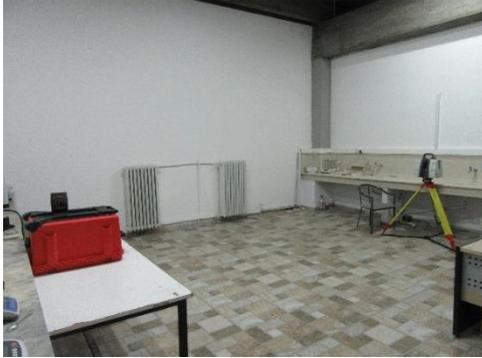
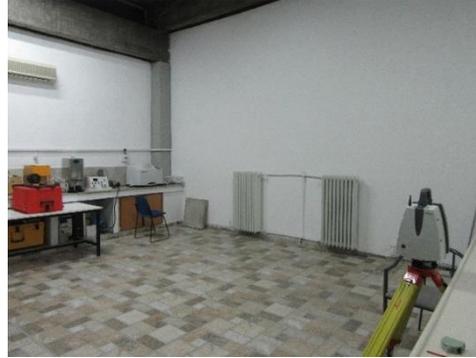
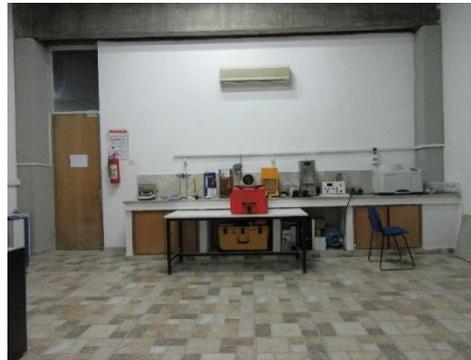
Figure 4.3. Test Atmosphere in Case Study-1, Stage-1

(a) View from the Room Entrance

(b) View from the Other Edge

(c) View Through the Entrance

After the parameters are decided, a test environment is designed based on the needs, and the test setup is established. While deciding on the test environment, particular attention is paid to the conditions of accessibility to the planned maximum data acquisition distance and the stability of the ambient light of the atmosphere. Consequently, the tests are carried out in an isolated room with a 6x6 m settlement area, illuminated by constant lights.

The corresponding test atmosphere and the experimental setup are demonstrated in Figure 4.3 (a), (b), and (c) and Figure 4.4, respectively.

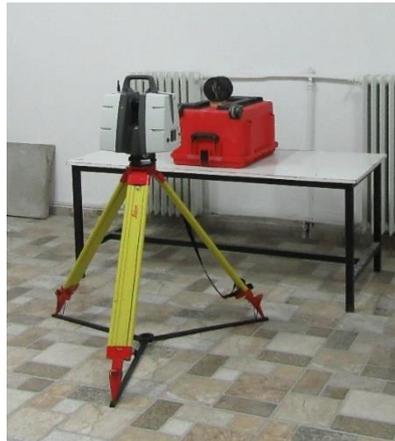
Figure 4.4. Experimental Setup in Case Study-1, Stage-1

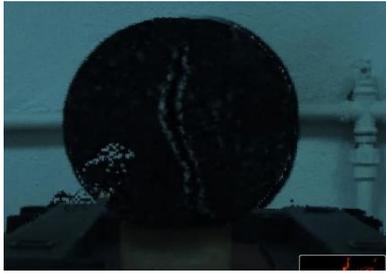
(a) Color from Scanner

(b) Hue/Intensity Map Color

Figure 4.5. Representative Change in Colors in Case Study-1, Stage-1

1. Importing of each scan data in Leica Cyclone Register 360
2. Optimization of the cloud color by changing the color setting to the Hue/Intensity map. This modification regulates the visual representation of the points according to their normal directions, with different colors. Thus, it eases the selection of the edge points and increases the accuracy of the measurement. The representative change in the view is shown in Figure 4.5 (a) and (b)
3. Selection of crack edges by providing the maximum amount of zoom-in view
4. Measurement of the distances between the chosen points using the software's distance measuring tool

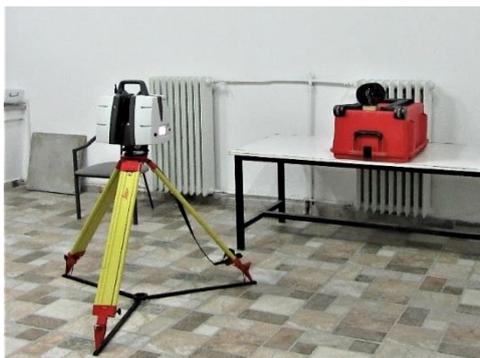
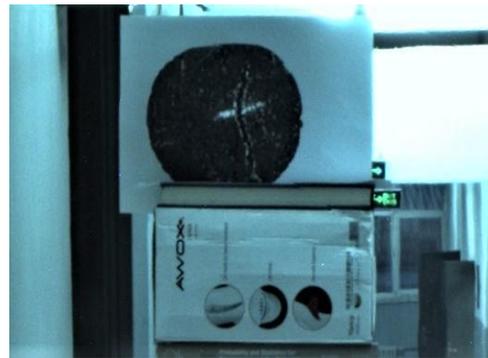
(a) Sample position in Case Study-1, Stage-1

(b) Sample position in Case Study-1, Stage-2

Figure 4.6. Sample Positions in Case Study-1

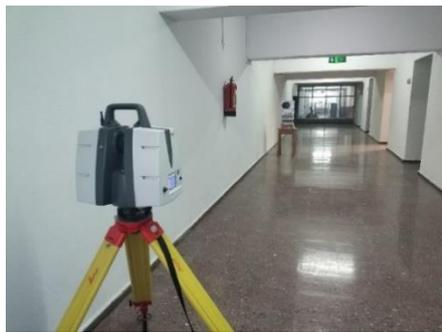
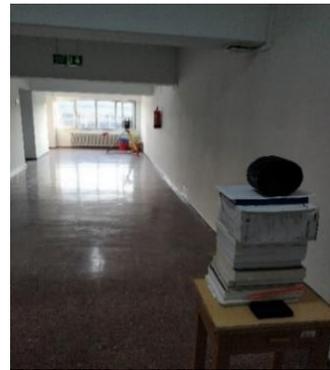
Figure 4.7. Test Atmosphere in Case Study-1, Stage-2

(a) View from the Laser Scanner (b) View from the Object

After deciding on the parameters, the test setup is established. The need for a wide area to scan the object is eliminated by the modified method on the incidence angle. A long and relatively narrow corridor with fixed lighting is chosen as the experiment environment to reach up to the maximum scanning distance easily.

The corresponding test atmosphere and the experimental setup are demonstrated in Figure 4.7 (a), (b).

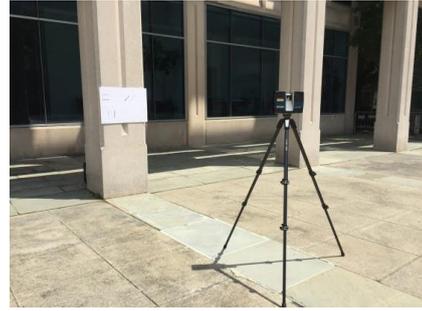
(a) Foam Board for Cracks Simulation

(b) Scanning Set-up

Figure 4.9. The Experiment Setup (Shi & Ergan, 2019)

As illustrated in Figure 4.9 (a) below, the researchers simulated the cracks with different dimensions by cutting the white foam board manually and prepared the related testbed as given in Figure 4.9 (b). They used the Faro Focus S150 terrestrial laser scanner for data acquisition. Furthermore, they used a digital caliper for measuring the ground truth values of the crack dimensions and used a laser meter for arranging the scanning distances Figure 4.10 (a).

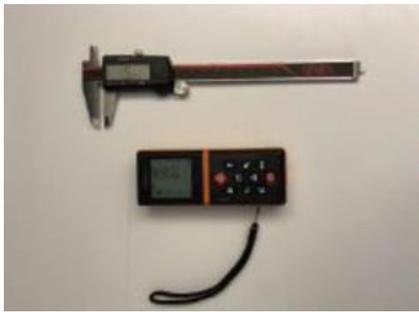
(a) Digital Caliper & Laser Distance
Meter

(b) Measurement in
Point Cloud Processing Tool

Figure 4.10. The Measurement Process (Shi & Ergan, 2019)

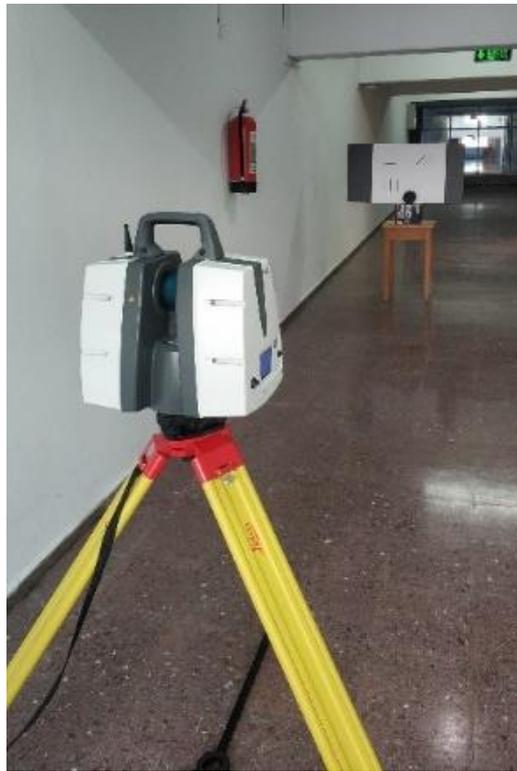
Figure 4.13. The Experiment Setup in Case Study-2

Later, the experiment setup is installed, as demonstrated in Figure 4.13. During the installation, the laser scanner is calibrated, and then the target setup is located accordingly. To verify the values designed for scanning distances, both the laser scanner's built-in distance measurement tool and laser distance meter are used.

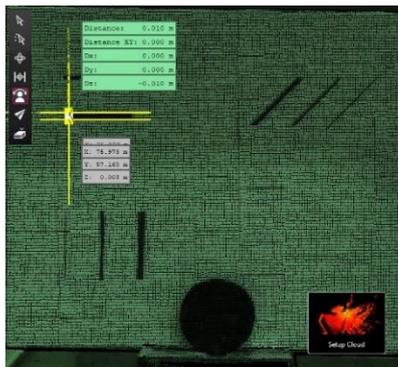
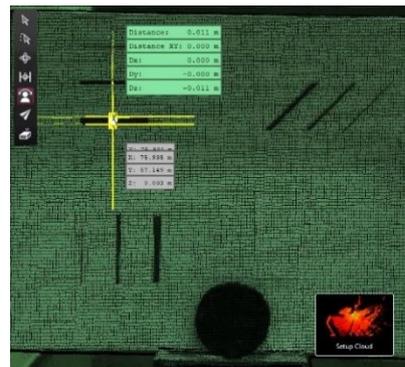
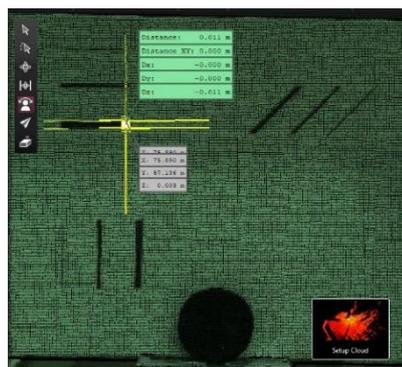
(a). Left End (10 mm)

(b). The Middle (11 mm)

(c). Right End (11 mm)

point throughout the dimensions is chosen as a point of interest, and five repetitive measurements are taken via digital compass at that place. Then, these repetitive measurements are averaged to obtain a final measurement value for each dimension as given in Table 4.13. The purpose of this process is to minimize the error caused by manual measurement on the foam board.

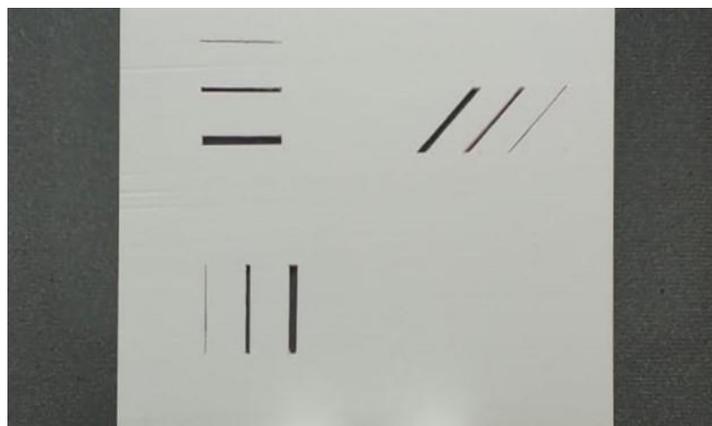
Figure 5.3. Foam Board Specimen*

*The ground truth values of the specimen's crack widths are given in Table 4.13 in Chapter 4.

Subsequently, two test setups are established. In the first setup, a foam board specimen, which is previously scanned in Chapter 4, is used, as shown in Figure 5.3. In the second one, the RC specimen showed in Figure 5.4 is scanned.

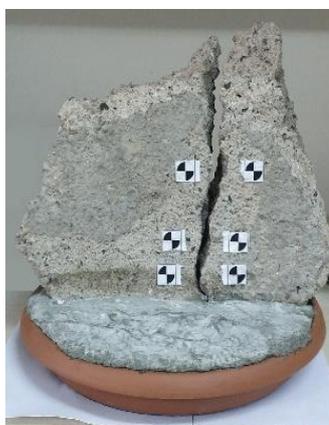
Figure 5.4. Labeled RC Specimen*

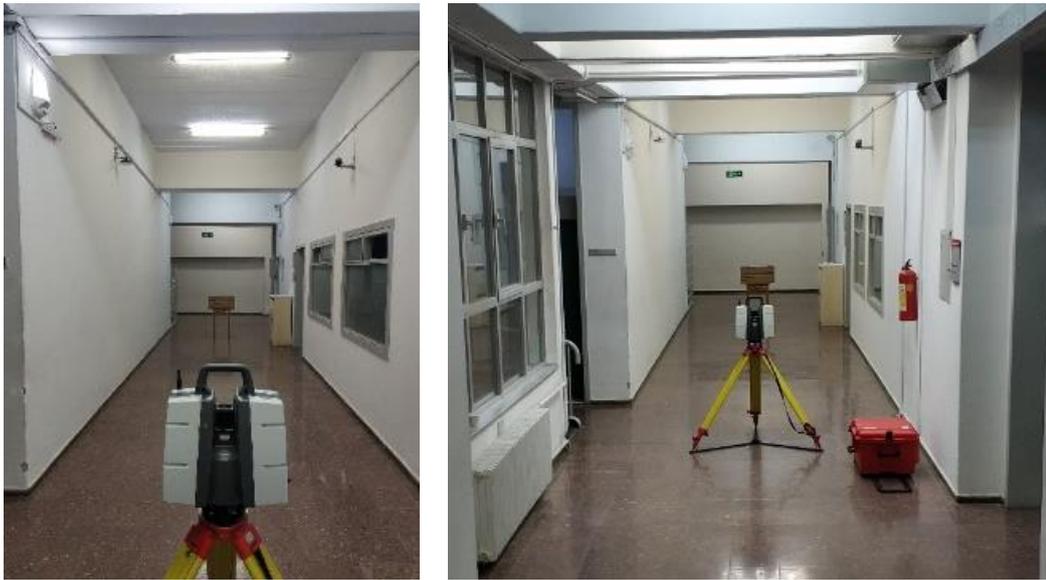
(a) A Closer Look

(b) View from a Distance

After deciding on the positioning method to be utilized, the test environment should be selected appropriately. It is essential because of two conditions; (1) the area must

be free of human action, and the illumination conditions must be constant throughout the scans to reduce the level of noise in the scan data, and (2) there should be enough space to reach 10 m as the maximum scanning distance. The experiments are carried out in a long corridor, illuminated by constant lightning. In this way, the first condition is satisfied. Moreover, particular attention is given to prevent human action while performing scans. The corresponding test atmosphere and the experimental setup are demonstrated in Figure 5.8 (a) and (b).

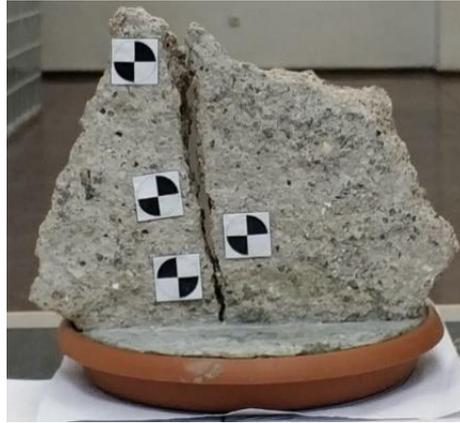
Figure 5.9. RC Specimen Used in Case Study-1*

In this case study, the RC specimen given in Figure 5.9 below, is scanned multiple times with predefined scan settings that will also be used while scanning other building materials.

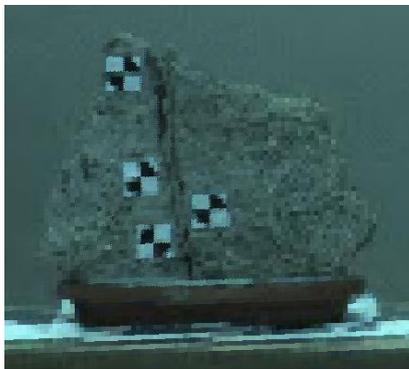
(a) Color from Scanner

(b) Hue/Intensity Map Color

1. Import each scan into the software.
2. Optimize the cloud color by changing the color setting to the Hue/Intensity map. This modification regulates the visual representation of the points according to their normal directions, with different colors. Thus, it eases the selection of the edge points and increases the accuracy of the measurement. The representative change in the view is shown in Figure 5.10.
3. Select the two edges of each crack in the object by providing the maximum amount of zoom-in view.
4. Measure the distances between the chosen points using the software's distance measuring tool with a 2-decimal place precision.

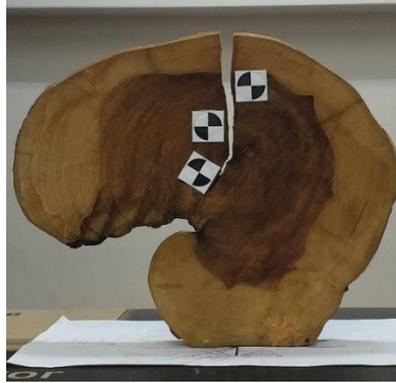
Figure 5.12. Wooden Specimen Used in Case Study-2

In this case study, the wooden specimen given in Figure 5.12 is scanned multiple times following the same scan settings used in the previous section.

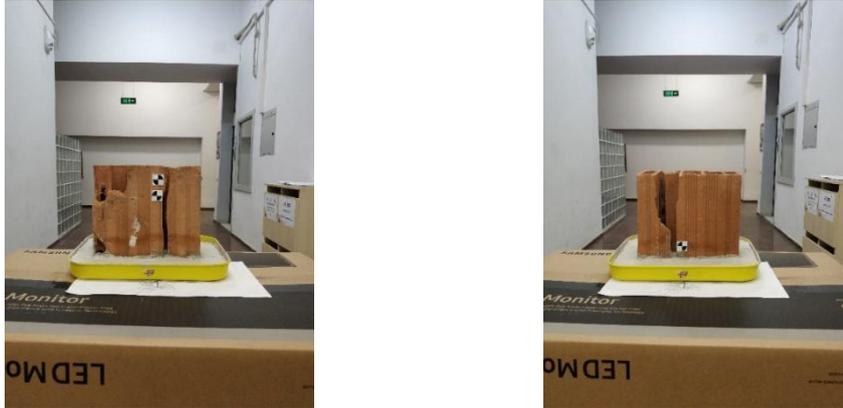
(a) Front Face of the Specimen

In this case study, the masonry brick specimen given in Figure 5.14 is scanned multiple times following the same scan settings used in the previous case studies.
