## Traditional Dwellings of GÖlde (İNCESU): A Rural Heritage in the Process of Change

Esra Eken & F. Nurşen Kul

To cite this article: Esra Eken & F. Nurşen Kul (2021) Traditional Dwellings of GÖlde (İNCESU): A Rural Heritage in the Process of Change, Vernacular Architecture, 52:1, 41-62, DOI: [10.1080/03055477.2021.1981593](https://doi.org/10.1080/03055477.2021.1981593)

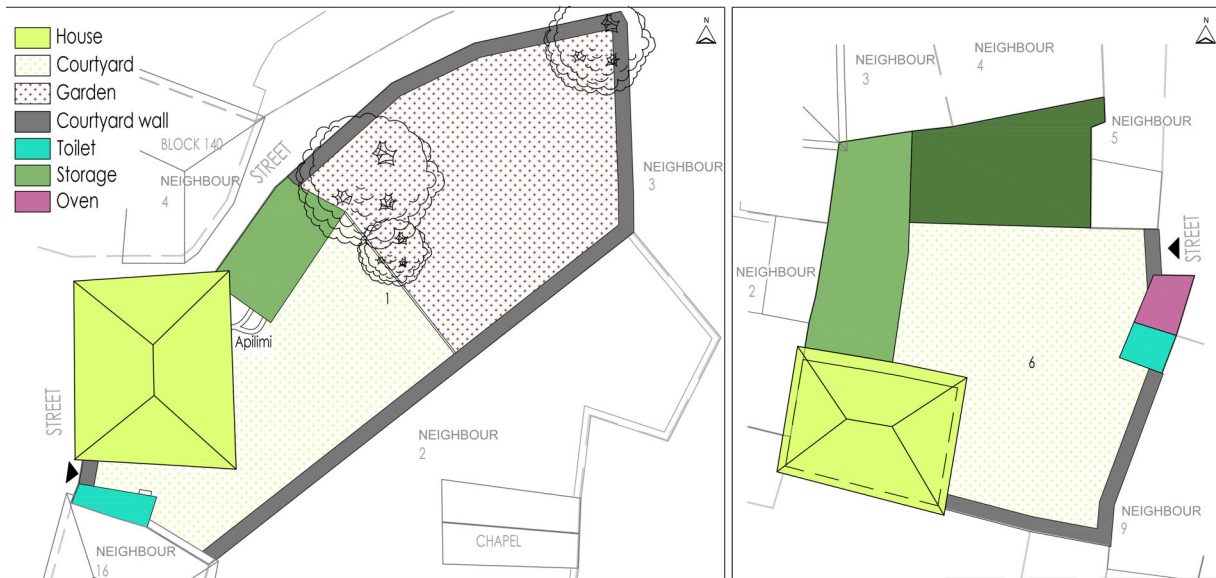
Figure 6. Reconstructed drawings of two dwelling units. DB's dwelling in the Rum neighbourhood (left) and IB's dwelling in the Turkish neighbourhood (right).

Traditional dwelling units in Gölde were situated on large lots due to the need for privacy and the requirements of the agricultural economy. Each lot was surrounded by high stone masonry walls to prevent direct vision from the street. In addition to the two- or three-storeyed residential houses, several other service spaces were located within the lots, such as storage for agricultural products, stables, hay barns, poultry houses, toilets and ovens. The open spaces within the lot formed the courtyard. In some dwellings, a garden was also present (Fig. 6).

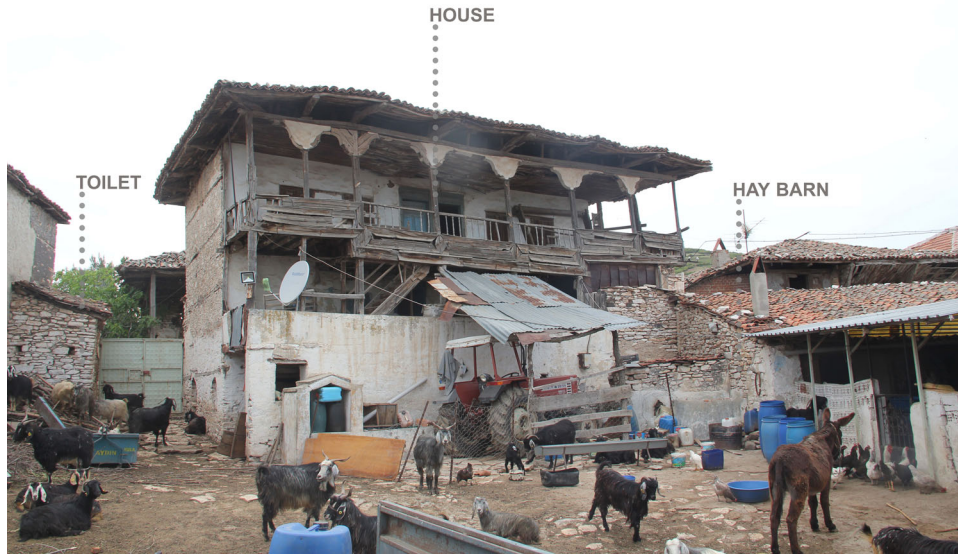
Figure 7. DB's dwelling unit. The unit comprises the house, various service buildings and the courtyard. The stable, hay barn, toilet, poultry houses and storage spaces in the courtyard are visible. The courtyard serves as an open shelter for the sheep and chickens during the daytime.

Today, agricultural vehicles such as tractors and *patoz* (threshing machines) are also kept in the courtyards. These vehicles are housed under cover to protect them from the rain. Except when grazing, and at night, the sheep and poultry were free to roam in the courtyard during the day (Fig. 7).

The toilets were generally attached to the street-facing wall of the courtyard (Fig. 7). Locals stated that this location was chosen so that sewage could be drained from the street at specific time intervals.<sup>25</sup>

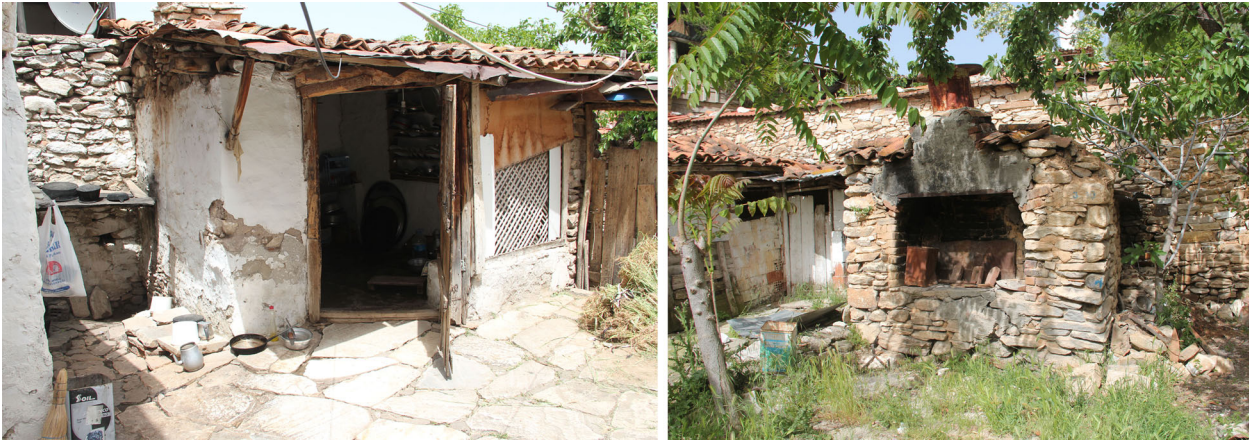
Figure 8. Kitchen in the courtyard of the RG's family (left) and an oven in a dwelling unit (right).

In traditional dwelling units, the kitchen was generally a separate service building in the courtyard. However, only one kitchen building can be observed in Gölde today (Fig. 8, left). It is found in the courtyard of RG's house which is described by the current landlords as a Rum house. The landlords believe this to be the original kitchen.<sup>26</sup> The fact that the building

Ovens were also commonly observed in the courtyards (Fig. 8, right). Though ovens can be found in many of the lots at present, interviewee DB stated that, in the past, not every family had their own oven. Instead, they used the ovens of their neighbours to make bread.<sup>27</sup> Additionally, according to interviewee OG, the construction of the original ovens was different from that of the current rectangular ovens. Since no original ovens were found during the fieldwork, OG explained the technique used to construct them:

Ovens were only built by first generation stonemasons. We cannot construct them. Firstly, a rectangular stone platform was constructed. Then, a semi-circular wooden framework was made, and flagstones were aligned vertically around the framework by placing them like upside-down steps that hung 1.5cm-2cm above the ground on the inside, forming an arch. In the final step, the keystone was placed between two stones at the top of the oven.<sup>28</sup>

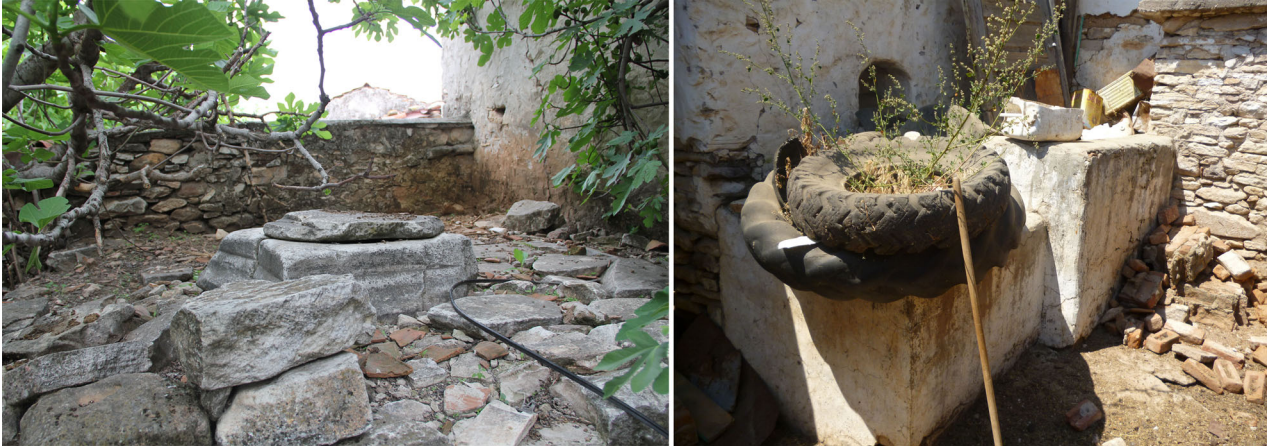
Figure 10. A well to store rainwater in the courtyard of a house (left) and an apilimi attached to the courtyard wall of another house (right).

Other distinctive elements in the courtyard were identified in some houses. These included a number of private water wells (Fig. 9). These wells were slightly elevated from the ground and covered with a metal cover or a stone (Fig. 10, left). Although Rum interviewees emphasised that the Turkish name for these wells was *sarnıç*, the current locals called the wells *mahzen* and they believed that the main function of the *mahzen* was the storing of wine for fermentation. Thus, the current locals attributed the existence of a

There were no fountains in Gölde, we drank water from the wells in the square and on the roads. However, some houses had wells that collected rainwater. They were embedded and covered in the courtyards of the houses. Their walls had been robbed. We would take the water out of the bucket, and it was used for cleaning and cooking.<sup>29</sup>

Also associated with the Rum community were two interconnected stone pools that were attached to the inner courtyard walls (Fig. 9, indicated as A). This element was called an *apilimi* (Fig. 10, right) and it was used to obtain grape juice. After crushing the grapes within the first pool, the grape juice flowed into the other pool from the hole in the base of the first. Only two examples were found during our survey (Fig. 9).

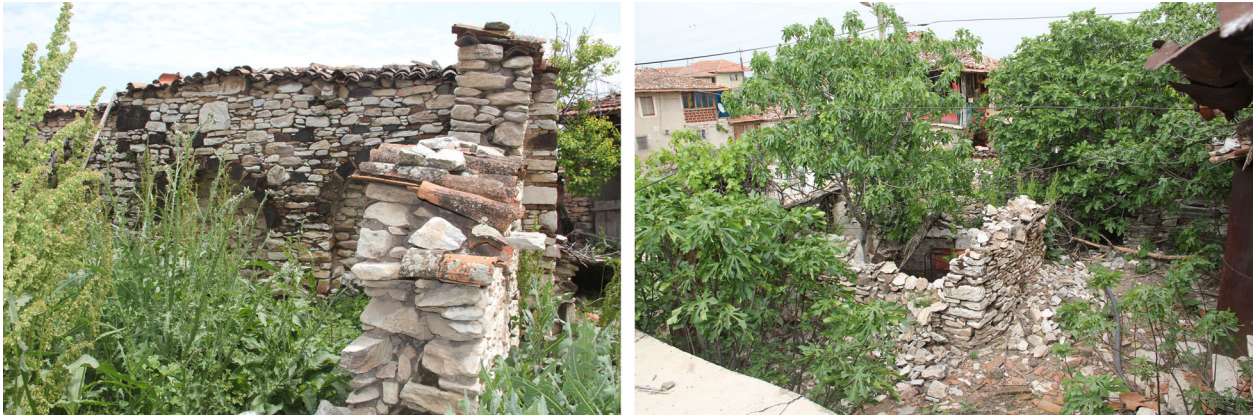
Figure 11. Ruined walls in two dwelling units located within the Rum neighbourhood.

The last distinctive structures were the ruined walls within the courtyards of some of the houses that included specific architectural elements, such as niches or earthen pipes within the walls (Fig. 11). Current locals, EC, İM, HU and İG, emphasised that, while some Rum families had commercial lands in the north part of the settlement, others used the ground floor of their houses, or a building within their courtyard, for commercial activities.<sup>30</sup> Thus, these ruined walls may have belonged to former shop buildings. The fact that such walls are only seen in the houses located in the Rum neighbourhood strengthens this argument (Fig. 9, indicated as S).

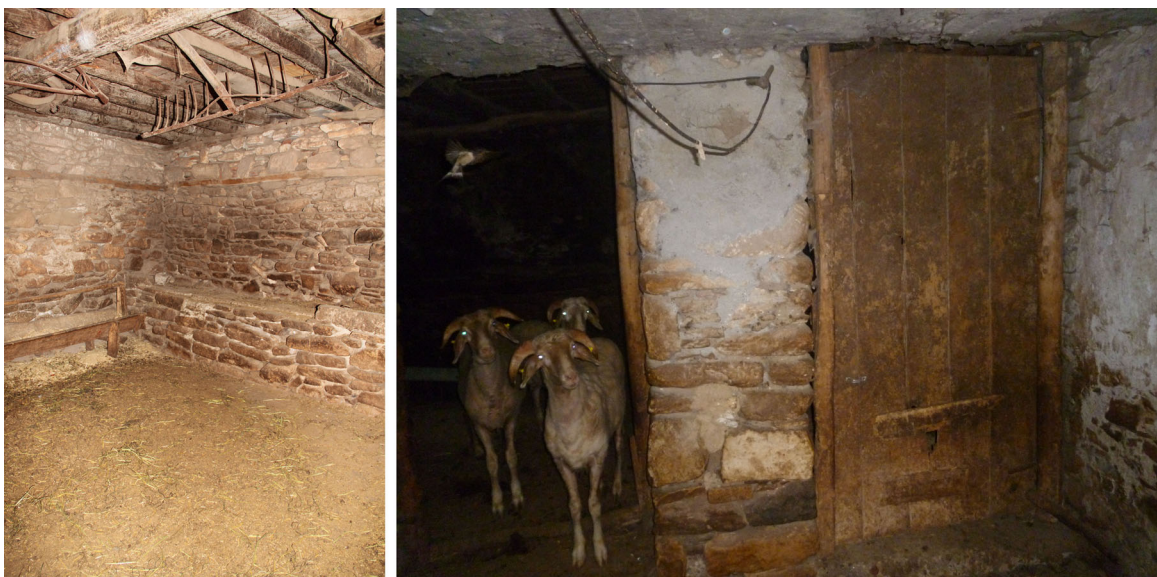
Figure 12. Stable of a house and the low stone masonry platform (tabla), on one side of the stable.

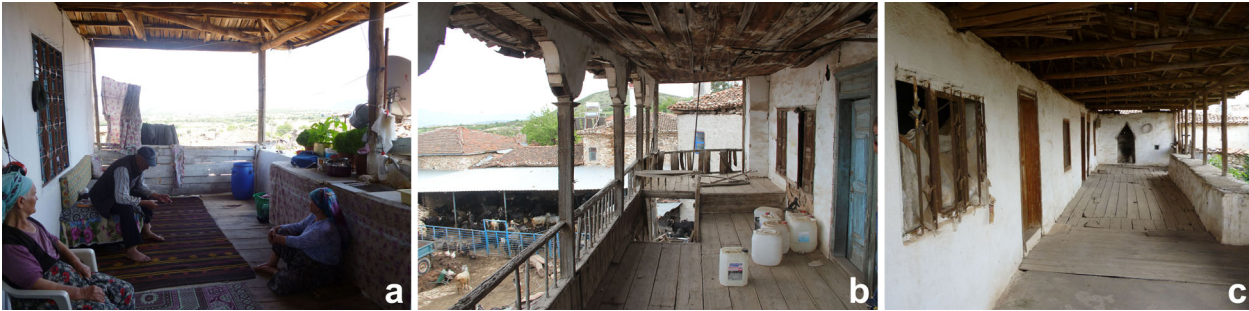
Figure 13. (a) a sofa used for a family gathering, (b) a sofa including *seki* (raised platform) and (c) the sofa of an abandoned house including fireplace.

Most houses included a semi-open outer *sofa* which was open to the courtyard on one side, with the rooms positioned at the other side (Figs 13 and 14). In the Gölde settlement, 80 of 90 houses studied were designed with an outer *sofa* and they were distributed evenly throughout the settlement (Fig. 9). This typical plan form is generally called a 'Turkish House'.<sup>32</sup> However, the uniform distribution of this plan type in Gölde, housing both Turk and Rum inhabitants, shows that there is no obvious difference in the way in which living space was used between these two ethnic groups.<sup>33</sup>

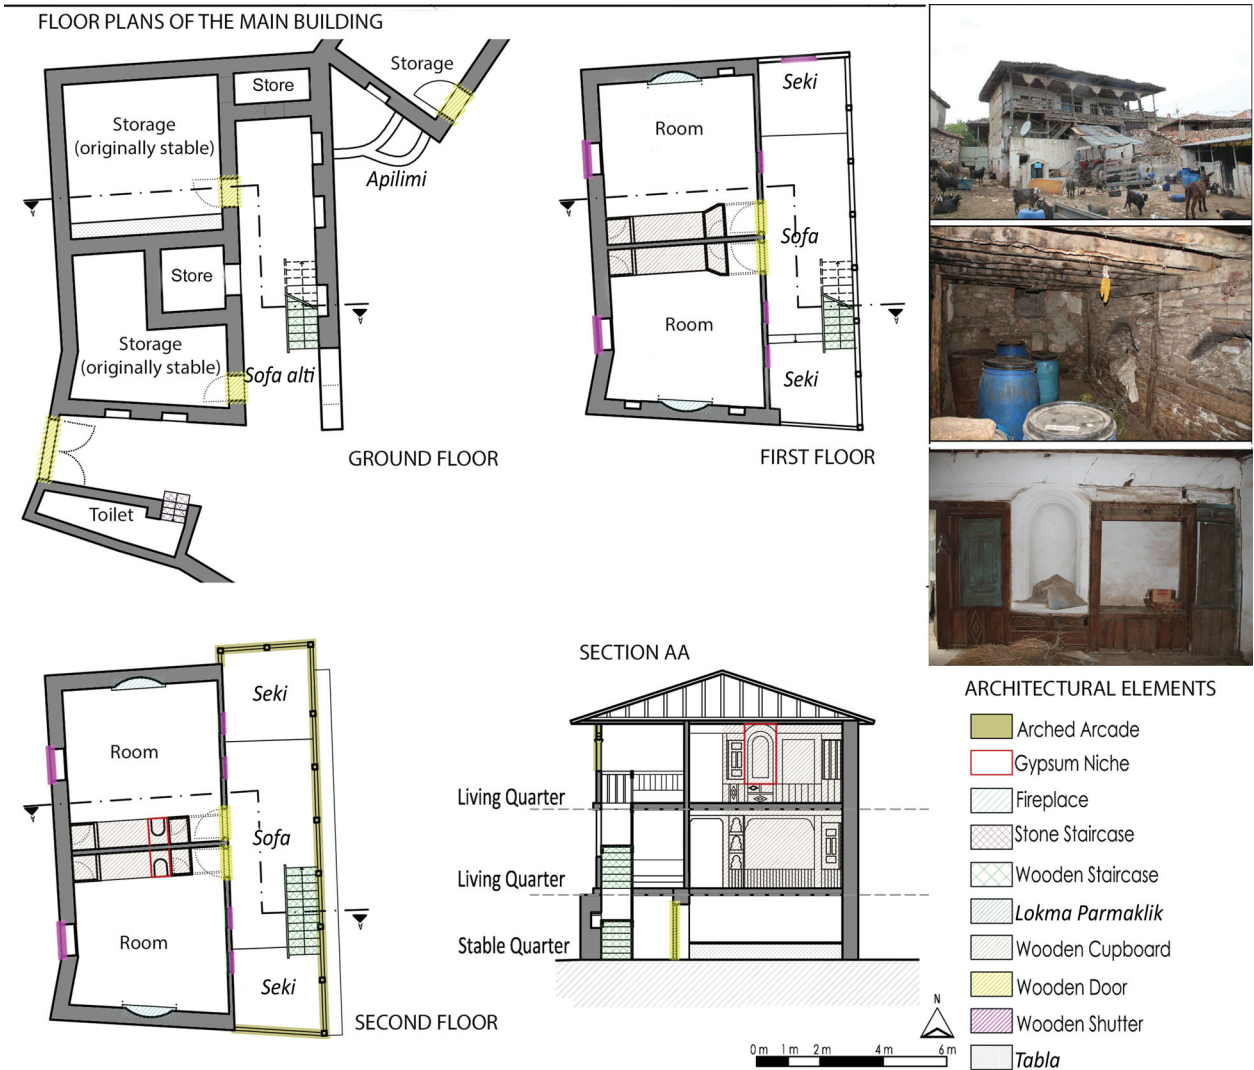
Figure 14. Reconstructed drawing of DB's house, which had a plan type that included an outer sofa (indicated as P1 in Fig. 9).

In 77 of the 80 houses that had a plan type with an outer *sofa*, the facade with the *sofa* was the main elevation facing the courtyard (Fig. 14). The house was entered through the courtyard, which served as a privacy barrier between the house and the street. Only three of the houses that included an outer *sofa* had the main facade facing the street, with an entrance to the house that was directly from the street. In these three houses, the entrance door opened into an area called

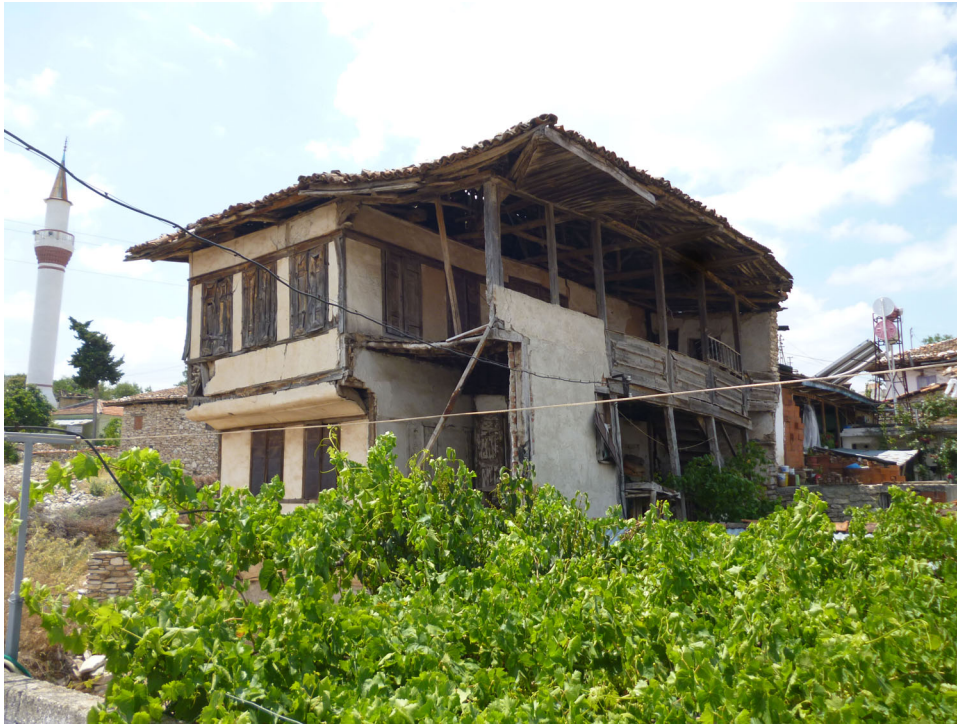
Figure 15. The house that has projection towards the street.

*taşlık* on the ground floor of the house which provided access to the courtyard and upper floors.<sup>34</sup> While all three houses were located in the Rum neighbourhood, one of them was differentiated from the others because its main facade had projections towards the street on both floors (Fig. 15). In this way, the living space was enlarged, and a direct view of the street was provided with the windows located at the projection (Fig. 15).

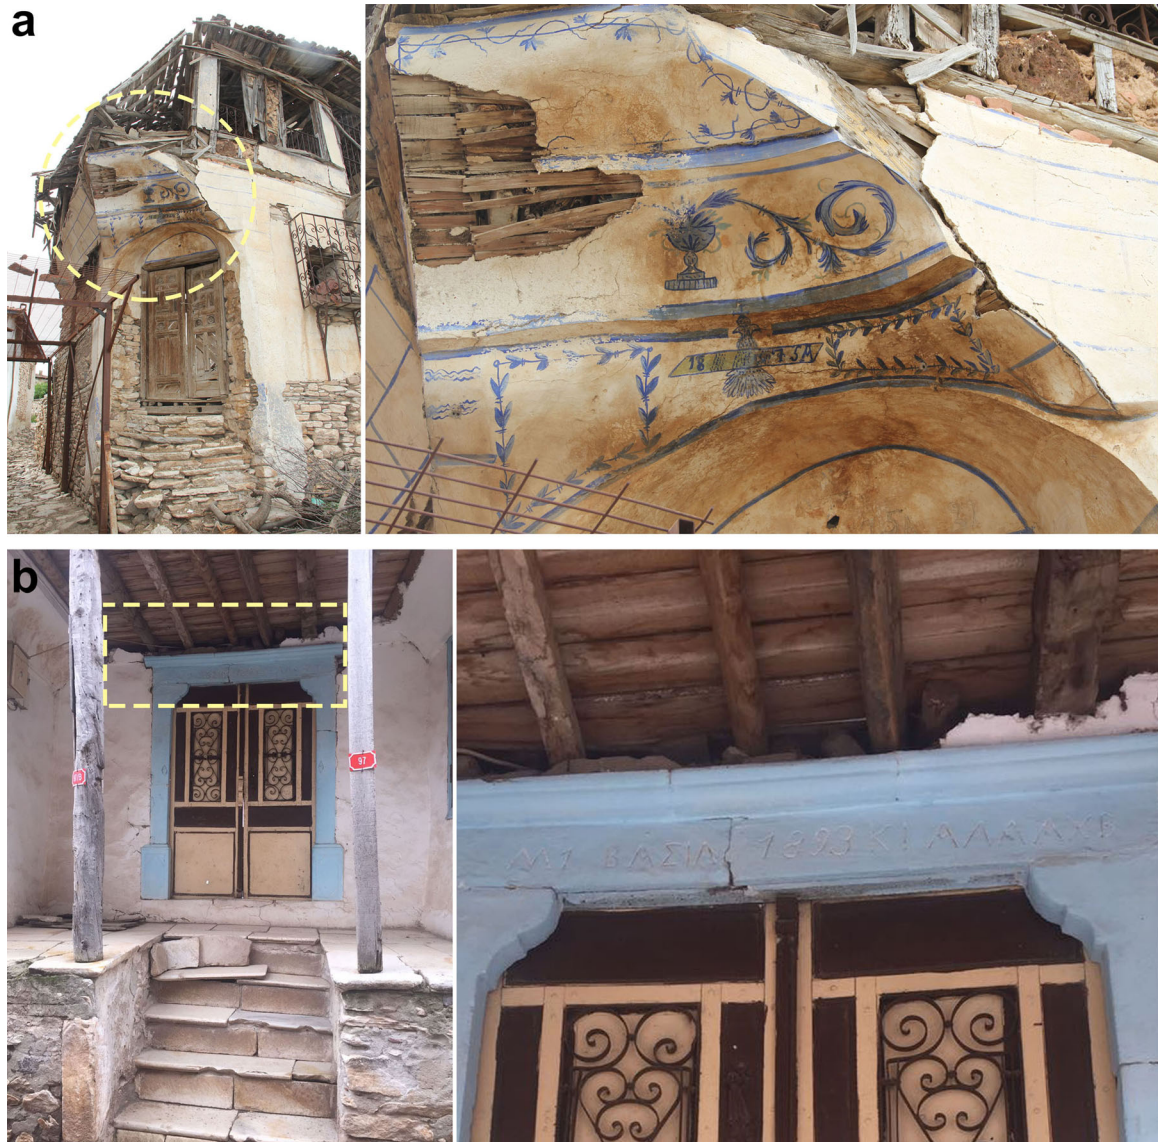
Figure 17. (a) Gölde Evi, located in the village square, with the inscription and hand-drawn ornamentation above the entrance door, and (b) ME's house, which has an entrance from the street directly through a marble staircase and precast iron door.

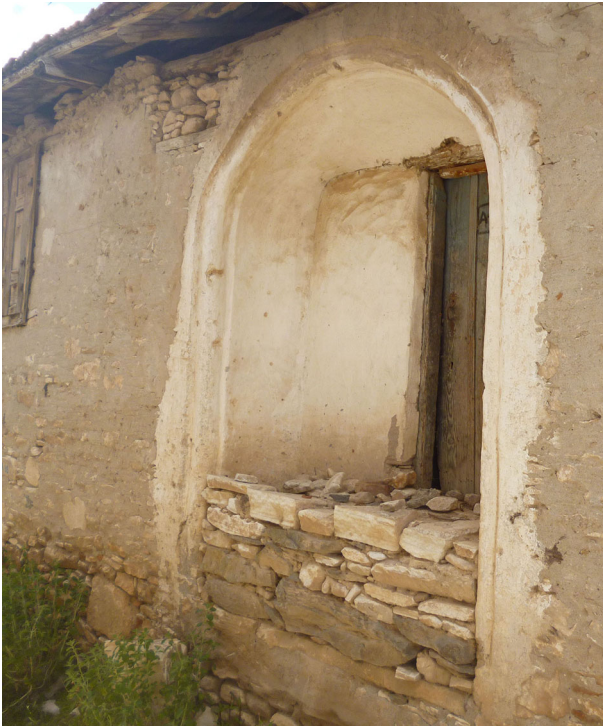
Figure 18. A house that had an arch-shaped entrance on the street facade.

Among the houses that had this plan type, three reflect some western influences. They had westernised entrances that included marble staircases starting at the street level (Figs 9, 17 and 18). Two were located around the village square and had Greek inscription panels that indicated construction dates as 1875 and 1893 (Fig. 17). One of them, *Gölde Evi* (Gölde House) that was constructed in 1875, also had hand-drawn ornamentation above the entrance door (Fig. 17, a). ME's house, constructed in 1893, had a precast iron entrance door in addition to a marble staircase (Fig. 17, b). Another house was located in the northern part of the settlement that had an arched entrance above street level (Fig. 18). Although there is no staircase at present, traces of this could be observed. All three of these houses were located in the Rum neighbourhood (Fig. 9).

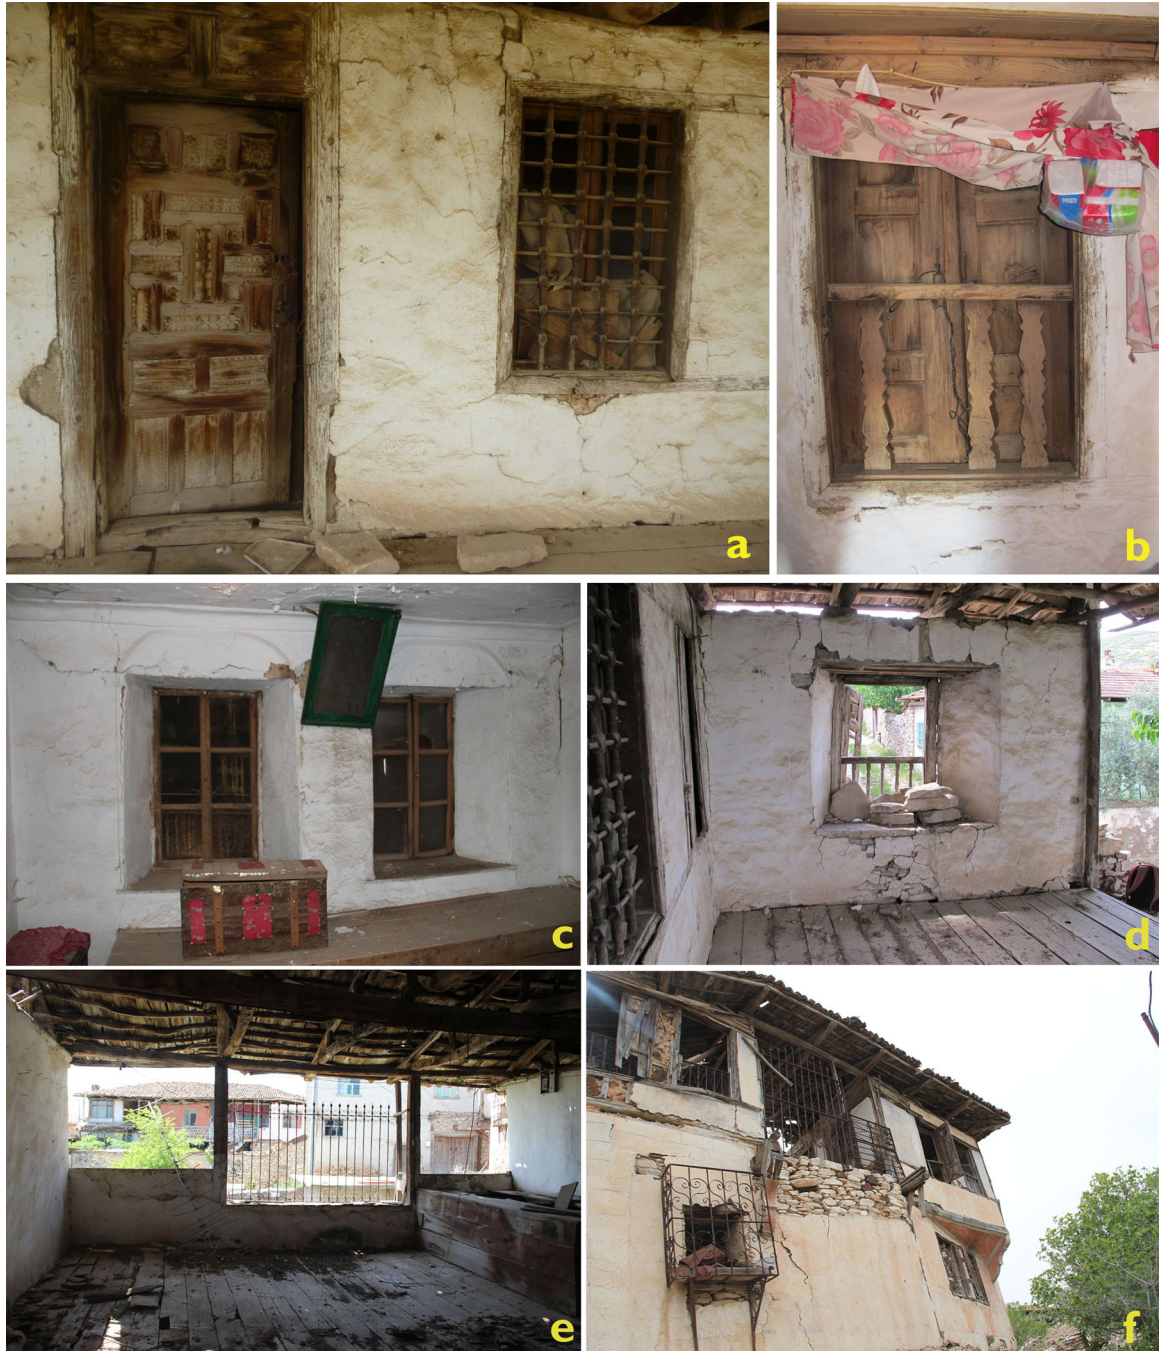
Figure 20. (a) Single-leaf wooden door and lokma parmaklık in the window opening, (b) wooden shutter and balustrade in the window of a room, (c) double-glazed casement windows in a room of RG's house, (d) wooden shutter and balustrade in a sofa window, (e) iron railing in iwan of HÇ's house, (f) iron railing in iwan and window in Gölde Evi.

geometric figures. Sunlight entered the house through the *sofa* and through window openings. The window openings of the houses of Anatolian towns only consisted of wooden frames and shutters until the nineteenth century.<sup>36</sup> This can still be seen, especially in the abandoned houses (Figs 15 and 20, b and d).

Other sub-elements of the windows were *lokma parmaklık* (barred grills), balustrades and iron railings (Fig. 20).<sup>37</sup> *Lokma parmaklık* and wooden balustrades were found in the majority of houses that were observed internally in both neighbourhoods (Fig. 20, a, b and d). However, iron railings on the windows or *iwan* were observed only in three houses, all of which are located in Rum neighbourhood (Fig. 9). Çil claimed that these iron railings on the buildings were a later addition, which were added with the purpose of protection from attacks during the tense period

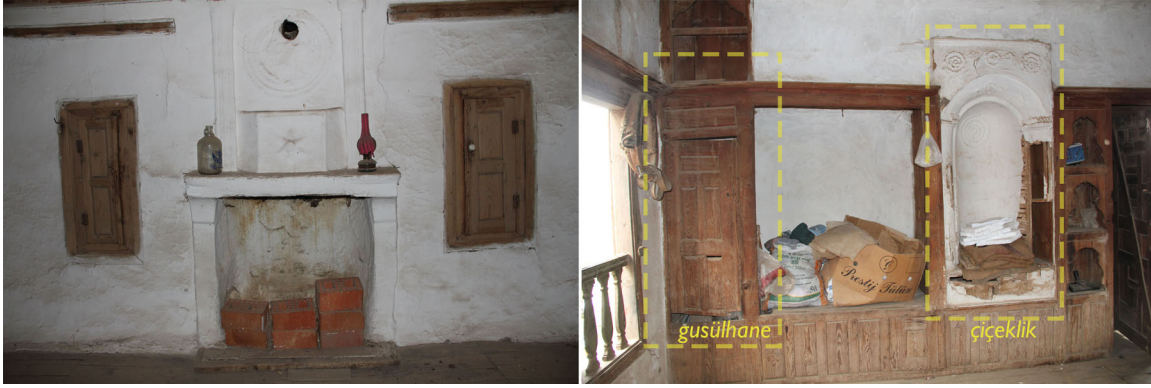
Figure 21. Fireplace with two embedded cupboards (left); gusülhane and çiçeklik in wooden cupboard in the room of a house located in the Rum neighbourhood (right).

activities of the families.<sup>40</sup> Each room on the first floor of the house was assigned for the nuclear family of a married son of the houseowner. Therefore, as many families could live in a house as there were rooms on the upper floor(s). The rooms were used as living rooms during the day and comprised timber seating elements (*sedir*) which were elevated nearly 60 cm from the floor. These rooms were transformed into bedrooms at night by laying down mattresses which were stored in the cupboards (Fig. 21).

The fireplace was located in the exterior wall and provided warmth and cooking facilities (Fig. 21, left). An embedded wooden cupboard could be located on each side of the fireplace, and wooden cupboards might also be found in the partition wall between the rooms. Additional spaces for flowers (*çiçeklik*) and for bathing (*gusülhane*) might also be found along this wall (Fig. 21, right). Warm water was transported to the *gusülhane* using water cans and dirty water was drained to the street through a hole on the floor of this space. A *gusülhane* was observed in the majority of those houses examined, in both neighbourhoods.

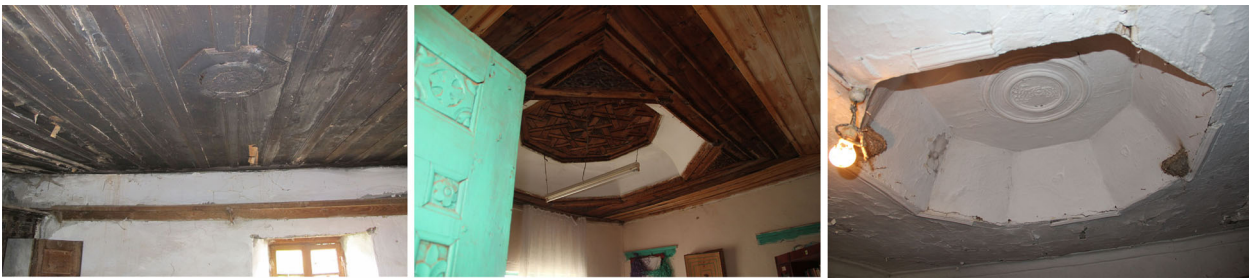
Figure 22. Protruding tavan göbeği (left), embedded tavan göbeği covered with wooden elements (middle) and embedded tavan göbeği covered with plaster and whitewash (right).

*göbeği*. This ornamental feature was located at the centre of the ceiling and was either octagonal or rectangular (Fig. 22). Some scholars suggest that *tavan göbeği* reflects an old Turkish (shamanic) belief.<sup>41</sup> According to this belief, *tavan göbeği* is located in the centre of the sacred space, which is the projection of the universe on earth, and is an echo of earlier traditions in which the smoke outlet in a dwelling was directly facing the pole star.<sup>42</sup> However, Asatekin claims that *tavan göbeği* only reflects the higher status of the room, as well as the

observed in one of the rooms of RG's house, in the Rum neighbourhood (Fig. 22, right). In this case, the ceiling included *tavan göbeği* and it was completely covered with lime plaster and whitewash. Additionally, it included a grape figure within the circular ornamentation, which was made of gypsum.

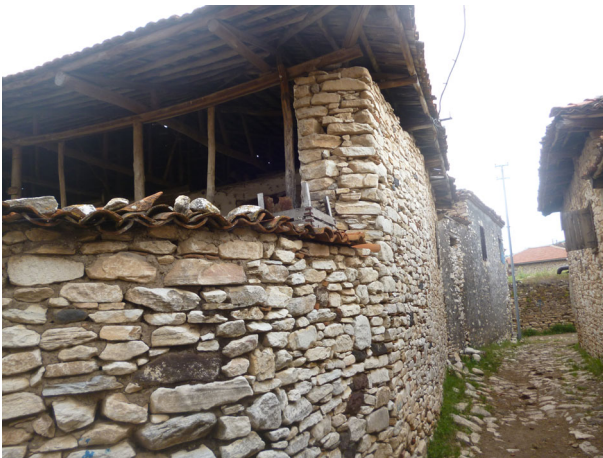
Figure 23. Roads bordered with thick stone masonry walls of the houses and courtyards.

In the majority of the houses, the exterior walls were not rendered (Fig. 23). Internally, walls were covered in a double-layer plaster that comprised a thick layer of mud plaster and a fine layer of lime plaster (Fig. 24, a).<sup>45</sup> The mud plaster was obtained by mixing yellow sand with water and adding straw into the mixture (Fig. 24, b). The lime plaster was created

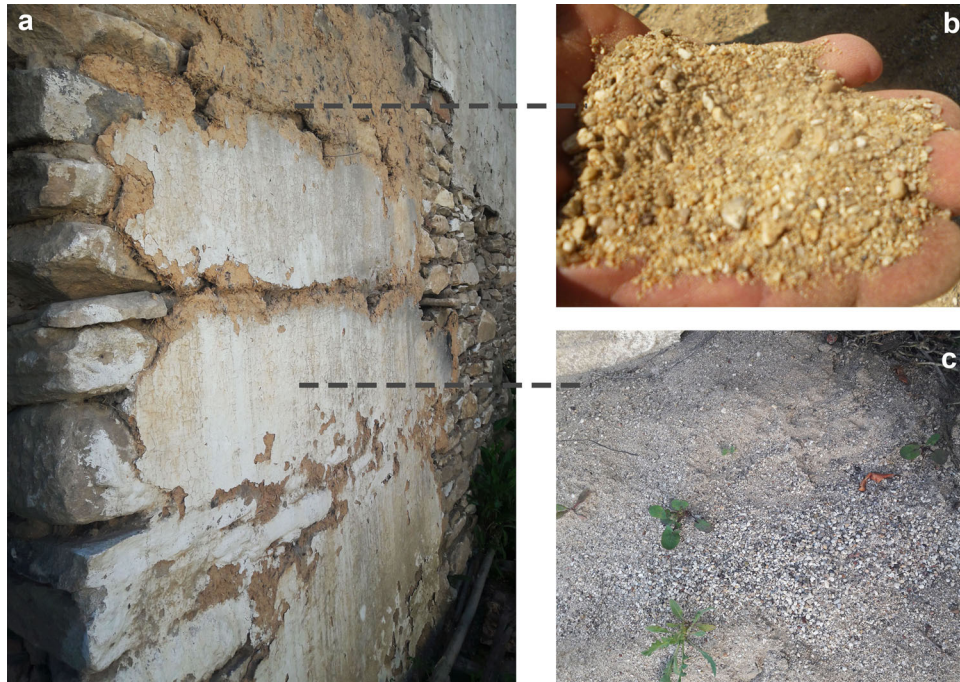
Figure 24. (a) Double-layer plaster on the wall, (b) yellow soil for the mud plaster, (c) fine sand for the lime plaster.

by mixing lime, which was obtained by cooking limestone at a high temperature for three days in the furnace, with water and fine sand brought from the riverbed (Fig. 4 and 24, c).<sup>46</sup>

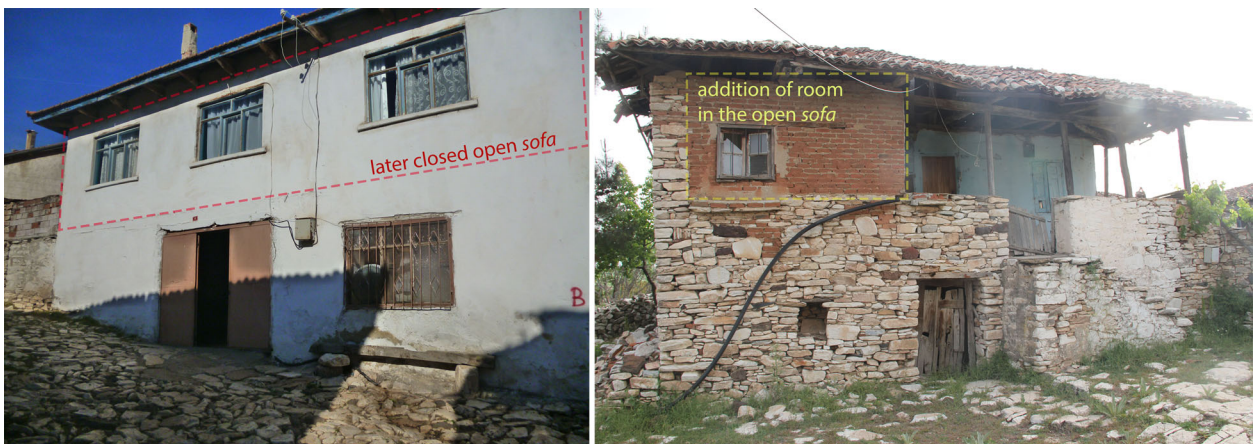
Figure 26. A house where the outer sofa was later closed (left) and the addition of a room in the outer sofa of another house (right).

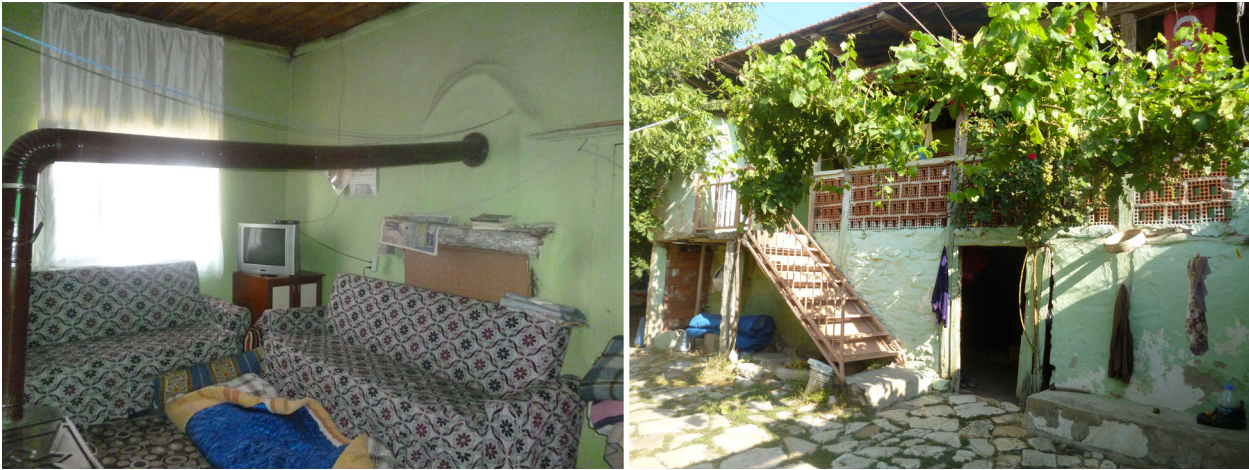
Figure 27. Closed fireplace in a room (left) and steel staircase addition in the courtyard (right).
