CONSTRUCTION TECHNIQUES OF TRADITIONAL TIRILYE HOUSES

A THESIS SUBMITTED TO
THE GRADUATE SCHOOL OF NATURAL AND APPLIED SCIENCES
OF
MIDDLE EAST TECHNICAL UNIVERSITY

December 2021

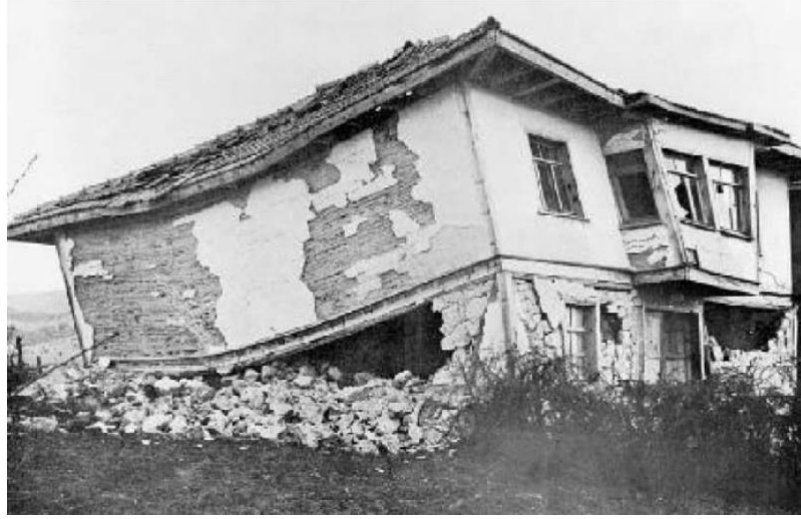
Figure 2.40. Traditional house in Iğdiş village after 1970 Gediz earthquake (Şahin Güçhan, 2007, p.843, fig no:1)

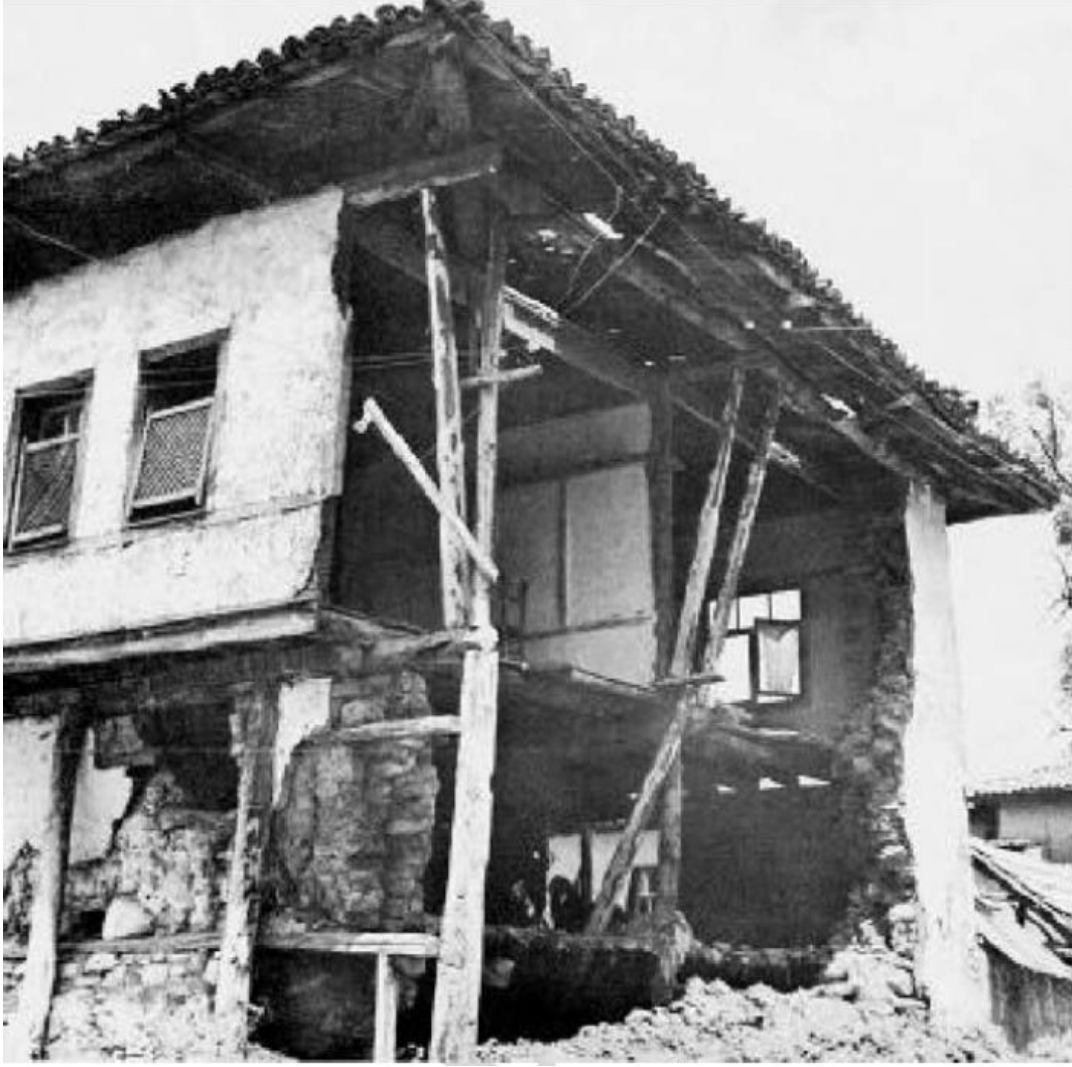
Figure 2.41. Traditional house in Örencik, after 1970 Gediz earthquake (Şahin Güçhan, 2007, p.844, fig no:3)

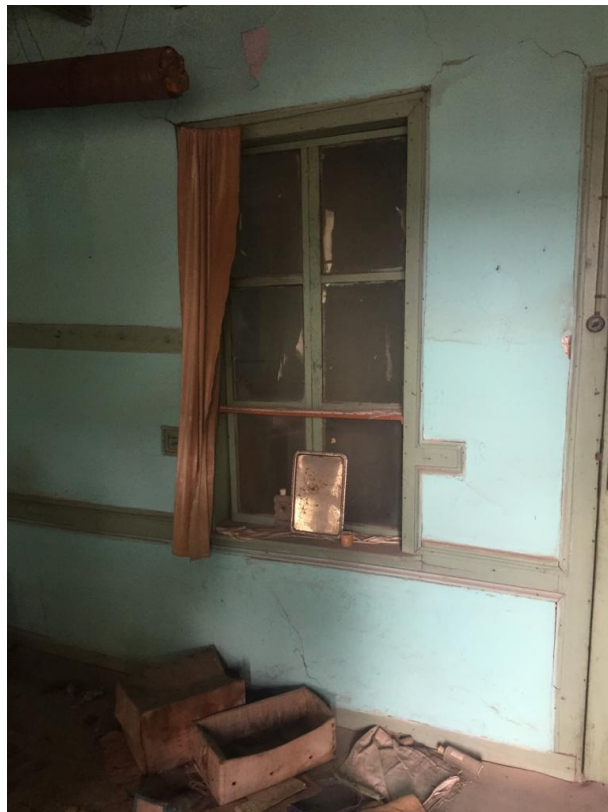
Windows can be found on the partition walls in Tirilye houses. The purpose of using these windows is to illuminate the places that do not get enough daylight. It is especially preferred to illuminate circulation spaces in Tirilye houses. Generally, double-wing windows are used (Figure 2.69).

Figure 2.69 Interior window opening on partition wall of the room in the first floor (F2 space) of House No:1 (Eskipazar Street, lot no: 2192/5)

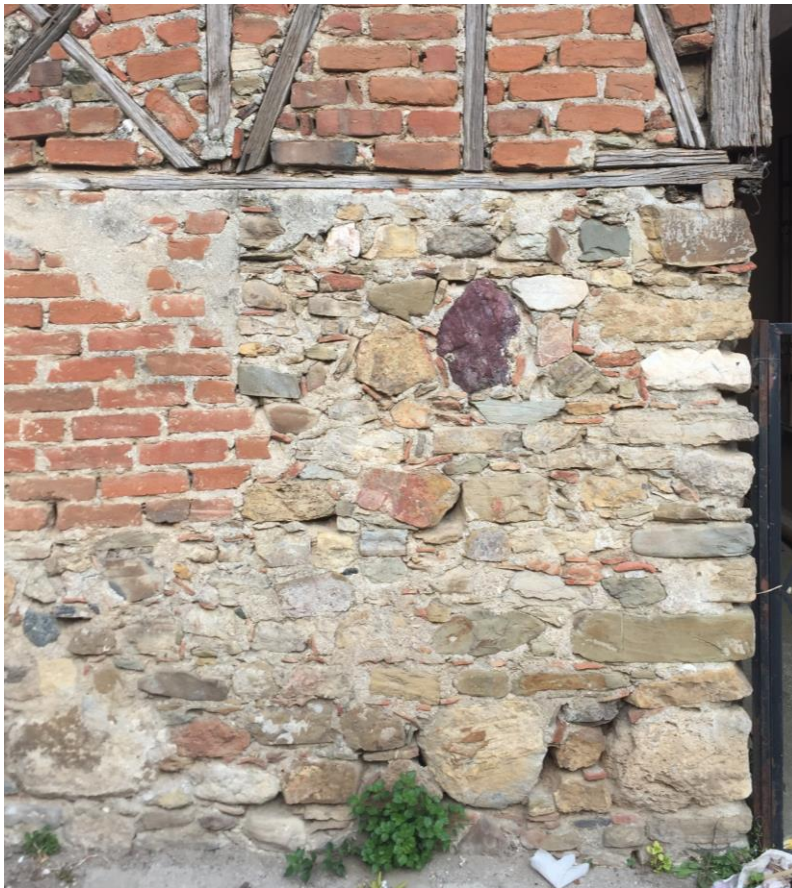
Figure 3.6. Rubble stone masonry wall coursing example (Lot no: 2167/1)

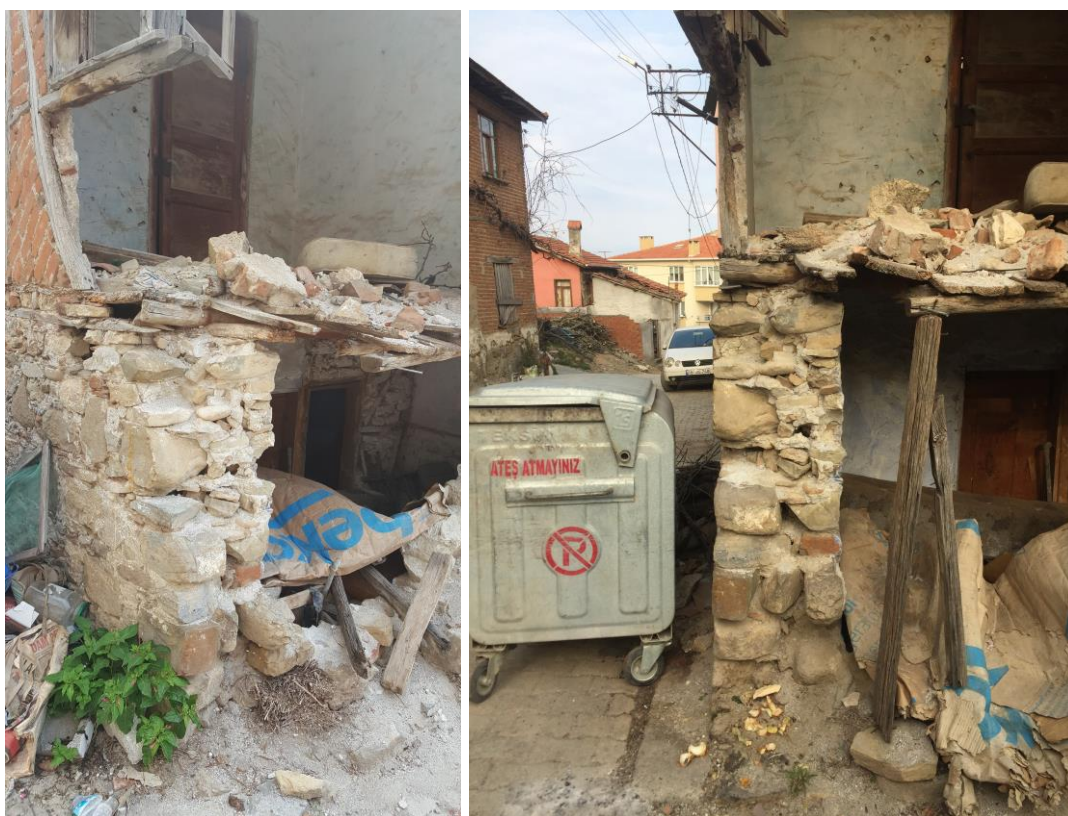
Figure 3.12. Masonry wall coursing without lintel (Lot no: 2167/1)

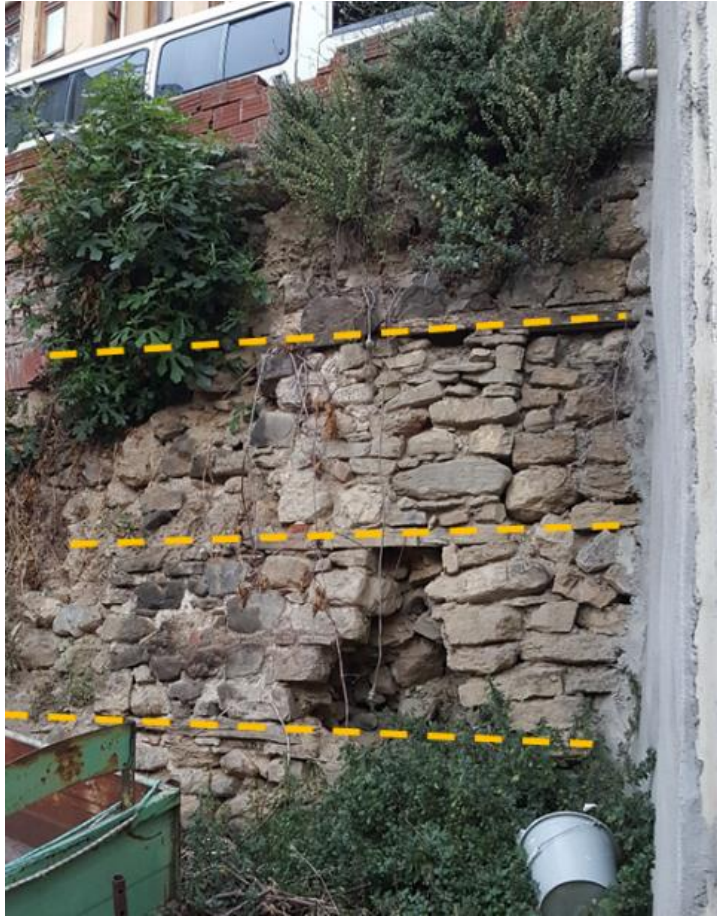
Figure 3.13. Timber lintel levels on the highly deteriorated stone masonry wall
(Cami street Lot no: 2186/2)

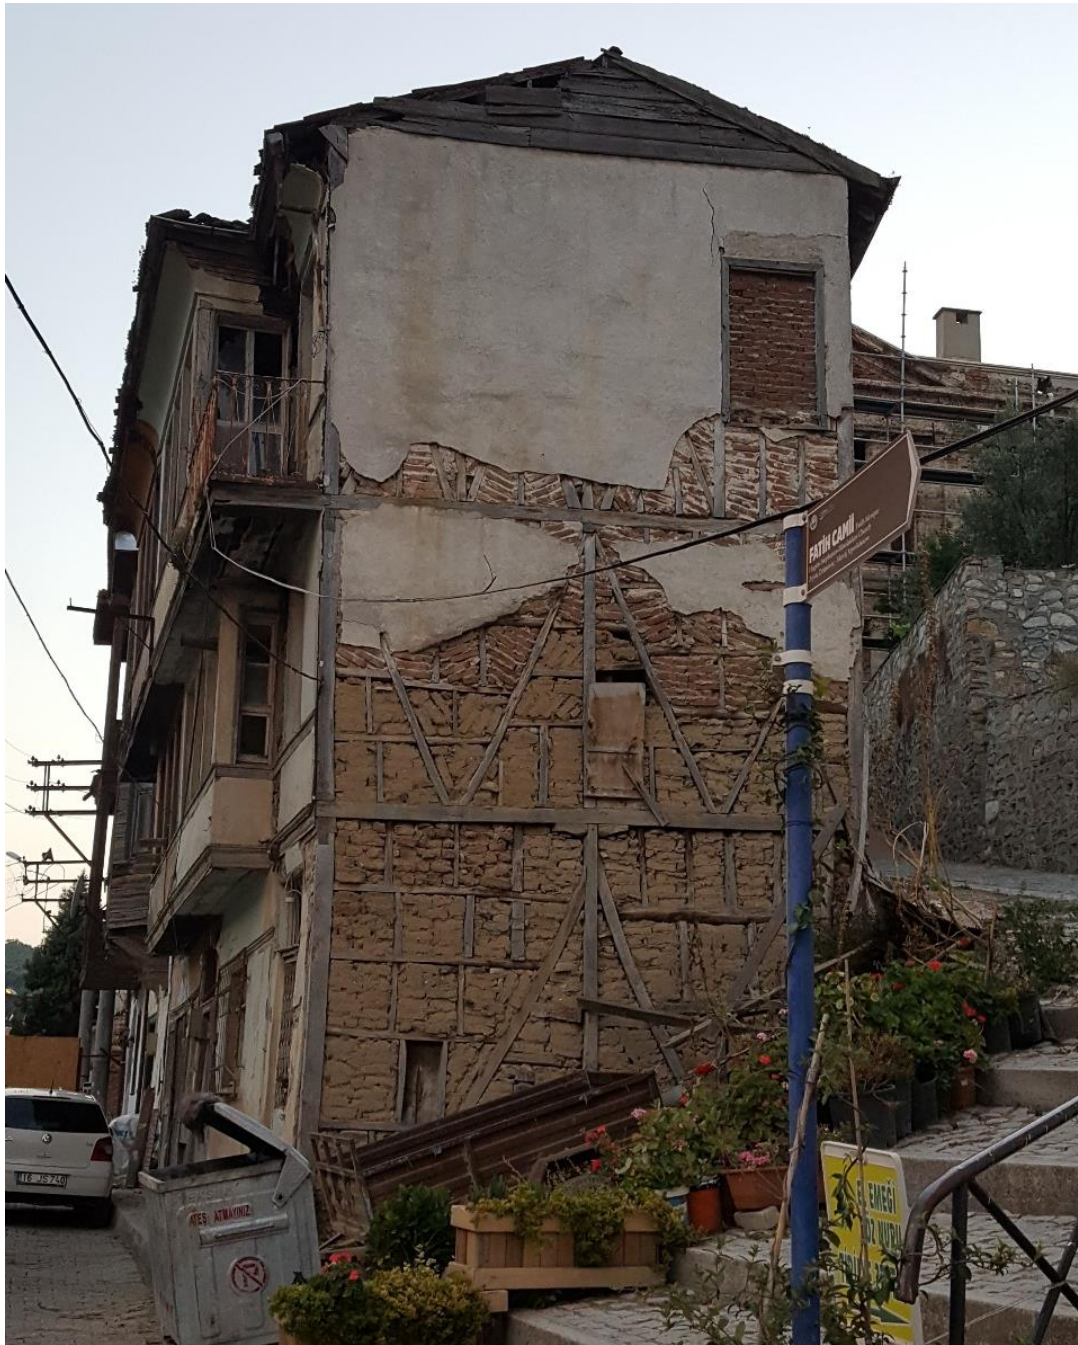
Figure 3.17. An example for timber frame wall usage on the ground, mezzanine, and top floors (House No:2, Eskipazar St, Lot no: 2188/7)

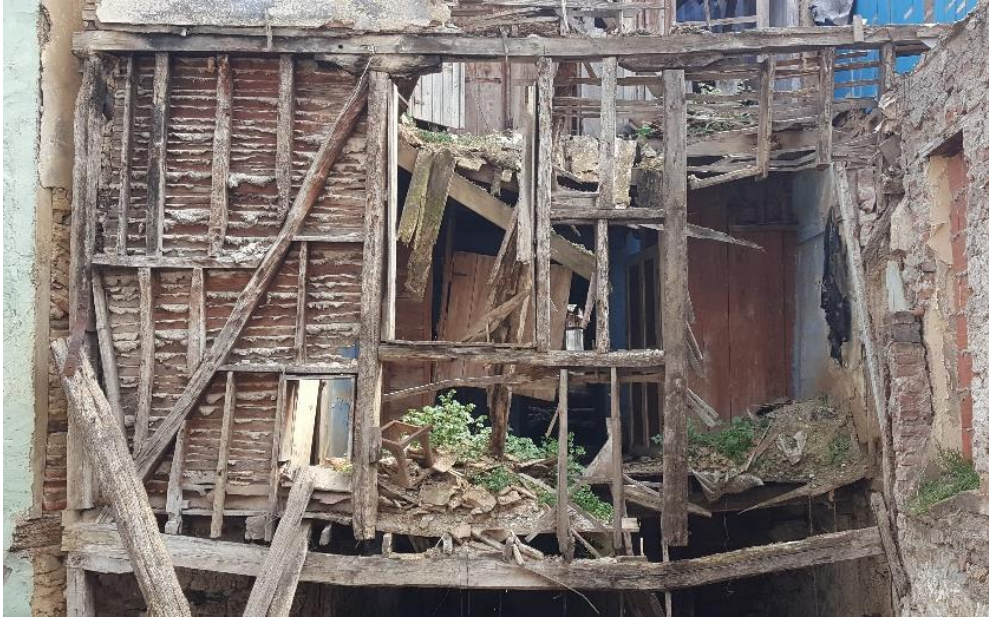
Figure 3.23. Highly deteriorated example of a timber frame wall, with timber lath covering on the interior face with plaster (House No:10, Eskipazar St, Lot no: 2245/11)

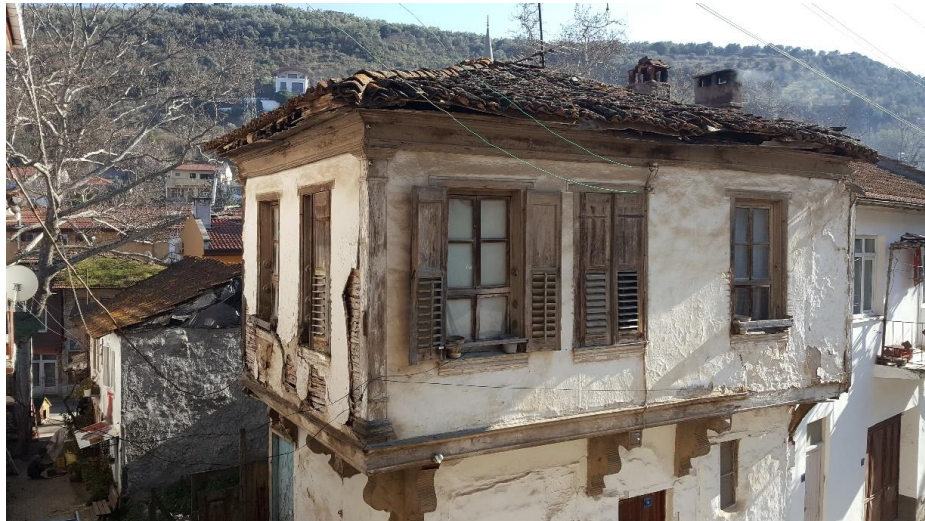
Figure 3.39. An example to hipped roof with closed eaves

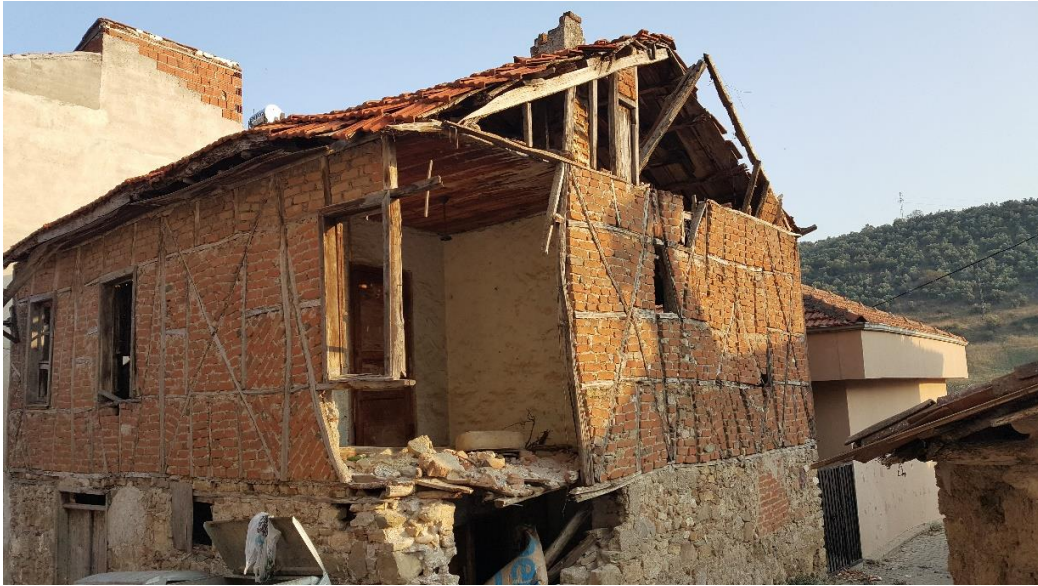
Figure 3.40. An example of the deteriorated gable roof structure

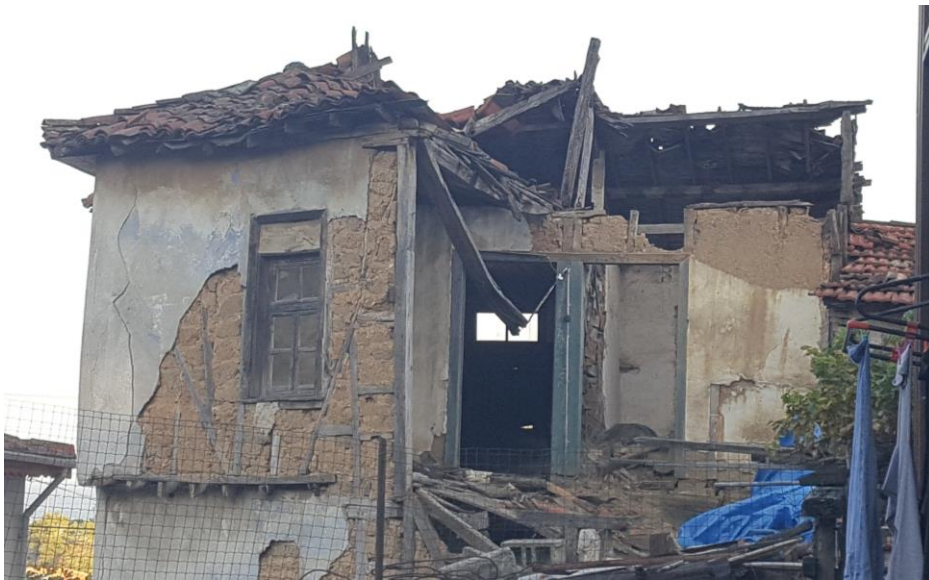
Figure 3.41. An example of the deteriorated 3-sided roof structure

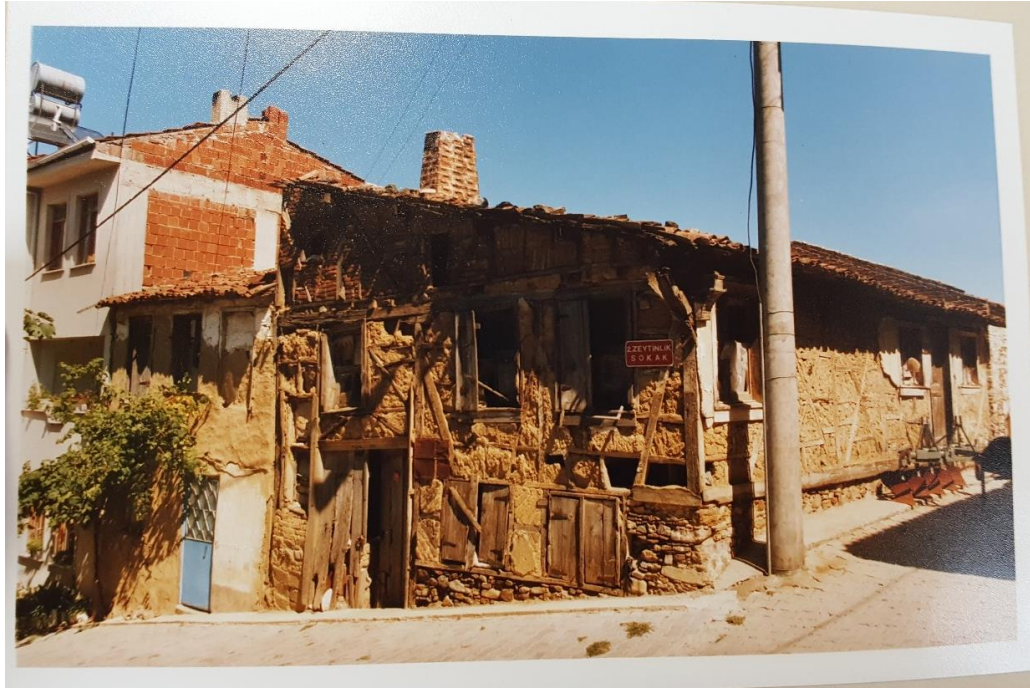
Figure 3.42. An example of a one-sided roof structure (Taken from Bursa KVKBKM archive, Lot no:2254/8)

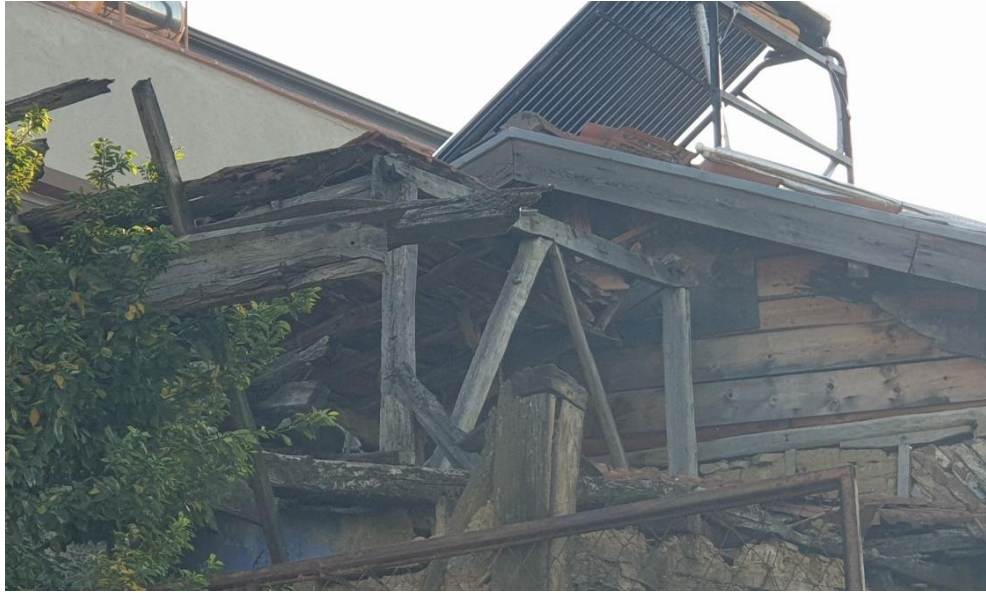
Figure 3.44. Highly-deteriorated roof structure and the connection of king posts, ridge purlin, and braces

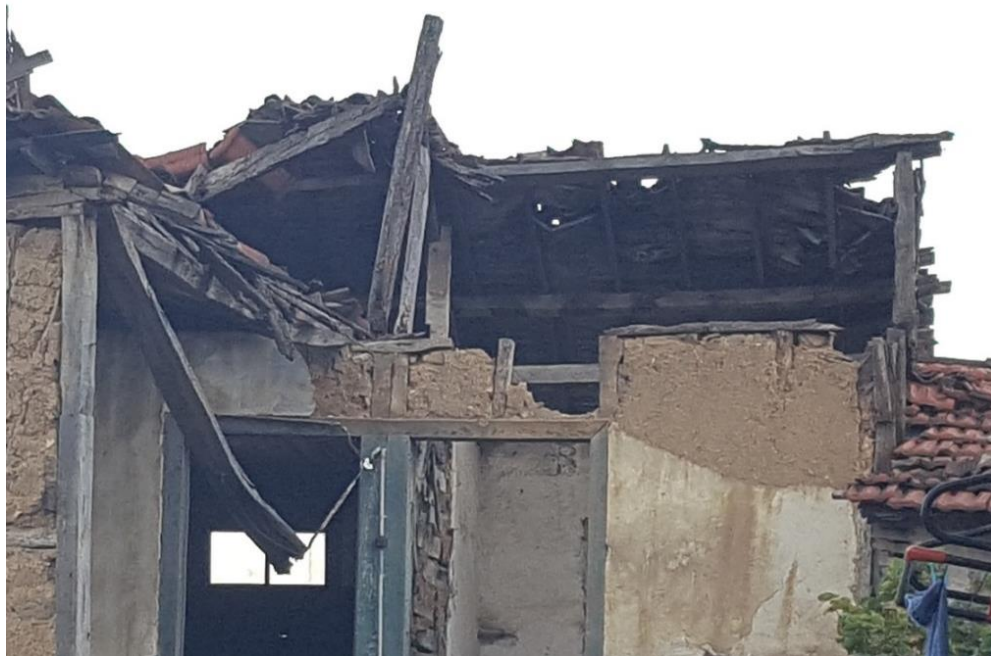
Figure 3.45. Highly deteriorated timber roof structure, purlins are below the rafters

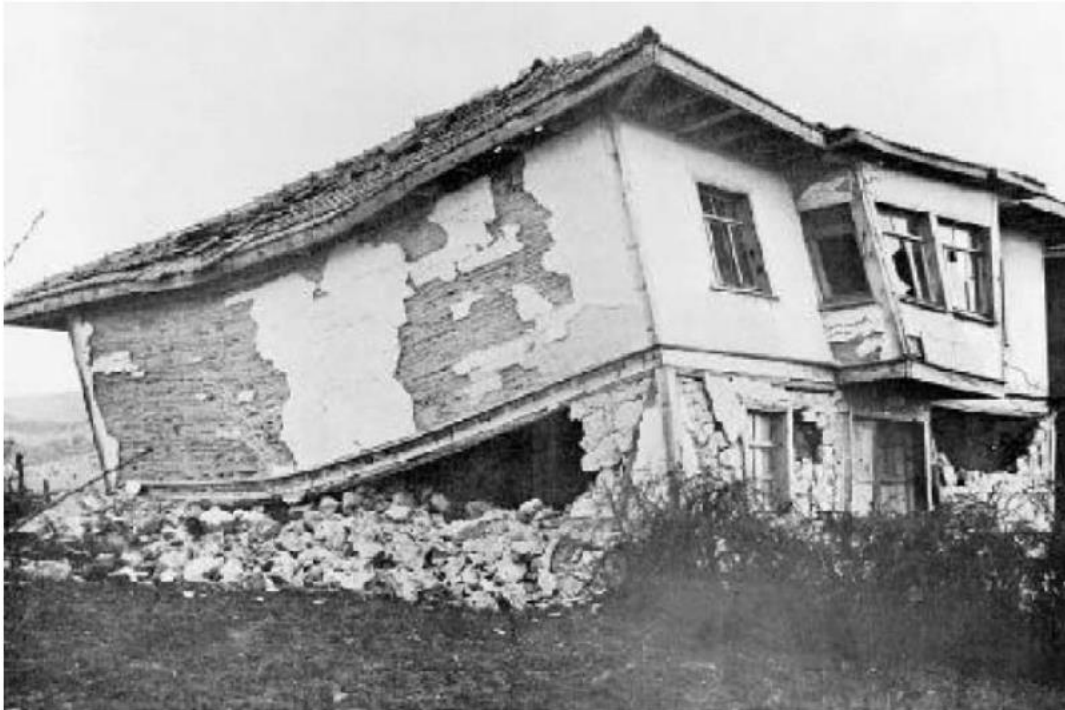
Figure 4.1. Traditional house in Iğdiş village after 1970 Gediz earthquake, destruction of ground floor masonry wall of a traditional house while the timber-frame upper floor still preserves its integrity (Şahin Güçhan, 2007, p.843, fig no:1)

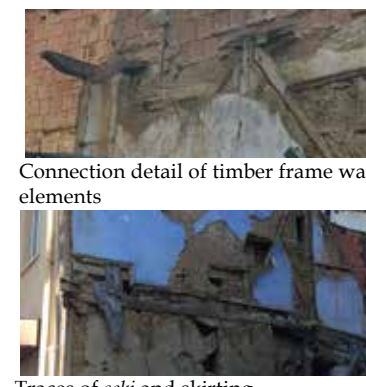
Traces of *seki* and skirting, gap between wall plate and skirting shows the missing floor girders
