NONLINEAR PERFORMANCE ANALYSIS OF STEEL LATTICE ENERGY
DISTRIBUTION TOWERS

A THESIS SUBMITTED TO
THE GRADUATE SCHOOL OF NATURAL AND APPLIED SCIENCES
OF
MIDDLE EAST TECHNICAL UNIVERSITY

FEBRUARY 2022

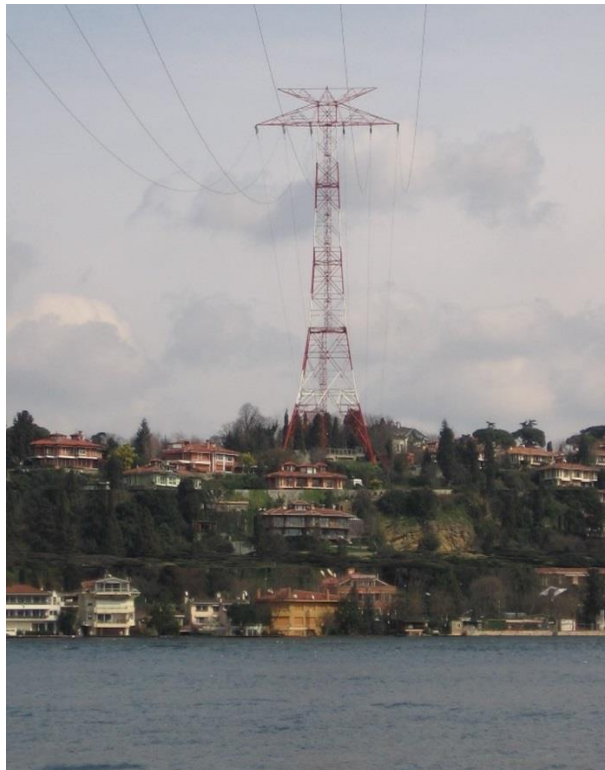
Figure 1.1. 154 kV Bosphorus crossing steel lattice transmission tower

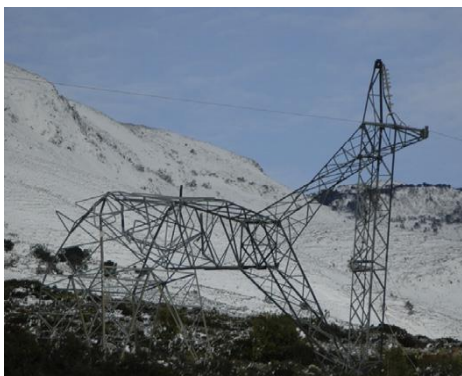
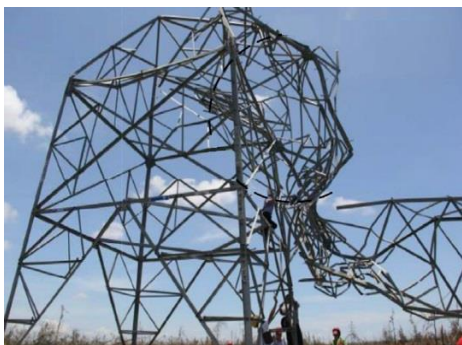
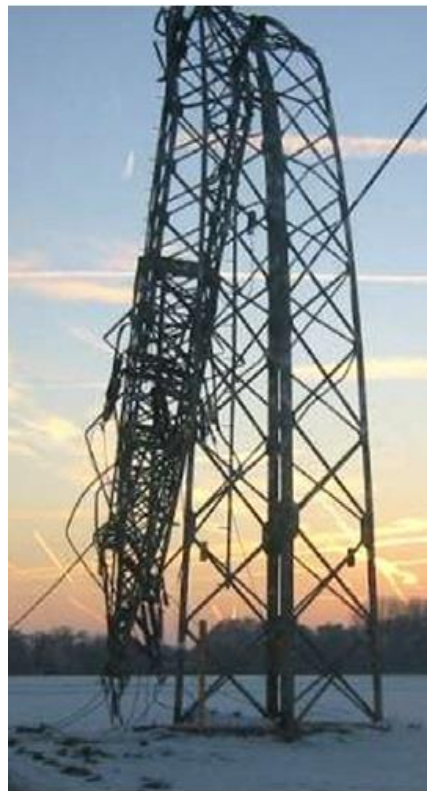
Figure 1.2. Examples of reported tower failures: (a) Kefallonia Island, Greece, 2006; (b) Hainan, China, 2014; (c) Münsterland, Germany, 2005

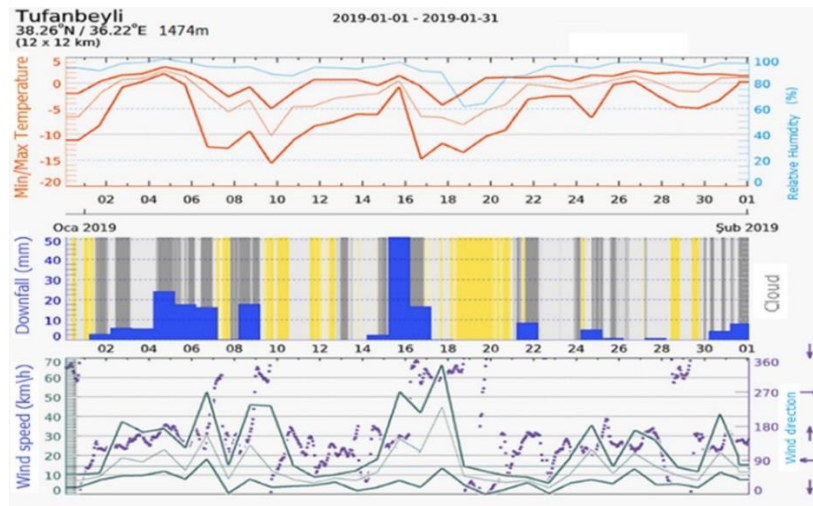
Figure 3.1. Meteorological data from Tufanbeyli station for January 2019

The meteorological data obtained from Tufanbeyli station indicates wind speeds of up to 60 km/h and a minimum temperature of approximately -15°C (Figure 3.1). In addition to the meteorological data, photographs taken by field staff indicate thick

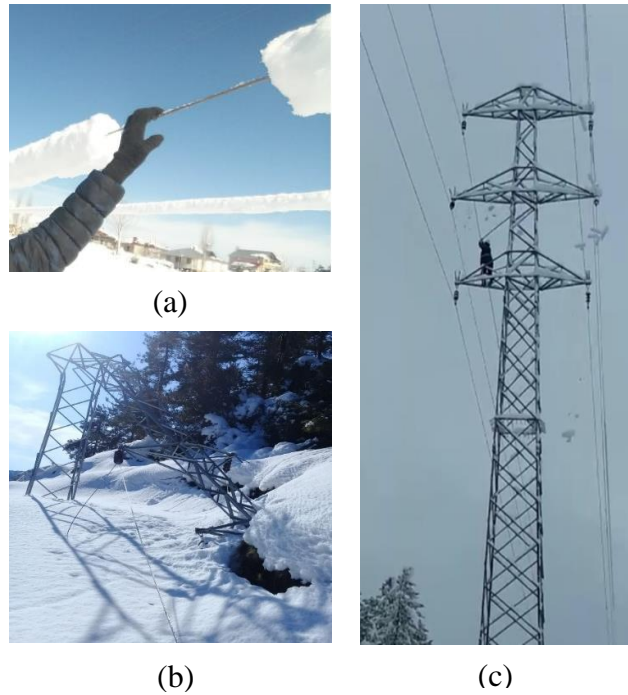
Figure 3.2. Observations during the day of the incident: (a) ice sleeves around conductors; (b) a collapsed tower; (c) staff removing ice on conductors

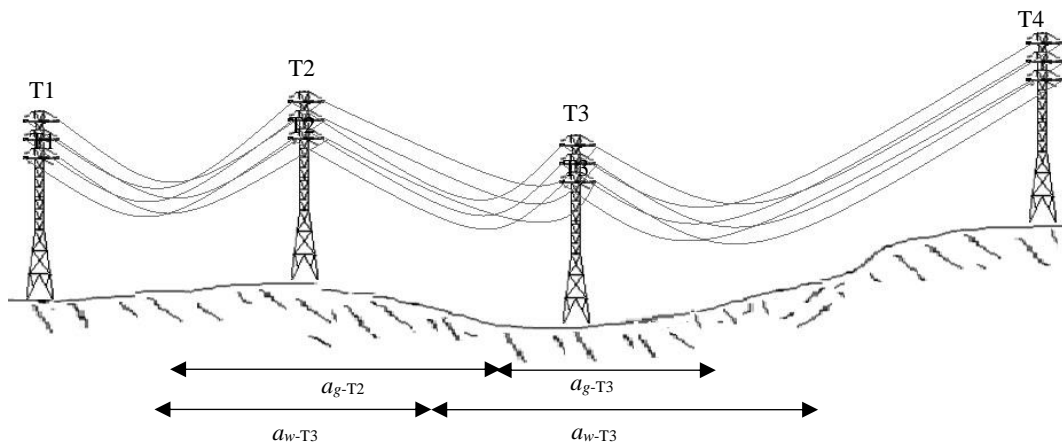
Among the properties given in Table 3.3, back span is the distance between the tower that is considered and the previous tower along the line. Weight span (a_g) is the horizontal distance between the lowest point of the conductor on either side of the tower. Weight span is used for determination of the total conductor weight supported by each tower. Wind span (a_w) is the distance between middle points of the span on either side of the tower. Wind span is used for determination of the lateral load supported by each tower due to the wind load on conductors. Determination of weight and wind spans for a sample power line is illustrated in Figure 3.4. As illustrated, the wind spans of towers T2 and T3 are a_{w-T2} and a_{w-T3} , and the weight spans are a_{g-T2} and a_{g-T3} .

Figure 3.4. Wind and weight spans for towers

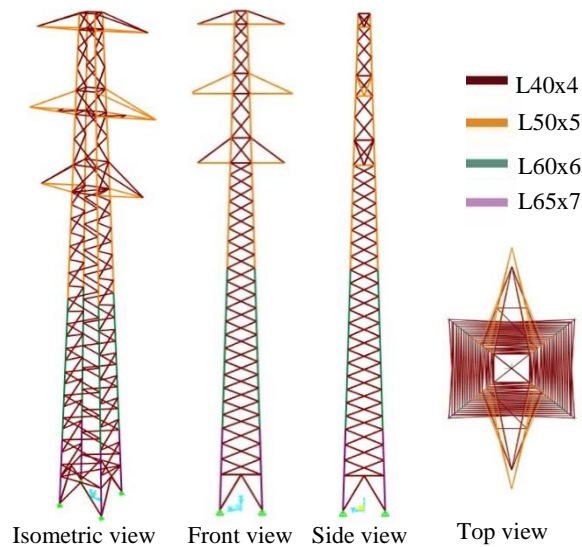
Structural modeling and numerical analysis of the towers were conducted within PLS-TOWER and SAP 2000 software. PLS-TOWER software was used for verification of the results obtained from the SAP2000 models. After similar responses were achieved for a suspension type RU+4 tower, modeling and analysis of the towers were continued with SAP2000 software, as it allows for a rapid model buildup and post-processing of the analysis results. Eighteen RU type and three DU type towers were modeled according to the design and construction drawings (TEDAŞ, 2000). A separate 3-dimensional numerical model was prepared for each tower by utilizing 2-node frame elements. Brace and horizontal members were modeled as pinned connected elements. As mentioned earlier, this is the general approach used in modeling of lattice type distribution towers, since the structural response is close to ideal pinned behavior due to the members being connected usually with a single bolt. Leg members were modeled as continuous elements. The weight of the connection components was neglected in the study since they have no significant contribution to the response. Tower bases were modeled as pinned with all three translational degrees of freedom being restrained. Several views from the numerical model of the RU-4 suspension tower are shown in Figure 3.5.

Figure 3.5. Structural analysis model of RU-2 type tower

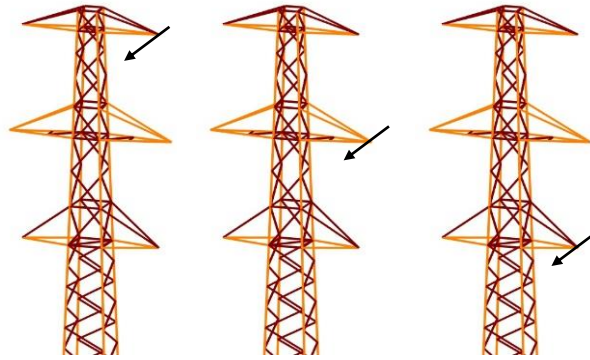
Figure 3.6. Conductor break loading cases used for suspension towers

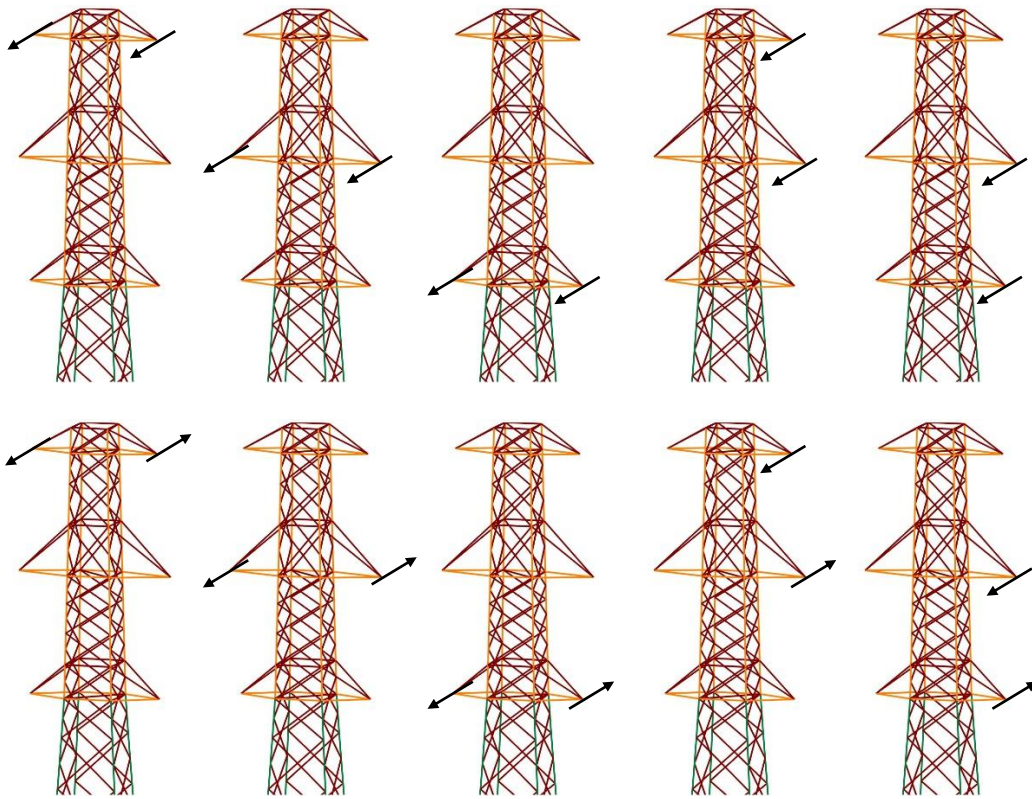
Figure 3.7. Conductor break loading cases used for tension towers

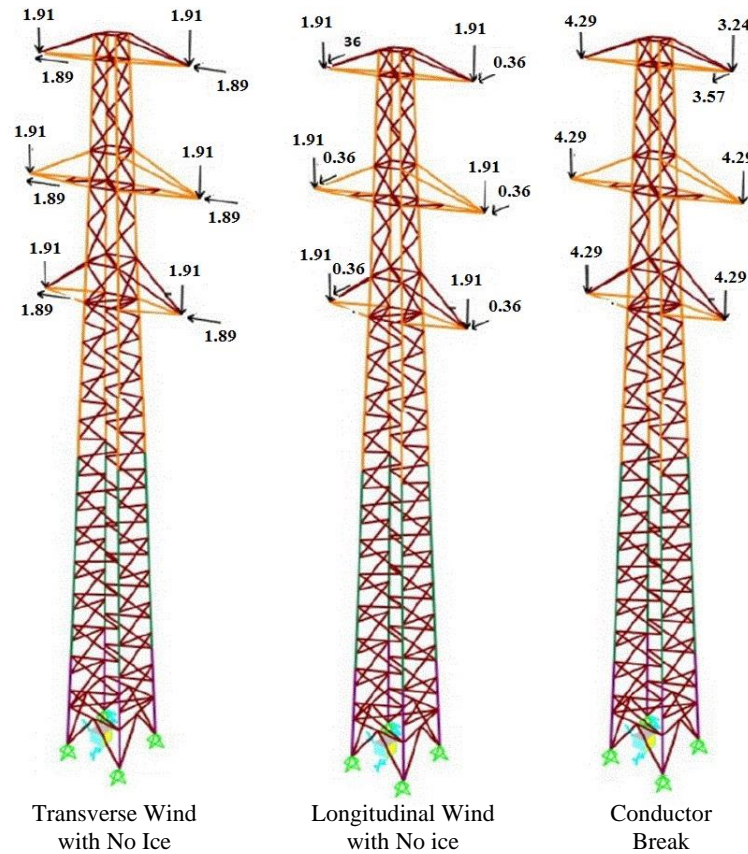
Figure 3.9. Loading cases and calculated loads (kN) on tower No.112 (RU-4 type tower)

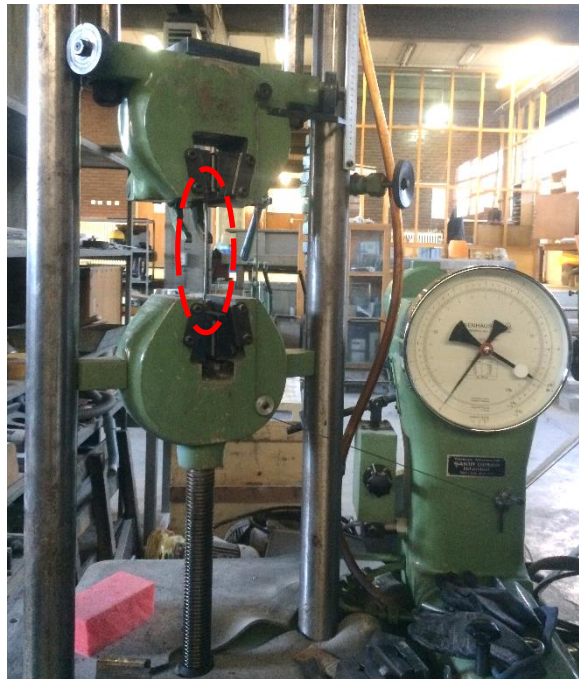
Material tests are frequently used in validation studies for the failure investigation of structures since the analytical solutions may not represent the in-place material properties. In order to guarantee accurate modeling of failure condition for the investigated towers, two series of tensile loading tests were conducted on samples taken from the investigated line. The first of these tests was conducted on a piece of 3/0 AWG conductor. This type of conductor is formed by six aluminum wires that are wrapped around a central steel wire. Tensile loading tests were conducted on these steel and aluminum wires using the setup shown in Figure 3.11. Based on the results obtained from these tests the ultimate tensile capacity of the conductor was determined to be 36.19 kN. This measured strength is 22% higher than the nominal ultimate tension capacity of 29.72 kN specified in TEDAŞ Technical Manual on Design of Distribution Lines (TEDAŞ, 2000).

Figure 3.11. Tensile testing of conductor steel and aluminum wires

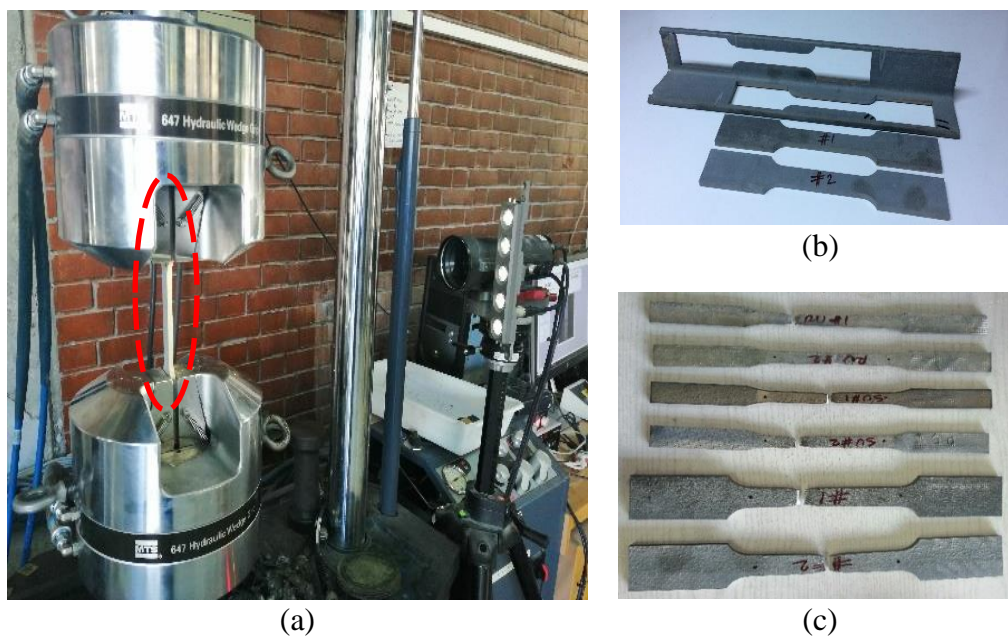
The second series of material tests were conducted on coupon samples extracted from two L40x4 and one L70x7 steel angle profiles that were taken from the failed towers. It should be noted that even though taken from failed towers, the angle profiles themselves were virtually undamaged. Six coupon samples were tested as part of this series. Details of the tests are shown in Figure 3.12. Complete stress-strain curves obtained from these tests are given in Figure 3.13 with the yield and ultimate tensile strength values tabulated in Table 3.8. The average yield and tensile strengths were determined to be 310 MPa and 440 MPa, respectively. As mentioned earlier, the investigated towers were designed based on St37 steel class. The minimum specified yield and tensile strengths for this class of steel are 240 MPa and 370 MPa, respectively. Based on these values, it can be concluded that the investigated towers were constructed out of a steel class that is higher than the St37 class assumed in design.

Figure 3.12. Tension testing of steel coupon samples: (a) sample in the testing machine; (b) coupon samples extracted from the steel angle section; (c) tested coupon samples

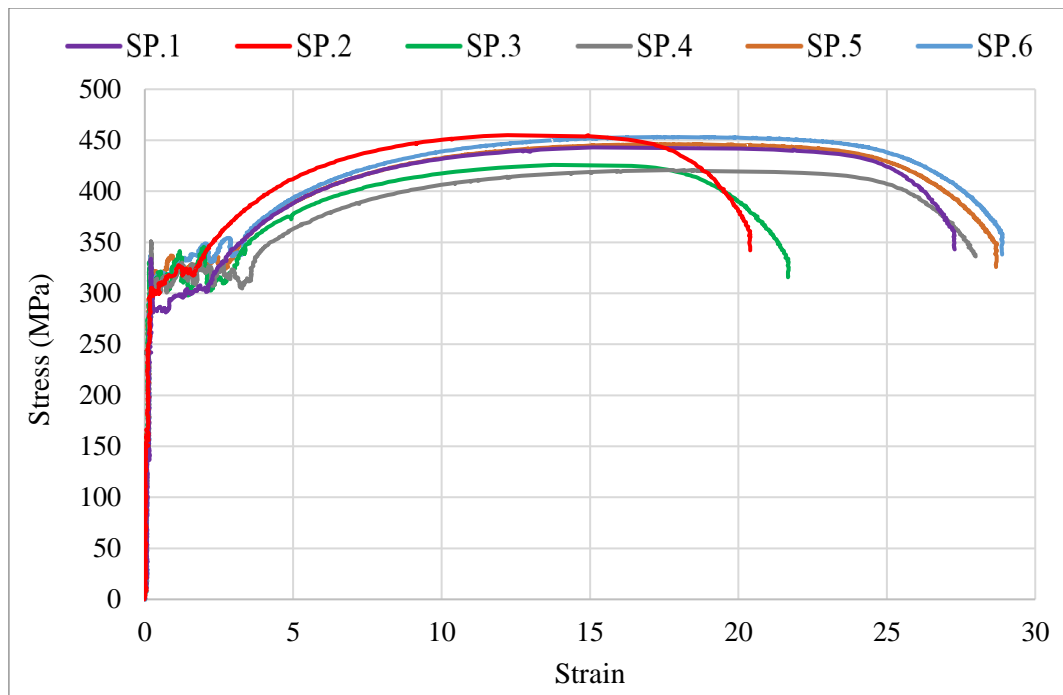
Figure 3.13. Stress-strain curves of the test specimens

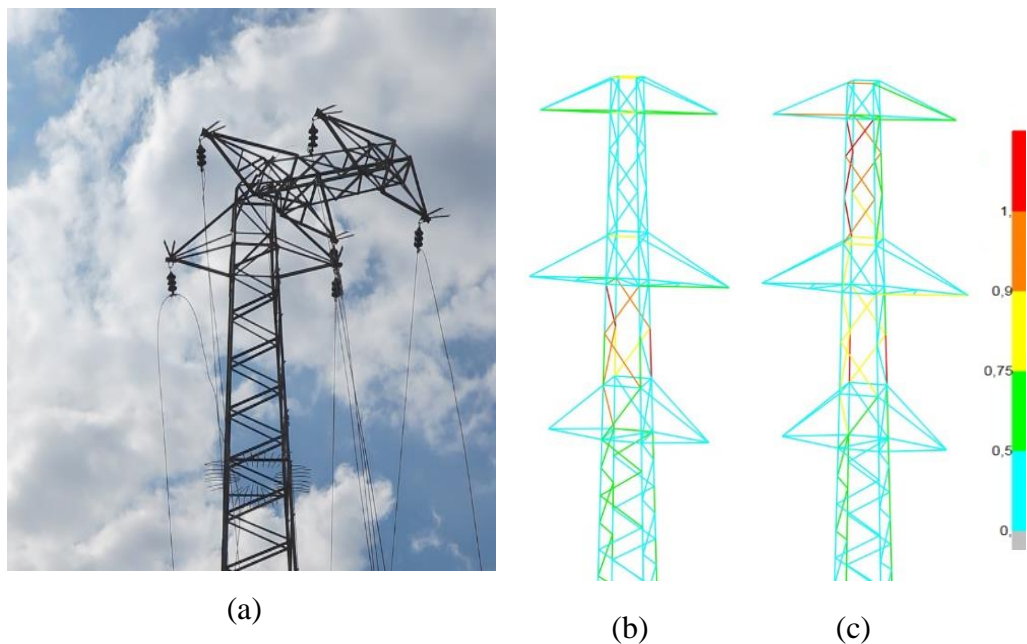
In suspension towers analyzed under conductor break loading case, some of the members were observed to be overloaded. Furthermore, results indicate that the critical members are located between the middle and upper crossarms in TCB load case, and between middle and lower crossarms in MCB loading case. In these cases, tower failure occurred due to bolt bearing of the horizontal and brace members in cage part of the towers. For a representation of the general behavior, analysis results from MCB and TCB loading cases are compared with the observed damage for tower No.106 in Figure 3.14. As evident, the predicted damage as a result of conductor break is consistent with the actual damage observed in the field.

Figure 3.14. Results for tower No.106: (a) damage observed in the field; (b) member capacity ratios in MCB loading case; (c) member capacity ratios in TCB loading case

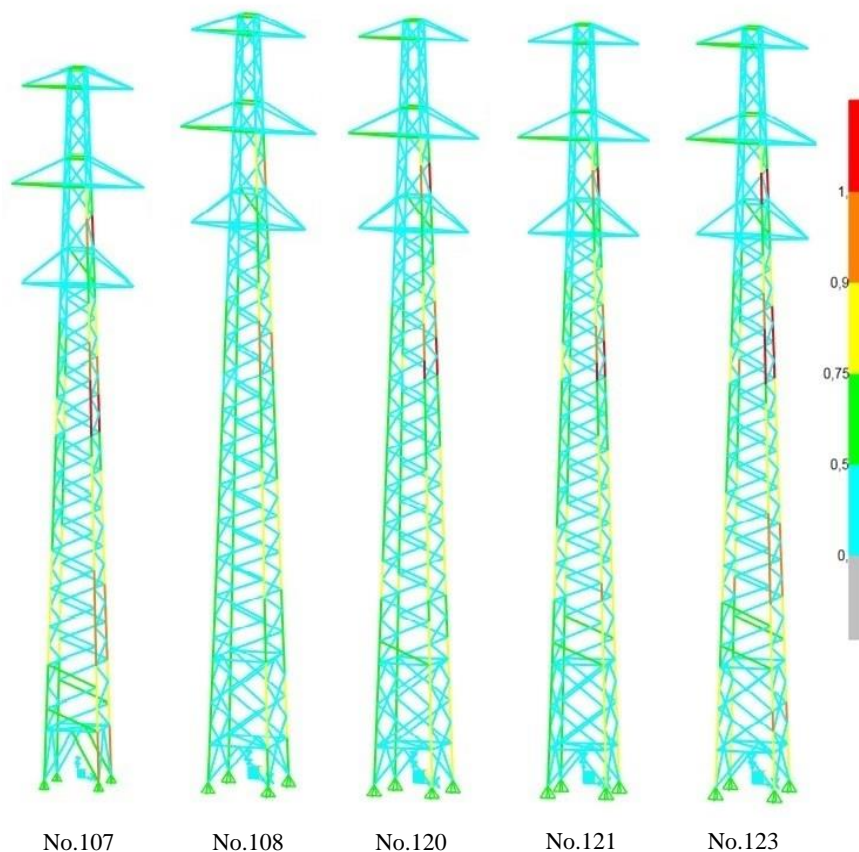
As evident in Table 3.11, member overloading occurred in some of the suspension towers in the IWI loading case with 60 km/h wind. Analysis models for some of these towers are shown in Figure 3.15. As evident in figures, the overloaded leg members are located at the location where member cross-section changes. The governing limit state for these leg members is buckling under compressive axial load.

Figure 3.15. Member capacity ratios obtained under IWI loading case with 60 km/h wind

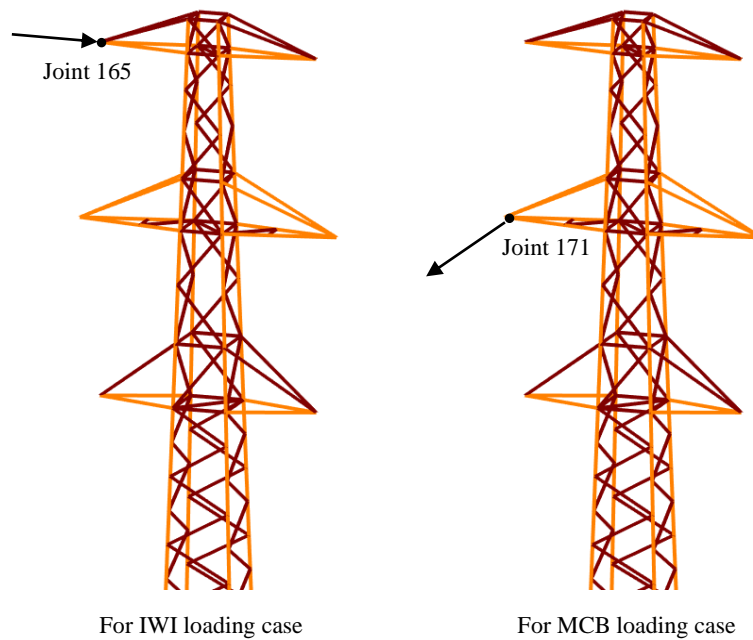
loading case. Displacement of this joint in the direction parallel to the line was monitored during the analysis, because this was the main deformation mode expected to occur under the broken conductor loading. For the IWI loading case, on the other hand, the main deformation mode was in the direction perpendicular to the line. For this reason, displacement at the tip of the top cross arm in the direction perpendicular to the line (i.e., at joint 165) was monitored for the IWI loading case.

Figure 4.2. Monitored joints and degrees of freedom for IWI and MCB loading cases

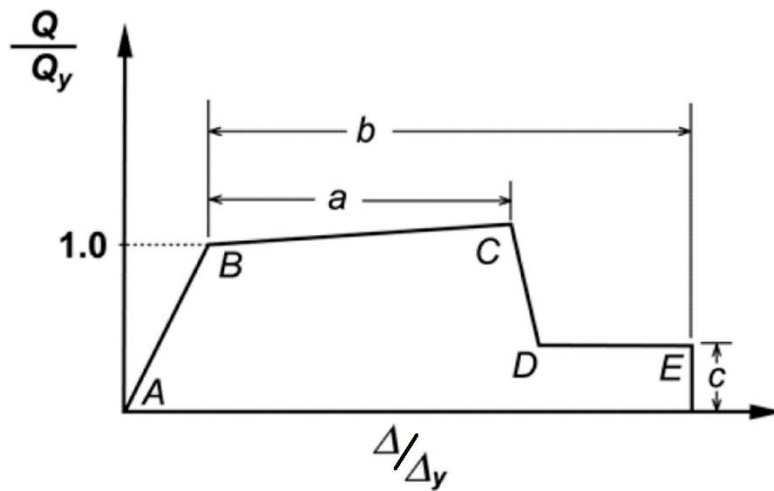
In the towers investigated in the current study, plastic hinge properties for the members were calculated according to FEMA356 (FEMA, 2000), which provides extensive recommendations for the load-deformation modeling of individual elements. A generalized force-deformation hinge model specified by FEMA 356 is shown in Figure 4.3. The load Q and total displacement Δ are normalized by limit load Q_y , and limit deformation Δ_y respectively in generalized hinge curve. The post-yield response is defined by parameters a , b , and c , for which the numerical values are provided in FEMA 356. Five points (A-E) are marked on the force-deformation curve, based on the parameters a , b , and c .

Figure 4.3. Generalized hinge curve for steel members (FEMA, 2000)

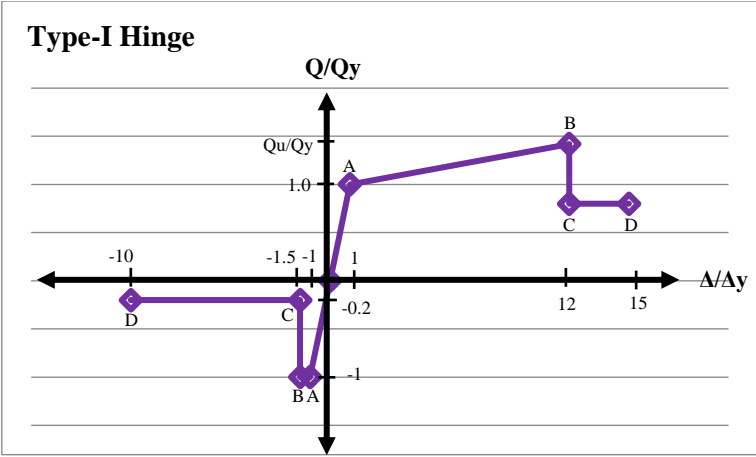
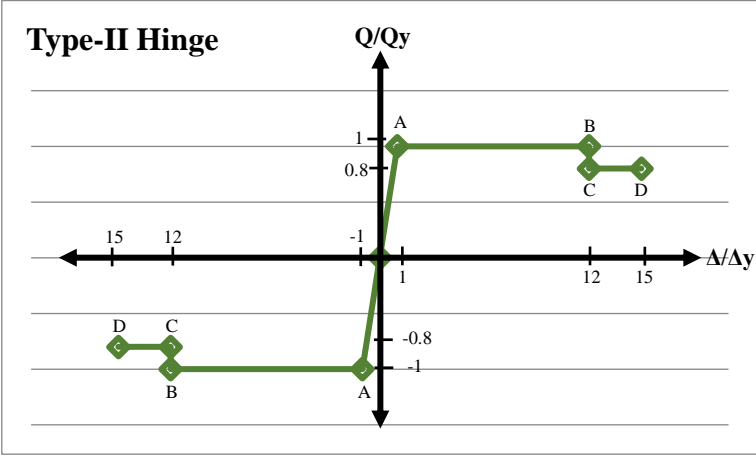
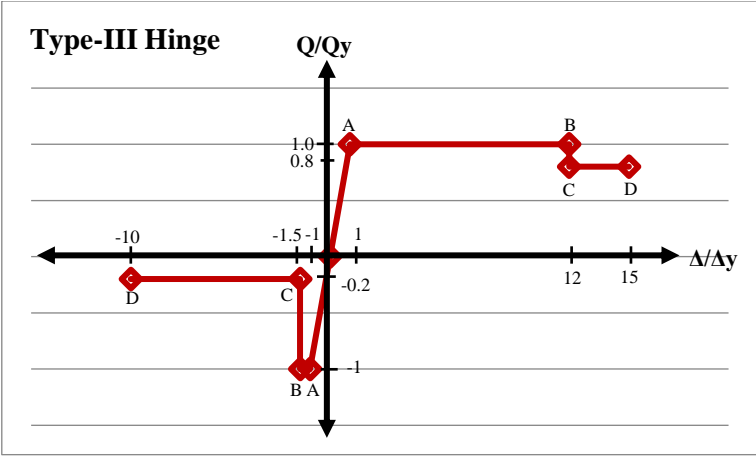
Axial hinges used for the members in the investigated towers were grouped as Type-I, Type-II, and Type-II, as shown in Figure 4.4 to Figure 4.6. These hinge properties were assigned to the built-in zero-length elements that are located at the center of each structural member in the investigated towers. As evident, the axial hinges used for the members have different behavior in tension and compression.

Figure 4.4. Type-I Hinge Properties

Figure 4.5. Type-II Hinge Properties

Figure 4.6. Type-III Hinge Properties

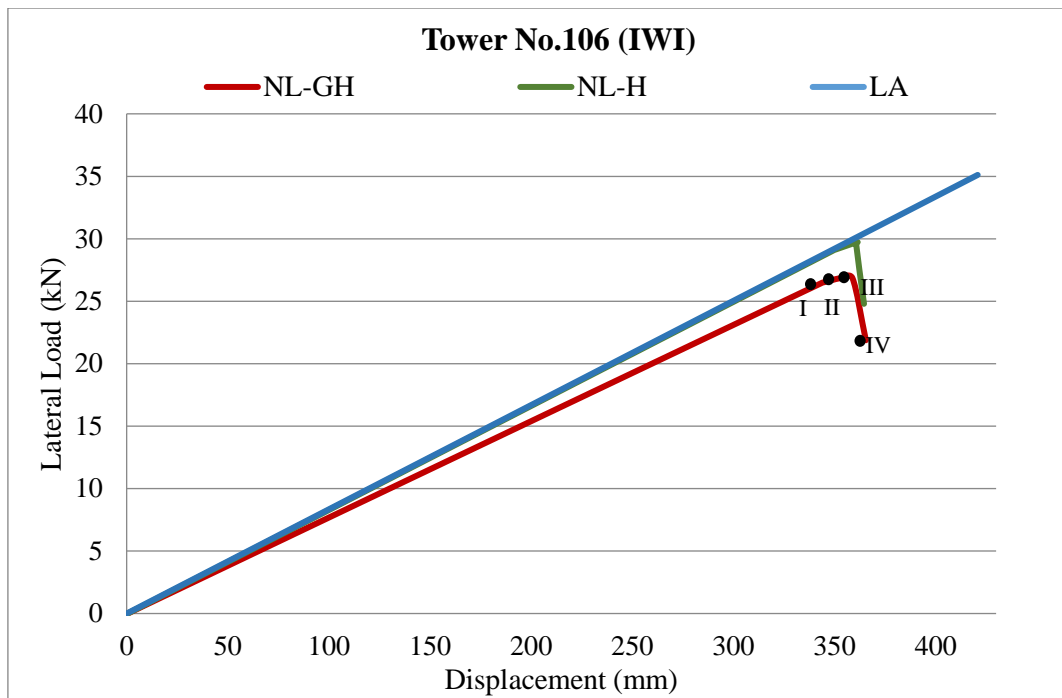
According to pushover curves, it is seen that the linear behavior is valid until the formation of the first hinging in a leg member, which corresponds to buckling of this member. This damage results in a decrease in the lateral stiffness of towers. The load-carrying ability of the towers continues to increase until the formation of hinging in multiple members. After the ultimate capacity is reached, the towers cannot tolerate the load redistribution of failed members and total collapse occurs suddenly.

Figure 4.7. Load-displacement response of Tower No.106 under IWI loading case

Figure 4.8. Progression of damage in Tower No.106 under IWI loading case

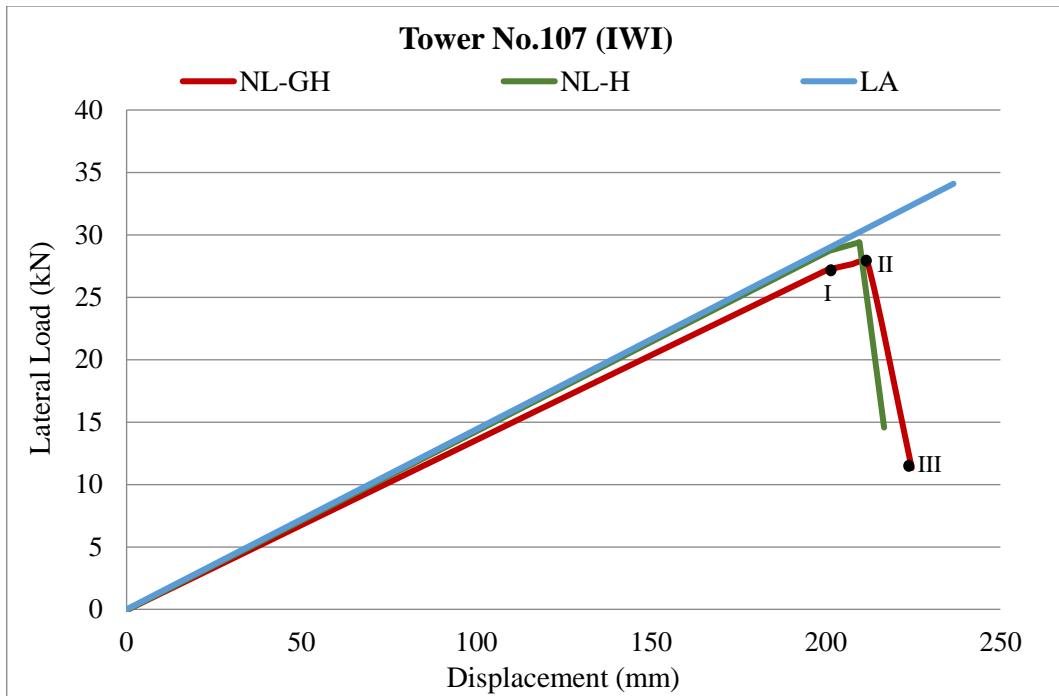
Figure 4.9. Load-displacement response of Tower No.107 under IWI loading case

Figure 4.10. Progression of damage in Tower No.107 under IWI loading case

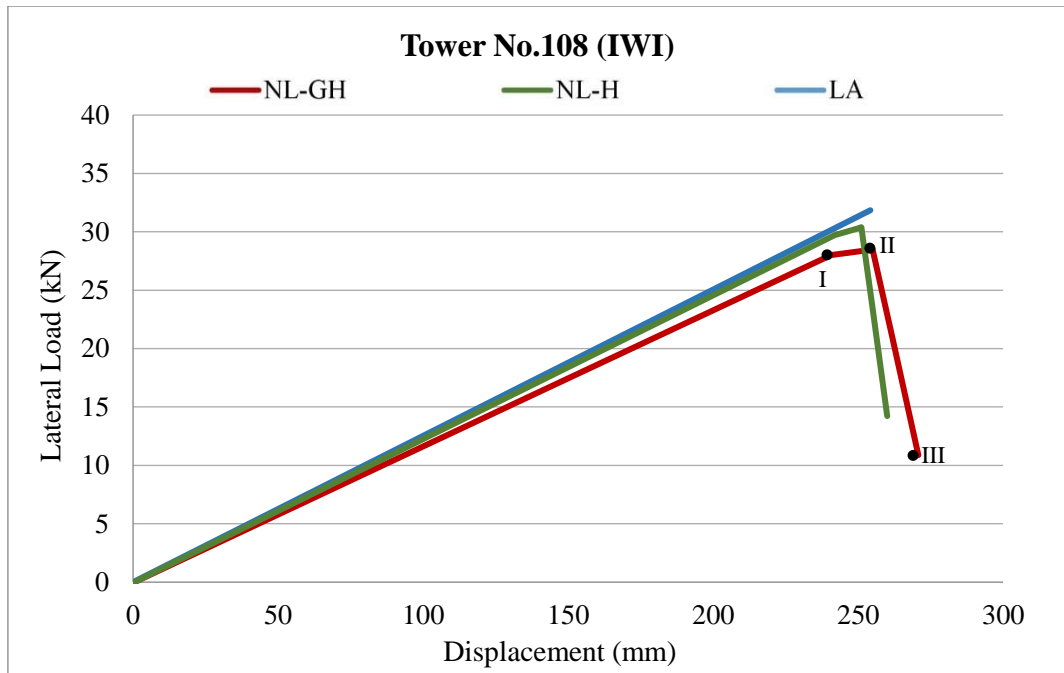
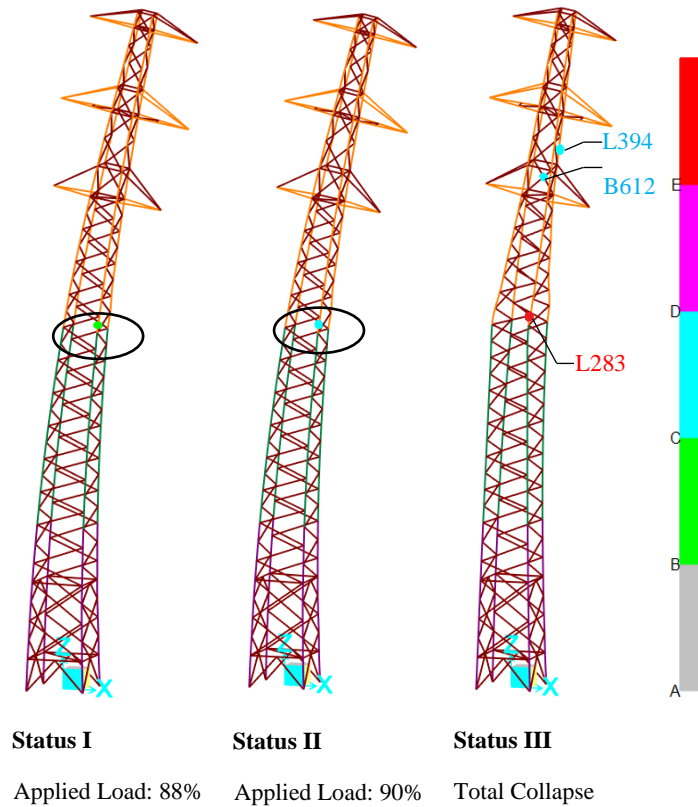
Figure 4.11. Load-displacement response of Tower No.108 under IWI loading case

Figure 4.12. Progression of damage in Tower No.108 under IWI loading case

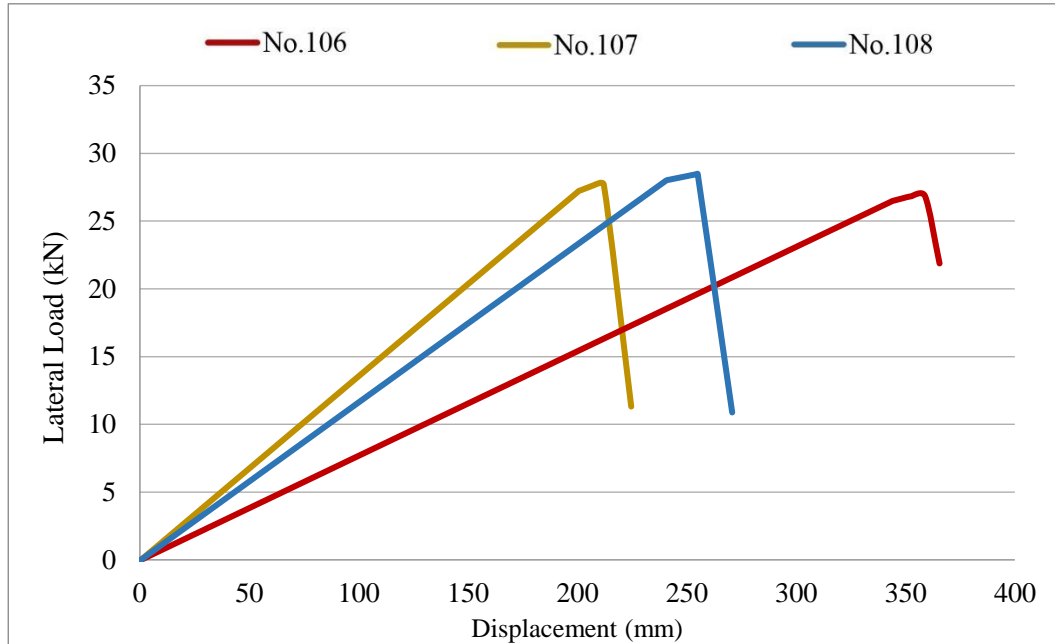
Figure 4.13. Pushover curves of the towers under IWI loading case

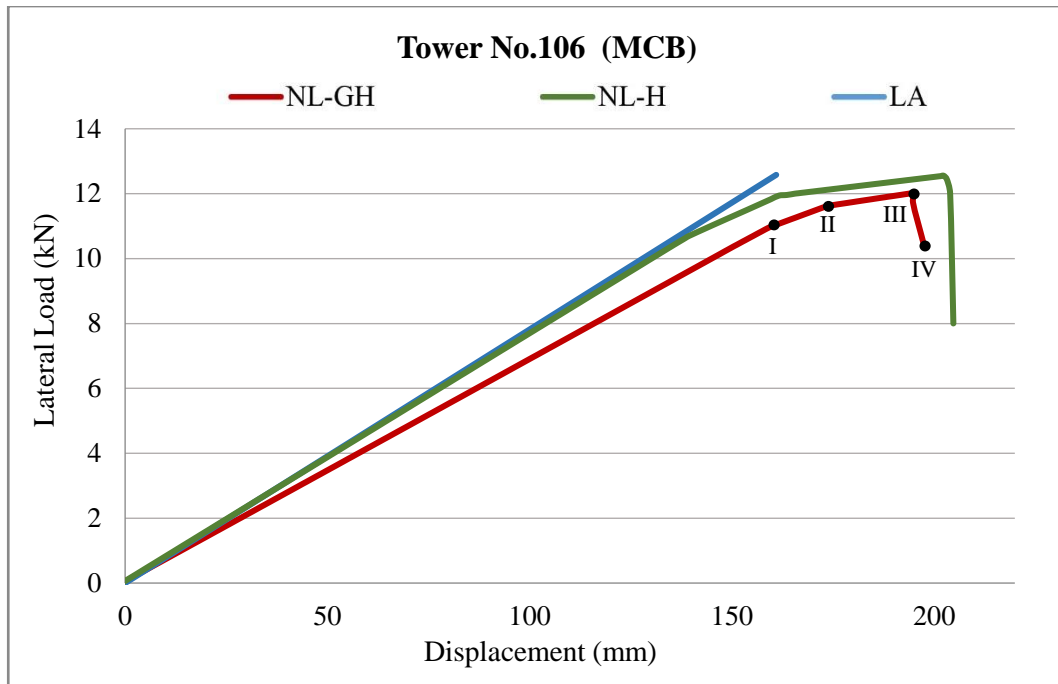
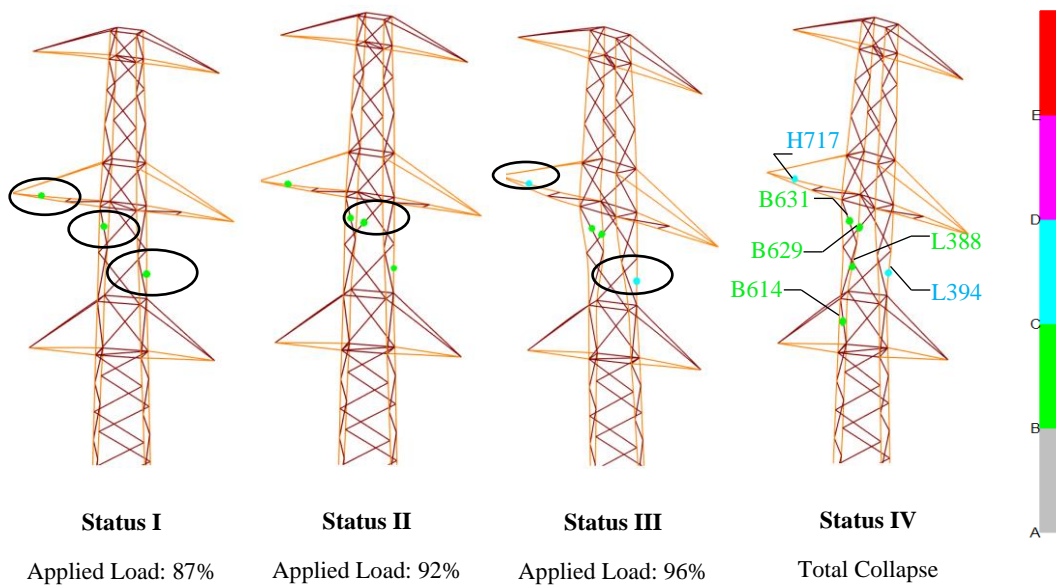
Figure 4.14. Load-displacement response of Tower No.106 under MCB loading case

Figure 4.15. Progression of damage in Tower No.106 under MCB loading case

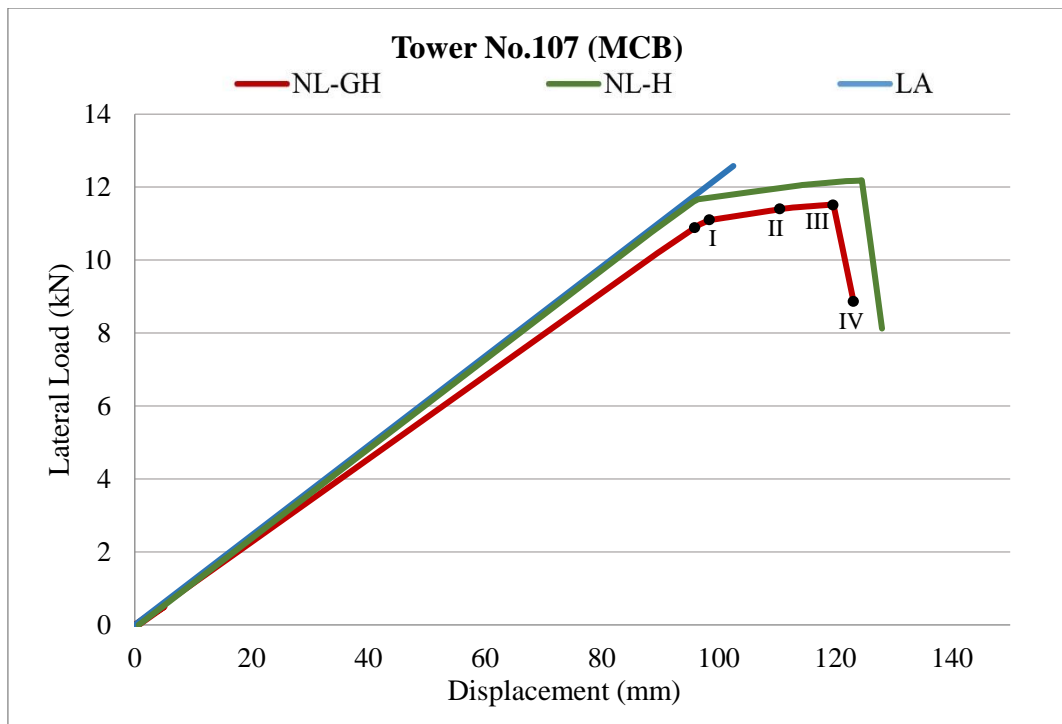
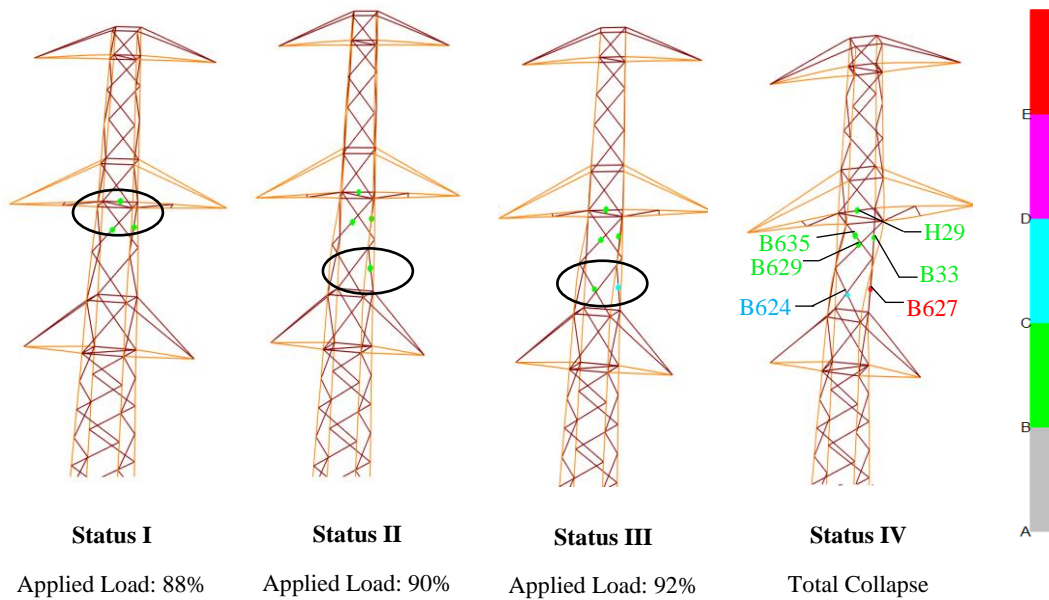
Figure 4.16. Load-displacement response of Tower No.107 under MCB loading case

Figure 4.17. Progression of damage in Tower No.107 under MCB loading case

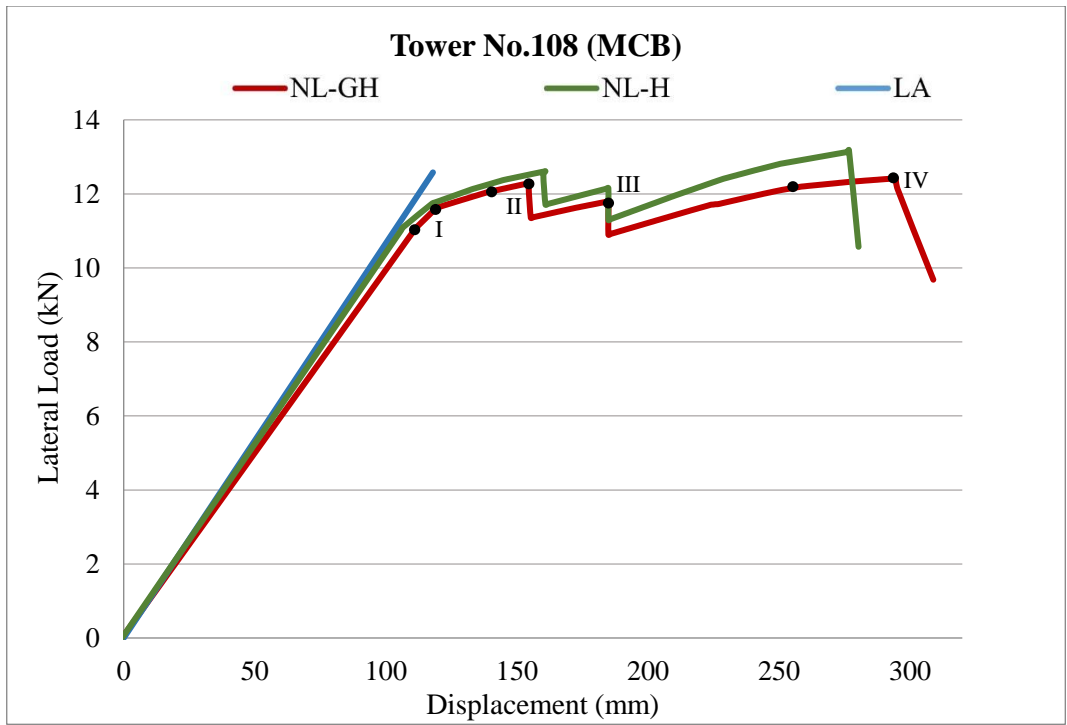
Response of tower No.108 remained linear until B631 brace member reached its bolt bearing capacity. After that B629 brace member and H717 horizontal member, located in the middle of the cage, also developed hinging due to bolt bearing failure. With further loading, L394 leg member reached its buckling capacity, and then B629 and B635 brace members underwent bolt bearing failure.

Figure 4.18. Load-displacement response of Tower No.108 under MCB loading case

Figure 4.19. Progression of damage in Tower No.108 under MCB loading case

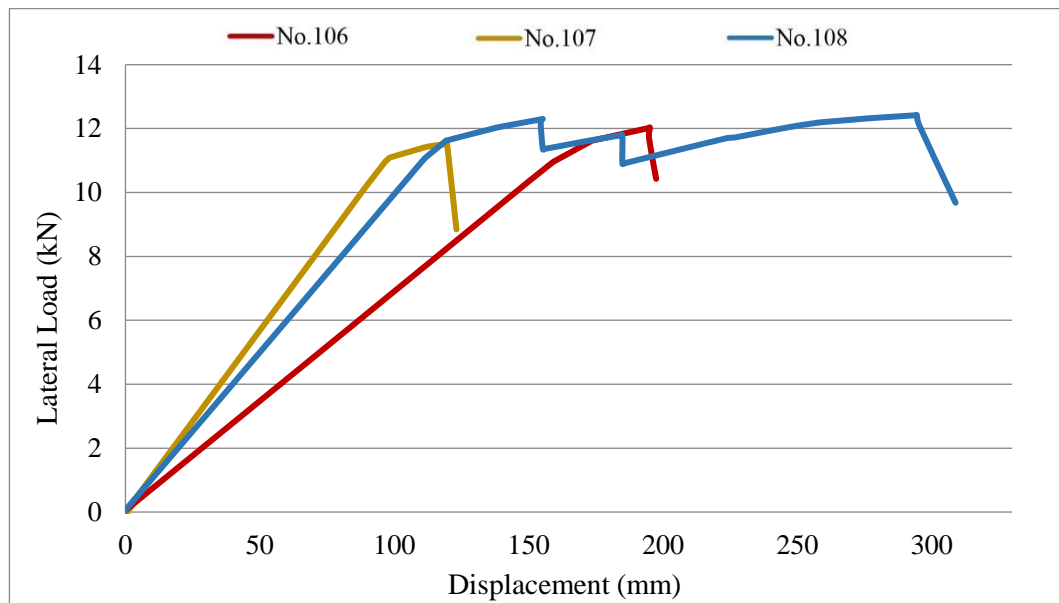
It is interesting to note that No.106 and No.107 towers showed very similar failure paths, while considerable differences are observed in the response of No.108 tower. The reason for this difference is related with the progression of failure in the towers. For No.106 and No.107 towers member buckling occurred at the analysis step before the total collapse condition, while for No.108 tower member damage at the same analysis step includes bolt bearing deformation. This behavior provides a more ductile failure mechanism compared to sudden collapse due to member buckling. This type of ductile response of No.108 tower compared to the other towers is also evident in load-displacement plots presented in Figure 4.20. The relatively lower stiffness of No.106 tower is due to this tower being longer than the others.

Figure 4.20. Pushover curves of the towers under MCB loading case

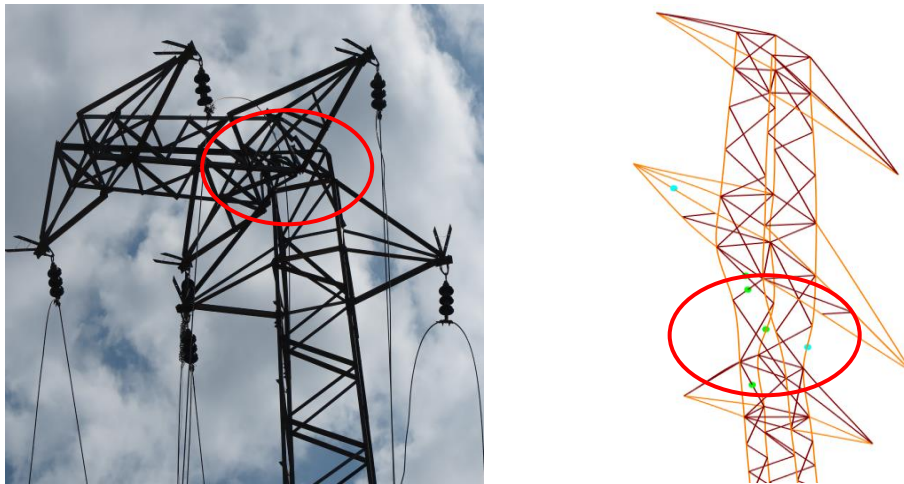
case in No.107 and No.108 towers, and MCB loading case in No.106 tower. Comparison of the observed and predicted failures in each of the investigated towers are presented in Figure 4.21, Figure 4.22, and Figure 4.23. Predicted total collapse patterns of all three towers by nonlinear analyses agree well with the failure patterns observed at the site.

Figure 4.21. Observed and predicted collapse of No.106 tower

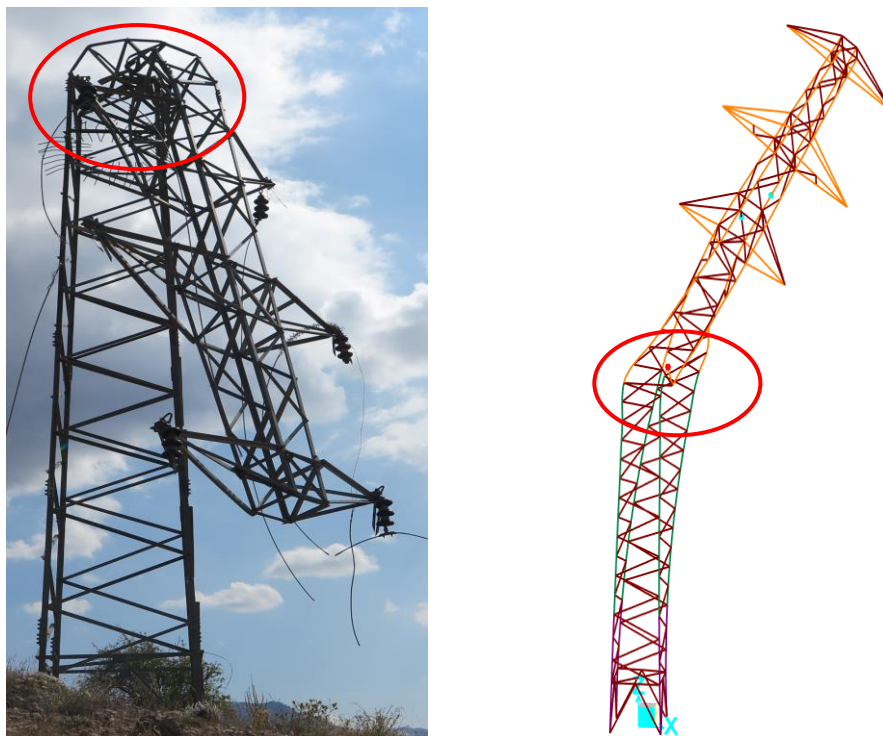
Figure 4.22. Observed and predicted collapse of No.107 tower

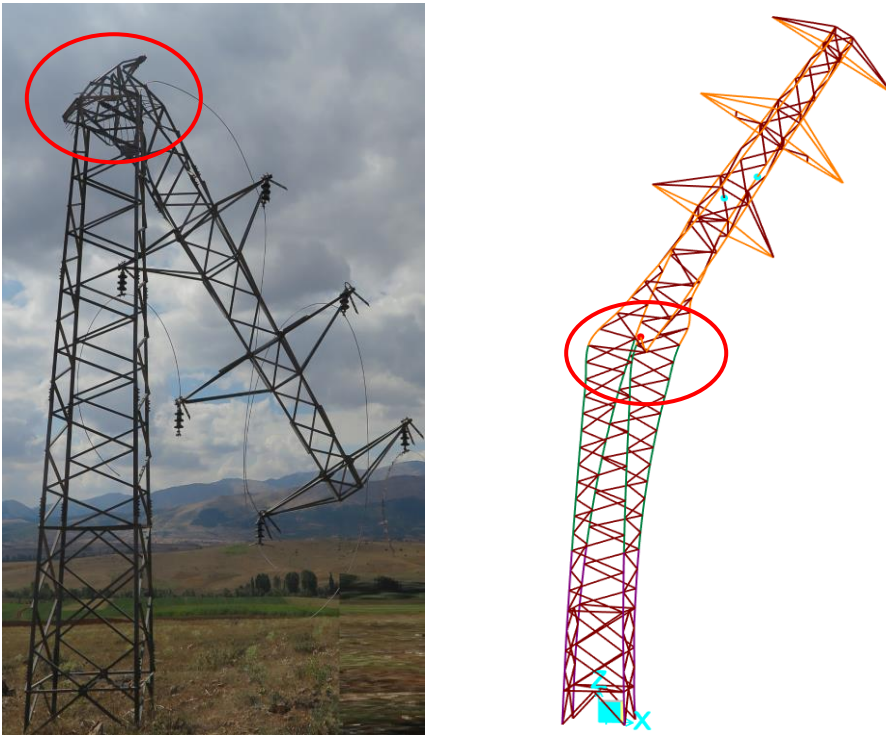
Figure 4.23. Observed and predicted collapse of No.108 tower
