NONLINEAR PERFORMANCE ANALYSIS OF STEEL LATTICE ENERGY
DISTRIBUTION TOWERS

A THESIS SUBMITTED TO
THE GRADUATE SCHOOL OF NATURAL AND APPLIED SCIENCES
OF
MIDDLE EAST TECHNICAL UNIVERSITY

FEBRUARY 2022

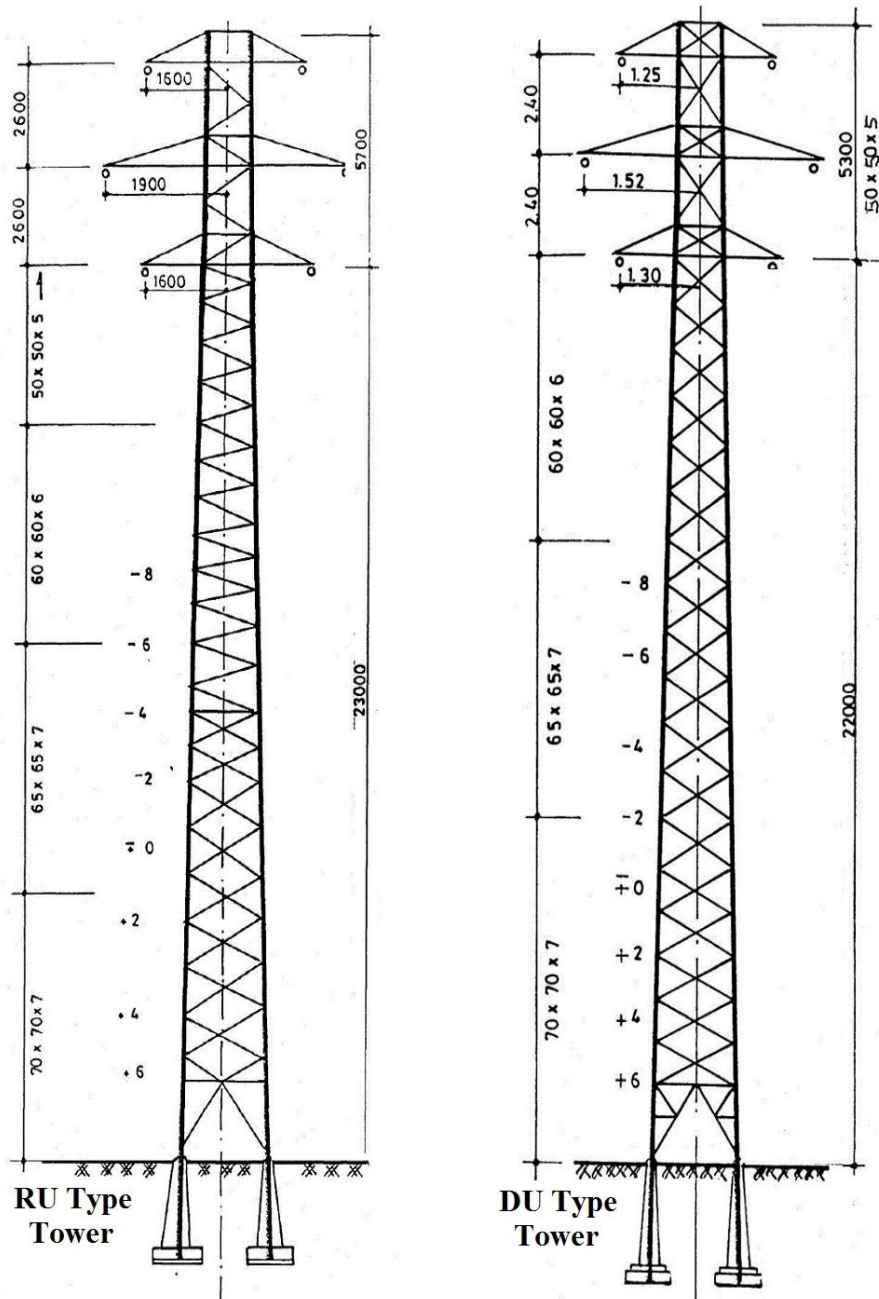
Figure A.1. Schematic figures of RU and DU type towers

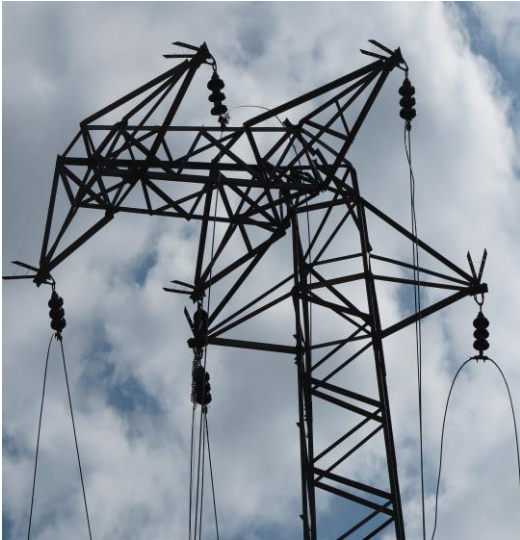
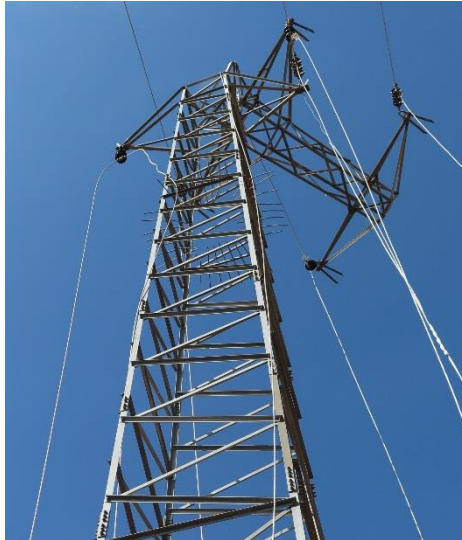
Figure B.1. No.106 tower (Torsional deformation of the tower cage between the middle and bottom crossarms)

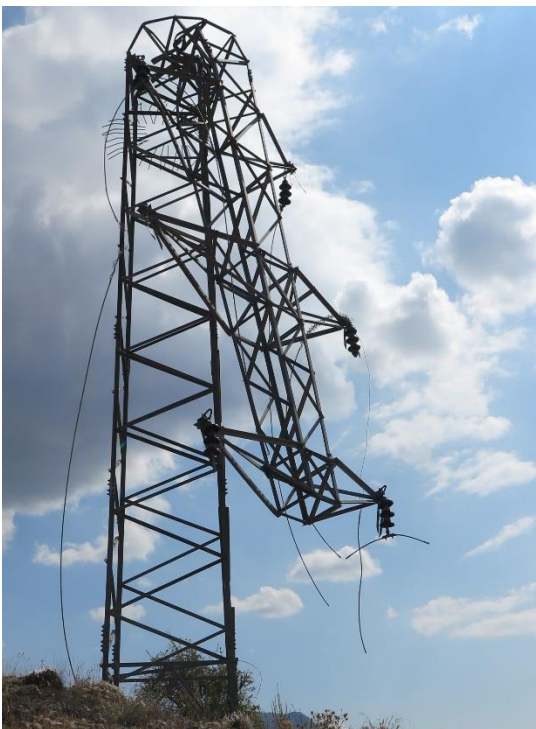
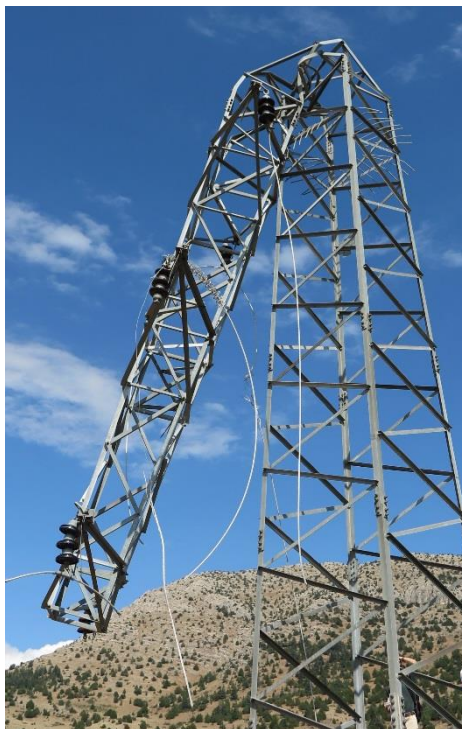
Figure B.2. No.107 tower (Buckling of leg members in tower body)

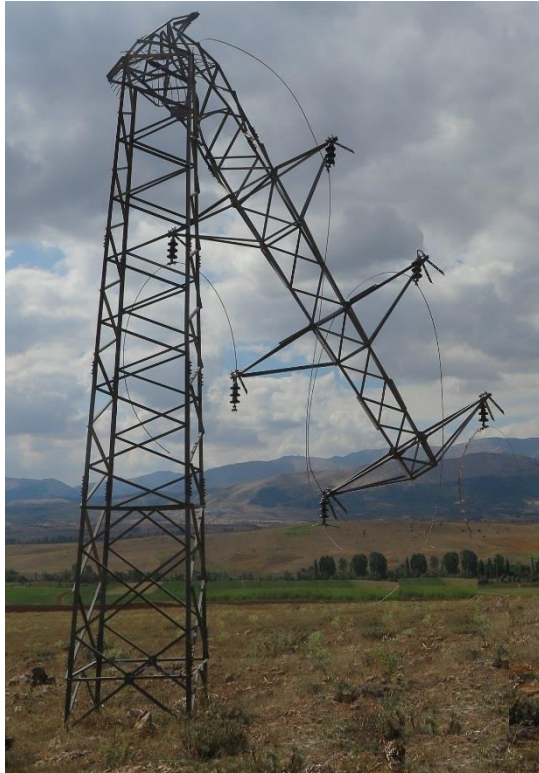
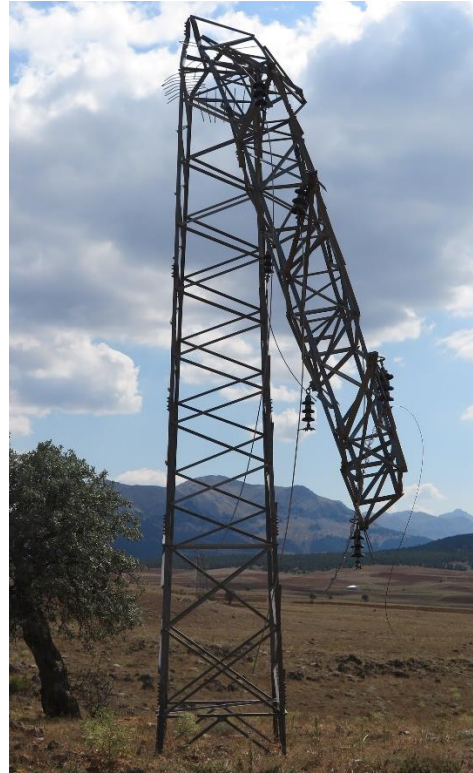
Figure B.3. No.108 tower (Buckling of leg members in tower body)

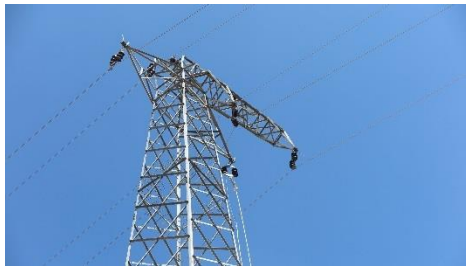
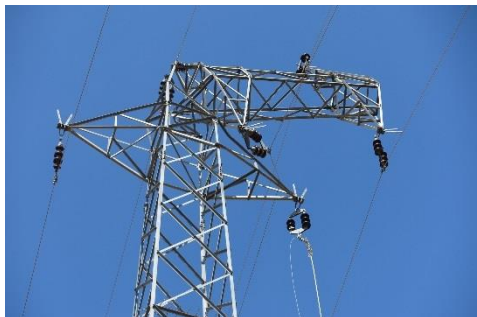
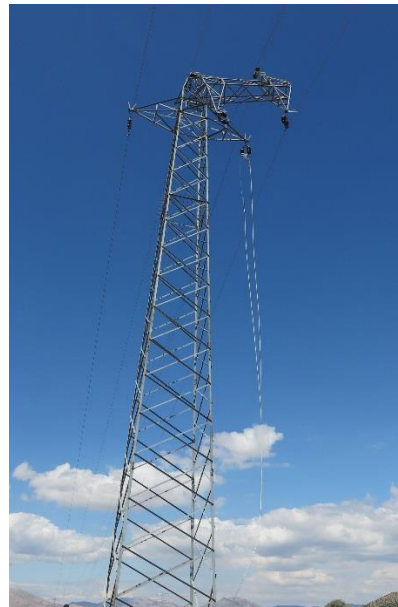
Figure B.4. No.116 tower (Torsional deformation of the tower cage between the middle and bottom crossarms)

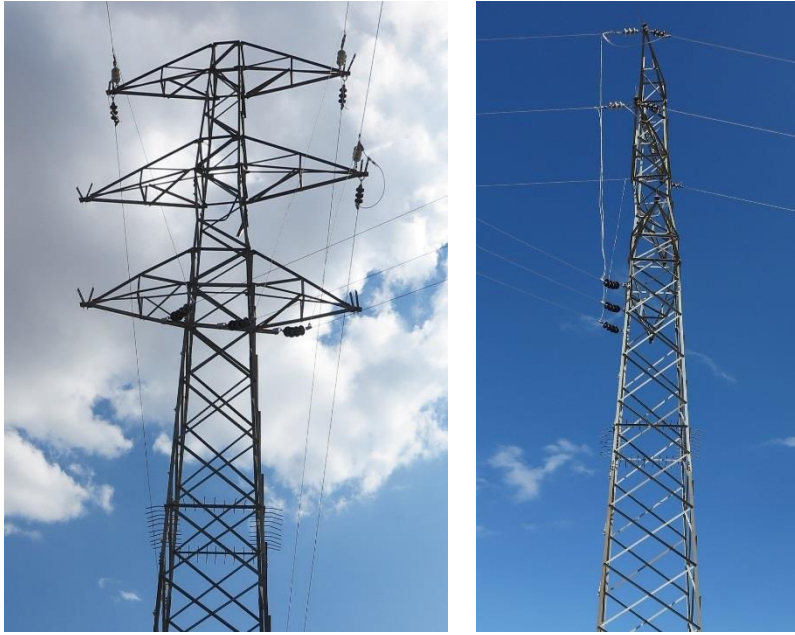
Figure B.5. No.127 tower (Deformation of the tower cage)
