THE INFLUENCE OF MANUFACTURING DEFECTS ON STRUCTURAL
PERFORMANCE OF COMPOSITE OVERWRAPPED PRESSURE VESSELS

A THESIS SUBMITTED TO
THE GRADUATE SCHOOL OF NATURAL AND APPLIED SCIENCES
OF
MIDDLE EAST TECHNICAL UNIVERSITY

FEBRUARY 2022

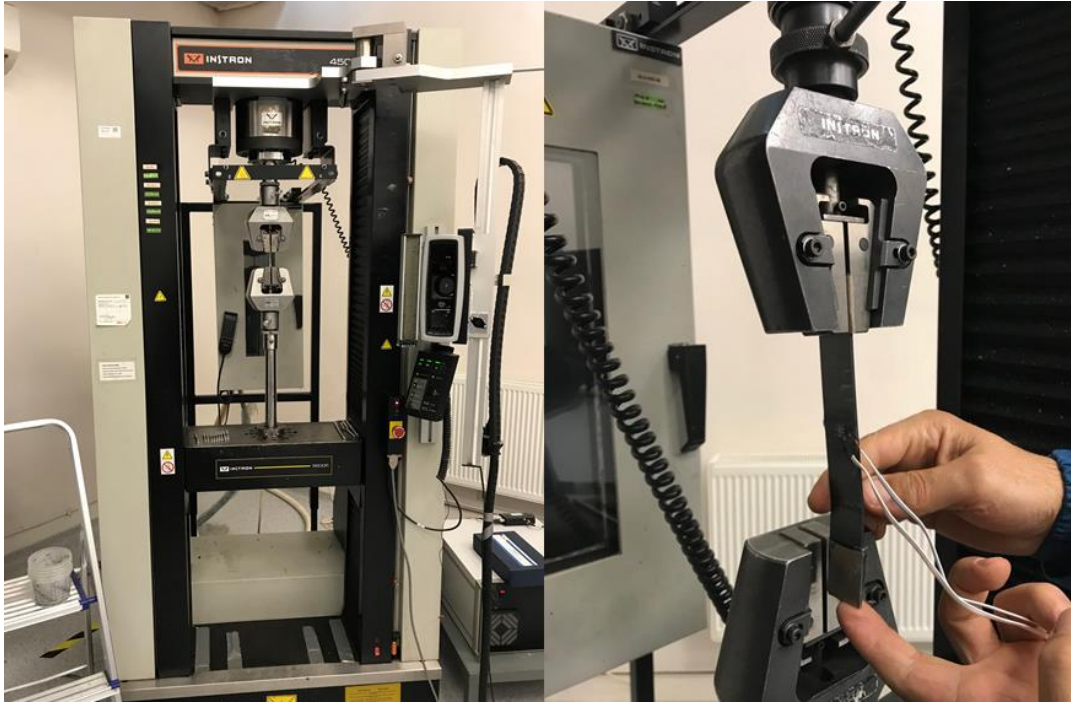
Figure 3.3 Transverse tensile testing setup of carbon/epoxy coupons

Instron testing machine with 20 tons capacity is used for the tensile testing. Class 0.5 load cell is used and crosshead speed is determined as 2mm/min. Tensile testing setup of 90° carbon/epoxy coupon is given in Figure 3.3.

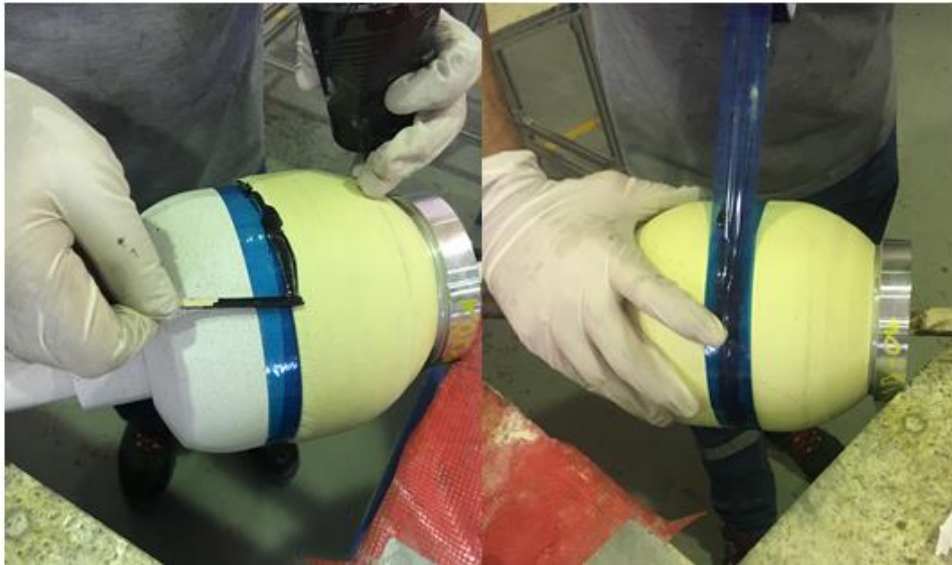
Figure 3.8 Adhesion of EPDM liner on the mandrel

Adhesion process is applied on the water soluble mandrel and the epoxy based adhesive material is cured for 3 hours at 60 °C under -0.80 bar vacuum pressure applied. After curing of the adhesive, the residuals are being removed with grinding to achieve smooth surface before filament winding process.

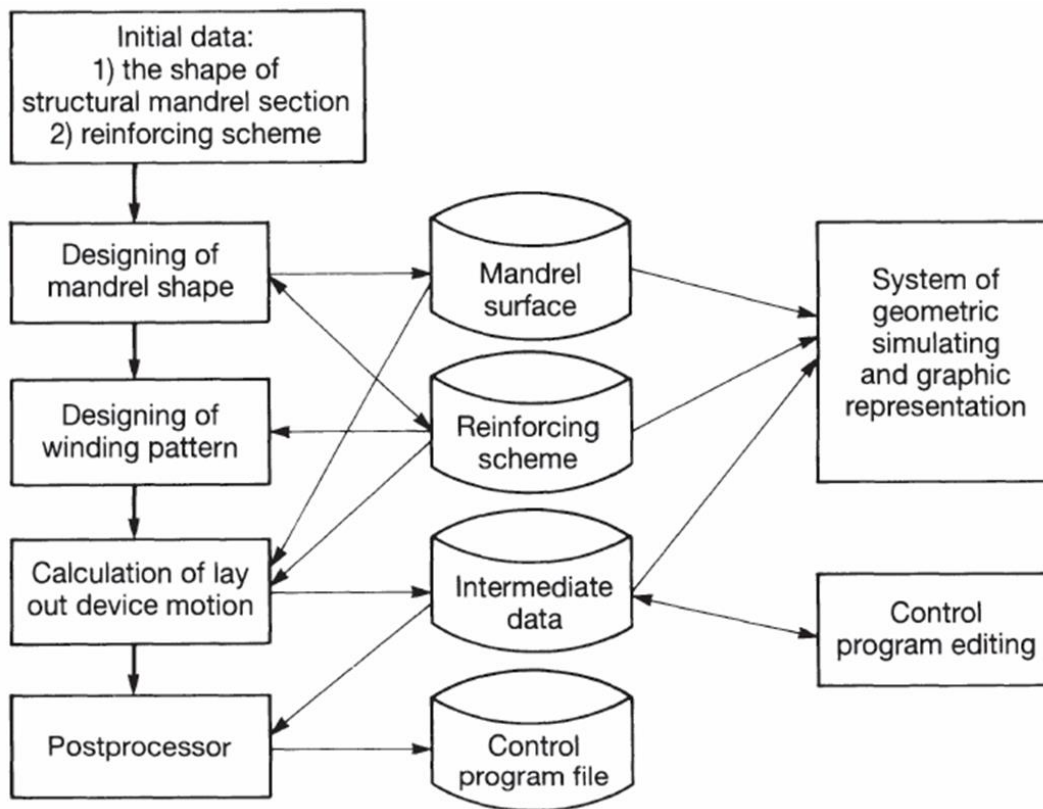
Figure 3.9 Filament winding process design steps (10)

Firstly, at the winding software the mandrel generation shall be done. Since the mandrel has an axisymmetric geometry, the mandrel geometry is defined with radius, length positions and the winding angle at these positions that are defined in the design stage of the COPV sample. After geometrical parameters are defined to the software, it is required to specify the fiber bandwidth.

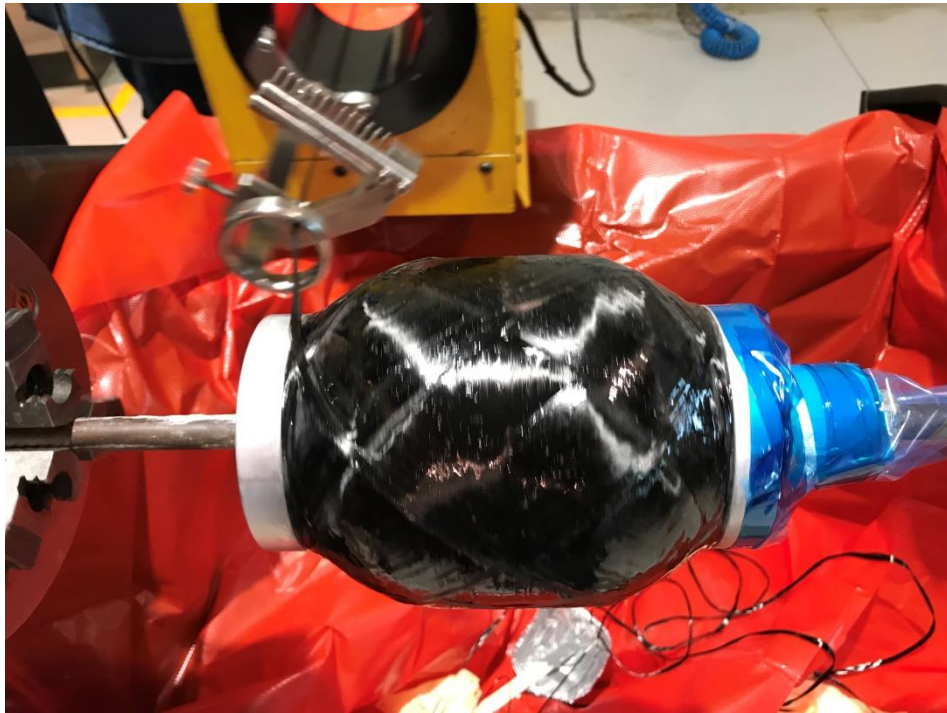
Figure 3.10 Helical layer winding process of XOXOO COPV sample

For the winding of 5 layers with the sequence of XOXOO starting from the inner side of the composite is wound by using a single helical winding program for two helical layers and a single hoop winding program for three hoop layers. Same programs are used for the winding of OXOX and XOX layer configurations. The program is selected from the filament winding machine and the machine axes move to the starting point of the first helical layer. Resin impregnated fiber is pulled by hand and fastened to the left polar opening by circling around 3 times before starting to winding process. The winding process of first helical layer takes approximately 10 minutes with the 20 rpm of mandrel speed and the fiber tension is set to 2 kg of load. In order to achieve complete coverage of the helical layer, the machine travels 116 circuits. After finishing the helical layer, the impregnated fiber cuts and the ending of the fiber is attached to the left opening by the tackiness of the resin. Helical layer winding for COPV is shown in Figure 3.10.

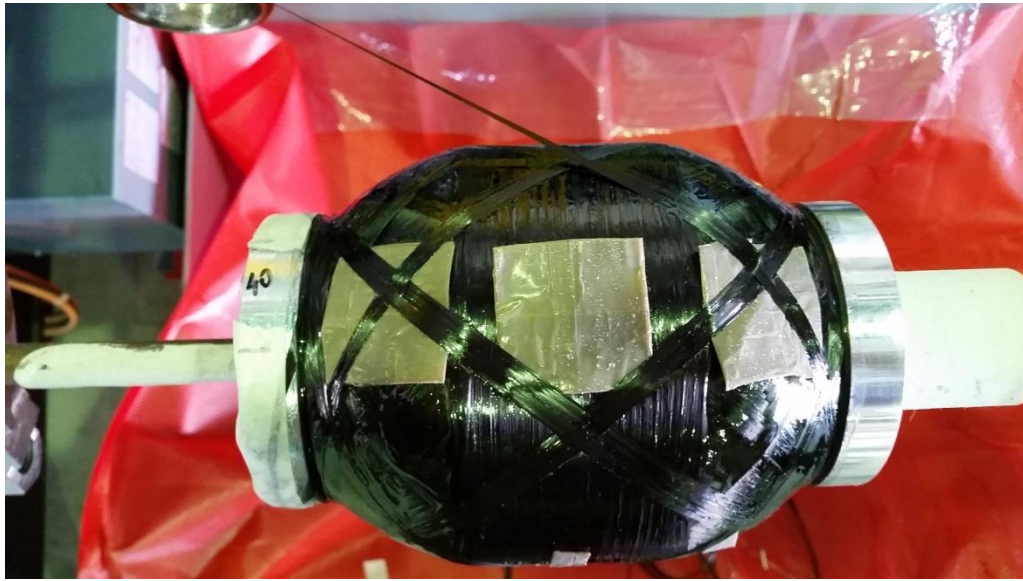
Figure 3.11 Embedding of PTFE delamination defects to calibration COPV sample
During winding of the second helical layer, the artificial defects manually attached on the hoop layer to the predetermined locations by the help of the tackiness of the epoxy resin. Sometimes during winding of the helical layer, artificial defects may separate from the surface. By carefully handling of the artificial defect, mandrel speed set to the value of 1-2 rpm and the tensioned fiber holds the defect at some point.

Embedding of the artificial defects during filament winding process of calibration COPV Sample is shown in Figure 3.11.

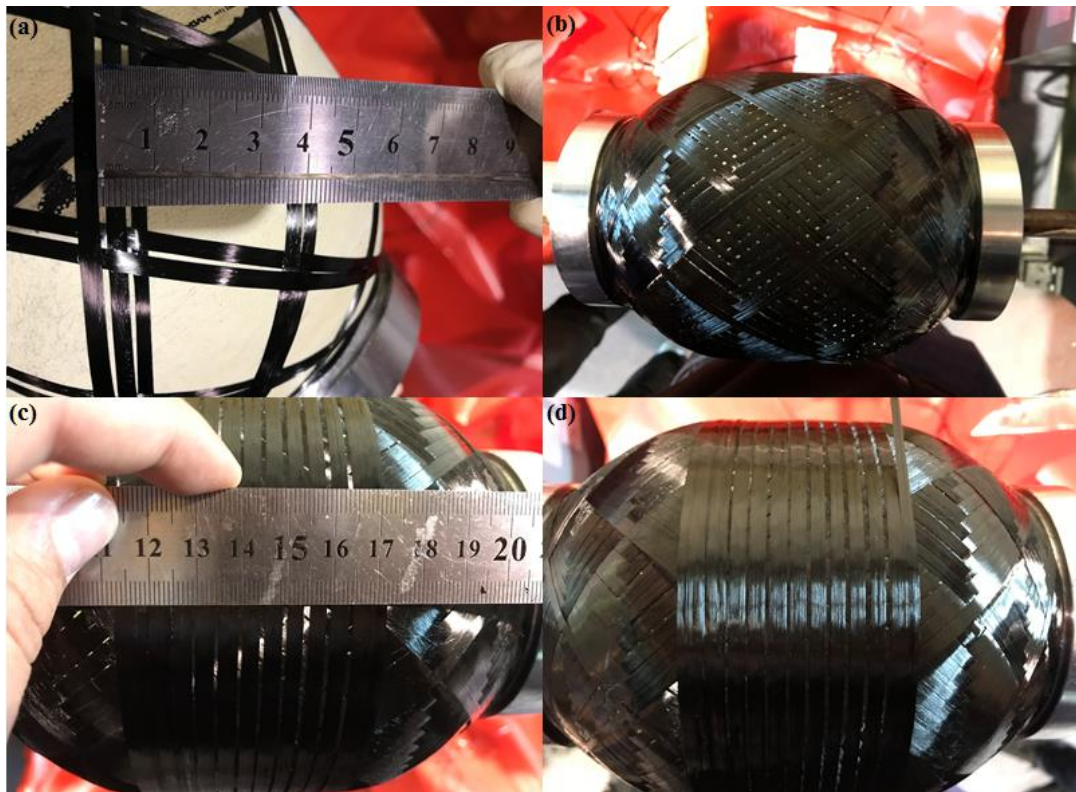
Figure 3.15 (a) 1.0-1.5 mm spaced winding of helical layer in COPV (b) spaced wound helical layer (c) 1.0-1.5 mm spaced winding of hoop layer in COPV (d) completed spaced wound XOX COPV sample

For the COPV samples that has no gap, the bandwidth is chosen as 3 mm as explained in the generating winding program for COPV. When single layer is completely wound, there are no gaps observed with 3 mm bandwidth. In order to observe 1.0-1.5 mm gaps between each fiber bundle, the bandwidth is selected between 4.5 mm. The winding software calculated the pattern as 5 with 78 circuits when bandwidth is defined as 4.5 mm. As it can be seen from Figure 3.15, the helical and hoop layers with spaced winding are achieved by using defined methodology.

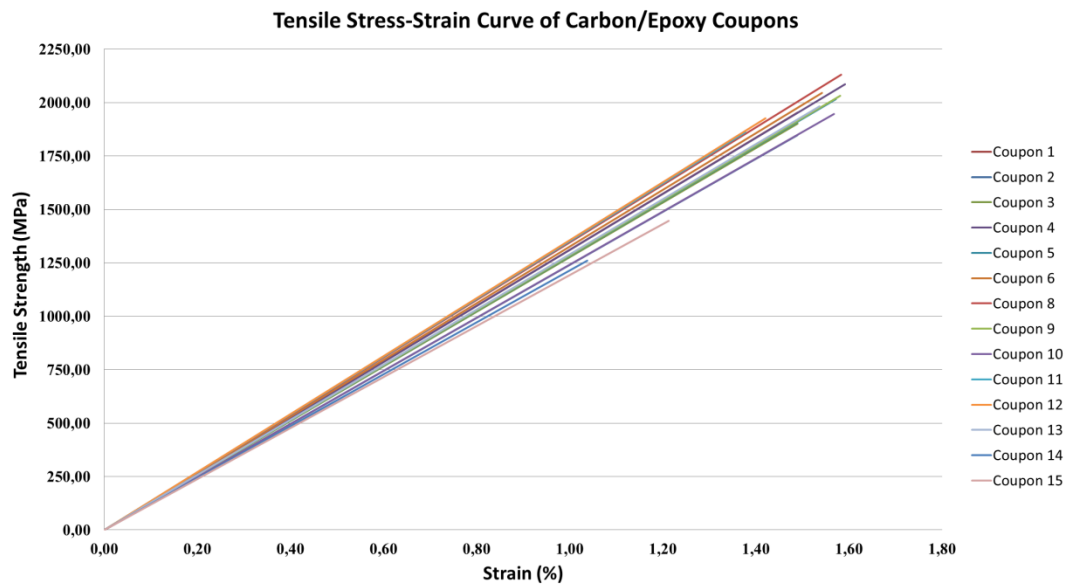
Figure 4.1 Longitudinal tensile stress-strain curve of carbon/epoxy coupons

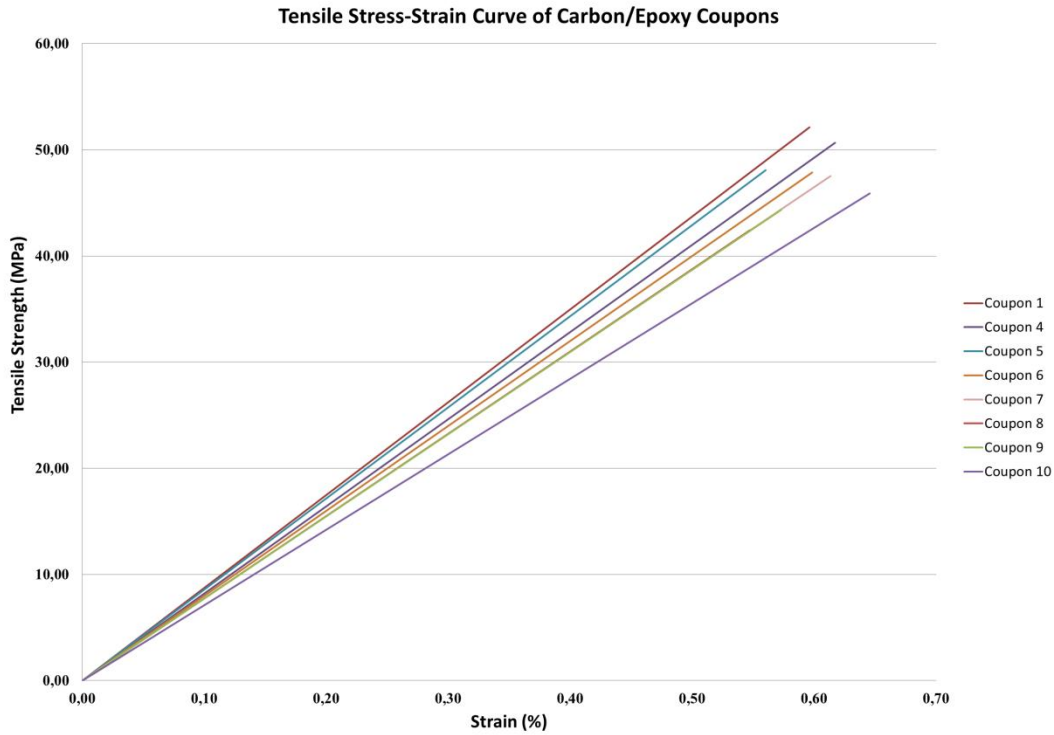
Figure 4.3 Transverse tensile stress-strain curve of carbon/epoxy coupons

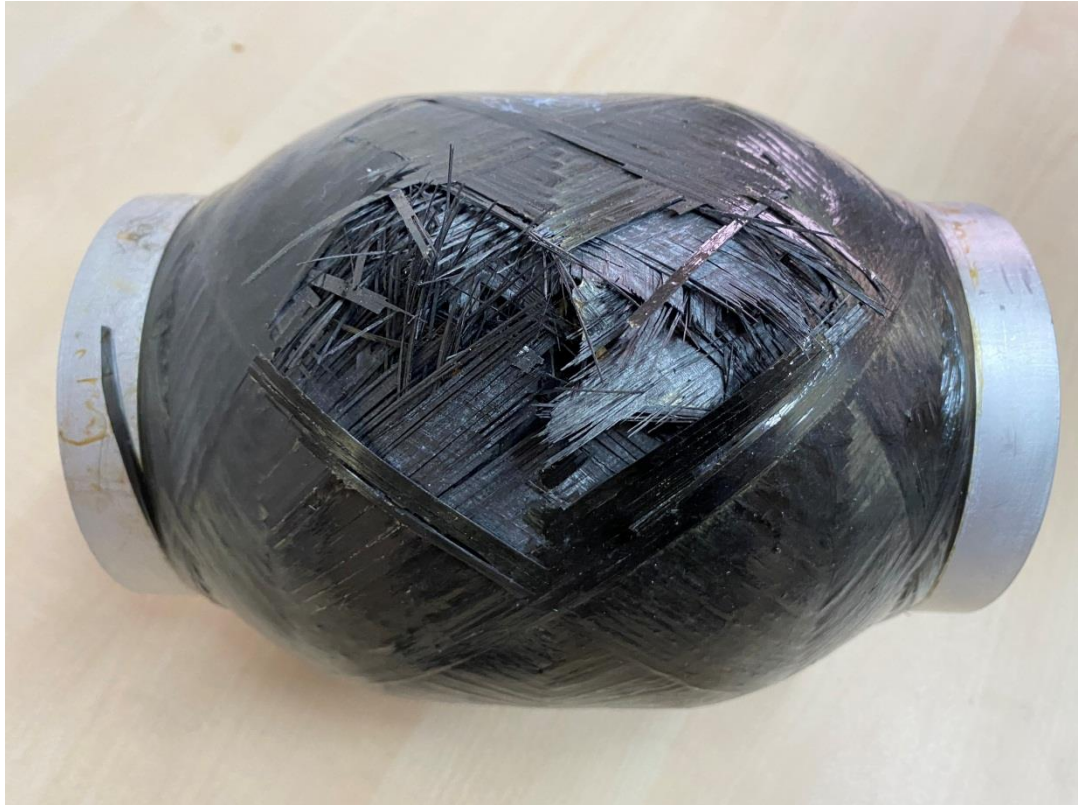
Figure 4.9 Macro image of XOX COPV (with no defect) failure surface.

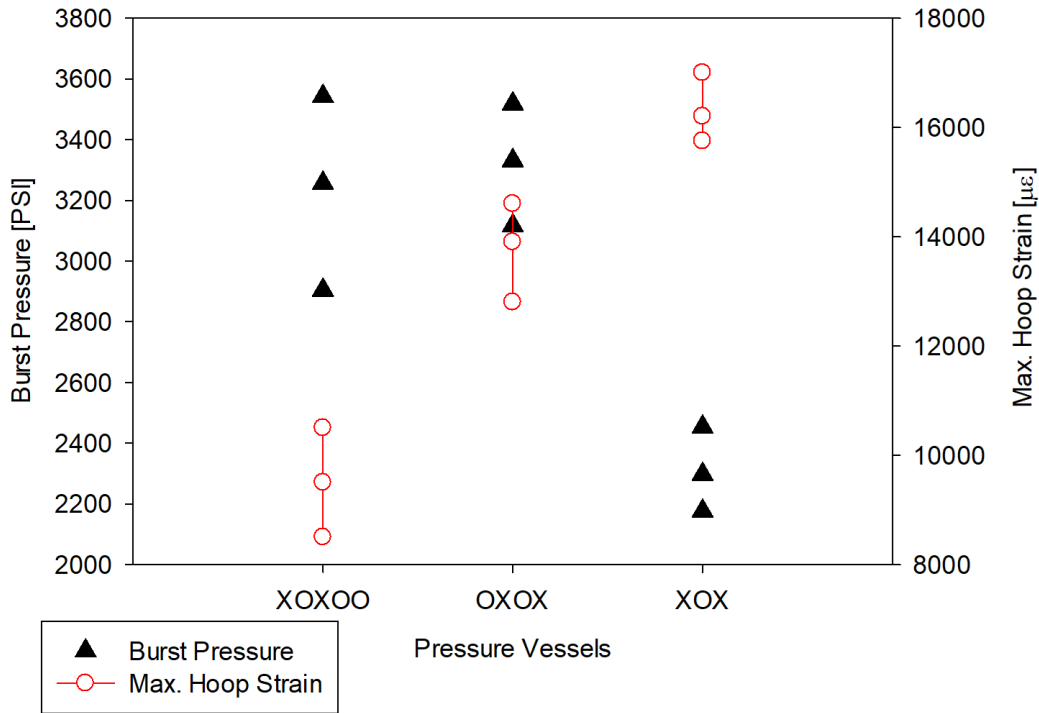
Figure 4.12 Burst pressures and maximum hoop strains for XOX, OXOX and XOXOO layer configurations

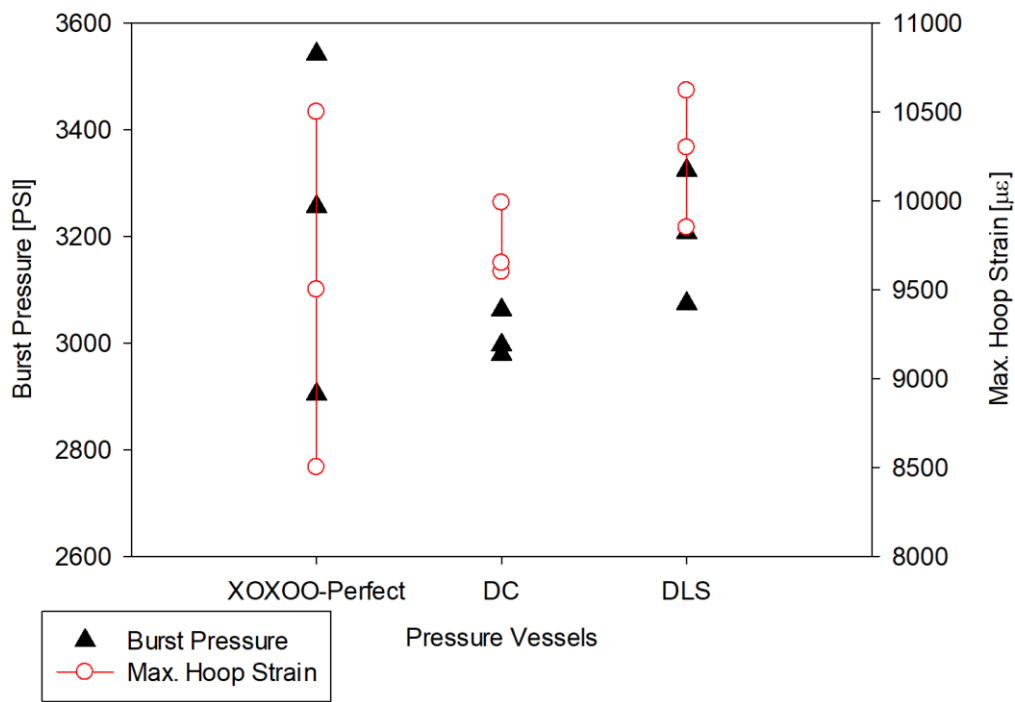
Figure 4.17 Burst pressures and maximum hoop strains for XOXOO layer configuration with delamination

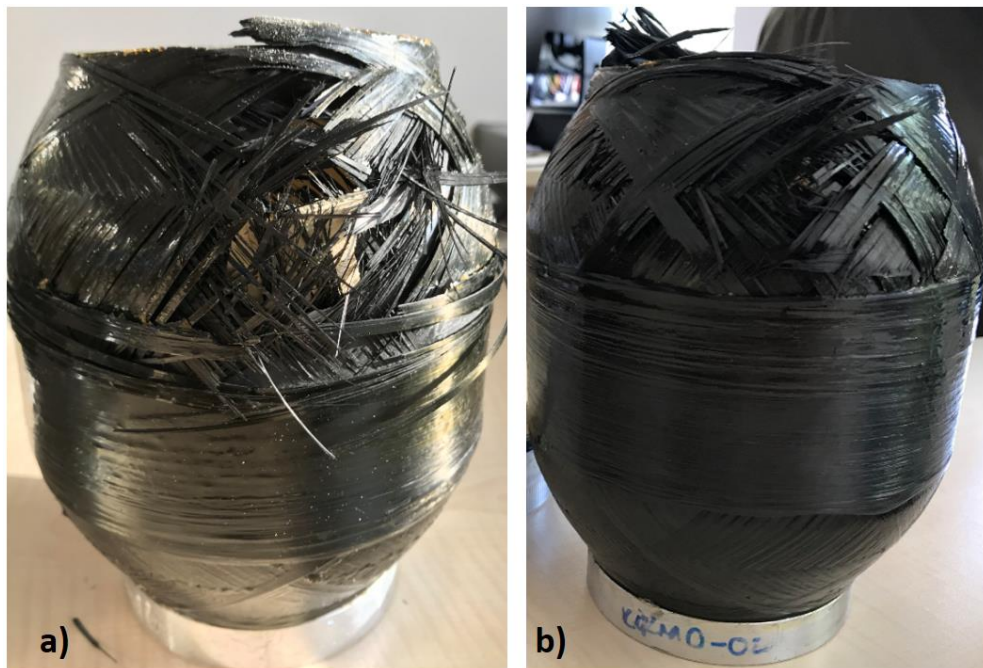
Figure 4.18 Burst modes of the XOXOO windings a) DC b) DLS

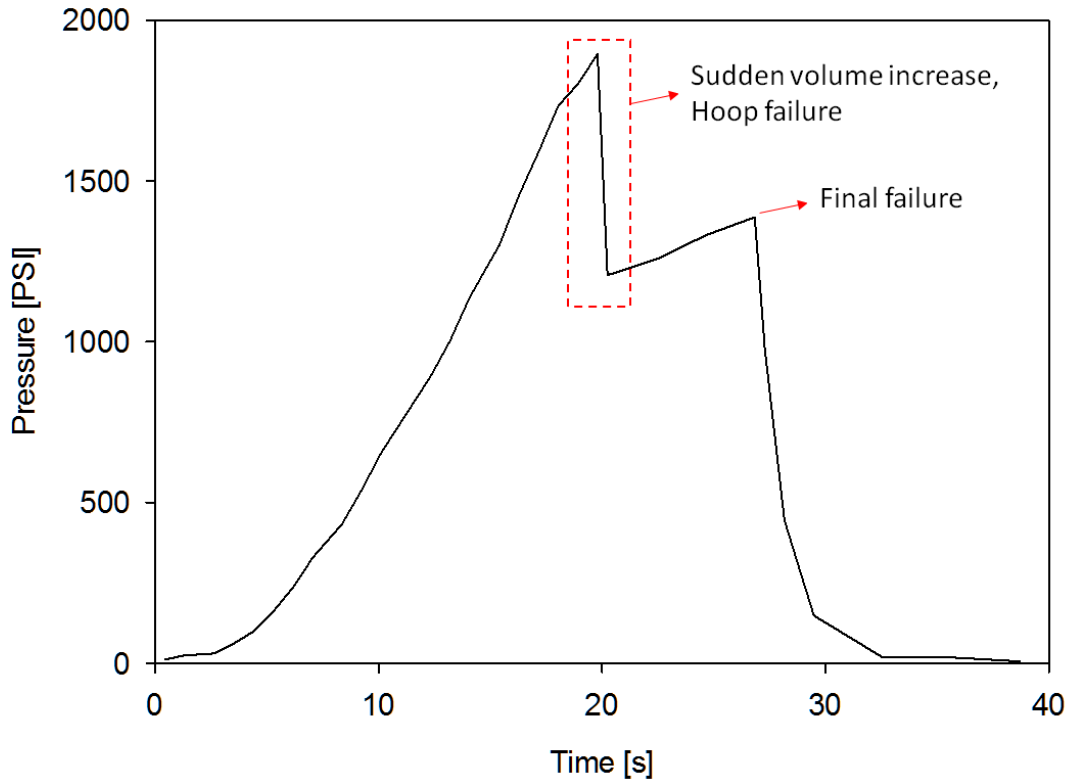
Figure 4.22 Pressure vs. time graph of XOX DC sample

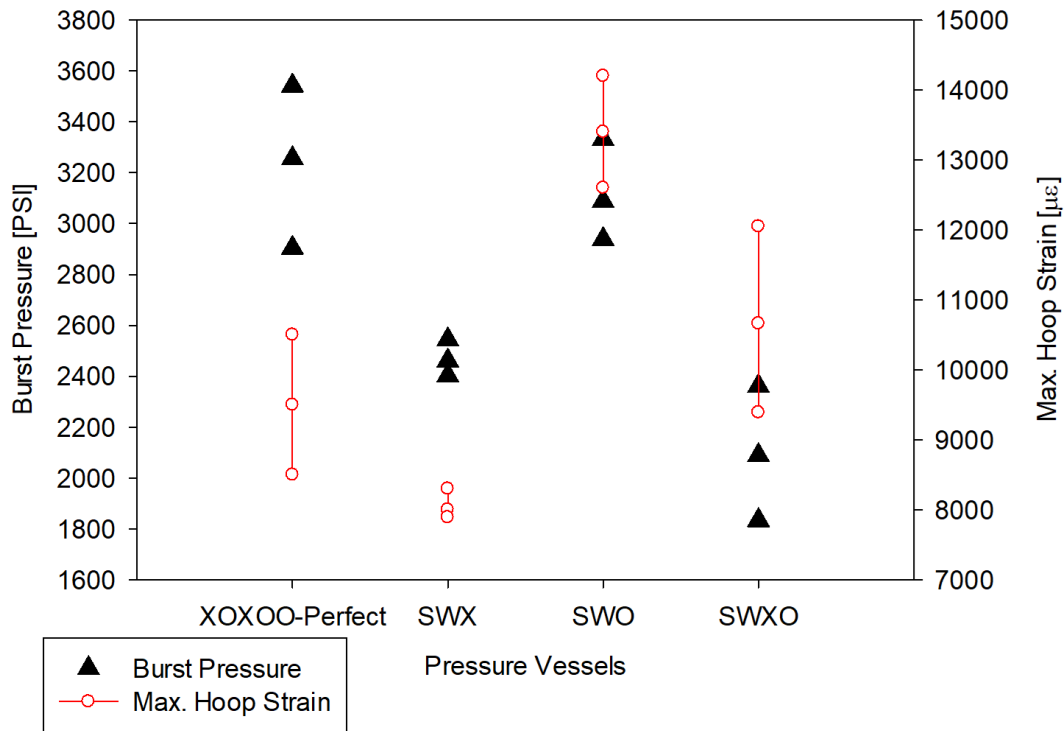
Figure 4.24 Burst pressure and maximum hoop strains for spaced winding XOXOO COPVs
