ENGINEERING GEOLOGICAL CHARACTERIZATION OF THE ROCK
MASSES AND THEIR EVALUATION BY SPATIAL ANALYSES,
DETERMINATION OF THE ROCK SLOPE FAILURE SUSCEPTIBILITY
ZONES AND HAZARD ASSESSMENT OF MUDURNU (BOLU)

A THESIS SUBMITTED TO
THE GRADUATE SCHOOL OF NATURAL AND APPLIED SCIENCES
OF
MIDDLE EAST TECHNICAL UNIVERSITY

IN PARTIAL FULFILLMENT OF THE REQUIREMENTS
FOR
THE DEGREE OF DOCTOR OF PHILOSOPHY
IN
GEOLOGICAL ENGINEERING

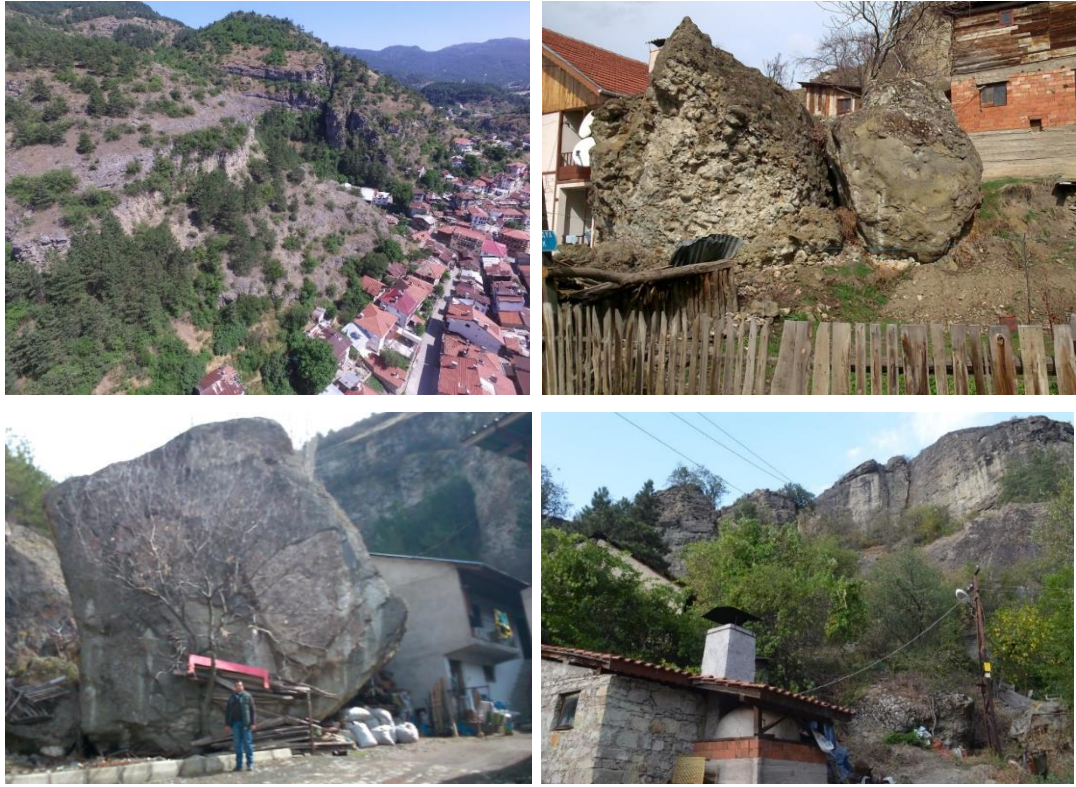
Figure 4: Views from the rock mass of the east side of the Mudurnu valley which shows those houses that are under the threat of the large blocks

The slopes are prone to instability through modes of failure that are different on the western and eastern sides of the valley, as a consequence of the different rock mass properties which makes Mudurnu an attractive and distinctive site for the investigation of rock mass failure. Geological units outcropped in the Mudurnu county center are Quaternary alluvium, Late Cretaceous Üzümlü formation, and Değirmenözü member (Saner, 1980). The Üzümlü formation is composed of the alternation of thin-thick bedded volcanoclastic sandstone and thin-bedded shale. On the east side, the Üzümlü formation outcrops as volcanoclastic sandstone that is prone to rock falls. Volcanoclastic blocks are held in place by a less durable matrix that has low strength. As a result, the matrix decomposes due to weathering which

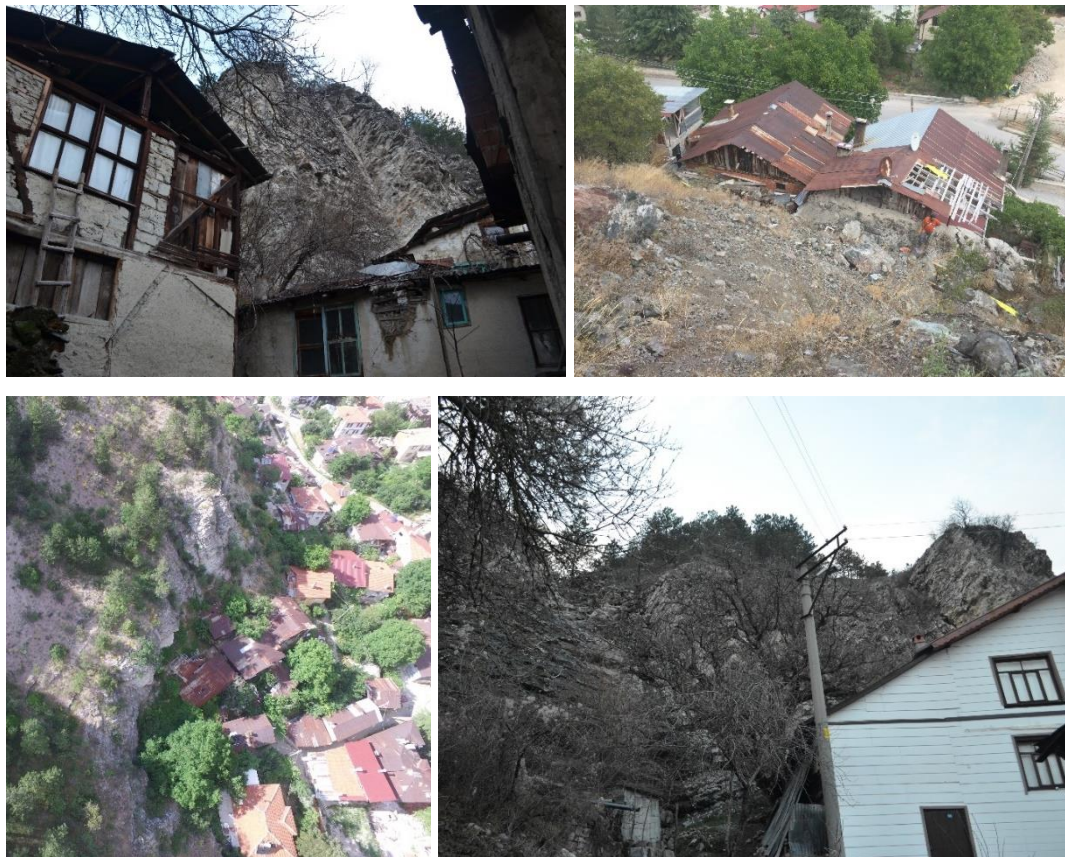
Figure 5: Views from the rock mass of the western side of the Mudurnu valley and houses under threat

leads to the fall of rock blocks. The discontinuous limestone found in the study area belongs to the Late Cretaceous Değirmenözü member of the Yenipazar formation. The discontinuous Pelagic Limestone creates discontinuity-controlled complex kinematic failures (i.e., a combination of the planar, wedge, or toppling failures) on the western side of the Mudurnu valley.

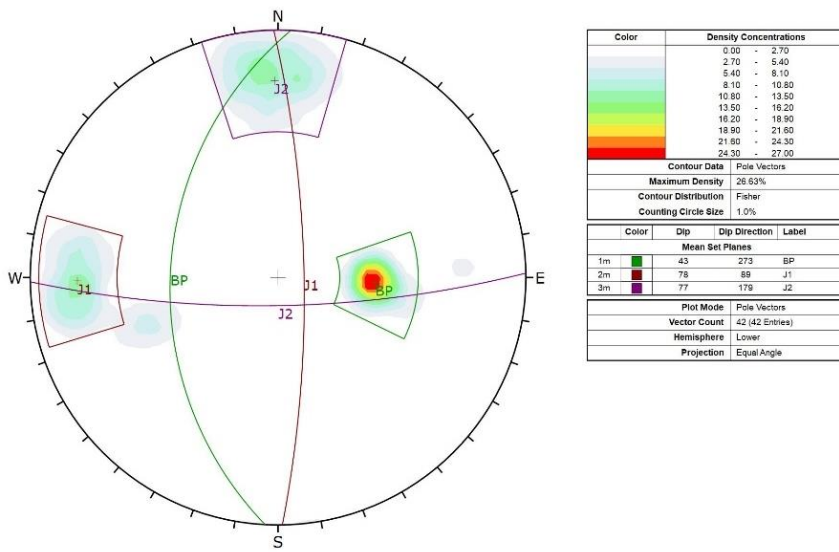
Figure 12: Distribution of the discontinuities and the identified sets of Sector 2

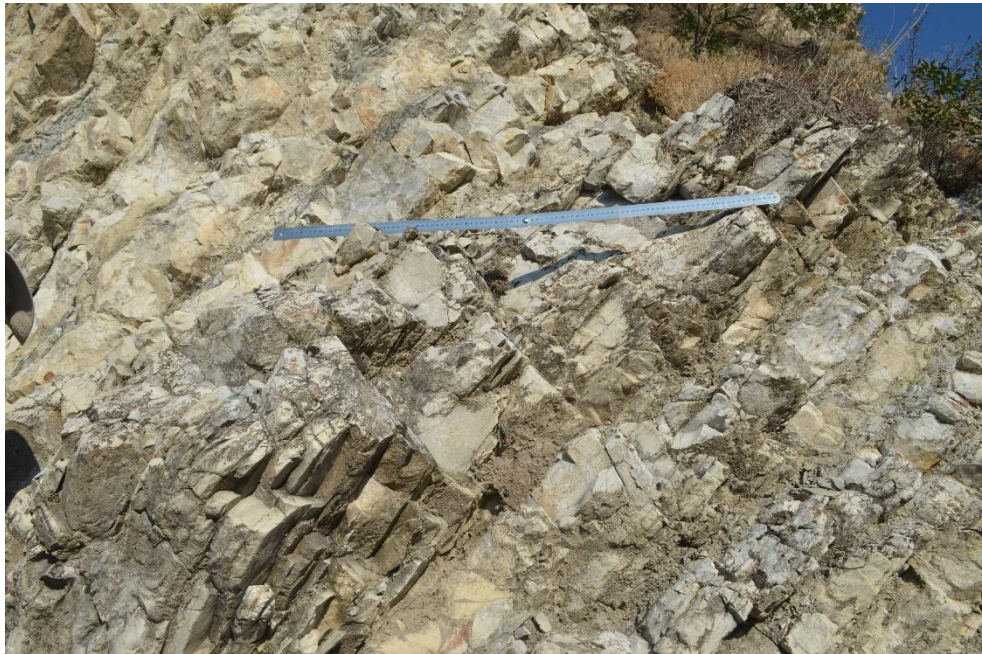
Figure 17: A close-up view of discontinuous limestone. Note the 2 m long measuring tape as a scale

The rock mass was characterized according to the field observations and the scan-line survey method as follows. The lithology was identified as limestone that is pinkish gray to light gray in color (Figure 17). The discontinuity orientation measurements collected by the scan-line survey revealed that there were three discontinuity sets (BP, J1, and J2). The discontinuity sets had strong to very strong strengths according to the field identification where several blows of a geological hammer were required to fracture the surfaces (ISRM, 2007). In general, the limestone was slightly weathered to moderately weathered at several locations. The discontinuity surfaces were described as undulating rough to undulating smooth, and the apertures were classified as closed in general, but there were moderately wide and open surfaces as well. Clay and silty clay infilling were observed in the apertures. The discontinuities were close to moderately spaced, in general. Persistence was high. Block sizes varied between medium to large. Water was not observed during any of the field studies conducted at different seasons of the year. However, some color changes were detected at several places. In addition, surface drainage flow through the slope face was encountered at one location (Figure 18a) in the spring season during snow melt. Hence, it is almost certain that surface drainage could affect the strength of rock masses, especially during the spring season when snow melt is encountered.

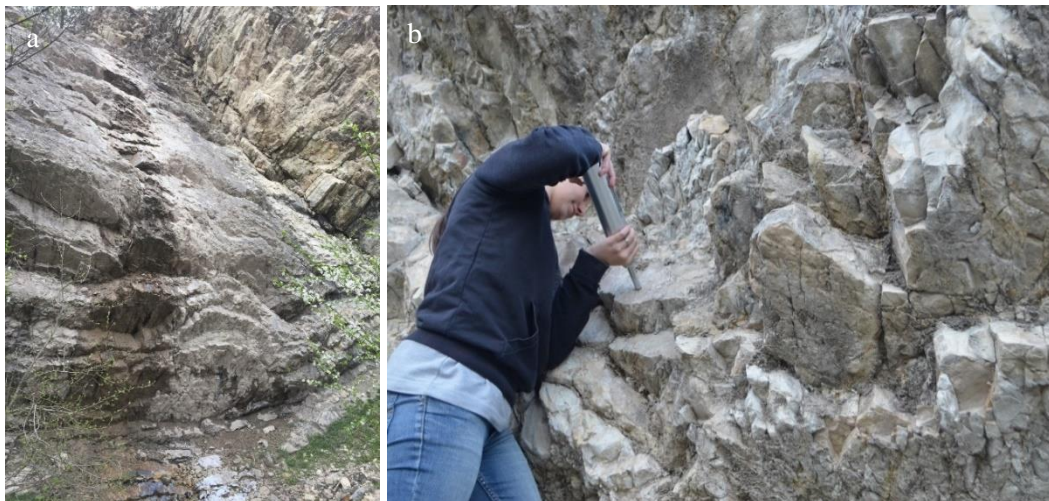
Figure 18: a) The surface drainage flow observed in the spring season, b) Schmidt hammer measurement in the field

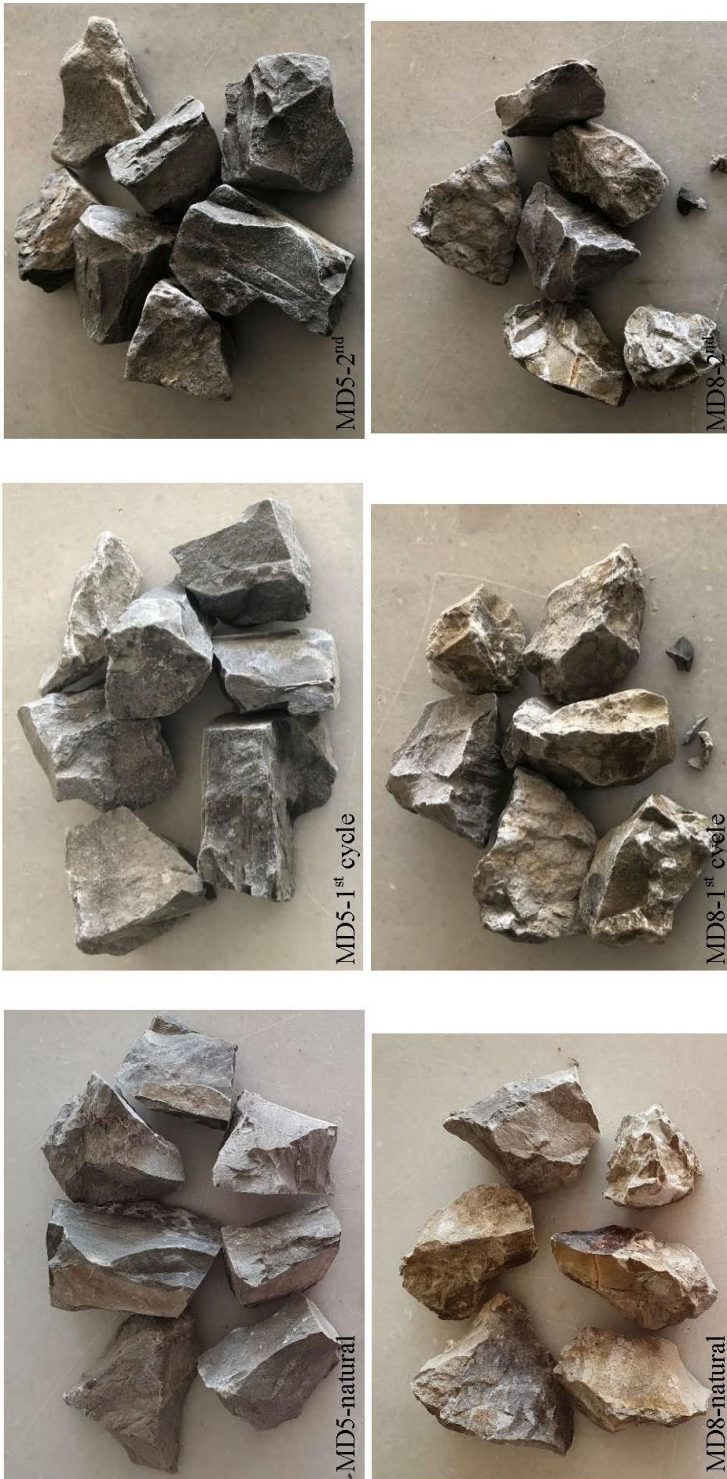
Figure 22: Slake Durability tested rock samples from Sectors 5 and 8. The first column shows a view of specimens before the test, whereas the second and third columns present the condition of the specimen following the 1st and 2nd cycles, respectively

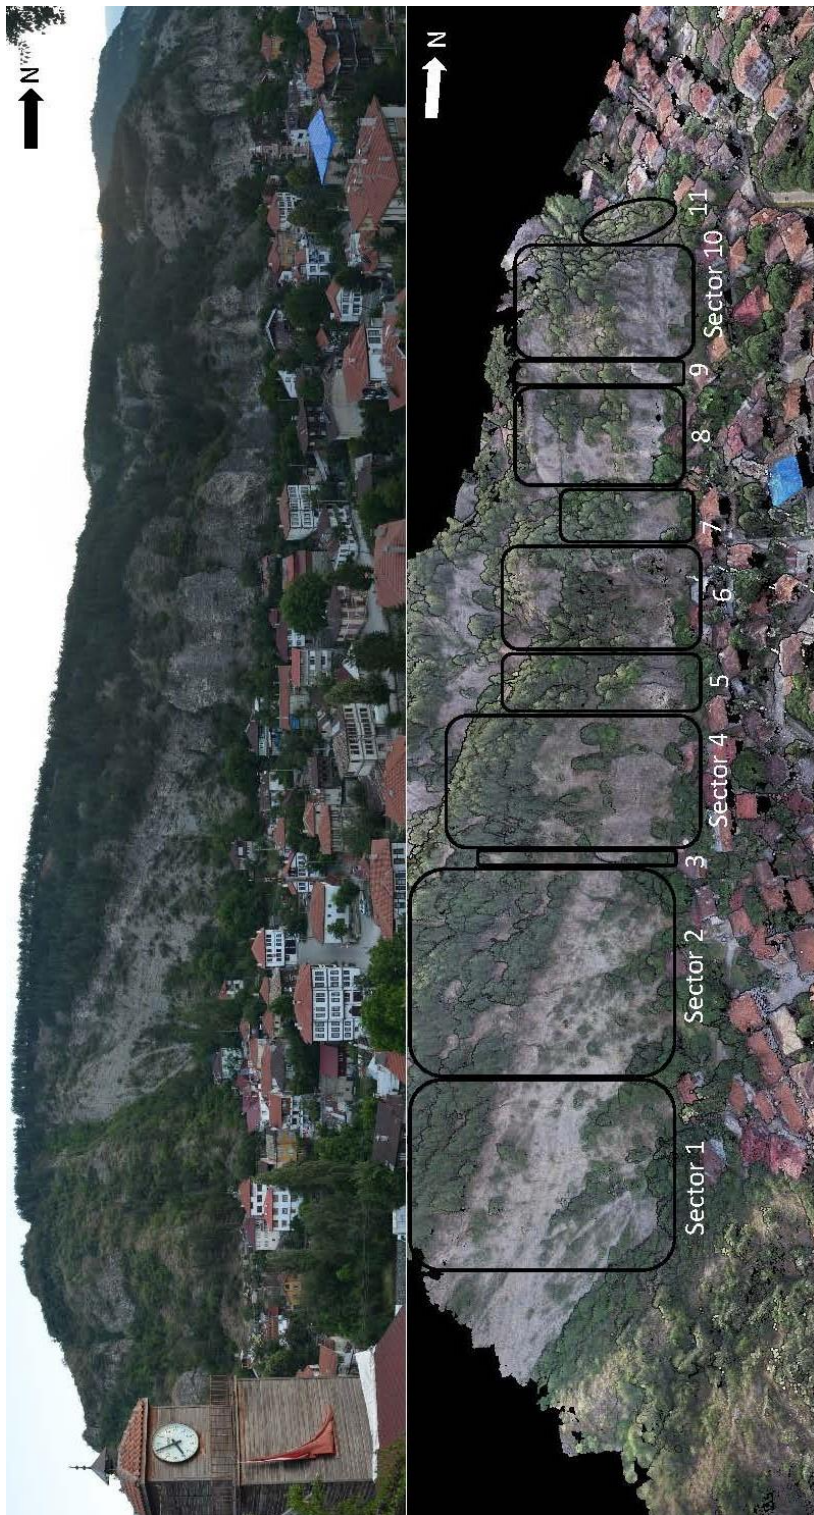
Figure 28: Delineated sectors defined as a result of a detailed evaluation of the rock mass characteristics

After the identification of the sectors, the discontinuity characteristics were gathered from the point cloud per sector. For the detection of discontinuity set orientations, the Discontinuity Set Extractor (DSE) method was utilized (Riquelme et al., 2014), as explained in Chapter 3.2.1. Afterwards, the results were compared with the field survey measurements. All the sectors were not physically accessible due to the steep nature of the slopes in the area; however, the DSE results were validated with data collected from Sectors 2, 4, 6, 8, and 10. The results obtained with DSE were comparable with those from the field observations. Thus, DSE results were accepted as reliable, and DSE was utilized to extract the discontinuity orientations of the inaccessible sectors. Discontinuity sets identified using DSE are given in Figures 29 through 35. In these figures, each set is represented by a different color. Table 10 gives the discontinuity orientations obtained from the field survey and the DSE method.

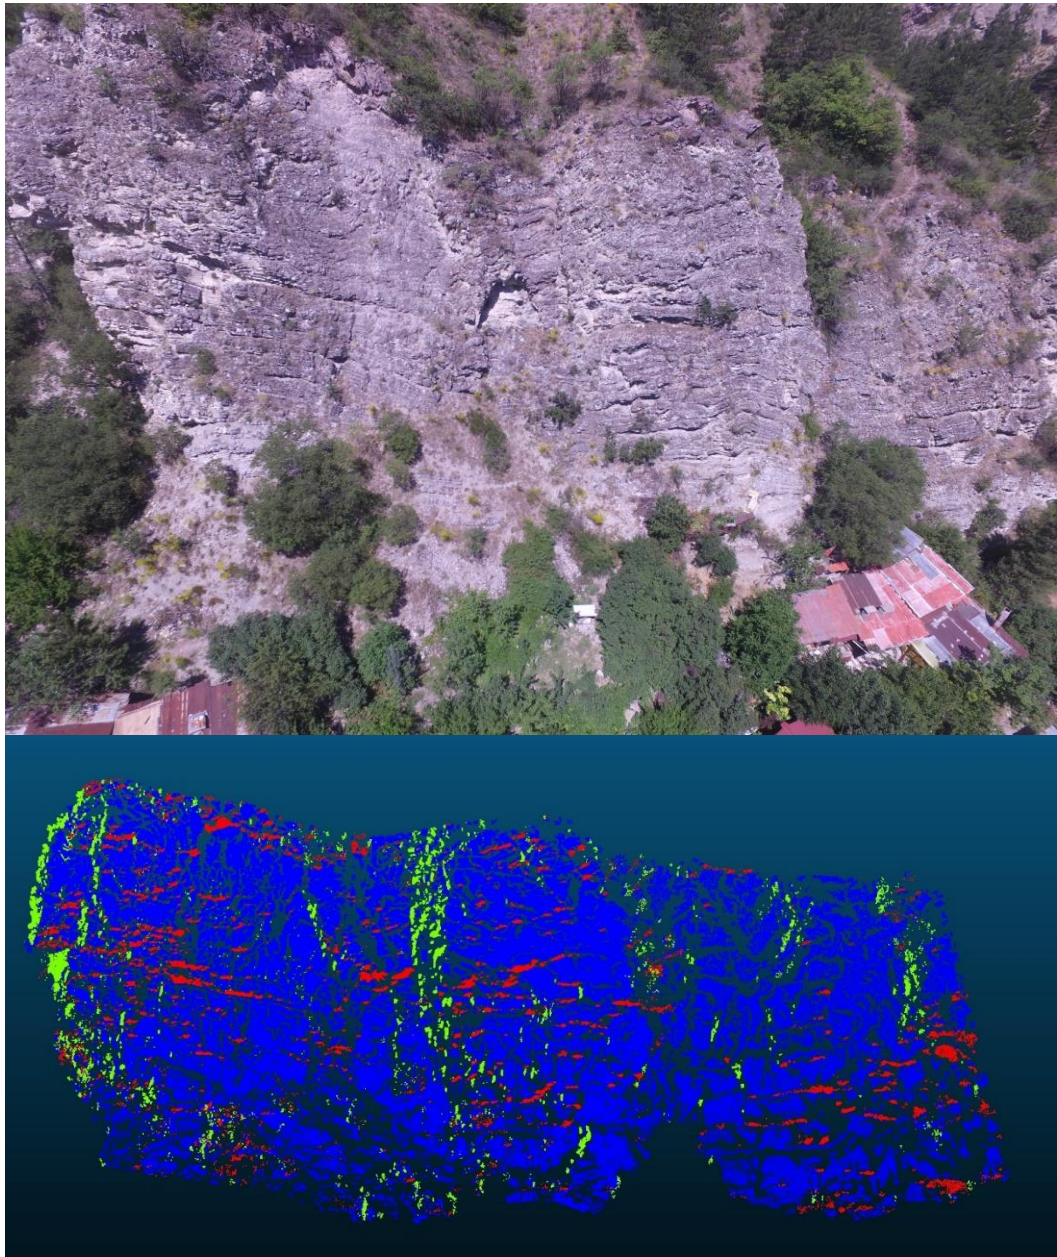
Figure 30: A view of Sectors 3 and 4 and the discontinuity sets identified by utilizing DSE

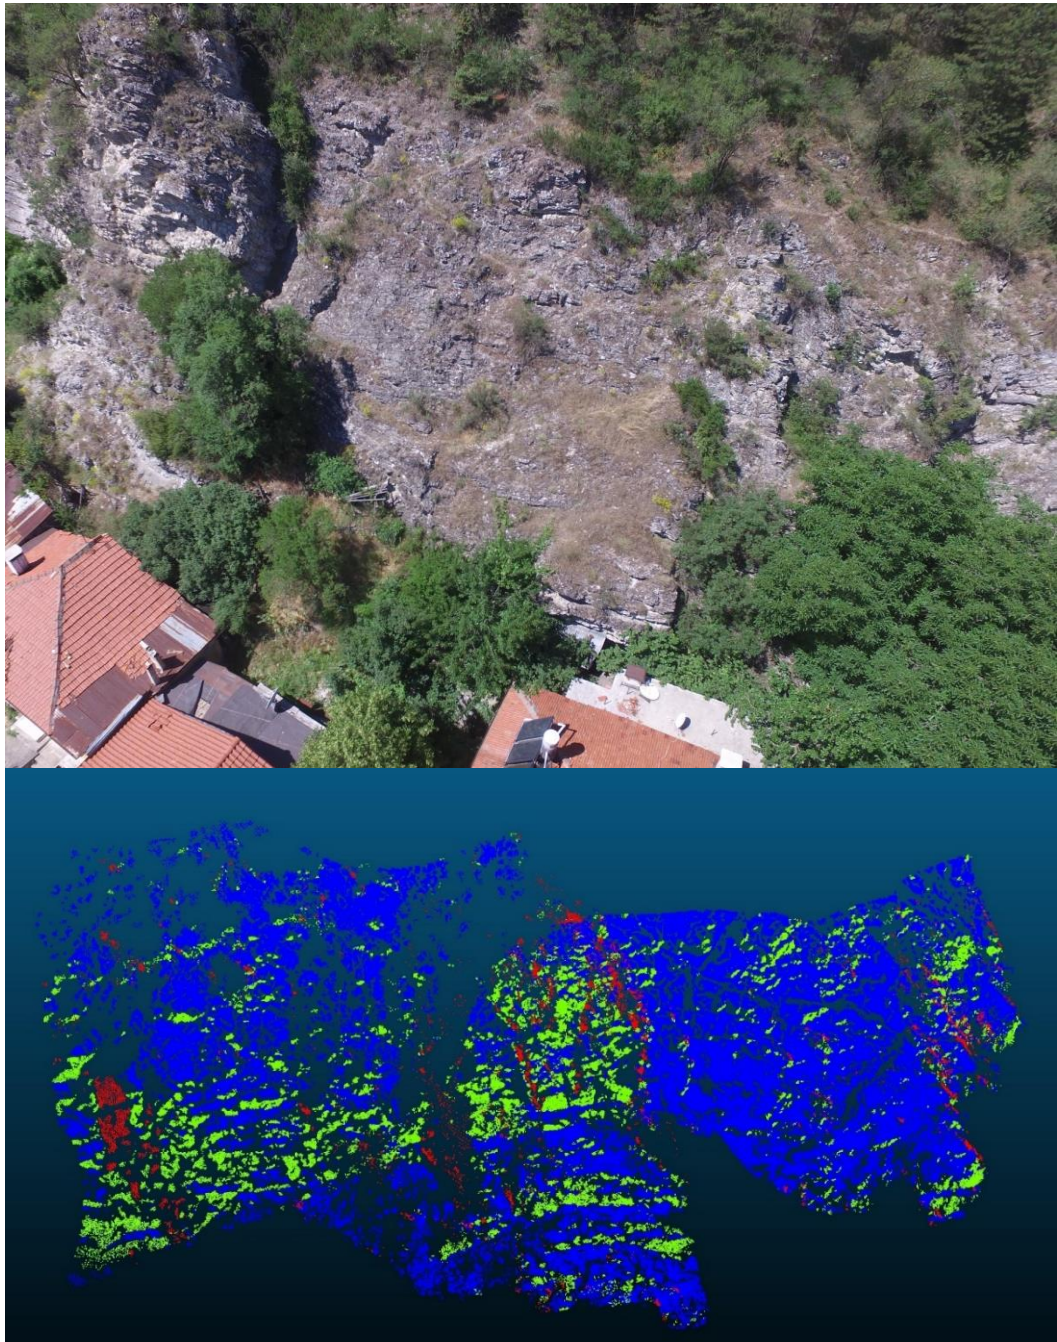
Figure 32: A view of Sectors 6 and 7 and the discontinuity sets identified by utilizing DSE

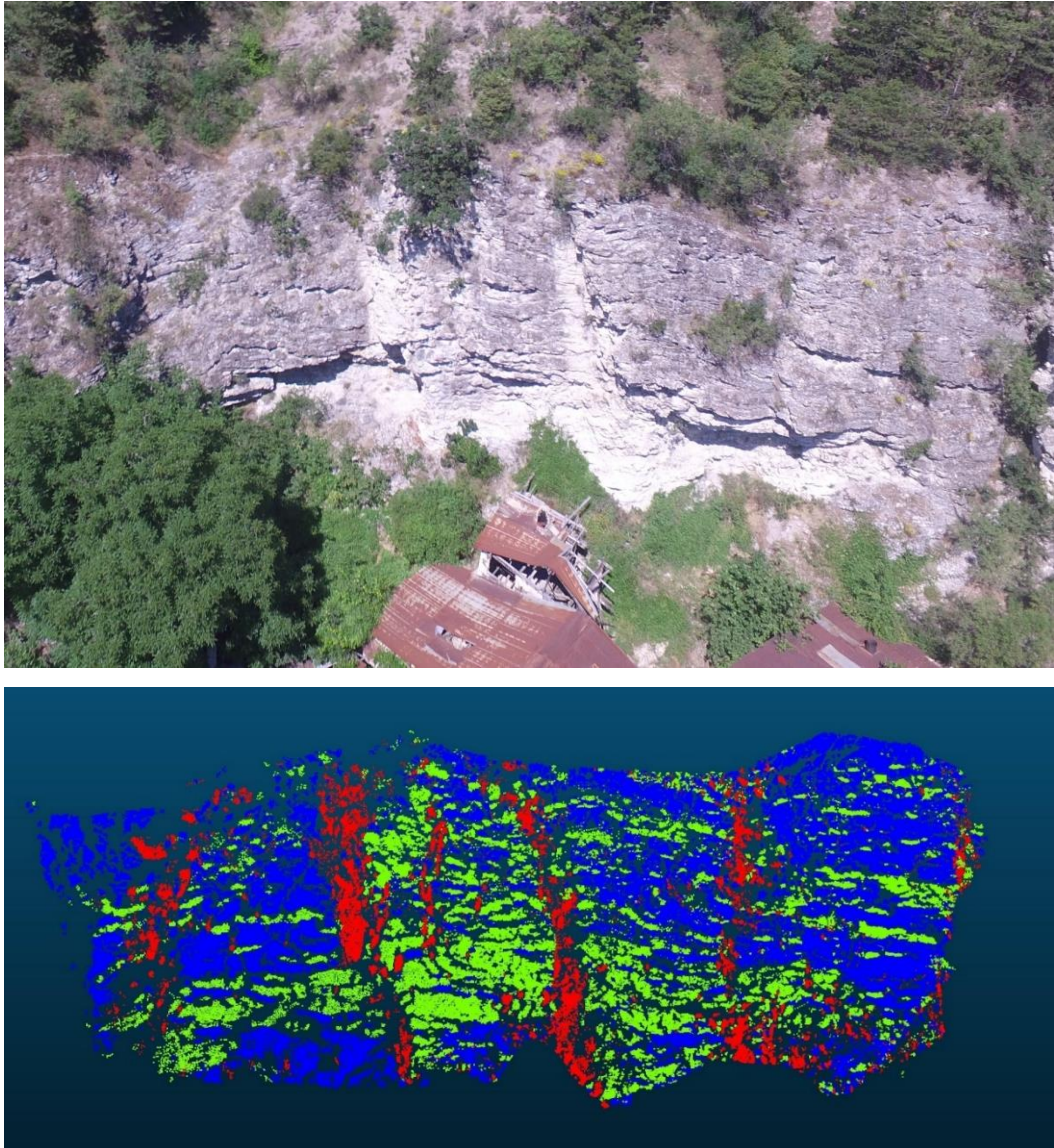
Figure 33: A view of Sector 8 and the discontinuity sets identified by utilizing DSE

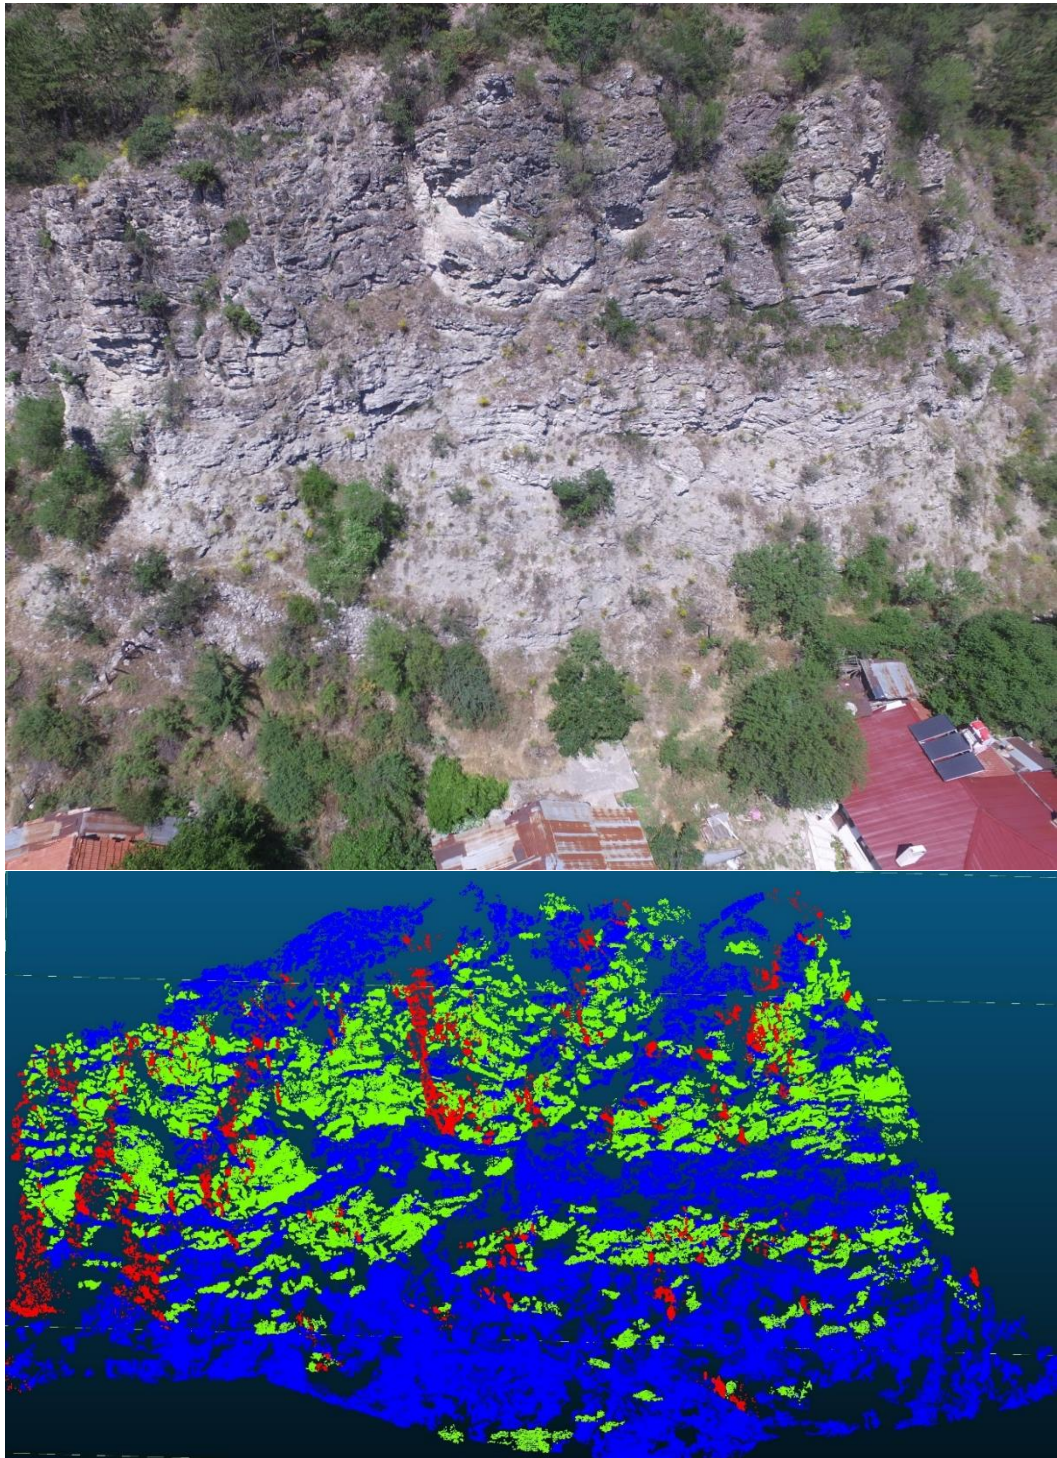
Figure 34: A view of Sectors 9 and 10 and the discontinuity sets identified by utilizing DSE

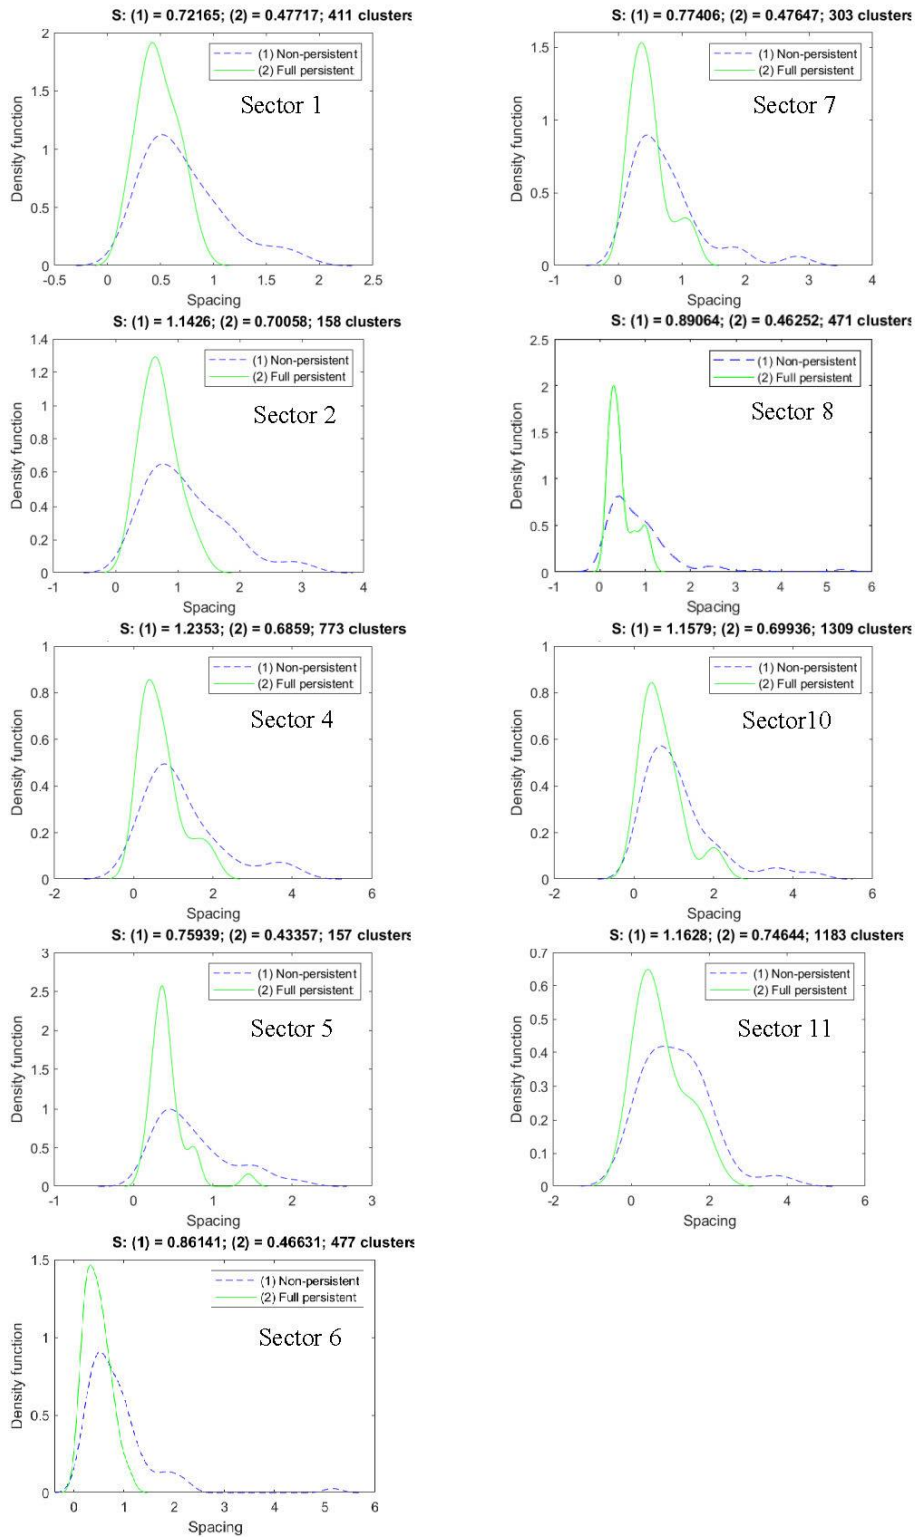
Figure 36: The distribution of bedding plane spacing for each sector

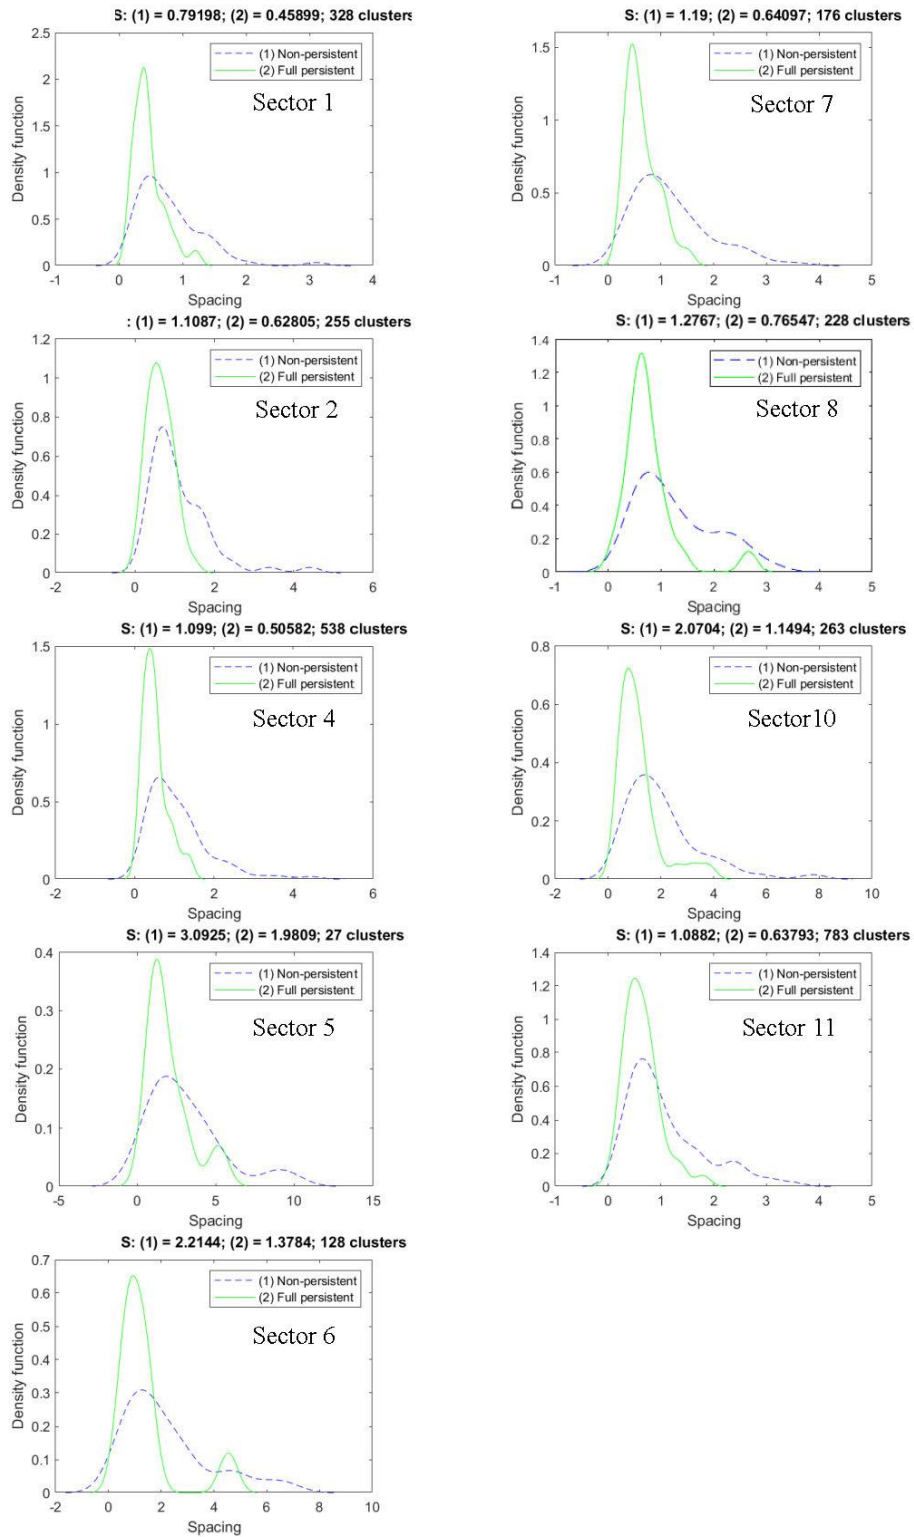
Figure 37: The distribution of J1 spacing for each sector

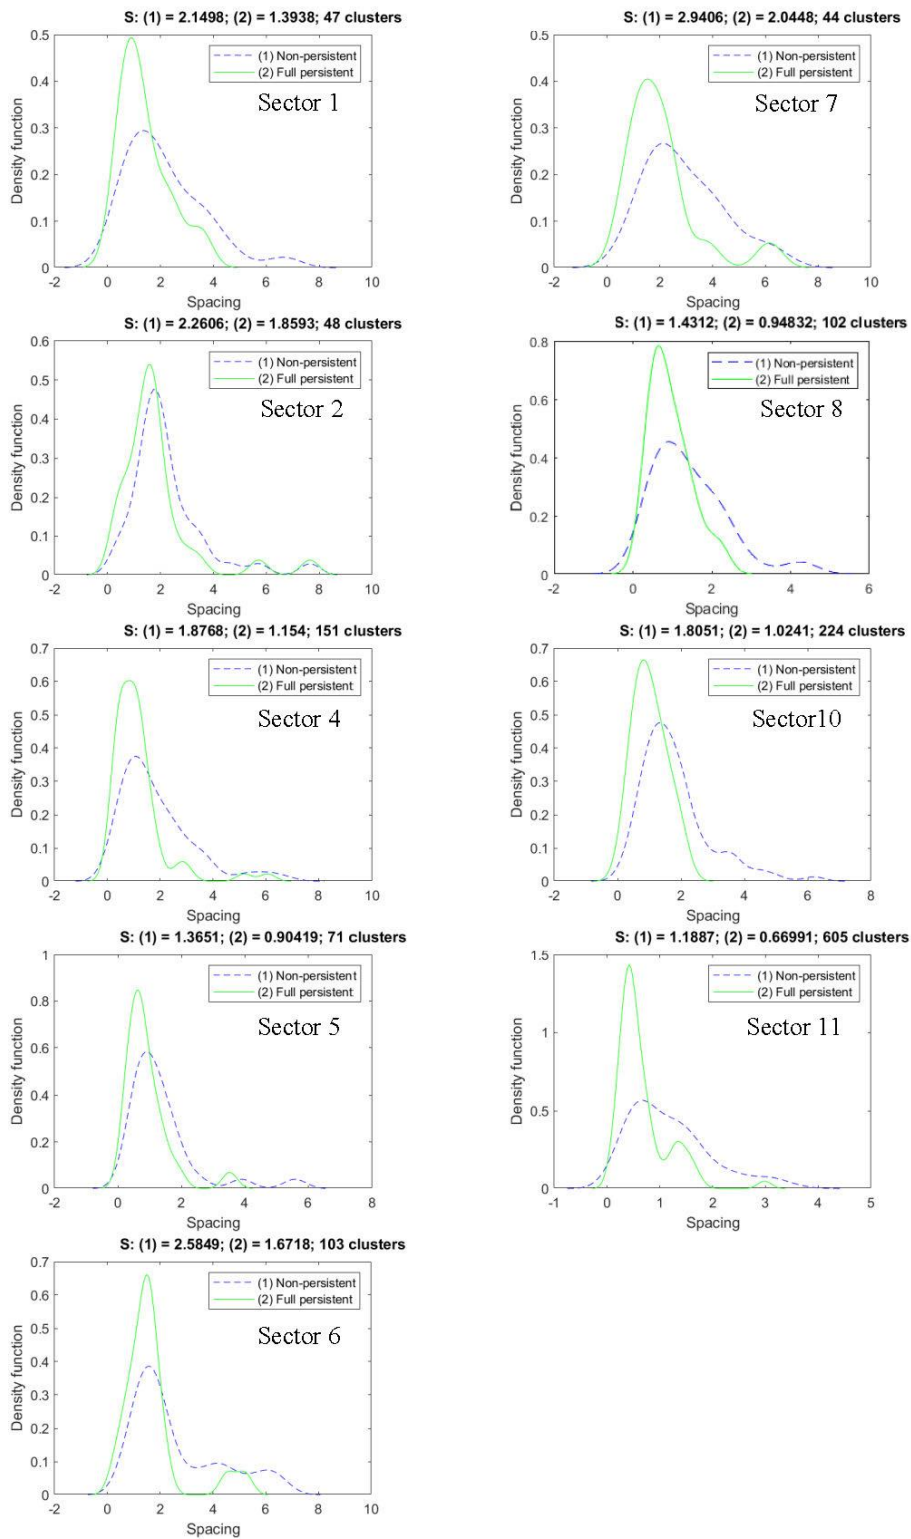
Figure 38: The distribution of J2 spacing for each sector

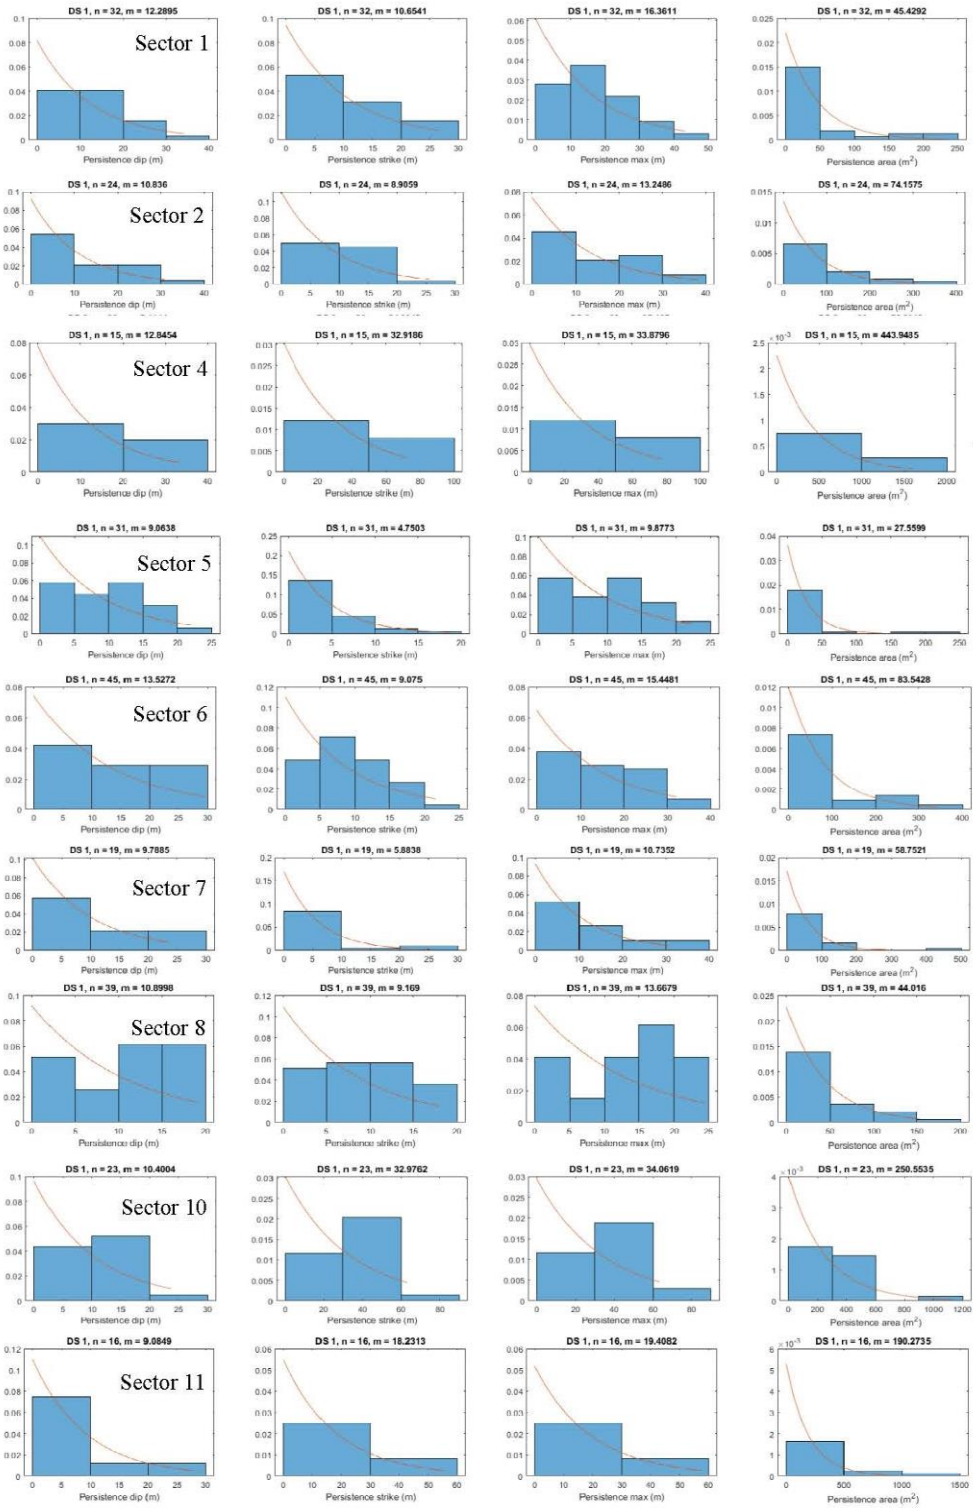
Figure 39: The distribution of bedding plane persistence for each sector

The DSE results are accepted as reliable based on the comparison of results with the field measurements. For the sake of identifying discontinuity characteristics in a wider area, including the physically inaccessible locations, a 3D point cloud was employed and the DSE methodology was applied. The distributions of normal spacing and persistence of the discontinuity sets were obtained by the DSE methodology for each sector. The distributions of normal spacing of BP, J1 and J2 are presented in Figures 36, 37, and 38, respectively. Also, the distributions of persistence of BP, J1 and J2 are presented in Figures 39, 40, and 41, respectively.

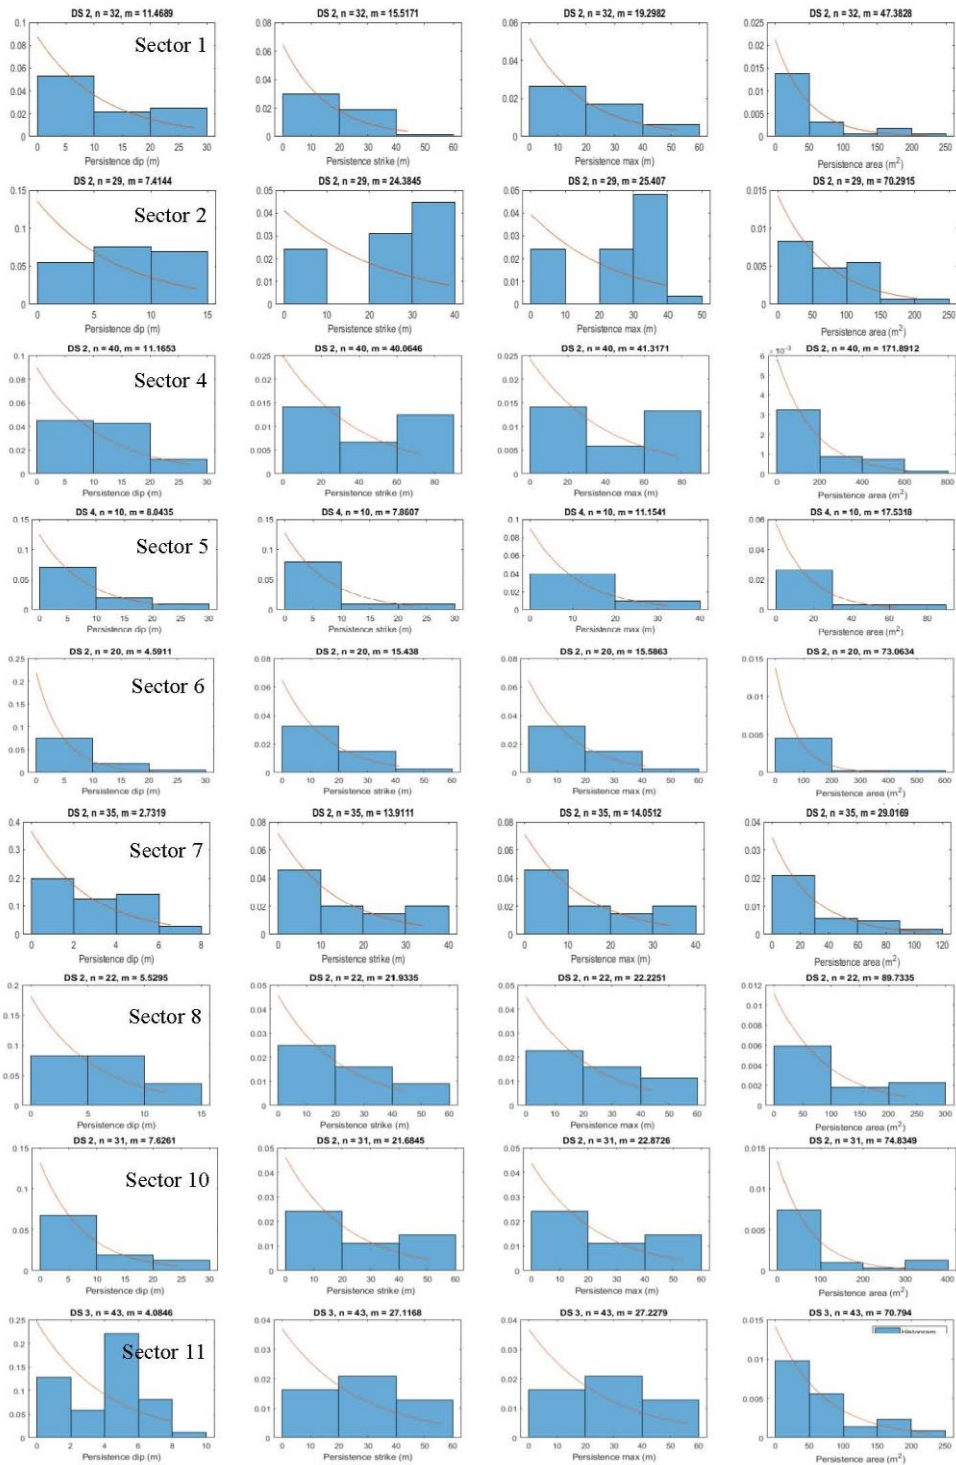
Figure 40: The distribution of J1 persistence for each sector

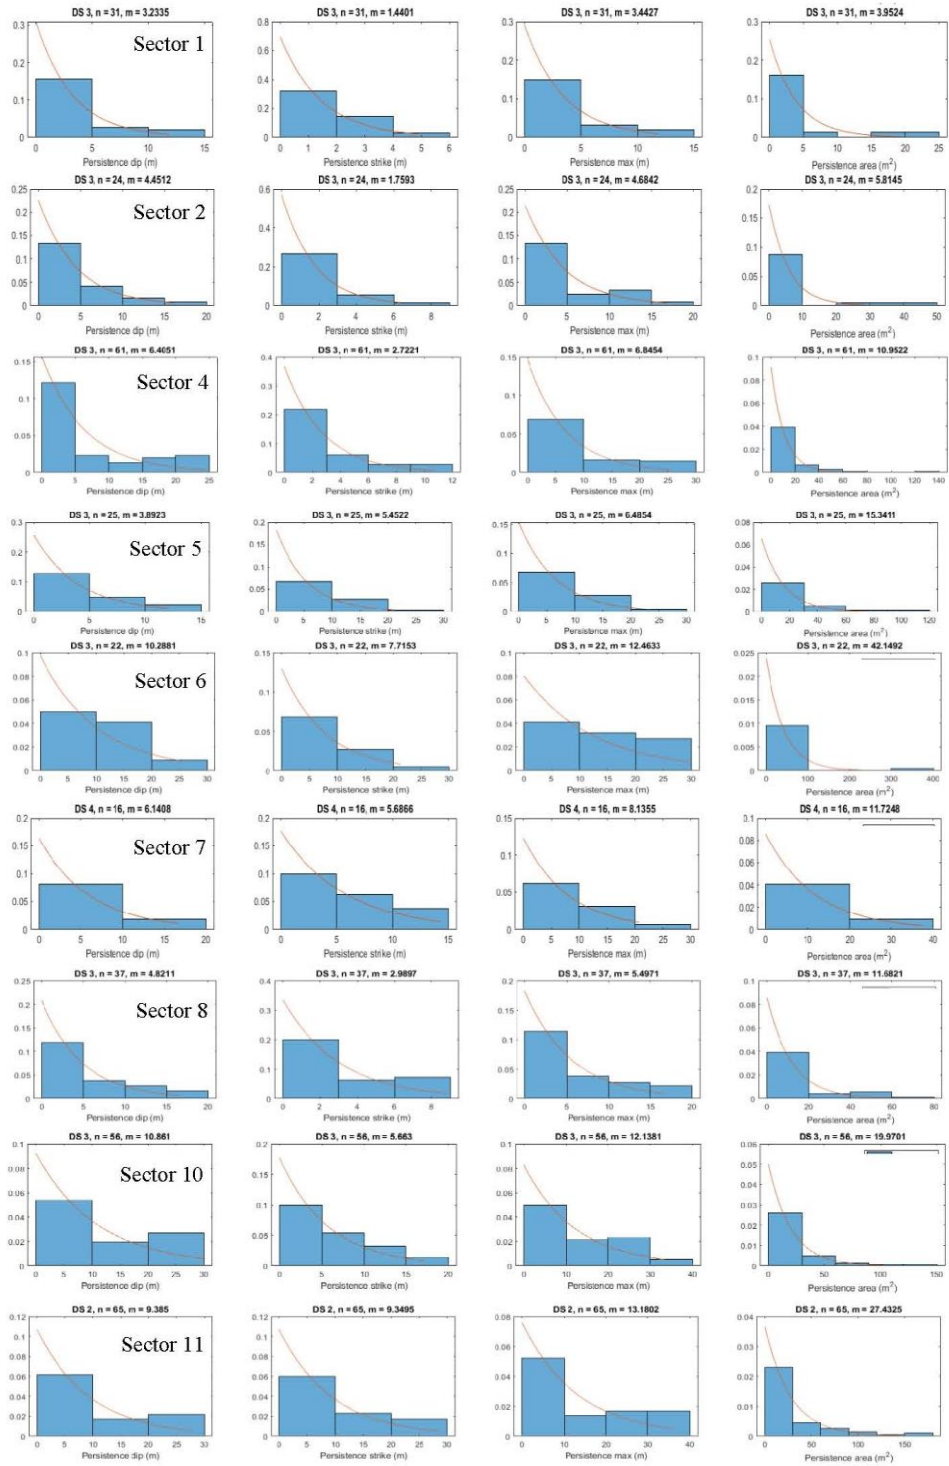
Figure 41: The distribution of J2 persistence for each sector

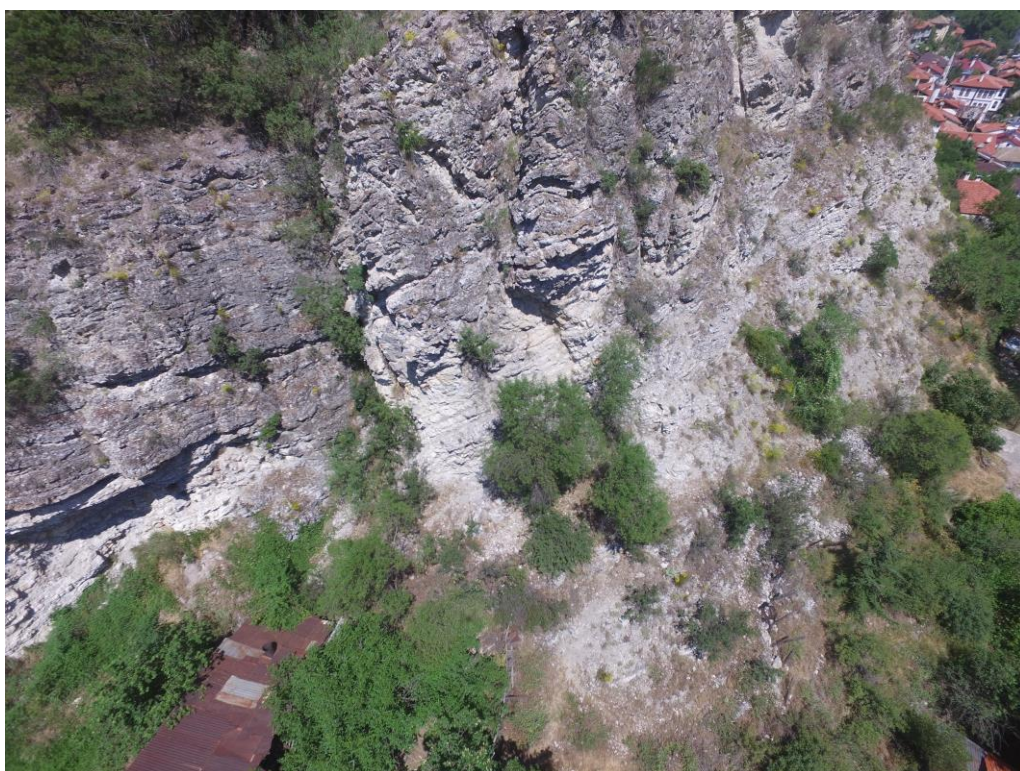
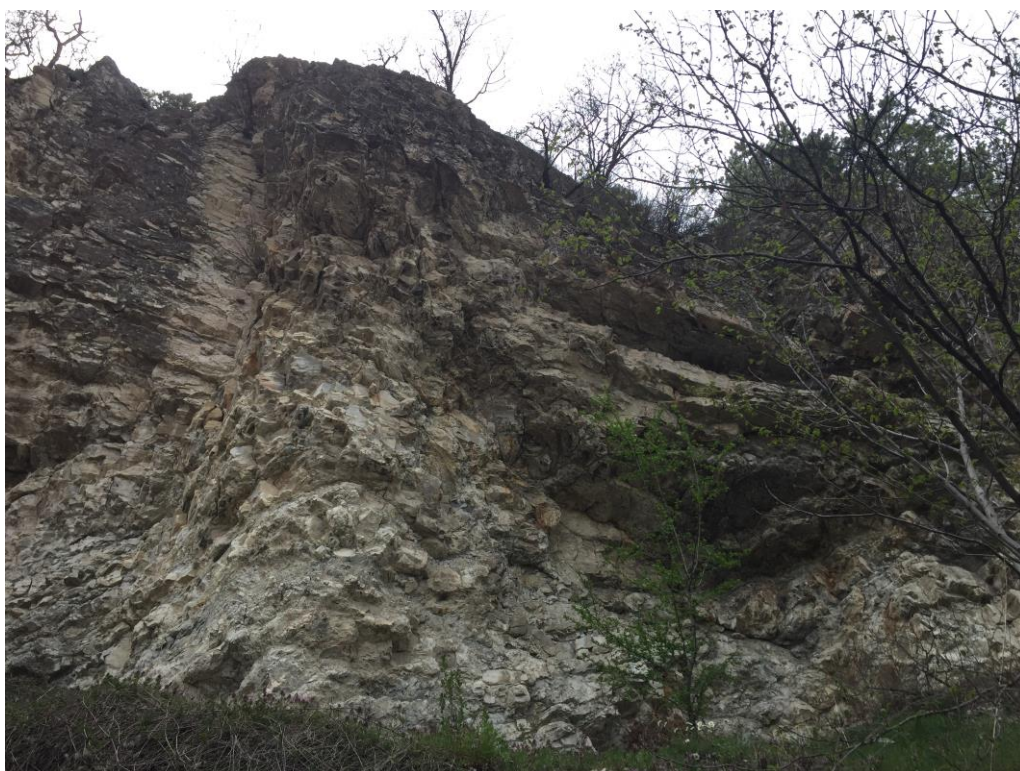
Figure 42: General views from the discontinuous rock mass on the western side of the Mudurnu valley
