ENGINEERING GEOLOGICAL CHARACTERIZATION OF THE ROCK
MASSES AND THEIR EVALUATION BY SPATIAL ANALYSES,
DETERMINATION OF THE ROCK SLOPE FAILURE SUSCEPTIBILITY
ZONES AND HAZARD ASSESSMENT OF MUDURNU (BOLU)

A THESIS SUBMITTED TO
THE GRADUATE SCHOOL OF NATURAL AND APPLIED SCIENCES
OF
MIDDLE EAST TECHNICAL UNIVERSITY

IN PARTIAL FULFILLMENT OF THE REQUIREMENTS
FOR
THE DEGREE OF DOCTOR OF PHILOSOPHY
IN
GEOLOGICAL ENGINEERING

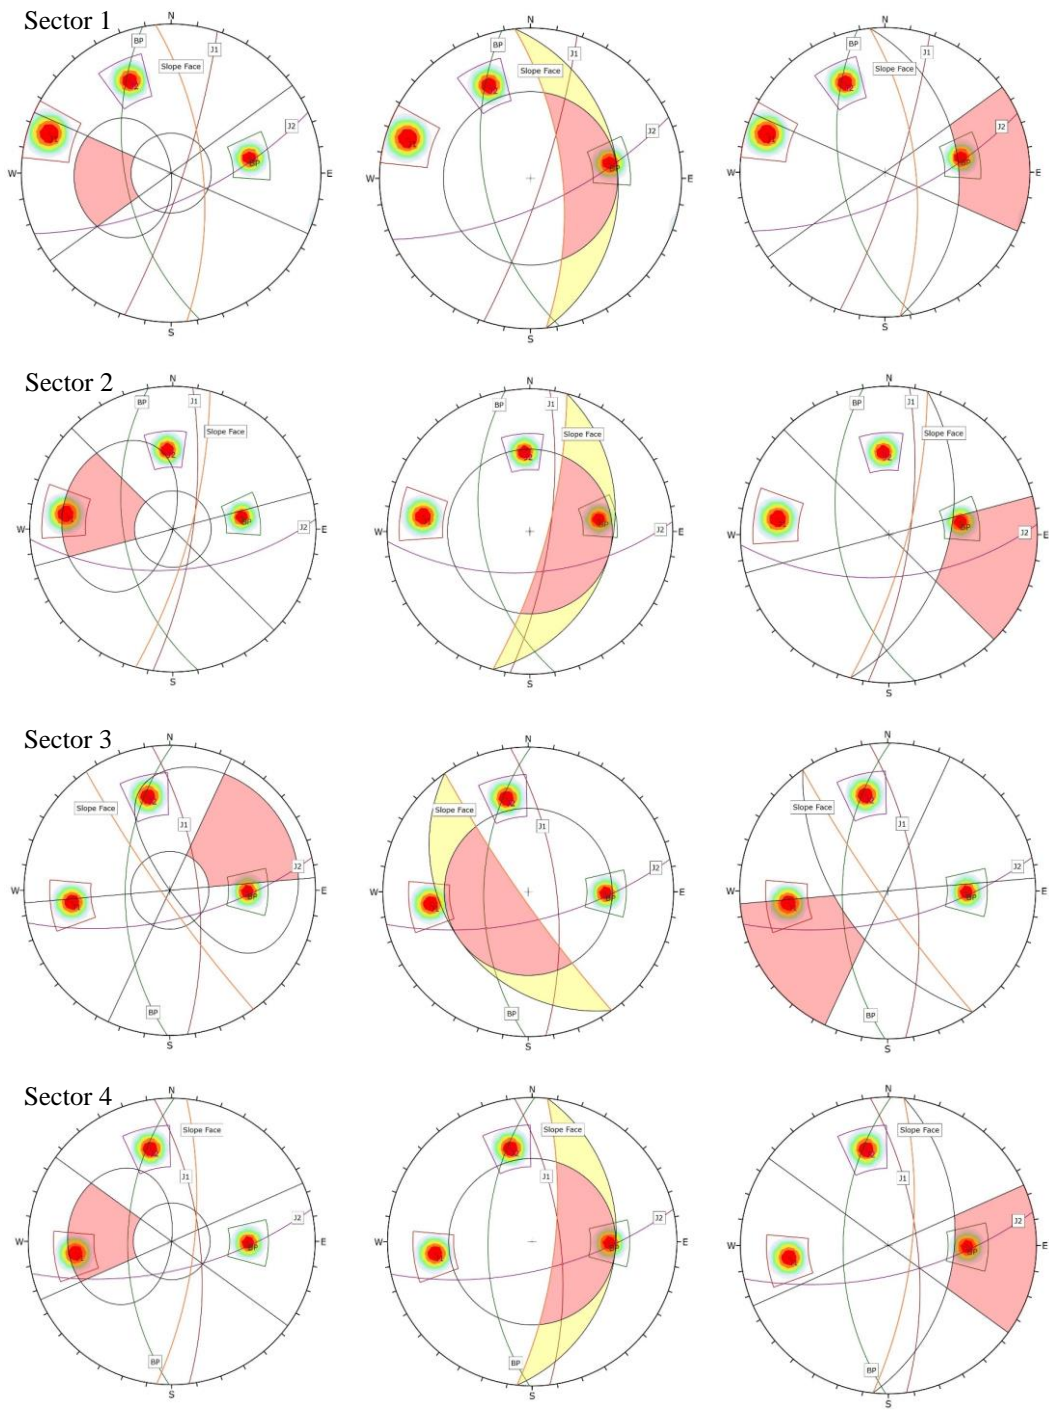
Figure 43: The distribution of discontinuity sets and the kinematic analysis results of Sectors 1, 2, 3, and 4 (i.e., planar failure analysis on the left, wedge failure analysis in the middle, and toppling failure analysis on the right)

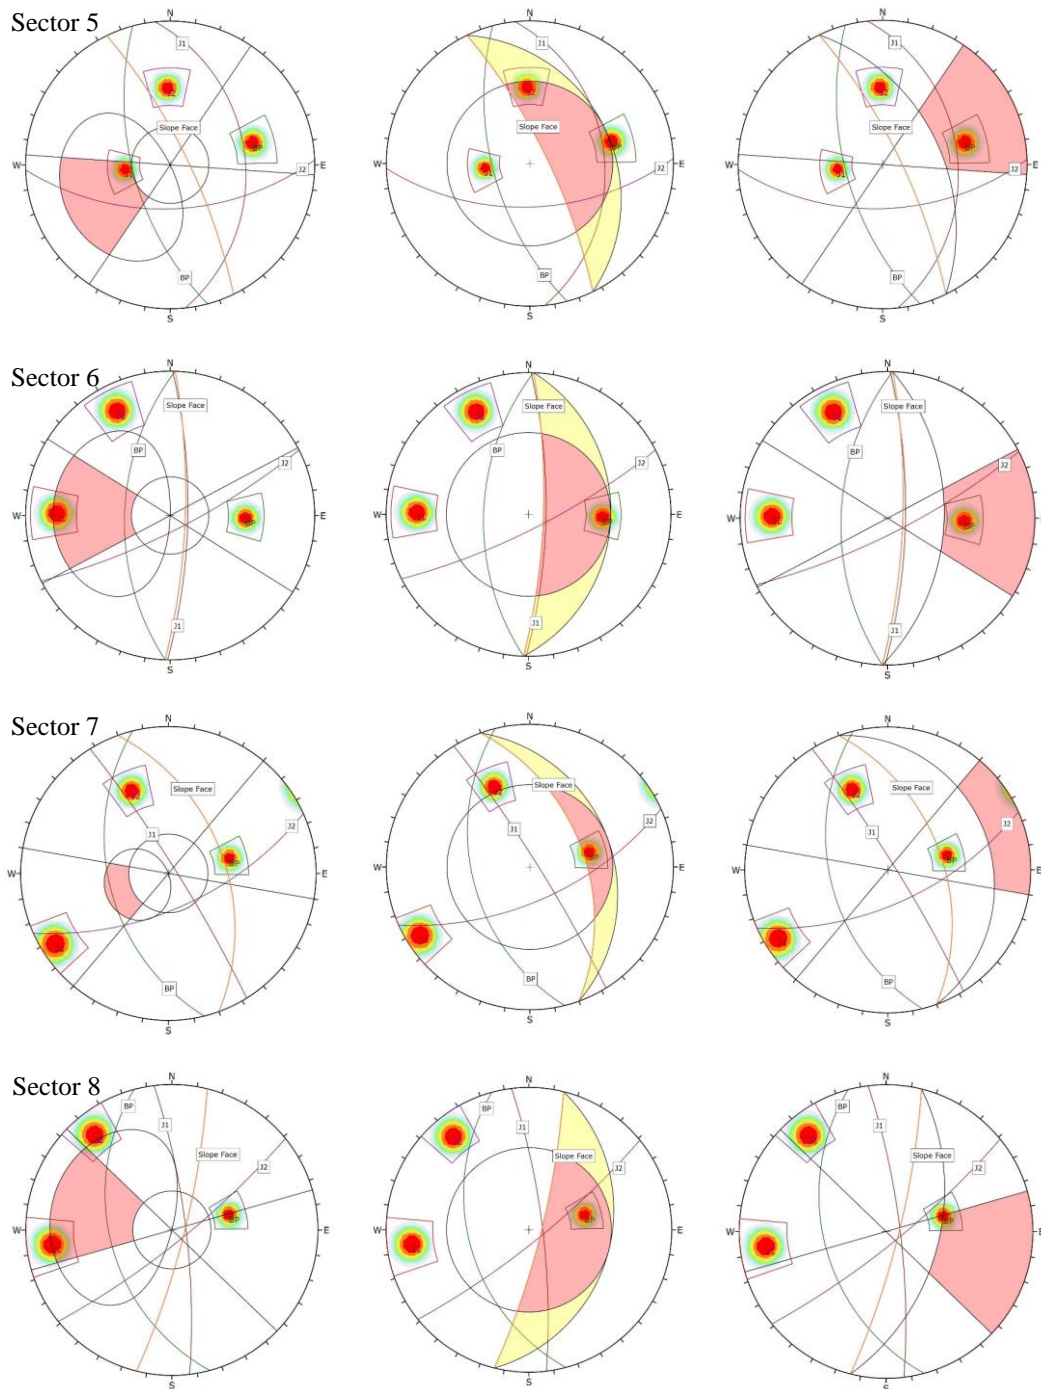
Figure 44: The distribution of discontinuity sets and the kinematic analysis results of Sectors 5, 6, 7, and 8 (i.e., planar failure analysis on the left, wedge failure analysis in the middle, and toppling failure analysis on the right)

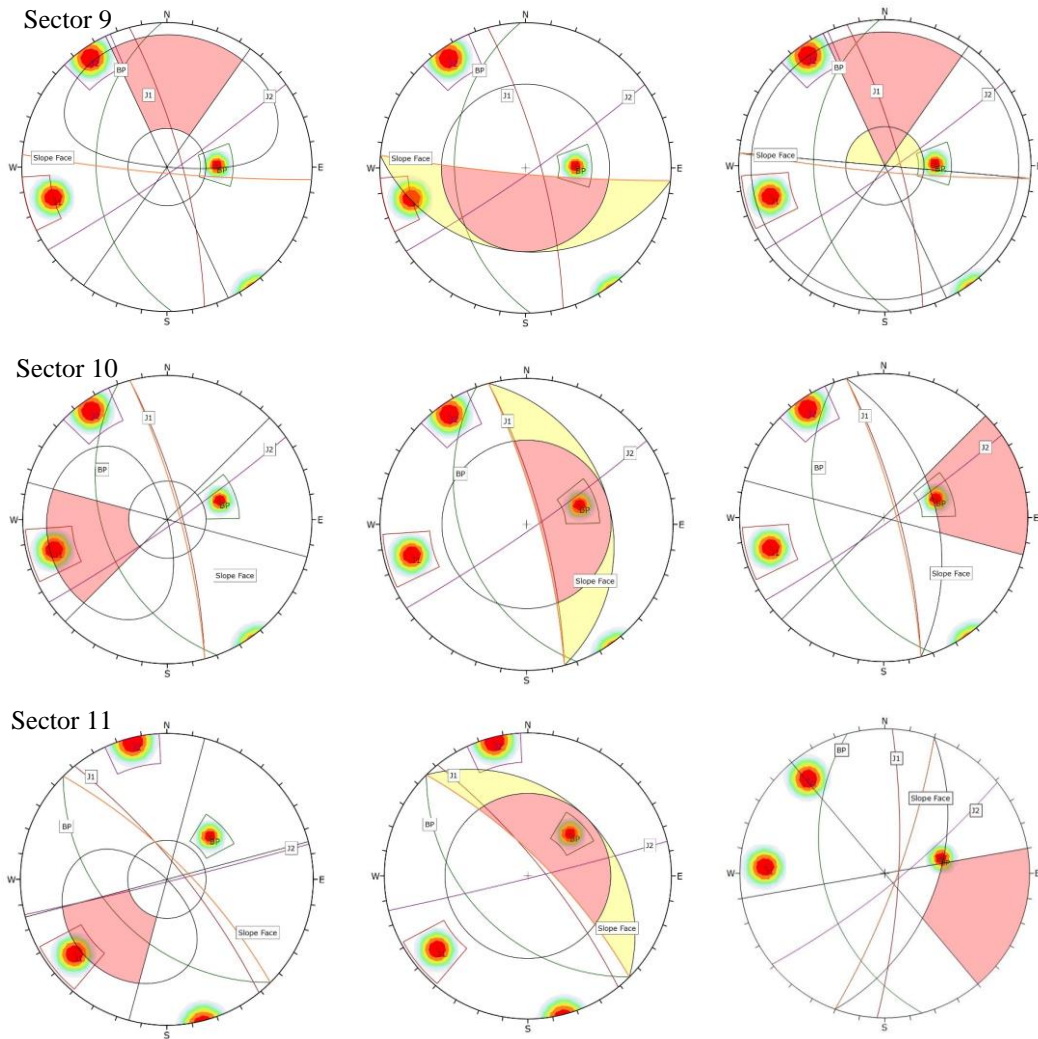
Figure 45: The distribution of discontinuity sets and the kinematic analysis results of Sectors 9, 10, and 11 (i.e., planar failure analysis on the left, wedge failure analysis in the middle, and toppling failure analysis on the right)

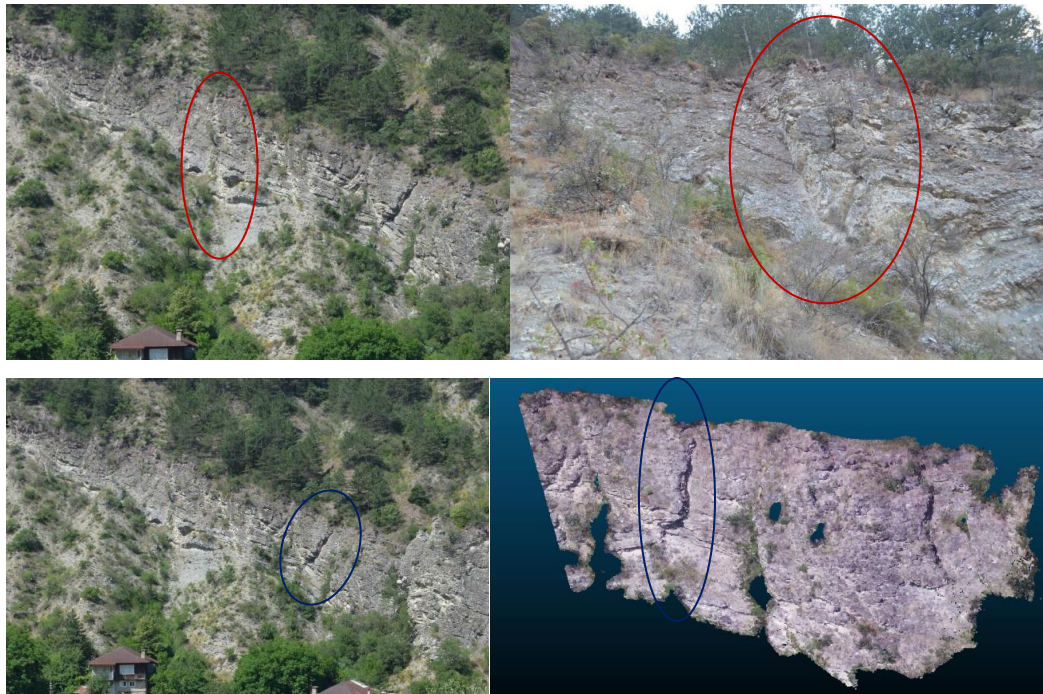
Figure 46: Blocks identified in Sector 2 for the back analysis

parameters at the time of failure. The failed blocks identified for back analysis in Sectors 2, 5, 6, 8, and 10 are shown in Figures 46, 47, 48, 49 and 50, respectively. Note that two identifiable blocks have been used in back analysis per sector. In the following figures, these blocks were specified through color-coding, where Block 1 was marked by a red circle and Block 2 by a dark blue circle. Several images of the same block were provided where images from different angles have been available.

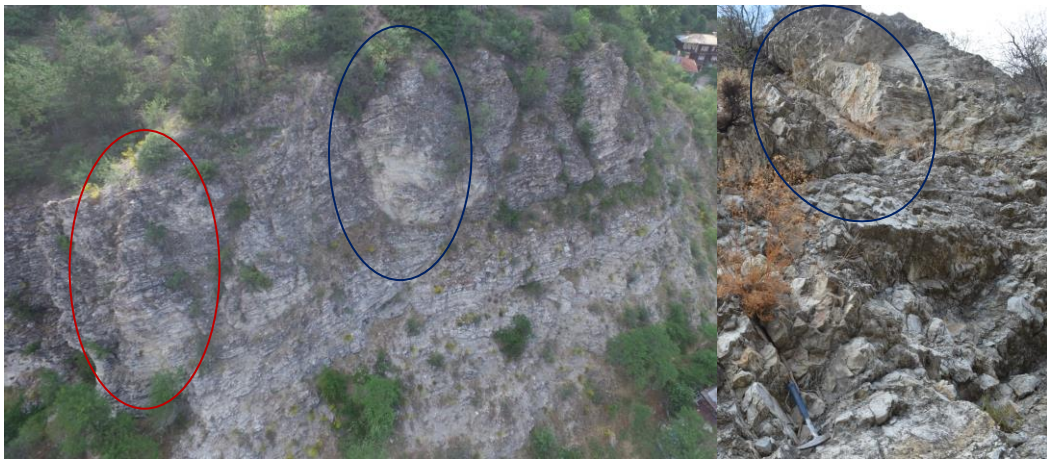
Figure 50: Blocks identified in Sector 10 for the back analysis

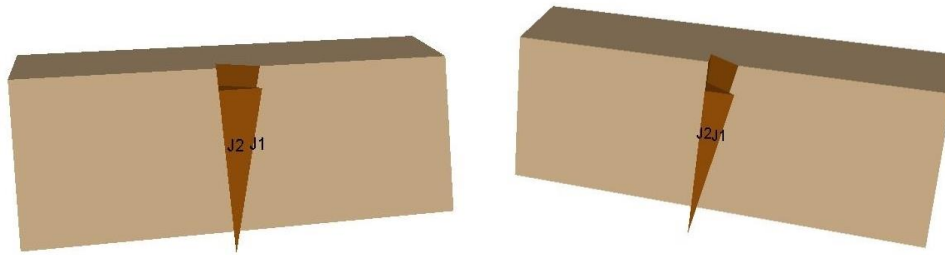
Figure 51: Geometry of the blocks in Sector 2 analyzed by Swedge software through back analysis

The geometry of the blocks analyzed by the back analysis in Sectors 2, 5, 6, 8, and 10 are given in Figures 51, 52, 53, 54 and 55, respectively. Back calculation of observed failures in the study area was performed to independently estimate the strength parameters of the rock mass discontinuities. Swedge software (Rocscience, 2022) was utilized for the analysis.

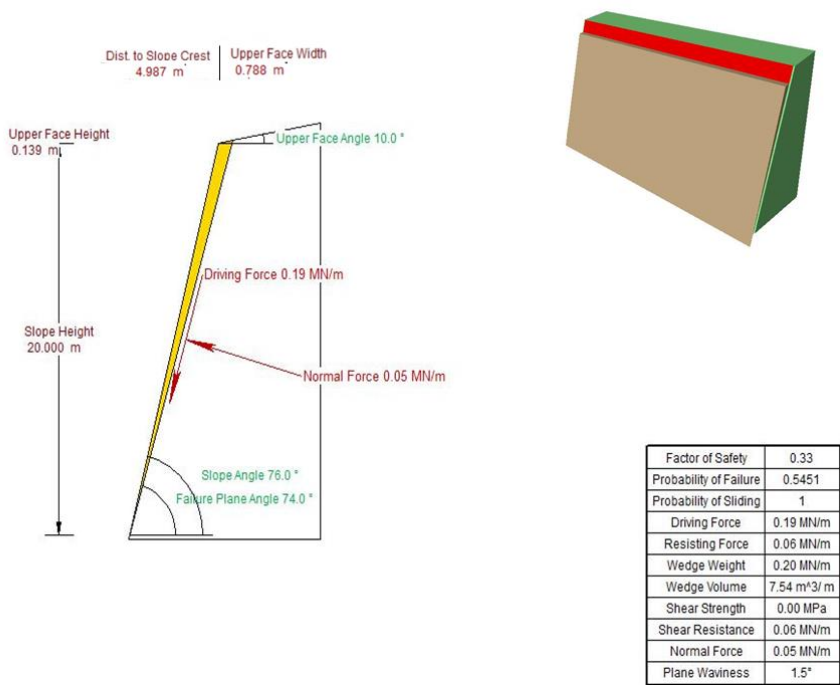
Figure 56: 2D and 3D view of the block generated in Sector 2 by Rocplane software

The kinematic analysis concluded that Joint set 1 (J1) can cause planar failures in Sectors 2, 4, 5, 6, and 8 of the study area. The deterministic and probabilistic analyses were applied by using the Rocplane software. The 2D and 3D views of the blocks and the calculated results for deterministic (i.e., factor of safety) and probabilistic (i.e., probability of failure) analysis are given in Figures 56, 57, 58, 59, and 60. For the probabilistic analysis of planar failure, the parameters introduced based on their statistical distribution are slope face dip angle, failure plane dip angle, JRC and JCS.

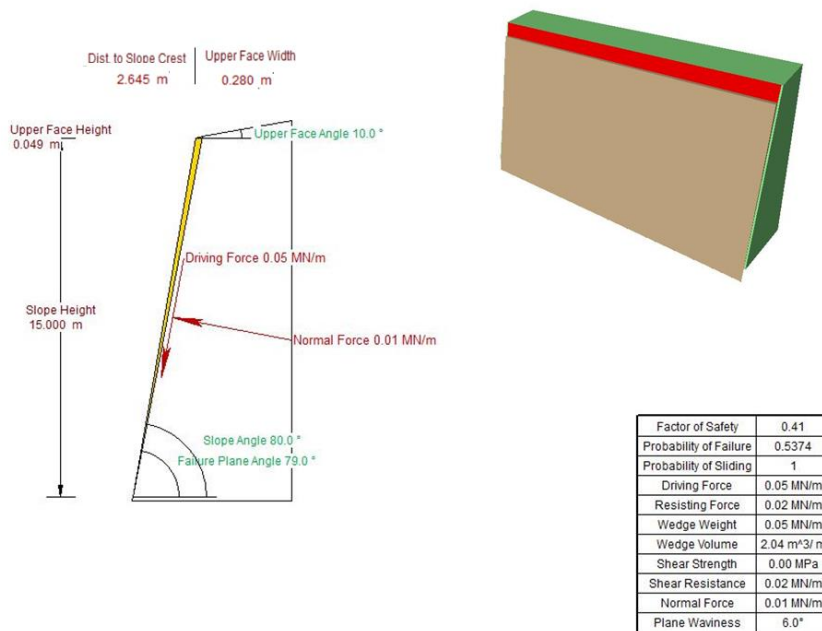
Figure 60: 2D and 3D view of the block generated in Sector 8 by Rocplane software

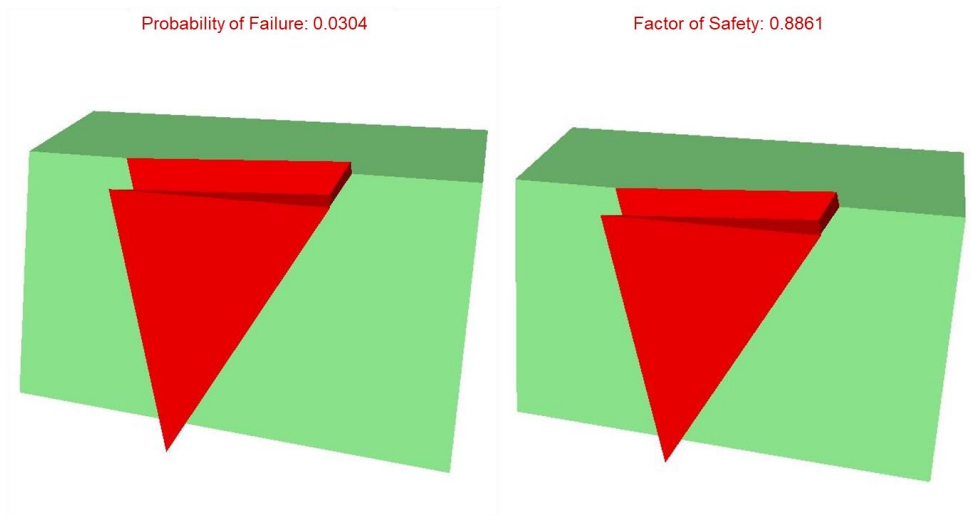
Figure 61: 3D view of the block generated in Sector 2 by Swedge software

The kinematic analysis revealed that the intersection of Joint set 1 (J1) and Joint set 2 (J2) may produce wedge failures in Sectors 2, 4, 5, 6, 8, and 10 of the study area. In addition, the intersection of the Bedding plane and Joint set 2 (J2) is capable to cause wedge failures in Sectors 3 and 9. The deterministic and probabilistic analyses were applied by using Swedge software. The 3D views of the blocks and the calculated results for deterministic (i.e., the factor of safety) and the probabilistic (i.e., probability of failure) analysis are given in Figures 61 to 68. For the probabilistic analysis of wedge failure, the parameters introduced based on their statistical distribution are slope face dip direction, slope face dip angle, dip directions of joint planes 1 and 2, dip angles of joint planes 1 and 2, JRC of set 1 and 2 and JCS of set 1 and 2.

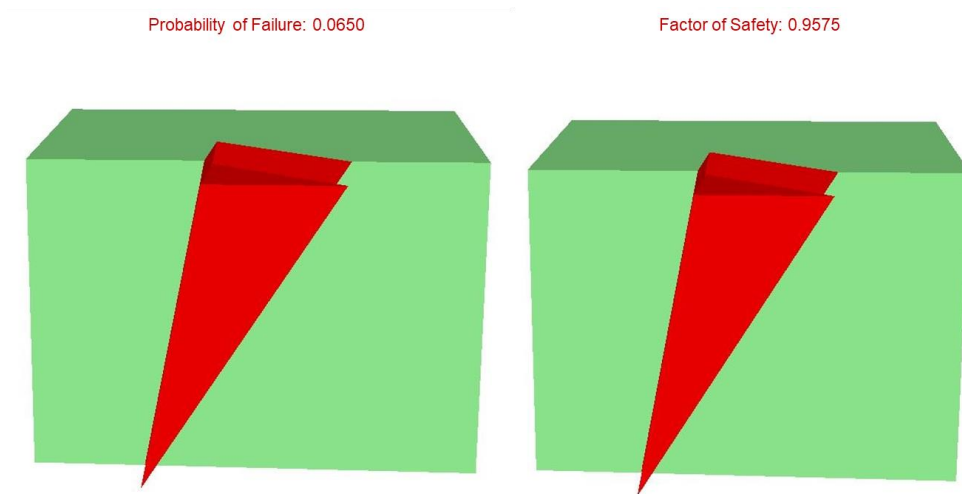
Figure 64: 3D view of the block generated in Sector 5 by Swedge software

Factor of Safety: 0.6250

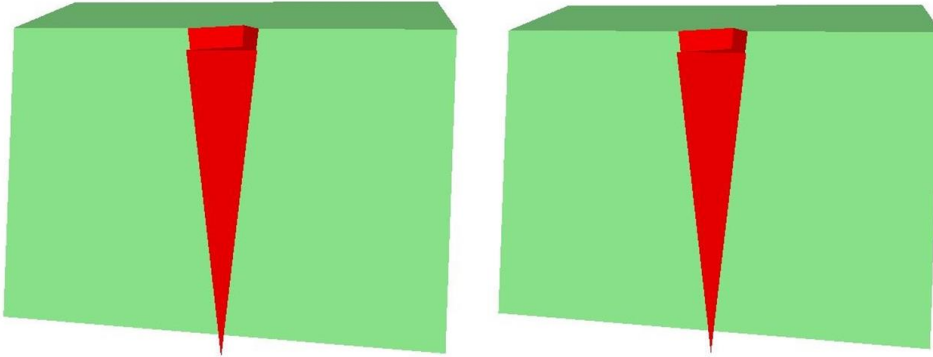
Figure 65: 3D view of the block generated in Sector 6 by Swedge software

Factor of Safety: 0.5259

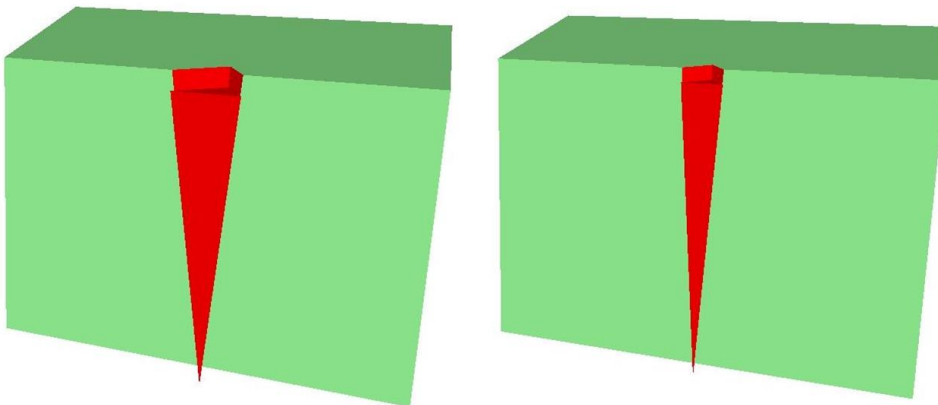
Figure 66: 3D view of the block generated in Sector 8 by Swedge software

Factor of Safety: 3.1148

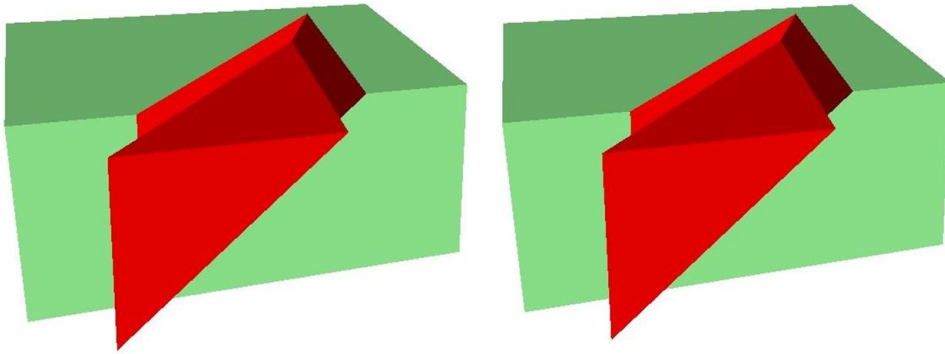
Figure 67: 3D view of the block generated in Sector 9 by Swedge software

Factor of Safety: 0.3865

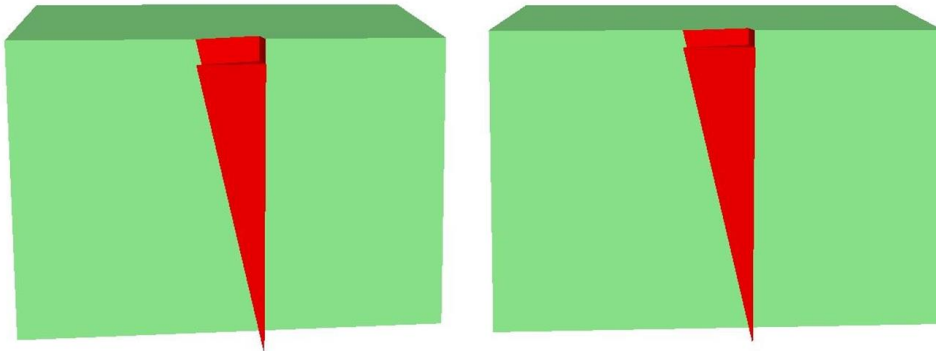
Figure 68: 3D view of the block generated in Sector 10 by Swedge software

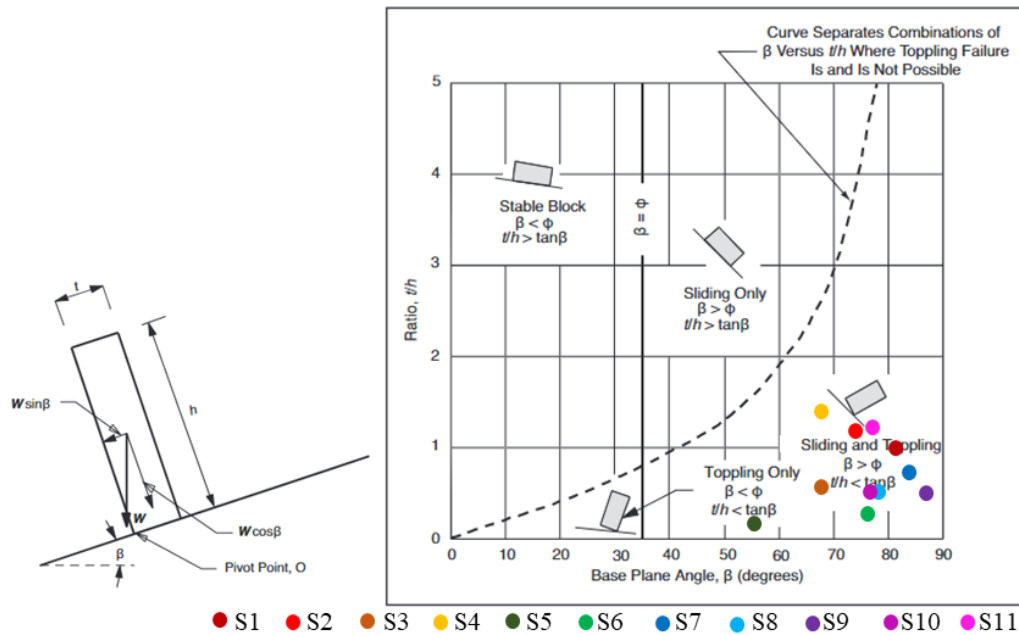
Figure 69: Sliding and toppling conditions of a block on an inclined plane (Hoek and Bray, 1981). Note that the condition of each sector were marked by a circle in different color

Unlike planar and wedge types of failures, a toppling failure entails rock columns or blocks rotating about a fixed point. Toppling failure occurs when the center of gravity of a block falls outside the dimension of its base (Norrish and Wyllie, 1996). The toppling failure potential of a block can be measured by its slenderness ratio which is the thickness (t) to height (h) ratio. The location of the resultant force of a block is controlled by this ratio (Kliche, 2018). Figure 69 shows the conditions required for sliding and toppling failure to develop. According to this figure, toppling failure can arise when $t/h < \tan\beta$.

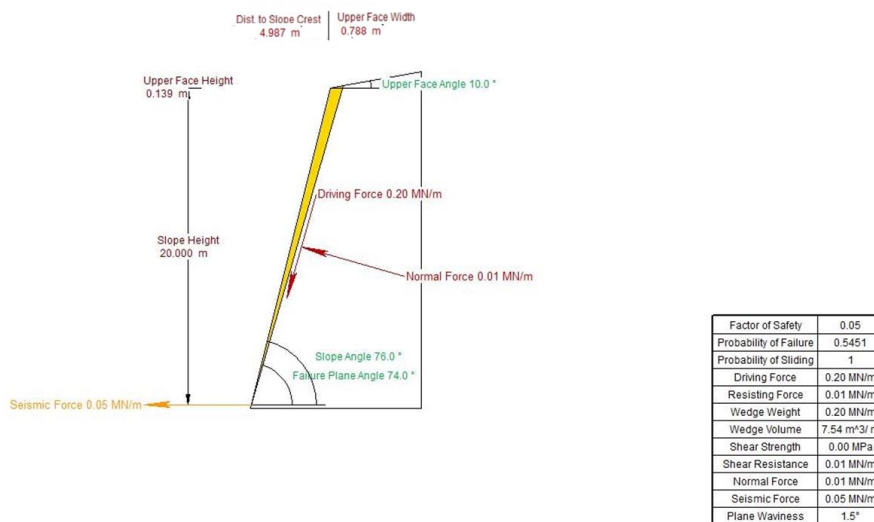
Figure 70: 2D view of the block generated for the pseudo-static analysis in Sector 2 by Rocplane software

The pseudo-static stability analysis of planar failure was applied by using both the deterministic and probabilistic options of the Rocplane software. The 2D views of the blocks and the calculated results for deterministic (i.e., the factor of safety) and probabilistic (i.e., probability of failure) analyses are given in Figures 70, 71, 72, 73, and 74. For the probabilistic analysis of planar failure, the parameters introduced based on their statistical distribution are slope face dip angle, failure plane dip angle, JRC and JCS. These parameters were found to be normally distributed based on the DSE methodology for the dip angles and field measurements for JRC and JCS. The normal distribution was used along with the mean, standard deviation, relative minimum and relative maximum values of each parameter to perform the probabilistic analysis.

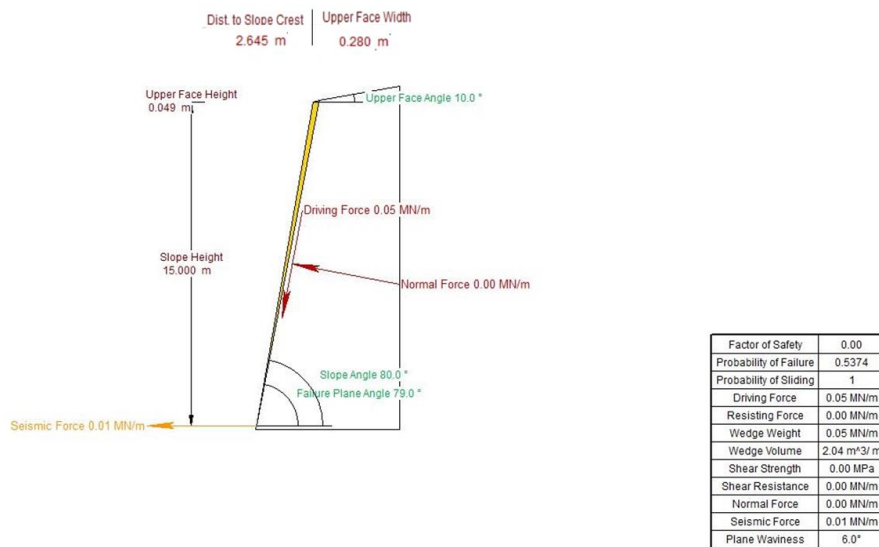
Figure 74: 2D view of the block generated for the pseudo-static analysis in Sector 8 by Rocplane software

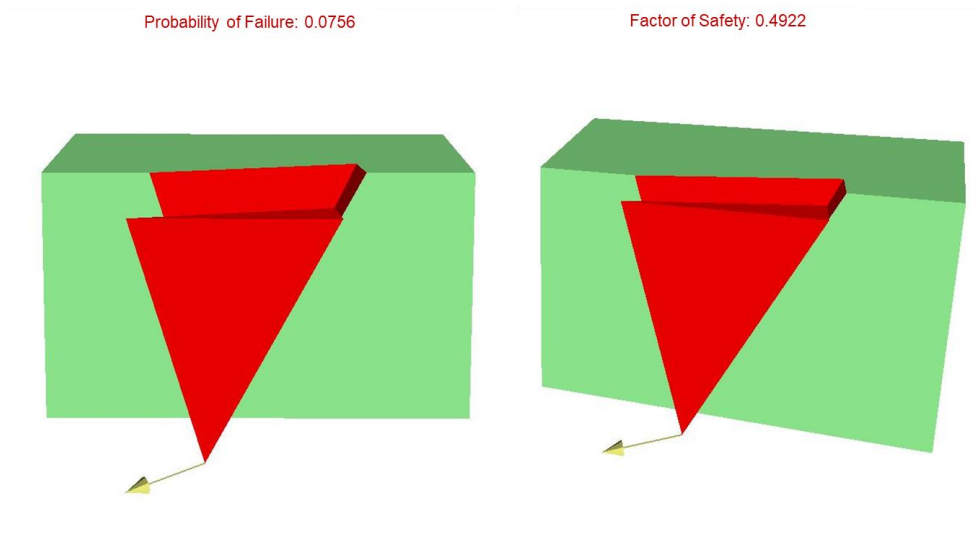
Figure 75: 3D view of the block generated for the pseudo-static analysis in Sector 2 by Swedge software

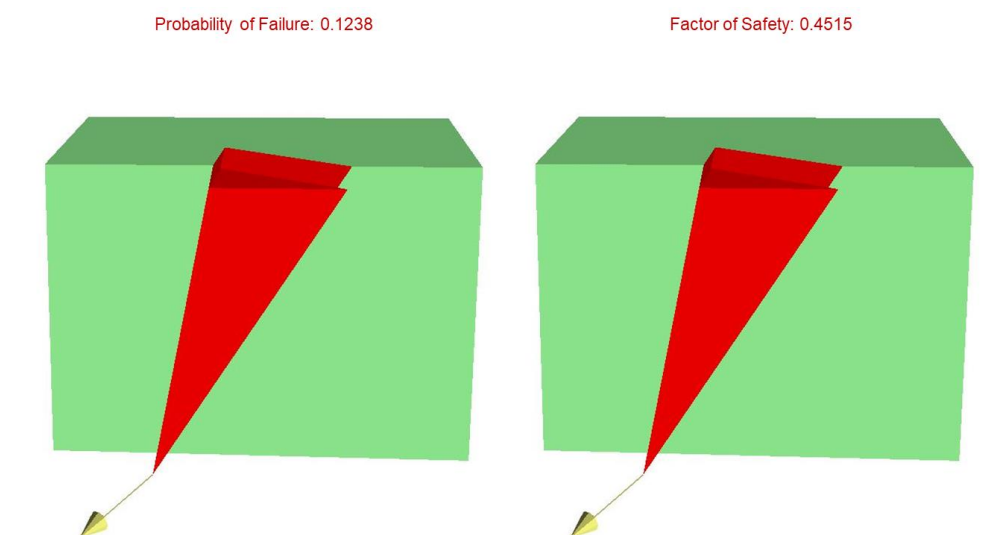
Figure 78: 3D view of the block generated for the pseudo-static analysis in Sector 5 by Swedge software

Factor of Safety: 0.0762

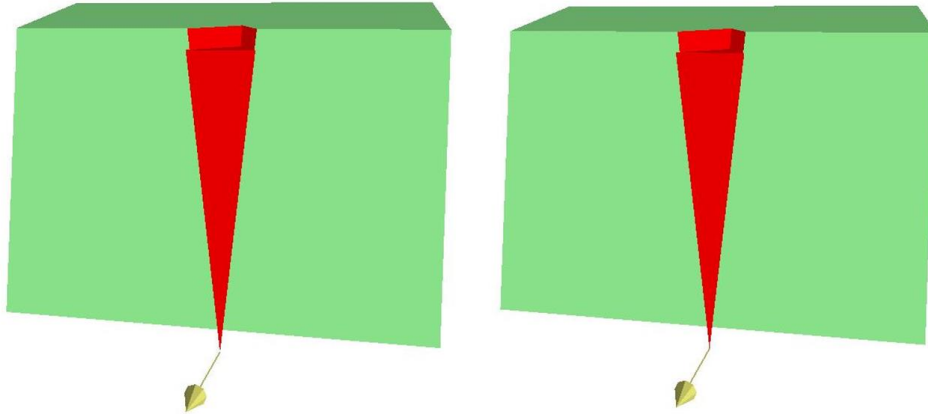
Figure 79: 3D view of the block generated for the pseudo-static analysis in Sector 6 by Swedge software

Factor of Safety: 0.0000

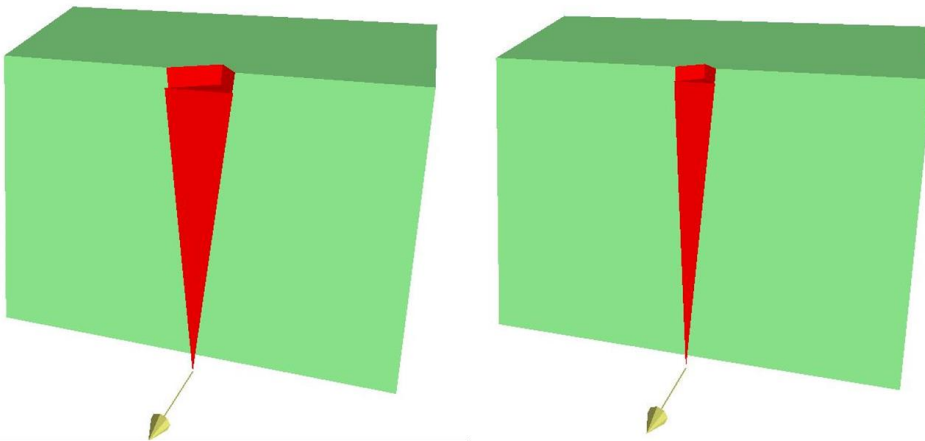
Figure 80: 3D view of the block generated for the pseudo-static analysis in Sector 8 by Swedge software

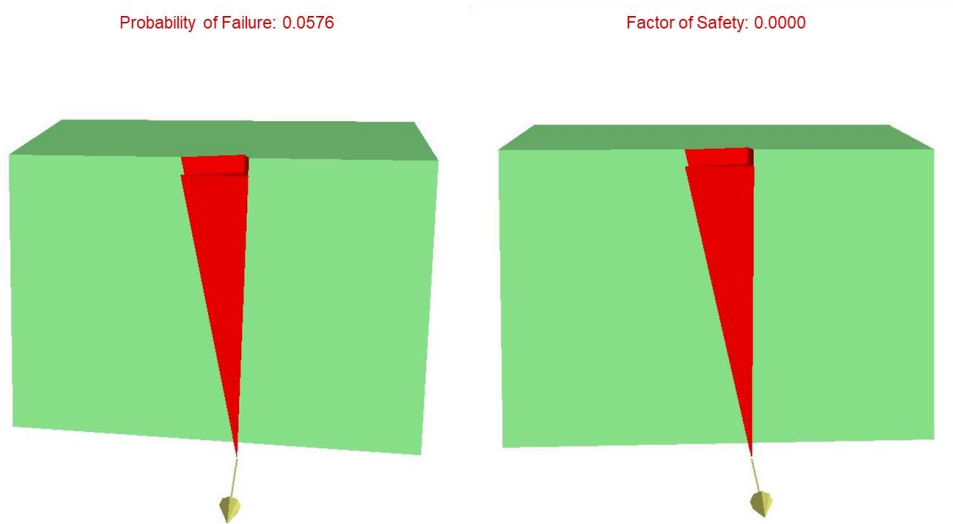
Figure 82: 3D view of the block generated for the pseudo-static analysis in Sector 10 by Swedge software

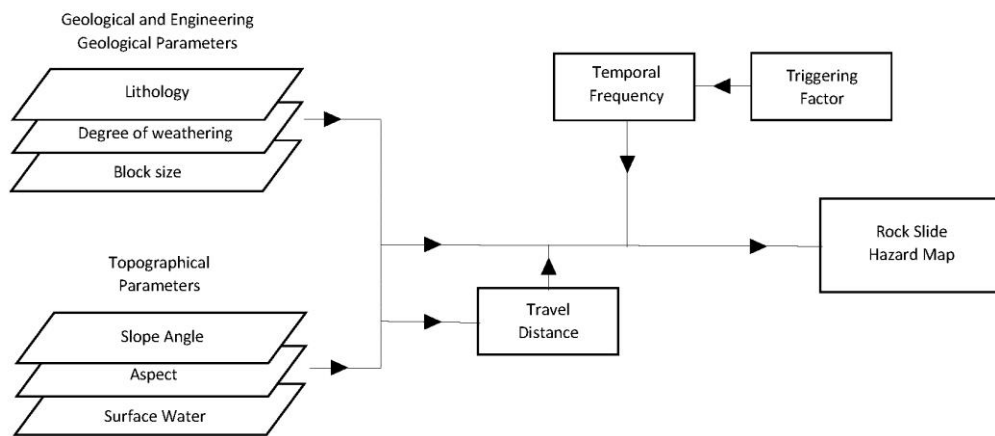
Figure 83: Flowchart of the discontinuous rock slope hazard assessment

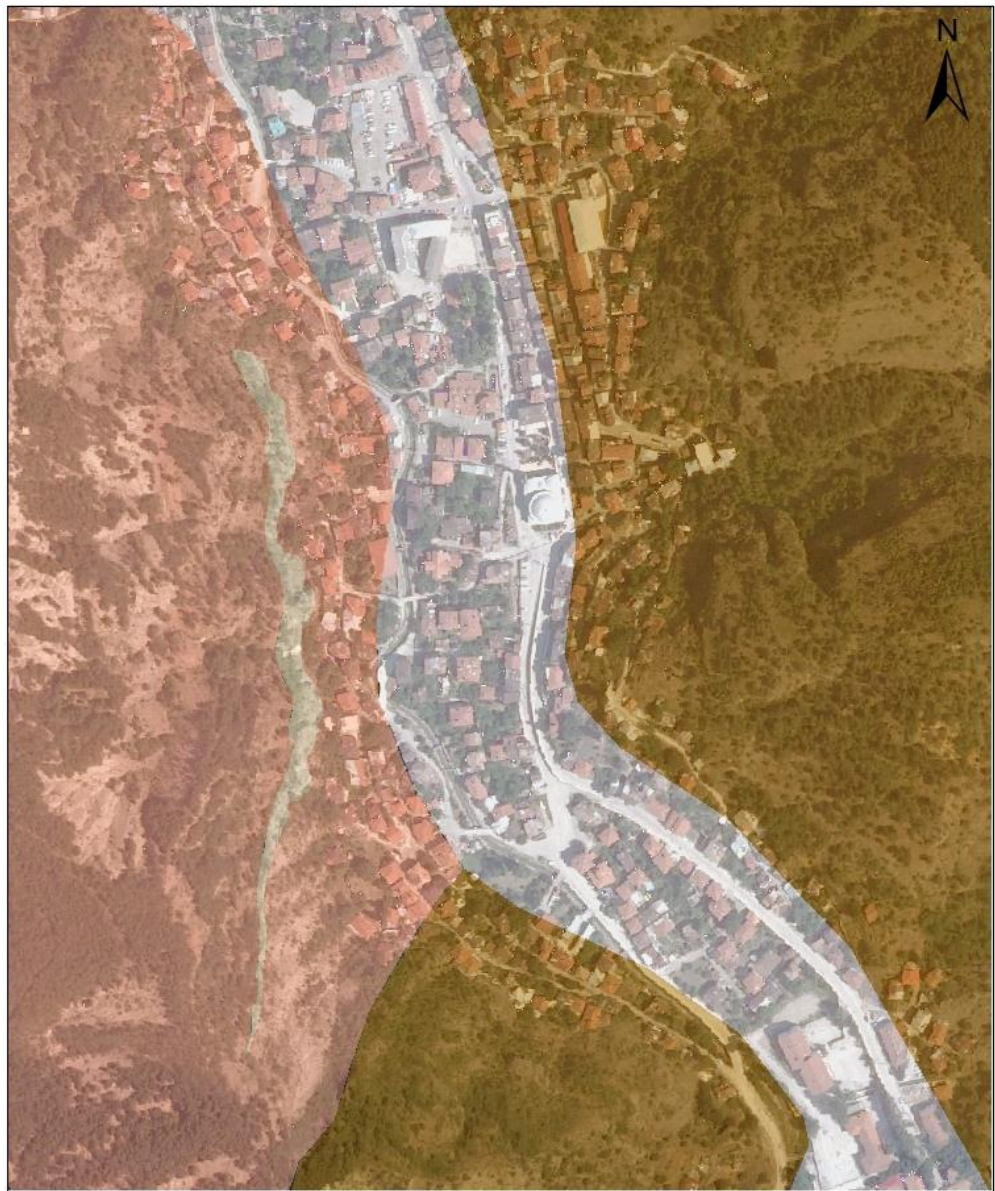
Figure 84: Lithology classes identified in the study area

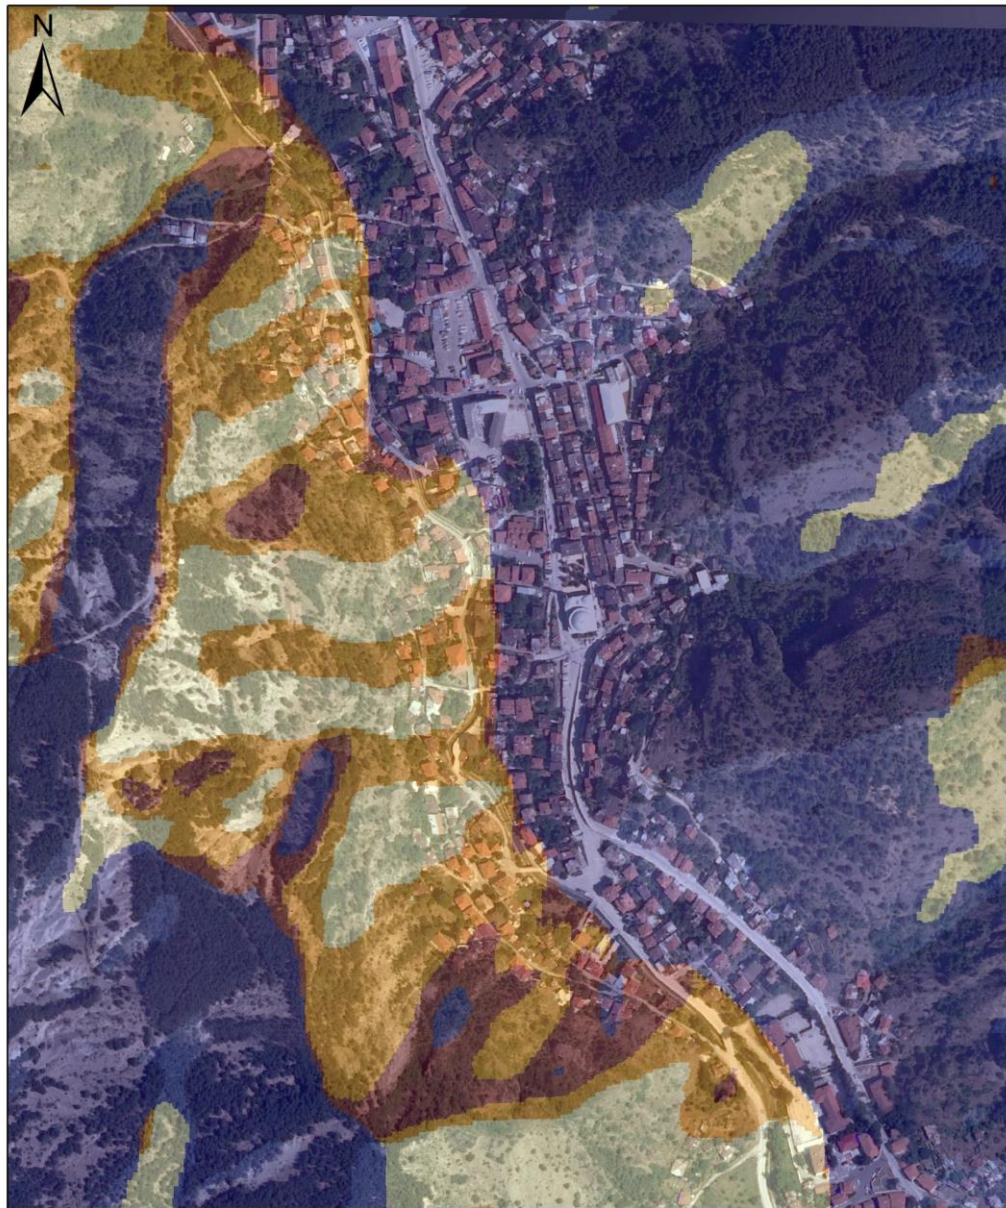
Figure 89: Aspect map of the study area extracted from the DEM

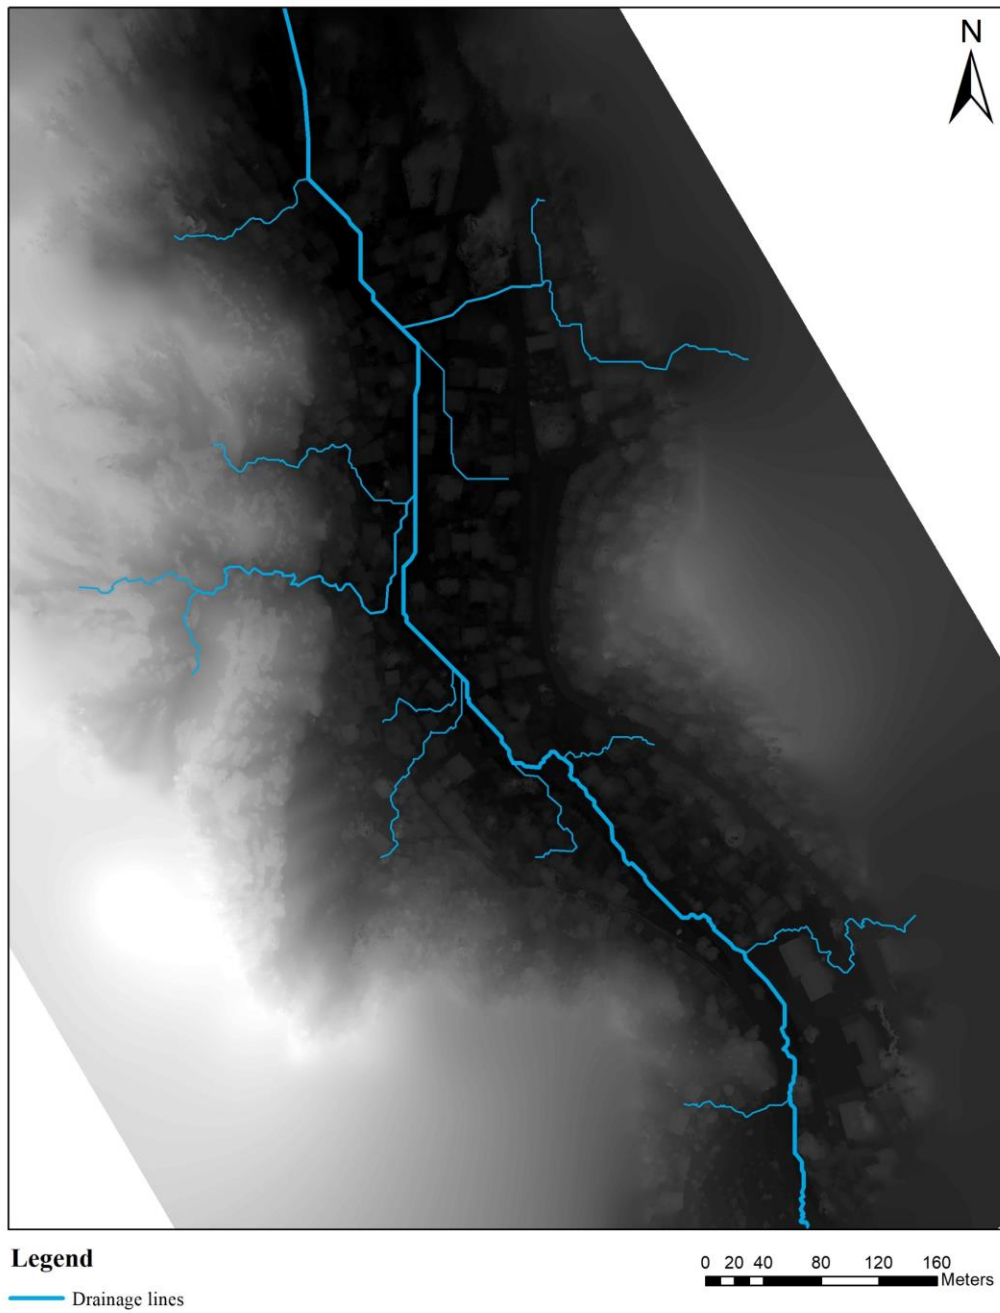
Figure 90: Surface water drainage pattern of the study area extracted from the DEM

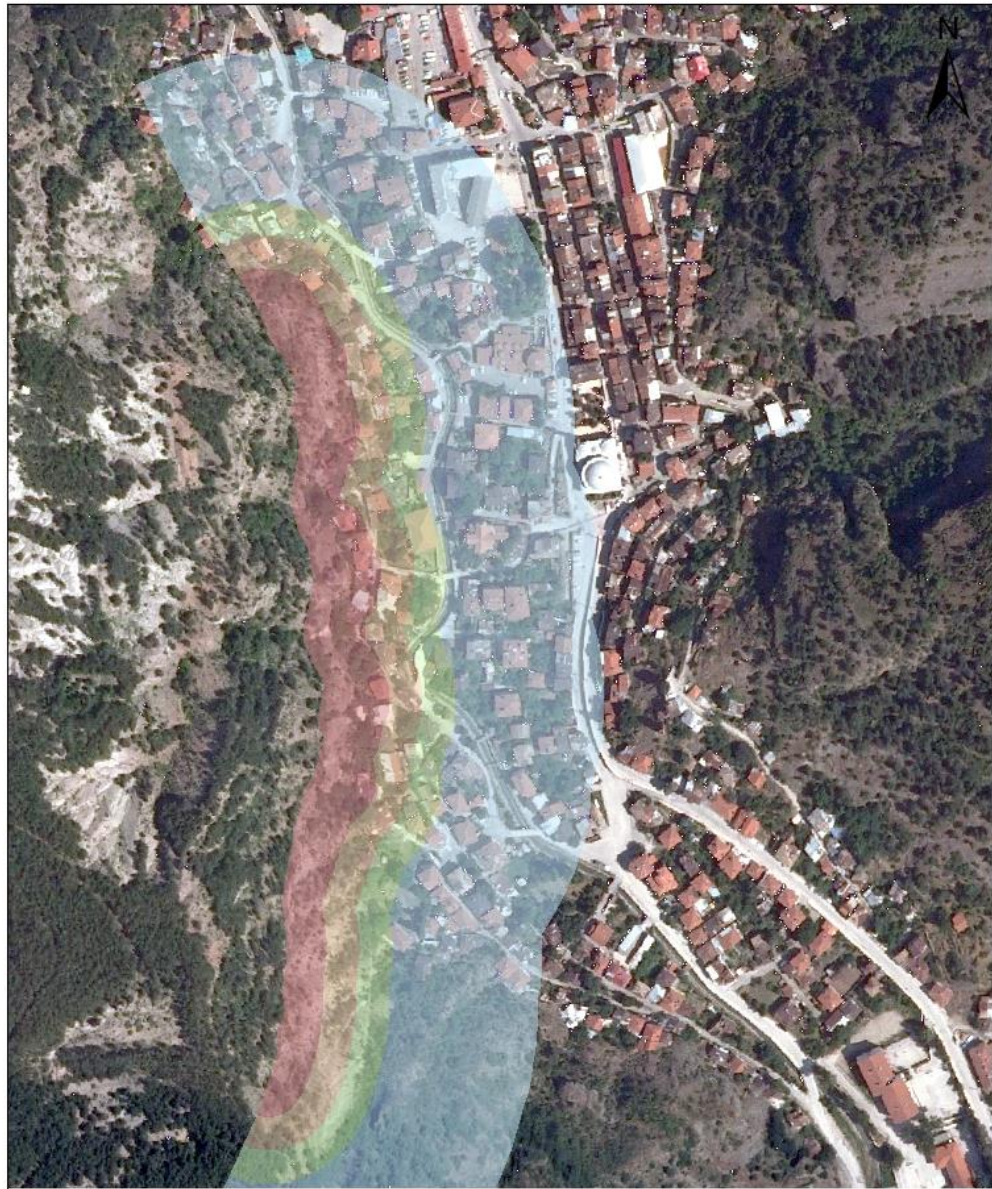
Figure 95: Zones showing the distance to the sliding blocks from the discontinuous slope face

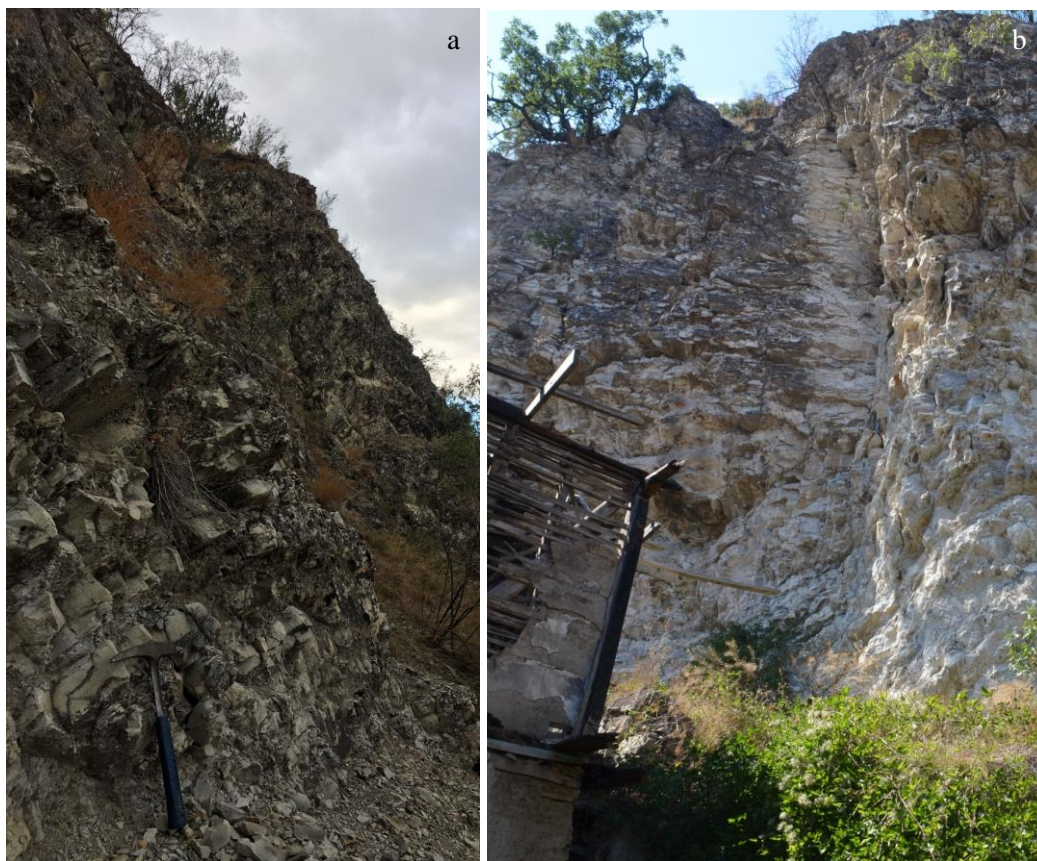
Figure 99: Example images for different failure types possible on the western side of the Mudurnu valley. a) Toppling (lower leftern side) and planar (upper part) failures, b) wedge failure

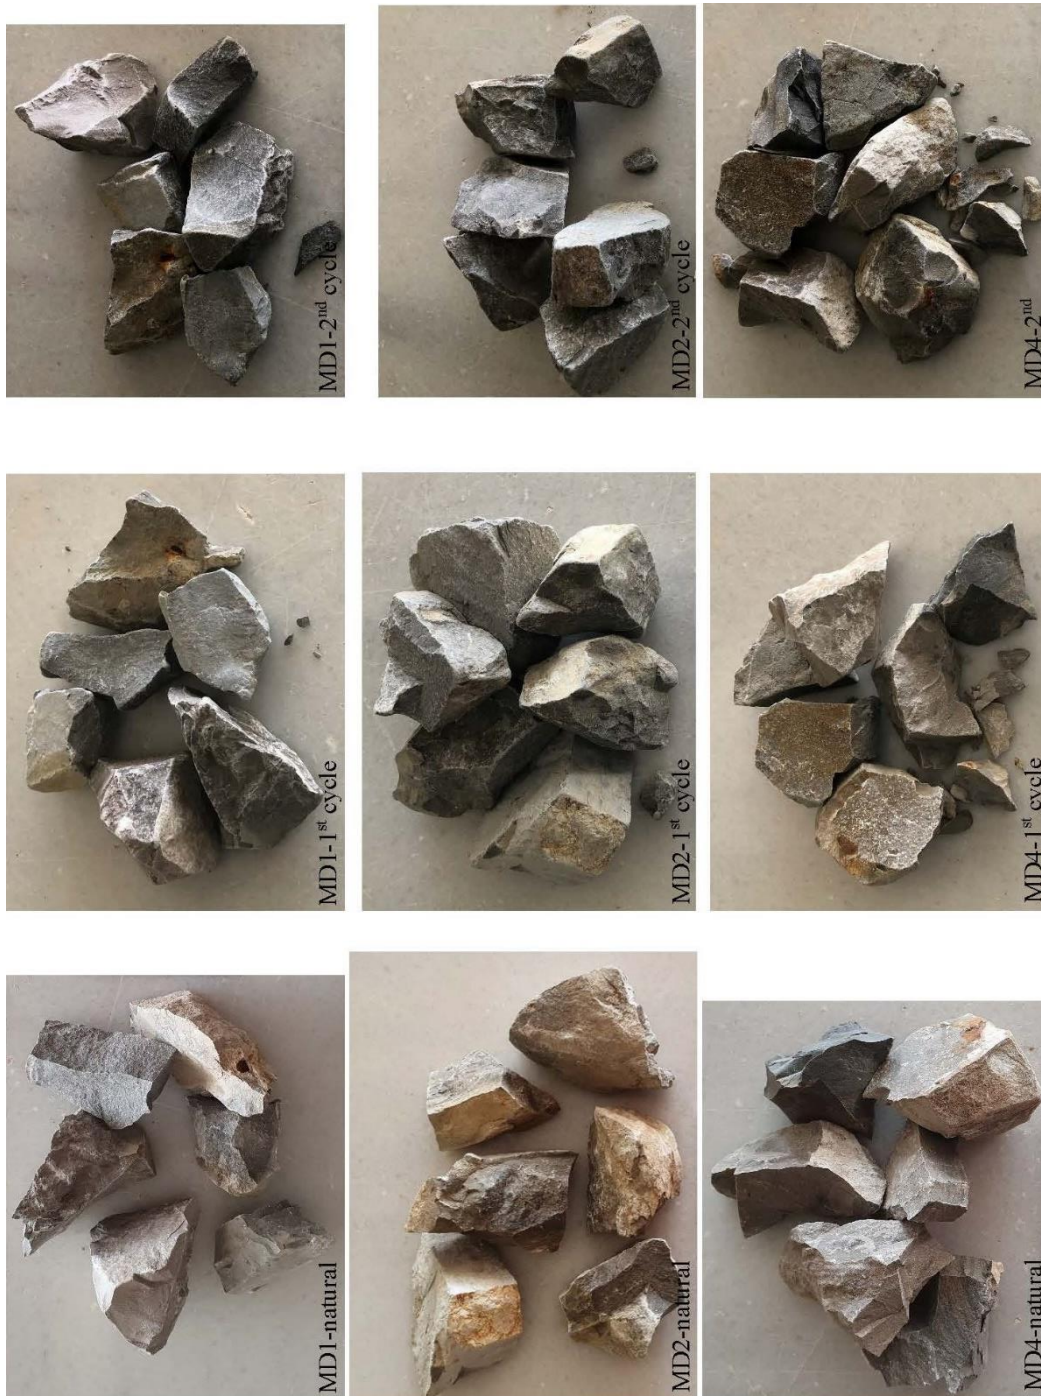
Figure C 2: Slake Durability tested rock samples from Sectors 1, 2 and 4. The first column shows a view of specimens before the test, whereas the second and third columns present the condition of the specimen following the 1st and 2nd cycles, respectively

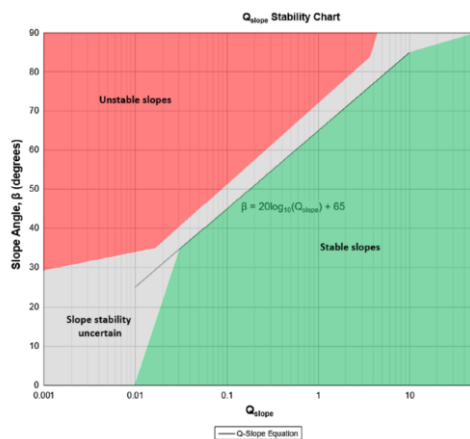
Figure D 1: Q-slope stability chart (Barton and Bar, 2015)
