ENGINEERING GEOLOGICAL CHARACTERIZATION OF THE ROCK
MASSES AND THEIR EVALUATION BY SPATIAL ANALYSES,
DETERMINATION OF THE ROCK SLOPE FAILURE SUSCEPTIBILITY
ZONES AND HAZARD ASSESSMENT OF MUDURNU (BOLU)

A THESIS SUBMITTED TO
THE GRADUATE SCHOOL OF NATURAL AND APPLIED SCIENCES
OF
MIDDLE EAST TECHNICAL UNIVERSITY

IN PARTIAL FULFILLMENT OF THE REQUIREMENTS
FOR
THE DEGREE OF DOCTOR OF PHILOSOPHY
IN
GEOLOGICAL ENGINEERING

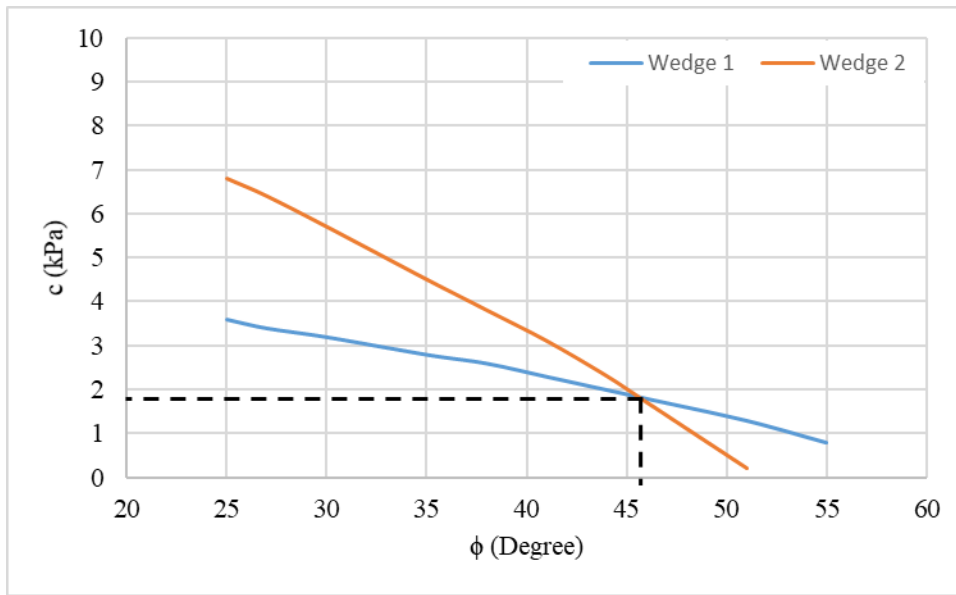
Figure E 1: Variation of the c - ϕ pairs in terms of the Mohr-Coulomb failure criterion where the intersection point identifies the back-calculated shear strength parameters of Sector 5

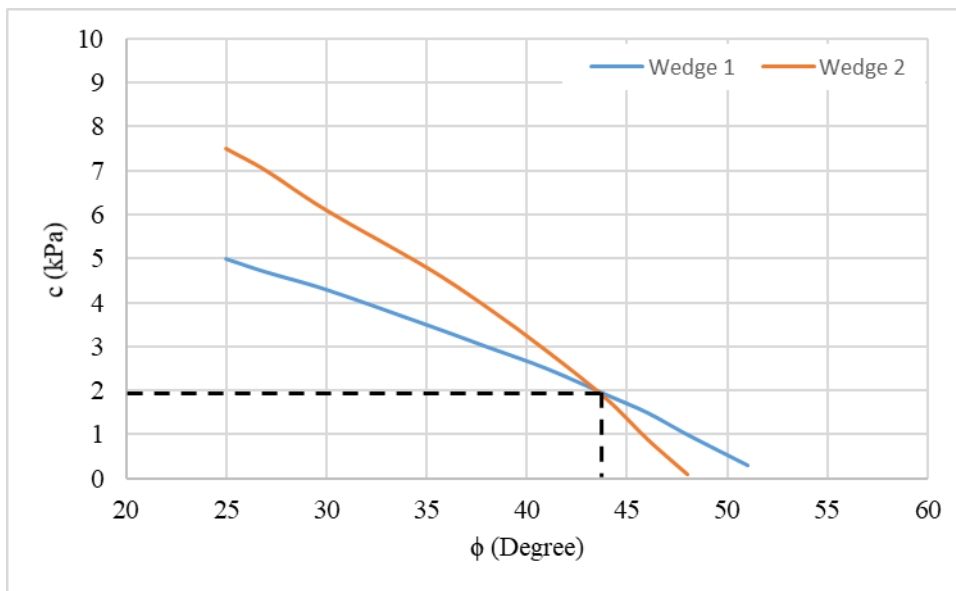
Figure E 2: Variation of the c - ϕ pairs in terms of the Mohr-Coulomb failure criterion where the intersection point identifies the back-calculated shear strength parameters of Sector 10
