FIRE VULNERABILITY ASSESSMENT FOR HERITAGE PLACES:
A CASE OF THE CITY OF SAFRANBOLU WORLD HERITAGE SITE

A THESIS SUBMITTED TO
THE GRADUATE SCHOOL OF NATURAL AND APPLIED SCIENCES
OF
MIDDLE EAST TECHNICAL UNIVERSITY

JUNE 2022

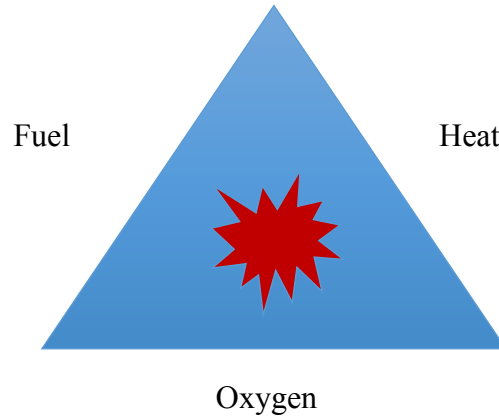
Figure 4 The Fire Triangle

Fire incidents happen when a fuel that can be a flammable material is reached its ignition temperature by a heat source such as flame in the oxygen presence (Kidd, 1995) (Figure 4). The existence of three elements: fuel, heat, and oxygen, are necessary for a fire occurrence. If any of those elements are removed, fires can be prevented or extinguished (CFPA-E, 2013).

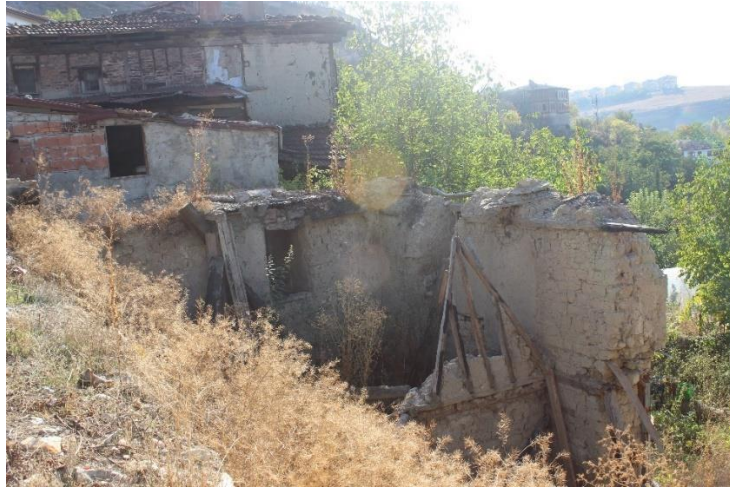
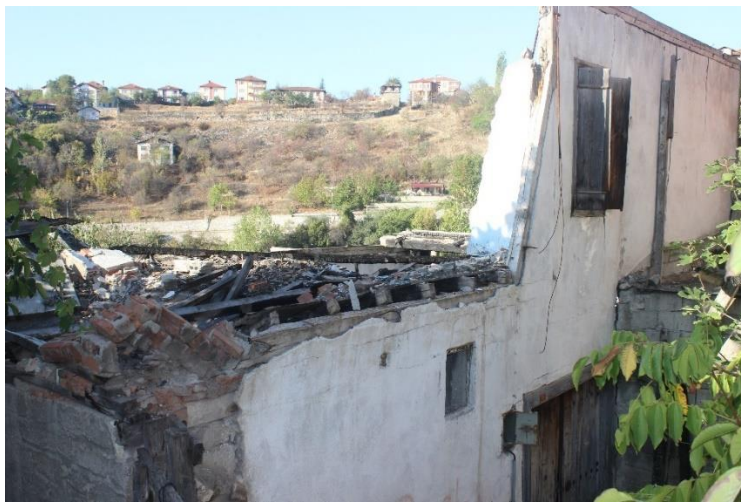
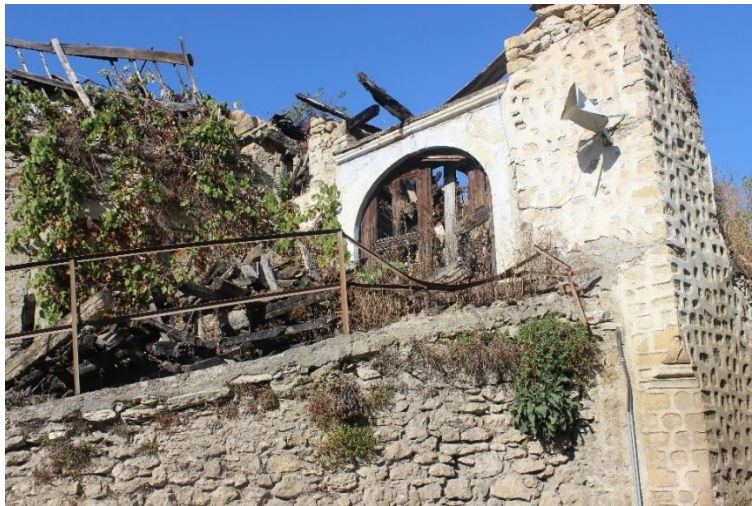
Figure 8 Some samples of burnt traditional buildings that were investigated during the site survey conducted in October 2020

In addition to fires in traditional buildings, fires happen in traditional environments. For example, between 2013 and 2017, 17 fires occurred in Historic Safranbolu [URL 7]. Some traditional buildings burnt due to fires in Safranbolu can be seen in Figure 8. When considering the significance of cultural heritage, this number is critical. The occurrence of many fires in such areas where the traditional urban pattern is dominant poses a severe risk to the sustainability of cultural heritage sites. Since a fire that will occur in the historical tissue can spread rapidly to the nearby environment due to being constructed very close to each other in a street pattern, including narrow and dead-end streets, the fires in these areas may cause more destructive consequences.

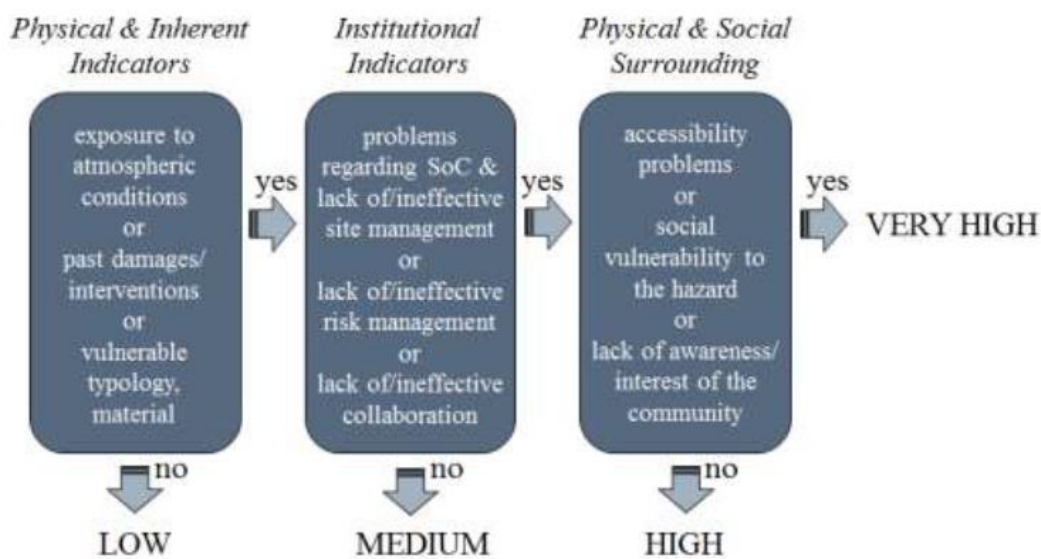
Figure 36 Natural Hazards Vulnerability Assessment method developed by Yıldırım Esen (2014, p.197)

The logic of the Yıldırım Esen (2014) method was adapted to the Fire Vulnerability Assessment of Heritage Places in this research. Yıldırım Esen (2014) developed a simplified model for risk assessment of archeological sites at a territorial scale. She identified natural, institutional, and human-induced hazards to which archaeological sites in İzmir were exposed. She evaluated the vulnerabilities of those sites through physical, institutional, and social factors by the method that she developed and assessed risks accordingly. Her approach was based on four vulnerability categories: low, medium, high, and very high (Figure 36) (Yıldırım Esen, 2014).

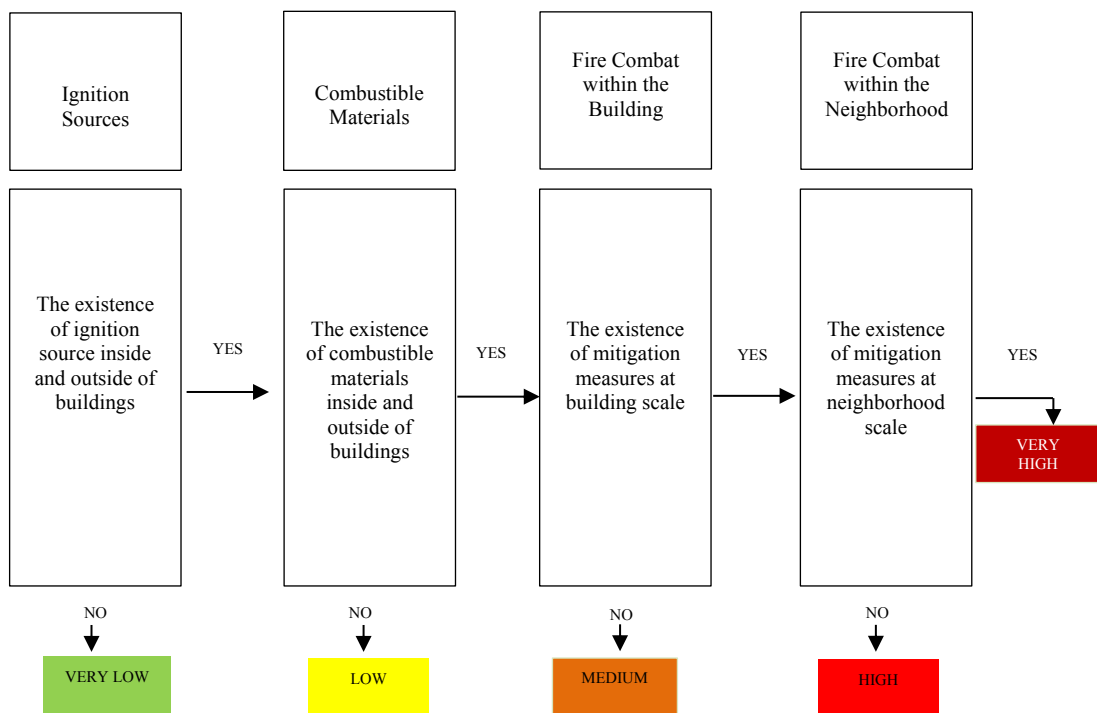
Figure 37 A Proposal for Fire Vulnerability Assessment Algorithm for Heritage Places (prepared by the author)

This simplified vulnerability assessment method will be straightforward for heritage places exposed to fire risk on an urban scale. It classifies the fire vulnerability of cultural heritage following meeting criteria related to those indicators both inside and outside heritage buildings. This simplified FVA method contributes to identifying the most vulnerable traditional areas that need a further detailed and refined fire risk assessment. This method evaluates indicators related to the built environment and firefighting measures within the building and neighborhood scales in FVA.

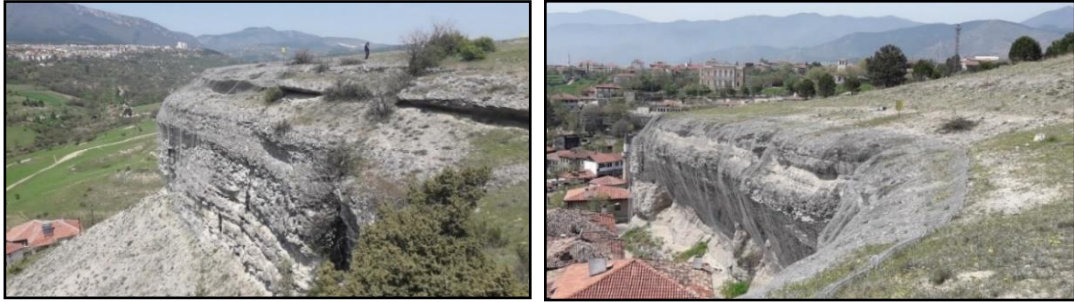
Figure 50 Interventions made by Provincial AFAD Directorate (Karabük Provincial AFAD Directorate Archive)

Neighborhood	Rockfall events and Risk	Interventions defined by Provincial AFAD Directorate
Çavuş and Akçasu Neighborhood	21 residential buildings in Çavuş Neighborhood- Rockfall Risk -Three residential buildings in Akçasu Neighborhood- Rockfall Risk	Çavuş Neighborhood- 250 m Wire Covering -opening ditch in enough depth and width
İzzetpaşa Neighborhood	13 residential buildings- Rockfall Threat	-East: 200 m Wire covering for 10-40 cm rocks at 20-10 m height -Middle: Wire Covering 30 m in length and 10 m in height -West: 100 m Wire covering at 20 m height
İsmetpaşa Neighborhood	Eight residential buildings- Rockfall Threat	-South: Wire covering 55 m length and 15 m height -North: Wire covering 80 m length and 15 m height

Some of the interventions made by the Provincial AFAD Directorate for rockfall can be seen in the picture below.

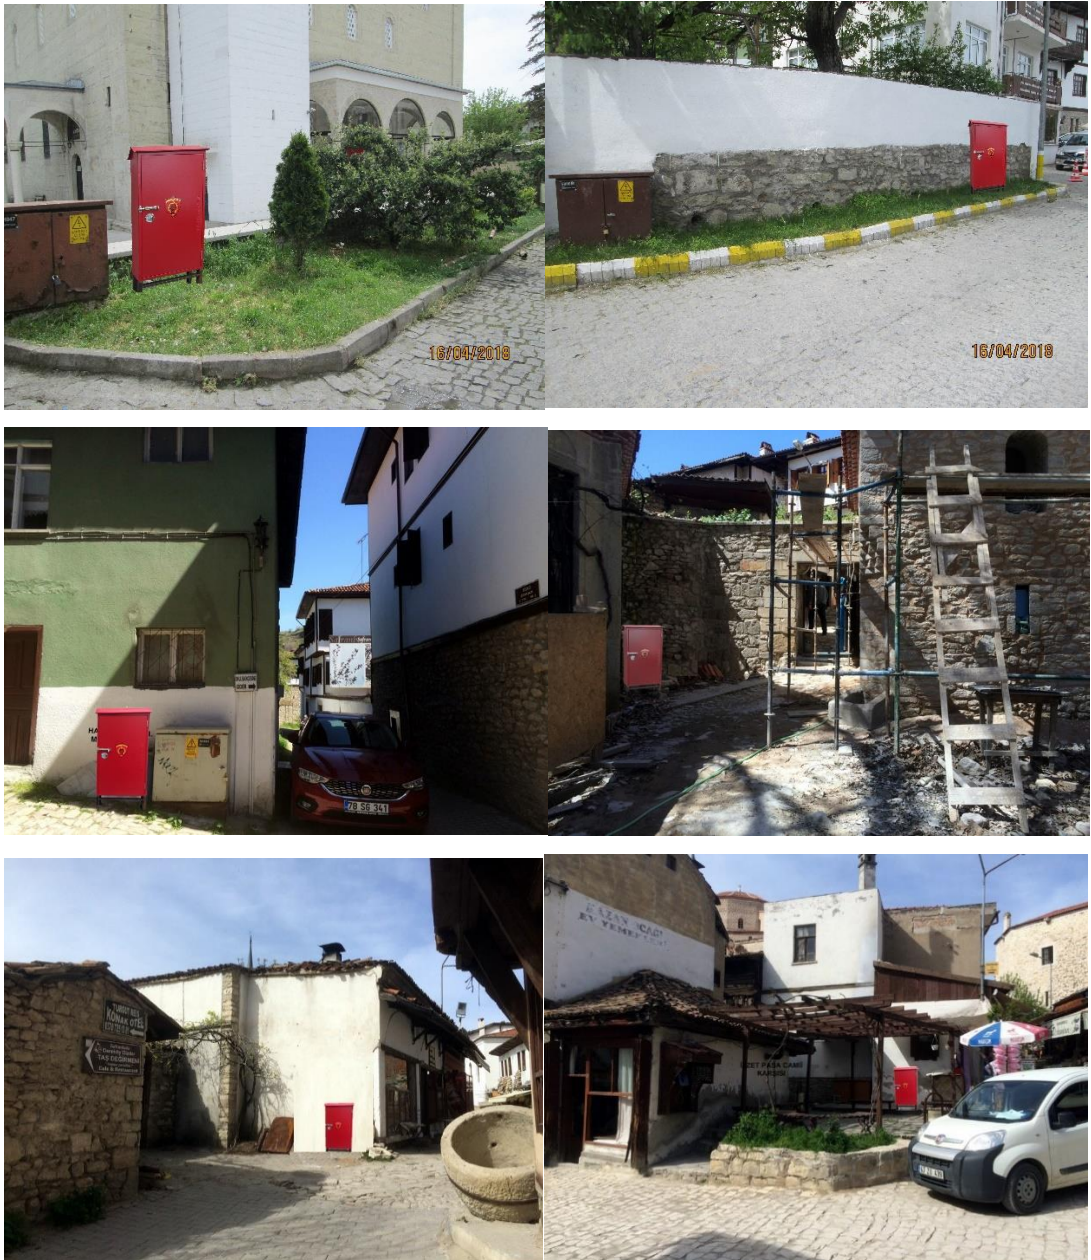
Figure 58 Fire Cabinet in Safranbolu (Fire Brigade Archive)

Fire cabinets provide intervention in difficult access regions during a possible fire. In the City of SWHS, Safranbolu Fire Brigade implemented fire cabinets to some parts of the site.

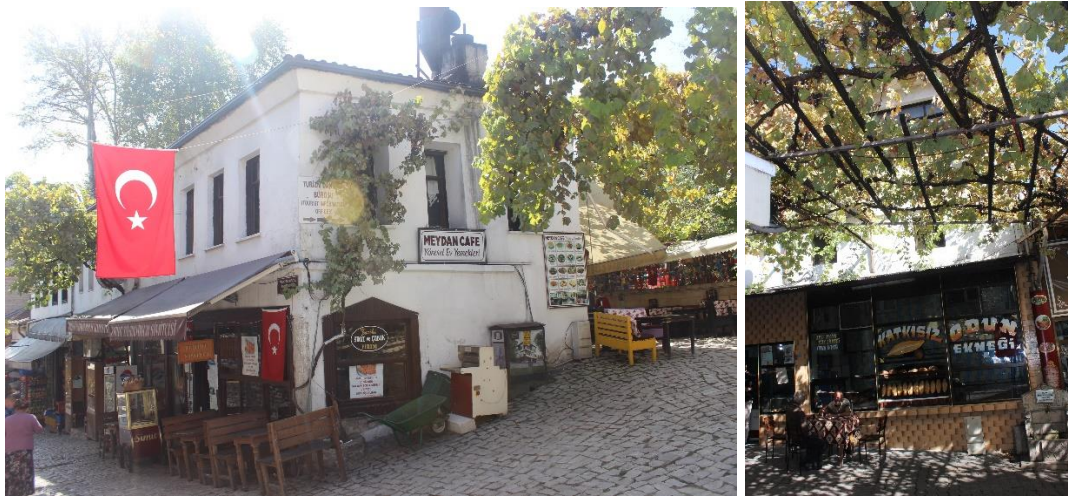
Figure 62 Bakeries in Çarşı Region (photos taken by the author during the site survey conducted in October 2020)

Furthermore, some restaurants and bakeries use fire ignition sources. The existence of kitchens in restaurants and active bakery facilities can be evaluated as fire ignition sources in the neighborhood. For example, on holidays, when approximately twenty thousand tourists fill the streets of the bazaar, how to respond to a fire that may arise from LPG cylinders used in restaurants or cafeterias or for any other reasons becomes

necessary to fire risk mitigation in Safranbolu (Anonymous, 2018).

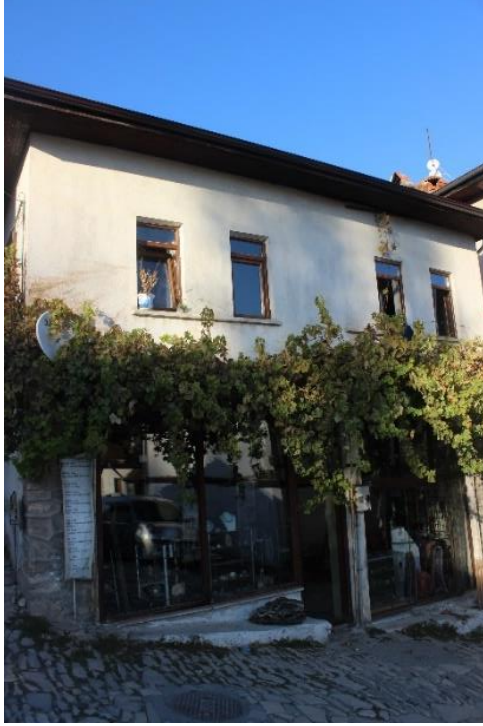
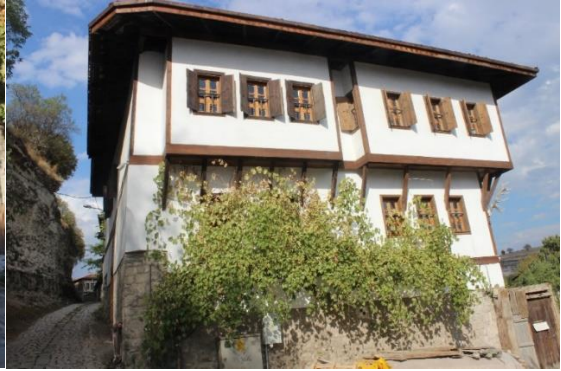
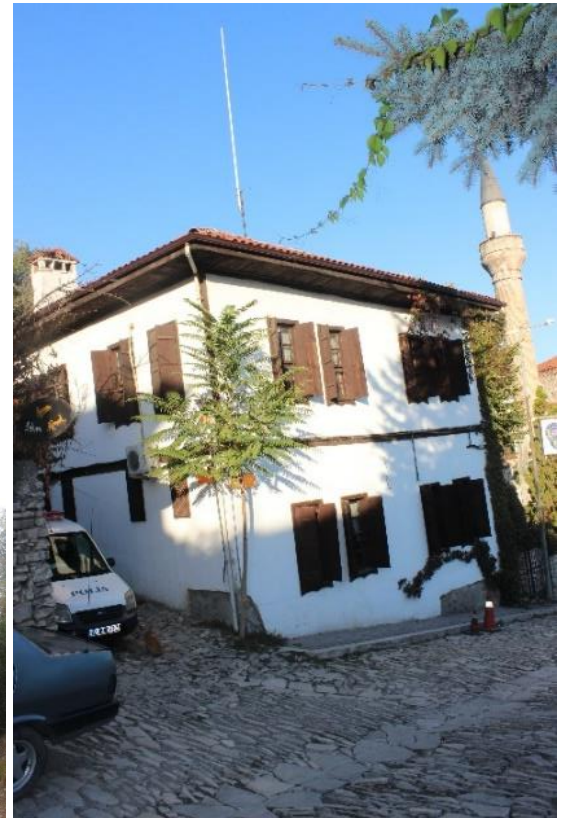
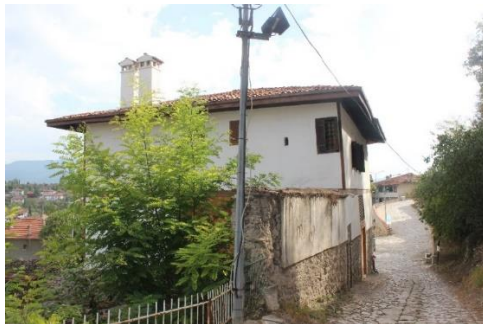
Figure 63 Some vegetation examples in plots in Hükümet Street in Çeşme Neighborhood (photos taken by the author during the site survey conducted in October 2020)

Park, overgrown vegetation, trees, forest, bush, and garbage close to traditional buildings and environments can cause fires. As was discussed during the site survey, dry grass in the neighborhood causes fires in Safranbolu (Çeşme Neighborhood Mukhtar, Personal Interview, 2020). Due to Safranbolu’s natural characteristics, there are various vegetation examples exist. For example, between 2015 and 2020, 31 grass and 14 rubbish fires happened in Çarşı Region (Fire Brigade Archive). Different vegetation samples were investigated during the site surveys (Figure 63).

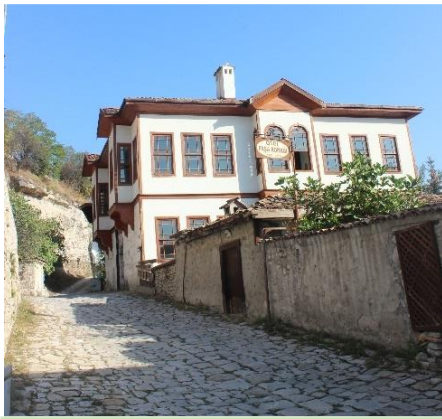
Buildings in Good Condition

Figure 65 Samples from Building Conditions in the City of Safranbolu WHS (photos taken by the author during the site survey conducted in October 2020)

The structural condition of traditional buildings contributes to the flammability degree of materials in their construction systems. The construction materials can be more flammable with decayed structural systems and materials. Since the older the building is, the more flammable materials such as timber used in the building are. Furthermore, the structural conditions of traditional buildings in the Safranbolu WHS are primarily average and poor (Figure 65, Figure 67). In addition, most of the vacant traditional buildings are in poor condition in the Çeşme Neighborhood in Safranbolu. This situation also affects the fire vulnerability of those buildings.

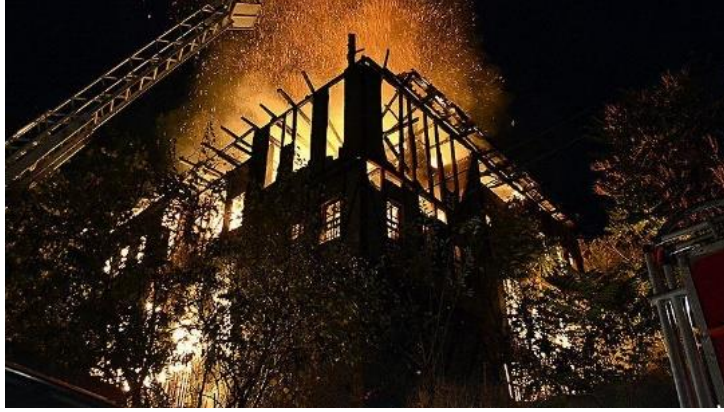
Figure 69 Historic Building Fire on 26 September 2016 [URL 45]

Mehmet Gökçü, who is the Chief of Safranbolu Fire Brigade, evaluated that the riskiest buildings were vacant ones in Safranbolu (Gökçü, 2020). In addition, the existence of abandoned historic buildings and using those buildings illegally without any fire safety controls cause fires in Safranbolu (Yılmaz, 2018). For example, the news: ‘A historic building burnt due to fire./Safranbolu'da tarihi konak yandı.’ [URL 45] stated that a three-storey vacant historic building burnt due to fire on 26 September 2016. 150 years of the historic building became useless after the fire [URL 45].

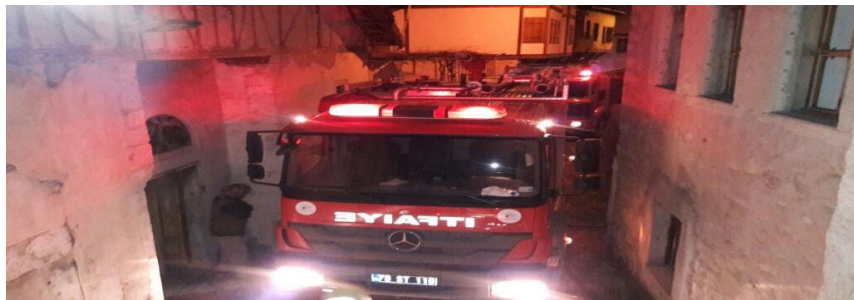
Figure 70 A Narrow Street in Safranbolu (FIRESKILLS, 2017)

There are problems related to accessibility in and to the City of Safranbolu WHS. Accessibility in and to the site is challenging in some parts of Safranbolu. The traditional organic pattern is settled on a high slope. Firefighting became difficult for the passing of fire trucks. The City of SWHS consists of narrow and dead-end streets. The width of some streets is less than 4 meters, allowing fire trucks to pass during response and emergency. The street width is less than 4 meters, the average width for fire trucks defined by the Turkey Fire Regulation of Buildings (BYKY, 2009). In addition, the City of SWHS has a unique topography that shapes its urban pattern. These authentic characteristics of the site increase the fire vulnerability of the site since it produces accessibility problems during response and emergency times (Figure 70).

Some streets are less than 4 meters in width in some parts of Safranbolu, and the slope makes accessibility difficult. Due to being a touristic destination, the City of SWHS is crowded with pedestrian and motorized traffic. For example, on holidays, approximately twenty thousand tourists fill the streets of the bazaar in Safranbolu (Anonymous, 2018). Çarşı Region cannot be capable of excessive traffic and population, and accessibility is difficult during firefighting due to rough land characteristics and the existence of narrow streets (Yılmaz, 2018). Gökçü stated that

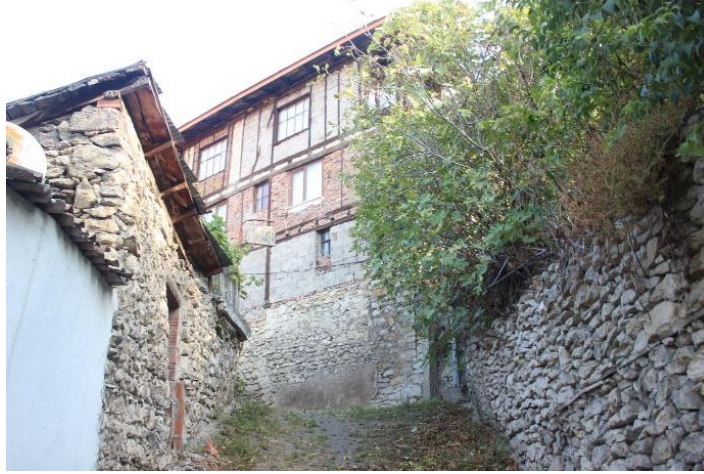
Figure 71 Çuhadar Street Width Less than 4-meters and the slope is more than 15 %. (Uluç, 2020)

For example, Çuhadar Street's width is less than 3 meters. In addition, fire trucks cannot pass through the narrow sections of the street under Hıdırlık, and there is no fire hydrant in this region. The street entering from Hükümet Street to Akçe Street in Çeşme Neighborhood is very narrow; as a result, it is not possible to enter by vehicle to this street. In addition, there is no fire hydrant inside the building block.

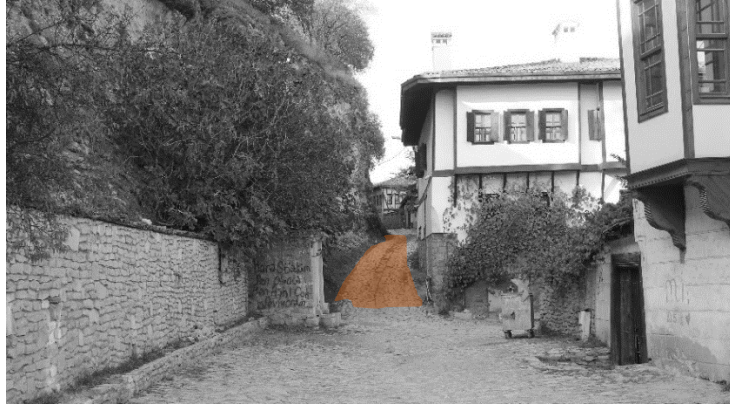
Figure 72 Gümüş Street and Hükümet Street Junction, the width is less than 4 meters, and the slope is more than 15 %. (Uluç, 2020)

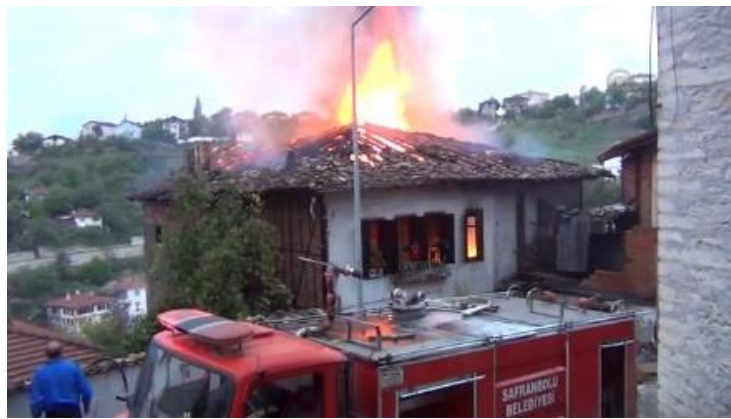
Figure 73 Historic Residential Fire on 15 September 2015 [URL 44]

Accordingly, for example, the news: ‘‘Historic Residential Fire in Safranbolu/Safranbolu'da tarihi ev yangını’’ [URL 44] stated that fire combat was challenging due to narrow streets and cars parking on the streets during the fire on 15 September 2015. The two-storey historic building was 150 years old and became unusable after the fire [URL 44]. (Figure 73)

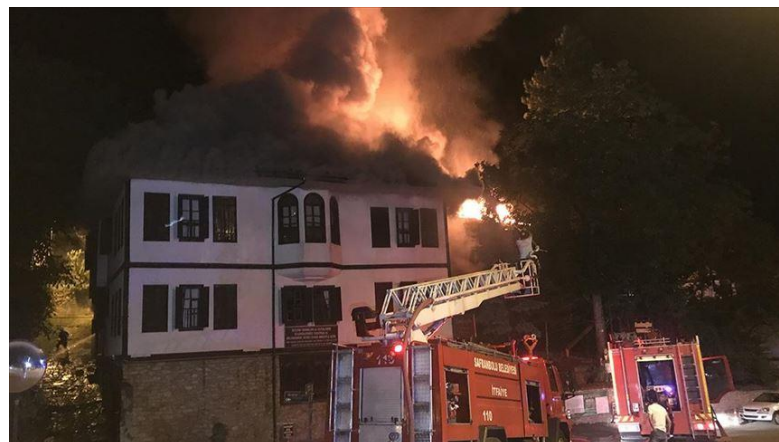
Figure 74 Historic Residential Fire on 25 July 2020 [URL 48]

Another news: ‘‘Fire in Historic Building in Safranbolu /Safranbolu'da tarihi konakta yangın’’ [URL 48] stated that it was challenging to intervene against fire due to narrow streets on 25 July 2020 fire. 150 years and three-storey of two historic buildings were damaged due to the fire [URL 48]. (Figure 74)

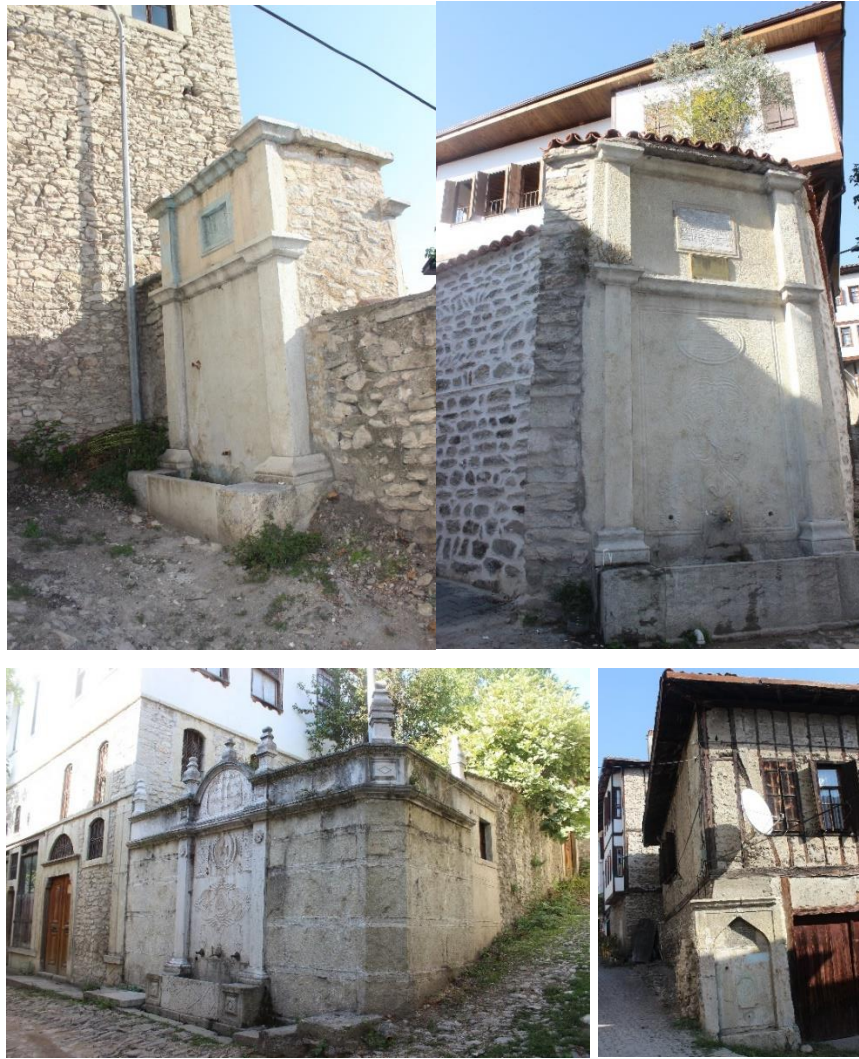
Figure 75 Fountains in the City of SWHS that were investigated during the site survey in 2020

Furthermore, many traditional and modern fountains can be evaluated as *water supply sources* for firefighting in the City of SWHS. Many traditional or modern fountains are settled in Safranbolu (Figure 75). However, while some of those fountains are used, some are not. Therefore, further investigations should be conducted to utilize fountains during firefighting. The amount of water and the pressure of water should be evaluated by experts. Fountains in the site were shown in the analysis.

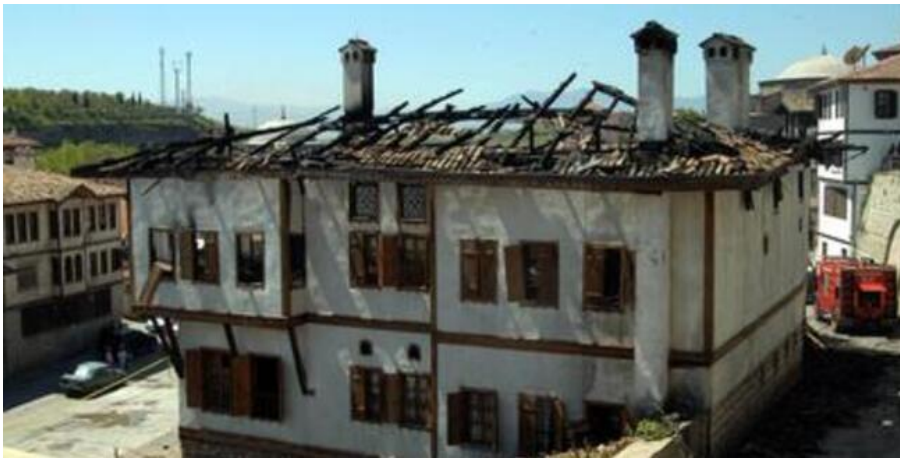
Figure 76 Historic Building Fire on 3 May 2010 [URL 43]

Yılmaz (2018) asserted that there was no field study including mapping, water supply, and firefighting area according to building characteristics in Safranbolu with the support of all parties on fire safety. Suitable fire trucks for various settlement attributes are absent (Yılmaz, 2018). The news: ‘‘Fire in Historic Building in Safranbolu (*Safranbolu’da tarihi konakta yangın*) [URL 43]’’ stated that there was insufficient technical capacity in Safranbolu to combat the fire on 3 May 2010. This historic building was 474 years old, used as a hotel, and restored [URL 43]. (Figure 76)

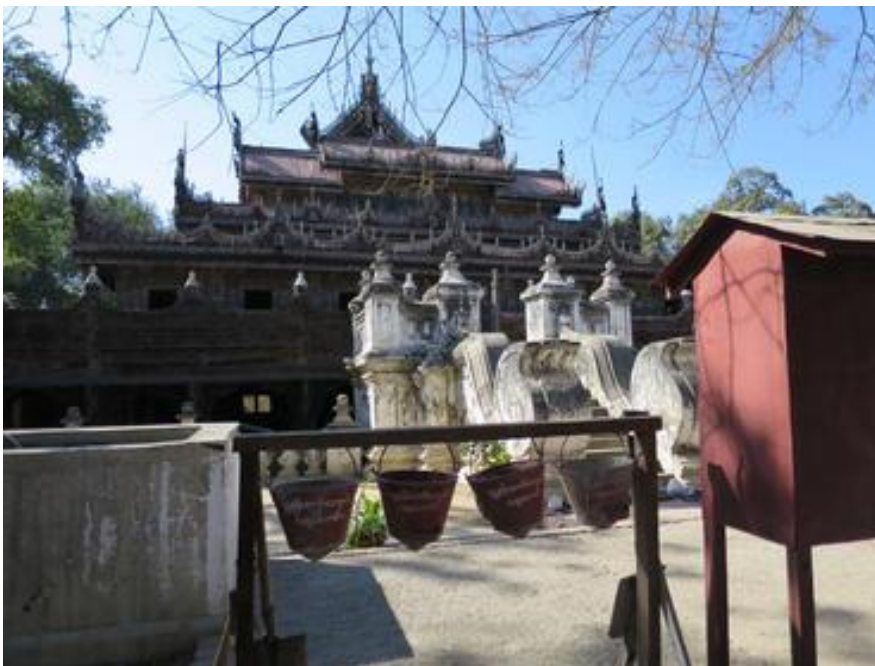
Fire suppression shovels and sand buckets at Shwe-nandaw Kyaung in Mandalay, Myanmar (<https://www.wmf.org/fire>)

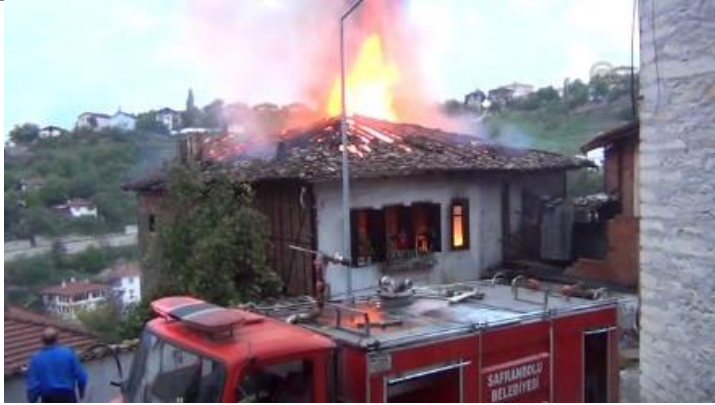
3	26 September 2016	A historic building burnt due to fire./ <i>Safranbolu'da tarihi konak yandı.</i> [URL 45]	150 years/three storey/empty/fires frequency in winter/after fire unusable (Address: Akçasu Neighborhood Ulukavak Street, "Emeksizler Evi")

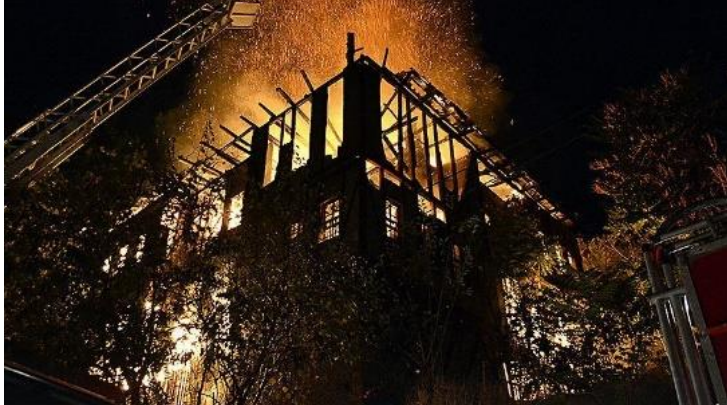
4	7 October 2017	Fire in Historic Building in Safranbolu/ <i>Safranboluda Tarihi Konakta Yangın</i> [URL 46]	150 years/2 storey/ after fire unusable (Address: Hüseyin Çelebi Neighborhood Taşminare Street)

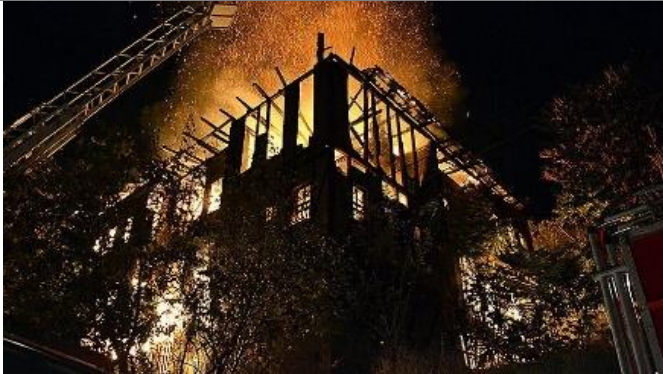
6	25 July 2020	Fire in Historic Building in Safranbolu / <i>Safranbolu'da tarihi konakta yangın</i> [URL 48]	150 years/3 storey/2 konaks were damaged/ narrow streets so difficult to intervene

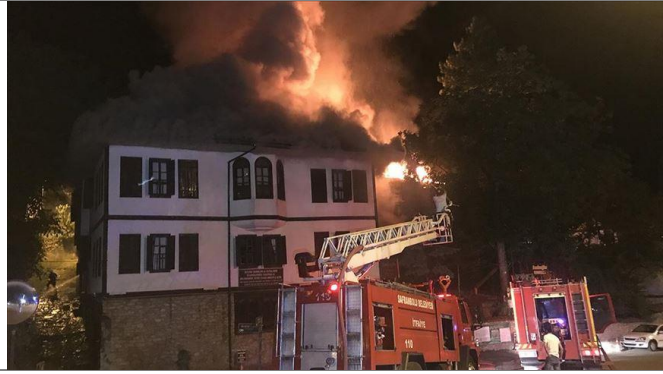
7	30 March 2021	Financial loss occurred in the historical building fire in Safranbolu, two people were injured./ <i>Safranbolu'da tarihi konakta çıkan yangında maddi hasar oluştu, iki kişi yaralandı</i> [URL 49]	130 years/3storey/ (Address: İzzetpaşa Neighborhood Akseki Street)
