THE ARCHAEOMETRICAL INVESTIGATIONS OF SOME IRON
COMPONENTS FROM THE OTTOMAN PERIOD STRUCTURES

A THESIS SUBMITTED TO
THE GRADUATE SCHOOL OF NATURAL AND APPLIED SCIENCES
OF
MIDDLE EAST TECHNICAL UNIVERSITY

SEPTEMBER 2022

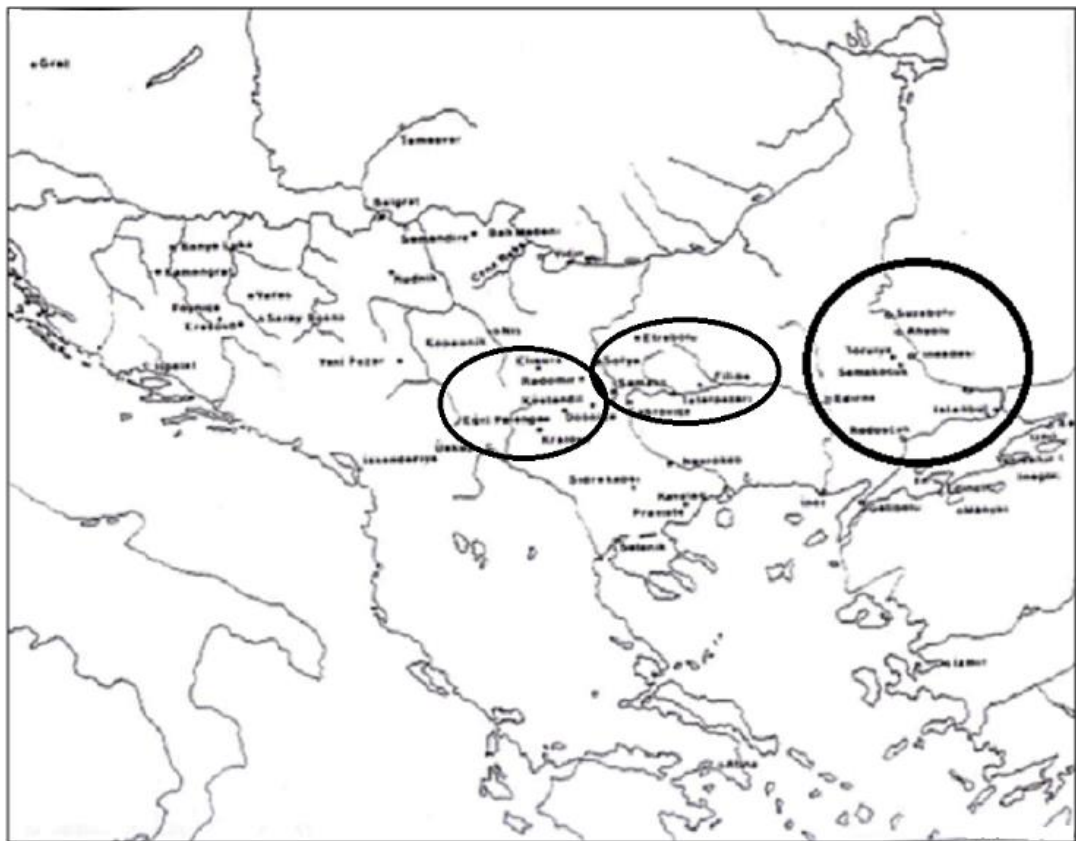
Figure 2. 1 The most important iron ore deposits and production centers in Rumelia in the Ottoman period (Tanyeli 1990).

There were many production centers in Anatolia even though the state did not interfere or pay much attention. Important iron production centers in Anatolia were within the Erzincan province, Sivas, Bilecik, the Marmara region near Kırklareli and Sakarya. However, Rumelia - Bulgaria, Bosnia (Dobnice, Kostendil, Sofia, Etrebolu, Samakov, Filibe and Tatarpazarı), Yugoslavia (Eğri Palanga and Kratova) and Kırklareli (Demirköy) - always had a major role in the iron production industry because of their accessibility to Istanbul (Eruz 2004). Maps (Figures 2.1 and 2.2) are given to show the most important iron ore deposits and production centers in the Ottoman period (Tanyeli 1990).

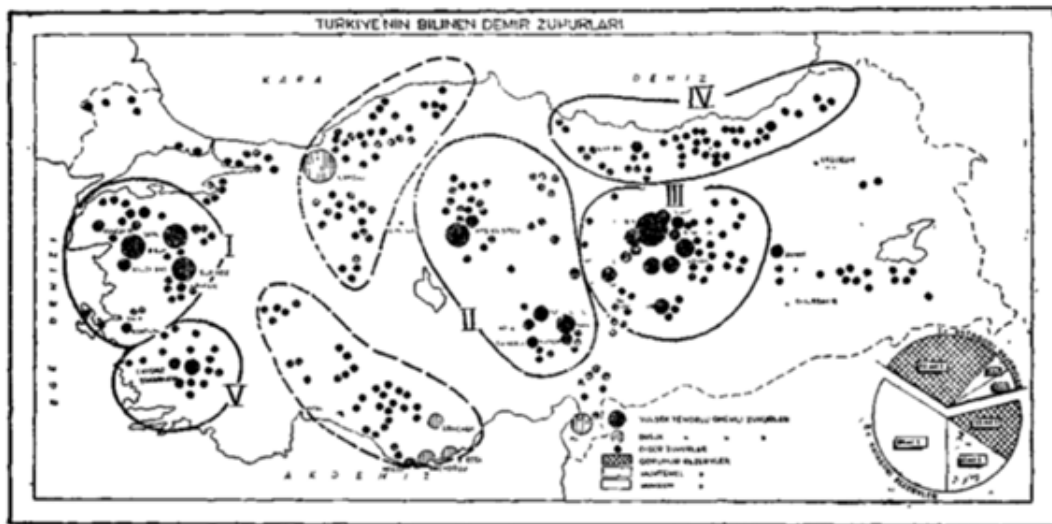
Figure 2. 2 The important iron ore deposits and production centers in Anatolia in the Ottoman period (http://www.maden.org.tr/resimler/ekler/bd987257ff0eddc_ek.pdf)

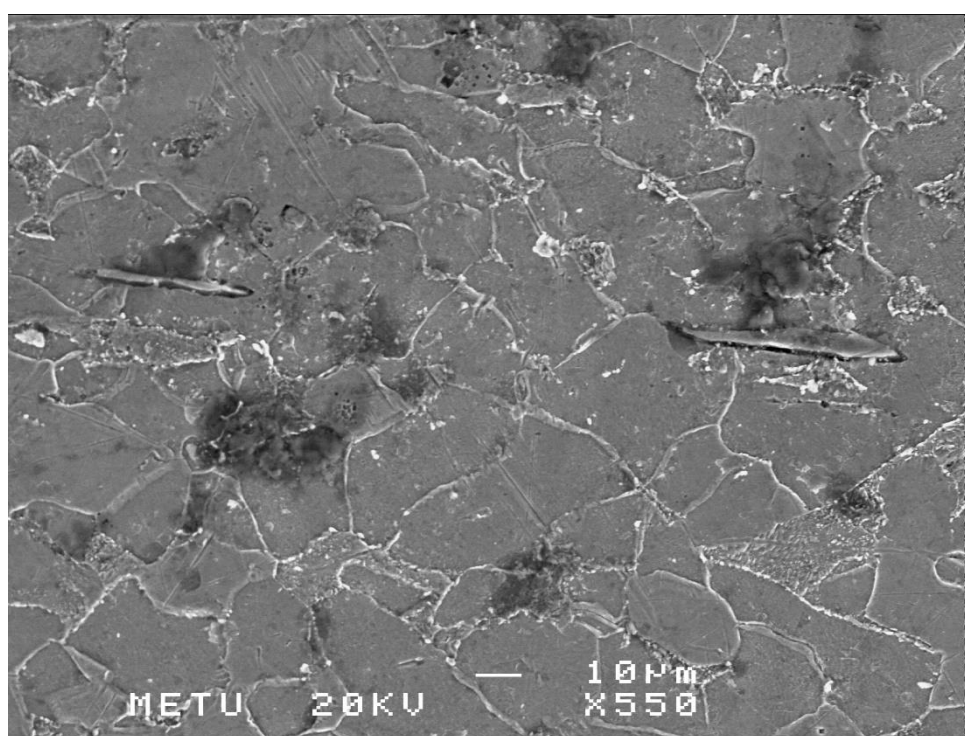
Figure 4. 3 SEM image (550x) of a nail head (MSH-KAP-01): Shark (sword) shaped images containing manganese sulfide (MnS) and pitting corrosion locations having Fe, Si, Mn and O.

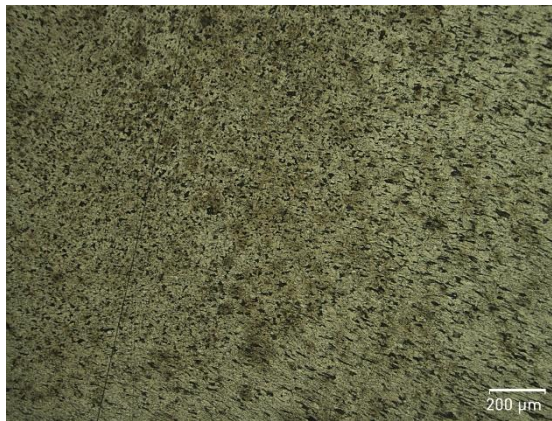
(c) GMH-Me-04 (200x), interior

Figure 4. 22 Microstructural images of samples taken by Huvitz digital microscope after etching with nitric acid in alcohol (a, b, c).

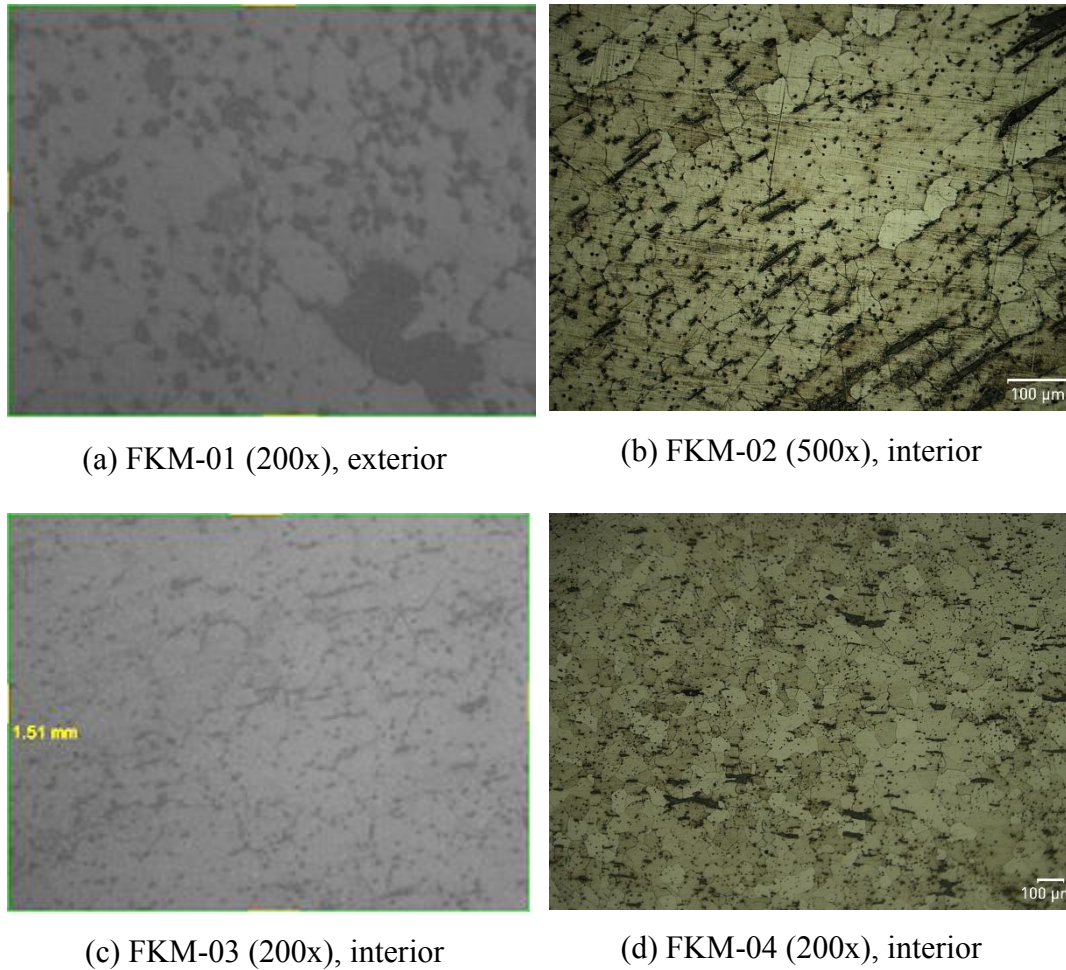
Figure 4. 26 Microstructural images of iron samples by Nikon metallographic microscope (a, c) and Huvitz digital microscope (b, d) after etching with nitric acid in alcohol (19th cc).

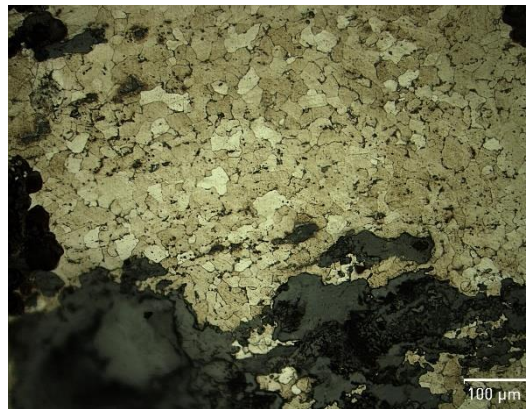
(h) FKM-09 (500x), buried

Figure 4. 27 Microstructural images of iron samples by Nikon metallographic microscope (g) and Huvitz digital microscope (e, f, h) after etching with nitric acid in alcohol (19th cc).

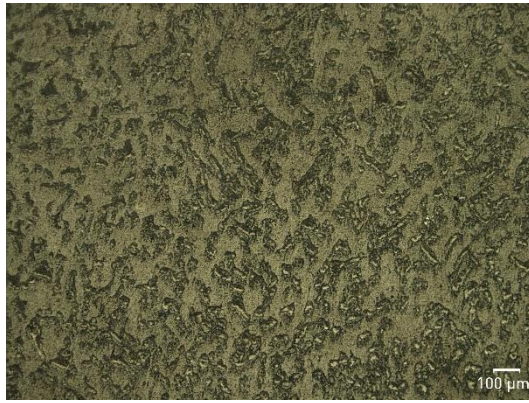
(k) T-N-01 (200x), exterior

A nail and a door lock piece (T-N-01 and T-D-01 respectively) from the dwelling in Tekkekoy, Samsun, have 98.4% - 96% total ferrite and 14.9% - 36% pearlite respectively. The nail sample (T-N-05) has ferritic and pearlitic structure, but it has more ferritic grains than the door lock piece (T-D-01). The nail sample (T-N-05) has little amount of corrosion / slag fragments. A window hinge sample (T-W-01) has pearlitic structure, corrosion / slag fragments and locally deep corrosion fragments. The hardness values of Tekkekoy iron samples are in medium hard and very hard range (from 202 HB to 290 HB). The two nails (T-N-01 and T-N-05) have hardness values of 219 HB and 210 HB respectively. The door lock piece (T-D-01) from the same dwelling has a hardness value of 202 HB and a window hinge pin (T-W-01) has the hardness value of 290 HB, being in very hard range.

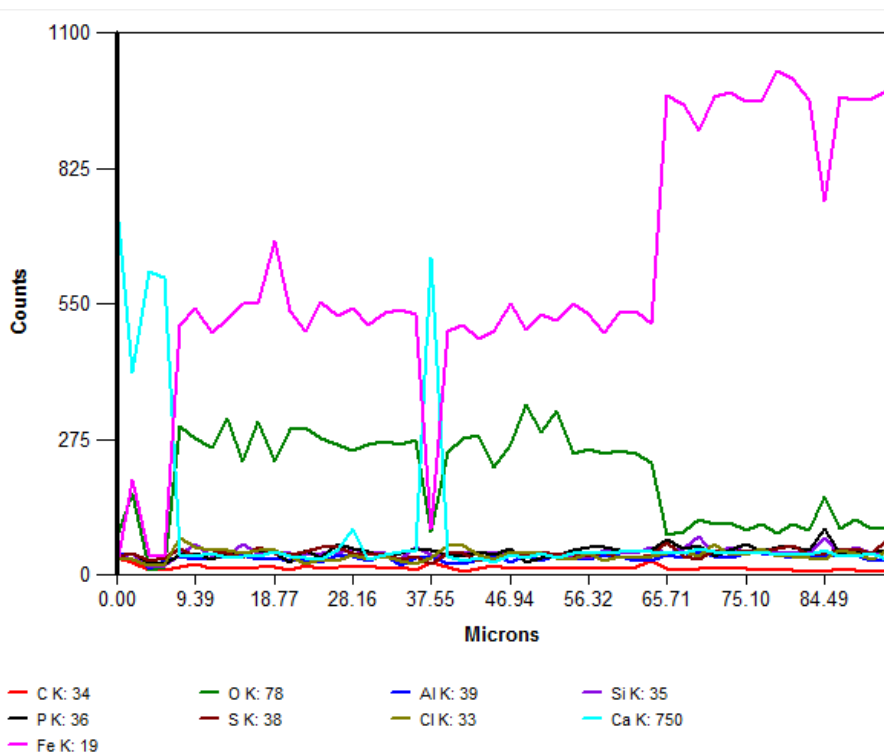
Figure 4. 47 EDX line scan spectrum of an iron object (MSH-KAP-02) starting from transformed media (TM) to main metal body: calcium is the most abundant impurity in the corrosion layer.

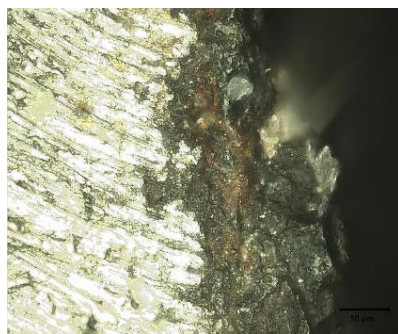
(a) FKM-02 (1000x)

Corrosion layers of the 19th century iron objects consist of samples from Foça - İzmir dwellings and Tekkekoy - Samsun. Corrosion layer characteristics were examined in four objects of Foça samples being a load bearing nail for jointing main timber beams (FKM-02) (Figure 4.54 a, b); a female hinge for a main entrance door (FKM-05) (Figure 4.54 c); a nail piece (FKM-11) partially open to atmosphere from a stone house and a nail from an Ottoman layer excavation (FKM-07) (Figure 4.55

c, d and a, b). The nail used for jointing main timber (FKM-02) taken from the interior has a compact and well observed corrosion layer having ICL around 50-75 μ m thickness. The female hinge for the main entrance door (FKM-05) belonging to interiors has also a compact and well observed corrosion layer with an ICL around 100-125 μ m thickness. The nail sample (FKM-07) representing the burial condition and the nail (FKM-11) which was partially exposed to atmospheric conditions, both have thick corrosion layers with cracks and porous areas in it. The ICL of the nail sample (FKM-07) from a burial condition does not have a uniform compact layer and its thickness is variable between 350-600 μ m. The other nail sample (FKM-11) located in the lower part of the stone wall affected by dampness problems has the thickest ICL being around 1300 μ m with deep cracks.

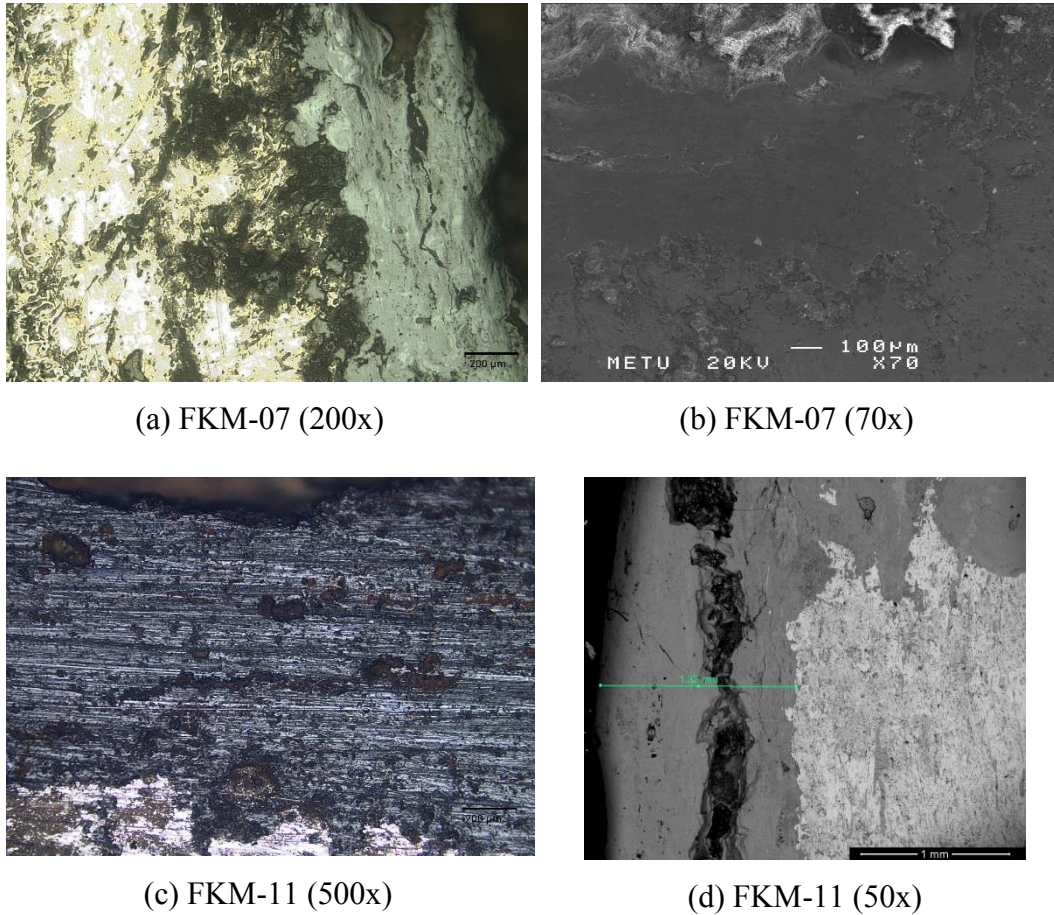
Figure 4.55 Digital microscopy images (a, c) and SEM images (b, d) of iron samples (FKM-07 and FKM-11) after etching with nitric acid in ethanol. FKM-07 is in burial conditions and FKM-11 is partially exposed to atmospheric conditions (19th cc).

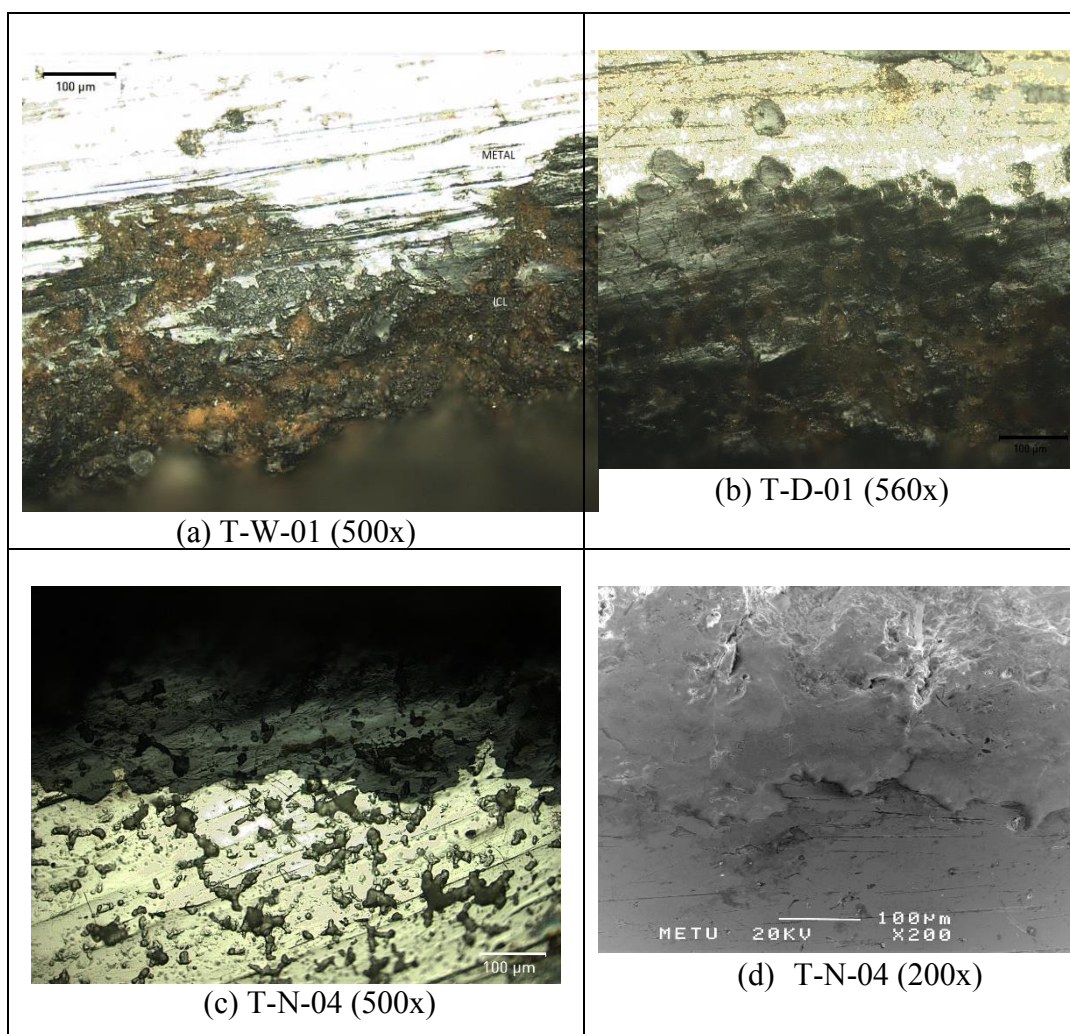
Figure 4. 56 Digital microscopy images (a, b, c) and SEM image (d) of iron samples (T-W-01, T-D-01 and T-N-04) after etching with nitric acid in ethanol (19th cc).

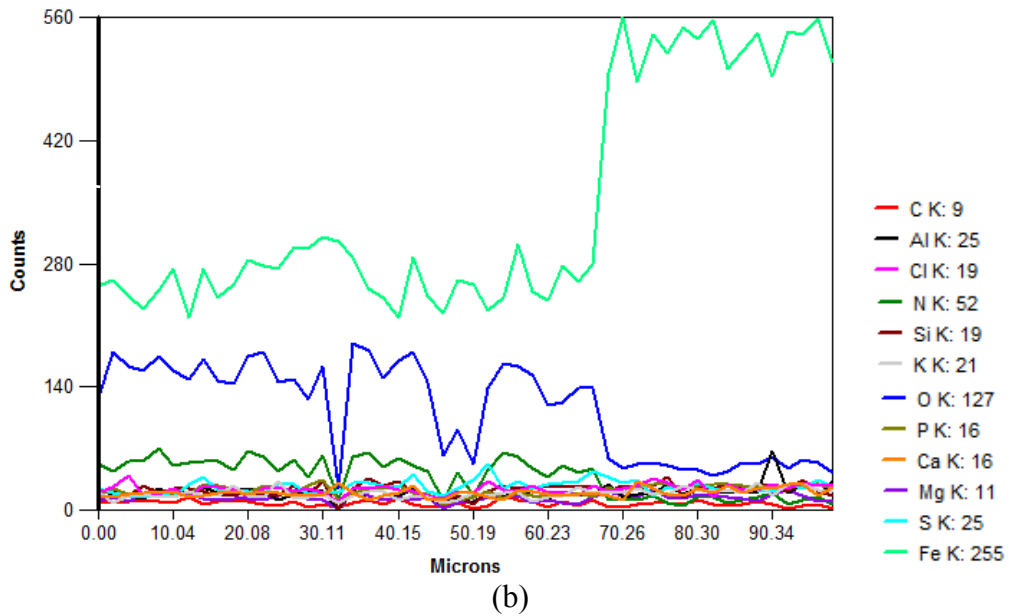
Figure 4. 64 SEM image of a nail (T-N-04) starting from transformed media (TM) to main body (a) and its EDX line scan spectrum (b): Fe, N, Al, S, Si, Cl, K, Ca and Mg.

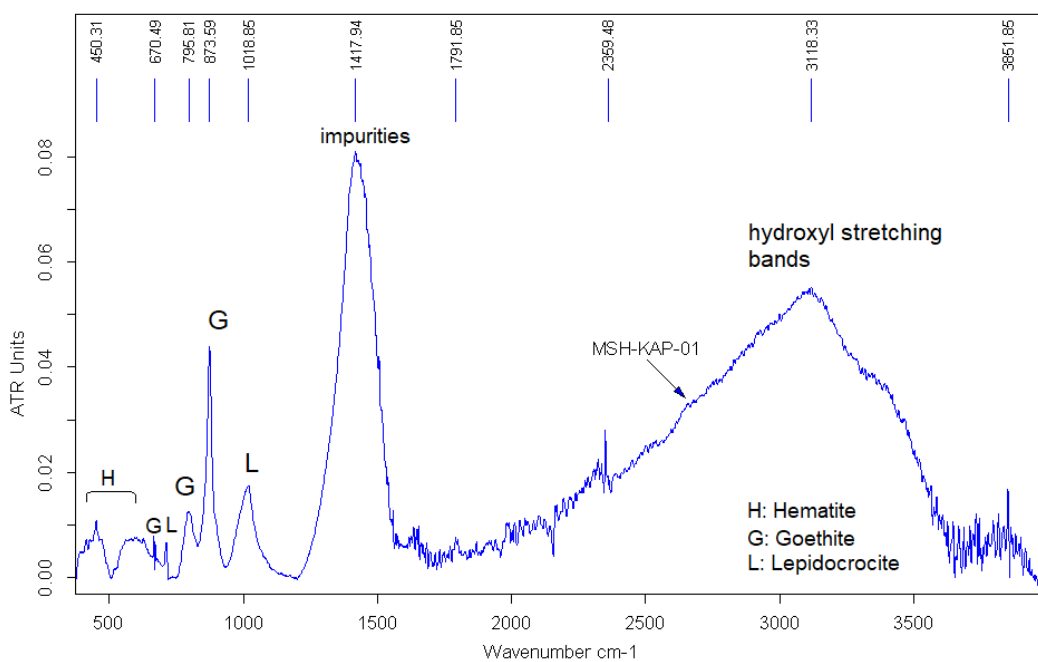
Figure 4. 67 FTIR spectrum of corrosion layer including ICL and TM of the nail (MSH-KAP-01) from the dome representing outdoor atmospheric condition: Goethite (α -FeOOH), lepidocrocite (γ -FeOOH) and hematite (α -Fe₂O₃).

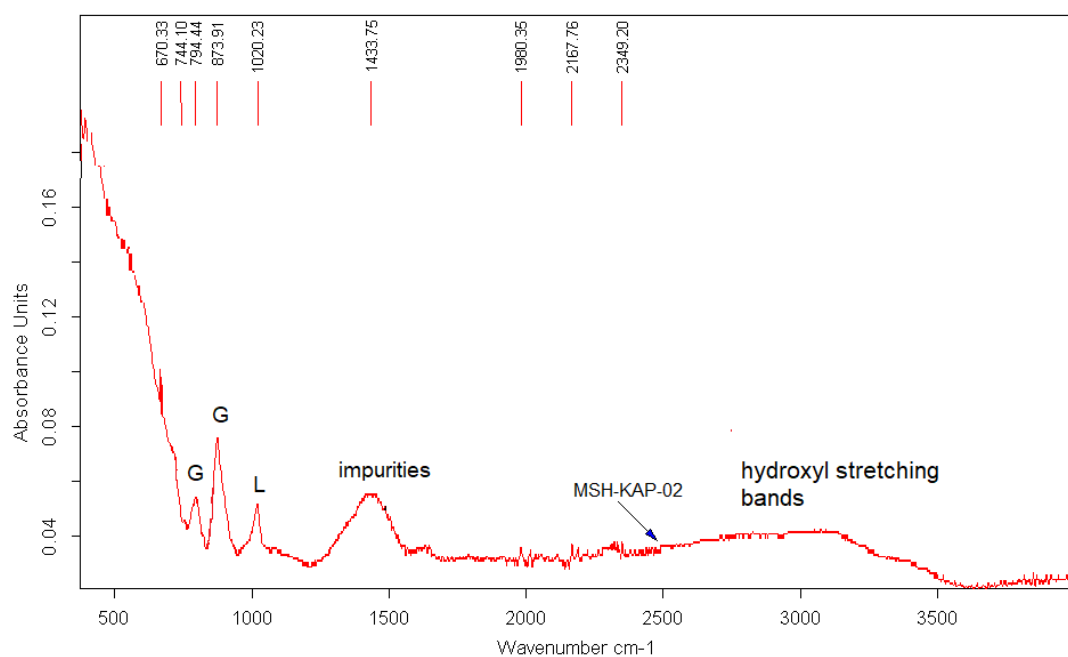
Figure 4. 69 FTIR spectrum of corrosion layer including ICL and TM of the iron piece convenient to anchoring (MSH-KAP-02) at the wall representing indoor atmospheric condition: Goethite (α -FeOOH), and lepidocrocite (γ -FeOOH).

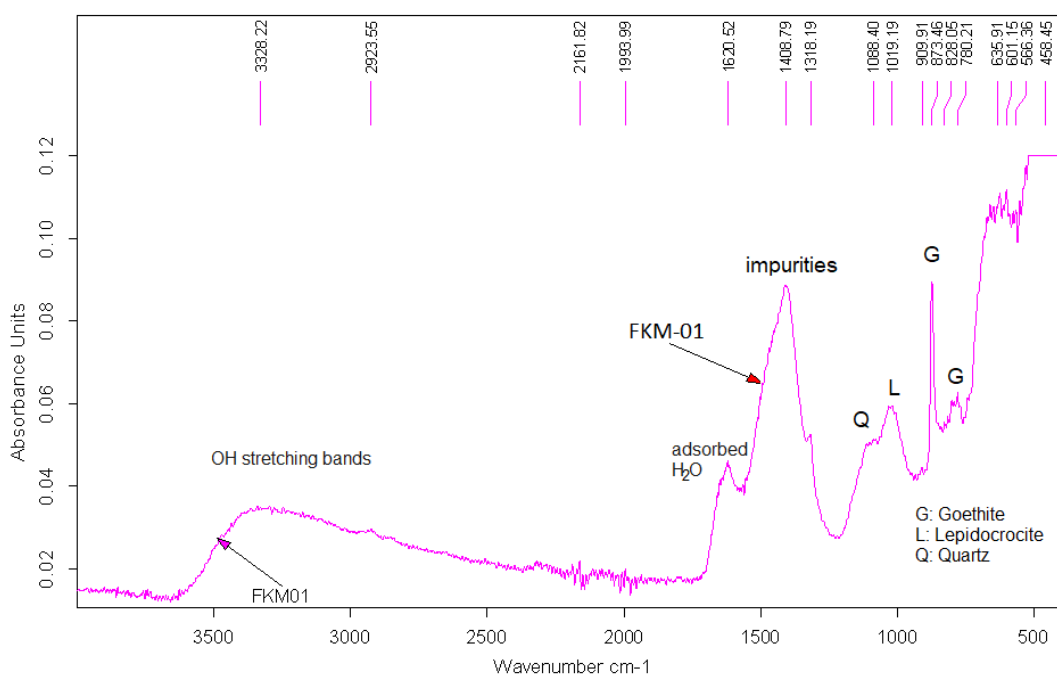
Figure 4. 70 FTIR spectrum of corrosion layer including ICL and TM of the window guard iron piece (FKM-01) at the dwelling in Foça representing partially open outdoor atmospheric conditions: Goethite (α -FeOOH), lepidocrocite (γ -FeOOH) and quartz.

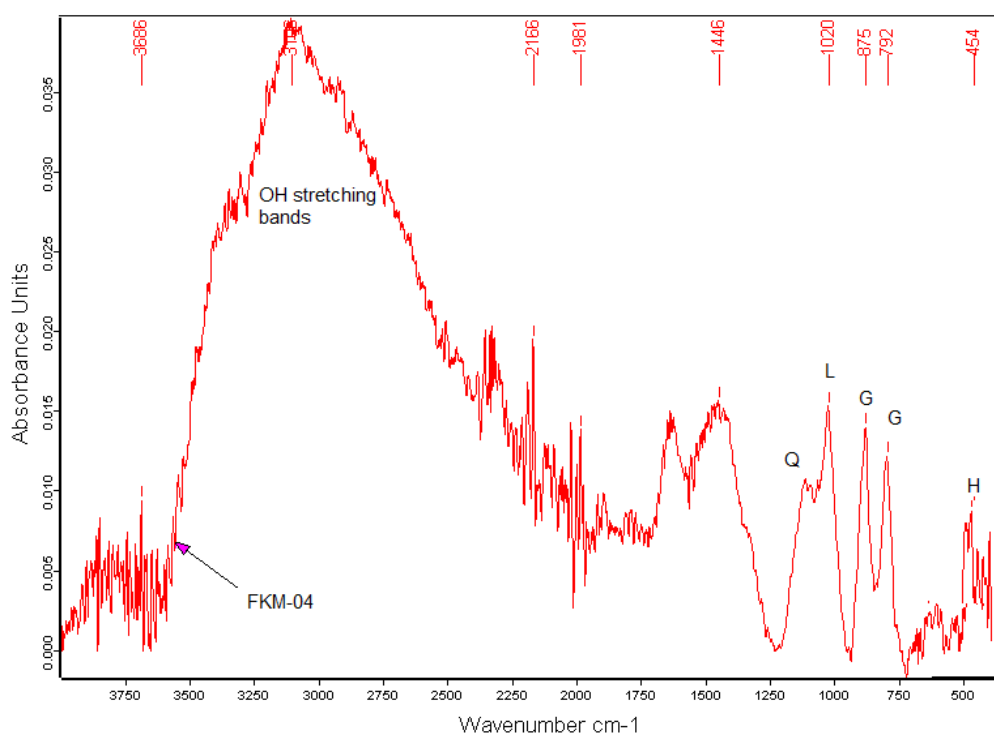
Figure 4. 73 FTIR spectrum of corrosion layer including ICL and TM of the door's male hinge (FKM-04) at the dwelling in Foça representing partially open outdoor atmospheric conditions: Goethite (α -FeOOH), lepidocrocite (β -FeOOH) and quartz.

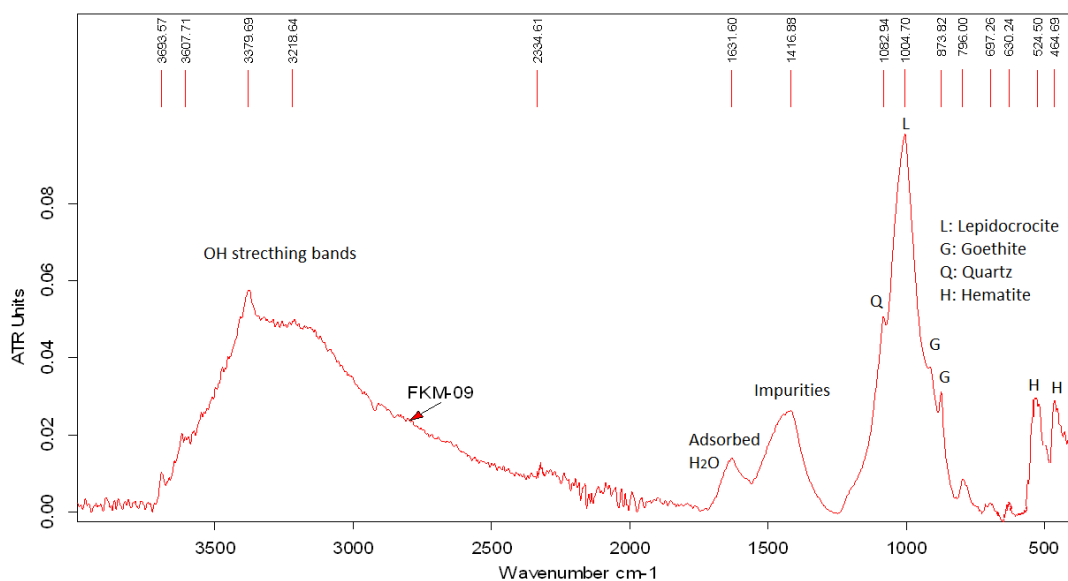
Figure 4. 78 FTIR spectrum of corrosion layer including ICL and TM of the iron piece (FKM-09) from the Ottoman layer excavations in Foça showing buried conditions: Quartz, goethite (α -FeOOH), lepidocrocite (γ -FeOOH) and hematite (α -Fe₂O₃).

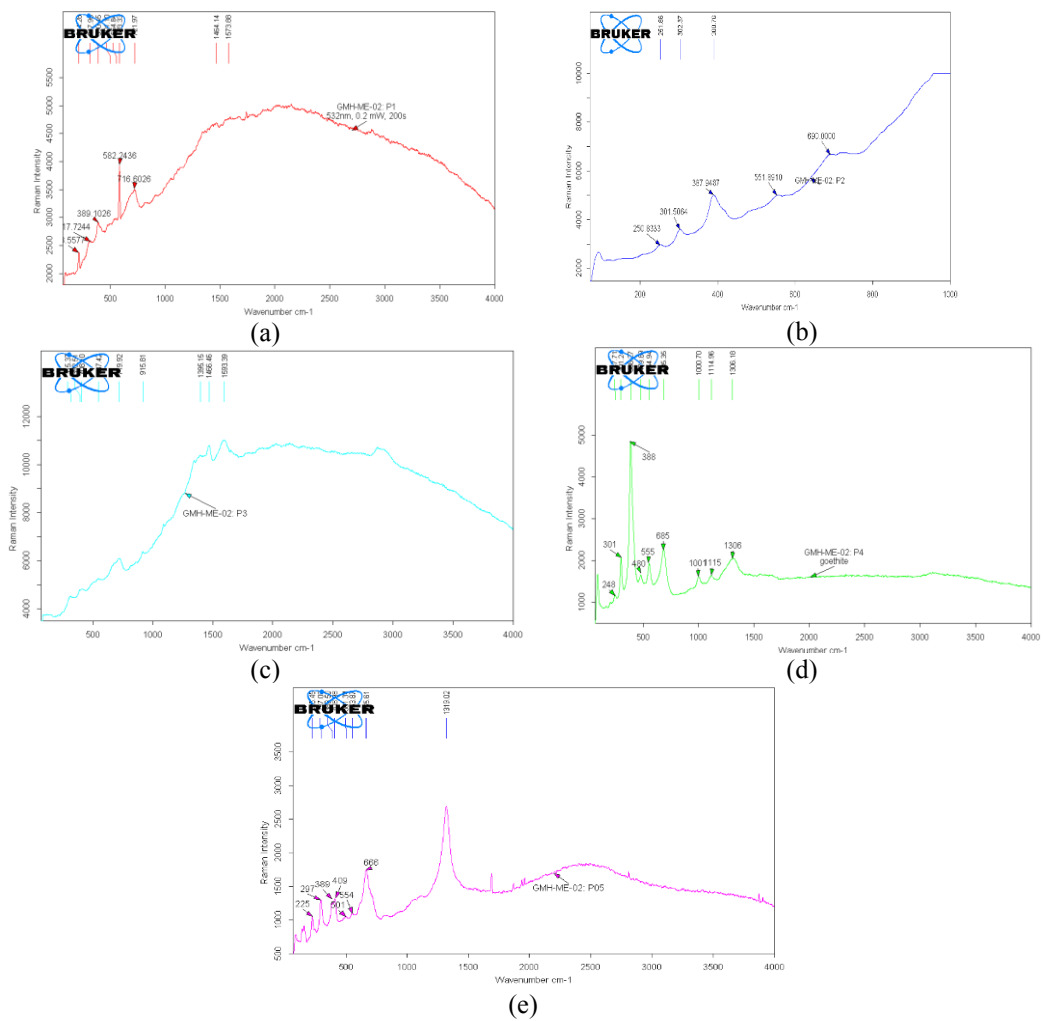
Figure 4. 84 Raman spectra of the first five points located around RF in the corrosion layer of a door lock piece (GMH-Me-02): goethite is the most abundant phase together with hydrated iron (III) oxide or oxyhydroxide, hematite and akaganeite.

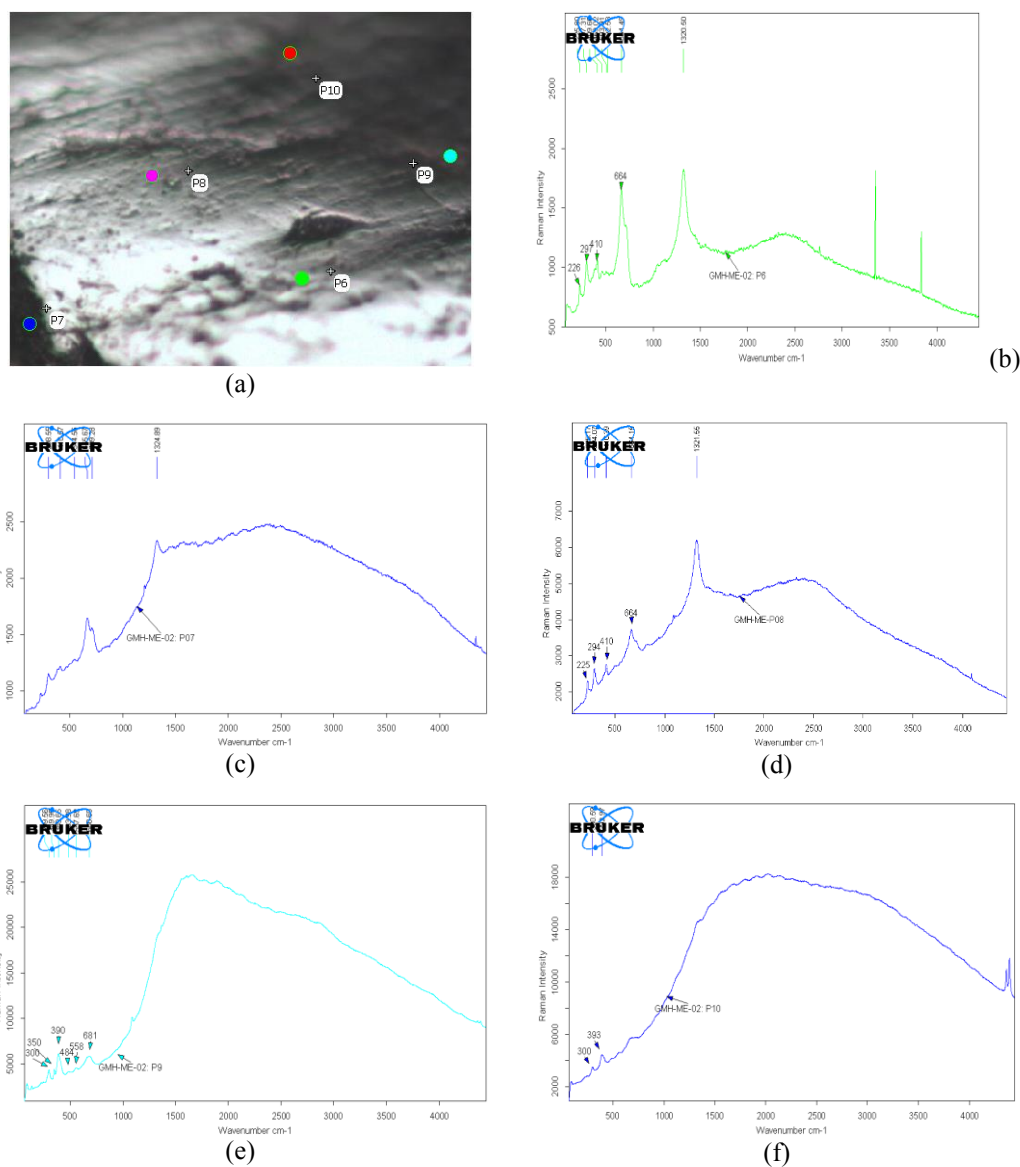
Figure 4. 85 Raman spectra of the second five points located in the ICL after RF in the corrosion layer of a door lock piece (GMH-Me-02): hydrated iron (III) oxide or oxyhydroxide and goethite are the most abundant phases with some hematite.

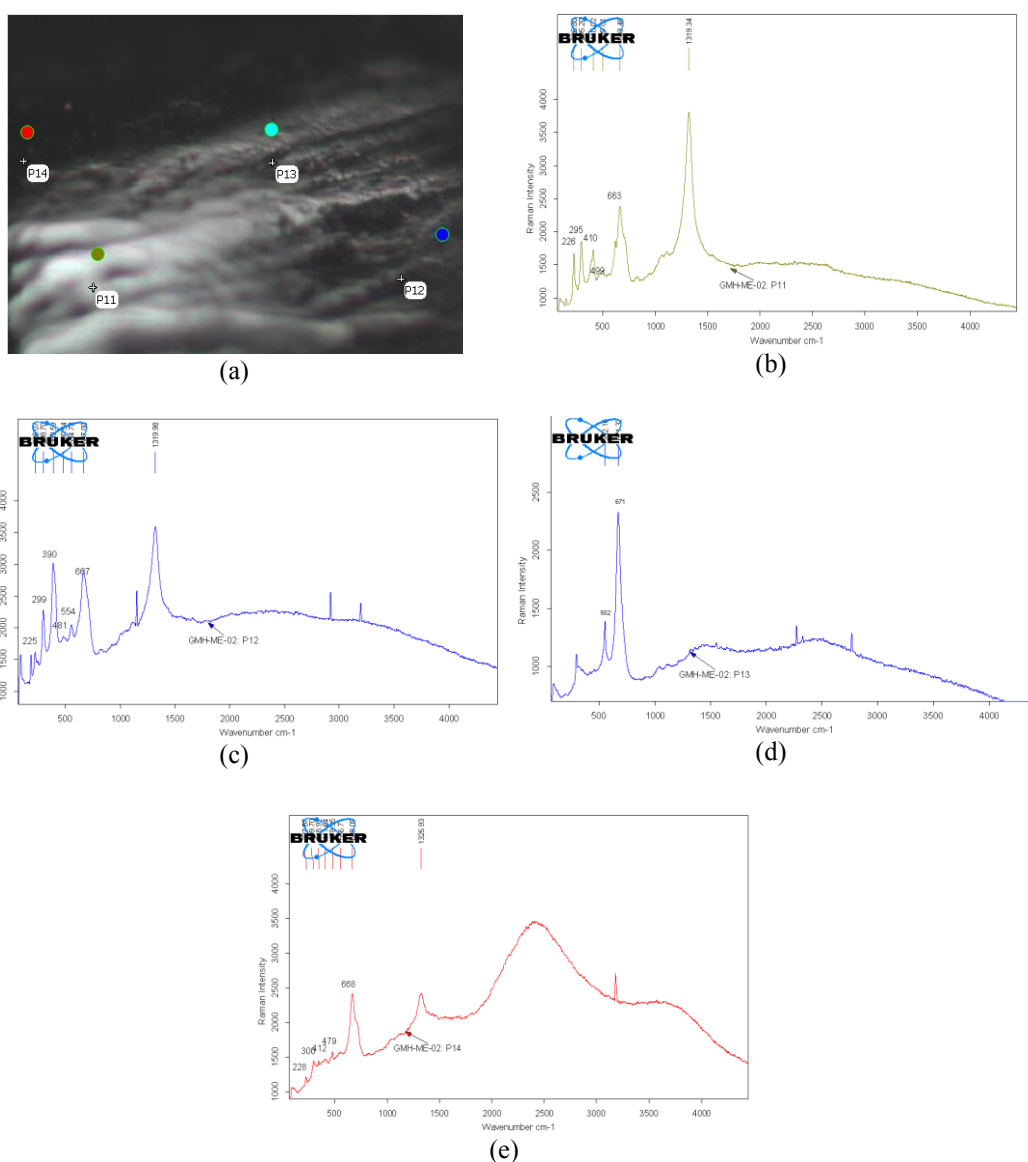
Figure 4. 86 Raman spectra of the third region with four points located in the ICL of a door lock piece (GMH-Me-02): Hydrated iron (III) oxide or oxyhydroxide, hematite, goethite and magnetite are the iron oxides observed.

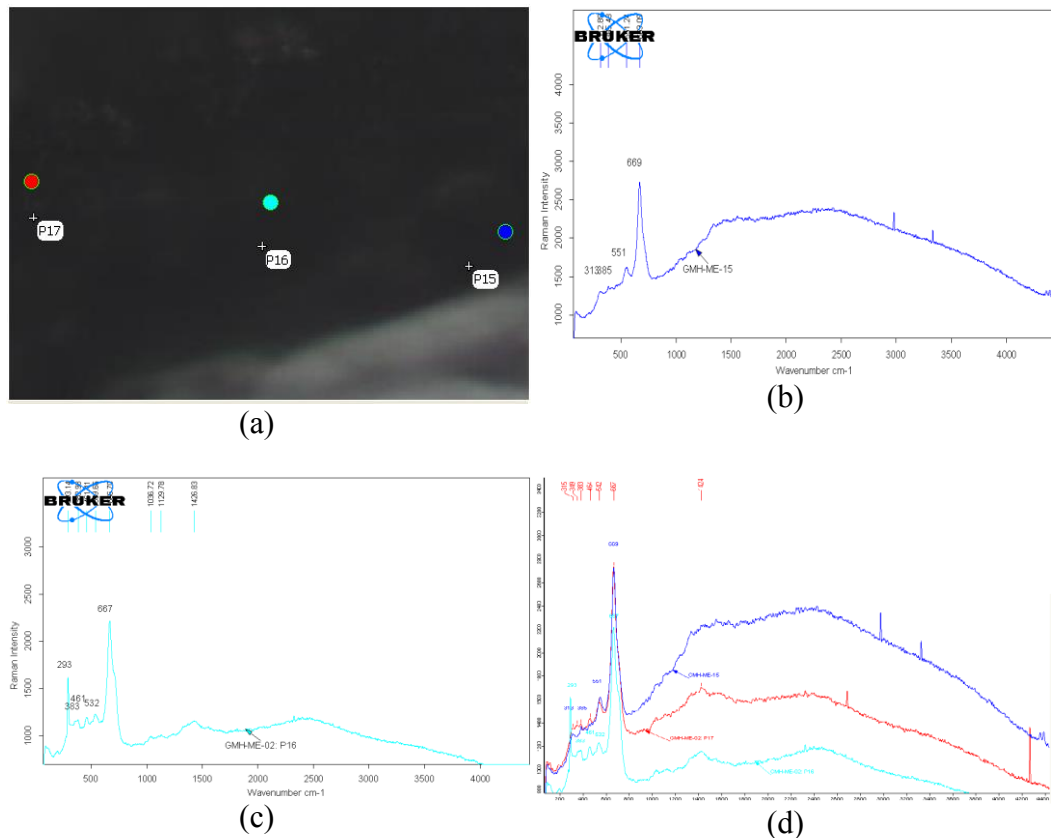
Figure 4. 87 Raman spectra of the fourth region with three points located in the ICL of a door lock piece (GMH-Me-02): magnetite.

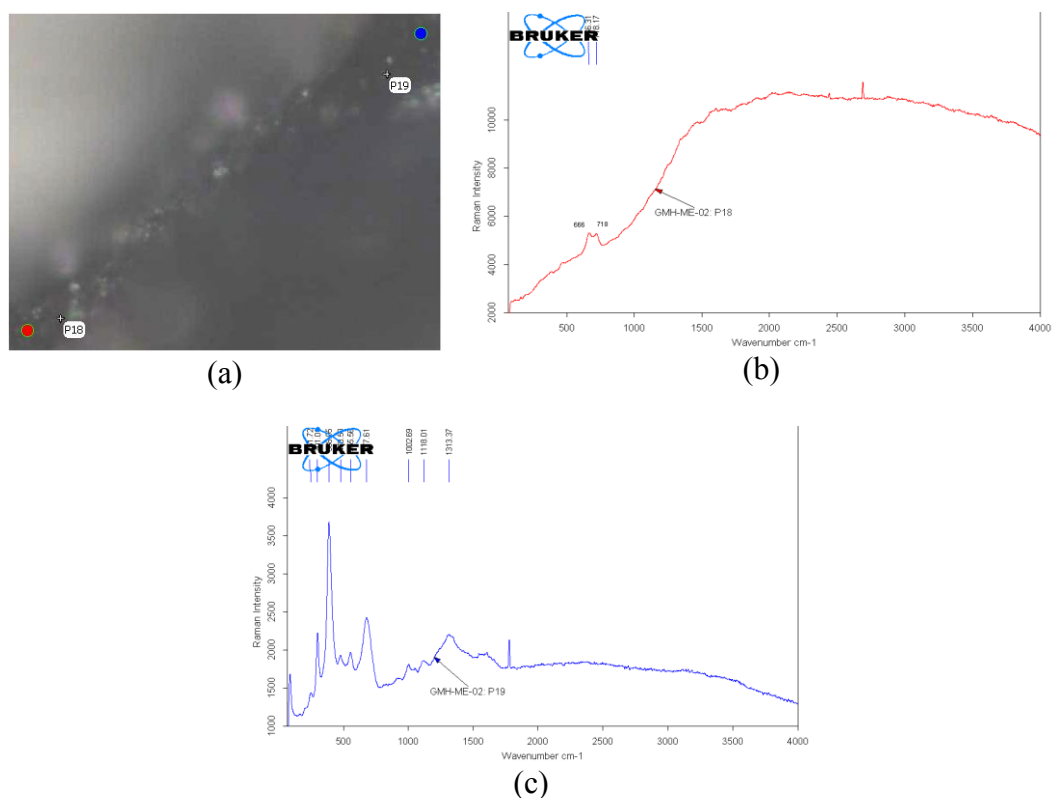
Figure 4. 88 Raman spectra of the fifth region with two points located close to the TM of a door lock piece (GMH-Me-02): goethite is the most abundantly observed iron oxide together with hydrated iron (III) oxide or oxyhydroxide.

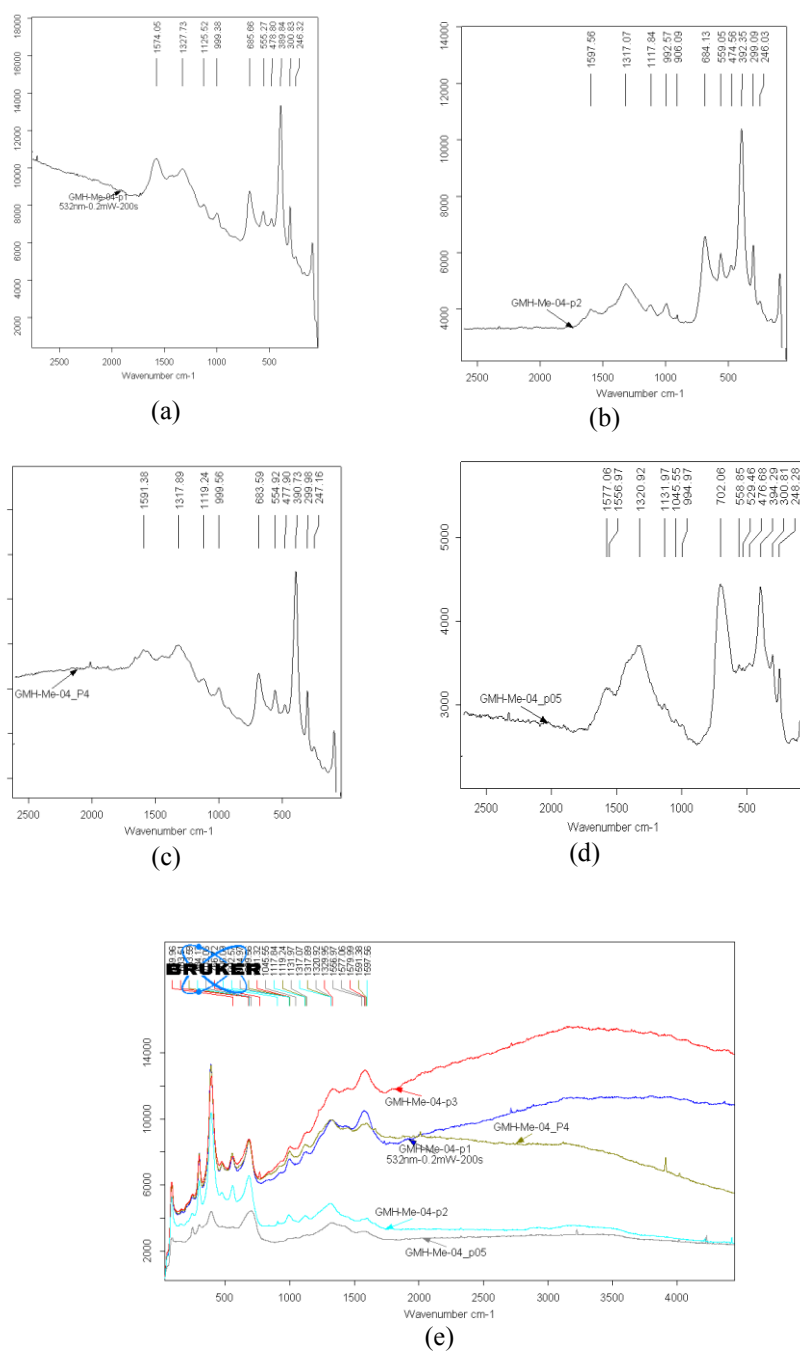
Figure 4. 90 μ -Raman spectra of the first five points located around RF in the corrosion layer of a plaster nail from interior (GMH-Me-04) (a, b, c, d, e): goethite is the most abundant phase from p1 to p4 (a, b, c, e); presence of hydrated iron (III) oxide or oxyhydroxide together with some goethite (d).

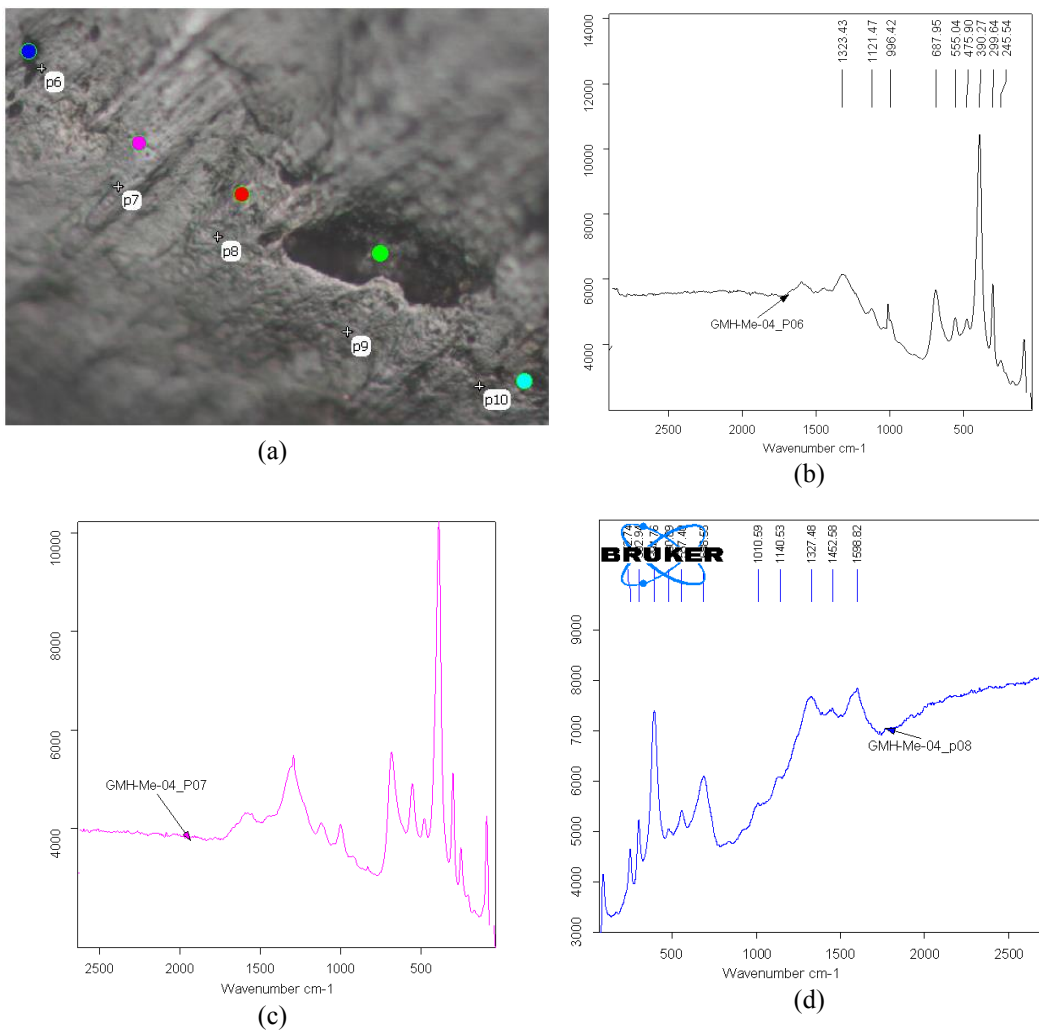
Figure 4. 91 μ -Raman spectra of the second 5 points located in the ICL after RF in the corrosion layer of a plaster nail from interior (GMH-Me-04): Goethite is the most abundant phase.

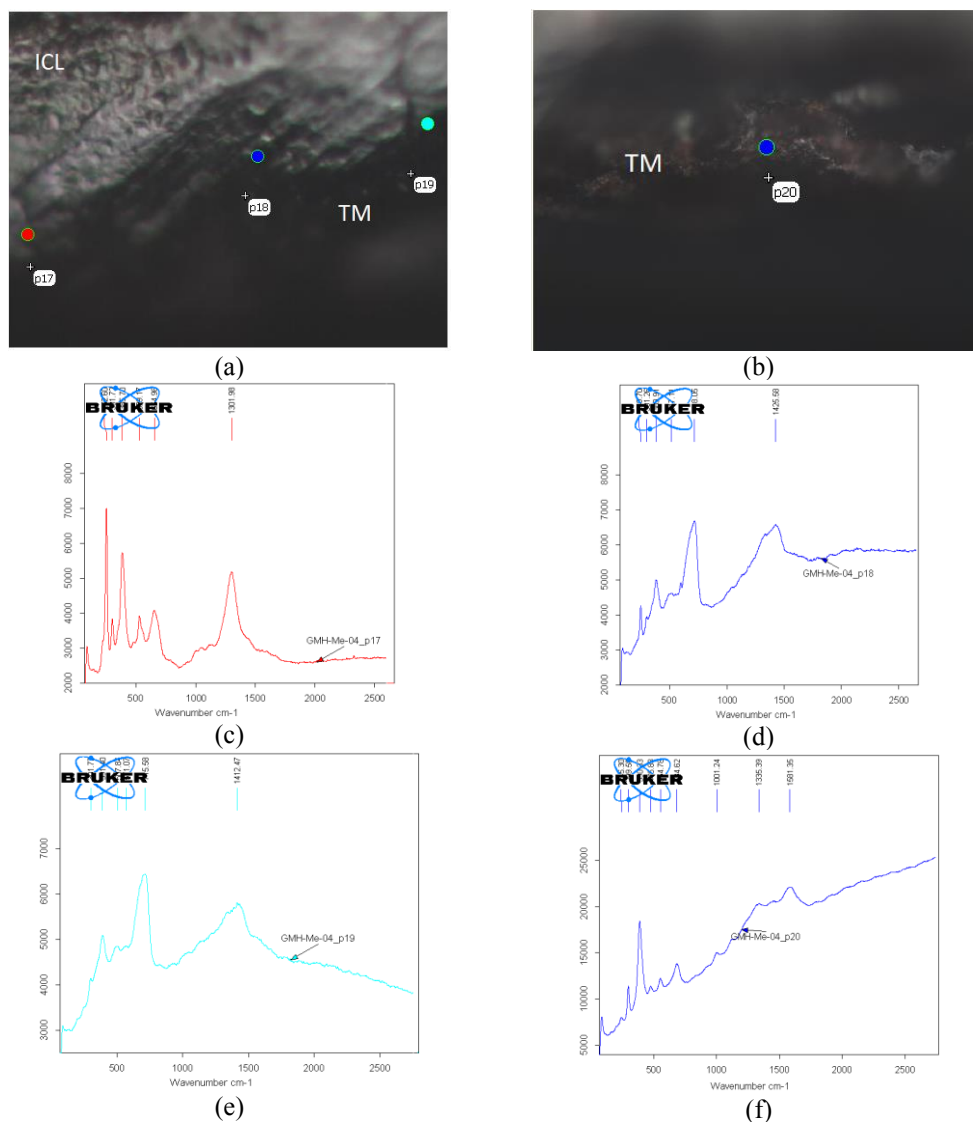
Figure 4. 94 μ -Raman spectra of the fourth area where 3 points are located close to the TM in the corrosion layer (a, c, d, e) and the fifth area where 1 point is located in the TM (b, f) of a plaster nail from interior (GMH-Me-04): Lepidocrocite (c), hydrated iron (III) oxide or oxyhydroxide (d, e) and goethite (f) are the phases observed.

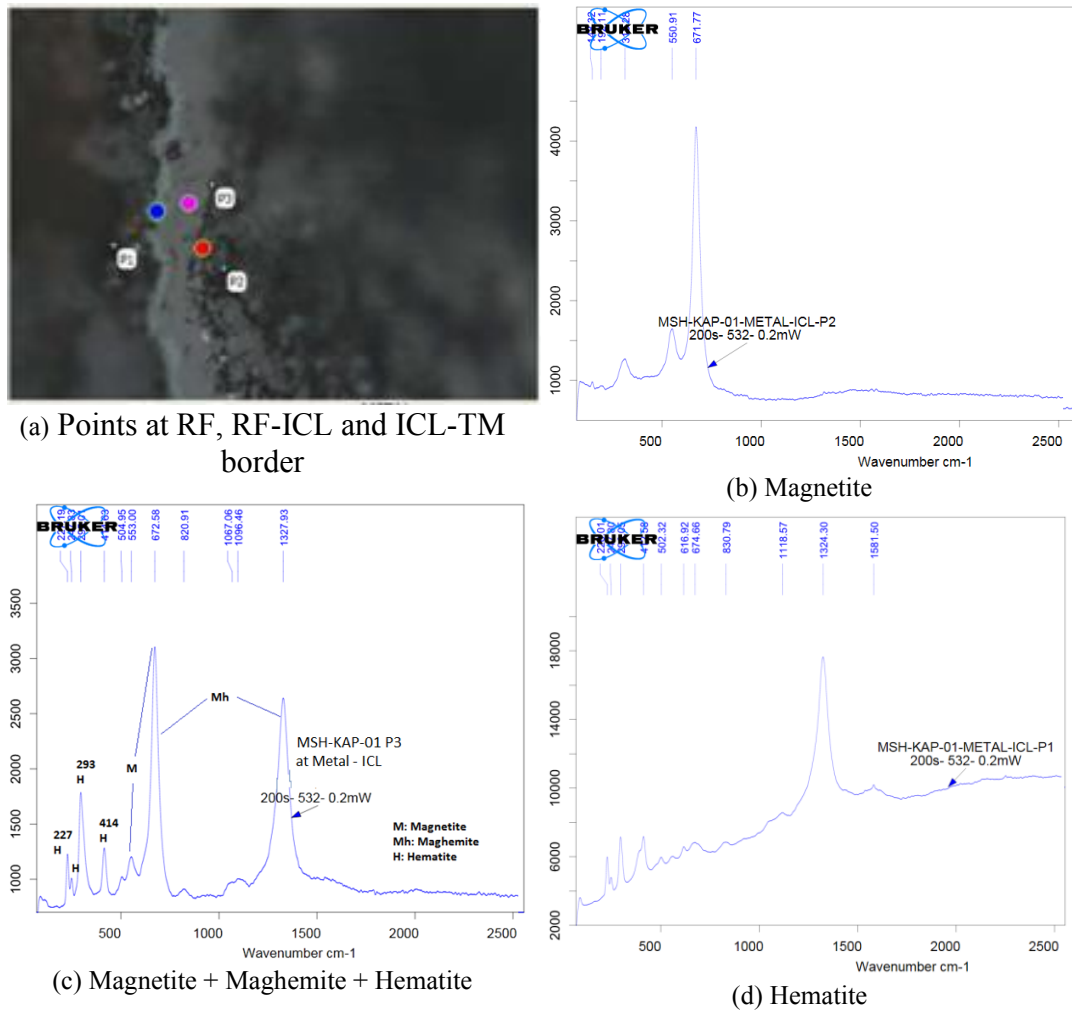
Figure 4. 96 μ -Raman spectra of the nail (MSH-KAP-01) at the RF and the transition zones: points of measurement (a); reaction-front (p2) having magnetite (M) (b); RF-ICL transition zone (p3) showing magnetite (M), maghemite (Mh) and hematite (c); ICL-TM transition zone (p1) showing hematite (H) (d).
