THE ARCHAEOMETRICAL INVESTIGATIONS OF SOME IRON
COMPONENTS FROM THE OTTOMAN PERIOD STRUCTURES

A THESIS SUBMITTED TO
THE GRADUATE SCHOOL OF NATURAL AND APPLIED SCIENCES
OF
MIDDLE EAST TECHNICAL UNIVERSITY

SEPTEMBER 2022

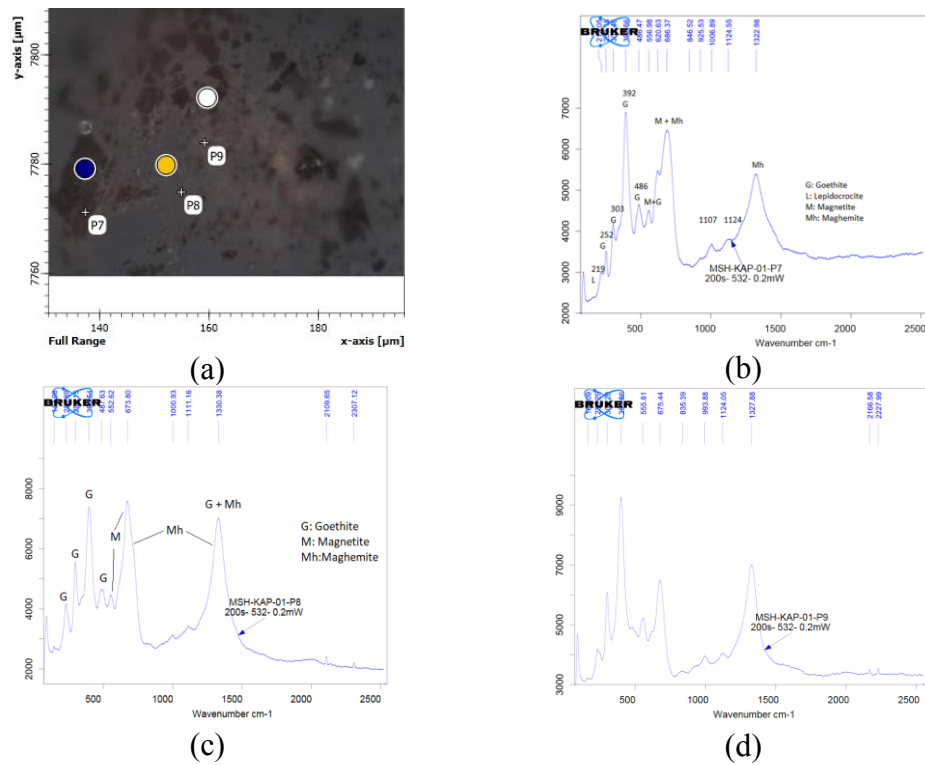
Figure 4. 98 μ -Raman spectra of a nail (MSH-KAP-01) at TM: measurement points (a); presence of goethite, magnetite + maghemite, lepidocrocite (b); presence of goethite, magnetite + maghemite (c); and presence of goethite (d).

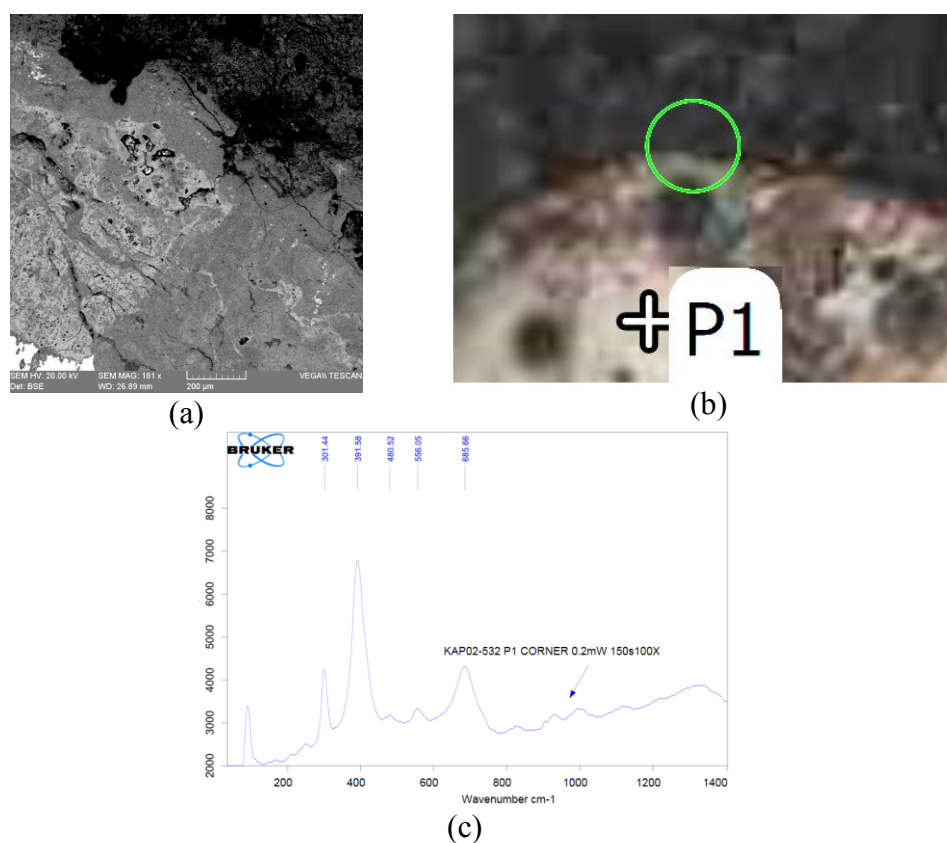
Figure 4. 99 SEM image of the corrosion layer at an iron object (MSH-KAP-02) (a) (16th cc); measurement point at RF (b); and μ -Raman spectrum indicating presence of goethite (c).

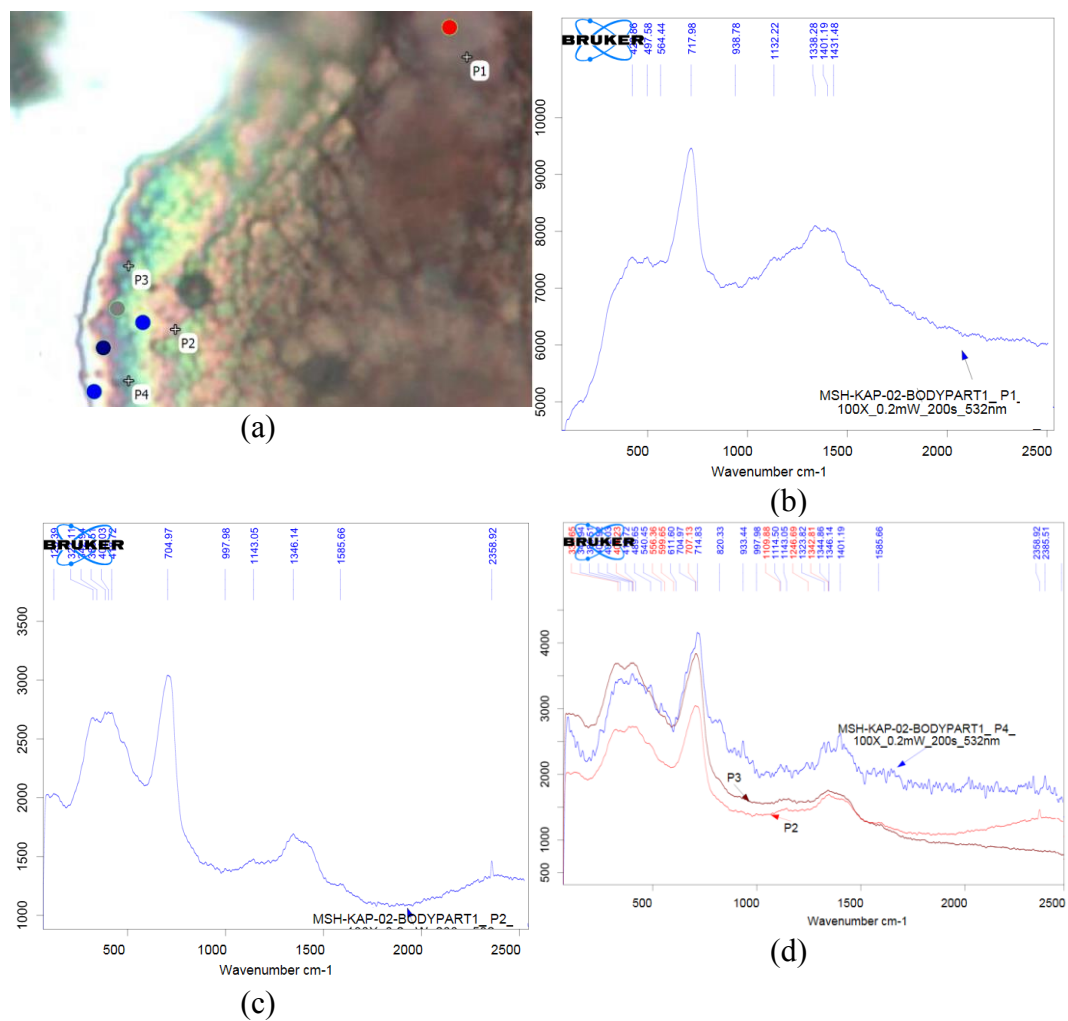
Figure 4. 100 μ -Raman spectra of an iron object (MSH-KAP-02) at RF towards ICL: measurement points (a); and presence of hydrated iron (III) oxide or oxyhydroxide at P1 to P4 (b, c, d).

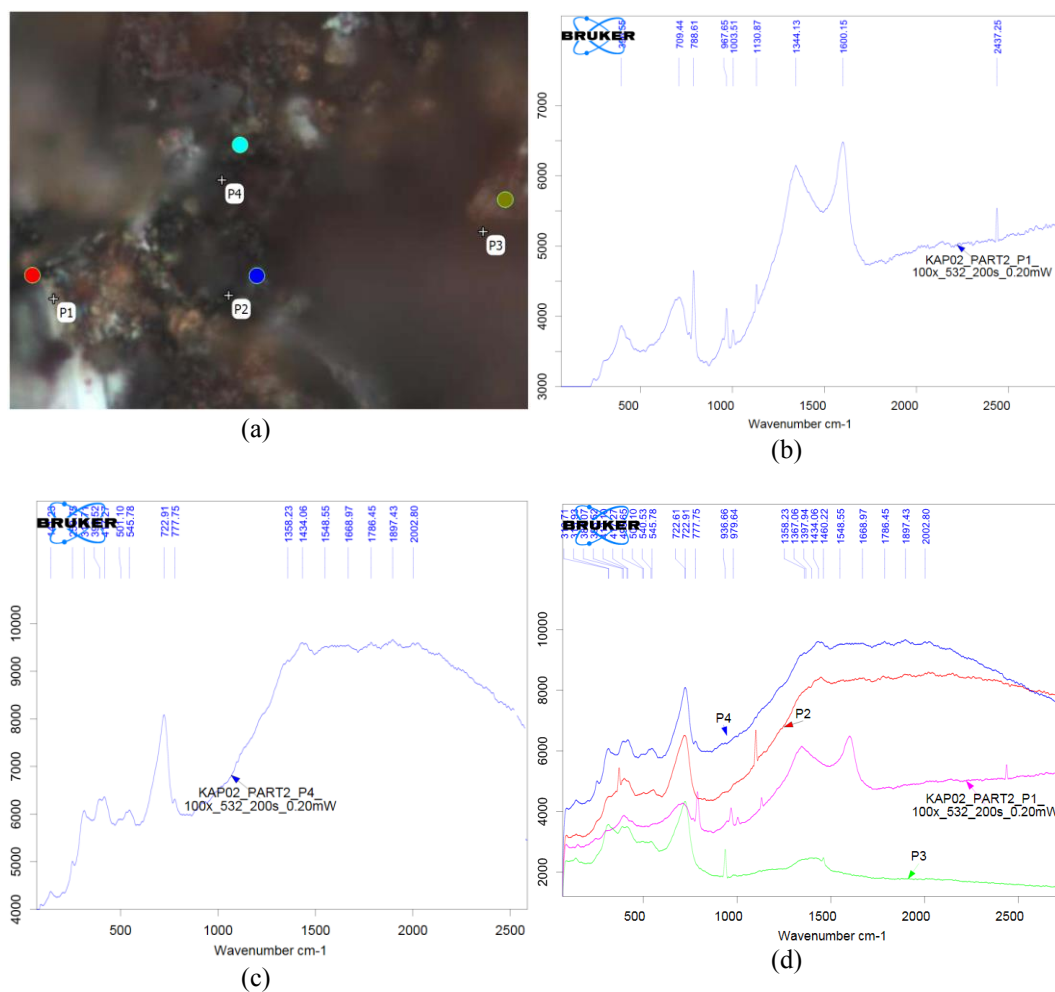
Figure 4. 101 μ -Raman spectrum of an iron object (MSH-KAP-02) at ICL: measurement points (a); and presence of hydrated iron (III) oxide or oxyhydroxide from P1 to P4 (b, c, d).

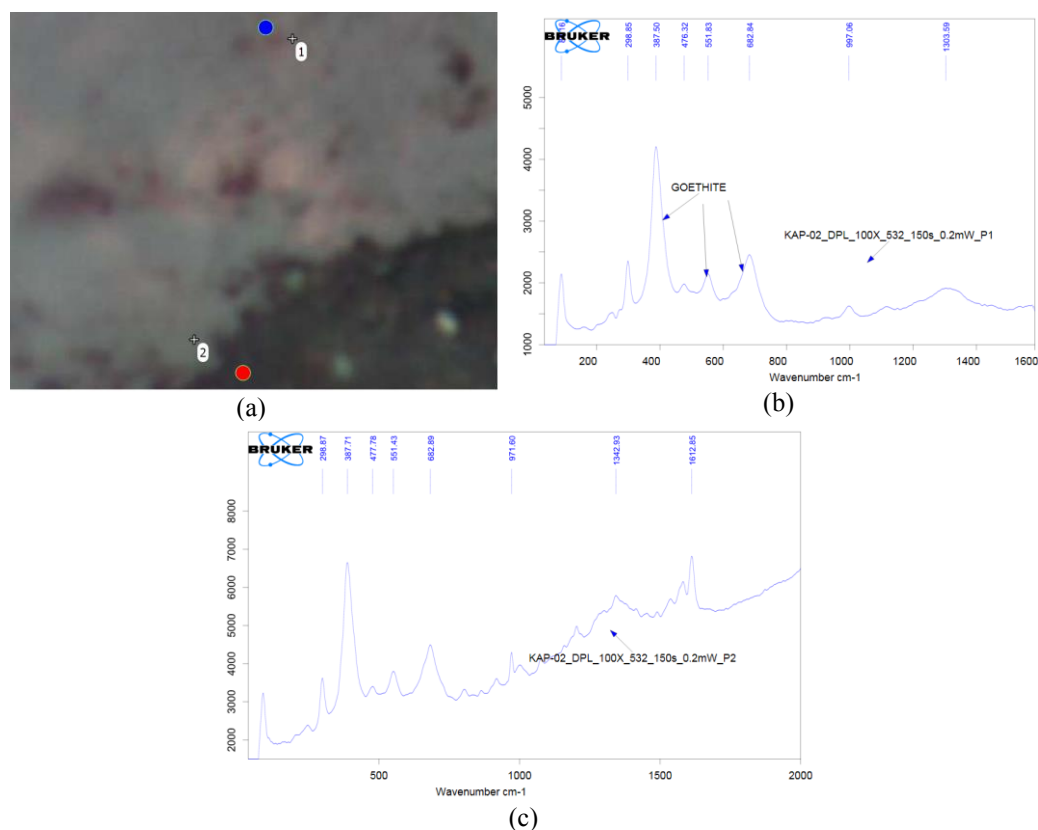
Figure 4. 102 μ -Raman spectrum of an iron object (MSH-KAP-02) at ICL towards TM: measurement points (a); and presence of goethite at p1 and p2 (b, c).

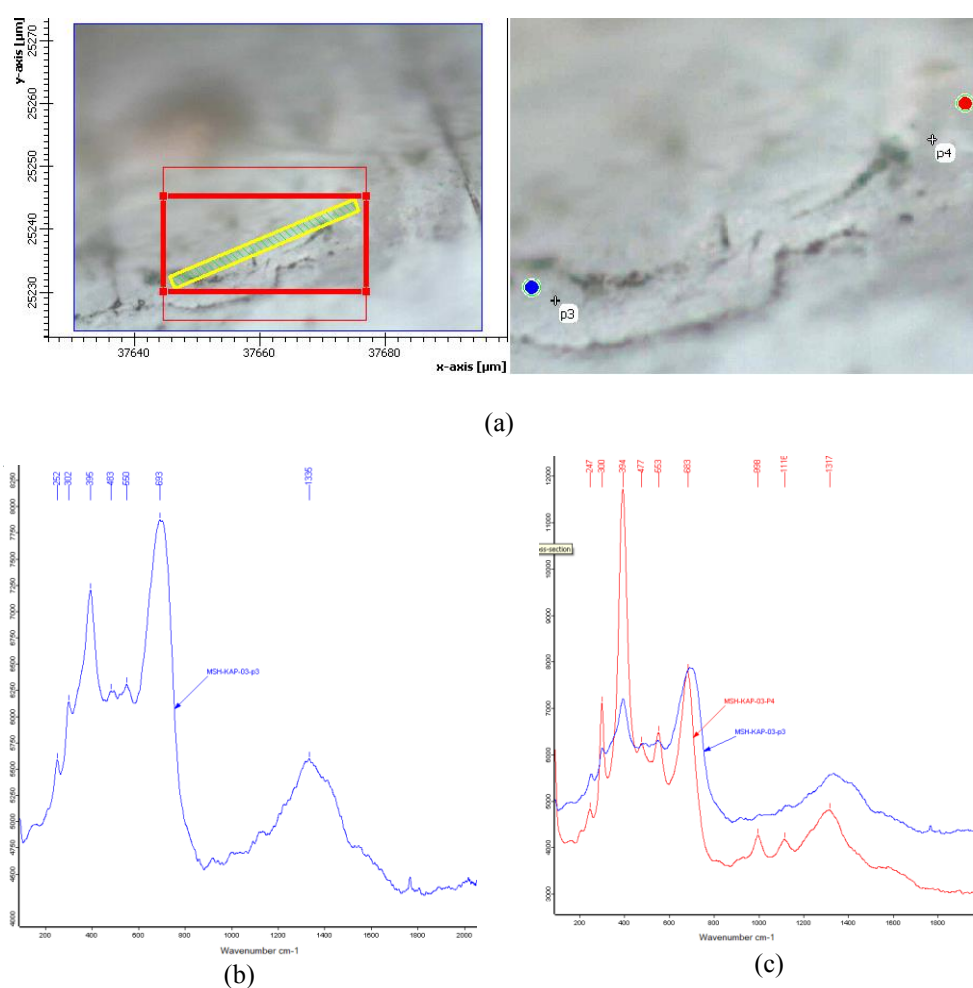
Figure 4. 105 μ -Raman spectra of the 2 points located in the ICL after RF (MSH-KAP-03): measurement points (a); magnetite with some goethite at p3 (b); and goethite is the main phase observed at p4 (c).

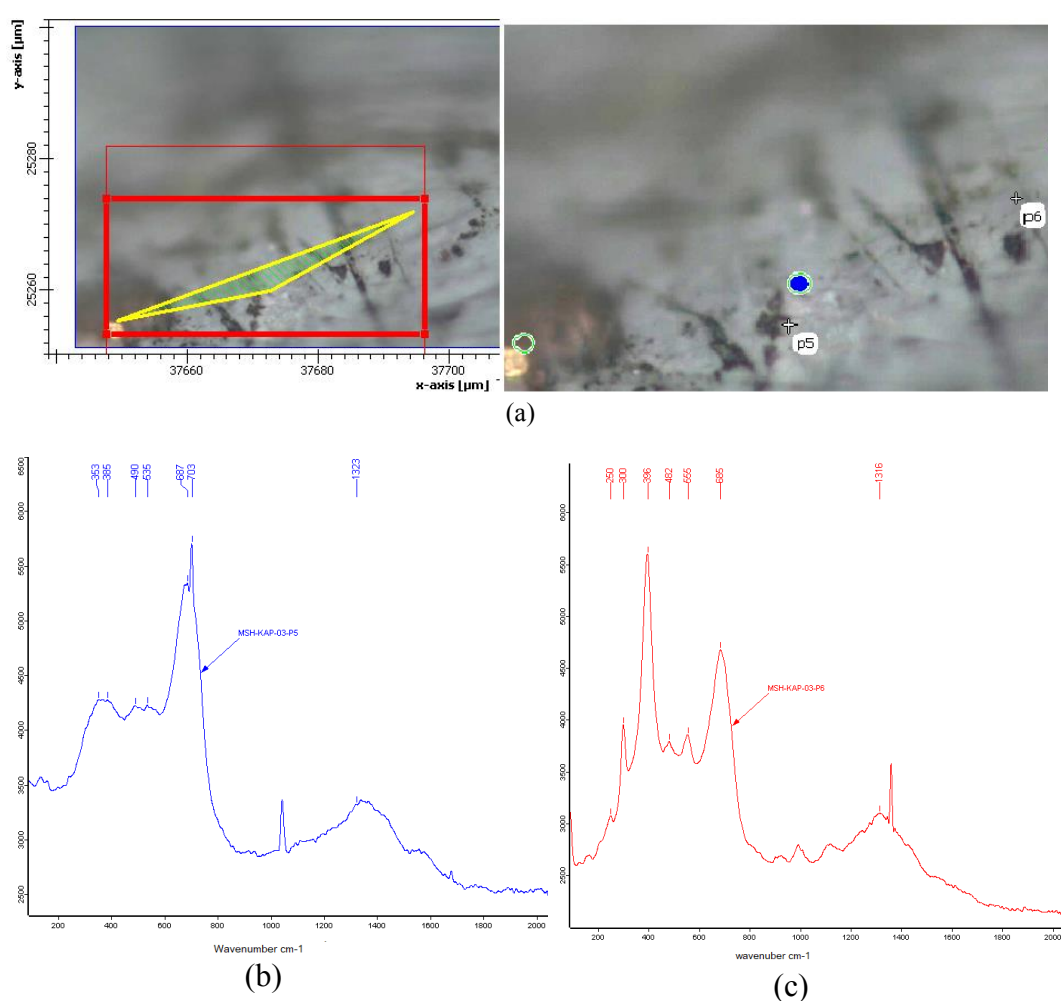
Figure 4. 106 μ -Raman spectra of the successive area where 2 points are located in the ICL (MSH-KAP-03): measurement points (a); hydrated iron (III) oxide or oxyhydroxide at p5 (b); and goethite at p6 (c).

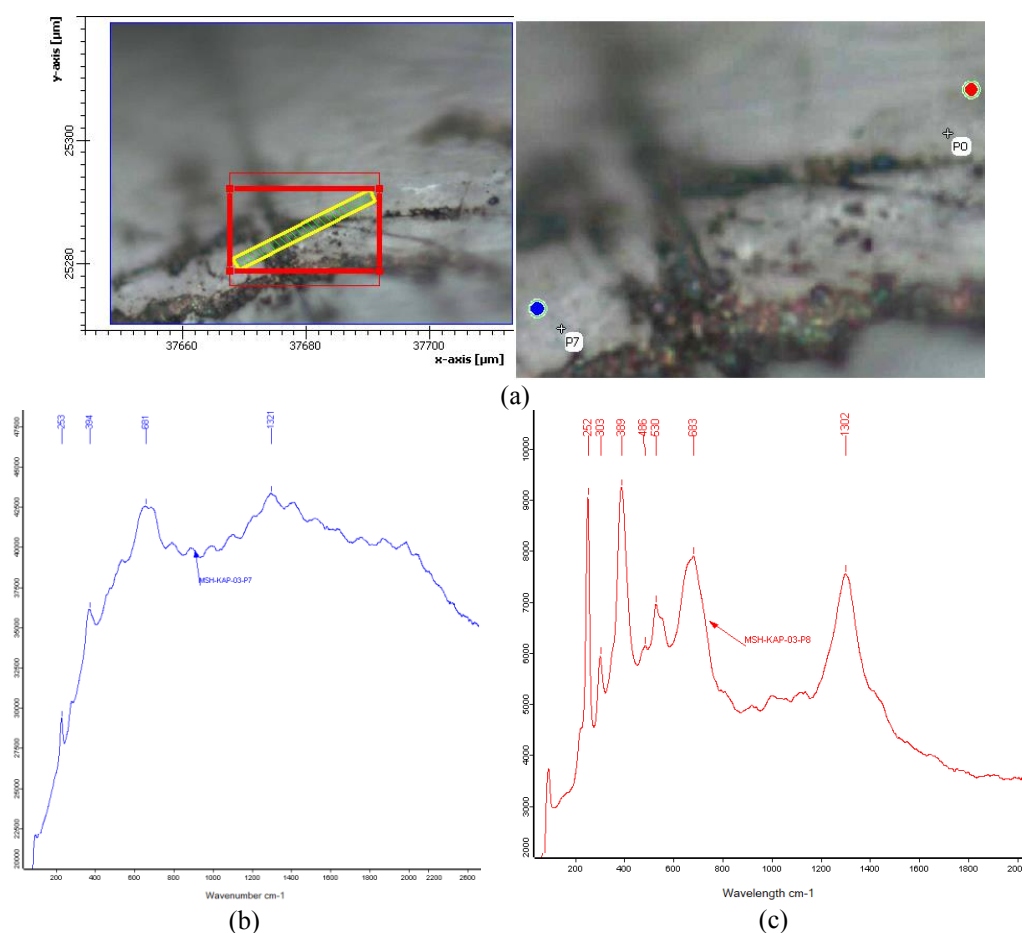
Figure 4. 107 μ -Raman spectra of the successive step where 2 points are located in the ICL (MSH-KAP-03): measurement points (a); hydrated iron (III) oxide or oxyhydroxide, goethite and lepidocrocite at p7 (b); and goethite and lepidocrocite at p8 (c).

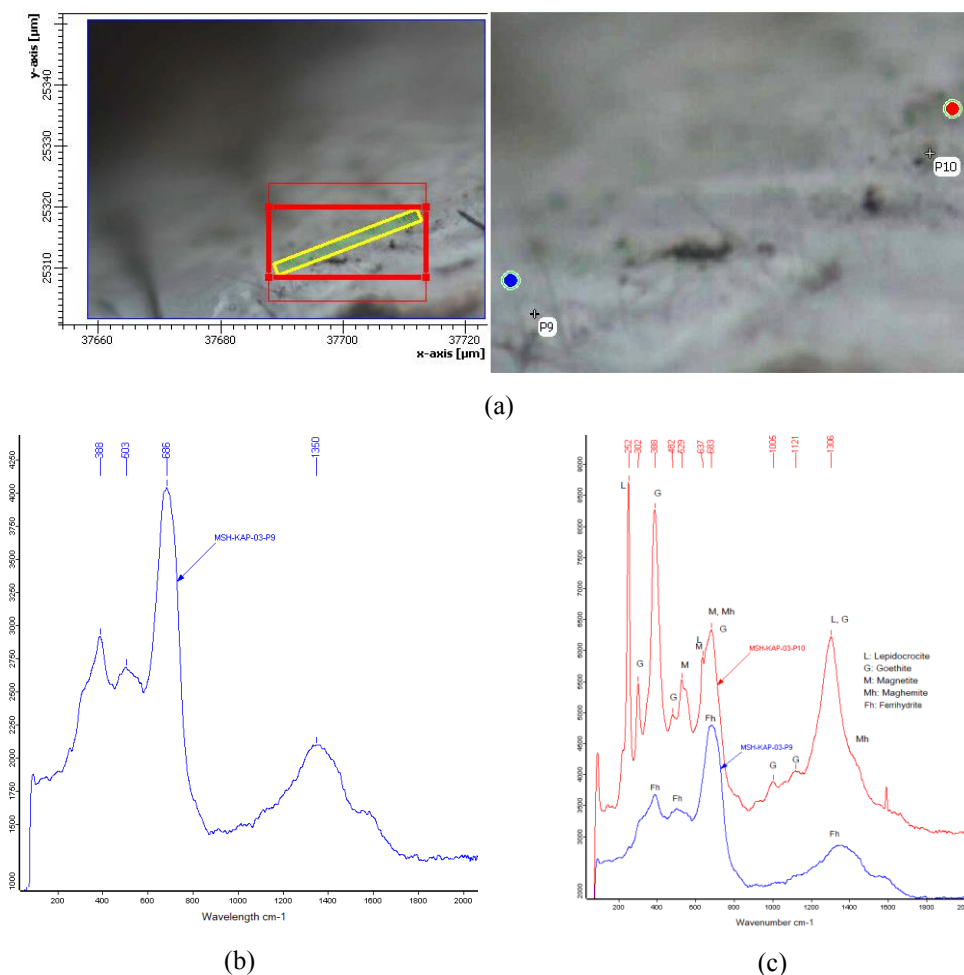
Figure 4. 108 μ -Raman spectra of the successive area where 2 points are located in the ICL (MSH-KAP-03): measurement points (a); hydrated iron (III) oxide or oxyhydroxide at point 9 (b); and maghemite, magnetite, goethite and lepidocrocite are the phases observed at point 10 (c).

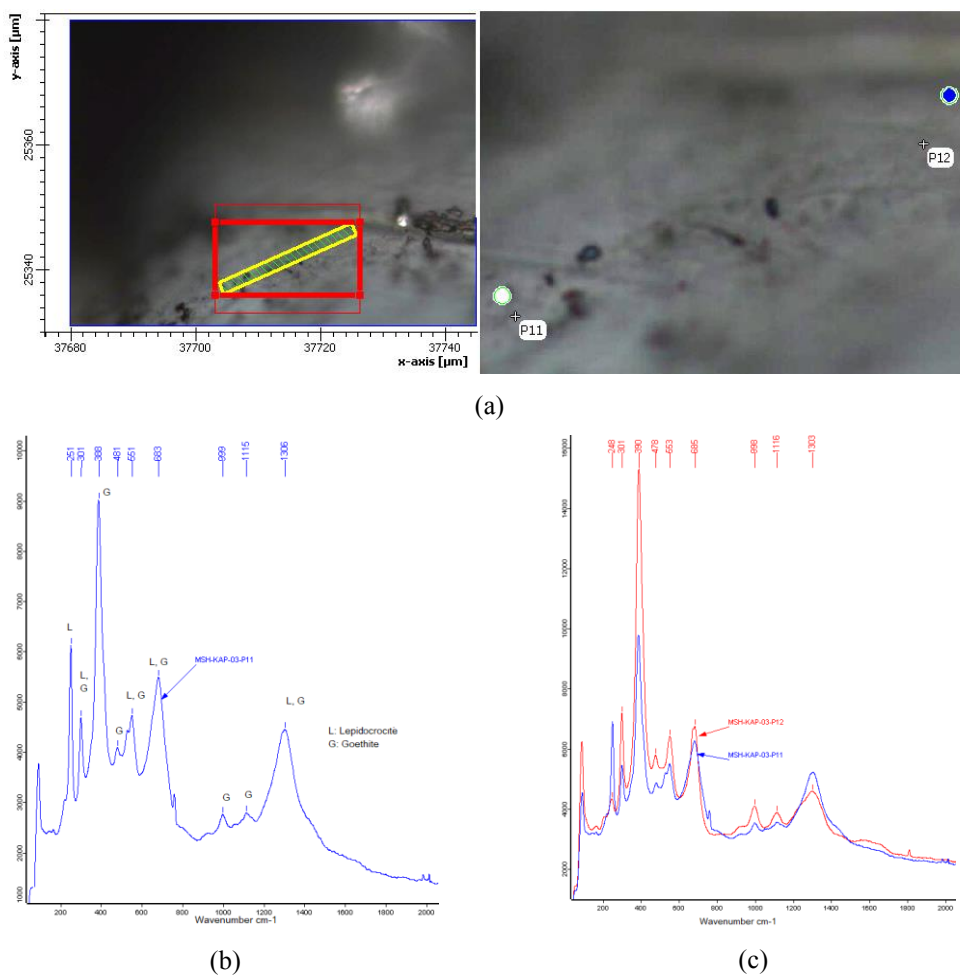
Figure 4. 109 μ -Raman spectra of the successive area where 2 points are located in the ICL close to TM border of a nail (MSH-KAP-03): measurement points (a); goethite and lepidocrocite at point 11 (b); and goethite at point 12 (c).

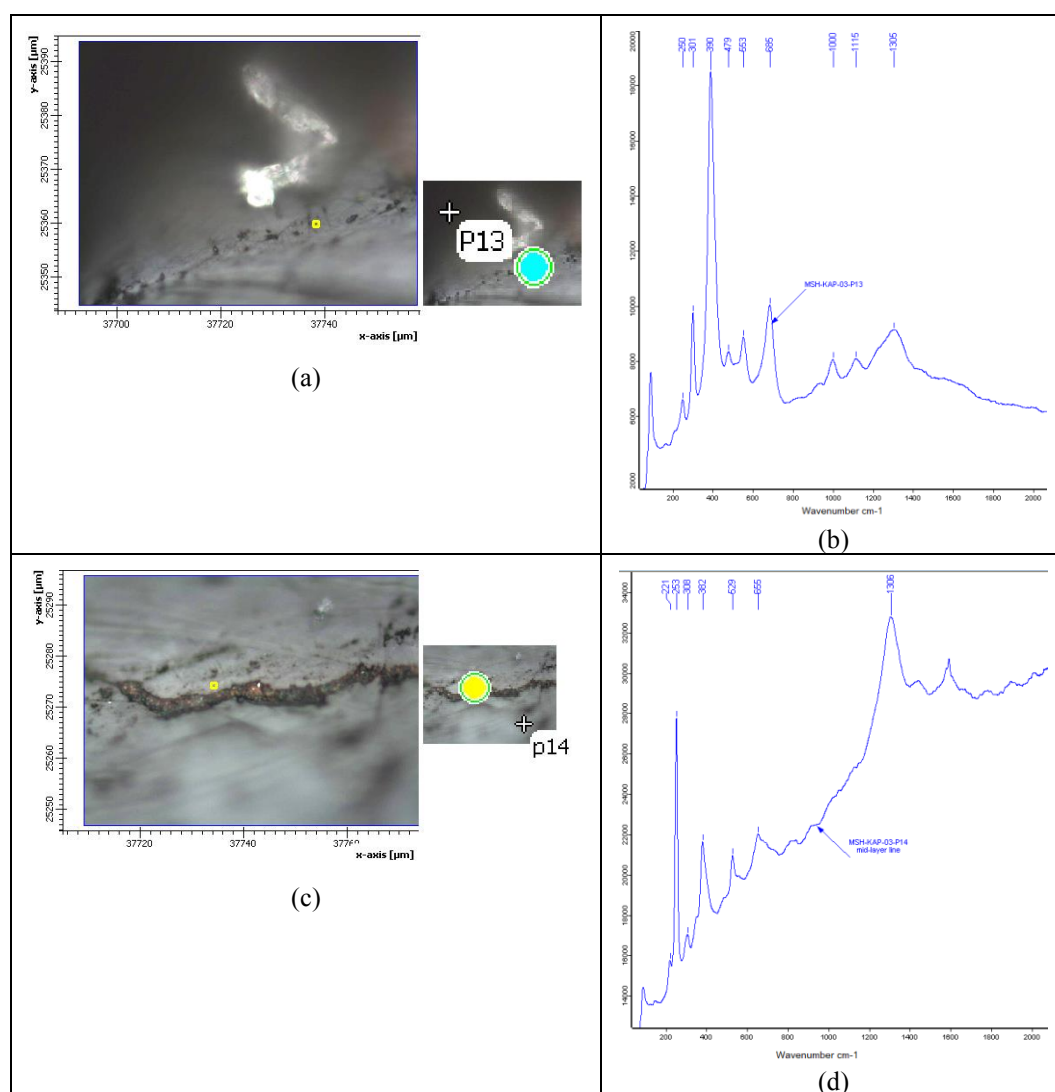
Figure 4. 110 μ -Raman spectra of the successive areas where 2 points are located in the TM of a nail (MSH-KAP-03): measurement points (a, c); goethite at point 13 (b); and lepidocrocite at point 14 (d).

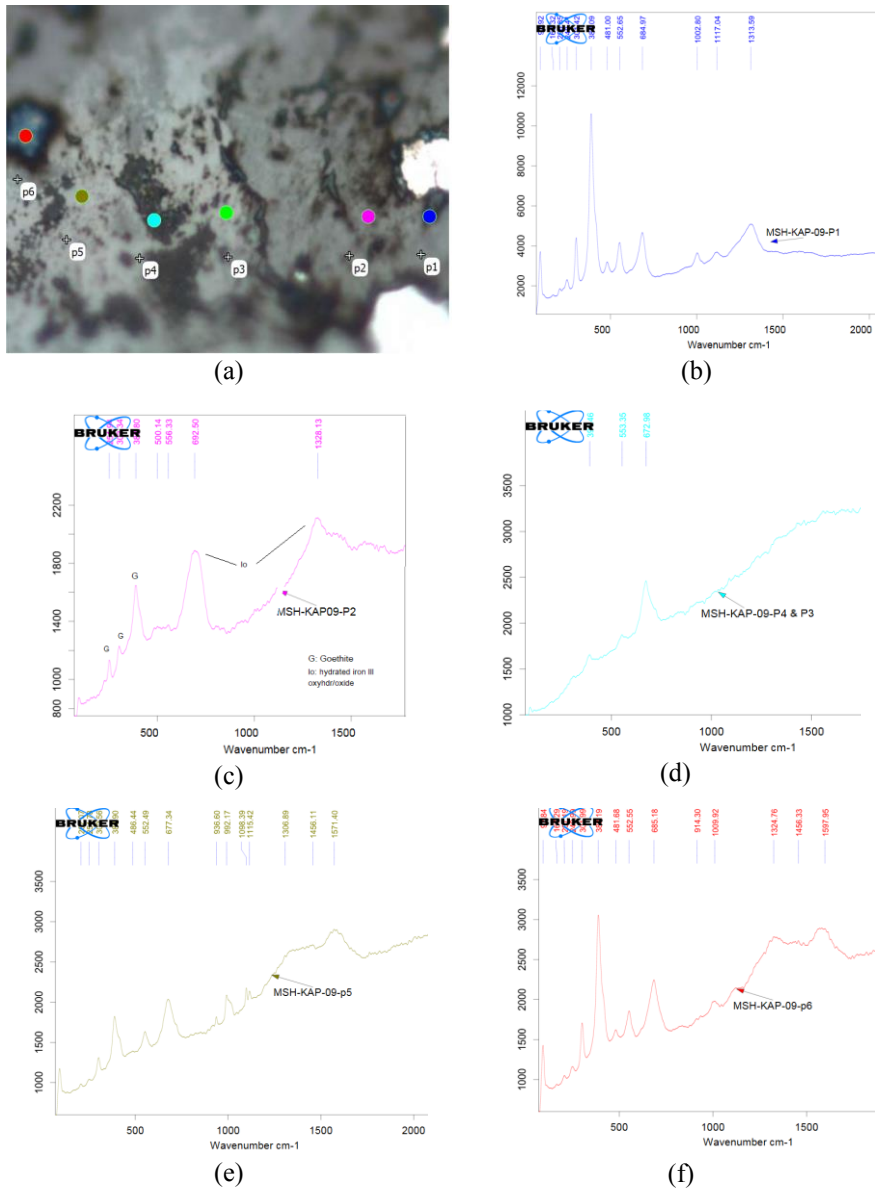
Figure 4. 112 μ -Raman spectra of the two points located in RF towards ICL of a nail (MSH-KAP-09): measurement points (a); goethite at point 1 (b); hydrated iron (III) oxide or oxyhydroxide and goethite at point 2 (c); magnetite at point 3 and 4 (d), maghemite, magnetite, goethite at point 5 (e); and goethite at point 6 (f).

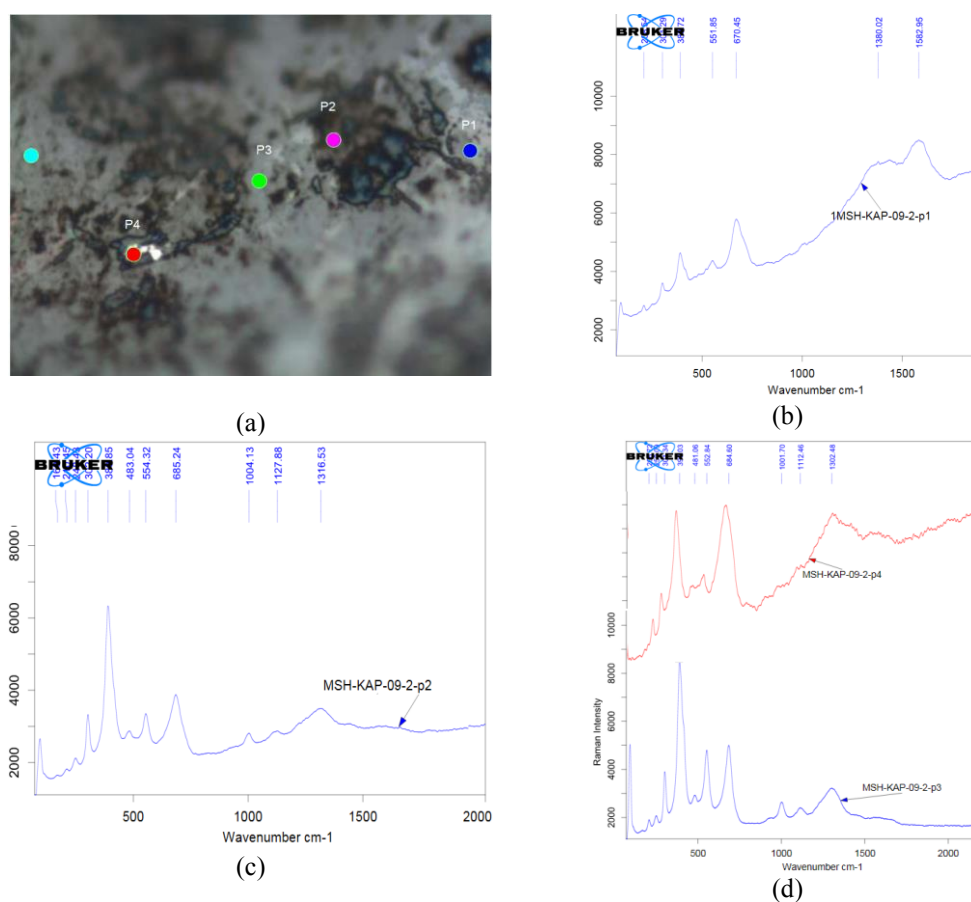
Figure 4. 113 μ -Raman spectra of the successive four points located in the ICL after RF in the corrosion layer of a nail (MSH-KAP-09): measurement points (a); hydrated iron (III) oxide or oxyhydroxide with some goethite at p1 and p4 (b); and goethite is the main phase observed at p2 and p3 (c, d).

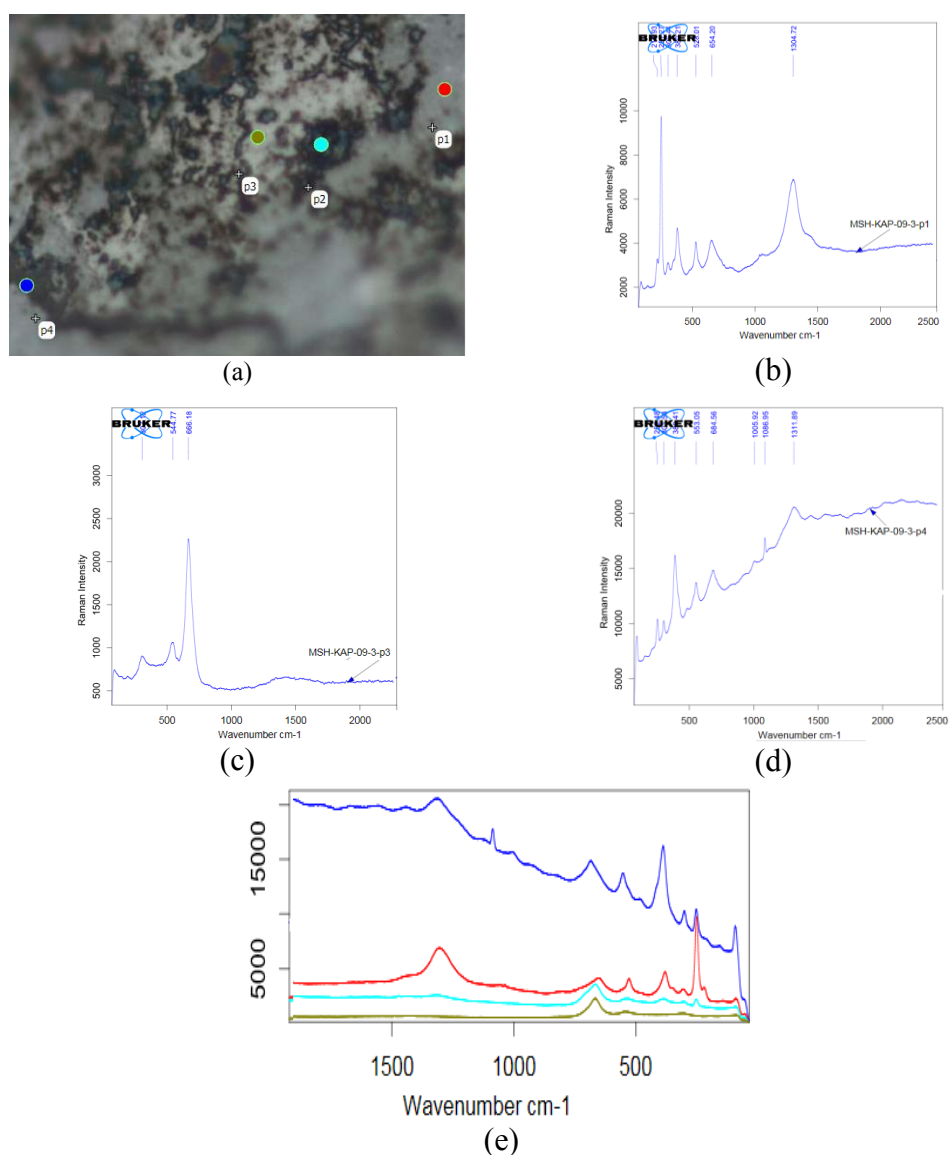
Figure 4. 114 μ -Raman spectra of the successive area where 4 points have been located in the ICL of a nail (MSH-KAP-09): measurement points (a); lepidocrocite at p1 (b); magnetite at p2 and p3 (c); and goethite at p4 (d).

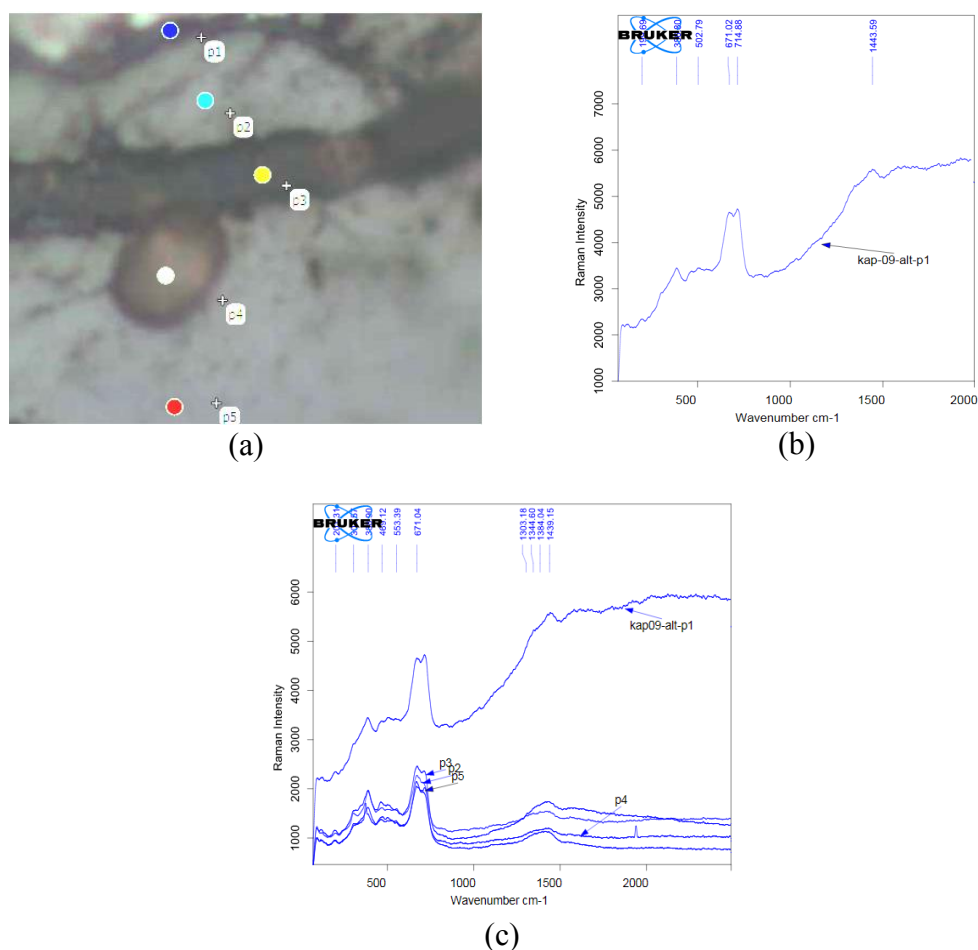
Figure 4. 115 μ -Raman spectra of the successive area where 5 points are located in the ICL of a nail (MSH-KAP-09): measurement points (a); maghemite at point 1 (b); hydrated iron (III) oxide or oxyhydroxide together with goethite at point 2 to 5 (c).

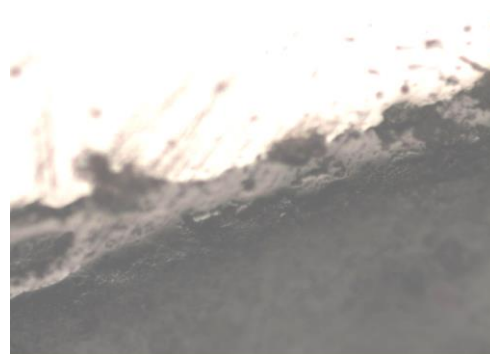
(b) MSH-KAP-12

Figure 4. 117 Digital microscopic (a) and Raman microscopic (b) images of a timber jointing nail (MSH-KAP-12) after etching with nitric acid in alcohol (16th cc).

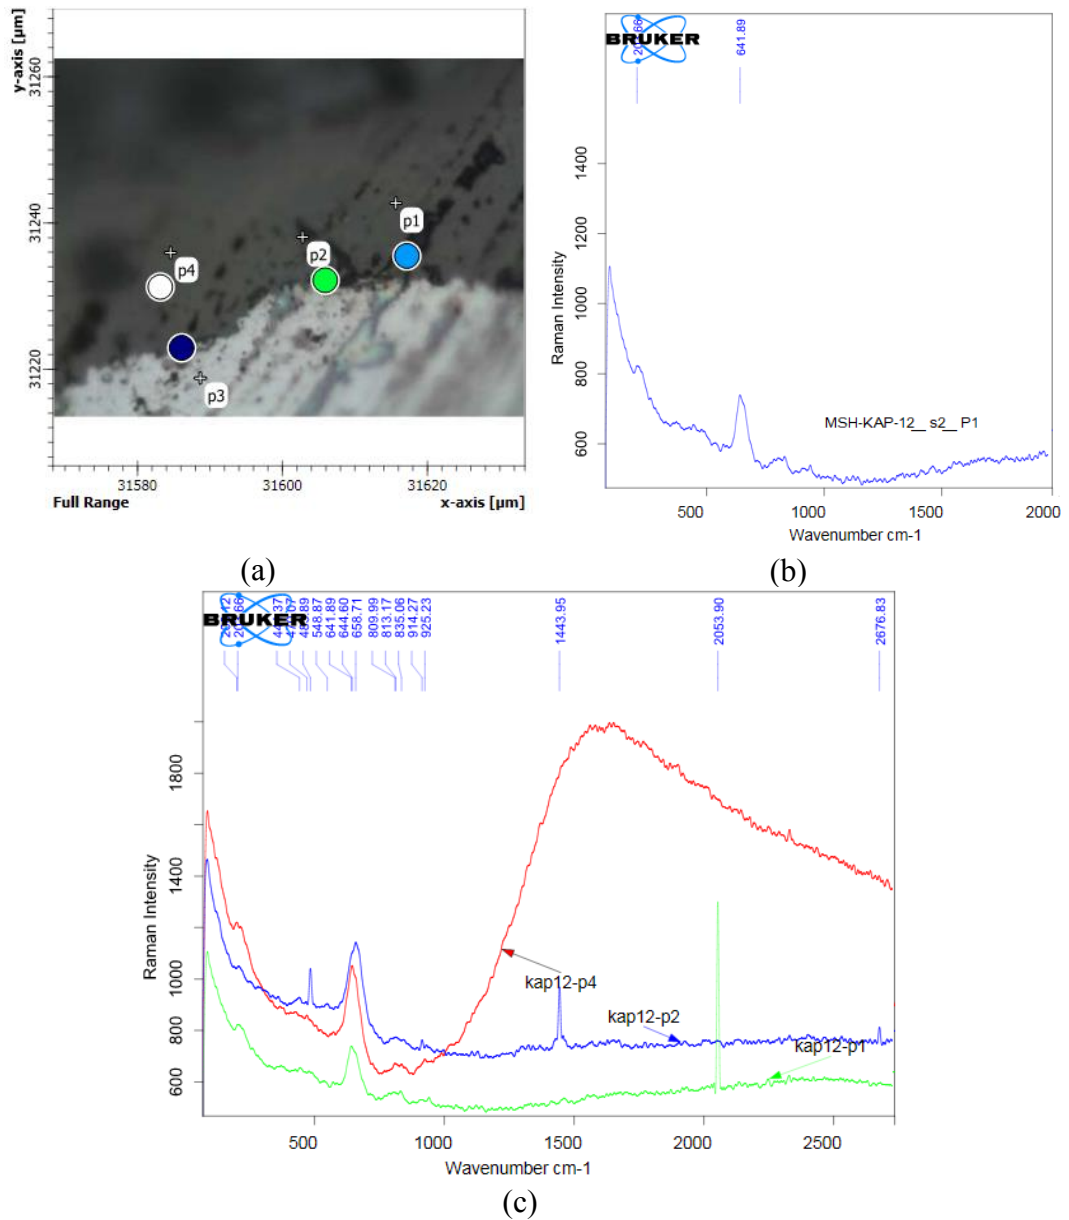
Figure 4. 119 μ -Raman spectra of the successive area where 4 points are located in the ICL of a nail (MSH-KAP-12): measurement points (a); wustite at p1 (b); wustite at p1 to p4 (c).

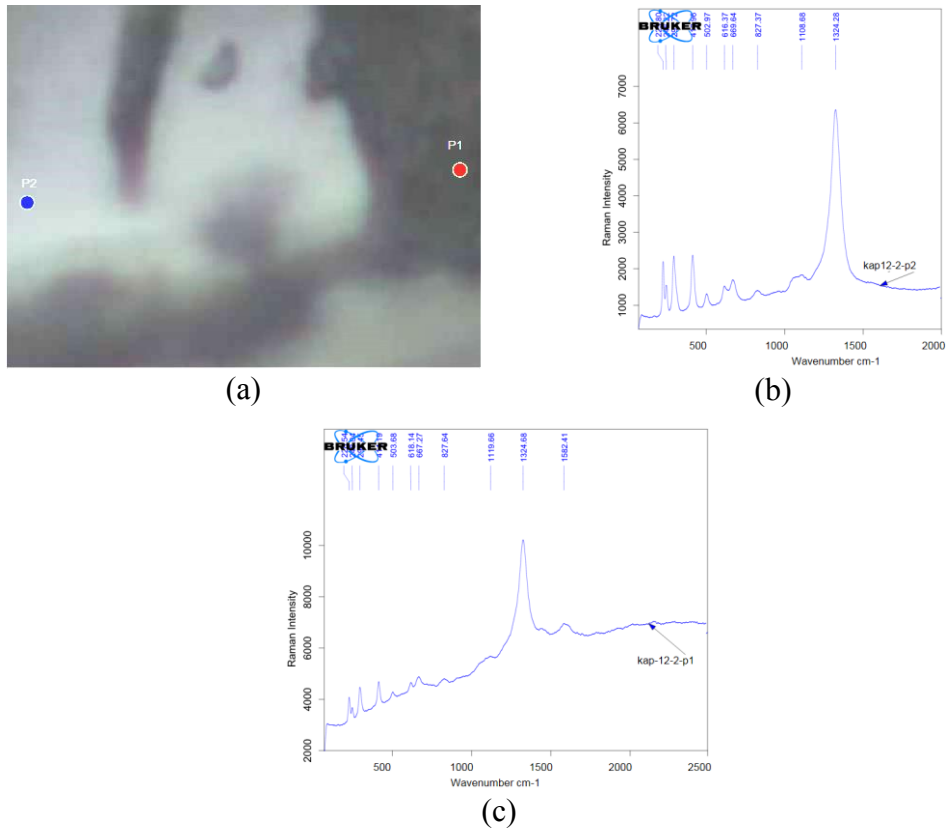
Figure 4. 120 μ -Raman spectra of the successive area where 2 points are located in the ICL towards TM of a nail (MSH-KAP-12): measurement points (a); hematite at p1 to p2 (b, c).

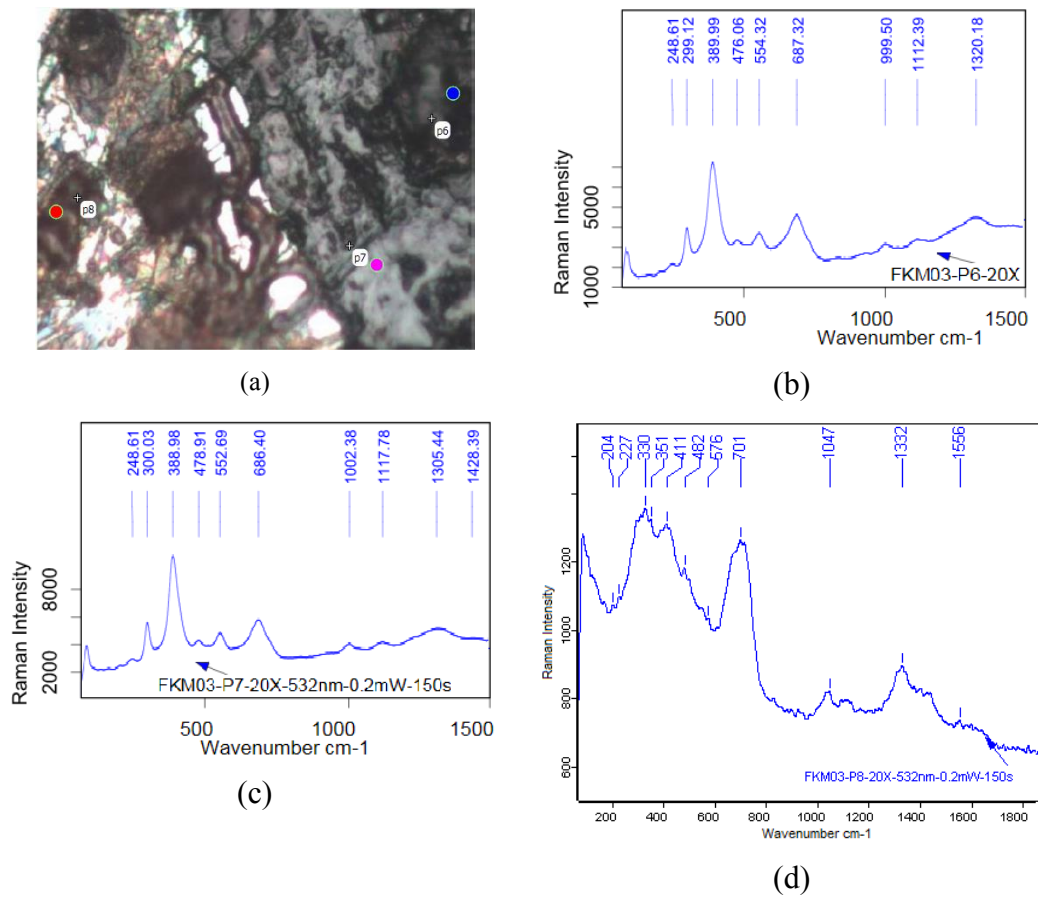
Figure 4. 124 μ -Raman spectra of the 3 points located in the ICL towards TM of a door lock piece (FKM-03): measurement points (a); goethite at p6 and p7 (b, c); and hydrated iron (III) oxide or oxyhydroxide at p8 (d).

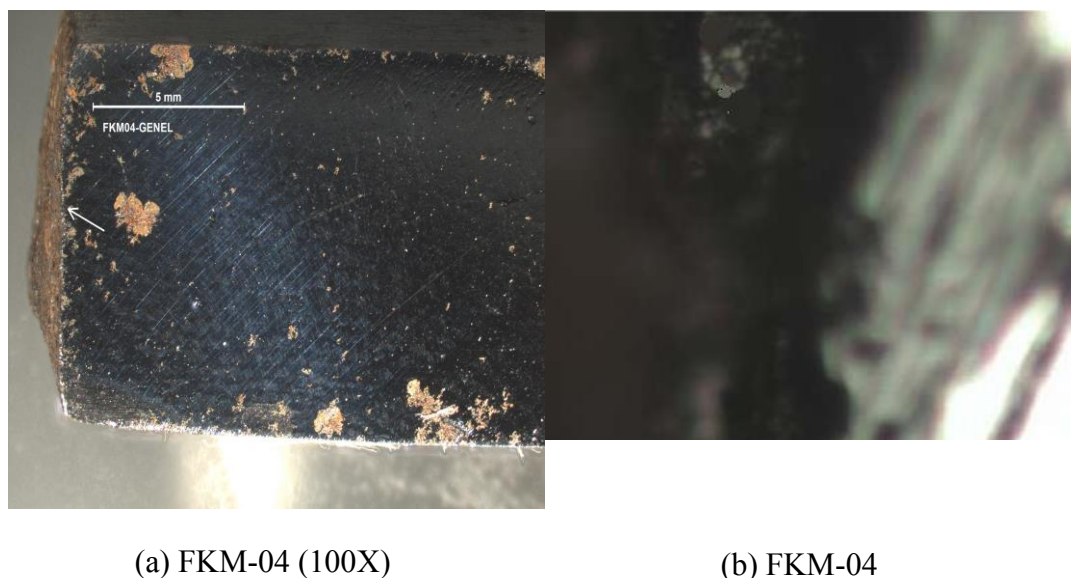
Figure 4. 125 Stereo microscopic (a) and Raman microscopic (b) images of a male hinge (FKM-04) (19th century) after etching with nitric acid in alcohol.

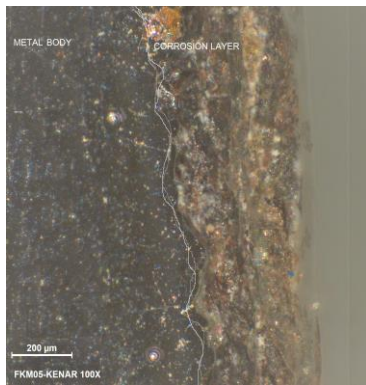
(a) FKM-05 (100X)

The next object analyzed from the Foça dwellings is a female hinge (FKM-05) used in the main entrance door. It shows a compact corrosion layer by stereo microscopic and SEM views (Figure 4.127 a and b). Starting from the metal body towards TM, 3 points were analyzed (Figures 4.128 a). At point 1 in the RF, a goethite phase is detected with its weak main peaks at 396 cm^{-1} and 301 cm^{-1} together with hydrated iron (III) oxide or oxyhydroxide having a large band around 690 cm^{-1} and $\sim 1320\text{ cm}^{-1}$ (Figure 4.128 b). At point 2 in the ICL, hydrated iron (III) oxide or oxyhydroxide having a large band around 695 cm^{-1} and $\sim 1321\text{ cm}^{-1}$ is detected together with a poorly crystalized goethite phase having its weak main peaks at 386 cm^{-1} , 304 cm^{-1} and 250 cm^{-1} (Figure 3.18 c). At point 3 close to TM, hydrated iron (III) oxide or oxyhydroxide with a noticeable presence of maghemite (γ -Fe₂O₃) having a large asymmetric band around 720 cm^{-1} and broad bands $\sim 1314\text{ cm}^{-1}$ to 1558 cm^{-1} is detected together with a poorly crystalized goethite phase having its main peaks at 391 cm^{-1} , 304 cm^{-1} and 250 cm^{-1} (Figure 4.128 d). The iron oxides layering by μ -Raman Analysis in the corrosion of the iron hinge piece (FKM-05) is summarized in the Table 4.39.

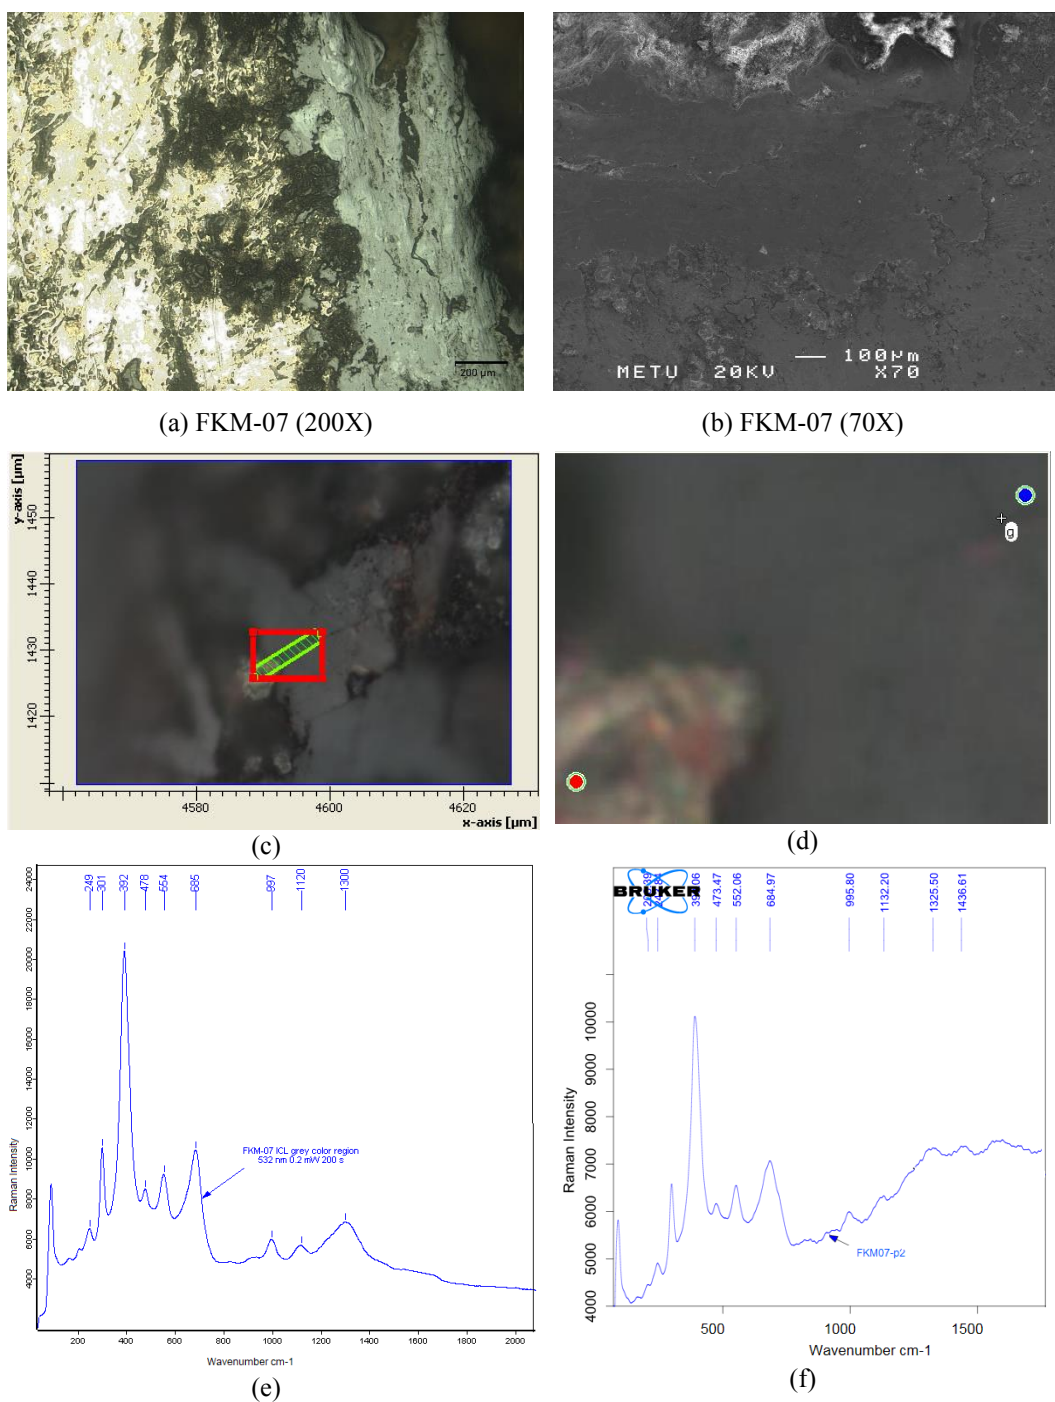
Figure 4. 129 Digital microscopic (a) and SEM (b) images of a buried nail (FKM-07) after etching with nitric acid in alcohol (19th cc). μ -Raman spectra of the 2 points located in the ICL: Measurement points (c, d); goethite at p1 and p2 (e, f).

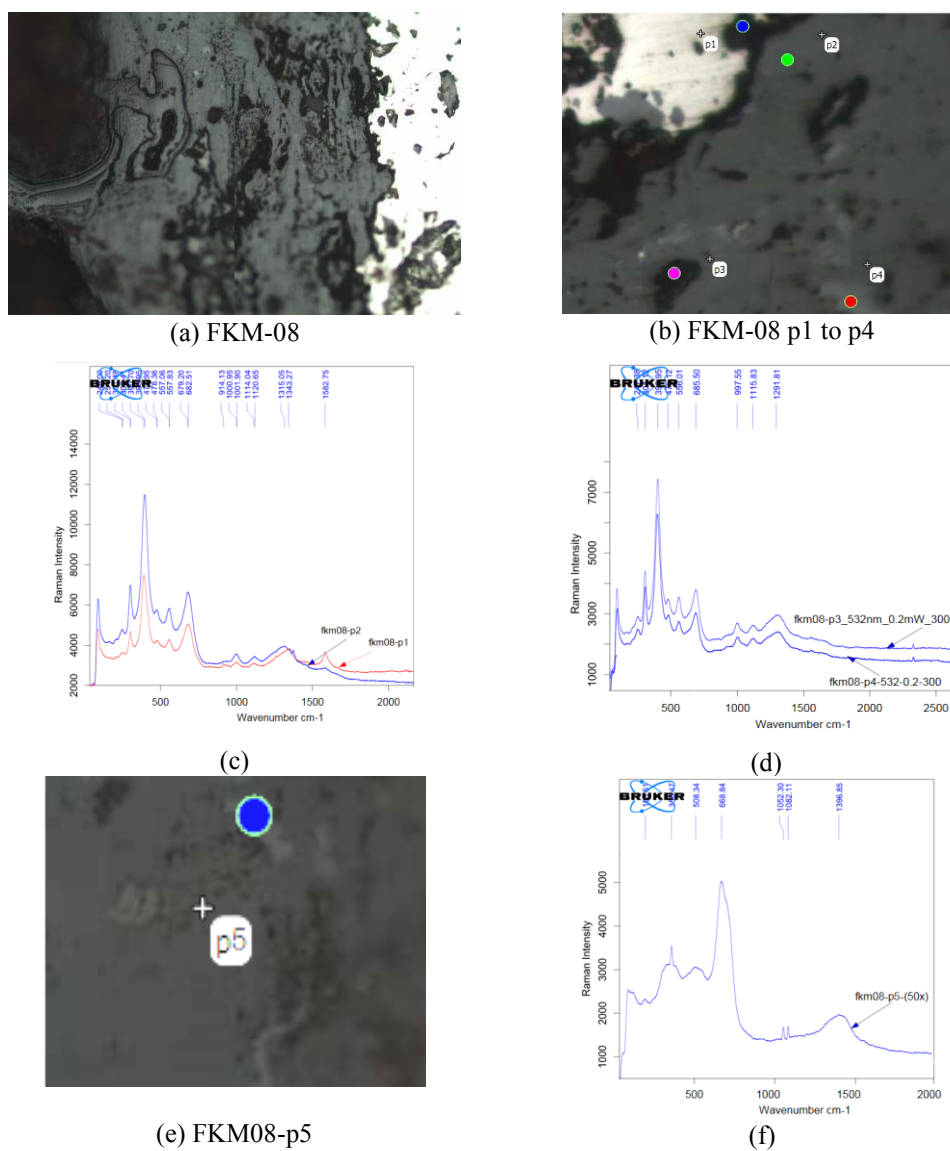
Figure 4. 131 Raman microscopic image of an L-shaped iron object (FKM-08) from the Ottoman layer excavation (19th cc) (a); μ -Raman spectra taken at the 4 points located in the RF towards ICL: measurement points (b); goethite at p1 and p2 (c); goethite at p3 and p4 (d); μ -Raman spectra taken at a marble located in ICL: measurement point (e); hydrated iron (III) oxide or oxyhydroxide at p5 (f).
