THE ARCHAEOMETRICAL INVESTIGATIONS OF SOME IRON
COMPONENTS FROM THE OTTOMAN PERIOD STRUCTURES

A THESIS SUBMITTED TO
THE GRADUATE SCHOOL OF NATURAL AND APPLIED SCIENCES
OF
MIDDLE EAST TECHNICAL UNIVERSITY

SEPTEMBER 2022

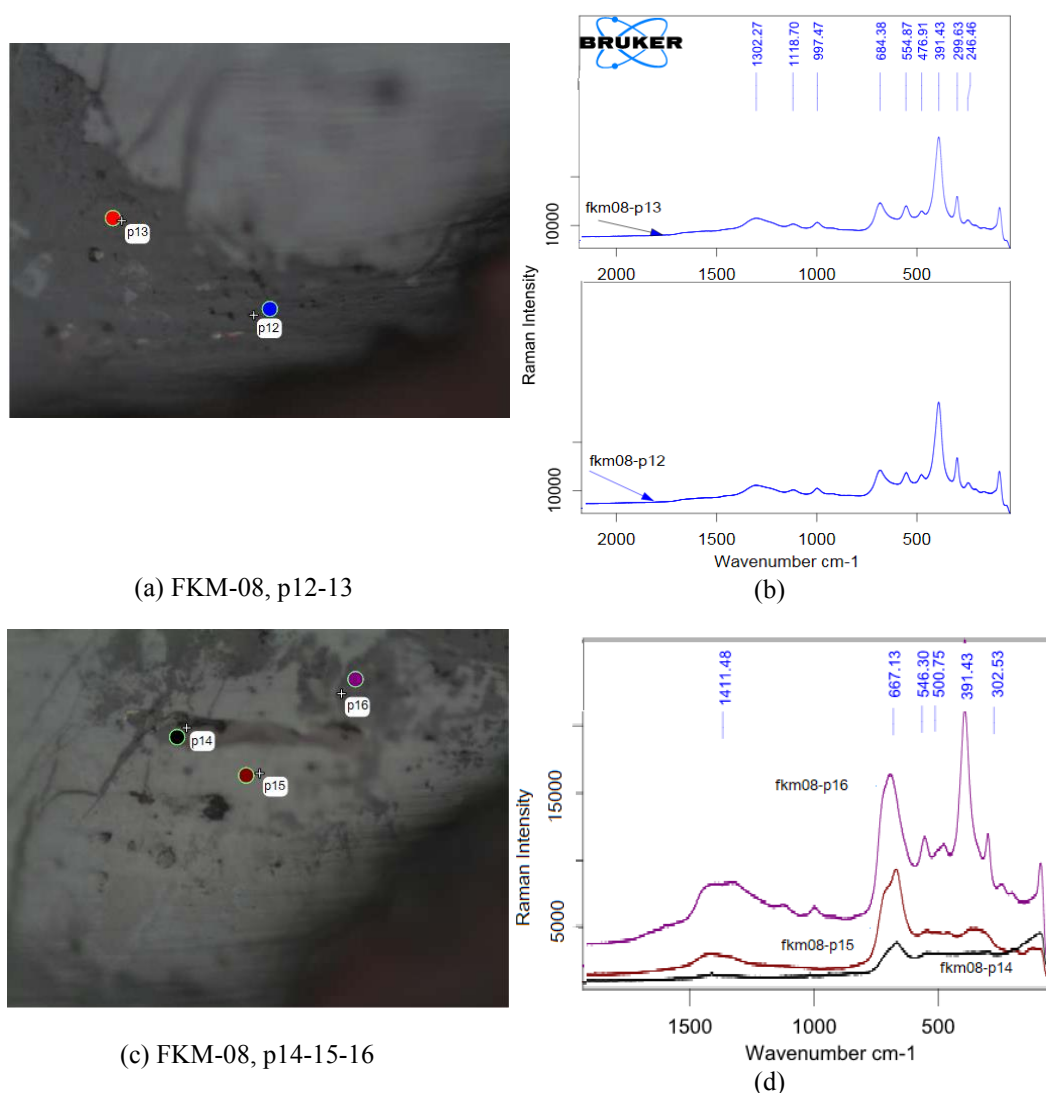
Figure 4. 135 μ -Raman spectra taken at 5 points located in the ICL near TM of an iron object (FKM-08): measurement points (a, c); goethite at p12 and p13 (b); goethite and magnetite / maghemite at p16 and hydrated iron (III) oxides or oxyhydroxides at p14 and p15 (d).

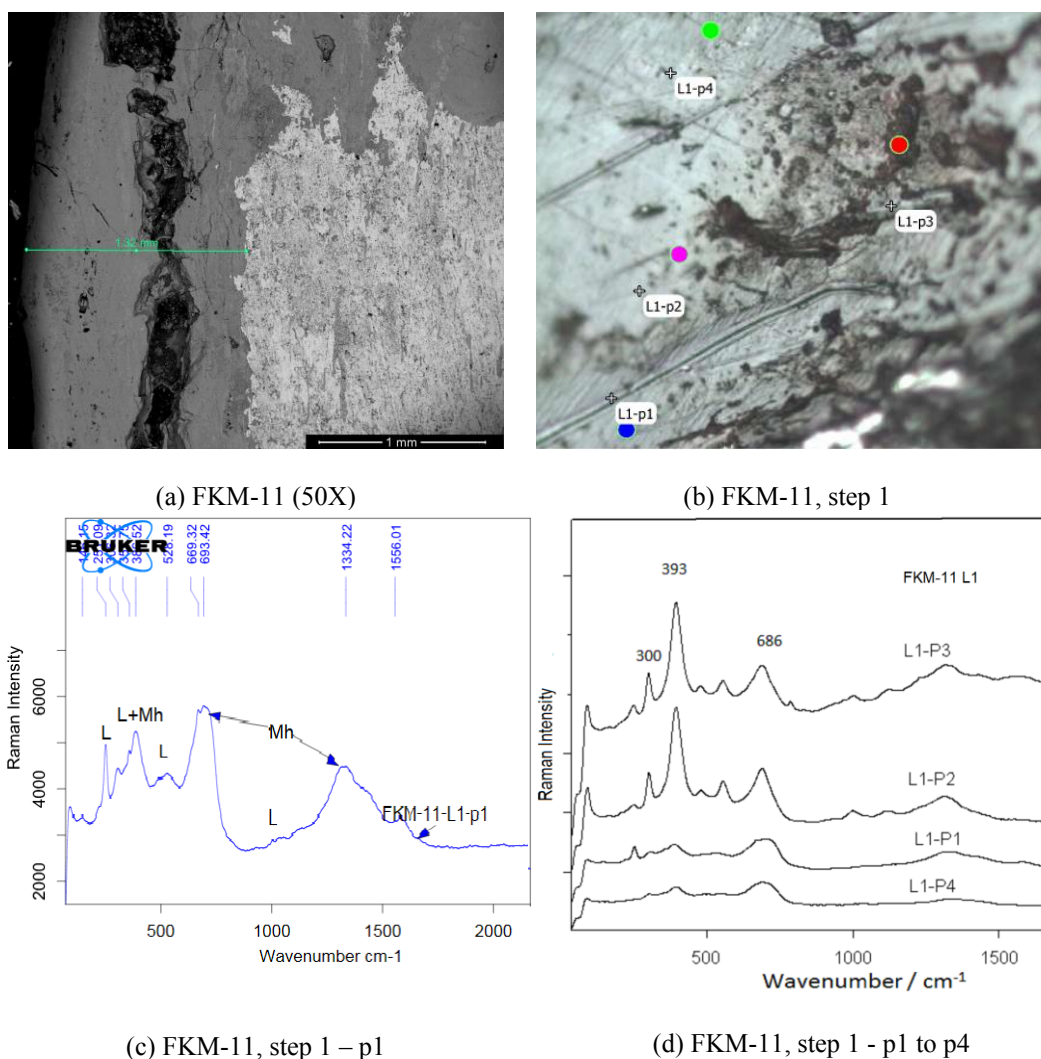
Figure 4. 141 SEM image (a) of a nail (FKM-11) from a dwelling in Foça (19th cc). μ -Raman spectra taken at 4 points located in the RF towards ICL: measurement points (b); maghemite (Mh) and lepidocrocite (L) at p1 and p4 (c); goethite at p2 and p3 (d).

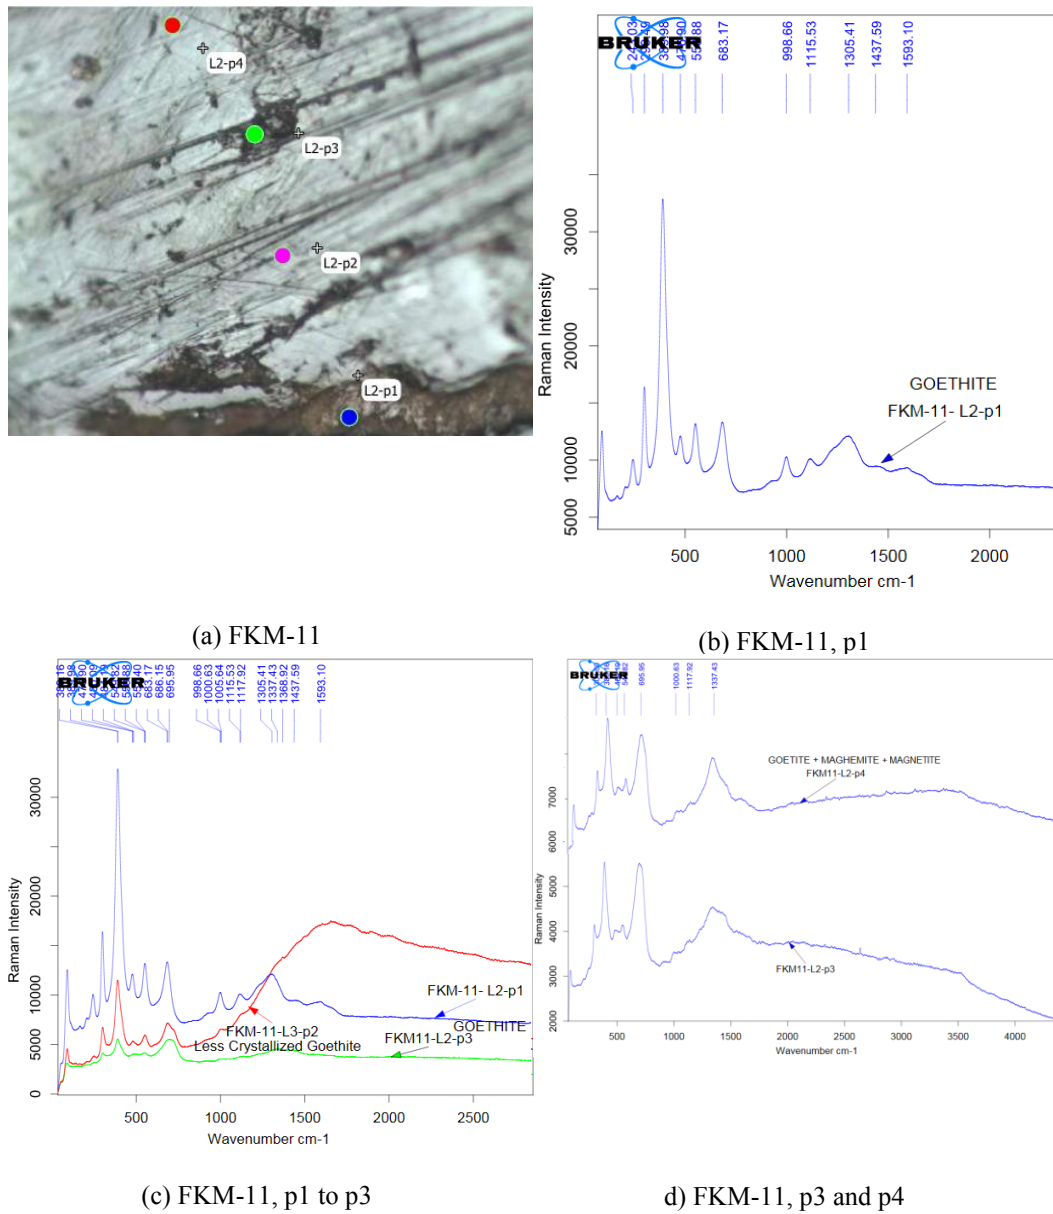
Figure 4. 142 μ -Raman spectra at the successive 4 points in the ICL next to RF: measurement points (a); goethite at p1 (b); goethite at p1 and p2, goethite with maghemite and magnetite at p3 (c); goethite with maghemite and magnetite at p3 and p4 (d).

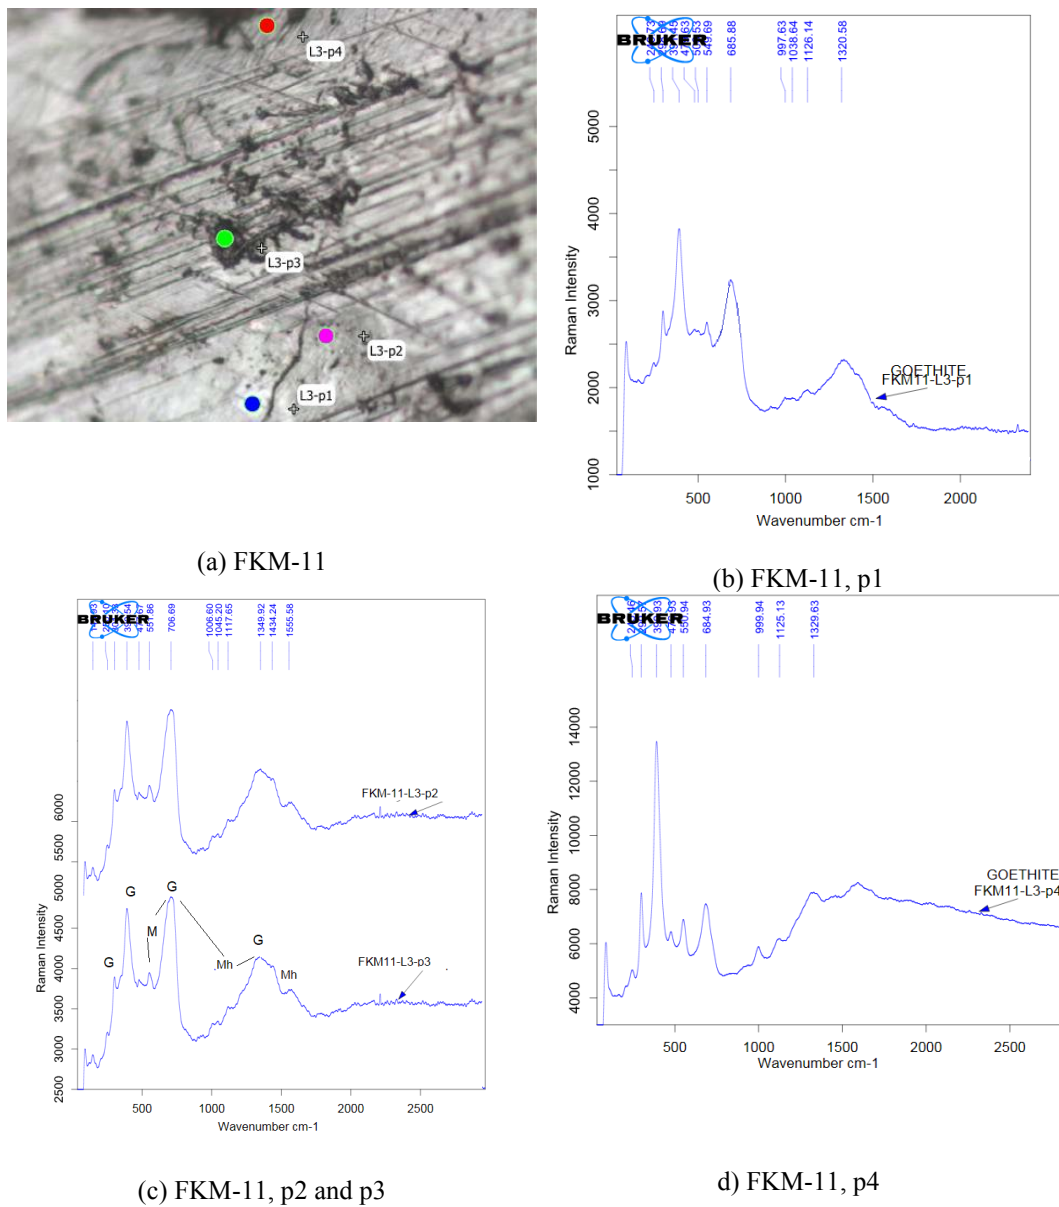
Figure 4. 143 μ -Raman spectra at the successive 4 points located in the ICL: measurement points (a); goethite at p1 (b); goethite, maghemite / magnetite at p2 and p3 (c); goethite at p4 (d).

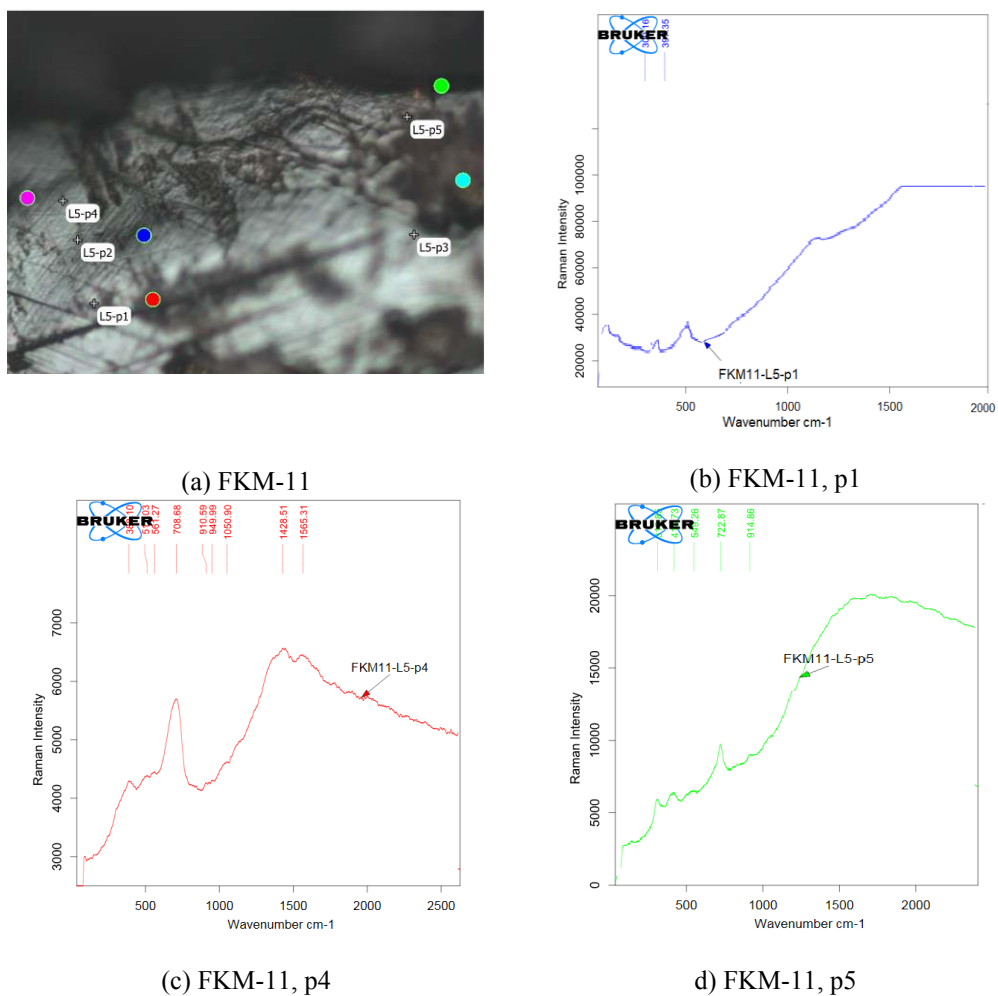
Figure 4. 145 μ -Raman spectra taken at successive 5 points located in the ICL near TM: measurement points (a); goethite at p1 (b); hydrated iron (III) oxides or oxyhydroxides at p2 to p5 (c, d).

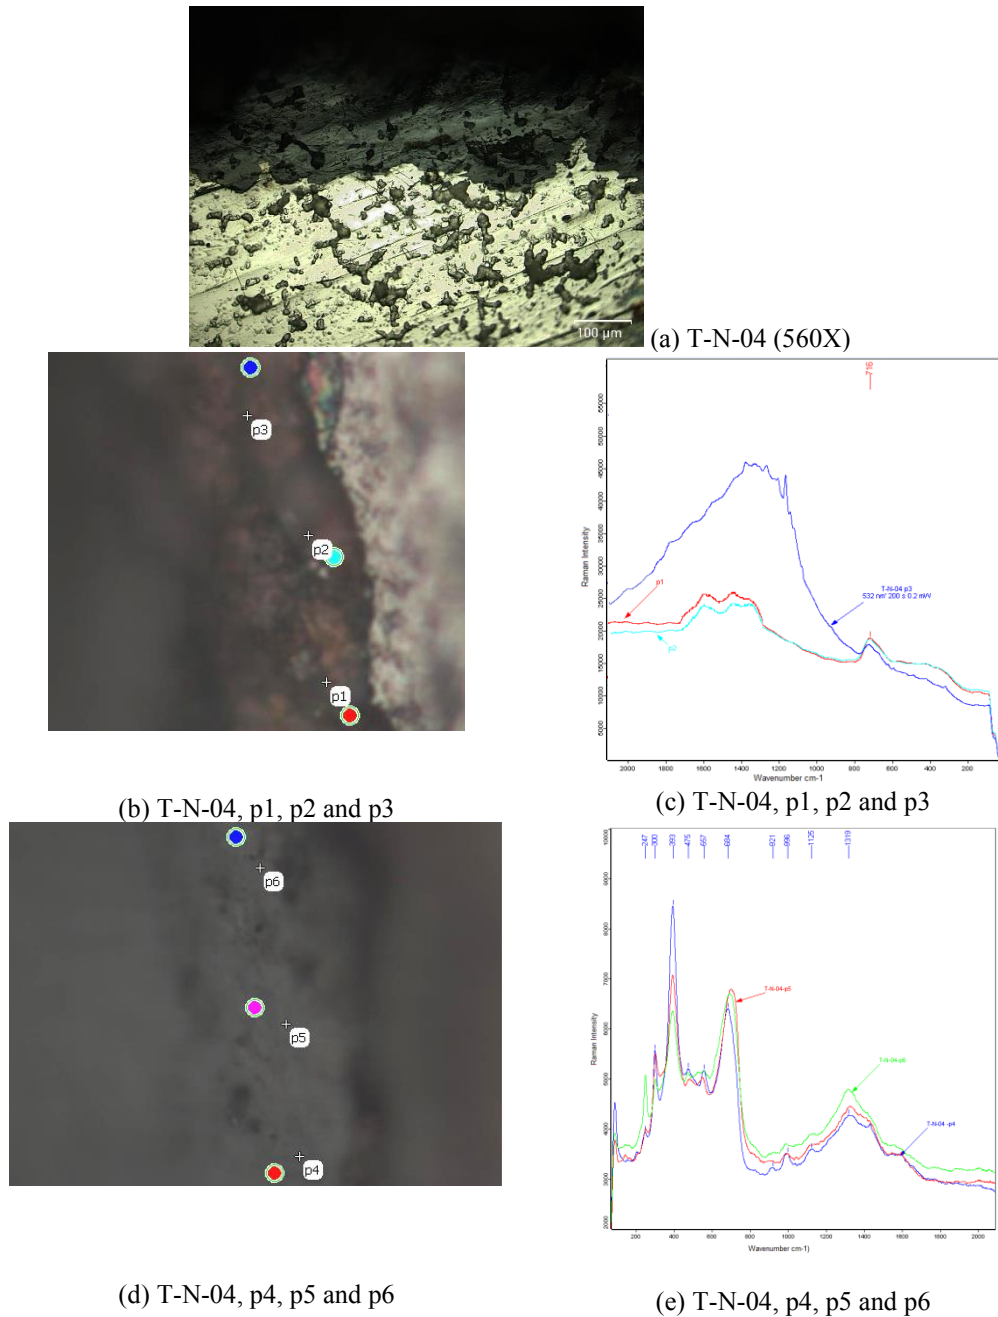
Figure 4. 149 Digital microscopic (a) image of the nail (T-N-04) from the door frame of a dwelling in Tekkekoy, Samsun after etching with nitric acid in alcohol (19th cc). μ -Raman spectra taken at 6 points located in RF towards ICL: measurement points (b, d); hydrated iron (III) oxides or oxyhydroxides at p1 to p3 in RF (c); goethite at p4 to p6 in RF - ICL border (e).

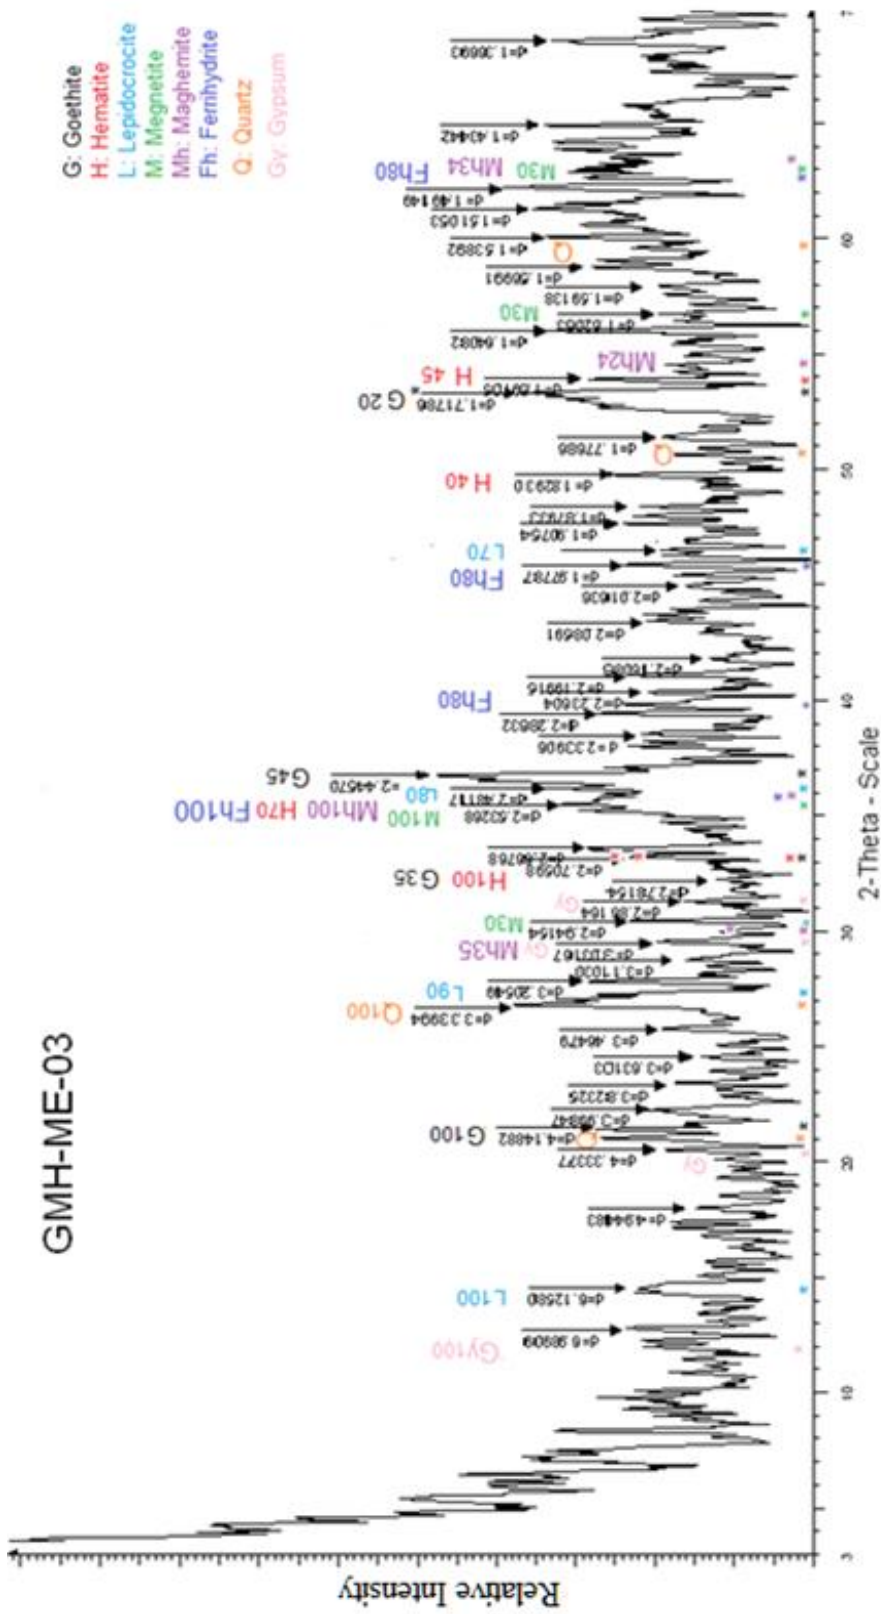
Figure 4. 152 XRD spectra of the corrosion layer powder including ICL and TM of the plaster nail (GMH-ME-03) (15th cc): maghemite (Mh), magnetite (M), hematite (H), goethite (G) and lepidocrocite (L) are identified.

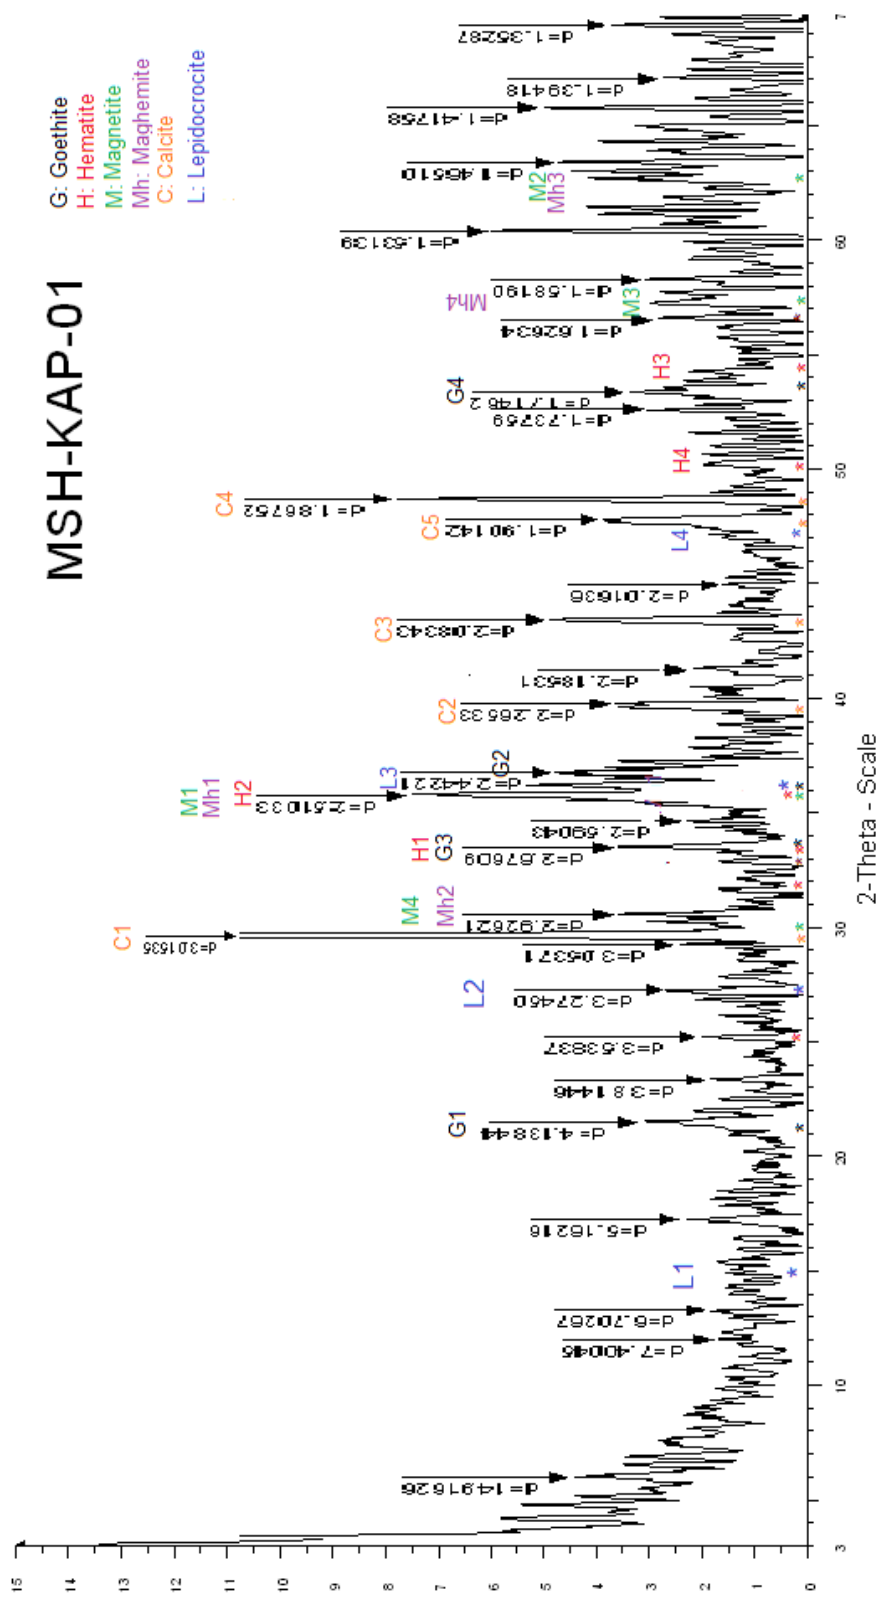
Figure 4. 153 XRD spectra of the corrosion layer powder including ICL and TM of the nail (MSH-KAP-01) (16th cc): goethite (G), maghemite (Mh), magnetite (M), hematite (H), lepidocrocite (L) and calcite (C).

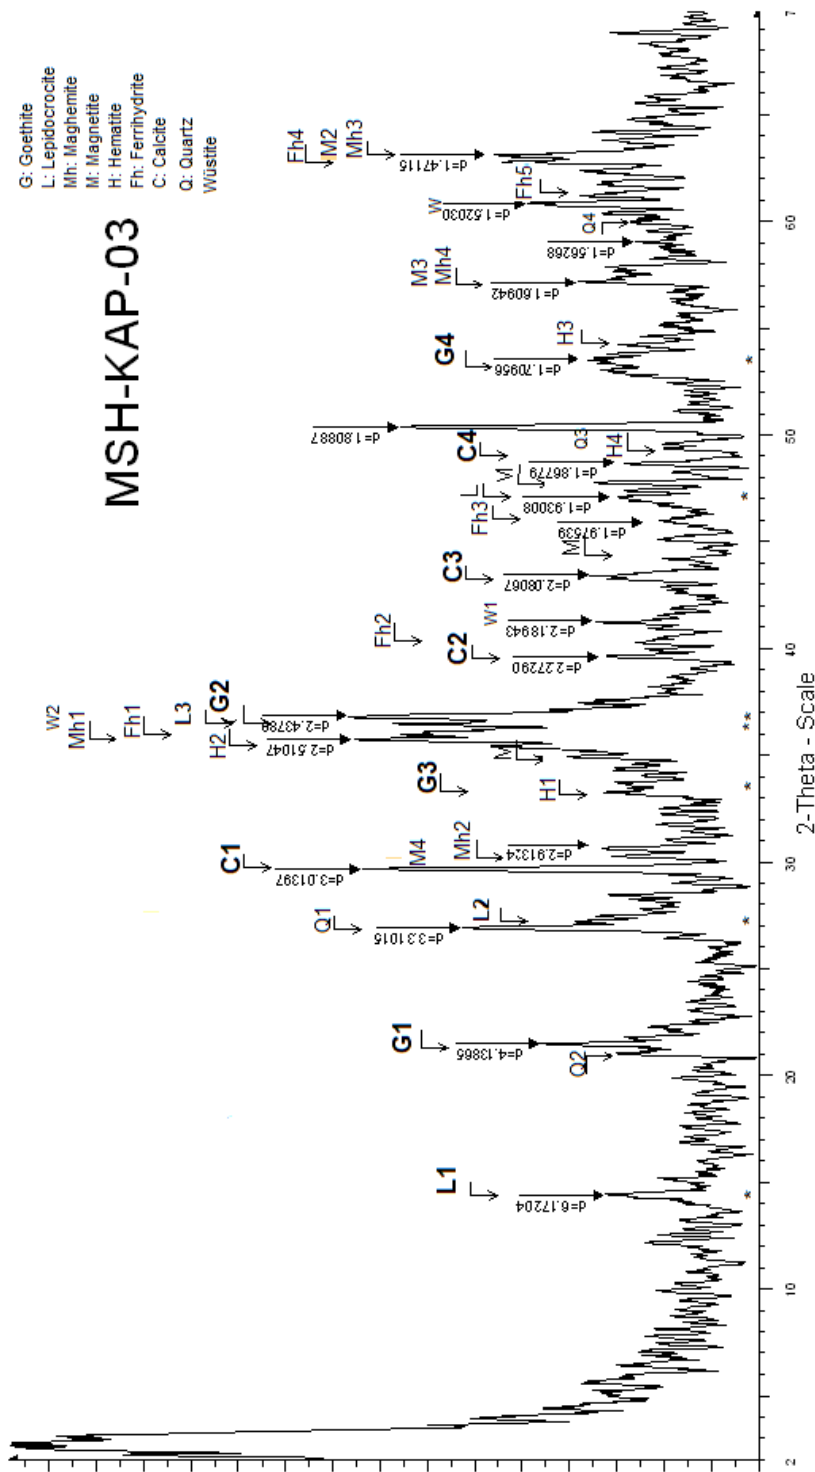
Figure 4. 154 XRD spectra of the corrosion layer powder including ICL and TM of the nail (MSH-KAP-03) (16th cc): maghemite (Mh), magnetite (M), hematite (H), goethite (G), lepidocrocite (L), ferrihydrate (Fh), wüstite (W), quartz (Q) and calcite (C) are identified.

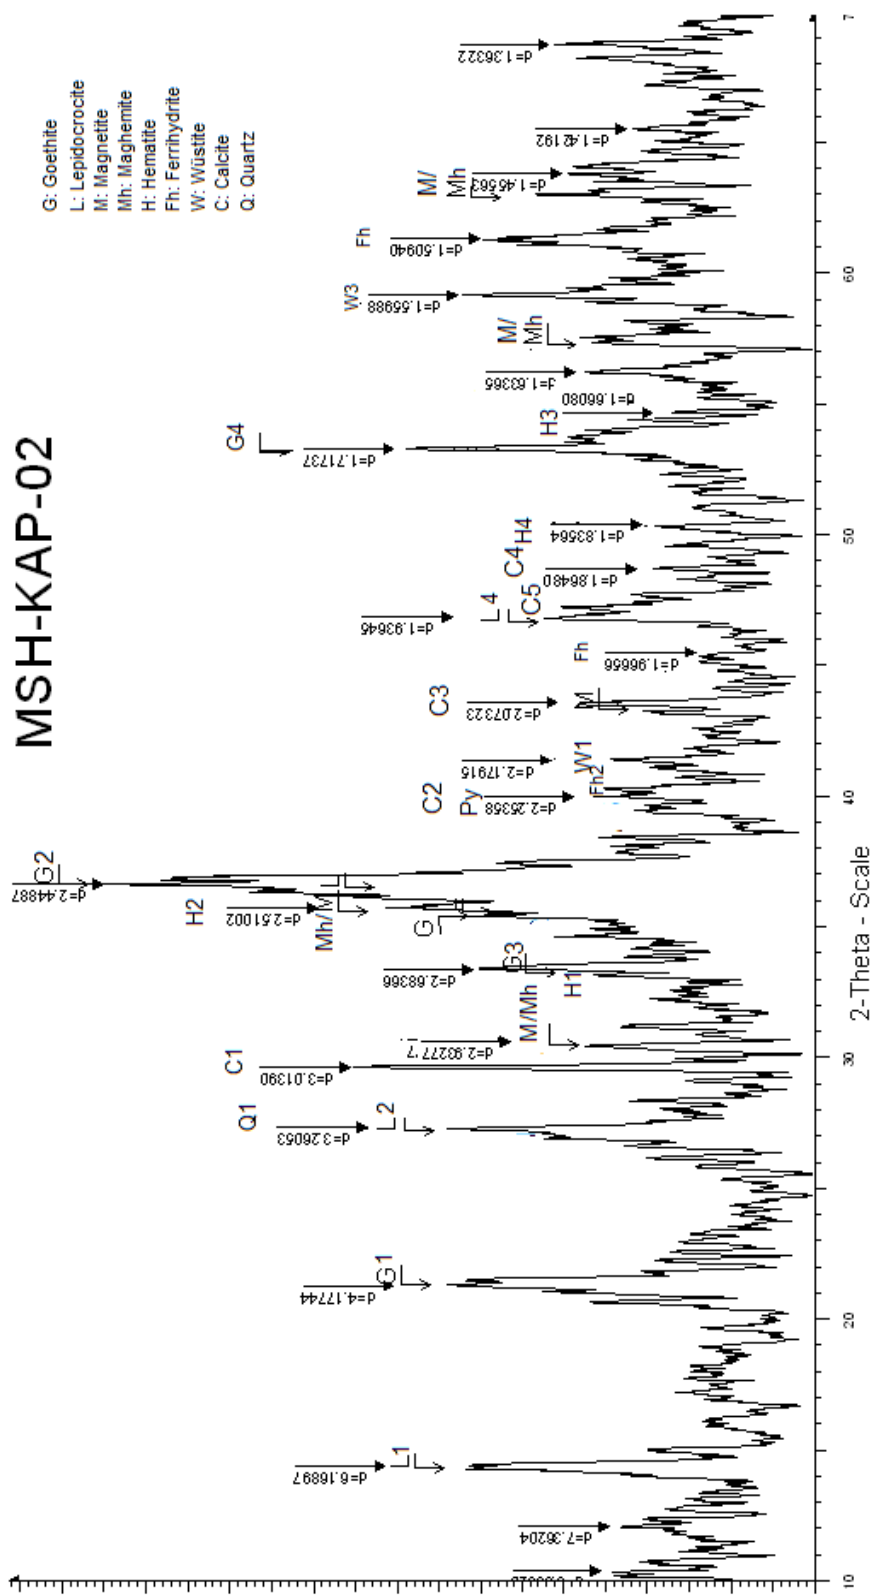
Figure 4. 155 XRD spectra of the corrosion layer powder including ICL and TM of the iron joining piece (MSH-KAP-02) (16th cc): maghemite (Mh), magnetite (M), hematite (H), goethite (G), lepidocrocite (L), ferrihydrate (Fh), wüstite (W), quartz (Q) and calcite (C)

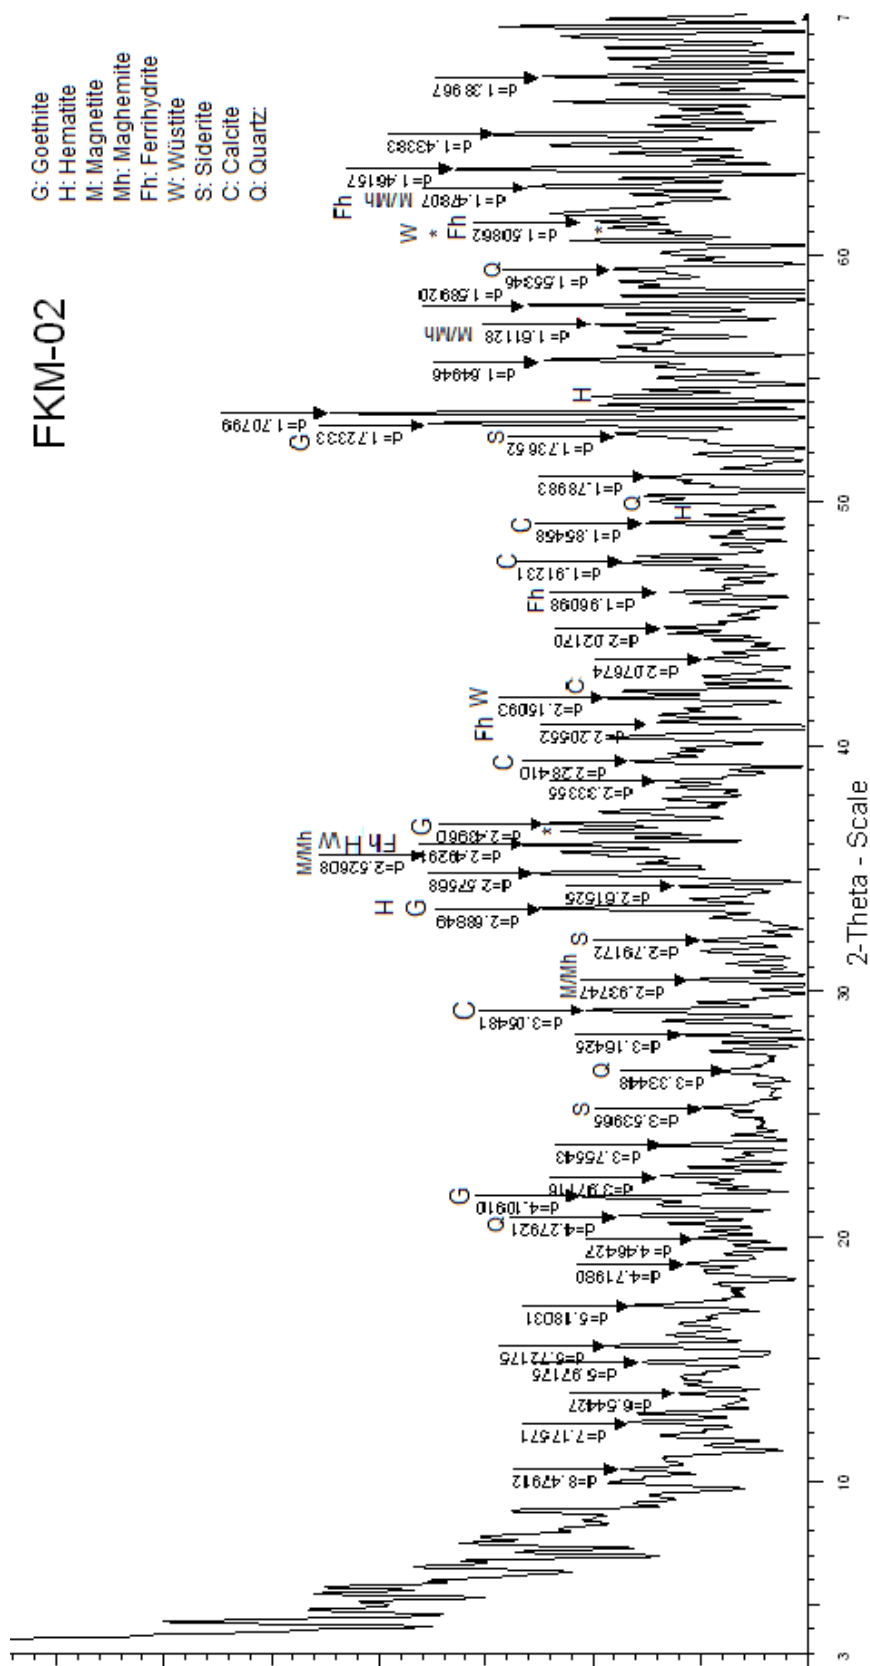
Figure 4. 156 XRD spectra of the corrosion layer powder including ICL and TM of the iron nail (FKM-02) (19th cc): goethite (G), maghemite (Mh), magnetite (M), hematite (H), ferrihydrite (Fh), wustite (W), siderite (S), quartz (Q) and calcite (C).

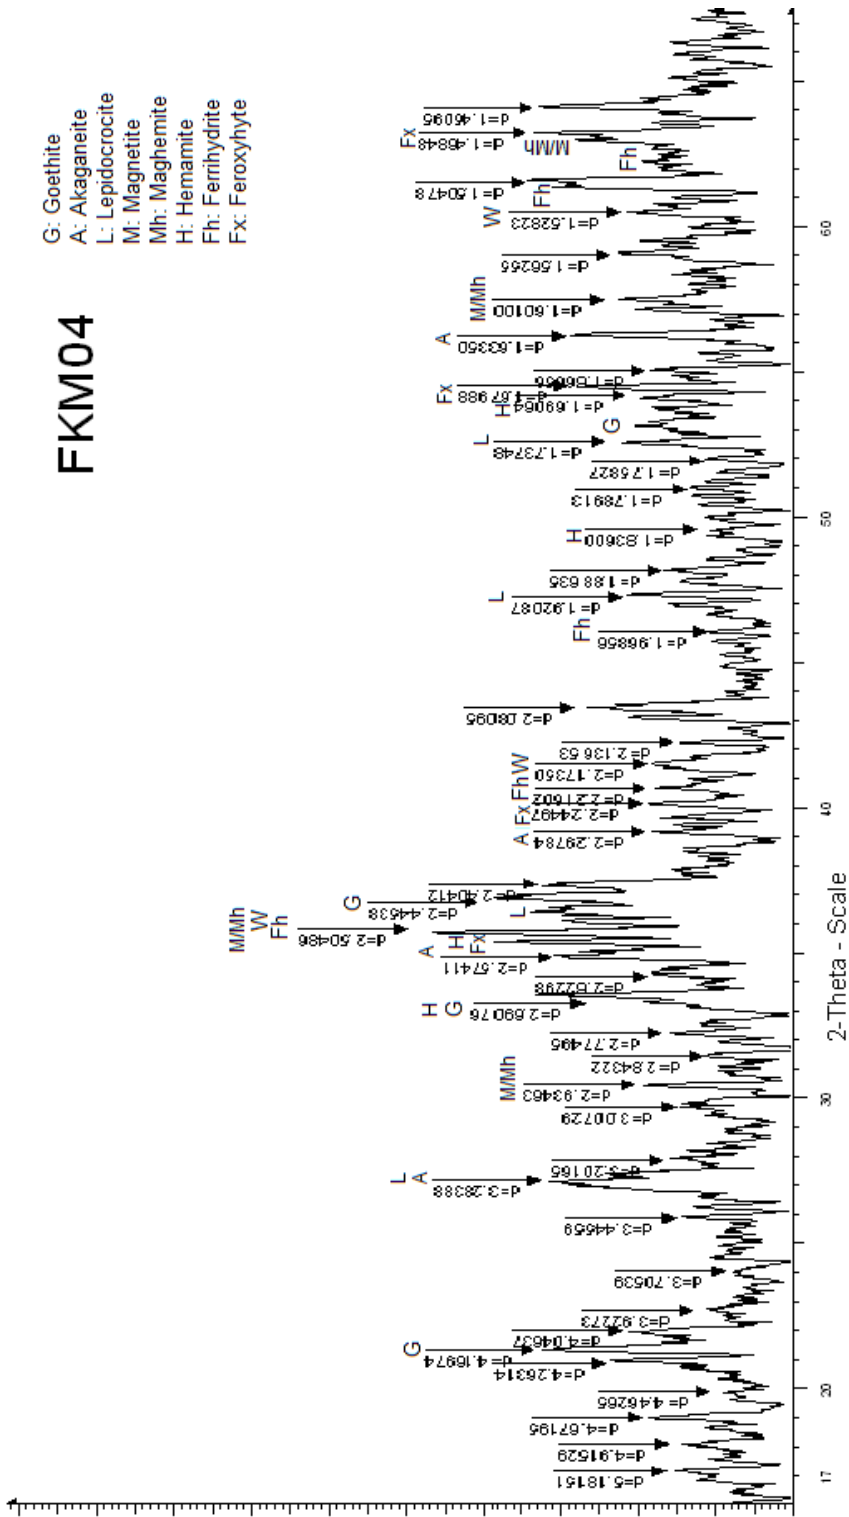
Figure 4. 157 XRD spectra of the corrosion layer powder including ICL and TM of the main entrance door hinge (FKM-04) (19th cc): goethite (G), akaganeite (A), maghemite (Mh), magnetite (M), hematite (H), lepidocrocite (L), ferrihydrite (Fh), ferroxyhyte (Fx).
