Subsurface Characterization at Ground Failure Sites in Adapazari, Turkey

Jonathan D. Bray[1]; Rodolfo B. Sancio[2]; Turan Durgunoglu[3]; Akin Onalp[4];
T. Leslie Youd[5]; Jonathan P. Stewart[6]; Raymond B. Seed[7]; Onder K. Cetin[8];
Ertan Bol[9]; M. B. Baturay[10]; C. Christensen[11]; and T. Karadayilar[12]

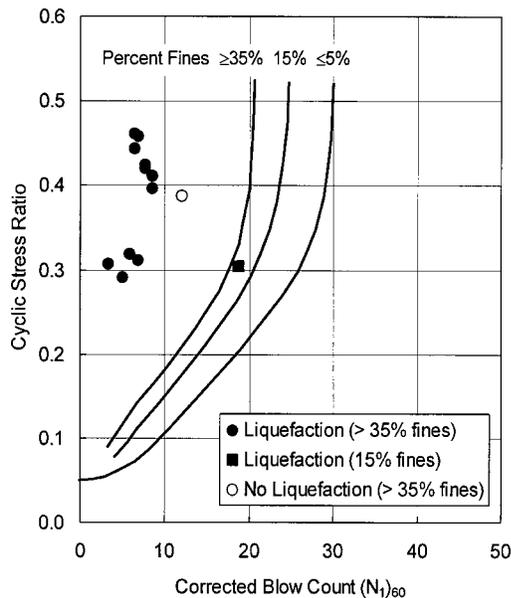
Fig. 3. Relationship between cyclic stress ratio and standard penetration test penetration resistance for sands and silty sands based on field performance data showing data for critical layers at selected sites in Adapazari [modified from Youd et al. (2001) after Seed et al. (1985)]

The level of shaking in Adapazari was sufficiently intense that the CSRs induced in the critical soil layers within the upper 6 m by the earthquake were largely between 0.3 and 0.5. As shown in Fig. 3, over this range, the SPT- (and CPT-) based cyclic resistance ratio (CRR) curves are nearly vertical. Hence uncertainty in estimating the demand from this event for the free-field case does not significantly affect the liquefaction triggering assessment. However, the liquefaction assessment is highly sensitive to penetration resistance, so care was taken to employ standard U.S. methods and measure the actual SPT energy to achieve reliable normalized SPT blow-counts, $(N_1)_{60}$, and CPT tip resistances, q_{c1N}.

Most of the soils in Adapazari contain significant fines (i.e., >35% passing the number 200 sieve). Hence, the CRR line shown in Fig. 3 for percent fines ≥ 35% is applicable for the vast majority of the SPT-based liquefaction triggering analyses. The liquefaction-triggering database of the well-used Seed et al. (1985) correlation, which was readopted with only a minor revision in Youd et al. (2001), is dominated by cases for clean sands and silty sands with less than 35% fines. Only 13 cases with more than 35% fines were available when this CRR line was developed.

In Table 2, the characteristics of the critical soil layers in terms of liquefaction triggering at the 12 building sites investigated in Adapazari are summarized. The data points for these critical soil layers are shown on the CSR versus $(N_1)_{60}$ plot in Fig. 3, which was presented previously. The soil characteristics data that forms the basis for the critical soil layers described in Table 2 are plotted in Fig. 18. Soils that liquefied in Adapazari often contain grain size distributions outside of that commonly believed to be susceptible to liquefaction [Fig. 18(a)]. The Adapazari soils contain a

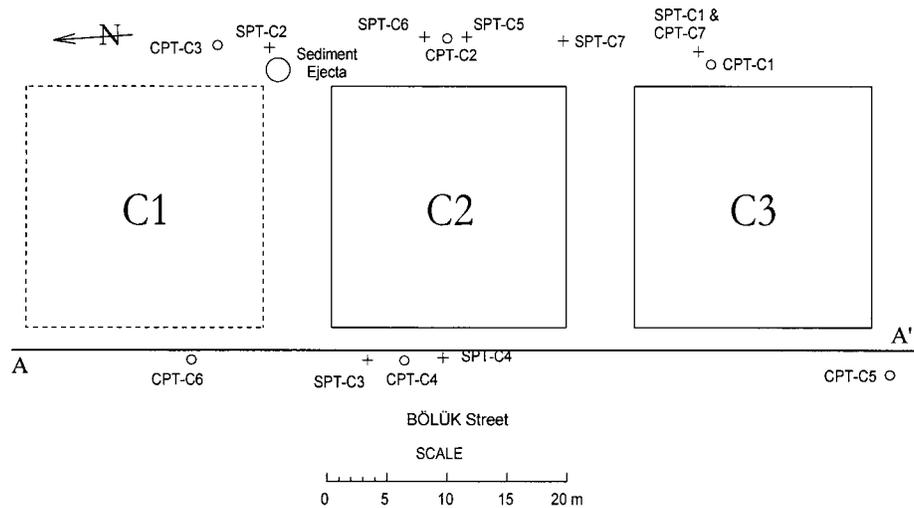
Fig. 4. Plan view of Site C and location of subsurface explorations

The middle building (designated C2 in Fig. 4) and the building to its north (designated C1) moved toward the street and down-

ward (Bray and Stewart 2000). For example, building C2 translated 57 cm towards the street (west), 34 cm towards building C1 (north), and the relative downward vertical movement between it and the pavement was about 35 cm. However, there was no evidence of distress to building C3, which is located directly south of building C2. Significant pavement distress and sediment ejecta were observed in the alley between buildings C1 and C2, but no ground failure was observed in the alley between buildings C2 and C3. The sediment ejecta is classified as a brown low plasticity sandy silt. Inspection of the structural components of buildings C2 and C3 showed no evidence of significant structural distress. Building C1 was demolished after the earthquake.

As shown in Fig. 4, six CPTs and seven exploratory borings were performed at Site C. The generalized subsurface conditions along the western side of the buildings are shown in Fig. 5. The subsurface conditions at this site appear to have significant variations

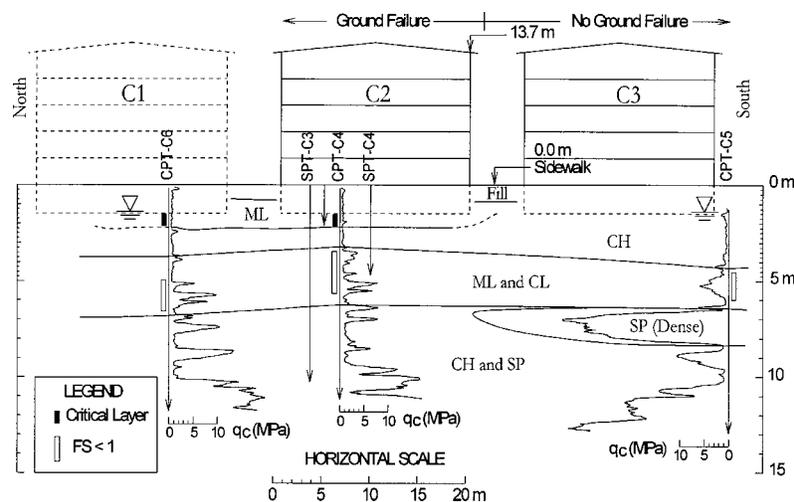
Fig. 5. North to south generalized soil profile of Site C (cross section A-A′ in Fig. 4)

Building C3's mat foundation is underlain by 2.5 m of tan brown plastic silty clay. Between approximately 4 and 5.5 m a red-brown to gray stratum of low plasticity medium dense sandy silts interspersed with more plastic clayey silts was identified. At approximately 6 m below the surface and down to about 8 m, a dense gray sand ($q_{c1N} > 160$) with some fine gravel was found. Interbedded clayey silts and medium dense silty sands continue below this layer down to the extent of the exploration (~ 13 m).

Different than at building C3, the soil directly beneath the foundation of building C2 is a meter-thick deposit of loose, tan brown, low plasticity silt, with a water content consistently greater than 0.9 LL. Below this deposit down to a depth of about 8 m, the soils are interbedded loose to medium dense silts and sandy silts, with no dense clean sand with fine gravel layer as was present under building C3. Beyond a depth of 8 m and up to the

Reexamining Fig. 5, which also identifies layers with FS$_l$<1 and the critical layer with respect to liquefaction, there are two significant differences in the soil conditions below building C2, which underwent severe ground failure, and the "undamaged" building C3, which did not. Most importantly, loose, liquefiable, low plasticity sandy silts lie directly beneath building C2, but are absent directly under building C3. The liquefaction of these soils directly below building C2's mat foundation most likely led to the observed horizontal translation of the building on the order of 66

cm. Additionally, at a depth of 6–8 m, a layer of dense sand with fine gravel that should not have liquefied under building C3 is in sharp contrast to the alternating layers of liquefiable silty sands and low plasticity silts in the soil deposit underlying building C2 over a similar depth, and this may have also contributed to ground failure being observed at building C2, but not at building C3.

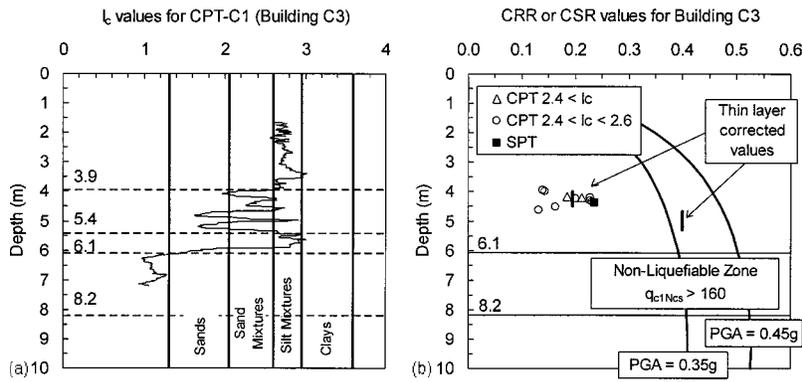
Fig. 6. (a) Soil behavior index (I_c) values for CPT-C1 (Building C3), and (b) cyclic stress ratio (CSR) induced by the earthquake versus depth for free-field acceleration of 0.35g and 0.45g compared with the cyclic resistance ratio (CRR) of the soil for Building C3

Some limited portions of the stratum of sandy silt found between depths of 3.9 and 5.4 m under building C3 are possibly liquefiable [I_c<2.6 as shown in Fig. 6(a)]. Samples retrieved from these soils have LL=26–36, with water contents near the LL, and clay contents (%<5 μm) close to, but generally exceeding, 15%. Due to the low liquid limits and high water contents, these thin silt layers are considered potentially liquefiable, although these soils would not be liquefiable if the Chinese criteria are strictly applied. The free-field CSR for PGA values of 0.35 and 0.45g are greater than the cyclic resistance of these soils [Fig. 6(b)]. The SPT data from a nearby boring corroborates this finding. The dense sand stratum (6.1–8.2 m), the clean to silty sand layer (8.5–9.3 m), and the medium dense to dense gray low plasticity silt to silty sand (10–13 m) are susceptible to liquefaction based on soil type, but only the layer between 8.5 and 9.3 m has (q_{c1N})$_{cs}$ values lower than 160, which is the asymptote of the Robertson and Wride (1998) clean sand liquefaction-triggering curve. Hence liquefaction of these dense sands is not likely even at the high CSRs experienced in Adapazari.

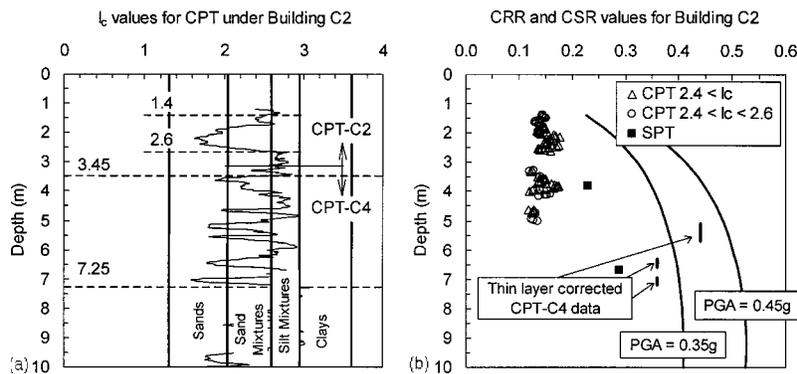
The loose, low plasticity silt at a depth from 1.4 to 2.6 m, which is directly below the mat foundation of building C2, is judged to have liquefied based on the low I_c values (<2) and estimated CRR values of about 0.15 (Fig. 7). Over this depth interval, soil samples indicate FC=66–87, LL=23–33, w_n/LL =1–1.3, and clay content (%<5 μm) between 14 and 28%. The characteristics of the sediment ejecta found between buildings C2 and C1 are consistent with those of the shallow low plasticity silt. This further indicates that the shallow loose silt deposit liquefied. At greater depths, numerous loose to medium dense layers of silt to silty sand found between 3.45 and 7.25 m have I_c values lower than 2.6. These silts have LL<31 and w_n/LL~1, but clay contents >23%. Again, these soils are considered potentially liquefiable for this study. As can be seen in Fig. 7(b), the values of the soil's CRR obtained from the analysis of CPT-C4 and neighboring SPTs in the range of depth of 3.45–7.25 m is lower than the free-field CSR for PGA=0.35g, and hence these strata most likely liquefied. Below a depth of 8 m, the soil liquefaction evaluation for building C2 is consistent with that previously presented for soils below building C3.

Fig. 7. (a) Soil behavior index (I_c) values for CPT-C4 (Building C2), and (b) cyclic stress ratio (CSR) induced by the earthquake versus depth for free-field acceleration of 0.35g and 0.45g compared with the cyclic resistance ratio (CRR) of the soil for Building C2

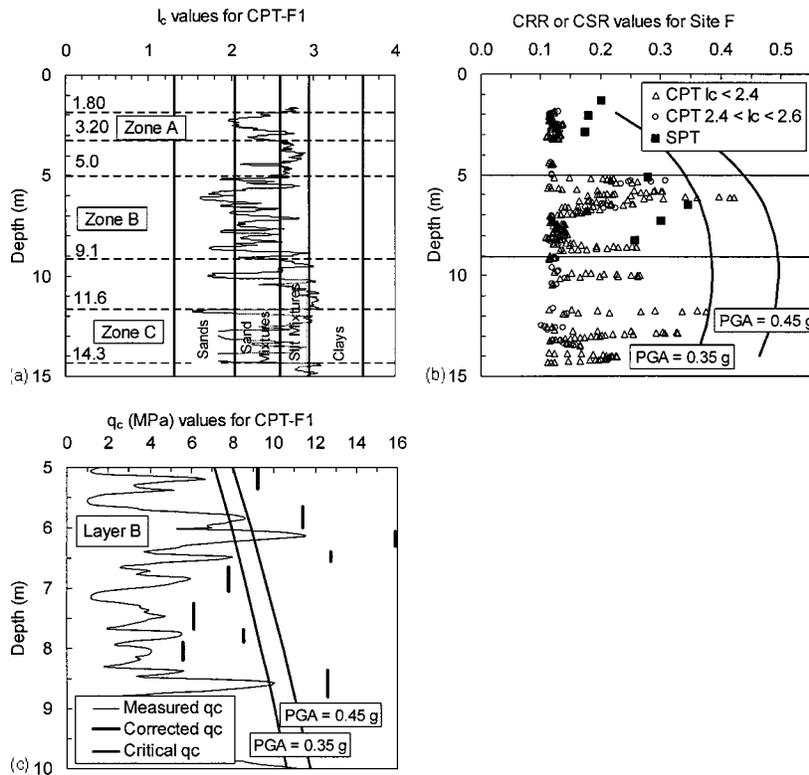
Fig. 10(a) shows where the soils had values of $I_c<2.6$ in a representative CPT profile. Comparisons between the free-field CSR induced by the earthquake and CRR of the soils susceptible to liquefaction are shown in Fig. 10(b). The CSR induced by the earthquake is significantly greater than the CRR of the soil in Zone A; thus the shallow, loose silt is judged to have liquefied.

The large fluctuations of the cone tip penetration resistance in Zone B indicate significant soil stratification as shown in Fig. 10(c). In this zone, the stiffer layers are seldom greater than 40

Fig. 10. Representative soil data for Building F: (a) Soil behavior index (I_c) values for CPT-F1, (b) cyclic stress ratio (CSR) induced by earthquake versus depth for peak ground acceleration (PGA)=0.35g and 0.45g compared with the cyclic resistance ratio (CRR) of the soil, and (c) measured q_c, thin layer corrected q_c, and critical q_c for PGA=0.35g and 0.45g versus depth for Zone B

cm; therefore the full penetration resistance is not sensed by the 10 cm² cone tip used in these studies. These layers would need to be thicker than 75 cm for the tip resistance to reach its maximum value (Lunne et al. 1997). A correction factor as recommended by Youd et al. (2001) has been applied to the stiffer silt layers, which are susceptible to liquefaction, as shown in Fig. 10(c). Thin-layer corrections indicate that much of the Zone B soil did not liquefy for PGA<0.45g (i.e., all but four thin layers at depths of around 6.5–8 m). Consistent with the CPT results, the equivalent clean sand normalized SPT value, $(N_1)_{60\text{-cs}}$, exceeded 30 for some of the silt lenses indicating that much of the Zone B soils did not liquefy. Once thin layer corrections are made to the susceptible soil layers in Zone C, they are found to have not liquefied.

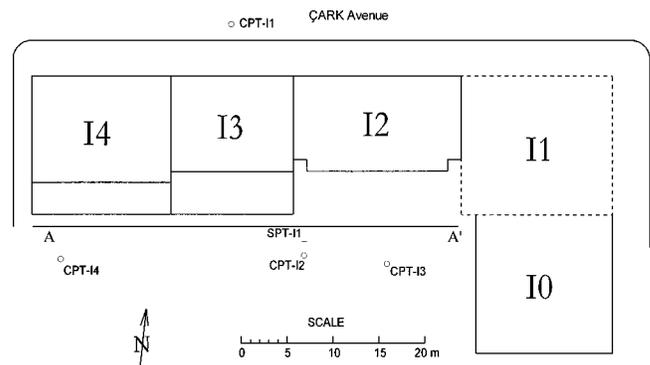
Fig. 11. Plan view of Site I and location of subsurface exploration points

The group of buildings shown in Fig. 11 corresponds to a block located along Çark Avenue (Line 1) in the Semerciler District, Adapazari (N40.77681° E30.39223°). Consistent with most foundation systems in Adapazari, building I3 is founded on a 35-cm-thick mat foundation, reinforced with 1.2-m-deep tie-beams. The height-to-width ratio for these buildings is between 1.1 and 1.3. The first building of the group from east to west, designated I1, experienced total failure of the columns of its first

story. The other four buildings suffered light to moderate structural damage. Buildings I3 and I4 have 6 stories each and displaced vertically relative to the surrounding ground 17 and 12 cm, respectively. Building I2 has only 4 stories, but it moved downward 30–35 cm. Brown soil ejecta were found about 25 m south of building I1.

As indicated in Fig. 11, four CPT profiles and one exploratory boring with SPT were performed at this site. The water table was found to be at a depth of about 0.8 m. The site's generalized subsurface profile is shown in Fig. 12. Directly below the foundation level and to a depth of approximately 3 m lies a stratum of stiff high plasticity gray silty clay. A sequence of highly stratified brown low plasticity sandy silt, clayey silt, and high plasticity silty clay was found from 3 to 7 m. The color of the soil in this deposit transitions to gray at about 4 m. The normalized SPT penetration resistance $[(N_1)_{60}]$ of the soils between 3 and 5 m is about 7, and about 14 for the soils between 5 and 7 m. Below 7 m

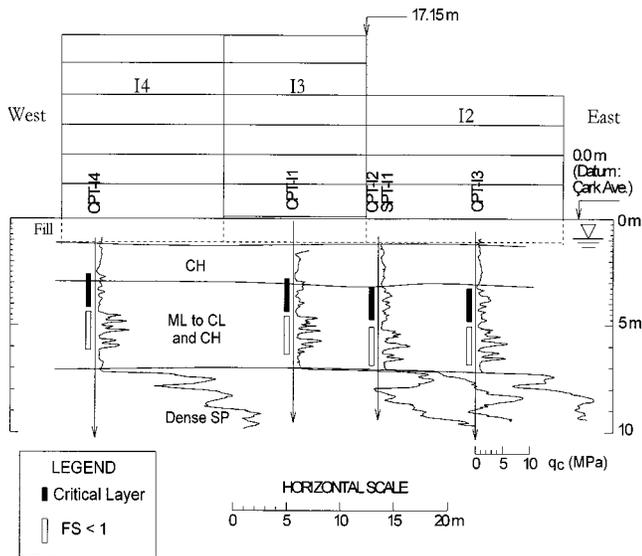
Fig. 12. West to east generalized soil profile of Site I (cross section A-A′ in Fig. 11)

In contrast to Sites C and F, where shallow loose silt deposits immediately below the building foundations were largely responsible for the occurrence of ground failure with buildings sliding laterally, these shallow liquefiable soil deposits were absent at Site I. The nearly vertical movement experienced by these buildings appears to be primarily due to the liquefaction and softening of strata between 3 and 7 m and subsequent downward movement of relatively heavy buildings into the softened soil or postearthquake induced liquefaction settlement. Consistent with the findings of Sancio et al. (2002) in the Adapazari silts, but inconsistent with findings by Yoshimi and Tokimatsu (1977) in studies involving generally clean sands, a clear relationship between building height or weight and the amount of observed downward displacement was not apparent. At Site I, the taller buildings settled less than the shorter building, indicating that other factors possibly related to variations in subsurface condi-

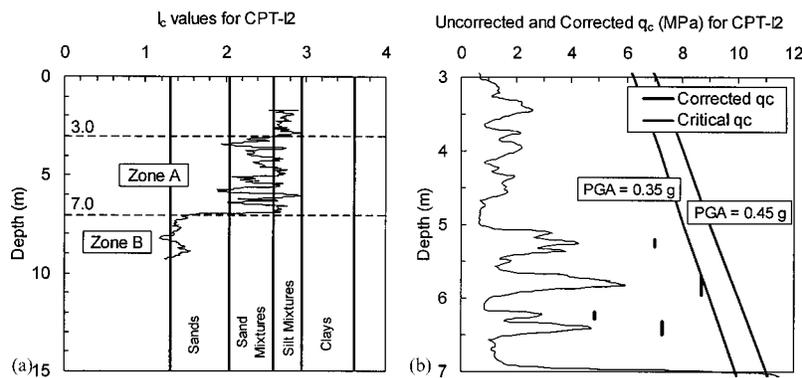
The stratified silts and clays between 3 and 7 m [Zone A in Fig. 13(a)] were found to be the only part of the subsurface profile below Site I that met both CPT conditions that render a soil liquefiable according to Youd et al. (2001) [i.e., $I_c<2.6$ and $(q_{c1N})_{cs}<160$]. Soil samples show that some lenses have LL <35 and $w_c/LL>0.9$, but in general the soils have $30<LL<40$. Fig. 13(b) indicates that over the depth of 3–7 m the tip resistance corresponding to the threshold of liquefaction for free-field PGAs of 0.35 and 0.45g is generally greater than the measured tip resistances, even after correcting for thin layers. Therefore those layers in Zone A that have values of $I_c<2.6$ with LL <35 and $w_c/LL>0.9$ that also have low penetration resistances most likely liquefied during the Kocaeli earthquake. The soils between depths of 3 and 4.6 m had the lowest factor of safety against liquefaction and are therefore judged to be the critical layer (see Fig. 12). Conversely, the stratum of gray poorly graded sand [Zone B in Fig. 13(a)] has a penetration resistance characterized by $q_{c1N}>160$ and $(N_1)_{60\text{-cs}}>30$ and should not have liquefied.

Fig. 13. (a) Soil behavior index (I_c) values for CPT-I2, and (b) thin layer corrected q_c and critical q_c for free-field acceleration of 0.35 and 0.45g versus depth for CPT-I2

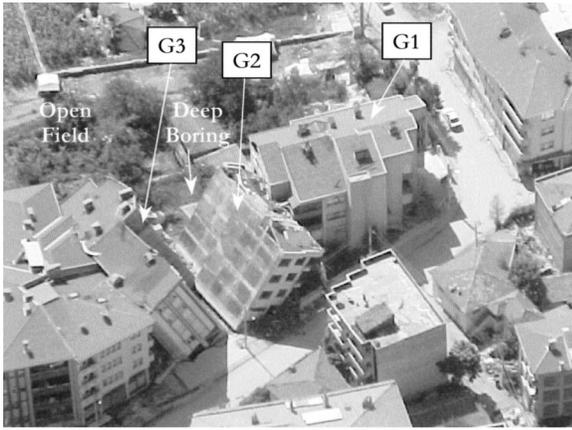
Fig. 14. Aerial view of Site G 13 days after the Kocaeli earthquake

The group of Site G buildings shown in Fig. 14 is located in Yenigün District, Adapazari (N40.77450° E30.40896°), which is only 350 m north of Site F. The irregularly shaped building G1 has a length (E-W) of 22.2 m, a width (N-S) of 14.1 m, and a height of 11.2 m, with a height-to-width ratio of 0.8. This building experienced vertical movement of approximately 10 cm with no significant tilting and suffered light damage aside from that caused by the impact of building G2. The adjacent 4 and 5 story buildings (designated G2 and G3, respectively) experienced bearing capacity type failures with excessive tilt. These buildings have been demolished. According to building drawings, building G3 was 21.7 m long with its width varying between 8.6 and 6.2 m. The structure was 14 m high, so its maximum height-to-width ratio was 2.3. The mat foundation of these buildings consists of 25- to 30-cm-thick reinforced concrete slabs with 1–1.2-m-deep tie-beams. The ground immediately surrounding these buildings was littered with brown sediment ejecta, which were classified as

low plasticity (LL~30) silty sand (SM). Sand boils were not observed away from the buildings, i.e., in the open field to their rear (see Fig. 14).

Although all buildings seem to have a similar subsurface soil profile, foundation type, and embedment depth, the shape of the structure appears to have had a significant effect on their individual performance. Low aspect ratio building G1 settled only slightly, which allowed the apartment owners to reinhabit it after repairing the damage caused by the adjacent overturned building G2. High aspect ratio buildings G2 and G3 experienced bearing failure, and were later demolished.

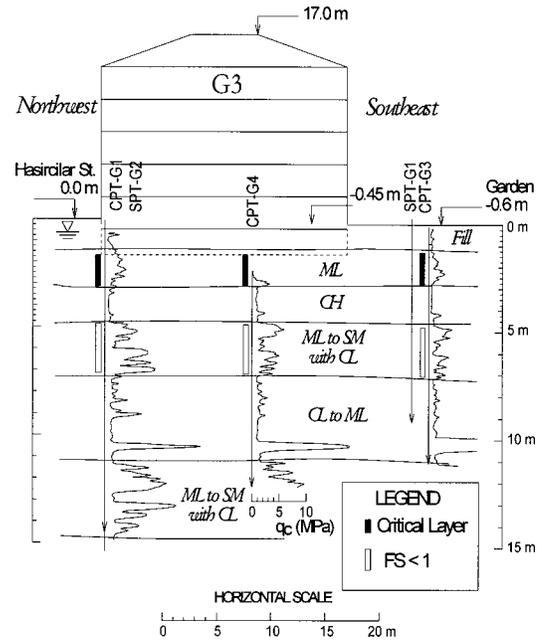
Fig. 15. Northwest to southeast generalized subsurface profile of Site G

A total of four CPT profiles, two borings with SPT, and one very deep boring were performed at this site. The upper 15 m of the generalized subsurface profile of this site is depicted in Fig. 15. The first 1.5 m below the sidewalk level consist of clayey soil followed by approximately 1.5 m of loose $[(N_1)_{60}<10]$ to medium dense reddish brown sandy clayey silt. The soil samples of this deposit generally exhibit LL$<$35 and w_c/LL$>$0.9. The brown sediment ejecta identified during the postearthquake reconnaissance appear to have originated in this stratum based on color and LL similarity. The depth to the water table was found to fluctuate between 0.4 and 0.6 m below the sidewalk level.

mately 5 and 7.4 m lies a medium dense gray low plasticity silt grading to silty sand interbedded with thin strata of clayey silt. The fines content of the soils in this deposit varies ($22\% < FC < 100\%$) and most samples have $LL < 35$. A thick deposit of gray silty clay to clayey silt with $36 < LL < 58$, but predominantly $LL > 50$, lying approximately between 7.4 and 11.3 m, was found overlying sequences of medium dense to dense silt and sand mixtures interbedded with silty clay and clayey silts down to 25 m.

The brown silty soils located in the upper 3 m (Zone A) was judged to be primarily responsible for the bearing failure experienced by buildings G2 and G3. At a number of sites where the potentially liquefiable soils at depths of about 5–7.5 m (Zone B) at Site G were replaced with a dense coarse sand that was nonliquefiable (e.g., Site B; profile shown in Fig. 17), bearing capacity failures occurred. Thus softening of the lower Zone B soils is not required to produce a bearing capacity failure for a tall slender

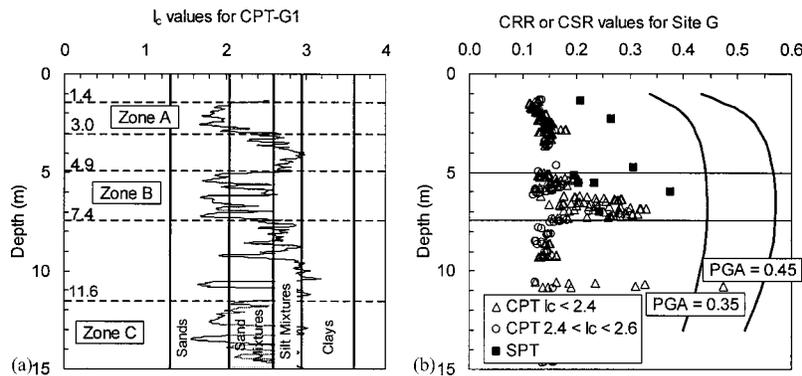
Fig. 16. Representative soil data for Site G: (a) Soil behavior index (I_c) values for CPT-G1, and (b) cyclic stress ratio (CSR) induced by earthquake versus depth for peak ground acceleration (PGA)$=0.35g$ and $0.45g$ compared with the cyclic resistance ratio (CRR) of the soil

Fig. 16 shows values of I_c in a representative sounding CPT-G1, as well as a comparison of CRR and CSR values for Site G. As can be observed, the subsurface conditions beneath this site are remarkably similar to the conditions under Site F (see Fig. 10). The liquefaction evaluation of the soils at Site G is similar to that at Site F and is not discussed further for brevity. However, the liquefaction evaluation is summarized in Fig. 15 by showing layers with $FS_l < 1$ and the critical layer.

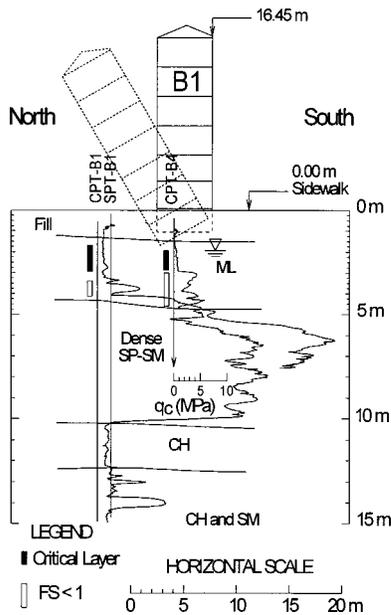
Fig. 17. Soil profile at Site B where a tall slender building failed in bearing

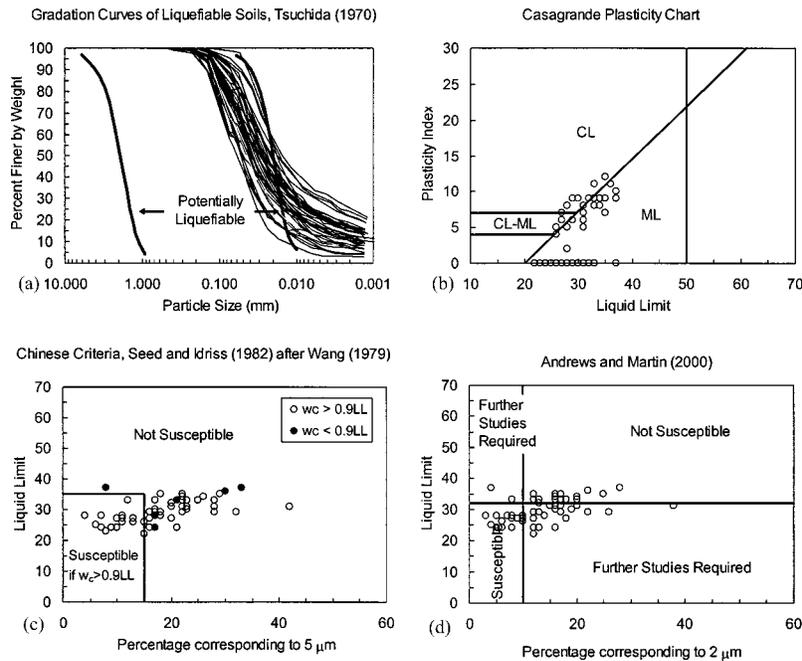
Fig. 18. Characteristics of liquefiable soils in Adapazari: (a) grain size distributions; (b) plasticity chart; (c) Chinese criteria for liquefaction of clayey soils after Seed and Idriss (1982) (after Wang 1979); and (d) liquefaction criteria for silty soils after Andrews and Martin (2000)

significant amount of clay-size particles, yet they liquefied. Moreover, many of these soils have significant plasticity [Fig. 18(b)]. The soil index data for these soils that liquefied are also plotted in Fig. 18(c) to allow evaluation of the robustness of the Chinese criteria. Only a few of the soils tested satisfy all conditions of the Chinese criteria. For the silts of Adapazari, low liquid limits ($\leqslant 35$ or so) and high water contents ($w_c \geqslant 0.9$ LL or so) are good indicators of liquefaction or significant strength loss due to shaking, as shown in Fig. 18(c) and Table 2. The percent clay fraction criterion is not a reliable screening tool, because many cases of ground failure occurred in soils that had more than 15% clay-size (5 μm) particles. An examination of the Andrews and Martin (2000) liquefaction criteria for silty soils [Fig. 18(d)] also indicates that the percent clay-size (<2 μm) criterion is not a reliable indicator of liquefaction susceptibility, and that soils with LL >32 can liquefy.
