**CONSERVATION AND RESTORATION PROBLEMS OF  
KAYA KÖYÜ (LEVISSİ) HOUSES**

**A THESIS SUBMITTED TO  
THE GRADUATE SCHOOL OF NATURAL AND APPLIED SCIENCES  
OF  
THE MIDDLE EAST TECHNICAL UNIVERSITY**

**MAY 2001**

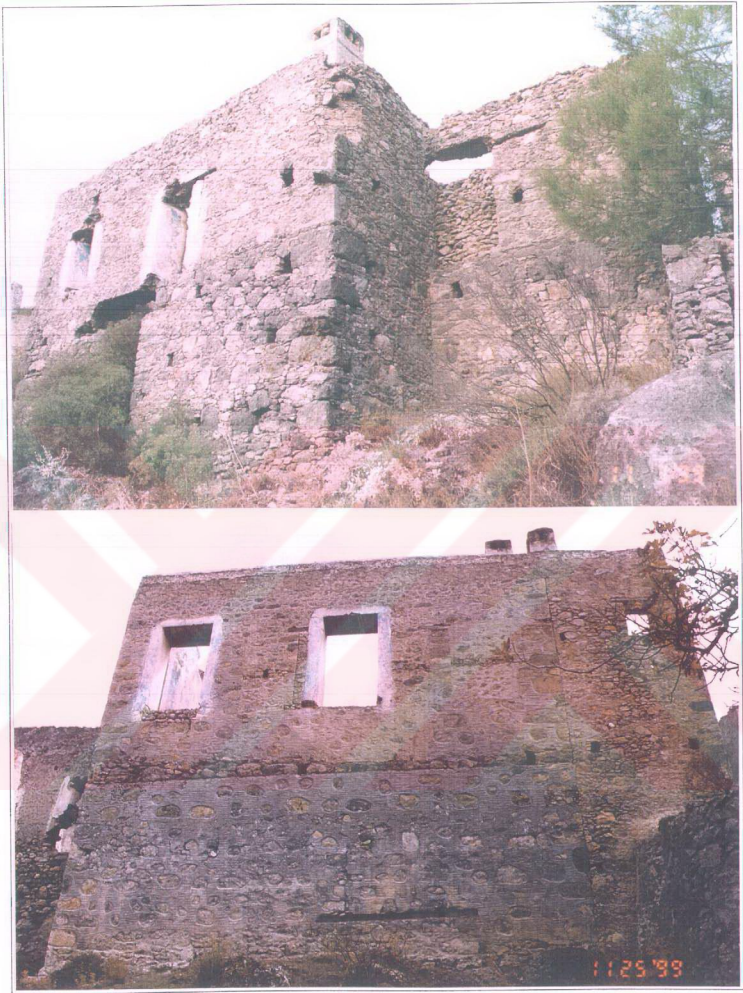
Figure 4.26:Traces That Reflect the Construction Process (E.9.7)

In addition to this information gathered from the unfinished buildings, it is also possible to see the traces of this gradual construction process. For example, horizontal joints that have been determined at the ground floor level indicate that the building had been kept unfinished at this level for a while (Figure 4.26).

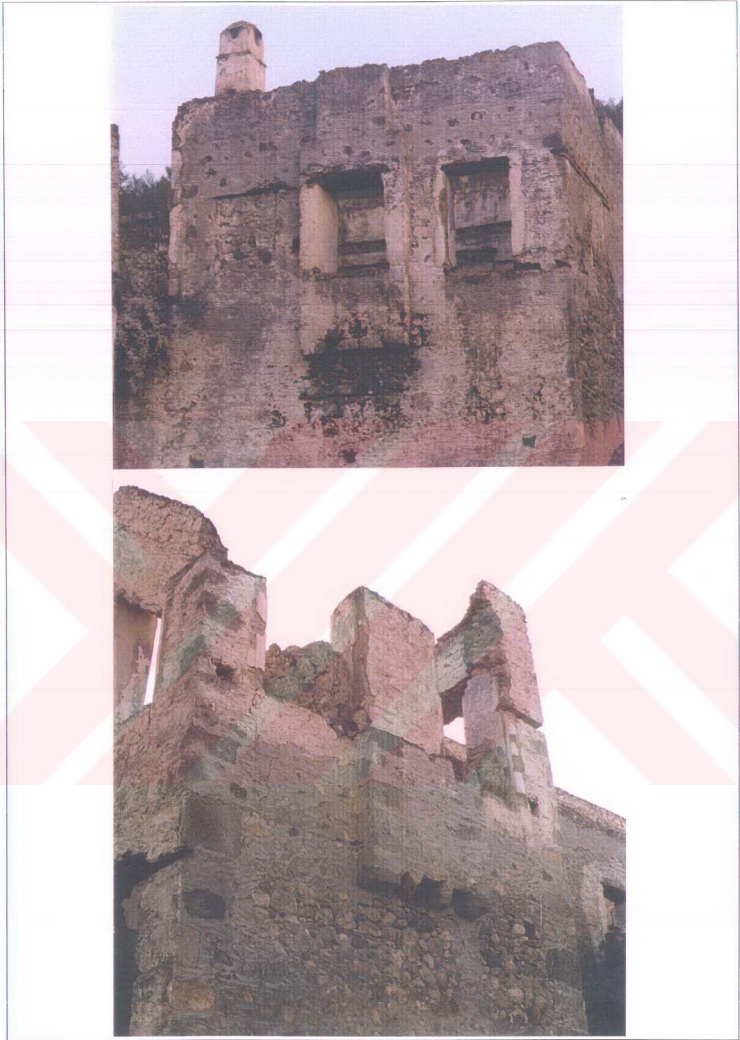
Figure 4.27: Cancellation of the Wall Type Fireplace

unites with the wall and makes a projection of about 20 cm on the wall. In order to put the hearthstone at the ground level, the outer construction of the fireplace should start between 50-100 cm below the ground. For this reason, it is normal to built a projection for the wall type fireplace at the secondary living room, which has been constructed up to the ground floor level in line with the design decisions and left unfinished at that level. If it is decided not to built this fire place while completing the construction of the building, the fire place projection is kept at this position and the wall on it continue regularly. The reason for relinquishing from the decision of building a wall type fireplace is mostly the decision of changing the space into a living space, which has a corner type fireplace. Cancellation of the wall type fire place and construction of a corner type fireplace instead has also been seen at the finished buildings (Figure 4.27).

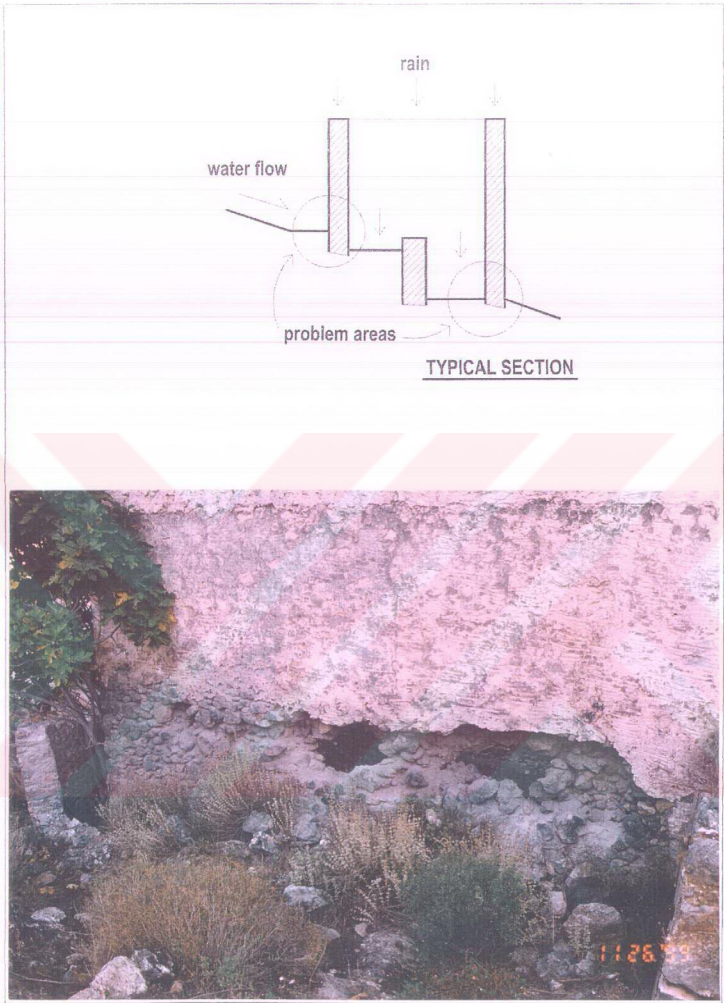
Figure 4.40 Typical problem areas in terms of the rain and ground water

3. It has been observed that the walls, which have been subjected to extensive surface water and rain penetration have detached joints and for this reason they suffer from material loss. The sections affected from the water are usually the hillside façades and the inner parts of the front façades of the buildings (Figure 4.40)

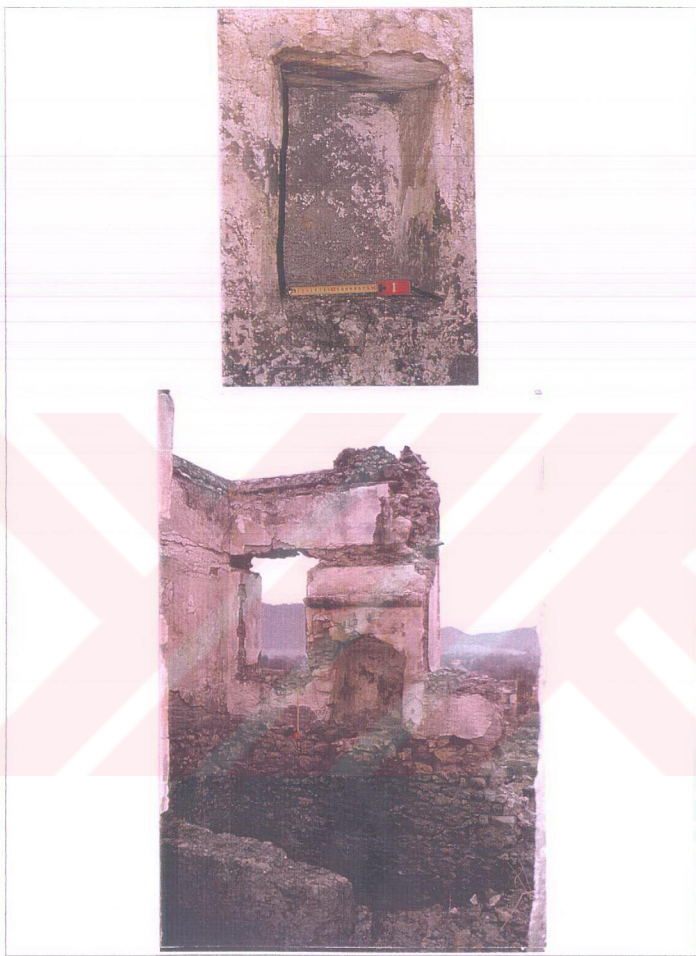
Figure 5.8: Niche on the southern Wall of Space E

**Semi Opened Entrance Space (E):** It provides the entrances of MR1 and MR3 spaces. It has one open side and three closed sides, and a covered roof. It had been built two steps above the front courtyard. It is 4,16 m by 2,21 m, and it takes up 9,19 square meters. The southern wall gets lower at the entrance side in the form of a parapet wall. On this wall there is a niche, which is 34 cm wide, 50 cm high and 24 cm deep (figure 5.8). Its walls are rough plastered and painted white. The floor had been covered with the earth of the roof which had caved in. The original floor covering is a type of screed composed of *argilo* mortar and small pieces of rubble stones.

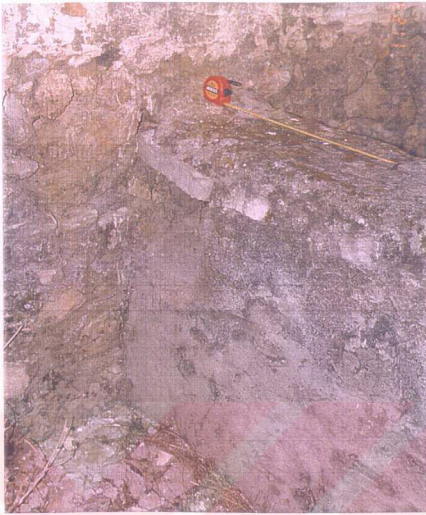
Figure 5.10: Hidden Niche of Space MR1

No openings had been left in order to provide access to the other side of the wall via the basement floor. The only evidence that would be regarded in terms of the function of this space is the hidden niches that has been found out at the corner where the ground floor support wall connects to the western wall (Figure 5.10). This space has no window openings, except for the construction holes.

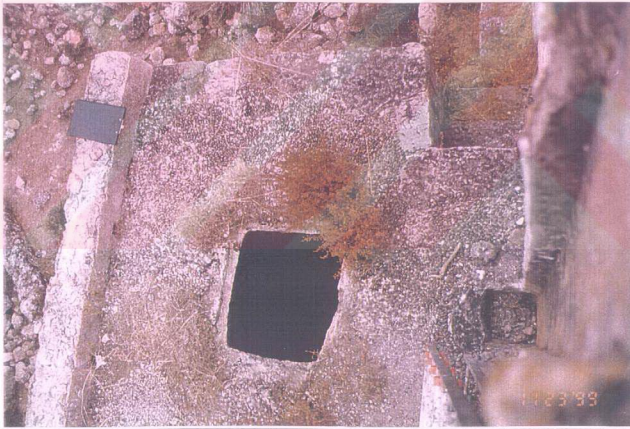
Figure 5.11: Top View of the Cistern (C)

**Cistern (C):** At the entrance façade (eastern façade) of the building there is a cistern, which had been attached to the building. It is 2,72 m by 2,82 m. Stone steps reach the terrace of the cistern. The opening of the cistern is in the middle of the terrace and it has the dimensions of 62 cm by 66 cm. It has a pebbled stone pavement (Figure 5.11). There is a parapet wall at the western and northern sides, which is 20 cm high. There are indentations, which had most probably been formed in order to tie horses or mules on the façades of the cistern at the entrance courtyard (Figure 5.12).

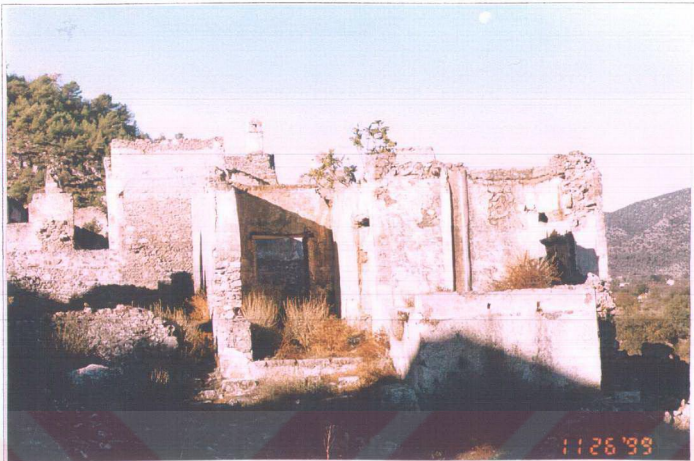
Figure 5.14: Entrance (Eastern) Facade

The entrance façade (eastern façade) is the most articulated façade of the building (Figure 5.14). The solid-void relation between masses of the cistern, secondary living space and the entrance space create a movement on this façade. The level difference between the ground of the entrance courtyard and the parapet of the roof is nearly 4,40 m. This difference reaches even 5,00 m at the northern corner. However, such a height differentiation may not be noticed because of the mass of the cistern and the steps of the entrance space. On northern side of this façade, the part where the window of the secondary living space and the doors of the basement floor service spaces are located, there is a partly demolished section. One of the main elements of this façade is the vertical drain channel of cistern. This façade had been rendered with nailing technique, except for the internal façades of the entrance space. The façade of the main building has a waved and linear texture, whereas the façade of the cistern had been subjected to pointed nailing. The cistern parapet is rough plastered. The façade had been painted completely. The dominant color is white, yet layers of blue have been determined.

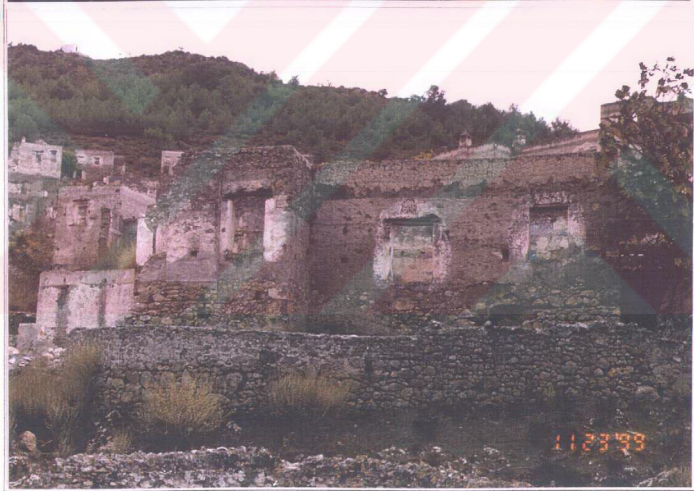
Figure 5.15: Main (Northern) Facade

The main (northern) façade is the highest façade of the building (Figure 5.15). The level difference between the ground of lower courtyard and the roof parapet is high as 5,12 m. The mass of the secondary living space is about 1,65 m in the front of the characteristic main room façade line. The wall type fireplace in the secondary living space, which is between two windows, makes a projection on this façade as one of its main elements. There are ornaments, which are made with brick pieces, above the windows that are on the façade of the characteristic main room (Figure 5.16). The façade had been plastered and rendered with nailing technique. However, figures and textures, which are applied in the form of horizontal strips, at certain parts create a difference from the rest of the façade. There is also a noticeable dissimilarity at the roof parapet level. There are construction holes on the façade at certain intervals and levels. No trace of a balcony terrace has been observed. White and blue colors have been determined around the window openings. The rest of the façade is unpainted.

problematic area in this context is the partial demolition that has taken place due to the expulsion of wooden lintel and the decay of material over the entrance door of the basement floor, which is under the characteristic main room. Small structural cracks have been observed, especially at certain parts on the front façade.

The most serious problematic parts of the building in terms of the decay of the materials are at the northern and southern façades, areas starting from the ground level up to 1,5 m high all across the façade. The decay in these areas is to an extent that has led to loss of materials.

It has been recognized that the reason of this decay is the decomposition of the binding material due to the rising damp. It will be necessary to make detailed laboratory analysis to define the possible causes of these problems and level of decay in these materials.

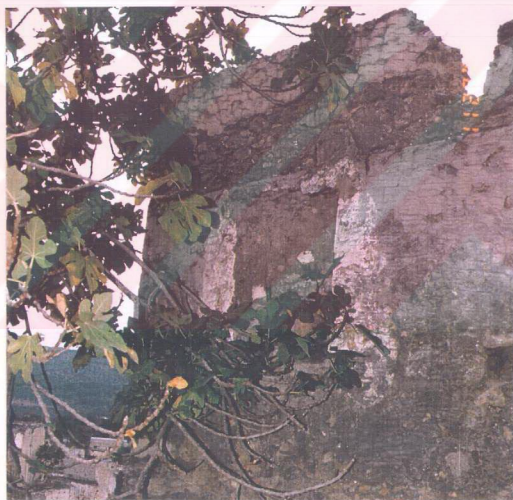
Figure 5.17: Window Alteration on Western Facade

The western façade of the building does not directed to its courtyard. The height of the façade, which is 4,60 m at the northern corner, gets low as 3,30 m in the upper courtyard at the southern corner due to the slope. On northern side of this façade, there is a trace of a window, which had been closed formerly. The mass of the toilet is at the southern side. The façade had not been plastered nor painted. The only exemption is the closed window, around which white and blue colors have been determined (Figure 5.17).

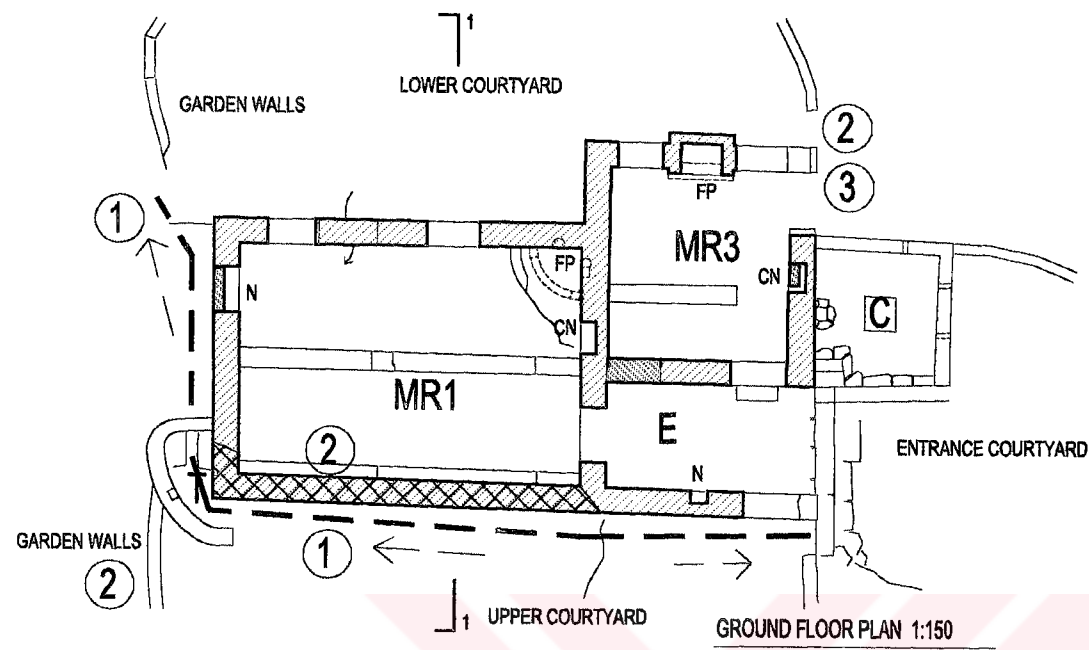
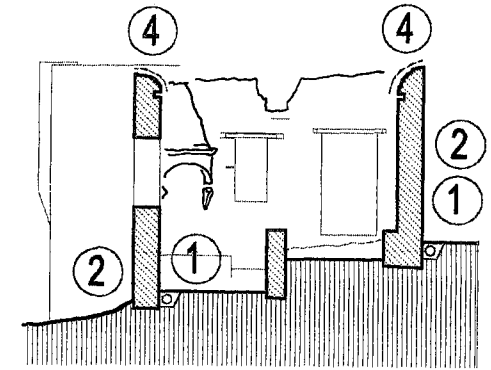
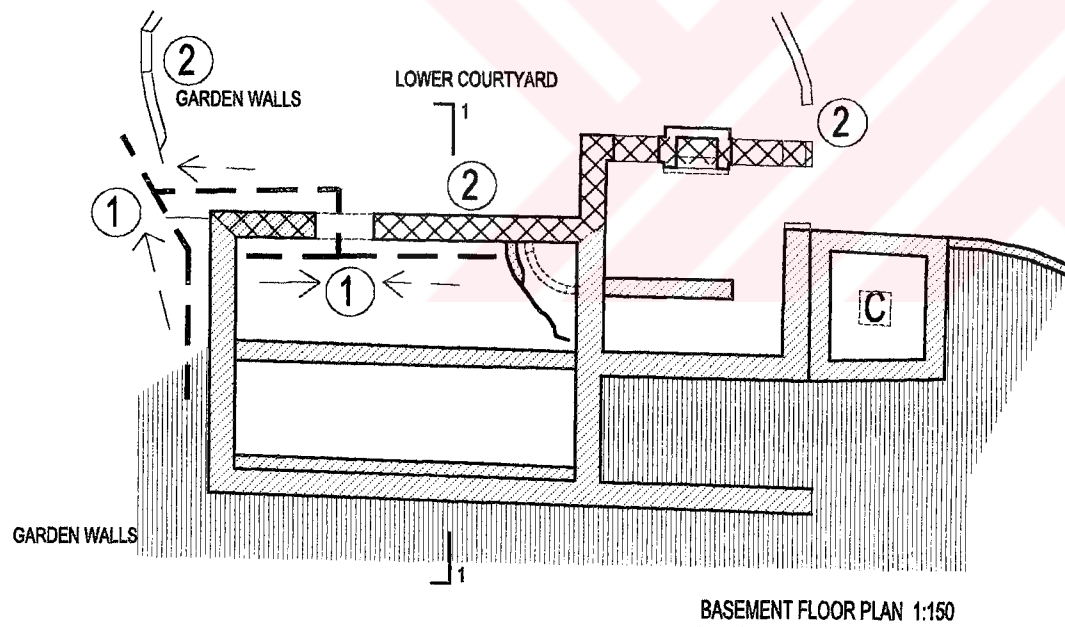
SECTION 1-1 1:150

The aim of this intervention at the initial stage is to determine the sources of decay and to eliminate them. In this respect, it has been observed that the most important reason of the decay on the walls of the building is the rising damp. It has been observed that the northern and southern façade walls had deteriorated because of this problem. In order to eliminate this problem, it has been proposed that a drainage system can be installed around the walls of the building, except for the western wall. It will be appropriate to determine the details of the drainage application after a comprehensive analysis at the site.

Parapets form the second problematic group, which suffers from the rain penetration. As the roof floor had been destroyed, the rainwater easily penetrates inside the walls from the parapets. Consolidation of the parapet detail is necessary for the elimination of this problem. For this reason, capping of the deteriorated sections with appropriate mortar and plaster and filling of the cracks can be proposed. It should be maintained that the mortar and the plaster that would be used in this repair work should be the same with the original ones, but they should be distinguishable from the original with a difference of color degree. Originally, the mortar that had been applied for cisterns were used in the

- ① APPROPRIATE DRAINAGE CHANNEL
- ② CONSOLIDATION OF DECAYED WALL STRUCTURE
- ③ STRUCTURAL TIE FOR THE DEMOLISHED WALL CORNERS
- ④ CONSOLIDATION TREATMENTS OF THE PARAPET WALL

After the elimination of the causes of decay, the deteriorated materials should be repaired and replaced. The most problematic parts in this respect are the lower sections of the northern and southern façade walls. These sections necessitate repair of mortar and replacement of missed rubble stones. As the construction technique is rubble stone masonry, it will be a practical solution to use the stones that can be found on the ground at the sections, which had been demolished.

The demolition that can be seen at the northwestern corner of the secondary living space of this building is a common decay type at Kaya Köyü buildings. Because of such a demolition, the remaining parts of the northern and western walls of the secondary living floor can hardly maintain their stability. After the consolidation treatment, these walls can be connected to each other at the parapet level. A more comprehensive static examination may necessary in order to determine the materials to be used and details of this reinforcement.
