**GEO TECHNICAL EVALUATIONS AND DETERMINISTIC DESIGN
CONSIDERATIONS FOR PITWALL SLOPES AT ESKİHİSAR
(YATAĞAN-MUĞLA) STRIP COAL MINE**

**A DOCTOR OF PHILOSOPHY THESIS
in
Geological Engineering
Middle East Technical University**

**By
ULUSAY, Reşat
September - 1991**

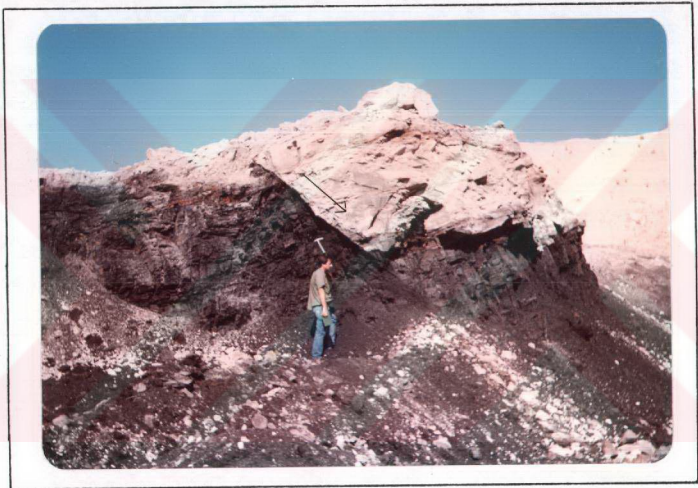
Figure 18: A normal fault affecting overburden and the coal seam at Ertrans section-approximate throw is 2 m (Plate 3-Photo. No.11).

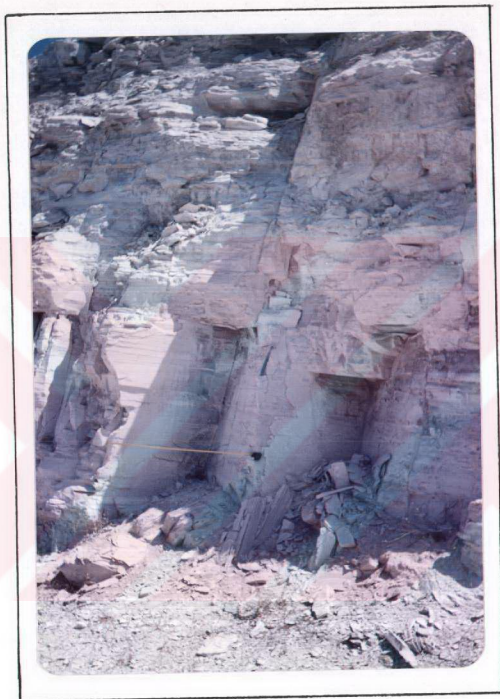
In the study area the cross joints are well observed within the laminated and compact marls and clayey limestone of the main Sekköy formation, as well as in the coal seam. The joints are more continuous in marls and coal seam (Figure 19). In sandstones of Yatağan formation the joints are poorly developed.

Figure 19: A view of a well - developed cross joints in the compact marl - length of tape: 1.2 m (Plate 3-Photo. No.12).

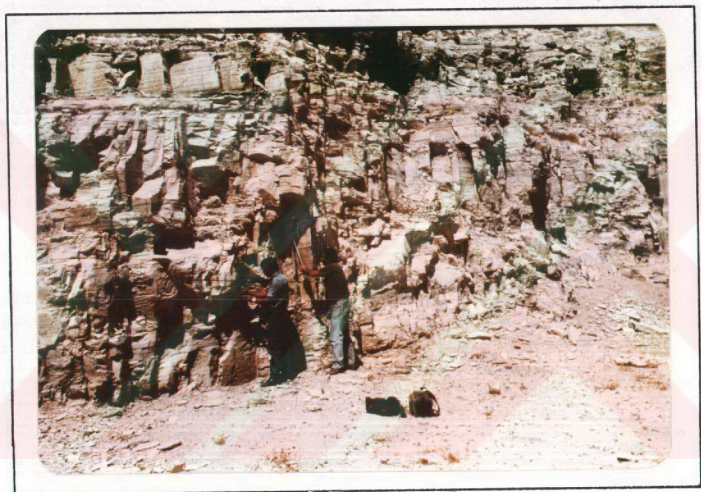
Figure 23: View showing discontinuity survey conducted on compact marls and joint pattern developed in this rock unit (Plate 3-Photo No. 13).

data does not belong to a single distribution. Thus it is concluded that persistence of joints does not fit to any distribution. The persistence of the joints, both in the main Sekkøy formation and in the coal seam, ranges between 1 m to 5 m. However, in the central part of the pit the persistence value occasionally exceeds 5 meters (Figure 23).

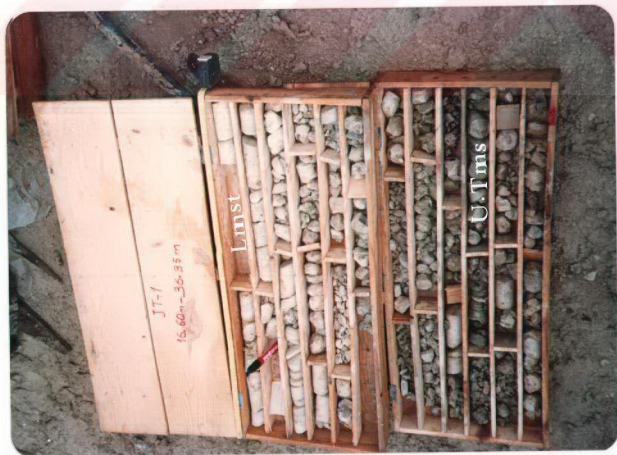
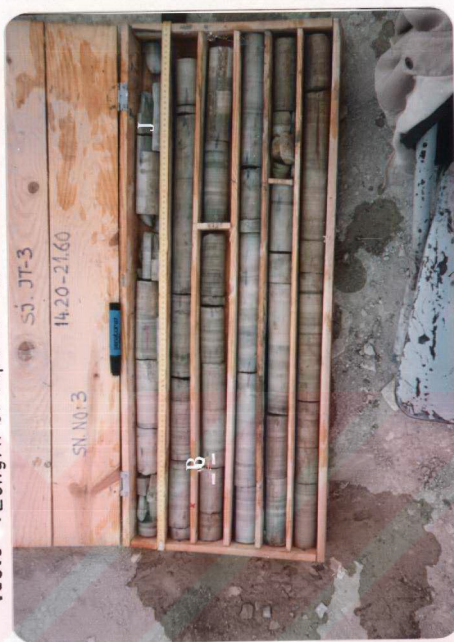
Low core recoveries and RQD values recorded in the alternating sequence located at the upper levels of main Sekköy formation may be seen in Figure 31a. Presence of weak and soft materials in the sequence and the low spacing between bedding planes have an important role on their core quality. Whereas, at lower levels, particularly in compact marls, mechanical parameters show significant improvement (Figure 31b). According to the rock type, location and depth, rock quality trends are clearly identifiable from the borehole logs. A perceptible improvement in the core quality towards the central part, however, is noted particularly in the upper zone of the rocks of hangingwall. In boreholes JT1, JT4, JT6 through JT8, drilled at locations close to the basin margins, approximately 84 % of all RQD values recorded in the main Sekköy formation are below 50%. On the contrary, 50% of all RQD values are above 50% in boreholes JT2 and JT3 which are located at the central part.

Figure 31: Views of cores taken from geotechnical boreholes: (a) limestone and alternating upper sequence of main Sekkøy formation (Borehole No. JT1); (b) compact marls (Borehole No. JT3)

levels of detrital facies. This may be the results of weathering and the fractured nature of the rock at upper levels (Figure 31a). However, based on the observations made on outcrops, this situation is not quite representative for the rock exposed throughout the site. Conglomerates in the lower levels of the same facies have marginally higher quality.

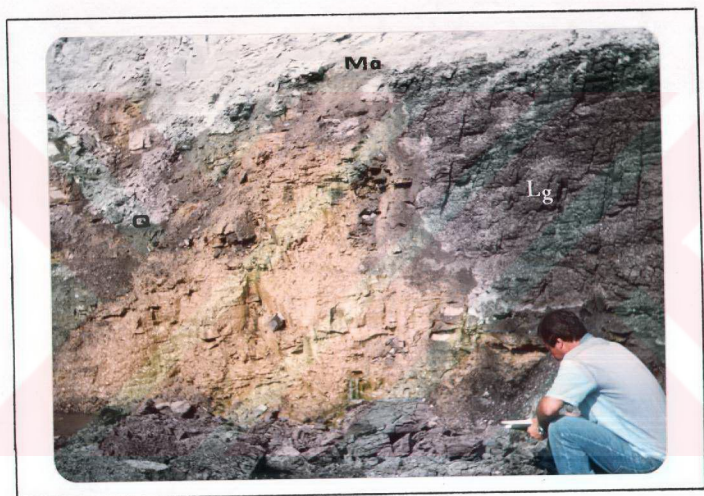
In the first stage of groundwater monitoring studies, individual seepage points and seepage lines were identified all around the pitwalls (Plate 3). Zones of seepage are noted along the boundary between the compact marls and the coal seam, particularly within the coal seam. Slow rate of flow observed on the coal face along the ninth slice was evident (Figure 33). However, flow rate measurements could not be performed on the wall faces due to uncontrolled flow.

Figure 33: Seepage from the coal seam and compact marl/coal seam boundary at the new higwall face - south of ninth slice (Lg: Lignite; Ma: Marl; Plate 3-Photo. No.16).

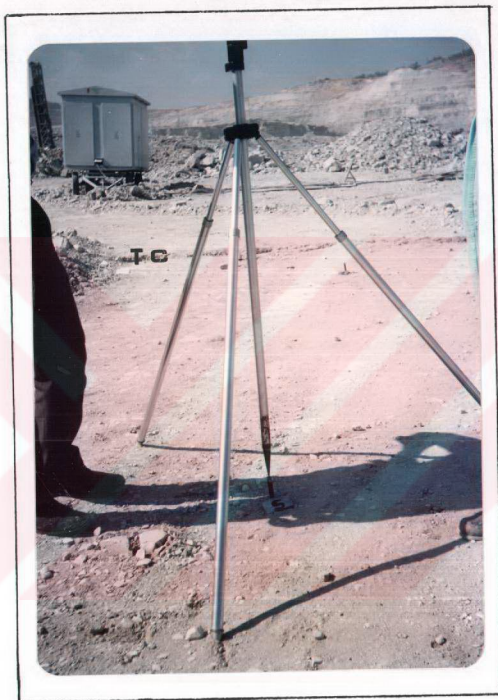
A survey network consisted of targets installed at various strategic locations throughout the slide and the station on a stable ground some distance from the pit were established for each monitored location. Targets themselves consists of reflector prisms mounted on a sturdy tripod by means of a conic catcher specially made for this study. Prisms were installed on steel bars which were labeled and fixed permanently to the unstable ground (Figure 34).

Figure 34: A monitoring target consisting of reflector prism, tripod and labeled steel bar for the monitoring of surface displacements (TC: Tension crack; Plate 3-Photo. No.17).

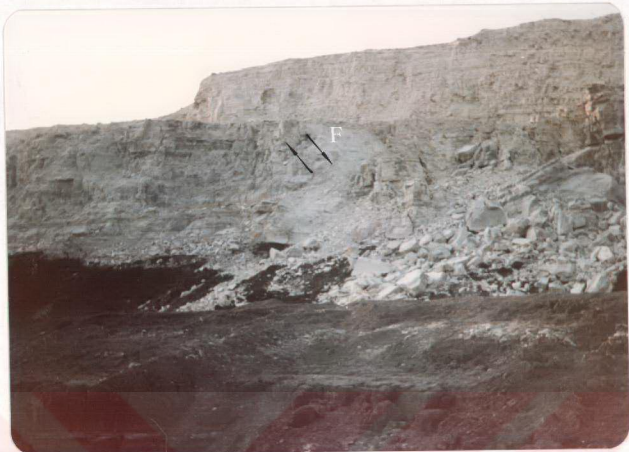
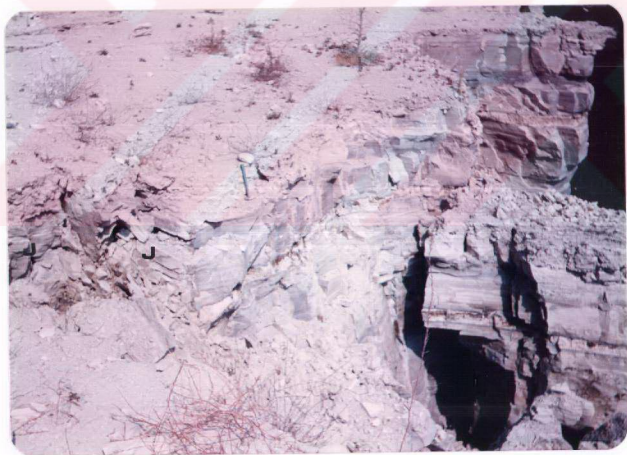
seam was shifted back to the next mining bench resulting in a considerably high and steep individual bench including marl and coal and then instability has started to develop (Figure 35a). Direction of the movement, which was estimated from the considerations on the positions of the failed blocks and the fault surface limited the failure in the west, is approximately SE. On the other hand, tension cracks with a large extend behind the crest and the toe of the upper bench caused a suspicion that a subsidiary bench movement into the void created by previous failure may be expected. Thus, a monitoring system consisting of 17 monitoring targets, which were installed in a vertical pattern to the main cracks, were set up on the +539 and +552 benches (Figure 36). Monitoring was started in July 28, 1989 and continued until September 14, 1989. After this date the equipment was not available due to the intensive surveying program of TKI.

Figure 35: (a) General view of slide 6 (F: fault);
(b) Tension crack and separation in the
rock mass parallel to the steeply dipping
joints (J) (Plate 3-Photo. No.18 and 19).

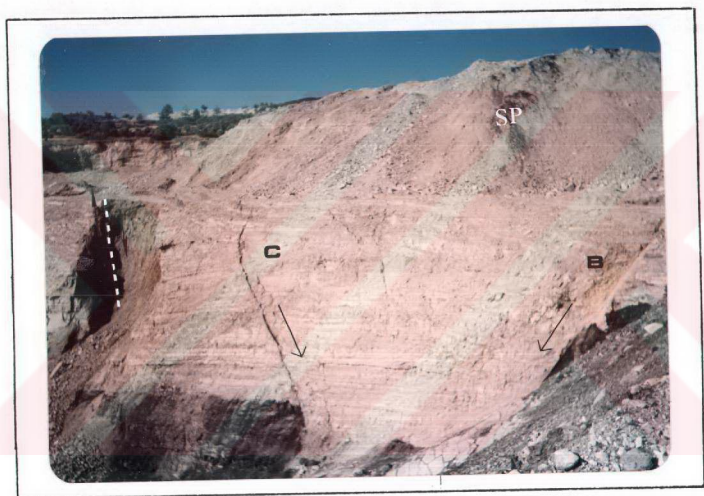
A projection of vertical displacement data of each station, plotted in Figure 39a, was made. By 11 September when the rate of movement drastically increased it was evident that highwall failure was inevitable. The first slide, which is bounded by the fault, occurred in the south (Figure 40). It was a spoon shaped, shallow seated slide within the marls. In this area this slide was followed by similar instabilities. The equilibrium was reached in September 15.

Figure 40: Slide initiation and separations along faults B and C in the new highwall at the south of ninth slice (SP: spoil pile; Plate 3-Photo. No.21).

correspond to the strikes of discontinuities in the unstable area. Thus, it can be stated that discontinuities more likely act as release surface or surfaces of separation. Detailed discussion of the failure mode in this area, which is based on kinematic assessments, are introduced in Chapter 8.

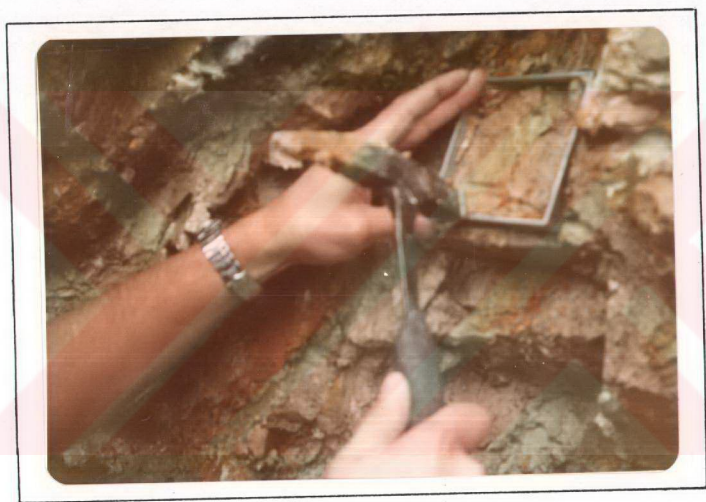
Samples from the fault gouges were recovered with an orientation parallel to the displacement. In some locations where digging of sampling face was difficult, 100 mm square by 20 mm thick specimen cutters were utilized for undisturbed sampling (Figure 41). Some of the blocks were

Figure 41: Undisturbed and oriented sampling from a fault gouge using metal specimen cutter (Plate 3-Photo. No.22).

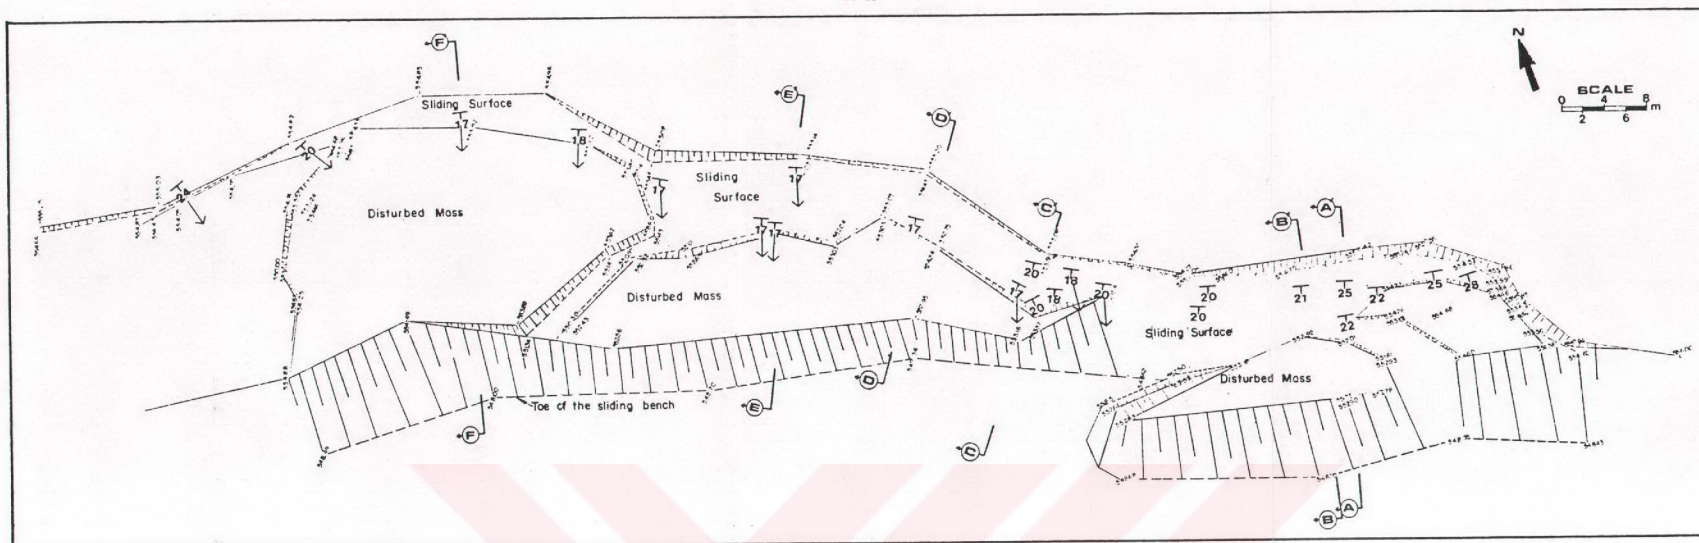
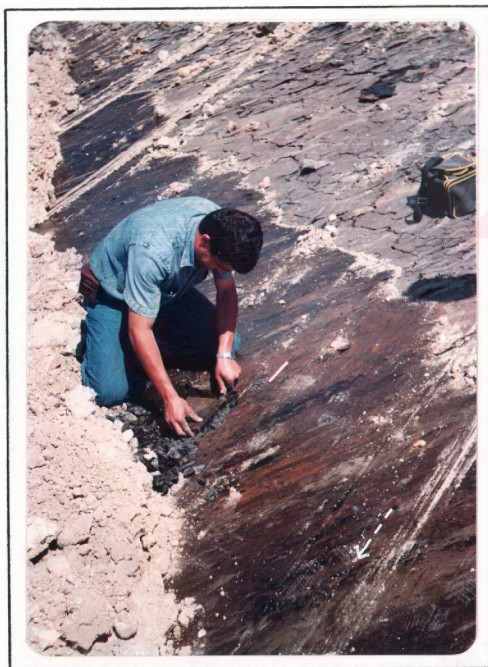
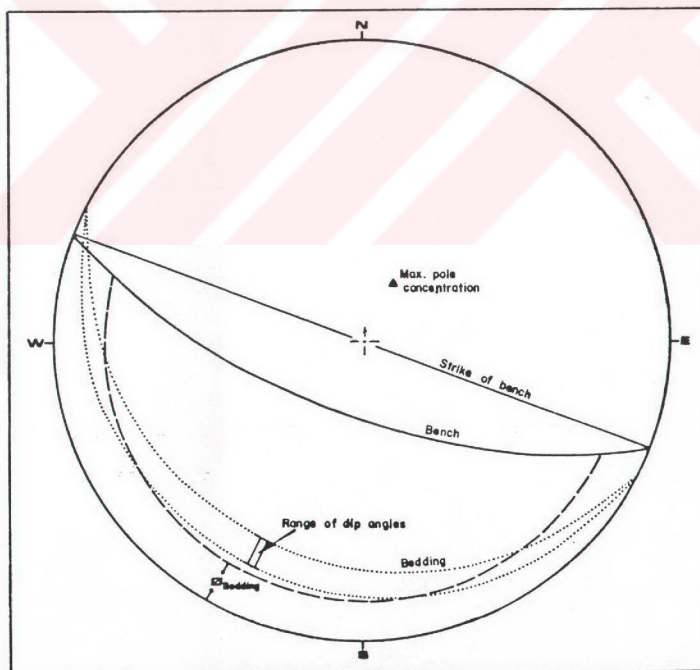
Figure 62: Plane failure on footwall material-slide 8: (A) instability plan and structural features; (B) sliding surface and linear traces parallel to movement direction (Plate 3-Photo. No.24); (C) kinematic check of the failure.

The mode of plane failure, which occurred along the black clay representing upper levels of footwall, is apparent for this slide (Figure 9). Bedding strikes measured on different parts of the sliding surface are almost parallel to those of wall face (Figure 62a). On the other hand linear traces produced on the sliding surface by the weight of sliding mass and parallel to the direction of movement were recognized (Figure 62b). The directions of these traces were also in a good agreement with the dip direction of sliding surface (Figure 62a). Besides, sliding

surface daylight on the 70° bench face. It is also noted that the laboratory derived residual internal friction angle of black clay is equal to or from place to place smaller than the inclination of sliding surface. These conditions, illustrated on a stereographic projection in Figure 62c, kinematically satisfy plane failure conditions (Markland, in Bell, 1981 ; Hoek and Bray, 1977; Herget, 1981).

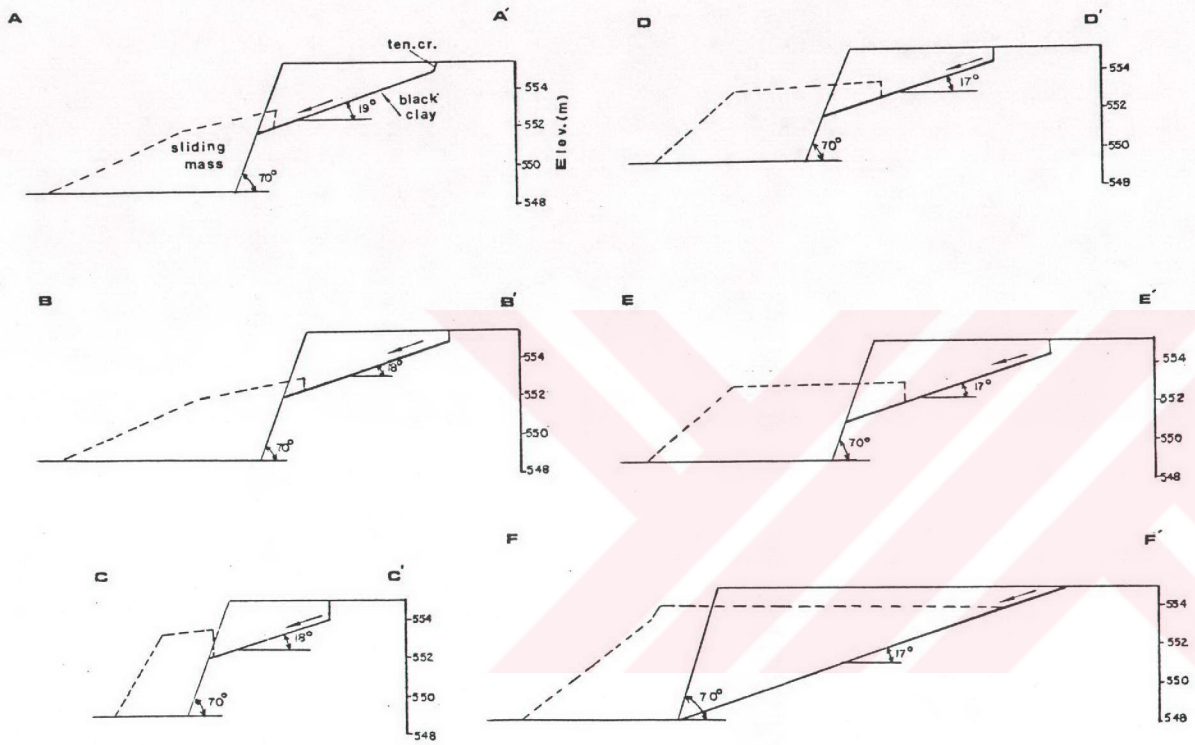
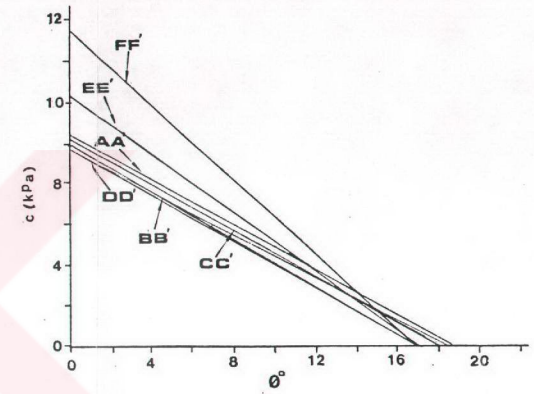
Figure 63: Back analysis of slide 8 developed along the black clay.

Six bench profiles (Figure 63a) parallel to movement direction were prepared from the instability plan for back calculation of the shear strength parameters of the sliding surface. Observations revealed that in the vicinity of unstable area the slope and very shallow tension crack were dry. However, a few moist zones were recognized on the black clay surface due to the seeping surface water. Thus, no groundwater condition was included in the analyses.

Considering that all parameters to be accurately known, the cohesion was back calculated from the slide only as a function of the predetermined internal friction angle by many iterations of the equation 2 given in Appendix D.1. The diagram given in Figure 63b shows back analysis of plane failure using Mohr-Coulomb linear failure criterion discussed in Chapter 6. Because of the variations in the mechanical properties of the same material in different places, the back calculation of ϕ and c from more than two slopes give as many as $n(n-1)/2$ points of intersections for

curves (ϕ , c) (Sancio, 1981). Accepting this idea of having all the variables affecting the stability, Figure 63b gives bounds for the pair (ϕ , c). In this case, (ϕ , c) varies between (14, 2) and (17, 0). The (ϕ , c) envelopes of profiles DD', EE' and FF' intersect each others at $\phi=17^\circ$ and $c=0$. While, other profiles yielded a factor of safety of about 0.9 for the same strength values. In the former profiles the inclination of sliding surface is 17° which is equal to the laboratory derived residual friction angle of the sliding surface. On the other hand, in other profiles sliding surface inclination ranges between 18° and 19° .

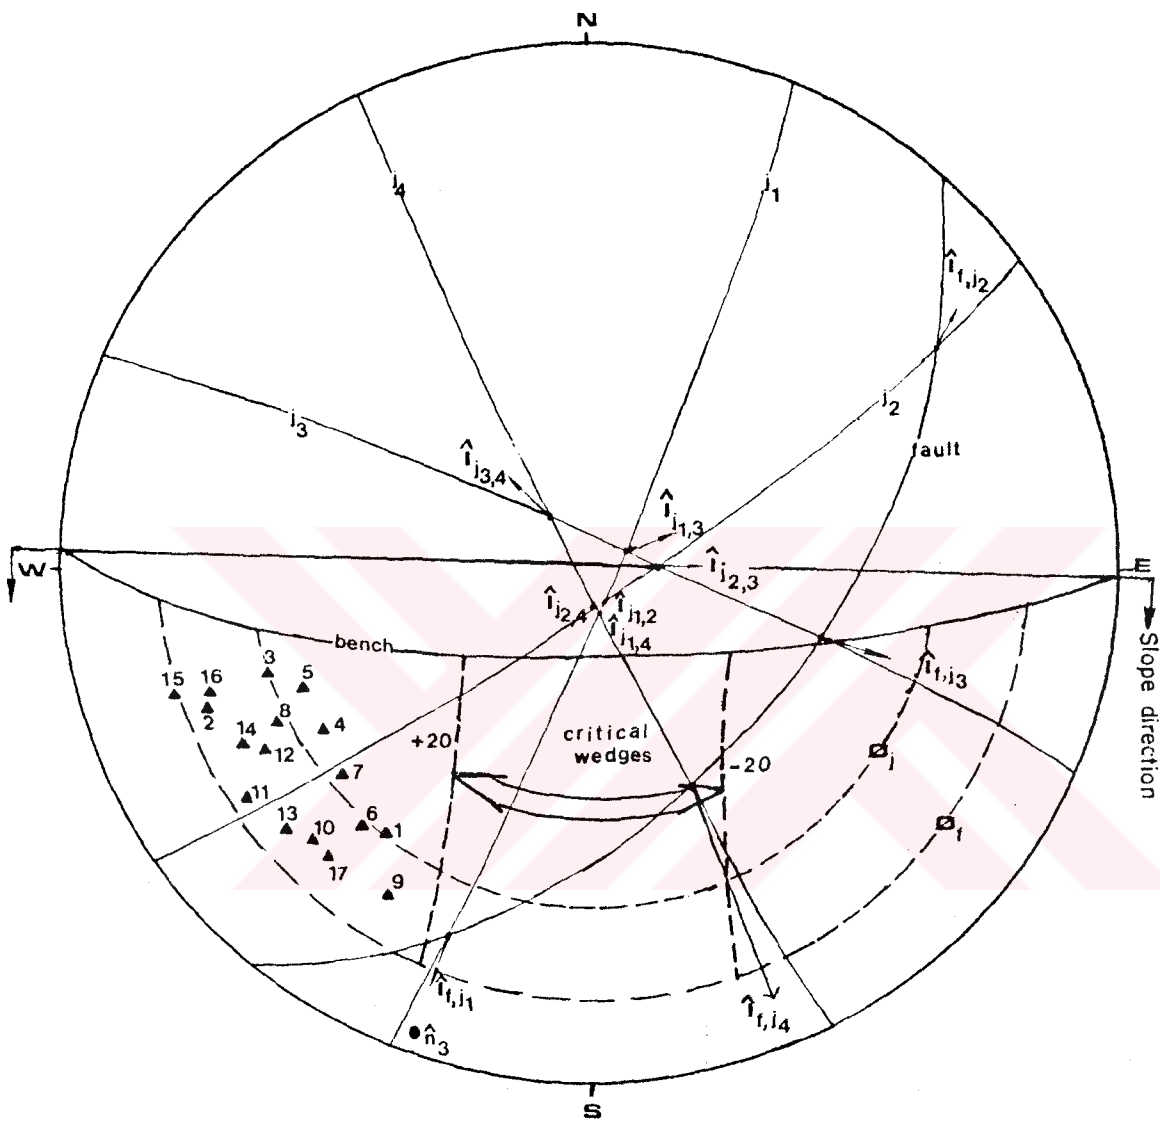
Figure 66: Kinematic analysis of possible lines of intersection and monitoring station movements for slide 6.

The orientations of discontinuity sets determined along E-W direction (see Figure 24a) were analyzed to assess kinematically possible failure modes. A lower hemisphere equal area projection of discontinuities with the addition of a local joint set (j4) and the bench face orientation is shown in Figure 66. The residual friction angles from linear fit for the fault and joints were included in the analysis. The bedding planes were not taken into consideration due to their nearly horizontal position.

As it can be seen in Figure 66, neither fault nor each joint set can satisfy the kinematic requirements for plane sliding. Besides, all the lines of intersection of joint sets are steeper than the bench face inclination without any daylighting. Therefore, the only possible mode of failure may be resulted in the combination of the fault and joints. For this purpose, kinematic checks were performed for four intersections, $I_{f,j1}$, $I_{f,j2}$, $I_{f,j3}$ and $I_{f,j4}$ (Figure 66).

these intersections are not kinematically possible to cause a wedge failure with respect to the face orientation and thus they were eliminated from further considerations. The only two intersection points falling into most critical wedge area (Herget, 1981) were considered (Figure 66). An initial rapid evaluation of likely failure mechanism was made using the stability charts for friction only case presented by Hoek and Bray (1977). The analyses yielded factors of safety smaller than 1 and 2.32 for $I_{f,j4}$ and $I_{f,j1}$, respectively. Hoek and Bray (1977) suggest that a wedge having a factor of safety in excess of 2 is unlikely to fail under the most severe conditions. Besides, the plunge of $I_{f,j1}$ is very flat and ranges between the internal friction circles of two discontinuities. On the other hand, the line of intersection of either plane, fault and joint set 4, lies between the dip direction of the planes (Figure 66). According to Hocking's rule (Hocking, 1976) this geometric relation will satisfy the condition that the wedge will slide down the line of intersection of both planes. Thus, it was concluded that the mode of failure of this instability was wedge type involving the fault and joint set 4.

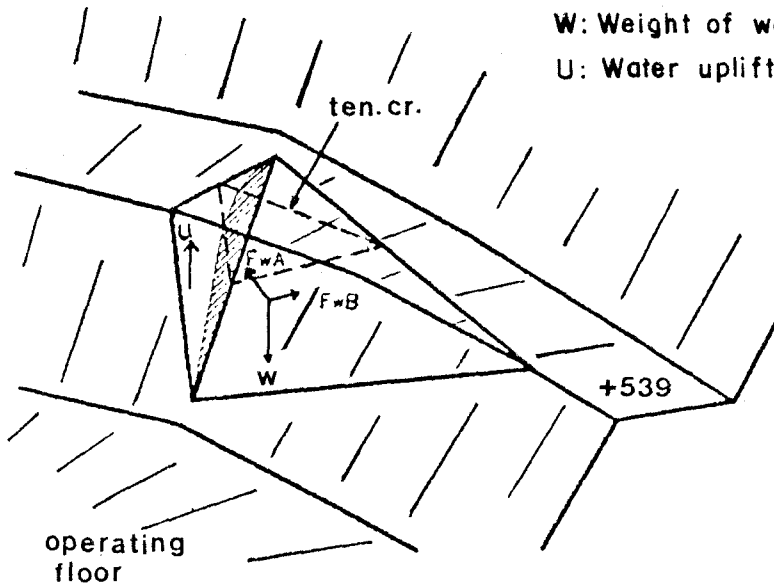
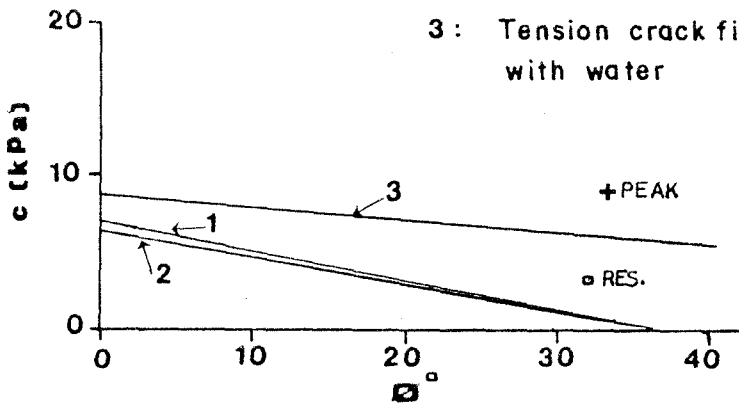
Figure 67: Back analysis of slide 6.

A more sophisticated analysis was than made of the unstable configuration for back analyzing. The back analysis method for the wedge ($I_{f,j4}$) was based on the analytical solution given by Hoek and Bray (1977 ; Appendix D.3). A computer model named WEDFA (WEDge FAilure), including the conditions of water pressure, tension crack position and external loads were developed by the author (Appendix E.4). A simplified diagram illustrating the forces acting on the wedge is illustrated in Figure 67a.

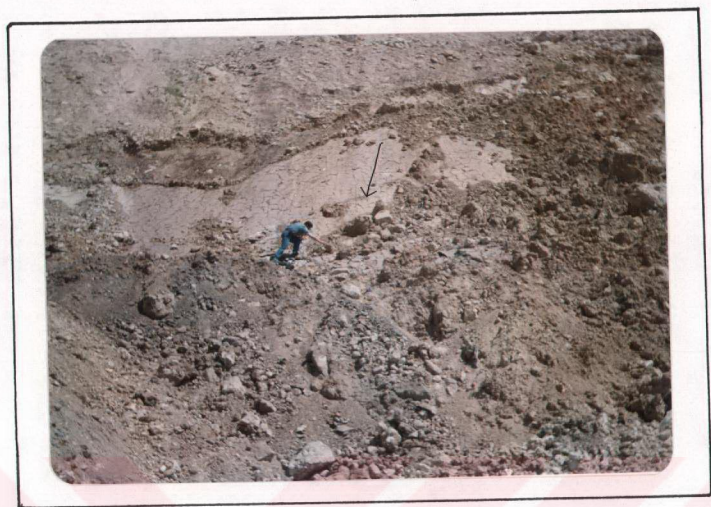
Figure 70: View from plane sliding surface developed along a clay bed in footwall at Ertrans section-slide 1b (Plate 3-Photo. No.25).

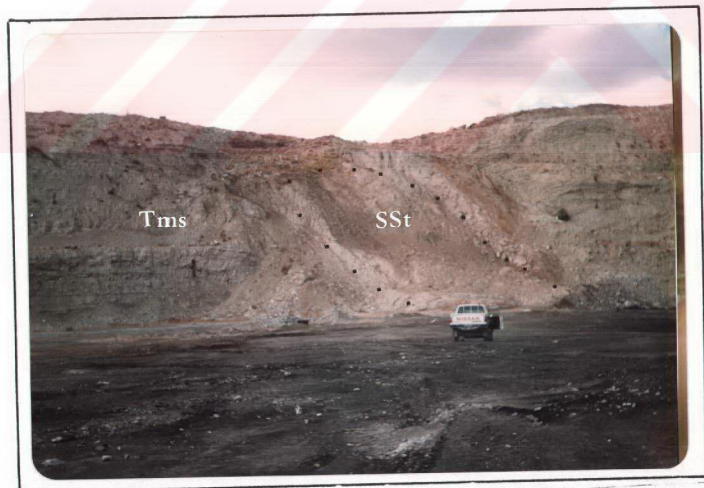
- c) Slide 5: It is a local instability developed through highly decomposed sandstone which represents a relict portion of Yatağan Formation in the north. It is obvious from its spoon shaped form (Figure

Figure 71: General view of slide 5, developed along a circular slip surface within a highly decomposed sandstone (SSt) (Tms : Sekkøy formation ; Plate 3-Photo. No.26).

71) that the failure developed along a shallow circular slip surface. It may also be concluded that the material showing a soil-like behavior has lost its strength due to steepening of the slope and probable softening after rainfall and then failed through the weaker link in the mass.
