**THE RESTORATION PROJECT OF
ZAIMOĞLU KONAĞI IN SİVRİHİSAR**

**A THESIS SUBMITTED TO
THE GRADUATE SCHOOL OF NATURAL AND APPLIED SCIENCES
OF
THE MIDDLE EAST TECHNICAL UNIVERSITY**

**IN PARTIAL FULFILLMENT OF THE REQUIREMENTS FOR THE DEGREE OF
MASTER OF SCIENCE
IN
RESTORATION
THE DEPARTMENT OF ARCHITECTURE**

APRIL 2003

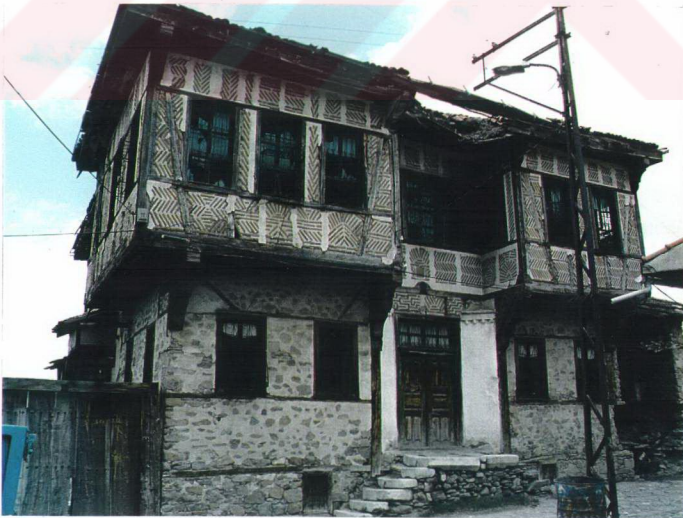
Figure 3.1 North east façade of the dwelling

There are plaster detachments on the façade. Discoloration and fiber formation is seen on the timber surfaces: on the window frames, on the shutters of the windows of the basement floor, on the main entrance door, on the brackets, on the timber boards framing the façade. Mass degradation by the insect attack is seen on the timber elements: on the courtyard door and on the wings of the windows. Material loss of lime plaster is seen on the timber frame structural elements of the first floor: on the upper east part and the upper north part. Mass degradation by insect attack is seen on these timber elements. Material loss of white lime joint (finishing material) is seen on the rough-cut stone masonry surfaces: at the bottom parts of the ground floor level of the façade, up to 150-180cm from the ground. Material loss of white lime joint (finishing material) and mud-mortar (binding material) is seen on the stone masonry surfaces: on the courtyard wall, the lower parts of the façade up to 50cm from the ground and on the wall of the entrance platform. There is granular disintegration on the brick surfaces. The roof in the middle part is collapsed. The façade of the service building is also collapsed.

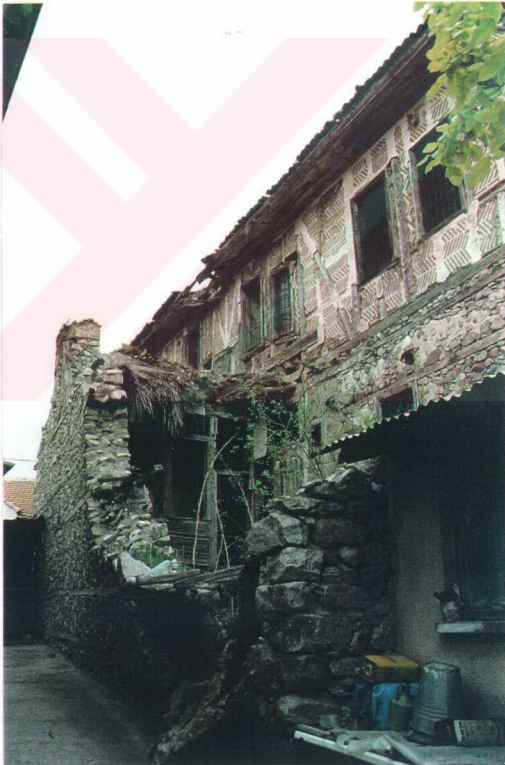
Figure3.2 The service courtyard C-02

There are the rough-cut stone masonry walls on the southwest and northwest. The northwest wall is approximately 630cm in height in the north corner. There are remains of lime plaster B on the wall. The west part of the northwest wall and upper parts of the southwest wall are collapsed. There is buckling problem on the wall.

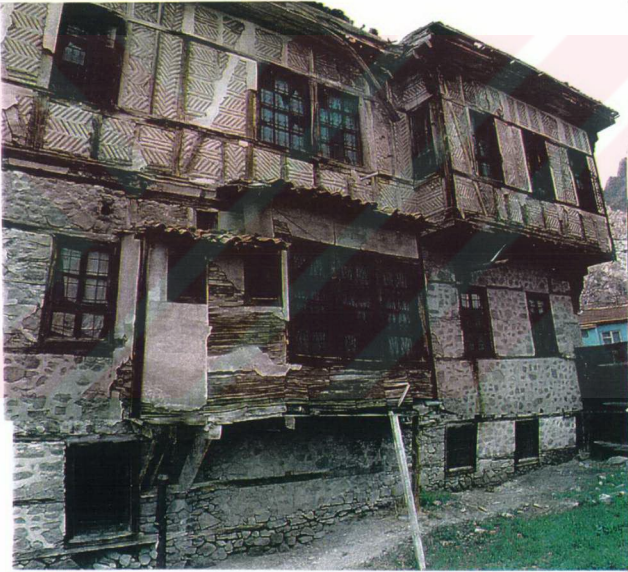
Figure 3.3 South-east façade of the dwelling

There are plaster detachments on the façade. Discoloration and fiber formation is seen on the timber surfaces: on the window frames, on the brackets, on the timber boards framing the façade. Mass degradation by the insect attack is seen on the timber elements: on the timber lintels, on the wings of the windows and on the eave cover. Material loss of lime plaster is seen on the projection of the ground floor and on the timber frame structural elements of the first floor. Discoloration and fiber formation is seen on the wood lath surfaces. Mass degradation by insect attack is seen on these timber elements. Material loss of white lime joint (finishing material) is seen on the

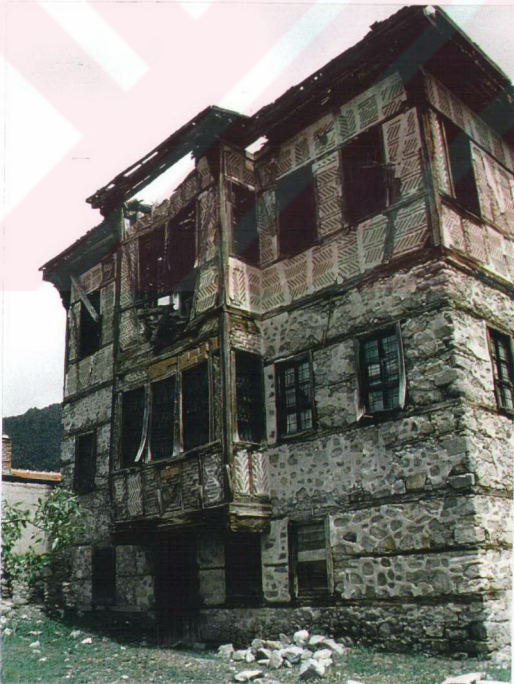
Figure 3.4 South-west façade of the dwelling

There are plaster detachments on the façade. Discoloration and fiber formation is seen on the timber surfaces: on the window frames, on the door wings, on the timber boards framing the façade at the south part. Mass degradation by the insect attack is seen on the timber elements: on the wings of the windows, on the timber boards framing the façade, on the brackets and on the roof cover. Material loss of lime plaster is seen on the timber frame structural elements of the first floor and the projected part. Mass degradation by insect attack is seen on these timber elements. Material loss of white lime joint (finishing material) is seen on the rough-cut stone masonry walls. Material loss of white lime joint (finishing material) and mud-mortar (binding material) is seen on the stone masonry walls up to 50-70cm from the ground. There is granular disintegration on the brick surfaces. The first floor level of the projection is collapsed.

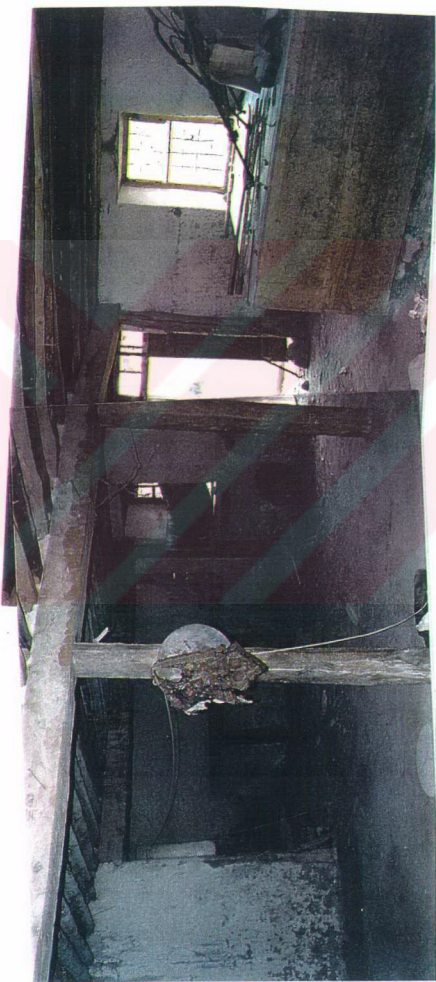
Figure 3.5 View from the space MB-01

removed. There is R-02A1 type wrought iron grill fixed into the window frame. Flaking of whitewash is seen. Mud plaster has fallen down at the bottom of the wall up to the window due to rising damp. There are detachments on the plastered surface.

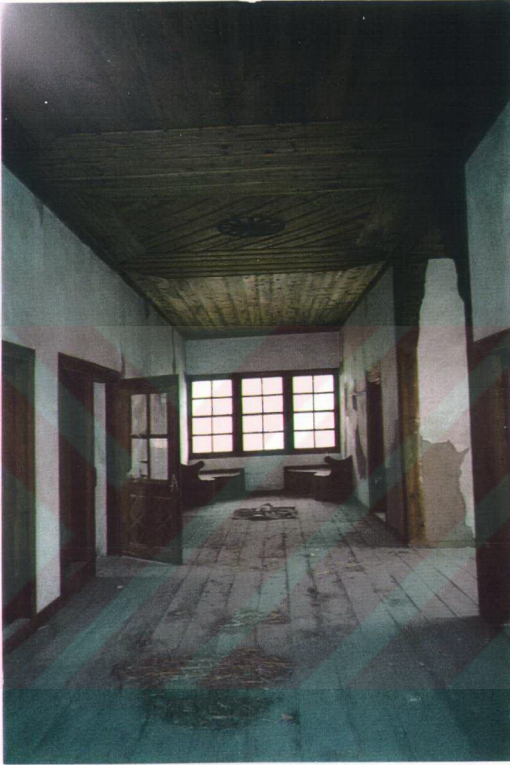
Figure 3.7 View from the space MF-01

on the panels. The SH-01 type second gypsum shelf is located at 1326cm from the west corner, 165cm above the floor. There are surface cracks and detachments of plaster from the wall. Partial loss of the outer layer of the plaster –lime plaster A- is seen on the wall where the inner layer –mud plaster- is exposed.

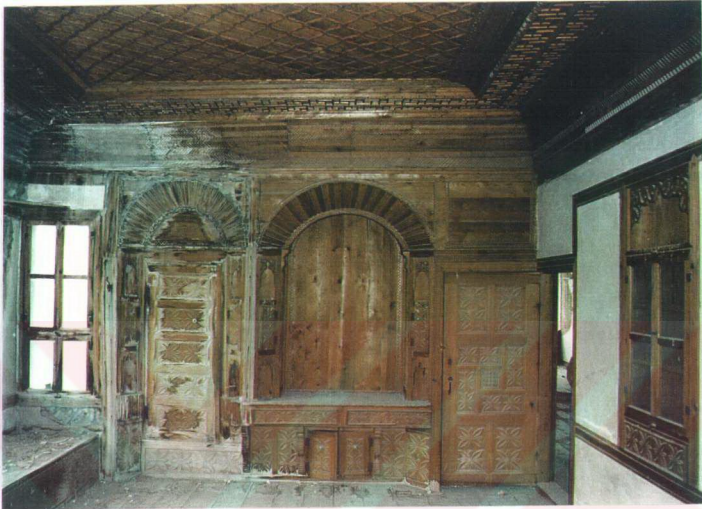
Figure 3.8 View from the space MF-02

9,5cm far from the west corner, 82,5cm high from the floor. The thickness of the frames is 11,5cm and the window within this frame is WO-04B. It has four glazed wings that are vertically divided into three and horizontally divided into four. The upper and lower frames of the windows continue along the wall. There are surface cracks and detachments of plaster from the wall. Partial loss of the outer layer of the plaster –lime plaster A- on the lower parts of the wall where the inner layer –mud plaster- is exposed.

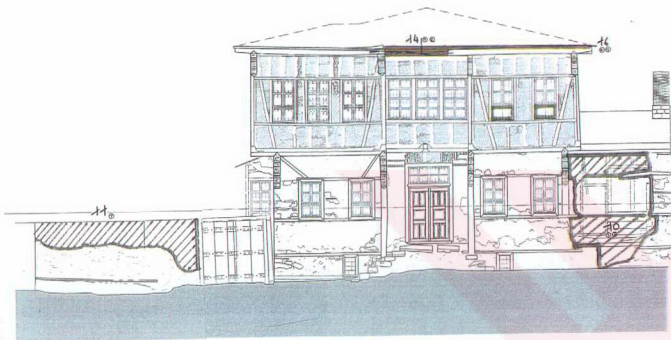
FRONT FACADE

- 10 THE NORTHEAST FACADE OF THE KITCHEN SPACE 80-01 AND ITS RELATED ARCHITECTURAL ELEMENTS ARE MISSING
 - 11 THE NORTHEAST WALL OF THE COURTYARD
 - 12 THE SOUTHWEST WALL OF THE SPACE 80-08 AND

- 13 SOME MASONRY WALLS UNDER THE WINDOWS ON THE SOUTHEAST WALL OF THE SPACE 80-01 AND THE NORTHWEST WALL OF THE SPACE 80-07 ARE PARTIALLY MISSING
- DEMOLISHMENT

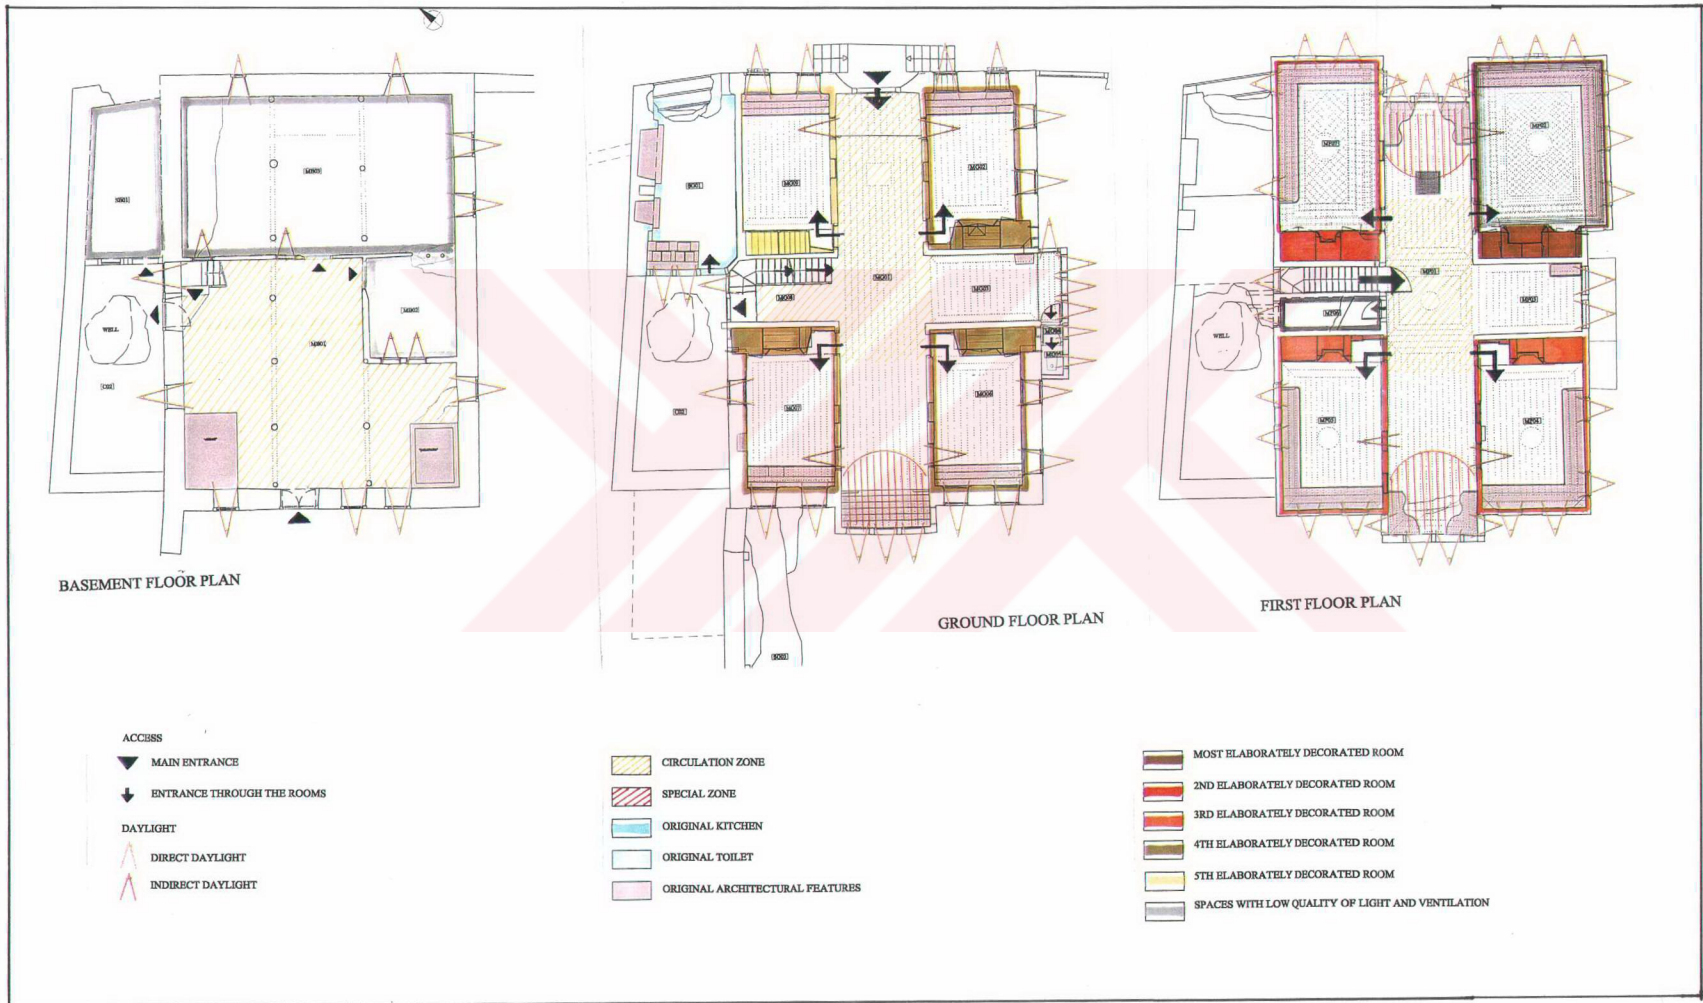
Drawing 7.1 Space analyses

The original WC, space MG-05 is still functioning. It has ventilation and sewage system. But there is no water and electricity installations and no equipment necessary for the health as lavatory inside.

The original kitchen space SG-01 has lost its function and space MG-09 was being used as kitchen. There is no electricity and water installation, no equipment for health as lavatory and sewage system in space SG-01.
