RESTORATION PROJECT OF ABACIOĞLU HANI
IN KEMERALTI, İZMİR

A THESIS SUBMITTED TO
THE GRADUATE SCHOOL OF NATURAL AND APPLIED SCIENCES
OF
THE MIDDLE EAST TECHNICAL UNIVERSITY

HÜLYA YÜCEER

SEPTEMBER 1997

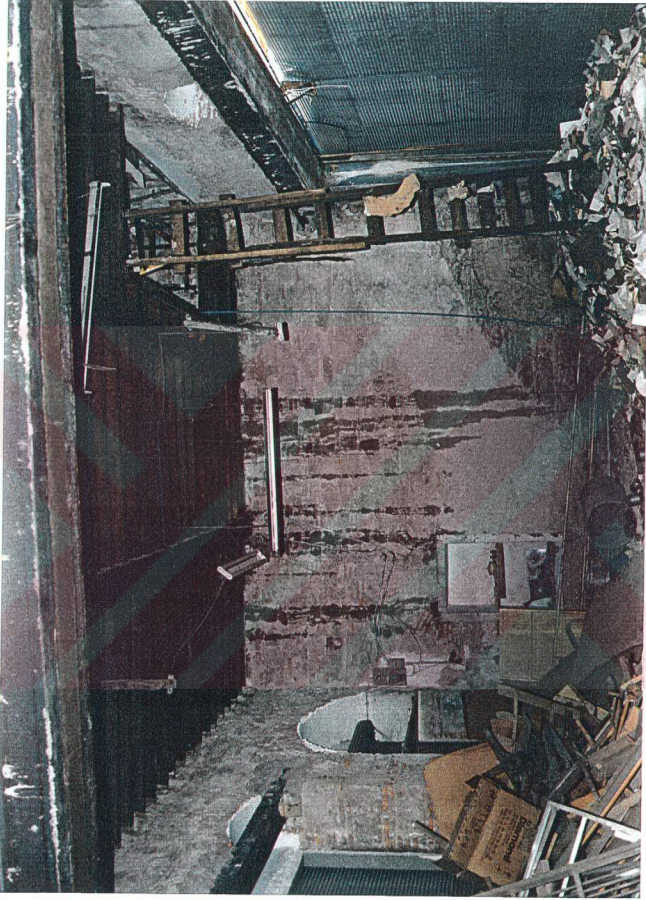
Figure 12- Space 1 Ground Floor North Wall

The first is used in other spaces by different construction techniques. For instance, walls of the second group on the north-east wing is constructed by alternate use of stone and brick on the ground floor (Figure 12 and Figure 13), while a different technique is used for the first floor walls. These are again load-bearing walls of stone and brick alteration, but a timber frame is inserted in to these walls (Figure 14 and Figure 15).

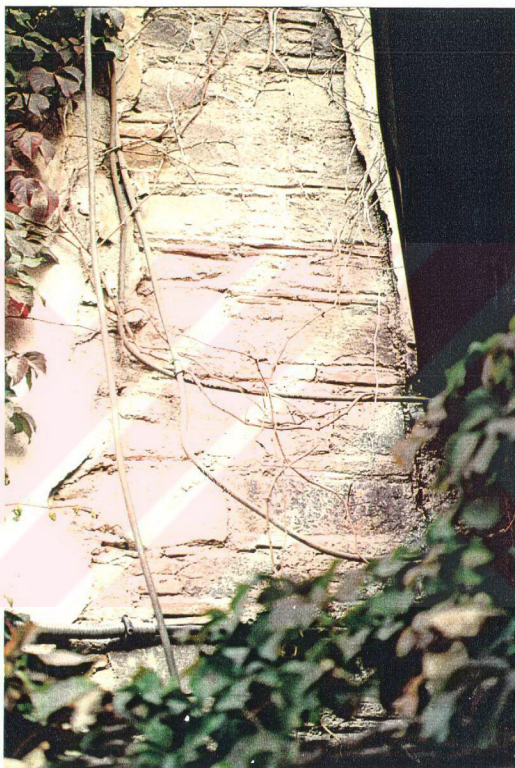
Figure 16- South-West wall facing courtyard (Space 8)

Stone: As observed from the parts where plasters are lost on the exterior wall of NE wing and SW wing, cut stone is used in alteration with brick (Figure 16 and Figure 17). In the interior walls of the same wing rubble stone used with brick on the first floor and rough stone in alteration with brick on the ground floor.

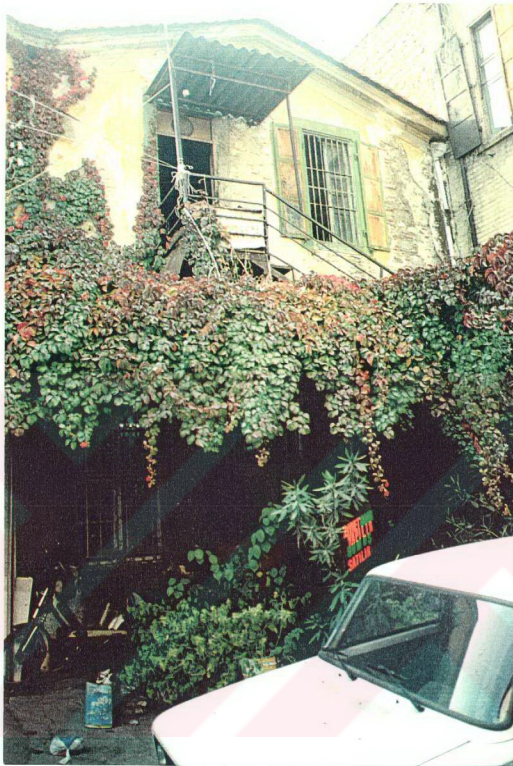
Figure 17- East wall facing courtyard (Space 17)

Walls: Since, both exterior and interior walls are plastered, the construction technique and material of the walls are deduced from the wall thickness and from the parts seen where the plaster is lost. The walls are constructed with alternating cut stone and brick (Figure 17 and Figure 18). Later, during a site visit on April 3, 1997, construction technique of the NE wing is obviously seen due to a renewal carried out in space 1 and space 2 (Figure 13, 14, 15, 16). Thus, as suggested before the exterior and separation walls in between spaces are masonry on ground floor, but on the first floor a timber construction is added in order to bind the roof trusses and to strengthen the wall (?). The thickness of exterior walls of ground floor change between 0.60-0.70 m at NE wing and this reduces to 0.45-0.50 m at upper floor, while the separation walls are about 0.40 m. At the SE wing, where space 9 and 10 are placed the walls are masonry constructed with cut stone and brick. The thickness of the walls are approximately 0.65 m.

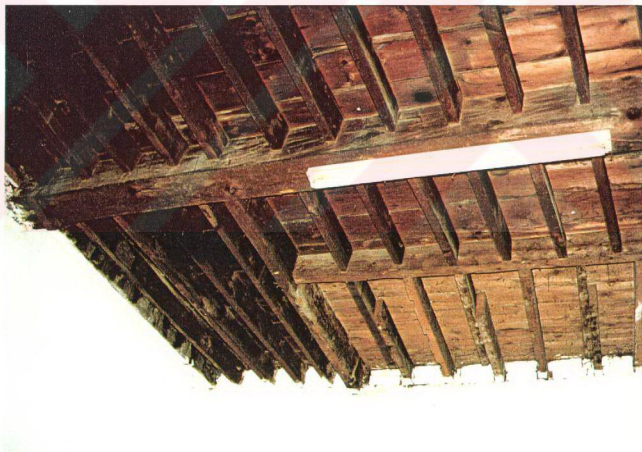
Figure 22- Timber beams and joists separating two floors in Space 13

Timber Elements: Spaces which are constructed with masonry system, are divided in to two floors by a timber beams and joists. Three 30x30 beams span the narrow interval and in between these three 25 joists of 6x12 cm are placed and finished by timber panels (Figure 22)

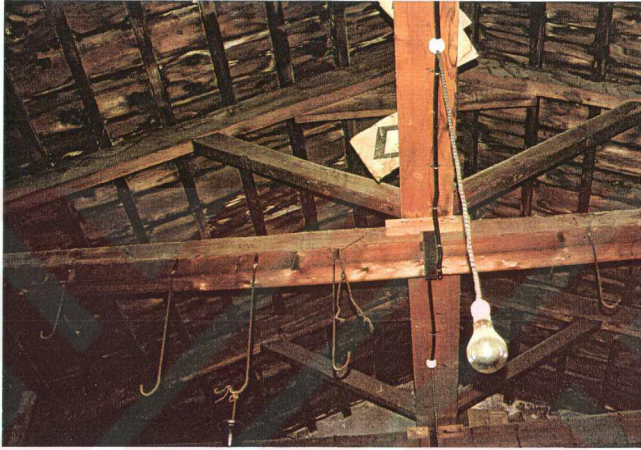
Figure 23- Timber roof truss of Space 2

Timber roof trusses are used as the super structure of space 1, 2, 3, 4, 5, 6, 7, 8 in between exterior walls three for each space (Figure 23) and for space 10, 11 and 12 trusses are used to span the separation walls in between spaces.
