REHABILITATION OF MALATYA-NARLI NO:7  
RAILROAD TUNNEL

A THESIS SUBMITTED TO  
THE GRADUATE SCHOOL OF NATURAL AND APPLIED SCIENCES  
OF  
MIDDLE EAST TECHNICAL UNIVERSITY

BARIŞ DİVLELİ

SEPTEMBER 2004

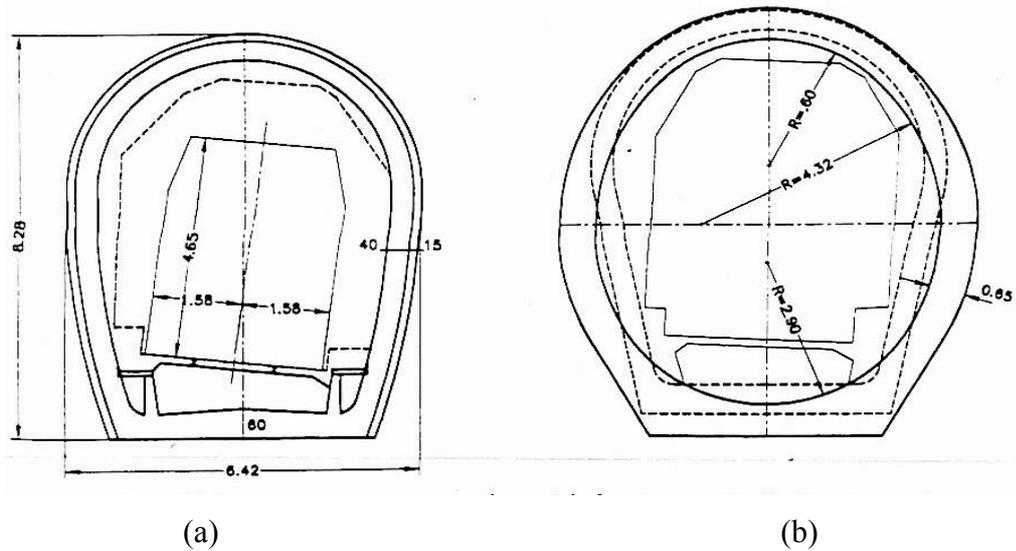
Figure 2.5 Sidi Mezghiche Tunnel-Cross Sections,  
a) Before the Collapse, b) After the Collapse  
(after Panet, 1996)

A collapse of the supported tunnel occurred over a length of 100 m with a large deformation of the support on 100 meters more. The failure went up to the ground surface. The deformed cross section had the shape of a keyhole. Figure 2.5 shows the condition of the tunnel before and after cave-in or collapse.

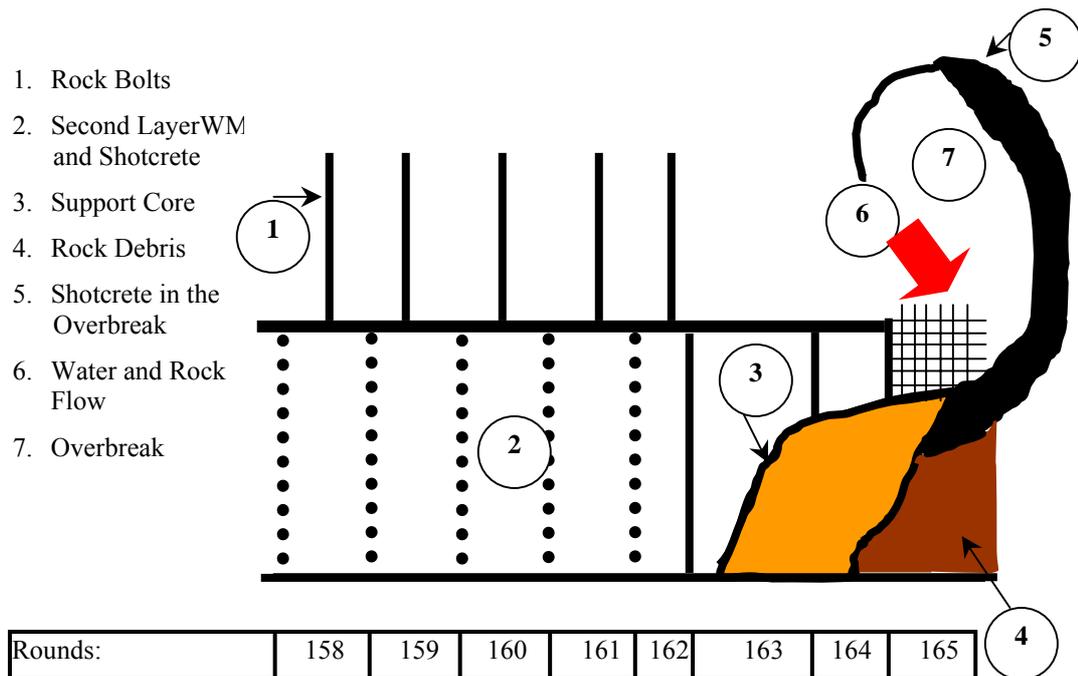
Figure 2.6 First Collapse in Round 165 (after Etkesen et al., 2002)

On October 11, 1995; from the right side of the crown of Round 165, the ground fell down and an overbreak chimney of 12 m<sup>3</sup>, occurred. Overbreak volume stabilized within three meters above the tunnel crown. The collapse occurred between km 41+831 and 41+840. Figure 2.6 shows the first collapse.

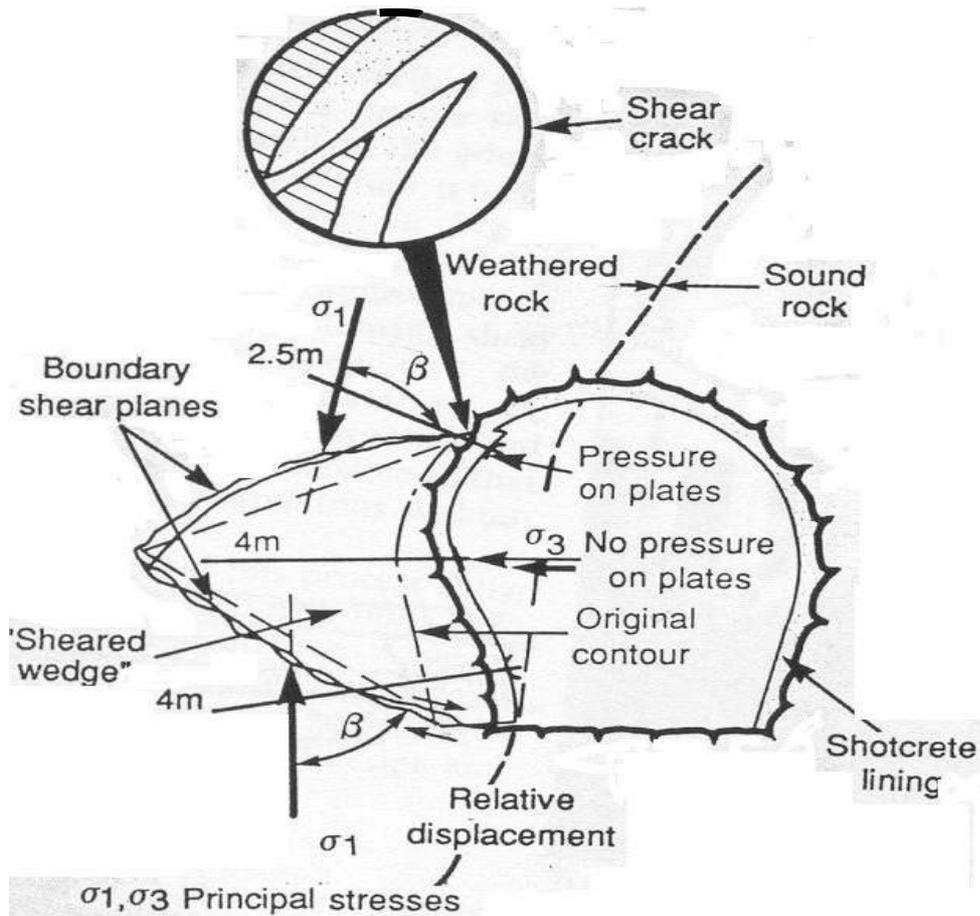
Figure 2.7 Side Wall Failure Showing Configurations of Shear Planes (after Hagenhofer, 1990)

The collapse happened on March 10, 1989. The left side wall failed within chainage 1175 to 1185, where the tunnel ran along a sharp boundary of completely different ground. The right side was within strong rock while the rock adjacent to the tunnel on the left was completely weathered and totally disintegrated to loose ground comprising clay silt and fine sand. Figure 2.7 shows the side wall failure within chainage 1175 to 1185.

The failing tunnel side stabilized after attaining a maximum convergence of about 0.60 m measured at the invert.

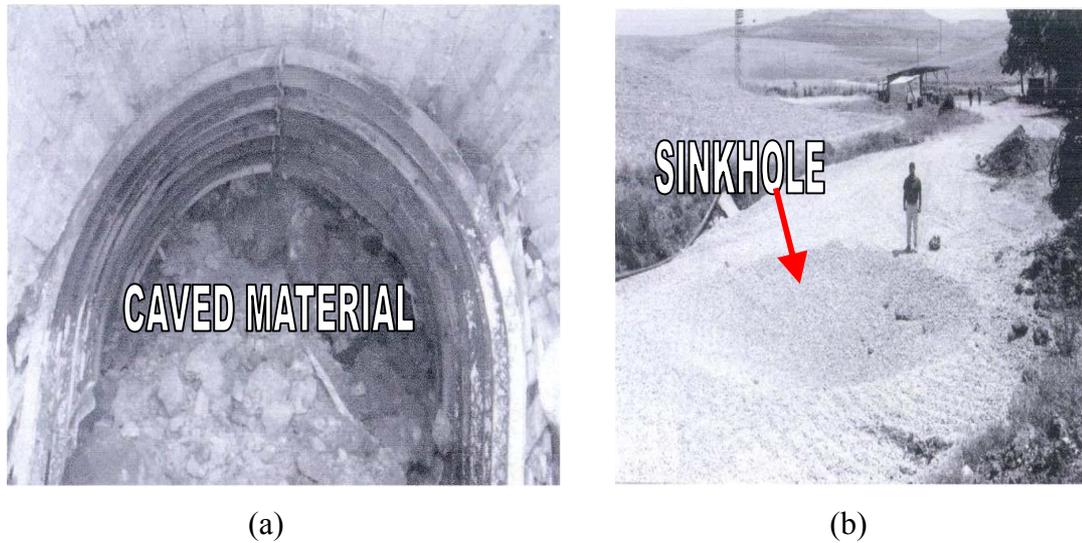
Figure 2.8 (a) View of the Collapse in the Tunnel Face  
(b) View of the Sinkhole Form at the Surface  
(after Türkmen and Özgüzel, 2003)

Kurtkulağı irrigation tunnel which is 1255 m in length and 3.50 m in diameter, is an important part of the Yumurtalık Plain Irrigation Project. The tunnel was excavated using conventional drill and blast, but some tunneling problems occurred as illustrated in Figure 2.8.

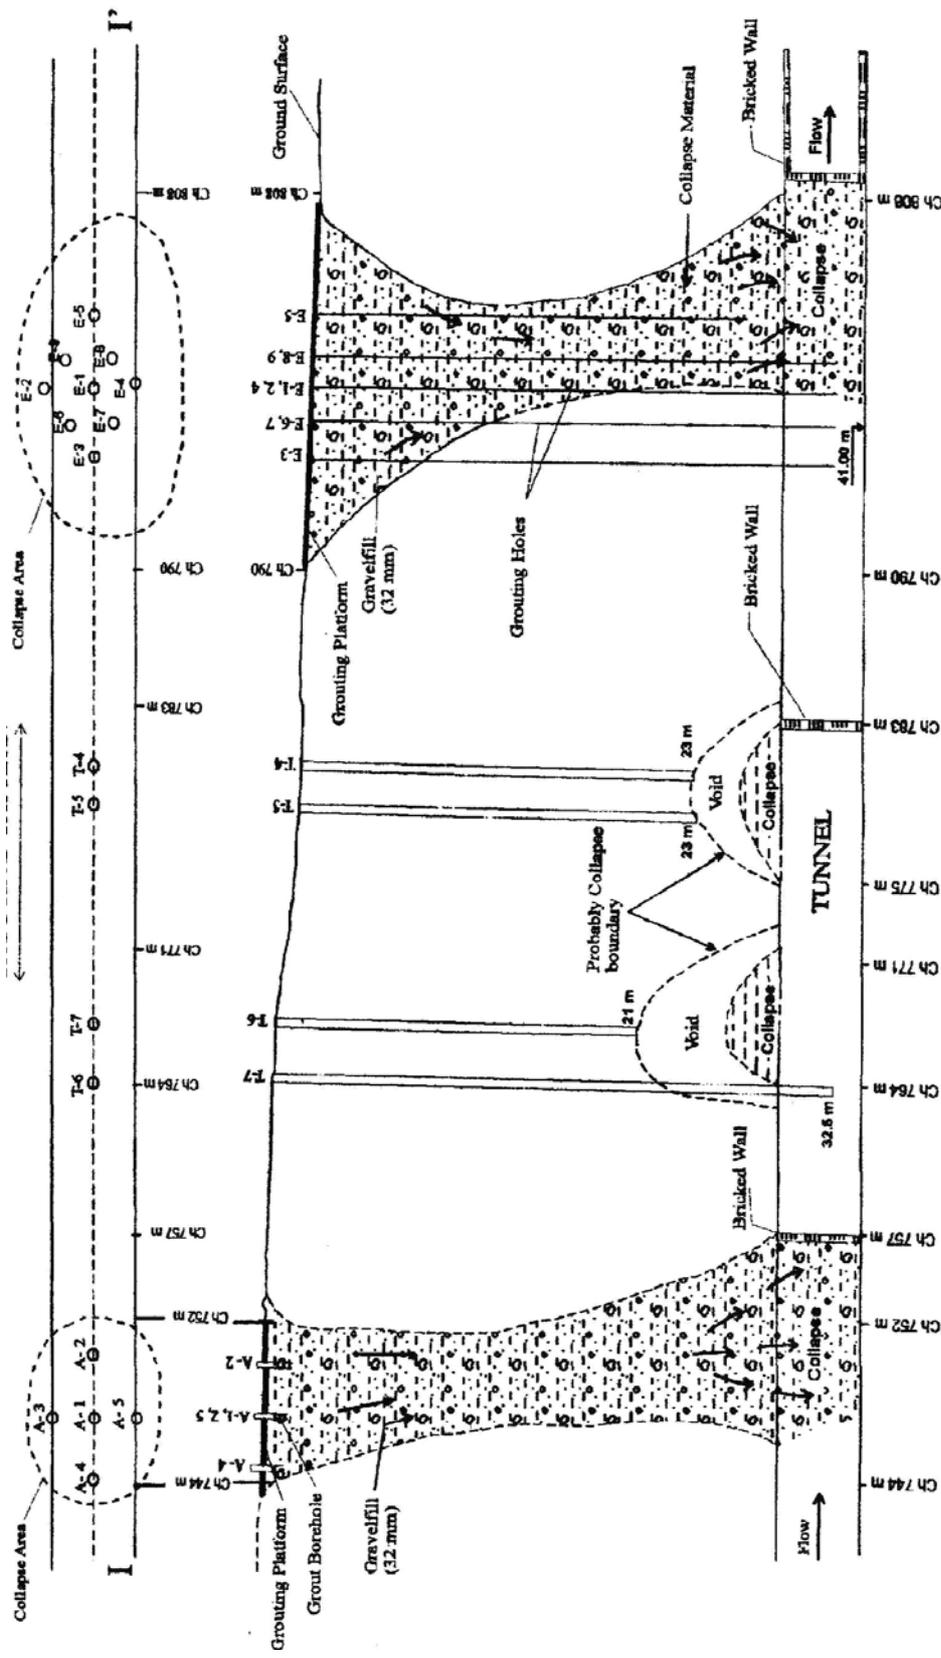
Figure 2.9 Cross-Section of the Collapsed Area and Grouting Pattern in Kurtkulağı Irrigation Tunnel (after Turkmen and Özgüzel, 2003)

During the tunnel advance a fault zone of approximately 150 m was encountered. During excavation two major collapses occurred between chainage 744-810 m in a fault zone even reaching the ground surface where sinkholes were formed as demonstrated in Figure 2.9. Tunnelling was being performed at both sides of the fault zone, the tunnel faces collapsed. Collapse of the tunnel face continued during removal of the muck material from the tunnel. Consolidation grouting was applied to prevent collapsing, but it failed because this zone consists of the clayey material. During the removal of the collapsed material, the tunnel arch collapsed and two major sinkholes at the surface and several collapses in the tunnel formed.

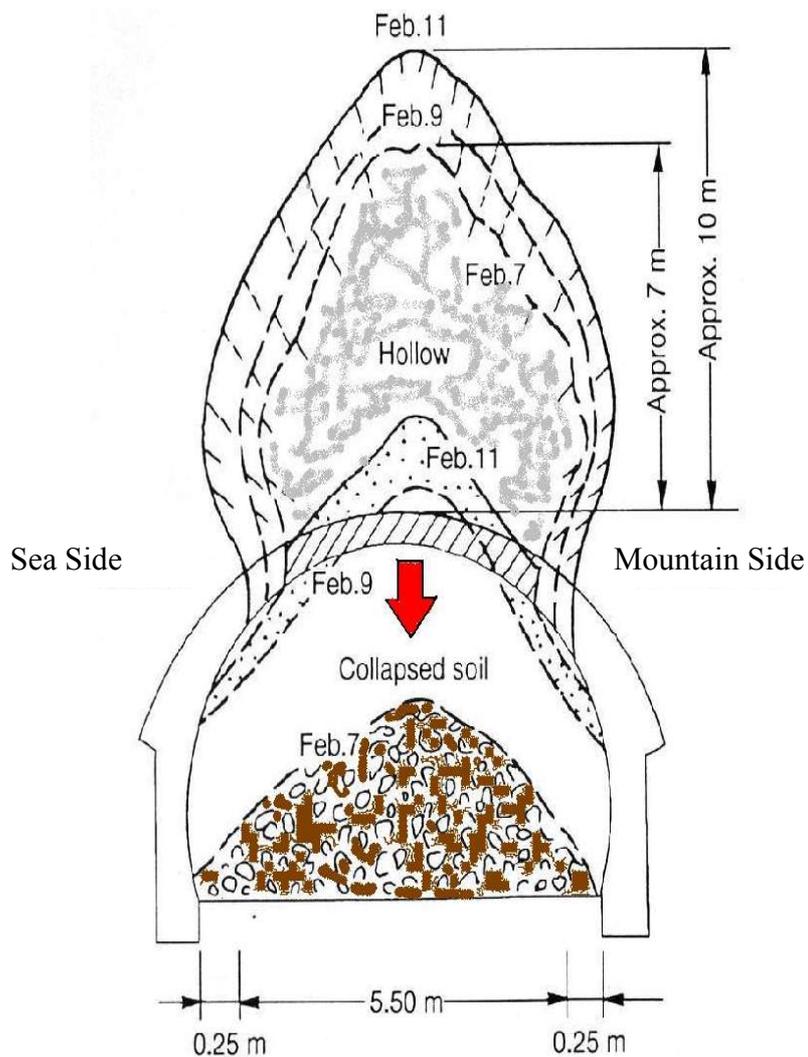
Figure 2.10 Section of the Collapsed Zone in the Kinoura Tunnel (after Kunita et al., 1994)

The Noto Offshore Earthquake, which occurred off the coast of Suzu City, Japan, on February 7, 1993, damaged the crown arch of the tunnel over a length of approximately 10 m, resulting in the formation of a gap when the ground soil collapsed about 10 m above the arch (Figure 2.10). In addition, cracks on the secondary lining and tunnel entrance and small collapses on the entrance slope face were observed.

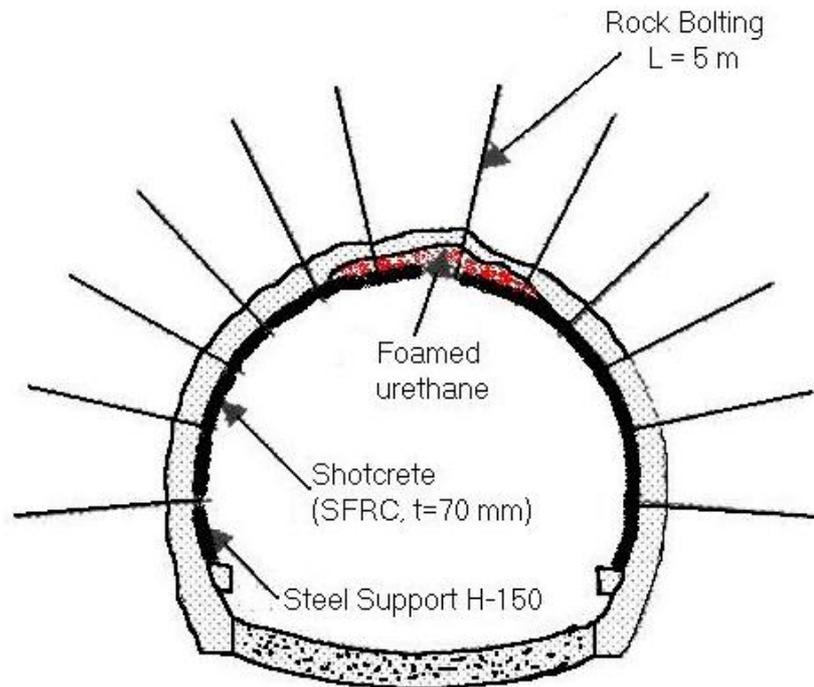
Figure 2.11 Outline of the Countermeasures in Tsukayama Tunnel  
(after Asakura and Kojima, 2003)

Shortly after completion, the tunnel deformed in such a way that both sidewalls were pushed into the tunnel space accompanied by mud-pumping at the tracks and heaving at the base. The arch crown was pushed upwards and failed in a bending and compressive manner. As a countermeasure against this deformation, invert concrete was installed to close the tunnel section.

In 1990 a wide area of the crown settled where compressive failure had occurred and many shear cracks developed in a radial manner with their center at the settled part. The possible collapse of the area was a serious concern. Thus, preventative work against a collapse of the area was taken immediately as a temporary measure. As permanent countermeasures, backfilling, rock bolting, reinforcement and shotcreting with steel fibers were applied, as shown in the Figure 2.11.

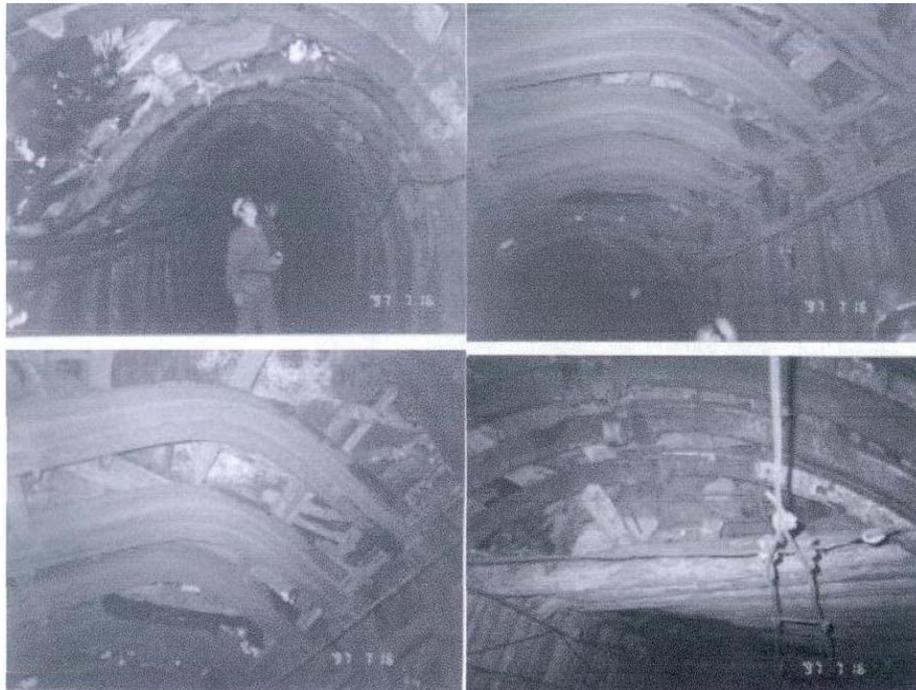
Figure 2.14 Some Failed Tunnels in Jiulongkou Mine (after Song and Lue, 2001)

Some of the supports in the permanent access tunnel of the Jiulongkou Coal Mine had failed and large deformations were observed as shown in Figure 2.14.

In recent years, the supports of the southern main access tunnels were repaired with steel sets and timbers. The standing duration was only approximately 12 months for steel sets and 3 months for timbers after each repair. Therefore, it was decided to perform repair of the deformed tunnels with a new approach.

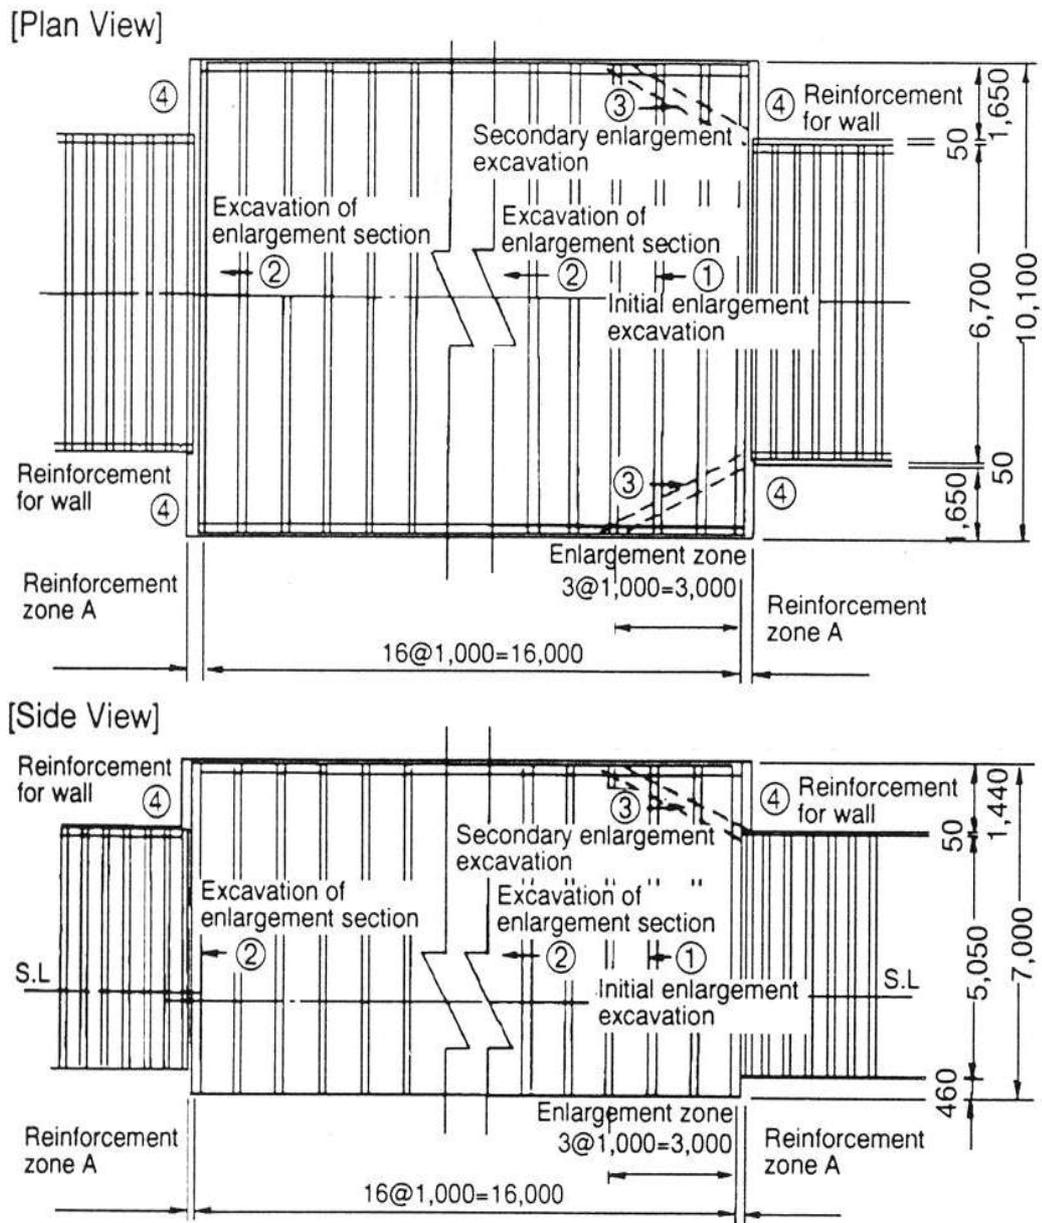
Figure 2.16 Phased Excavation of the Collapsed Zone  
(after Kunita et al., 1994)

The Noto Peninsular Offshore Earthquake occurred off the coast of Suzu City, Japan. As a result of the earthquake, the Kinoura Tunnel was critically damaged by a collapse of the arch and forced out of service. Because the width of the excavation in the collapsed zone was greater than the width of the existing tunnel, excavation was carried out in the sequence as shown in Figure 2.16. During the excavation of the enlargement zone it was found that the rock mass deteriorated considerably.

The original lining was removed with a large breaker in 1-m steps, leaving center core at the face. During the excavation, the ground above the arch fell and the face in the fallen material collapsed. Therefore, forepoling (l=3 m), shotcreting were adopted for face stabilization.

Mortar grouted dowel rockbolts were mainly used, although self-drilling bolts also were used where ground condition were bad.

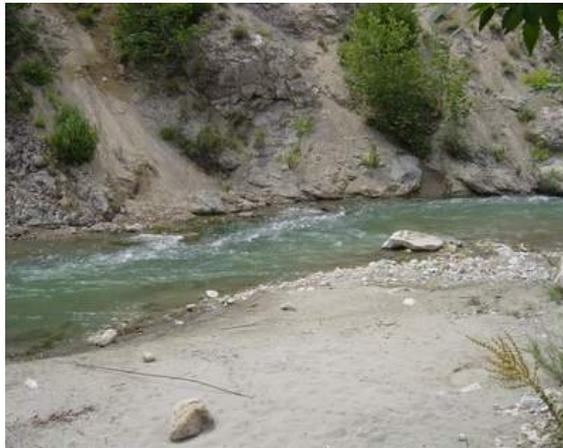
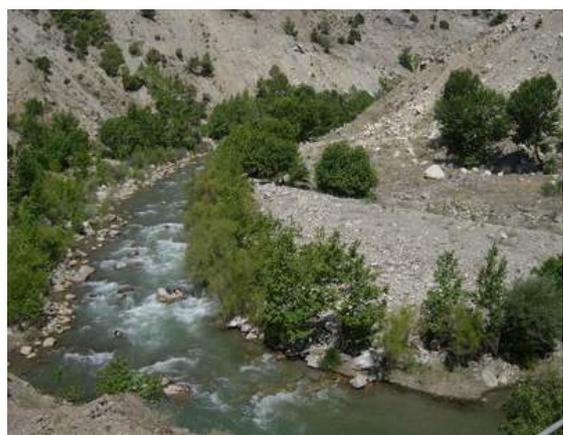
As shown in Figure 3.5 and 3.6, the riverbed takes place between the right and left bank of the creek and has been displaced towards left (west) due to Alisliseki landslide.

Figure 3.5 The Creek Flowing Parallel to the Tunnel

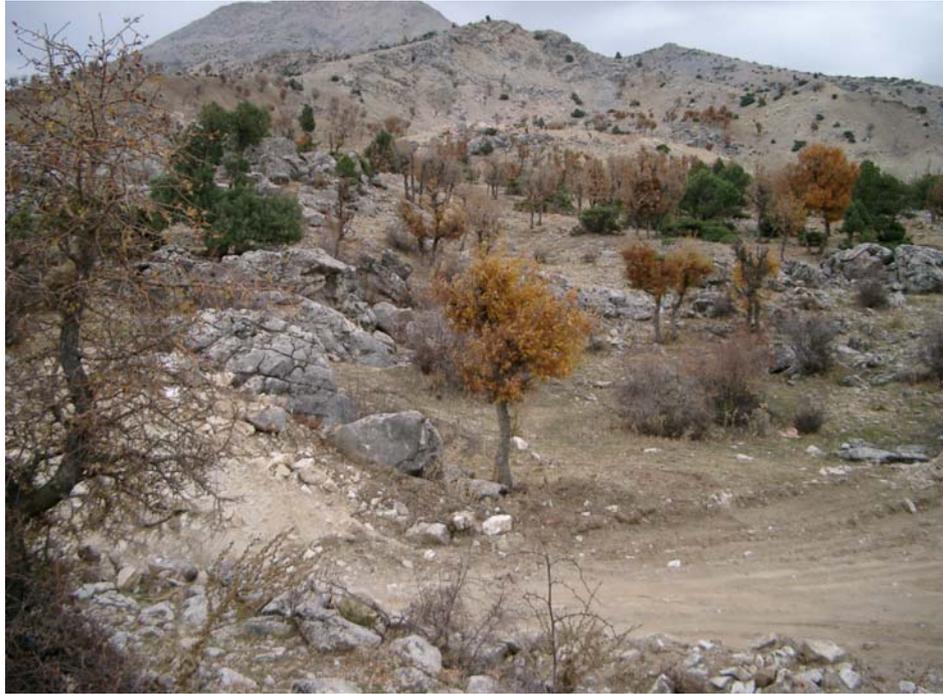
Morphology of the surrounding of the tunnel clarifies that Kapidere riverbed was squeezed by the hillside. The landslide morphology observed along the Alisliseki ridge and other bank of the creek confirmed the existence of the landslide as shown in Figure 3.7 and 3.8.

Figure 3.7 Alıslıseki Landslide scarp, Swellings and Settlements at the Mountain Side (after Ergun et al., 2002)

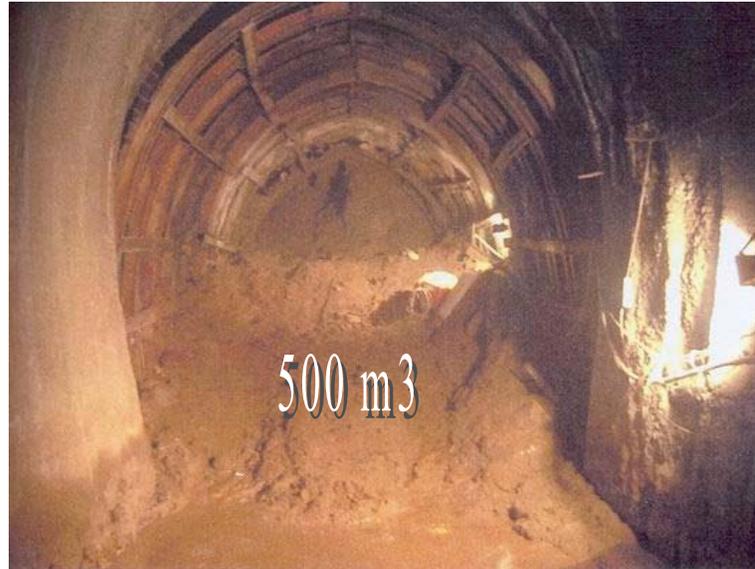
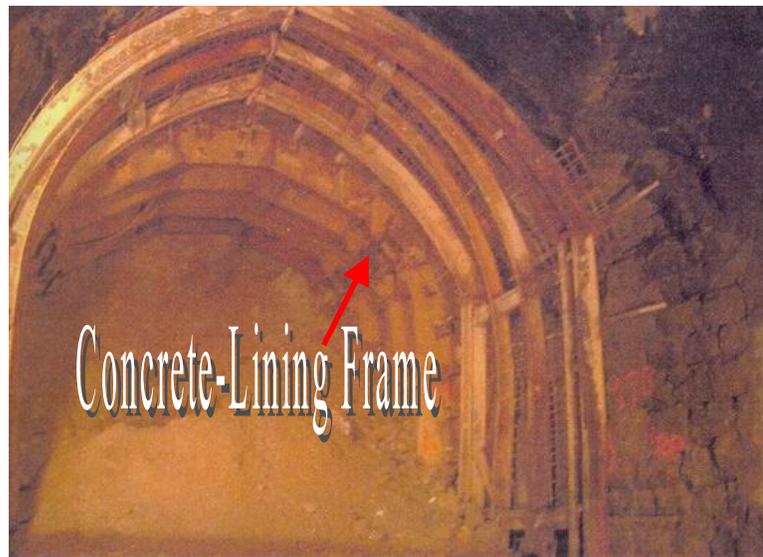
Figure 4.3 Appearance of the Roof-Fall, (a) from Malatya Side and (b) from Narlı Side

While cleaning up of the roof-fall material in the tunnel, a new roof-fall occurred at a 3-meter long section, on February 7, 2003 in such a manner that the loose material at the roof poured into the tunnel's cavity as shown in Figure 4.3.

Before removal of the muck-material a cement injection was made into the loose material existing in the roof. Initially, 5.5 m<sup>3</sup> of cement was grouted between km 155+660 and 669 (195-204 m from the Narlı entrance) and then 47 m<sup>3</sup> of cement between km 155+669 and 676 (204-211 m) as demonstrated in Figure 4.4.

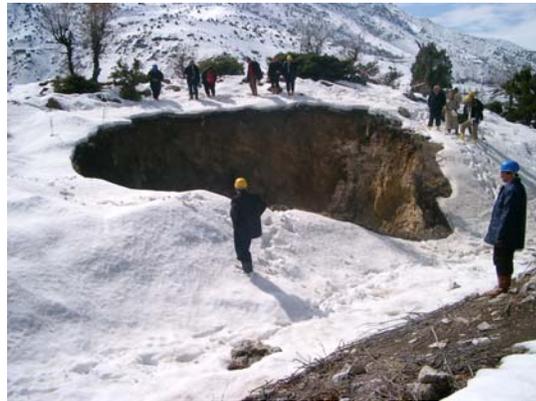
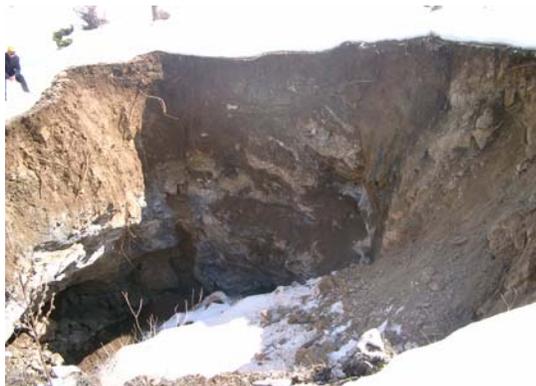
Figure 4.11 Sinkhole Developed at the Surface as a Result of the Collapse

As a result of the two collapses occurred in the tunnel a sinkhole was developed on the ground surface as a result flow of 500 m<sup>3</sup> material into the tunnel from the tunnel roof. The dimensions of the sinkhole were about 15x10x20 meters. The sinkhole developed at the ground surface and a sketch of the collapsed area with the sinkhole developed at the surface are shown in Figures 4.11 and 4.12, respectively.

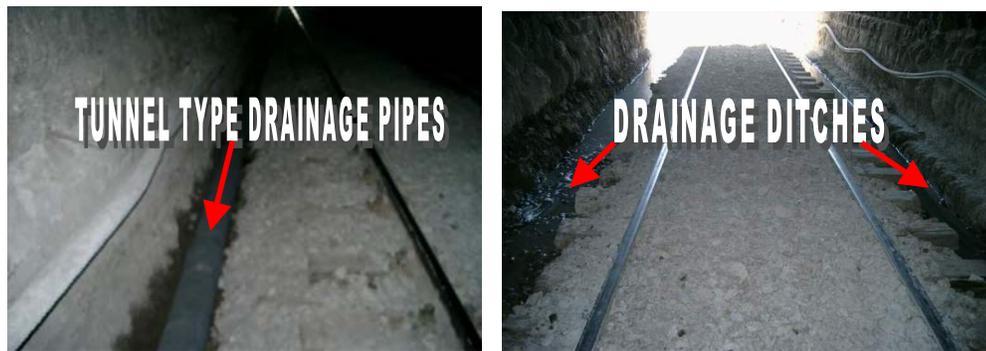
Figure 4.22 Water Drainage Ditches before and after Inserting the Tunnel Type Drainage Pipes

Along the both sides of the tunnel drainage channels were constructed inside the invert at the floor. The drainage pipes having a diameter of 200 mm and surrounded by geotextile were inserted along the tunnel bottom as demonstrated in Figure 4.22.

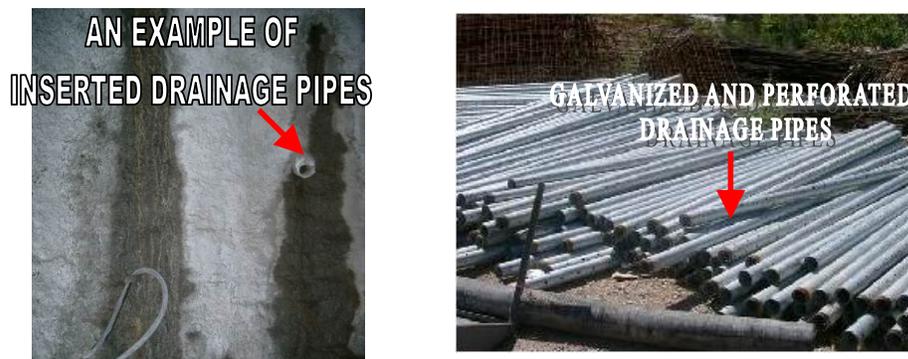
Figure 4.23 Perforated Drainage Pipes at the Walls of the Tunnel

Along the mountain side of the tunnel, galvanized and perforated drainage pipes having a diameter of 75 mm and length of 10 m and spacing of 5.0 meters were inserted into the tunnel wall with a staggered pattern as shown in Figure 4.23 and 4.24. The location of the upper holes of the drainage pipes were 2.0 meters and the lower holes were 0.5 m from tunnel bottom.

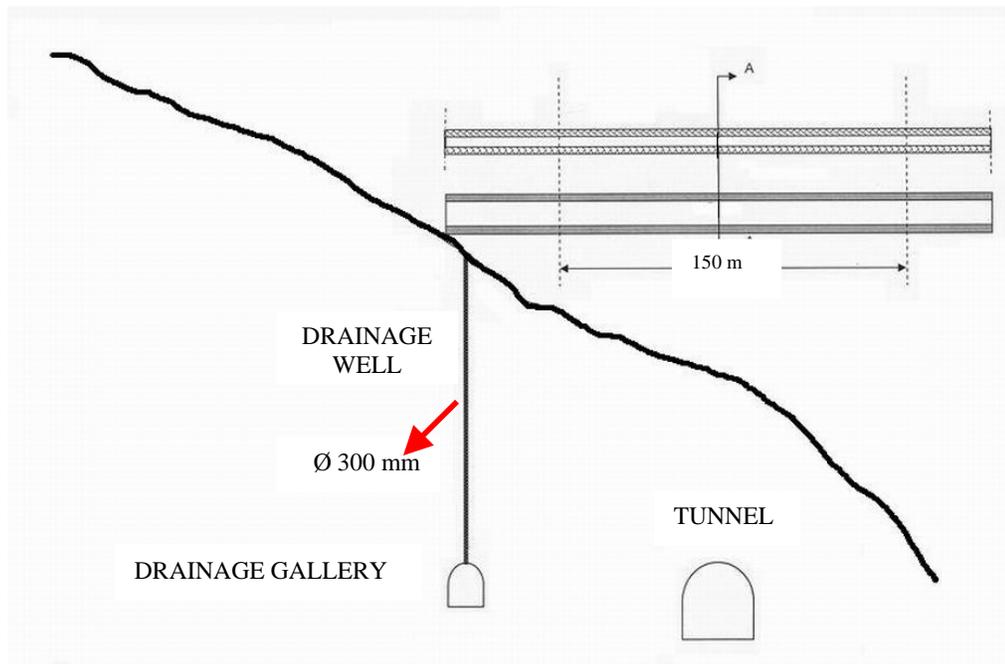
Figure 4.25 The Drainage System above the Tunnel

On the earth surface above the tunnel, a total of 11 drainage wells, spaced 15 meters to the each other and having a diameter of 300 mm were sank vertically from the surface to the drainage gallery, in order to collect the surface and underground water inside of the drainage gallery as demonstrated in Figure 4.25.

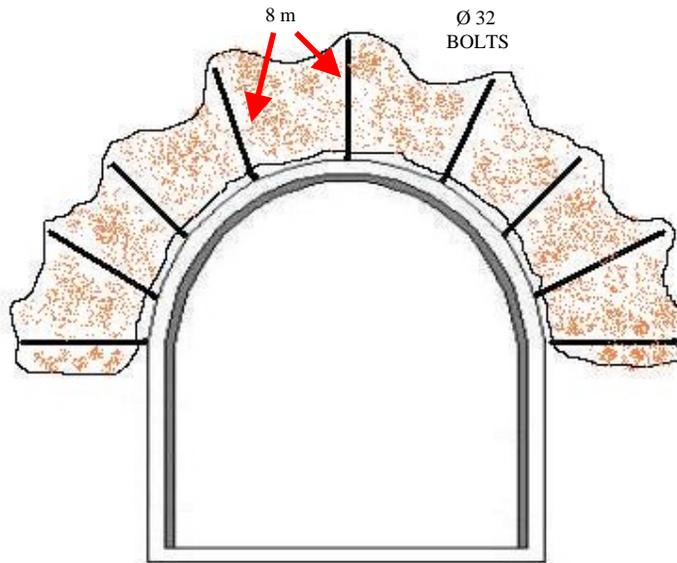
Figure 4.32 Concrete Injection Covering the Roof

After injection of grout having a thickness of 8.0 m at the arch part of Sections 2, 3, 7 and 10, these sections were reinforced with ribbed or threaded bolts as shown in Figure 4.32. However, the thickness of the injection was 5.0 meters at the border of 3 and 4. And also, the quantities of the applied injection in different sections are given in Table 4.2.

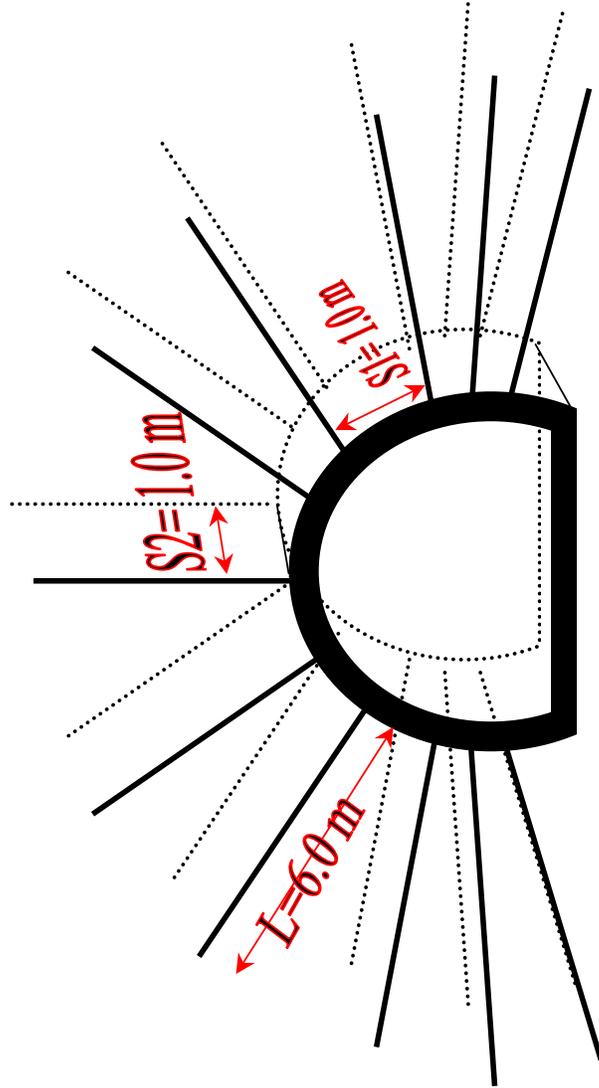
Section B was the most problematic section of the tunnel affected by excessive deformation and displaced towards the creek side as much as 1.70 m. This section taking place between km 155+563-610 was reinforced with self-drilling anchors (SDA) as shown pattern in Figure 5.2. The other two sections, namely, A1 and A2 have been reinforced by the same type of bolts having different pattern as shown in Figure 5.3.

Figure 5.2 Mai Bolt (SDA) Installation Pattern for Section B

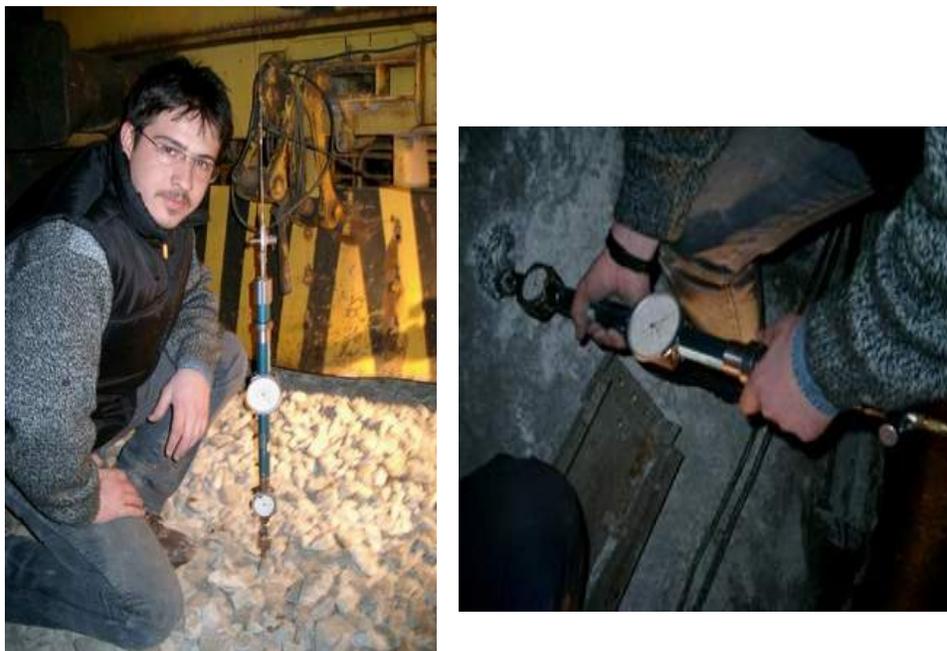
Convergence measurements were taken as three times between the dates January 22 and April 30, 2004. Consequently, the movement occurring due to displacement of the tunnel from the mountain side towards the creek side was tried to be determined. The measuring period was about 100 days. The measurement could not be taken after this period because rock reinforcement was started in the tunnel.

Figure 6.5 Convergence Measurement at a Station

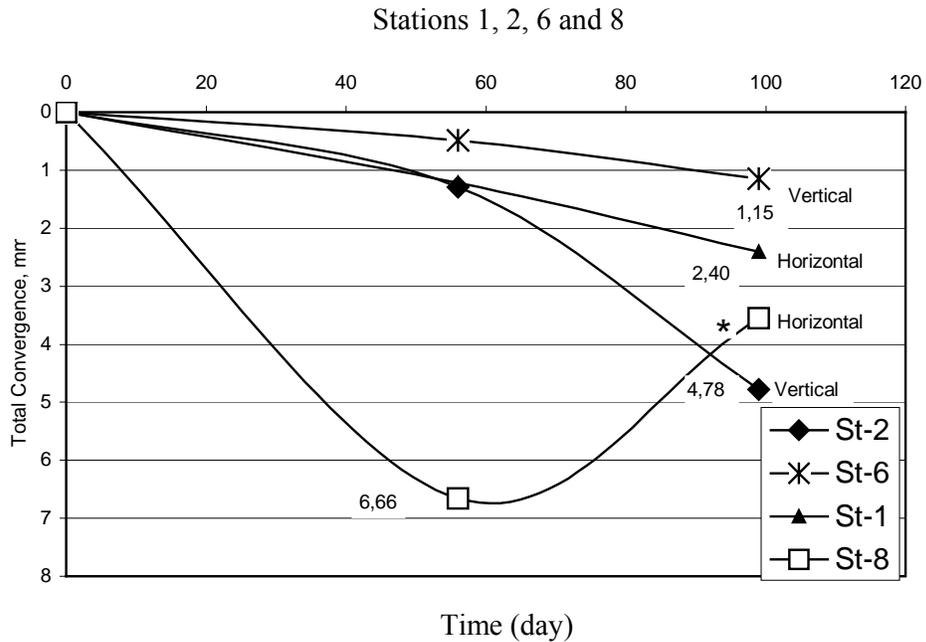
In this section the relation between “convergence and time” is evaluated. A total of 90 convergence measurements were taken in the tunnel in 100 days. Typical plots obtained from the measurements are shown in Figure 6.6. Considering the maximum vertical convergence at Stations 2 and 6 occurred in 100 days, they were 1.15 mm and 4.78 mm respectively. The maximum horizontal convergence occurred at Stations 1 and 8.0 were 2.40 mm and 6.66 mm respectively. Figures showing vertical and horizontal convergences obtained from different stations are presented in proceeding pages in this section. The measurements could not be continued due to initiation of the rock reinforcement work. However, it can be concluded with the available data that although small, that are still movements in the tunnel that may cause instability.

Figure 6.6 “Convergence” vs. “Time” Relation for Stations 1, 2, 6 and 8

(\* ) Fixed rebar was unstable so the measured value is not correct

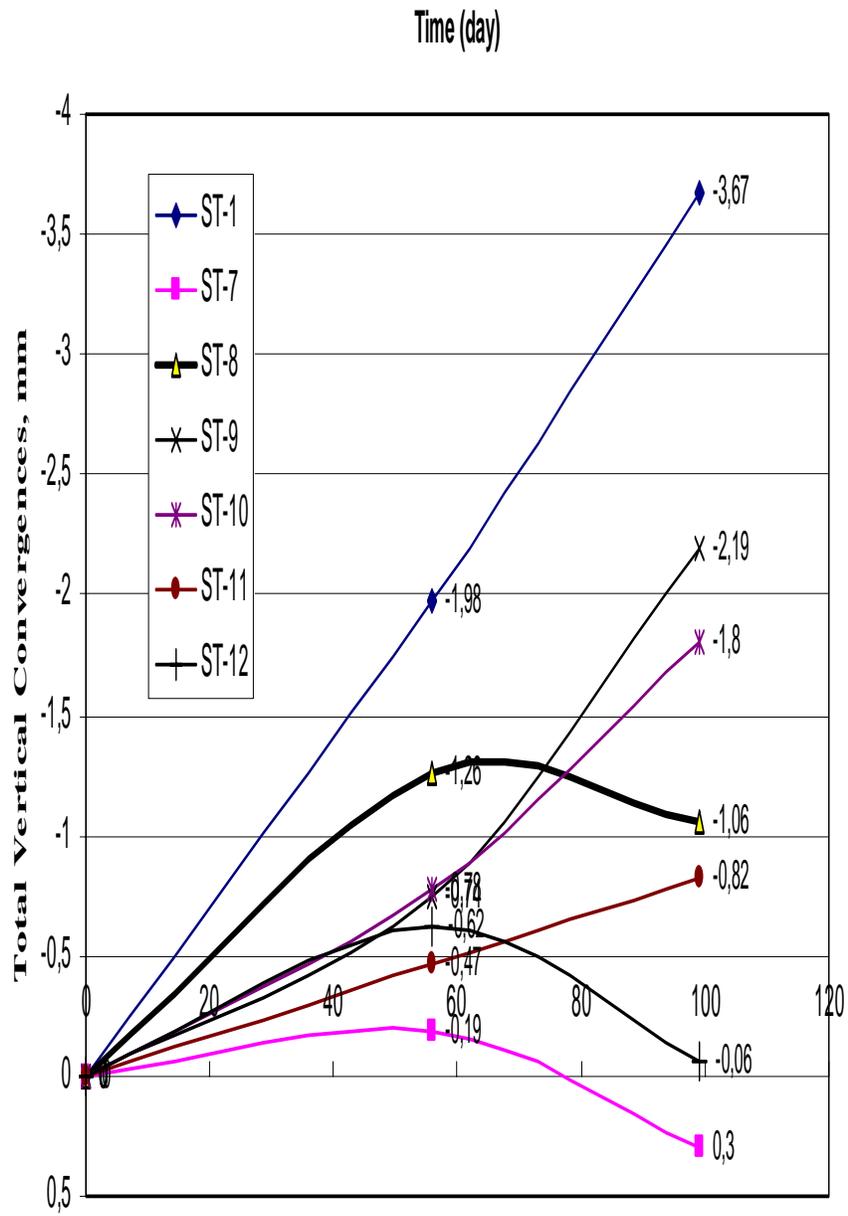
The convergence results obtained from Stations 9, 10, 11, 12 and 13, installed in tunnel Sections 8, 9, 10 and 12, are less than 1.0 mm (see Table 6.1 and Figures 6.9 to 6.12). Although more data is needed to be able to interpret the results, it can be concluded that 167 meters of the tunnel is stable (including Section 14) as seen in Figure 6.3.

It is very difficult to interpret the results of convergence because only three measurements (including, “0”) had been taken in 100 days and then, the rock reinforcement process was started and caused measurements to be stopped. However, considering the horizontal and vertical convergences larger than 1.0 mm (please see, Table 6.1 and Figures 6.9, 6.10, 6.11 and 6.12). It can be concluded that:

Figure 6.9 Relationship Between Convergence (Dilation) and Time for Vertical Stations

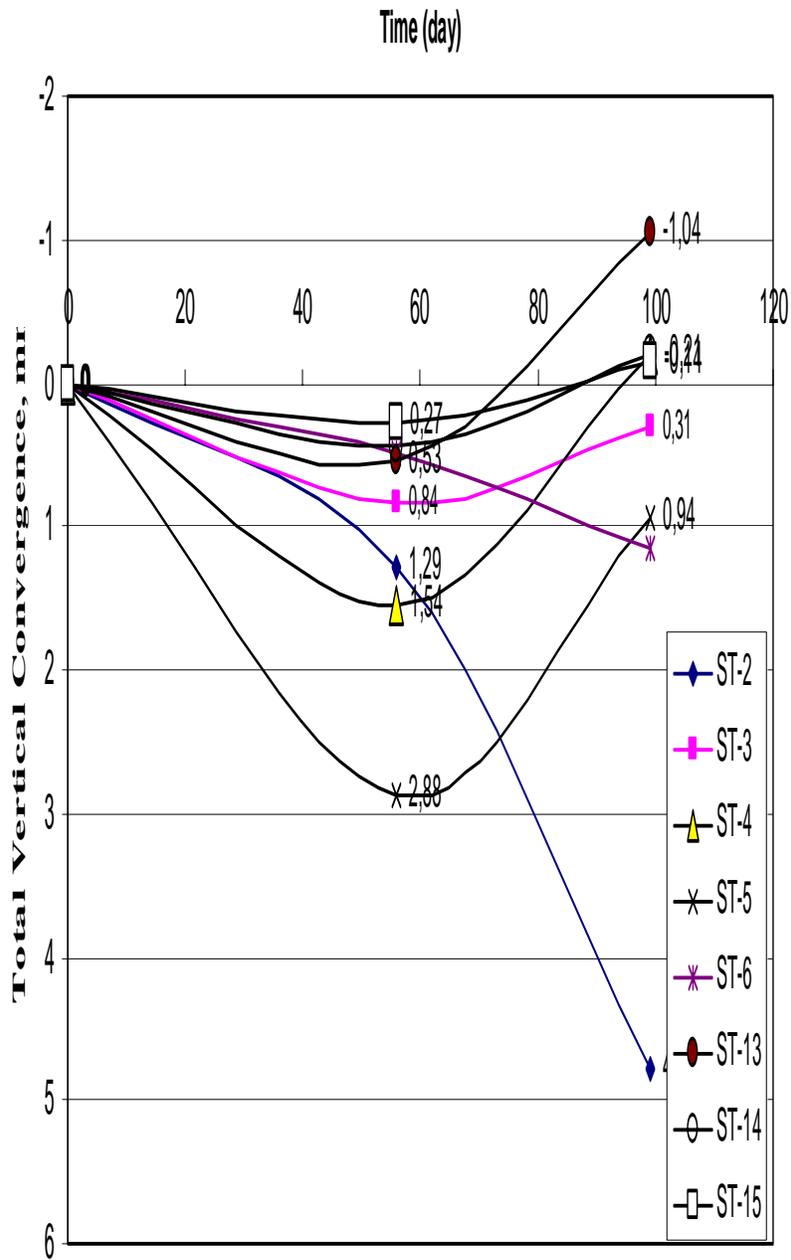
Figure 6.10 Relationship Between Convergence (Closure) and Time for Vertical Stations

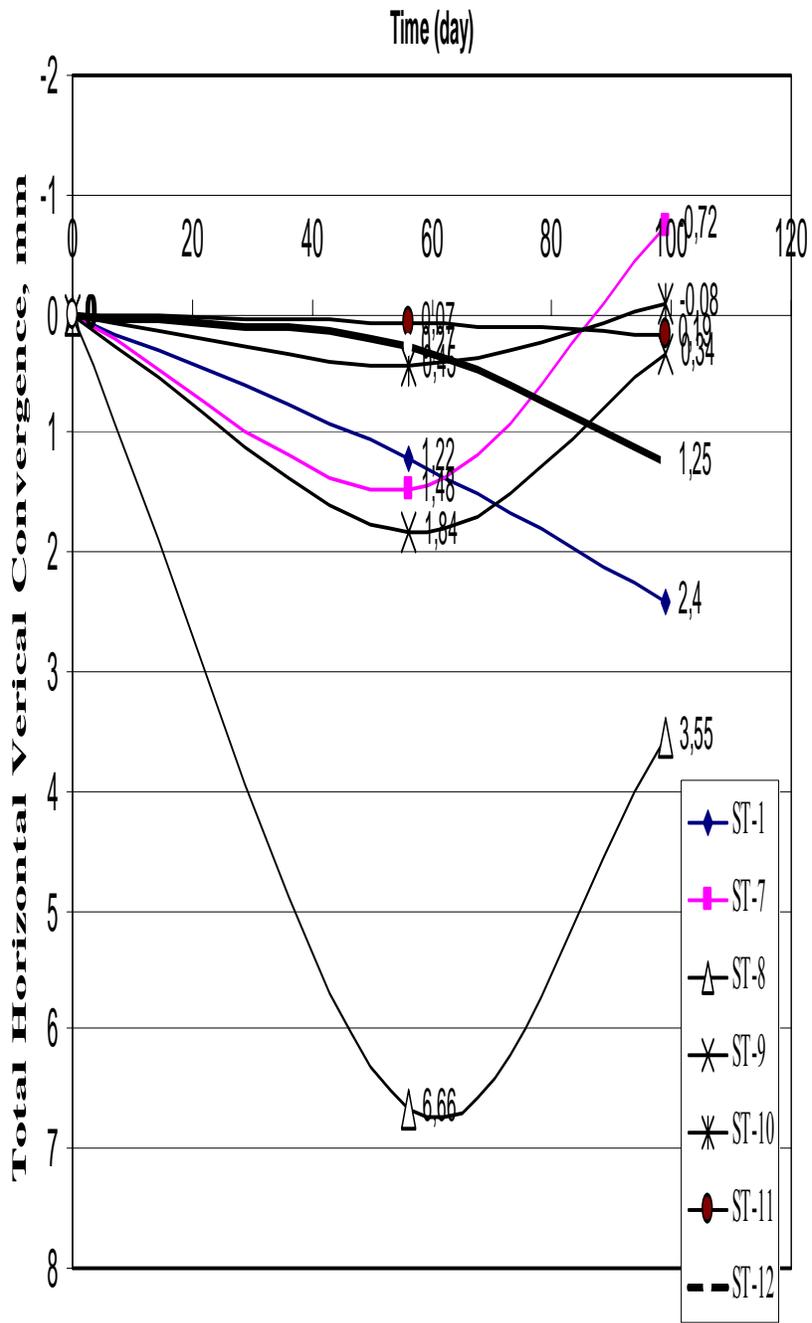
Due to the compression, closure was observed in the tunnel at Stations 4 and 5 installed in Section 4. The maximum horizontal movement was 8.78 mm at Station 4 probably due to compressive stresses acting from the mountain side. Consequently, it was concluded that there were still movement in Section 4.

Figure 6.11 Relationship Between Convergence (Closure) and Time for Horizontal Stations

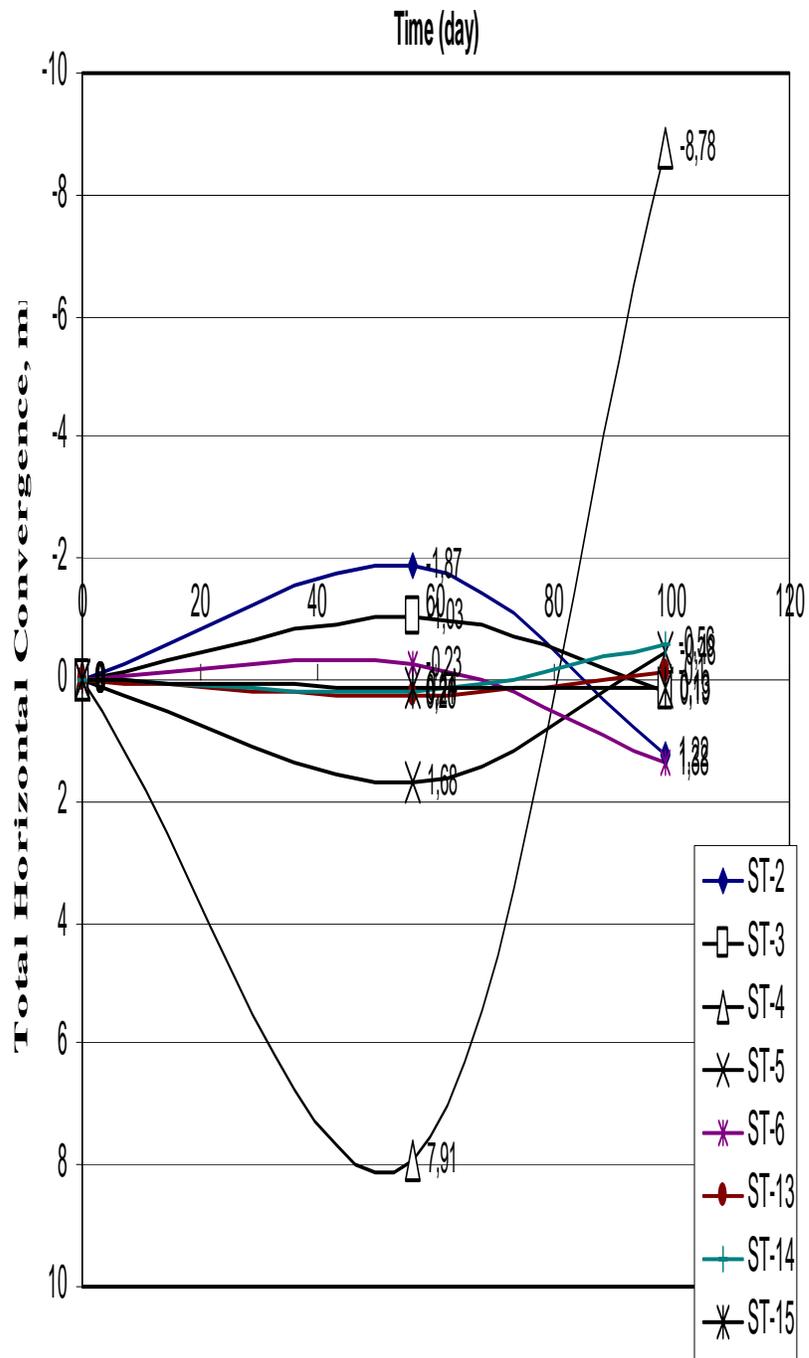
Figure 6.12 Relationship Between Convergence (Dilation) and Time for Horizontal Stations
