**RESTORATION PROJECT OF A TRADITIONAL HOUSE
IN CAMİŞERİF DISTRICT 5227 STR. NO: 14 MERSİN**

**A THESIS SUBMITTED TO
THE GRADUATE SCHOOL OF NATURAL AND APPLIED SCIENCES
OF
MIDDLE EAST TECHNICAL UNIVERSITY**

JULY 2005

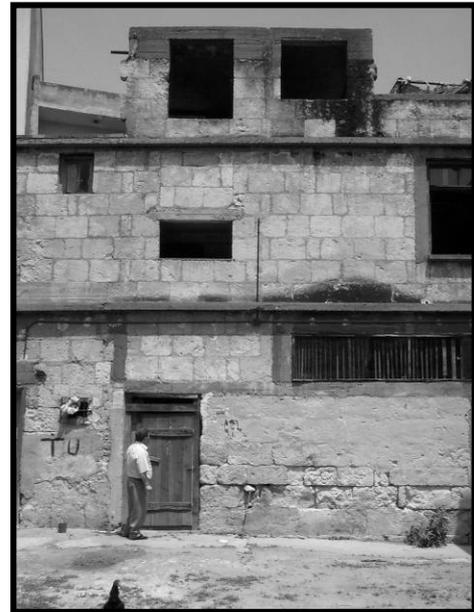
Figure 3-2 Northern Part of West Façade

northern part of the façade is constructed with cut stone masonry. Partial cement based plaster remainings can be observed. It is 11,93m long. Between the stories at the levels +3,74 and +6,55m from the datum line, there is a reinforced concrete slab with a thickness 0,13m, projects 0,08m.

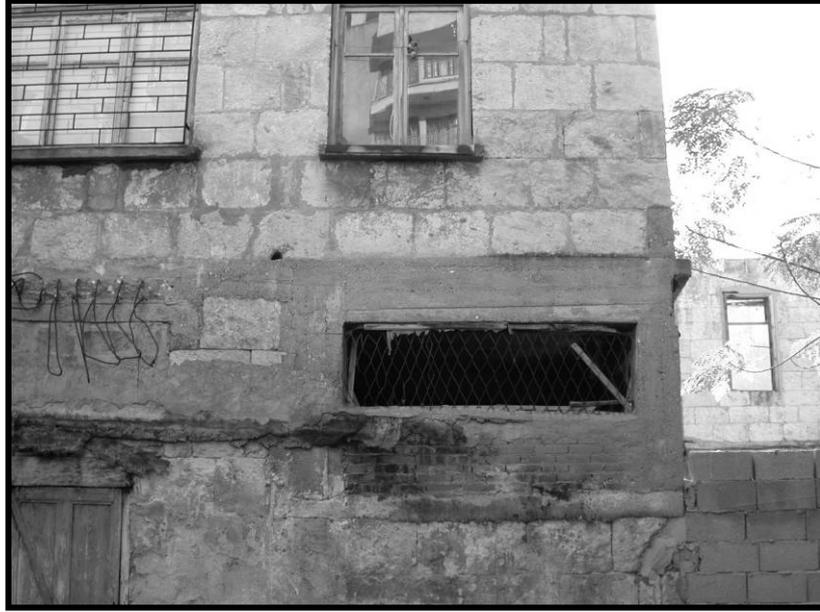
Figure 3-4 North Façade

contemporary four storey high building at +7,53m from datum line. It rises up to +8,26m from datum line where the wing of the roof attaches *cihannüma* 3,97m from the east end of the north façade. The gable of the roof is covered carelessly by irregular tin plates. Because of some material loss on the tin material, vertical timber structural elements and some horizontal timber covering plate remainings can partially observed. The remainings of the timber material are severely deteriorated. 3,97m from the east end of the north façade, *cihannüma* begins. *Cihannüma* stands on a cut stone masonry wall which can be viewed only in two rows because of the attached reinforced concrete slab. The reinforced concrete slab is at +6,46m from datum line. After the slab, the cut stone masonry wall can be viewed till +7,05m from datum line. After this level, the timber skeleton structure *cihannüma* can be viewed. The timber structure gable roof of *cihannüma* has been collapsed till 3,26m to the south direction from the north façade plane of *cihannüma*. The viewed, standing roof at the back, begins from +9,48m from datum line and reaches to +10,44m from datum line at the top. The gable is empty and the inner timber structure can be seen. The north façade of *cihannüma* is covered by timber plates. There are some partial, irregular tin plate covering interventions done below +8,37m from datum line. There is a window remaining is located on the façade. The window's upper level is at +9,62m. It is 0,87m wide. There is a solid timber shutter can be seen. The lower level is covered with a thick timber element and it blocks the observation and the measurements. The timber

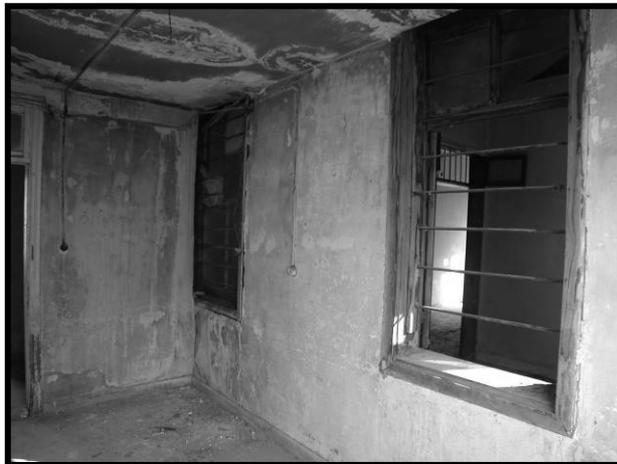
Figure 3-19 Space I11

The west wall of the space is 2,16m long and 2,56m in height. There is a window (W17a) located on this wall. It is located 0,14m from the south wall of the space at +4,56m from datum line with 1,82*1,84m dimensions. There are some material losses of plaster and also organic growth is observed on the wall where the window is located. The source of the problems is most probably is the water penetration from the window.

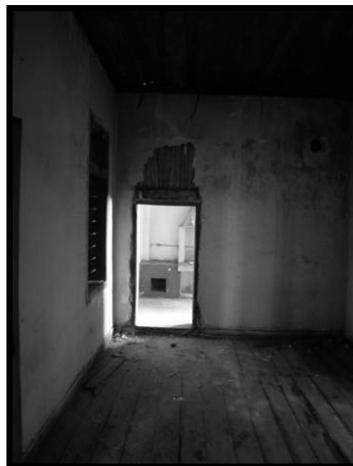
Figure 3-21 Space I16

The north wall of the space I16 is 3,21m in length and 3,49m in height. There is a door opening located 0,32m from the west end with 0,85*1,83m dimensions. The door opening has a door frame inside, and the plasters around the frame are lost. The plaster till +6,52m from datum line over the door opening are lost and the vertically oriented timber laths of the structure can be observed. There is a

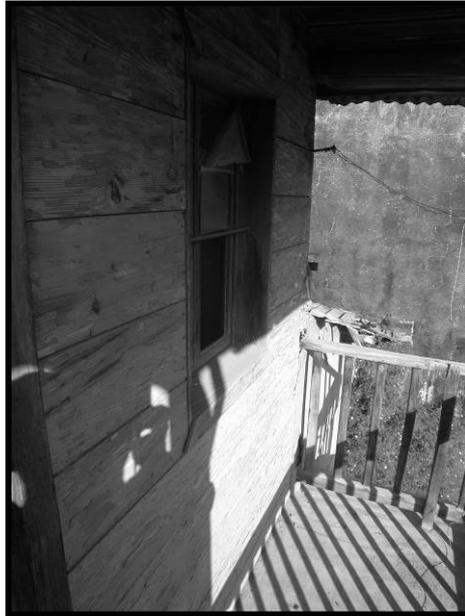
Figure 3-28 Space C05

The floor is a timber structure floor at +7,33m from datum line. The floor is covered by a metal based sheet material.

The ceiling is a timber lathed ceiling. The distance between the laths is 0,25m. There are 9 laths are located. The laths are in south to north direction. It is in a good condition.

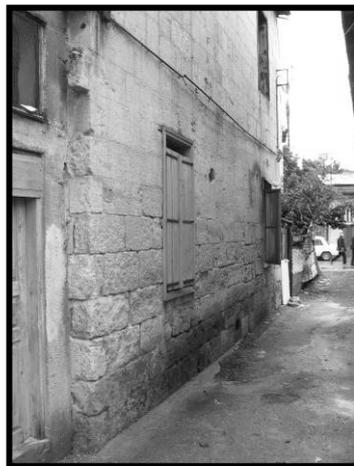
Figure 3-65 Cut stone wall masonry with lime mortar at the west façade

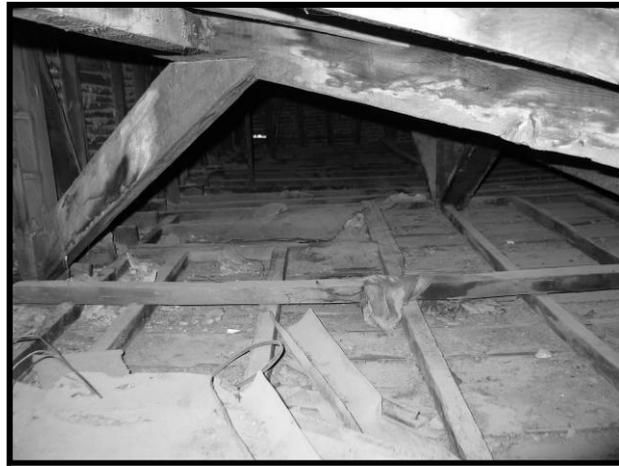
Figure 3-66 Timber roof structure

The timber roof structure is a gable roof. It is covering all the southern original part of the building including the projection and cihannüma. It is covered with terracotta tiles which are French type. It is a hanging roof structure supported by the stone masonry load bearing walls. The roof structure is covered by the ceiling of a space at the bottom which is connected to the king trusses of the structure which can be either “Bindirmeli” or “Çıtalı” type of ceiling. The structural elements of the roof structure are rough cut timber. Timber roof structure of the southern part of cihannüma is partially covered by zinc plate.

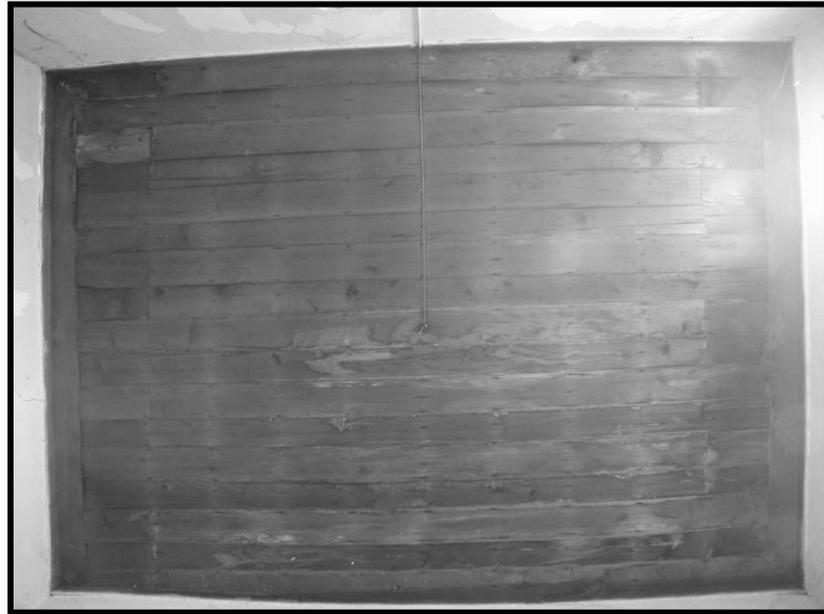
Figure 3-67 “Bindirmeli” Type of Ceiling

The term “*Bindirmeli*” is the locally used term for this type of construction technique of ceiling in Mersin’s dialect of construction. This ceiling type is connected to the timber roof structure’s timber beams. 21cm wide timber boards are nailed to the structural beams. The boards are nailed with approximately 19cm gap between each other and then the second row of timber boards are nailed to the first rows to fill the gap. These timber elements are well processed and finished timber boards which are considered to be named as fine cut timber. There is an approximate value of 1cm overlapping of the timber boards. There is a plastic based coating sheet is used as water isolation material at the space I19. It is a

nylon sheet, nailed to the ceiling irregularly by the help of some irregular shaped rough cut timber laths.

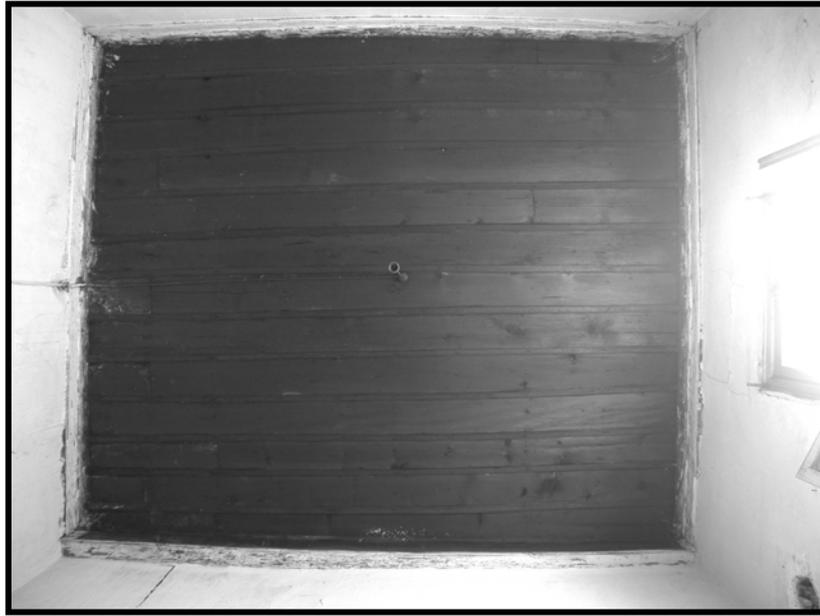
Figure 3-68 “Çıtalı” type of ceiling

The term “Çitalı” refers to the lathed ceiling type which is a widely used ceiling construction technique in Ottoman residence architecture. This ceiling type is connected either to the timber roof structure’s timber beams or to the timber structure flooring beams. 23cm wide timber boards are nailed to the structural beams. These timber elements are well processed and finished timber boards which are considered to be named as fine cut timber. The boards are nailed side by side with a minimum gap. Timber laths (4cm wide and 2cm high) are nailed to the timber boards over the joints. These timber laths are also considered to be named as fine cut timber. There is a plastic based coating sheet is used as water isolation material at the spaces I15 and G01. It is a nylon sheet, nailed to the ceilings irregularly by the help of some irregular shaped rough cut timber laths.
