**A STUDY ON DAM INSTRUMENTATION RETROFITTING:
GÖKÇEKAYA DAM**

**IN PARTIAL FULFILLMENT OF THE REQUIREMENTS
FOR
THE DEGREE OF MASTER OF SCIENCE
IN
CIVIL ENGINEERING**

DECEMBER 2008

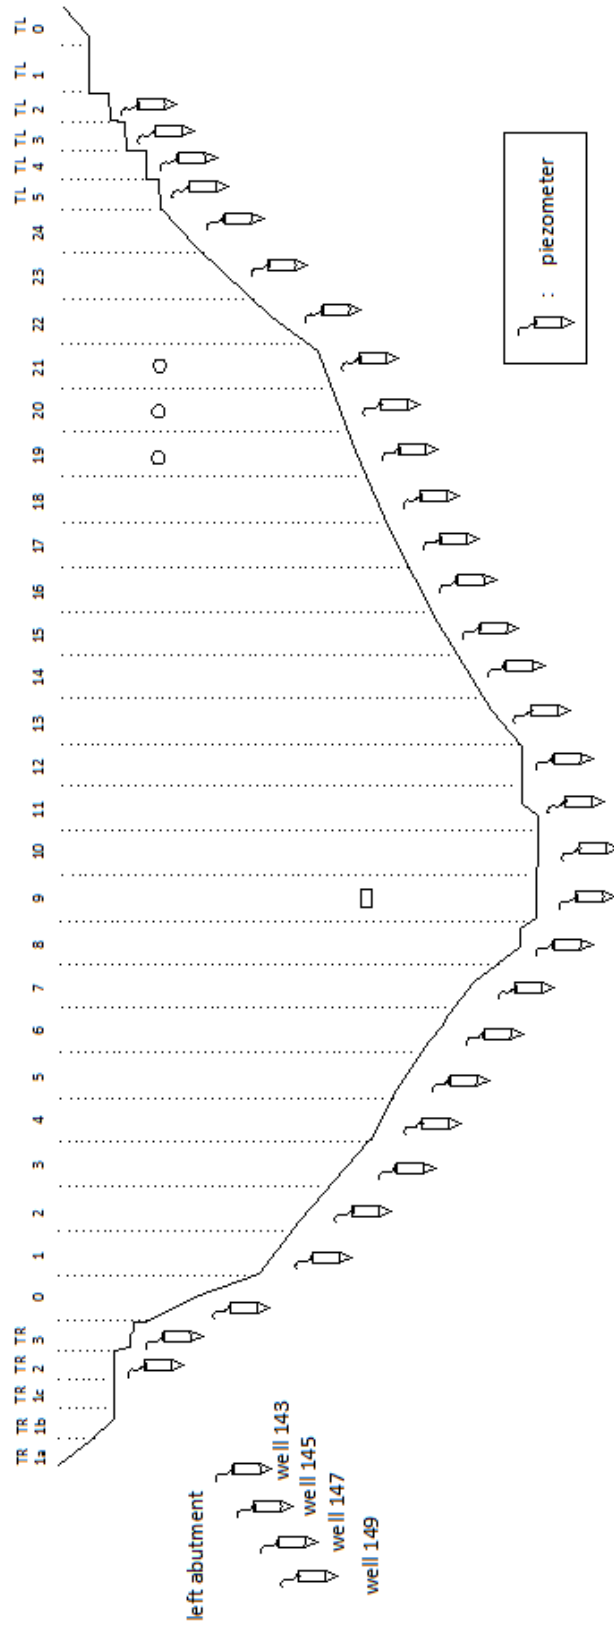
Figure 5.1 Piezometer-configuration in Option 1

In Gökçekaya Dam, three options for piezometer applications were proposed. Definition sketches are presented to demonstrate the instrumentation configuration for piezometers in Figures 5.1-5.3 In Option 1, the total number of required vibrating wire piezometers was determined as 35. On the right thrust block, TR-2 and TR-3 blocks (Figure 4.5) were selected and one of their drain holes was considered to be utilized for piezometer installation. Similarly, on the left thrust block, 4 blocks, from TL-2 to TL-5, were chosen to be monitored. Since this option concentrates on the amount of data gathered, all blocks from 0 to 24 were equipped with piezometers to monitor the change of pore water pressure between the sequential blocks. In this option, the existing standpipe piezometer holes on the right abutment were also evaluated. By considering their condition and location, wells 149, 147, 145 and 143 have been added to the monitoring system by installing piezometers. In the computations, the average depth where piezometers are embedded is taken as 10 m. The possible costs of drilling and backfilling are ignored.

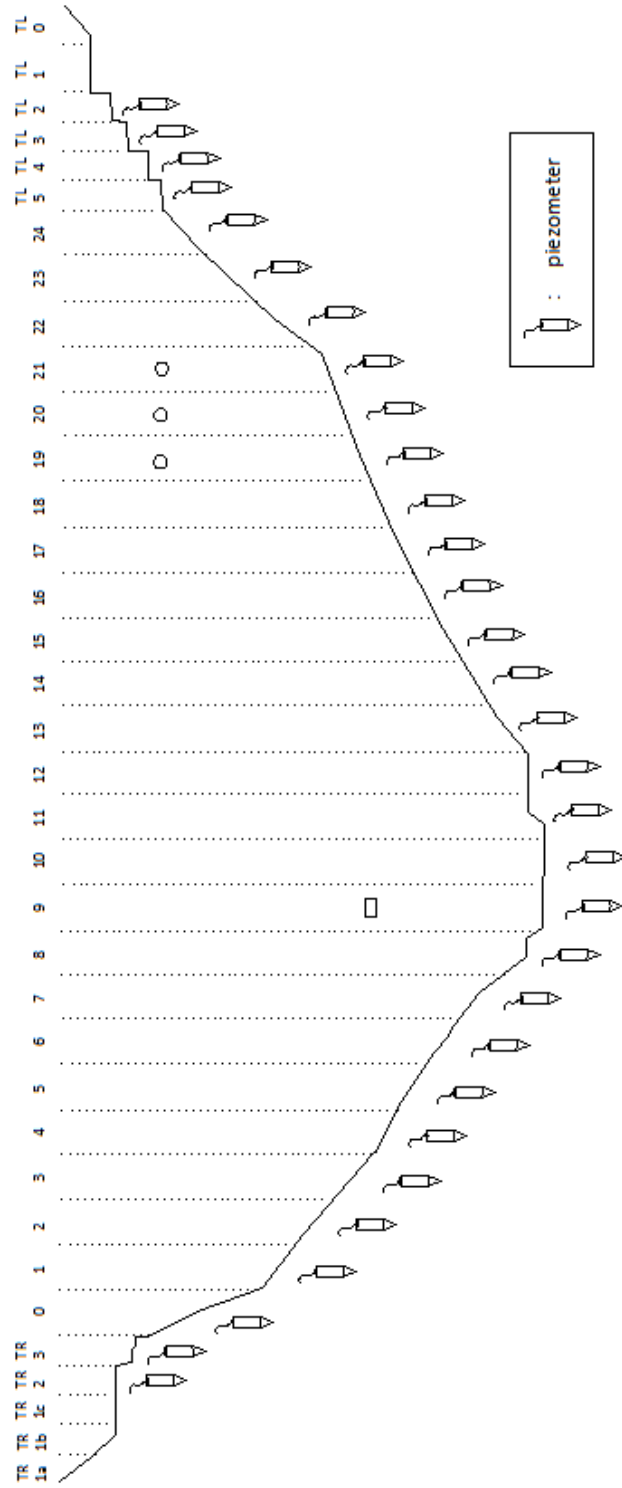
Figure 5.2 Piezometer-configuration in Option 2

In Option 2, the existing right abutment drain holes have been excluded because of the consistent results of manual well reading up to date and the closeness of the piezometers on blocks, TR-2, TR-3, and 0. The other installations in dam body have been taken as the same as Option 1. Total number of instruments in this option is 31. The Option 3 was suggested as a lower-cost alternative to Option 1 and Option 2.

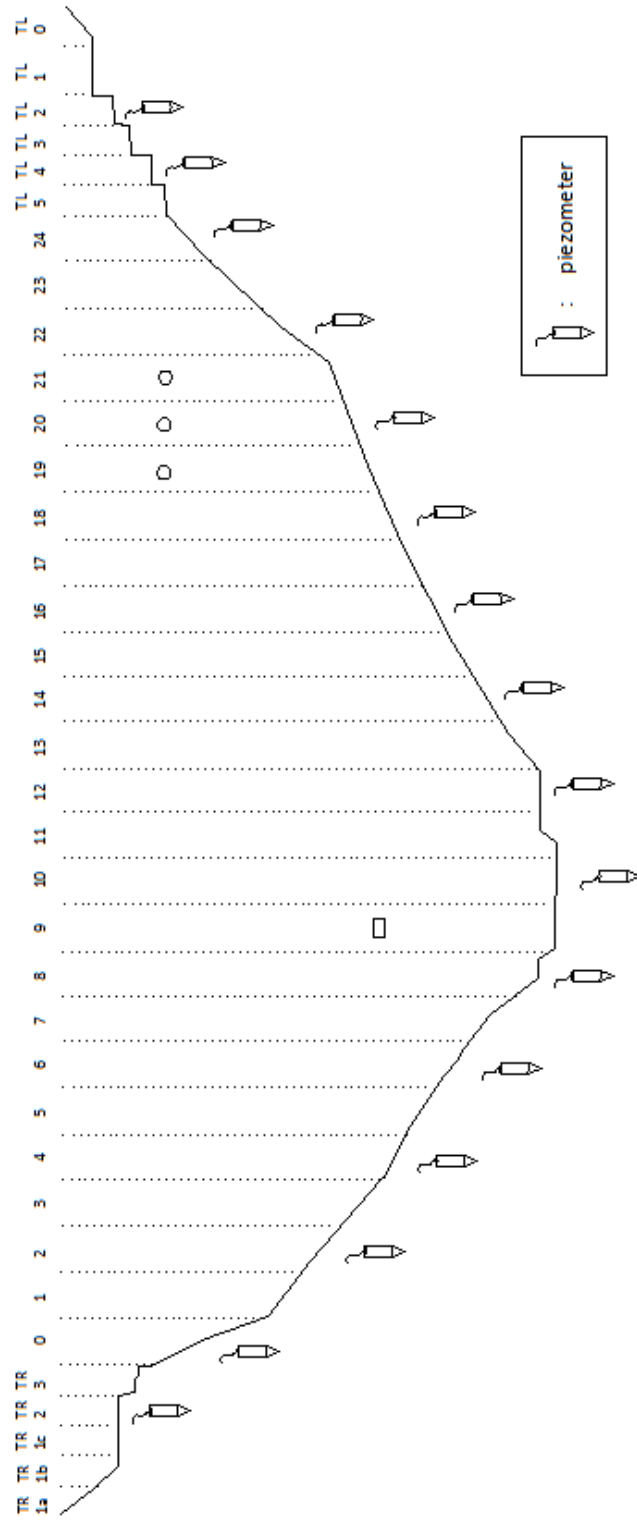
Figure 5.3 Piezometer-configuration in Option 3

In Option 3, the piezometers on the existing right drain holes were similarly discarded as in Option 2. Moreover, unlike the previous options, only one piezometer for two blocks was utilized. So the blocks with even numbers have been equipped with piezometers. These cost-cutting actions reduce the total number of instruments to 16.

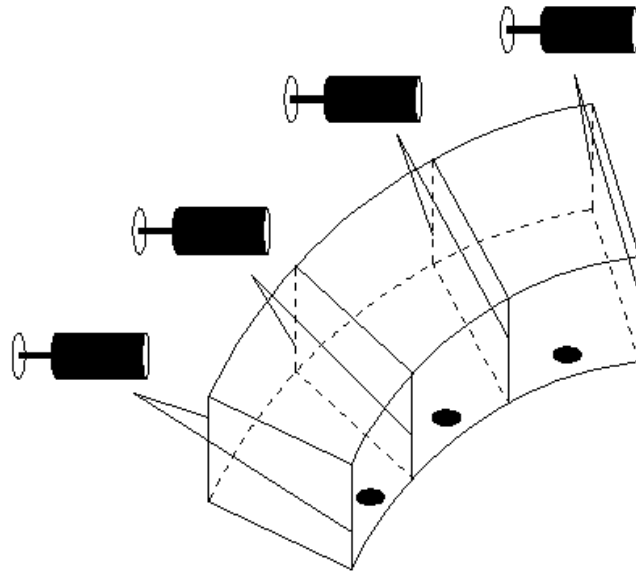
Figure 5.4 Jointmeter arrangement in Option 1

In Option 1, along the inspection gallery, every joint was equipped with two surface mount jointmeters. One jointmeter has been proposed for the downstream side, whereas the other one for the upstream side of the joint as seen in Figure 5.4. The reason behind this layout is that the hydraulic loading on an arch dam creates either tension or compression on the different zones of the shell and two piezometers on both the upstream and downstream faces help to monitor the movement precisely. Moreover, after the repair works on the leaking joint on Block

1, the downstream face of the horizontal joint has been suggested to be instrumented with surface mount jointmeters in order to verify the performance of the repair works done. After the computations, a total number of 65 surface mount jointmeters are required in this option. Cables have been conveyed along the ceiling of the gallery by cable trays and a total length of 10.12 km of cable was required.

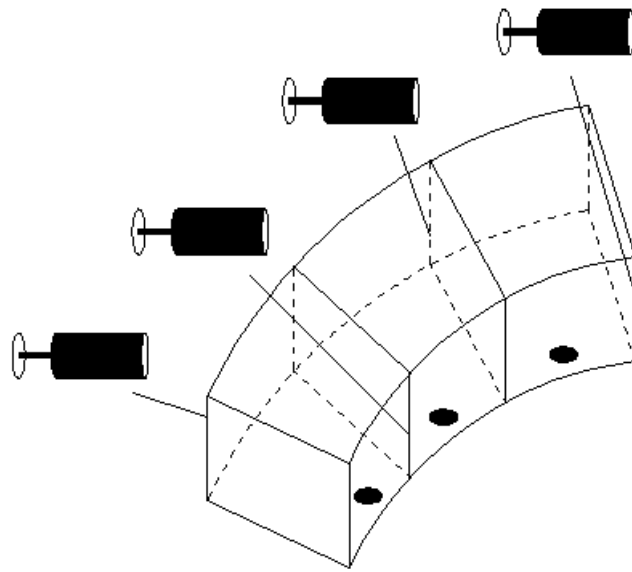
Figure 5.5 Jointmeter arrangement in Option 2

Option 2 suggests a more economical layout than Option 1 by minimizing the data loss by proper placing of 34 surface mount jointmeters. In this option, a construction joint has been equipped with only one surface mount jointmeter on either downstream or upstream face. In addition to this, if a joint has been monitored on its downstream

face, the neighboring joints have been instrumented on the upstream face as shown in Figure 5.5. This layout has created an alternating plan and thus reduced the required number of instruments. As a result of fewer instruments, total length of cables has been reduced to 5.59 km.

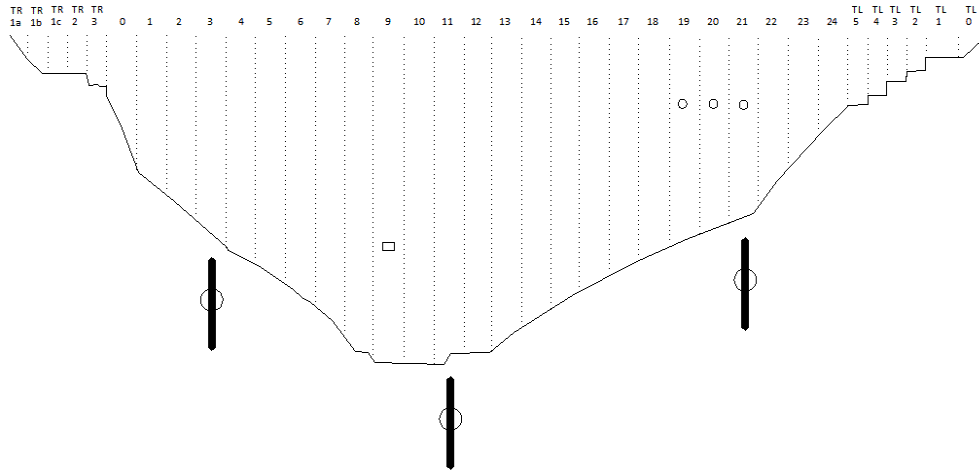
Figure 5.6 Tiltmeter arrangement in Option 1

Option 1 recommends installing three surface mount clinometers inside the gallery. The dam body was first divided into two and the location of the first clinometer was determined as block 11. The remaining two clinometers were installed to the blocks 4 and 21 (see Figure 5.6). The reason behind the selection of blocks 4 and 21 was the equality between their distances to the thrust blocks and the height from the crest of the dam. Finally, the total required length of the cable has been determined as 441 m.

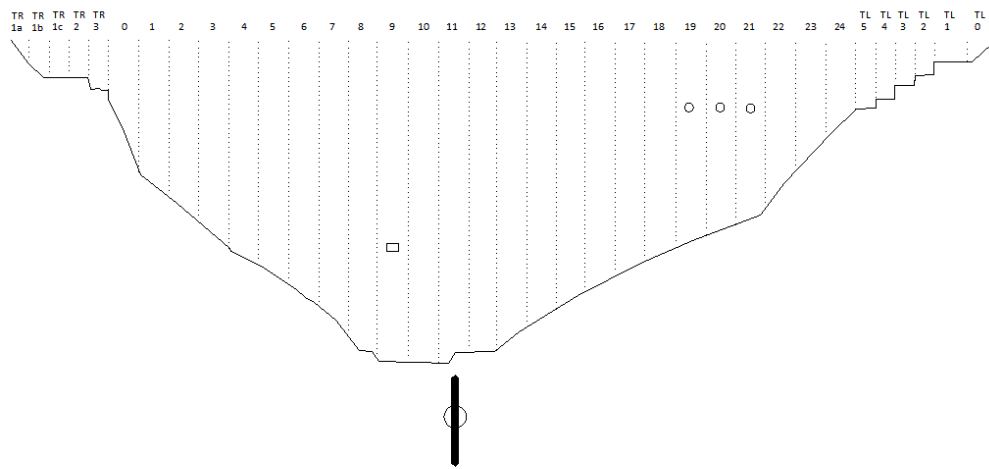
Figure 5.7 Tiltmeter arrangement in Option 2

Option 2 suggests installing only one clinometer on the block 11 as shown in Figure 5.7. As a result of being an economical alternative, this layout reduces the total cost around one third. In Table 5.4, the costs of two rotation (tilt) monitoring options are compared to each other according to their cost items and total costs. Detailed tables concerning cost computations are presented in Appendix E.
