BUILDINGS UNDER RECURRING NEAR-FIELD EARTHQUAKES

A THESIS SUBMITTED TO
THE GRADUATE SCHOOL OF NATURAL AND APPLIED SCIENCES
OF
MIDDLE EAST TECHNICAL UNIVERSITY

SEPTEMBER 2010

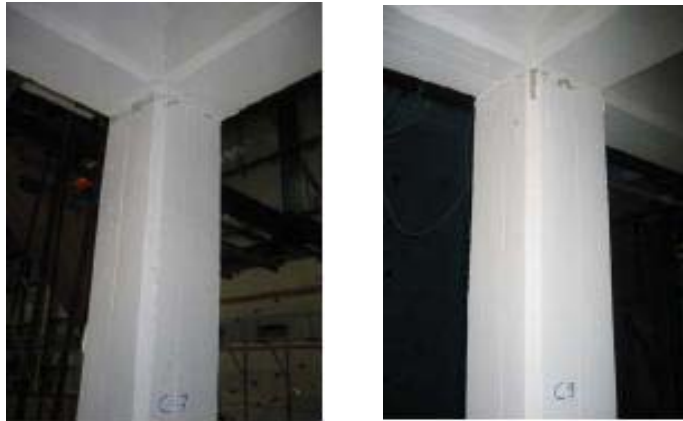
Figure 3.7 Damage observed at the second story columns after the 0.15 PGA test (Adapted from Jeong and Elnashai, 2004)

Damage pattern was identified by visual inspection after the 0.15 PGA test (Figs. 3.6 and 3.7). Only minor damage occurred during the test. It was observed at the top of second story columns. No cracks were observed at the bottom of these members. The beams were undamaged (Jeong and Elnashai, 2004).

Damage pattern identified through visual inspections after the 0.15g PGA test showed that only light damage occurred at the top ends of the second story columns as depicted before in Figs. 3.6 and 3.7. Thus, these columns were judged to be in IO performance level. The acceptance limits of ASCE/SEI-41 (2007) were found to be very conservative since the columns were calculated in CP performance level (Table 3.5).

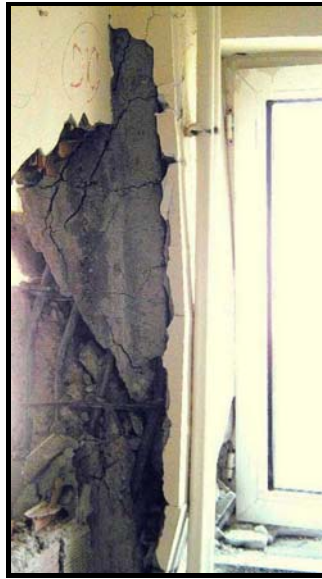
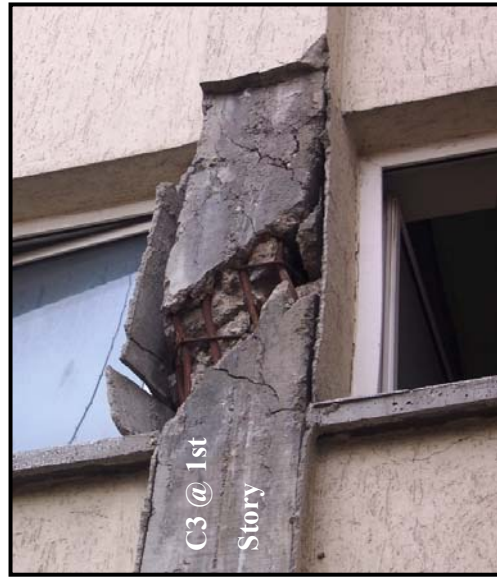
Figs 4.36 and 4.37 indicate extensive shear damage in the first story captive column-C12 and first story captive column-C3.

Figure 4.37 Damage to the first story captive column-C3 (a) inside and (b) outside view (Bolu)

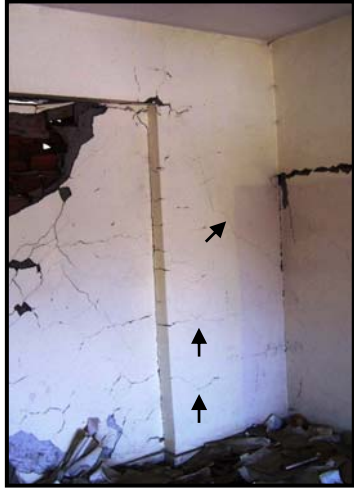
In the second story columns, damage was lighter than that of the first story. It consisted of shear (Figure 4.38) or combined flexural and shear cracks (Figs. 4.39 and 4.40).

Figure 4.39 Shear and flexural cracks in the second story column-C12 (Bolu)

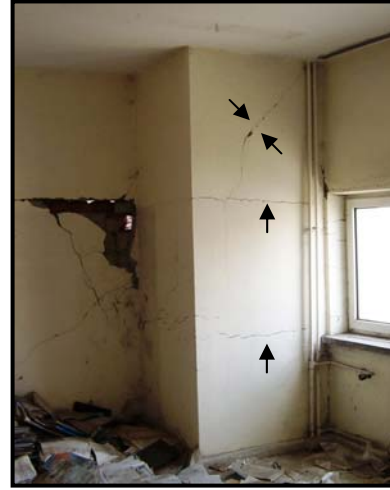
Figure 4.40 Shear and flexural cracks in the second story L-shaped corner column-C16

Overall detailing of the columns was insufficient to achieve a ductile behavior for the following reasons: (i) inadequate stirrup spacing, (ii) insufficient transverse reinforcement area (iii) non-existing confinement zones (iv) 90° hooks of the horizontal hoops and probably poor workmanship. These were observed through shear damage in captive columns and incipient shear cracking in bottom three story columns.

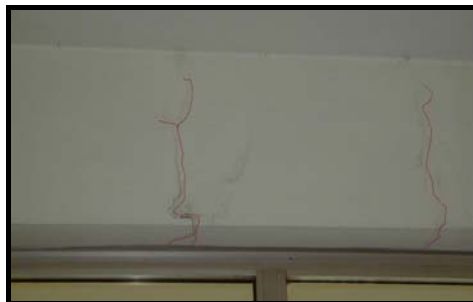
Beams in the bottom three floors suffered flexural cracking in different intensities (Hairline cracks-extensive flexural cracks). Damage was the most severe in the ground floor beams (Figs. 4.41-4.44) and they were judged to be in a performance level between “immediate occupancy” and “life-safety”. Spalling of concrete was rarely noticed.

Figure 4.41 Flexural cracks in the ground floor beam-B8 (Bolu)

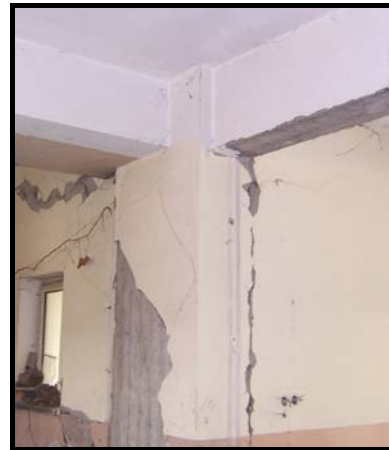
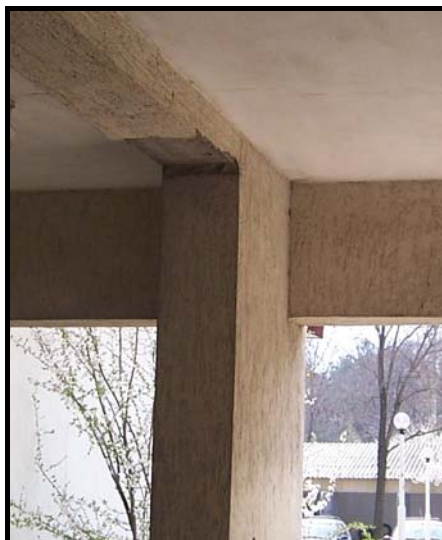
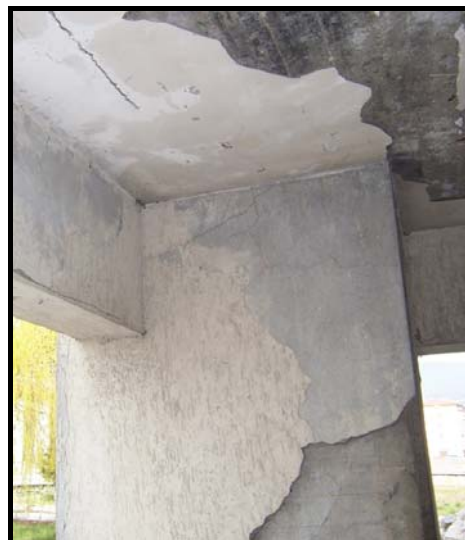
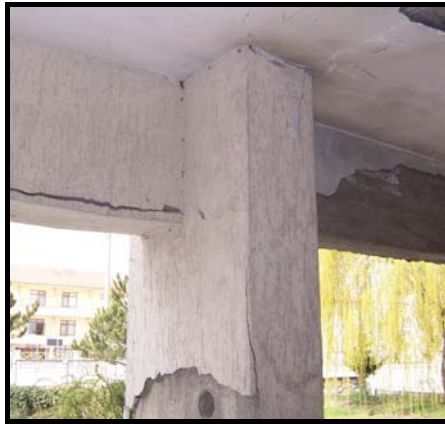
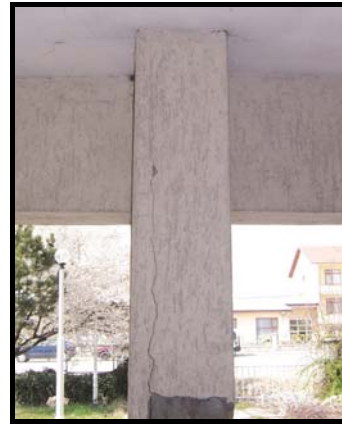
Although no transverse reinforcement was used, no distress was observed in the interior and exterior beam-column joints (Figs. 4.45-4.50). Critical shear stress might have not been reached.

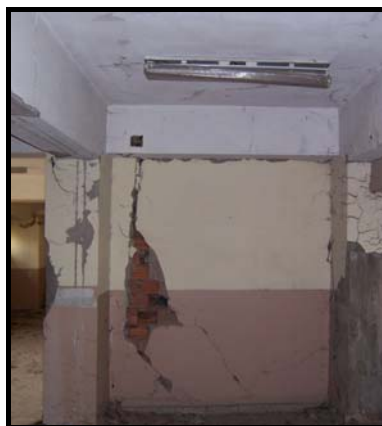
Figure 4.51 Severe damage to the infill wall between the ground floor columns-C6 and C10 (Bolu)

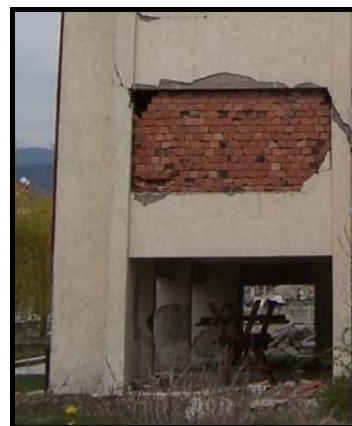
Figure 4.52 Severe damage to the infill wall between the first floor columns-C12 and C16 (Bolu)

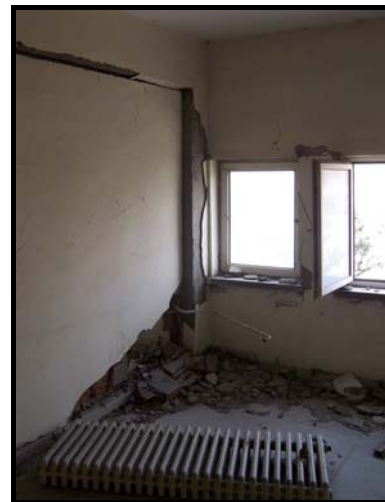
Nonstructural damage in the portions of bottom three stories was significant; partial or complete collapse was observed in the partitions, ceiling panels, lighting fixtures, heating, ventilation, air-conditions equipment and windows (Figs 4.55 and 4.56)

Figure 4.56 Nonstructural damage to the heating system and partition walls (Bolu)

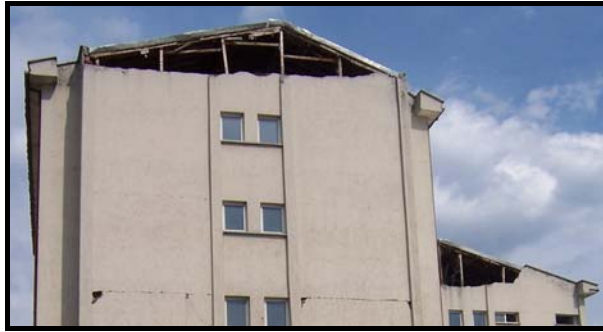
Structural damage observed in the upper two stories was relatively minor. Nonstructural damage was noticeable in these stories. Crackings in the plaster were observed. The damage in the roof consisted of cracking and collapse of the support walls (Figure 4.57). The fallen parts posed threat to the safety of the people outside the building.

Figure 4.57 Damage to the roofs of the main and the adjacent building (Bolu)

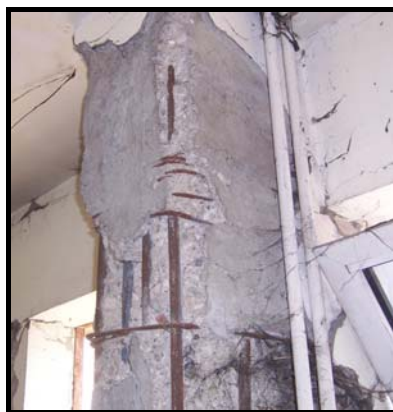
Poor workmanship was noted considering the damage to the ground story column-C3 (Figure 4.58) and first story column-C4 (Figure 4.59). Transverse and longitudinal bars were improperly placed in those columns during the construction.

Figure 4.58 Disengagement of ties (Bolu)

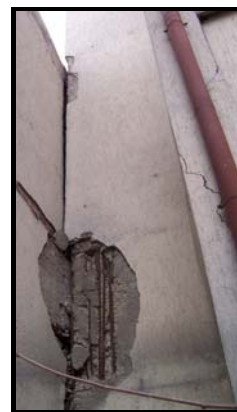
Figure 4.59 Longitudinal reinforcement in the first story L-shaped corner column-C4

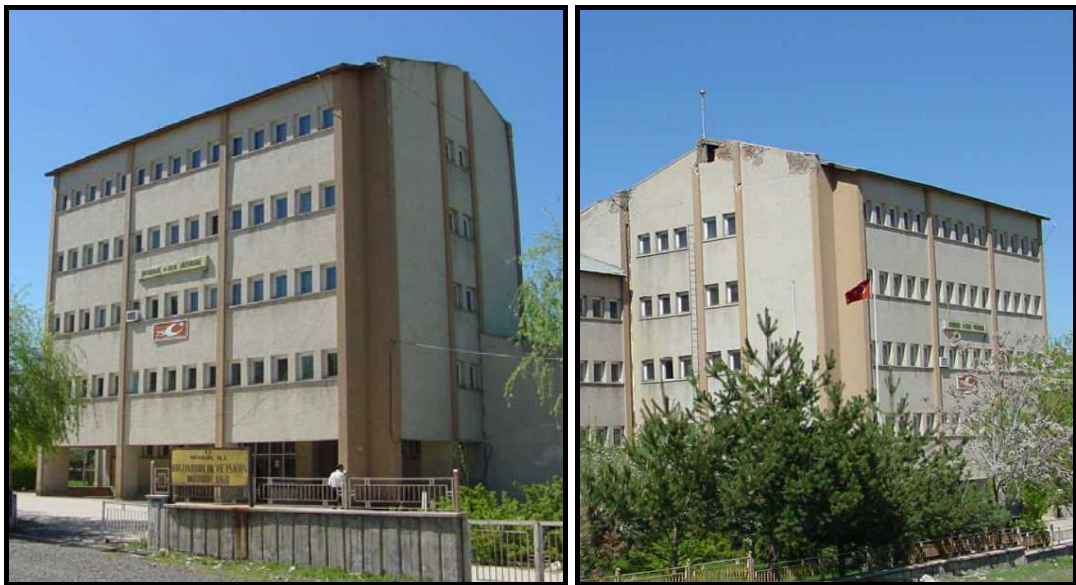
The building in Bingöl sustained moderate damage that corresponds to a level between “immediate occupancy-life safety” after the earthquake (Figure 4.60).

Figure 4.60 Side views of the MPWR building in Bingöl after the 2003 earthquake (a) the case study building, (b) the case study building and the adjacent four-story facility

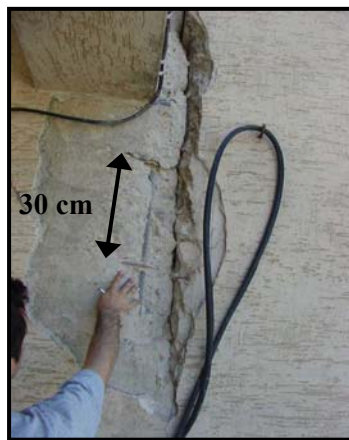
Another significant damage occurred in the ground story column-C12 (Figure 4.63) and L-shaped corner column-C16 (Figure 4.64). The column-C12 was adjacent to the one-story facility building at the ground floor and a partial spalling of concrete cover was observed at its contact surface with the adjacent structure.

Figure 4.63 Damage to the ground floor column-C12 and sparsely spaced ties

The existence of inadequate lateral reinforcement was observed in the ground story column-C12 (Figure 4.63). Distance between the transverse bars was measured as 30 cm, even more than what it should be in design (20 cm). The transverse reinforcement which consisted of $\Phi 8$ ties spaced at 30 cm intervals was insufficient in the existence of columns with 30 and/or 40 cm width.

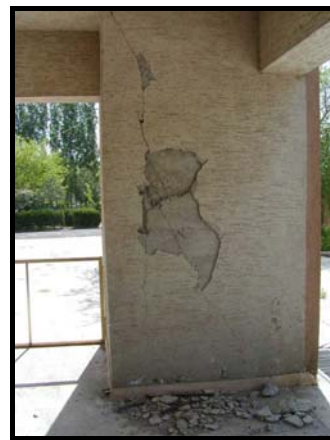
Figure 4.64 Extensive shear crack in the ground floor L-shaped column-C16

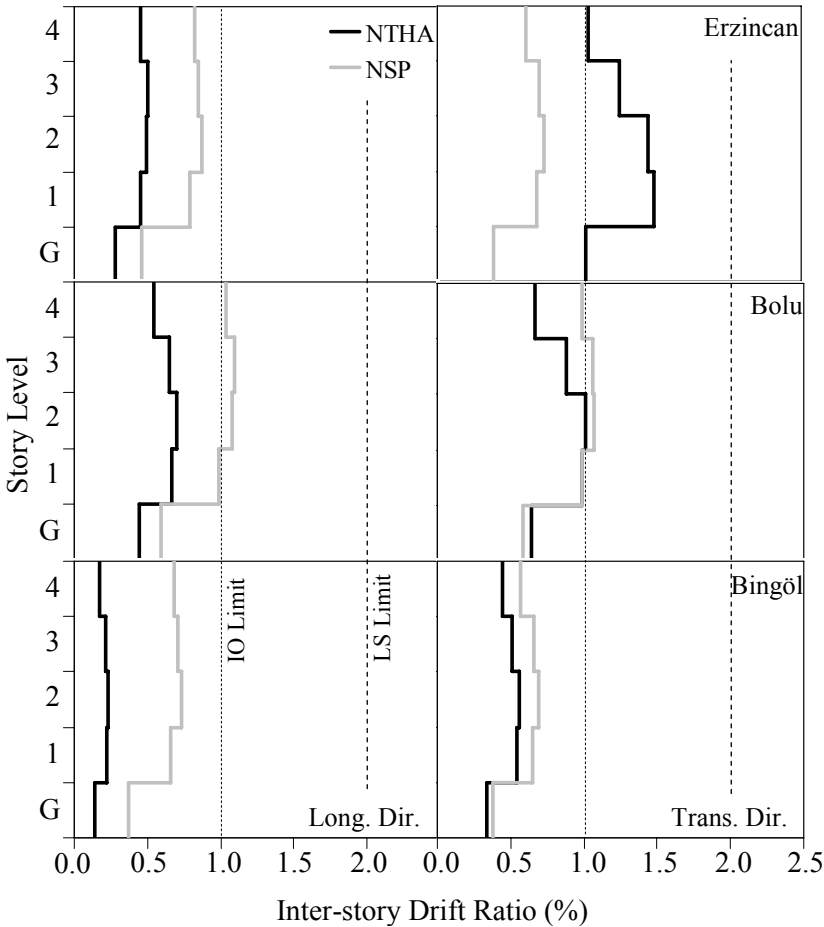
Figure 5.13. Comparison of ISDRs according to the NTHA and nonlinear static analysis results in the longitudinal and transverse directions of the buildings

The maximum ISDRs obtained from the NTHA and NSP are compared for the longitudinal and transverse directions of the buildings as depicted in Figure 5.13. The discrepancy between two analyses is due to divergent maximum displacement values shown in Table 5.6. This discrepancy can be observed in Figure 5.14 where maximum story displacements regarding the NTHA and NSP are shown.

The ISDRs of Figure 5.13 indicates that the Erzincan building falls to IO level according to CM method and determined to be in IO-LS according to NTHA results while it was judged to have a performance level of IO after the earthquake.

The building in Bolu is at IO level according to the NTHA result while it is slightly higher than IO level according to CM method. The building was judged to be in LS-CP performance level just after the earthquake. The Bingöl building had a performance level of IO for both analyses while it was judged to be in IO-LS after the earthquake.

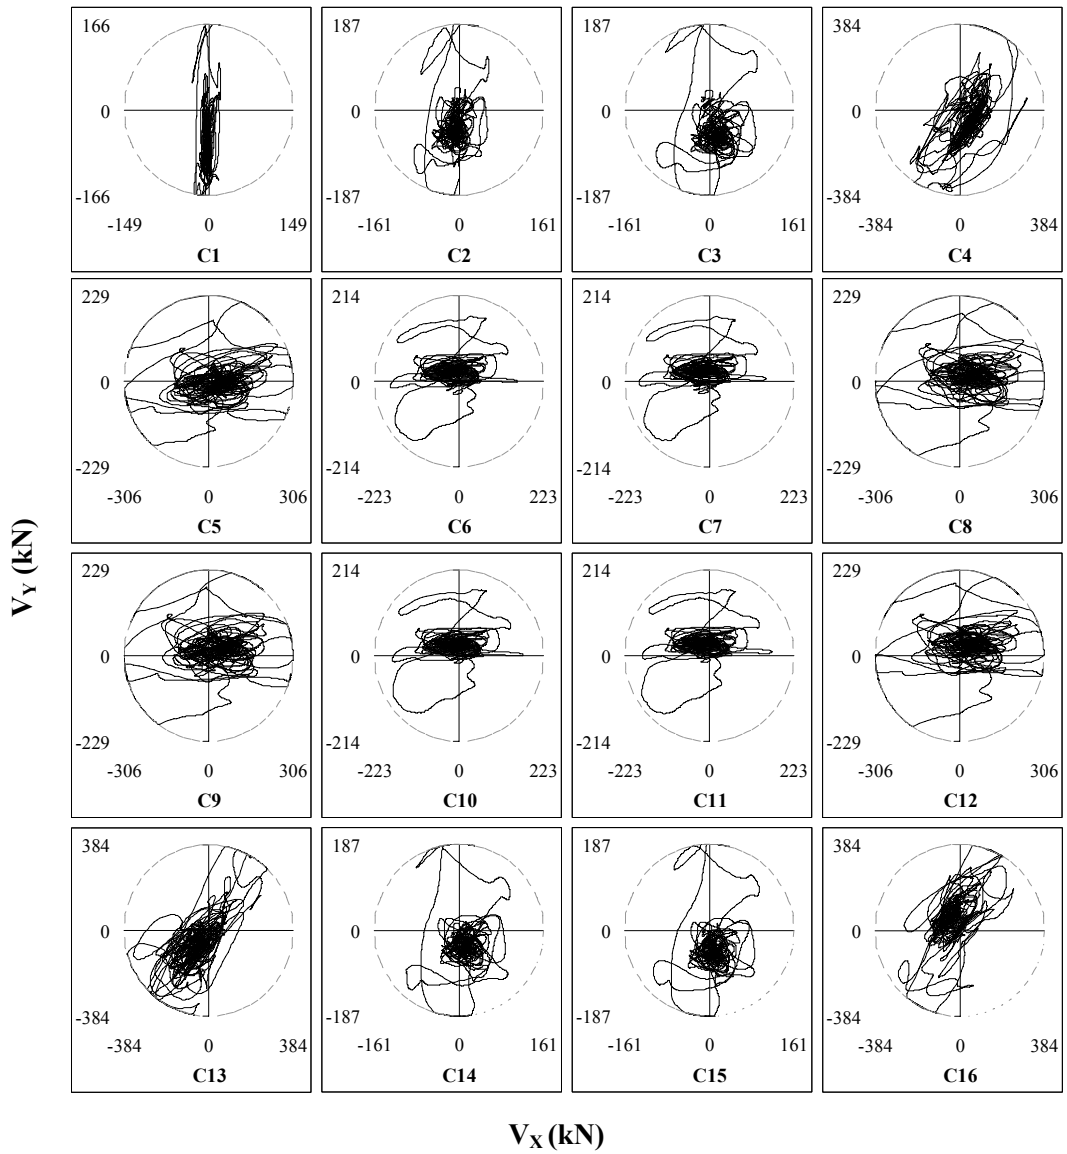
Figs. 5.13, B.1 and B.2 indicate that except for the interior columns-C6,C7,C10 and C11, all ground, first and second story columns of the Erzincan building reach their shear force capacities that corresponds to CP performance level. However, the technical report prepared by the MPWR engineers (Technical Report on Retrofit of the MPWR buildings in Erzincan and Bingöl, 2004) indicates that

only minor hairline shear cracks were observed at the L-shaped corner columns of the ground story in the Erzincan building.

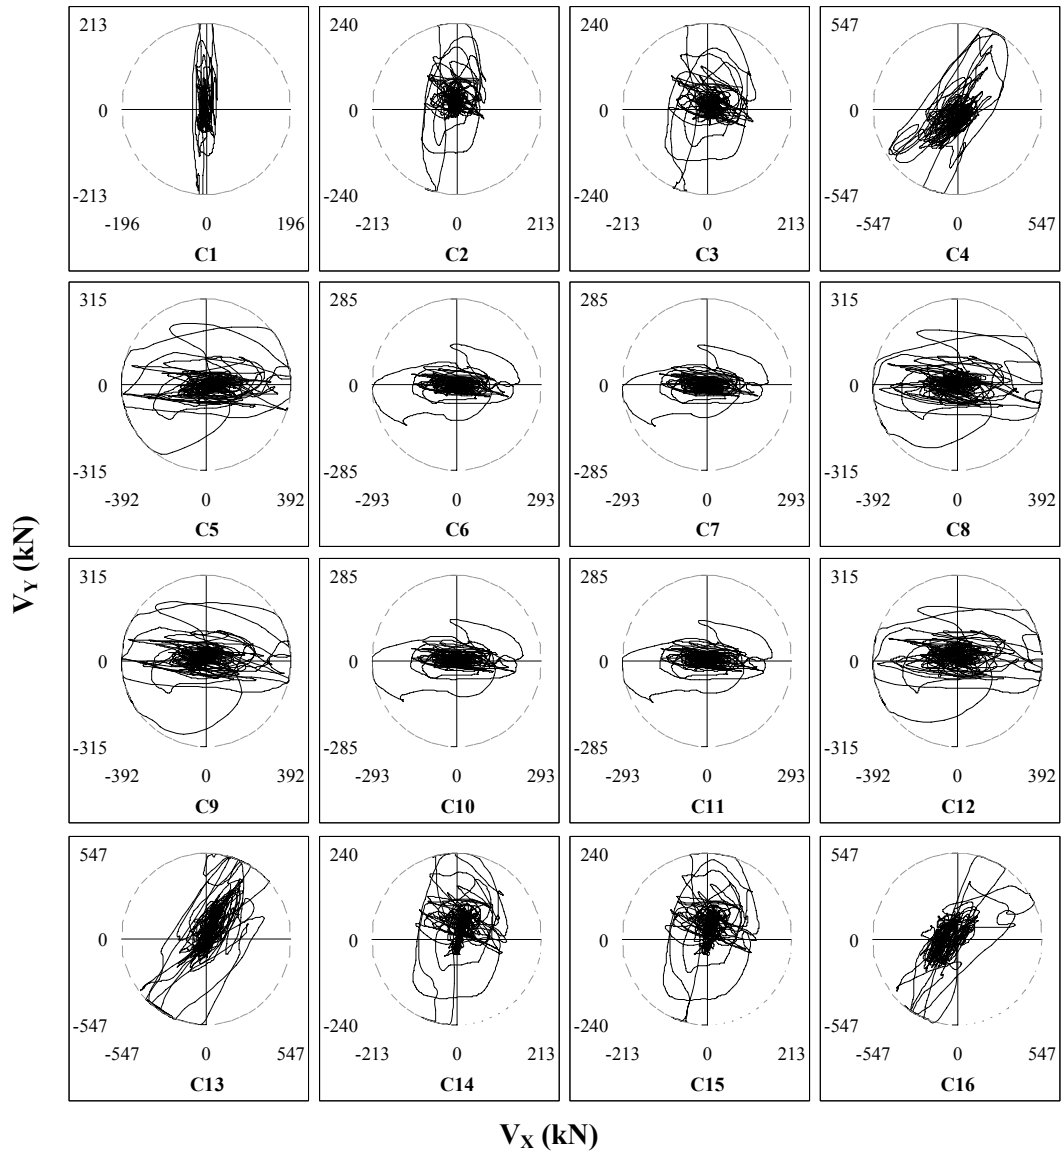
Figure 5.16 Bi-directional shear response history of the ground story columns in the Bolu building. The dashed lines represent the shear strength calculated by the Eq. 5.1. The values are in the longitudinal (X) and transverse (Y) directions of the building

Figure 5.14 indicates that all ground story columns of the Bolu building reach their shear capacities corresponding to a CP level. In the first and second stories, shear demand of the interior columns and the columns C2 and C13 are lower than their shear capacities (Figs. B.3-B.4) but the rest are also in CP level.

The investigations following the earthquake indicate that severe shear damage was observed at the ground story columns of the Bolu building. The first and second story columns also sustained shear damage but the shear crack width was smaller than those occurred at the ground story columns. Shear failure was observed only in the captive column-C3 of the ground and first stories.

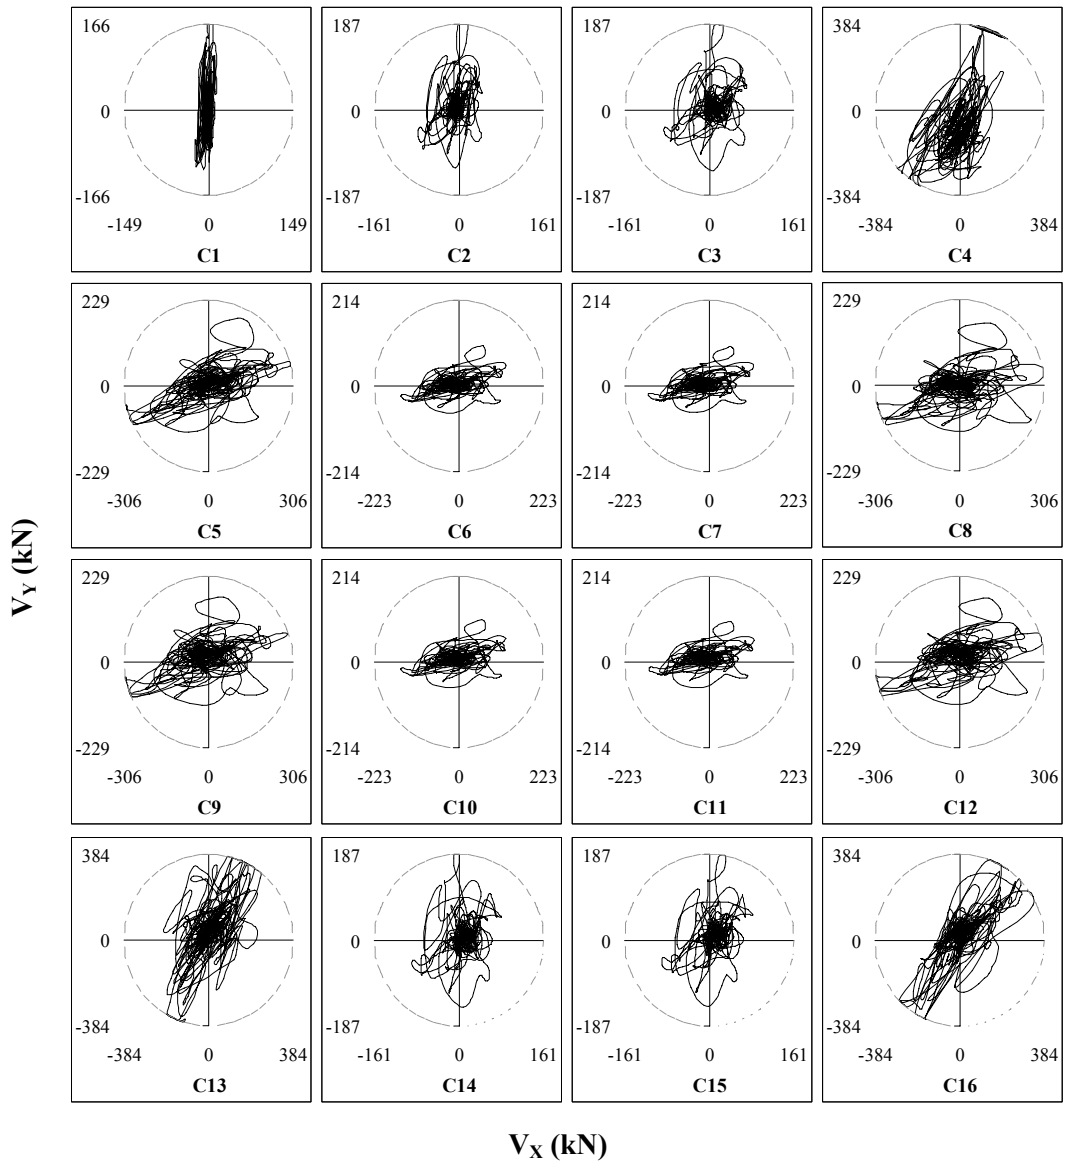
Figure 5.17 Bi-directional shear response history of the ground story columns in Bingöl building. The dashed lines represent the shear strength calculated by the Eq. 5.1. The values are in the longitudinal (X) and transverse (Y) directions of the building

In the Bingöl building, the computational results show that except for the four interior columns, all ground story columns reach their shear capacities corresponding to a CP performance level (Figure 5.17). The columns C2, C6-C12 of the first story (Figure B.5) and C1 and C4 of the second story (Figure B.6) are also in CP level. However, the observed damage in the columns of the Bingöl building consisted of only minor shear cracks at the exterior frame and severe shear damage in the captive column-C3, but no shear failure was noticed.

In the light of performed analyses, it is obvious that the computed damage for the columns overestimates the observed damage for all buildings. The reason why it is overestimated may be due to the limitation of the shear strength assigned to the columns with nonconforming condition, in accordance with the prescriptions of ASCE/SEI-41. This guideline assures that for such columns “*where the longitudinal spacing of transverse reinforcement exceeds half the component effective depth, the transverse reinforcement shall be assumed not more than 50 percent effective in resisting shear*”. Hence, during the calculation of shear capacities of columns by means of Eqn. 5.1, only half of the term corresponding to the contribution of transverse reinforcement was taken into consideration. Moreover, in the presence of low quality concrete, the effect of this limitation in calculating the shear capacity of a column becomes significant that this provision should be reexamined.

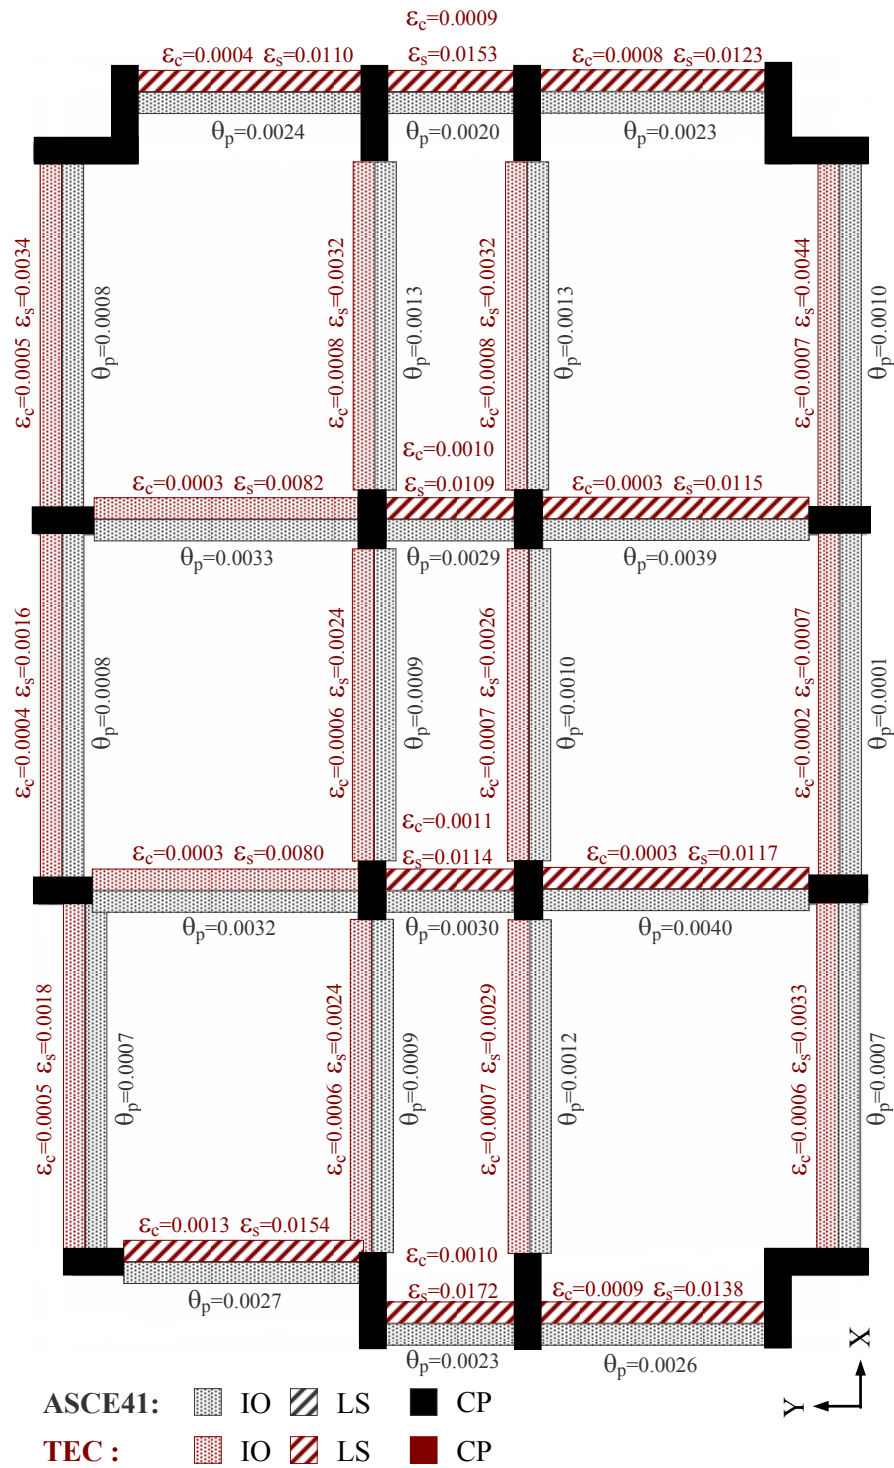
Figure 5.20. Comparative assessment of the ground floor beams in the Bingöl building as per ASCE/SEI-41 and TEC

TEC and ASCE/SEI-41 give varying degrees of damage level for evaluation of the beams. Figs. 5.16-5.18 assure that the damage level estimation based on TEC are more conservative than ASCE/SEI-41 in some beams. This is clearly evident from Figure 5.20 that the beams in the transverse direction of the Bingöl building are in IO level according to ASCE/SEI-41 while most of them are in LS level according to TEC. This difference is related to the different acceptance criteria and limit values that were described in the preceding paragraphs. As a footnote related to TEC, following rationalization may be offered: critical criterion in determining the performance level of the nonconforming beams is the steel strain. That is because the longitudinal reinforcement ratio of the beams is very low (0.16-0.21%) compared to that of most other typical beams. Thus, while high strain values occur in the tension steel, compressive strain in the extreme fiber of the concrete section is still at a very low value which is the typical behavior in an under-reinforced section.

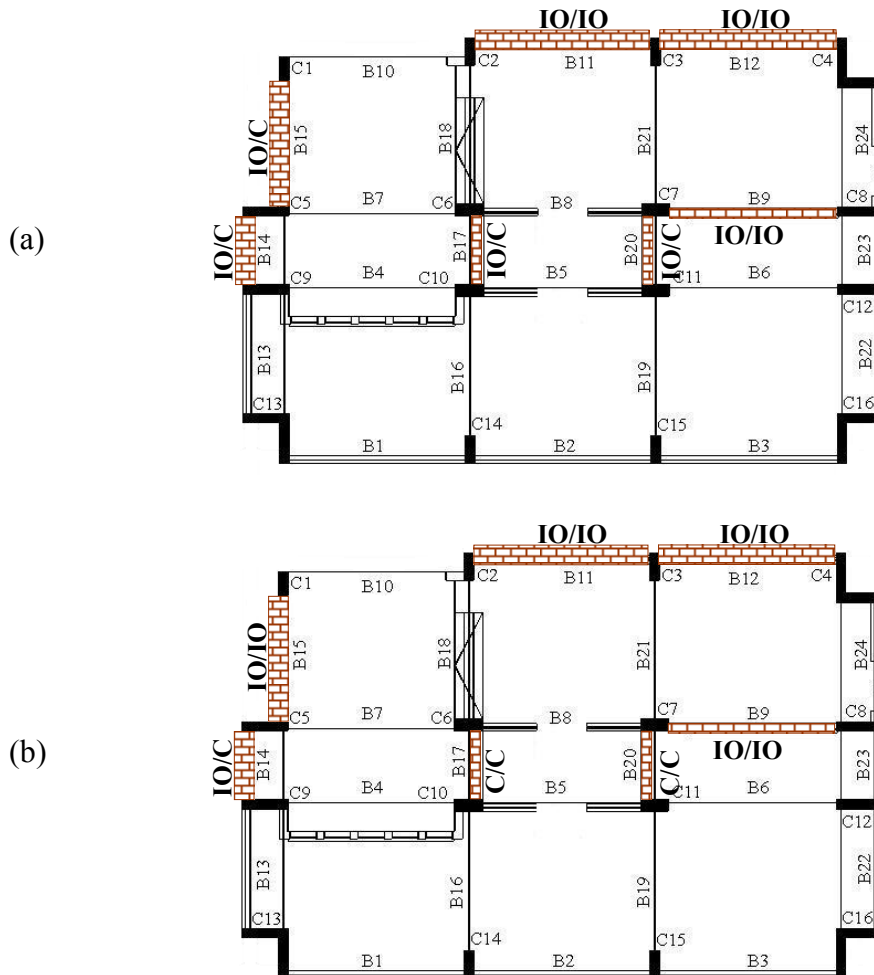
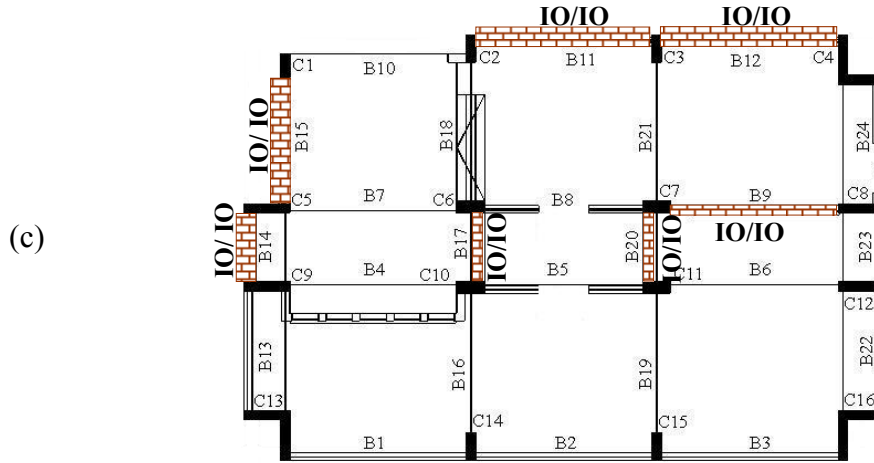
Figure 5.21. Comparison of the observed and calculated damage of the ground story infill walls regarding the (a) Erzincan and (b) Bolu buildings. (Observed Damage/Calculated Damage) IO : Immediate Occupancy C: Collapse

In Figure 5.21, “observed damage/calculated damage” is given through qualitative comparison for each in-filled frame. The infill walls were assumed to collapse when they reached their calculated critical strength. Since, infill walls are so brittle with negligible deformation capacity, behavior of the infill walls are limited by their strength values. In the evaluation process, the critical value of shear or compressive strength of the representative strut was taken into account. If the force demand reached the capacity, the infill wall was assumed to fail; otherwise it was assumed to be in immediate occupancy level. The assessment results indicate that the calculated damage in the Erzincan building matches the observed damage at the 43, 36, and 54 percent of the infill walls for the ground, first and second story, respectively. In the Bolu building, those values are 86, 93, 69 and in the Bingöl building, the agreement is 100, 79 and 69. The consistency between the calculated and observed damage is more obvious for the infill frames in the longitudinal direction of the buildings (Figure 5.18) but the assessment results overestimate the damage levels for those in the transverse direction in which the calculated ISDRs are much higher.
