THE RESTORATION PROJECT OF UKUR HAMAM IN BİRĐİ

A THESIS SUBMITTED TO
THE GRADUATE SCHOOL OF NATURAL AND APPLIED SCIENCES
OF
MIDDLE EAST TECHNICAL UNIVERSITY

SEPTEMBER 2011

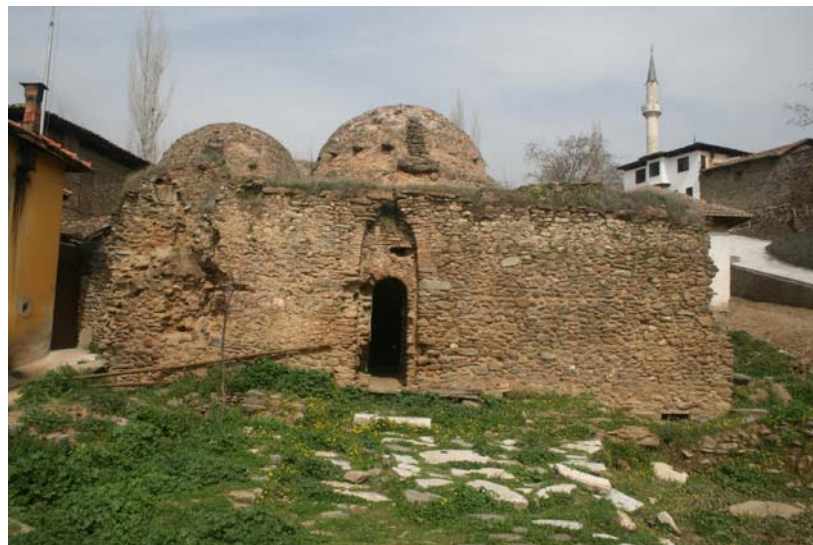
Figure 8, West Facade of Çukur Hamam,

Moreover, there is also a rectangular canal going under the facade directly to the space z03 which is just 0.40m from the left corner of the wall while facing the wall. The dimensions of this canal are 0.13m in height and 0.40m in width.

The north corner of the wall which is also the west wall of the space z01 is highly damaged. There is severe area loss at the edge of this corner; the door of the courtyard of the neighbor building is installed to this corner. At the lower parts, approximately 1.19m below the datum line the sub-foundation of the adjacent building has come over the wall surface.

In addition to that the south west corner of the wall has collapsed This part starts in vertically from the datum line to the up left corner and the width of this collapsed area is 0.40m. The damage is also visible from the space Z03. There is a deep crack at the intersection of the south and west walls of the space.

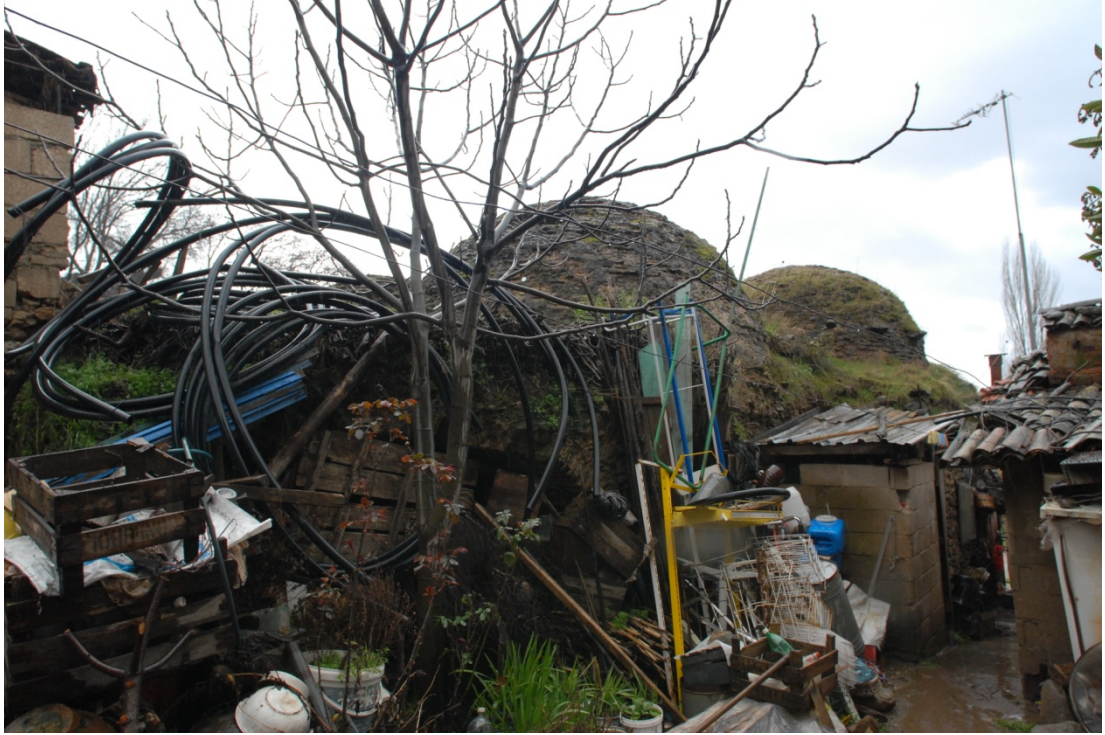
Figure 11, North Facade of Çukur Hamam

The North facade of the building is measured 14.51m. The facade can be reached from the courtyard of the building at north. A toilet is constructed where Z04 space projects at the north facade.that part cannot be observed because of this. There is also a fireplace which is used as an oven constructed by using the wall surface. The empty areas are used as a dump area for unused material by them. The construction technique of this wall is rubble stone masonry with brick fragments. The binding material is lime mortar.

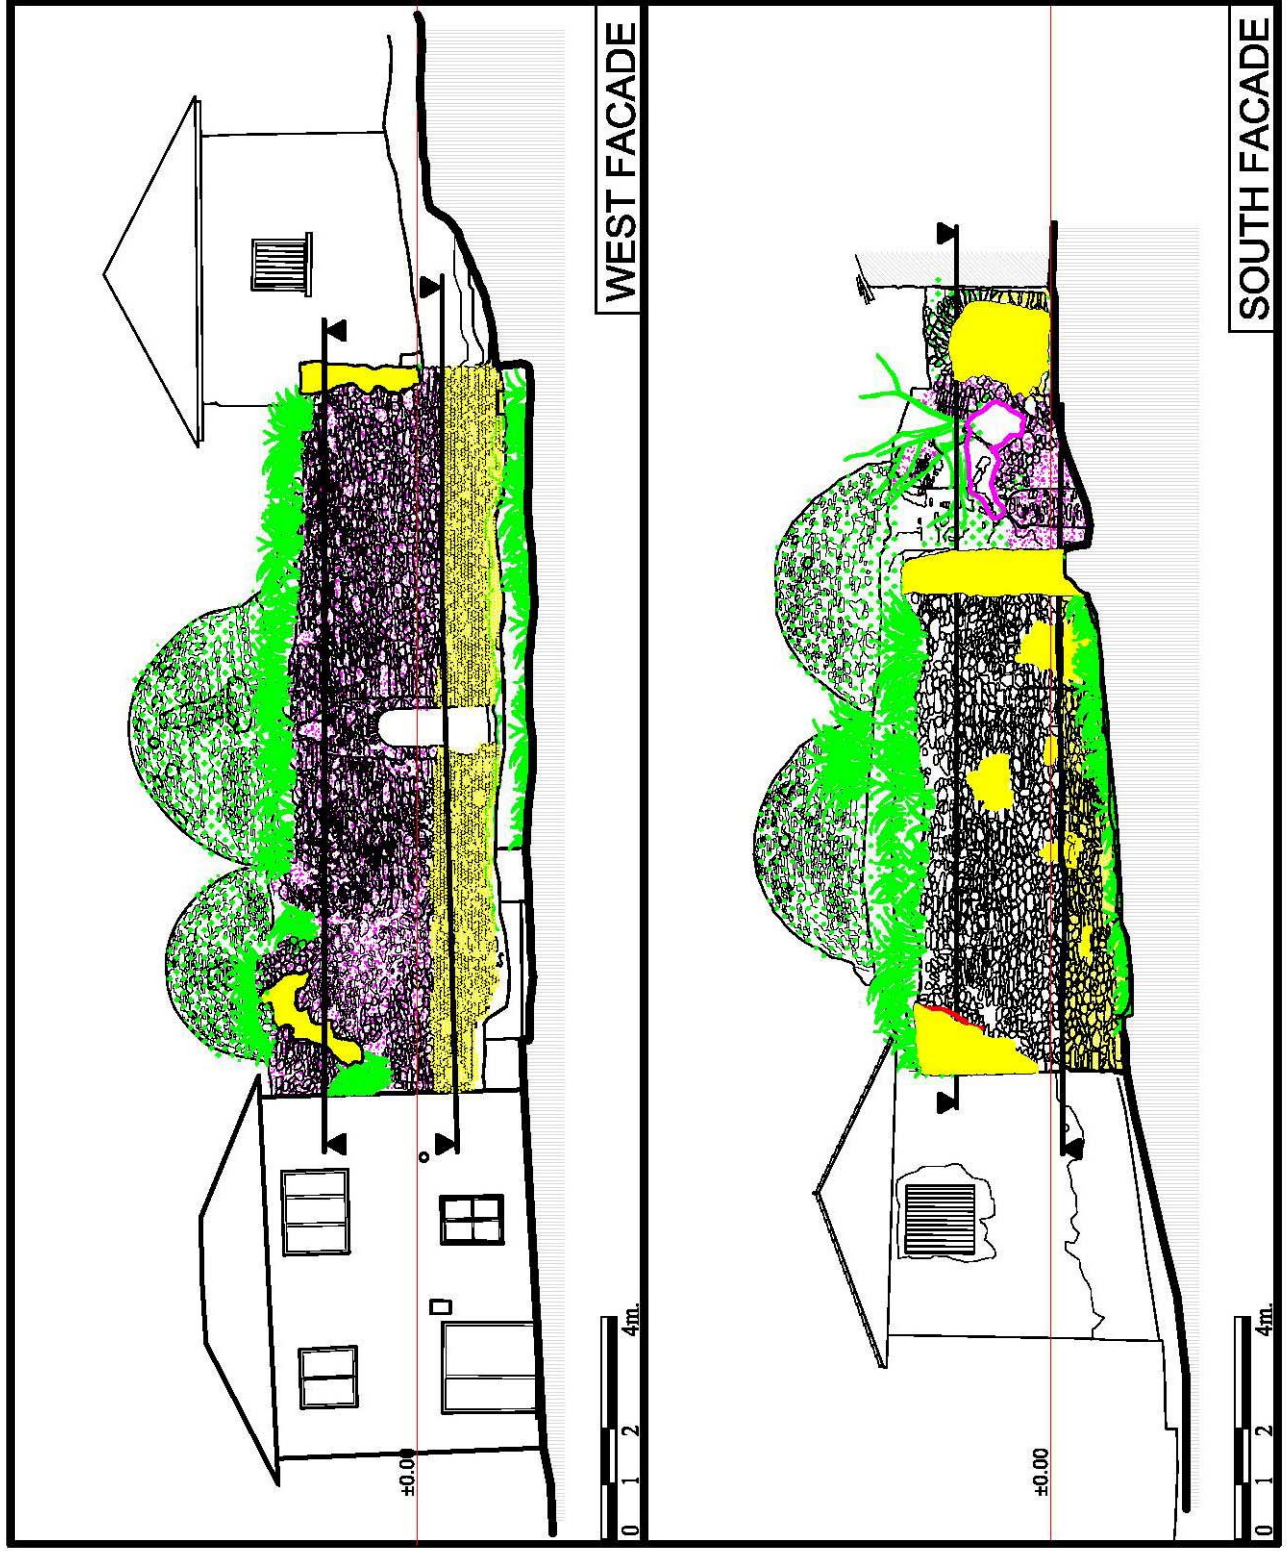
Figure 36, Deterioration Mappings, Facades

The south facade of the hamam is much more damaged than the west facade of the building. The corner of south facade and west facade is highly damaged. Starting 0.26m below the datum line to the top of the facade, the exterior face of it lost with a “v” shape in dimensions 0.17m at bottom and 1.18m at the widest point. Starting from the right corner, while facing, the wall the upper parts of the wall is also damaged. Rain water penetration caused material loss at these areas.

The infill material of the wall is exposed due to the plaster and mortar loss below the datum line 3.85m, 5.71 and 7.63m from the west wall. Moreover, the cause of these detachments and loss of mortar below the datum line can be rising damp.

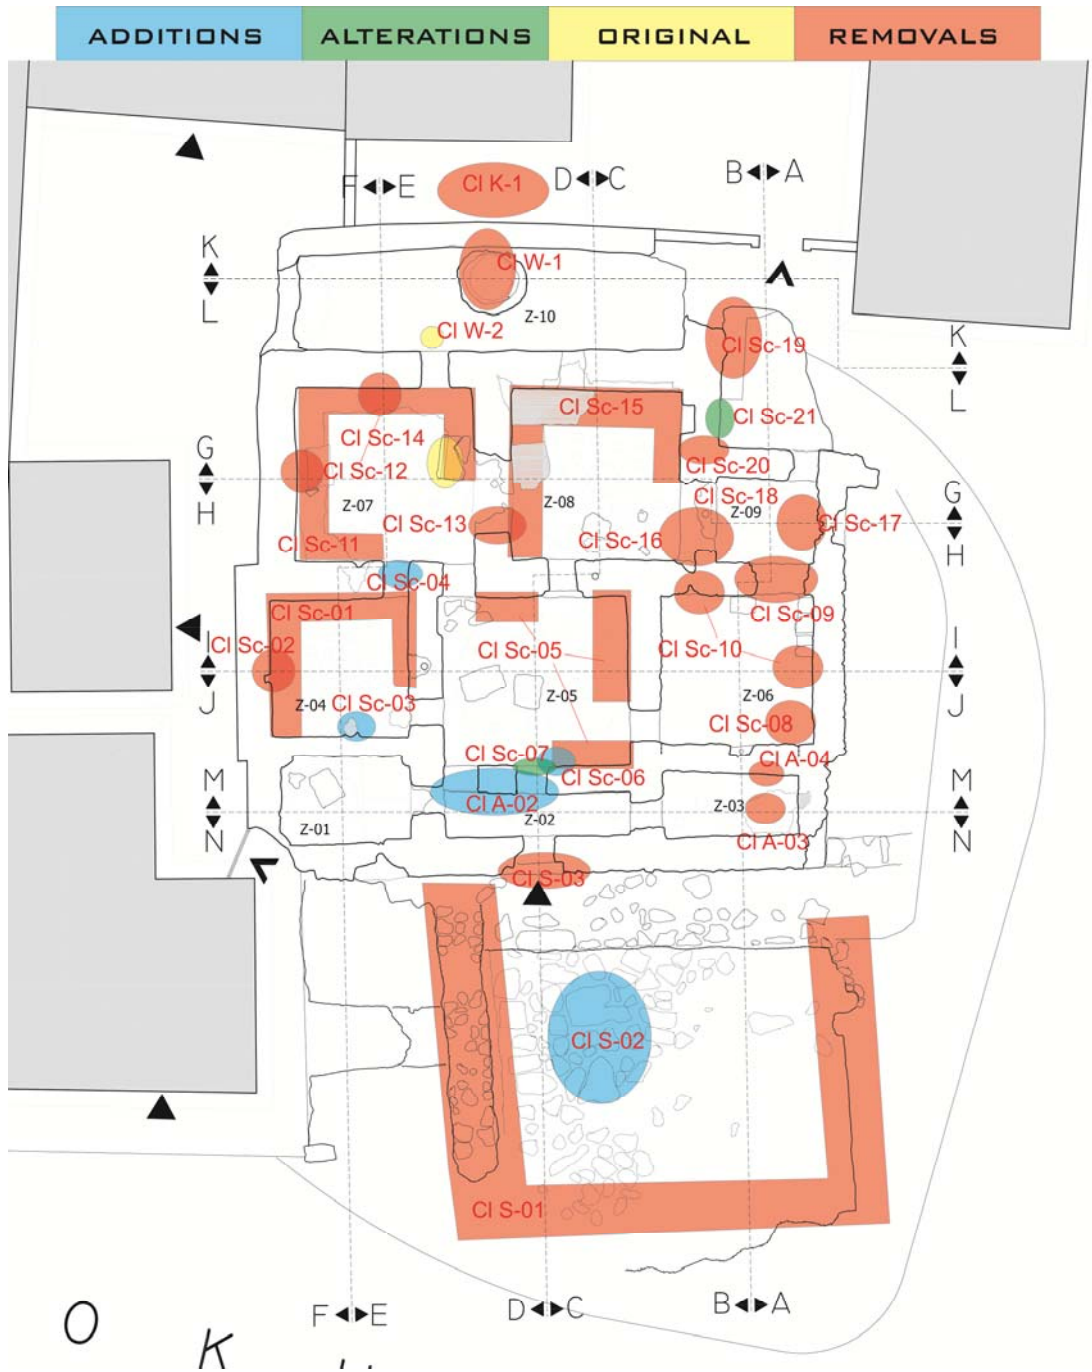
Figure 47, Evaluation of Clues, Mapping at Plan

location of *soğukluk* section. The existence of two layers of floor covering one below the other one (Cl S-02) at *soğukluk* section is questionable. According to WS and T, the one below belongs to the first and second phase of the building, the one above belongs to the third phase. In addition, the terra cotta pipe going vertically at the top of the door of *Aralık* section (Cl S-03) may refer to a missing chimney. Depending on CS, a chimney was build here.

Existence of a curved horizontal line of plaster at 20 cm above the ground level at the north wall of Z04 (Cl Sc-01) may indicate a *seki*. Depending on the traces coming from the building, there was a *seki* was here. Furthermore, the hole and the terra cotta pipe seen through the hole at the north wall of Z04 (Cl Sc-02), may refer to a missing tap and basin at this wall. Depending on the clues study and comparative study, there was a tap and basin. The vertical plaster trace going vertically from *cehennemlik* to the dome at west wall of Z04 (Cl Sc-03) is questionable. This may be a trace of a

The door between Z04 and Z07 has a different form and construction technique (CI Sc-04) which is questionable. Depending on the traces and comparative study within the building, at the second phase, this addition was made. The existence of a curved horizontal line of plaster at a certain level from the ground Z05 (CI Sc-05) may refer a missing *seki* at this space. According to the traces and comparative study, there was a *seki* existing there. The vertical plaster trace going vertically from *cehennemlik* to the dome at west wall of Z05 (CI Sc-06) is questionable. This may be a trace of a chimney which was built to work like a *tüteklik* at second phase. Furthermore, the door establishing the connection between Z02 and Z05 has iron installations at Z05 side (CI Sc-07) which might be used as a door frame. This alteration was made at third phase of the building. The superstructure of Z06 (CI Sc-08) had been collapsed. But from the corners of this space the form and construction technique is observed and the lower levels of the dome had remained. The opening between Z06 and Z09 can be seen as a door opening (CI Sc-09), but the terra cotta pipes going horizontally in the wall makes this thought impossible. The terra cotta pipe and the circular hole on it at the north and east wall of Z06 (CI Sc-10) may refer to a missing tap and basin at this wall. Depending on the traces coming from the building, there was a tap and basin here. The existence of a curved horizontal line of plaster at a certain level from the ground at Z07 (CI Sc-11) may refer a missing *seki* at this space. According to T and CS, there was a *seki* here. The hole and the terra cotta pipe seen through the hole at the north wall of Z07 and the terra cotta pipe and the circular hole on it at the east wall of Z07 (CI Sc-12) may refer to a missing tap and basin at these walls. Depending on the traces, there was a tap and basin here. The opening between Z07 and Z08 (CI Sc-13) starts with a smooth vertical surface and continues a half arch at west. The rest of this opening is collapsed. The smooth part indicates a door opening between these two spaces. In addition, the rounded canal on the marble flooring remained in Z07 (CI Sc-14) can be a trace of waste water disposal system at Çukur Hamam. According to comparative study, there should be a system like this at the building. The existence of a curved horizontal line of plaster at a certain level from

the ground at Z08 (Cl Sc-15) may refer a missing *seki* at this space. According to the traces and comparative study, there was a *seki* here.
