THE CONSERVATION PROPOSAL OF
HASANAĞALAR (ALAYDIN) HOUSE IN ALANYA

A THESIS SUBMITTED TO
THE GRADUATE SCHOOL OF NATURAL AND APPLIED SCIENCES
OF
MIDDLE EAST TECHNICAL UNIVERSITY

FEBRUARY 2012

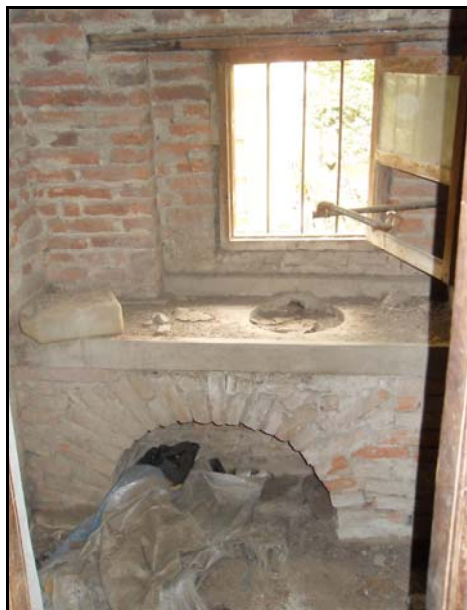
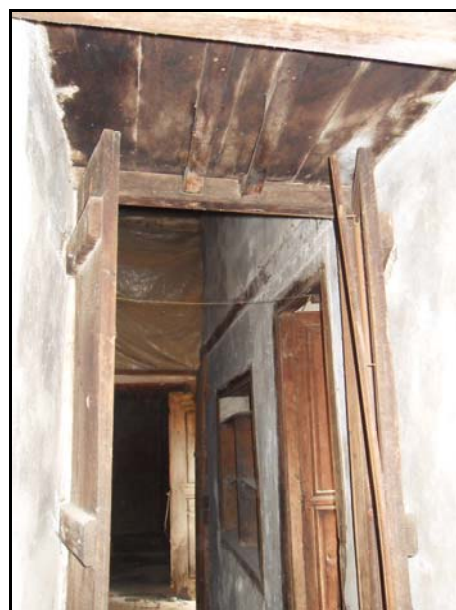
The space has a square shape. Dimensions of the space are 1.40 (x) and 1.26m (y) in average. South wall of the space is rubble stone masonry wall with timber bonding. West, north and east walls are brick masonry walls. All walls are unplastered. There are cement repairs on south wall of the space. (See Figure 2.22)

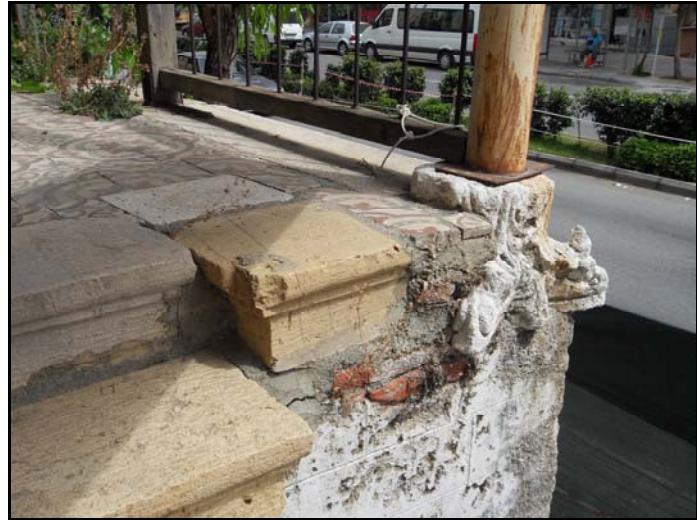
stone masonry. There are fourteen of reused profiled stone. There are stone bases under the metal pillars carrying the projection.

Figure 2.74. Reused materials in staircase S01

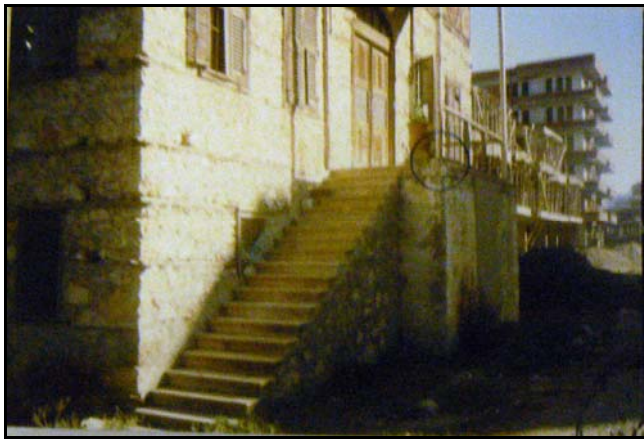
Figure 3.11. Reused materials in the entrance landing (*Alanya Museum Archive*)

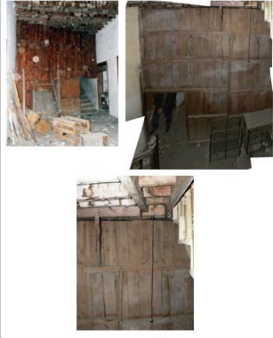
<u>AD-3</u>	The timber partition wall, between spaces E01 and E05 is an addition.	The construction technique used in the wall is different from other interior walls of the space. The other walls are generally constructed with timber frame system with brick infill or bagdadi technique and all of them are finished with limeplaster and linewash.

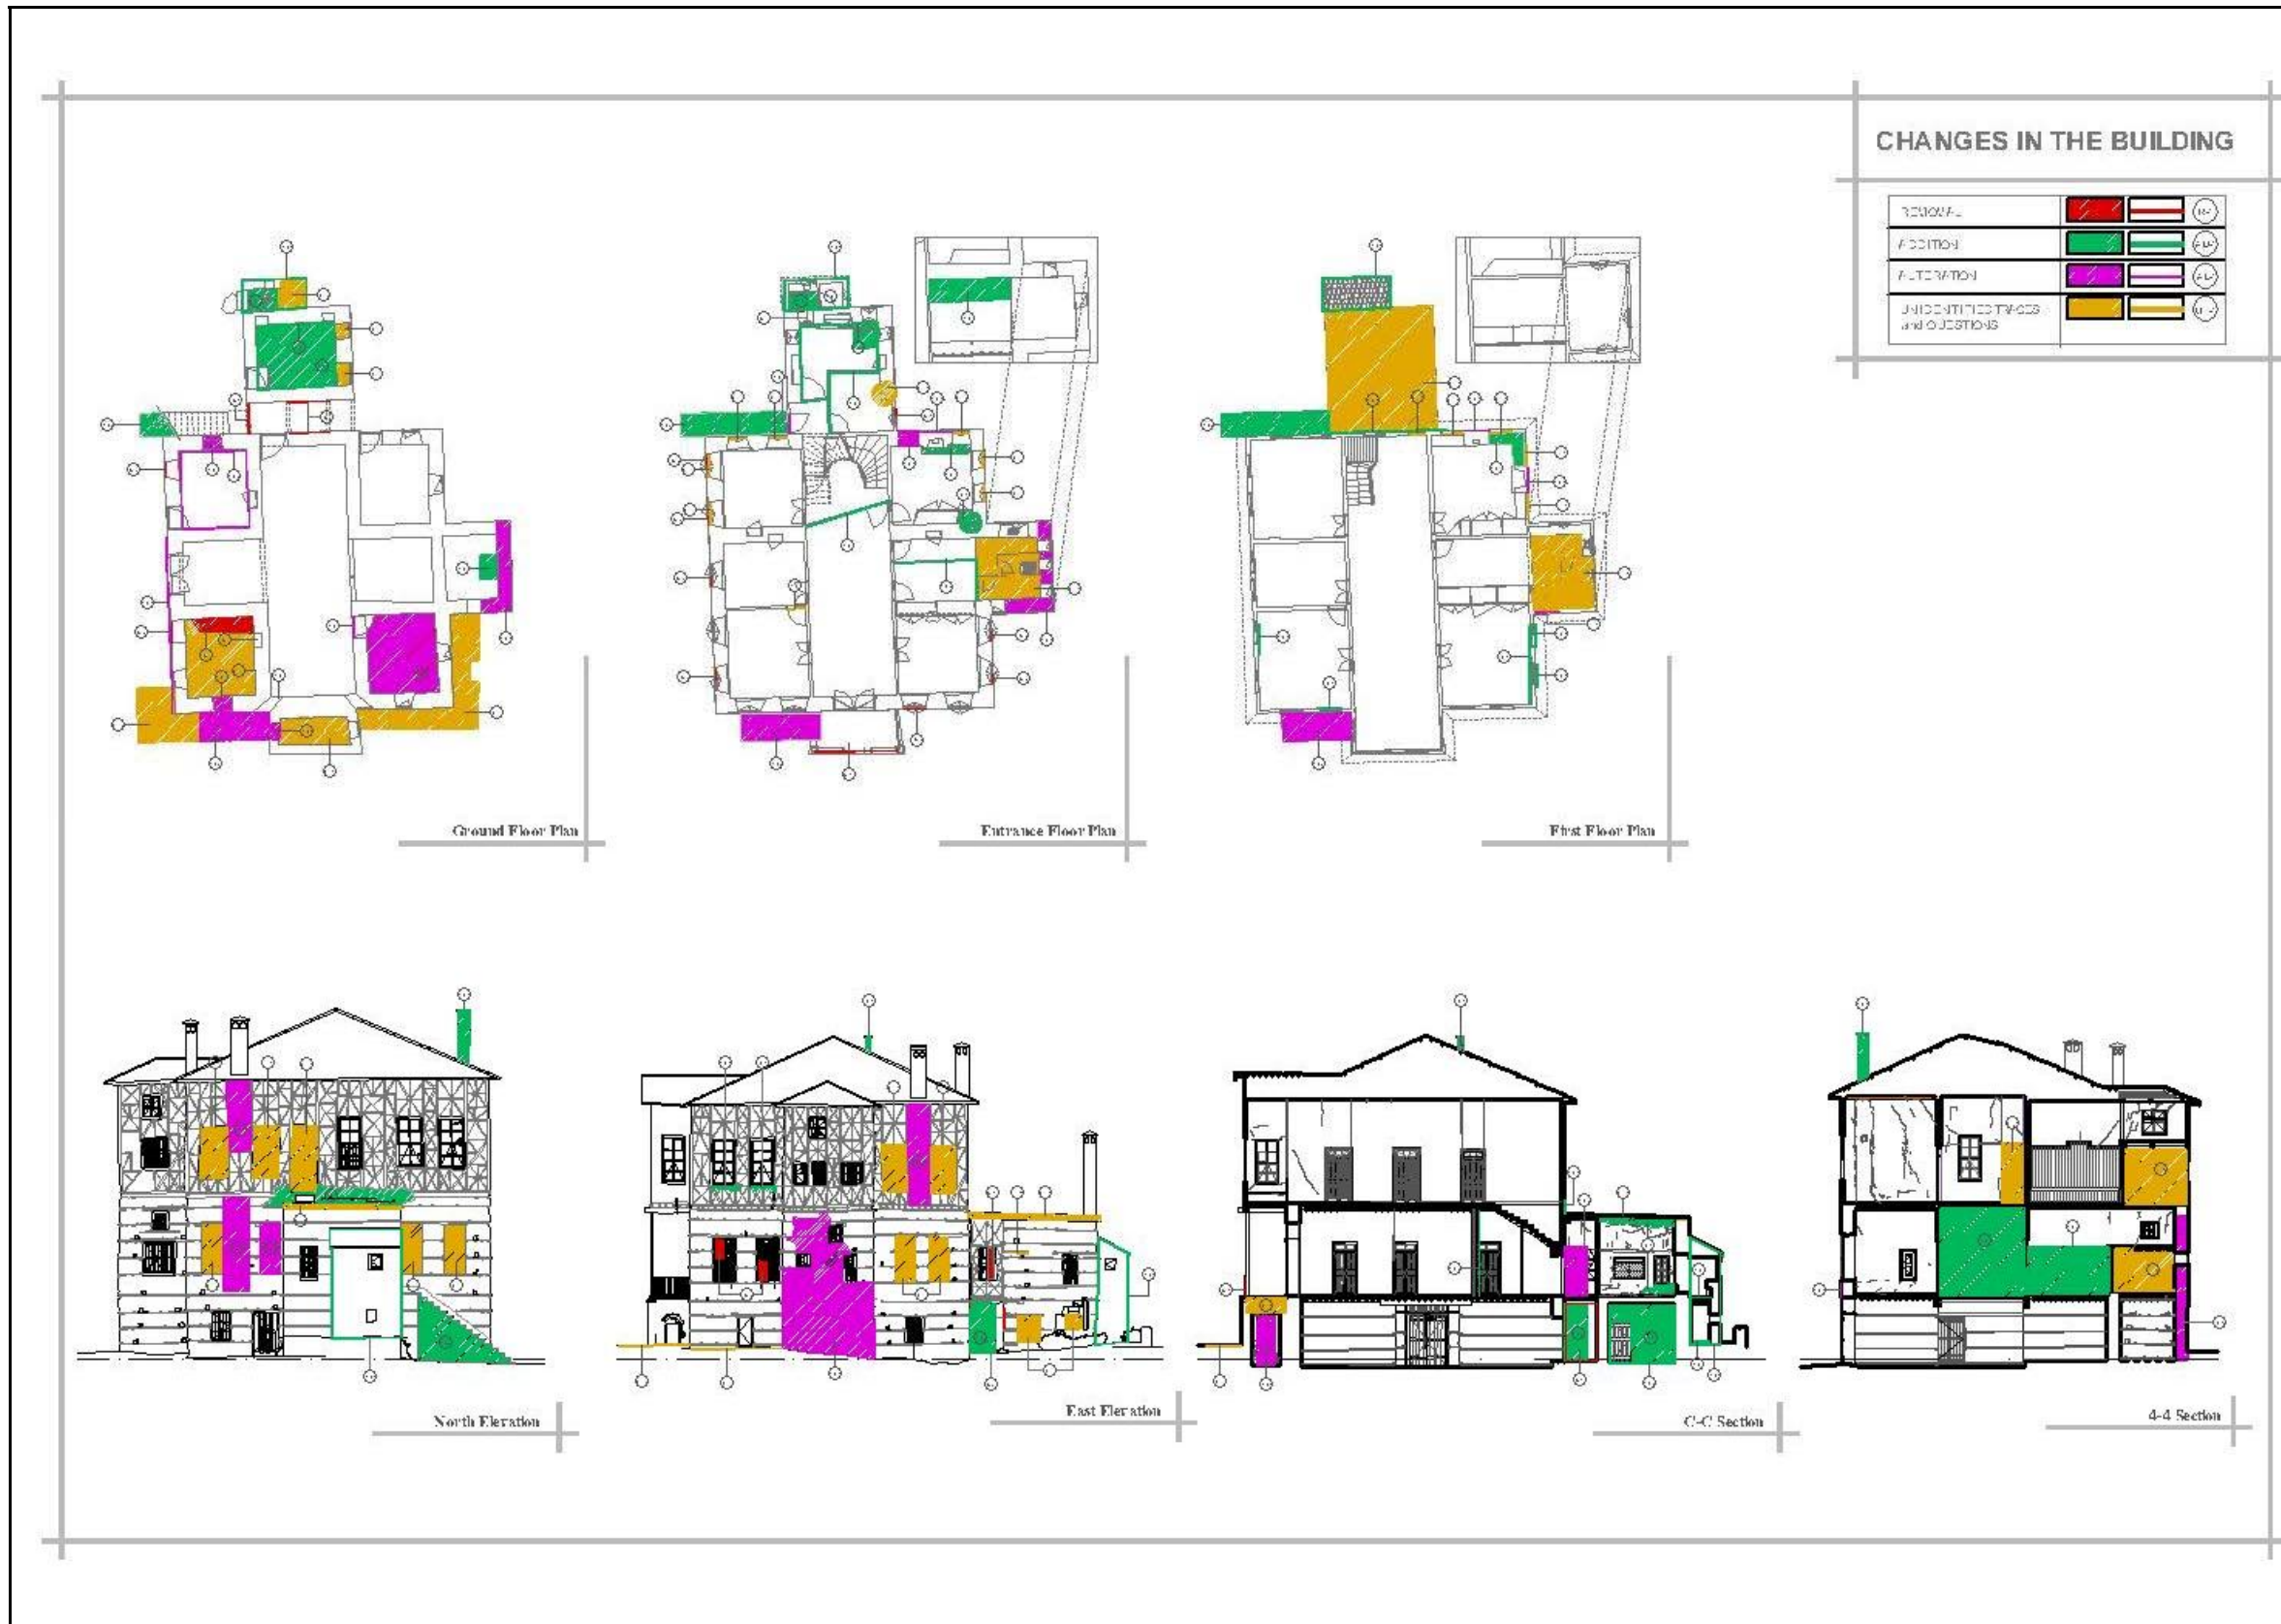
Figure 4.1. Changes in the Building

The building has changed by effects of users and environment. Changes in the building are evaluated according to the data coming from traces within the building, historical study and comparative study. There are removals additions alterations and unidentified traces as changes in the building(See Table 4.1, 4.2, 4.3, 4.4 and Figure 4.1) Due to this analyse, changes in the building can be summarized as spatial changes, changes in architectural elements and changes in materials.

Changes in materials are cement repairs in particular parts of the building, chimney repairs, repairs on wall jointing and alterations/removal in floor and wall finishing. The repairs and alterations in floor and wall finishing are later interventions. Removal of floor finishing is probably formed because of the disuse of the building too.

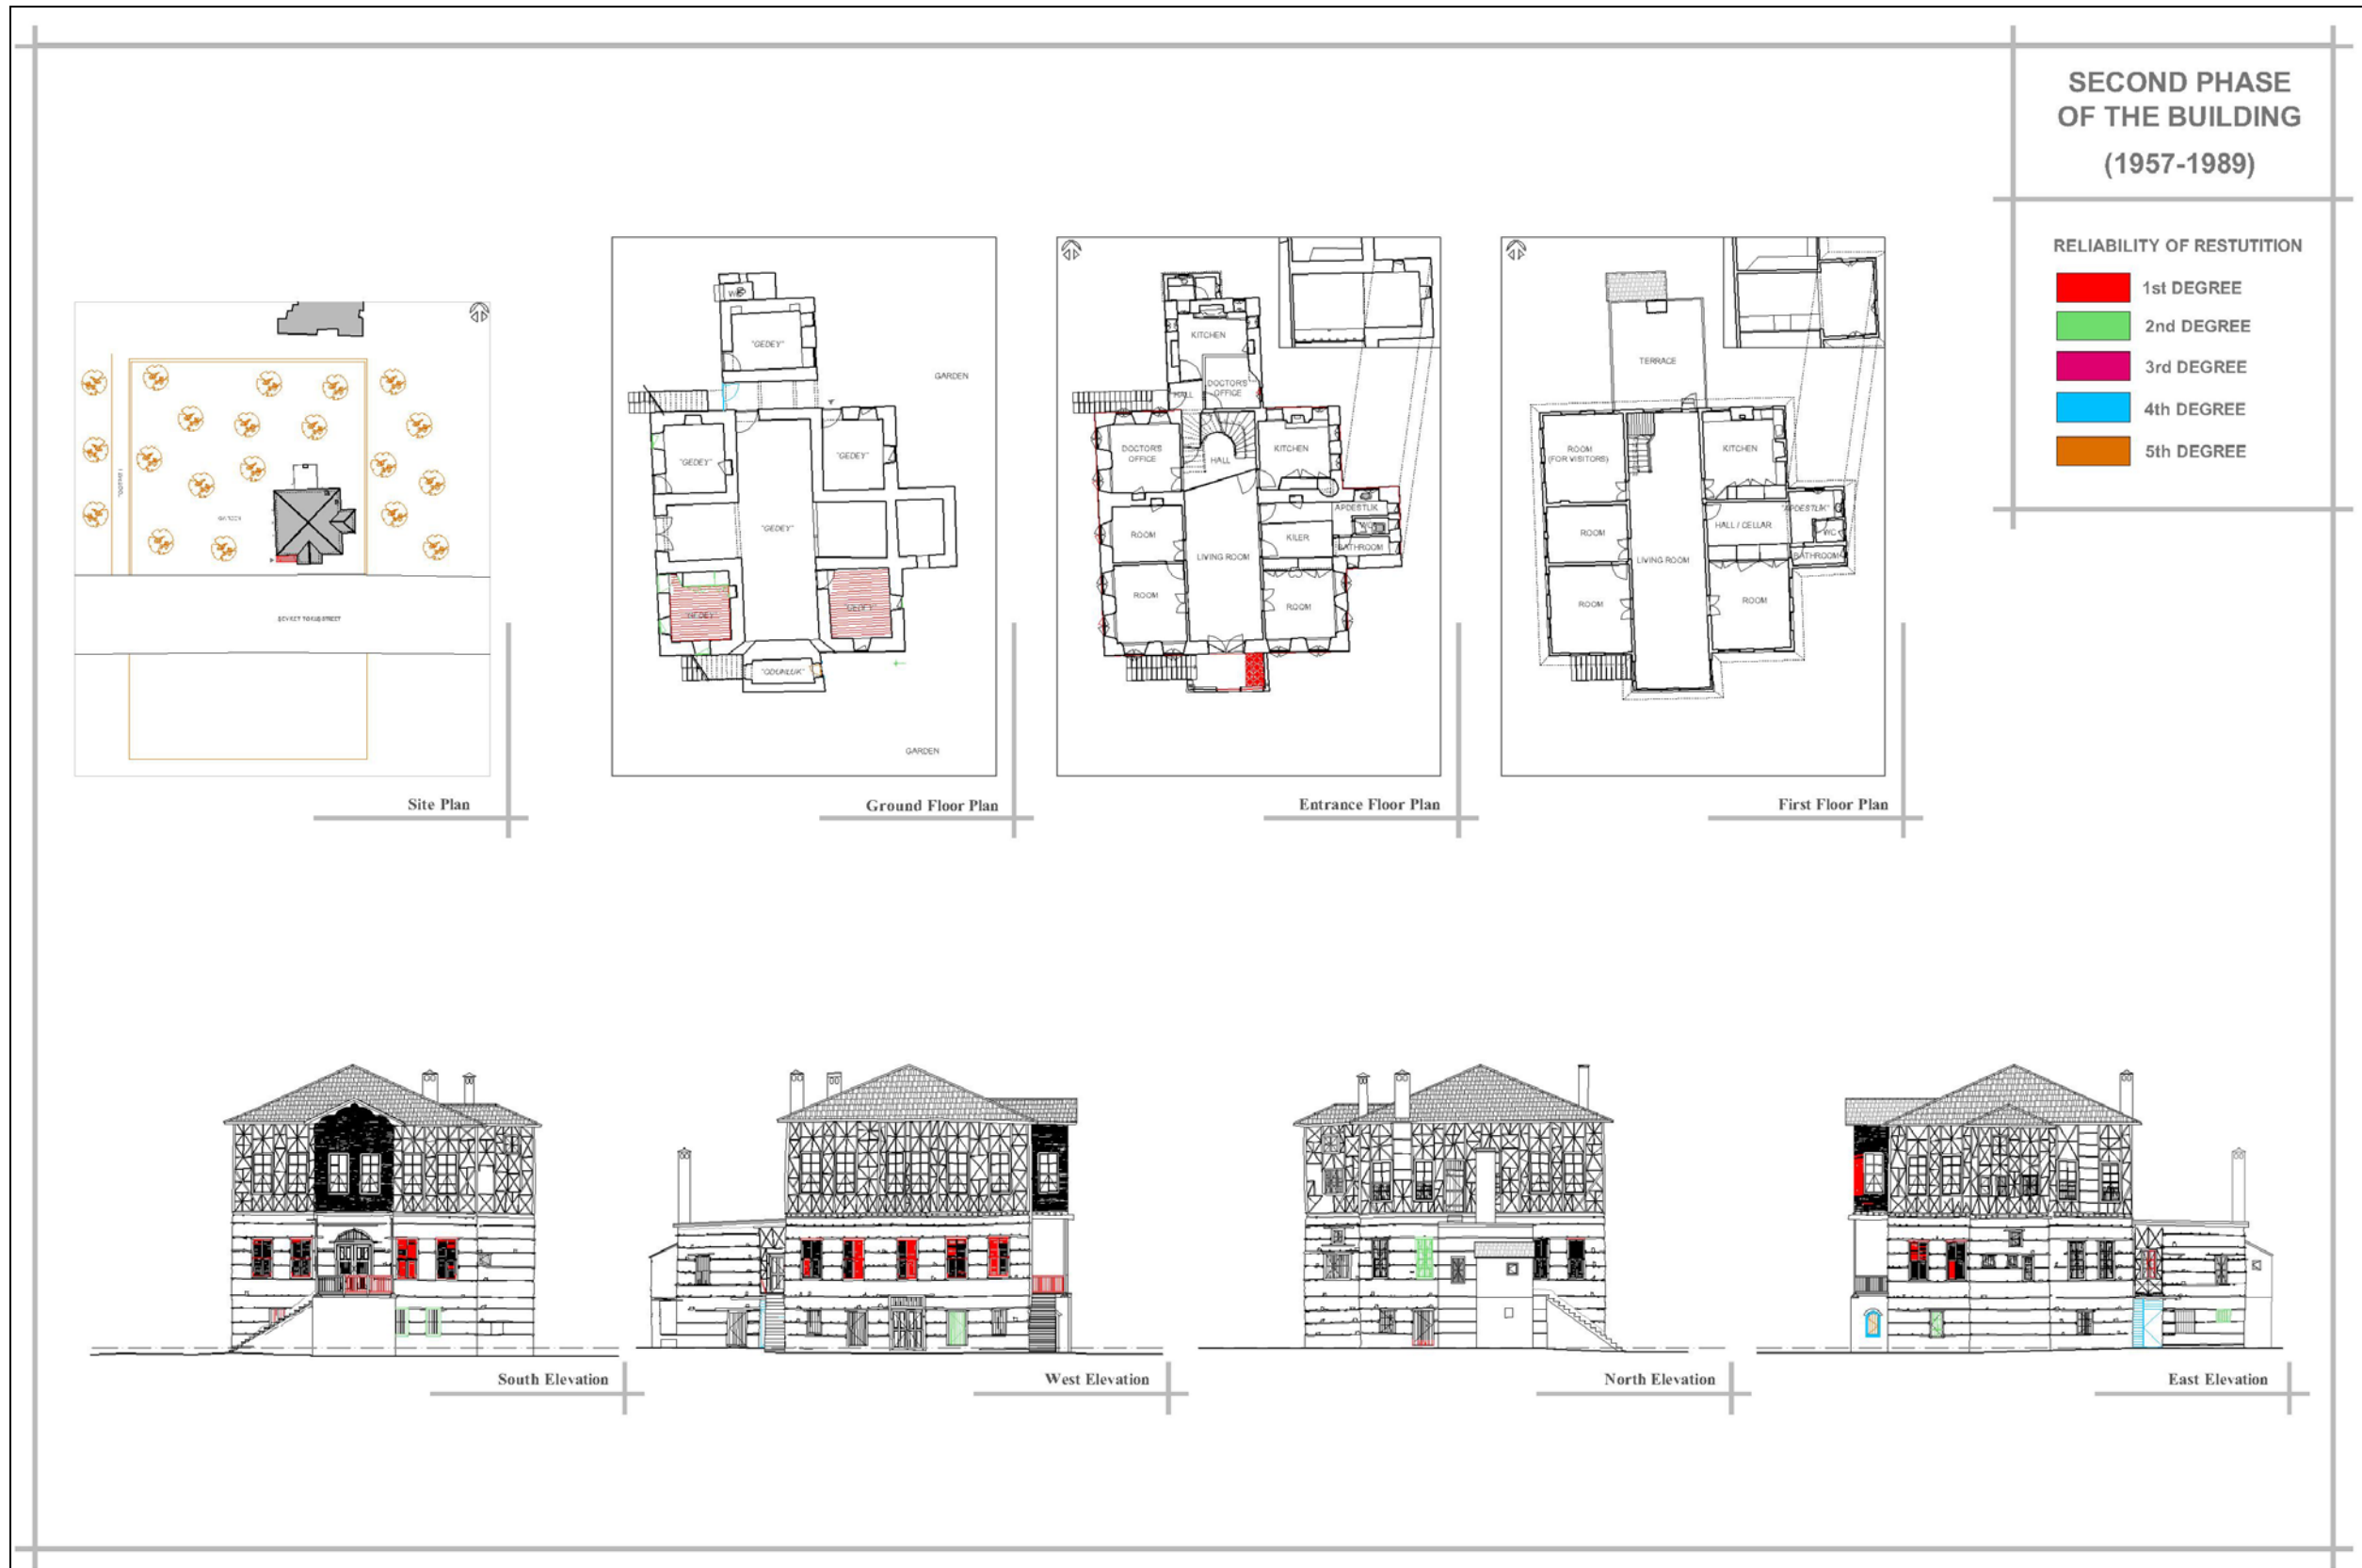
Figure 4.5. Second Phase of the Building

In 1957-1958, Şevket Tokuş Street that lyes throught the building lot of the building. The building lot was divided into two. Between 1958-1989; the building was divided between inheritors and new buildings were costruccted in the building lot. Due to the literature research in terms of the building, there were no defined garden of the building. The trees in the garden were logged. (See Figure 4.5)

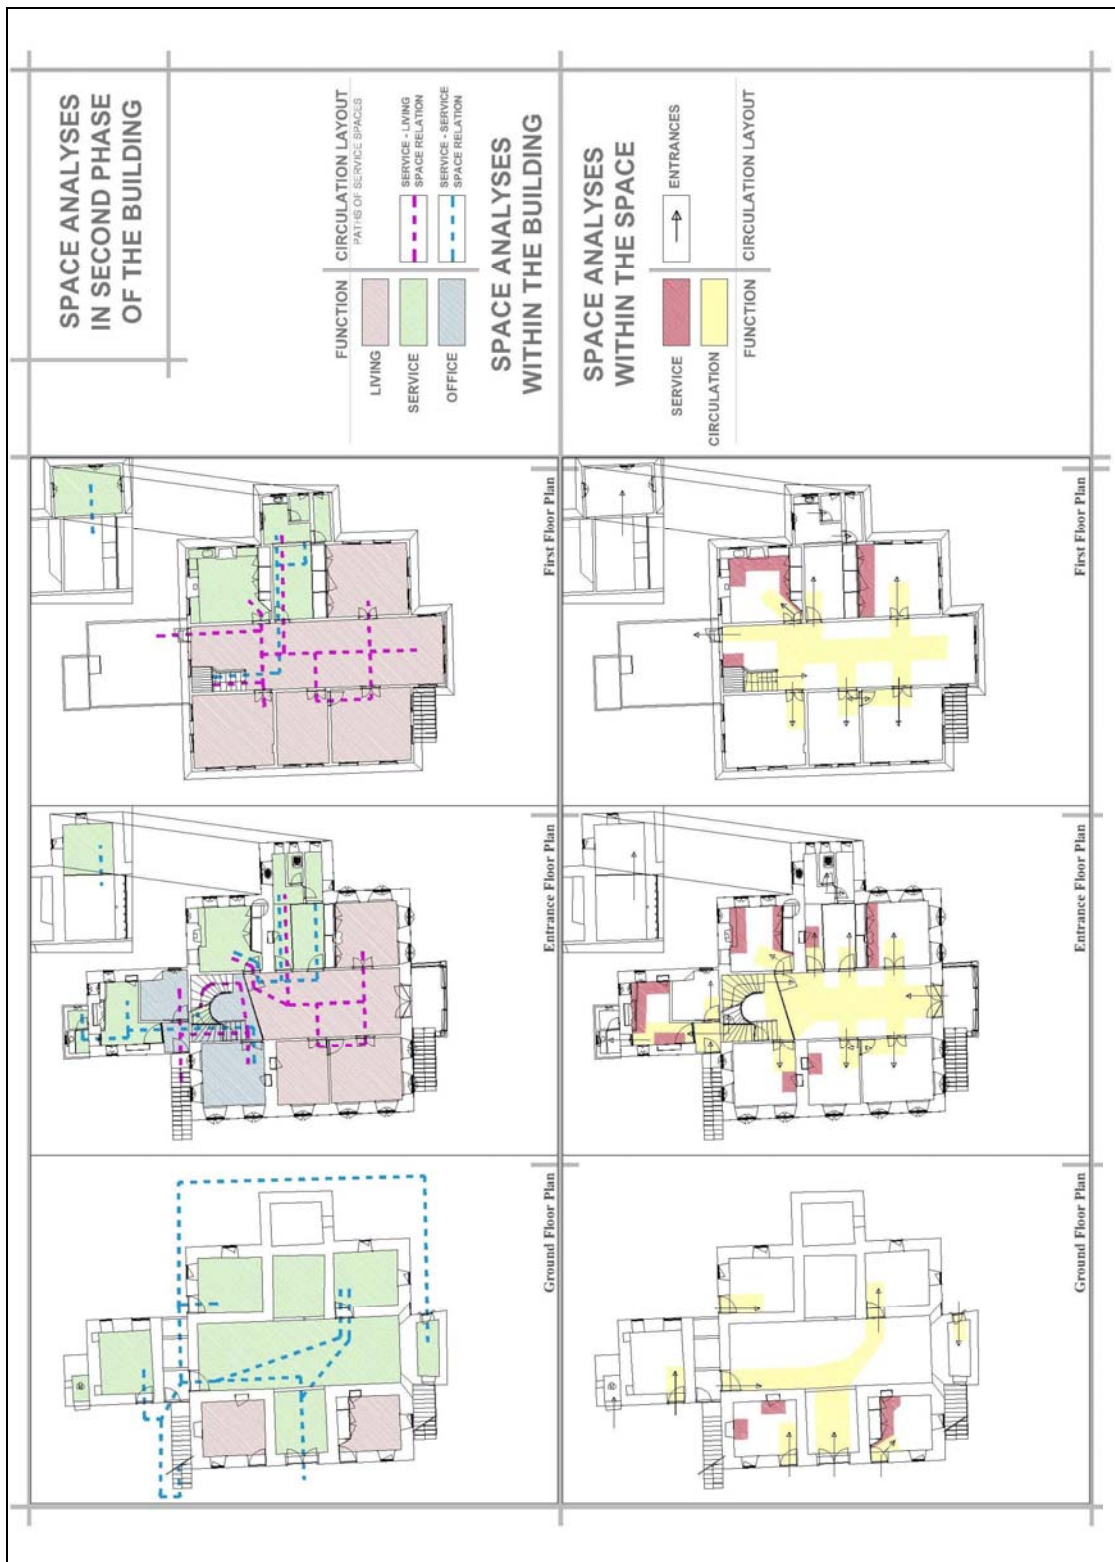
Figure 4.6. Space Analyses in the Second Phase of the Building

With the changes in site plan, the entrance stair was reconstructed as adjacent to the south façade. Due to the division of the building, the second entrance was opened in north mass, open to the space E14. The window was converted to a door. Spaces E17 and E18 was added to the north service mass as a floor. (See Figure 4.6)

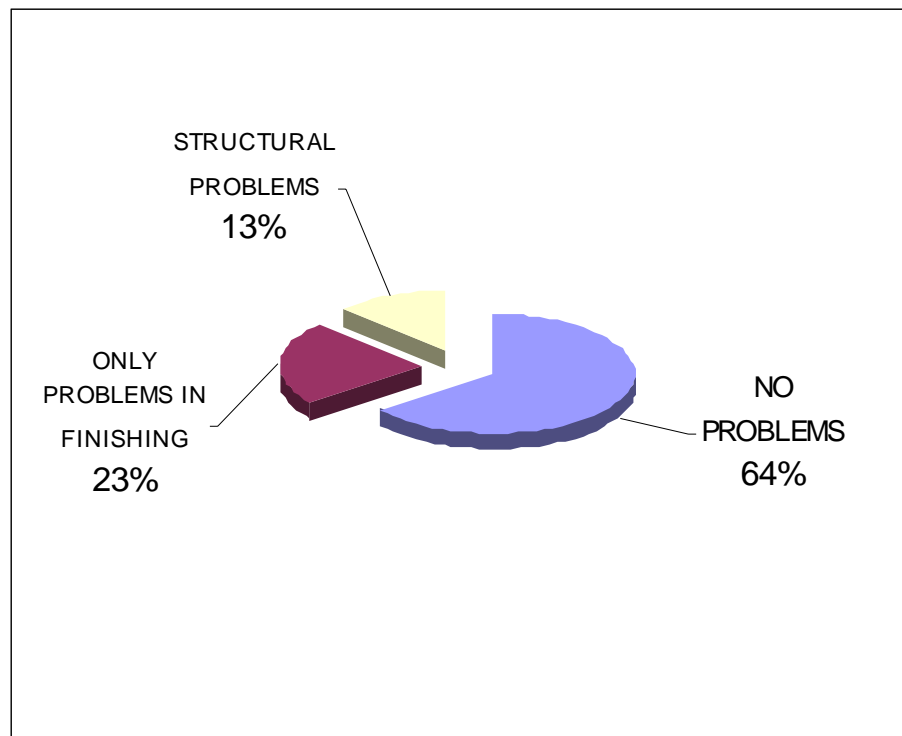
Figure B.6. Problems of the buildings
